FINAL EL CUERVO DEL SUR WETLAND HABITAT MITIGATION AND MONITORING PLAN

City of San Diego
Transportation & Storm Water Department
2781 Caminito Chollas
San Diego, CA 92105

February 28, 2014

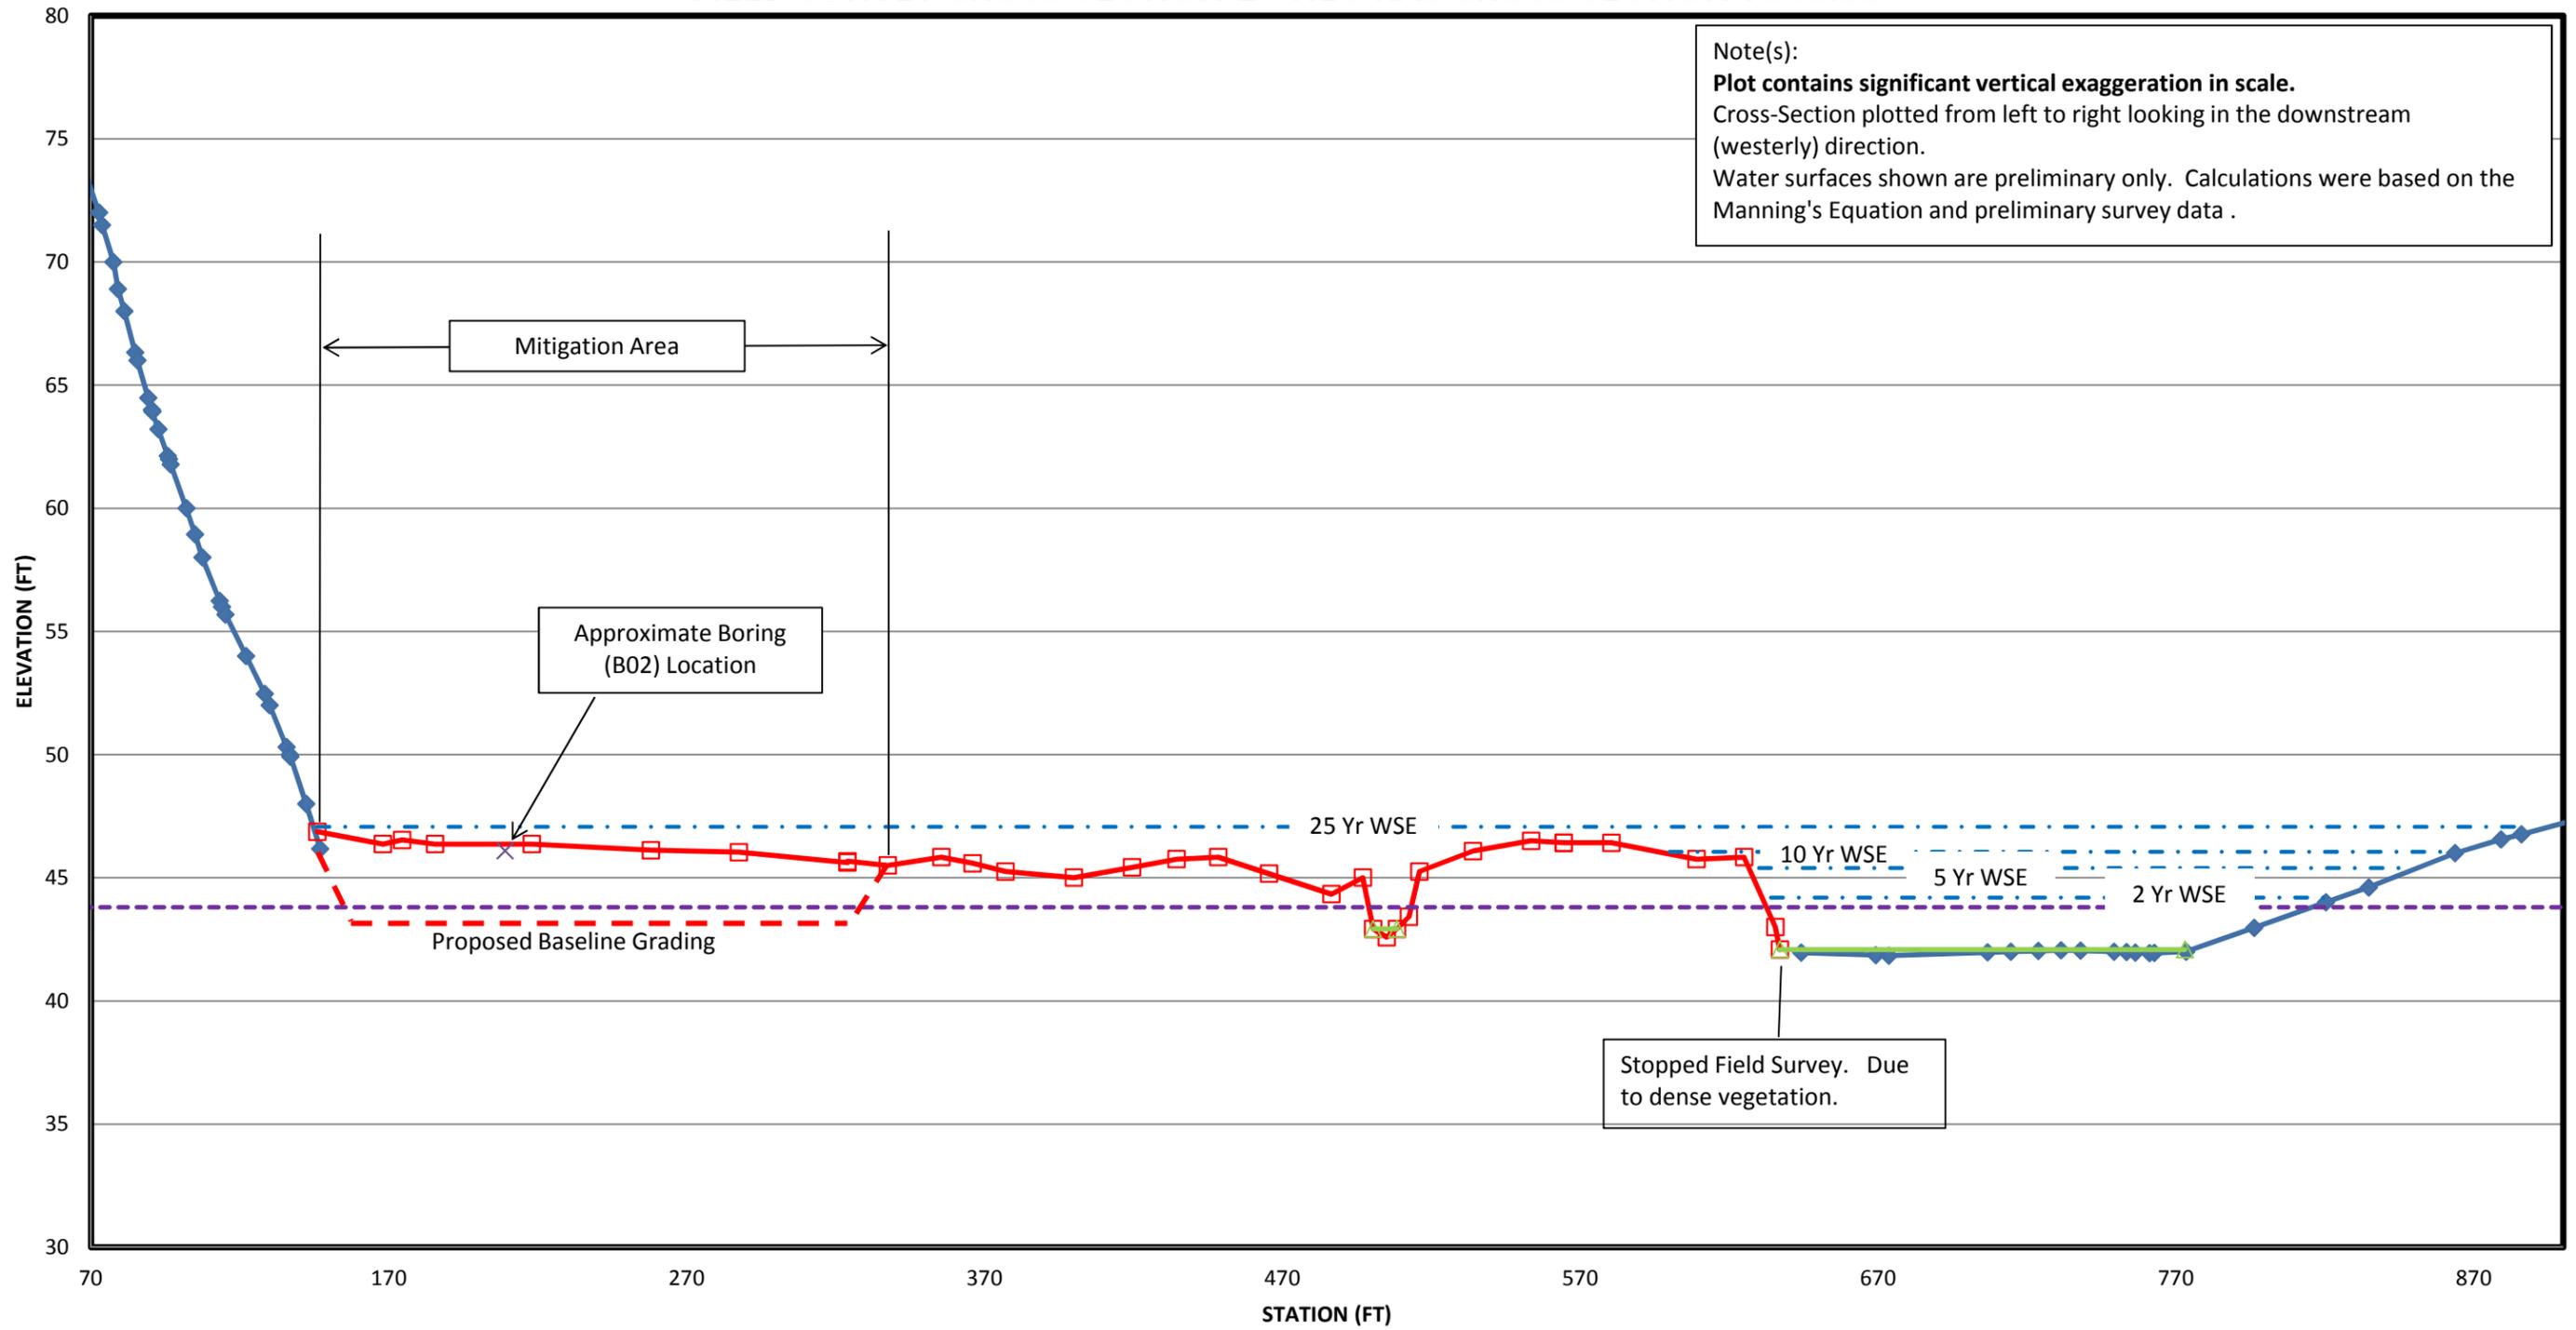
**FIGURE 3. LOS PENASQUITOS CREEK
EL CUERVO DEL SUR - SECTION B-B
FIELD SURVEY CROSS-SECTION 2 - HEC-RAS CROSS-SECTION 7566.95**

- ◆ Existing 2-Ft Contour
- Field Survey Existing Ground
- ▲ Surveyed Water Surface Elevation
- - - Winter High Water Mark (March 2013)
- Storm Event Water Surface Elevation

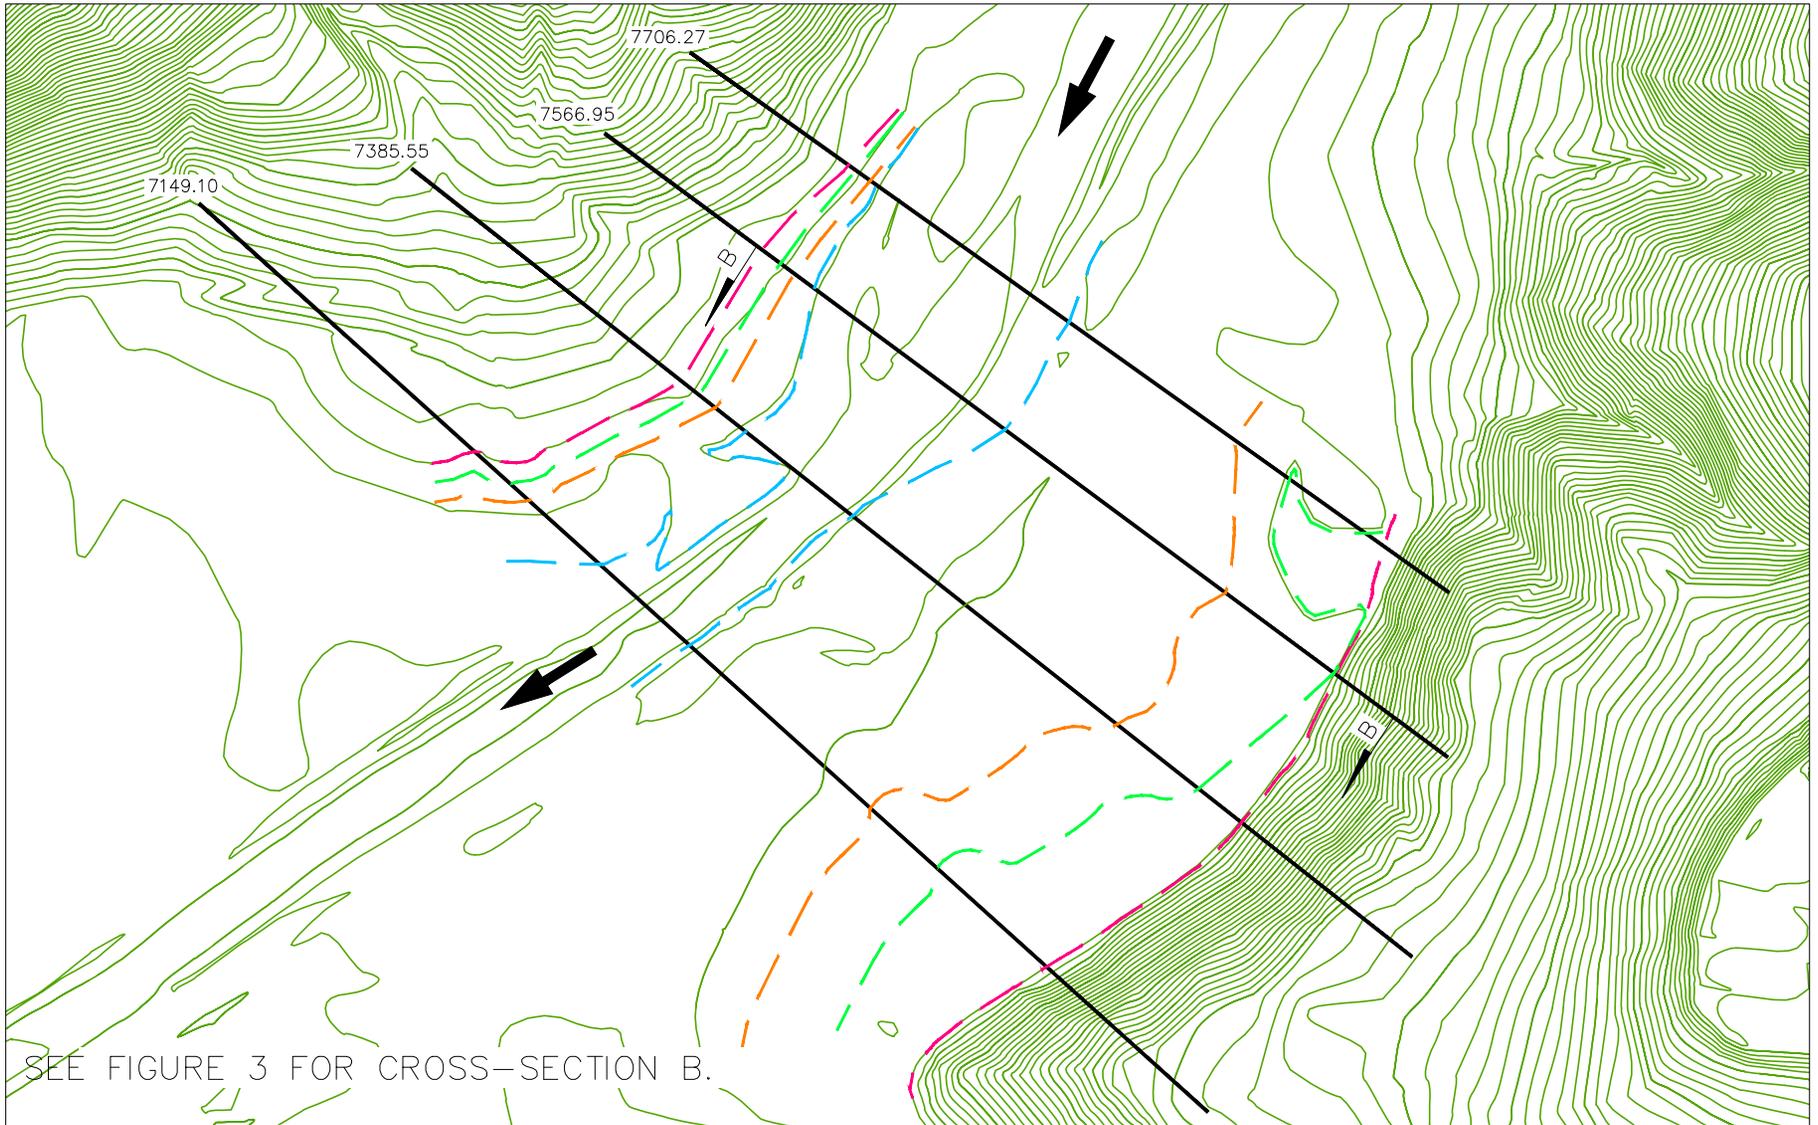
FIGURE 4.
LOS PENASQUITOS CREEK
EL CUERVO AL OESTE
FLOODPLAIN MAP

2-Year Floodplain	
5-Year Floodplain	
10-Year Floodplain	
25-Year Floodplain	
HEC-RAS Cross-Section Label	
Flow Direction

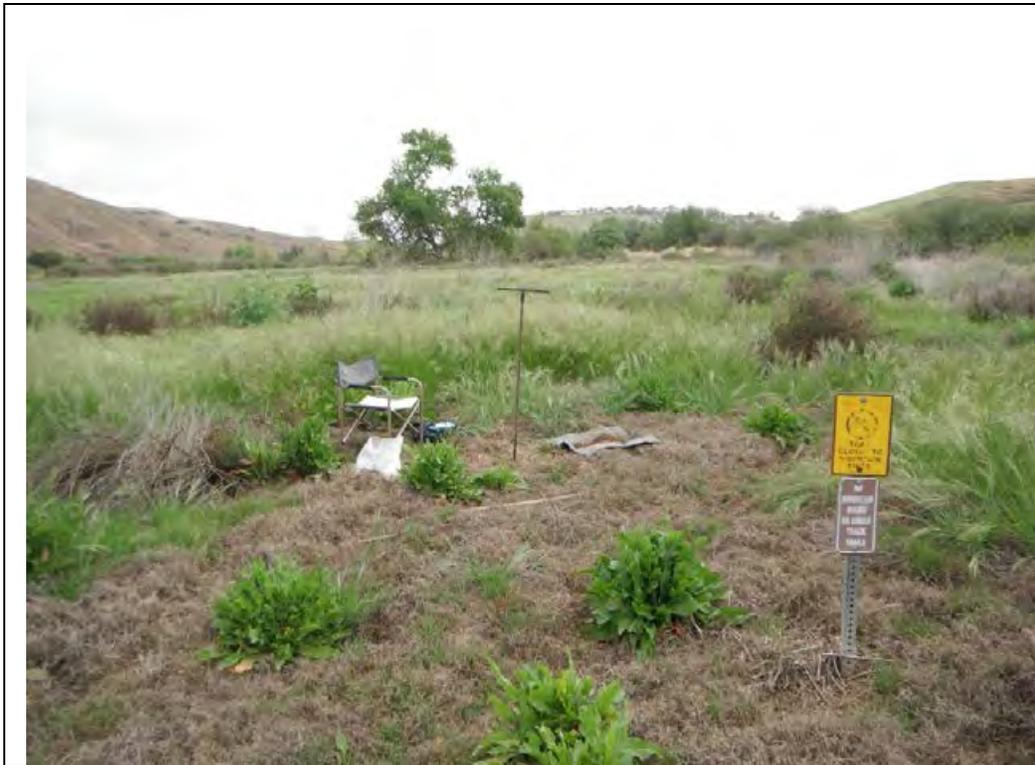
Photograph #01
Date: 04/16/13
Comments:
Work area **during**
work activities.
Location B-5
within the El
Cuervo al Oeste
area of Los
Penasquitos
Canyon Preserve,
California.

Alluvium was encountered in each of the explorations and less than a foot of topsoil/colluvium was encountered at the surface of B-01 and B-03. The alluvium ranged from yellowish brown to grayish brown silty to clayey, fine to medium grained sands, to gray to yellowish brown clays. In general the materials became finer (silts and clays) below the measured groundwater level.

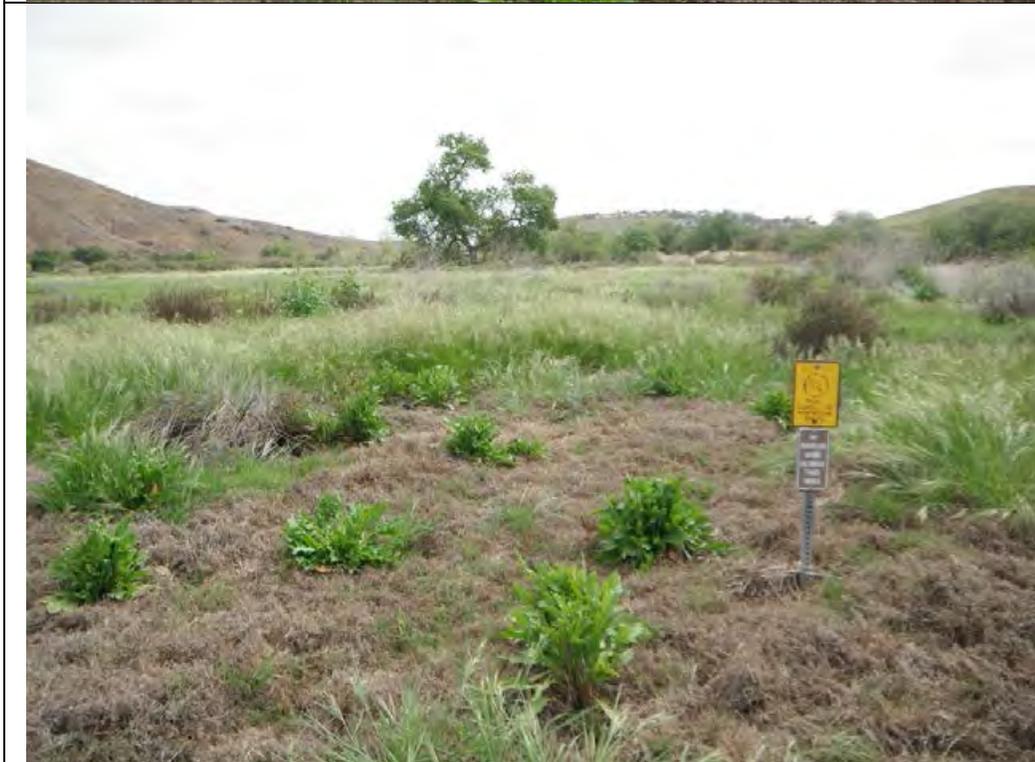
Photograph #02
Date: 04/16/13
Comments:
Work area **after**
work activities.
Location B-5
within the El
Cuervo al Oeste
area of Los
Penasquitos
Canyon Preserve,
California.

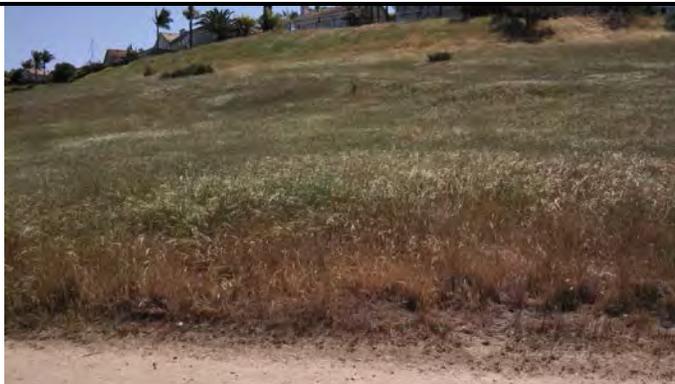
View East: Looking up to previous location of CA-SDI-1087 from the access road below. The original site extent included the location of the current housing development up on the ridge.

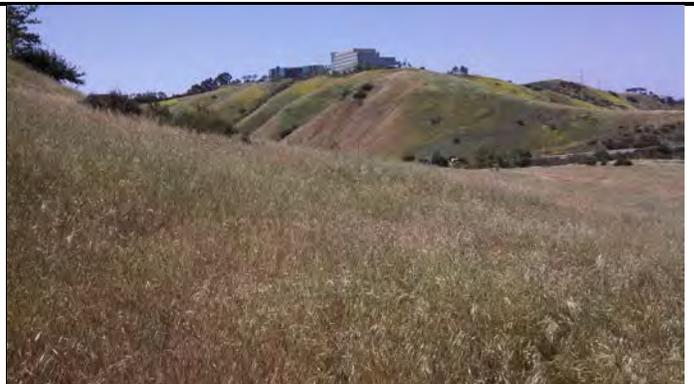
View West: Looking across CA-SDI-1087 (foreground) from inside the sites' eastern boundary, towards the access road.

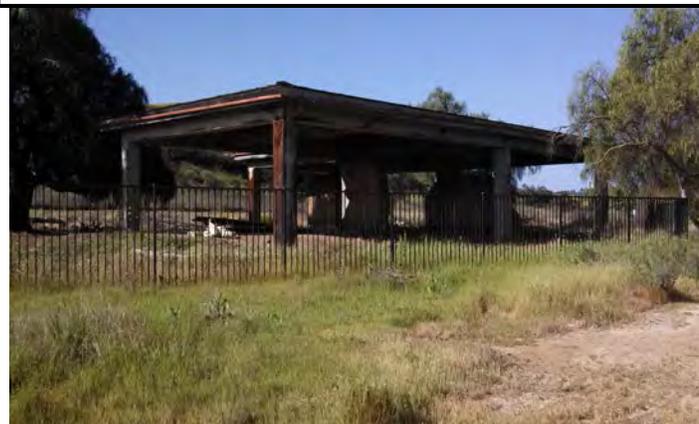
View NE: The Ruiz-Alvarado Adobe with a perimeter fence and protective roofing.
