## INDIVIDUAL BIOLOGICAL ASSESSMENT REPORT

**Site Name/Facility:** Nestor Creek Channel Section 04 of 04  
**MSWSMP Map No.:** 134  
**Date:** 13 July 2010  
**Biologist Name/Cell** \_\_\_\_\_  
**Phone No.:** W. Larry Sward/619.992.4170

**SITE PHOTOS Map 134 Nestor Creek Channel. 23 June 2010**

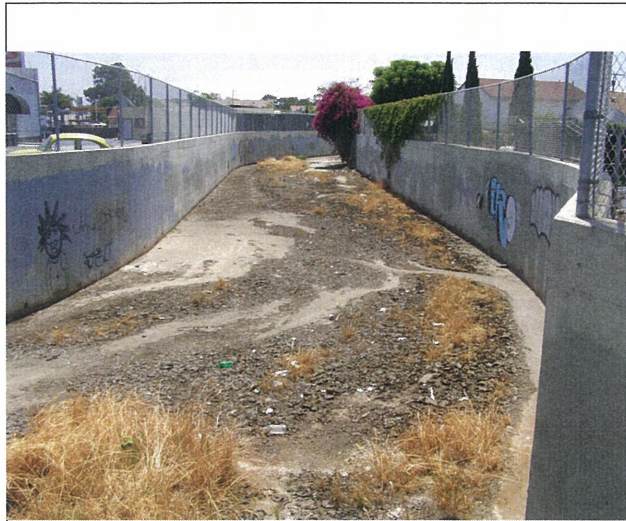
**PHOTO NOTES:**

Concrete channel with small patches of disturbed wetland and unvegetated channel. Looking southeast from near Palm Avenue. 23 June 2010.

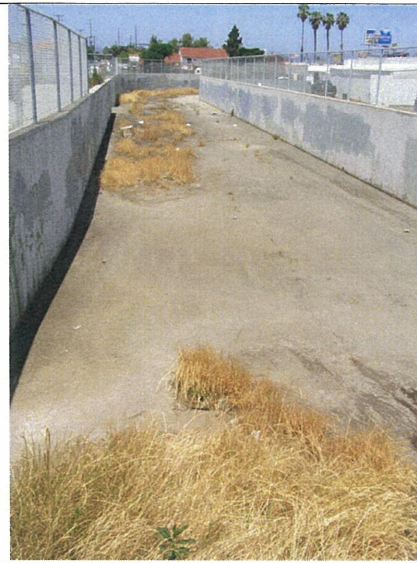
**PHOTO NOTES:**

Concrete channel with small patches of disturbed wetland and unvegetated channel. Looking west from near Saturn Boulevard. 23 June 2010.

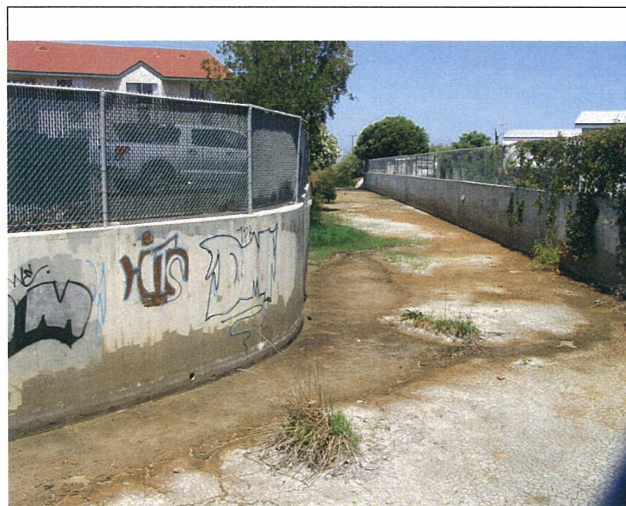
**PHOTO NOTES:**

Concrete channel with small patches of disturbed wetland and unvegetated channel. Disturbed wetland and southern willow scrub also exist at terminus of channel. Looking northwest from bend in channel, north of Palm Avenue. 23 June 2010.

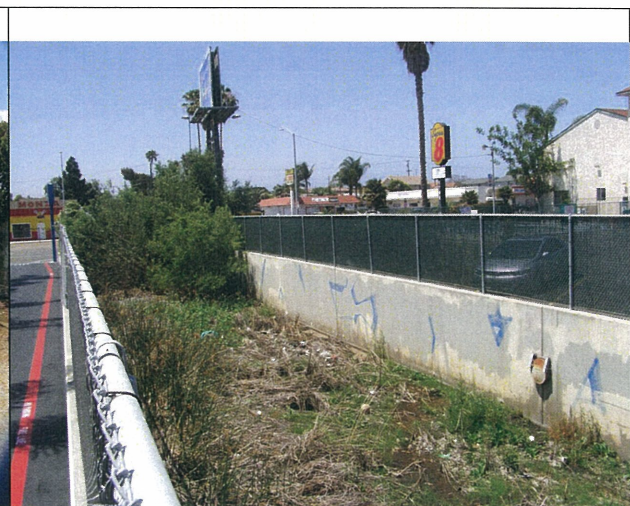
**PHOTO NOTES:**

Concrete channel with southern willow scrub near Palm Avenue, freshwater marsh along along east wall of channel, and disturbed wetland in middle and along west wall of channel. Looking north from bend in channel. 23 June 2010.
