## INDIVIDUAL BIOLOGICAL ASSESSMENT REPORT

**Site Name/Facility:** Chollas Creek Channel Emergency Maintenance

**Master Program**

**Date:** March 3, 2016

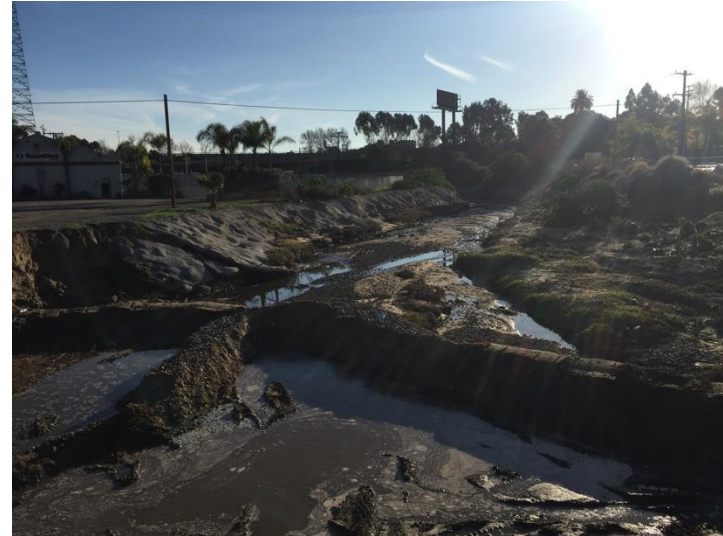
**Photograph 11:** Looking downstream from the National Ave. bridge from the south end of MMP Map 93; Figure 3b during maintenance work.

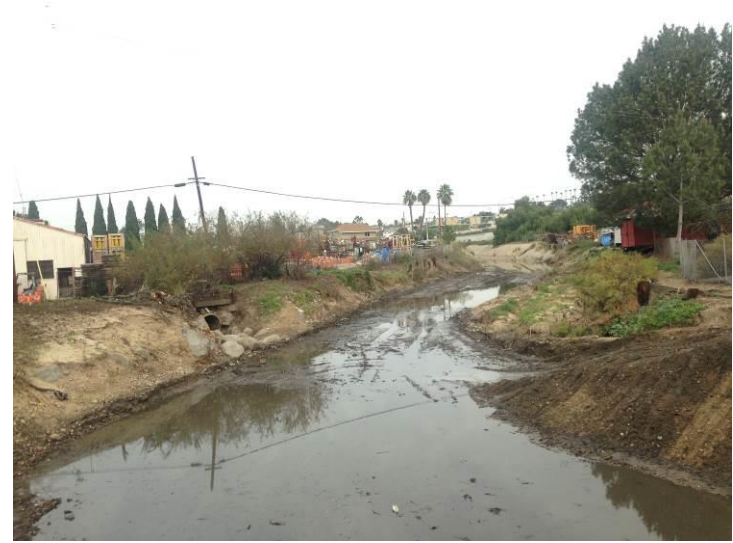
**Photograph 7:** Looking upstream from the National Ave. bridge following completion of maintenance.

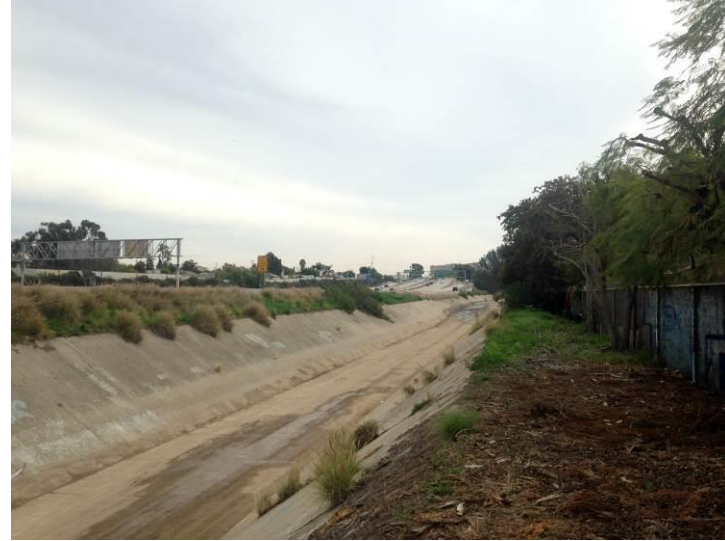
**Photograph 7:** Looking downstream at the concrete channel following completion of maintenance work.
