INDIVIDUAL BIOLOGICAL ASSESSMENT REPORT

Site Name/Facility: Auburn Creek Channel Emergency Maintenance
Master Program
Map No.: 77
Date: April 12, 2016
Biologist Name/Cell
Phone No.: Scott Gressard (858-997-6874)

Auburn Creek Channel (MMP Map 77) - Emergency Channel Maintenance

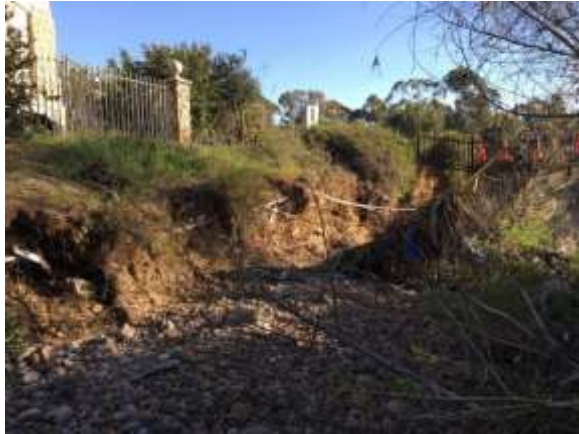
(February 25, 2016)

Photograph 1: Looking downstream (south) from the south end of MMP Map 77; Figure 3 prior to maintenance at the bank erosion east side of the channel.

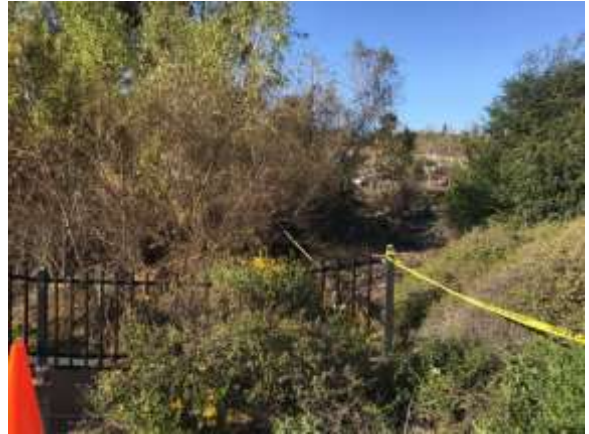
(February 25, 2016)

Photograph 2: Looking upstream from just east of the Federal Blvd. culvert inlet at the downstream end of the channel prior to maintenance (MMP Map 77; Figure 3).

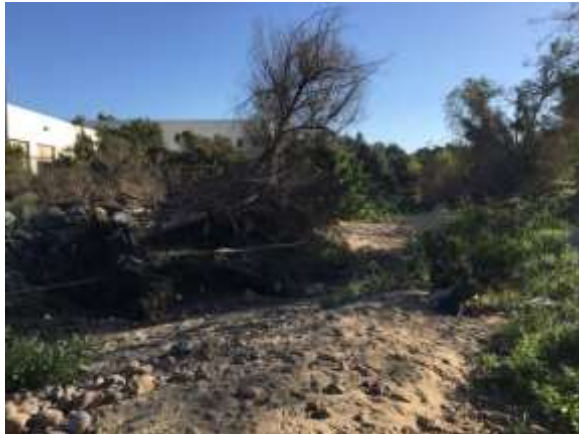
(February 25, 2016)

Photograph 3: Looking downstream from the north end of MMP Map 77; Figure 3 prior to maintenance at the two uprooted willow trees in the channel.

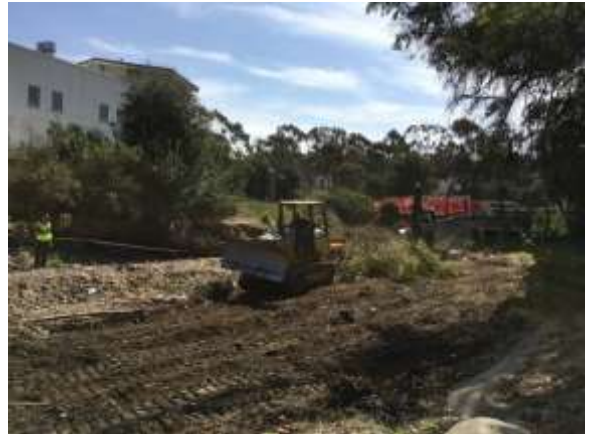
(March 4, 2016; 11:37am)

Photograph 4: Looking southeast toward the downstream culvert as crews remove sediment and debris from the south end of the channel (MMP Map 77; Figure 3).

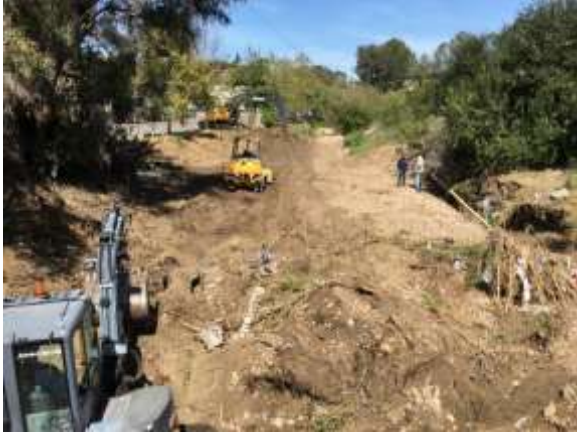
(March 4, 2016; 12:25)

Photograph 5: Looking upstream from the south end of MMP Map 77; Figure 3 during maintenance as crews finished removing vegetation in the channel.

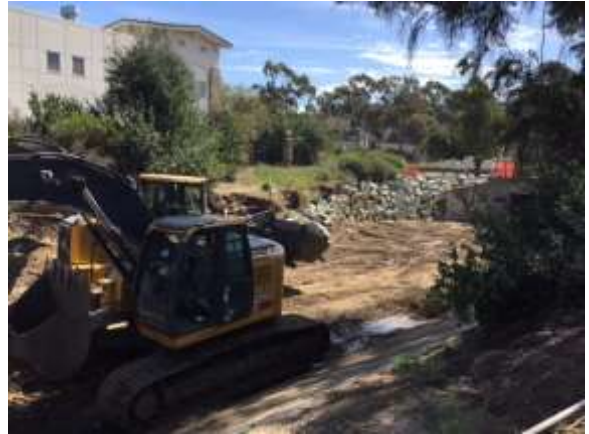
(March 5, 2016; 12:23pm)

Photograph 6: Looking towards the downstream culvert from the west side of the channel during maintenance at the dozer installing rip rap on the east channel bank (MMP Map 77; Figure 3).

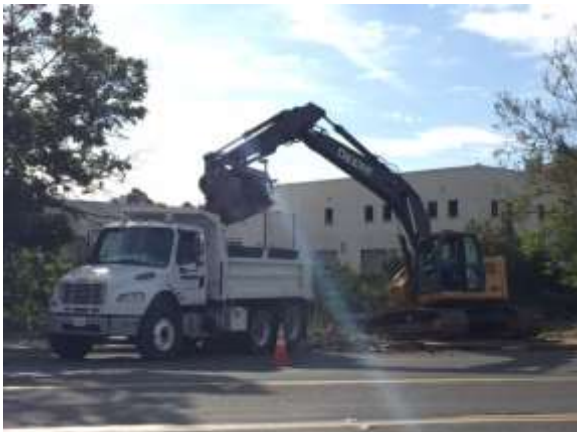
(March 5, 2016; 8:31am)

Photograph 7: Looking east from the West side of Home Ave. at the Excavator removing sediment from the channel and loading it into a dump truck in the Access/Staging area.

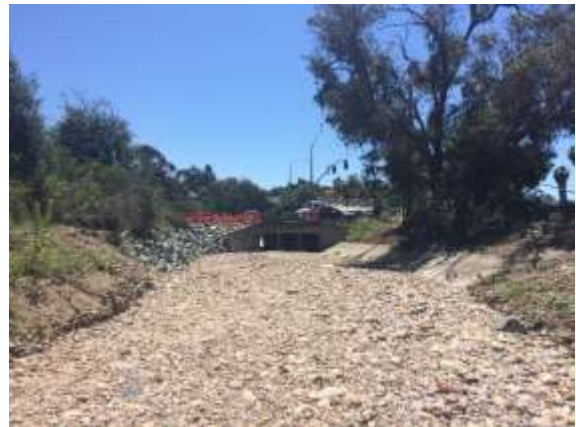
(March 18, 2016; 1:02 pm)

Photograph 8: Looking downstream toward the Federal Blvd. box culvert south end of MMP Map 77 following maintenance. The completed rip rap installation is visible on the east bank of the channel.

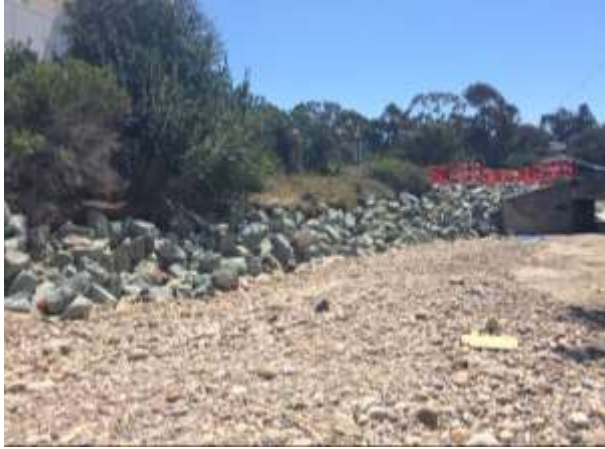
(March 18, 2016; 1:03 pm)

Photograph 9: Detailed view of completed rip rap installation on the east bank of the channel. Looking downstream towards Federal Blvd. box culvert.

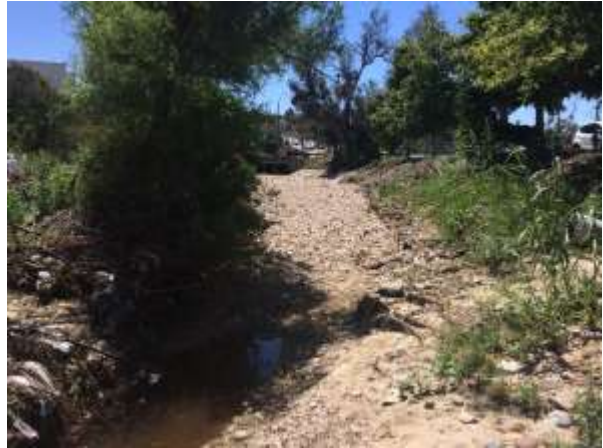
(March 18, 2016; 1:04 pm)

Photograph 10: Looking downstream from the North end of MMP Map 77 following maintenance. Location of previously uprooted tree, which was removed during maintenance.

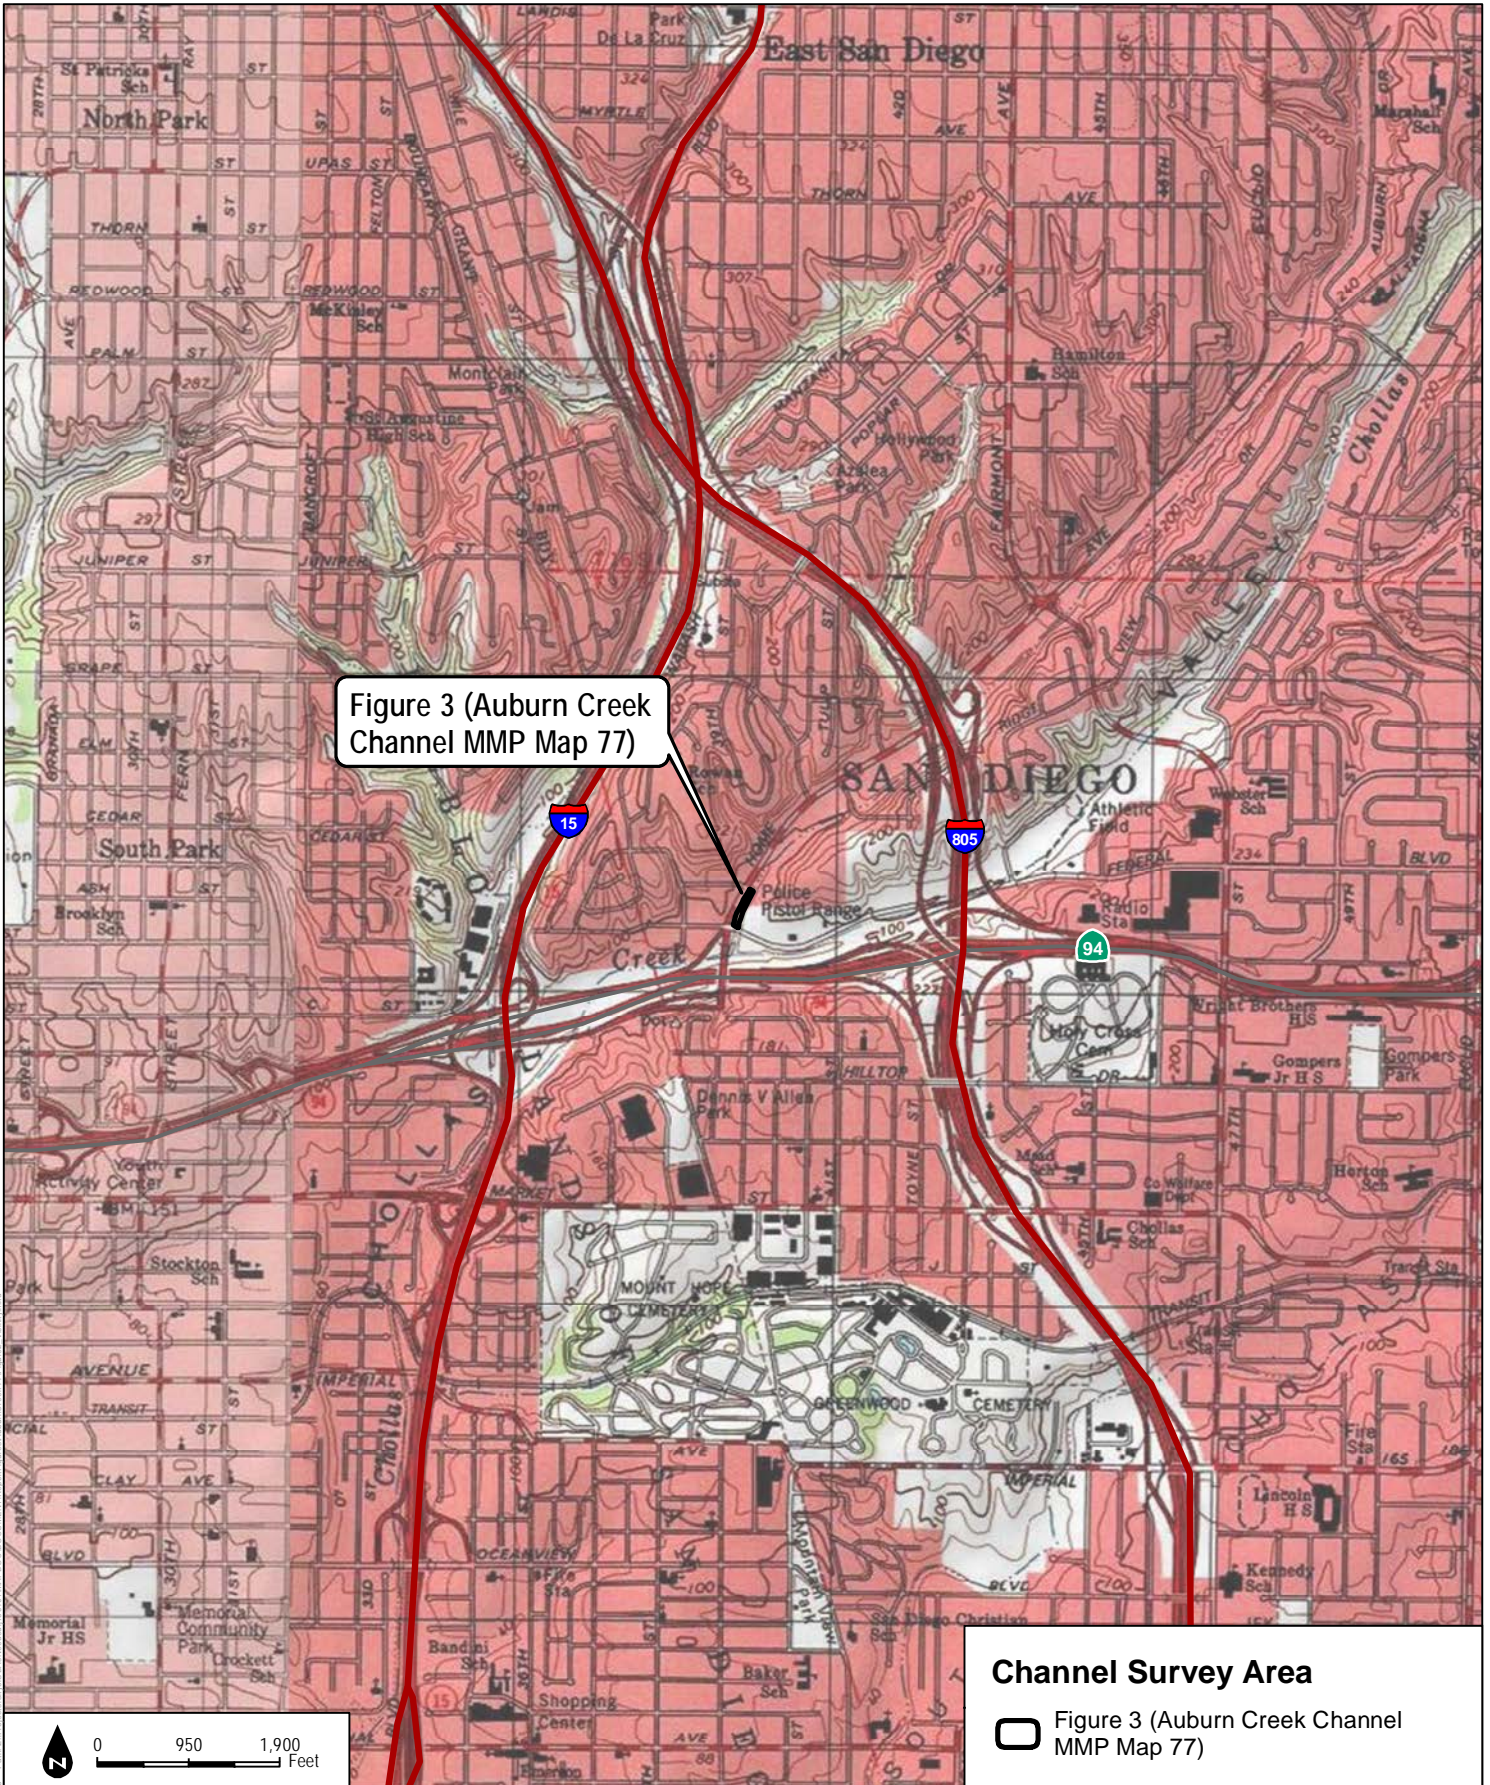
Figure 3 (Auburn Creek Channel MMP Map 77)

Emergency work consisted of 3 components along a total length of approximately 270 linear feet (MMP Map 77; Figure 3). A slope repair of the eastern bank of the channel occurred from the Federal Boulevard culvert inlet to 125 linear feet upstream. This segment of the channel, along with an additional 110 linear feet upstream of the slope repair, was cleared (sediment and vegetation removal) as part of this emergency maintenance within the full approximately 23-foot channel bed width. Within an additional 35 linear feet upstream of the channel maintenance area, debris and two large uprooted trees were accessed and removed (no sediment or living vegetation was removed). For purposes of this IBA, only the slope repair and channel maintenance area (vegetation and sediment removal) are considered impacted areas; the additional debris removal did not result in

any loss of vegetation or stream function and therefore is not included in the impact totals, but is depicted on Figure 3.

In addition, areas surrounding the emergency maintenance area include areas of ornamental vegetation and developed land. These areas were not affected by the maintenance and therefore are not discussed in this IBA, but are illustrated on Figure 3.

For the Master Maintenance Program, a program-level jurisdictional delineation was conducted within subject storm water facility channels and sedimentation basins with results categorized by HUs. Mapping was conducted along the channel (MMP Map 77; Figure 3).
