INDIVIDUAL BIOLOGICAL ASSESSMENT REPORT

Site Name/Facility: Chollas Creek Channel Emergency Maintenance
Master Program
Map No.: 71
Date: June 27, 2016
Biologist Name/Cell
Phone No.: Scott Gressard (858-997-6874)

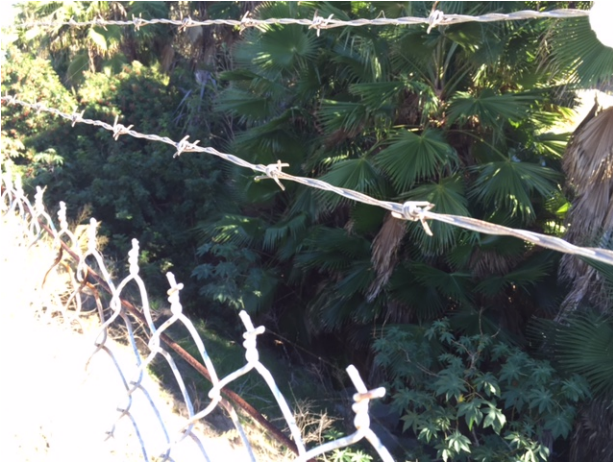
Photograph 1: Photo Point 1 (32.754070W, - 117.057860N) looking upstream from the north side of the channel at vegetation (exotic) growing up in the channel prior to maintenance (MMP Map 71; Figure 3).

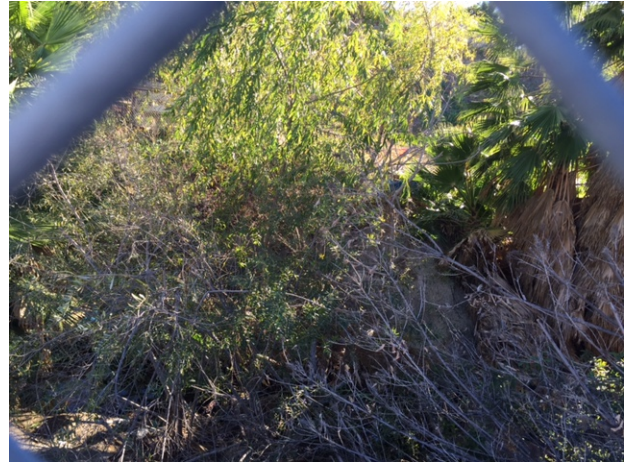
Photograph 2: Photo Point 2 (32.754396W, - 117.055708 N) looking into the channel from the east end of the maintenance area prior to the start of work at vegetation build up (MMP Map 71; Figure 3).

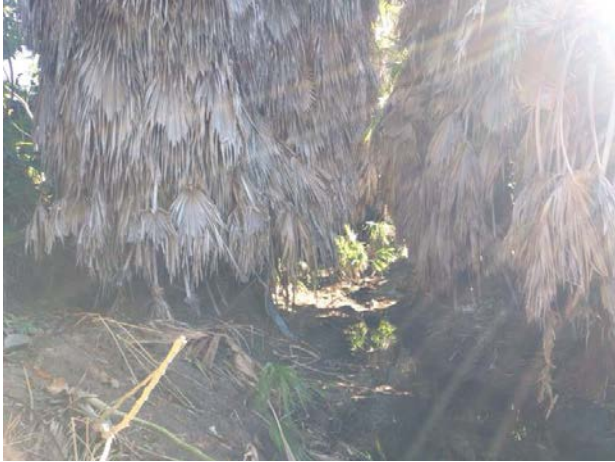
Photograph 3: Photo Point 3 (32.754146W, - 117.056850N) Looking east from within the channel prior to clearing MMP Map 71; Figure 3.

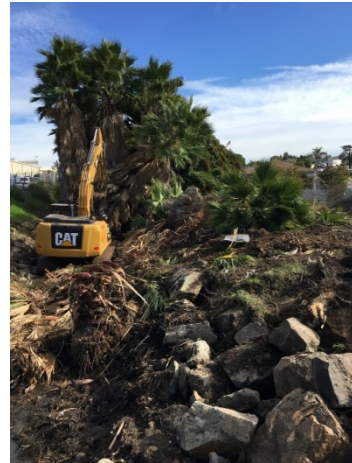
Photograph 4: Photo Point 4 (32.753933W, - 117.058237N) Looking east into the channel from Rolando Boulevard at the maintenance area within the disturbed wetland (palm-dominated) in MMP Map 71; Figure 3 at the start of maintenance.

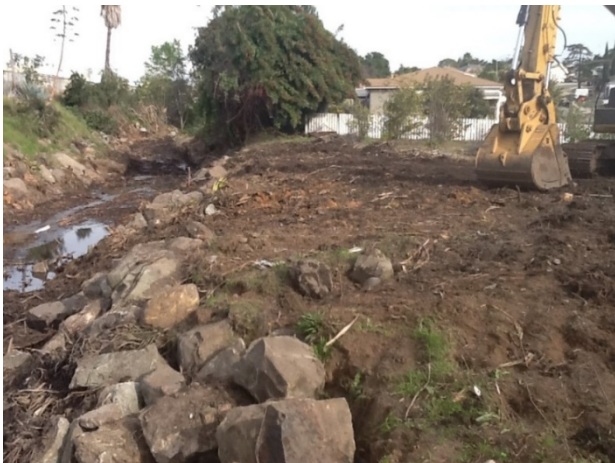
Photograph 5: Photo Point 4 (32.753933W, - 117.058237N) Looking upstream from the east end of the maintenance and staging area at the cleared section within the channel (MMP Map 71; Figure 3).

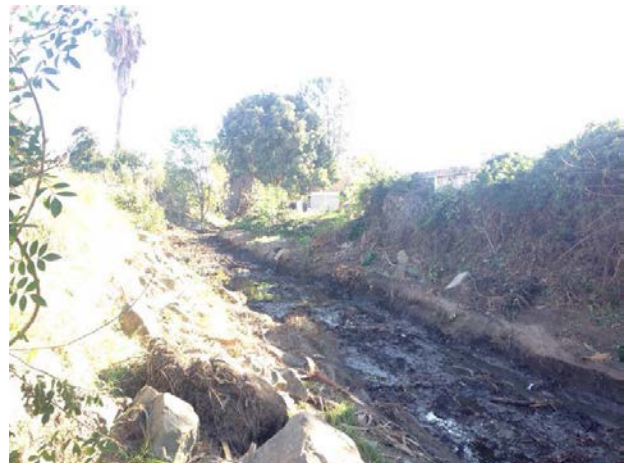
Photograph 6: Photo Point 1 (32.754070W, - 117.057860N) looking east from the north side of the channel at cleared channel section in MMP Map 71; Figure 3.

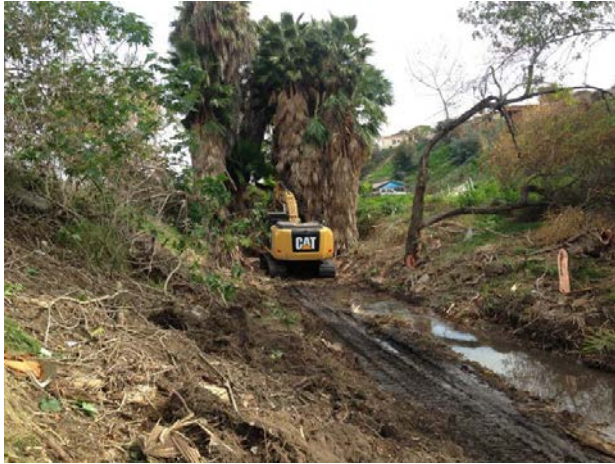
Photograph 7: Photo Point 3 (32.754146W, - 117.056850N) looking east upstream from the north side of the channel as the Excavator works to clear vegetation and sediment from the channel (MMP Map 71; Figure 3).

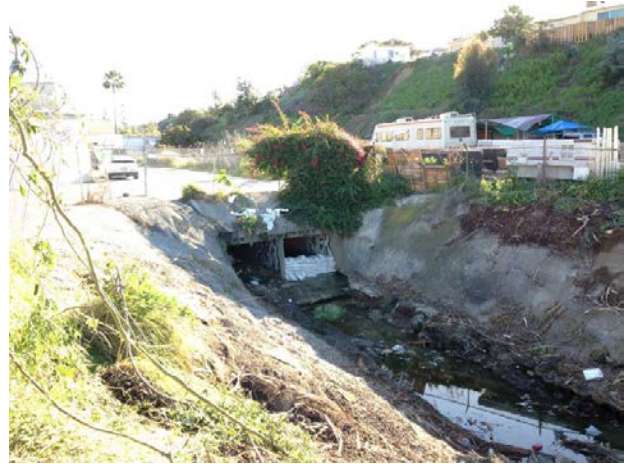
Photograph 8: Photo Point 2 (32.754396W, - 117.055708) looking into the channel from the east end of the maintenance area at the upstream outlet following maintenance (MMP Map 71; Figure 3).

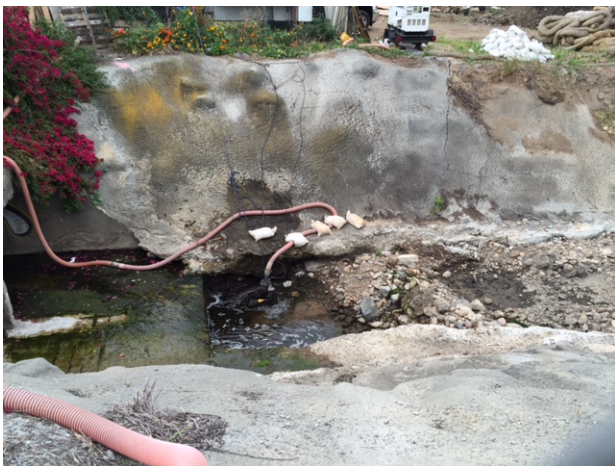
Photograph 9: Photo Point 2 (32.754396W, - 117.055708) looking into the channel from the east end of the maintenance area near the conclusion of maintenance at the diversion pump inlet where downstream flows are being collected and carried downstream of the work area (MMP Map 71; Figure 3).

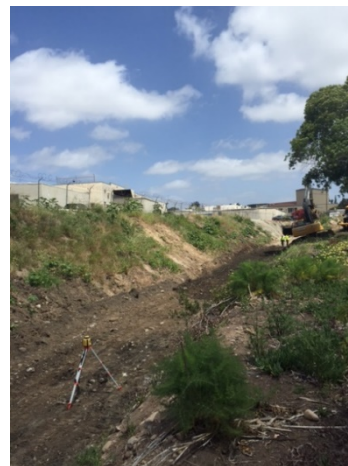
Photograph 10: Photo Point 3 (32.754146W, - 117.056850N) looking east upstream from the south side of the channel after maintenance was completed (MMP Map 71; Figure 3).

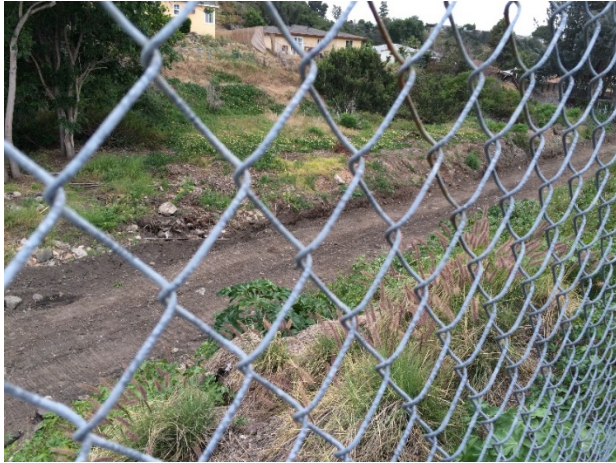
Photograph 11: Photo Point 1 (32.754070W, - 117.057860N) looking southwest from the north side of the channel at cleared channel section in MMP Map 71; Figure 3.

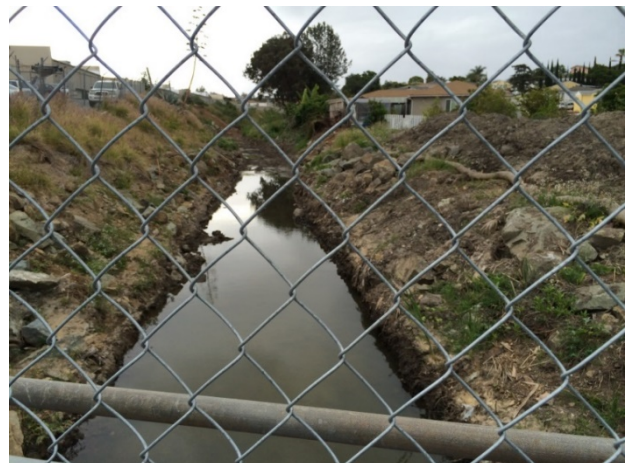
Photograph 12: Photo Point 4 (32.753933W, - 117.058237N) looking upstream from Rolando Boulevard at the cleared channel following maintenance (MMP Map 71; Figure 3).
