## INDIVIDUAL BIOLOGICAL ASSESSMENT REPORT

**Site Name/Facility:** Auburn Creek Channel Emergency Maintenance  
**Master Program**  
**Map No.:** 67&68  
**Date:** February 26, 2016  
**Biologist Name/Cell**  
**Phone No.:** Scott Gressard (858-997-6874)

Auburn Creek (MMP Map 67 & 68) - Emergency Channel Maintenance

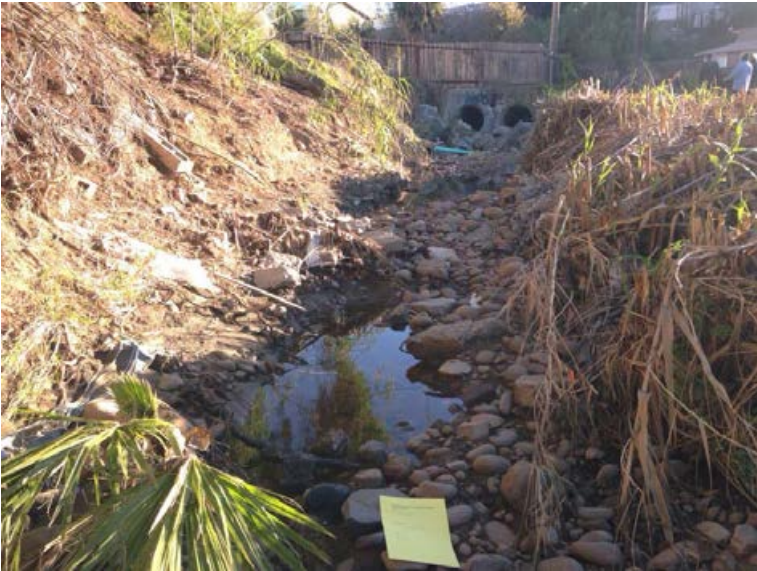
**Photograph 1:** Photo Point 3 approximately 100 feet west of the outlet culvert in Auburn Creek Map 67, facing upstream, prior to work beginning (bearing 58 NE, 32.74814N, -117.08587W).

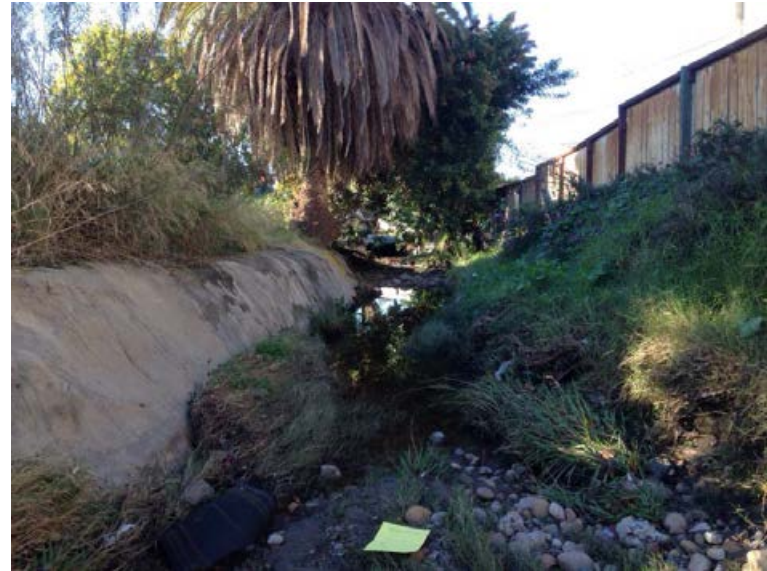
**Photograph 2:** Photo Point 6 on Auburn Creek Map 67, facing downstream, prior to work beginning (bearing 210N, 32.74787N, -117.08617W).

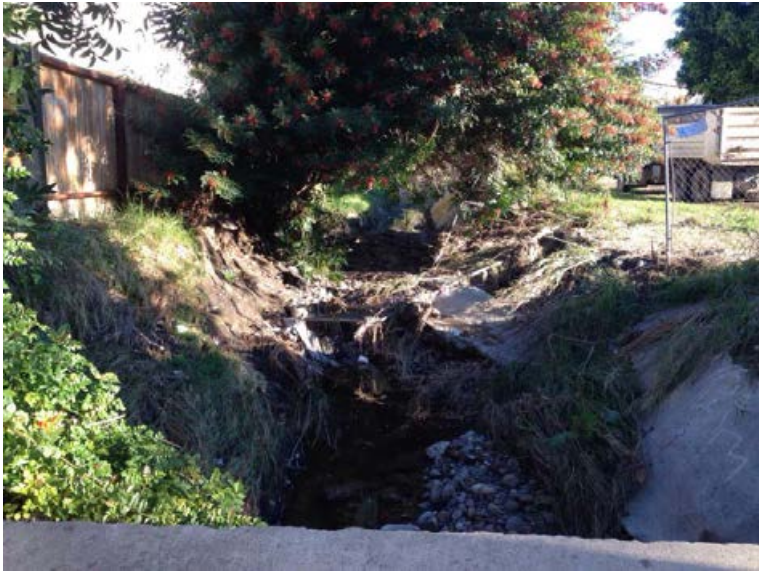
**Photograph 3:** Photo Point 7 on Auburn Creek Map 67, facing upstream (bearing 6N, 32.74757N, -117.08644W). Taken from the top of the outlet culvert prior to work beginning.

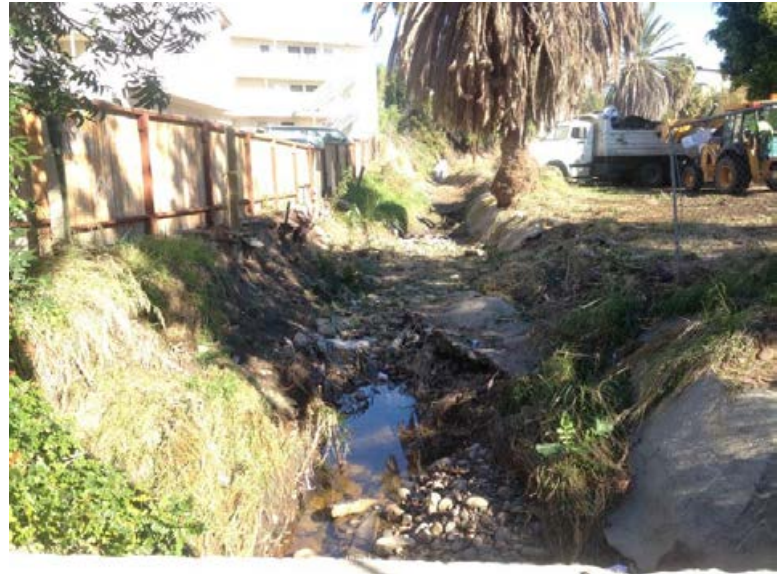
**Photograph 4:** Photo Point 7 showing the area of removed Brazilian peppertree (*Schinus terebinthifolius*) across the channel from the date palm (*Phoenix dactylifera*) on Auburn Creek Map 67 (upstream, 32.747570N, -117.086442W).

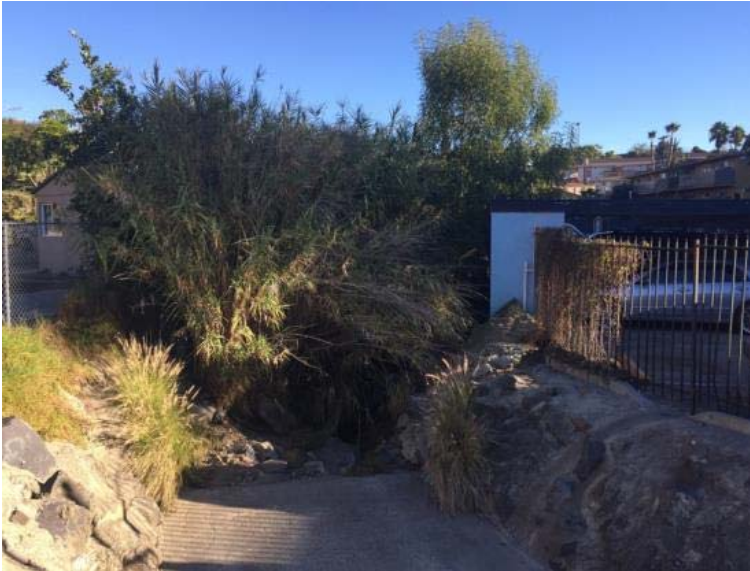
**Photograph 5:** Photo Point 9 at southwest part of Auburn Creek Map 68 prior to work beginning (bearing 15 N @ 32.74681N, -117.08698W).

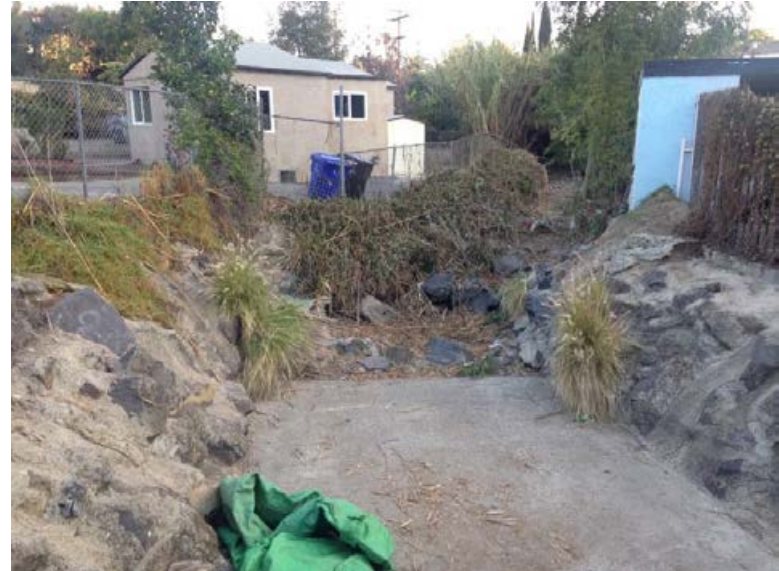
**Photograph 6:** Photo Point 8 above inlet culvert prior to work beginning on Auburn Creek Map 68 (bearing 190 SW, 32.747330N, -117.086380W).

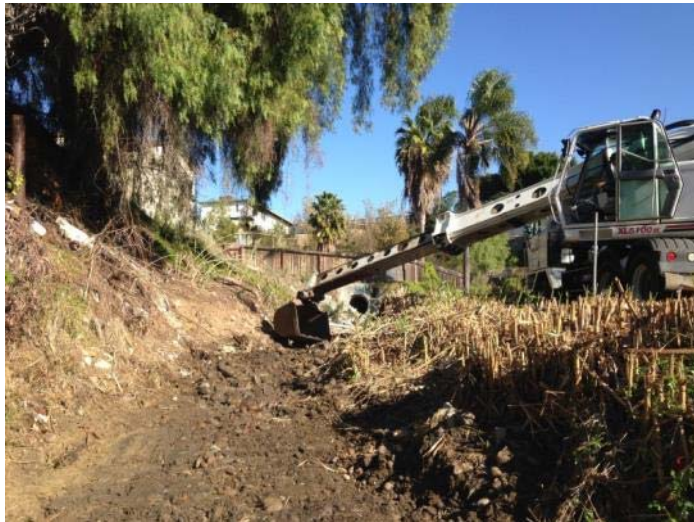
**Photograph 7:** Photo Point 3 showing the Gradall excavating sediment from Auburn Creek Map 67 (bearing 58 NE, 32.74814N, -117.08587W).

As part of this emergency maintenance, all sediment and vegetation that had accumulated within each of the two channel sections was removed. In the first section located directly north of Wightman Street (MMP Map 67; Figure 3a), all materials were excavated from the channel segments by a Gradall (i.e., excavating-type equipment with an extended arm) and Trackhoe. The Gradall was staged outside and above the channel within the disturbed Access/Staging area to the. A Pole Saw and chainsaws were also used to remove a large exotic tree on the southwestern end of this section.

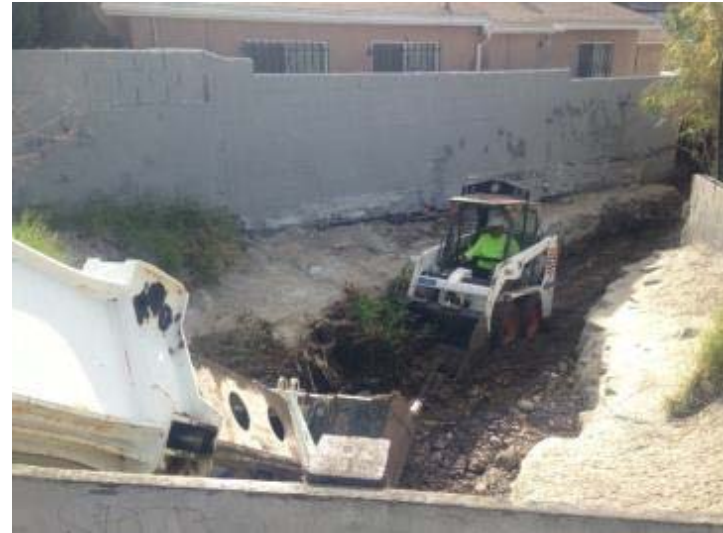
**Photograph 8:** Photo Point 8 showing the Bobcat and Gradall being used to remove vegetation from the channel at the end of the day on Auburn Creek Map 68 (bearing 190 SW, 32.747330N, -117.086380W).

In the second section located directly south of Wightman Street (MMP Map 68; Figure 3b), a Gradall was used to lower a Trackhoe and Bobcat into the channel. The Trackhoe and Bobcat pushed vegetation and sediment to a location that it could be removed by the Gradall, which was staged outside and above the channel at the north end (Wightman Street). Some vegetation and sediment within and adjacent to the channel were also removed using hand tools and chainsaws.

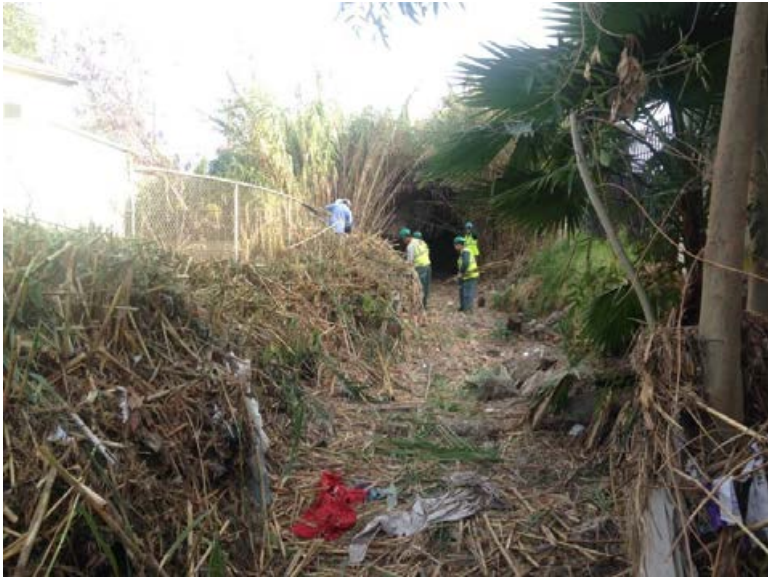
**Photograph 7:** Photo Point 11 showing Urban Corps crew using saw to cut giant cane (*Arundo donax*) on Auburn Creek Map 68 (upstream, 32.746913N, -117.086849W).

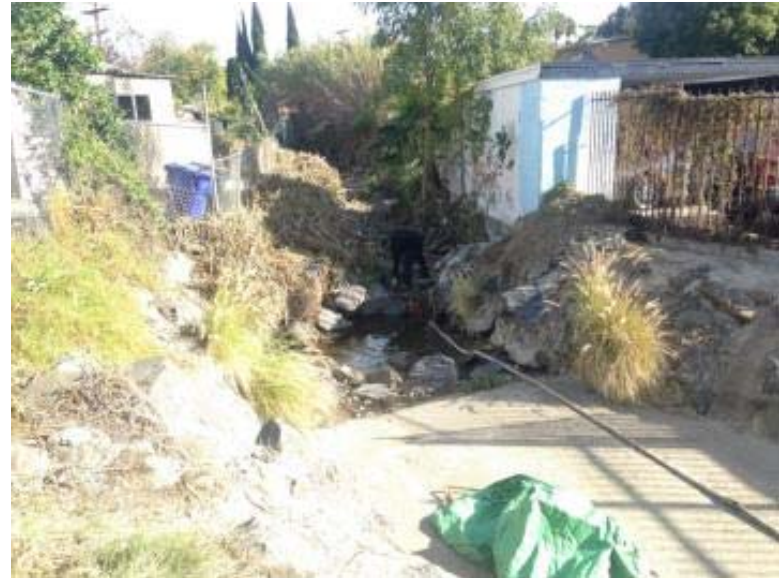
**Photograph 8:** Photo Point 9 showing crew pumping water from downstream work area through the channel outlet culvert (bearing 15 N, 32.746809N, -117.086978W).

The earthen channel did not have any standing water present during work. Pumps were used to bypass water

out of the work area and create dry work conditions.

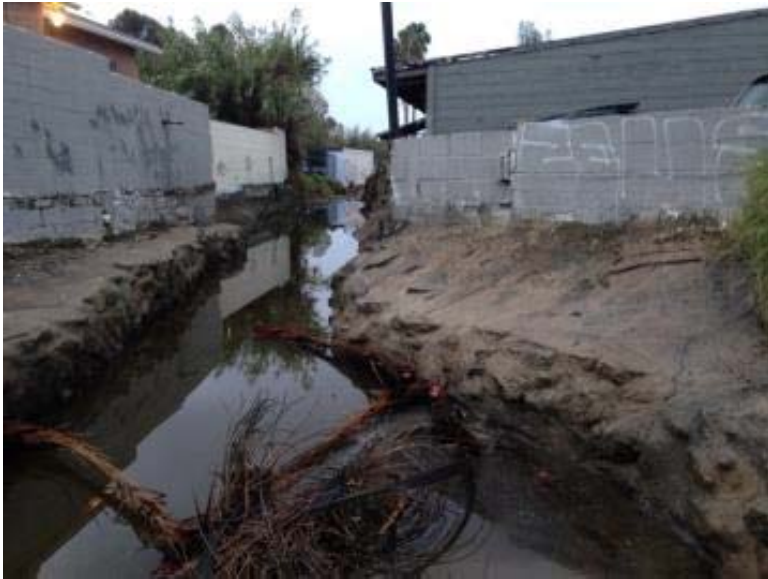
**Photograph 9:** Photo Point 9 showing water upstream of the outlet culvert on Auburn Creek Map 68 (bearing 15N, 32.746809N, -117.086978W).

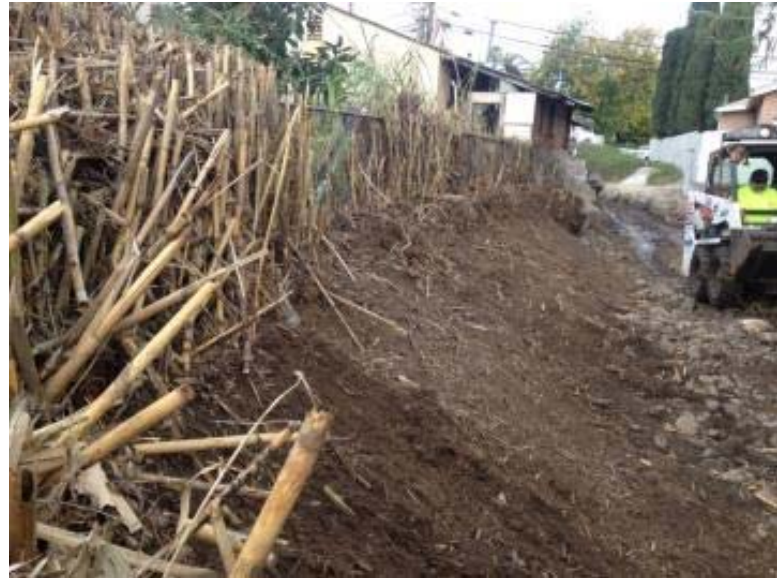
**Photograph 10:** Just west of Photo Point 14 showing the progress of giant cane clearing near the end of the day on Auburn Creek Map 68 (upstream, 32.747048N, -117.086654W).

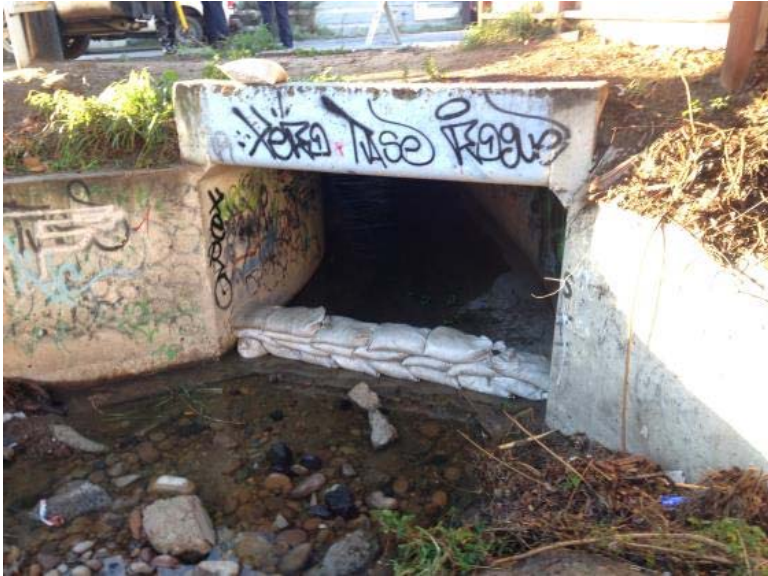
**Photograph 11:** Northeast of Photo Point 7 showing the sandbagging of the outlet culvert on Auburn Creek Map 67 (downstream).

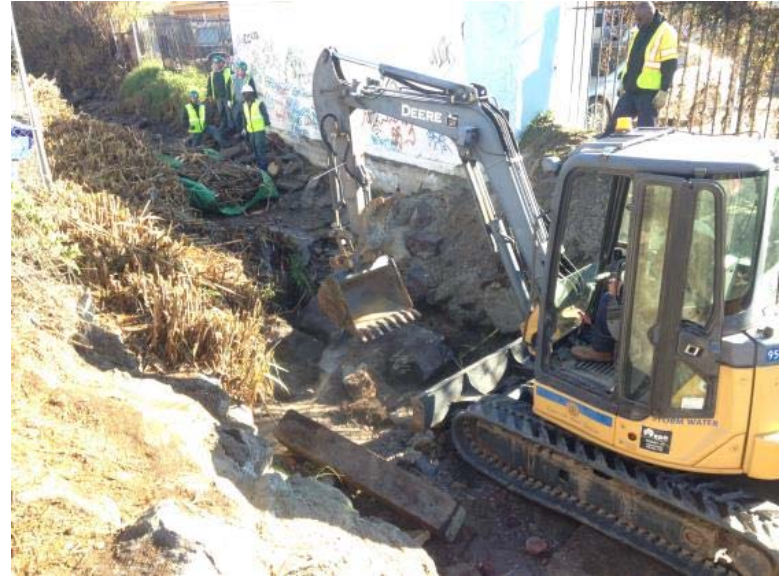
**Photograph 12:** Photo Point 9 showing the small excavator working in the channel (bearing 15 N, 32.746809N, -117.086978W).

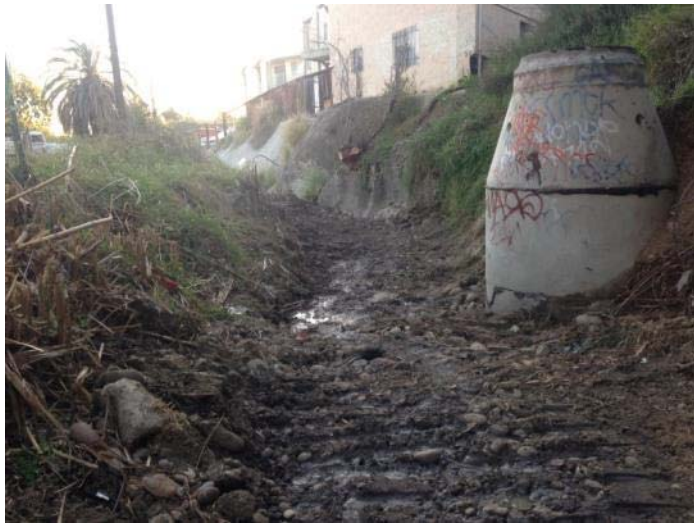
**Photograph 13:** Photo Point 4 showing Map 67 area of Auburn Creek following completion of work (bearing 226 SW, 32.74815N, -117.08589W).

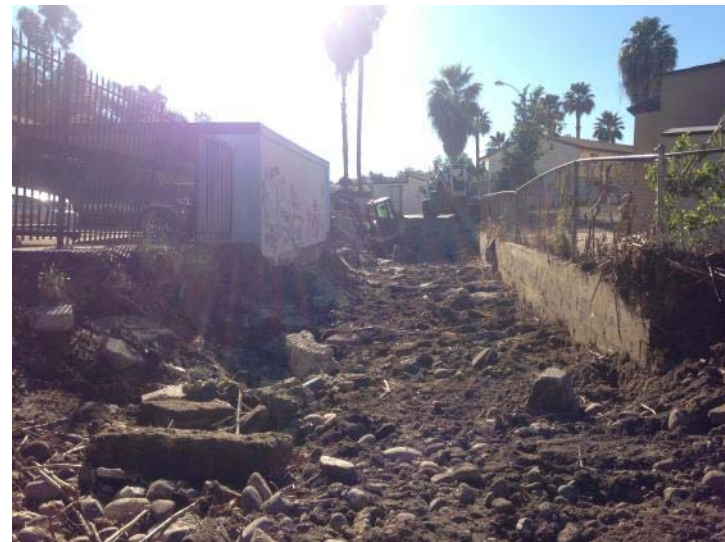
**Photograph 14:** Photo Point 12 showing the channel at the end of the work day (downstream, 32.746935N, -117.086746W).

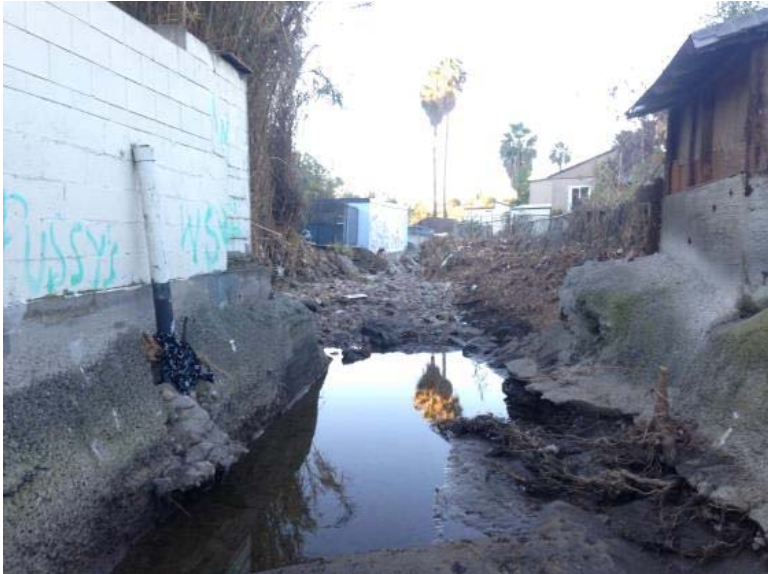
**Photograph 13:** Photo Point 13 showing Map 67 area of Auburn Creek following completion of work (downstream, 32.747211N, -117.086511W).

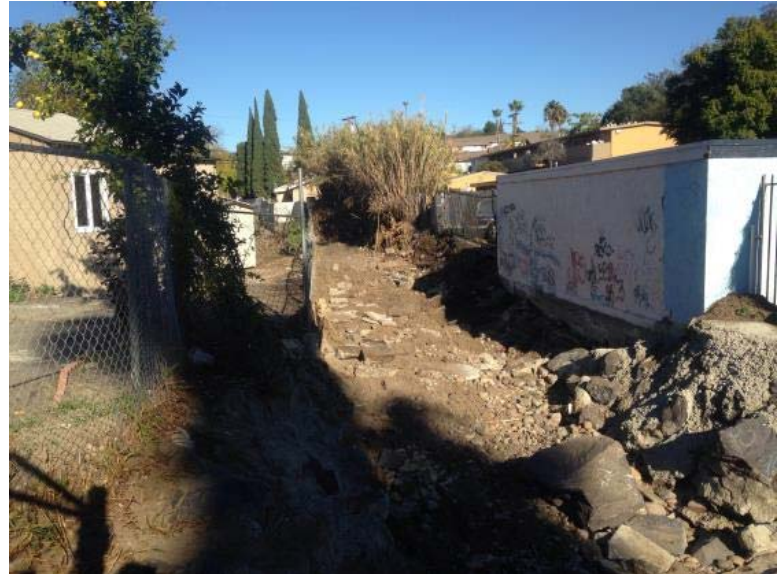
**Photograph 14:** Photo Point 9 showing the channel at the end of the work day (upstream, 32.746809N, -117.086978W).

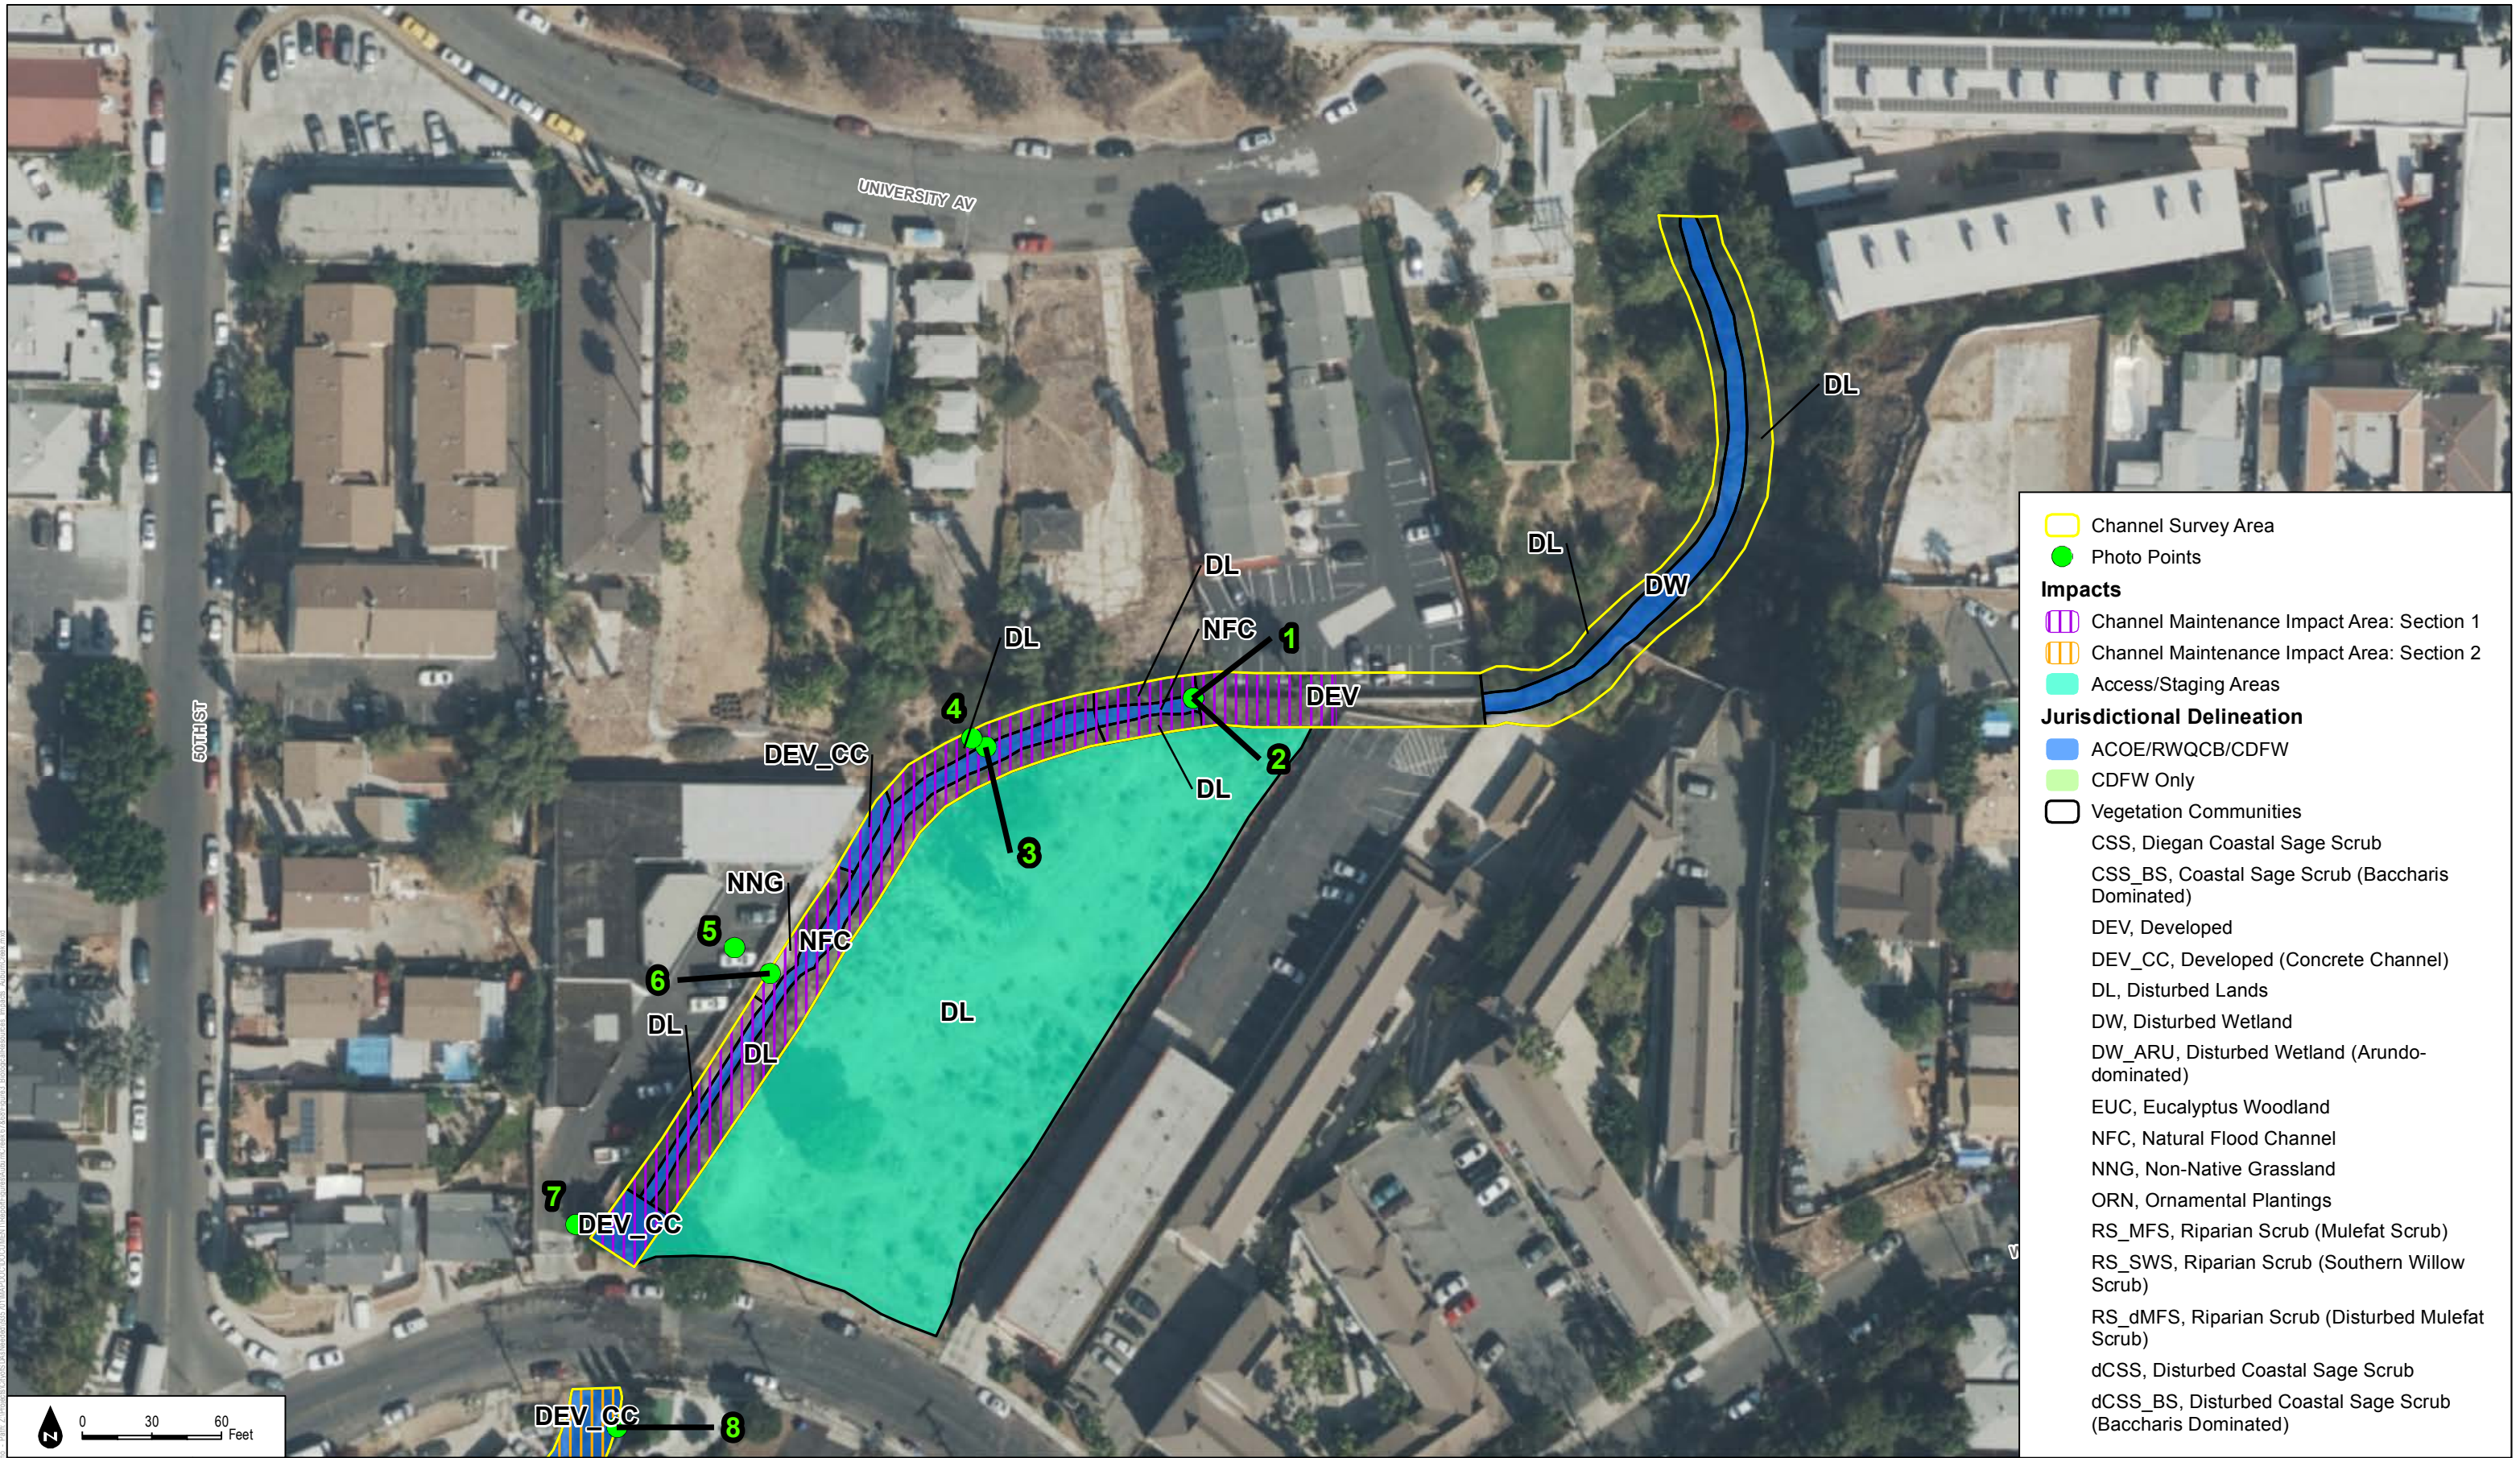
MMP Map 67; Figure 3a  
Biological Resources and Impacts

Assessments by City staff and engineers were conducted for each of the three sections of concern during the week of November 16th, 2015. In the first section (MMP Map 67; Figure 3a), the City's assessment determined that accumulated sediment and non-native vegetation had accumulated upstream of Wightman Street has constricted capacity into a single box culvert (5' x 8') under Wightman St. Erosive impacts from past storms

likely involving backwater effects were evident within the existing cobble and non-native vegetation and erosion impacts from flooding were visible along the adjacent slope (Attachment A), which supports a residential parking lot to the west. Based on recent communication with residents, it appears that 5015 and 5017 Wightman had flooded recently.
