INDIVIDUAL BIOLOGICAL ASSESSMENT REPORT

Site Name/Facility: Smythe Channel Emergency Maintenance
Master Program
Map No.: 130
Date: June 14, 2016
Biologist Name/Cell
Phone No.: Scott Gressard (858-997-6874)

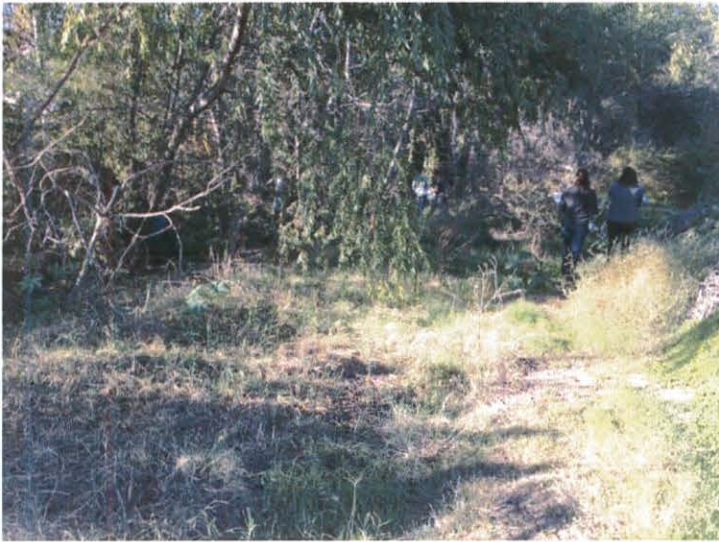
Photograph 1: Looking downstream from the eastern end of the channel above the Picador Blvd. culvert outlet at vegetation build up in the channel and on the access road prior to maintenance (MMP Map 130; Figure 3).

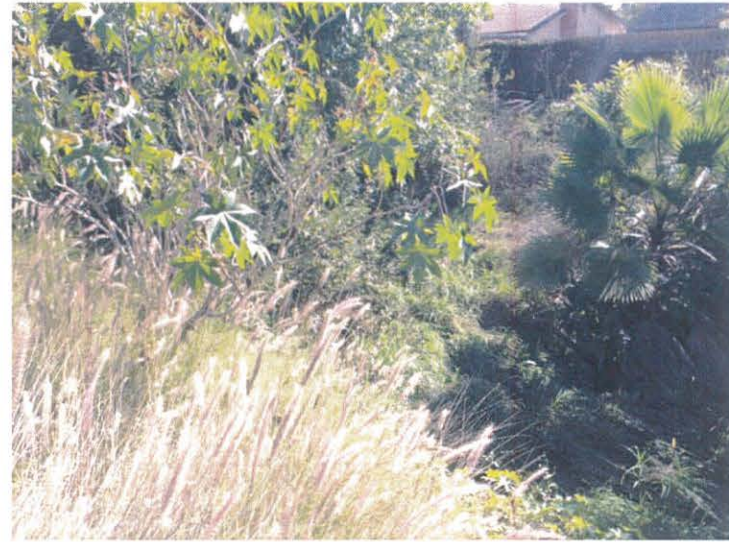
Photograph 2: Looking east from the downstream end of the channel near Del Sur Blvd. at vegetation and sediment build up prior to maintenance (MMP Map 130; Figure 3).

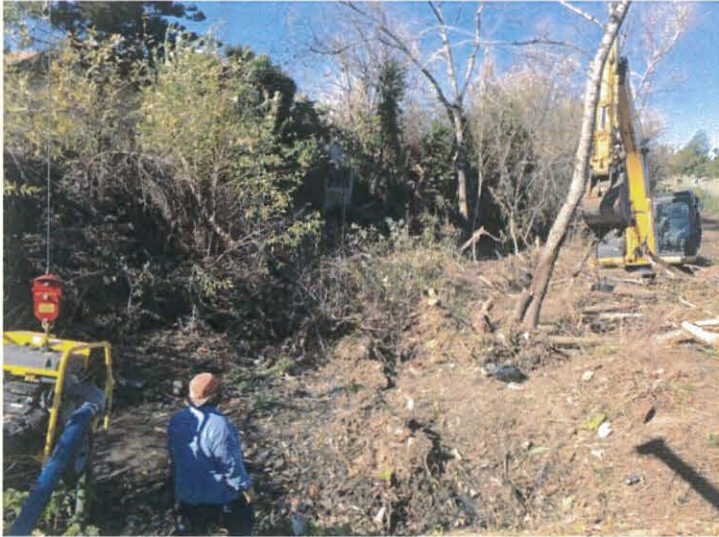
Photograph 3: Looking downstream from the eastern end of the channel above the Picador Blvd. culvert outlet as the Excavator breaks down large vegetation within the channel. The bypass pump is also pictured above the channel (MMP Map 130; Figure 3).

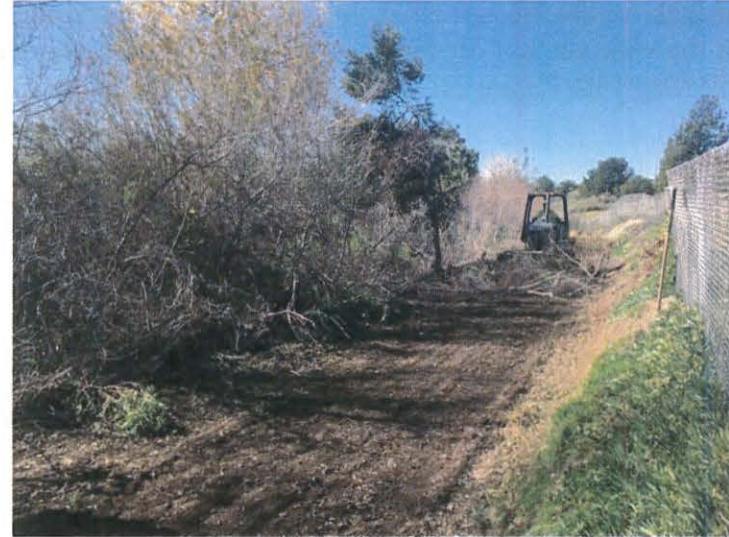
Photograph 4: Looking west from the east end of the channel as the Tracksteer/Bobcat clears vegetation and debris from the access road north of the channel (MMP Map 130; Figure 3).

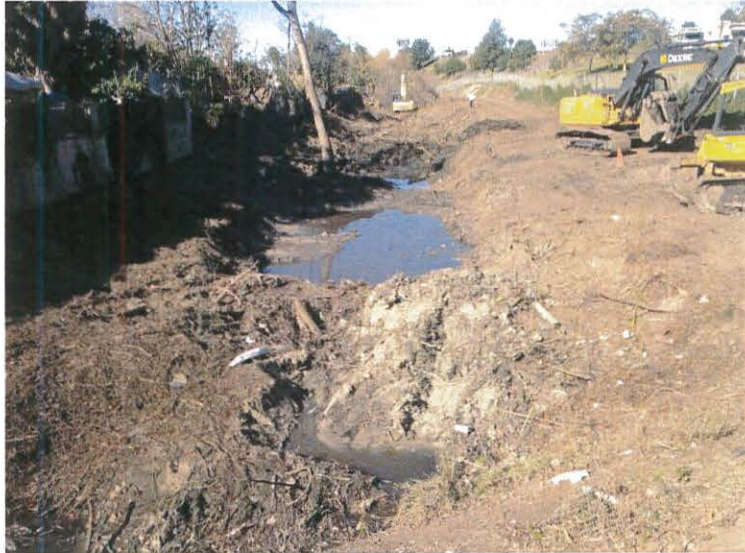
Photograph 5: Looking downstream from the eastern end of the channel above the Picador Blvd. culvert outlet after the majority of the vegetation had been cleared from the east end of the channel (MMP Map 130; Figure 3).

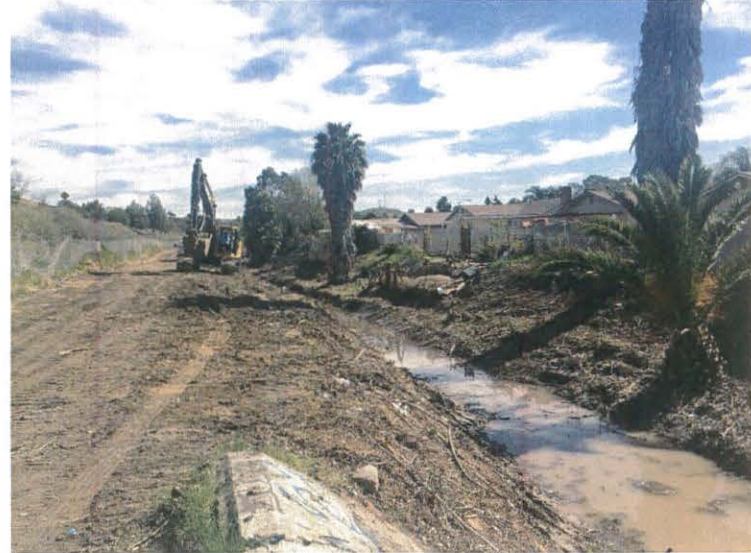
Photograph 6: Looking east upstream from the north side of the channel just above one of the concrete energy dissipator near the center of the maintenance area at the cleared section of the channel (MMP Map 130; Figure 3).

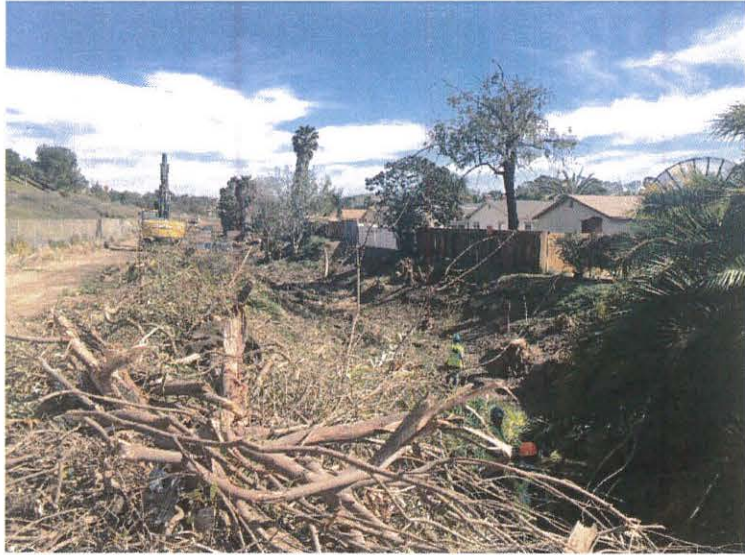
Photograph 7: Looking upstream from the north bank in the west end of the channel as Urban Corps crews clear the remaining vegetation from within the channel by hand (MMP Map 130; Figure 3).

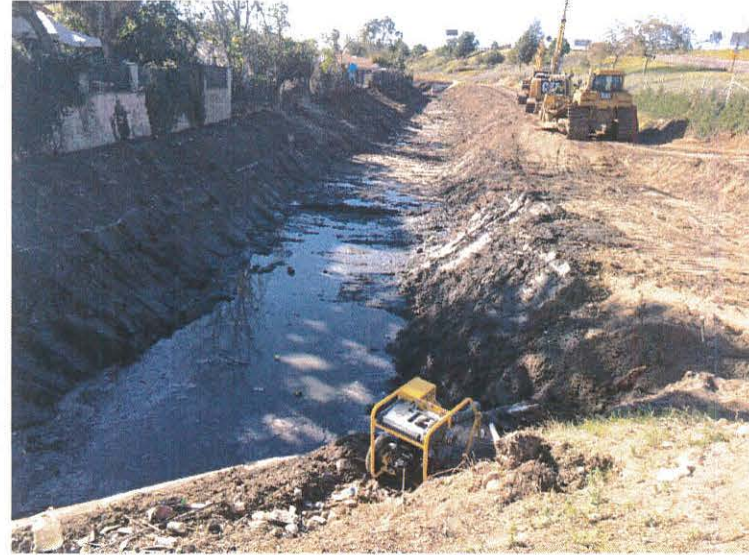
Photograph 8: Looking downstream from the eastern end of the channel above the Picador Blvd. culvert outlet at the completed channel following the removal of all vegetation and sediment (MMP Map 130; Figure 3).

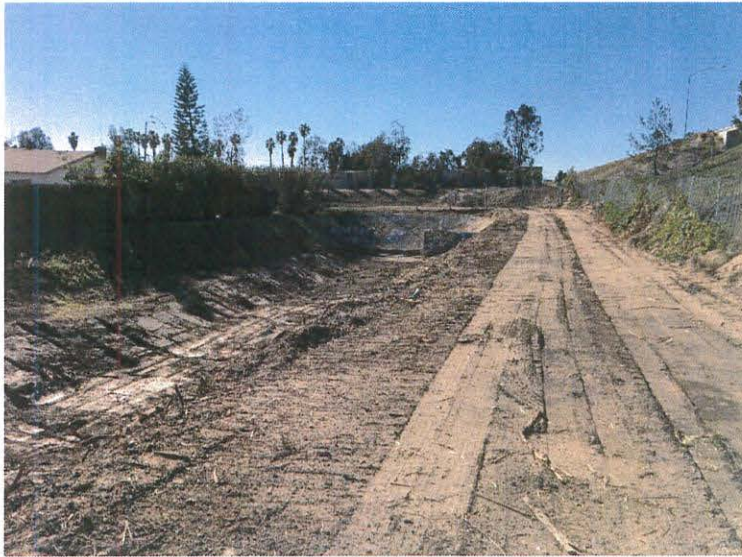
Photograph 9: Looking downstream from the west end of the channel at the culvert inlet that carries flows under Del Sur Blvd. after the completion of the maintenance (MMP Map 130; Figure 3).

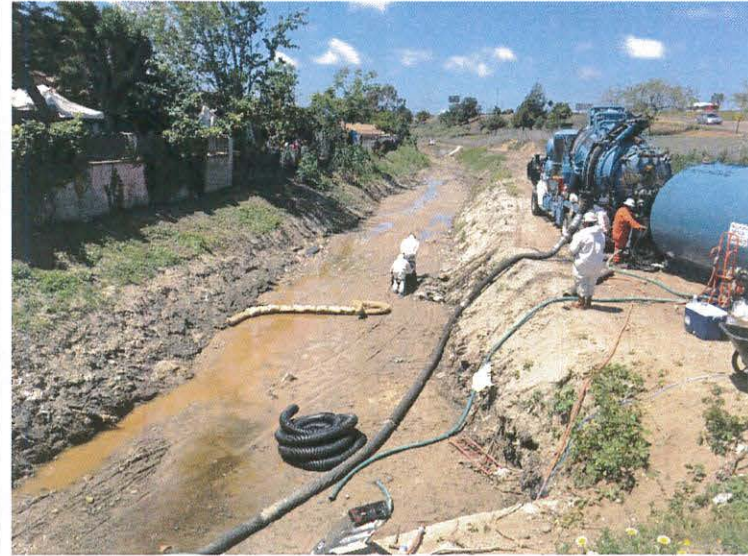
Photograph 10: Looking downstream from the eastern end of the channel above the Picador Blvd. culvert outlet as crews re-enter the channel in order to access and clear debris and sediment from the culvert outlet itself (MMP Map 130; Figure 3).

Following the initial debris and vegetation removal, a storm event washed material downstream into the culvert under Picador Blvd. Crews re-entered the channel and removed this debris from within the three-box culvert at the upstream end of the channel. Prior to the end of the 90-day RGP 63 authorization period, the Contractor also conducted a final minor grading to remove a small layer of sediment within the eastern section of the earthen channel in order to create positive downstream flows below the culvert outlet to the first grade control structure.

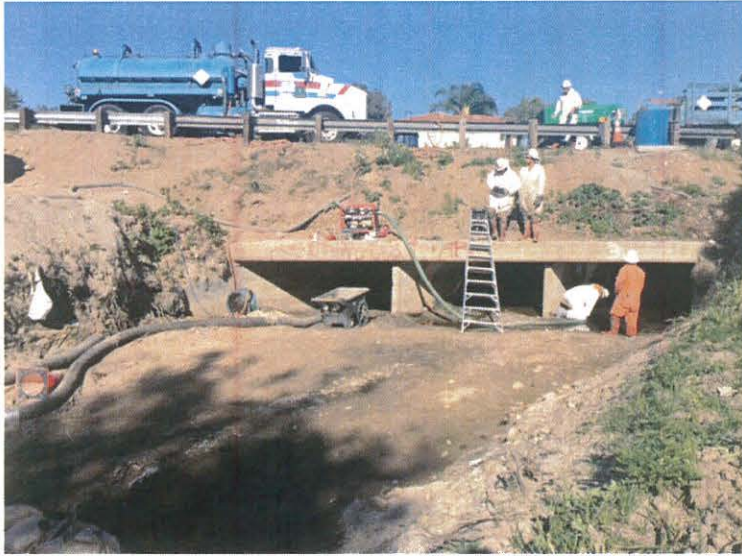
Photograph 11: Looking upstream at the three-box culvert outlet under Picador Blvd. as crews clear sediment and debris from within the culvert itself (MMP Map 130; Figure 3).

Following initial sediment and vegetation removal from the channel, a contractor was hired by the City to remove debris from the upstream three-box culvert using hand tools and tractor trucks. Prior to the end of the 90-day RGP 63 authorization period, the Contractor conducted final minor grading to create positive downstream flow in the east end of the channel from the three-box culvert outlet to the first grade control structure (concrete energy-dissipator). All work was monitored by a qualified biologist. Native American and archaeological monitors were also on-site, as needed. All equipment was removed from the site at the end of the project.
