Subject: **Miramar Landfill Allowable Height Increase, Transportation
Assessment**
City of San Diego, CA

Linscott, Law & Greenspan, Engineers (LLG) has prepared this traffic assessment to assess the potential traffic impacts in relation to the effect of a proposed 25-foot increase in allowable height of Phase II of the West Miramar Landfill. The proposed 25-foot height increase would provide the landfill with an estimated four additional years of service life. No changes to the landfill's maximum capacity of 8,000 tons per day or 2,000 vehicles per day are proposed.

Figure 3.2-1
Visual Resources Key Observation Points (KOPs)

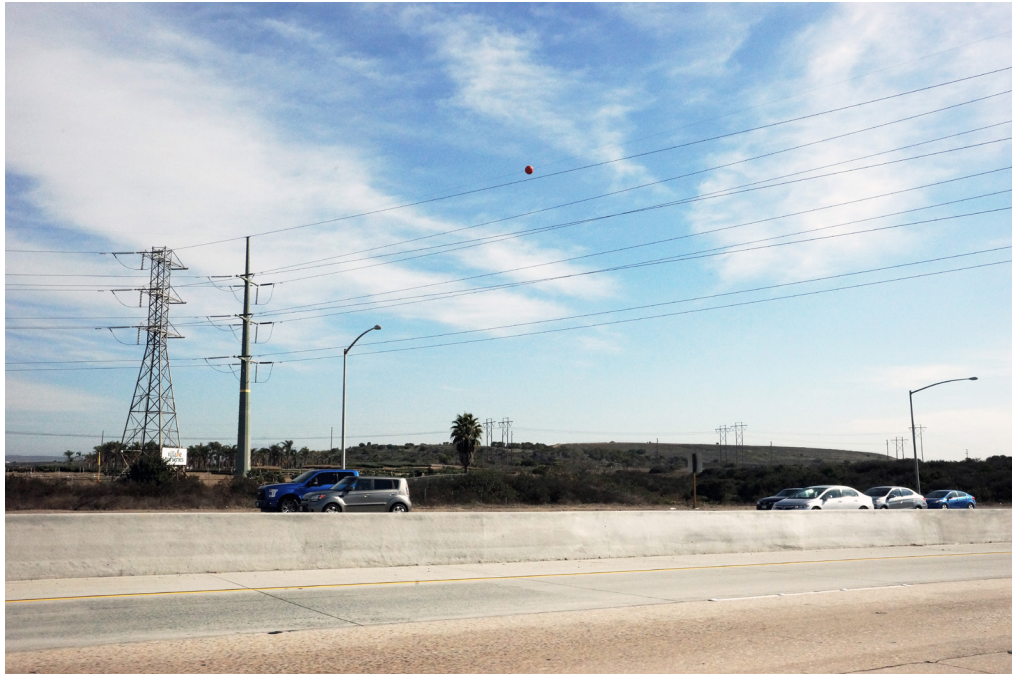
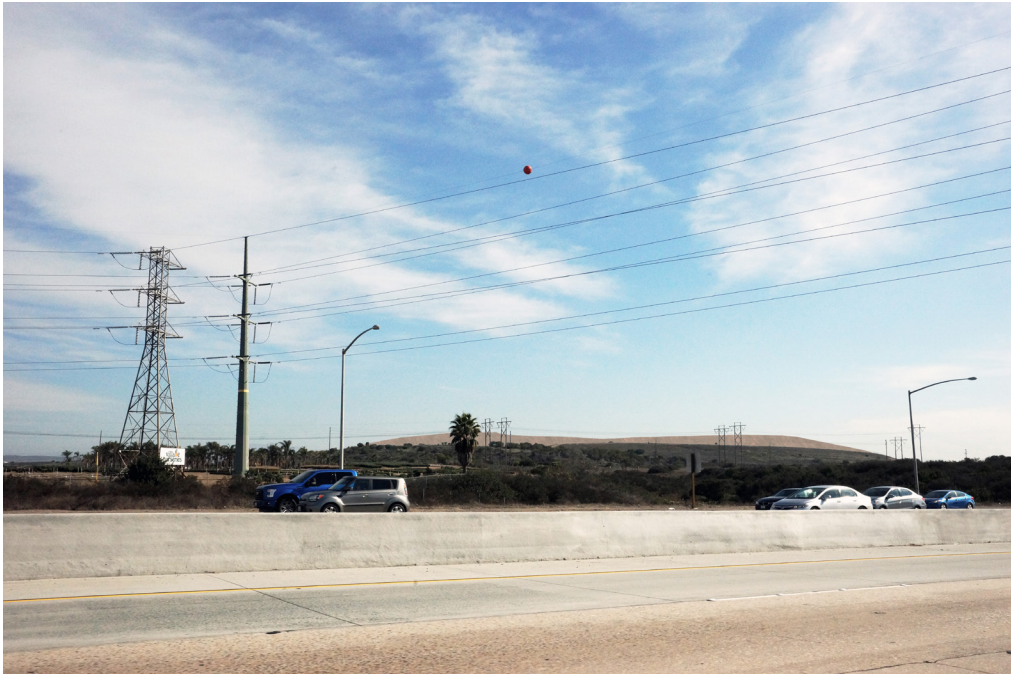
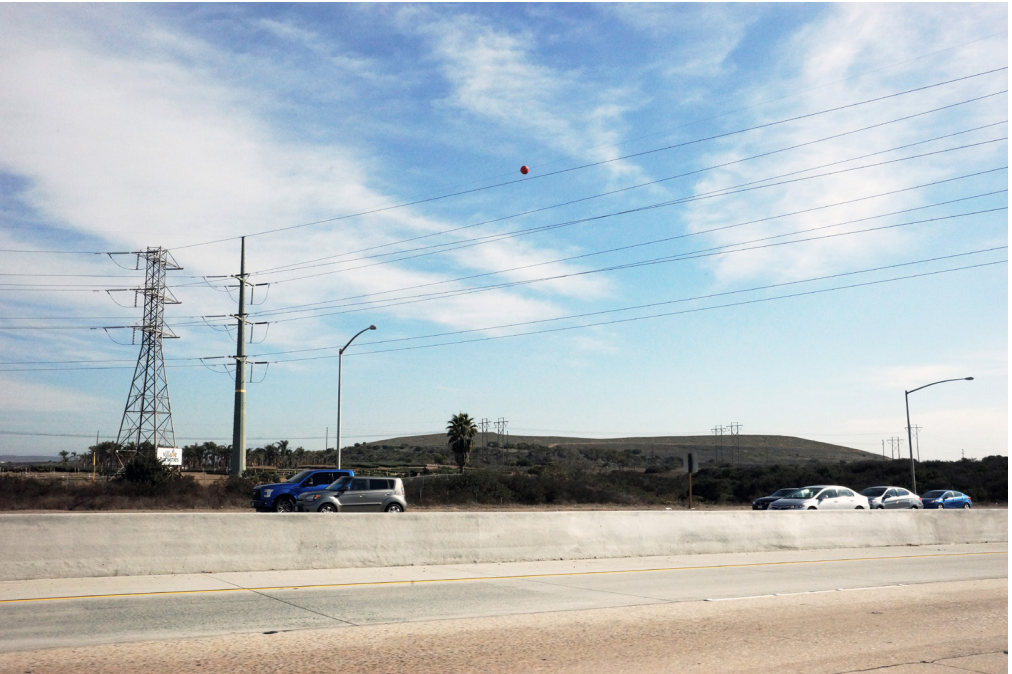
Figure 3.5-1
Visual Simulation at KOP #2
I-805 at Governor Drive Southbound On-Ramp

KOP #2 Existing View

KOP #2 Visual Simulation of Final Project (Before Re-vegetation)

KOP #2 Visual Simulation of Final Project (After Re-vegetation)

KOP are rated *adverse but less than significant* (Figure 3.5-1). Consequently, no mitigation measures are recommended for this KOP.

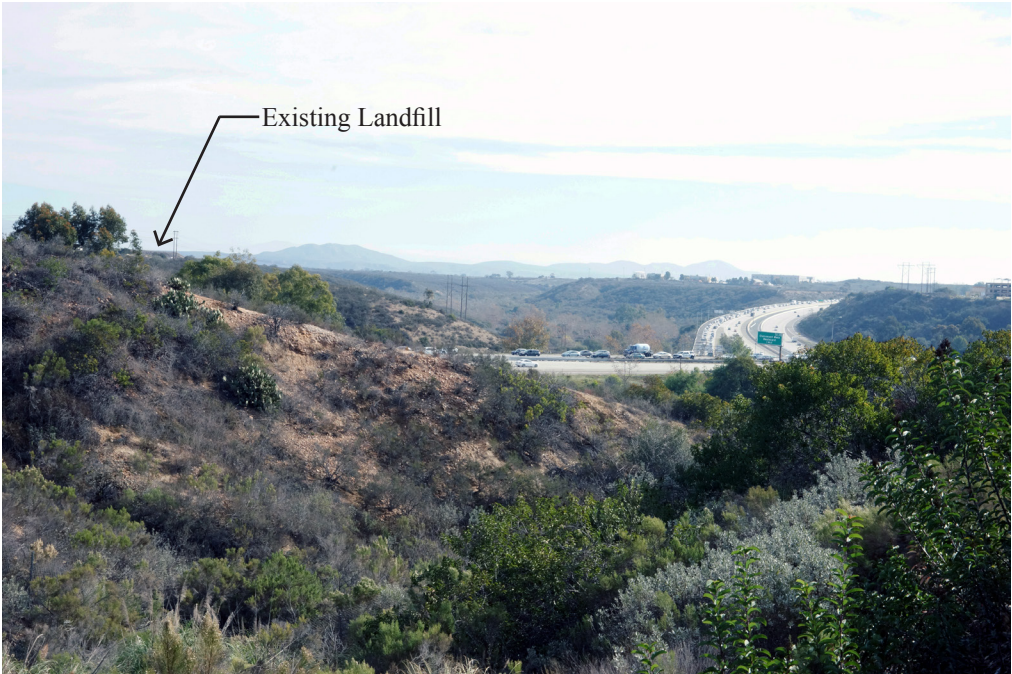
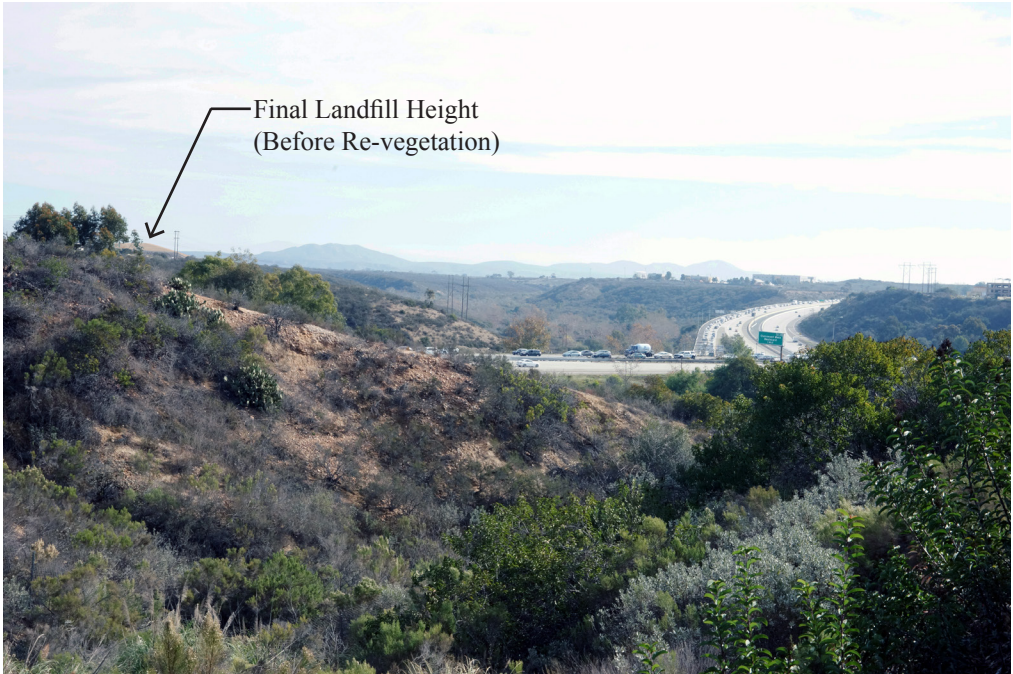
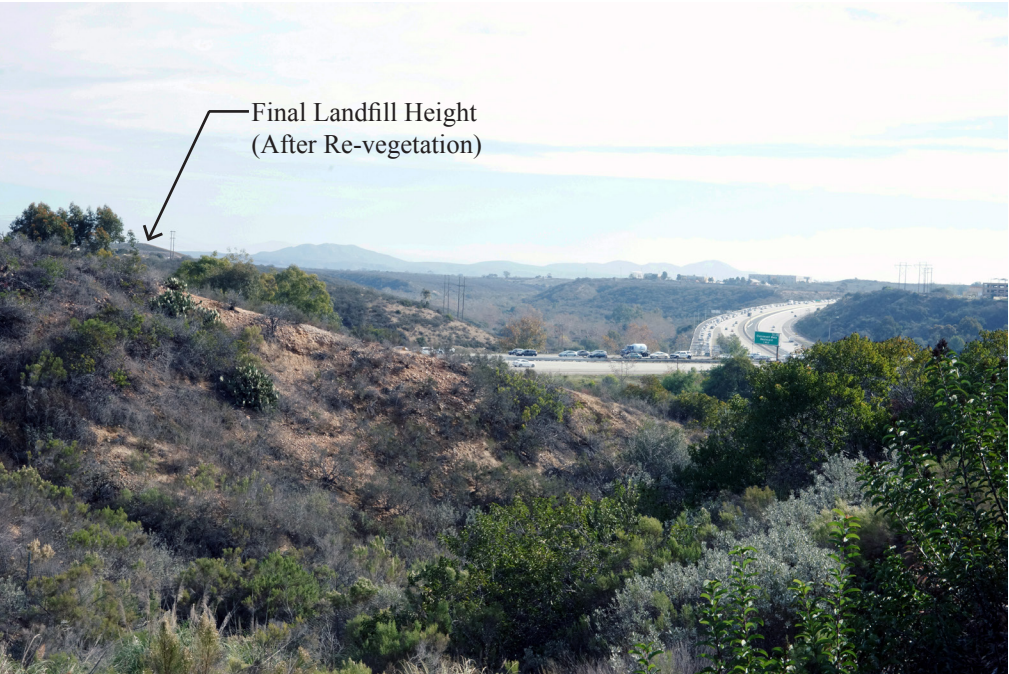
Figure 3.5-2
Visual Simulation at KOP #4
Pedestrian View from University City at Wolfstar Court

KOP #4 Existing View

KOP #4 Visual Simulation of Final Project (Before Re-vegetation)

KOP #4 Visual Simulation of Final Project (After Re-vegetation)

In conclusion, the visual impact susceptibility is classified as moderate based on high rankings for view quality and viewer sensitivity and a low ranking for viewer exposure. Visual impact severity is classified as low based on moderate rankings for visual contrast, and low rankings for project dominance and view impairment (see Table 3.5-1). Therefore, the project impacts for this KOP are rated *insignificant* (see simulation Figure 3.5-2). Consequently, no mitigation measures are recommended for this KOP.

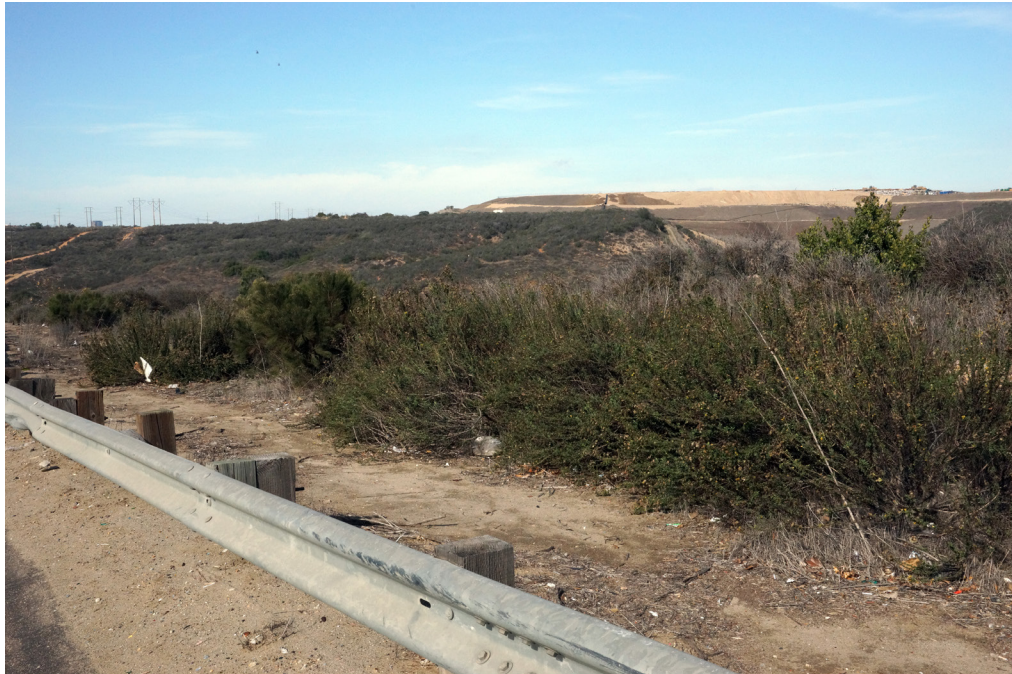
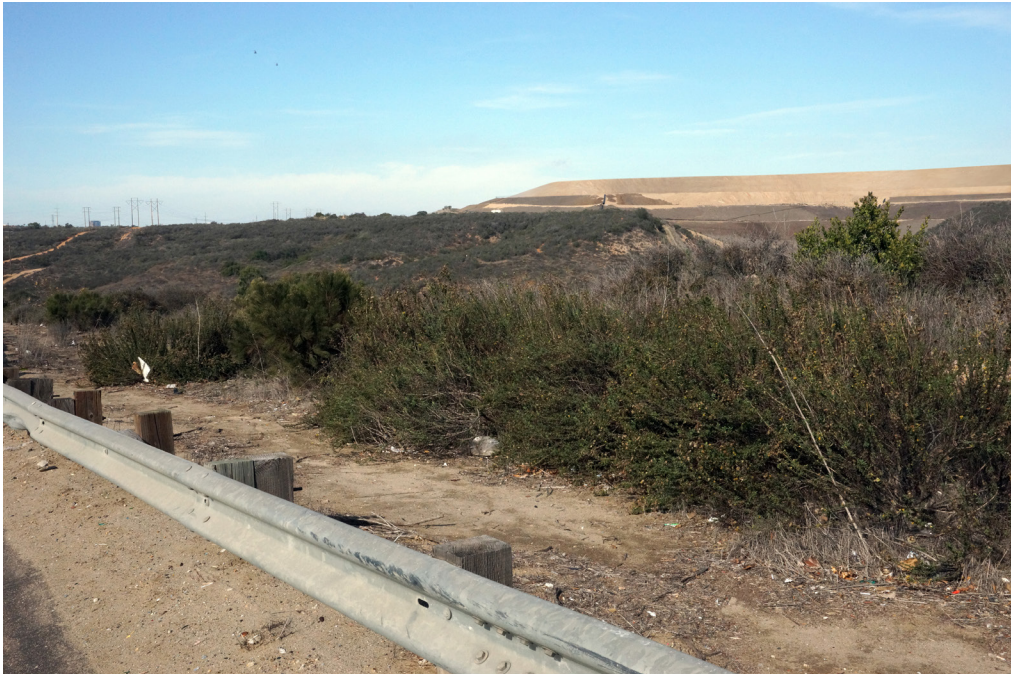
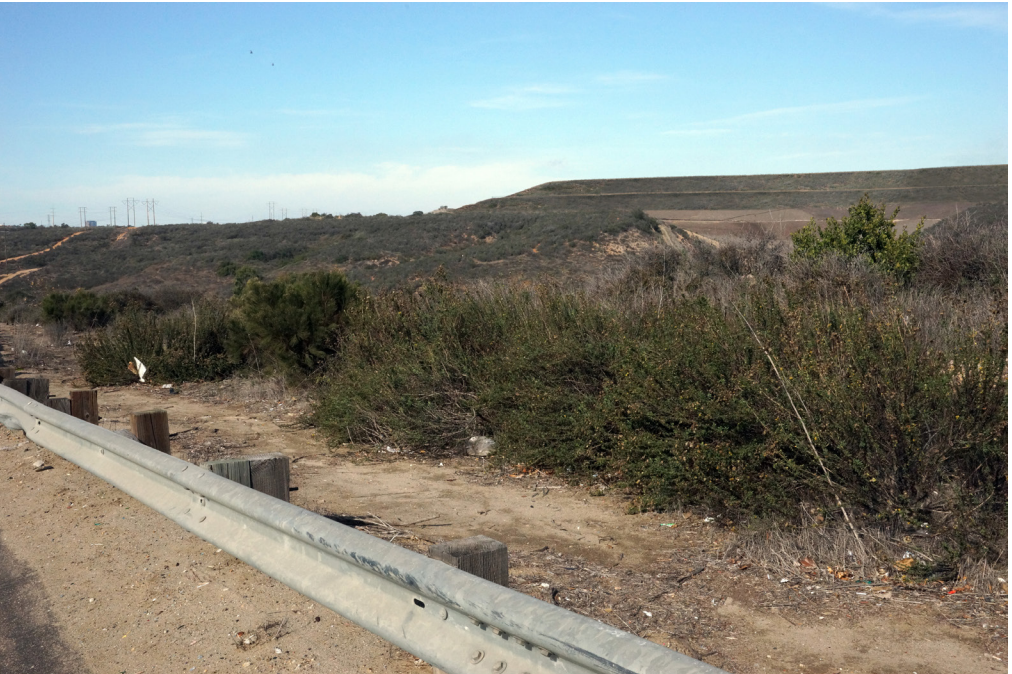
Figure 3.5-3
Visual Simulation at KOP #7
Westbound Along State Route 52 at Point Closest to Landfill

KOP #7 Existing View

KOP #7 Visual Simulation of Final Project (Before Re-vegetation)

KOP #7 Visual Simulation of Final Project (After Re-vegetation)

In conclusion, the visual impact susceptibility is classified as moderate, based on the moderate ranking for view quality and viewer sensitivity, and a high ranking for viewer exposure. Visual impact severity is classified as low based on a high ranking for visual contrast, a moderate ranking for project dominance and a low ranking for view impairment (see Table 3.5-1). Therefore, the project impacts for this KOP are rated *adverse but less than significant* (see simulation Figure 3.5-3). Consequently, no mitigation measures are recommended for this KOP.

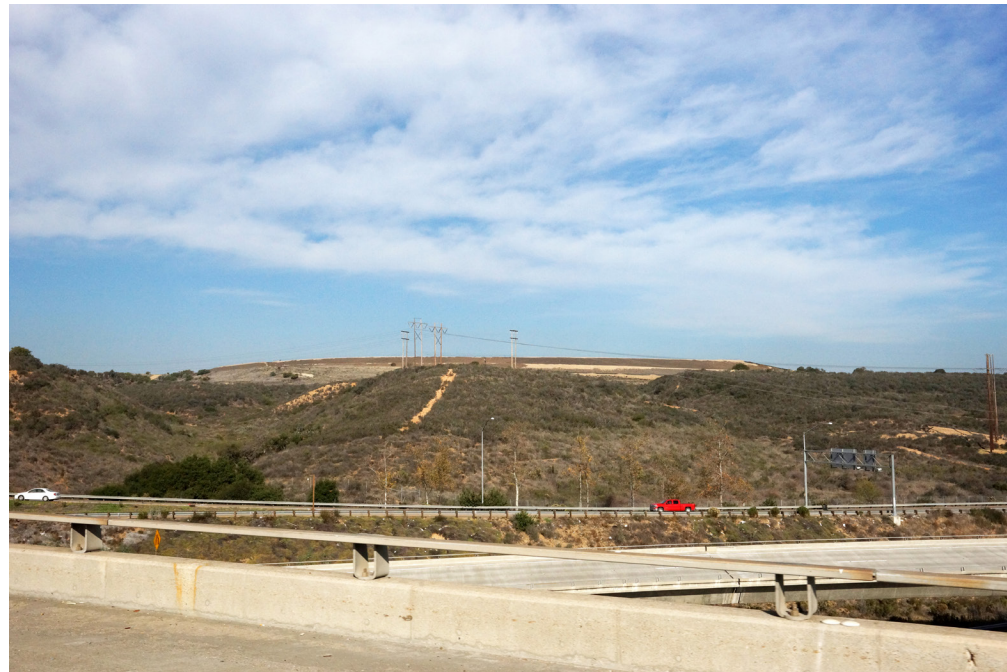
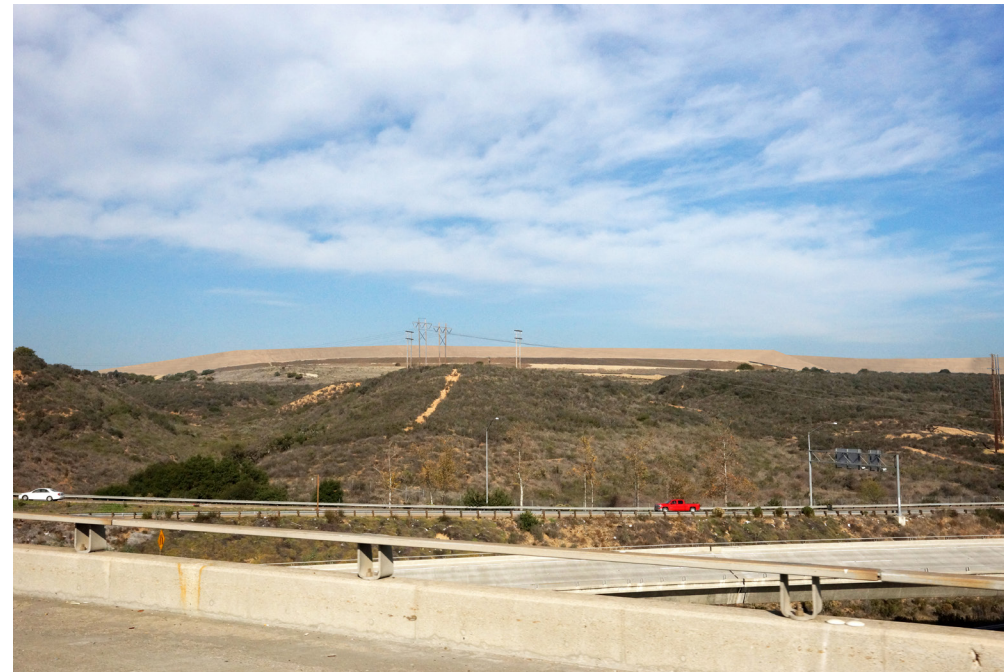
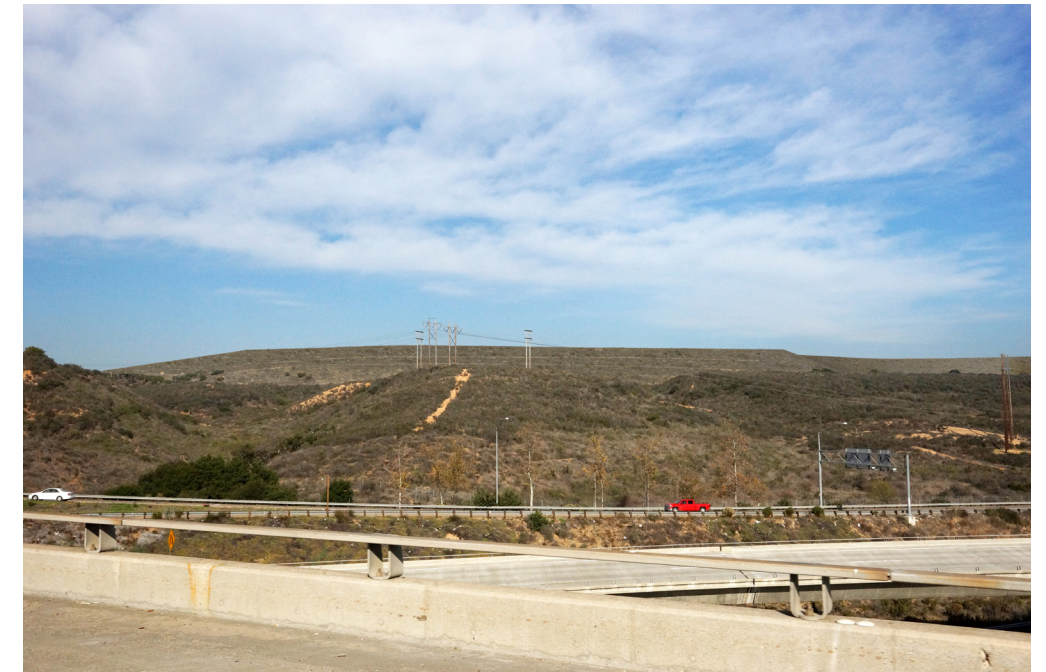
Figure 3.5-4
Visual Simulation at KOP #8
Traveler View Northbound from Interstate 805, Closest View to the Project

KOP #8 Existing View

KOP #8 Visual Simulation of Final Project (Before Re-vegetation)

KOP #8 Visual Simulation of Final Project (After Re-vegetation)

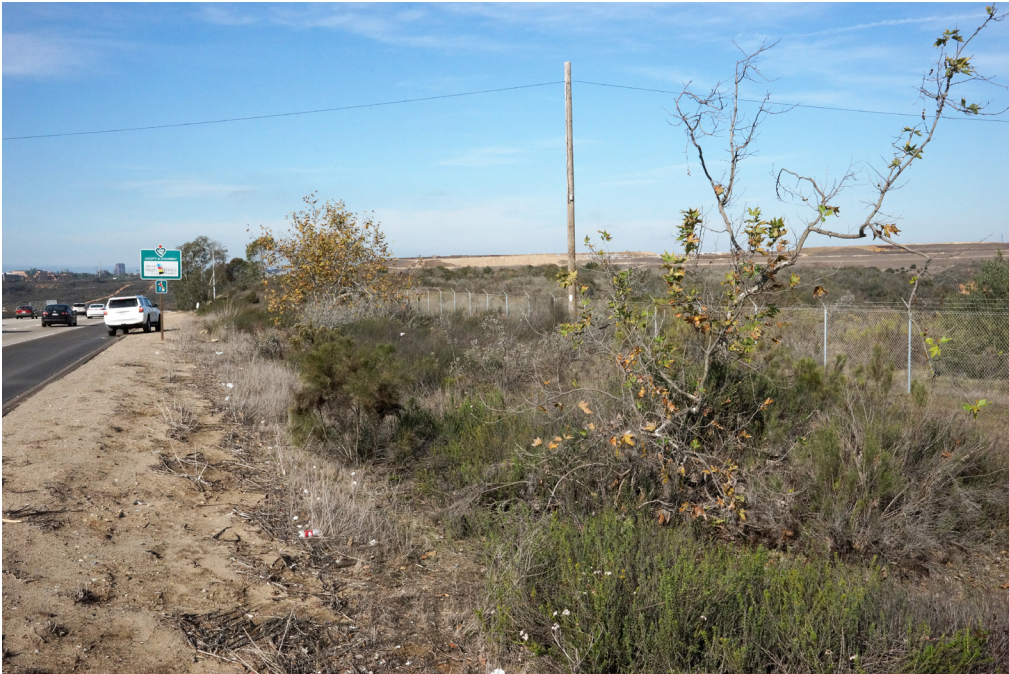
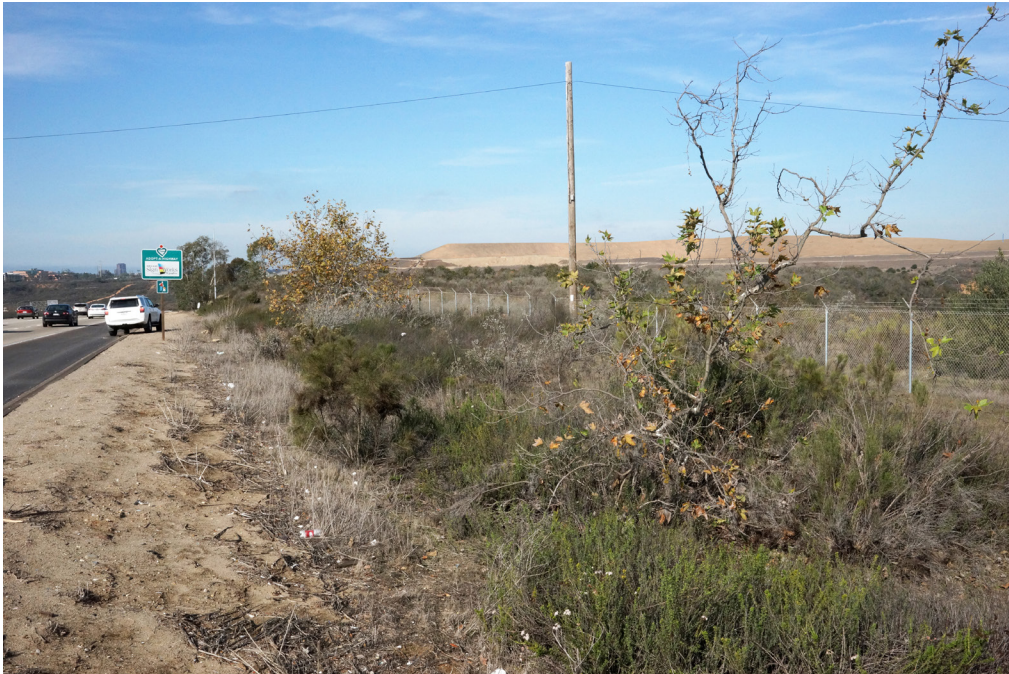
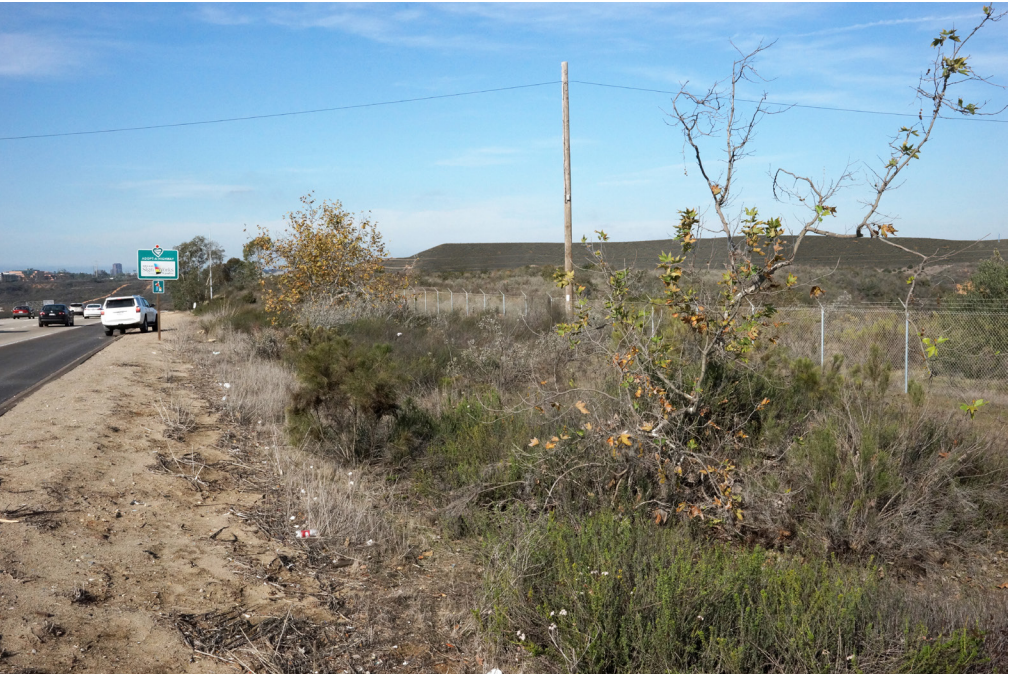
Figure 3.5-5
Visual Simulation at KOP #10
Traveler View Westbound Along State Route 52

KOP #10 Existing View

KOP #10 Visual Simulation of Final Project (Before Re-vegetation)

KOP #10 Visual Simulation of Final Project (After Re-vegetation)

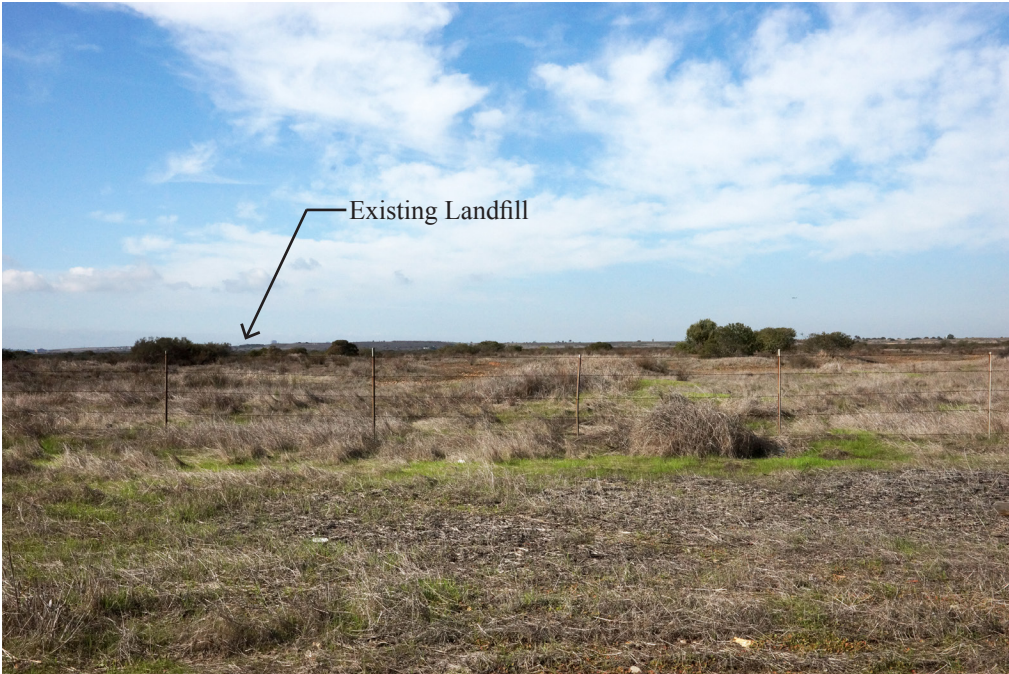
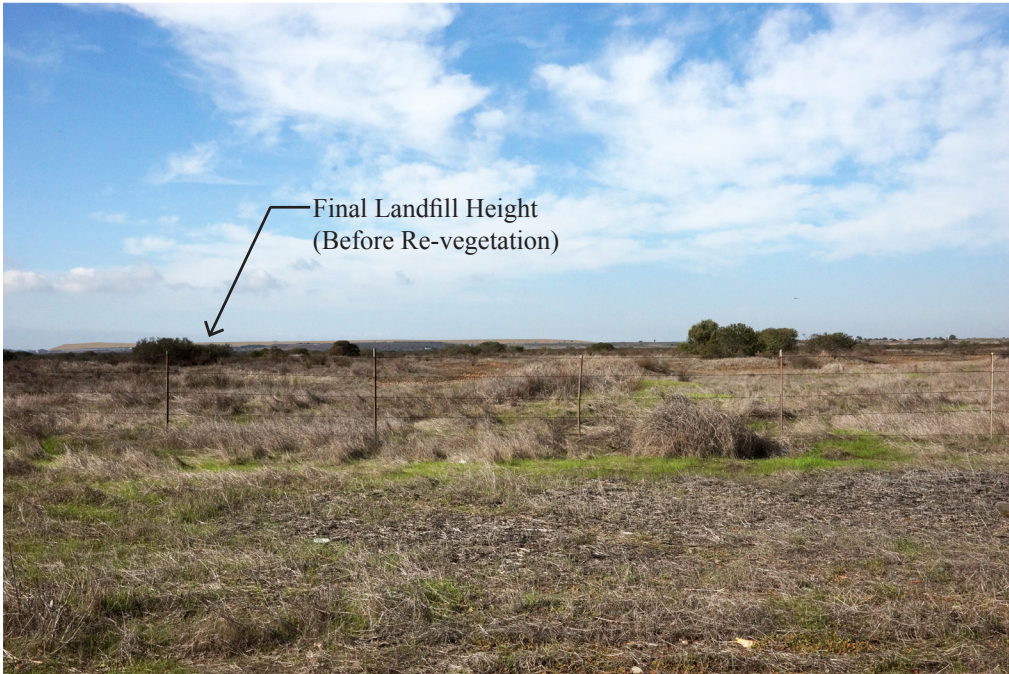
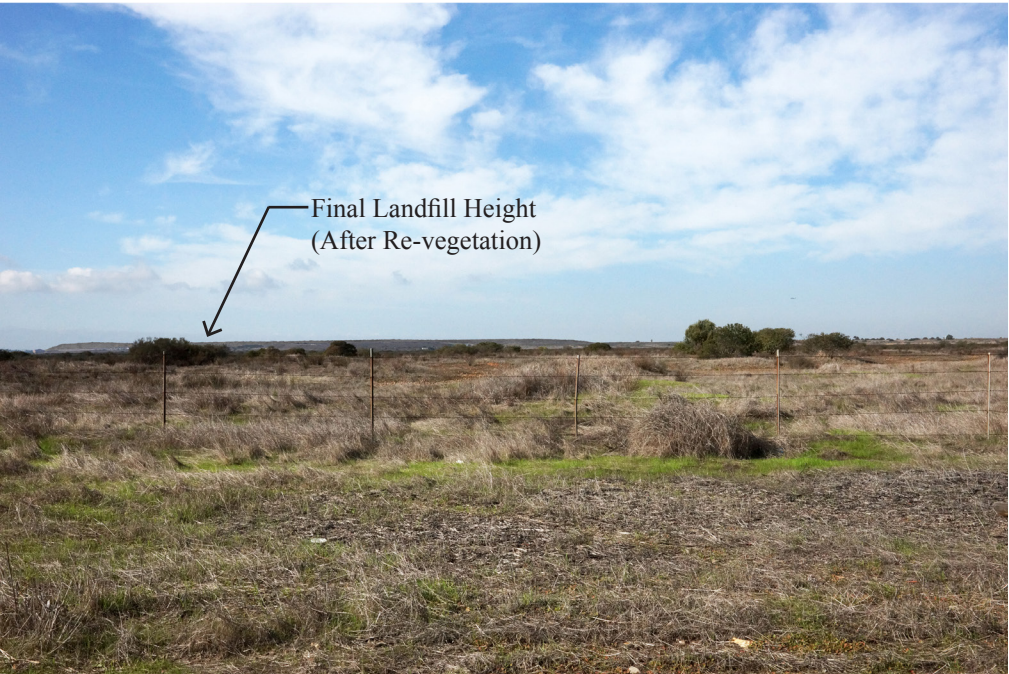
Figure 3.5-6
Visual Simulation at KOP #12
Traveler View at SR-52/SR-163 Interchange

KOP #12 Existing View

KOP #12 Visual Simulation of Final Project (Before Re-vegetation)

KOP #12 Visual Simulation of Final Project (After Re-vegetation)

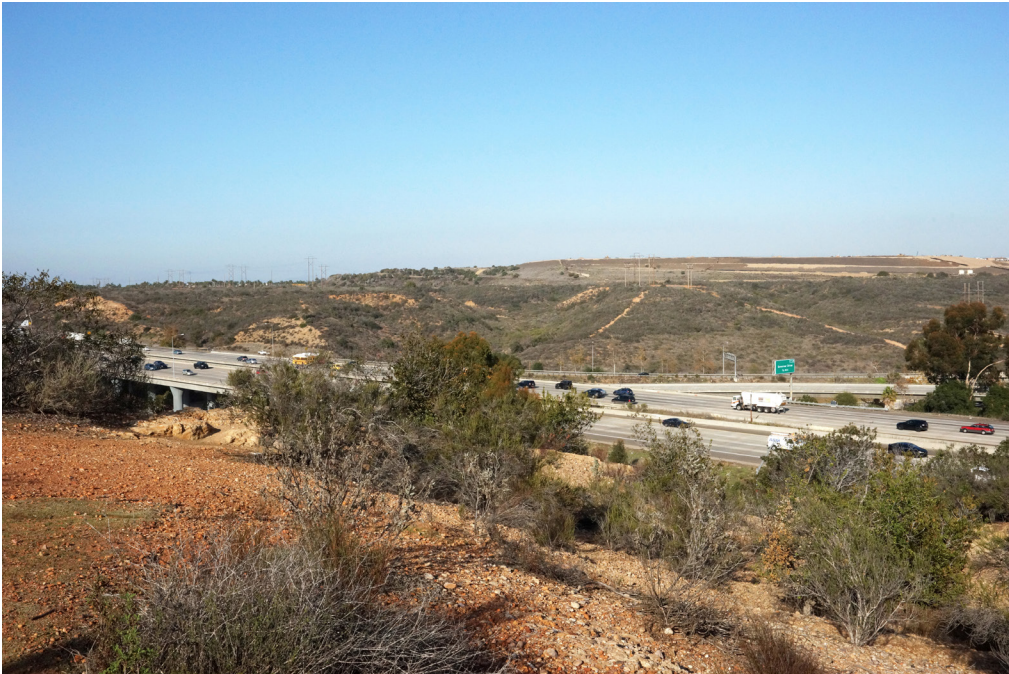
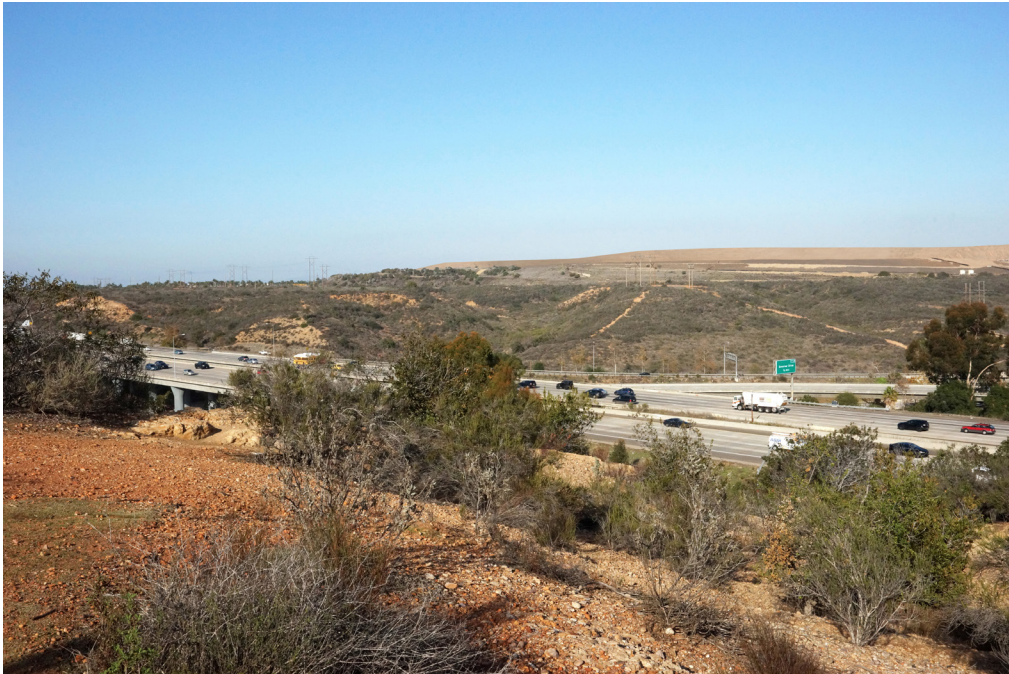
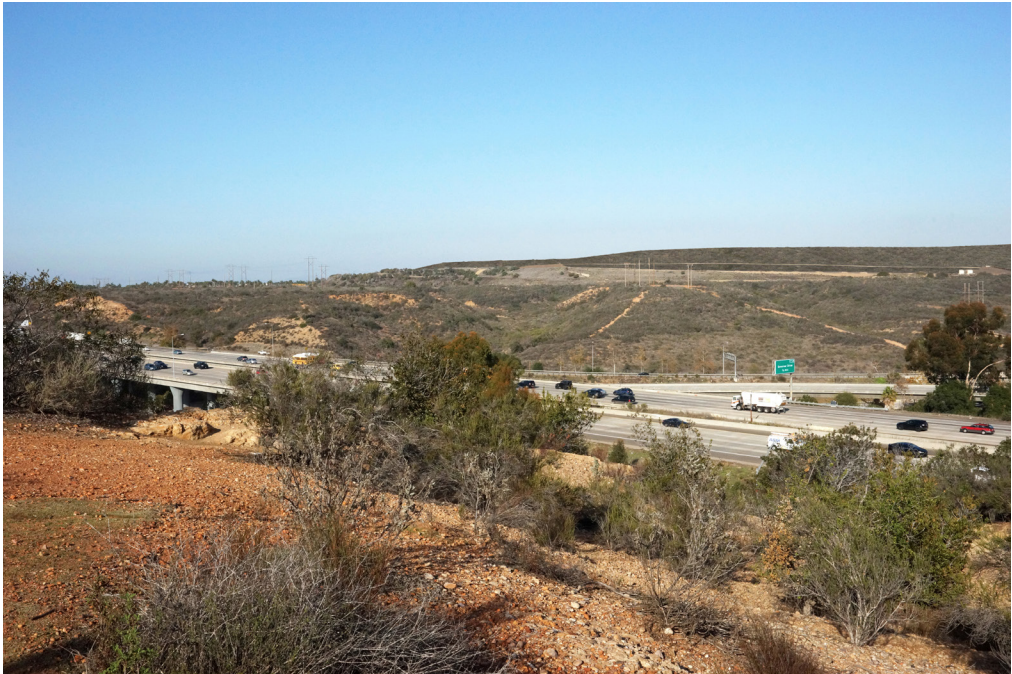
Figure 3.5-7
Visual Simulation at KOP #13
Hiker view from Marian Bear Memorial Park

KOP #13 Existing View

KOP #13 Visual Simulation of Final Project (Before Re-vegetation)

KOP #13 Visual Simulation of Final Project (After Re-vegetation)
