## INDIVIDUAL BIOLOGICAL ASSESSMENT REPORT

| <b>Site Name/Facility:</b> | Auburn Creek Channel |
| <b>Master Program Map No.:</b> | 70 and 76 |
| <b>Date:</b> | March 7, 2018 |

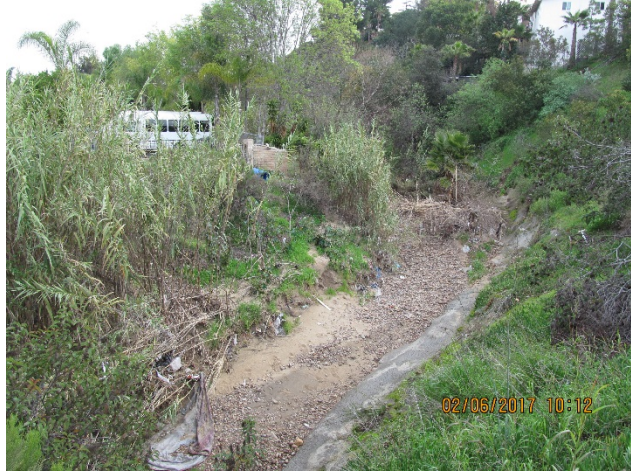
**PHOTO 1 NOTES:**

Map 76, Reach 1, looking upstream from the near the downstream end (2/6/17).

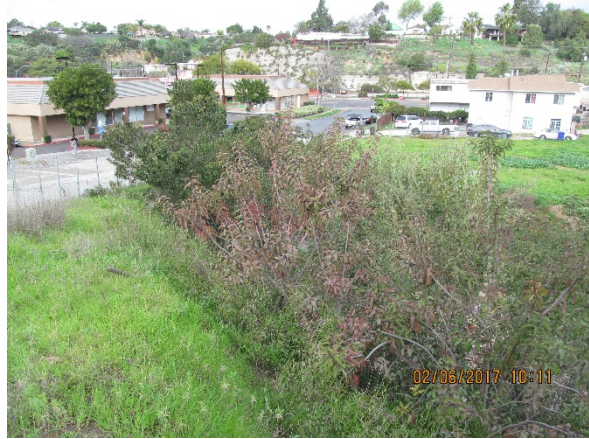
**PHOTO 2 NOTES:** Map 76, Reach 1, looking across the maintenance area at the access and staging areas (2/6/17).

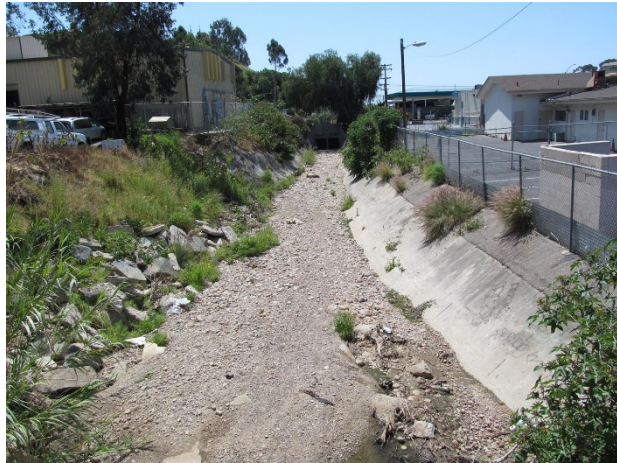
**PHOTO 3 NOTES:**

Map 70, Reach 5, looking downstream from the upper end (4/10/17).

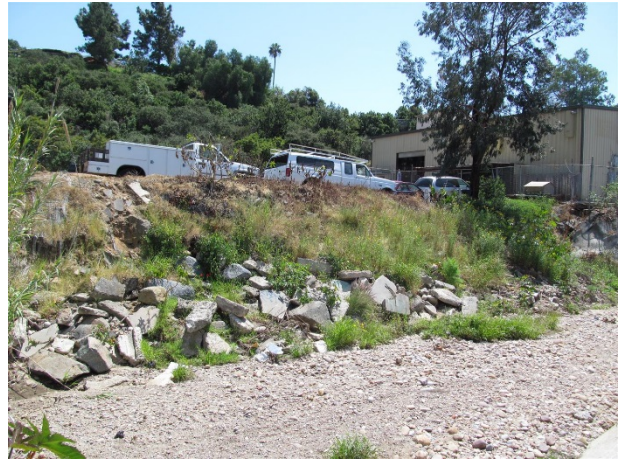
**PHOTO 4 NOTES:**

Map 70, Reach 5, looking southeast at the access area (4/10/17).

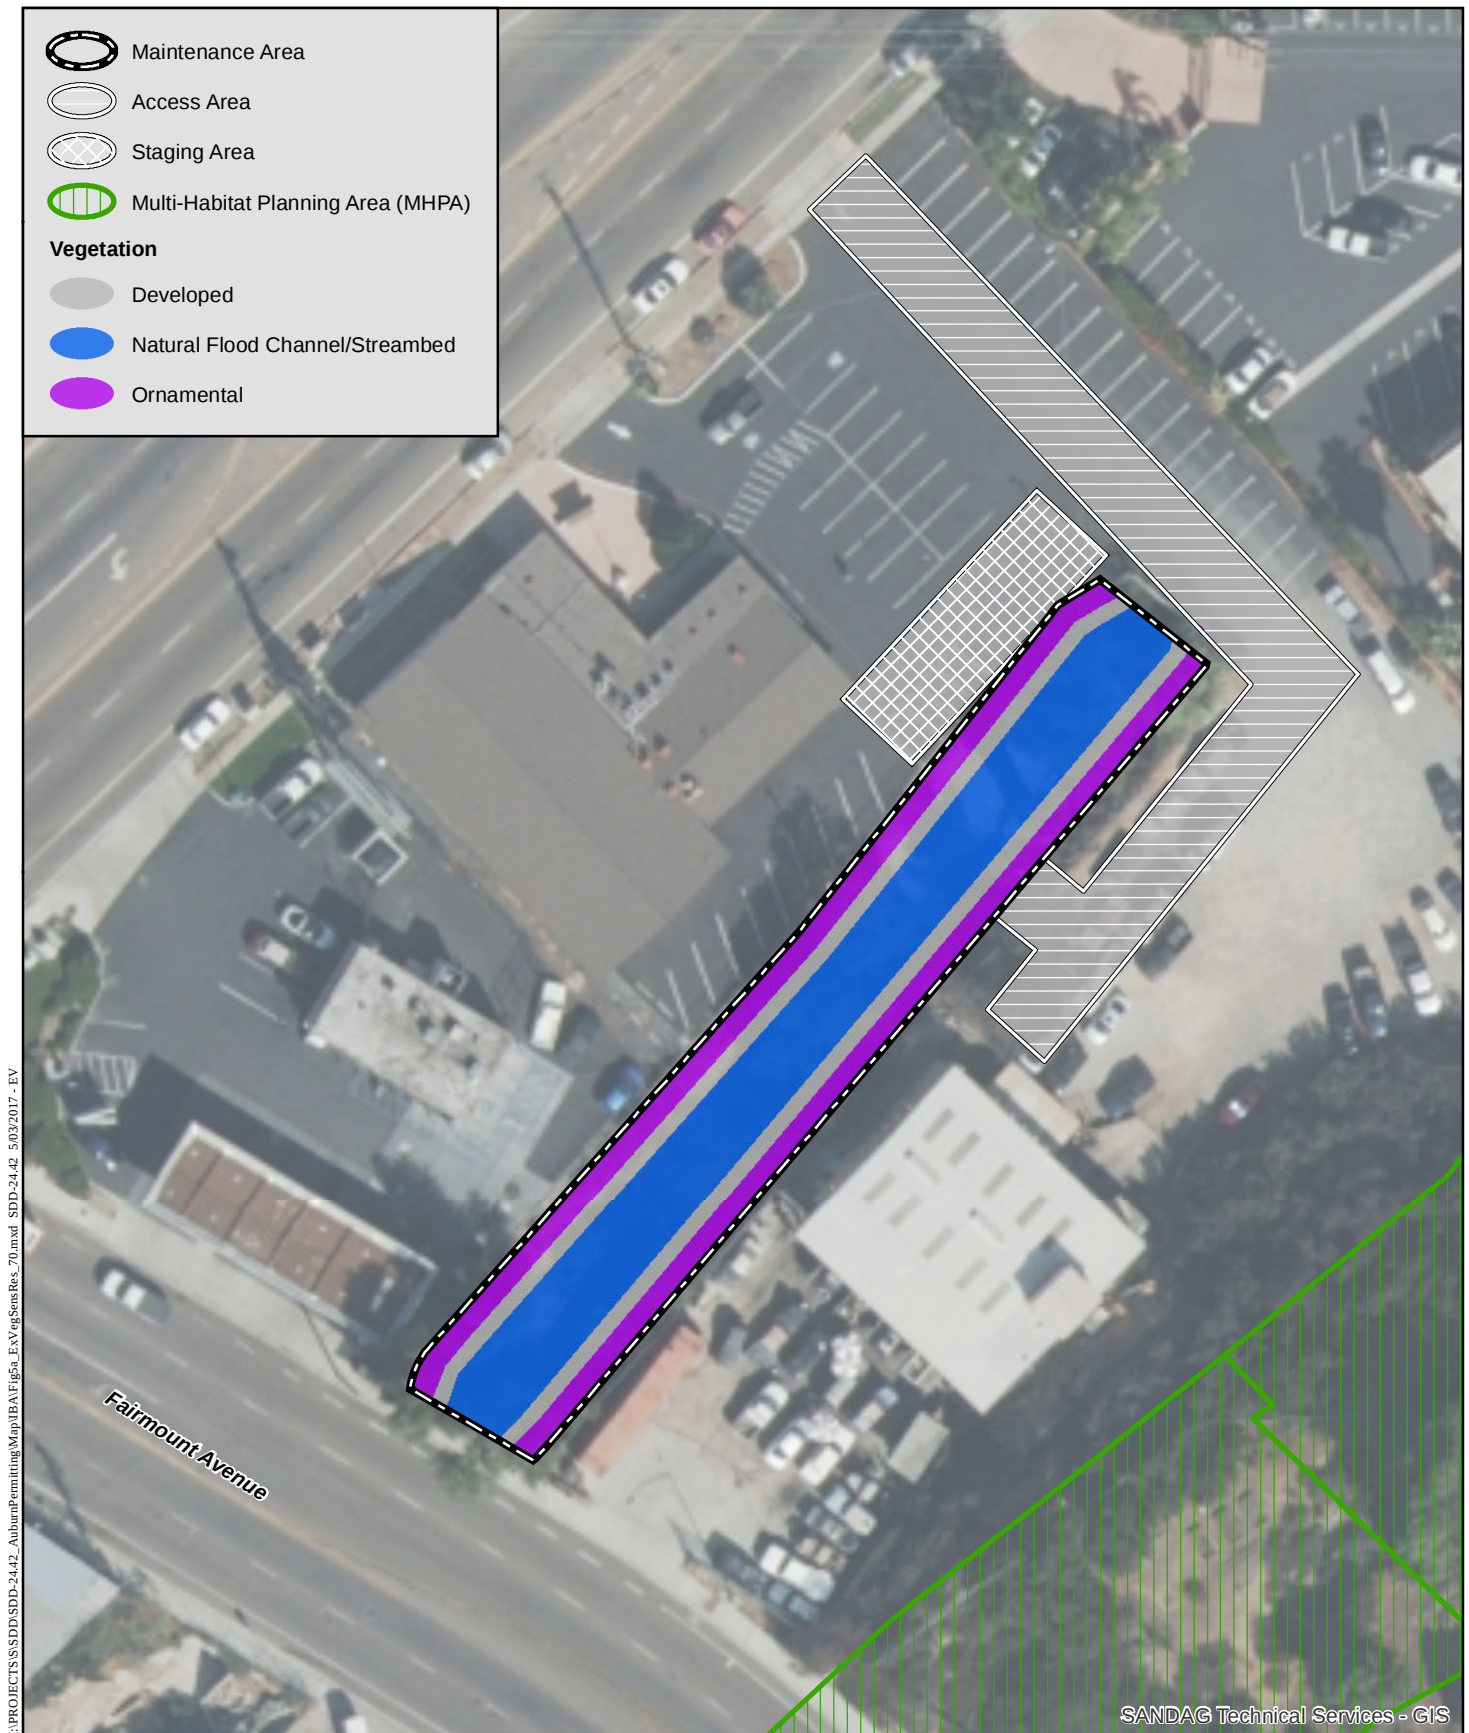
**Existing Vegetation and Sensitive Biological Resources, Auburn Creek Channel – Map 70/Reach 5**

Reach 5 has earthen-bottom and primarily concrete-lined banks, with a small section of one bank being partly earthen with rip-rap. The maintenance boundary is 0.24-acre composed of natural flood channel/streambed, ornamental, and developed. The staging and access areas, totaling 0.19 acre, are located just outside of Reach 5 and consist of a 0.15-acre access area between Home Avenue and the channel, and a 0.04-acre staging area in the uplands surrounding the

channel. This work area occurs within a developed area. Existing vegetation communities/land cover types within Reach 5 are described below.

Unvegetated portions of the earthen-bottomed channel are mapped as natural flood channel/streambed. Occasional plants are present in these areas; however, these areas are largely devoid of vegetation.

Ornamental/non-native vegetation grows along the margins of the maintenance area in Reach 5. This vegetation community is made up of predominantly non-native species, including horticultural plants, castor bean (*Ricinus communis*) and acacia (*Acacia* sp.).

Developed land includes the concrete-lined bank(s) of Reach 5 (0.05 acre), the access area between Home Avenue and the maintenance area (0.15 acre), and a staging area north of Auburn Creek (0.04 acre). Scattered individuals of upland weeds are present but the developed land is largely unvegetated.

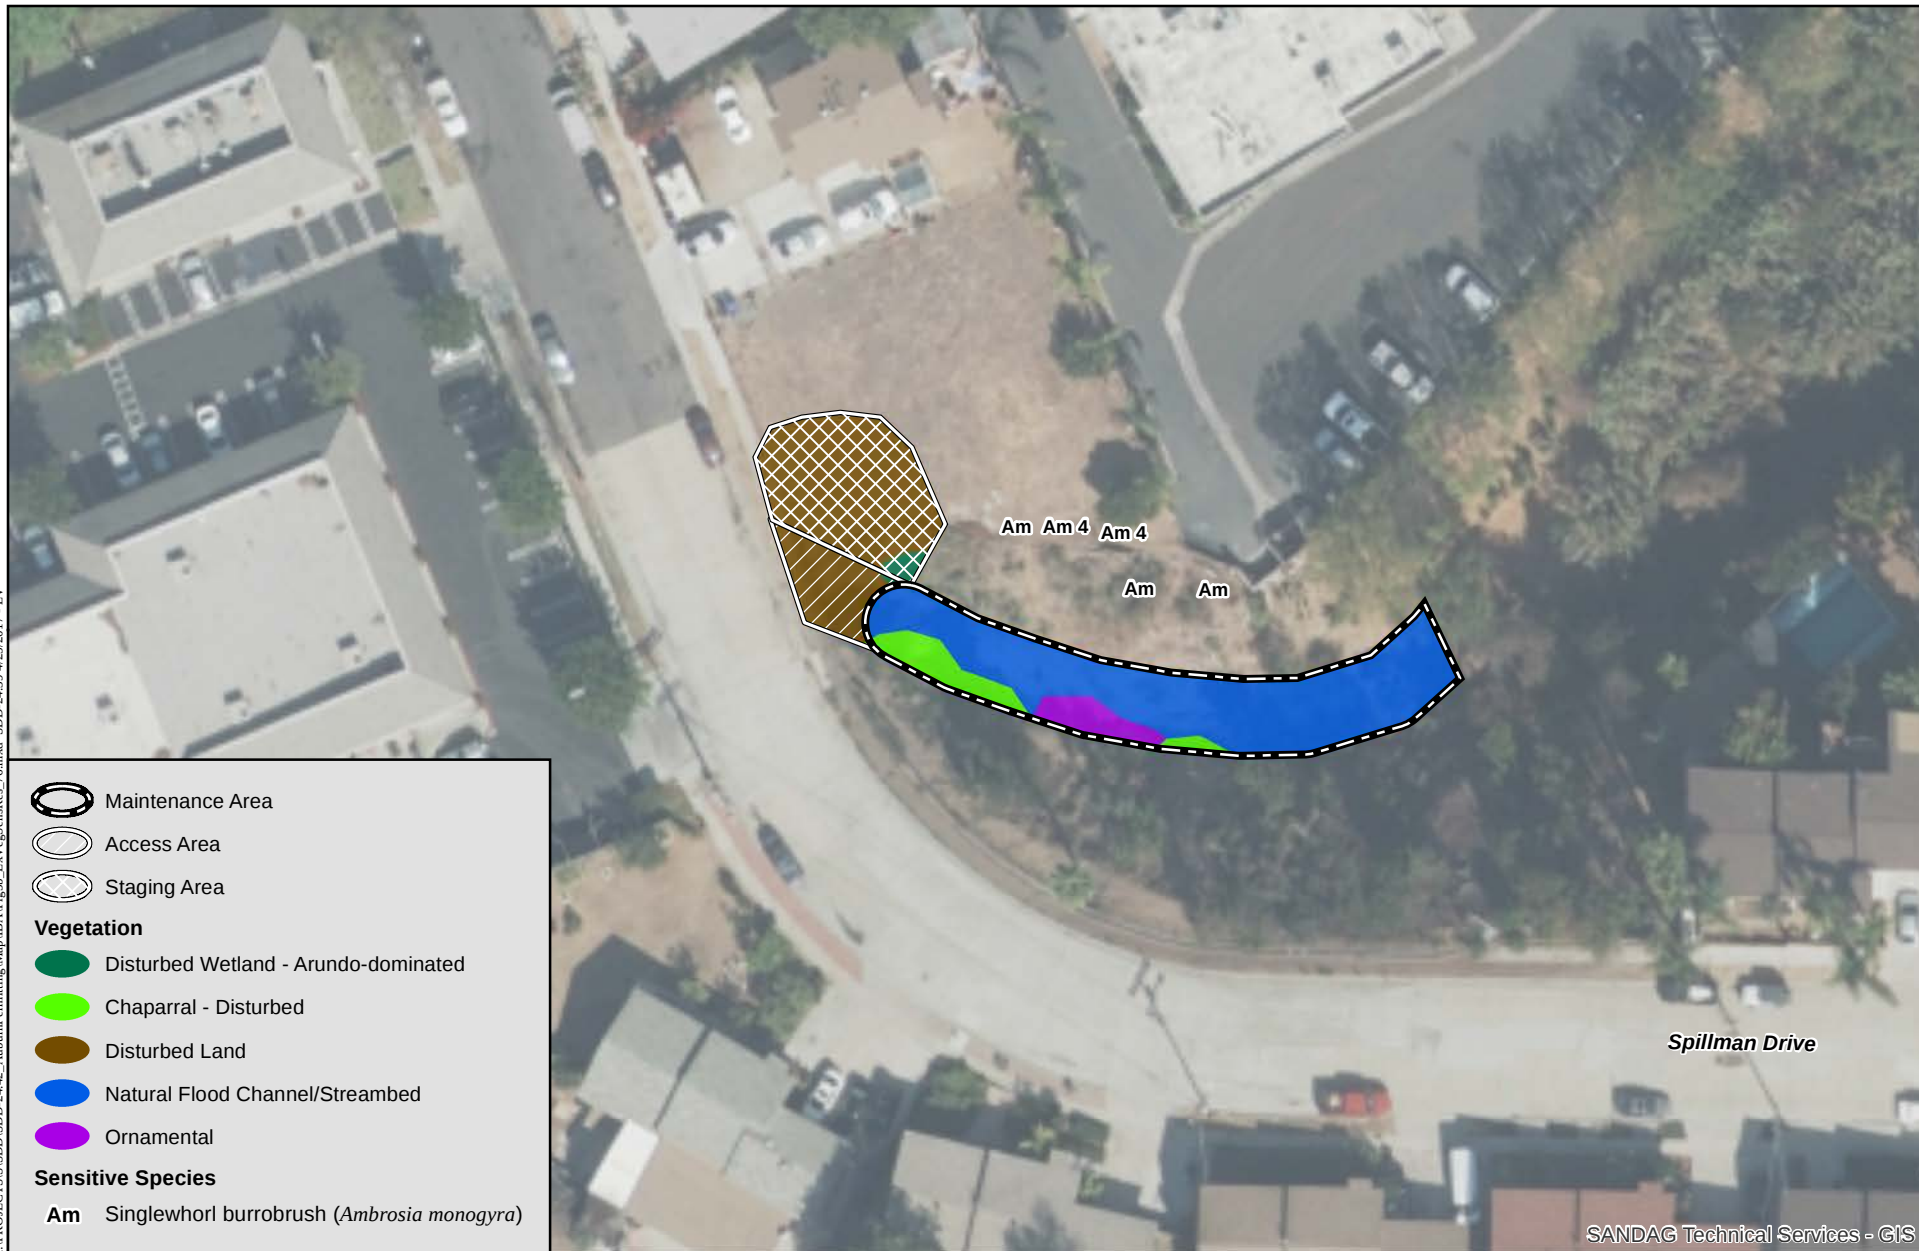
## Existing Vegetation and Sensitive Biological Resources, Auburn Creek Channel – Map 76/Reach 1

Reach 1 has an earthen-bottom and one concrete-lined bank. Most of the 0.07-acre maintenance area is unvegetated, but the work area overlaps disturbed chaparral and ornamental vegetation along the southern bank. The staging and access areas are located just outside of Reach 1, and consist of a 0.01-acre access area at Spillman Drive and a 0.03-acre staging area adjacent to the maintenance area. These areas are primarily disturbed lands, with a small patch of disturbed wetland (arundo-dominated).

Unvegetated portions of the earthen-bottomed channel are mapped as natural flood channel/streambed. Occasional plants are present in these areas; however, these areas are largely devoid of vegetation.

This vegetation community occurs in one patch within the staging area and is dominated by giant reed. Castor bean was also observed within this area.

This vegetation community occurs along the southern boundary of the maintenance area and is characterized by large, isolated laurel sumac (*Malosma laurina*) shrubs and low growing hottentot-fig (*Carpobrotus edulis*). Other shrubs present were toyon (*Heteromeles arbutifolia*), broom baccharis (*Baccharis sarothroides*), blue elderberry (*Sambucus nigra* ssp. *caerulea*), Indian fig (*Opuntia ficus-indica*), lemonadeberry (*Rhus integrifolia*), and fuschia-flowered gooseberry (*Ribes speciosum*).

Ornamental/non-native vegetation grows in a small patch along the southern bank of Auburn Creek, in Reach 1. This vegetation community is composed of predominantly non-native species, including horticultural shrubs and trees, hottentot-fig, fennel (*Foeniculum vulgare*), cheeseweed (*Malva parviflora*), smilo grass (*Stipa miliacea*), nasturtium (*Tropaeolum majus*), Russian thistle (*Salsola tragus*), poison oak (*Toxicodendron diversilobum*), and buckwheat (*Eriogonum fasciculatum*).

Disturbed land makes up most of the staging area and the entire access area. This vegetation community is composed primarily of non-native species, including hottentot-fig, garland daisy (*Glebionis coronaria*), green-stem filaree (*Erodium moschatum*), and cheeseweed.

No sensitive plant species were observed within the maintenance, access, or staging areas. One low-sensitivity plant species, singlewhorl burrobush (*Ambrosia monogyra*), was observed outside of the work area on Map 76 in Reach 1. Eleven individuals were observed on the northern bank of Auburn Creek (Figure 5b).
