## INDIVIDUAL HISTORIC ASSESSMENT REPORT

**Site Name/Facility:** 11000 Roselle St./11100 Flintkote Ave. Channel, Map No. 9 in PEIR

**Site Name/Facility:** Soledad Creek Channel, Map No. 11 in PEIR

**Site Name/Facility:** Soledad Creek Channel, Map No. 12 in PEIR

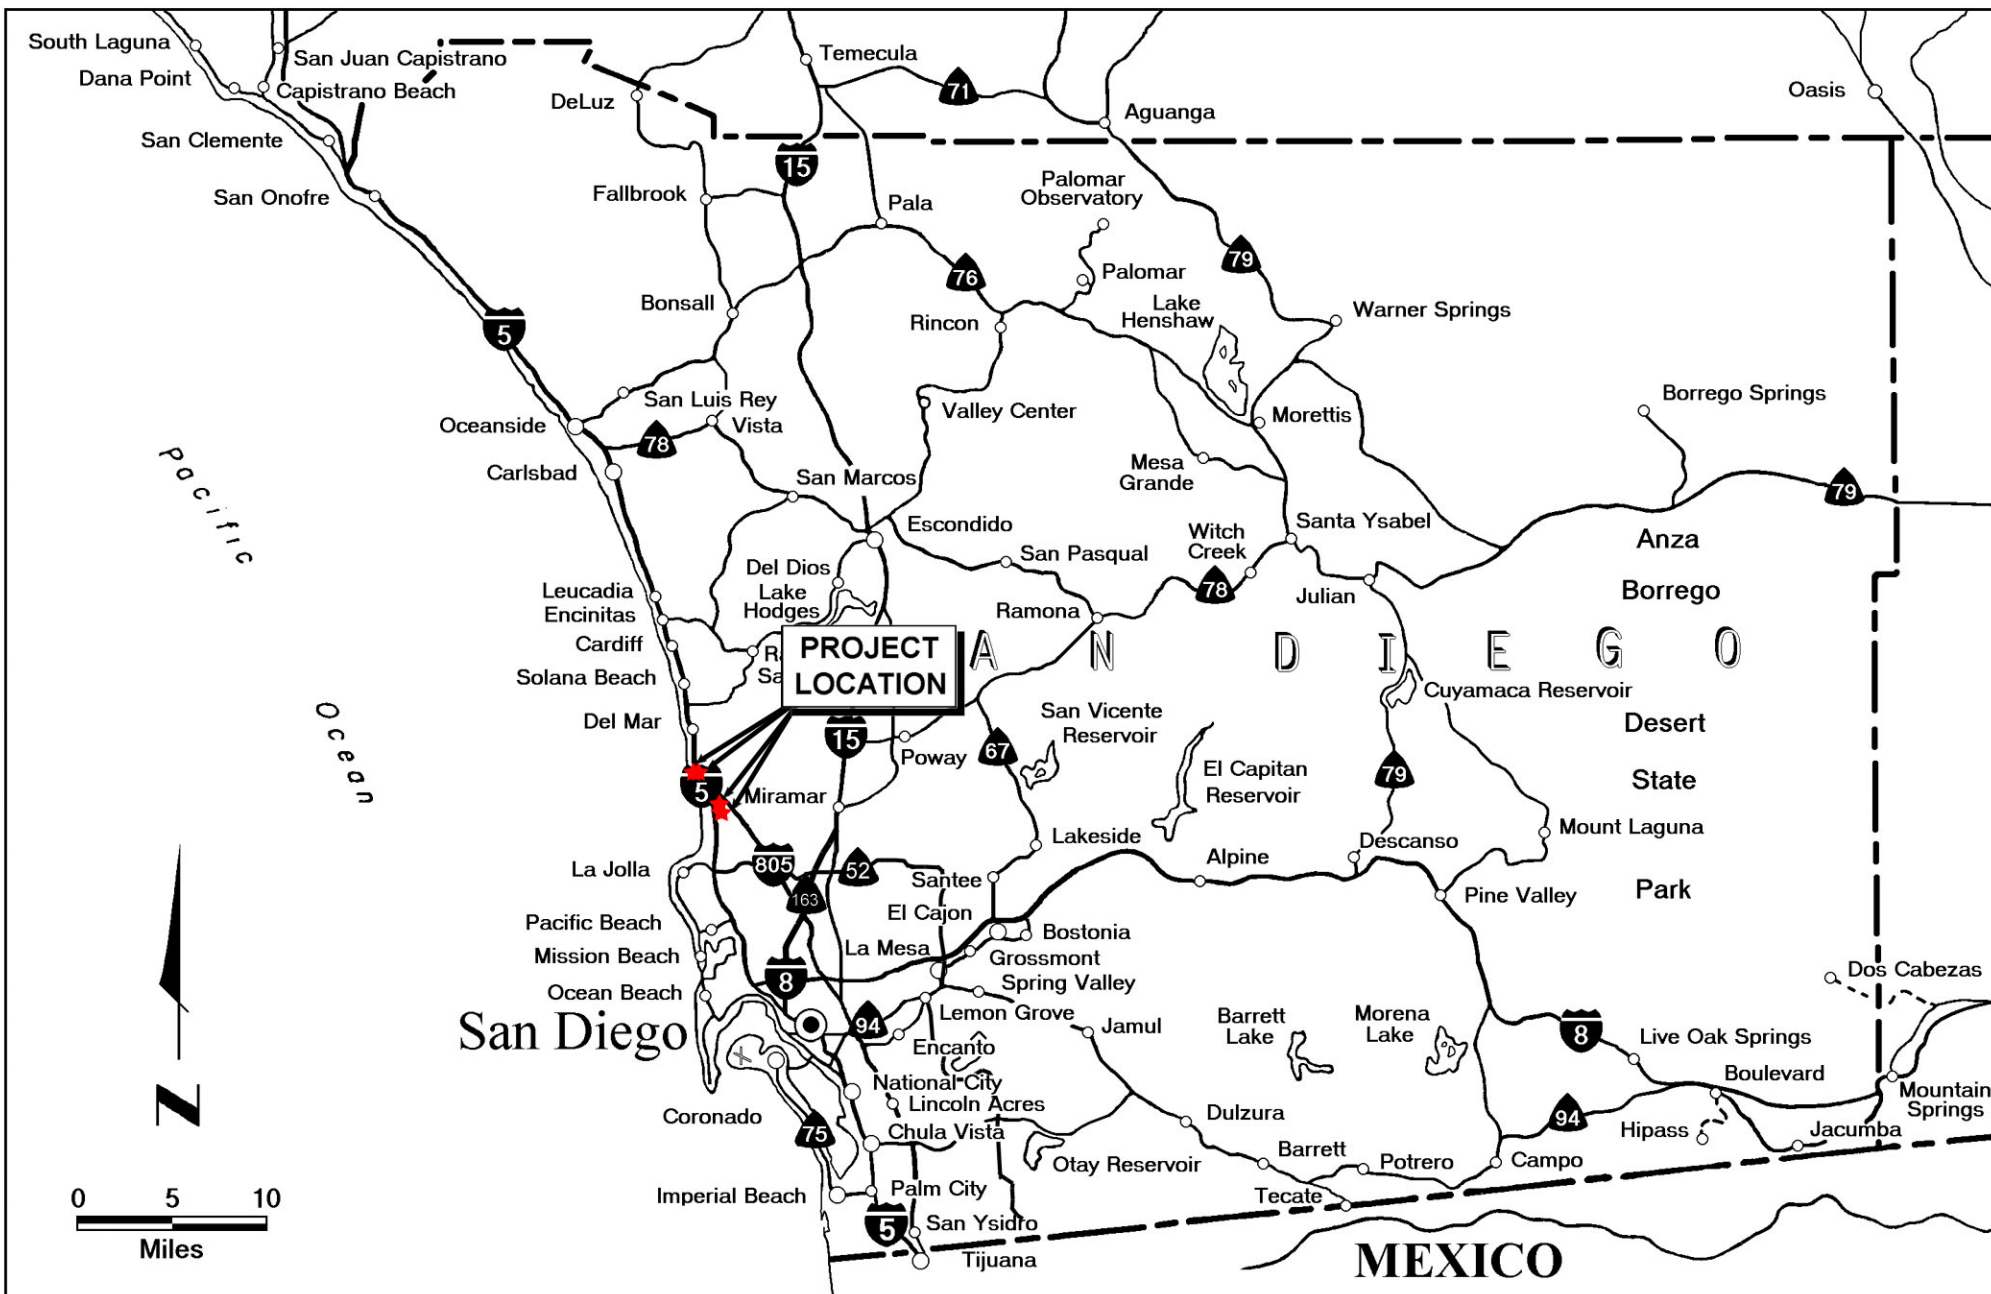
The channel runs directly through a business complex parking lot between Flintkote Avenue and Sorrento Creek, and is bisected by Roselle Street. The southeastern-most and northwestern-most ends of this channel, as well as the edges bisected by Roselle Street, have small landscaped lawns above them; however, the rest of channel is completely lined with concrete. Some vegetation grows within and along the sides of the channel, but this soil is on top of concrete. The location of the channel is shown in Figures 1 and 2. Figure 3 is an aerial photograph of the channel showing the Area of Potential Effects.

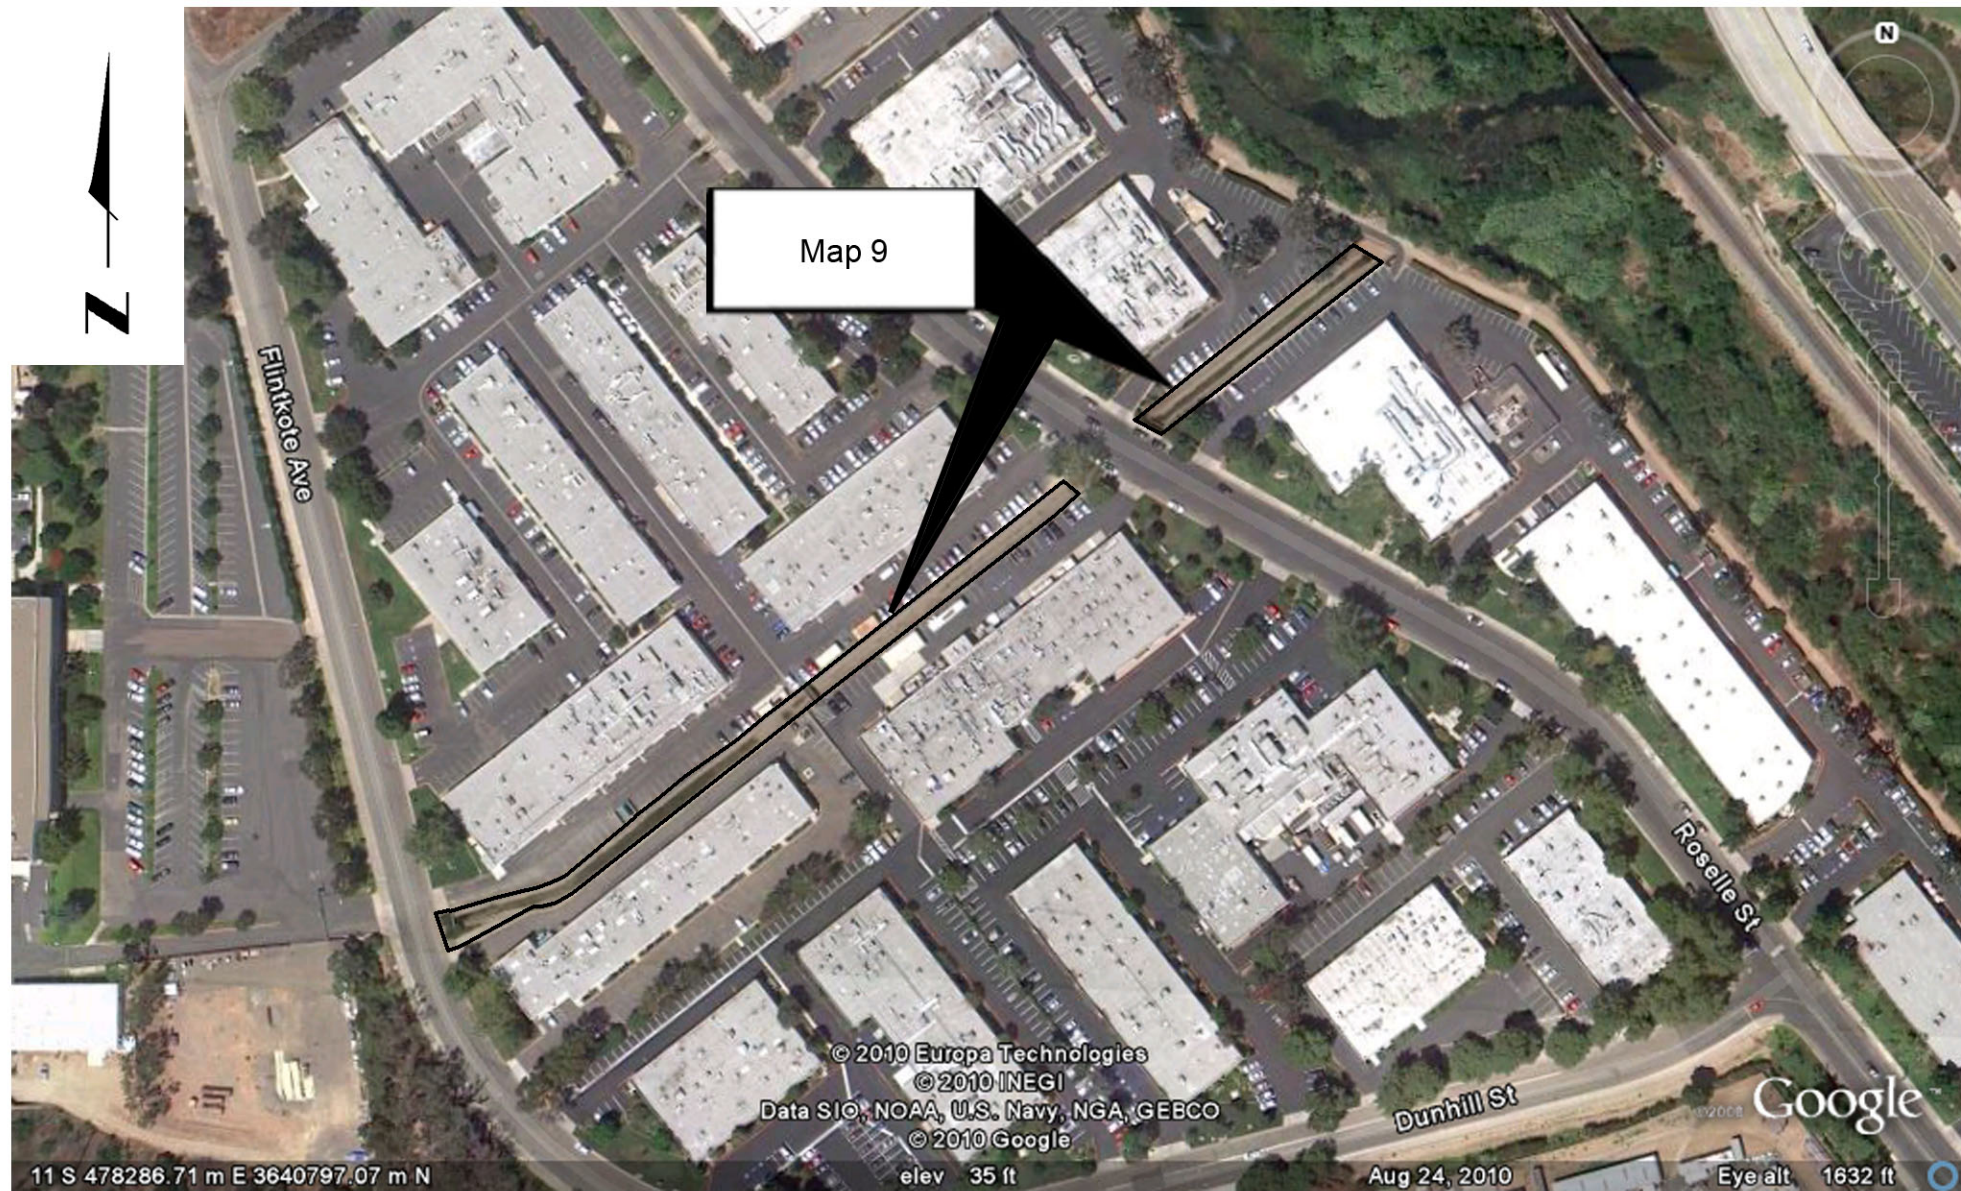
Figure 3

Area of Potential Effect

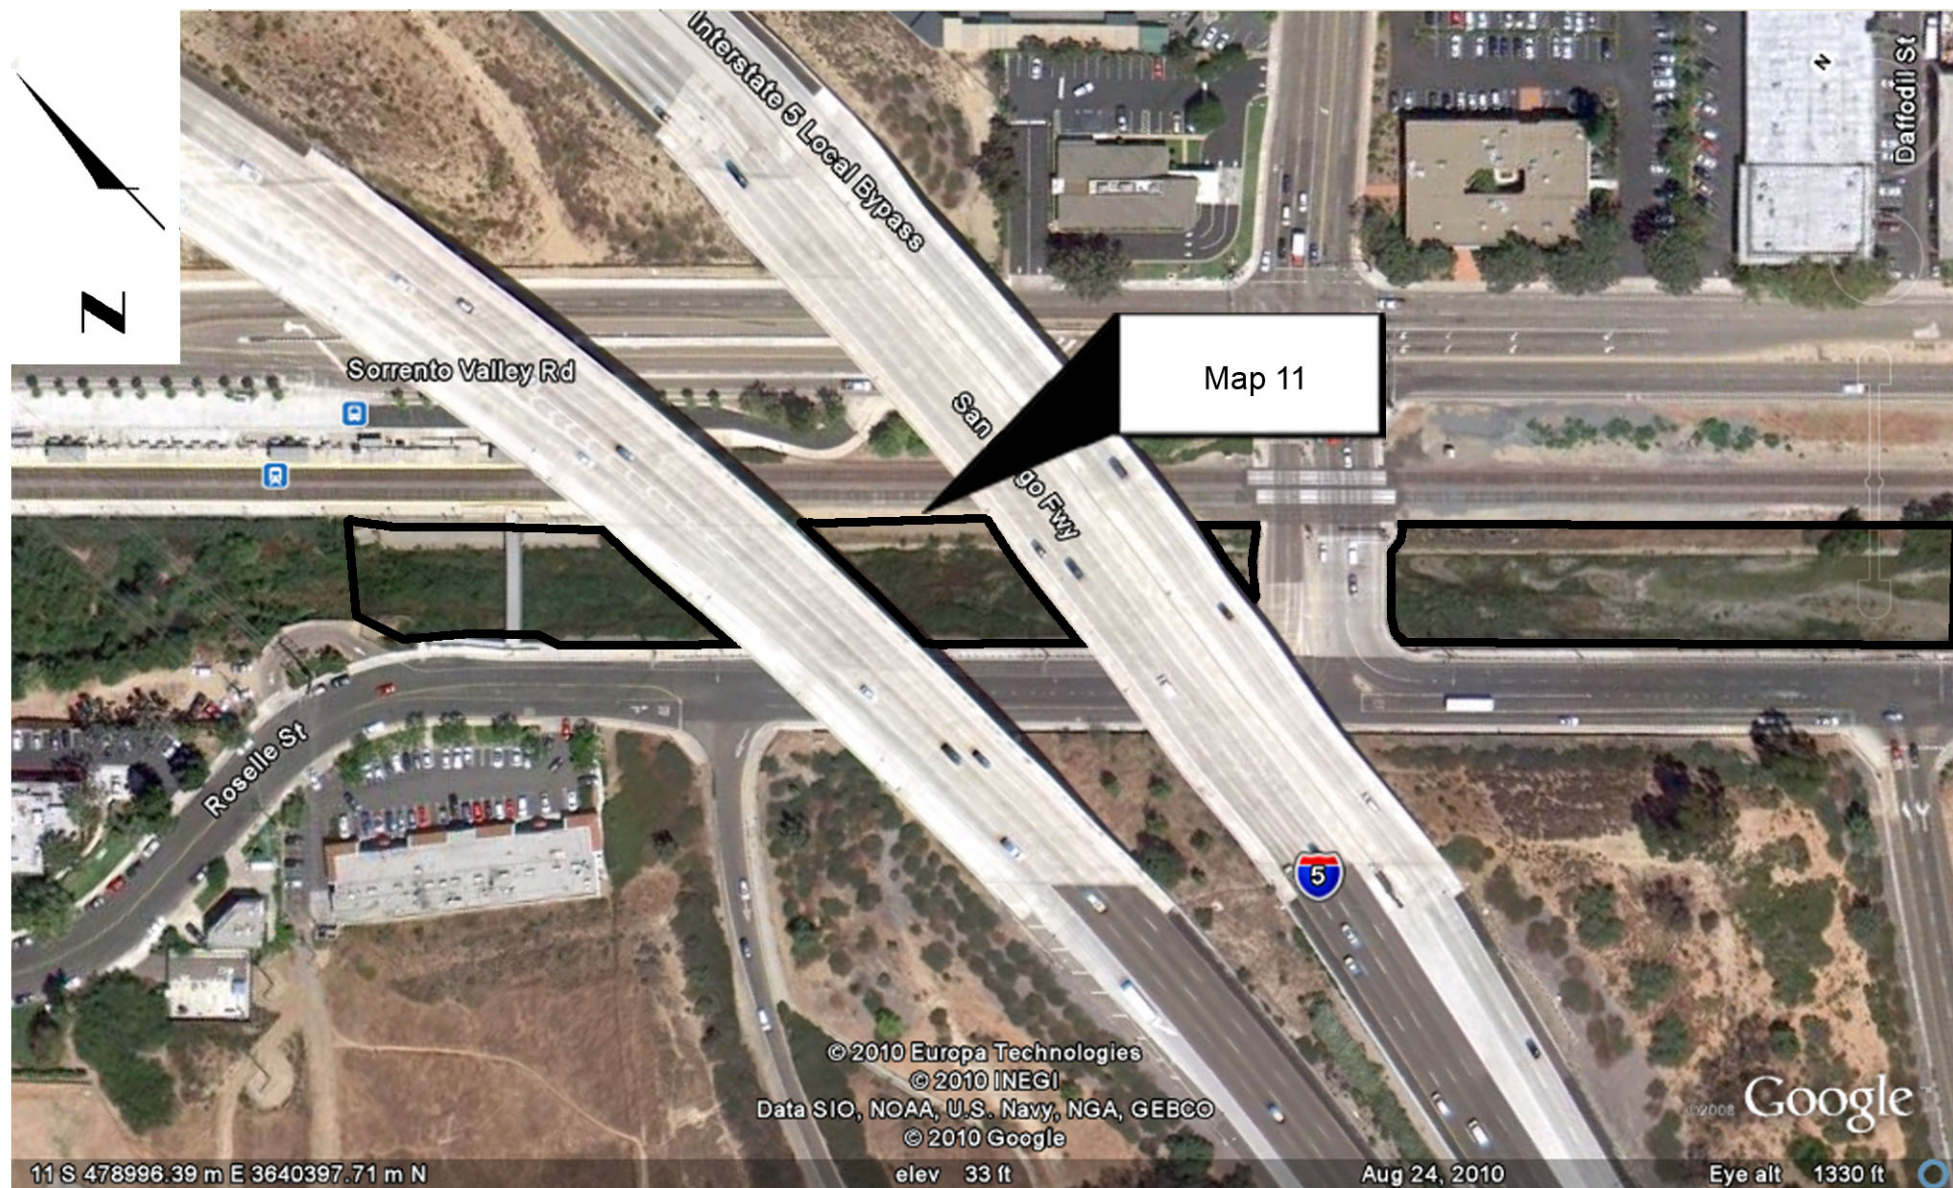
The surveyed portion of this map was a concrete-lined channel running parallel to the railroad tracks on the south side of Sorrento Valley Road. The southwestern bank is completely lined with concrete until it joins Roselle Street. The northeastern bank has a partially vegetated area with average to poor visibility, about 25 feet wide, between the concrete lining and the railroad tracks. The interior of the channel has very thick vegetation with no ground visibility. Map 11 is immediately north of Map 12. The location of the channel is shown in Figures 1 and 2. Figure 3 is an aerial photograph of the channel showing the Area of Potential Effects (APE).

Area of Potential Effect

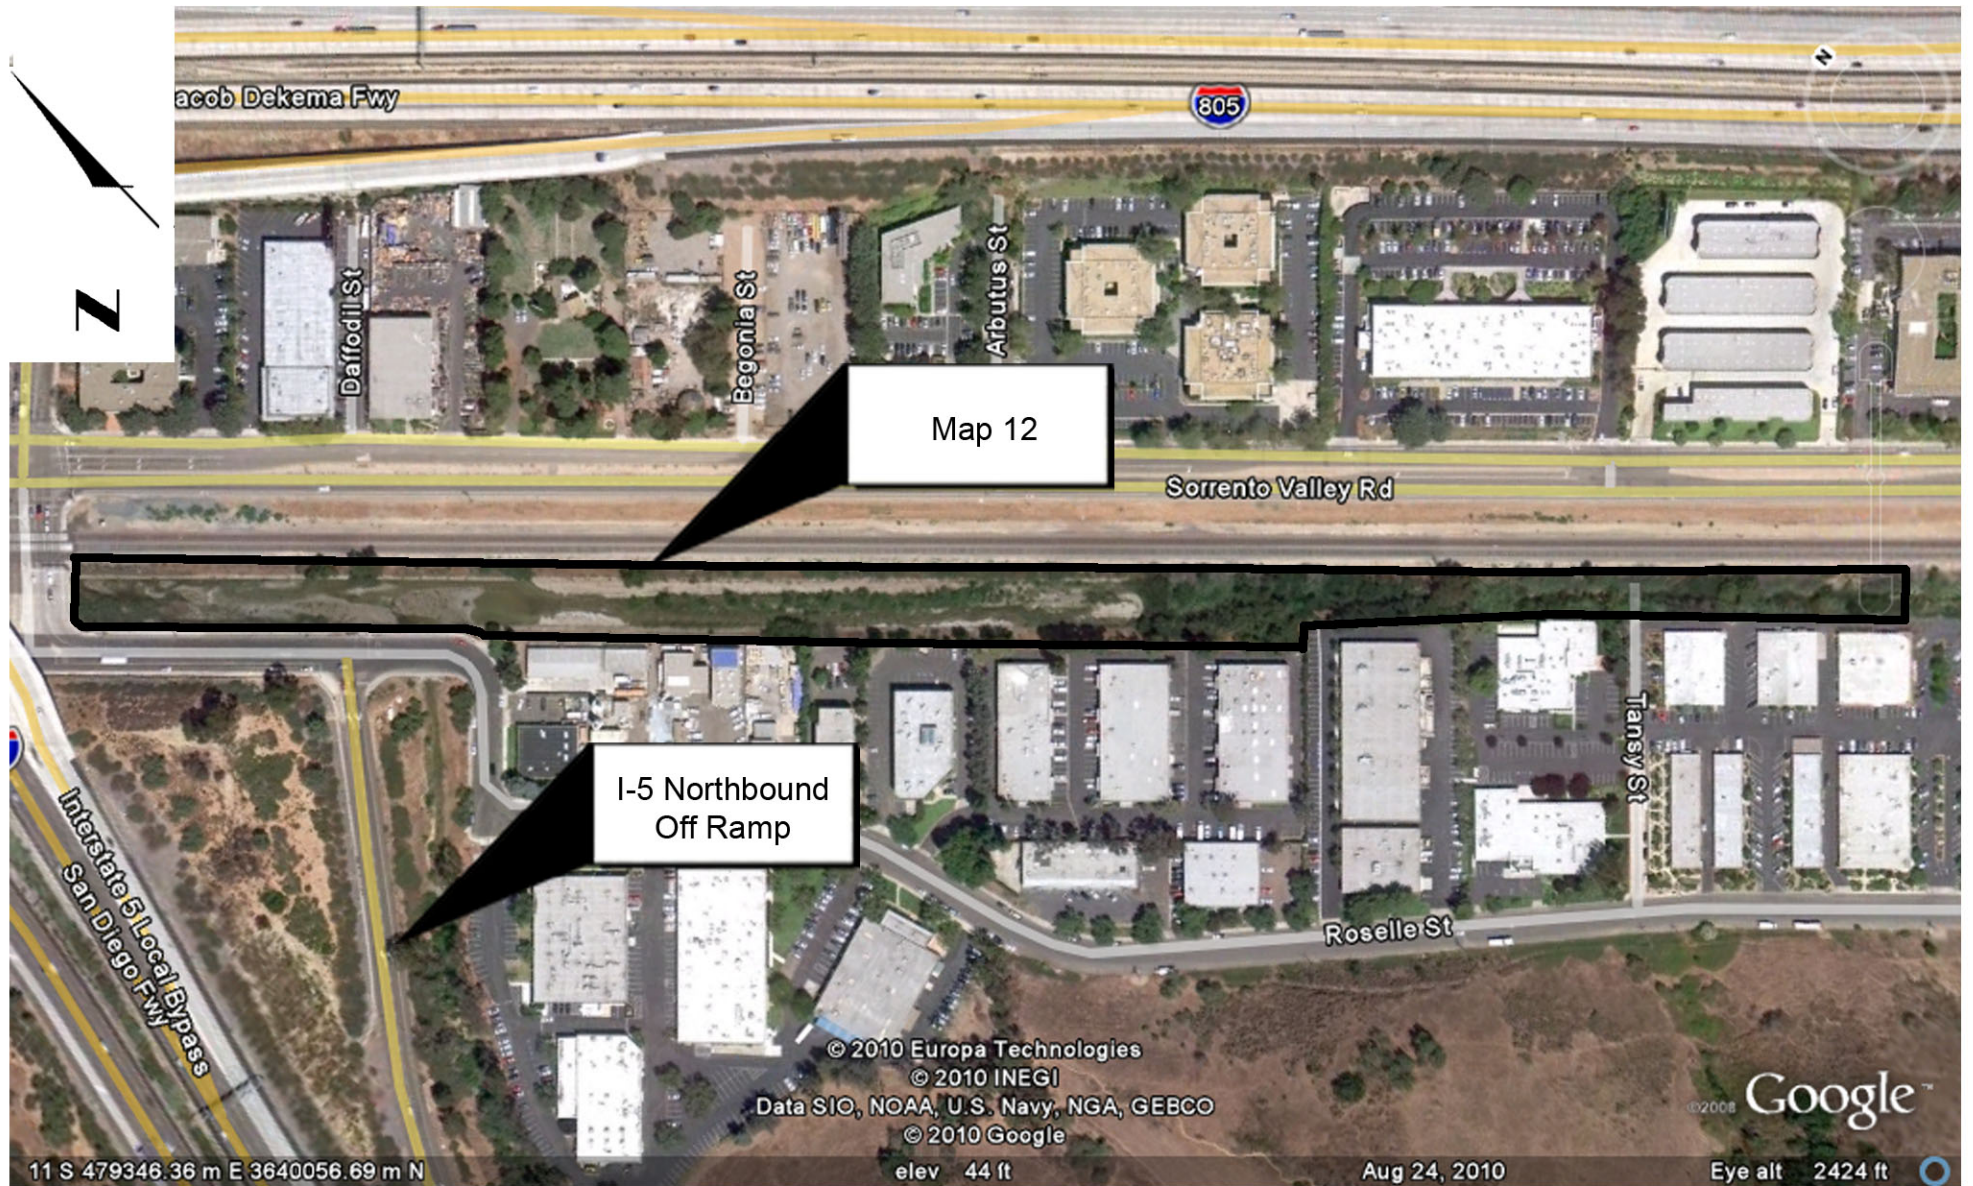
The second (southeastern) half of the channel is completely unlined and has very thick vegetation with zero visibility within the channel. The banks are much the same as the lined portion, except that the vegetation is much thicker. Nearly the entire length of the channel has vegetation within it. Map 12 is immediately adjacent to Map 11 (located to the northwest) and overlaps Map 13 (located to the southeast). The location of the channel is shown in Figures 1 and 2. Figure 3 is an aerial photograph of the channel showing the Area of Potential Effects (APE).

Area of Potential Effect
