WETLANDS ASSESSMENT MEMO

Subject **Wetland Assessment for University Community Plan PEIR**

University Community Plan Amendment Draft PEIR Wetland Memo

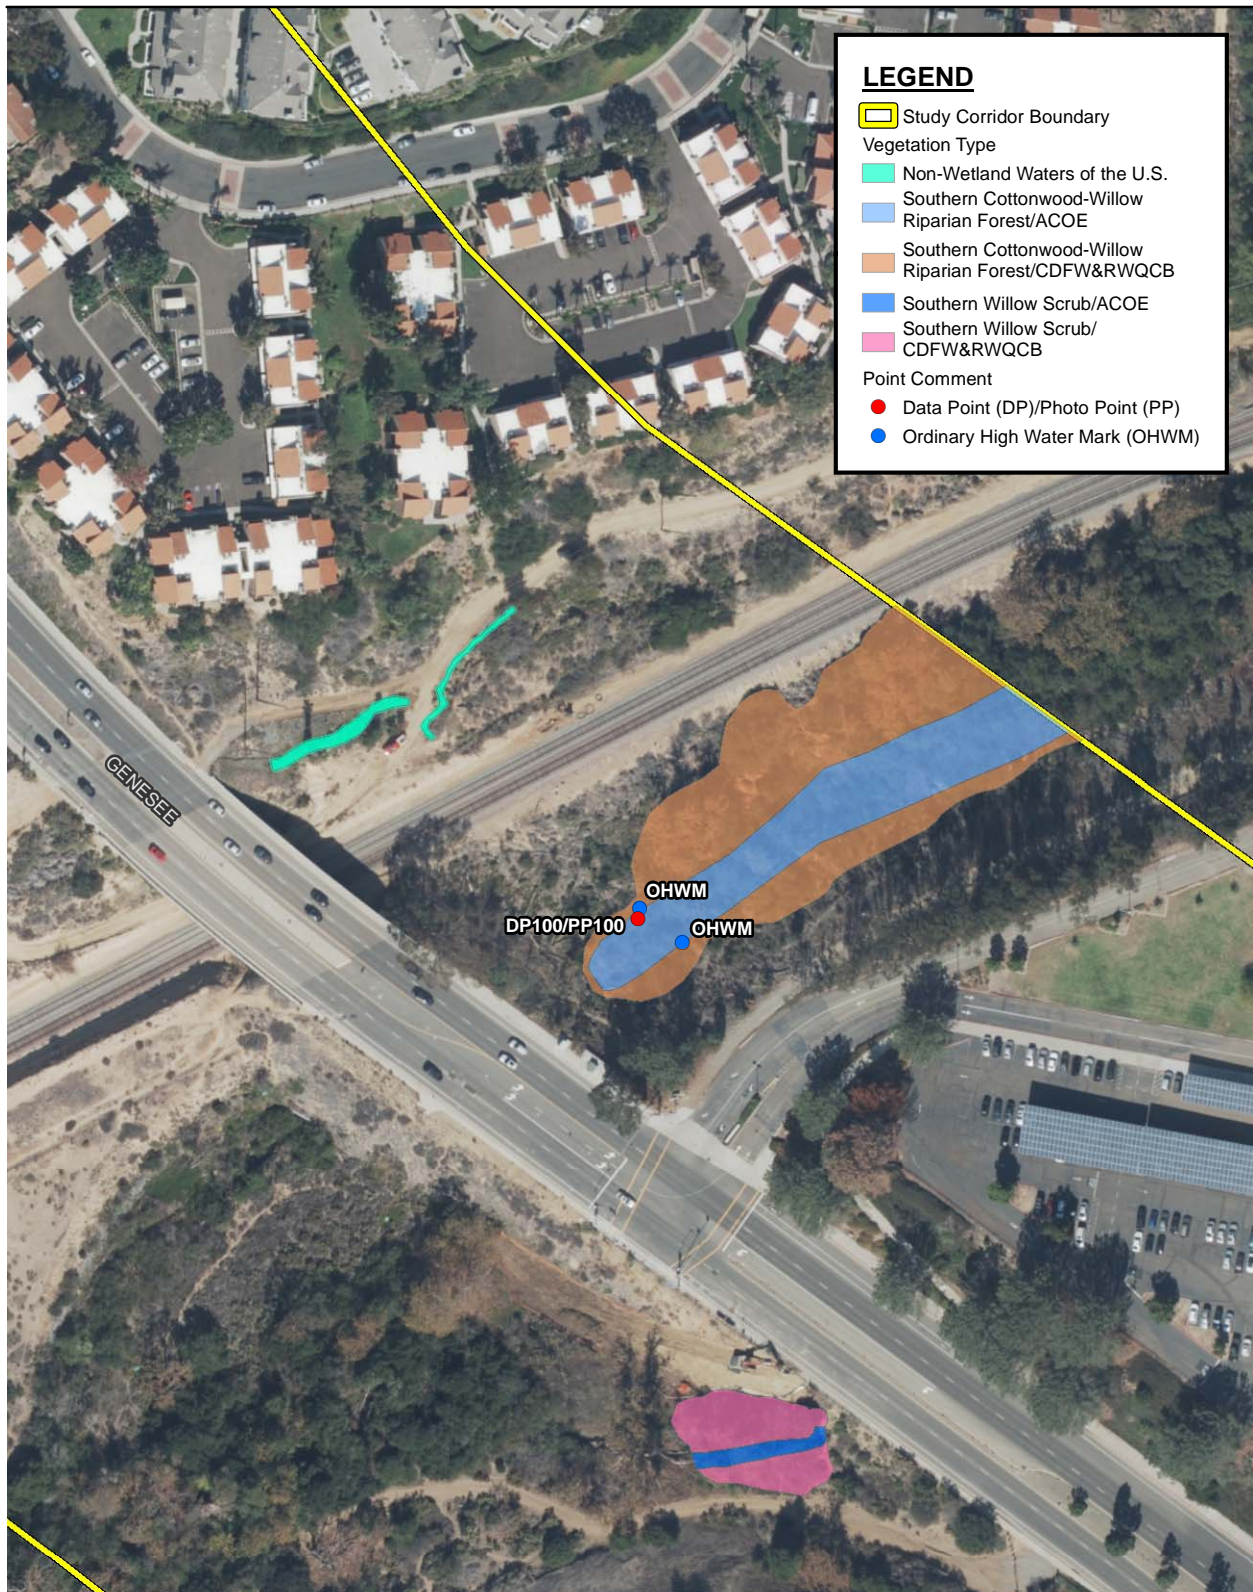
Figure 1
Potential Federal & State Jurisdictional Aquatic Resources
Genesee Avenue Corridor at Rose Canyon

Table 4 provides a summary of the jurisdictional areas. A total of 0.48 acre of federal jurisdictional waters (including potential wetlands); 1.33 acres of potential state jurisdictional waters (including potential wetlands and riparian habitat); and 1.33 acres of wetlands under City of San Diego's jurisdiction were identified within the survey area (Figure 4). Site conditions at the Genesee Avenue Corridor at Rose Canyon have not noticeably changed since the wetland delineation conducted by Merkel and Associates in 2004 as the results of the current assessment are consistent with the results of the previous delineation.

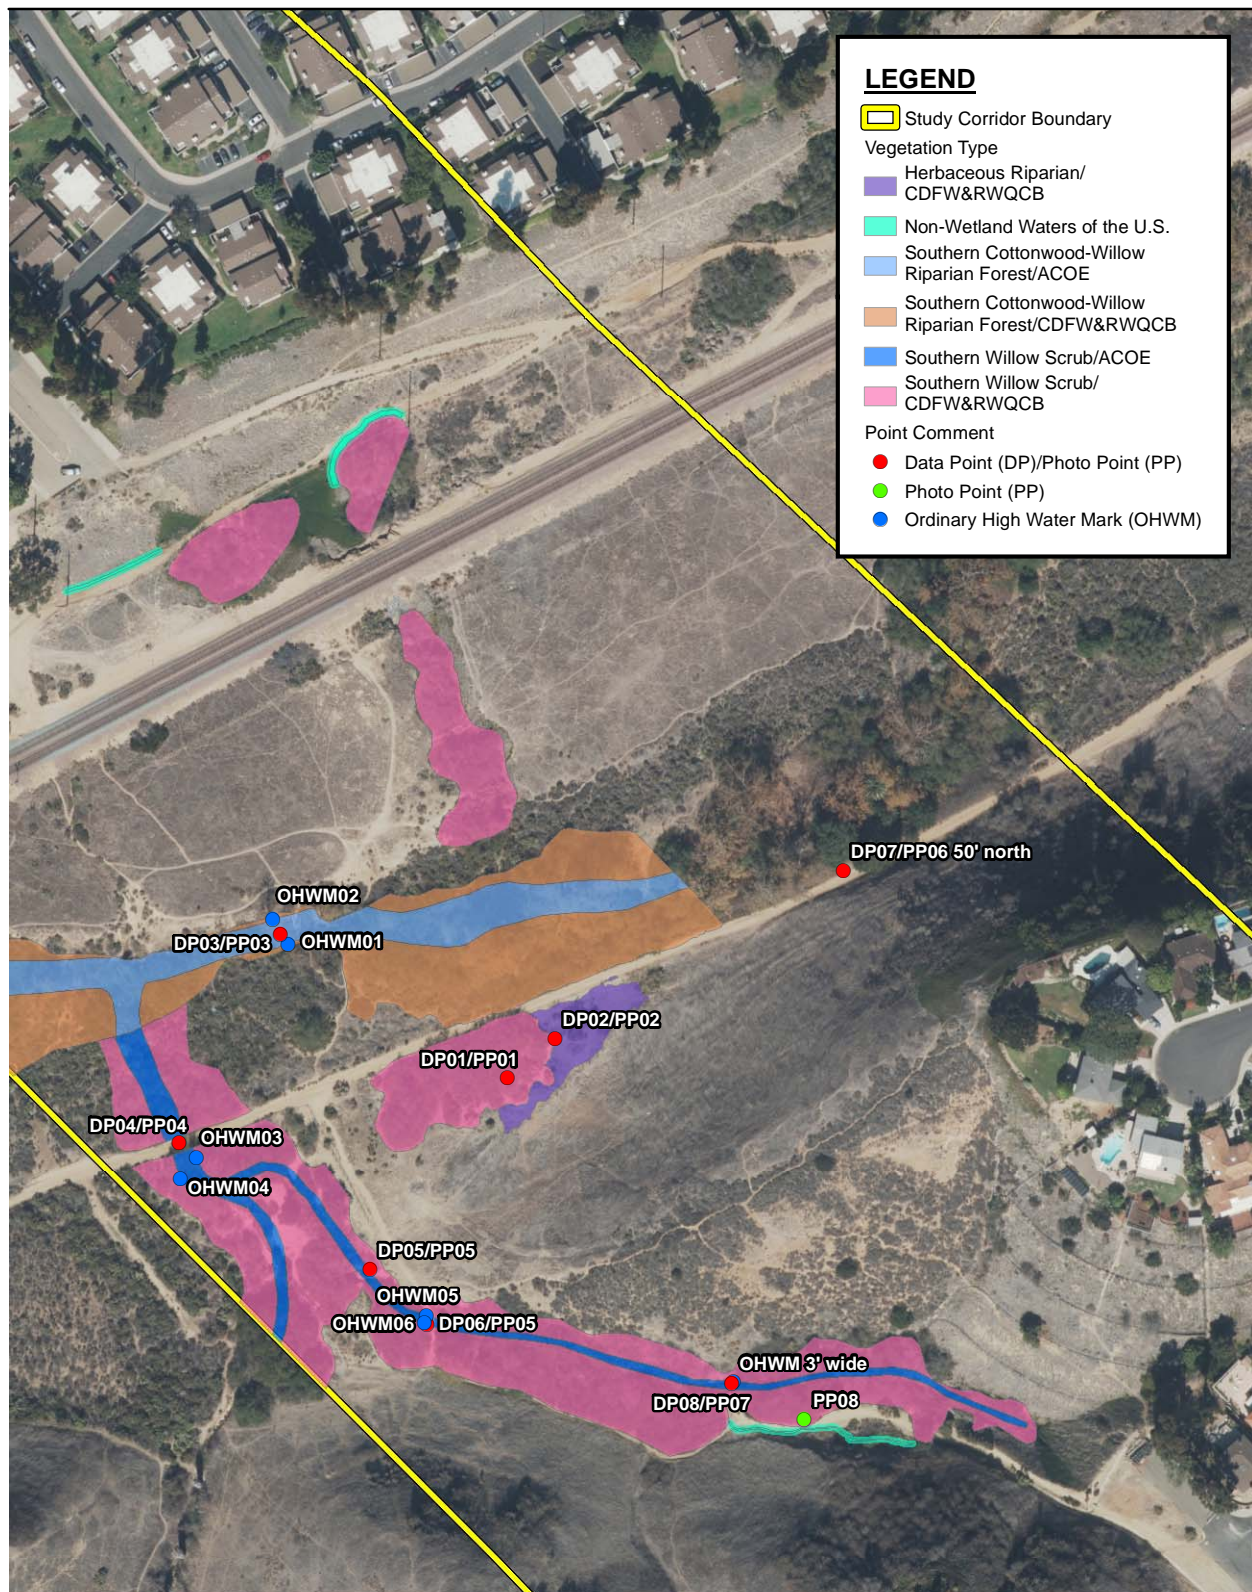
Figure 2
Potential Federal & State Jurisdictional Aquatic Resources
Regents Road Corridor at Rose Canyon

As shown in Table 4, there was a total of 1.06 acres of federal jurisdictional waters (including potential wetlands), 3.83 acres of potential state jurisdictional waters (including potential wetlands and riparian habitat), and 3.83 acres of wetlands under City of San Diego's jurisdiction identified within the survey area (Figure 5).

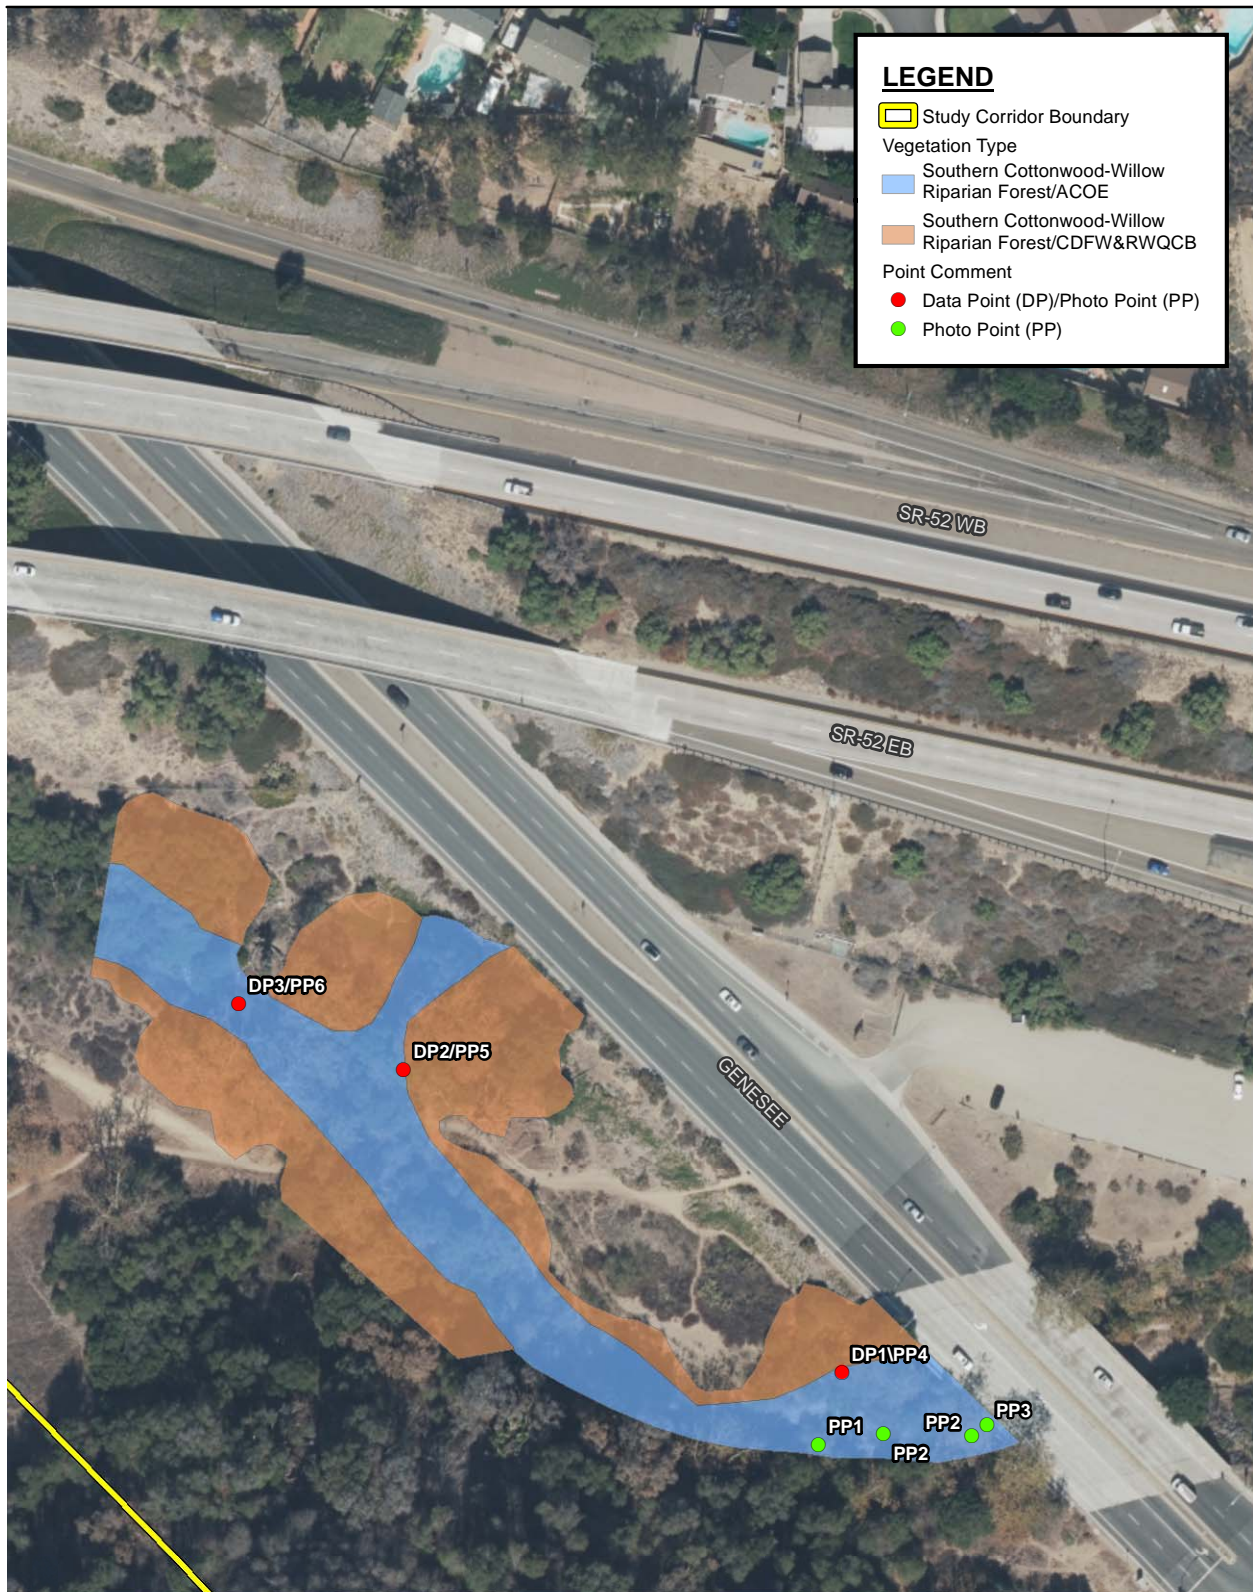
Figure 3
Potential Federal & State Jurisdictional Aquatic Resources
Genesee Avenue Corridor at San Clemente Canyon

As shown in Table 4, there were a total of 0.86 acre of federal jurisdictional waters (including potential wetlands), 1.88 acres of potential state jurisdictional waters (including potential wetlands and riparian habitat), and 1.88 acres of wetlands under City of San Diego's jurisdiction within the survey area (Figure 3).

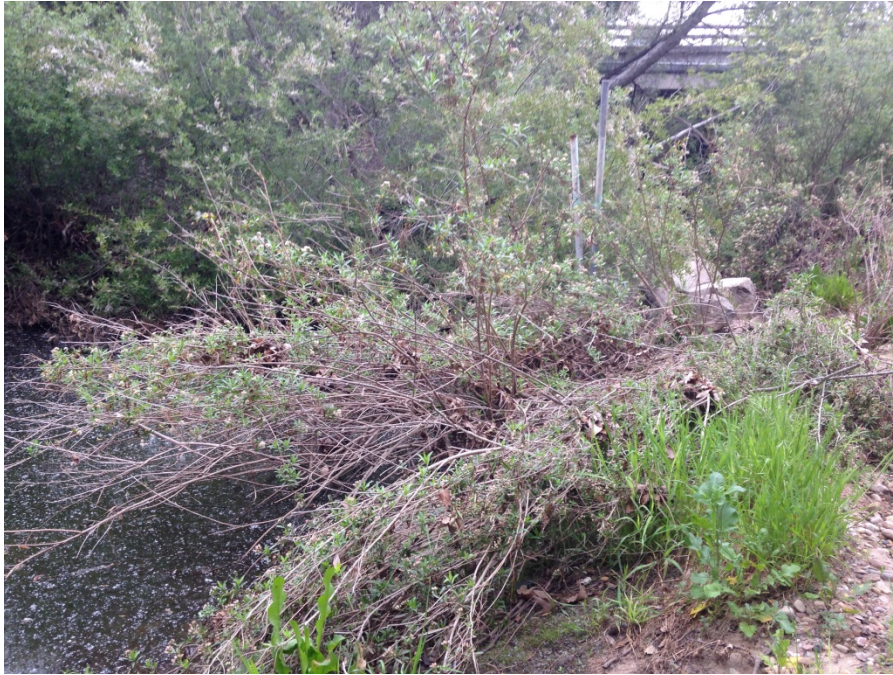
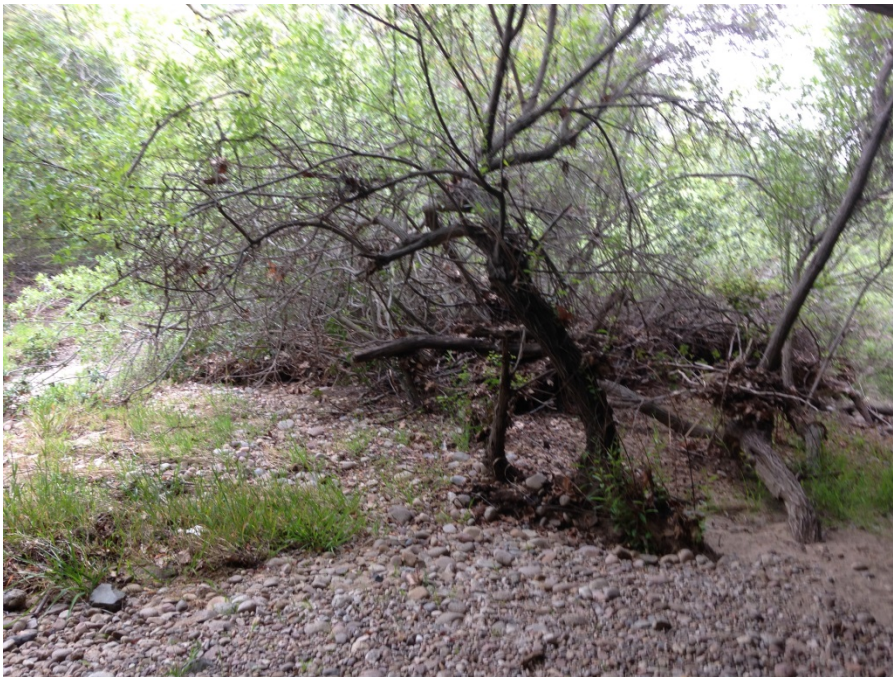
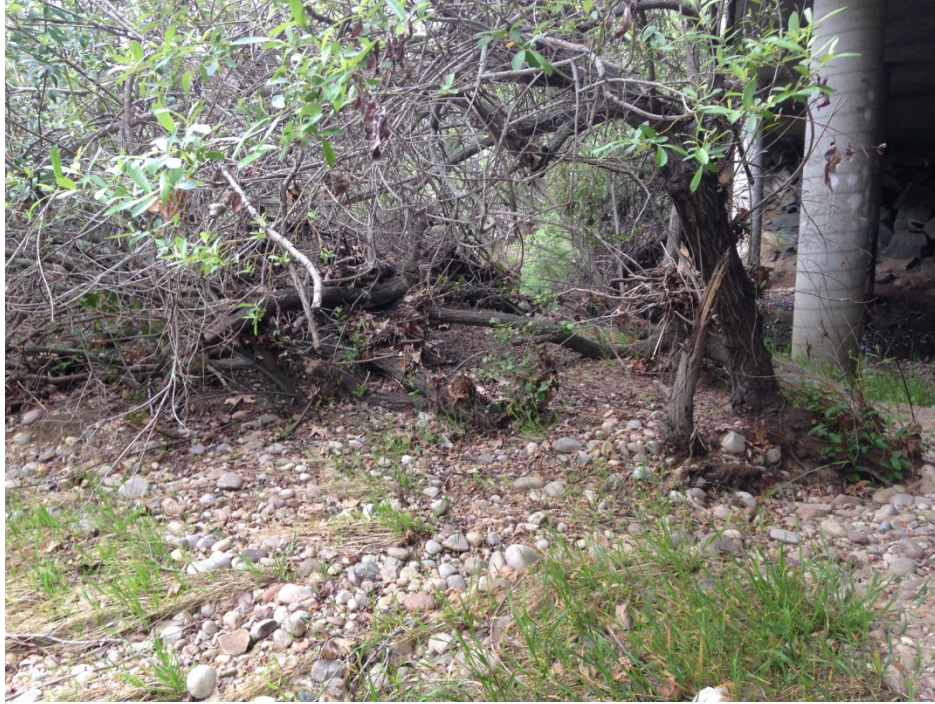
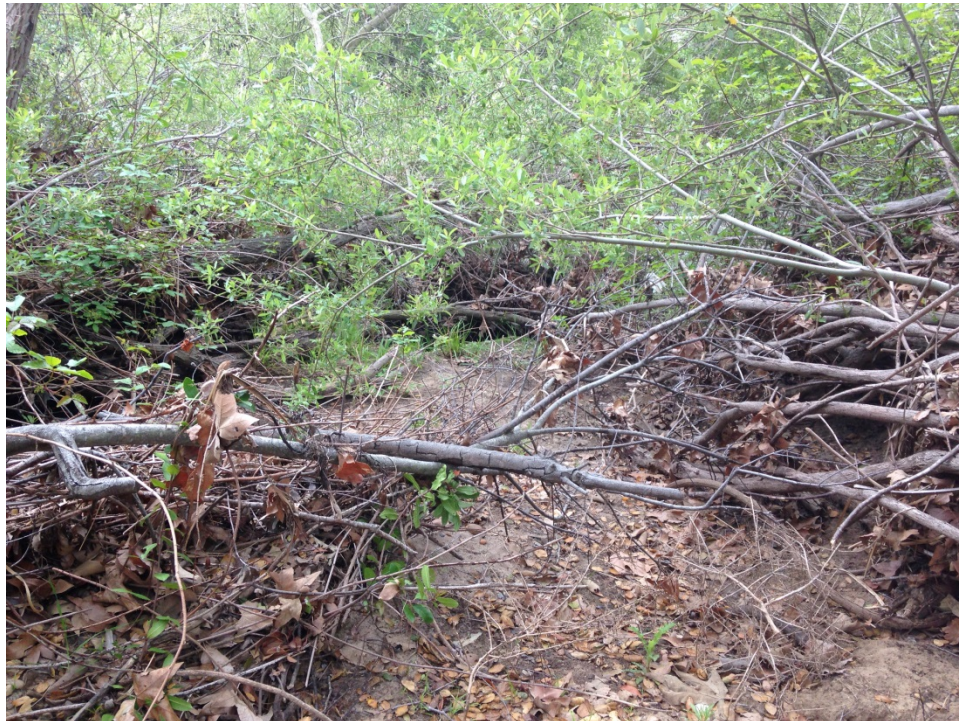
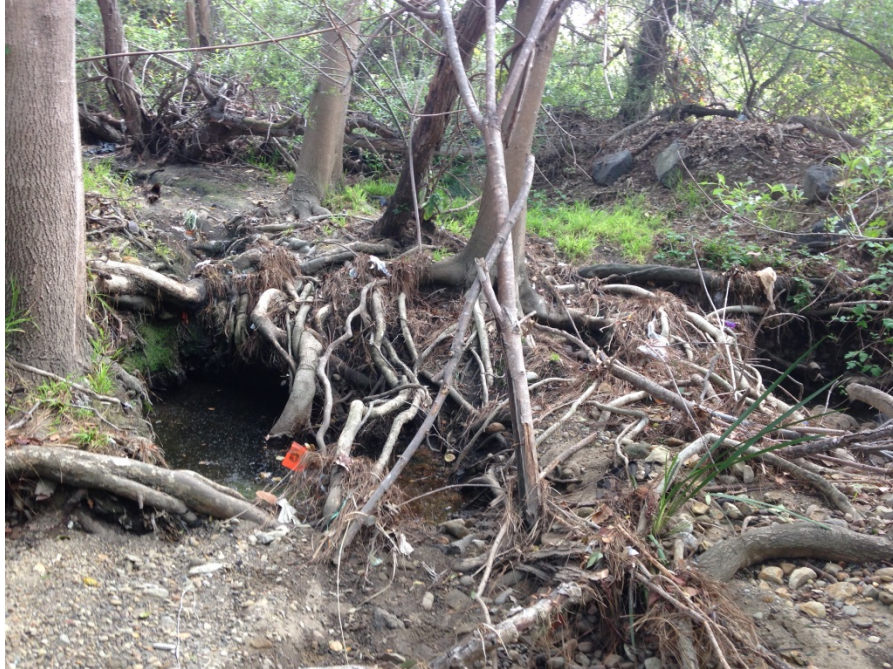
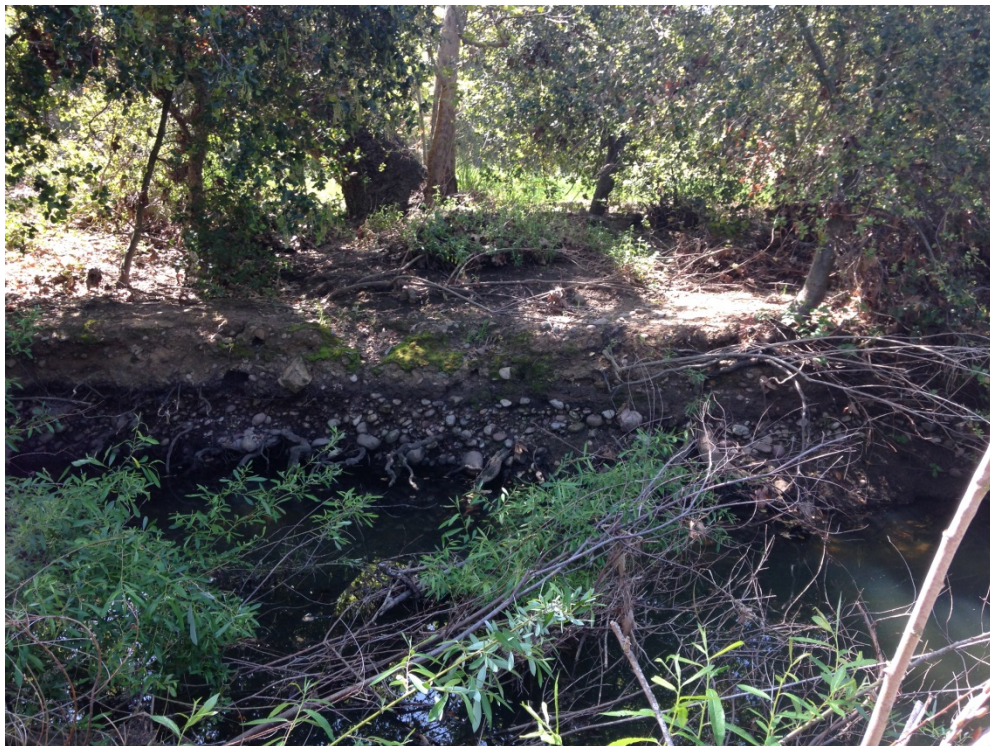
Southern cottonwood-willow riparian forest occurs along San Clemente Creek west of Genesee Avenue (Attachment A, Photographs 1-6). Dominant tree species include: western sycamore (*Platanus racemosa*), arroyo willow (*Salix lasiolepis*) and coast live oak (*Quercus agrifolia*). Dominant shrub species include poison oak (*Toxicodendron diversiloba*) and mule fat (*Baccharis salicifolia*). Common plantain (*Plantago major*) was the most common understory species. Panic veldt grass (*Ehrharta erecta*), bristly ox-tongue (*Helminthotheca echinoides*) and pale spike-rush (*Eleocharis macrostachya*) were associate species, also present in the understory.

Photograph 1. Southern riparian forest along San Clemente Creek. Data Point 1/Photo Point 1

Photograph 2. Southern riparian forest along San Clemente Creek. Data Point 2/Photo Point 2

Photograph 3. Southern riparian forest along San Clemente Creek. Data Point 3/Photo Point 3

Photograph 4. Southern riparian forest along San Clemente Creek. Data Point 4/Photo Point 4

Photograph 5. Southern riparian forest along San Clemente Creek. Data Point 5/Photo Point 5

Photograph 6. Southern riparian forest along San Clemente Creek. Data Point 6/Photo Point 6

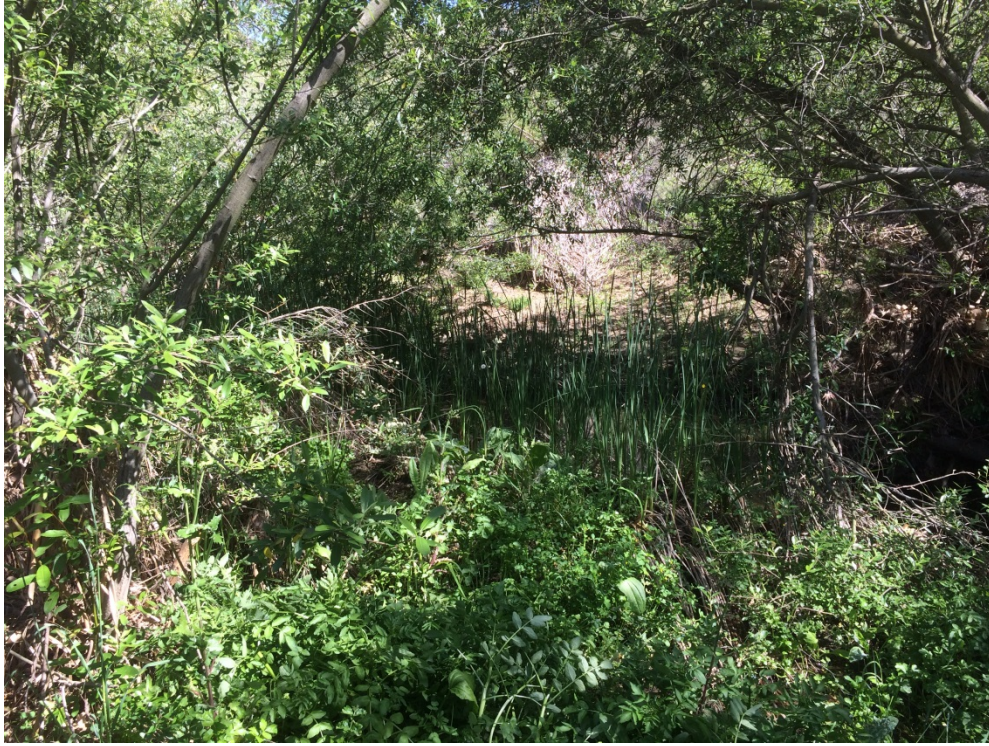
Southern cottonwood-willow riparian forest occurs along Rose Creek and its north-flowing tributary, west of Genesee Avenue (Attachment A, Photograph 7). This community is dominated by arroyo willow with western sycamore and Fremont's cottonwood (*Populus fremontii*) as scattered emergents along the creek. Poison oak is the dominant shrub species. Water cress (*Nasturtium officinale*) is the dominant understory herbaceous species, with cattails (*Typha* sp.) common plantain, pale spike-rush, and common celery (*Apium graveolens*) as minor associates.

Photograph 7. Southern riparian forest along Rose Creek. Data Point 100/Photo Point 100

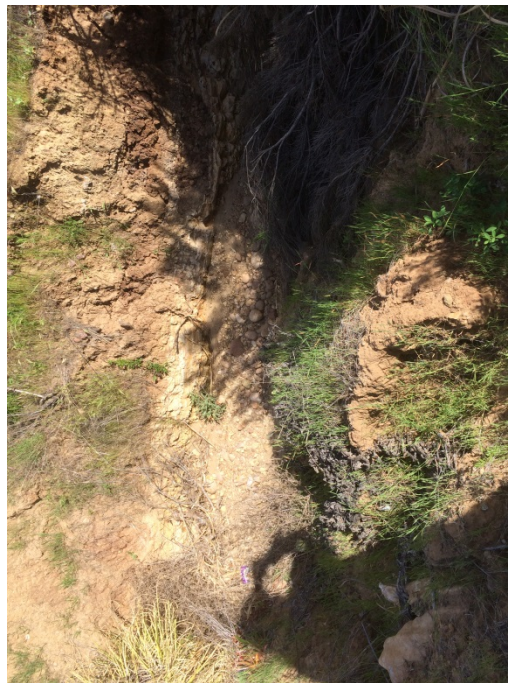
Along the north side of the railroad tracks is an intermittent stream that has a defined bed and bank with an OHWM (Attachment A, Photograph 8). This appears to be an erosional feature and not a natural stream. The feature's headwaters are at Genesee Avenue and flows to the east to a patch of willows that is likely hydrologically connected to Rose Creek. As such, this feature is considered federal non-wetland WOUS and state waters.

Photograph 8. Non-wetland waters of the U.S. north of Rose Creek.

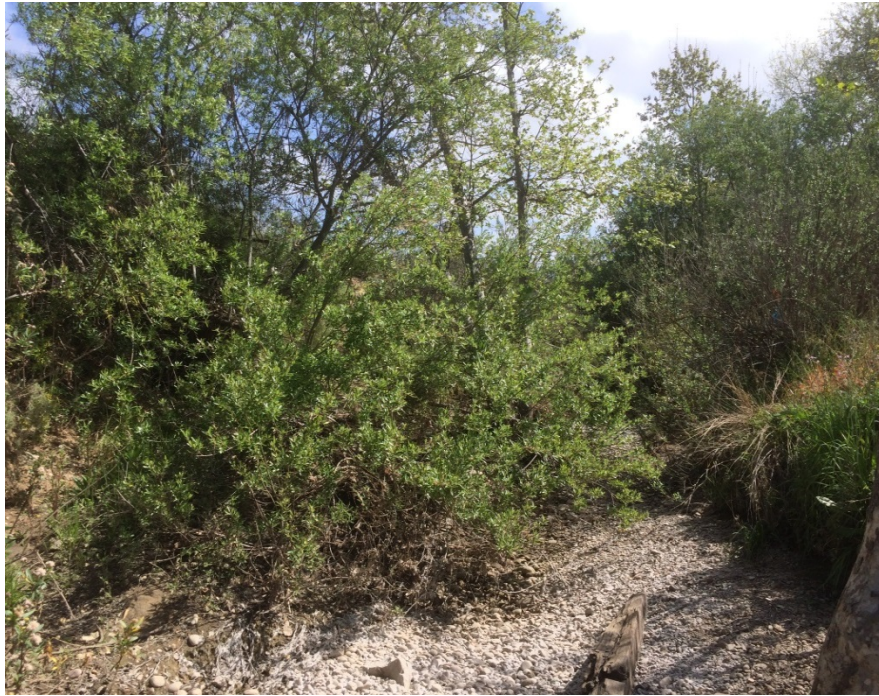
Southern cottonwood-willow riparian forest occurs along Rose Creek, with dominated by arroyo willow with western sycamore and Fremont's cottonwood (*Populus fremontii*) as scattered emergent along the creek (Attachment A, Photograph 9).

Photograph 9. Southern riparian forest along Rose Creek. Data Point 3/Photo Point 3

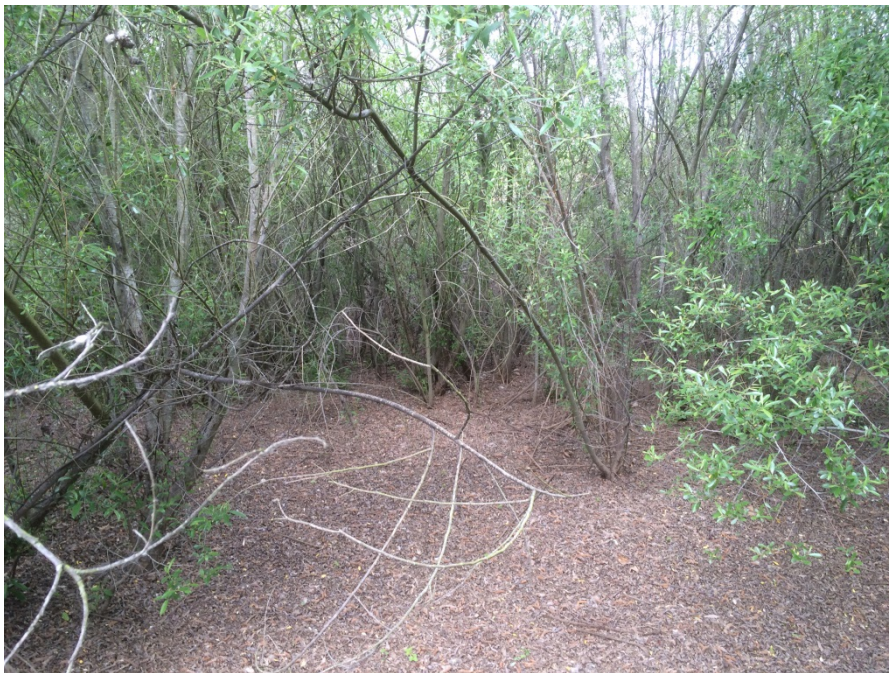
Photograph 10. Southern willow scrub along Rose Creek. Data Point 1/Photo Point 1

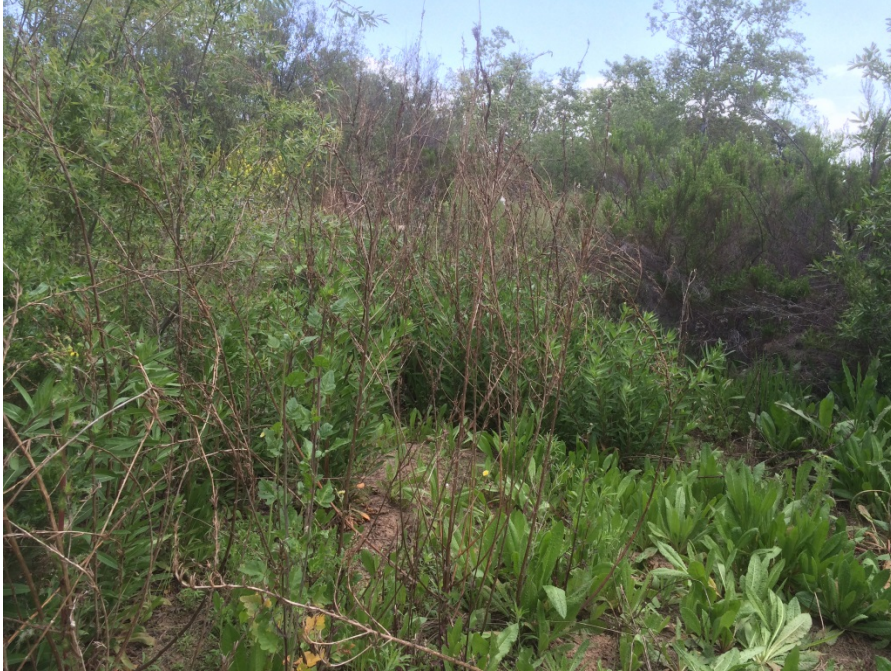
Along the southern floodplain of Rose Creek there is low spot between the toe of the north-facing slopes and the riparian forest that collects water and supports a mixture of herbaceous, wetland species that was previously identified as a native grassland/wet meadow (Merkel 2004). This herbaceous riparian community is dominated by bristly ox-tongue, Hooker's evening-primrose (*Oenothera elata* subsp. *hookeri*) and willow dock (*Rumex salicifolius*). Several individuals of arroyo willow and coyote bush (*Baccharis pilularis* subsp. *consanguinea*) are scattered along the upper periphery of this community (Attachment A, Photograph 11).

Photograph 11. Herbaceous riparian along Rose Creek. Data Point 2/Photo Point 2

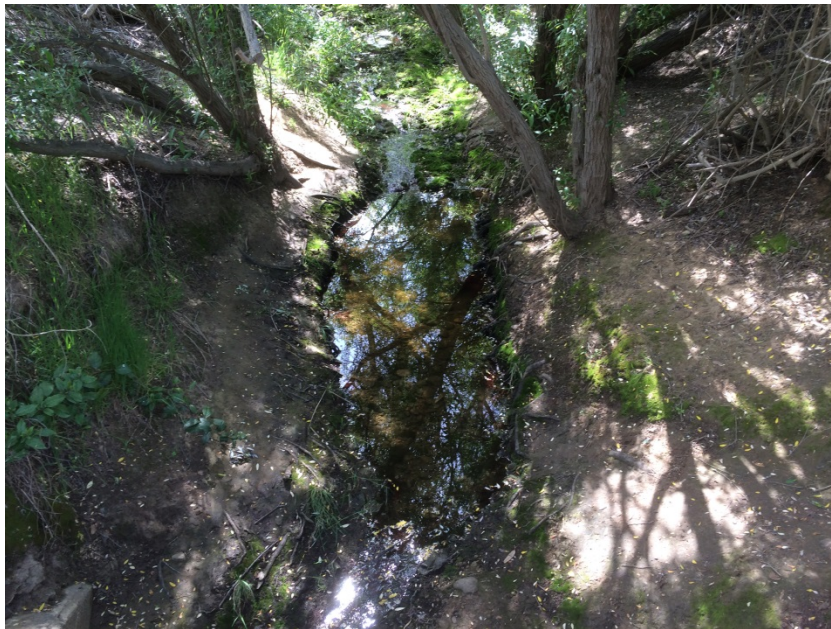
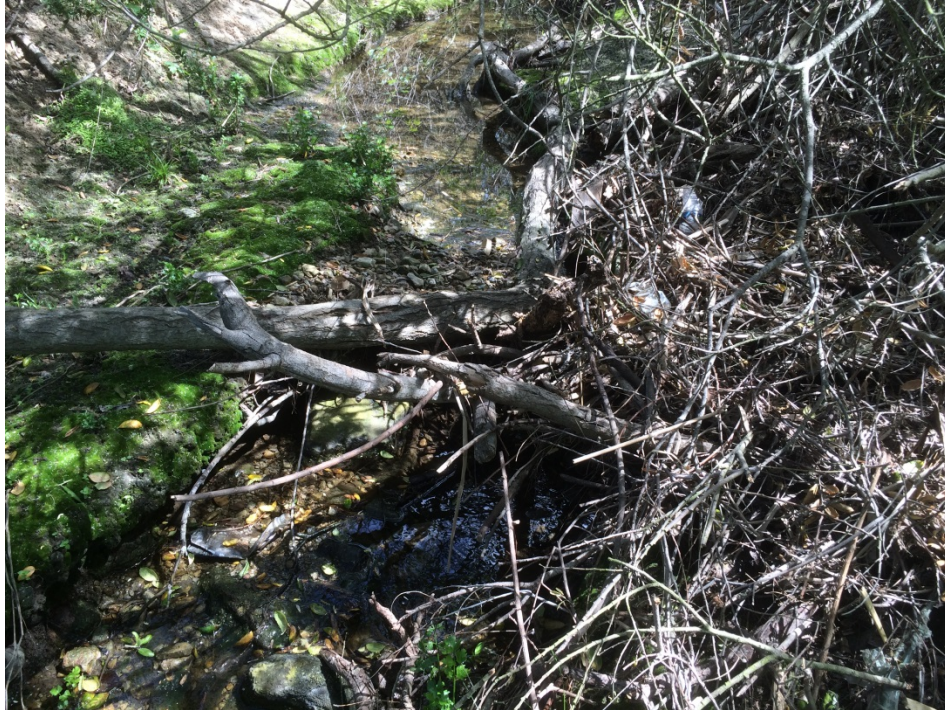
Southern willow scrub occurs along the tributaries to the Rose Creek at this site. Arroyo willow was the sole dominant along these tributaries. One tributary flows north from the residential development on the southern bluffs at the terminus of Regents Road (from the south) (Attachment A, Photographs 12 and 13). The wetland delineation conducted by Merkel and Associates in 2004 delineated jurisdictional waters much further upslope along this drainage than the current assessment. The wetland delineation conducted by Merkel and Associates in 2004 mapped jurisdictional waters with coastal and valley freshwater marsh, up a steep manufactured slope to the residential development. This area is now overgrown with Hottentot-fig (*Carpobrotus edulis*) with no visible bed and bank or wetland/riparian plant species.

**Photograph 12. Southern willow scrub along north-flowing tributary to Rose Creek.
Data Point 6/Photo Point 6**

**Photograph 13. Southern willow scrub along north-flowing tributary to Rose Creek.
Data Point 8/Photo Point 8**

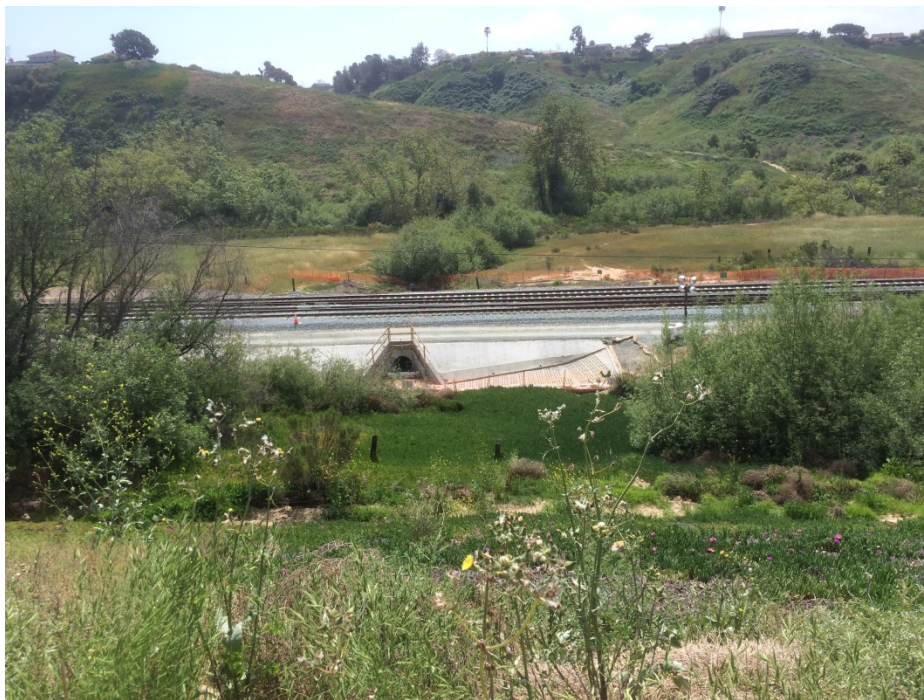
A second tributary flows south from north of the railroad tracks (Attachment A, Photograph 14). These tributaries are primarily maintained by urban runoff from the surrounding urban areas. The south-flowing tributary north of the railroad tracks "headwaters" are at a broken concrete stormwater pipe so this is not likely a natural feature. This feature is within the earth trail with southern willow scrub adjacent. This feature has an OHWM and is hydrologically connected to Rose Creek via a concrete culvert under the railroad tracks and therefor would be considered non-wetland waters of the U.S. and state waters.

Photograph 14. Southern willow scrub along south-flowing tributary to Rose Creek.

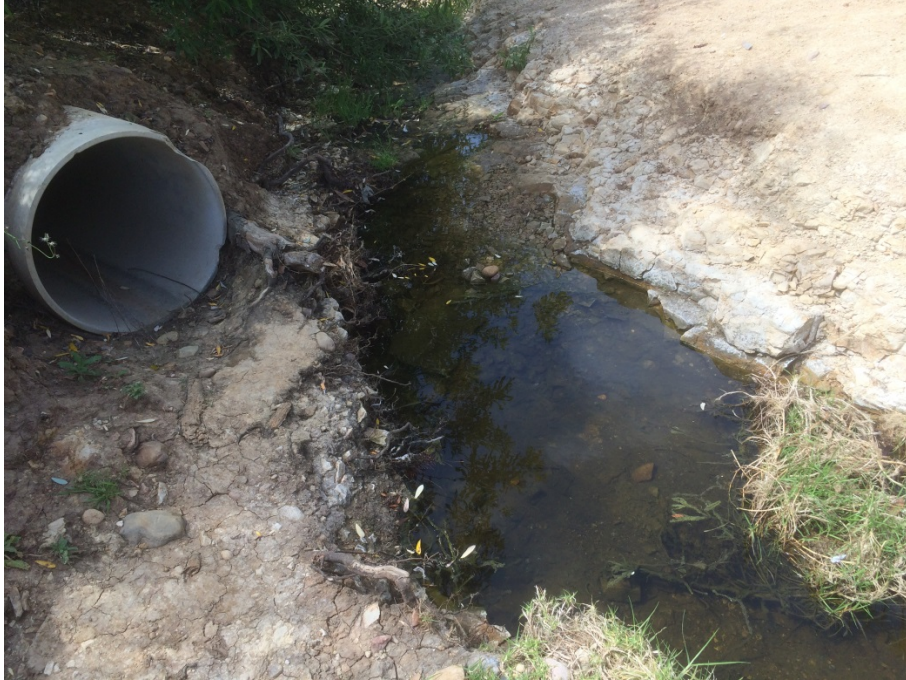
Photograph 15. Headwaters of south-flowing tributary to Rose Creek
