Canyon Sewer Cleaning Program and Long Term Sewer Maintenance Program Progress Report

Public Utilities Dept.

2021 Annual Report
July 1, 2020 – June 30, 2021

October 2021

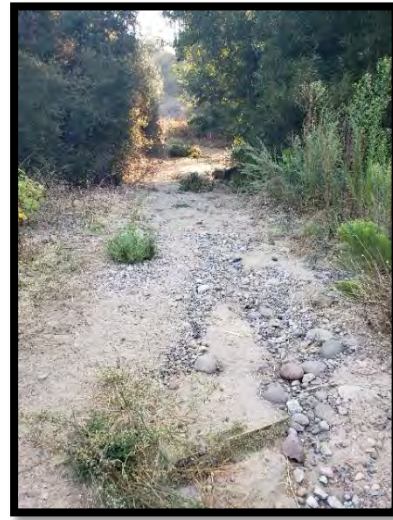
Chocolate Canyon, September 2020

Public Utilities crews completed access path maintenance in multiple canyon areas to facilitate access for cleaning, inspections and maintenance. Path maintenance is usually limited to trimming or mowing vegetation that has grown on the pathways. Maintenance on the access path precedes manhole cleaning and maintenance.

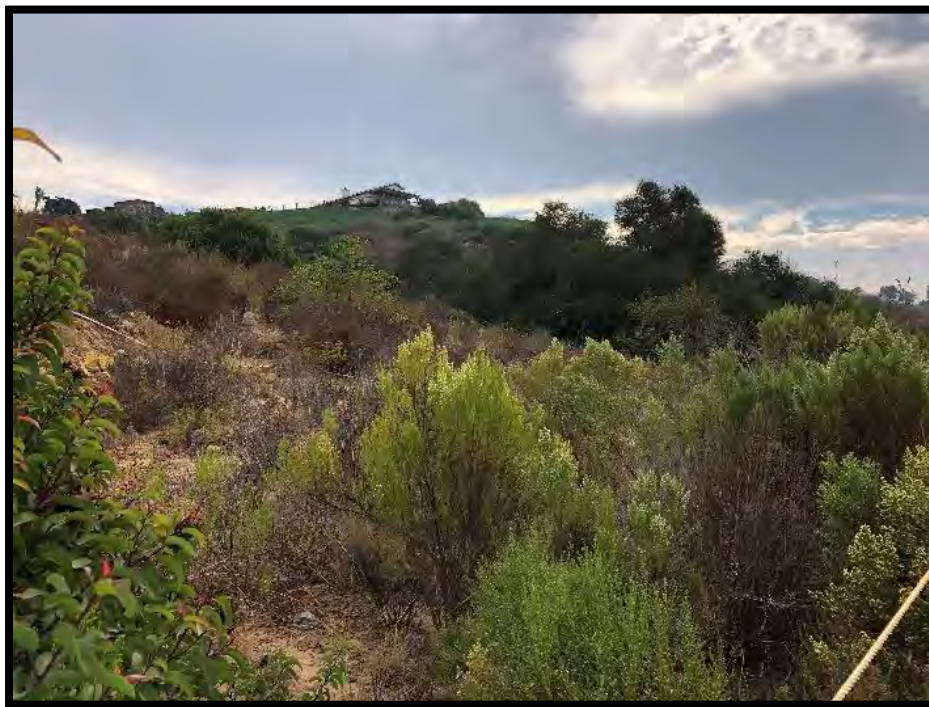
Tecolote Canyon Revegetation, October 2020

During this reporting year, monitoring for 10 canyon sewer revegetation projects was completed. Monitoring for three additional projects is ongoing. Monitoring for two new revegetation sites was initiated in FY-20.

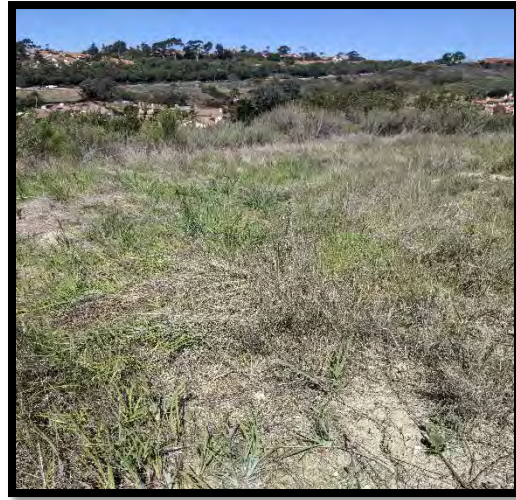
Canyon View: Native grassland, April 2021

This site has successfully achieved the goal of restoring low quality non-native uplands into high quality native habitats. This project completed the 5-year maintenance and monitoring period in 2017 and received sign-off in spring of 2018. The mitigation area continues to sustain mature native habitats in 2021. The site is dominated by native coastal sage scrub species including California sagebrush (*Artemisia californica*), black sage (*Salvia mellifera*), bush sunflower (*Encelia californica*), and native grassland species.

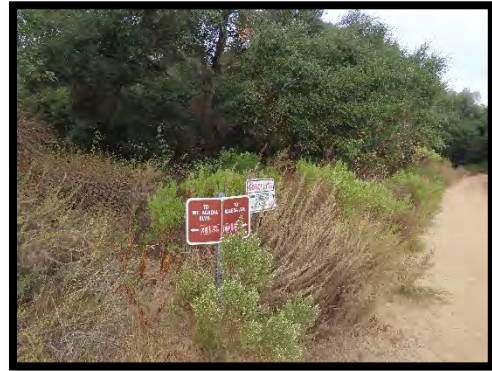
Central Tecolote: Upland and oak riparian habitat, October 2020

Maintenance in 2021 included the removal of target invasive species including black mustard (*Brassica nigra*), sweetclover (*Melilotus* sp.), prickly lettuce (*Lactuca serriola*), and tocalote (*Centaurea melitensis*). The restored habitats onsite continue to mature with willows exceeding 20 feet in height and sage scrub established to full shrub stature. The oak margins are lined with Mexican elderberry (*Sambucus mexicana*), and poison oak (*Toxicodendron diversilobum*) has formed dense thickets in the oak tree understory.

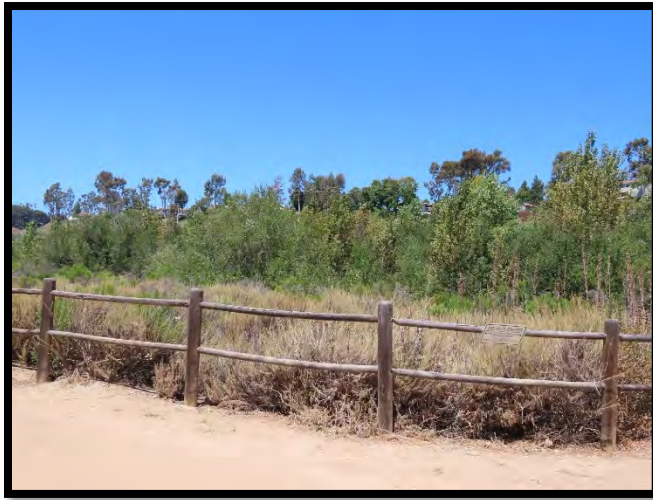
Rose Canyon: Coastal sage scrub and riparian habitat, June 2021

As of summer 2021, native vegetative cover at the site is very high, with upland habitats exceeding 95 percent cover with a high diversity of species that includes California sagebrush, lemonadeberry (*Rhus integrifolia*), broom baccharis (*Baccharis sarothroides*), coyote bush (*Baccharis pilularis*), and San Diego goldenbush (*Isocoma menziessii*). The wetland creation habitat exceeds 100 percent cover in some sections of the project area with a good vertical richness of both trees and shrubs. Many cottonwood (*Populus fremontii*) and willow (*Salix* spp.) saplings were observed on the site. The native grassland habitat continues to do well, with increased coverage of purple needlegrass and (*Stipa pulchra*), and beardless wild rye (*Elymus triticoides*). The site will continue to receive maintenance to help ensure native habitat continues to increase in maturity and spatial coverage. This year maintenance crews focused on control and removal of non-native species such as mustard and sweet clover.

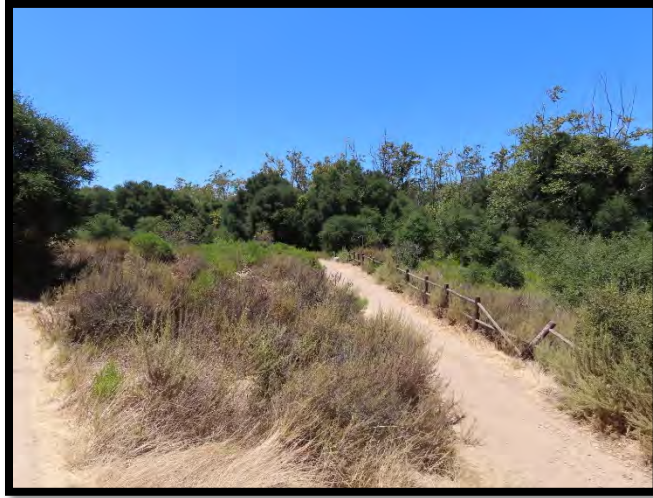
San Clemente Canyon: Diegan coastal sage scrub with oak woodland, June 2021

Construction was initiated in October 2007 and received regulatory sign-off from the USACE in January 2015. The upland and wetland planting areas for the project continue to show steady establishment of target species in 2021, with vegetative cover in portions of the wetland habitat over 100 percent cover. The wetlands support a willow or oak overstory and a well-developed understory including species such as mulefat (*Baccharis salicifolia*) and spiny rush (*Juncus acutus*). The site will continue to receive maintenance help ensure native habitat continues to increase in maturity and spatial coverage. In 2020/21 maintenance crews focused on control and removal of non-native annuals such as black mustard and sweet clover. Available mitigation acreage below reflects actual acreage of habitats restored at the end of the 5-year maintenance period and rounded totals of assignments to date.

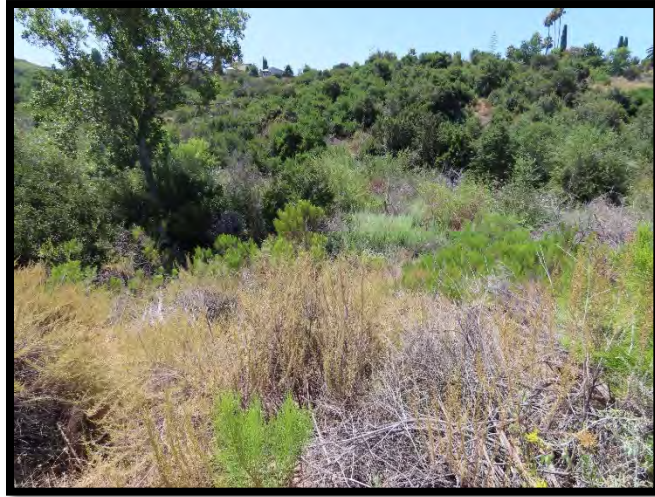
Rancho Mission Canyon: Coastal sage scrub and southern willow scrub, June 2021

The site completed the 5-year long-term maintenance and monitoring period in March 2013 with regulatory sign-off and approval in summer of 2013. The site continues to support target native cover of 100%, exceeding the Year 5 goal of 90%. The site is continuing to mature with dense thickets of vegetation found throughout the riparian corridor. Trees within the site continue to mature with some individuals exceeding 30 feet in height, and the understory is well developed with a diverse variety of herbs and shrubs. During 2021 assessment some non-native species were observed in the upland areas adjacent to the mitigation area including: Mexican fan palm (*Washingtonia robusta*), tree tobacco (*Nicotiana glauca*) and black mustard which were subsequently treated and removed during maintenance visits. The site will continue to be monitored to ensure non-natives do not become established in the mitigation areas.

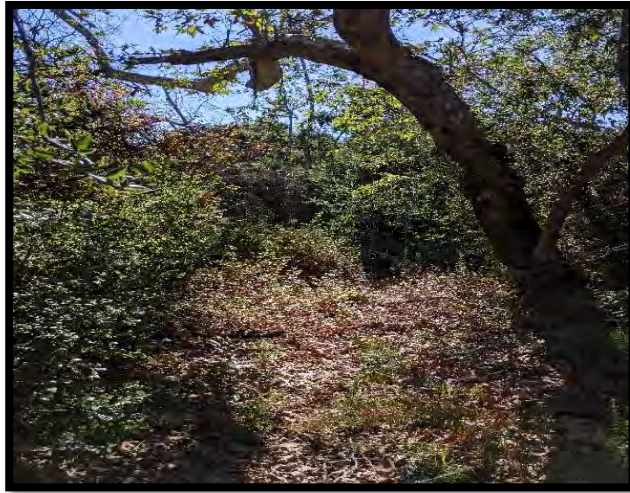
Tecolote Canyon: Riparian forest, August 2020

A qualitative review of the site in the spring of 2021 estimated vegetative cover to be over 90 percent in the Diegan coastal sage scrub habitats, and 80 percent in the riparian areas. Available mitigation acreage below reflects actual acreage of habitats restored at the end of the 5-year maintenance period and rounded totals of assignments to date.

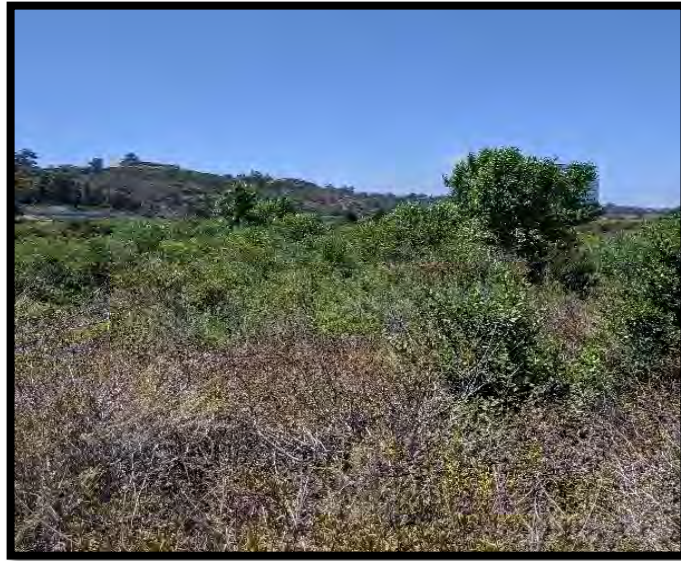
San Diego River: Riparian forest and coastal sage scrub, August 2020

In 2021, native vegetation at the site continues to mature with trees reaching heights of 25-30 feet, and total vegetative cover at approximately 95 percent. The site supports a well-developed understory of spiny rush, arrowweed (*Pluchea sericea*), and mulefat. Non-native annuals including Spanish false fleabane (*Pulicaria paludosa*), and mustard were observed sporadically throughout the site, primarily along the edges and trails. As part of long-term management of the site, these areas were treated and will continue to receive maintenance to help ensure non-native species do not become established. Trash from nearby illegal encampments continues to be removed from the site and adjacent areas.

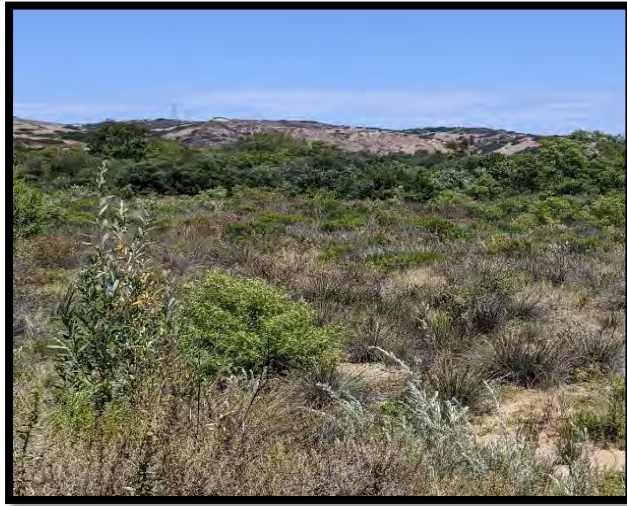
Los Peñasquitos North: Freshwater marsh and riparian woodland, August 2020

The site was assessed in spring of 2021 and remained in good condition. The site continues to mature with vegetative cover approaching 95% and willows occasionally reaching heights of 25 to 35 feet. No trash or debris or unauthorized trails were observed onsite. Vegetation within the wetland habitat is predominately spiny rush, deer grass (*Muhlenbergia rigens*), and various species of willows. Invasive species, including black mustard and rabbit's foot grass (*Polypogon monspeliensis*) were observed occasionally and maintenance crews cut and treated small numbers of pampas grass (*Cortaderia selloana*) that were observed within the mitigation area.

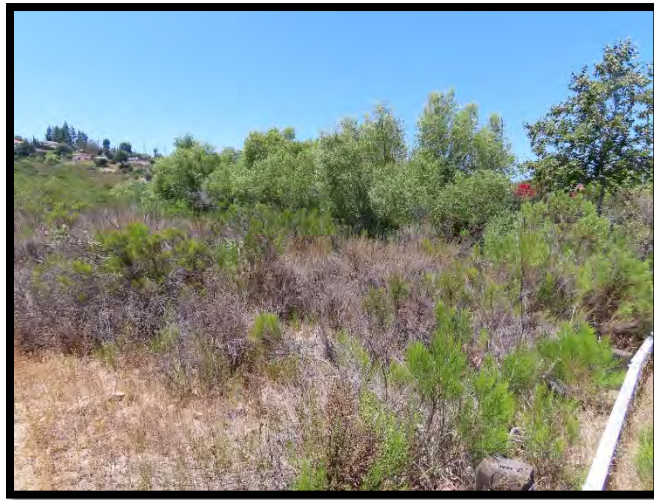
Lake Murray: Baccharis and southern willow scrub, June 2021

A site visit was conducted to assess the current condition of the mitigation site. Fifth year success criteria required an average combined cover of 90% for the upland restoration and wetland enhancement areas. The wetland enhancement area exceeds 100% native cover throughout all of the defined enhancement site. The wetland overstory continues to mature, increasing in density and height with species such as Fremont cottonwood (*Populus fremontii*), Western sycamore (*Platanus racemosa*), and various types of willows reaching heights of 40 feet or more. The understory is diverse with species such as spiny rush, spike sedge (*Carex nardina*), evening primrose (*Oenothera elata*), San Diego marsh elder (*Iva hayesiana*), and broad-leaved cattail (*Typha latifolia*). The upland areas, while not as successful as the riparian areas, are continuing to fill in with native coastal sage scrub species including California sagebrush, lemonadeberry, flattop buckwheat (*Erigeron fasciculatus*), laurel sumac (*Malosoma laurina*), and black sage (*Salvia mellifera*). As part of the annual maintenance effort this year, non-native species including black mustard and bristly oxtongue (*Helminthotheca echioides*) were removed from the upland habitat areas.

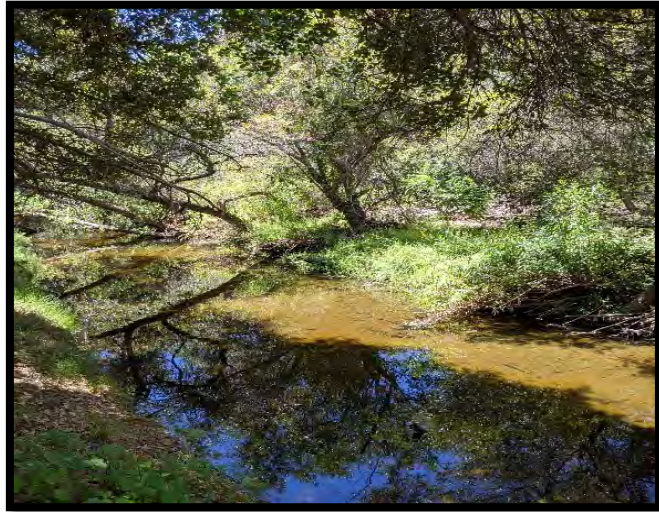
El Rancho Peñasquitos: Riparian forest, August 2020

The El Rancho Peñasquitos Wetland Enhancement Project continues to meet the success criteria outlined in the Mitigation Plan. Many of the larger treated plants have begun to deteriorate and decompose, allowing for the establishment of native species in their direct vicinity. Park and Recreation has taken over long-term management of the site and manages the land consistent with the Multiple Species Conservation Plan which includes targeting the treatment or removal of invasive exotics as part of routine park management. During the 2021 annual assessment, several small palms were identified along the creek corridor and non-native annuals including fennel (*Foeniculum vulgare*), black mustard, and wild oat (*Avena fatua*) were recorded along the wetland/upland transition areas of the site and subsequently treated and removed. The site will continue to be monitored and maintained to ensure non-native species do not become established in the mitigation area.

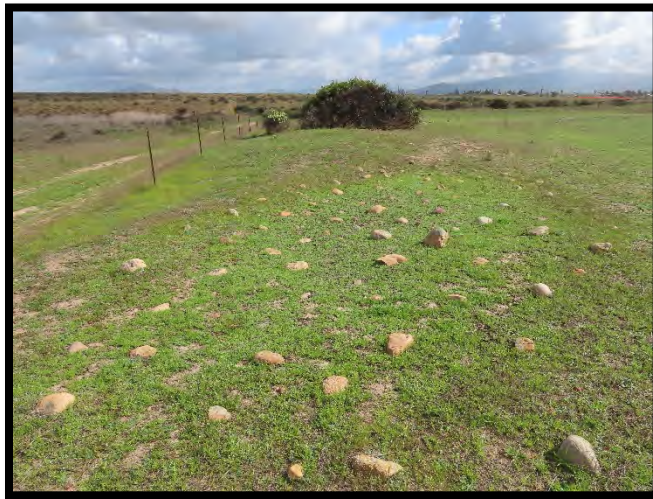
Otay Mesa Upland Mitigation: Maritime succulent scrub and vernal pools, March 2021

In August 2019, portions of the mitigation area were burned during a wildfire. The fire moved through the area quickly and fire retardant was dropped in some areas. During the 2019/2020 annual monitoring visits, it was documented that the burned areas were recovering well and the burn scar was barely noticeable in most areas. Some non-native weed species such as red-stem filaree (*Erodium cicutarium*) did return, but those were treated and/or removed during maintenance visits. The fencing installed in 2014 and 2017 was intact and functioning as intended. Rainfall amounts in 2019/2020 were above average and the mitigation area benefitted greatly from the additional moisture. Non-native species removal and native upland species restoration activities are being implemented in the surrounding areas by the Park and Recreation Open Space Division and a maintenance contractor obtained by PUD.

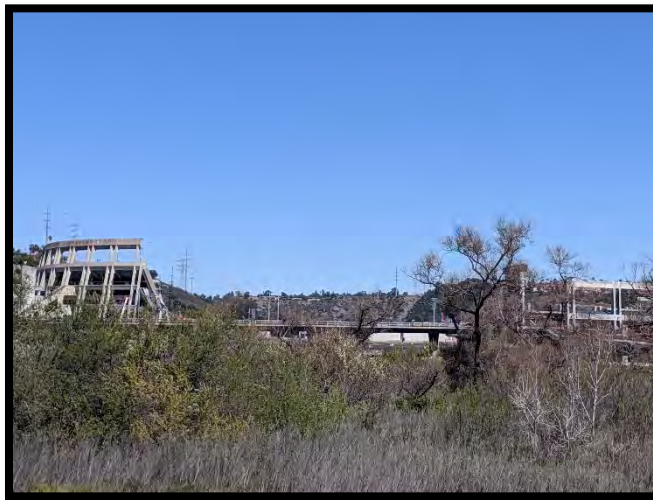
Stadium Mitigation Site: Riparian scrub and forest, February 2021

Work at the Stadium Mitigation site began in August 2016 with the initial cleanup, removal of illegal encampments, and removal of non-native vegetation. Recent work onsite included the replacement planting of container plants, installation of willow cuttings, and hand broadcasting of seed. The project is now in year three of the maintenance and monitoring period with vegetation communities continuing to diversify, mature, and increase in density.
