**Canyon Sewer Cleaning Program  
and  
Long Term Sewer Maintenance Program  
Progress Report**

**Public Utilities Dept.**

**2020 Annual Report  
July 1, 2019 – June 30, 2020**

August 2020

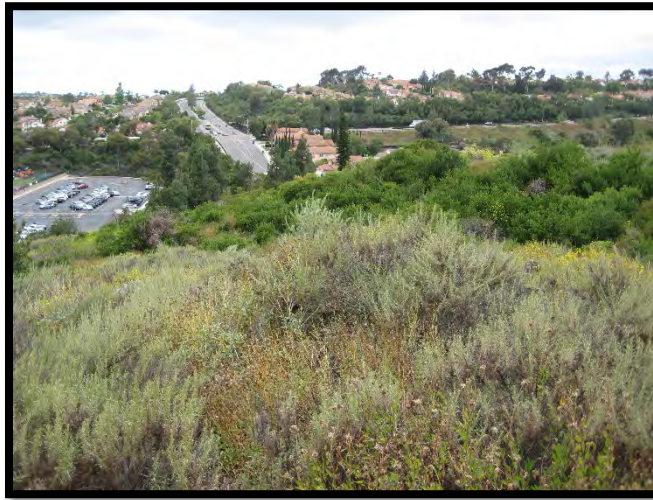
Canyon View: Coastal sage scrub habitat, May 2020

This site has successfully achieved the goal of restoring low quality non-native uplands into high quality native habitats. This project completed the 5-year maintenance and monitoring period in 2017 and received sign-off in spring of 2018. The mitigation area continues to thrive in 2020. The site is dominated by native coastal sage scrub species including California sagebrush (*Artemisia californica*), black sage (*Salvia mellifera*), bush sunflower (*Encelia californica*), and native grassland species.

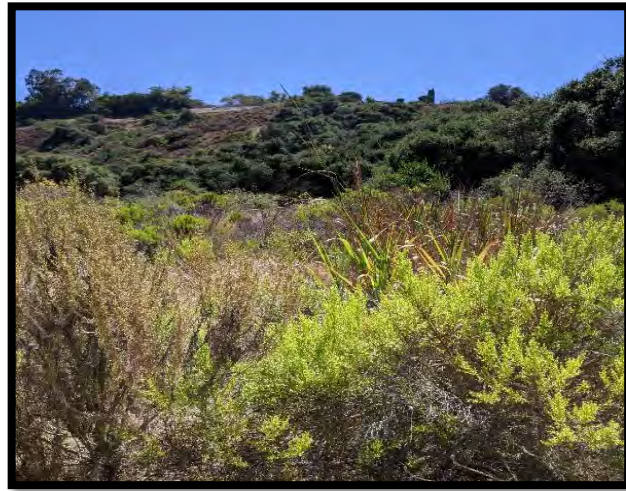
Central Tecolote: Upland and oak riparian habitat, August 2020

PUD continues to monitor and maintain the site. Maintenance in 2020 included the removal of target invasive species including black mustard (*Brassica nigra*), sweetclover (*Melilotus* sp.), prickly lettuce (*Lactuca serriola*), and tocalote (*Centaurea melitensis*). The restored habitats onsite continue to mature with willows exceeding 20 feet in height and sage scrub established to full shrub stature. The oak margins are lined with Mexican elderberry (*Sambucus mexicana*), and poison oak (*Toxicodendron diversilobum*) has formed dense thickets in the oak tree understory.

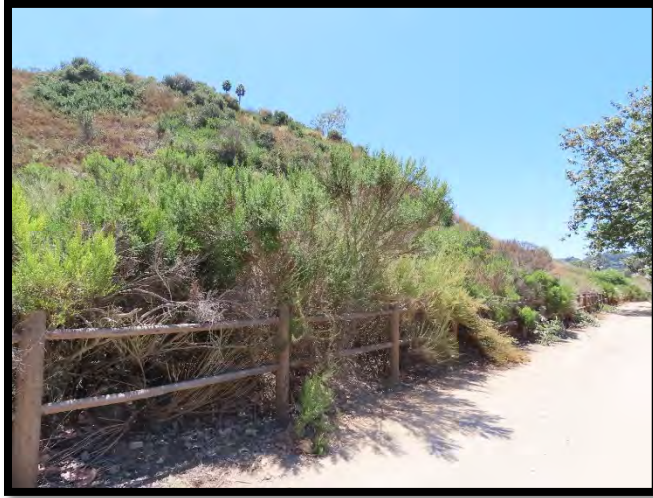
Rose Canyon: Mulefat scrub, August 2020

As of summer 2020, native vegetative cover at the site is very high, with upland habitats exceeding 95 percent cover with a high diversity of species that includes California sagebrush, lemonadeberry (*Rhus integrifolia*), broom baccharis (*Baccharis sarothroides*), coyote bush (*Baccharis pilularis*), and San Diego goldenbush (*Isocoma menziesii*). The wetland creation habitat exceeds 100 percent cover in some sections of the project area with a good vertical richness of both trees and shrubs. Many cottonwood (*Populus* spp.) and willow (*Salix* spp.) saplings were observed on the site. Higher than average rainfall for the year contributed to site hydrology, but did not cause any obvious damage to plants or erosion within the mitigation areas. The native grassland habitat continues to do well, with increased coverage of purple needlegrass and (*Stipa pulchra*), and beardless wild rye (*Elymus triticoides*). The site will continue to receive maintenance to help ensure native habitat continues to increase in maturity and spatial coverage. This year maintenance crews focused on control and removal of non-native species such as mustard and sweet clover.

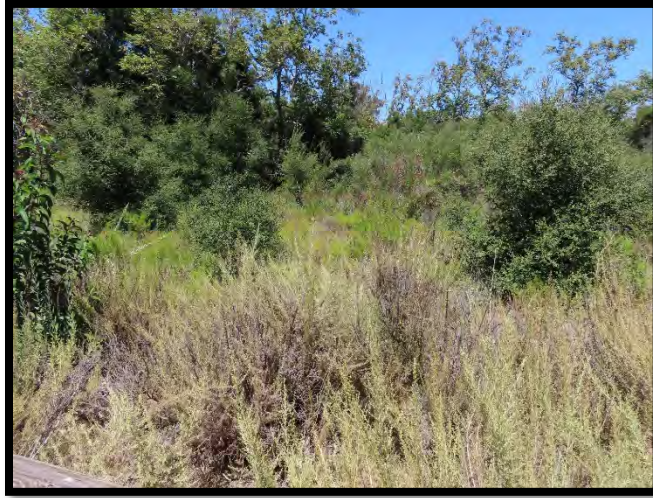
*San Clemente Canyon: Diegan coastal sage scrub with oak woodland, August 2020*

Construction was initiated in October 2007 and received regulatory sign-off from the USACE in January 2015. The upland and wetland planting areas for the project continue to show steady establishment of target species in 2020, with vegetative cover in portions of the wetland habitat over 100 percent cover. The wetlands support a willow or oak overstory and a well-developed understory including species such as mulefat (*Baccharis salicifolia*) and juncus (*Juncus acutus*). The site will continue to receive maintenance help ensure native habitat continues to increase in maturity and spatial coverage. In 2019/20 maintenance crews focused on control and removal of non-native annuals such as black mustard and sweet clover. Available mitigation acreage below reflects actual acreage of habitats restored at the end of the 5-year maintenance period and rounded totals of assignments to date.

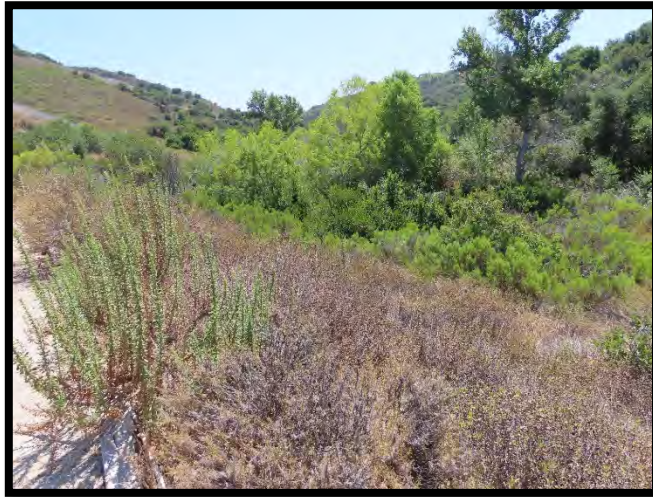
*Rancho Mission Canyon: Southern willow scrub, August 2020*

The site completed the 5-year long-term maintenance and monitoring period in March 2013 with regulatory sign-off and approval in summer of 2013. The site continues to support target native cover of 100%, exceeding the Year 5 goal of 90%. The site is continuing to mature with dense thickets of vegetation found throughout the riparian corridor. Trees within the site continue to mature with some individuals exceeding 30 feet in height, and the understory is well developed with a diverse variety of herbs and shrubs. During the mitigation assessment some non-native species were observed in the upland areas adjacent to the mitigation area including: tree tobacco (*Nicotiana glauca*) and black mustard. The site will continue to be monitored to ensure non-natives do not become established in the mitigation areas.

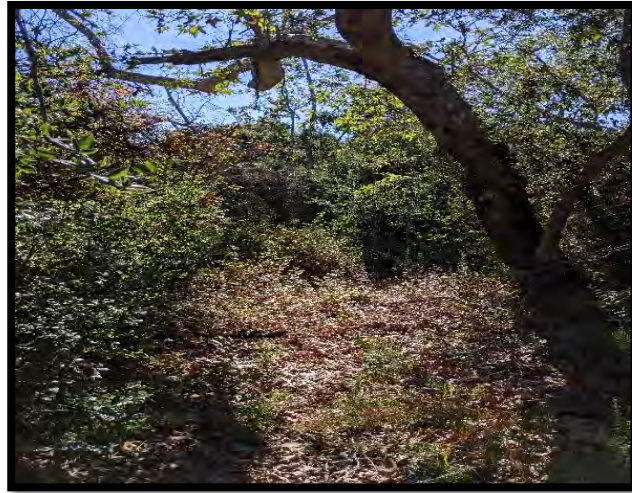
*Tecolote Canyon: Riparian forest, August 2020*

A qualitative review of the site in the summer of 2020 estimated vegetative cover to be over 90 percent in the Diegan coastal sage scrub habitats, and 80 percent in the riparian areas. Available mitigation acreage below reflects actual acreage of habitats restored at the end of the 5-year maintenance period and rounded totals of assignments to date.

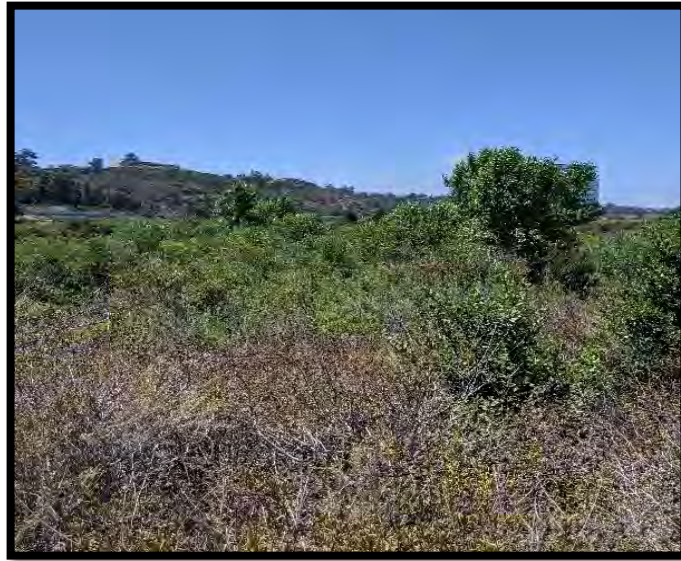
San Diego River: Riparian forest and coastal sage scrub, August 2020

The site includes the creation of 3.43 acres of native riparian habitat and 2 acres of Diegan coastal sage scrub habitat. The project site was graded in the fall of 2005 to create a basin along the southern bank of the San Diego River. The long-term maintenance, monitoring, and reporting program started June 14, 2006 and the site successfully completed 5-years of maintenance and monitoring in June of 2011.

In 2020, native vegetation at the site continues to mature with trees reaching heights of 25-30 feet, and total vegetative cover at approximately 95 percent. The site supports a well-developed understory of spiny rush, arrowweed (*Pluchea sericea*), and mulefat. Non-native annuals including Spanish false fleabane (*Pulicaria paludosa*), and mustard were observed sporadically throughout the site, primarily along the edges and trails. As part of long-term management of the site, these areas were treated and will continue to receive maintenance to help ensure non-native species do not become established. Trash from nearby illegal encampments continues to be removed from the site and adjacent areas.

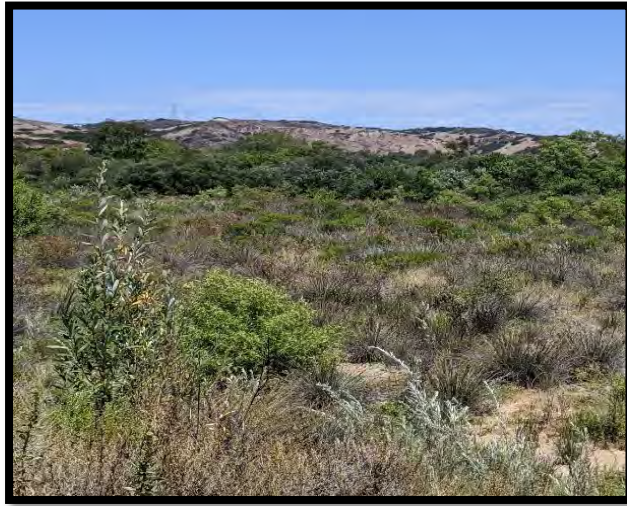
Los Peñasquitos North: Freshwater marsh and riparian woodland, August 2020

The site was assessed in summer of 2020 and remained in good condition. The site continues to mature with vegetative cover approaching 95% and willows reaching heights of 25 to 35 feet. No trash or debris or unauthorized trails were observed onsite. Vegetation within the wetland habitat is predominately spiny rush, deer grass (*Muhlenbergia rigens*), and various species of willows. Invasive species, including black mustard and rabbit's foot grass (*Polypogon monspeliensis*) were observed occasionally and maintenance crews cut and treated several pampas grass (*Cortaderia selloana*) were observed within the mitigation area, but not in large numbers in early 2020.

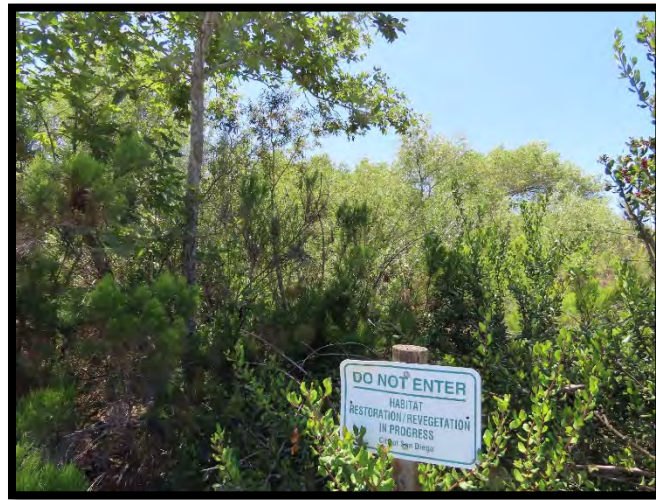
Lake Murray: Southern willow scrub, August 2020

A site visit was conducted to assess the current condition of the mitigation site. Fifth year success criteria required an average combined cover of 90% for the upland restoration and wetland enhancement areas. The wetland enhancement area exceeds 100% native cover throughout all of the defined enhancement site. The wetland overstory continues to mature, increasing in density and height with species such as Fremont cottonwood (*Populus fremontii*), Western sycamore (*Platanus racemosa*), and various types of willows reaching heights of 40 feet or more. The understory is diverse with species such as spiny rush, spike sedge (*Carex nardina*), evening primrose (*Oenothera elata*), San Diego marsh elder (*Iva hayesiana*), and broad-leaved cattail (*Typha latifolia*). The upland areas, while not as successful as the riparian areas, are continuing to fill in with native coastal sage scrub species including California sagebrush, lemonadeberry, flattop buckwheat (*Erigeron fasciculatum*), laurel sumac (*Malosoma laurina*), and black sage (*Salvia mellifera*). As part of the annual maintenance effort this year, non-native species including black mustard and bristly oxtongue (*Helminthotheca echioides*) were removed from the upland habitat areas.

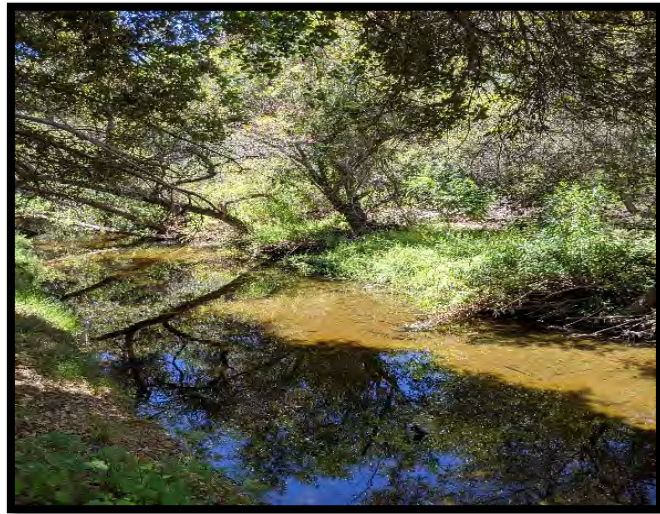
El Rancho Peñasquitos: Riparian forest, August 2020

The El Rancho Project included enhancement of 5.53 acres of southern cottonwood willow riparian forest, by eradicating targeted non-native species. Project efforts began March 26, 2006 and regulatory sign-off was received in early 2010. This project treated 6,720 non-native plants, targeted species included Canary Island date palm (*Phoenix canariensis*), Mexican fan palm (*Washingtonia robusta*), Eucalyptus, Peruvian pepper tree (*Schinus terebinthifolius*), Brazilian pepper tree (*Schinus terebinthifolia*), and edible fig (*Ficus carica*).

The El Rancho Peñasquitos Wetland Enhancement Project continues to meet the success criteria outlined in the Mitigation Plan. Many of the larger treated plants have begun to deteriorate and decompose, allowing for the establishment of native species in their direct vicinity. Park and Recreation has taken over long-term management of the site and manages the land consistent with the Multiple Species Conservation Plan which includes targeting the treatment or removal of invasive exotics as part of routine park management. During the 2020 annual assessment, several small palms were identified along the creek corridor and non-native annuals including fennel (*Foeniculum vulgare*), black mustard, and wild oat (*Avena fatua*) were recorded along the wetland/upland transition areas of the site. The site will continue to be monitored and maintained to ensure non-native species do not become established in the mitigation area.

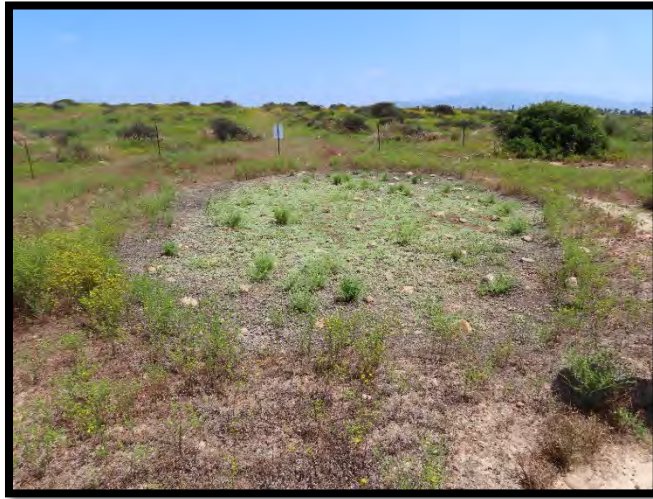
Otay Mesa Upland Mitigation: Maritime succulent scrub and vernal pools, May 2020

In August 2019, portions of the mitigation area were burned during a wildfire. The fire moved through the area quickly and fire retardant was dropped in some areas. During the 2019/2020 annual monitoring visits, it was documented that the burned areas were recovering well and the burn scar was barely noticeable in most areas. Some non-native weed species such as red-stem filaree (*Erodium cicutarium*) did return, but those were treated and/or removed during maintenance visits. The fencing installed in 2014 and 2017 was intact and functioning as intended. Rainfall amounts in 2019/2020 were above average and the mitigation area benefitted greatly from the additional moisture. Non-native species removal and native upland species restoration activities are being implemented in the surrounding areas by the Park and Recreation Open Space Division and a maintenance contractor obtained by PUD.

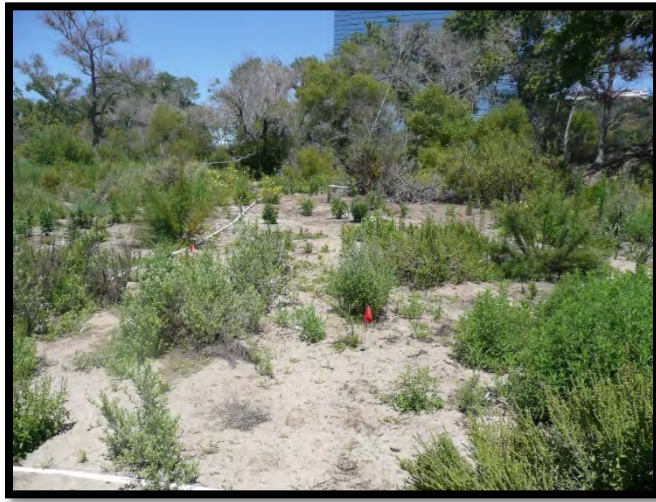
Stadium Mitigation Site: Riparian scrub, June 2019

Work at the Stadium Mitigation site began in August 2016 with the initial cleanup, removal of illegal encampments, and removal of non-native vegetation. Recent work onsite included the replacement planting of container plants, installation of willow cuttings, and hand broadcasting of seed. The project is now in year two three of the maintenance and monitoring period with vegetation communities continuing to diversify, mature, and increase in density.
