# SedonaPacific

January 27, 1999

**INVENTORIED HISTORIC RESOURCES WITHIN**  
**PROJECT AREA BALLPARK AND ANCILLARY DEVELOPMENT PROJECTS,**  
**AND ASSOCIATED PLAN AMENDMENTS**

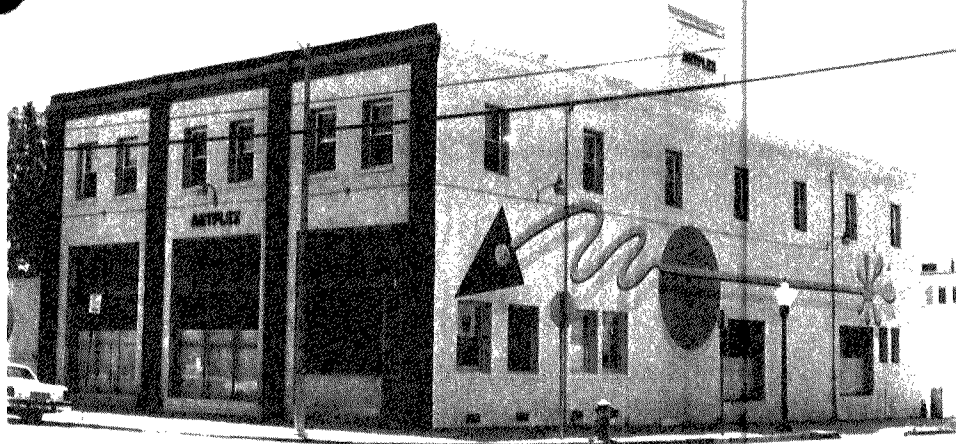
The roofline flashing and in-filled windows along the east facade were most likely the result of a 1984 fire which damaged the building. The building remains in fair condition, although it does show signs of recent neglect.
