Barrio Logan Historical Resources Survey

Prepared by:

City of San Diego
City Planning & Community Investment
Community Planning & Urban Form Divisions
202 C Street, MS 5A
San Diego, California 92101

February 01, 2011

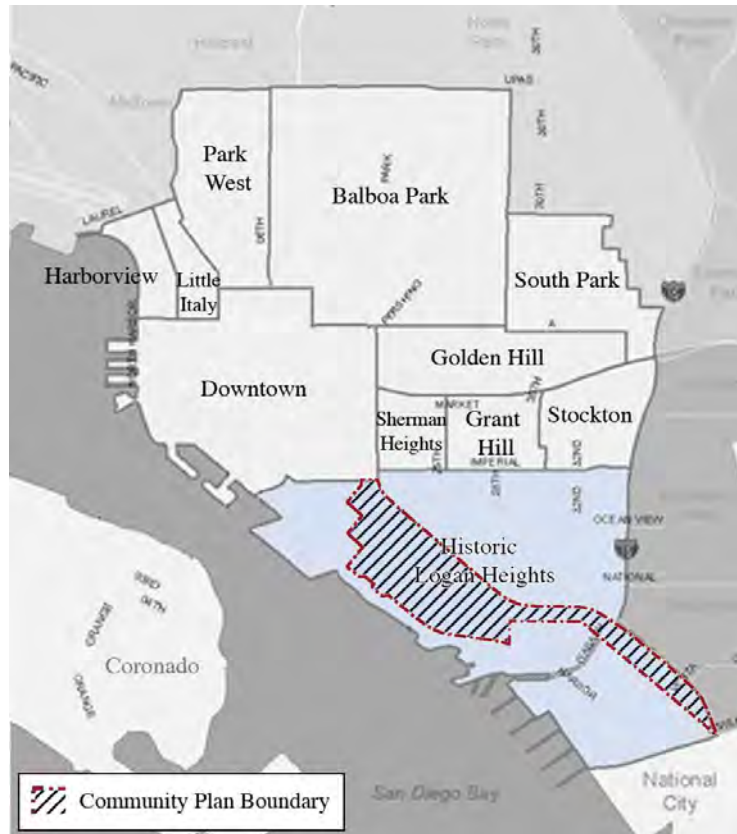
Figure 6. Approximate boundaries of Logan Heights from circa 1905 to 1963 (Norris 1983, Brandes 1983)

By 1905, the East End was known as Logan Heights, after the main thoroughfare through the area, Logan Avenue (**Figure 6**). It is unclear if this signified an official city name change (Brandes 1983, Norris 1983, Crane 1972).

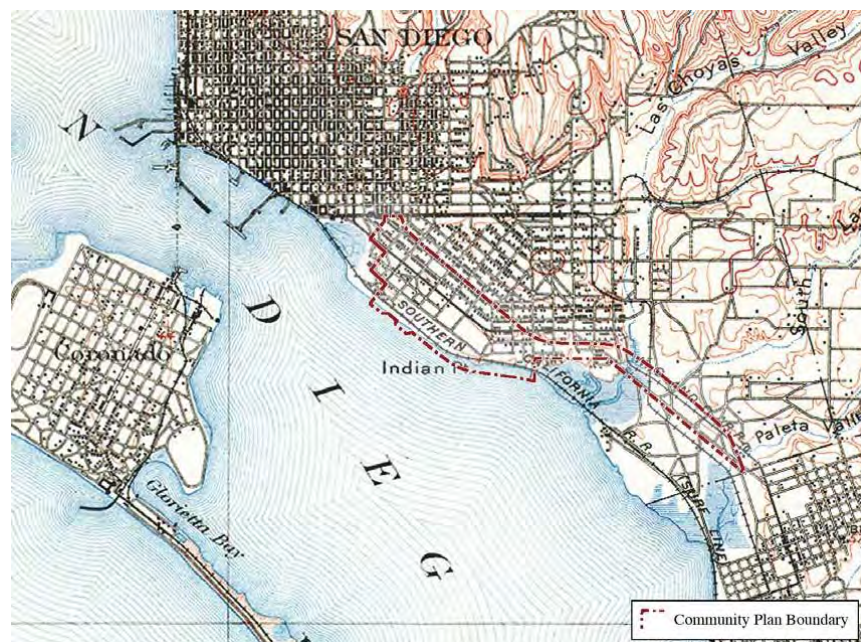
Figure 7. USGS San Diego Quadrangle, 1902. The small black squares define buildings present in 1902. Note the Southern California Railroad tracks running along the bay and the lack of development east of Chollas Creek.

At the start of the 20th century, Logan Heights was primarily residential and the configuration of streets was complete (**Figure 7**). Improvements to Logan Heights at this time included buried water lines and fire hydrants. Sanborn Fire Insurance Maps published in 1906 illustrate residential development within the plan area, including 248 residences, six flats (apartment buildings), nine stores, a Chinese laundry, three warehouses, and several buildings marked as "hay and grain storage." The area southwest of the Southern California Railroad tracks was tideland and the area around the mouth of Chollas Creek at the bay was an estuary, both locations were unsuitable for permanent structures. Due to lack of development, the future residential areas south of Main and east of 30th Street were not included in the 1906 Sanborn maps.

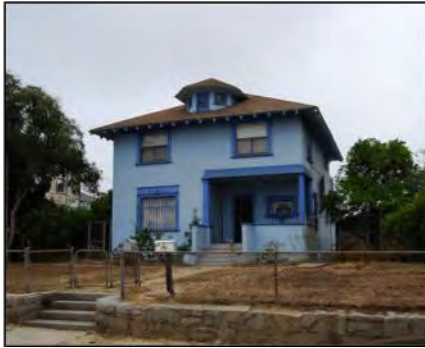
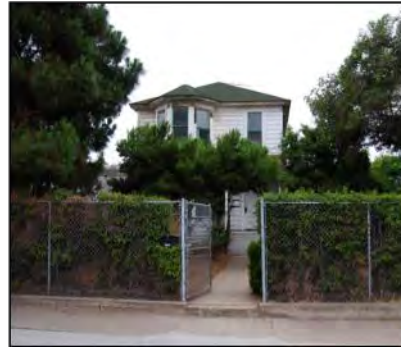
Plate 3. Residences designed by architects Hebbard and Gill in 1897. 2073-77 Logan Avenue (left) and 2085 Logan Avenue (right).

Homes in the plan area at the turn of the century were nearly all single-family residences, one per lot, most with outhouses and a stable. Logan Avenue between South 16th Street and 26th Street and National Avenue from South 16th Street to 27th Street contained the highest density. A smaller number of homes were present on Newton Avenue, Main Street, and Boston Avenue. Popular residential architectural styles during this period included Craftsman, Folk Victorian, and Colonial Revival. The prominent San Diego architectural firm of Hebbard and Gill, designed two Barrio Logan residences on Logan Avenue, both completed in 1897 **(Plate 3)**.

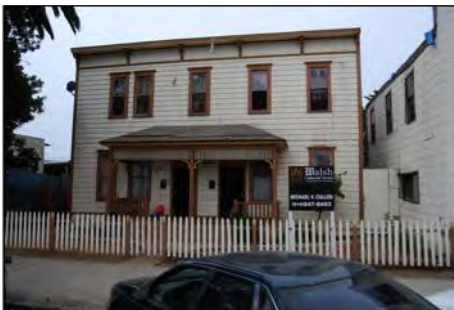
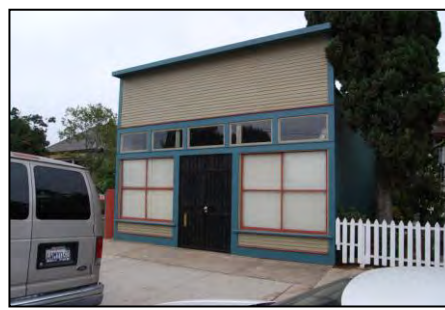
Plate 4. Early 20th century examples of a multiple-family dwellings (1831-1833 National Avenue, built 1903) and a commercial storefront (2215 Logan Avenue, built 1907) in the plan area.

By 1906, an emerging commercial district appeared on Logan Avenue between Beardsley and Sampson Streets **(Figure 8)**. Logan Avenue contained six businesses including a drug store, a meat and produce shop, two offices, a grocery, a hay and grain store, and two warehouses. The San Diego Soda Works, the single industrial building shown on the 1906 map, was on the north side of Logan between Beardsley and Cesar Chavez. One street to the east, on National Avenue between Beardsley and Cesar Chavez, was a Chinese Laundry, and on Sigsbee and Newton, a hay and grain warehouse stood at the corner. Commercial buildings were built in a variety of architectural styles including False-Front Commercial and Folk Victorian. Some of the business structures were mixed-use, with residential units above the retail store fronts **(Plate 4)**.

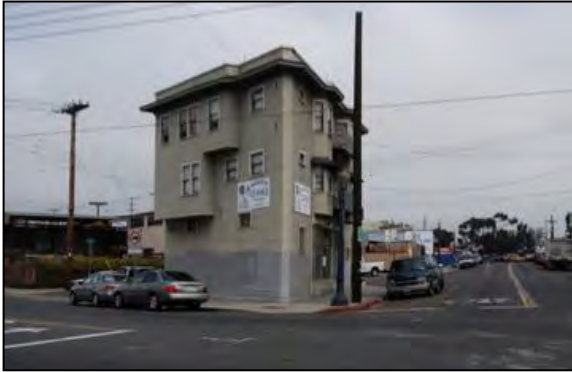
Plate 5. An example of a mixed-use building, containing a store below and residential units above (940-950 S. 26th Street), built 1911.

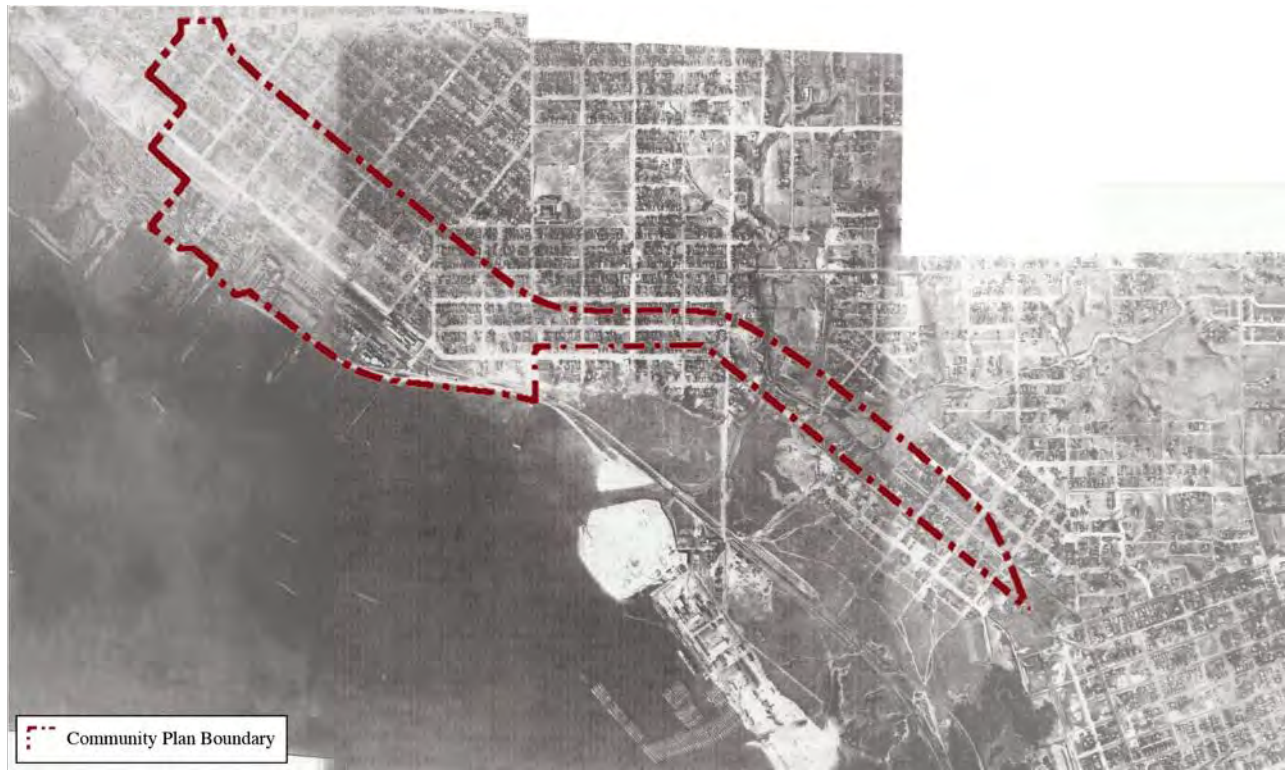
Plate 7. Aerial Photograph of plan area, 1928. In 1928, the bayfront was an active place, with many wharfs and industries. The Navy Destroyer Base is visible in the center bottom of the photograph (now the Naval Station San Diego). San Diego was the Navy's home base for the Pacific Fleet.

Along with the fishing industry, beginning in the 1920s, prominent businesses along the bay in the plan area included the Benson Lumber Company (west of Harbor Drive roughly between South 16th and Beardsley Streets) (**Plates 7 and 8**). Benson Lumber Company maintained a sawmill, planing mill, and lumberyards, as well as its own company wharf to catch the lumber that had been cut in northern California and then floated down the California coast. Southeast of the Benson Lumber Company was the Standard Oil Works, with its large fuel tanks, machinery shops, and oil loading dock, the Bolivar Packing Company (corner of Harbor and Beardsley), as well as the Chas. R. McCormick Lumber Company (between Cesar Chavez and Sampson) with its planing mill, sash and door factory, and lumber yards, and the San Diego Marine Construction Company (on a wharf at the end of Sampson). To the northwest of Benson Lumber Company, fish canneries and wharfs were located on the bayside of Harbor, between Beardsley and Dewey. In 1921, fishing businesses operated from this location, including West Coast Crab & Lobster Company, Southern Reduction Company, Lower California Fisheries Company Tuna Cannery, the International Packing Corporation Fish Canneries, the Sun Harbor Packing Corporation, and the Normandy Sea Food Company. Tucked in between the canneries was the Southwest Onyx and Marble Company. The Standard Oil Company of California was located on the bay between Sicard and Schley (**Figure 12**).

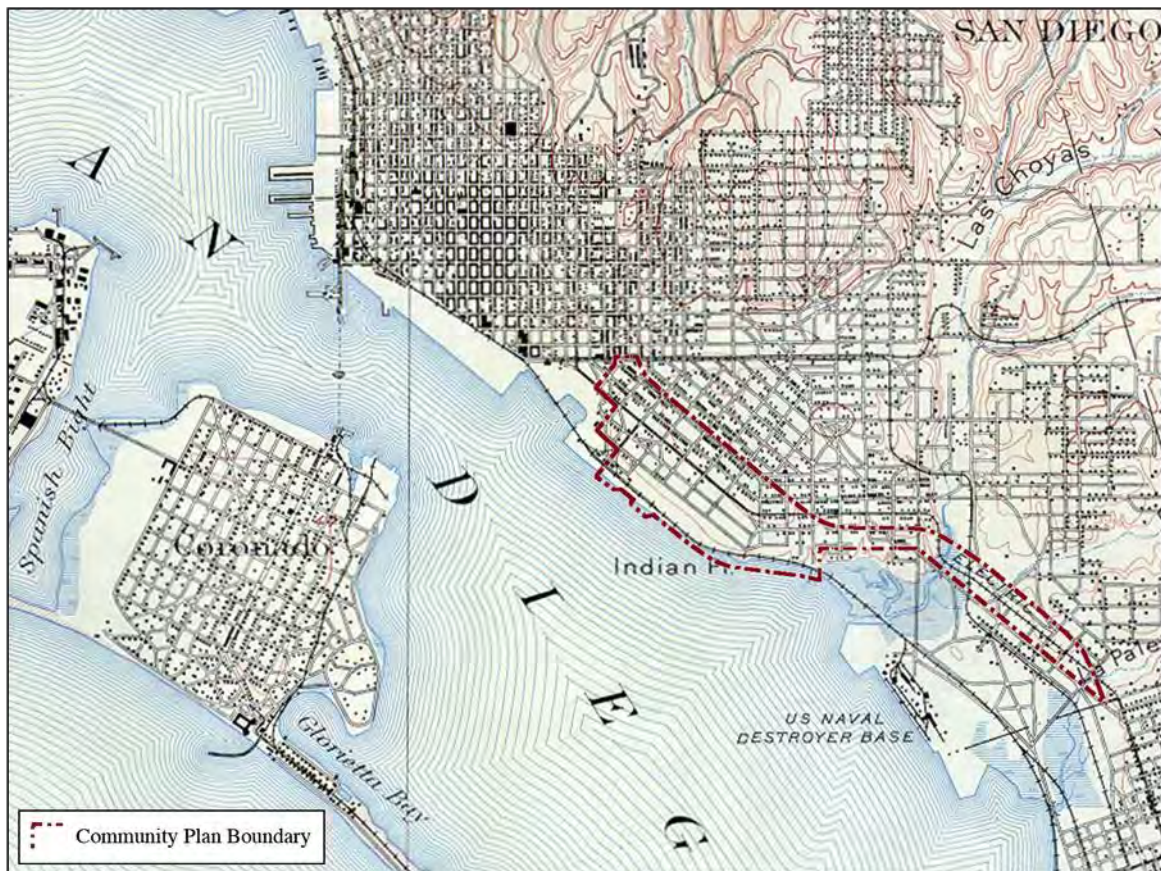
Figure 12. USGS San Diego Quadrangle, 1930.

Note the density of development near the Chollas Creek drainage (undeveloped in the 1902 USGS map) and the concentration of buildings on the northern end of the bayfront representing the lumberyards, canneries, and other bayfront industries.

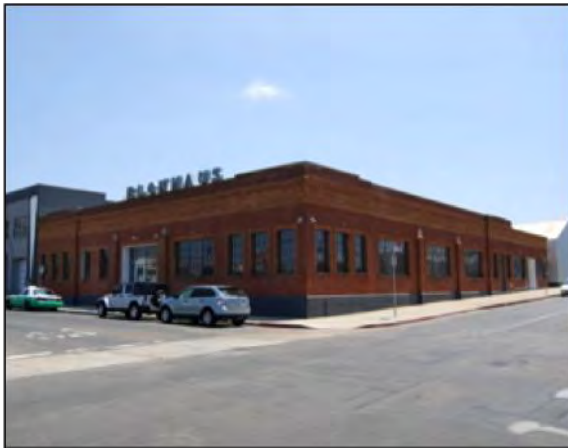
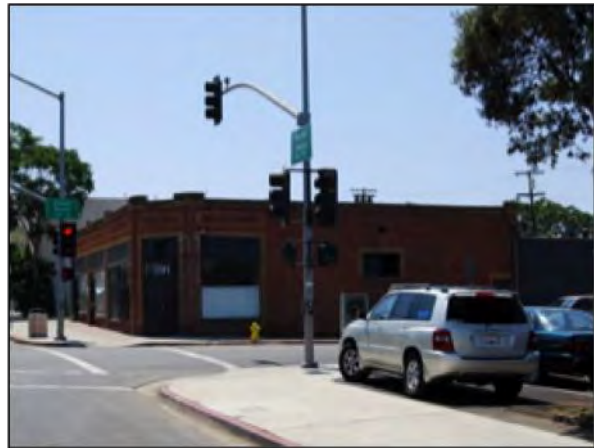
Plate 10. Examples of commercial buildings in the plan area.
(left) 1894 Main Street, built 1930, designed by Charles and Edward Quayle (Quayle Brothers Architects).
(right) 1701-1715 National Avenue, George Kostakos Building, built 1925, builder Bert Nobel,
City of San Diego Historic Landmark.

Although the commercial center of Logan Heights continued to expand along Logan Avenue (it was most concentrated between Dewey and South 26th Streets [**Figure 13**]), businesses were scattered throughout the community. By 1946, the Barrio Logan plan area contained twenty-two restaurants (in comparison to only one in 1921), three drugstores, a bank, a hotel (1819-25 Newton), a laundry, and a nursery. A second movie house (1796-1798 Logan) showed films several blocks northwest from the original movie house at 2171-2175 Logan. Numerous car-related businesses within the plan area served the needs of the neighborhood's automobile owners including thirteen gas stations, nine auto repair shops, and a used car sales lot. Prominent commercial buildings were built in the simple and inexpensive Block style, though some were also built in the Mission Revival or Streamline Moderne styles (**Plate 10**).

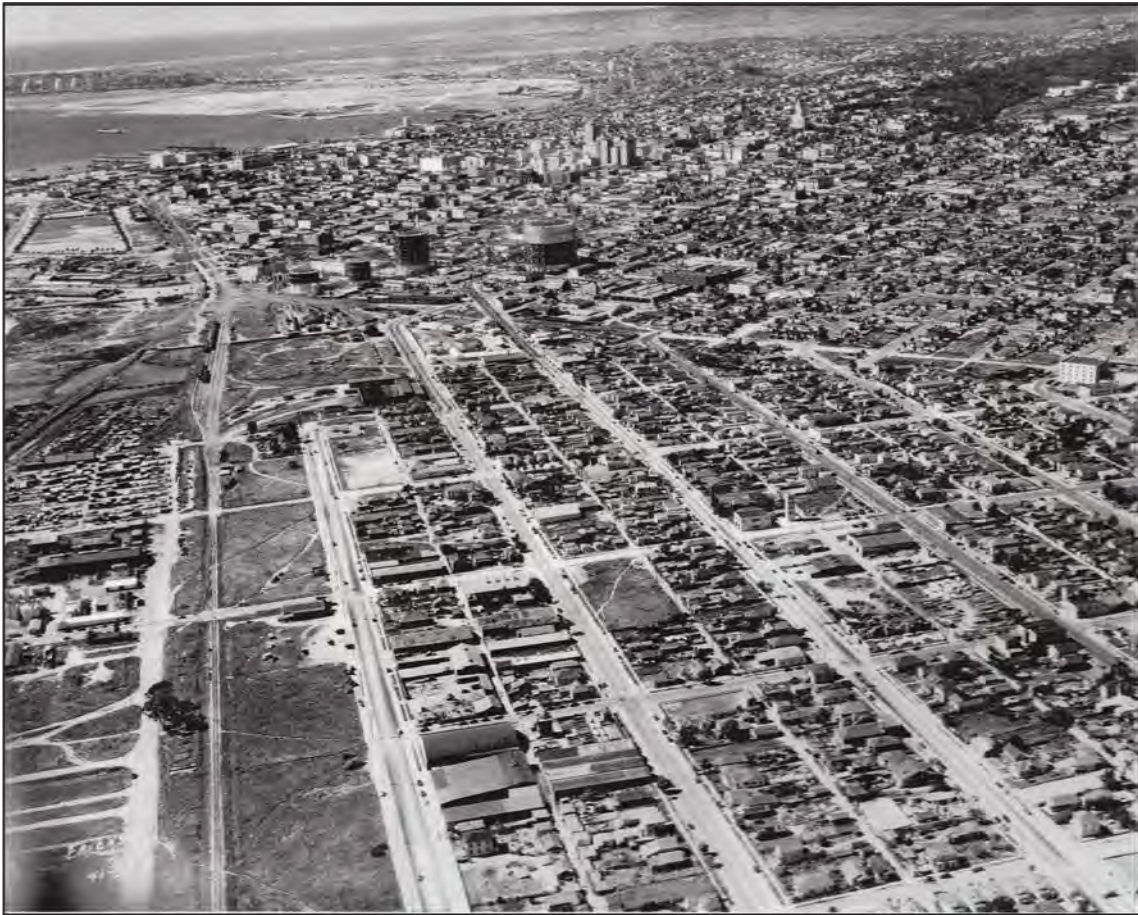
Plate 12. Close-up aerial photograph of the plan area during World War II, facing north. The railroad tracks are on the left side of the frame (left of Main Street). The dirt track to the left of the railroad tracks is Harbor Drive. Note the denseness of development at that time. Many of the buildings had outbuildings or second residences behind. *Courtesy of SDHS.*

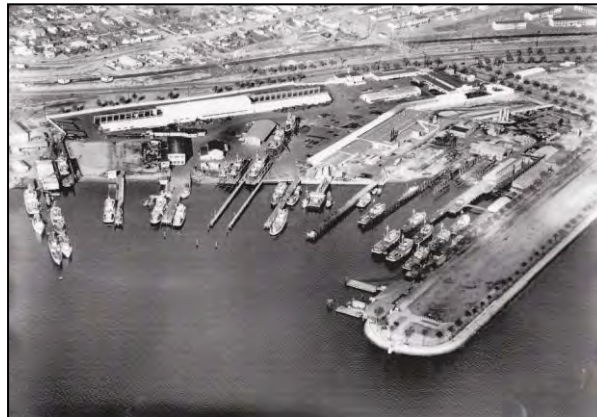
Plate 13. National Iron Works (later NASSCO), ca. 1939. The jetty was a Navy landing strip for the U.S. Naval Station planes. Courtesy of SDHS (#83:14578-17).

While San Diego's small shipbuilding industry was focused on fishing vessel construction in the period between 1900 and 1940, prior to World War II companies began to bid on the construction of large naval and commercial shipping crafts (Harris 1974:55). The National Iron Works (later NASSCO), the Harbor Boat and Yacht Company and the San Diego Marine Construction Company were established or expanded on the Barrio Logan bayfront in the mid-1940s and 1950s (**Plate 13**). The San Diego Marine Construction Company with its wharfs and machinery shops at the base of Sampson Street and National Iron Works (then called Lynch Ship Building Company) and its large overhead crane were located at the base of S. 28th Street (1946 Sanborn). The end of World War II led to a plunge in employment for those working in war-related industries but the outbreak of the Korean War as well as increasing tension between the United States and the Soviet Union once again stimulated the shipbuilding industries in the bayfront in the early 1950s.

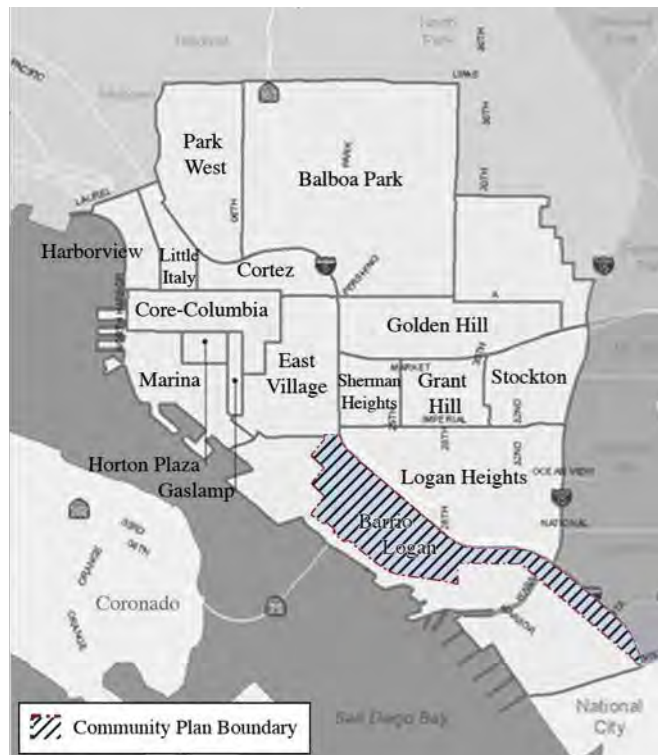
Figure 17. Approximate boundaries of Barrio Logan after 1969 (Norris 1983, Brandes 1983)

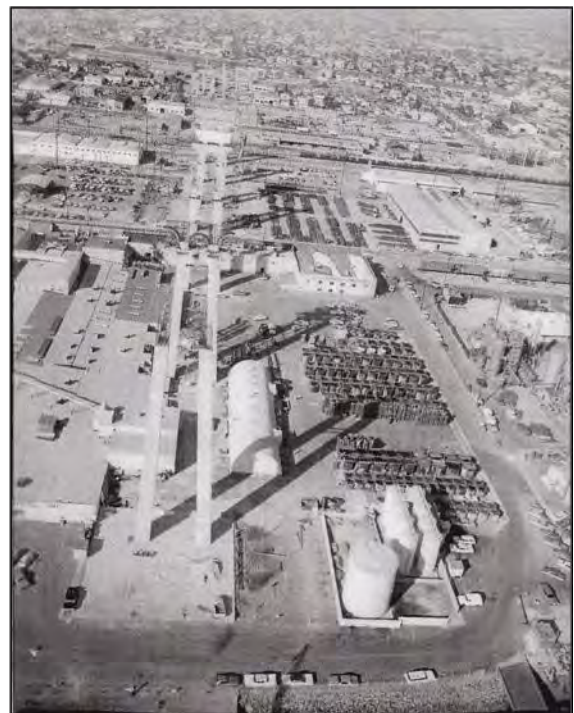
Plate 14. Coronado Bridge construction over Barrio Logan in 1969, facing east.
Courtesy of SDHS (#UT-85-08564-2)

The completion of the San Diego-Coronado Bay Bridge in 1969, which towered over Barrio Logan with its on-ramps and support pylons, displaced more families and businesses, creating a dramatic visual change to the neighborhood (**Plate 14**). The residents were not aware of their rights to protest against the bridge and many felt they had no choice but to leave (Delgado 1998). Barrio Logan's population dropped from 20,000 to 5,000 between 1969 and 1979 and many of the older homes and buildings were razed for industrial structures (Delgado 1998).

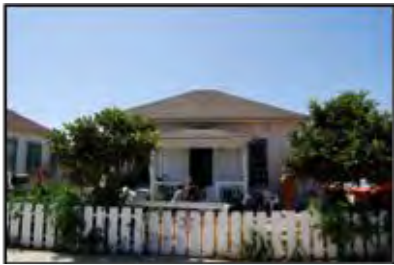
Plate 17. Personalized, fenced front yard in use by residents. 2679 Newton Ave.

Fencing that extends to the very edges of the front yard is the most common of the characteristics identified by Arreola and Rojas and the most frequent element observed in Barrio Logan (**Plate 17**). Of the nearly 500 properties included in the recent historic resources survey of Barrio Logan, nearly 90 percent of the single-family and multiple-family homes had an enclosure of some type around the front yard. Residents personalize their front yards with gardens, shrines, garden furniture, and personal effects.

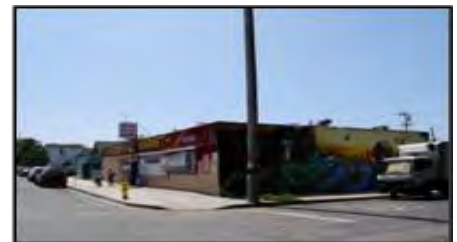
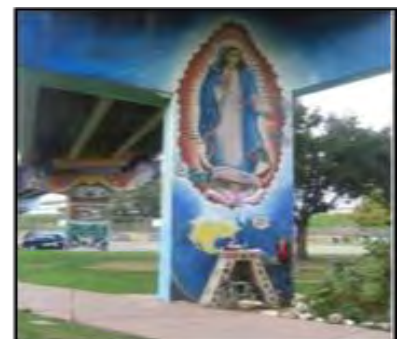
Plate 19. Store with murals at 2001 National Ave.; Chicano Park shrine

Shrines, far less common than the use of enclosures and color in *barrios* according to Arreola and Rojas, are still usually found in front yards in Mexican American neighborhoods. No yard shrines were observed in Barrio Logan, but one communal shrine is present in Chicano Park, which is devoted to the Virgin of Guadalupe, the patron saint of Mexico (**Plate 19**).
