PROPOSED EAST END
HISTORIC AND PLANNED
DISTRICTS

Public History

May 1983

**EAST END
PLANNED DISTRICT &
HISTORIC DISTRICT**

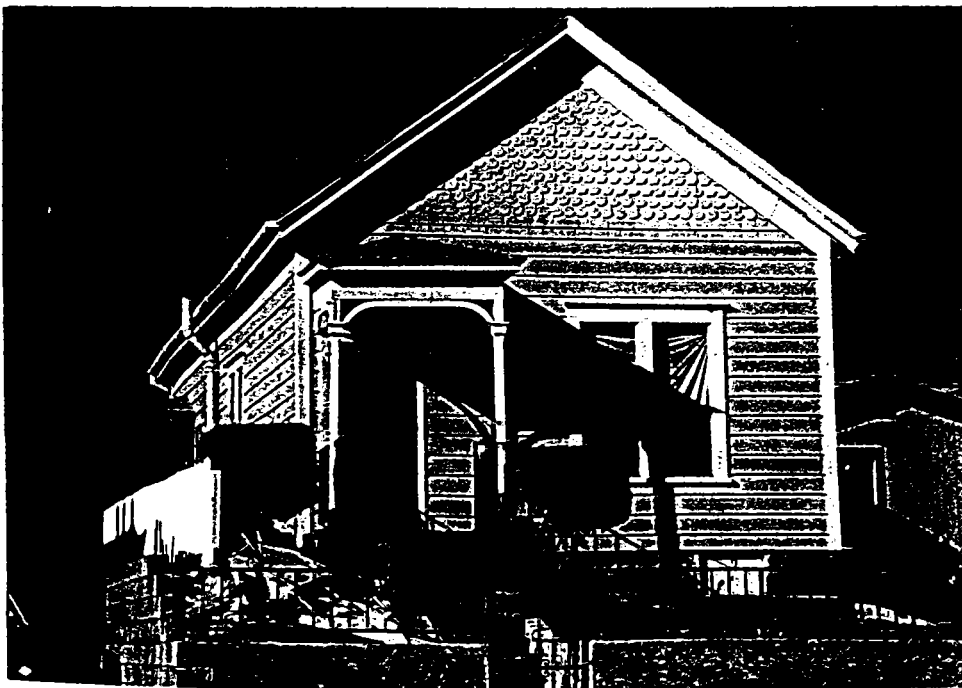
- 7a. Architectural style: Lot 32 Queen Anne Cottage
- 7b. Briefly describe the present physical description of the site or structure and describe any major alterations from its original condition:

8. Construction date:
Estimated 1910 Factual _____
9. Architect _____
10. Builder _____
11. Approx. property size (in feet)
Frontage 45 Depth 90
or approx. acreage 1983
12. Date(s) of enclosed photograph(s)
1983

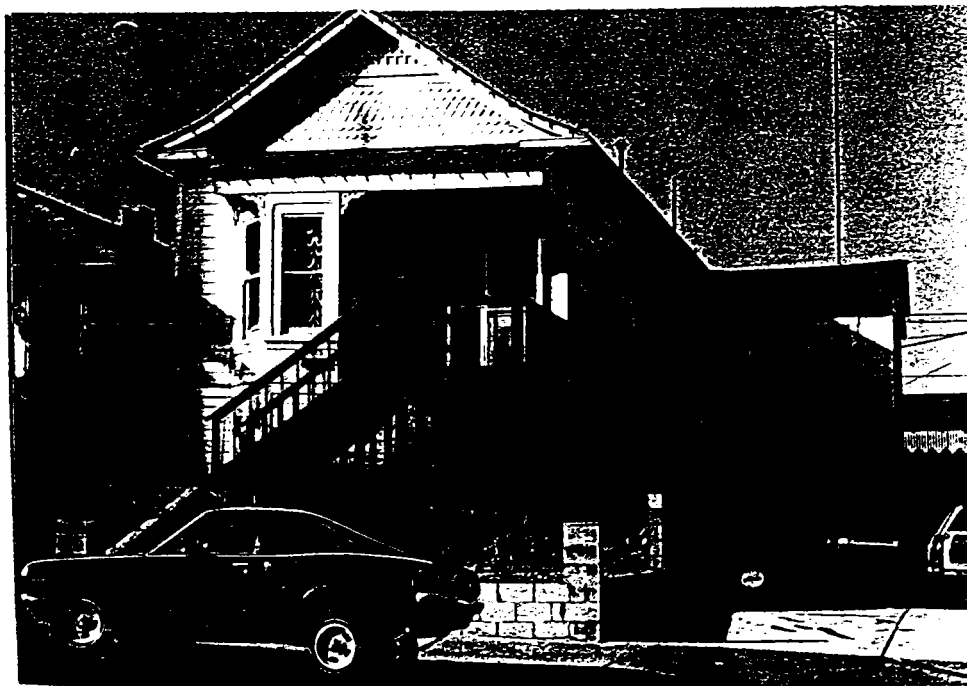
- 7a. Architectural style: Late Victorian bungalow
- 7b. Briefly describe the present physical description of the site or structure and describe any major alterations from its original condition:

8. Construction date:
Estimated 1906 Factual _____
9. Architect _____
10. Builder _____
11. Approx. property size (in feet)
Frontage 60 Depth 10
or approx. acreage _____
12. Date(s) of enclosed photograph(s)
1983

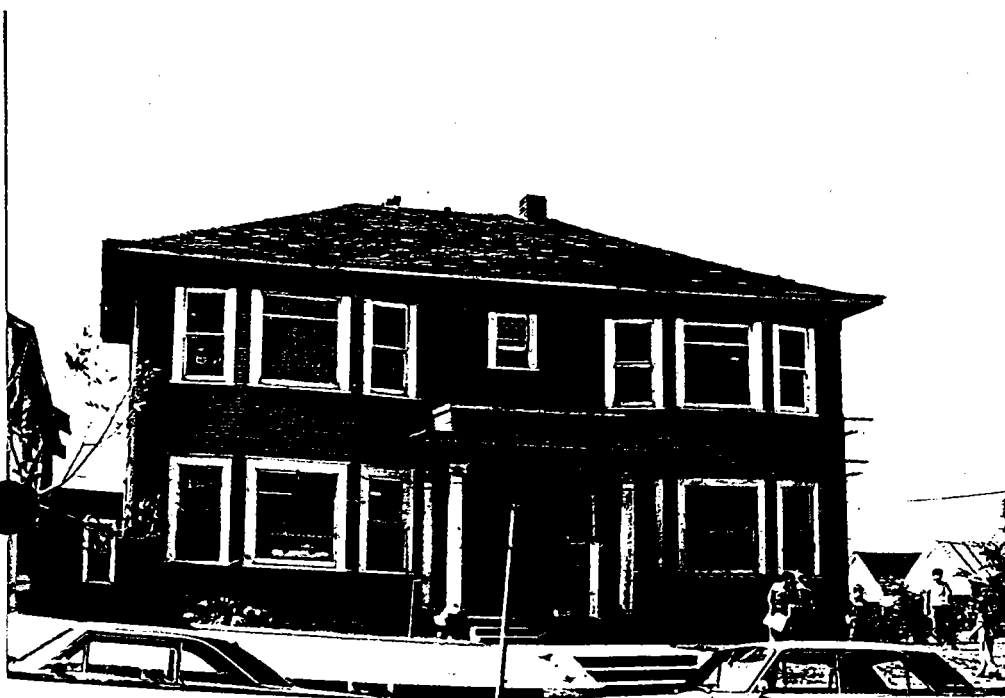
The home has all the earmarks of having been designed by a classic architect. Buildings around the home appear to be of the same vintage. The main building is two story, a medium pitched roof with several brick chimneys. Facing Logan Avenue, it has matching windows on both sides of the facade at both stories. These are in each of the four places vertical sashed windows on either side of a large single sash window. The portico over the front steps and entrance is supported by four Ionic pillars and is in fact a small porch which appears to have no accessibility. Above that is a small double sash window with diamond shaped panes. The yard is partly cement and partly grass. The shiplap siding is painted green; the white pillars and window frames are deteriorating.

8. Construction date:
Estimated 1915 Factual _____
9. Architect _____
10. Builder _____
11. Approx. property size (in feet)
Frontage 75 Depth 100
or approx. acreage _____
12. Date(s) of enclosed photograph(s)
1983

13. Condition: Excellent ____ Good ____ Fair ☒ Deteriorated ____ No longer in existence ____
14. Alterations: not seen
15. Surroundings: (Check more than one if necessary) Open land ____ Scattered buildings ____ Densely built-up ____
Residential ☒ Industrial ☒ Commercial ☒ Other: _____
16. Threats to site: None known ☒ Private development ____ Zoning ____ Vandalism ____
Public Works project ____ Other: _____
17. Is the structure: On its original site? ☒ Moved? ____ Unknown? ____
18. Related features: _____

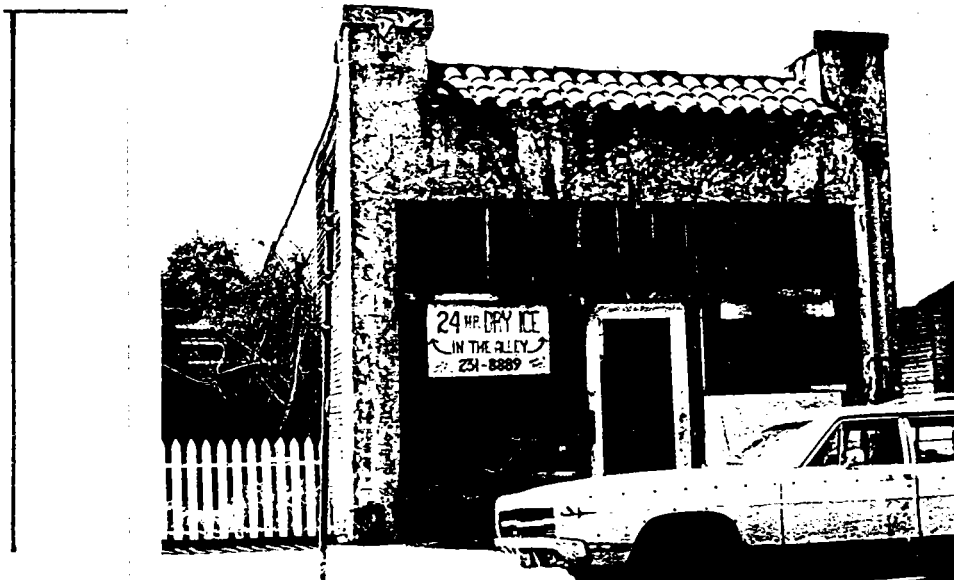
- 7a. Architectural style: _____ Early 20th Century Commercial _____
- 7b. Briefly describe the present *physical description* of the site or structure and describe any major alterations from its original condition: _____ Legal Description: Mannasse and Schiller Subdivision, Block 139, lot 32. _____
The building appears to be structurally sound although interior and exterior signs of deterioration are apparant. The sides of the structure have overlapping siding while the front exterior facade exhibits a 1920's stucco finish with tile parapet. Large store-front windows are topped with a horizontal band of smaller vertical paned windows. A central glass and wood-framed door stands flush with the front facade.

8. Construction date: _____
Estimated 1905 Factual _____
9. Architect _____
10. Builder _____
11. Approx. property size (in feet)
Frontage 50' Depth 150'
or approx. acreage _____
12. Date(s) of enclosed photograph(s)
April, 1983

13. Condition: Excellent _____ Good _____ Fair _____ Deteriorated ☒ No longer in existence _____
14. Alterations: A stucco facade with tile parapet was apparently added to this building at a later date.
15. Surroundings: (Check more than one if necessary) Open land _____ Scattered buildings _____ Densely built-up _____
Residential ☒ Industrial ☒ Commercial ☒ Other: _____
16. Threats to site: None known _____ Private development _____ Zoning ☒ Vandalism _____
Public Works project _____ Other: _____
17. Is the structure: On its original site? ☒ Moved? _____ Unknown? _____
18. Related features: _____

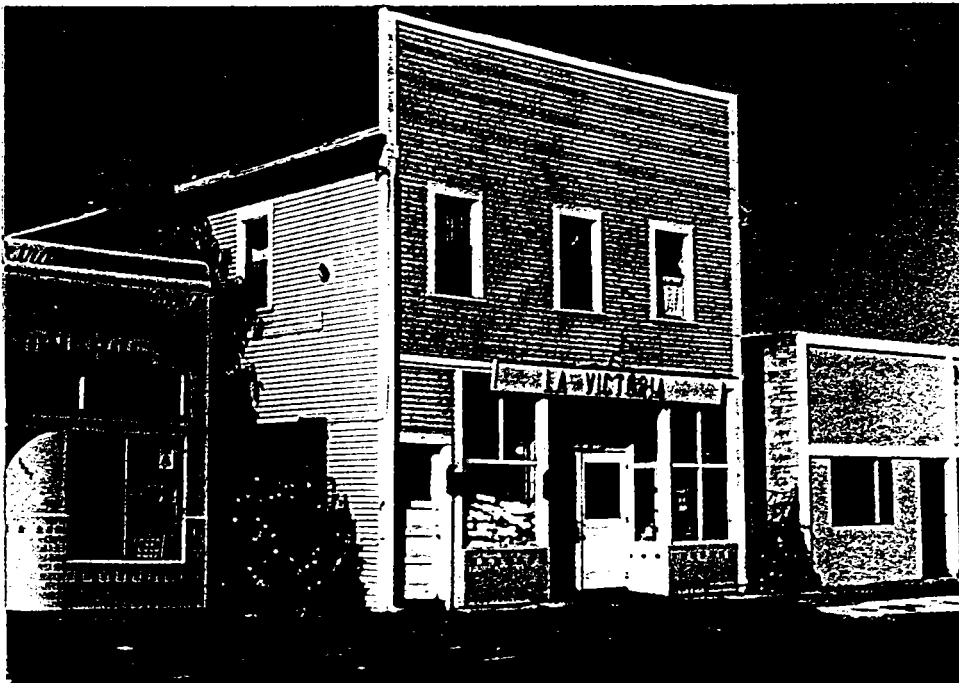
This building has a medium pitched roof which is unusual behind a false front. The roofing material is composition shingle with a single chimney toward the rear. The floor plan is rectangular and the building is two story with the apartments upstairs. The exterior is shiplap horizontal siding. The windows are wood sash, double-hung rectangular with two panes. The first floor faces the street with a double door, one leading to a store, the other to the 2nd store at the first level. The first floor faces the street having the double doors, transom windows and floor to ceiling display windows on either side. An additional door leads to the second stair floor level.

8. Construction date:
Estimated 1901 Factual _____
9. Architect _____
10. Builder _____
11. Approx. property size (in feet)
Frontage 50 Depth 100
or approx. acreage _____
12. Date(s) of enclosed photograph(s)
1983

13. Condition: Excellent _____ Good ☒ Fair _____ Deteriorated _____ No longer in existence _____
14. Alterations: None apparent
15. Surroundings: (Check more than one if necessary) Open land _____ Scattered buildings _____ Densely built-up ☒
Residential _____ Industrial _____ Commercial ☒ Other: _____
16. Threats to site: None known ☒ Private development _____ Zoning _____ Vandalism _____
Public Works project _____ Other: _____
17. Is the structure: On its original site? ☒ Moved? _____ Unknown? _____
18. Related features: _____

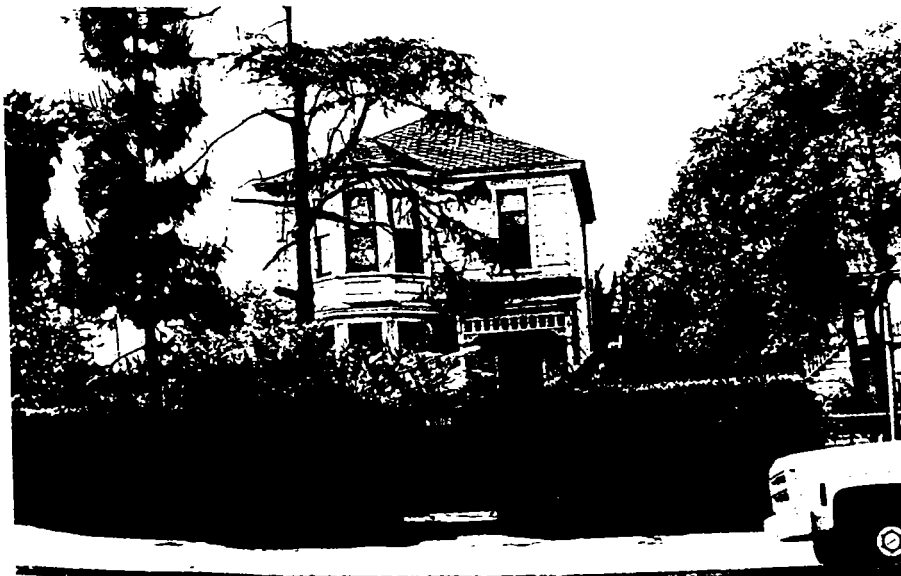
- 7a. Architectural style: Victorian
- 7b. Briefly describe the present *physical description* of the site or structure and describe any major alterations from its original condition: Legal Description: San Diego Land and Town Company Addition, Portion of block 142, lots 29 and 30, and East one half of lot 31.
This two story doubled gabled residence has an asphalt shingled roof and shiplap siding. A roof overhang is slight and un-ornamented. The second story has a curved bay with three rectangular double sash windows; this bay follows through to the first floor below in a similar pattern. The front porch is simple with wooden jigsaw ornamentation and is covered with a small roof. The balance of the house is plain with the shiplap siding; plumbing is on the exterior. The carriage house splits the property line between this residence and that at 2973-77 Logan Avenue. It is conceivable that the carriage house was shared by the Osborn family who resided in both homes.

8. Construction date: Estimated 1895 Factual _____
9. Architect Hebbard/Gill?
10. Builder _____
11. Approx. property size (in feet)
Frontage 100' Depth 100'
or approx. acreage _____
12. Date(s) of enclosed photograph(s)
April, 1983

13. Condition: Excellent ____ Good ____ Fair X Deteriorated ____ No longer in existence ____
14. Alterations: _____
15. Surroundings: (Check more than one if necessary) Open land ____ Scattered buildings ____ Densely built-up ____
Residential X Industrial ____ Commercial X Other: _____
16. Threats to site: None known ____ Private development X Zoning X Vandalism ____
Public Works project ____ Other: _____
17. Is the structure: On its original site? X Moved? ____ Unknown? ____
18. Related features: _____

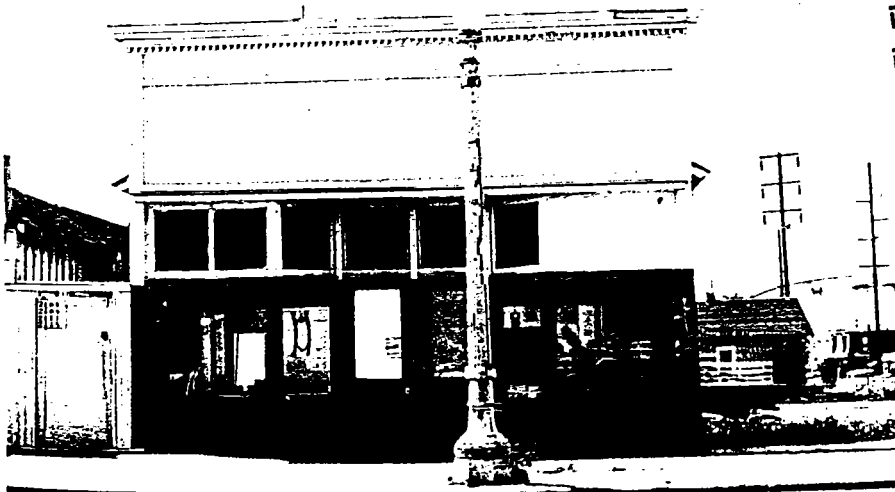
This rectangular one and a half story false front building has a medium gabled roof and parapet with crown molding entablature. The exterior facade consists of vertical shiplap siding, double front doors with kick panels below. Two front doors lead to the conclusion that the building is presently divided in half to provide two locations for businesses. All windows are wood sash, single pane. Above the main display windows are a series of rectangular smaller windows giving light into a deep building.

8. Construction date: Estimated 1905 Factual _____
9. Architect _____
10. Builder _____
11. Approx. property size (in feet)
Frontage 50 Depth 100
or approx. acreage _____
12. Date(s) of enclosed photograph(s)
1983

13. Condition: Excellent ____ Good ____ Fair X Deteriorated ____ No longer in existence ____
14. Alterations: _____
15. Surroundings: (Check more than one if necessary) Open land ____ Scattered buildings ____ Densely built-up ____
Residential ____ Industrial ____ Commercial X Other: _____
16. Threats to site: None known ____ Private development ____ Zoning X Vandalism ____
Public Works project ____ Other: _____
17. Is the structure: On its original site? ____ Moved? ____ Unknown? ____
18. Related features: _____

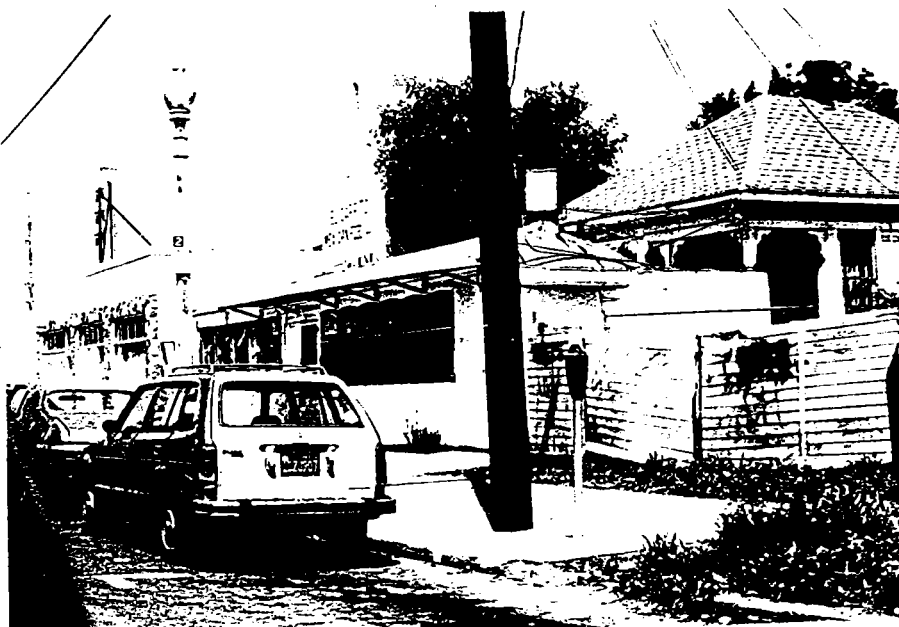
This commercial fast-food Mexican restaurant was placed in old street-car on the front part of the lots blocking an otherwise superb residence. Nonetheless it is in itself unique and the entrance is through a single screened door. To the left and right of the entrance runs a continuous series of narrow vertical arched windows. A small addition has been attached to the back of the car. Aluminum siding is the primary facing material and a poorly constructed fence protects the property line from intruders.

8. Construction date:
Estimated 1930 Factual _____
9. Architect _____
10. Builder _____
11. Approx. property size (in feet)
Frontage 75 Depth 100
or approx. acreage _____
12. Date(s) of enclosed photograph(s)
1983

13. Condition: Excellent ____ Good ____ Fair X Deteriorated ____ No longer in existence ____
14. Alterations: A small addition has been "tacked" on to the rear of the car
15. Surroundings: (Check more than one if necessary) Open land ____ Scattered buildings ____ Densely built-up X
Residential ____ Industrial ____ Commercial X Other: _____
16. Threats to site: None known ____ Private development ____ Zoning X Vandalism ____
Public Works project ____ Other: _____
17. Is the structure: On its original site? ____ Moved? ____ Unknown? ____
18. Related features: A deteriorated fence skirts the property line.

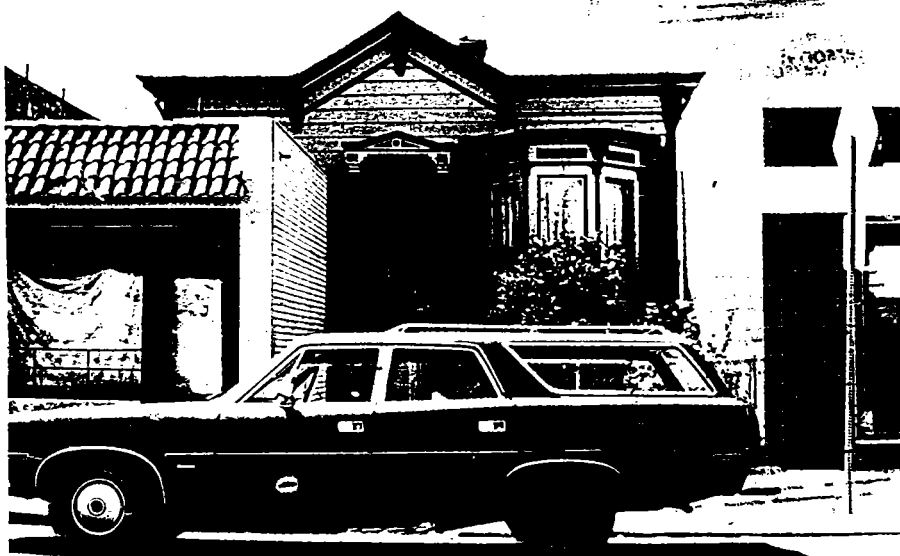
This Victorian Gothic Cottage has a touch of Italianate influence. The front bay window and center-gabled roof confirm the Victorian design as well as the transomed entryway and modified arch. The exterior walls of overlapping boards appear to be modern. Of particular interest is the Italianate bay with double-paned vertical sash windows. A small decorative arch supported by plain slender posts frames the four-paned glass and wood door. While restoration efforts have greatly improved the building's outward appearance, the effect is somewhat marred by the presence of a vacant and deteriorated structure which edges the front property line and particlly obscures the residence to the rear.

8. Construction date:
Estimated 1900 Factual _____
9. Architect _____
10. Builder _____
11. Approx. property size (in feet)
Frontage 50 Depth 100
or approx. acreage _____
12. Date(s) of enclosed photograph(s)
1983

13. Condition: Excellent ____ Good X Fair ____ Deteriorated ____ No longer in existence ____
14. Alterations: _____
15. Surroundings: (Check more than one if necessary) Open land ____ Scattered buildings ____ Densely built-up X
Residential ____ Industrial ____ Commercial X Other: _____
16. Threats to site: None known ____ Private development ____ Zoning X Vandalism ____
Public Works project ____ Other: _____
17. Is the structure: On its original site? X , Moved? ____ Unknown? ____
18. Related features: A commercial structure along the front property line partially blocks the approach to this residence.

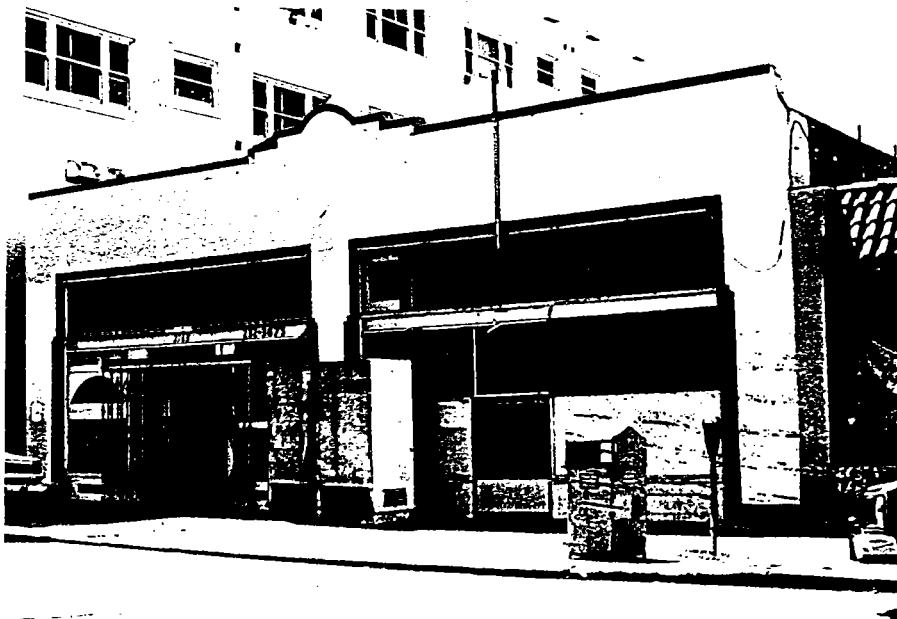
The California Mission facade is typical of 1920's and in commercial use, particularly in garages and gas stations. The facade as is the case here camouflaged the presence of windows added on and entryways which are non-descriptive. This rectangular stucco and brick building has two arched entries and one double door front entry with peep windows. The arched windows are now boarded up as are several other openings. With the exception of the abbreviated mission facade along the roofline, and ornamental brick trim around the windows and doorways, the structure is unadorned. A run-down appearance characterizes this building and wrought-iron grillwork adds little to the altered facade. From the appearance in the rear, it appears that the building was likely constructed about 1902 and that the facade is an add on to the front in the 1920's.

8. Construction date:
Estimated 1902 Factual _____
9. Architect _____
10. Builder _____
11. Approx. property size (in feet)
Frontage 50 Depth 100
or approx. acreage _____
12. Date(s) of enclosed photograph(s)
1983

13. Condition: Excellent ____ Good ____ Fair ____ Deteriorated X No longer in existence ____
14. Alterations: Windows boarded and openings faced with wrought iron grillwork
15. Surroundings: (Check more than one if necessary) Open land ____ Scattered buildings ____ Densely built-up X
Residential ____ Industrial ____ Commercial X Other: _____
16. Threats to site: None known X Private development ____ Zoning ____ Vandalism ____
Public Works project ____ Other: _____
17. Is the structure: On its original site? X Moved? ____ Unknown? ____
18. Related features: _____

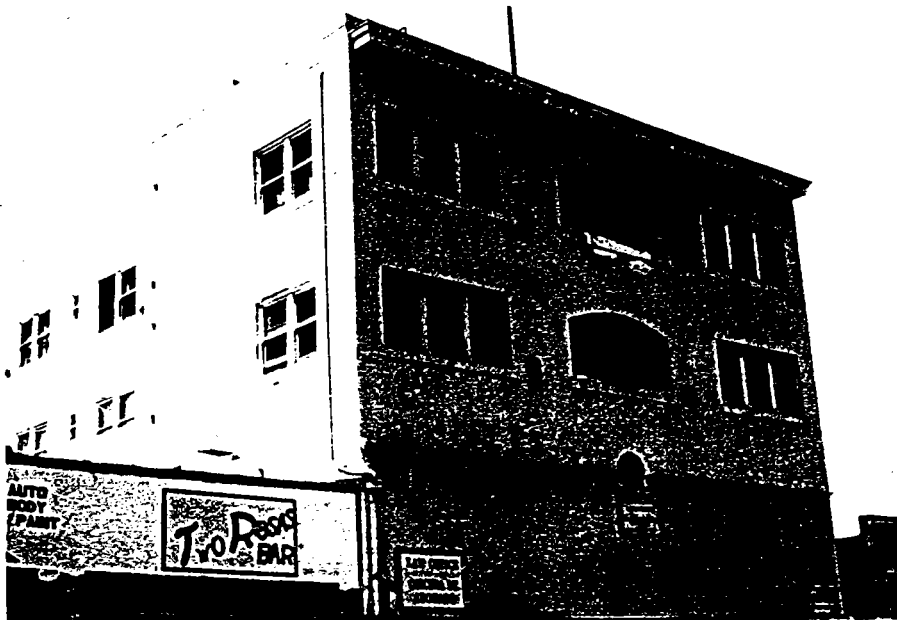
This rectangular, three-story stucco building is a flat Mediterranean building with arched front windows, a flat roof and parapet with entablature. The second and third story windows are flat sash with molded trim. Two recessed upper story balconies open to the front.

8. Construction date:
Estimated 1913 Factual _____
9. Architect _____
10. Builder _____
11. Approx. property size (in feet)
Frontage 50 Depth 100
or approx. acreage _____
12. Date(s) of enclosed photograph(s)
1983

13. Condition: Excellent ____ Good X Fair ____ Deteriorated ____ No longer in existence ____
14. Alterations: _____
15. Surroundings: (Check more than one if necessary) Open land ____ Scattered buildings ____ Densely built-up X
Residential ____ Industrial ____ Commercial ____ Other: _____
16. Threats to site: None known ____ Private development ____ Zoning X Vandalism ____
Public Works project ____ Other: _____
17. Is the structure: On its original site? X Moved? ____ Unknown? ____
18. Related features: _____

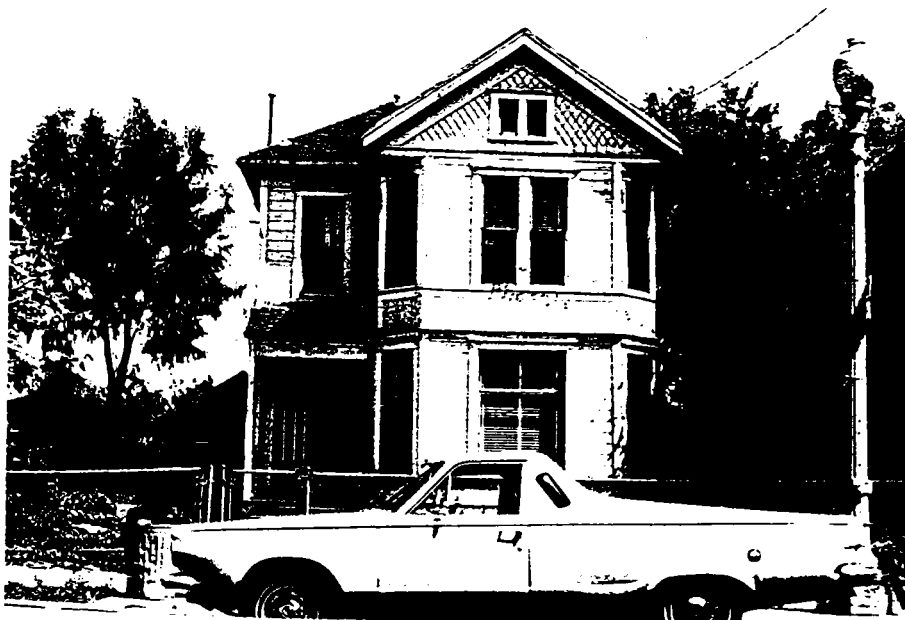
San Diego Land & Town Add. Block 175, EXC HWY/OP lots 19-20. This L-shaped two and a half story home is a good example of a typical homestead style prevalent during the late 1800s and early 1900s. The structure has a high gable with a composition shingle roof. A small double window compliments the gable end. The second story windows are double hung with decorative lintels. The front corners of the ell facing the street are cutaway to make room for angled corner windows on both the first and second stories. The exterior facade is clapboard siding with fish scale shingles decorating the gable end. The flat front door with a side panel and plain molding opens to a small porch supported by slender square posts.

8. Construction date: Estimated 1900 Factual _____
9. Architect unknown
10. Builder unknown
11. Approx. property size (in feet)
Frontage 50 Depth 140
or approx. acreage _____
12. Date(s) of enclosed photograph(s)
Spring 1983

13. Condition: Excellent ____ Good ____ Fair ☒ Deteriorated ____ No longer in existence ____
14. Alterations: _____
15. Surroundings: (Check more than one if necessary) Open land ____ Scattered buildings ____ Densely built-up ☒
Residential ☒ Industrial ____ Commercial ☒ Other: _____
16. Threats to site: None known ____ Private development ____ Zoning ☒ Vandalism ____
Public Works project ____ Other: _____
17. Is the structure: On its original site? ____ Moved? ____ Unknown? ☒
18. Related features: _____

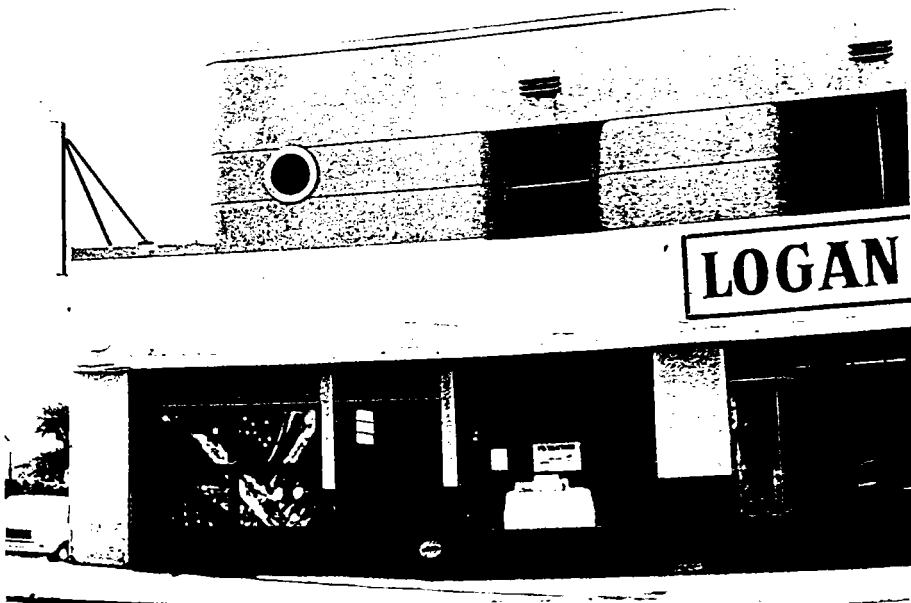
- 7a. Architectural style: Streamline Moderne
- 7b. Briefly describe the present *physical description* of the site or structure and describe any major alterations from its original condition:
San Diego Land & Town Addn, Block 143, lots 28-29.
This structure is a good example of a streamline moderne style
popular during the late 1920's and early thirties. The two
story building has a flat roof, plain parapet and recessed
windows on the second floor. Large glass display windows
front the building along with decorative tile work which
partially frames the lower windows and central front door.
A porthole window on the second story and the rounded corners
of the building are typical of this style.

8. Construction date:
Estimated _____ Factual 1926
9. Architect unknown
10. Builder unknown
11. Approx. property size (in feet)
Frontage 100 Depth 100
or approx. acreage _____
12. Date(s) of enclosed photograph(s)
April, 1983

13. Condition: Excellent ___ Good ☒ Fair ___ Deteriorated ___ No longer in existence ___
14. Alterations: _____
15. Surroundings: (Check more than one if necessary) Open land ___ Scattered buildings ___ Densely built-up ☒
Residential ___ Industrial ___ Commercial ☒ Other: _____
16. Threats to site: None known ___ Private development ___ Zoning ☒ Vandalism ___
Public Works project ___ Other: _____
17. Is the structure: On its original site? ☒ Moved? ___ Unknown? ___
18. Related features: _____

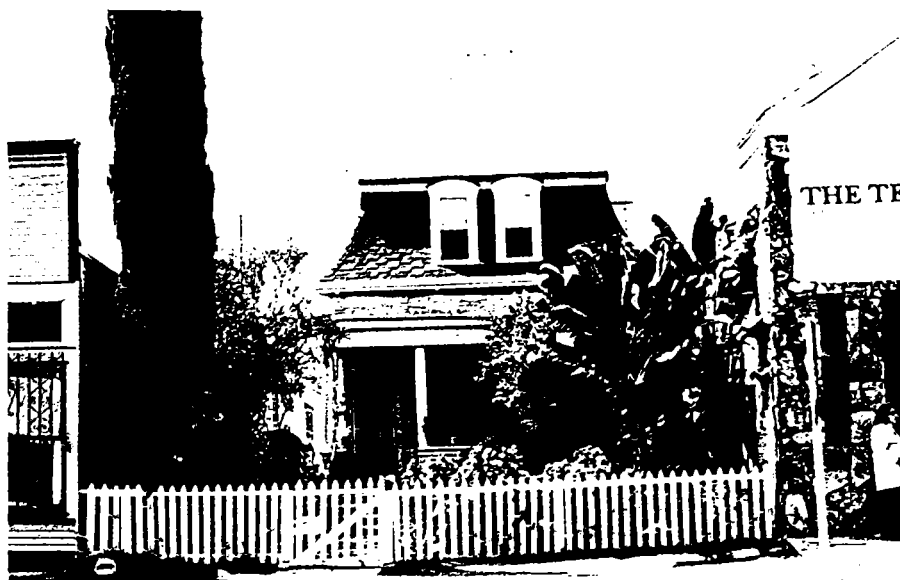
- 7a. Architectural style: Mansard Cottage Style
- 7b. Briefly describe the present *physical description* of the site or structure and describe any major alterations from its original condition: Legal Description: San Diego Land and Town Company Addition, Block 144, lot 46.
This late 19th century house is characterized by a gently sloping mansard roof with arched dormer windows on the second floor. The roofing material is composition shingle, while exterior walls utilize clapboard siding. Decorative brackets can be found at corner eaves. Flat vertical four-paned windows face the first floor exterior and a flat front door with plain molded trim is protected by the recent addition of a screen. A covered porch supported by delicate colonial-style pillars fronts the lower story and a picket fence runs along the property line.

13. Condition: Excellent _____ Good X Fair _____ Deteriorated _____ No longer in existence _____
14. Alterations: An aluminum screen door has been added to the front.
15. Surroundings: (Check more than one if necessary) Open land _____ Scattered buildings _____ Densely built-up _____
Residential X Industrial _____ Commercial X Other: _____
16. Threats to site: None known _____ Private development _____ Zoning X Vandalism _____
Public Works project _____ Other: _____
17. Is the structure: On its original site? X Moved? _____ Unknown? _____
18. Related features: _____

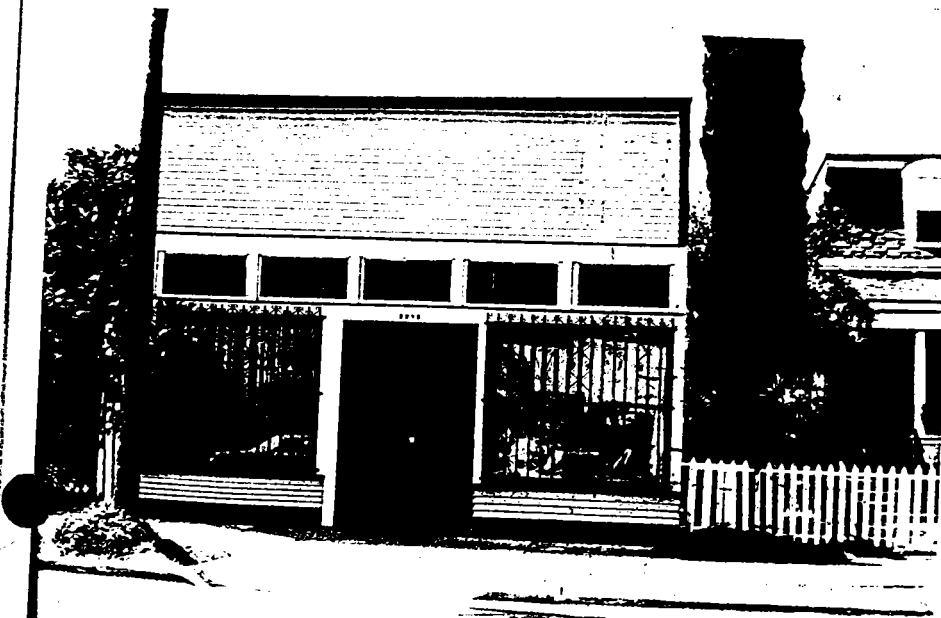
This is an excellent example of its kind and one of the few remaining in the area. Some deterioration is apparent, but restoration is feasible. The simple box-like structure is characterized by exterior clapboard siding, a gabled roof in the rear behind the facade. Five horizontal single pane windows bridge two large square display windows and central double front doors. The addition of wrought iron grillwork around windows and door have altered the original appearance of the building somewhat.

13. Condition: Excellent ____ Good ____ Fair x Deteriorated ____ No longer in existence ____
14. Alterations: Grillwork around front windows and door.
15. Surroundings: (Check more than one if necessary) Open land ____ Scattered buildings ____ Densely built-up x
Residential x Industrial ____ Commercial x Other: _____
16. Threats to site: None known ____ Private development ____ Zoning x Vandalism ____
Public Works project ____ Other: _____
17. Is the structure: On its original site? ____ Moved? ____ Unknown? x
18. Related features: _____

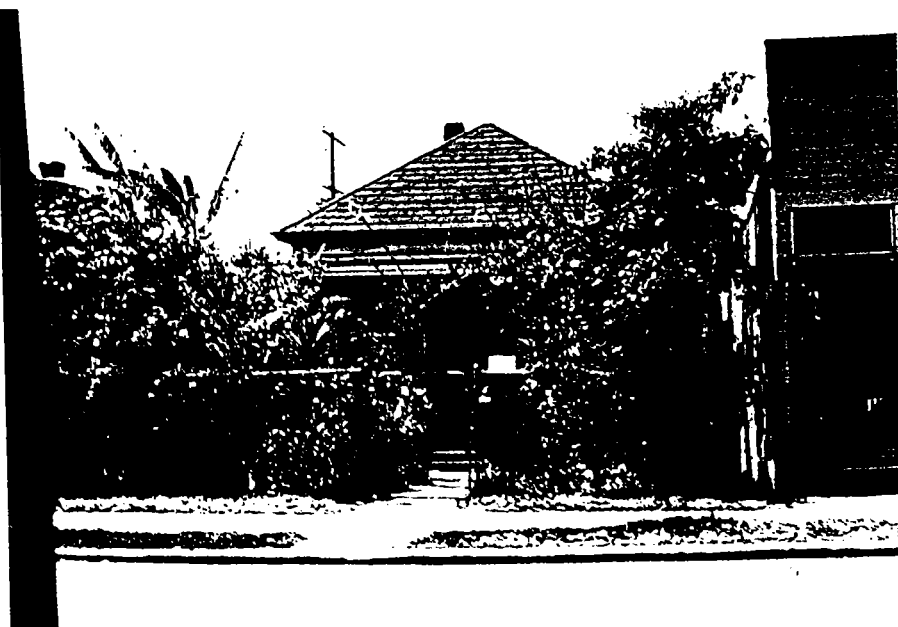
This cottage or bungalow is characterized by a medium gabled roof, shingled with asphalt shingles but with clapboard siding. The front steps lead to an open front porch supported by plain box pillars. A flat front door with plain molded trim compliments flat vertical windows arranged on either side of the central entrance. Thick vegetation dominates the yard and a chain link fence edges the property line. A single chimney sets at the rear of the house at roof line.

13. Condition: Excellent ____ Good ____ Fair x Deteriorated ____ No longer in existence ____
14. Alterations: _____
15. Surroundings: (Check more than one if necessary) Open land ____ Scattered buildings ____ Densely built-up x
Residential x Industrial ____ Commercial x Other: _____
16. Threats to site: None known ____ Private development ____ Zoning x Vandalism ____
Public Works project ____ Other: _____
17. Is the structure: On its original site? x Moved? ____ Unknown? ____
18. Related features: _____

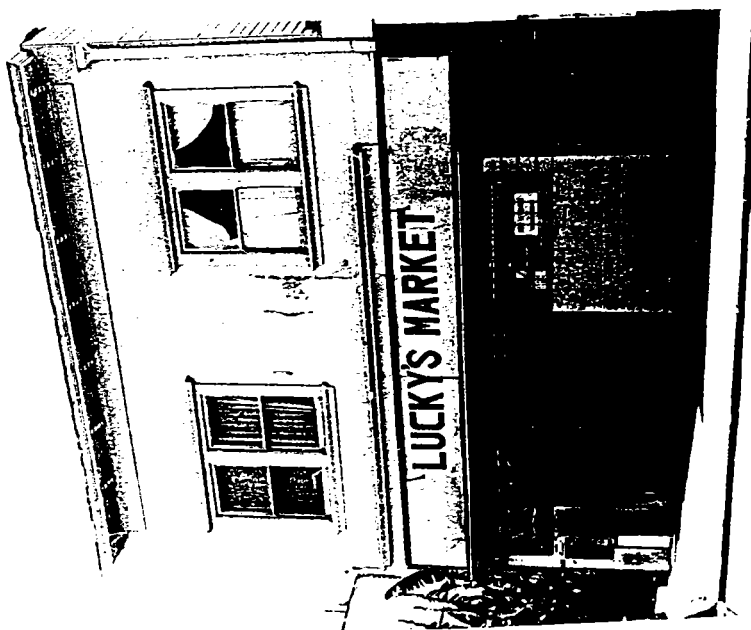
This rectangular two story building is typical of a number of similar structures which have established a sense of visual harmony along Logan Avenue. The commercial building has a partially stuccoed facade topped by a simple parapet and small unadorned brackets, and a flat roof. Side walls utilize shiplap siding. A central entryway with wrought iron grillwork and two narrow horizontal windows with grillwork, give a somewhat forboding appearance to the store. An additional entrance to one side leads to second floor apartment (s). It appears that what once may have been storefront windows have more recently been bricked in and painted, leaving only the top portion of those windows exposed.

13. Condition: Excellent ____ Good ____ Fair X Deteriorated ____ No longer in existence ____
14. Alterations: Storefront windows appear to have been bricked in.
15. Surroundings: (Check more than one if necessary) Open land ____ Scattered buildings ____ Densely built-up ____
Residential X Industrial X Commercial X Other: ____
16. Threats to site: None known ____ Private development ____ Zoning X Vandalism ____
Public Works project ____ Other: ____
17. Is the structure: On its original site? X Moved? ____ Unknown? ____
18. Related features: ____

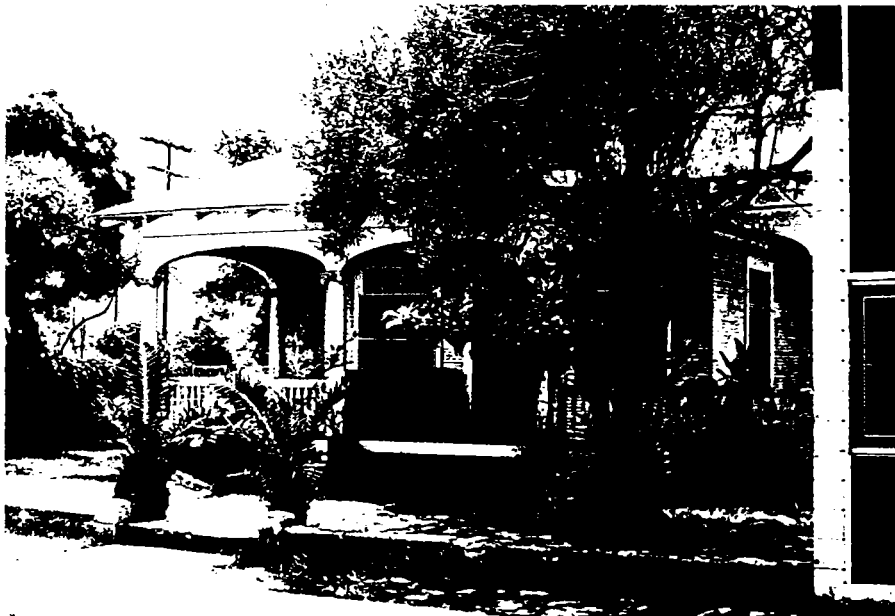
The single story residence has a long roof axis with asphalt shingles. The overhanging roofline is supported by exposed beam ends. This bungalow style is reminiscent of that found across the border from Mexacali to Tiajuana with a Spanish-style veranda and open arched areas supported by ionic columns and ballustrated railings. Windows are double sashed except for those near the front door. The yard is bordered by a low concrete wall about six inches high and contains several palm and olive trees.

13. Condition: Excellent _____ Good ☒ Fair _____ Deteriorated _____ No longer in existence _____
14. Alterations: _____
15. Surroundings: (Check more than one if necessary) Open land _____ Scattered buildings _____ Densely built-up _____
Residential ☒ Industrial _____ Commercial ☒ Other: _____
16. Threats to site: None known _____ Private development _____ Zoning ☒ Vandalism _____
Public Works project _____ Other: _____
17. Is the structure: On its original site? ☒ Moved? _____ Unknown? _____
18. Related features: Interstate-5 intrudes along the east side of the yard.

A mortgage taken out on August 5, 1909, indicates a probable construction date of 1910. The structure is a good example of an early California bungalow and is in fairly good condition. An encroachment on the east side of the property occurred when I-5 was constructed and may eventually pose a threat to this site.

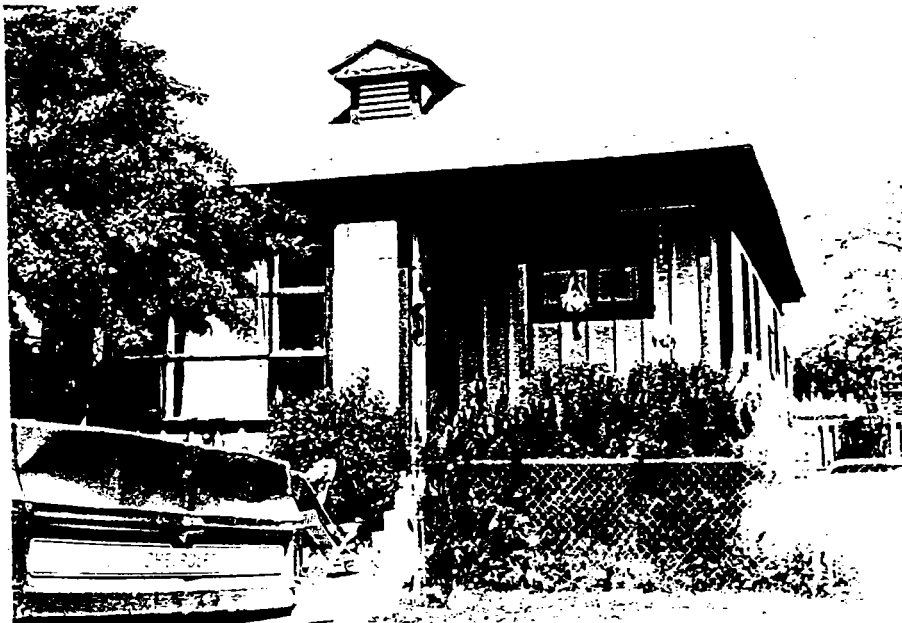
- 7a. Architectural style: Bungalow
- 7b. Briefly describe the present *physical description* of the site or structure and describe any major alterations from its original condition: Legal Description: Reed & Hubbell's Addition, Block 3, East 12½ feet of lot 31, all of lot 32, and West 5 feet of lot 33
The single story residence has a medium gabled roof with small vent dormer at the front of the house. The roof overhang is plain, but wide and the siding is board and batten. The rectangular house has no porch and recessed entryway. Window sizes and shapes vary, including large nine-paned front window, common to tract housing of the 1940's.

13. Condition: Excellent ____ Good X Fair ____ Deteriorated ____ No longer in existence ____
14. Alterations: _____
15. Surroundings: (Check more than one if necessary) Open land ____ Scattered buildings ____ Densely built-up ____
Residential X Industrial ____ Commercial ____ Other: _____
16. Threats to site: None known ____ Private development ____ Zoning X Vandalism ____
Public Works project ____ Other: _____
17. Is the structure: On its original site? X , Moved? ____ Unknown? ____
18. Related features: _____

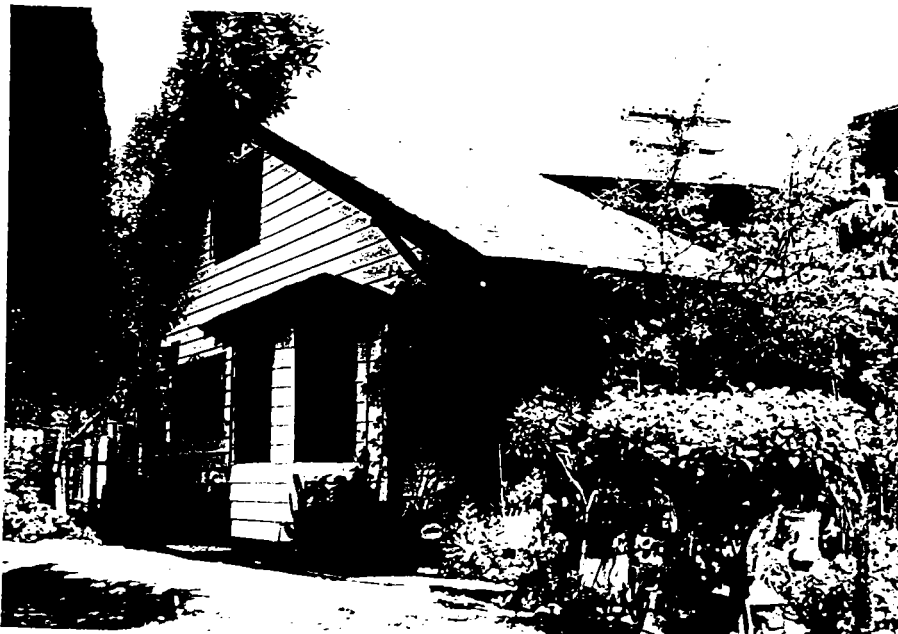
- 7a. Architectural style: Country Bungalow
- 7b. Briefly describe the present *physical description* of the site or structure and describe any major alterations from its original condition: Legal Description: Reed & Hubbell's Addition, Block 3, South 80 feet of lot 47 and all of lot 48.
This one and a half story frame building with a steep pitched "H" shaped roof is reminiscent of a country style home with bayed windows at street level at either end of the house. Windows are double sash and are newly painted brown. The siding is shiplap. A porch on the north side of the house is protected from the street by brush and shrubbery. The residence has been well maintained.

13. Condition: Excellent _____ Good ☒ Fair _____ Deteriorated _____ No longer in existence _____
14. Alterations: Extensive use of grillwork around windows somewhat mars the exterior facade of this structure.
15. Surroundings: (Check more than one if necessary) Open land _____ Scattered buildings _____ Densely built-up _____
Residential ☒ Industrial _____ Commercial _____ Other: _____
16. Threats to site: None known _____ Private development _____ Zoning ☒ Vandalism _____
Public Works project _____ Other: _____
17. Is the structure: On its original site? ☒ Moved? _____ Unknown? _____
18. Related features: _____

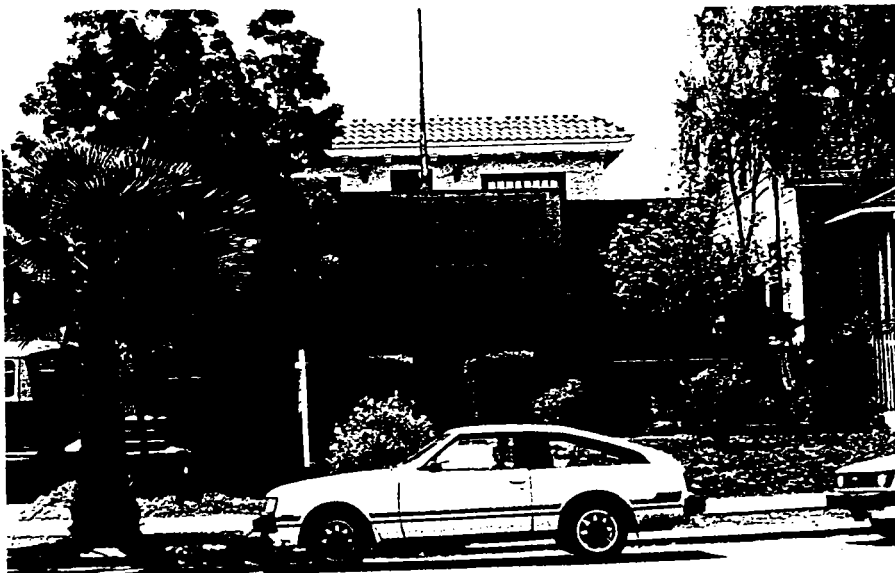
- 7a. Architectural style: Spanish Colonial Bungalow
- 7b. Briefly describe the present physical description of the site or structure and describe any major alterations from its original condition: Legal Description: Reed & Hubbell's Addition, Block, 7, Westerly 5 feet of Northerly 90 feet of lot 18 and all of lots 19 and 20.
This Spanish Colonial Revival home is the only one of its kind in the area. The residence possesses many of the traditional characteristics such as archways, a walled entrance area, stucco exterior, tile roofing and parapets, and wrought iron fencing. In the front are two interesting features; A small open patio, walled in with access from the house and a side door entrance from the driveway.

13. Condition: Excellent _____ Good ☒ Fair _____ Deteriorated _____ No longer in existence _____
14. Alterations: None apparant
15. Surroundings: (Check more than one if necessary) Open land _____ Scattered buildings _____ Densely built-up _____
Residential ☒ Industrial _____ Commercial _____ Other: _____
16. Threats to site: None known _____ Private development _____ Zoning ☒ Vandalism _____
Public Works project _____ Other: _____
17. Is the structure: On its original site? ☒ Moved? _____ Unknown? _____
18. Related features: _____

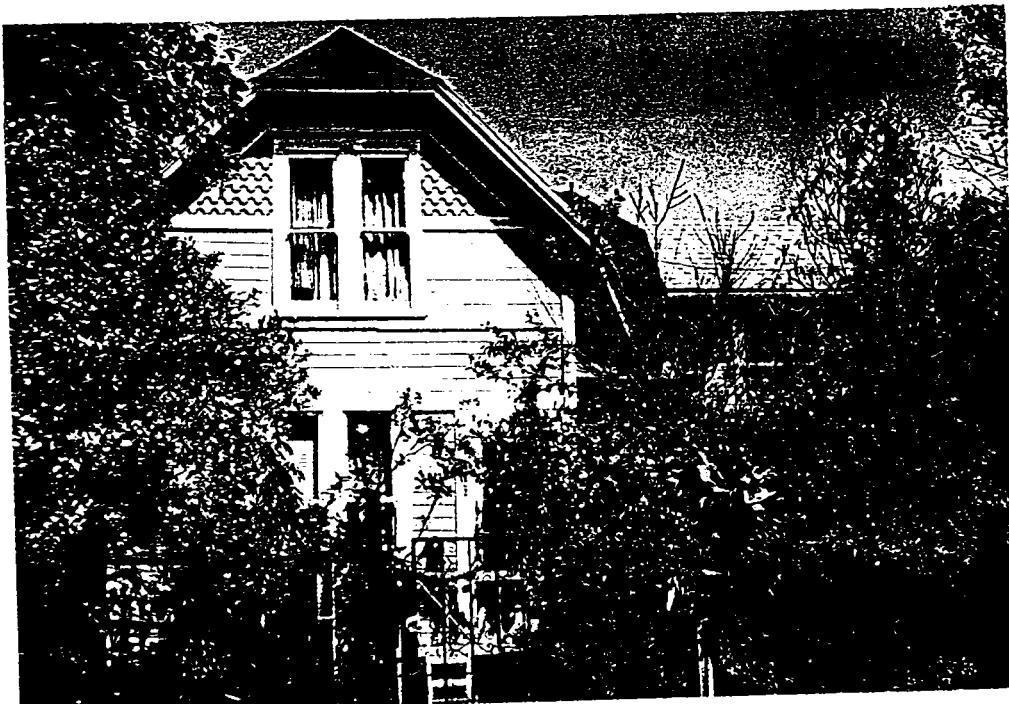
and 26 and South 8' of west 11 1/2' of lot 27, Block 1
Two story "L" shaped residence which has been kept up fairly well. The residence is smothered from view by trees and shrubs which have probably helped to preserve the home from street dust and gas fumes since it sets on a corner lot. The L shaped home has several styles of asphalt shingles on the L shaped gabled roof. Beneath the eaves at the facade are twin single sash windows with fish scale siding. Below that to street level are ship-lap siding. The windows at the second story appear to be double sash and more horizontal or rectangular while at the first floor, match somewhat the door being vertical in shape.

13. Condition: Excellent ___ Good ☒ Fair ___ Deteriorated ___ No longer in existence ___
14. Alterations: Has been rehabilitated on the exterior; interior not known
15. Surroundings: (Check more than one if necessary) Open land ___ Scattered buildings ___ Densely built-up ___
Residential ☒ Industrial ___ Commercial ___ Other: ___
16. Threats to site: None known ☒ Private development ___ Zoning ___ Vandalism ___
Public Works project ___ Other: ___
17. Is the structure: On its original site? ☒ Moved? ___ Unknown? ___
18. Related features: Landscaping

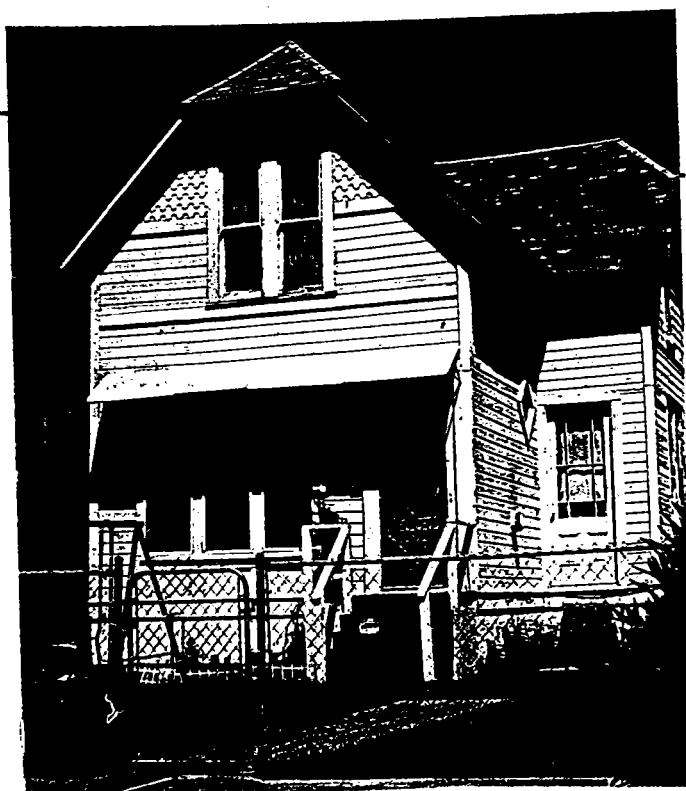
- 7a. Architectural style: Late Victorian
- 7b. Briefly describe the present *physical description* of the site or structure and describe any major alterations from its original condition: Legal Description: Reed & Hubbell's Addition, Block 1, E. 13½' of S. 81' of lot 27, and all of lot 28.
This two story late Victorian home is set back of the property line within an enclosed yard. The residence has been well maintained although a more imaginative color scheme on exterior walls would improve the overall appearance. A double pitched gabled roof is neatly covered with asphalt shingles. Shiplap siding and fishscale shingles used below the roofline on the facade, covers the exterior facade. All windows are vertical and double sash and appear to be original. A diamond-shaped window located at mid-story, probably aligns with a stairway, and a side door without stairs, suggests that lack of use caused their removal. Front stoop railings, a makeshift awning and an aluminum screen door detract from an otherwise fine home.

13. Condition: Excellent ____ Good X Fair ____ Deteriorated ____ No longer in existence ____
14. Alterations: These include removal of steps to side entrance, the addition of a front railing and an aluminum screen door.
15. Surroundings: (Check more than one if necessary) Open land ____ Scattered buildings ____ Densely built-up ____
Residential X Industrial ____ Commercial ____ Other: ____
16. Threats to site: None known ____ Private development ____ Zoning X Vandalism ____
Public Works project ____ Other: ____
17. Is the structure: On its original site? X Moved? ____ Unknown? ____
18. Related features: ____

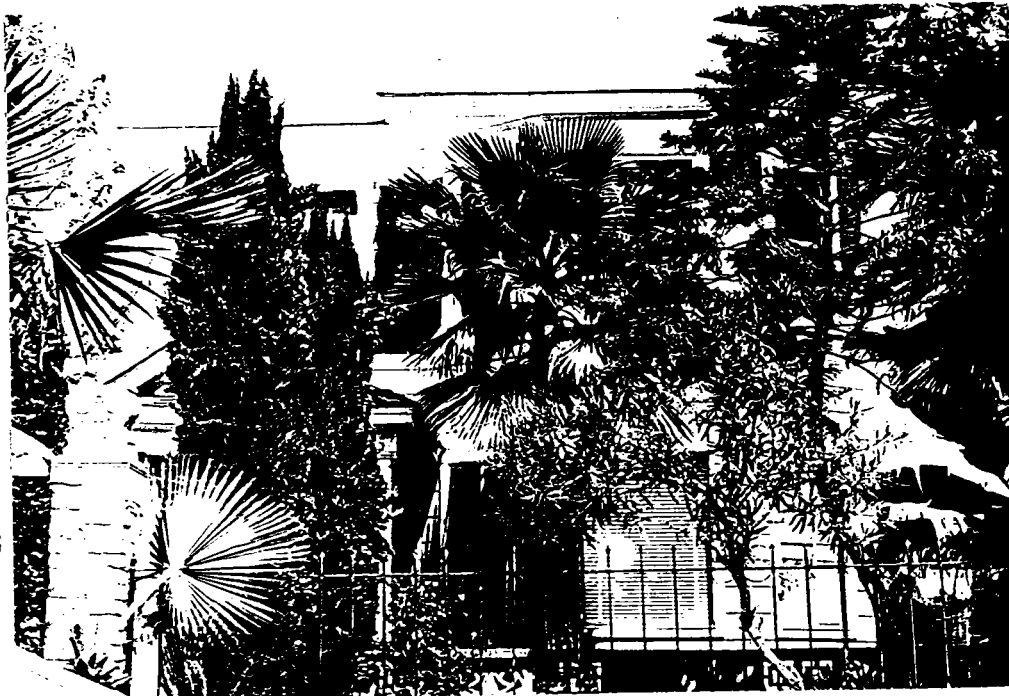
This Italianate structure is a two story villa with a centered low pitch gabled roof. A wide overhang gives the house a sweeping appearance, accentuated by the oval-shaped bays at the front of the home. Windows are large and single-paned; other double sash windows are vertical with four panes. The front entrance is covered with a pediment supported by four pillars. The entrance to the small front yard has a wrought iron fence and two ornate topped brick pillars which highlight the gate. A poor paint job on the second story mars the picturesque value.

13. Condition: Excellent ___ Good X Fair ___ Deteriorated ___ No longer in existence ___
14. Alterations: Rehabilitated
15. Surroundings: (Check more than one if necessary) Open land ___ Scattered buildings ___ Densely built-up ___
Residential X Industrial ___ Commercial ___ Other: ___
16. Threats to site: None known ___ Private development ___ Zoning X Vandalism ___
Public Works project ___ Other: ___
17. Is the structure: On its original site? X Moved? ___ Unknown? ___
18. Related features: ___
