PROPOSED EAST END
HISTORIC AND PLANNED
DISTRICTS

Public History

May 1983

**EAST END
PLANNED DISTRICT &
HISTORIC DISTRICT**

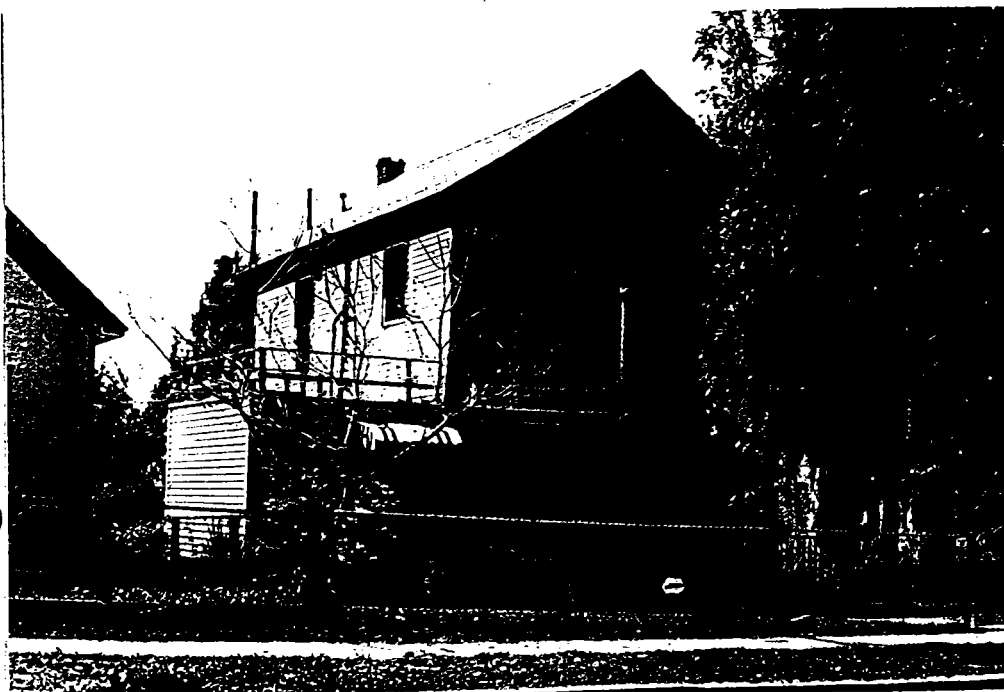
This two story rectangular-shaped home is a stylized form reflecting the frontier homestead. The roof is steep pitched, asphalt covered, and has a chimney at the rear. Clapboard siding is freshly painted a light tan and trimmed in dark brown. Windows and doors are vertical and double sash. An addition to the house is a single room in the same style as the main house with a sunporch above. This recent addition as well as an aluminum sunshade detract from the home's original appearance. It is possible the porch and railing were meant to blend with the porch over the front entryway.

13. Condition: Excellent ☒ Good _____ Fair _____ Deteriorated _____ No longer in existence _____
14. Alterations: Porch addition on east side of house is recent. New siding has been added as well.
15. Surroundings: (Check more than one if necessary) Open land _____ Scattered buildings _____ Densely built-up _____
Residential ☒ Industrial _____ Commercial _____ Other: _____
16. Threats to site: None known _____ Private development _____ Zoning ☒ Vandalism _____
Public Works project _____ Other: _____
17. Is the structure: On its original site? ☒ Moved? _____ Unknown? _____
18. Related features: _____

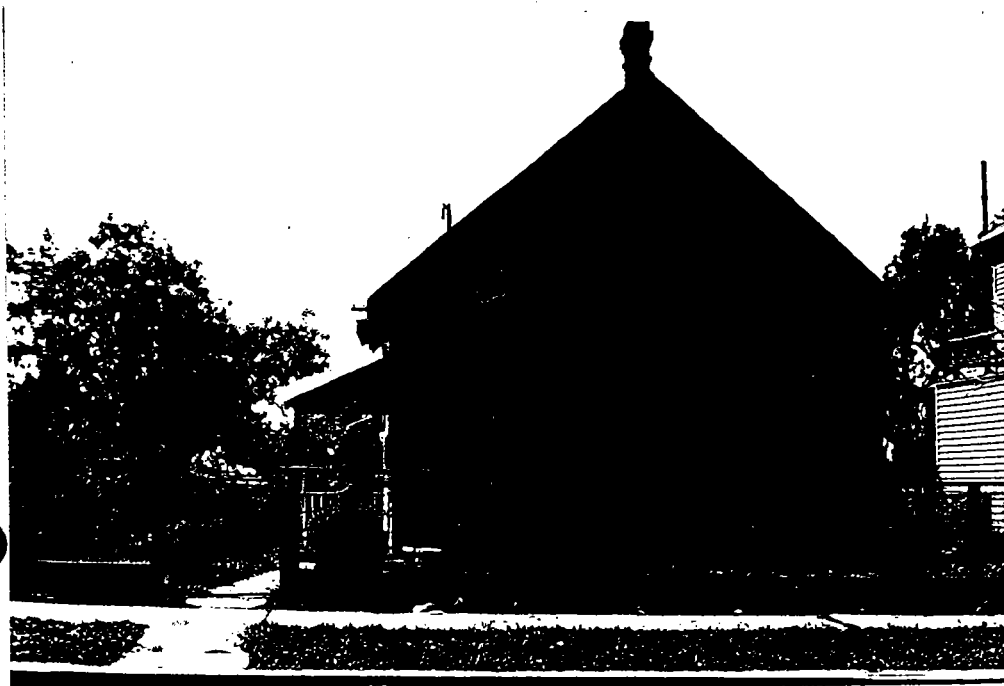
- 7a. Architectural style: Homestead House
- 7b. Briefly describe the present *physical description* of the site or structure and describe any major alterations from its original condition: Legal Description: Whitney Addition, Block 42, lot 18. Sensitive restoration has made this a good example of an early 20th century style. The one and a half story rectangular home has a high gabled roof with wood shingles and a board and batten exterior facade on the ground floor. The upper facade is faced with narrow board strips. Vertical double-hung sash windows with plain moldings and French doors characterize the front. Also, a small veranda with low gable supported by plain posts and decorative balustrade fronts the house. Along the east side of the building an additional entry with porch can be seen.

13. Condition: Excellent ☒ Good ☐ Fair ☐ Deteriorated ☐ No longer in existence ☐
14. Alterations: _____
15. Surroundings: (Check more than one if necessary) Open land ☐ Scattered buildings ☐ Densely built-up ☐
Residential ☒ Industrial ☐ Commercial ☐ Other: _____
16. Threats to site: None known ☐ Private development ☐ Zoning ☒ Vandalism ☐
Public Works project ☐ Other: _____
17. Is the structure: On its original site? ☒ Moved? ☐ Unknown? ☐
18. Related features: _____

This well preserved residence is one of a number of early 20th century styles to be found along Logan Avenue and represents part of the visual and architectural continuity still evident in the community.

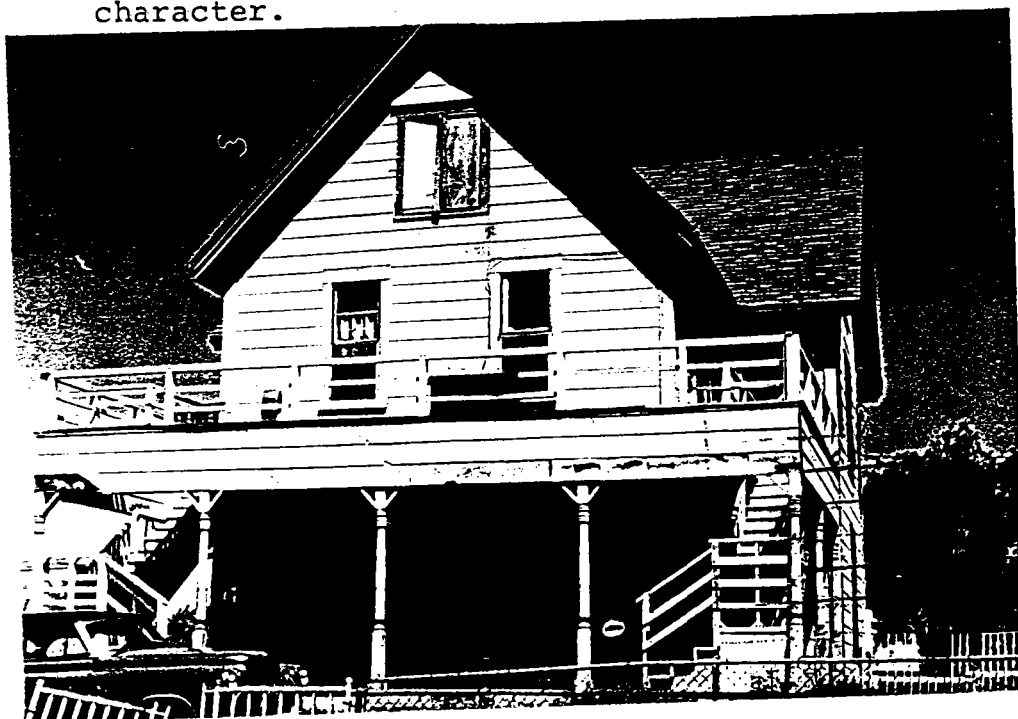
A variation of the Queen Anne house is this tri-gabled structure. The porch, supported by delicately carved posts, is tucked into the space created by two legs of an ell on the east and west sides of the building. Clapboard forms the exterior facade and asphalt shingles are used as the primary roofing material. Windows are vertical double-hung sash and a front entryway with aluminum screen door faces the street. Other features include a large brick chimney located midway along the front gable peak, the addition of a second story porch and stairways on the east and west sides of the house, indicating the conversion of this residence to multiple dwelling units. The building serves as an excellent example of Princess Anne simplicity although inappropriate modifications have somewhat marred its character.

13. Condition: Excellent ____ Good ____ Fair X Deteriorated ____ No longer in existence ____
14. Alterations: Conversion to multiple dwelling units has resulted in the addition of stairways and a second story porch.
15. Surroundings: (Check more than one if necessary) Open land ____ Scattered buildings ____ Densely built-up ____
Residential X Industrial ____ Commercial ____ Other: ____
16. Threats to site: None known ____ Private development ____ Zoning X Vandalism ____
Public Works project ____ Other: ____
17. Is the structure: On its original site? X Moved? ____ Unknown? ____
18. Related features: _____

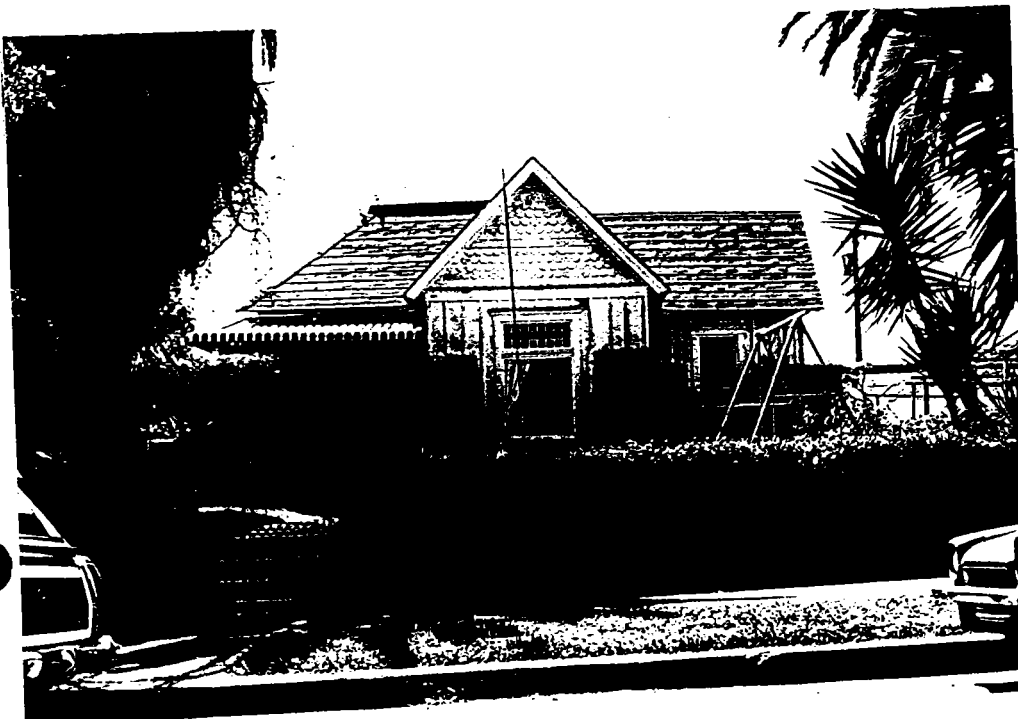
This bungalow cottage with medium to high pitched gabled roof has a boxed cornice, board and batten exterior facade, decorative fish scales and plain moldings around vertical double-hung sash windows. A leaded glass transom with multi-colored panes tops the front window. Asphalt roofing and an aluminum awning over the entryway detract somewhat from the character of the house. While the building appears to be structurally sound, there is some sign of deterioration with respect to paint and wood.

13. Condition: Excellent _____ Good _____ Fair X Deteriorated _____ No longer in existence _____
14. Alterations: Asphalt shingles and an aluminum awning are inappropriate alterations.
15. Surroundings: (Check more than one if necessary) Open land _____ Scattered buildings _____ Densely built-up _____
Residential X Industrial _____ Commercial _____ Other: _____
16. Threats to site: None known _____ Private development _____ Zoning X Vandalism _____
Public Works project _____ Other: _____
17. Is the structure: On its original site? X , Moved? _____ Unknown? _____
18. Related features: _____

19. Briefly state historical and/or architectural importance (include dates, events, and persons associated with the site.)
As part of the visual and architectural continuity to be found in this neighborhood, the bungalow cottage adds to the aesthetic quality of its surroundings.

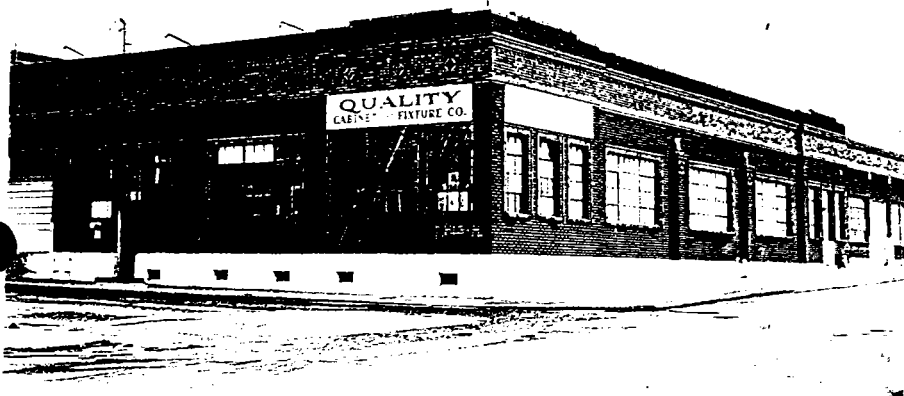
Mannassee & Schiller, Blk 138, lots 1-8 Sub of PL 1157
This one story brick building with a flat roof and skylights utilizes a concrete foundation and decorative brickwork of various sizes and shades to accent the exterior facade. Vertical and horizontal multi-paned windows front both street sides of this corner structure. Two recessed entryways can be seen on the 16th St. side and National Ave. side. One entrance along the east end appears to have been blocked up, while another vehicle entrance appears on the west side of the building. Narrow vertical bands of decorative brickwork extend slightly from the building surface and are topped with small decorative moldings.

13. Condition: Excellent _____ Good ☒ Fair _____ Deteriorated _____ No longer in existence _____
14. Alterations: one entrance on east end blocked up
15. Surroundings: (Check more than one if necessary) Open land _____ Scattered buildings _____ Densely built-up ☒
Residential _____ Industrial ☒ Commercial ☒ Other: _____
16. Threats to site: None known ☒ Private development _____ Zoning _____ Vandalism _____
Public Works project _____ Other: _____
17. Is the structure: On its original site? ☒ Moved? _____ Unknown? _____
18. Related features: _____

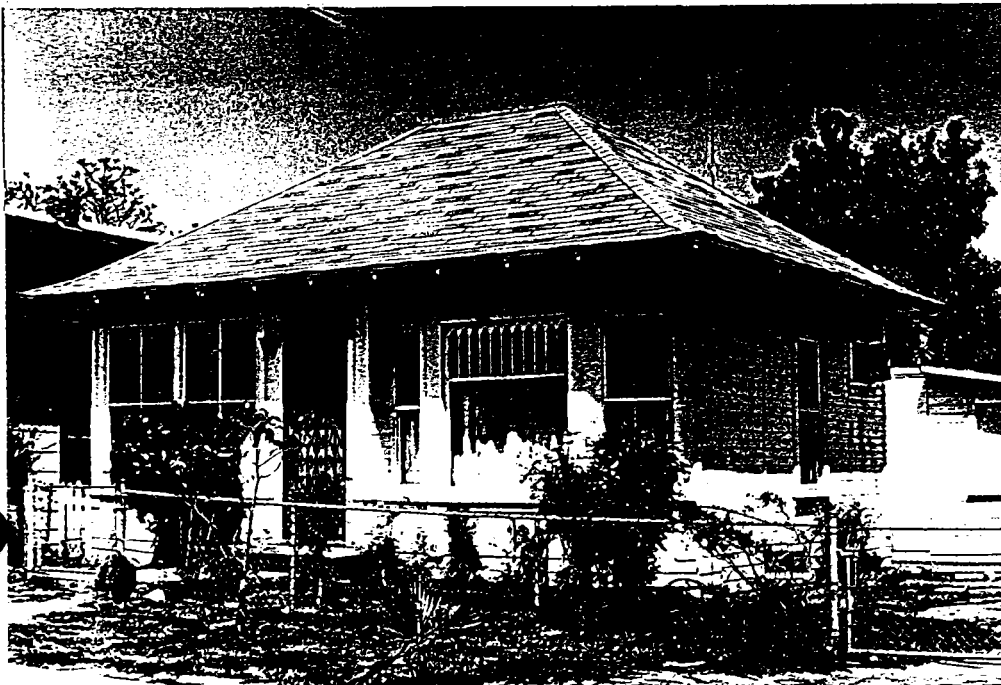
This well maintained example of a bungalow cottage is characterized by a high hipped roof supported by overhanging eaves. Asphalt roof shingles detract somewhat from the building's otherwise pleasant exterior facade. Shiplap siding with some overlapping siding and plain wood moldings around windows and front entryway are other characteristic features. Window sizes vary, but most are vertical double-hung sash. A modified bay with decorative window accents the front. Along the east side is a small square window which opens out. Another unfortunate distraction is the heavy screened front door with black grillwork which sharply contrasts with the light-colored exterior.

13. Condition: Excellent ____ Good X Fair ____ Deteriorated ____ No longer in existence ____
14. Alterations: Asphalt shingles and wrought iron grillwork detract from the building's exterior.
15. Surroundings: (Check more than one if necessary) Open land ____ Scattered buildings ____ Densely built-up ____
Residential X Industrial ____ Commercial ____ Other: ____
16. Threats to site: None known ____ Private development ____ Zoning X Vandalism ____
Public Works project ____ Other: ____
17. Is the structure: On its original site? X Moved? ____ Unknown? ____
18. Related features: ____

The well kept cottage serves as a good example of bungalow architecture found throughout this neighborhood, and, as such, creates a sense of visual unity worthy of preservation.

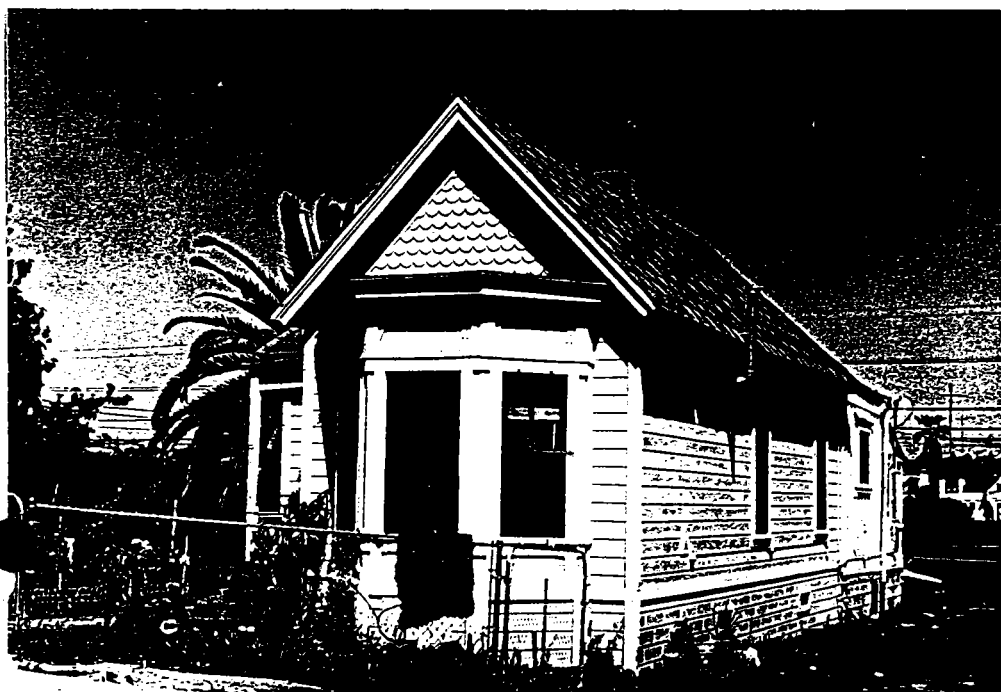
This single story late Victorian cottage has a steeply pitched roof and a single chimney at the rear. The siding is shiplap. Beneath the facade pediment are fishscale shingles. Additional features include a slanted front bay with vertical double-hung sash windows, a small porch supported by plain straight posts with decorative cutouts along the roofline, and what appears to be a more recent concrete block foundation. An addition to the back of the house shows poor workmanship and has siding and window sizes which vary from the main house.

13. Condition: Excellent ___ Good X Fair ___ Deteriorated ___ No longer in existence ___
14. Alterations: Rooms at the back of the house are additions.
15. Surroundings: (Check more than one if necessary) Open land ___ Scattered buildings ___ Densely built-up ___
Residential X Industrial ___ Commercial ___ Other: ___
16. Threats to site: None known ___ Private development ___ Zoning X Vandalism ___
Public Works project ___ Other: ___
17. Is the structure: On its original site? X Moved? ___ Unknown? ___
18. Related features: _____

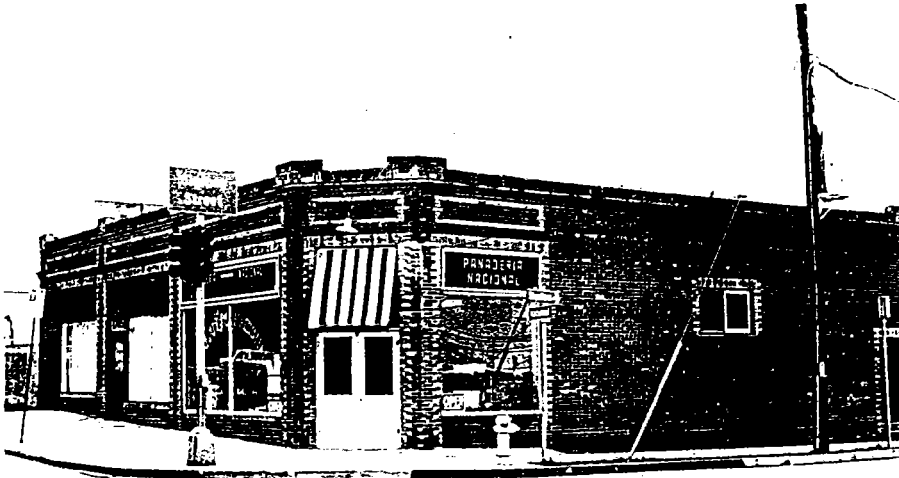
- 7a. Architectural style: Early 20th Century Commercial Style Building
- 7b. Briefly describe the present *physical description* of the site or structure and describe any major alterations from its original condition: Legal Description: Mannasse and Schiller Subdivision, Block 131, lots 45 and 46-48.
This is one of the few all brick structures to be found in this area. The use of wide and narrow bricks mixed with contrasting light-colored bricks used as a decorative accent around doors, windows and along the gabled parapet, adds much to this building's architectural appeal. Large plate glass windows have plain moldings and are of a flat structural type. One small horizontal window can be seen on the west facade along with a narrow recessed back entryway. Double wood and glass front doors form the main corner entrance. Two narrow doors along the north side of the building do not appear to be used for anything and graffiti mars one of these entrances.

13. Condition: Excellent ___ Good X Fair ___ Deteriorated ___ No longer in existence ___
14. Alterations: _____
15. Surroundings: (Check more than one if necessary) Open land ___ Scattered buildings ___ Densely built-up ___
Residential X Industrial X Commercial X Other: _____
16. Threats to site: None known ___ Private development ___ Zoning X Vandalism ___
Public Works project ___ Other: _____
17. Is the structure: On its original site? X Moved? ___ Unknown? ___
18. Related features: Two metal garages are located on side of building.

19. Briefly state historical and/or architectural importance (include dates, events, and persons associated with the site.)
- This site had been the location for a variety of small businesses which have included a grocery, dry goods store, tortilla manufacturer, photo studio and a custom radiator repair shop. The structure appears to be unaltered and is a good example of the type of brickwork done during the early part of the century. Relatively few all brick buildings still exist and this one should be preserved.

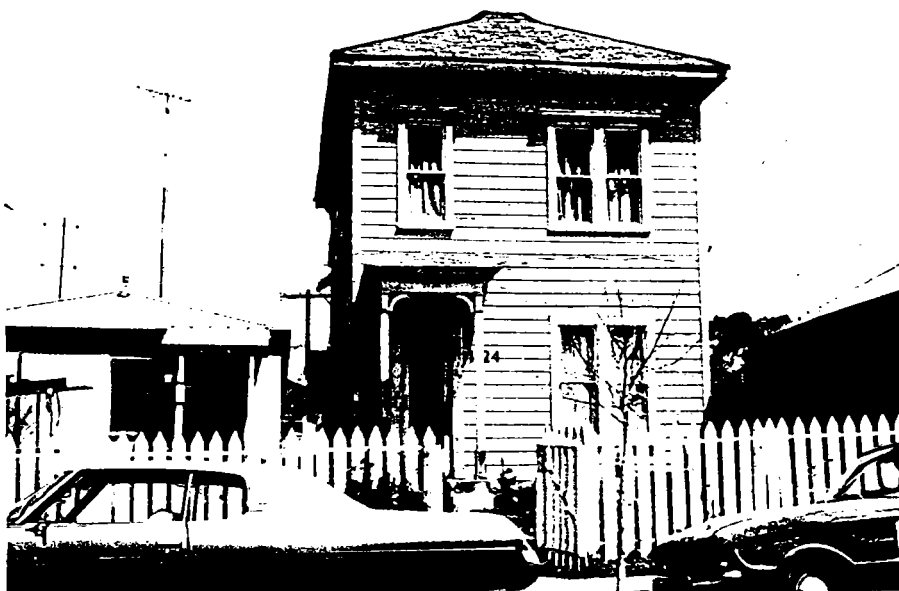
An example of the classic box, this two story house with low hipped roof was built sometime between 1900 and 1910. Although somewhat deteriorated, the building's defects are mostly cosmetic. Asphalt shingles and peeling paint detract from the otherwise sound structure. Siding is shiplap with narrow double-hung sash windows on both floor levels. The home has a narrow wood and glass front entrance with transom. Slender posts support a small covered front porch. Added details include plain moldings around windows, decorative brackets under roof eaves, and classical-style moldings around the front door. A picket fence edges the property line.

13. Condition: Excellent ____ Good ____ Fair X Deteriorated ____ No longer in existence ____
14. Alterations: _____
15. Surroundings: (Check more than one if necessary) Open land ____ Scattered buildings ____ Densely built-up ____
Residential X Industrial X Commercial X Other: _____
16. Threats to site: None known ____ Private development ____ Zoning X Vandalism ____
Public Works project ____ Other: _____
17. Is the structure: On its original site? X Moved? ____ Unknown? ____
18. Related features: _____

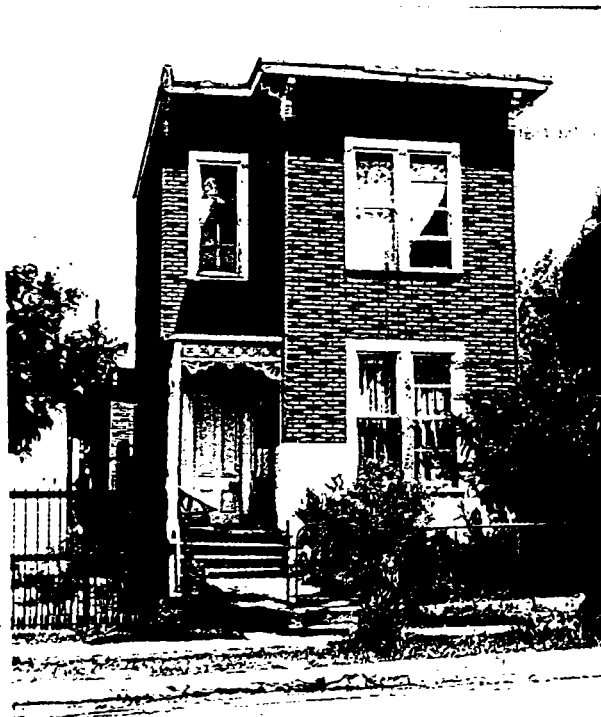
- 7a. Architectural style: Late Victorian
- 7b. Briefly describe the present physical description of the site or structure and describe any major alterations from its original condition:
Mannasse & Schiller Add, Blk 139, lot 11 & exc Ely 23ft lot 12
Asbestos brick siding adds to the somewhat deteriorated
appearance of this late Victorian box-shaped house. Vertical
clapboard siding along the lower front facade appears to be a
recent modification. A flat asphalt covered roof with wide eaves
supported by decorative corner brackets tops the dwelling. The
windows are vertical and double hung sash. A tiny porch
supported by delicately carved columns is tucked into the ell
formed by the house on the west side. Additional gingerbread
trim edges the porch roof. A door with simple moldings and
overhead transom faces the street. The porch steps seem to need
repair.

13. Condition: Excellent _____ Good _____ Fair X Deteriorated _____ No longer in existence _____
14. Alterations: asbestos siding
15. Surroundings: (Check more than one if necessary) Open land _____ Scattered buildings _____ Densely built-up X
Residential X Industrial X Commercial X Other: _____
16. Threats to site: None known _____ Private development _____ Zoning X Vandalism _____
Public Works project _____ Other: _____
17. Is the structure: On its original site? X Moved? _____ Unknown? _____
18. Related features: landscaping

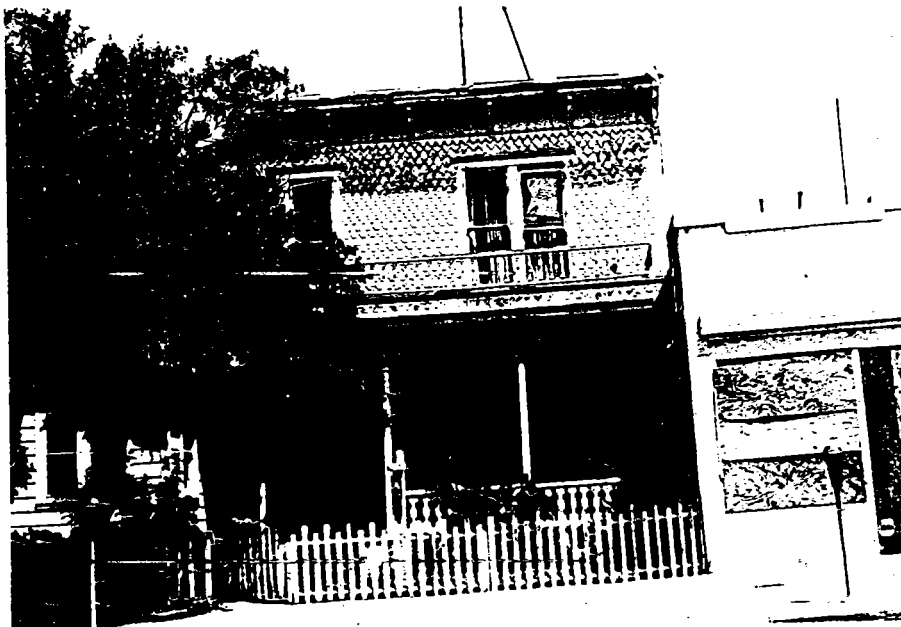
- 7a. Architectural style: Late Victorian
- 7b. Briefly describe the present *physical description* of the site or structure and describe any major alterations from its original condition: Legal Description: Mannasse and Schiller Subdivision, Block 139, lot 13.
A deteriorated facade best characterizes this example of a late Victorian residence. Despite its rundown condition, however, the building exhibits a number of features worthy of preservation. The box-shaped structure appears to have undergone no major alterations. A flat roof with plain parapet and decorative brackets utilizes asphalt roofing material. Shiplap siding covers the exterior ground floor front and sides of the building. Decorative fishscale shingles cover the second story facade. Slender posts with intricately carved brackets support a porch that runs along the entire front exterior. The porch is topped by a narrow balcony and carved balustrade. Other features include vertical double-hung sash windows with plain moldings and a narrow front entrance with wood and screen door. A low wood fence fronts the property line.

13. Condition: Excellent _____ Good _____ Fair _____ Deteriorated ☒ No longer in existence _____
14. Alterations: _____
15. Surroundings: (Check more than one if necessary) ☒ Open land _____ Scattered buildings _____ Densely built-up _____
Residential ☒ Industrial ☒ Commercial _____ Other: _____
16. Threats to site: None known _____ Private development _____ Zoning ☒ Vandalism _____
Public Works project _____ Other: _____
17. Is the structure: On its original site? ☒ Moved? _____ Unknown? _____
18. Related features: _____

Although deteriorated, this structure is worthy of restoration and is one of the few of its type left in the area. No major alterations exist and the decorative work is exceptional.

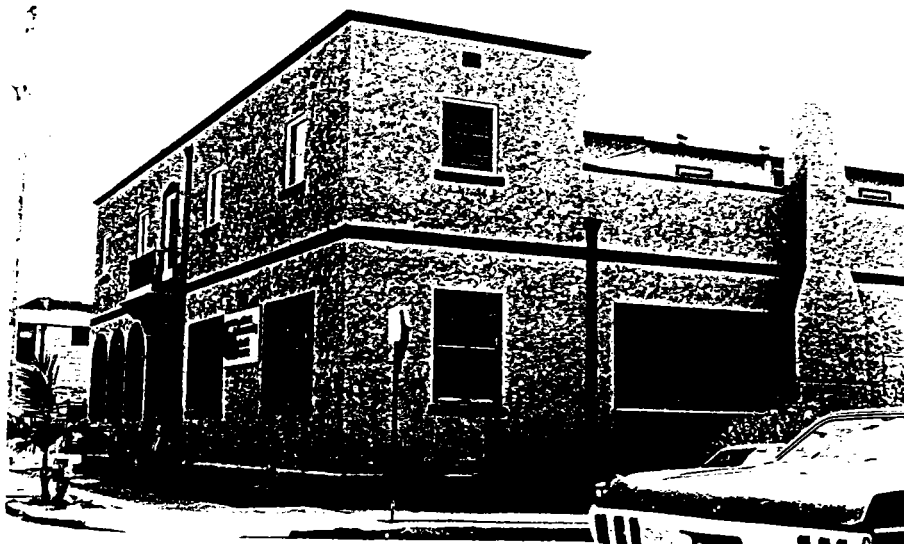
Mannasse & Schiller Block 130, Lots 43-48
This plastered two story building stands on a corner lot and has a concrete roof and an exterior chimney on one side. The second story has several flat windows with slipsills. Three arched windows on the ground floor enclose a former porch. There are also three flat windows on the first floor. Two concrete steps lead to the central entrance which has a braced hood with a tiny balcony above. This building was originally one story and has been changed considerably from its initial appearance.

13. Condition: Excellent _____ Good ☒ Fair _____ Deteriorated _____ No longer in existence _____
14. Alterations: second story added, windows altered, porch enclosed
15. Surroundings: (Check more than one if necessary) Open land _____ Scattered buildings _____ Densely built-up ☒
Residential _____ Industrial _____ Commercial ☒ Other: _____
16. Threats to site: None known ☒ Private development _____ Zoning _____ Vandalism _____
Public Works project _____ Other: _____
17. Is the structure: On its original site? ☒ Moved? _____ Unknown? _____
18. Related features: Palm tree, landscaping

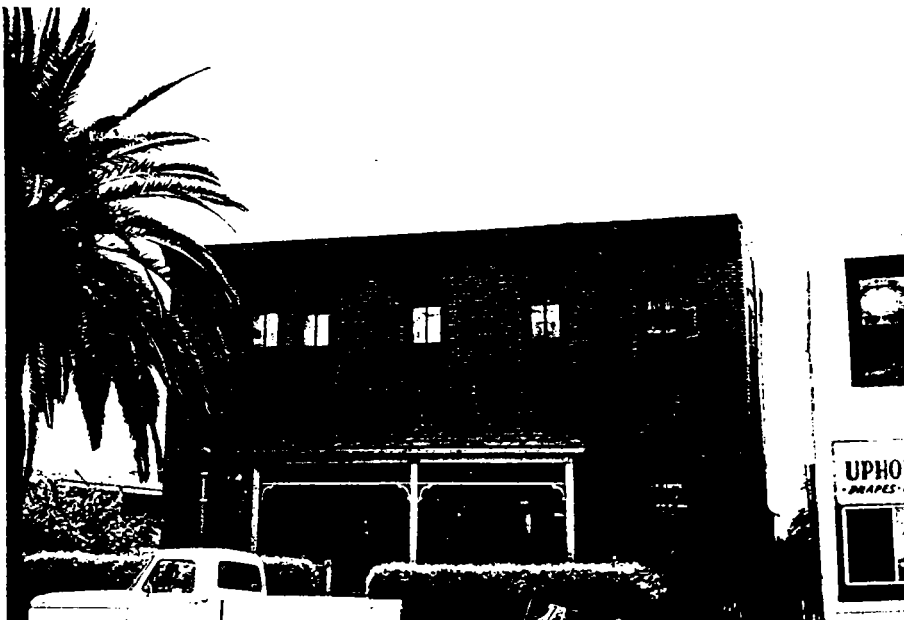
- 7a. Architectural style: Late Victorian
- 7b. Briefly describe the present *physical description* of the site or structure and describe any major alterations from its original condition:
Legal Description: Mannasse and Schiller Sub-division, Block 130, lots 40 and 41.
Somewhat deteriorated, this structure presents a rather run-down appearance. No major alterations other than asbestos siding have been added. The building is a duplex at present, with the owner residing at 1833 National. It has a flat roof, wooden parapet with brackets along the front, vertical double-hung windows and a central front porch supported by slender bracketed posts.

13. Condition: Excellent _____ Good _____ Fair X Deteriorated _____ No longer in existence _____
14. Alterations: Asbestos siding has been added to the exterior walls.
15. Surroundings: (Check more than one if necessary) Open land _____ Scattered buildings _____ Densely built-up _____
Residential X Industrial X Commercial X Other: _____
16. Threats to site: None known _____ Private development _____ Zoning X Vandalism _____
Public Works project _____ Other: _____
17. Is the structure: On its original site? X Moved? _____ Unknown? _____
18. Related features: _____

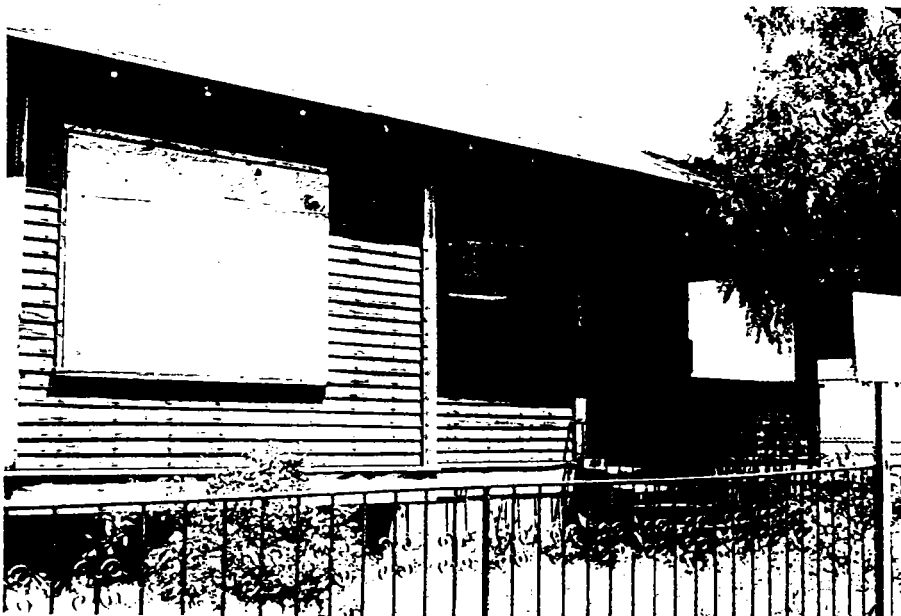
Mannasse & Schiller Blk 140, lots 9-10

A high hipped roof, supported by carved exposed rafters, characterizes this one story cottage with clapboard siding. Wooden steps with wrought iron rails lead to a partially enclosed corner front porch supported by plain vertical posts. Doors and windows have plain moldings and are boarded shut. The recent addition of decorative railings along the front property line and steps and the stripped siding indicate that owners of the property may be looking for tenants to rehabilitate this structure.

13. Condition: Excellent ____ Good ____ Fair X Deteriorated ____ No longer in existence ____
14. Alterations: Railings in front; windows and doors boarded shut
15. Surroundings: (Check more than one if necessary) Open land ____ Scattered buildings ____ Densely built-up X
Residential X Industrial X Commercial X Other: _____
16. Threats to site: None known ____ Private development ____ Zoning X Vandalism X
Public Works project ____ Other: _____
17. Is the structure: On its original site? X , Moved? ____ Unknown? ____
18. Related features: fence, trees

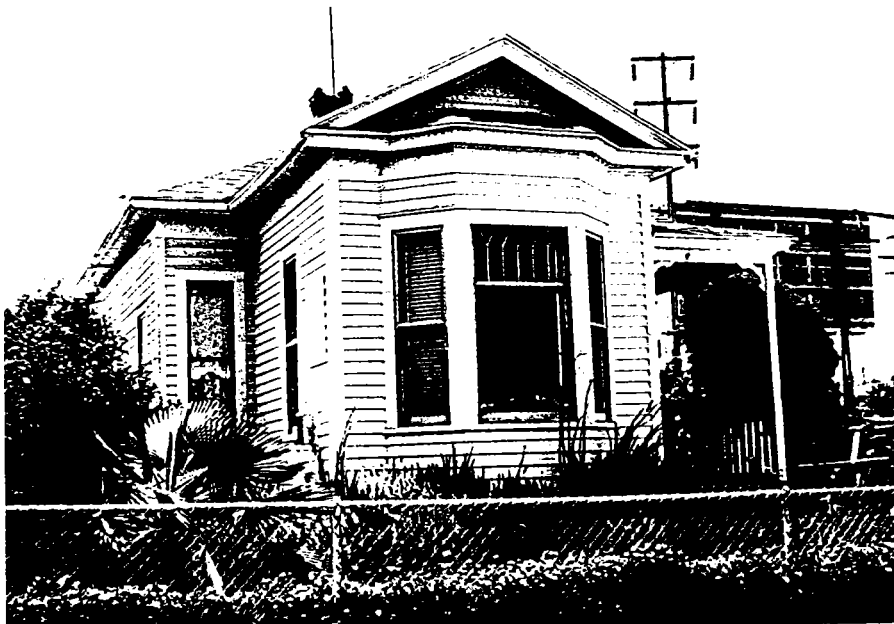
A fine example of a Queen Anne cottage variety of architecture, the building appears to be unaltered and many traditional features remain. These include fish scale shingles, high pitched gabled roof, overlapping siding and large front bay window. Plain wood moldings frame narrow double-hung sash windows and steps lead to a side entrance enclosed by a small porch supported by slender posts with decorative brackets. The house and grounds appear to be well maintained.

13. Condition: Excellent ____ Good X Fair ____ Deteriorated ____ No longer in existence ____
14. Alterations: _____
15. Surroundings: (Check more than one if necessary) Open land ____ Scattered buildings ____ Densely built-up ____
Residential X Industrial X Commercial X Other: _____
16. Threats to site: None known ____ Private development ____ Zoning X Vandalism ____
Public Works project ____ Other: _____
17. Is the structure: On its original site? X Moved? ____ Unknown? ____
18. Related features: _____

19. Briefly state historical and/or architectural importance (include dates, events, and persons associated with the site.)
This home is an especially well maintained example of a Queen Anne cottage with virtually no alterations and should be preserved as one of the best of its kind to be found in this area.

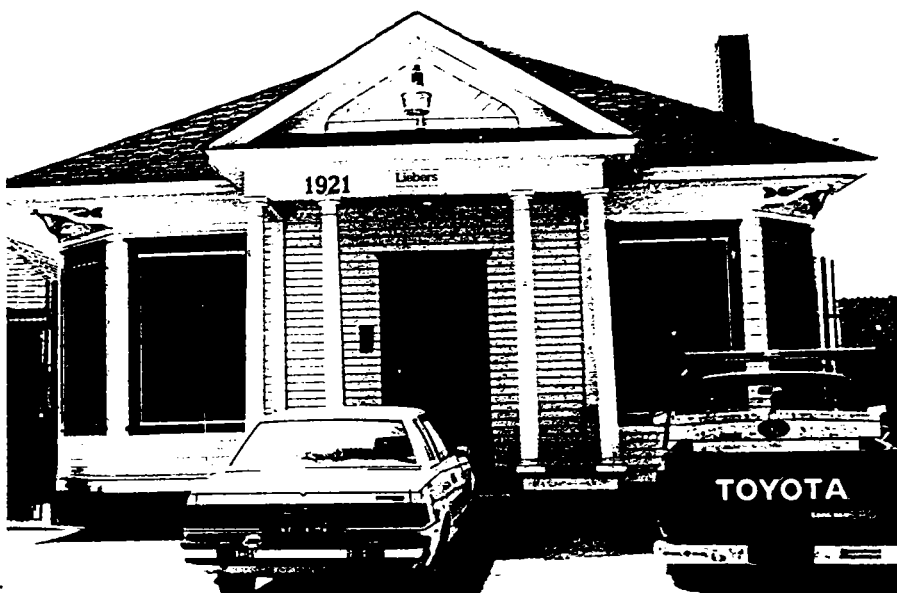
- 7a. Architectural style: Queen Anne Cottage Style with Classical Detail
- 7b. Briefly describe the present *physical description* of the site or structure and describe any major alterations from its original condition: Legal Description: Mannasse and Schiller Subdivision, Block 129, lots 43 and 44.
This structure incorporates some of the Queen Anne cottage style features such as a hipped roof with decorative corner brackets, a gabled porch and clapboard siding. The formal placement of windows and door and the use of Doric columns to support the gabled porch, lends a classical touch to the building. Although the house is well maintained, the use of the front yard as a parking area and grillwork around windows detracts from the overall appearance.

13. Condition: Excellent ___ Good X Fair ___ Deteriorated ___ No longer in existence ___
14. Alterations: A parking area has replaced the front yard.
15. Surroundings: (Check more than one if necessary) Open land ___ Scattered buildings ___ Densely built-up ___
Residential X Industrial X Commercial X Other: ___
16. Threats to site: None known ___ Private development ___ Zoning X Vandalism ___
Public Works project ___ Other: ___
17. Is the structure: On its original site? X Moved? ___ Unknown? ___
18. Related features: ___

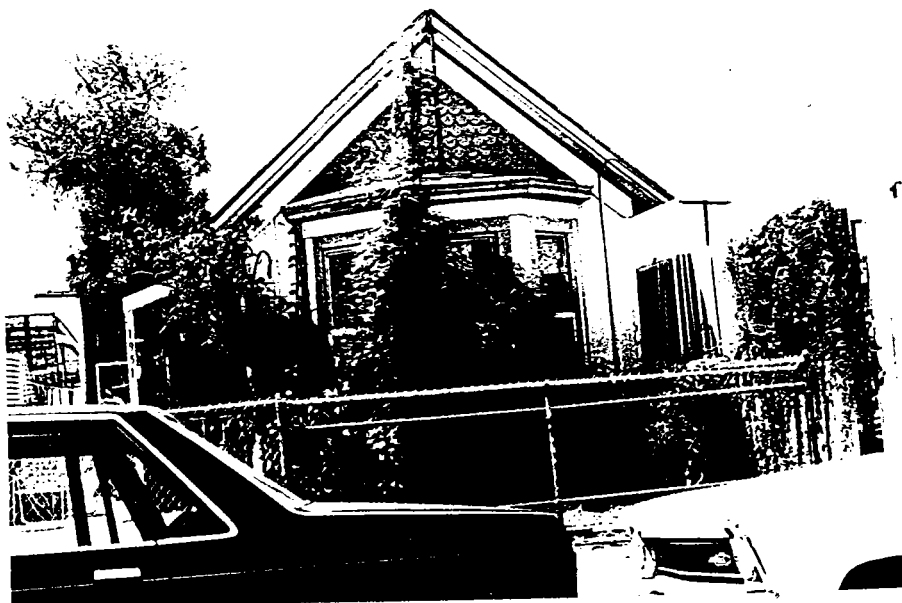
This structure is a modified Queen Anne cottage. The grounds and structure are not well maintained. A side porch and much of the exterior siding appears to be recent. The roofing has also been redone. Architectural features include a high gable roof, decorative shingles over the slanted bay, and vertical double-hung sash windows around the exterior facade. An aluminum fence on the building's west side is in direct contact with the structure and further detracts from the overall appearance of the house.

13. Condition: Excellent ____ Good ____ Fair X Deteriorated ____ No longer in existence ____
14. Alterations: Side porch and much of the exterior facade appear to be recent.
15. Surroundings: (Check more than one if necessary) Open land ____ Scattered buildings ____ Densely built-up ____
Residential X Industrial X Commercial X Other: ____
16. Threats to site: None known ____ Private development ____ Zoning X Vandalism ____
Public Works project ____ Other: ____
17. Is the structure: On its original site? X Moved? ____ Unknown? ____
18. Related features: ____

Despite recent alterations, this Queen Anne cottage serves as a good example of its type and should be preserved as one of the late Victorian styles to be found in the area.

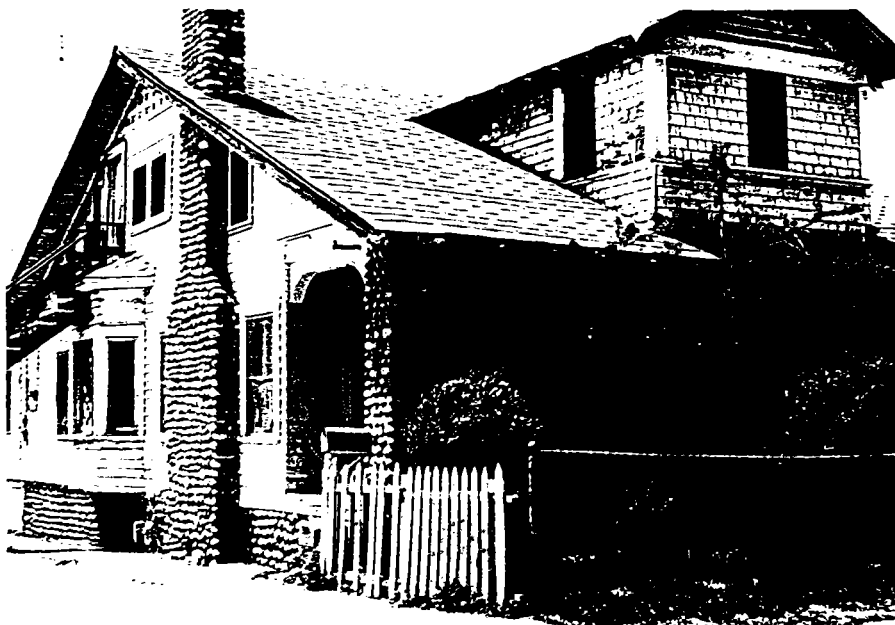
- 7a. Architectural style: American Semi-Bungalow with Craftsman Influence
- 7b. Briefly describe the present *physical description* of the site or structure and describe any major alterations from its original condition: Legal Description: Mannasse and Schiller Subdivision, Block 128, lots 32 and 33 and 34.
Unlike the typical one story bungalow with low overhanging roof, this home exhibits a high broad sloping roof reminiscent of a Swiss Chalet. Exposed rafter ends, fieldstone chimney, porch supports and foundation, and exterior shingles on the front gable, show a distinct Craftsman influence. Side and second story windows are largely vertical double-hung sash. Large, horizontal front windows have plain moldings and a slanted bay with diamond-shaped panes can be seen on the east side of the house. Steps lead to a central entrance. An additional entrance with stairs has been cut into the building's east side. Overlapping siding used on much of the house shows signs of deterioration.

13. Condition: Excellent _____ Good _____ Fair _____ Deteriorated X No longer in existence _____
14. Alterations: Second floor entrance has modified this dwelling from a single family residence to a duplex.
15. Surroundings: (Check more than one if necessary) Open land _____ Scattered buildings _____ Densely built-up _____
Residential X Industrial X Commercial X Other: _____
16. Threats to site: None known _____ Private development _____ Zoning X Vandalism _____
Public Works project _____ Other: _____
17. Is the structure: On its original site? X , Moved? _____ Unknown? _____
18. Related features: _____

19. Briefly state historical and/or architectural importance (include dates, events, and persons associated with the site.)
This bungalow is one of the few of its type to be found in the area. The extensive use of fieldstone is of particular interest and makes the home a fine example of the Craftsman influence.

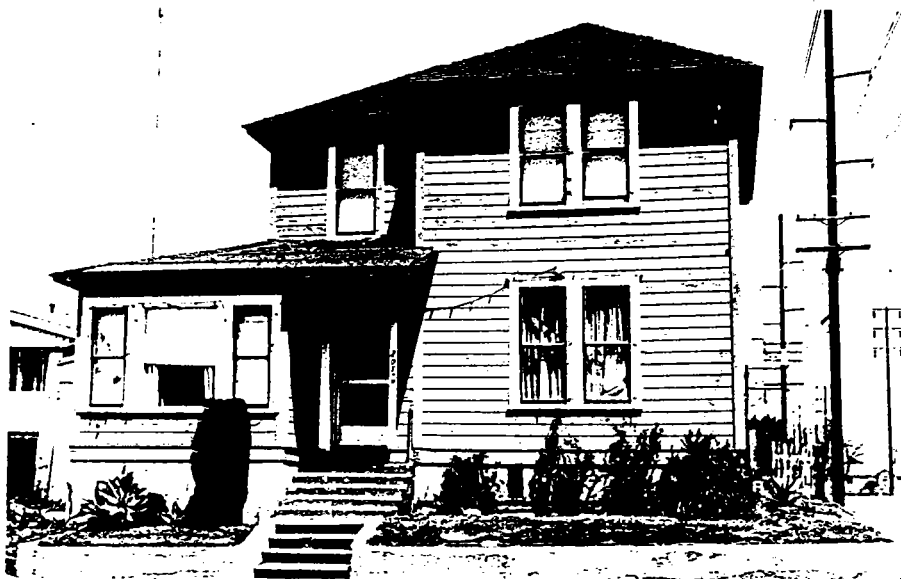
- 7a. Architectural style: Variation of a Homestead House
- 7b. Briefly describe the present physical description of the site or structure and describe any major alterations from its original condition: Legal Description: San Diego Land and Town Company Addition, Block 142, SWLY one half of lots 23 and 24.
This version of a homestead house has medium hipped gables, horizontal clapboard siding and vertical double-hung sash windows. A second lower roofline extends out over the central entrance and a front room. Although the house and grounds have been minimally maintained, there appear to be few, if any, alterations.

13. Condition: Excellent ____ Good ____ Fair X Deteriorated ____ No longer in existence ____
14. Alterations: _____
15. Surroundings: (Check more than one if necessary) Open land ____ Scattered buildings ____ Densely built-up ____
Residential X Industrial X Commercial X Other: _____
16. Threats to site: None known ____ Private development ____ Zoning X Vandalism ____
Public Works project ____ Other: _____
17. Is the structure: On its original site? X Moved? ____ Unknown? ____
18. Related features: _____

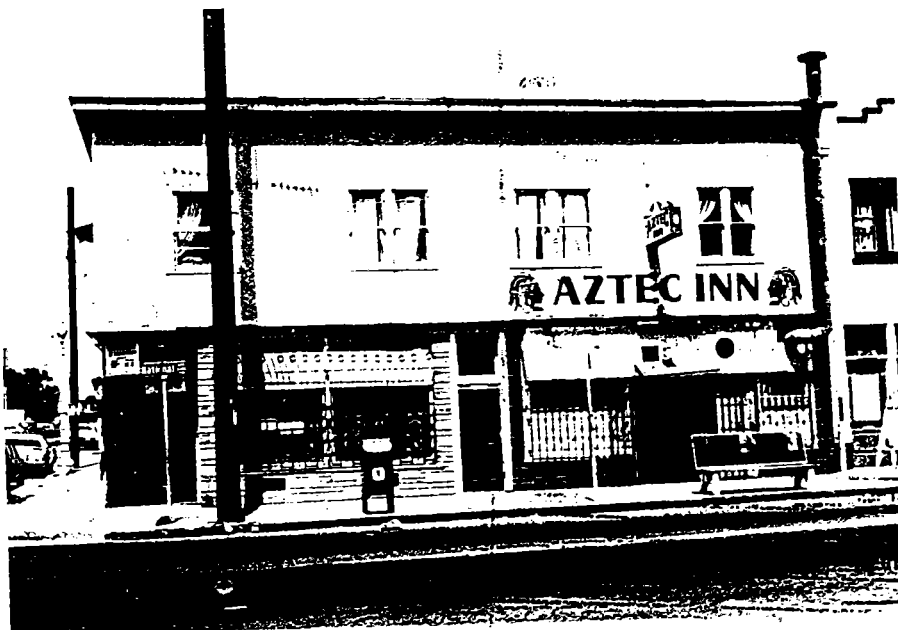
This commercial building with stucco facade has a flat roof, plain parapet and exposed rafter ends. Paired vertical double-hung sash windows are located along the second story. Large storefront windows with wrought iron grillwork and three entrances can be seen along the structure's lower facade. The building has been poorly maintained and inappropriate modifications such as flagstone covering across the front exterior and iron grillwork further detract from the structure's original appearance.

13. Condition: Excellent ____ Good ____ Fair X Deteriorated ____ No longer in existence ____
14. Alterations: Inappropriate siding along lower facade and grillwork around windows detract from this building's original appearance.
15. Surroundings: (Check more than one if necessary) Open land ____ Scattered buildings ____ Densely built-up ____
Residential X Industrial X Commercial X Other: _____
16. Threats to site: None known ____ Private development ____ Zoning X Vandalism ____
Public Works project ____ Other: _____
17. Is the structure: On its original site? X , Moved? ____ Unknown? ____
18. Related features: _____

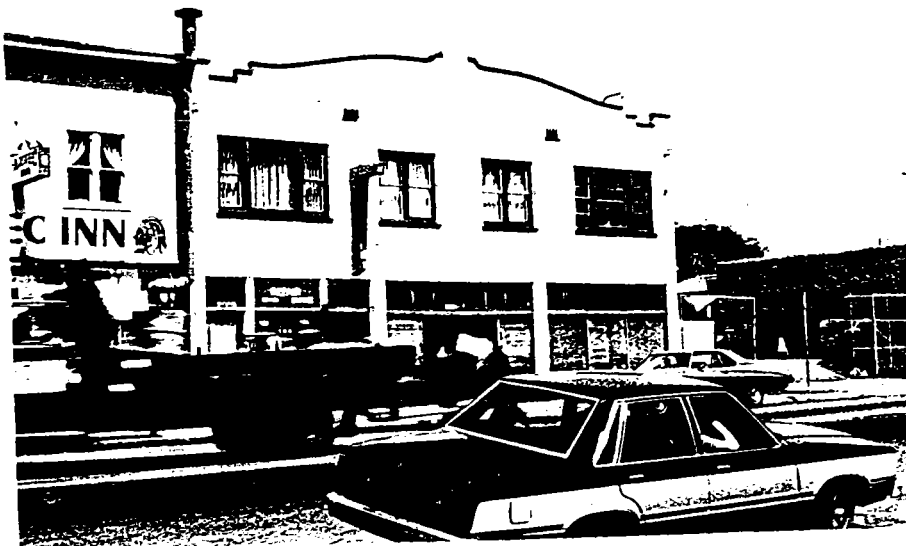
- 7a. Architectural style: _____ Mission Revival
- 7b. Briefly describe the present *physical description* of the site or structure and describe any major alterations from its original condition: Legal Description: Reed and Hubbell's Addition, Block 5, lots 27 and 28.
Although no major alterations exist, the building has not been well maintained. The structure shows a Mission Revival influence and includes large storefront windows, a decorative cornice which hides the flat roof, and residences on the second floor. Second story windows are vertical and horizontal double-hung sash. Some decorative tile work can be seen along the lower facade of the building. Storefront windows have been largely balcked out. One interesting note is the row of small square transoms above two of the major windows, a characteristic feature typical of a number of commercial structures to be found in the area.

13. Condition: Excellent _____ Good _____ Fair X Deteriorated _____ No longer in existence _____
14. Alterations: Most storefront windows have been blacked out.
15. Surroundings: (Check more than one if necessary) Open land _____ Scattered buildings _____ Densely built-up _____
Residential X Industrial X Commercial X Other: _____
16. Threats to site: None known _____ Private development _____ Zoning X Vandalism _____
Public Works project _____ Other: _____
17. Is the structure: On its original site? X Moved? _____ Unknown? _____
18. Related features: _____

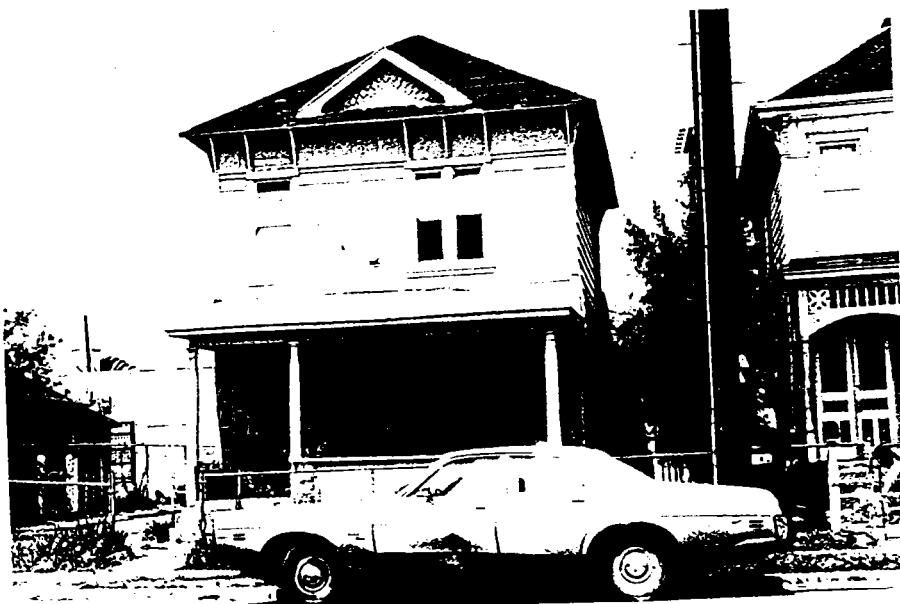
- 7a. Architectural style: American Foursquare
- 7b. Briefly describe the present physical description of the site or structure and describe any major alterations from its original condition: Legal Description: Reed and Hubbell's Addition, Block 5, lots 37 and 38.
One of the most popular of the early 20th century styles, this American Foursquare is characterized by a two story box-like shape, topped with a low hipped roof. A dormer, minus the usual window, fronts the home and is decorated with sawtooth shingles. Simple brackets with some cutout work support the overhanging eaves. Both floors have vertical double-hung sash windows. A porch supported by simple Doric columns extends across the entire front and a door with plain moldings and transom can be seen to one side. Horizontal shiplap siding forms most of the exterior facade, while the remainder, under the eaves, has been applied in a variety of decorative patterns.

13. Condition: Excellent ___ Good X Fair ___ Deteriorated ___ No longer in existence ___
14. Alterations: Iron grillwork around the front door and windows mars the exterior of this home.
15. Surroundings: (Check more than one if necessary) Open land ___ Scattered buildings ___ Densely built-up ___
Residential X Industrial X Commercial X Other: _____
16. Threats to site: None known ___ Private development ___ Zoning X Vandalism ___
Public Works project ___ Other: _____
17. Is the structure: On its original site? X Moved? ___ Unknown? ___
18. Related features: _____

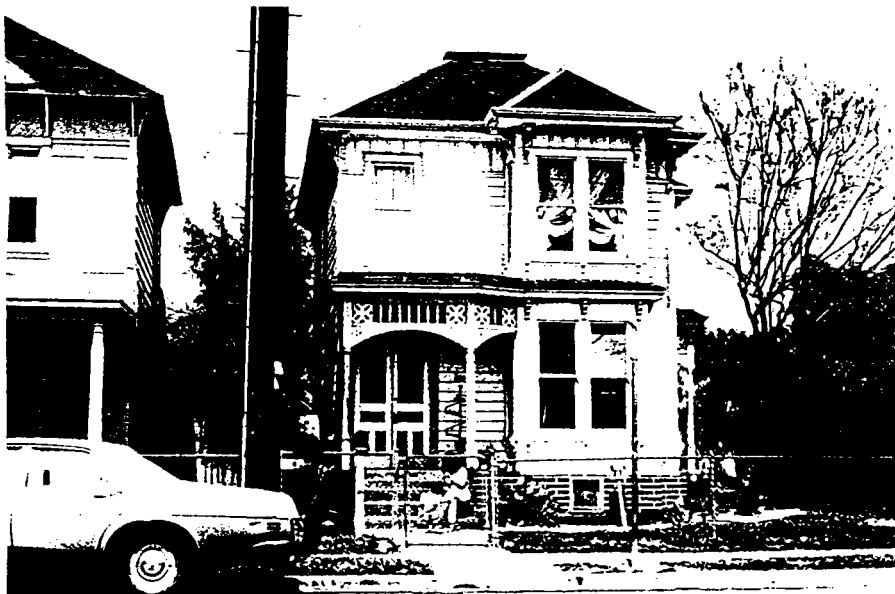
- 7a. Architectural style: Late Victorian Italianate
- 7b. Briefly describe the present *physical description* of the site or structure and describe any major alterations from its original condition: Legal Description: Reed and Hubbell's Addition, Block 5, lots 39 and 40.
This two story structure is of the Italianate variety. It has such decorative features as brackets under the overhanging eaves, a two story flat front bay, low pitched hip roof, double door with moldings and overhead transom and double windows across upper and lower bay. These, and additional single vertical windows are double hung sash and have plain moldings. Slender carved columns support a small front porch with fanciful trim around porch roof. The exterior facade is covered with horizontal shiplap siding except for the area below the roofline which is board and batten. A second porch along the east side of the house has decorative detail work much like the front porch. The structure appears to have a basement and a recent modification includes the application of a brick-like material to the exterior base of the residence. While the front and sides yards have been minimally landscaped, the house is well maintained and appears to be quite sound.

13. Condition: Excellent ____ Good ☒ Fair ____ Deteriorated ____ No longer in existence ____
14. Alterations: A brick-like material has been applied to the exterior base of the structure.
15. Surroundings: (Check more than one if necessary) Open land ____ Scattered buildings ____ Densely built-up ____
Residential ☒ Industrial ____ Commercial ☒ Other: _____
16. Threats to site: None known ____ Private development ____ Zoning ☒ Vandalism ____
Public Works project ____ Other: _____
17. Is the structure: On its original site? ☒ Moved? ____ Unknown? ____
18. Related features: _____
