PROPOSED EAST END
HISTORIC AND PLANNED
DISTRICTS

Public History

May 1983

**EAST END
PLANNED DISTRICT &
HISTORIC DISTRICT**

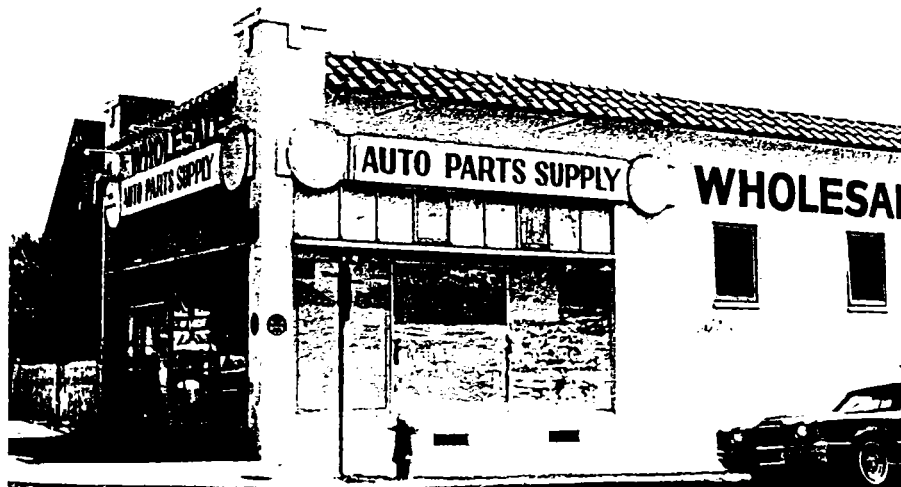
Reed & Hubbells Add. Blk 9, lot 24; Map 0327

This rectangular, one story building with a flat roof, tiled eaves, and stucco facade, exhibits the characteristic large storefront windows topped by a narrow horizontal band of smaller paned windows, typical of commercial structures throughout Logan Heights. Front corners project above the roofline and have simple decorative moldings. The windows and a central wood and glass entry are nearly flush with the exterior facade. An unfortunate element which detracts from this building is the use of paint to blank out some windows. Some graffiti also mars this otherwise sound structure.

13. Condition: Excellent _____ Good ☒ Fair _____ Deteriorated _____ No longer in existence _____
14. Alterations: Some windows blanked out with paint.
15. Surroundings: (Check more than one if necessary) Open land _____ Scattered buildings _____ Densely built-up ☒
Residential ☒ Industrial _____ Commercial ☒ Other: _____
16. Threats to site: None known ☒ Private development _____ Zoning _____ Vandalism _____
Public Works project _____ Other: _____
17. Is the structure: On its original site? ☒ Moved? _____ Unknown? _____
18. Related features: _____

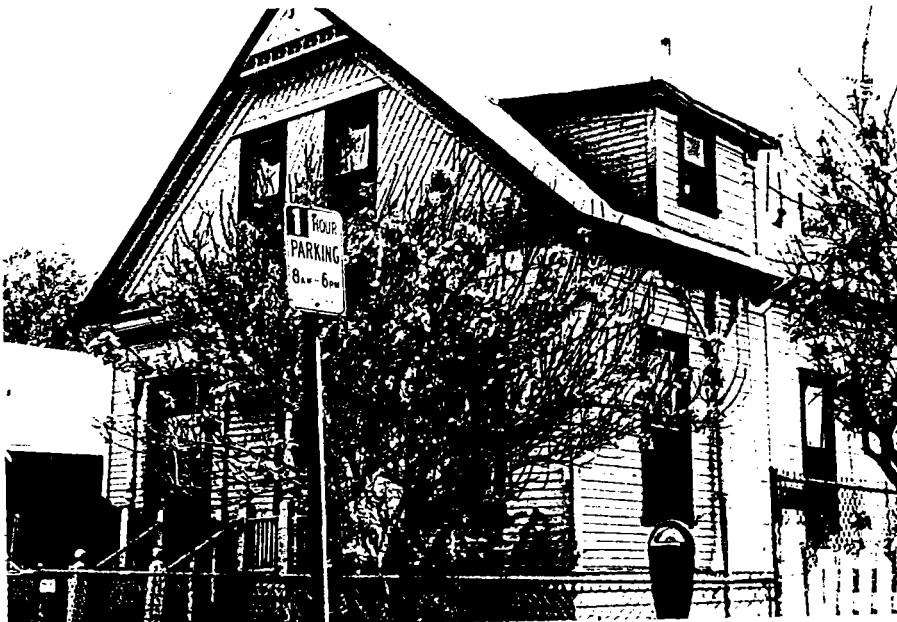
- 7a. Architectural style: Late Victorian
- 7b. Briefly describe the present *physical description* of the site or structure and describe any major alterations from its original condition:
Reed & Hubbell Add. Blk 9, Lot 17
This one and a half story home with a high pitched, gabled roof and small dormer, has an asphalt roof and shiplap siding on the exterior walls. The large gable utilizes two distinctive types of shingles and decorative work at the peak of the gable end. Moldings around vertical double hung sash windows, roof trim and front entrance are accented by a contrasting color. Steps with carved wood rails lead to a small front porch supported by delicately carved posts and railing. Both the house and grounds are relatively well maintained although a low chain link fence detracts somewhat from what appears to be an unaltered structure.

13. Condition: Excellent ____ Good x Fair ____ Deteriorated ____ No longer in existence ____
14. Alterations: none known
15. Surroundings: (Check more than one if necessary) Open land ____ Scattered buildings ____ Densely built-up x
Residential x Industrial ____ Commercial x Other: ____
16. Threats to site: None known x Private development ____ Zoning ____ Vandalism ____
Public Works project ____ Other: ____
17. Is the structure: On its original site? x Moved? ____ Unknown? ____
18. Related features: fence, landscaping, trees

This house is a fine example of late Victorian style and appears to have no major alterations. It should be preserved as one of the remaining early homes in the area and as a sample of the diverse architectural styles found in the district.

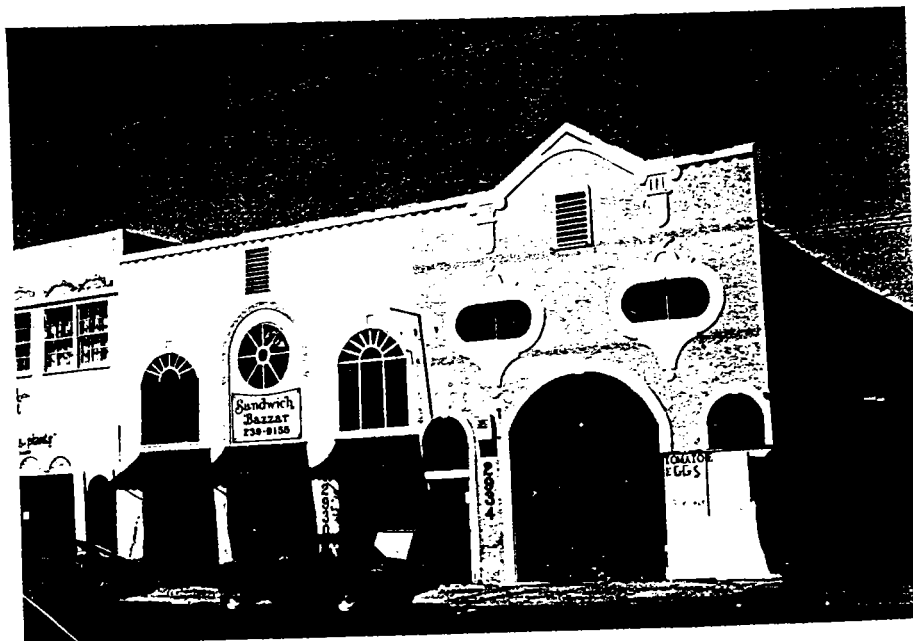
This two story wood structure with high pitched gable at one end was probably two adjoining buildings that have recently undergone an interesting stucco face lift. Arched windows, one round window and striped awnings give a Mediterranean feeling to the left side of the building, while the right side exhibits molded trims around as shed doorways and windows, reminiscent of the middle East. A decorative paint job gives the illusion of a parapet along the roof line and accents windows and doors in a rather creative and unusual fashion. The building designated as 2934 National Avenue does not appear to be in use except for perhaps storage and second floor apartments are vacant and all side windows are boarded shut.

13. Condition: Excellent ____ Good ____ Fair X Deteriorated ____ No longer in existence ____
14. Alterations: Exterior facades altered dramatically
15. Surroundings: (Check more than one if necessary) Open land ____ Scattered buildings ____ Densely built-up ____
Residential X Industrial X Commercial X Other: ____
16. Threats to site: None known ____ Private development ____ Zoning X Vandalism ____
Public Works project ____ Other: ____
17. Is the structure: On its original site? X , Moved? ____ Unknown? ____
18. Related features: ____

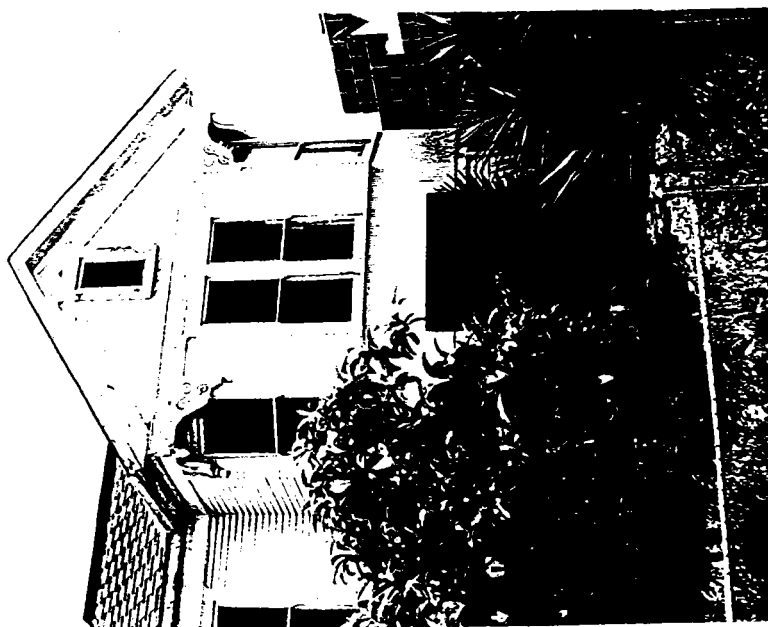
Reed & Hubbell Add. Block 9, lots 13 & 14

Although vacant and deteriorated, this late Victorian home with medium hipped roof and high pitched front gable; has possibilities for rehabilitation. Overgrown landscaping partially obscures the clapboard siding which covers the exterior. A horizontal band of narrow vertical wood strips extends around the house above the first floor windows, creating a visual division between the first and second stories. Fishscale shingles and a small vertical accent window accent the front gable along with vertical double-hung sash windows in the front cutaway corners. The second story corner windows are topped by decorative brackets and pendants. Lower windows appear to be vertical sash as well, although most have been boarded up.

13. Condition: Excellent ___ Good ___ Fair ___ Deteriorated X No longer in existence ___
14. Alterations: entrances and windows boarded up
15. Surroundings: (Check more than one if necessary) Open land ___ Scattered buildings ___ Densely built-up X
Residential X Industrial X Commercial X Other: ___
16. Threats to site: None known ___ Private development ___ Zoning X Vandalism X
Public Works project ___ Other: ___
17. Is the structure: On its original site? X Moved? ___ Unknown? ___
18. Related features: landscaping

This home is characteristic of a number of interesting late Victorian dwellings to be found in this area and should be preserved as part of the historical/architectural character still evident throughout most of the neighborhoods in Logan Heights.

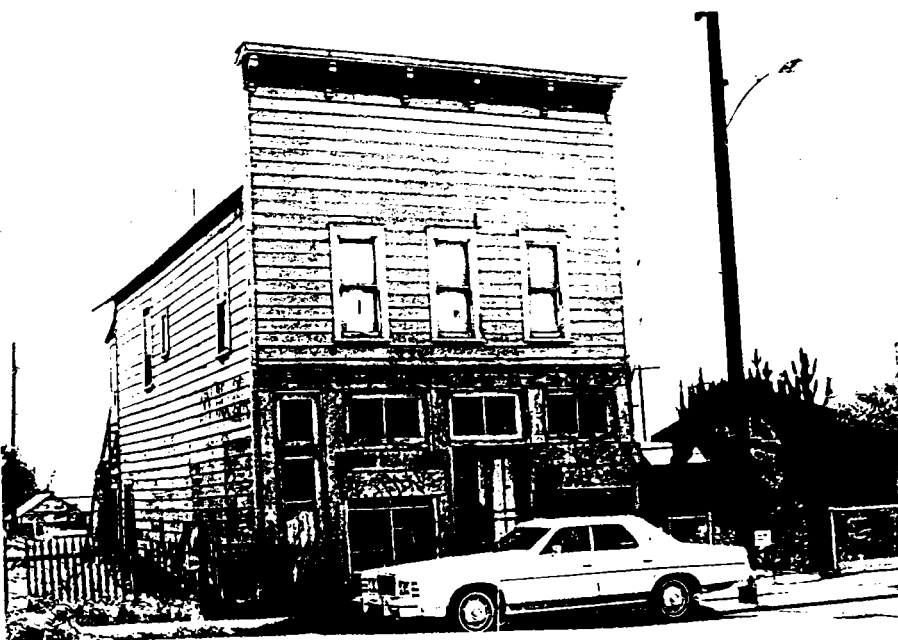
Whitney Add W 1/2 Lot 12 and all lot 13, Blk 41 Map 0168
This deteriorated false front building has a high gable roof hidden by a facade which extends well above the roofline. A plain parapet with decorative brackets caps the false front. Shiplap siding covers the exterior walls, and vertical double-hung sash windows with plain moldings can be seen at the second story level. Former storefront windows have been largely boarded up and are topped with horizontal double-paned transoms. A transom also tops the central double door commercial entrance and the narrow apartment entrance located to one side. Most transoms have broken glass, and graffiti mars the exterior facade. There appear to be additional entryways toward the rear, and a stairway at the back may or may not be original.

13. Condition: Excellent ____ Good ____ Fair ____ Deteriorated ☒ No longer in existence ____
14. Alterations: windows boarded; possible stairway addition at rear
15. Surroundings: (Check more than one if necessary) Open land ____ Scattered buildings ____ Densely built-up ☒
Residential ____ Industrial ☒ Commercial ☒ Other: ____
16. Threats to site: None known ____ Private development ____ Zoning ☒ Vandalism ☒
Public Works project ____ Other: ____
17. Is the structure: On its original site? ____ Moved? ____ Unknown? ☒
18. Related features: fence

A variety of businesses have existed on this site since 1926 including a dry goods store, house movers, and used furniture store. Although vacant and deteriorated, this building presents good possibilities for restoration and is one of only a few remaining two story false front structures left in San Diego.

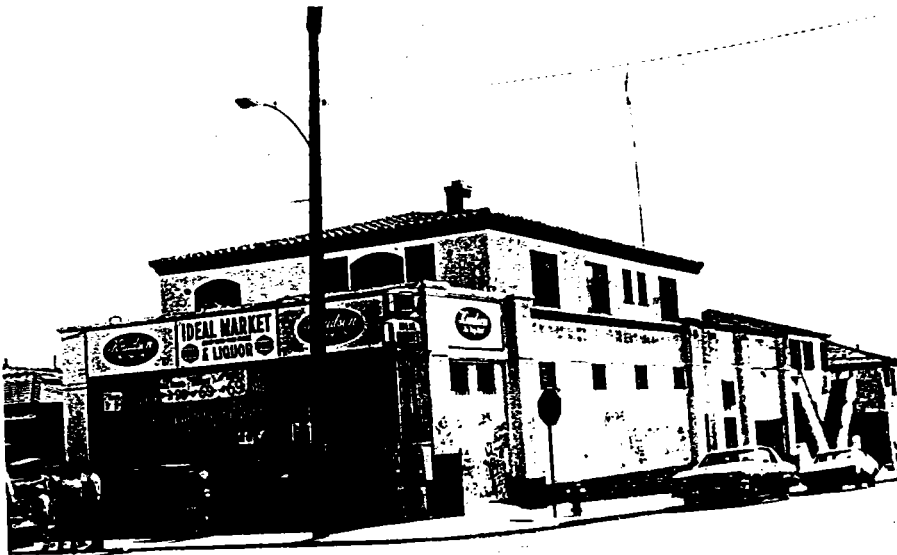
Characteristic features of this Mediterranean style building include a stucco facade; classical corner support columns and a recessed second floor apartment with tiled roof and arched front windows. Vertical paired sash windows can also be seen along the second story facade. Small square windows are located along the west side of the business and large storefront windows have been boarded for protection. Vandalism in the form of graffiti mars this otherwise sound structure.

13. Condition: Excellent ____ Good X Fair ____ Deteriorated ____ No longer in existence ____
14. Alterations: _____
15. Surroundings: (Check more than one if necessary) Open land ____ Scattered buildings ____ Densely built-up X
Residential ____ Industrial X Commercial X Other: _____
16. Threats to site: None known ____ Private development ____ Zoning X Vandalism ____
Public Works project ____ Other: _____
17. Is the structure: On its original site? X , Moved? ____ Unknown? ____
18. Related features: _____

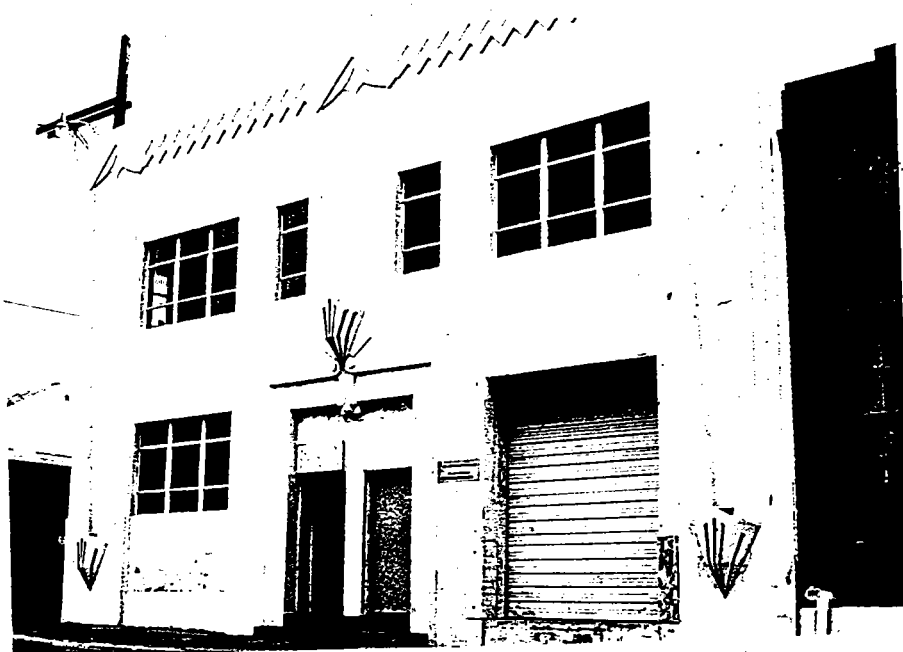
Mannasse & Schiller, Block 138, lots 1-6
This concrete building with a flat roof and sawtooth pattern on the front of the parapet, adjoins an alley on the north side and another older structure, housing the same business, to the south. Horizontal and vertical multi-paned windows extend across the upper facade. There is a similar window on the lower floor. A central entryway leads to two recessed interior doors, and a third entrance for vehicles is located to one side. Three-dimensional ornamentation along either end of the facade, above the central entrance, and across the roofline, indicates a definite Art Deco influence.

13. Condition: Excellent ___ Good X Fair ___ Deteriorated ___ No longer in existence ___
14. Alterations: one lower floor window may have been converted into an entrance.
15. Surroundings: (Check more than one if necessary) Open land ___ Scattered buildings ___ Densely built-up X
Residential ___ Industrial X Commercial X Other: ___
16. Threats to site: None known ___ Private development ___ Zoning X Vandalism ___
Public Works project ___ Other: ___
17. Is the structure: On its original site? X Moved? ___ Unknown? ___ see 1606
18. Related features: Older brick building adjoins this structure National Ave.

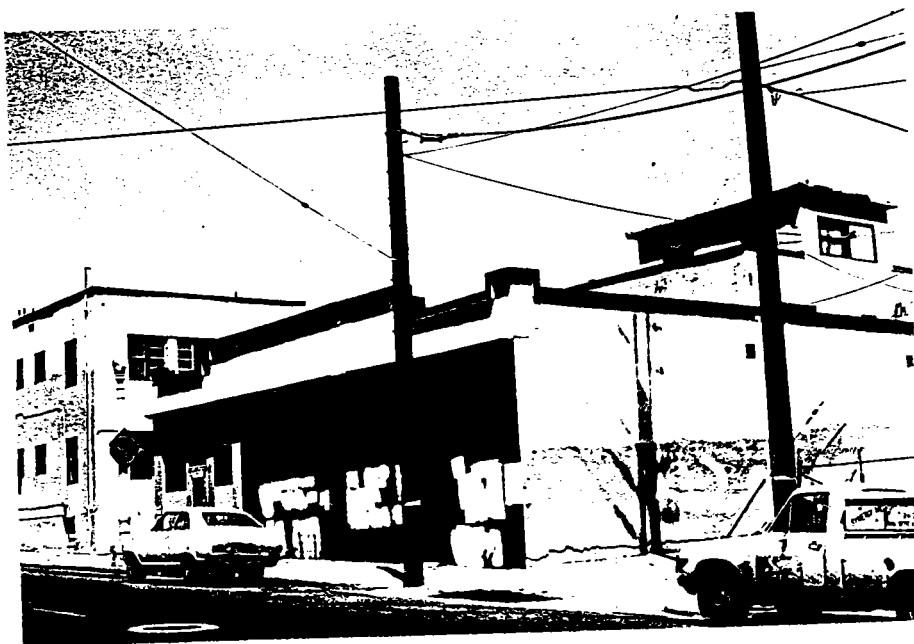
Although deteriorated, this structure appears sound.
