### MEMORANDUM

**To:** Antoinette Gibbs, City of San Diego Transportation & Storm Water Department  
**From:** Jasmine Bakker, Artemis Environmental Services, Inc.  
**Subject:** **Biological Resources Memorandum for the Guy Street Storm Drain Improvements Project (ESA Task Order #40)**  
**Date:** May 22, 2020  
**CC:** Mayra Medel, City of San Diego Transportation & Storm Water Department  
Michael Bever, ESA

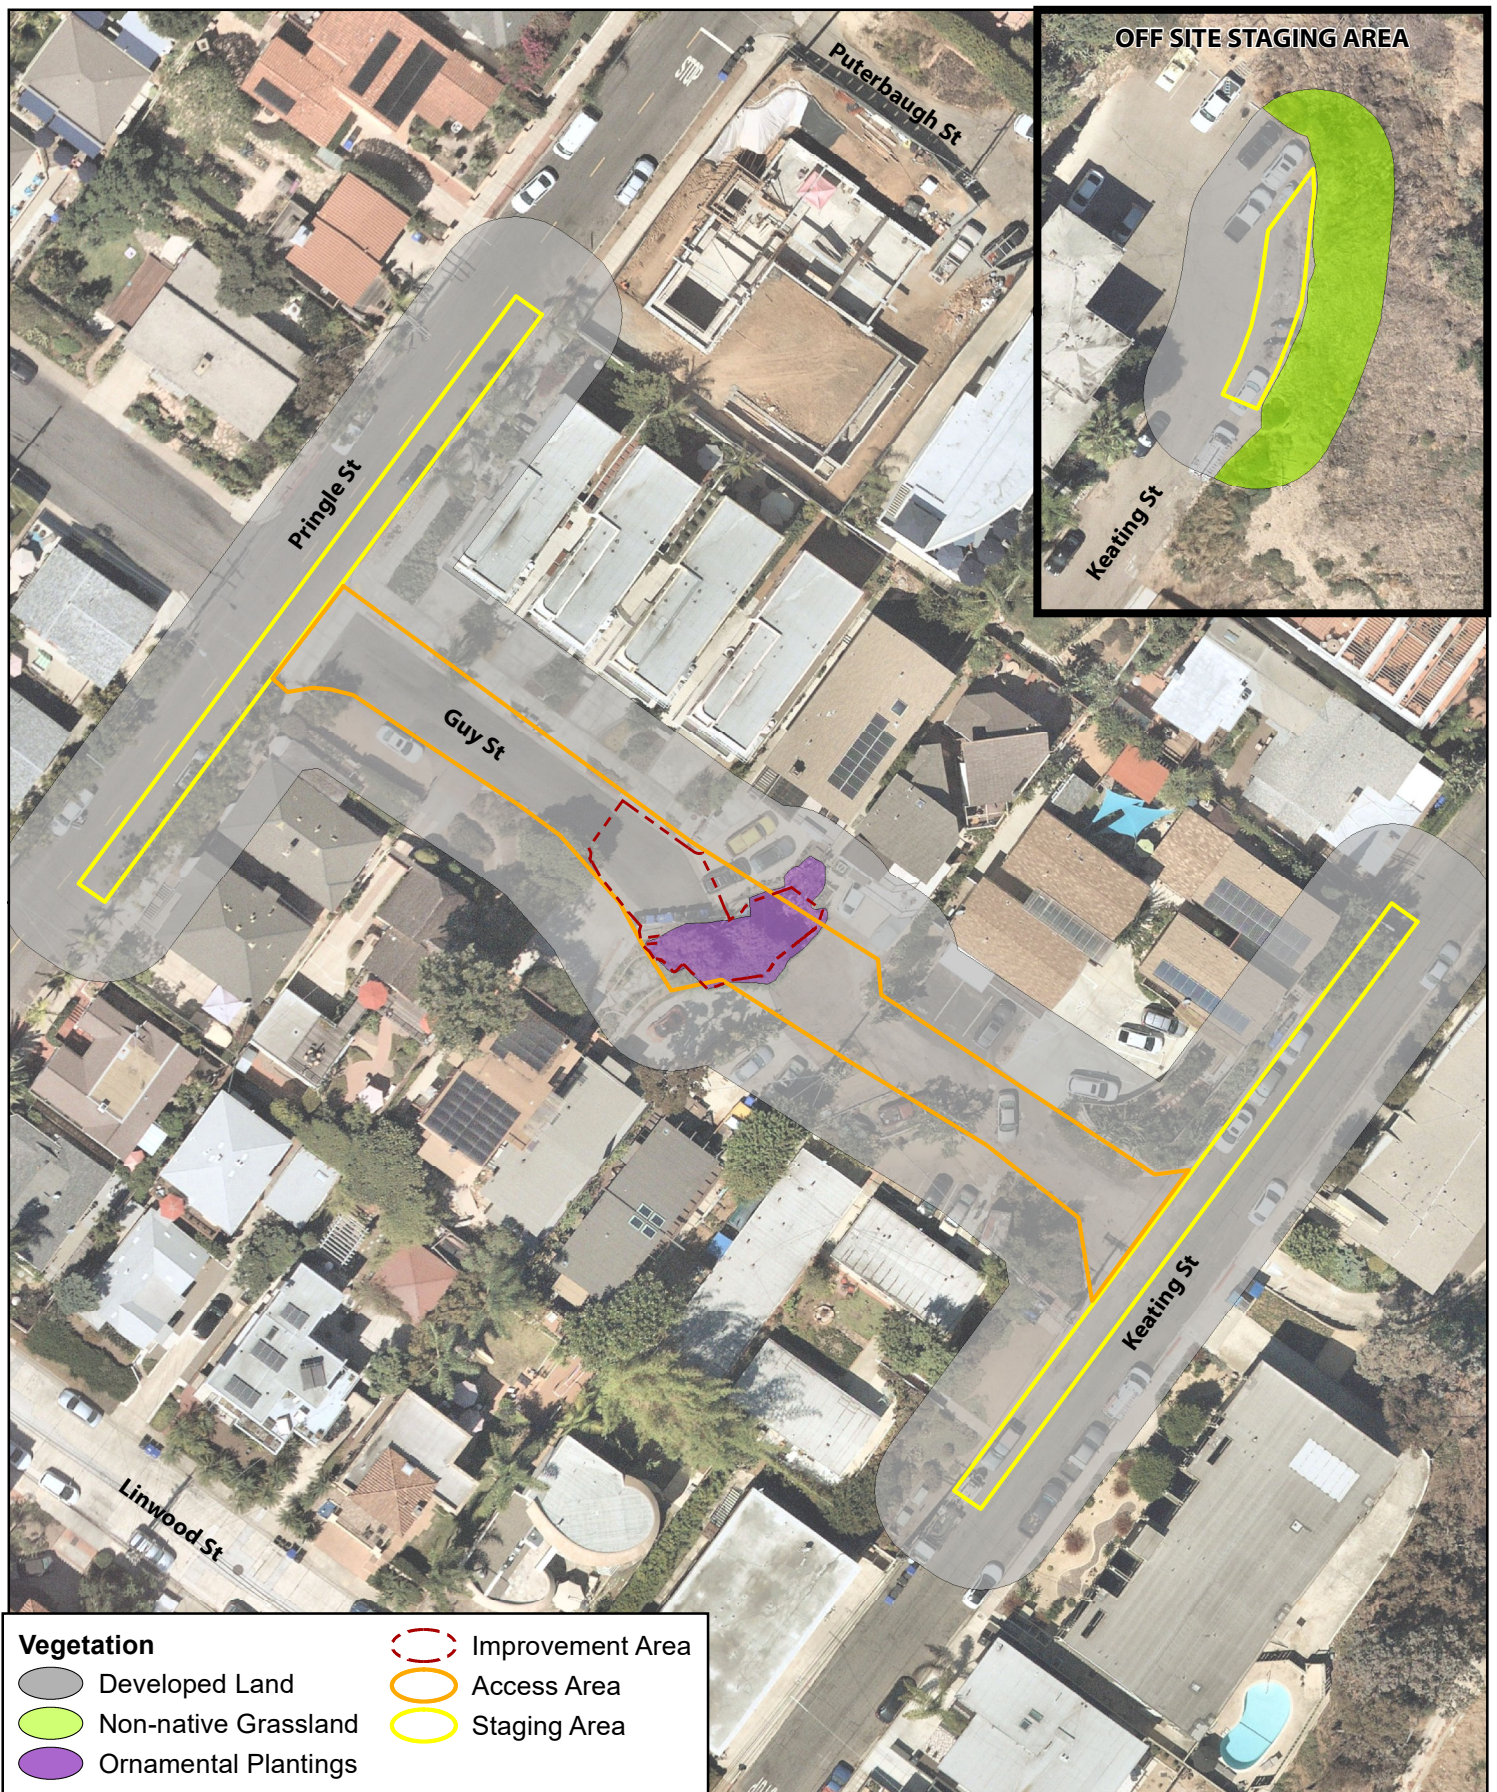
Figure 2

## Vegetation and Improvement/Access/Staging Areas

Three upland vegetation communities/land covers were mapped within the Project Study Area: non-native grassland, ornamental plantings, and developed land, described below. Table 3 identifies the vegetation community acreages that occur within the Project Study Area and proposed impacts. Appendix A, Figure 2: Vegetation and Improvement/Access/Staging Areas, displays the vegetation mapping conducted within the Project Study Area.

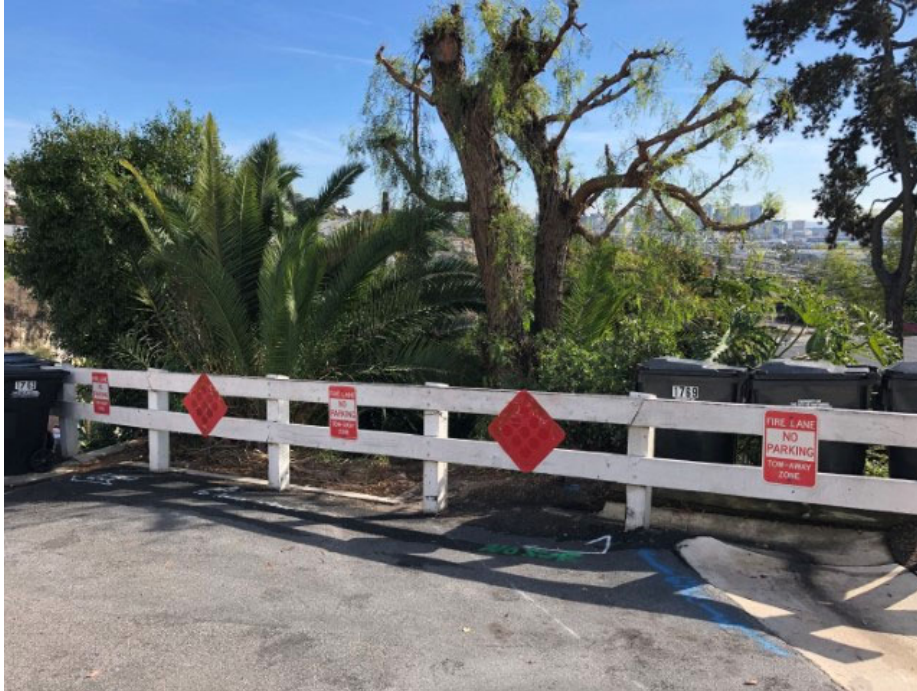
**Photo 1.** View facing southeast towards street barricade at upper portion of paper street; ornamental plantings (date palm and peppertree) at top of terraced landscaping.  
(Photo Coordinates: 32.745547, -117.181314)

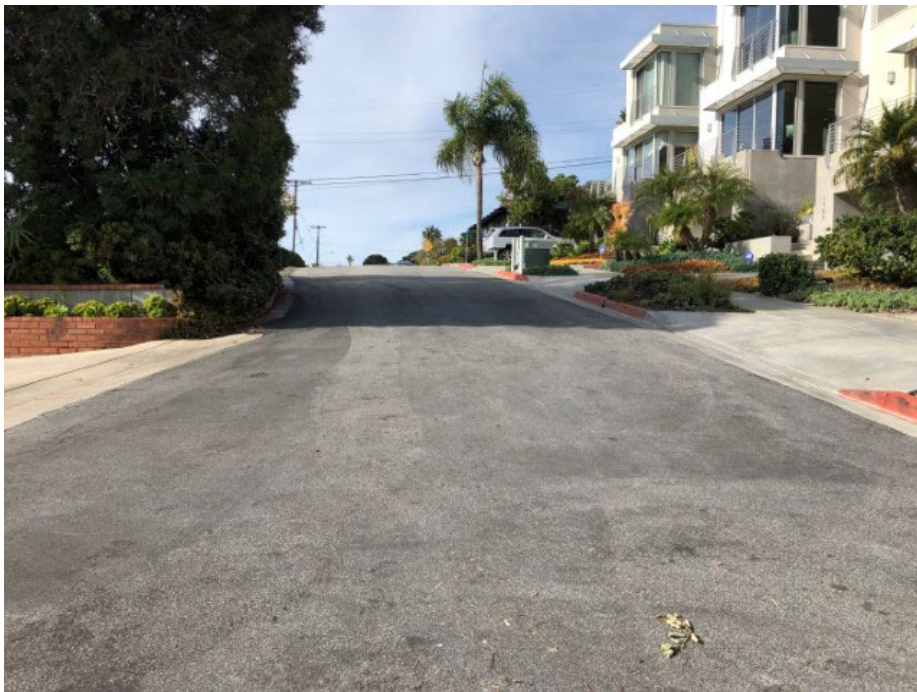
**Photo 2.** View facing northwest at Guy Street from street barricade at upper portion of paper street. (Photo Coordinates: 32.745562, -117.181306)

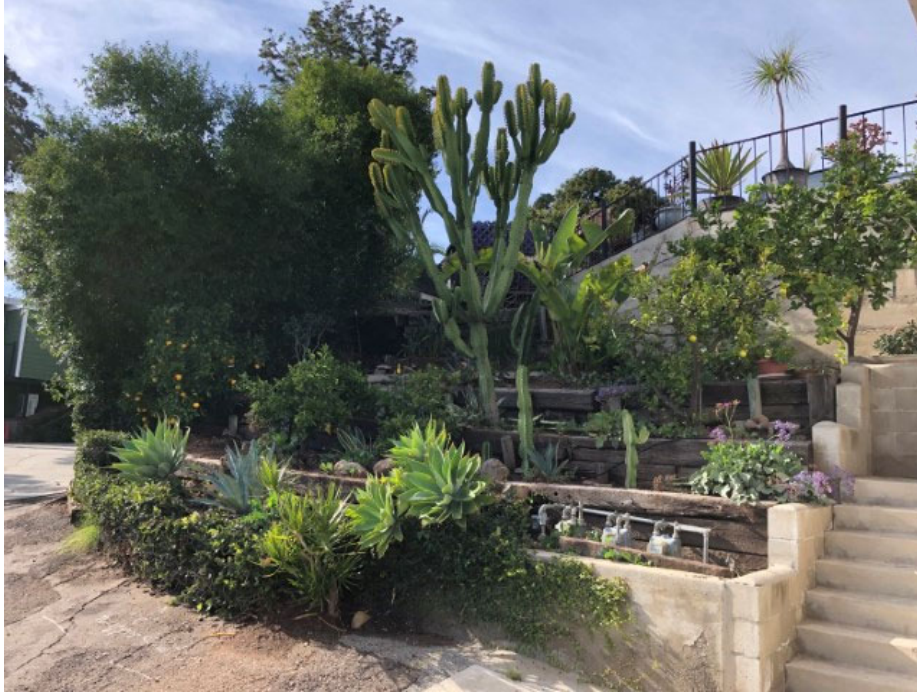
**Photo 3.** View facing west towards terraced landscaping at lower portion of paper street from corner of adjacent residence at 1772 Guy Street. (Photo Coordinates: 32.745513, -117.181034)

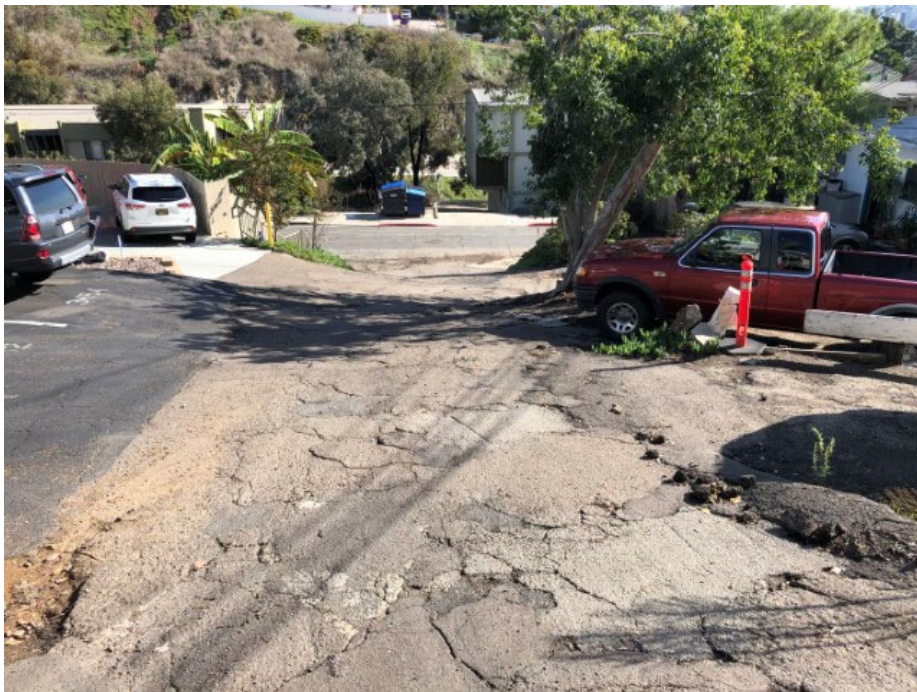
**Photo 4.** View facing southeast towards Keating Street from lower portion of paper street. (Photo Coordinates: 32.745415, -117.181079)

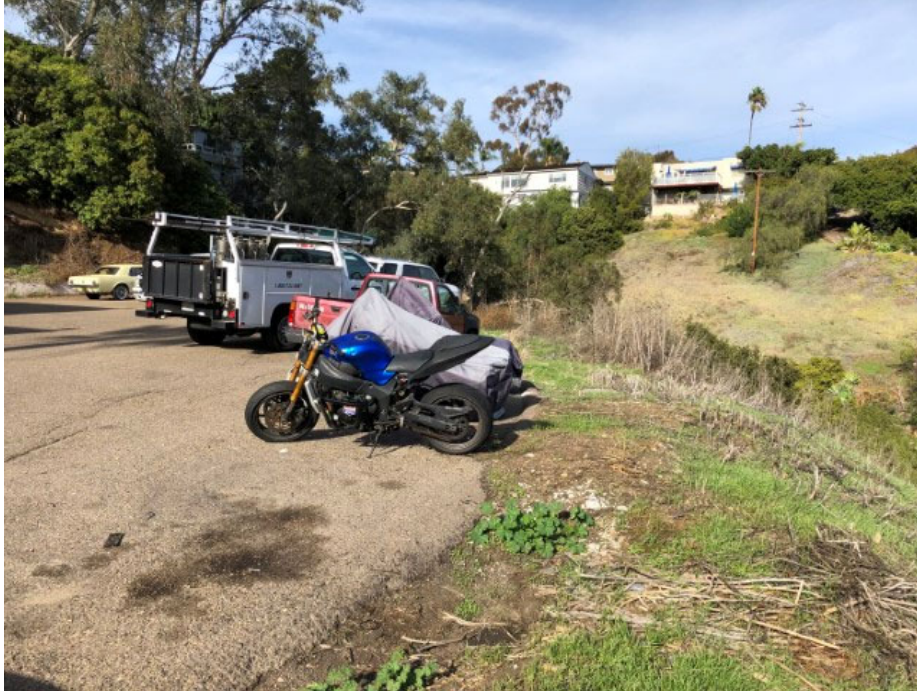
**Photo 5.** View facing north at Staging Area proposed at northeastern end of Keating Street; paved area currently used by adjacent residences for parking adjacent to non-native grassland.  
(Photo Coordinates: 32.747207, -117.178978)

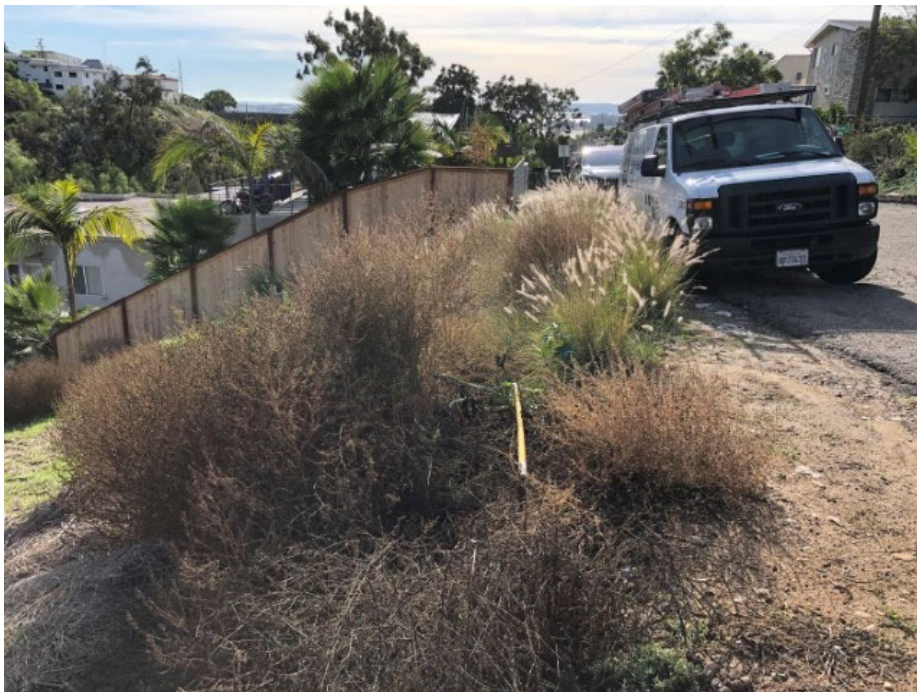
**Photo 6.** View facing southwest from Staging Area proposed at northeastern end of Keating Street.  
(Photo Coordinates: 32.747177, -117.178993)
