HISTORICAL GREATER MID-CITY SAN DIEGO PRESERVATION STRATEGY

VOLUME 2

**HISTORIC
RESOURCES
INVENTORY FORMS
(DPR 523)
APN 452-705-02
THROUGH
APN 534-411-41**

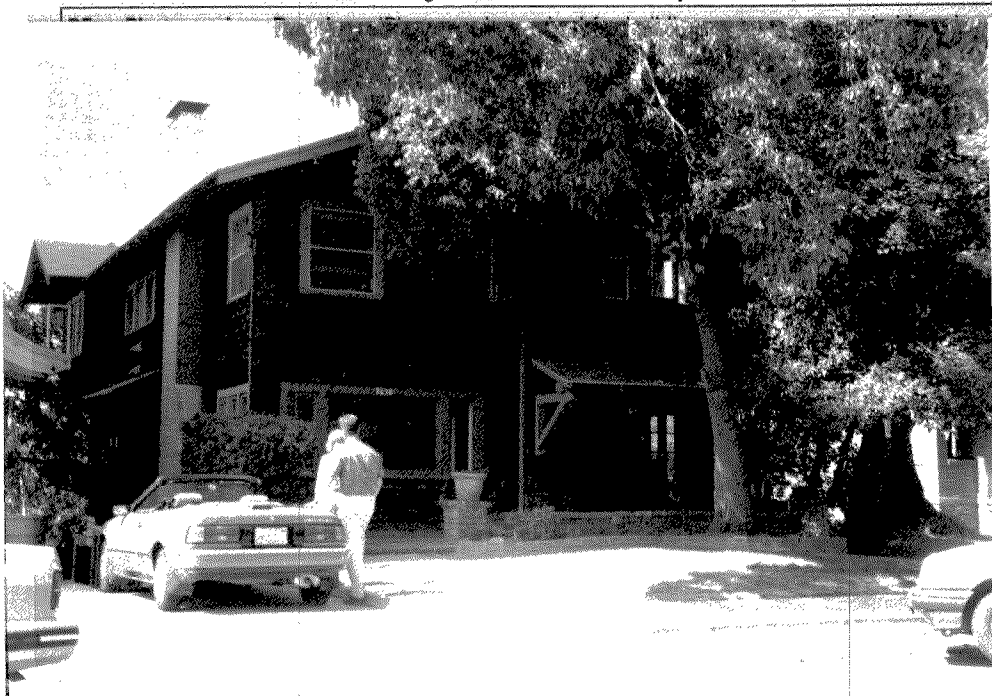
Photo Number: 140-06

Condition: Good

*P3b. Resources Attributes: (List attributes and codes) HP2. Single family property

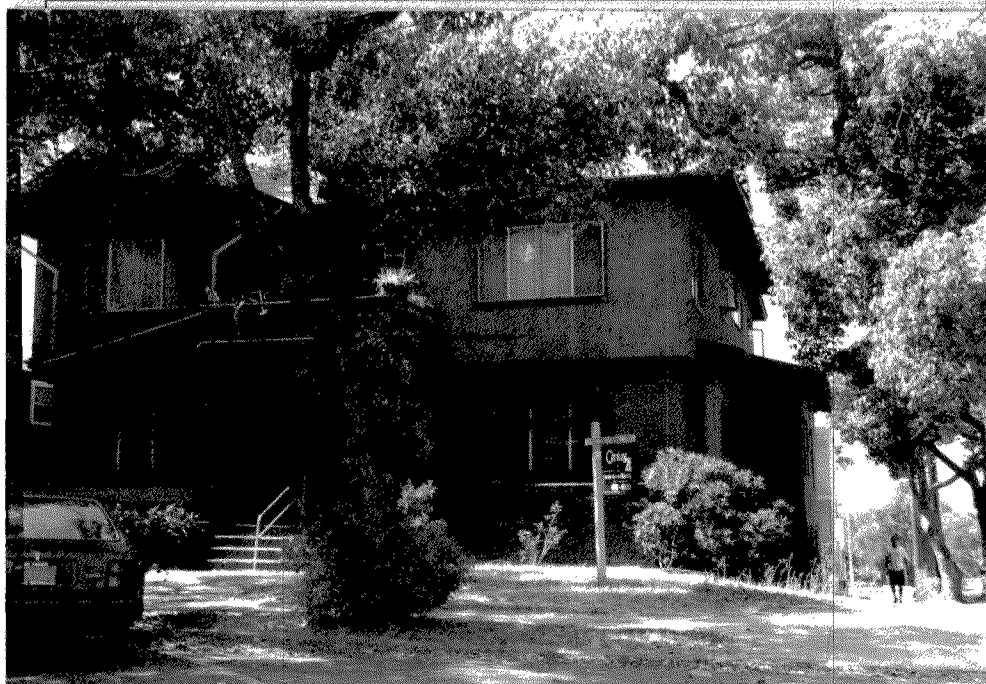
Photo Number: 140-07

Condition: Good

*P3b. Resources Attributes: (List attributes and codes) HP2. Single family property

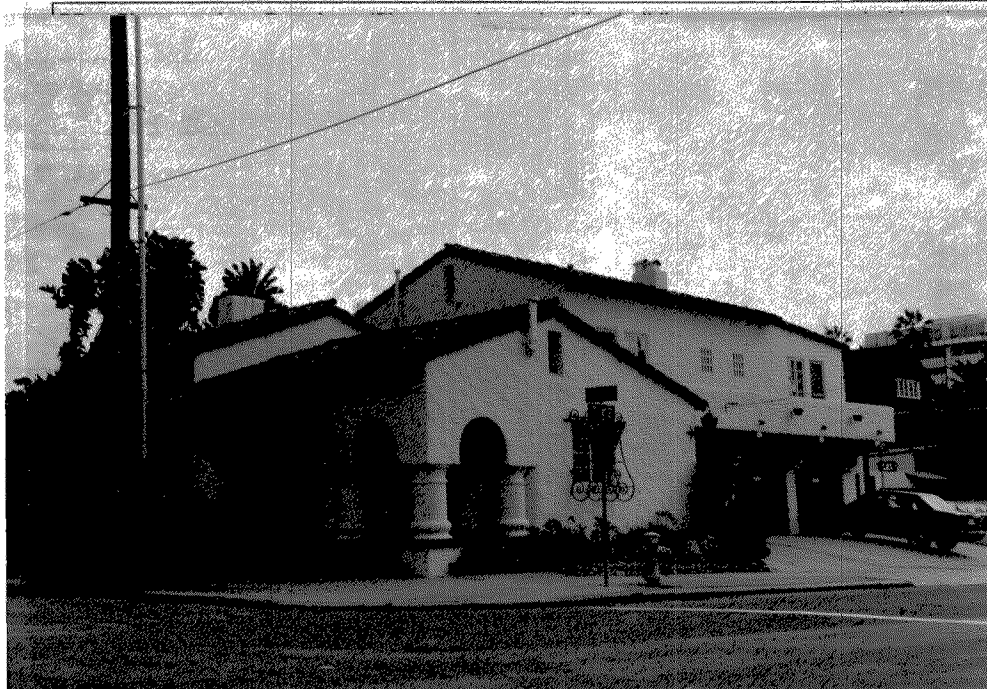
Photo Number: 142-16

Condition: Good

*P3b. Resources Attributes: (List attributes and codes) HP3. Multiple family property

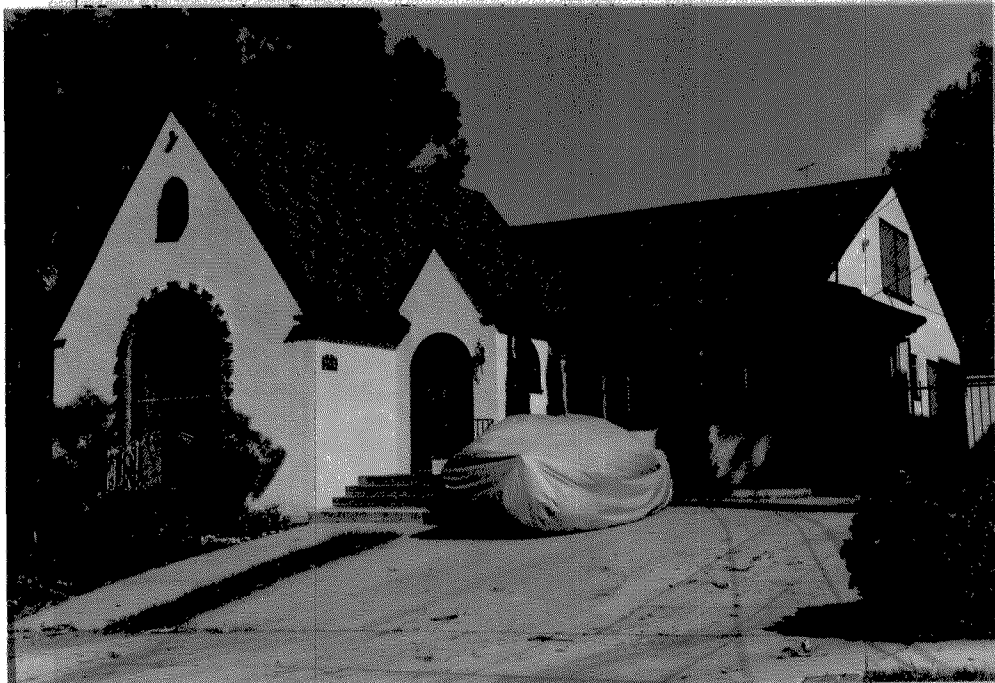
Photo Number: 142-18

Condition: Good

*P3b. Resources Attributes: (List attributes and codes) HP2. Single family property

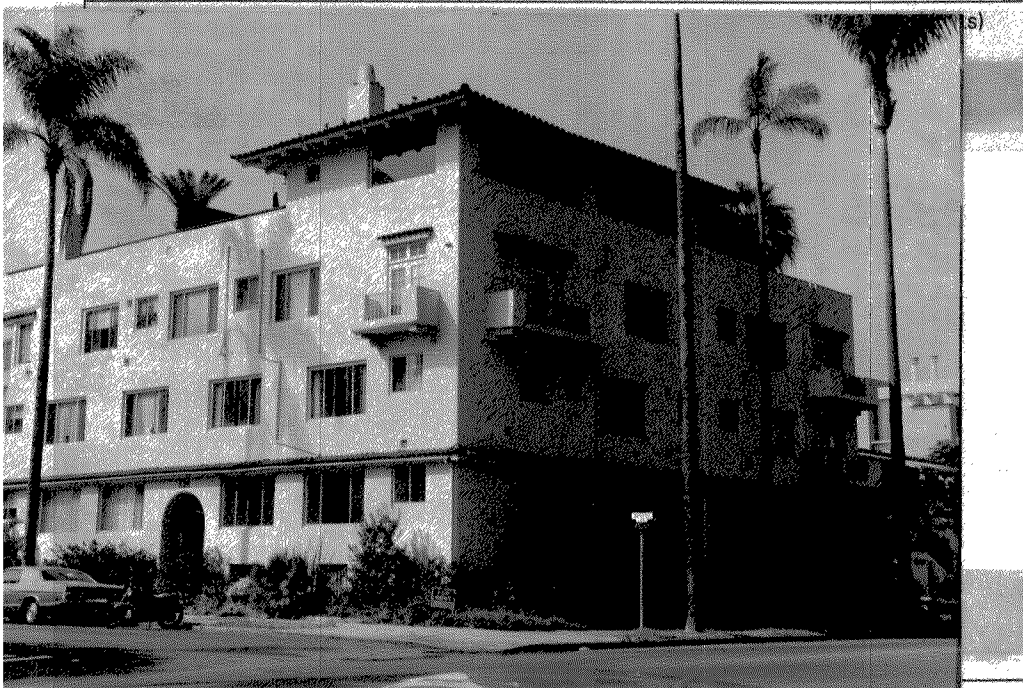
P5b. Description of Photo: (View, date, etc.)
Photo Number: 142-09
Date: June-October 1995

*P3a. Description: (Describe resource and its major elements. Include design, materials, condition, alterations, size, setting, and boundaries.)
Condition: Good

*P3b. Resources Attributes: (List attributes and codes) HP3. Multiple family property

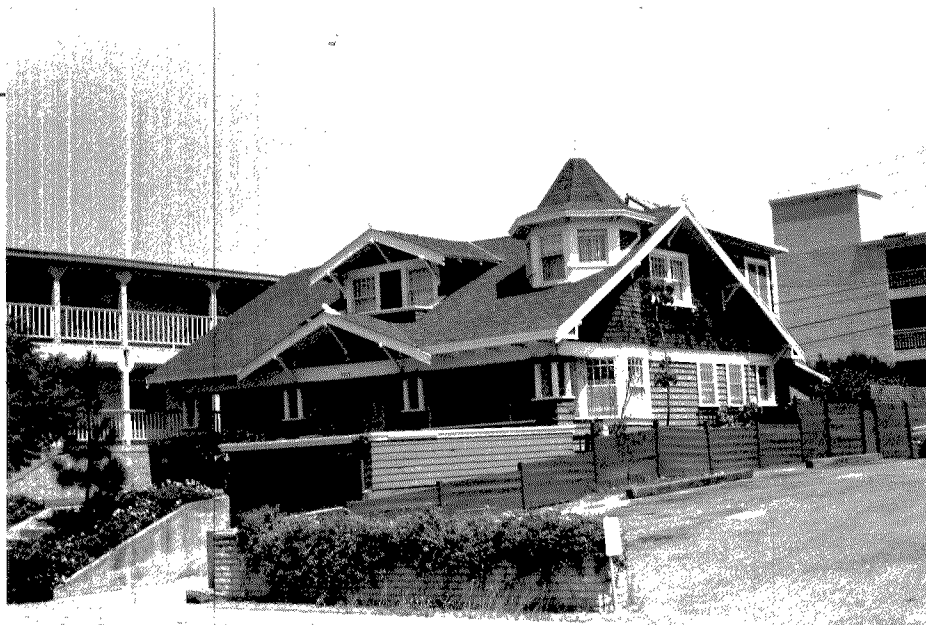
This one-and-a-half story house has a side gabled roof with overhanging eaves and exposed rafters. A gabled dormer rests in the center of the roof. A centered cross-gable rests below the dormer over the porch steps. The porch lies under the main roof and extends across the full width of the house. Each gable has triangular brackets under the eaves and finials at their points. An octagon shaped cupola with a hipped roof lies on the south end of the roof. A large shed roof dormer extends from the south end of the backside of the roof. A bay window lies on the south facade directly below the cupola. The ground floor has wood clapboard siding and shingle siding covers the gables. The roof above the porch is supported by four supports consisting of two or three columns resting on low piers. A flat roof garage with clapboard siding lies at street level in front of the house.

8. Construction date:
Estimated _____ Factual 1907
9. Architect Unknown
10. Builder Unknown
11. Approx. property size (in feet)
Frontage 50' Depth 140'
or approx. acreage _____
12. Date(s) of enclosed photograph(s)
August 1988

13. Condition: Excellent ☒ Good _____ Fair _____ Deteriorated _____ No longer in existence _____
14. Alterations: _____
15. Surroundings: (Check more than one if necessary) Open land _____ Scattered buildings _____ Densely built-up _____
Residential ☒ Industrial _____ Commercial ☒ Other: _____
16. Threats to site: None known _____ Private development ☒ Zoning ☒ Vandalism ☒
Public Works project _____ Other: _____
17. Is the structure: On its original site? yes Moved? _____ Unknown? _____
18. Related features: _____

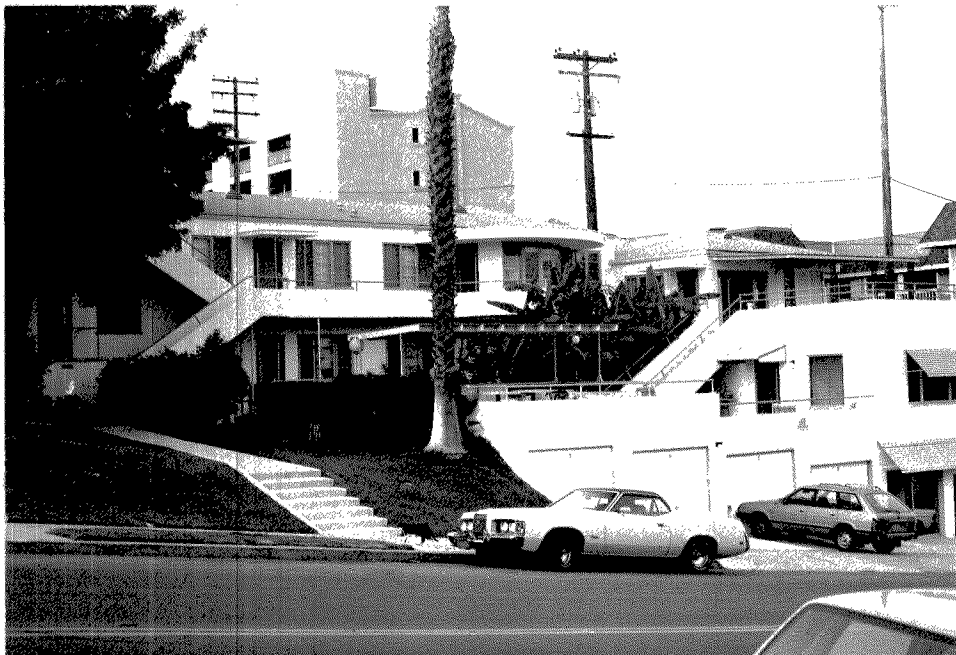
8. Construction date:
Estimated _____ Factual 1937
9. Architect Owen King
10. Builder Scott King and Arthur McKee
11. Approx. property size (in feet)
Frontage 140' Depth 75'
or approx. acreage _____
12. Date(s) of enclosed photograph(s)
August 1988

13. Condition: Excellent ☒ Good ☐ Fair ☐ Deteriorated ☐ No longer in existence ☐
14. Alterations: enclosed garage
15. Surroundings: (Check more than one if necessary) Open land ☐ Scattered buildings ☐ Densely built-up ☐
Residential ☒ Industrial ☐ Commercial ☒ Other: ☐
16. Threats to site: None known ☐ Private development ☒ Zoning ☒ Vandalism ☒
Public Works project ☐ Other: ☐
17. Is the structure: On its original site? ☒ Yes Moved? ☐ Unknown? ☐
18. Related features: landscaping

This apartment complex was built in 1937 by Arthur H. McKee and Scott King. McKee was a plasterer and he did the plastering on this building. McKee and King ran their own construction company. A few years later, Scott King founded the Travelodge Corporation. These apartments were designed by Scott King's brother as his master's thesis at the University of California, Berkeley. Nellie I. Fuller bought the building, with the help of her mother, in 1940. She says that Scott King used the down payment she gave him for this building to help build the first Travelodge Motel. Nellie and her mother both moved into this building. Nellie lived there until she sold the building in 1986. Scott King's brother, Owen King, lived in Los Angeles but was a vice-president of Travelodge Corporation. He may have designed some of the early Travelodge Motels. This apartment complex has always been called the Tropical Terrace Apartments. The Moderne Style of this building represents one of the architectural styles of the second phase of the Modern Movement. The "streamlined" appearance this style gives a building came as a result of the Machine Age Movement in design.

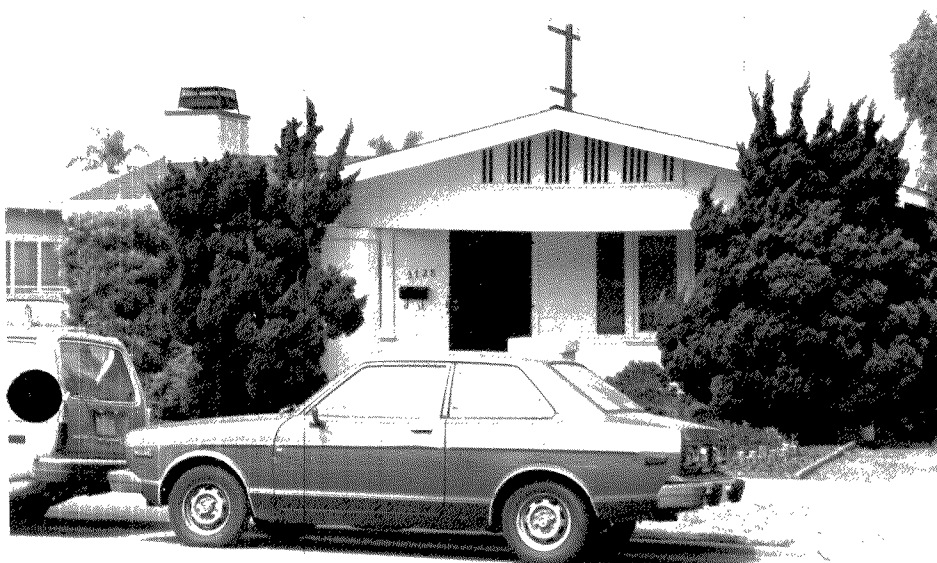
This one-story asymmetrical Craftsman structure has a low pitch roof and a cross gable. Exposed rafters are found on both the north and south facades of the structure with widely overhanging eaves present on all sides. A large front gable, that is offset to the north of the facade, covers an open porch that is slightly raised. Two tapered stucco columns act as support for the front gable. Vertical attic vents are present beneath the peaks of the front and side gables. A tripartite window with a fixed center and casement side panels is located on the front facade just south of the main entrance. A pair of adjoining casement windows are also located on the front facade as is a wood frame door with vertical glass panes. Located on the south side of the structure is an exposed wood chimney with brick detailing. Also located on the south facade is a small side gable and an assortment of double hung and casement windows. The same arrangement can be found on the north side of the structure. Mature foundation plants and a nicely manicured lawn set off the front yard. No alterations are apparent.

13. Condition: Excellent ☒ Good _____ Fair _____ Deteriorated _____ No longer in existence _____
14. Alterations: NONE KNOWN
15. Surroundings: (Check more than one if necessary) Open land _____ Scattered buildings _____ Densely built-up _____
Residential ☒ Industrial _____ Commercial _____ Other: _____
16. Threats to site: None known _____ Private development ☒ Zoning _____ Vandalism ☒
Public Works project _____ Other: _____
17. Is the structure: On its original site? ☒ Moved? _____ Unknown? _____
18. Related features: _____

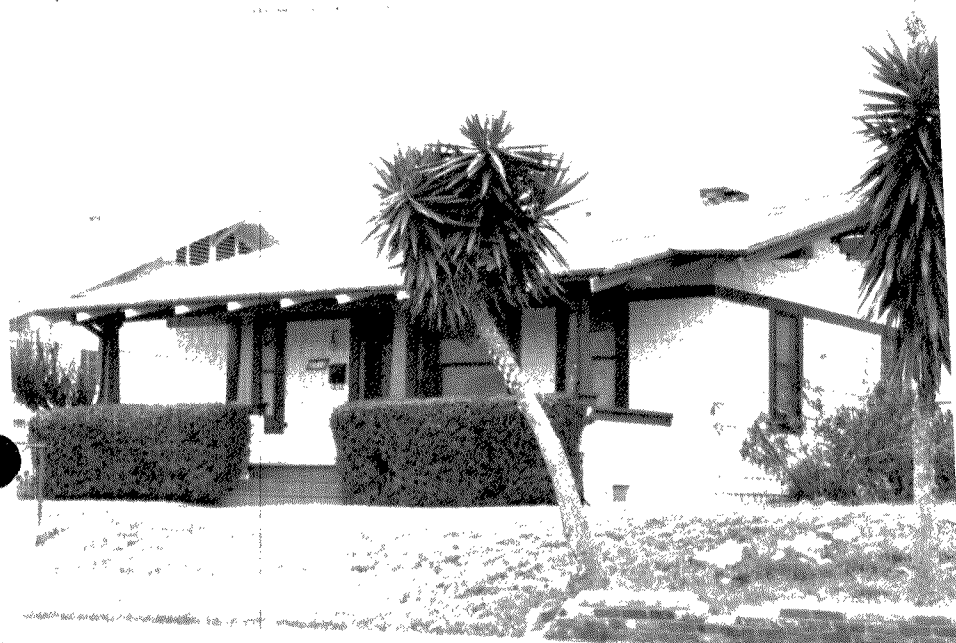
This 1½-story asymmetrical Craftsman home has a low-pitch roof with side gables. Wide overhanging eaves with exposed rafters are supported by stepped brackets. A shed roof extends out over the open veranda. Four narrow wood columns support the shed roof. Double-hung windows are used throughout the house with the largest one located on the front facade next to the main entry. The west facade features an oriel with a shed roof sheltering it. The entire structure is covered by shingled siding with decorative vertical vents visible beneath the peaks of the side gables. A wooden gate has been added that surrounds the rear yard. The house is set back on the lot behind a well-manicured lawn and hedge.

8. Construction date:
Estimated 1917 Factual _____
9. Architect David O. Dryden
(designer)
10. Builder David O. Dryden
11. Approx. property size (in feet)
Frontage _____ Depth _____
or approx. acreage _____
12. Date(s) of enclosed photograph(s)
May 1991

13. Condition: Excellent ☒ Good ☐ Fair ☐ Deteriorated ☐ No longer in existence ☐
14. Alterations: New roof
15. Surroundings: (Check more than one if necessary) Open land ☐ Scattered buildings ☐ Densely built-up ☐
Residential ☒ Industrial ☐ Commercial ☐ Other: ☐
16. Threats to site: None known ☐ Private development ☒ Zoning ☐ Vandalism ☒
Public Works project ☐ Other: ☐
17. Is the structure: On its original site? ☒ Moved? ☐ Unknown? ☐
18. Related features: ☐

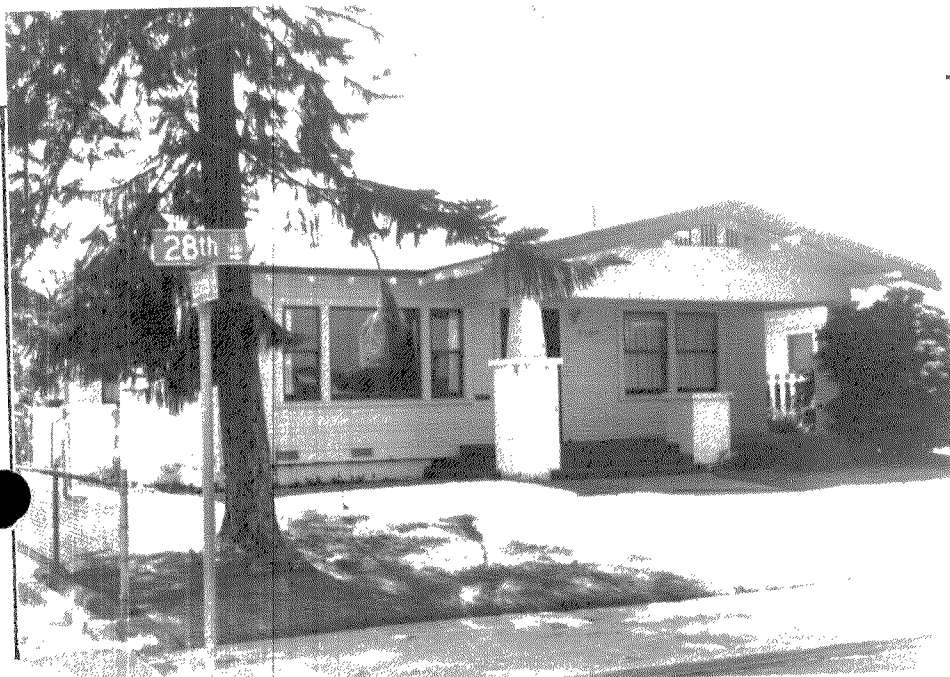
This is a one-story asymmetrical Craftsman structure with a low pitched roof and shiplap siding. A large gable dominates the front facade and extends out over the open porch. A large fixed window with adjacent double hung side panel is located just south of the main entrance. Two double hung windows are paired together north of the entrance on the front facade. A small gable sits in the center of the roofline on the north facade. Double hung and casement windows are used on both the north and south face. A second entry is located in the center of the south facade between two small gables. The stepped entry is raised and tops out to an open porch. A concrete retaining wall with a chain link fence topping it has been added to the southern portion of the property. A stucco garage is connected to the property and is located on Landis. An exposed stucco chimney is also located on the southern side of the property.

8. Construction date:
Estimated 1917 Factual _____
9. Architect --
10. Builder David Owen Dryden
11. Approx. property size (in feet)
Frontage _____ Depth _____
or approx. acreage _____
12. Date(s) of enclosed photograph(s)
May 1991

13. Condition: Excellent ☒ Good _____ Fair _____ Deteriorated _____ No longer in existence _____
14. Alterations: none known
15. Surroundings: (Check more than one if necessary) Open land _____ Scattered buildings _____ Densely built-up _____
Residential ☒ Industrial _____ Commercial _____ Other: _____
16. Threats to site: None known _____ Private development ☒ Zoning _____ Vandalism ☒
Public Works project _____ Other: _____
17. Is the structure: On its original site? ☒ Moved? _____ Unknown? _____
18. Related features: _____

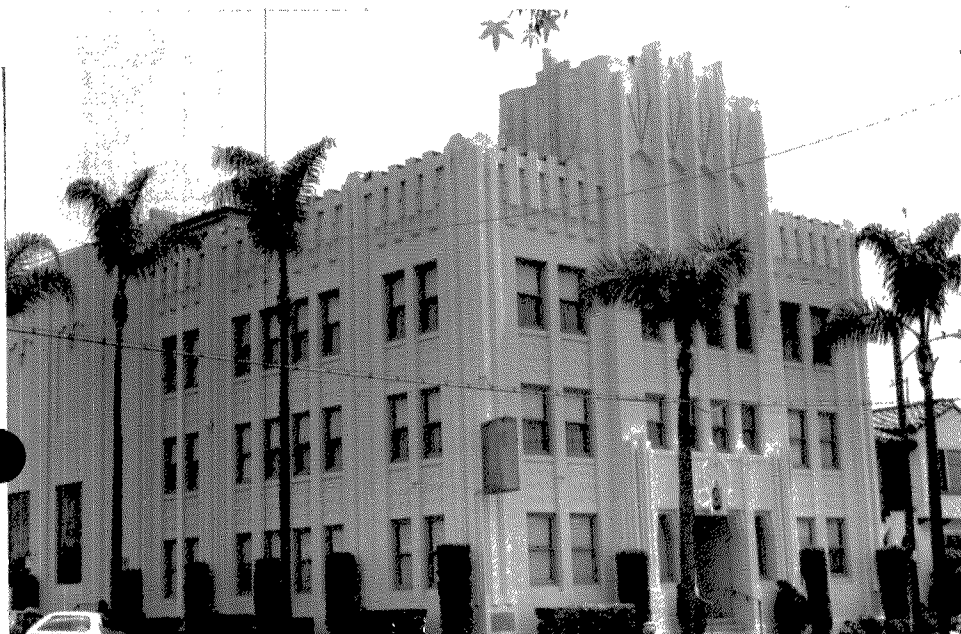
This is a three-story rectangular building in the Art Deco style. The roof is flat with a multi-layered corbelled parapet at the west end of the building. A central tower set flush with the front (Utah Street) facade rises approximately one story above the roofline. Windows in the auditorium portion of the building (east end) are tall and multi-paned. The main entry is recessed and elevated above grade. Four steps with two curving iron railings lead to the entry stoop. The wooden entry doors are original, and have frosted glass center panels. Two windows, one on either side of the stairs, are fixed variations on a triangular top [], matching the shape of the entry. Ornamentation is varied, with vertical emphasis more pronounced than horizontal. Vertical bands rise from the first floor to the top of the parapet on the north facade and the northwest and southwest corners of the west facade. Three horizontal zig-zag bands are inset in panels directly above the first and second floor windows. An organic ornamental mason's insignia is above the entrance. An original neon Mason's sign sits on the northwest corner. Hedges and palm trees along the north and west facades further emphasize the geometric ornamentation.

13. Condition: Excellent ☒ Good _____ Fair _____ Deteriorated _____ No longer in existence _____
14. Alterations: None noted
15. Surroundings: (Check more than one if necessary) Open land _____ Scattered buildings _____ Densely built-up _____
Residential ☒ Industrial _____ Commercial ☒ Other: School
16. Threats to site: None known _____ Private development _____ Zoning _____ Vandalism _____
Public Works project _____ Other: _____
17. Is the structure: On its original site? ☒ Moved? _____ Unknown? _____
18. Related features: Bushes/shrubs are shaped to complement the structure.

This building, designed by the Quayle Brothers, is significant for its Art Deco architecture. In the 1989 summer/fall issue of The Sophisticate, the magazine of the Art Deco Society of California (ADSC), the Silvergate Masonic Temple was awarded an "ADSC Art Deco Preservation Award" as "... a textbook example of the Art Deco style." The interior of the building includes many of the original decorative elements, such as Art Deco lighting fixtures, molding and stenciled ceilings. Egyptian Revival influence is also found on the interior in the "Egyptian Room."

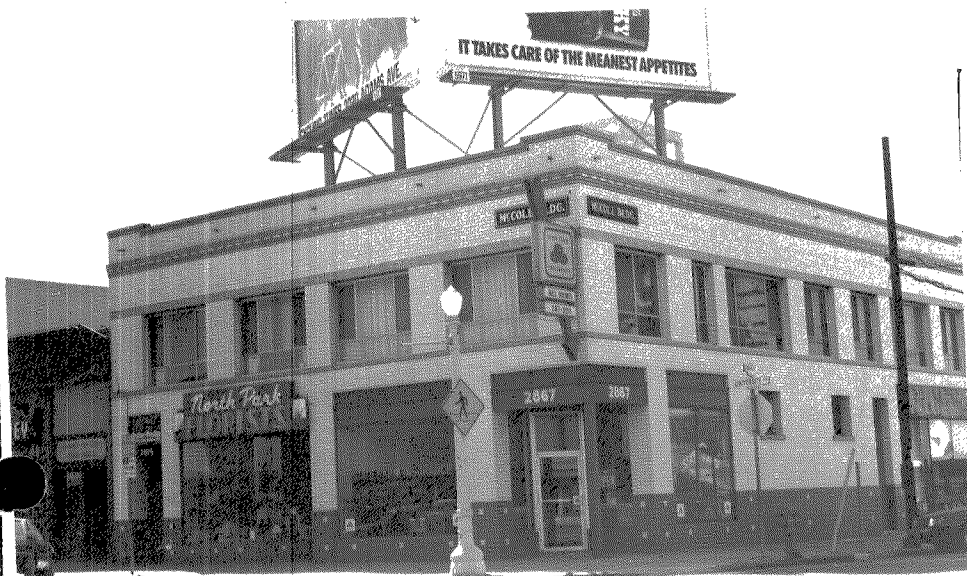
- 7a. Architectural style: Mission Revival
- 7b. Briefly describe the present *physical appearance* of the site or structure and describe any major alterations from its original condition: Legal Description: Blk 3, Lots 11 & 12 W 50 ft.

13. Condition: Excellent _____ Good X Fair _____ Deteriorated _____ No longer in existence _____
14. Alterations: windows, door, decorative tiles
15. Surroundings: (Check more than one if necessary) Open land _____ Scattered buildings _____ Densely built-up _____
Residential X Industrial _____ Commercial X Other: _____
16. Threats to site: None known X Private development _____ Zoning _____ Vandalism _____
Public Works project _____ Other: _____
17. Is the structure: On its original site? _____ Moved? _____ Unknown? _____
18. Related features: _____

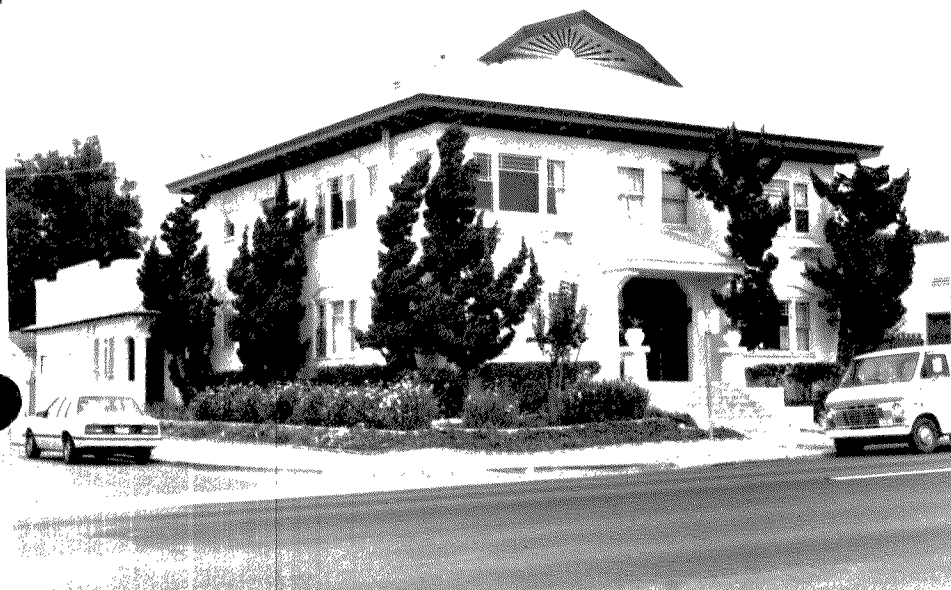
This two-story Italian Renaissance rectangular building is topped by a bellcast hipped gambrel roof with a sunburst attic vent. The overhanging eaves have a boxed cornice and are supported by exposed scrolled rafters. Two double-hung windows are located above the first floor entry. On the first and second floors on both sides of the entry, the windows have a central pane with a horizontal rectangular transom flanked by side panels topped with vertical rectangular transoms. Wooden plant boxes supported by scrolled brackets are located under these side panels. There are trapezoidal ribbonlike hood-molds and raised figures above the windows. An eight step concrete stoop with twin square capped concrete piers leads to four entry doors behind wrought iron screen doors. A half-hipped entry overhang is supported by curved concrete brackets. A sandcastle-type concrete wall a few inches high runs through the landscaping. A Mission style garage/apartment on Landis Street is topped by an espadana and attached to the main building by a freestanding wall pierced by a gate.

8. Construction date:
Estimated 1925 Factual _____
9. Architect Unknown
10. Builder Unknown
11. Approx. property size (in feet)
Frontage 150 Depth _____
or approx. acreage .1148
12. Date(s) of enclosed photograph(s)
1991

13. Condition: Excellent ☒ Good _____ Fair _____ Deteriorated _____ No longer in existence _____
14. Alterations: none apparent
15. Surroundings: (Check more than one if necessary) Open land _____ Scattered buildings _____ Densely built-up ☒
Residential ☒ Industrial _____ Commercial ☒ Other: _____
16. Threats to site: None known _____ Private development ☒ Zoning ☒ Vandalism _____
Public Works project _____ Other: _____
17. Is the structure: On its original site? ☒ Moved? _____ Unknown? _____
18. Related features: _____

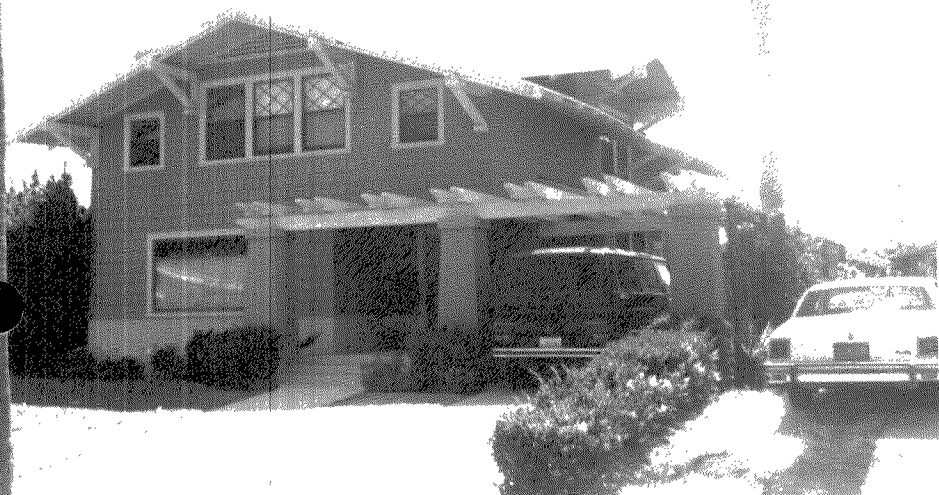
This is a two-story asymmetrical Craftsman home with a medium pitched shingled covered roof. There are gables on the front and rear of the home as well as the north and south facades. Triangular brackets are used as supports, there are four on each side of the building. Overhanging eaves and exposed rafters are visible on only the north and south facades. A patterned shingle siding covers the entire structure with the exception of a narrow stucco band that surrounds the lower section of the home. Five double hung windows with multi-paned uppers are present on the second floor front facade. A large fixed window with a patterned transom is located on the first story front facade. Small gables on the south and north facades overhang a patterned double hung window. There are other double hung windows dispersed over both sides of the home. An open porch is partially covered by a trellised roof that extends out over the driveway. This roof is supported by three large stucco columns. A stepped entry is offset to the north of the facade. A large wood door, which appears to be an addition, is located within this entry. At the north side of the structure a long concrete driveway leads to a small stucco garage. A wood fence, also an addition, surrounds the rear yard.

8. Construction date:
Estimated 1915 Factual _____
9. Architect unknown
10. Builder David Owen Dryden
11. Approx. property size (in feet)
Frontage _____ Depth _____
or approx. acreage _____
12. Date(s) of enclosed photograph(s)
May 1991

13. Condition: Excellent ☒ Good _____ Fair _____ Deteriorated _____ No longer in existence _____
14. Alterations: none known
15. Surroundings: (Check more than one if necessary) Open land _____ Scattered buildings _____ Densely built-up _____
Residential ☒ Industrial _____ Commercial _____ Other: _____
16. Threats to site: None known _____ Private development ☒ Zoning _____ Vandalism ☒
Public Works project _____ Other: _____
17. Is the structure: On its original site? ☒ Moved? _____ Unknown? _____
18. Related features: _____

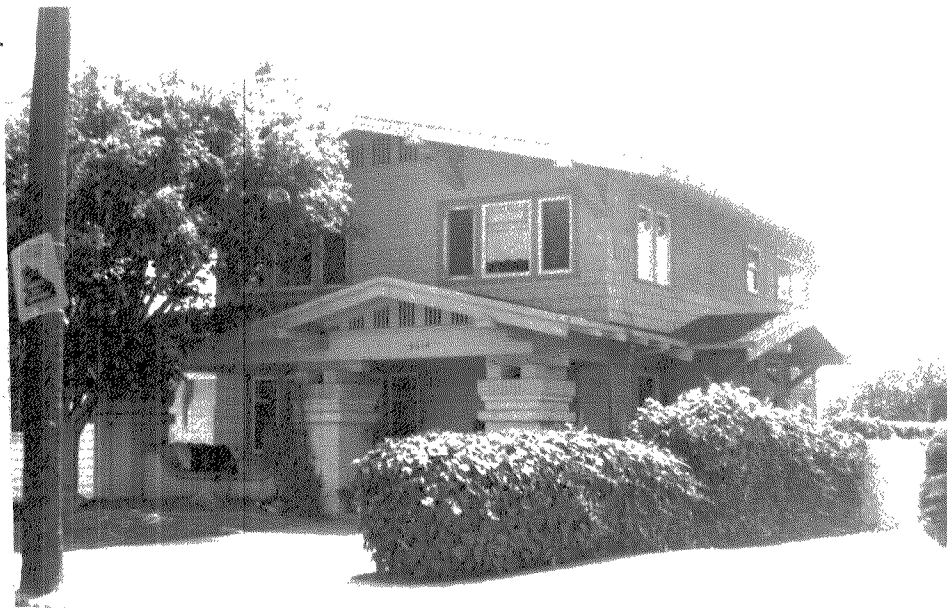
This is a two story Craftsman style house has multiple low-pitched gable roofs with widely overhanging eaves, exposed rafters and triangular knee brackets. The ground level has shiplap siding and the second level has plain shingle siding. A raised, open porch projects from the front facade and is sheltered by a front gable roof, supported by massive square piers. A low stucco wall with brick trim partially encloses the porch. The porch has two entrances, one from the front sidewalk (east) and the other from the driveway (south). A porte cochere roof extension lies to the south and leads to a one-car garage. Tripartite windows with fixed, multi-paned transomed centers and casement side panels, paired multi-paned casement windows, and double-hung windows are employed throughout the structure. Along the north and south facades there are projecting gabled roofs with exposed rafters and triangular knee brackets. On the south facade is an exterior stucco chimney with brick trim. A mature Fiscus tree stands in the southeast corner.

8. Construction date:
Estimated 1916 Factual _____
9. Architect David O. Dryden
(designer)
10. Builder David O. Dryden
11. Approx. property size (in feet)
Frontage _____ Depth _____
or approx. acreage _____
12. Date(s) of enclosed photograph(s)
May 1991

13. Condition: Excellent X Good _____ Fair _____ Deteriorated _____ No longer in existence _____
14. Alterations: none known
15. Surroundings: (Check more than one if necessary) Open land _____ Scattered buildings _____ Densely built-up X
Residential X Industrial _____ Commercial _____ Other: _____
16. Threats to site: None known _____ Private development X Zoning _____ Vandalism X
Public Works project _____ Other: _____
17. Is the structure: On its original site? X Moved? _____ Unknown? _____
18. Related features: _____

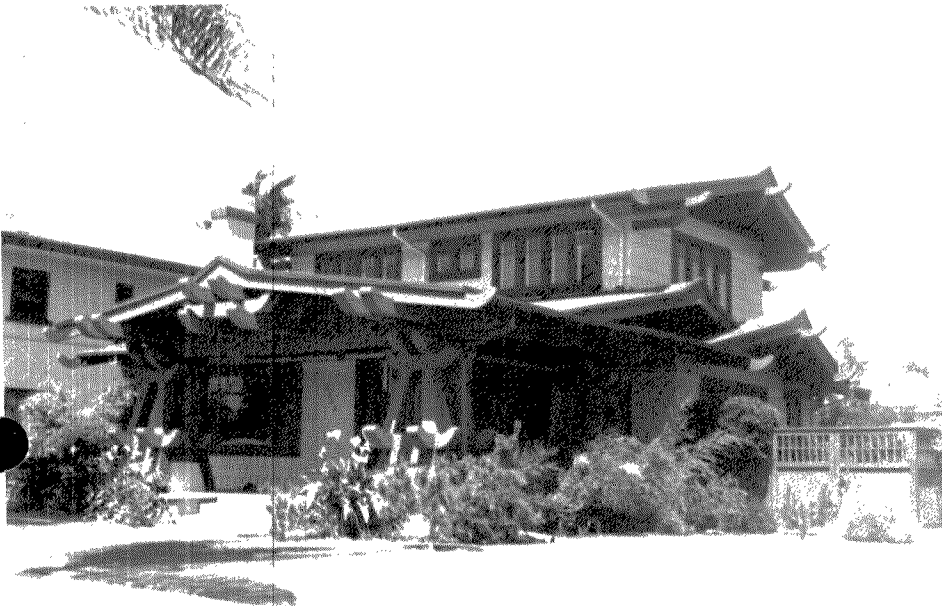
This Craftsman style house exhibits a highly dramatic Oriental mode. It has multiple low-pitched gabled roof planes with Oriental peaks, widely overhanging eaves, exposed rafters and false rafter ends. Heavy redwood beams and bracketed pillars support the raised, open porch. An exterior chimney of brick and stucco stands on the south side. Casement and fixed windows with multipane transoms and double-hung windows are employed throughout the house. Along the north facade is a bay window sheltered by a shed roof with widely overhanging eaves and exposed rafters. On the north side of the house is a trellised porte cochere which leads to a two-car garage. A wooden fence with lattice work has been added to the south of the house, enclosing a patio. The Oriental quality is further enhanced by Japanese-style landscaping.

8. Construction date:
Estimated 1915 Factual _____
9. Architect David O. Dryden
(designer)
10. Builder David O. Dryden
11. Approx. property size (in feet)
Frontage _____ Depth _____
or approx. acreage _____
12. Date(s) of enclosed photograph(s)
May 1991

13. Condition: Excellent ☒ Good _____ Fair _____ Deteriorated _____ No longer in existence _____
14. Alterations: None known
15. Surroundings: (Check more than one if necessary) Open land _____ Scattered buildings _____ Densely built-up _____
Residential ☒ Industrial _____ Commercial _____ Other: _____
16. Threats to site: None known _____ Private development ☒ Zoning _____ Vandalism ☒
Public Works project _____ Other: _____
17. Is the structure: On its original site? _____ Moved? _____ Unknown? _____
18. Related features: _____

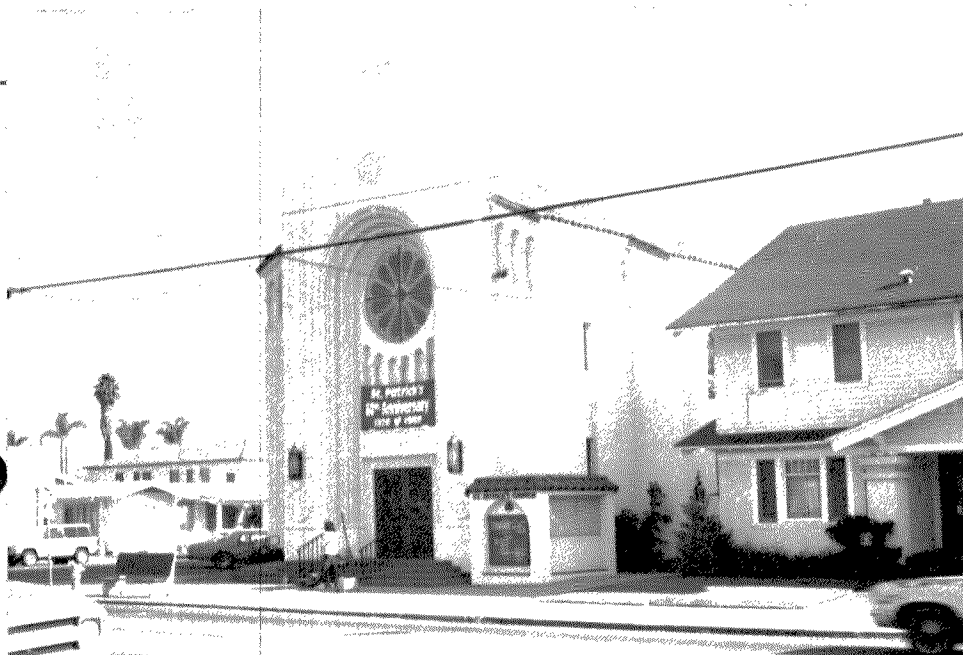
This Spanish Colonial Revival style stucco church's design is influenced by Lombardic detailing. An imposing western portico facing 30th Street has a rising gabled facade with a recessed rose window. The window is supported by a blind arcade over the solid wood paneled door's lintel. On either side of the entry, and at the apex of the gabled facade are embossed concrete coat-of-arms of the church's Augustinian order. The frieze above the lintel contains relief images of Augustinian saints. The gabled red tile roof behind the raised facade is supported by an interlacing blind arcade. The original concrete cross has been recently replaced by a metal one. An assembly hall building designed in a similar Spanish Colonial Revival style is attached to the rear of the church. To the south of the church building is the church's two-story Craftsman style rectory building.

8. Construction date: _____
Estimated _____ Factual 1928
9. Architect Frank L. Hope
10. Builder M.H. Golden (church)
C.S. Von Gunden (Assembly Hall)
11. Approx. property size (in feet)
Frontage 200 Depth _____
or approx. acreage .2296
12. Date(s) of enclosed photograph(s)
1989

13. Condition: Excellent ☒ Good _____ Fair _____ Deteriorated _____ No longer in existence _____
14. Alterations: Concrete cross replaced with metal one; handicap ramp added to main entry.
15. Surroundings: (Check more than one if necessary) Open land _____ Scattered buildings _____ Densely built-up _____
Residential ☒ Industrial _____ Commercial ☒ Other: _____
16. Threats to site: None known _____ Private development _____ Zoning _____ Vandalism ☒
Public Works project _____ Other: _____
17. Is the structure: On its original site? ☒ Moved? _____ Unknown? _____
18. Related features: Craftsman style rectory, 1949 built assembly hall, convent, and school

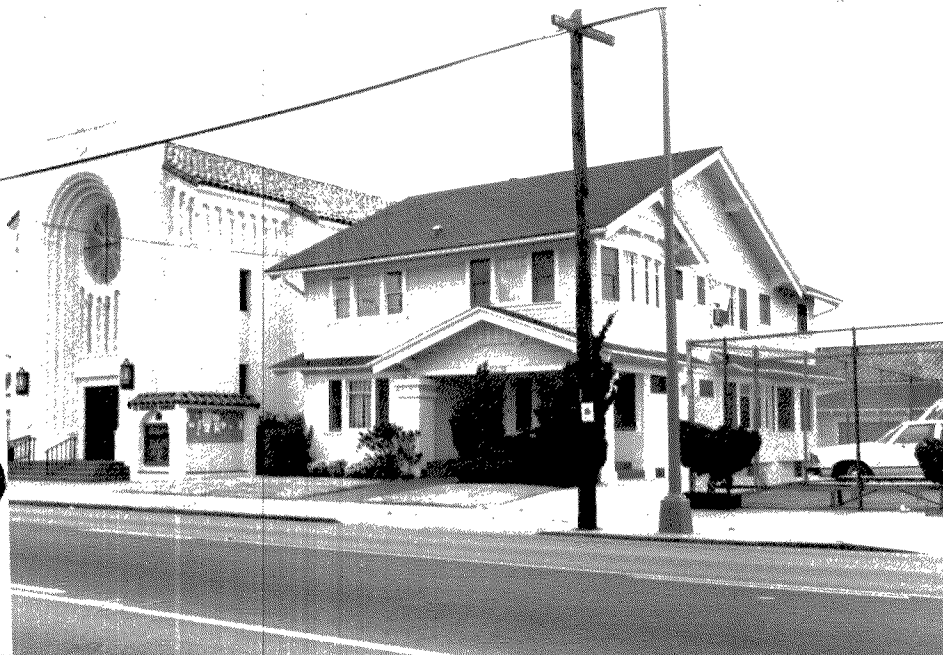
This 2½ story Craftsman style building has a medium pitched gable roof with non-boxed eaves supported by solid brackets. A second story, slightly curved bay at the southwest corner has a band of three fixed-sash windows with transoms flanked by double-hung windows at each end. The second floor is covered with shingle siding while the first floor siding is of stucco. A narrow shingled eave running around the building separates the floors. A gabled front porch roof with a vertical slot vent in the tympanum is supported by one freestanding and one attached concrete pier. A red concrete sidewalk leads to the red concrete porch. On the south side of the first floor is a slightly curved bay similar to the one on the second floor. Next to it, towards the rear, is a trapezoidal bay with a double-hung window on each side. On the north side is a central two-story bay with a double-hung window on each side. Shed roof overhangs supported by braces cover three-step stoops with wood railings that lead to side entry doors. There is a gabled roof over the first window at the northwest corner of the second story.

8. Construction date:
Estimated 1922 Factual _____
9. Architect Unknown
10. Builder Unknown
11. Approx. property size (in feet)
Frontage _____ Depth _____
or approx. acreage 0.06
12. Date(s) of enclosed photograph(s)
1991

13. Condition: Excellent ☒ Good _____ Fair _____ Deteriorated _____ No longer in existence _____
14. Alterations: Second story aluminum window, possible removal of chimney
15. Surroundings: (Check more than one if necessary) Open land _____ Scattered buildings _____ Densely built-up _____
Residential ☒ Industrial _____ Commercial ☒ Other: _____
16. Threats to site: None known ☒ Private development _____ Zoning _____ Vandalism _____
Public Works project _____ Other: _____
17. Is the structure: On its original site? ☒ Moved? _____ Unknown? _____
18. Related features: Spanish Colonial/Romanesque Church, International style school

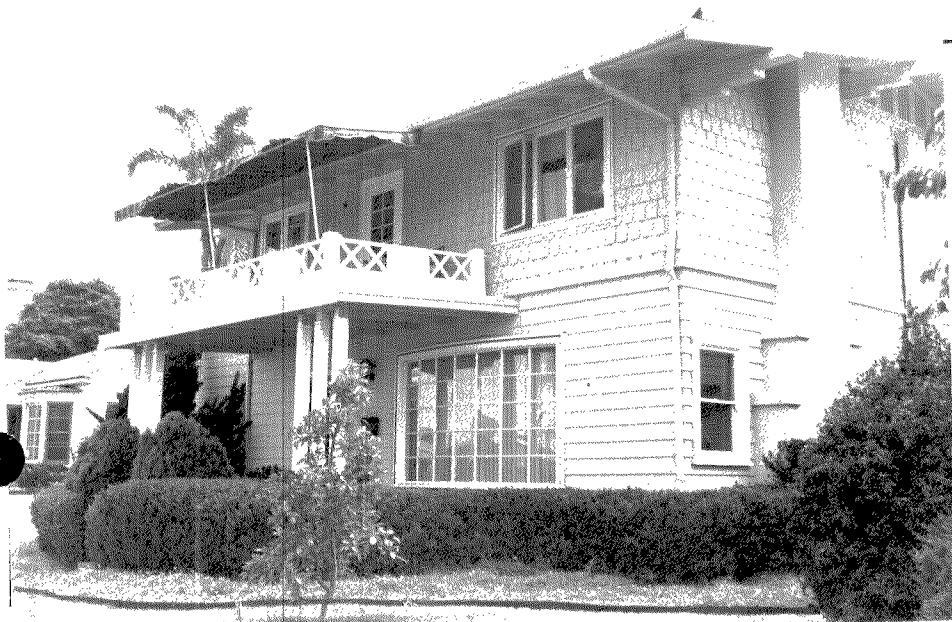
This two-story asymmetrical structure has a low pitch roof and side gables. Stepped brackets act as support for widely overhanging eaves. The second story of the structure features shingled siding while on the first story clapboard siding was used. A large portico, which has been added, extends out over the open porch. A white balustrade surrounds the top of the portico creating a balcony that is shaded by a cloth awning. A wood door with multiple glass panes has been added to the second story to allow access to the balcony. Offset to each side of this door are adjoining casement windows and a tripartite window with a fixed center pane and casement side panels. A large multi-paned window has been added to the front facade just north of the main entrance. On the north and south sides of the structure a diverse array of casement and double hung windows can be found. An exterior stucco chimney is located on the south facade. The rear yard is surrounded by a red brick wall. A long driveway leads to a small garage on the south side of the property.

13. Condition: Excellent ☒ Good _____ Fair _____ Deteriorated _____ No longer in existence _____
14. Alterations: NONE KNOWN
15. Surroundings: (Check more than one if necessary) Open land _____ Scattered buildings _____ Densely built-up _____
Residential ☒ Industrial _____ Commercial _____ Other: _____
16. Threats to site: None known _____ Private development ☒ Zoning _____ Vandalism ☒
Public Works project _____ Other: _____
17. Is the structure: On its original site? ☒ Moved? _____ Unknown? _____
18. Related features: _____

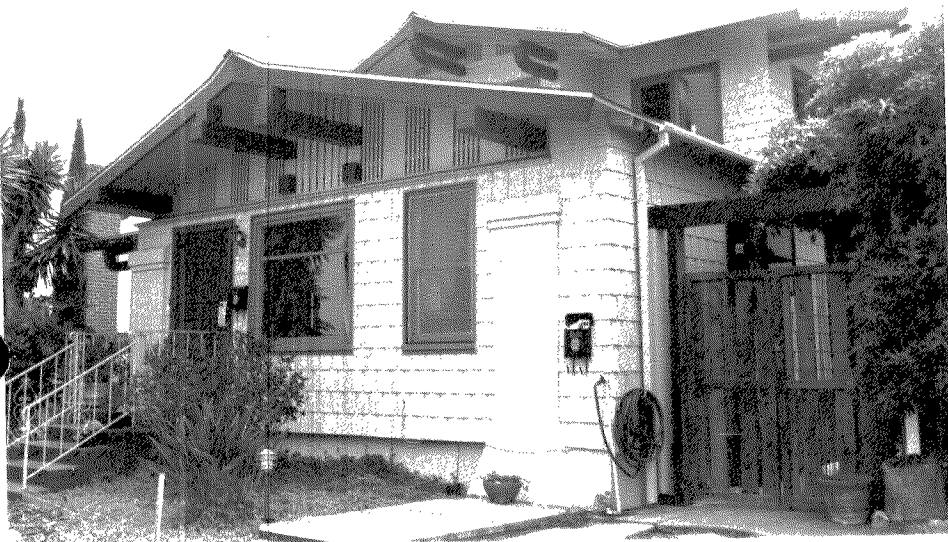
This two-story house has multiple low-pitched roof planes with Oriental roof lines, widely overhanging eaves, and false rafter ends. The second story is sheltered by a cross gable roof and the first story by a side gable roof with a front gable extending forward. Presently, this front gabled area contains a completely enclosed entry; but, it appears to have originally been an open porch. Along the front facade are two stucco pilasters that probably were initially used as porch supports. A fixed, transomed window and a double-hung window are also located on the front facade. Throughout the remainder of the house are tall casement windows, hung in both pairs and individually used. From the front sidewalk, several stepping stones lead to concrete stairs with iron railings which lead to the off-set entry door. On the north facade is an exterior chimney made of stucco.

13. Condition: Excellent X Good _____ Fair _____ Deteriorated _____ No longer in existence _____
14. Alterations: None Known
15. Surroundings: (Check more than one if necessary) Open land _____ Scattered buildings _____ Densely built-up _____
Residential X Industrial _____ Commercial _____ Other: _____
16. Threats to site: None known _____ Private development X Zoning _____ Vandalism X
Public Works project _____ Other: _____
17. Is the structure: On its original site? X Moved? _____ Unknown? _____
18. Related features: _____

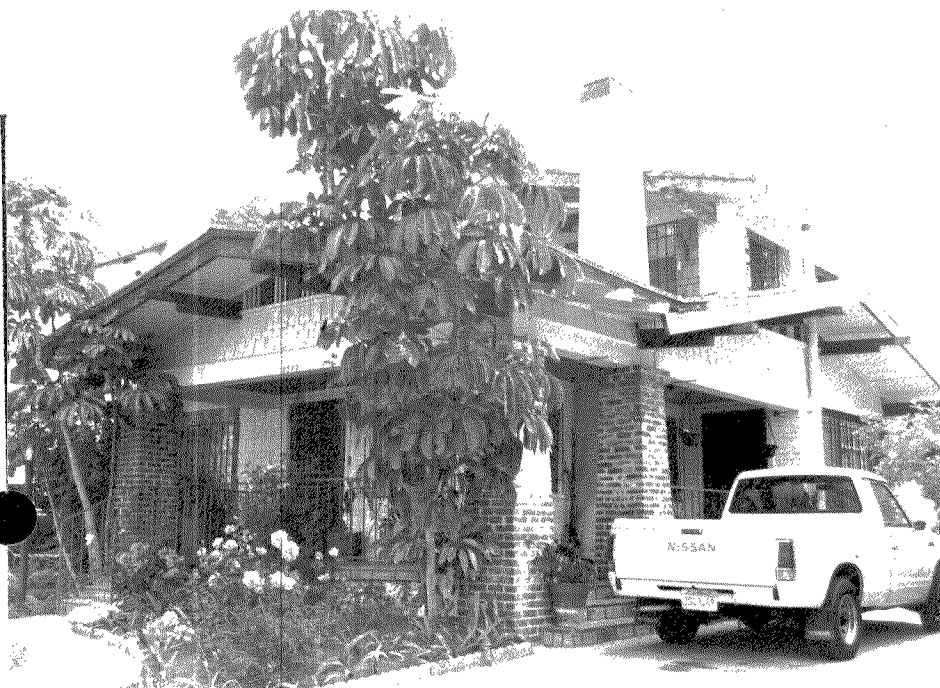
This two-story Craftsman structure has a low pitched roof with front and side gables. The entire structure is covered by shingled siding with the exception of a small area around each of the windows. All of the original windows have been replaced with vertical aluminum sliders. Widely overhanging eaves and exposed rafters are apparent on the roof and gables. A large front gable extends out over the veranda and is slightly offset to the north of the facade. The veranda wraps around the south side of the structure where an exposed stucco chimney is located. The front facade of the second story features a doorway, that has been added, which leads out onto the balcony that is created by the gable. There are two sliding vertical glass windows on each side of the second story. A side gable extends out over a recessed entry on the south side. Another side gable located on the north side shelters a set of vertical sliding glass windows. A wooden gate has been added that surrounds the rear yard.

13. Condition: Excellent X Good _____ Fair _____ Deteriorated _____ No longer in existence _____
14. Alterations: Iron bars on the windows, Removal of shutters on 2nd floor
15. Surroundings: (Check more than one if necessary) Open land _____ Scattered buildings _____ Densely built-up _____
Residential X Industrial _____ Commercial _____ Other: _____
16. Threats to site: None known _____ Private development X Zoning _____ Vandalism X
Public Works project _____ Other: _____
17. Is the structure: On its original site? X Moved? _____ Unknown? _____
18. Related features: _____

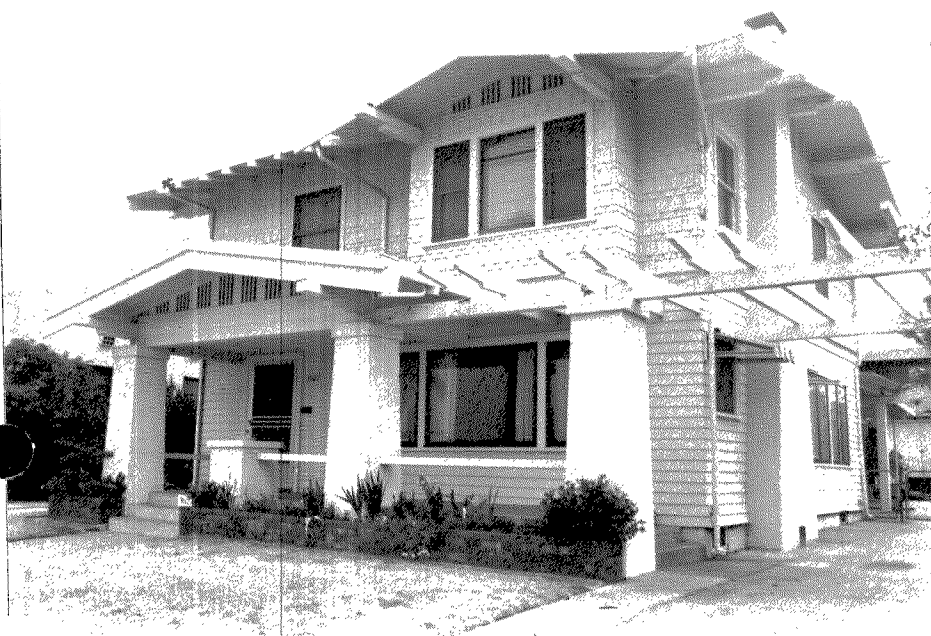
This two-story house has a low-pitched side gable roof and multiple front facing gables, all with widely overhanging eaves and exposed rafters. The first floor has clapboard siding and the second floor has plain shingle siding. A square oriel with a front gable projects from the second level front facade. Five tapered stucco piers in an L-shaped arrangement support the trellised porte cochere and the projecting front gable which shelters the raised veranda. The veranda is partially enclosed by a low, horizontal beam and has two entrances: one from the front sidewalk (west) and the other from the driveway (south). A three-sash window with a large fixed, transomed center and double-hung side panels is located on the second level front facade. Directly below it is a three-sash fixed window which appears to be an alteration. Double-hung and casement windows are employed throughout the remainder of the house. A stucco chimney stands on the south side and a brick planter box runs along the front side of the veranda. An aluminum awning above a first story window on the south facade has also been added.

13. Condition: Excellent _____ Good X Fair _____ Deteriorated _____ No longer in existence _____
14. Alterations: Aluminum sliding glass windows on first story
15. Surroundings: (Check more than one if necessary) Open land _____ Scattered buildings _____ Densely built-up _____
Residential X Industrial _____ Commercial _____ Other: _____
16. Threats to site: None known _____ Private development X Zoning _____ Vandalism X
Public Works project _____ Other: _____
17. Is the structure: On its original site? X Moved? _____ Unknown? _____
18. Related features: _____
