HISTORICAL GREATER MID-CITY SAN DIEGO PRESERVATION STRATEGY

VOLUME 2

**HISTORIC
RESOURCES
INVENTORY FORMS
(DPR 523)
APN 452-705-02
THROUGH
APN 534-411-41**

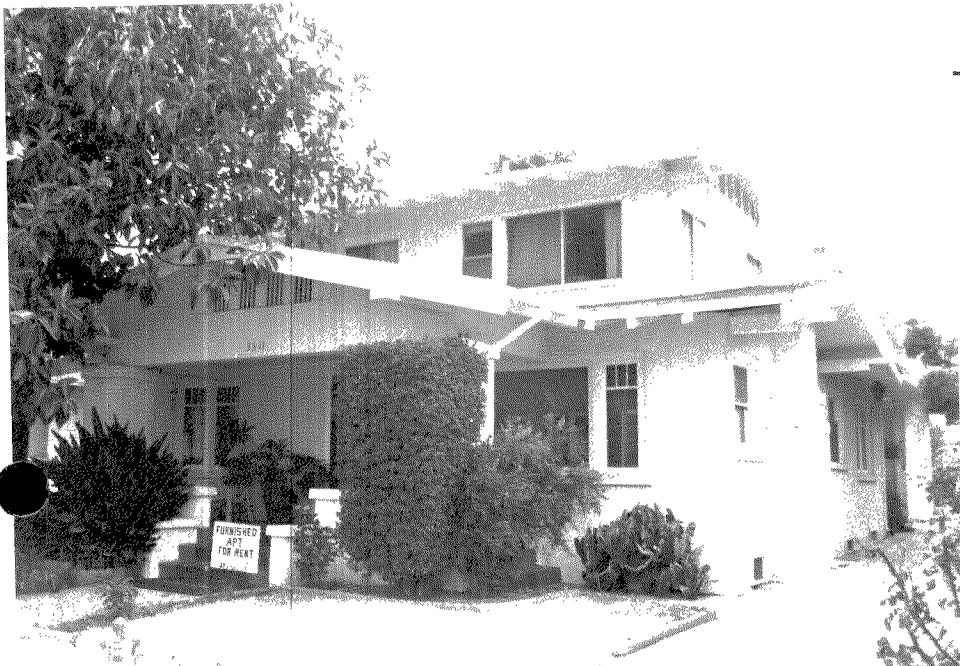
This is a two-story asymmetrical Craftsman home with a low pitch roof and front and side gables. The structure is entirely covered with stucco siding, an alteration. Overhanging eaves and exposed beams and rafter tails are present on the gables and the roof. A large front gable extends out over the open, slightly raised porch. Two tapered stucco columns support the gable. A pair of adjoining casement windows and a large tripartite window with a fixed center pane and casement side panels is located on the first story facade. The second story may be an addition due to the difference in brackets and rafter ends. Aluminum sliding glass windows on the second story are also an indication that it may have been added later. On the south facade a small gable extends out over a slightly recessed entrance. An exposed exterior stucco chimney is also located on the south facade. A large rubber tree blocks much of the north facade with only a large multi-paned fixed window visible on the first story. A long driveway on the south side leads to a small remodeled garage.

13. Condition: Excellent _____ Good X Fair _____ Deteriorated _____ No longer in existence _____
14. Alterations: Sliding glass windows on both sides of the second story
15. Surroundings: (Check more than one if necessary) Open land _____ Scattered buildings _____ Densely built-up _____
Residential X Industrial _____ Commercial _____ Other: _____
16. Threats to site: None known _____ Private development X Zoning _____ Vandalism X
Public Works project _____ Other: _____
17. Is the structure: On its original site? X Moved? _____ Unknown? _____
18. Related features: _____

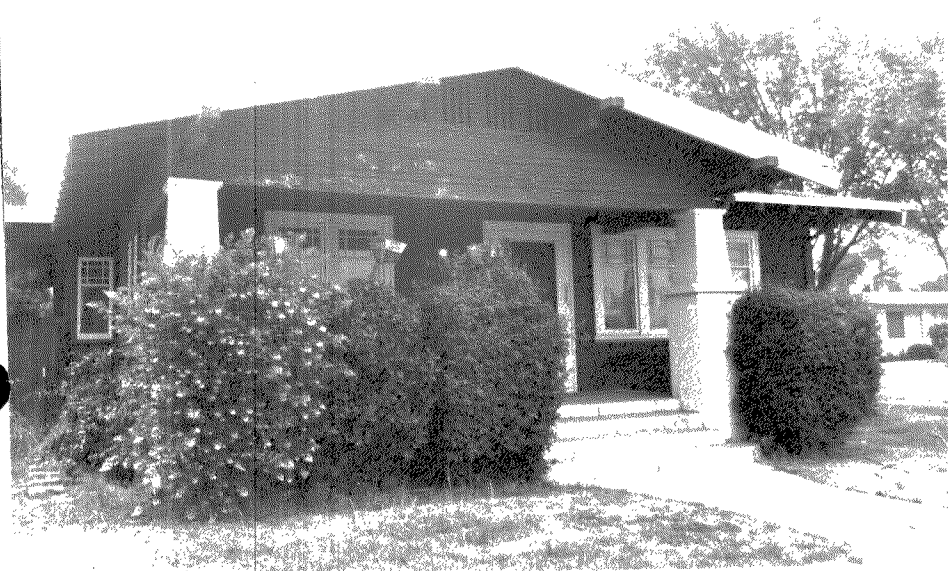
This one-story Craftsman style house has a low pitched cross gable roof with a low pyramidal roof in the center. A prominent front gable with widely overhanging eaves and exposed rafters shelters an open, raised full-width porch. The gable has vertical vents below its peak and it is supported by a pair of square stucco piers with tapered stucco columns. A concrete walkway and stairs lead to the entry which has a large wooden door with glass panel in the center. Along the front (west) facade is a tripartite window with a fixed center and casement side panel and an adjacent pair of casement windows, all with multi-panel transoms. Double hung and casement windows with multi-pane transoms are used throughout the remainder of the building. A rectangular bay with a flat roof and tall string windows projects from the south facade. The entire house has battered clapboard siding. A low L-shaped brick wall stands in the northwest corner of the lot.

13. Condition: Excellent ☒ Good _____ Fair _____ Deteriorated _____ No longer in existence _____
14. Alterations: none known
15. Surroundings: (Check more than one if necessary) Open land _____ Scattered buildings _____ Densely built-up _____
Residential ☒ Industrial _____ Commercial _____ Other: _____
16. Threats to site: None known _____ Private development ☒ Zoning _____ Vandalism ☒
Public Works project _____ Other: _____
17. Is the structure: On its original site? ☒ Moved? _____ Unknown? _____
18. Related features: _____

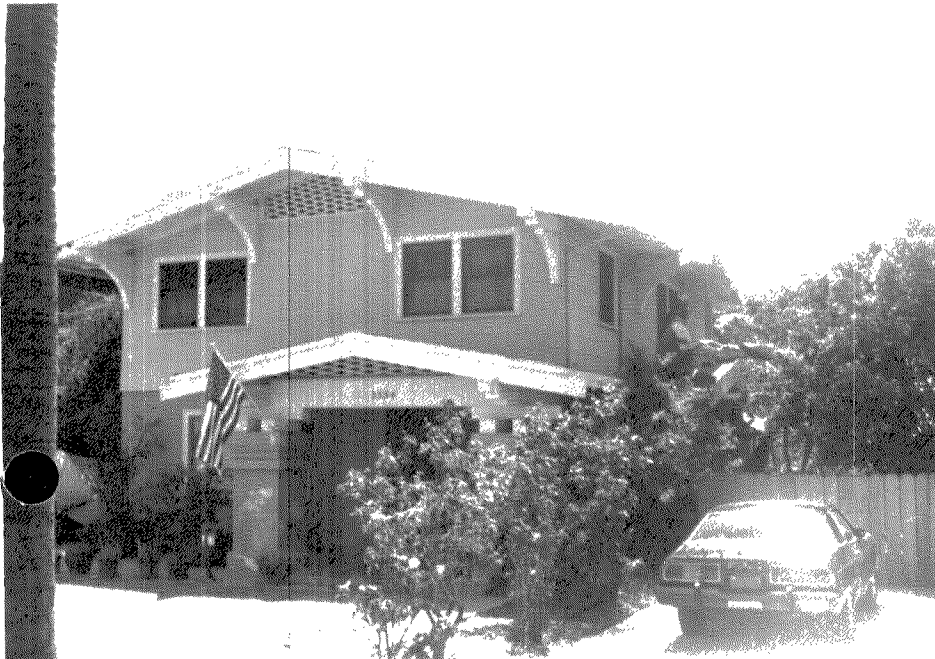
This two-story asymmetrical Craftsman style home has a medium pitch roof with front and side gables. The gables are supported by stepped brackets with overhanging eaves and exposed rafters surround the roof and gables. An overhanging front gable supported by two columns of stucco covered concrete extend out over the open porch. The second story is covered by asbestos siding and beneath the front gable a lattice style vent is visible. Two double hung windows with multi-paned uppers are present on the first and second stories as well as the north and south facades. An exposed stucco chimney is located on the south facade. The first floor of the home is sided with stucco as is a small garage located at the south rear of the property. A rear first floor addition was recently added along with aluminum sliding windows on the south facade.

13. Condition: Excellent ☒ Good _____ Fair _____ Deteriorated _____ No longer in existence _____
14. Alterations: _____
15. Surroundings: (Check more than one if necessary) Open land _____ Scattered buildings _____ Densely built-up _____
Residential ☒ Industrial _____ Commercial _____ Other: _____
16. Threats to site: None known _____ Private development ☒ Zoning _____ Vandalism ☒
Public Works project _____ Other: _____
17. Is the structure: On its original site? ☒ Moved? _____ Unknown? _____
18. Related features: _____

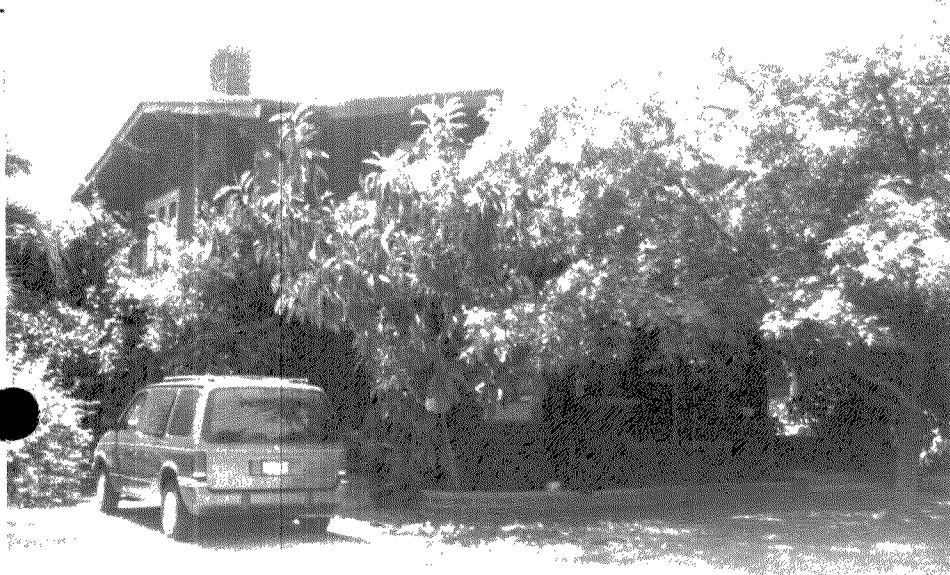
This two-story asymmetrical Craftsman home has a low-pitched roof with front and side gables. Stepped brackets act as support for both the roof and the first story front gable. A large tripartite window with a fixed center pane and casement side panels is located on the second story front facade. There is a combination of double-hung and casement windows located on the north and south facades of the second story. An exposed brick chimney is present on the south of the structure. The porch is open and slightly raised with stairs leading up to a main entry. A low brick wall surrounds the otherwise open porch. There are three brick pillars that rise out of the wall. Two of the pillars are used as support for the front gable, the other does not extend up to the gable and is thought to be used for decoration. Another large tripartite window is located on the front facade of the first story, just south of the main entrance. The wood frame door with vertical glass panes is probably an addition. The only alteration to the property is the wire fence which surrounds the rear portion of the yard.

13. Condition: Excellent ☒ Good _____ Fair _____ Deteriorated _____ No longer in existence _____
14. Alterations: None known
15. Surroundings: (Check more than one if necessary) Open land _____ Scattered buildings _____ Densely built-up _____
Residential ☒ Industrial _____ Commercial _____ Other: _____
16. Threats to site: None known _____ Private development ☒ Zoning _____ Vandalism ☒
Public Works project _____ Other: _____
17. Is the structure: On its original site? ☒ Moved? _____ Unknown? _____
18. Related features: _____

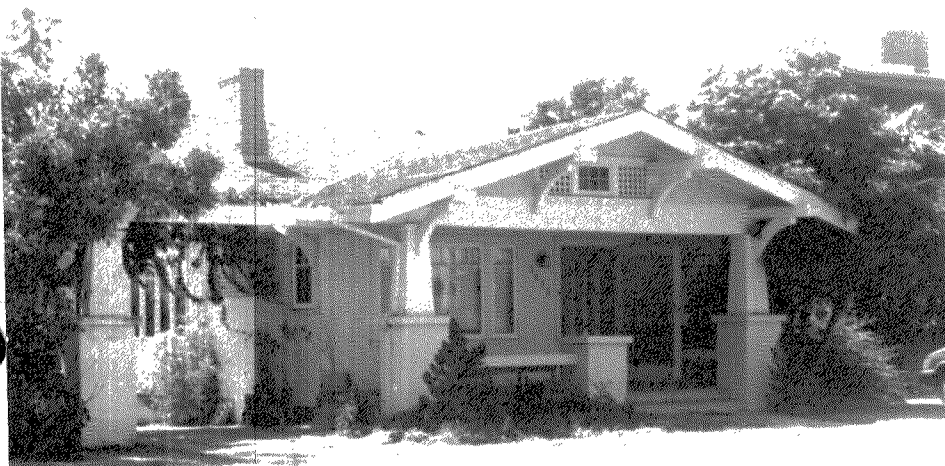
This is a one story house with a low-pitched cross gable roof, widely overhanging eaves, exposed rafters and curved brackets. The full-width entry porch is open, raised and recessed within a front gable roof supported by large square piers with tapered columns. Within the gable is a small multi-pane window with lattice vents on either side. A low, horizontal beam partially encloses the porch. The porch can be entered from both the east(front) via a concrete front walkway and from the south via a paved driveway. A trellised porte cochere and a two-car garage stand to the south. The asymmetrical front facade exhibits a large wooden door with vertical panes of glass, a tripartite window with a fixed center sash and casement side panels and a large fixed window. A bay window sheltered by a shed roof with widely overhanging eaves is located on the north facade. An exterior chimney made of brick lies on the south side.

13. Condition: Excellent ☒ Good _____ Fair _____ Deteriorated _____ No longer in existence _____
14. Alterations: none known
15. Surroundings: (Check more than one if necessary) Open land _____ Scattered buildings _____ Densely built-up _____
Residential ☒ Industrial _____ Commercial _____ Other: _____
16. Threats to site: None known _____ Private development ☒ Zoning _____ Vandalism ☒
Public Works project _____ Other: _____
17. Is the structure: On its original site? ☒ Moved? _____ Unknown? _____
18. Related features: _____

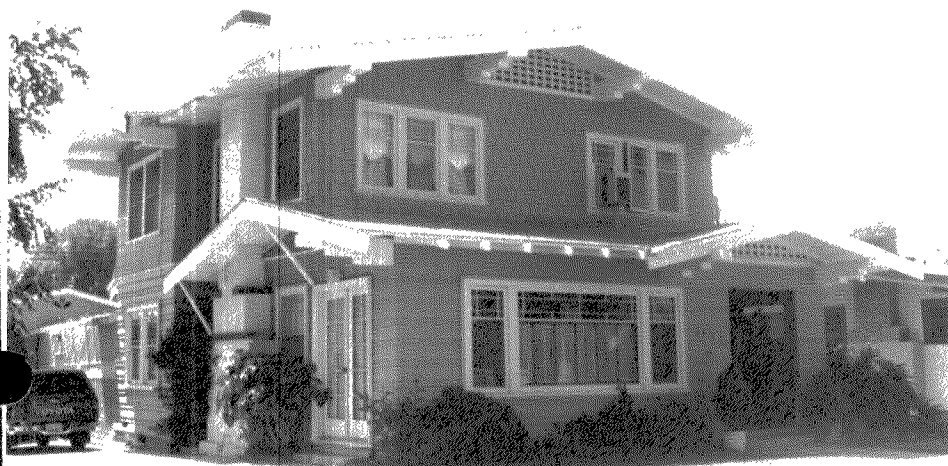
This two-story Craftsman home has a low pitched roof covered by asphalt shingling. Overhang eaves and exposed rafters are present as are front and side gables. The second story is covered by shingled siding and lattice style attic vents are visible within the peak of the front gable. Two sets of tripartite casement windows are present on the front facade of the second story. The first story is clapboard siding and dominated by a large tripartite window with a fixed center and side casement panels. French doors and a stepped entry under a side gable are located on the south facade as is a stucco exposed chimney with brick trim. A combination of double hung and casement windows are present on both the north and south facades. The porch has been partially enclosed with a small portion left open near the northern end. A small clapboard sided garage is set to the south rear at the end of a long concrete driveway. Alterations to the property include the partial enclosure of the porch and the addition of a wood frame door with vertical glass panes.

13. Condition: Excellent X Good _____ Fair _____ Deteriorated _____ No longer in existence _____
14. Alterations: None known
15. Surroundings: (Check more than one if necessary) Open land _____ Scattered buildings _____ Densely built-up _____
Residential X Industrial _____ Commercial _____ Other: _____
16. Threats to site: None known _____ Private development X Zoning _____ Vandalism X
Public Works project _____ Other: _____
17. Is the structure: On its original site? X Moved? _____ Unknown? _____
18. Related features: _____

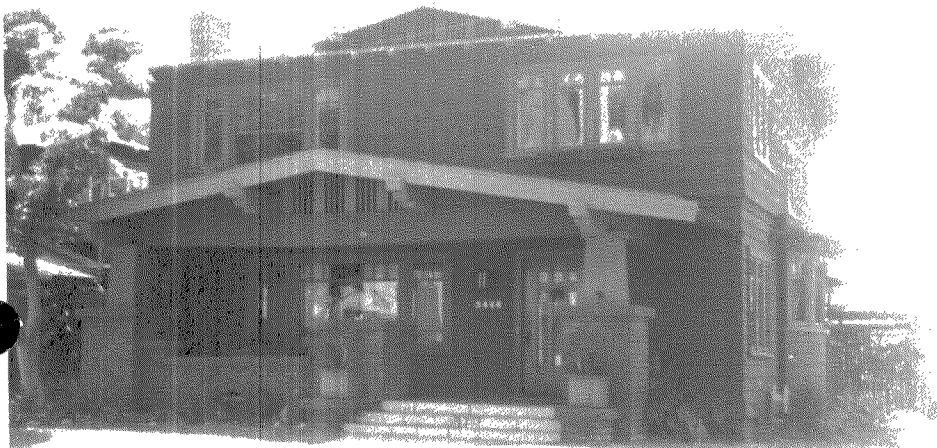
This two-story Craftsman home has a low pitch roof with front and side gables. It is an asymmetrical structure with overhanging eaves and exposed rafters. Stepped brackets support the overhanging eaves and the front and side gabling. A small front gable rests atop the second story, vertical vents are visible within the peak of that gable. Shingle siding is dominate on the second floor while clapboard siding is used on the first. The second story windows on the facade include a large tripartite with a fixed center and casement side-panels as well as four casement windows divided vertically. The first floor facade window is also tripartite with a fixed center and casement side panels. Two large brick column braces support the front gable which extends out over the raised open porch. Another column brace is present but does not extend up to the gable. The north facade is dominated by a large circular bay on the first floor. Tripartite casement windows are present on both the north and south facade. A large exposed brick chimney is located on the south facade. There are no visible alteration to the structure. Additions include a garage located on the north side of the property, and a wooden fence which surrounds the home which is punctuated by Japanese style arbors located on the north and south sides of the property.

13. Condition: Excellent X Good _____ Fair _____ Deteriorated _____ No longer in existence _____
14. Alterations: None known
15. Surroundings: (Check more than one if necessary) Open land _____ Scattered buildings _____ Densely built-up _____
Residential X Industrial _____ Commercial _____ Other: _____
16. Threats to site: None known _____ Private development X Zoning _____ Vandalism X
Public Works project _____ Other: _____
17. Is the structure: On its original site? X Moved? _____ Unknown? _____
18. Related features: _____

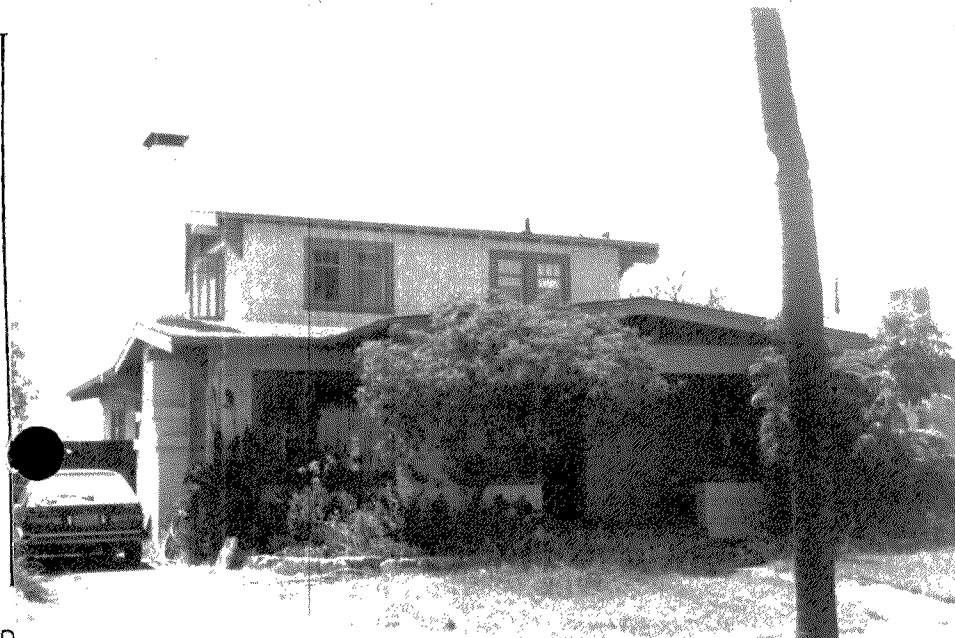
- 7a. Architectural style: Craftsman
- 7b. Briefly describe the present *physical appearance* of the site or structure and describe any major alterations from its original condition: Legal Description: Blk 66, Lot 34

This is a two-story house with low-pitched front and side gable roofs, widely overhanging eaves, exposed rafters and triangular knee brackets. It has a rectangular plan and plain shingle siding. A front gable roof supported by massive square piers shelters the open, full-width entry porch which is partially enclosed by a low, plain shingled wall. The porch is slightly raised and has two entrances, one via a flagstone path from the front sidewalk and the other from the driveway on the south side of the house. The entry door is wooden with vertical glass panels. Casement and fixed windows with multipane transoms are employed throughout the structure. A bay window projects from the ground level of the north facade and an exterior chimney made of stucco stands on the south facade. A small cobblestone curb borders the landscaped area in front of the house.

13. Condition: Excellent X Good _____ Fair _____ Deteriorated _____ No longer in existence _____

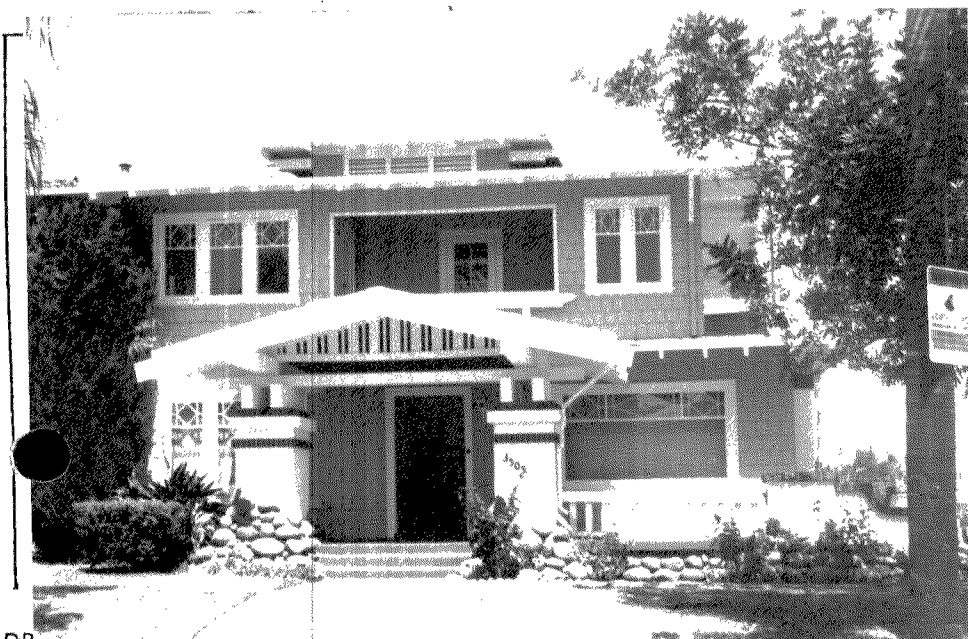
7b. Briefly describe the present *physical appearance* of the site or structure and describe any major alterations from its original condition: Legal Description: Blk 26, Lot 7/EXC St West end Subdivision

This is a two-story structure with multiple low-pitched side gable roofs, widely overhanging eaves and exposed rafters. The front facade is asymmetrically balanced with a centered, front gable roof sheltering an open partial-width porch. The gable has decorative vertical vents and is supported by square stucco piers with brick trim. Along the front of the porch is a wooden balustrade and a low cobblestone wall runs along the porch foundation. The south side of the porch is enclosed by a low stucco wall, also with brick trim. Above the entrance is a recessed balcony, sheltered within the main roof. The balcony has three separate entry doors leading to it from the house. Centered above the balcony is a flat roofed dormer with **three horizontal vents**. Casement and fixed windows with multipane transoms are employed throughout the structure. Along the south facade are double-hung windows and an exterior stucco chimney. The house as well as the one-car garage to the south are clad with plain shingle siding. A white picket fence runs between the house and the garage.

13. Condition: Excellent ☒ Good _____ Fair _____ Deteriorated _____ No longer in existence _____
14. Alterations: _____
15. Surroundings: (Check more than one if necessary) Open land _____ Scattered buildings _____ Densely built-up _____
Residential ☒ Industrial _____ Commercial _____ Other: _____
16. Threats to site: None known _____ Private development ☒ Zoning _____ Vandalism ☒
Public Works project _____ Other: _____
17. Is the structure: On its original site? ☒ Moved? _____ Unknown? _____
18. Related features: _____

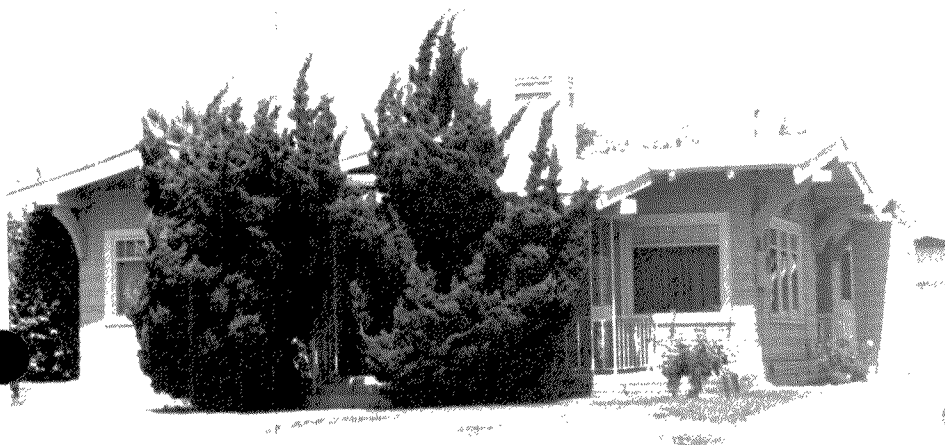
- 7a. Architectural style: Craftsman
- 7b. Briefly describe the present *physical appearance* of the site or structure and describe any major alterations from its original condition: Legal Description: Blk 27, Lot 8 West end subdivision

This 1½-story asymmetrical Craftsman home has a low-pitch roof with front and side gables. Wide overhanging eaves with exposed rafters are supported by triangular brackets. A small front gable shelters a tripartite window with casement side panels. All the windows have multipaned transoms and the house is covered with shingle siding. Next to the gable, a shed roof extends out over the open porch. Located in the center of the porch is a grey brick chimney that protrudes through the roof. The porch is surrounded by a low wrought iron railing. A large, fixed window is also located on the front facade. A stepped concrete walkway leads up to the open porch. The south facade features two side gables, each shelter tripartite windows with fixed centers and casement side panels. Between the two side gables, a shed roof extends out to shelter a raised porch that leads to a recessed entry. The north facade is designed much the same with the exception of the entry. No alterations are apparent.

13. Condition: Excellent ☒ Good _____ Fair _____ Deteriorated _____ No longer in existence _____

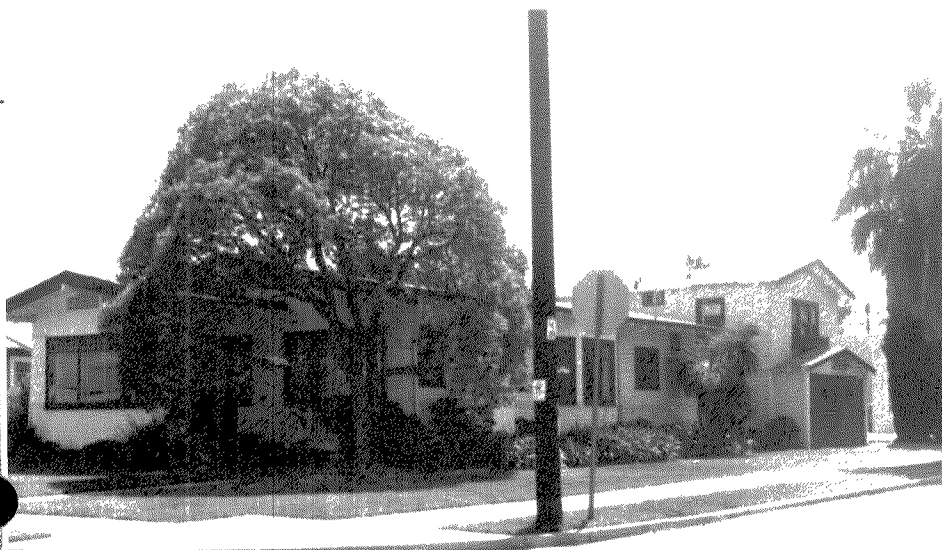
7b. Briefly describe the present *physical appearance* of the site or structure and describe any major alterations from its original condition: Blk 27 Lot 1

This one-story Craftsman style house has multiple low-pitched front gables with widely overhanging eaves and exposed rafters. The wall cladding consists of plain shingles with wooden clapboard between the window sills and the foundation. Several concrete steps lead to the wooden entry door which is flanked by louvred glass side panels. On the front facade are two tripartite windows with fixed centers, casement side panel multi-pane transoms. Double-hung and tripartite windows with fixed centers and casement side panels are employed throughout the remainder of the house. An oriel bay window and a deteriorating exterior brick chimney are located on the north facade. A two story two-car garage with medium-pitched front gables and clapboard siding is situated in the northwest corner of the lot. A tripartite window with a balconet is centered directly above the front gable which extends slightly and contains two wooden garage doors. Throughout the remainder of the garage double-hung windows are employed.

13. Condition: Excellent ☒ Good _____ Fair _____ Deteriorated _____ No longer in existence _____
14. Alterations: Two story addition in the back
15. Surroundings: (Check more than one if necessary) Open land _____ Scattered buildings _____ Densely built-up _____
Residential ☒ Industrial _____ Commercial _____ Other: _____
16. Threats to site: None known _____ Private development ☒ Zoning _____ Vandalism ☒
Public Works project _____ Other: _____
17. Is the structure: On its original site? ☒ Moved? _____ Unknown? _____
18. Related features: _____

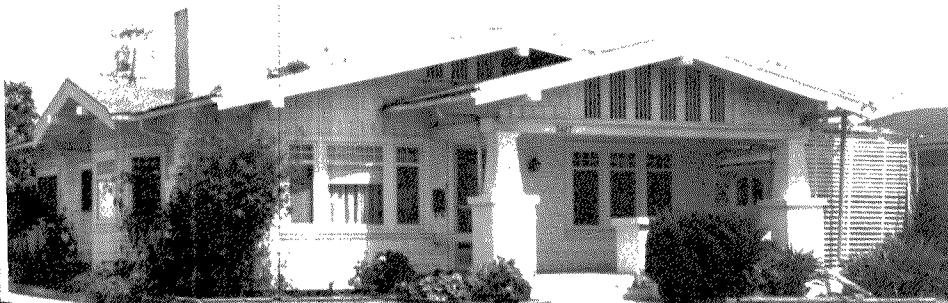
7b. Briefly describe the present *physical appearance* of the site or structure and describe any major alterations from its original condition: LEGAL DESC: Blk 32 Lot 10

This one-story asymmetrical Craftsman structure has a low pitch roof with multiple front and side gables. All of the gables have vertical vents within their peaks. A large front gable extends out from another gable to cover the open porch and is supported by stucco columns and piers. A third column is present on the porch but does not extend up to the gable and is thought to be used for decorative purposes. A trio of casement windows and a tripartite window with a fixed center pane and casement side-panels are located on the front facade. The north facade features a bay with a side gable sheltering it. Numerous casement and double hung windows are used on the north and south facades. The open porch swings around to the south side with another entry located there. Sliding glass windows are also used. A driveway runs along the south facade to the rear of the lot where an altered clapboard garage is located.

13. Condition: Excellent ☒ Good _____ Fair _____ Deteriorated _____ No longer in existence _____
14. Alterations: None known
15. Surroundings: (Check more than one if necessary) Open land _____ Scattered buildings _____ Densely built-up _____
Residential ☒ Industrial _____ Commercial _____ Other: _____
16. Threats to site: None known _____ Private development ☒ Zoning _____ Vandalism ☒
Public Works project _____ Other: _____
17. Is the structure: On its original site? ☒ Moved? _____ Unknown? _____
18. Related features: _____

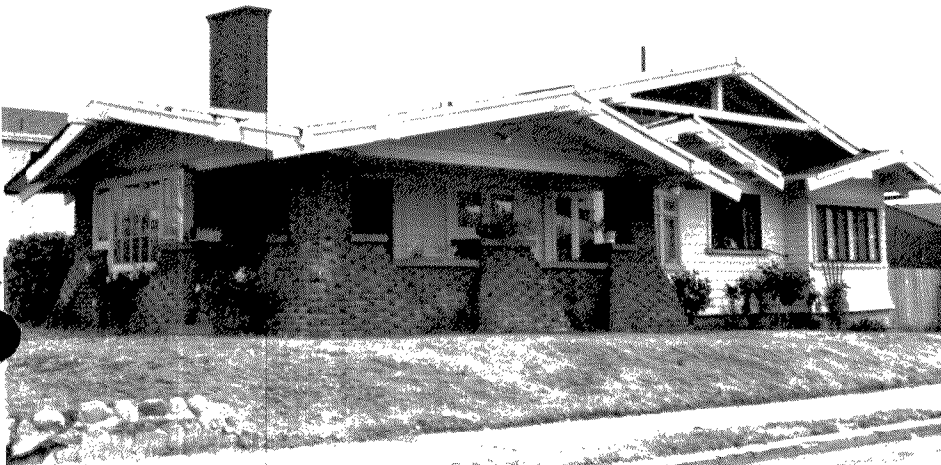
7b. Briefly describe the present *physical appearance* of the site or structure and describe any major alterations from its original condition: LEGAL DESC: Blk 24, Lots 23, 24

This one-story Craftsman home has a low-pitched, multigable roof with wide, overhanging eaves and exposed rafters. A truss beam supports the highest gable. The clapboard siding is somewhat weatherbeaten. A brick walled open porch is at the southwest corner. Trapezoidal brick piers are interspersed along the porch wall. Rectangular brick columns resting on the corner piers support the porch roof. The north part of the porch's west side has been enclosed with multipaned windows. A very slightly projecting bay on the south side has a tripartite window with a fixed center panel flanked by casement sidepanels with multipaned transoms. Adjacent is a pair of french doors leading onto the porch. New, metal framed sliding glass windows are at the southeast corner of the house.

13. Condition: Excellent ☒ Good _____ Fair _____ Deteriorated _____ No longer in existence _____
14. Alterations: Aluminum sliding windows
15. Surroundings: (Check more than one if necessary) Open land _____ Scattered buildings _____ Densely built-up _____
Residential ☒ Industrial _____ Commercial _____ Other: _____
16. Threats to site: None known _____ Private development ☒ Zoning _____ Vandalism ☒
Public Works project _____ Other: _____
17. Is the structure: On its original site? ☒ Moved? _____ Unknown? _____
18. Related features: _____

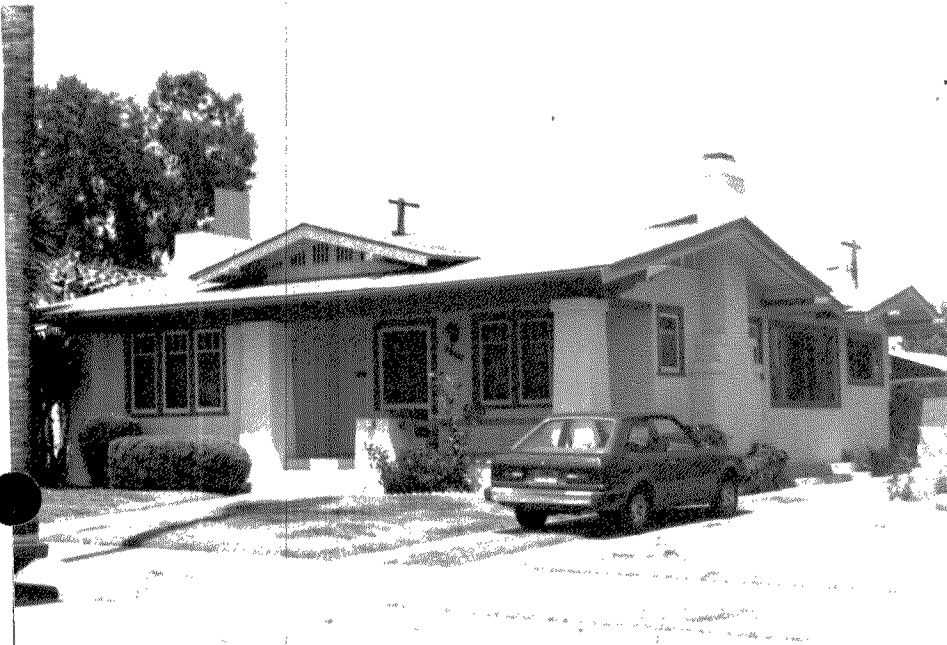
7b. Briefly describe the present *physical appearance* of the site or structure and describe any major alterations from its original condition: LEGAL DESC: Blk 2, Lots 17 & 18

This is a one-story Craftsman style house which has multiple low pitched roofs with widely overhanging eaves and exposed beams. It has a raised, partial-width open porch recessed within the main side gable roof. Two large stucco piers with slanted sides support the roof over the porch. A centered gable with vertical vents and exposed beams rest on the roof above the front facade. A tripartite window with a fixed center, casement side panels and multi-pane transoms is located on either side of the wooden front entry door. Casement windows placed individually and in groups are used throughout the remaining facades. Along the south facade aluminum windows have replaced some of the original wooden windows. Also on the south facade is an exterior chimney made of stucco.

13. Condition: Excellent ☒ Good _____ Fair _____ Deteriorated _____ No longer in existence _____
14. Alterations: Aluminum sliding windows/ stucco siding
15. Surroundings: (Check more than one if necessary) Open land _____ Scattered buildings _____ Densely built-up _____
Residential ☒ Industrial _____ Commercial _____ Other: _____
16. Threats to site: None known _____ Private development ☒ Zoning _____ Vandalism ☒
Public Works project _____ Other: _____
17. Is the structure: On its original site? ☒ Moved? _____ Unknown? _____
18. Related features: _____

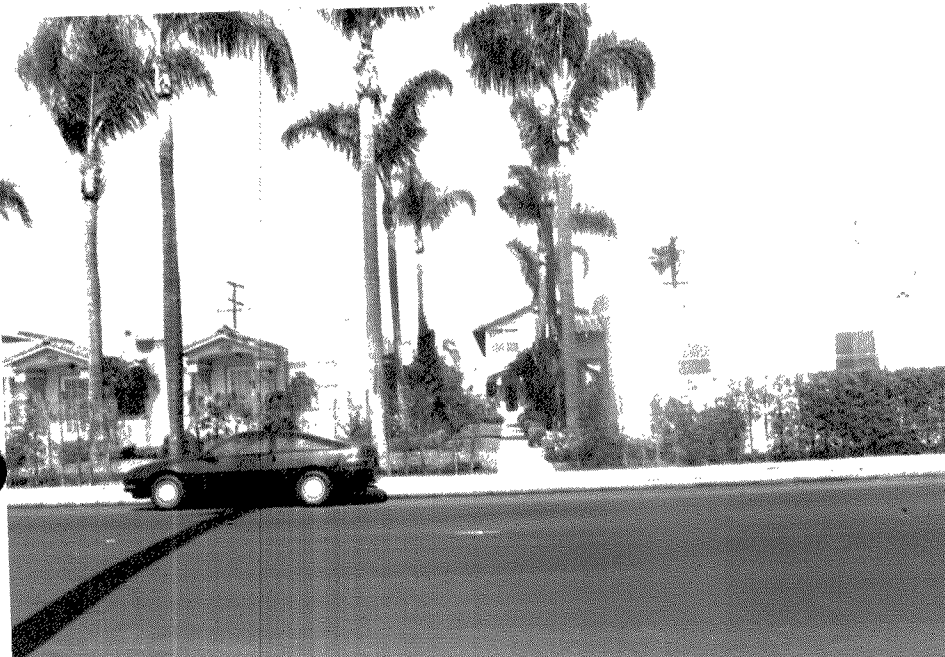
- 7a. Architectural style: Spanish Colonial Revival
- 7b. Briefly describe the present *physical appearance* of the site or structure and describe any major alterations from its original condition: Blk 17, Lots 17 - 20 S 1 ft. of E 30 ft. Lot 16 & All, Frary Heights

Florence Court consists of a row of detached, single-story, flat roofed, raised parapet wood-frame bungalows along the south of the property, facing a narrow garden courtyard. Along the north side of the courtyard are three detached units of similar style and construction. However, these are arranged along an east/west axis, opening to the street with a smaller garden courtyard presenting itself along the north-eastern corner of the property. Parking is provided by a two-story duplex/garage unit at the northeastern corner of the parcel. Access to the garage is provided by a narrow alleyway behind the court. The bungalows reflect Spanish Colonial Revival detailing in the use of smooth stucco-clad walls, flat roofs with raised, stepped parapets, triple terra cotta canales, wood-frame windows and paneled doors. Additional Spanish Colonial Revival inspired architectural features include red tile roofed gabled entries, supported by solid stucco-clad brackets. Mature plantings of tall queen palms line the interior of the courtyard along the central lawn area and the garden strip along the western facade of the northwest duplex bungalow.

13. Condition: Excellent ☒ Good _____ Fair _____ Deteriorated _____ No longer in existence _____
14. Alterations: _____
15. Surroundings: (Check more than one if necessary) Open land _____ Scattered buildings _____ Densely built-up ☒
Residential ☒ Industrial _____ Commercial ☒ Other: _____
16. Threats to site: None known ☒ Private development _____ Zoning _____ Vandalism _____
Public Works project _____ Other: _____
17. Is the structure: On its original site? ☒ Moved? _____ Unknown? _____
18. Related features: Located within an area of similar bungalow courts.

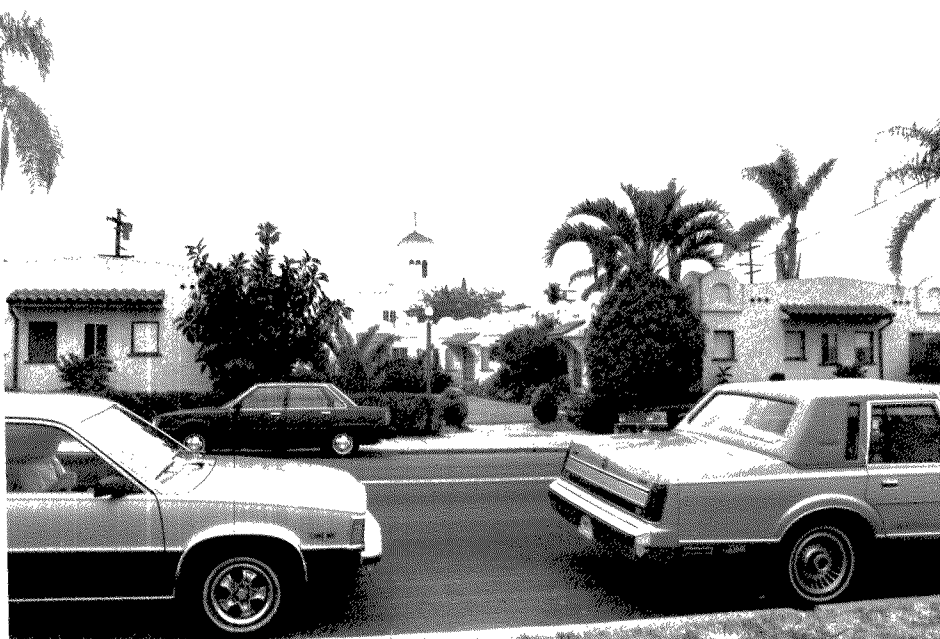
- 7a. Architectural style: Mission Revival Style Bungalow Court
- 7b. Briefly describe the present *physical appearance* of the site or structure and describe any major alterations from its original condition: Legal Description: Blk 1, Lots 21 thru 24, Frary Heights

The Chesterfield Court, situated on the northeastern corner of 30th and Upas Streets, consists of nine, individual, Spanish Colonial Revival-style bungalow units arranged around a garden courtyard. The courtyard, which opens towards 30th Street, is flanked by mature foundation plants and small trees. The individual bungalows are small wood frame, stucco-faced structures. Each unit has a flat roof with a raised, gabled parapet and blind arch belfry-styled corners. Overhanging the units' windows and entryways are red tile covered pent roof hoods and overhangs. Fenestration consists of single, double hung sash, wood frame windows; some windows have been replaced with aluminum slider windows though. Behind the court, facing the alleyway, are two detached, wood-frame, stucco-faced garage units.

13. Condition: Excellent _____ Good X Fair _____ Deteriorated _____ No longer in existence _____
14. Alterations: A small number of windows have been replaced with aluminum sliders
15. Surroundings: (Check more than one if necessary) Open land _____ Scattered buildings _____ Densely built-up X
Residential X Industrial _____ Commercial X Other: _____
16. Threats to site: None known X Private development _____ Zoning _____ Vandalism _____
Public Works project _____ Other: _____
17. Is the structure: On its original site? X Moved? _____ Unknown? _____
18. Related features: This is one of several bungalow courts built along 30th Street during the 1920's.

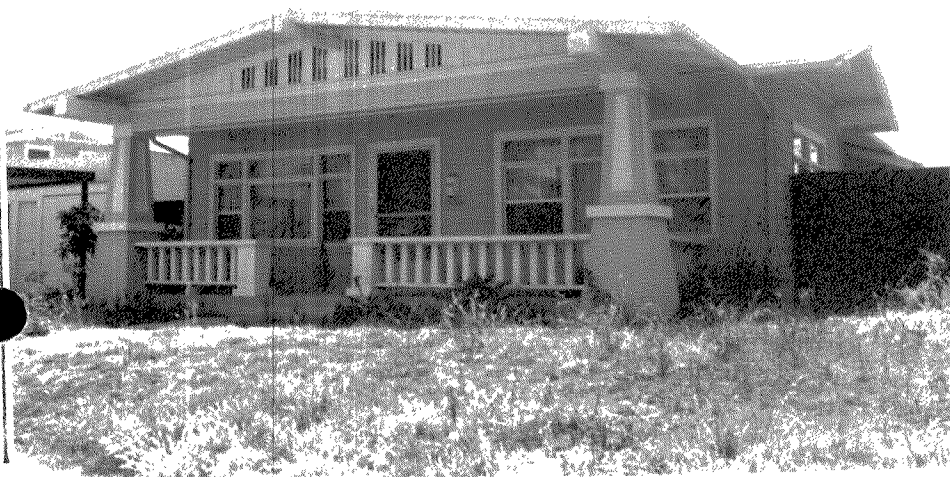
7b. Briefly describe the present *physical appearance* of the site or structure and describe any major alterations from its original condition: Blk 1 Lots 29& 30

This one-story asymmetrical Craftsman home has a low pitch roof and front and side gables. Clapboard siding covers the majority of the structure with shingle siding being used on the front gable. Wide overhanging eaves are supported by square brackets. Two fixed windows with small panes surrounding them are offset to each side of the main entry. The front gable extends out over the veranda and is supported by tapered stucco columns. A white balustrade surrounds the veranda. The north and south facades feature side gables that extends out from the wall. A pair of adjoining double hung windows rest beneath the side gables. A entry has been added to the south facade with an open slightly raised porch leading to it. The north facade features an exposed exterior chimney and a green-house window, which is an alteration. The rear yard is enclosed by a redwood fence. The house is set back on the lot behind a well manicured lawn.

13. Condition: Excellent ☒ Good _____ Fair _____ Deteriorated _____ No longer in existence _____
14. Alterations: _____
15. Surroundings: (Check more than one if necessary) Open land _____ Scattered buildings _____ Densely built-up _____
Residential ☒ Industrial _____ Commercial _____ Other: _____
16. Threats to site: None known _____ Private development ☒ Zoning _____ Vandalism ☒
Public Works project _____ Other: _____
17. Is the structure: On its original site? ☒ Moved? _____ Unknown? _____
18. Related features: _____

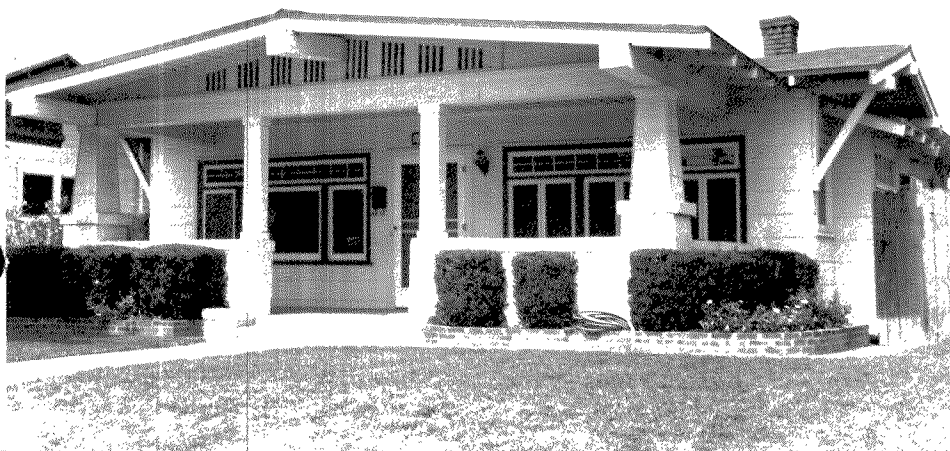
- 7a. Architectural style: Craftsman
- 7b. Briefly describe the present *physical appearance* of the site or structure and describe any major alterations from its original condition: LEGAL DESC: Blk 1, Lots 33 & 34

This one-story house has a low-pitched front and side gable roofs with widely overhanging eaves, exposed rafters and beams and triangular knee brackets. The front facade displays a prominent front gable which shelters a raised veranda. A low stucco wall partially encloses the veranda along the front (east), north and south sides. Located on top of the wall along the front side are two wooden, tapered columns with stucco piers and two square wooden columns which support the gable. The centered entry door is flanked by tripartite windows with multi-paned transoms. Single-sash casement windows are used throughout the remainder of the structure. A bay window with a shed roof extends from the north facade and directly behind it, an interior brick chimney protrudes from the roof. A stucco chimney is located on the exterior of the south facade. A low brick planter box with shrubs and flowers runs along the bottom of the veranda. Alterations include a greenhouse window on the north facade and a lattice enclosed porch in the back yard.

13. Condition: Excellent ☒ Good _____ Fair _____ Deteriorated _____ No longer in existence _____
14. Alterations: None known
15. Surroundings: (Check more than one if necessary) Open land _____ Scattered buildings _____ Densely built-up _____
Residential ☒ Industrial _____ Commercial _____ Other: _____
16. Threats to site: None known _____ Private development ☒ Zoning _____ Vandalism ☒
Public Works project _____ Other: _____
17. Is the structure: On its original site? ☒ Moved? _____ Unknown? _____
18. Related features: _____

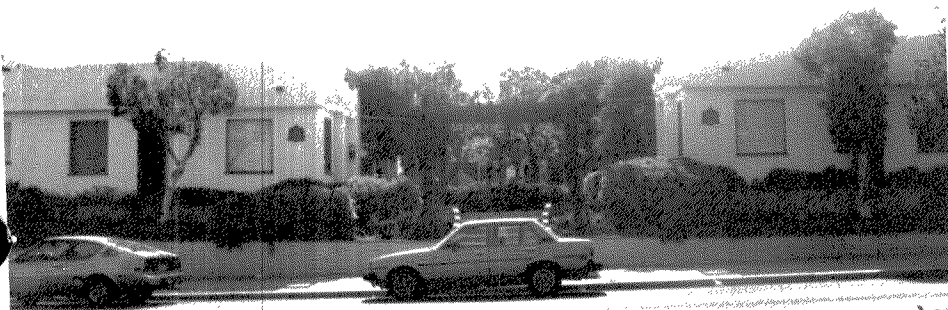
Thornwood Court is a U-shaped grouping of eight small, detached single-story bungalows, arranged around a narrow, communal garden court, in front of a two-story garage unit along the rear alleyway. A decorative free-standing, open-frame timber ramada shades the entrance to the courtyard along the street. Mature shrubs and small trees line the perimeter of the courtyard and the foundations of the bungalows. The wood-frame, stucco-clad bungalows have flat roofs with raised, stepped parapets. The bases of each parapet have double terra cotta cylindrical vents and are trimmed with an extended horizontal running board. Fenestration consists of fixed-pane windows along the street and double-hung windows elsewhere. The lack of decorative elements highlights the courts' Modernistic influences of the late 1920's.

13. Condition: Excellent ☒ Good _____ Fair _____ Deteriorated _____ No longer in existence _____
14. Alterations: _____
15. Surroundings: (Check more than one if necessary) Open land _____ Scattered buildings _____ Densely built-up ☒
Residential ☒ Industrial _____ Commercial ☒ Other: _____
16. Threats to site: None known ☒ Private development _____ Zoning _____ Vandalism _____
Public Works project _____ Other: _____
17. Is the structure: On its original site? ☒ Moved? _____ Unknown? _____
18. Related features: Close to similar examples of bungalow courts along 30th Street

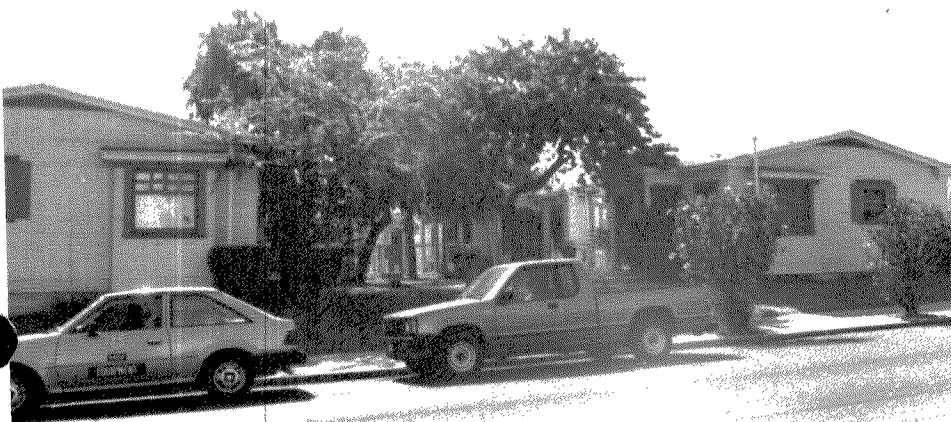
The Colonial Court is a U-shaped grouping of eleven small, detached single-story Colonial Revival style bungalows, arranged around a narrow, communal garden court. Mature shrubs and small trees occupy the narrow courtyard shading the front porches of the bungalows. The wood-frame, clapboard-sided bungalows have gabled, medium-pitched roofs and projecting side bays at the corners facing the street. Single-pane, fixed windows, with multilight wood-framed transoms, occupy the bays. Other fenestration consists of shuttered double-hung, wood-frame windows. Each main entry of the individual bungalows opens up to the central courtyard. They are protected by gabled porticos supported up by wooden posts.

13. Condition: Excellent ☒ Good ☐ Fair ☐ Deteriorated ☐ No longer in existence ☐
14. Alterations: _____
15. Surroundings: (Check more than one if necessary) Open land ☐ Scattered buildings ☐ Densely built-up ☒
Residential ☒ Industrial ☐ Commercial ☒ Other: _____
16. Threats to site: None known ☒ Private development ☐ Zoning ☐ Vandalism ☐
Public Works project ☐ Other: _____
17. Is the structure: On its original site? ☒ Moved? ☐ Unknown? ☐
18. Related features: Located near similar bungalow courts along 30th Street.

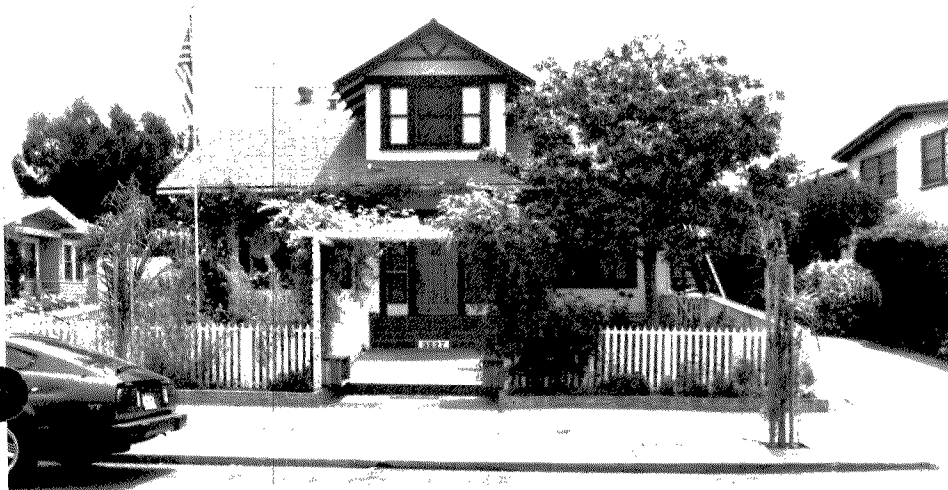
The Frery House is an example of early twentieth century vernacular, showing Craftsman stylistic influences. The two-story structure has clapboard siding and features a medium-pitched side gable roof with overhanging eaves, exposed rafters and supporting brackets. The front facade is symmetrical and features a projecting gable with a dormer roof centered above the raised entry. A tripartite window and double-hung side panels are located within the gable. Along the ground level of the front facade are two fixed windows. Some of the windows have leaded glass upper portions. The Frery House has had several alterations including an exterior wood stairway leading to the second floor, an addition to the kitchen and adjacent bedroom, a wood deck along the east side of the house and the enclosure of the once open entrance porch. A picket fence runs along the property and mature landscape is present throughout the site.

13. Condition: Excellent _____ Good X Fair _____ Deteriorated _____ No longer in existence _____
14. Alterations: porch, stairway, siding, etc.
15. Surroundings: (Check more than one if necessary) Open land _____ Scattered buildings _____ Densely built-up _____
Residential X Industrial _____ Commercial _____ Other: _____
16. Threats to site: None known X Private development _____ Zoning _____ Vandalism _____
Public Works project _____ Other: _____
17. Is the structure: On its original site? X Moved? _____ Unknown? _____
18. Related features: _____

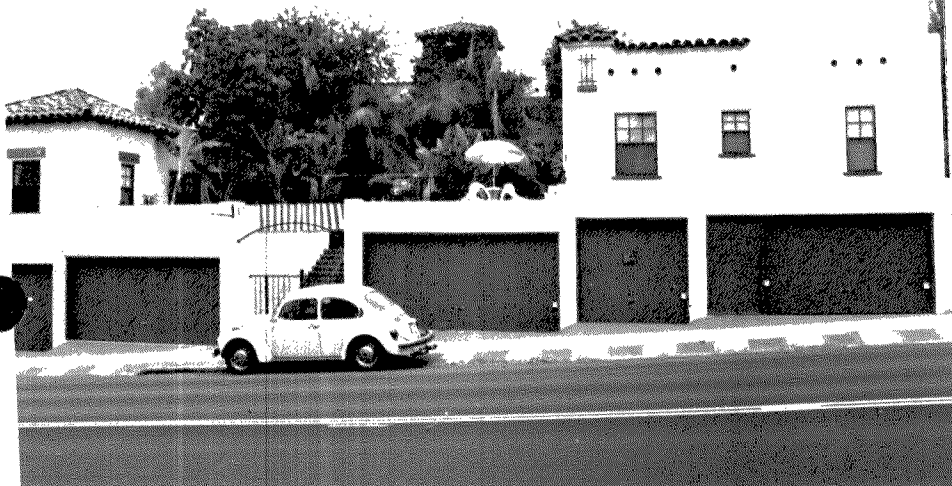
The La Madrid Apartments are a U-shaped garden apartment court consisting of a six-flat, two-story unit to the rear with two single-story Spanish Colonial Revival style duplexes on either side of its narrow, semitropical garden courtyard. Situated on either side of the central concrete stairway (as well as under the duplex units facing the street) are street-level parking garages. Access to the garages is through broad overhead swinging wooden garage doors. Heavy Spanish Colonial Revival detailing is present in the apartment court's hipped red tile roofs over the corners of the duplexes, wrought iron balconets, and stucco cladding. Single-terra cotta canales pierce the base of the parapets. Fenestration consists of several double-hung wood-frame windows with single-sash lowers and multilight uppers. A distinguishing feature of the rear six-unit flat is its hipped red tile roofed "belfry" which actually contains a church bell. Mature subtropical shrubs and trees occupy the interior of the courtyard area.

13. Condition: Excellent ☒ Good _____ Fair _____ Deteriorated _____ No longer in existence _____

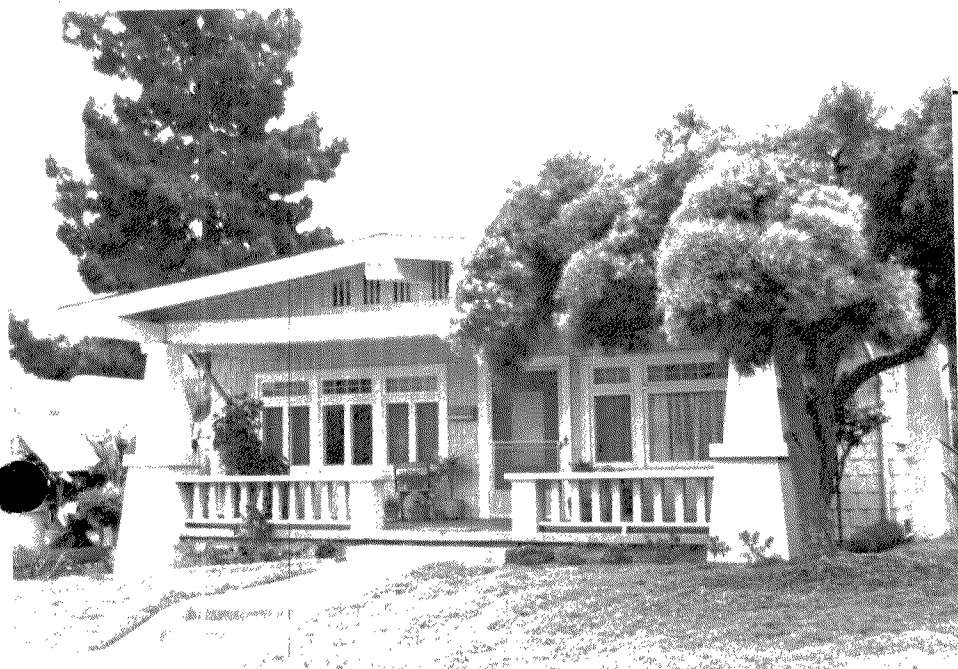
This one-story home has a cross gable asphalt shingle roof with wide overhanging eaves and exposed rafters and beams. Vertical vents are located in the gable above the raised open full-width porch which has a wooden balustrade. At each end of the porch is an elephantine column consisting of a trapezoidal wooden shaft resting on a trapezoidal stuccoed concrete pier. To the left of the wide wooden entry door with a glass center panel is a six sash tripartite casement window with multipaned transoms. To the right is a tripartite window consisting of a fixed central sash flanked on each side by a single casement glass sidepanel. The house is clad in shingle siding. A stuccoed chimney is on the south side. There are single, paired or tripartite casement windows elsewhere on the house as well as individual double hung windows. The property slopes to the west near the sidewalk.

13. Condition: Excellent ☒ Good _____ Fair _____ Deteriorated _____ No longer in existence _____
14. Alterations: None known
15. Surroundings: (Check more than one if necessary) Open land _____ Scattered buildings _____ Densely built-up _____
Residential ☒ Industrial _____ Commercial _____ Other: _____
16. Threats to site: None known _____ Private development ☒ Zoning _____ Vandalism ☒
Public Works project _____ Other: _____
17. Is the structure: On its original site? ☒ Moved? _____ Unknown? _____
18. Related features: _____
