HISTORICAL GREATER MID-CITY SAN DIEGO PRESERVATION STRATEGY

VOLUME 2

**HISTORIC
RESOURCES
INVENTORY FORMS
(DPR 523)
APN 452-705-02
THROUGH
APN 534-411-41**

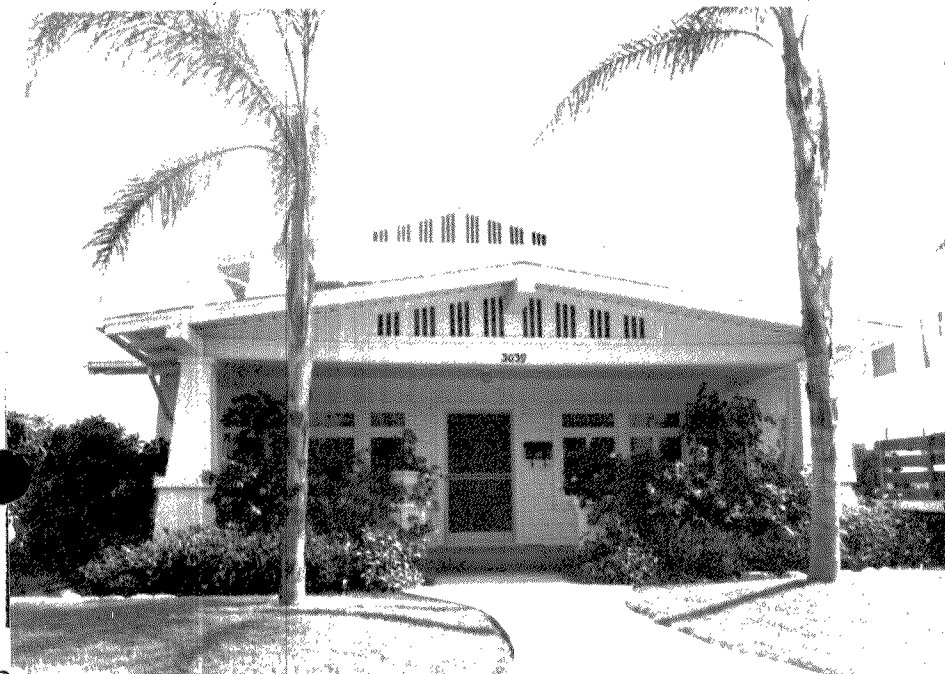
This two-story symmetrical Craftsman structure has a low pitch roof with front and side gables. Decorative vertical vents can be found beneath the peaks of the gable. Large square brackets support overhanging eaves. A large front gable extends out over the open veranda. This gable is supported by two tapered columns. A concrete walkway leads up to the front facade, which features two sets of tripartite windows, one with a fixed center pane and casement side-panels and the other with a trio of adjoining casement windows. Two sets of double hung windows are located on the second story beneath a gable. The east facade features an exposed stucco chimney that extends up through the side gable. There is another side gable on the west facade. This gable shelters a tripartite window with a fixed center pane and casement side-panels. A variety of double hung, casement and fixed windows are located on the east and west facades. A wood fence has been added that surrounds the rear yard of the property. There is a palm tree on each side of the concrete walkway.

13. Condition: Excellent ☒ Good _____ Fair _____ Deteriorated _____ No longer in existence _____
14. Alterations: None known
15. Surroundings: (Check more than one if necessary) Open land _____ Scattered buildings _____ Densely built-up _____
Residential ☒ Industrial _____ Commercial _____ Other: _____
16. Threats to site: None known _____ Private development ☒ Zoning _____ Vandalism ☒
Public Works project _____ Other: _____
17. Is the structure: On its original site? ☒ Moved? _____ Unknown? _____
18. Related features: _____

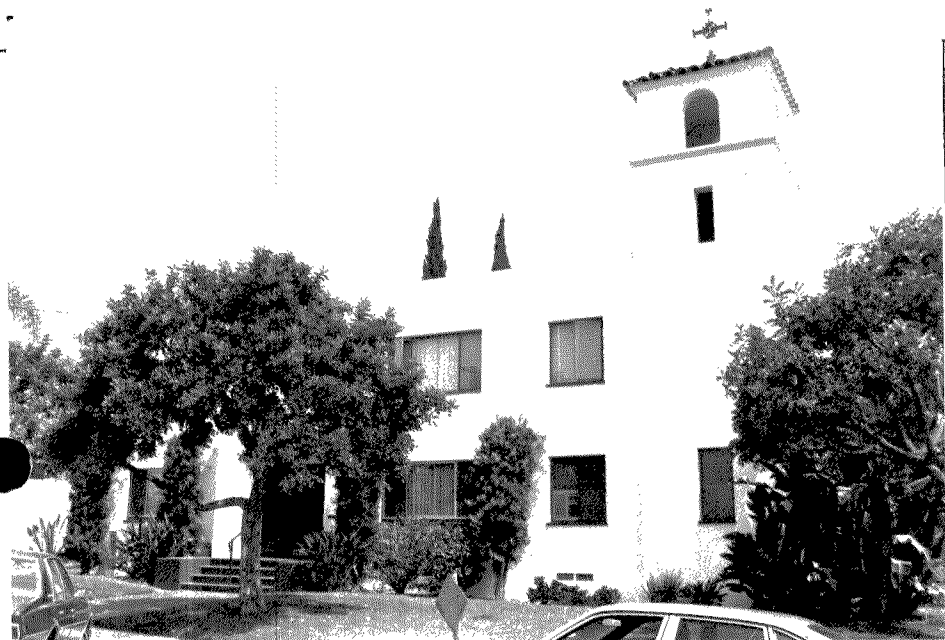
This Mission style stucco church design is influenced by its architects, Frank Mead and Richard Requa. It is built in a "H" design with very simple lines. The church, which is at least two stories high, has a flat roof with a bell tower in the southeast corner. The tower roof is pyramidal, bearing a cross on its peak. The roof is covered by red ceramic tile. The church is sided with stucco. The windows are all square casement windows. A few fixed windows can be found on the east facade. The bell tower contains square and arched openings. A recessed entry with a large wood door and glass side panels is located on the front facade. An arched moulding surrounds the entrance. An arcade connects the original structure with an addition built in the 1930's. There is a courtyard between the two buildings.

13. Condition: Excellent ☒ Good _____ Fair _____ Deteriorated _____ No longer in existence _____
14. Alterations: none visible
15. Surroundings: (Check more than one if necessary) Open land _____ Scattered buildings _____ Densely built-up _____
Residential ☒ Industrial _____ Commercial _____ Other: _____
16. Threats to site: None known _____ Private development ☒ Zoning _____ Vandalism ☒
Public Works project _____ Other: _____
17. Is the structure: On its original site? ☒ Moved? _____ Unknown? _____
18. Related features: An addition was added in the 1930's - formed "H" shape.

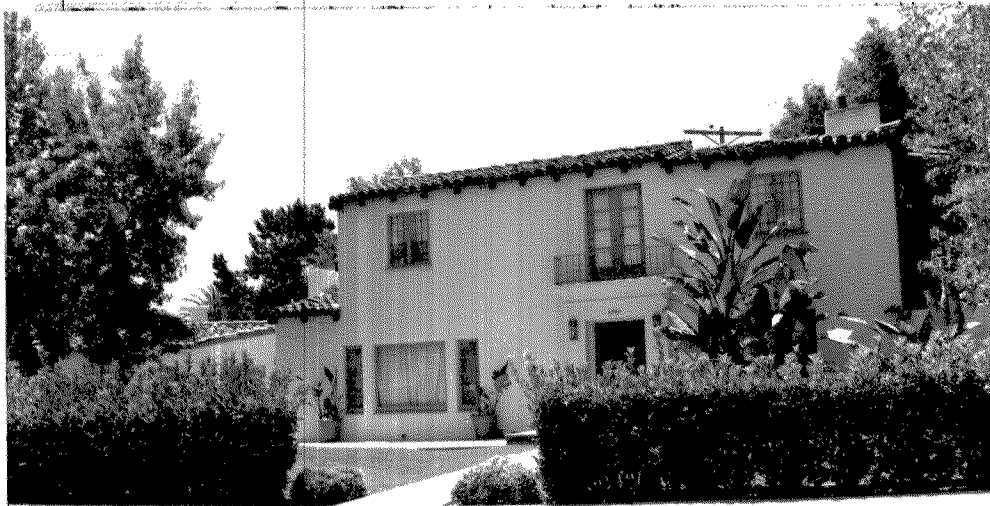
P5b. Description of Photo: (View, date, etc.)
Photo Number: 111-28A
Date: June-October 1995

*P3a. Description: (Describe resource and its major elements. Include design, materials, condition, alterations, size, setting, and boundaries.)
Condition: Good

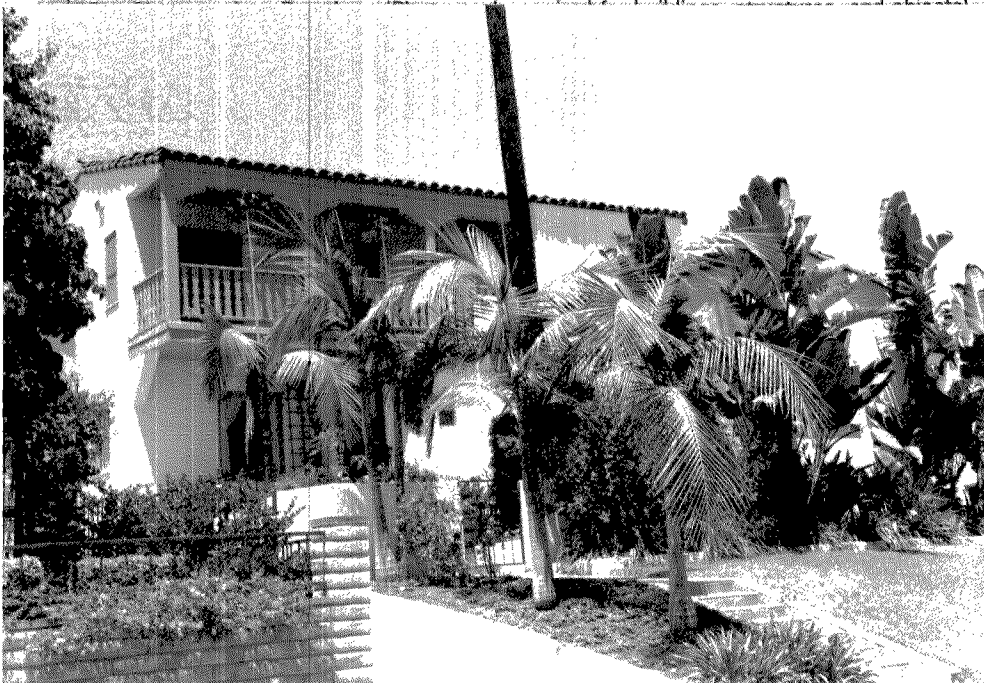
P5b. Description of Photo: (View, date, etc.)
Photo Number: 111-32A
Date: June-October 1995

*P3a. Description: (Describe resource and its major elements. Include design, materials, condition, alterations, size, setting, and boundaries.)
Condition: Good

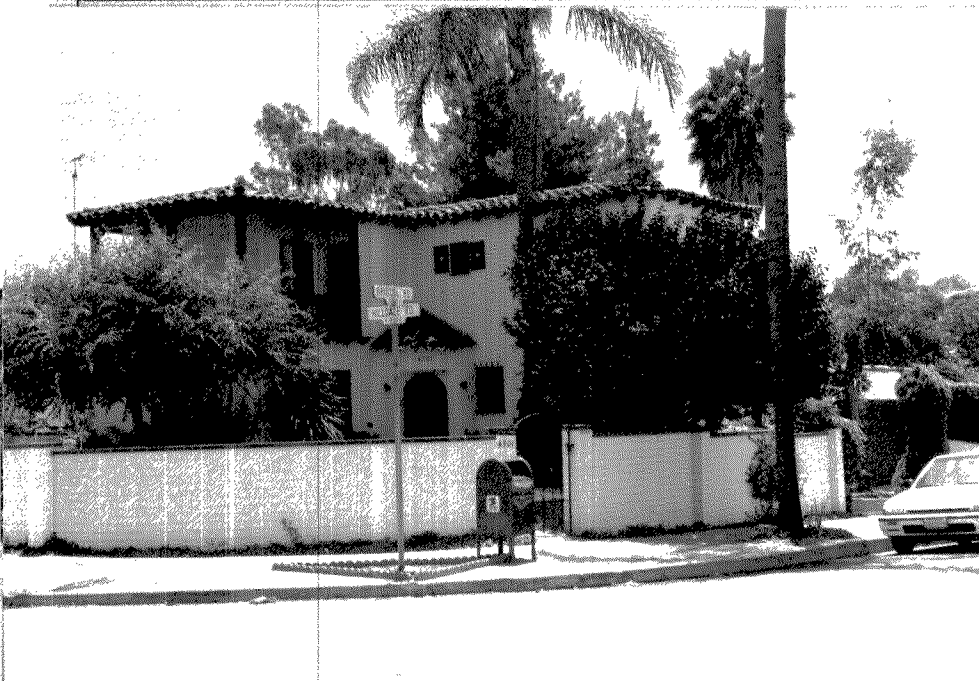
P5b. Description of Photo: (View, date, etc.)
Photo Number: 111-36A
Date: June-October 1995

*P3a. Description: (Describe resource and its major elements. Include design, materials, condition, alterations, size, setting, and boundaries.)
Condition: Good

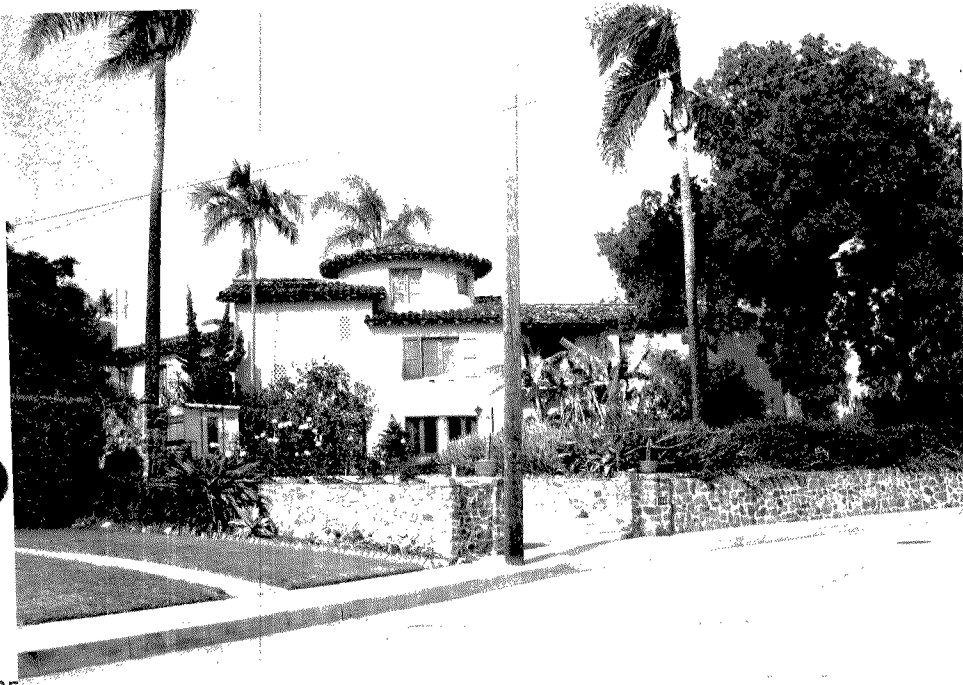
This is a two-story, L-shaped Spanish Colonial Revival stuccoed home with a three story cylindrical tower near the intersection of the two wings. The tower is topped by a low-pitched, conical roof covered with red clay tiles. Two wrought iron plantholder rings protrude from the wall beneath two triple-paned casement windows flanked by double-paneled wooden shutters on the second floor beneath the tower. To the east of these is a balconet supported by four flared brackets on top of exposed rafters. Access is via a single french door flanked by triple paned wood shutters. To the west of the tower is a blank wall pierced by two semicircular patterned concrete grilles. Two sets of twin rectangular casement windows separated by a flat column attached to the wall surface are located on the first floor beneath the tower. Below the balconette are a set of triple paned casement windows flanked by decorative wooden shutters. A solid walled balcony at the rear southeast corner of the house overlooks a canyon. A short rubble retaining wall along the street stretches the length of the property.

13. Condition: Excellent X Good _____ Fair _____ Deteriorated _____ No longer in existence _____
14. Alterations: none
15. Surroundings: (Check more than one if necessary) Open land X Scattered buildings _____ Densely built-up _____
Residential X Industrial _____ Commercial _____ Other: _____
16. Threats to site: None known X Private development _____ Zoning _____ Vandalism _____
Public Works project _____ Other: _____
17. Is the structure: On its original site? X Moved? _____ Unknown? _____
18. Related features: one story, two-car Spanish Colonial garage

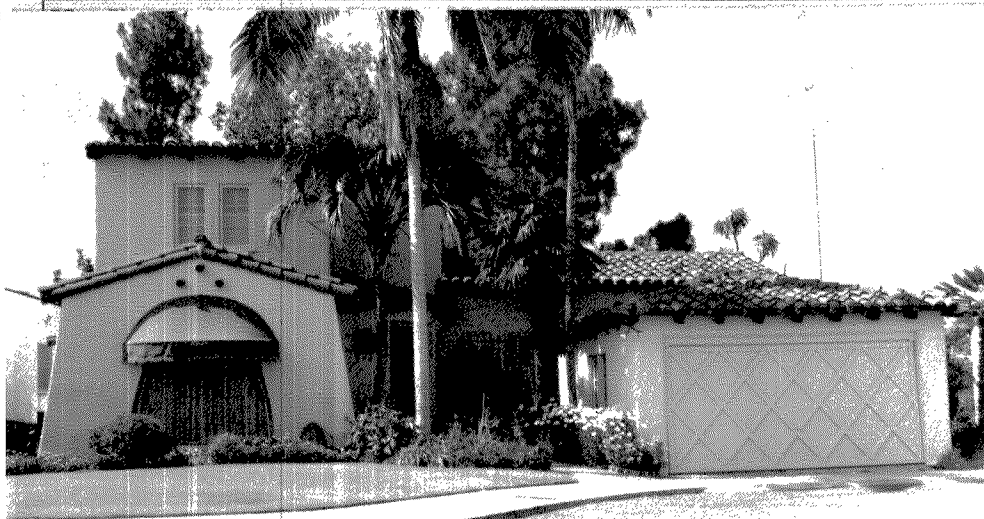
Photo Number: 106-06A

Condition: Good

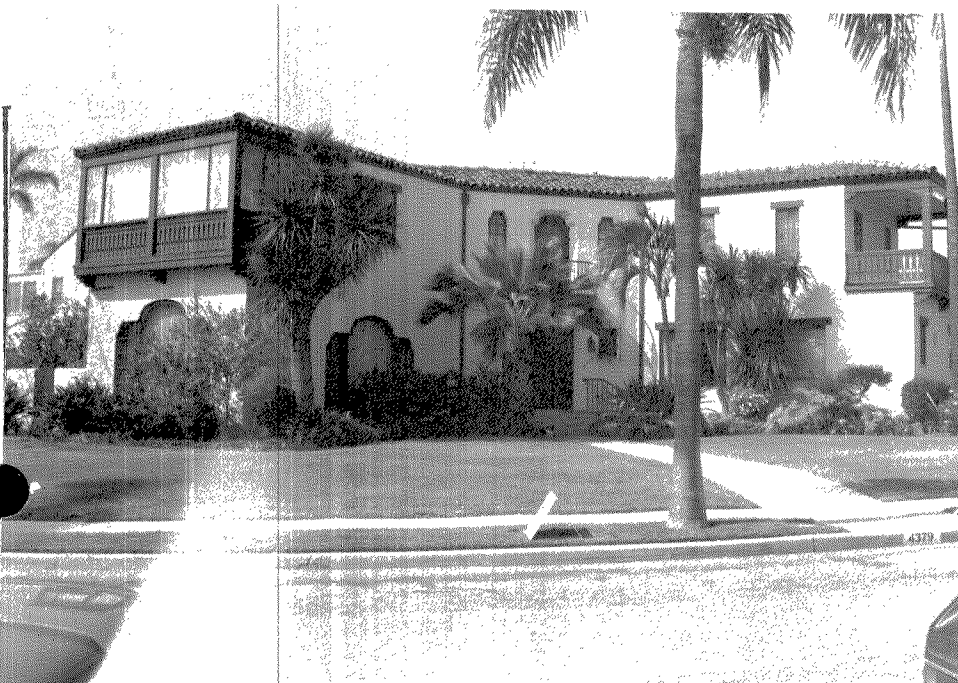
This U-shaped, two-story stucco house consists of a central entry hall flanked by north and east wings with second story balconies. It is topped by a red tile low-hipped roof. The northern wing contains two vertically oriented, eight paned windows with wood lintels. The southern wing has only one linteled window. The ground floors of the northern and eastern wings both hold Palladian-styled picture windows. A broad sidewalk leads up to the front stoop of the central hall. The wrought iron bannistered stoop is positioned in front of a massive wood paneled door, flanked by twin metal grilled windows and wall mounted lanterns. A wrought iron balcony with a multi-paned French door sits in a recessed doorway flanked by twin recessed windows. The glass enclosed eastern balcony is the only alteration. The building is surrounded by manicured lawns and mature foundation plants.

13. Condition: Excellent ☒ Good _____ Fair _____ Deteriorated _____ No longer in existence _____
14. Alterations: A glass enclosed second floor bedroom on the east balcony
15. Surroundings: (Check more than one if necessary) Open land _____ Scattered buildings _____ Densely built-up _____
Residential ☒ Industrial _____ Commercial _____ Other: a nearby canyon/hillside
16. Threats to site: None known _____ ☒ Private development _____ Zoning _____ Vandalism _____
Public Works project _____ Other: _____
17. Is the structure: On its original site? ☒ Moved? _____ Unknown? _____
18. Related features: Situated amongst similar Spanish Colonial Revival houses.

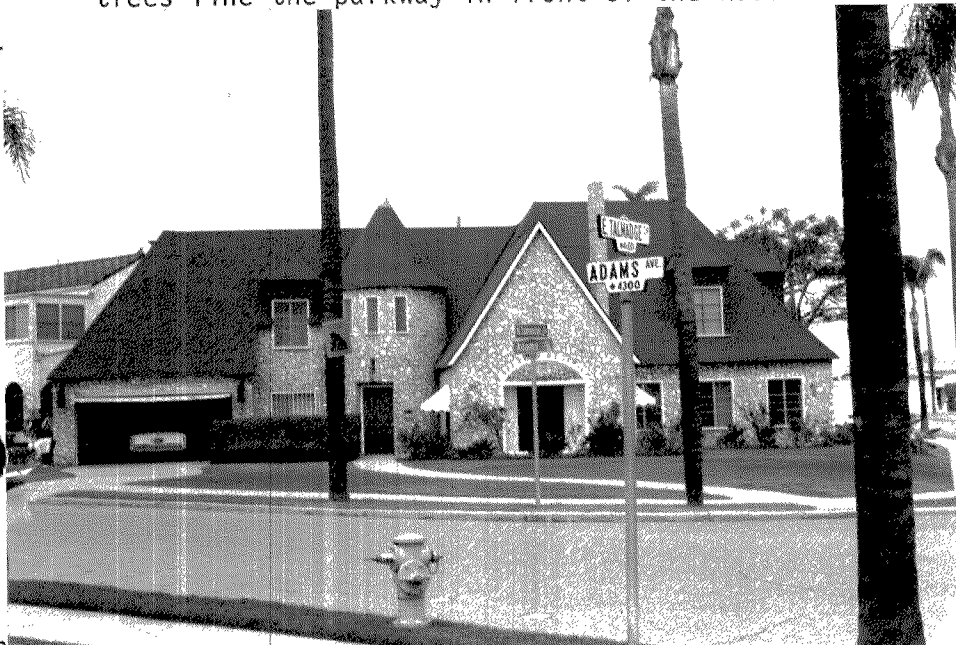
- Architectural style: French Eclectic
- Briefly describe the present *physical appearance* of the site or structure and describe any major alterations from its original condition: Legal Description: Lots 184 & 185, Talmadge Park
This one and one-half story house is constructed entirely of Dolomite marble and features a steeply hipped roof with lower cross gables. The asymmetrical front facade has a dominant front-facing gable projecting from the main roof of the house. Within the gable is a large fixed window with a segmental arch transom of stained glass. On the east and west facades of the gable are multipane double-hung windows with canvas awnings. A prominent round tower with a high, conical roof serves as the entrance. A curving concrete walkway leads to the recessed multipanel wooden door. Three tall multipane casement windows are located above the entrance. Other features along the front facade include two small wooden gables projecting from the roof facade, two multipane double-hung windows located directly below the gables, three multipane casement windows along the ground level and a tall, narrow chimney made of Dolomite marble. Throughout the remainder of the house, casement and double-hung windows are used and iron bars have been placed on all the first story windows. Aluminum sliding windows and doors have replaced some of the original wooden ones. An attached two-car garage is situated in the southwest corner. Tall slender palm trees line the parkway in front of the house.

13. Condition: Excellent ☒ Good ☐ Fair ☐ Deteriorated ☐ No longer in existence ☐
14. Alterations: Chimney
15. Surroundings: (Check more than one if necessary) Open land ☒ Scattered buildings ☐ Densely built-up ☐
Residential ☒ Industrial ☐ Commercial ☐ Other: ☐
16. Threats to site: None known ☒ Private development ☐ Zoning ☐ Vandalism ☐
Public Works project ☐ Other: ☐
17. Is the structure: On its original site? ☒ Moved? ☐ Unknown? ☐
18. Related features: ☐

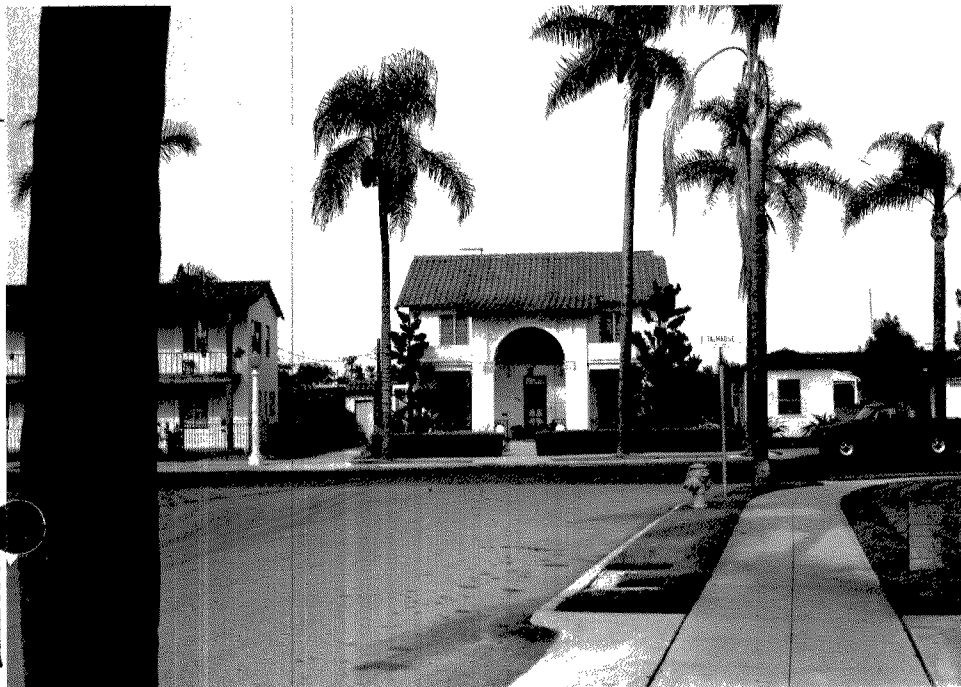
This two-story Italian Renaissance home has a medium pitched red tile roof. The large side gable has overhanging eaves and exposed worked rafters. Two chimneys intersect the roofline; an exterior stuccoed chimney on the southern facade and a central interior chimney. The structure is rectangular shaped and symmetrical with stucco siding. A grand entry dominates the front facade with a two-story classical arch with Corinthian pilasters covering the stepped porch. The porch is sheltered by a red tile pent roof and boxed balconies on the second floor which flank the archway. The balconies are reached by narrow, horizontally-paned French doors. The windows are wood framed and double-hung and the door is a single French door with transom and wrought iron balconette above. Two large tripartite windows along the front porch look out onto the finely manicured front lawn. The only alteration is a small addition/garage conversion on the north facade.

13. Condition: Excellent ___ Good X Fair ___ Deteriorated ___ No longer in existence ___
14. Alterations: addition/garage conversion on north facade
15. Surroundings: (Check more than one if necessary) Open land ___ Scattered buildings ___ Densely built-up X
Residential X Industrial ___ Commercial ___ Other: ___
16. Threats to site: None known X Private development ___ Zoning ___ Vandalism ___
Public Works project ___ Other: ___
17. Is the structure: On its original site? X Moved? ___ Unknown? ___
18. Related features: ___

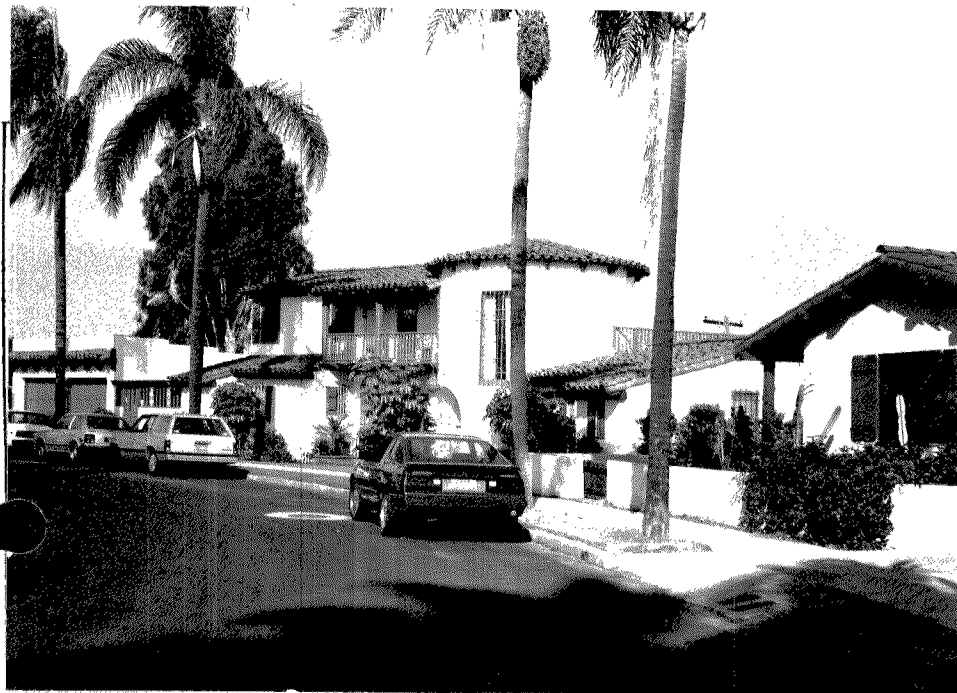
This two-story Spanish Colonial Revival home is irregularly shaped and has a low-pitched gabled roof. The roof consists of red tile with slightly overhanging eaves and exposed worked rafters. A large, round two-story turret separates the two-story central section from the one-story wings on the north and south. The center two-story section features an upper balcony with a turned wooden balustrade and heavy wooden lentil and posts. The balcony is cantilevered over the first story with large wooden brackets below. The windows are narrow and double-hung with horizontal multipanes and wooden shutters. The entry consists of a recessed arch within the round turret with a wide arched wood paneled door. A two-car garage with a flat roof is attached on the north wing of the structure. There are no apparent alterations.

13. Condition: Excellent ☒ Good _____ Fair _____ Deteriorated _____ No longer in existence _____
14. Alterations: _____
15. Surroundings: (Check more than one if necessary) Open land _____ Scattered buildings _____ Densely built-up _____
Residential ☒ Industrial _____ Commercial _____ Other: _____
16. Threats to site: None known _____ Private development ☒ Zoning ☒ Vandalism ☒
Public Works project _____ Other: _____
17. Is the structure: On its original site? ☒ Moved? _____ Unknown? _____
18. Related features: _____

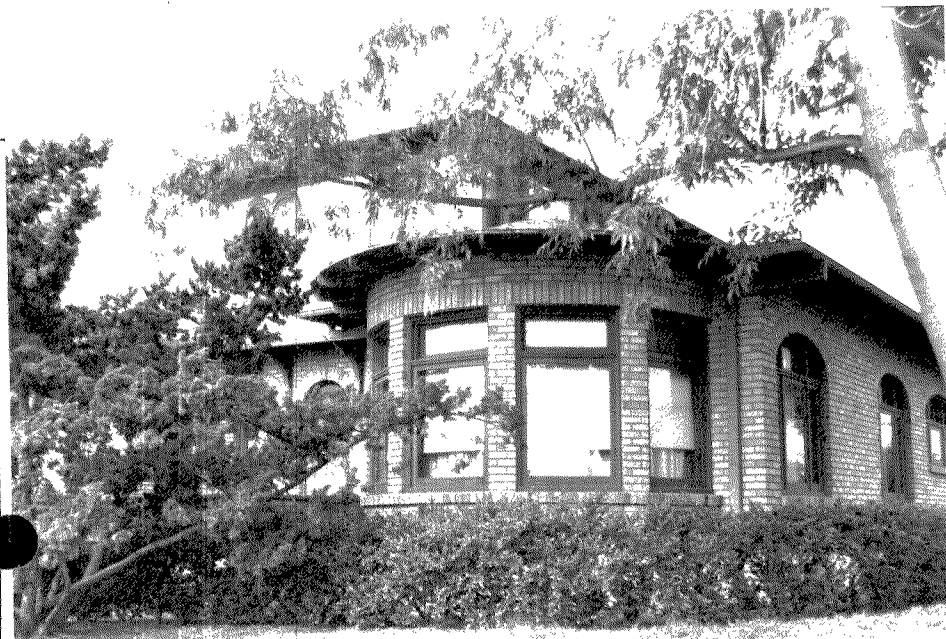
This is a two story brick house with a low pitched hipped roof, flared overhanging eaves and exposed rafters. The structure is irregularly shaped and has a very large, round bay window with a conical roof on the northwest corner. Five clay tile steps lead to an open front entry with a recessed central doorway. Two large wooden brackets and four fixed arched windows flank the arched doorway. Five fixed rectangular windows with transoms surround the northwest bay, and large semi-elliptical tripartite windows with hinged side windows and transoms are placed along the front (east), north and south facades. The second story has a narrow clapboard exterior, a pyramidal roof and is square in shape with two arched windows, hinged in pairs, on the front facade. Double-hung, narrow rectangular windows are also grouped in pairs along the other three facades.

13. Condition: Excellent X Good _____ Fair _____ Deteriorated _____ No longer in existence _____
14. Alterations: none apparent
15. Surroundings: (Check more than one if necessary) Open land _____ Scattered buildings _____ Densely built-up X
Residential X Industrial _____ Commercial X Other: _____
16. Threats to site: None known _____ Private development X Zoning X Vandalism _____
Public Works project _____ Other: _____
17. Is the structure: On its original site? X Moved? _____ Unknown? _____
18. Related features: _____

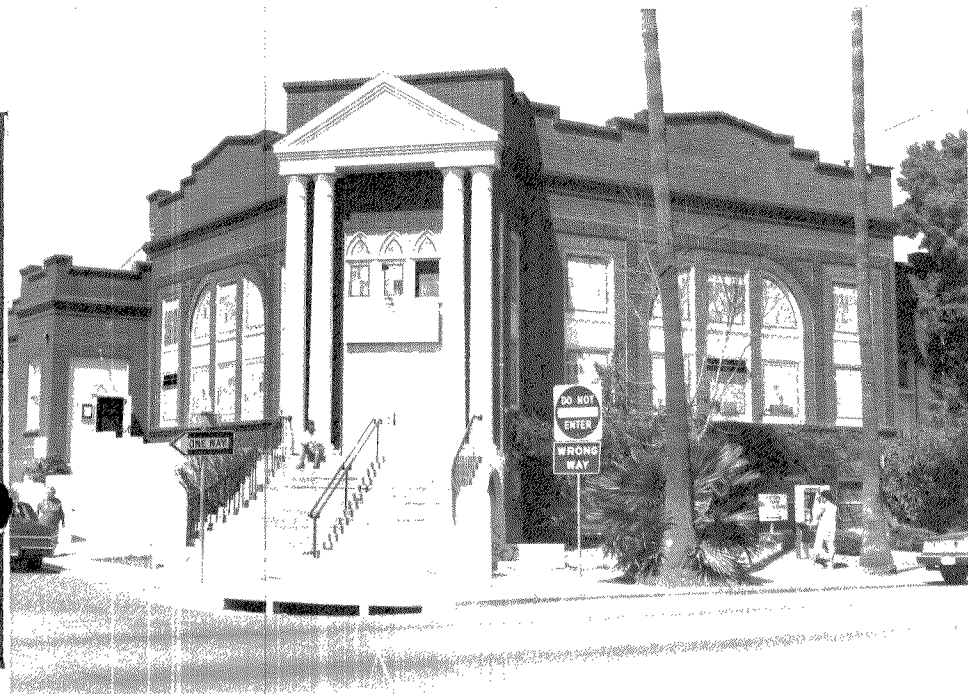
This one story brick-veneered wood framed building rests upon a sunken basement. A stepped parapet and water course surround the flat roof. A neo-classically inspired center gabled portico with twin Tuscan ordered columns juts out from the southeastern corner of the building. The portico flanks two multi-paneled wooden doors. A blank transom panel above the doors supports three small Gothic arched stained glass windows (the right pane is missing). A multi-step stoop provides access to the entry. Three wrought iron bannisters lead up from the street. The concrete stoop also shields the basement entry below it. Both street facades have multi-paneled semi-elliptic stained glass windows flanked by rectangular paneled vertical windows. The basement windows are frosted. A concrete block handicap ramp leads up to the Polk Ave. Bay entrance.

13. Condition: Excellent _____ Good _____ Fair X Deteriorated _____ No longer in existence _____
14. Alterations: Chain across main entry stoop, concrete block side handicap ramp
15. Surroundings: (Check more than one if necessary) Open land _____ Scattered buildings _____ Densely built-up X
Residential X Industrial _____ Commercial X Other: _____
16. Threats to site: None known _____ Private development _____ Zoning _____ Vandalism X
Public Works project _____ Other: _____
17. Is the structure: On its original site? X Moved? _____ Unknown? _____
18. Related features: _____

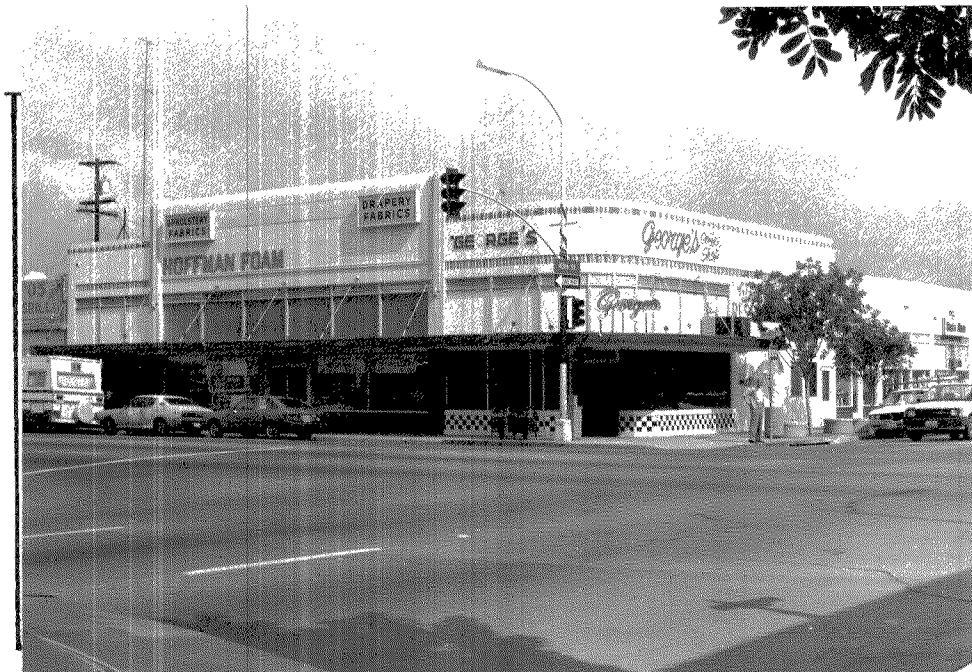
4288-98 University Avenue is a two story rectangular commercial structure in the Art Deco/Moderne style. The roof is flat, with a single raised parapet on the center of the south (front) facade. A guyed marquee runs the length of the south facade and extends around to the curved southeast corner of the building, dividing the storefront windows. A glazed ceramic tile wall base runs along the south and a portion of the east facade storefronts. Windows are single pane, set in aluminum frames. Windows above the marquee have been painted. Storefront doors are glass, with two entries on the south facade and one on the southeast corner. The south facade has the majority of the architectural art moderne decoration. Three stepped vertical bands curve over both ends of the raised parapet. A horizontal band of chevron molding decorates a frieze on the west end of the south facade. Streamlined horizontal bands run along the south facade. The southeast corner of the building is rounded, with a recessed corner entry. Alterations include signage, new tile at the southeast corner, and paint on windows.

13. Condition: Excellent _____ Good X Fair _____ Deteriorated _____ No longer in existence _____
14. Alterations: Signage, Painted windows, Tile at southeast corner
15. Surroundings: (Check more than one if necessary) Open land _____ Scattered buildings _____ Densely built-up X
Residential _____ Industrial _____ Commercial X Other: _____
16. Threats to site: None known X Private development _____ Zoning _____ Vandalism _____
Public Works project _____ Other: _____
17. Is the structure: On its original site? X Moved? _____ Unknown? _____
18. Related features: _____

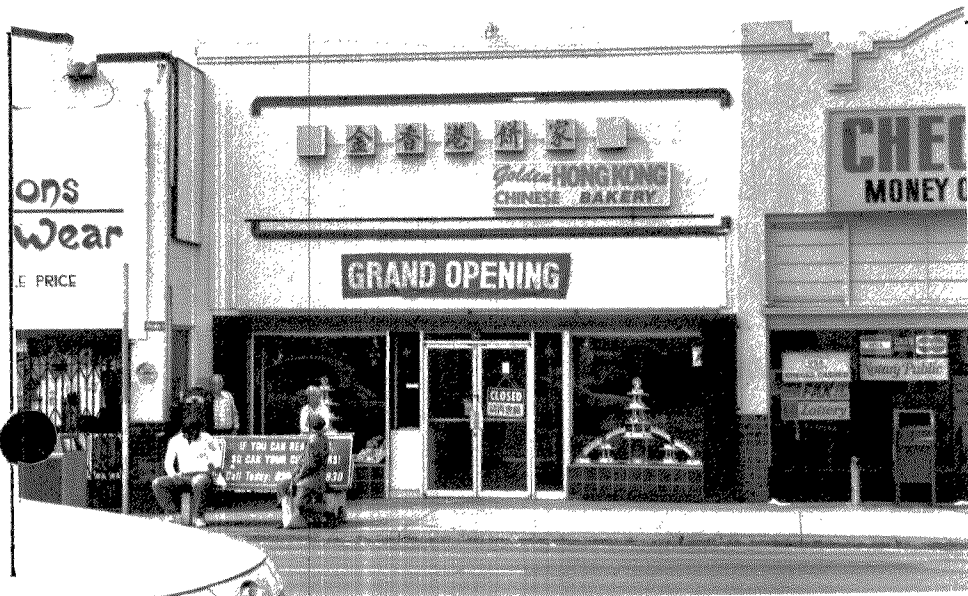
These two storefronts on University Avenue are one story in height in the Mission Revival architectural style. The roofs are flat with an espadana to the west and a stepped parapet to the east. A decorative crest is located at each stepped corner of the parapet and canales are located in the center. The siding is solid stucco on the upper front facade which may be covering large windows according to an early rendering of the structure. The north facade consists of large storefront windows with recessed entries and tiled skirting. Alterations include: aluminum framed glass doors and the removal of upper multipaned windows and red tile on the eastern portion of the building.

13. Condition: Excellent _____ Good ☒ Fair _____ Deteriorated _____ No longer in existence _____
14. Alterations: Doors, parapet and upper story windows
15. Surroundings: (Check more than one if necessary) Open land _____ Scattered buildings _____ Densely built-up ☒
Residential _____ Industrial _____ Commercial ☒ Other: _____
16. Threats to site: None known ☒ Private development _____ Zoning _____ Vandalism _____
Public Works project _____ Other: _____
17. Is the structure: On its original site? ☒ Moved? _____ Unknown? _____
18. Related features: _____

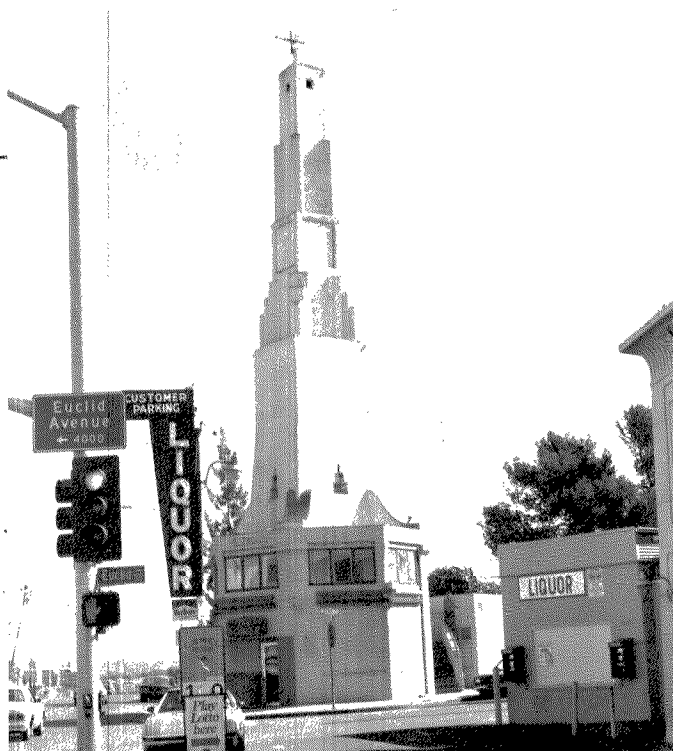
The Silver Tower Building is a two-part commercial structure in the Art Deco/ Assyrian Revival style. The Tower has a two-story octagonal base topped by a purely ornamental tower. To the east of the base, an "L"-shaped one-story structure (possibly an addition) forms a portion of the first floor business. The tower is approximately 70 feet tall and can be divided into four sections which step back at each new section (hence the Assyrian "ziggurat" influence). The largest section of the tower is rectangular, with four buttresses radiating like feet from the four corners. The remaining three sections are buttressed from the corners, with differing ornamental treatments. Eye bolts can be seen along the length of the tower and were most likely used to attach neon signage. Alterations include a reduction in height, covered windows on the first floor and the removal of the horizontal band on the first floor.

13. Condition: Excellent _____ Good X Fair _____ Deteriorated _____ No longer in existence _____
14. Alterations: Tower height was reduced, windows covered on first floor, part of horizontal first floor band is missing
15. Surroundings: (Check more than one if necessary) Open land _____ Scattered buildings _____ Densely built-up X
Residential _____ Industrial _____ Commercial X Other: _____
16. Threats to site: None known X Private development _____ Zoning _____ Vandalism _____
Public Works project _____ Other: _____
17. Is the structure: On its original site? X Moved? _____ Unknown? _____
18. Related features: _____

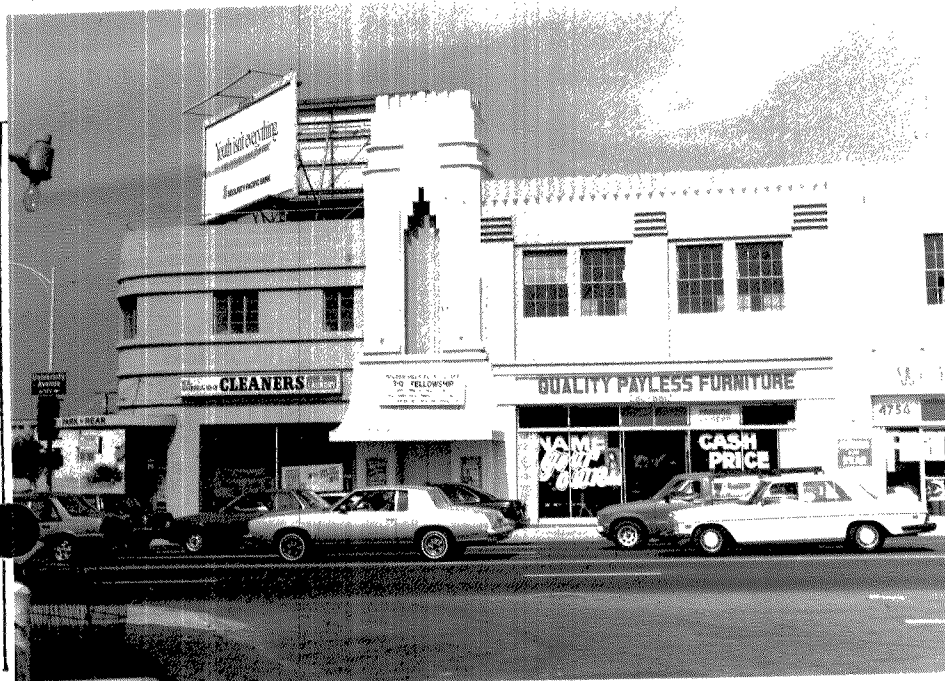
The Silverado Ballroom is a rectangular two-story building in the Art Deco and Art Moderne styles. The building is of brick construction, covered with smooth stucco. The roof is flat with a parapet, topped by a metal railing to the west, while crenellated to the east on the Art Deco portion. A crenellated central tower divides the two styles with a large geometric niche emphasizing verticality. This is also achieved with vertical bands on the southeast facade. Horizontal bands run along the curved southwest corner of the building, lending a horizontal emphasis and streamline moderne style to this section of the structure. Windows on the second floor are multi-paned while the first floor contains large storefront windows. The somewhat-recessed entry to the second floor ballroom is in the "tower" section. A guyed hood above the entry does not appear to be original. A neon roof sign reading "DANCE" is visible from the street. Other additions include the signage and billboards on the roof.

13. Condition: Excellent ☒ Good _____ Fair _____ Deteriorated _____ No longer in existence _____
14. Alterations: none present
15. Surroundings: (Check more than one if necessary) Open land _____ Scattered buildings _____ Densely built-up _____
Residential _____ Industrial _____ Commercial ☒ Other: _____
16. Threats to site: None known _____ Private development ☒ Zoning _____ Vandalism ☒
Public Works project _____ Other: _____
17. Is the structure: On its original site? ☒ Moved? _____ Unknown? _____
18. Related features: _____

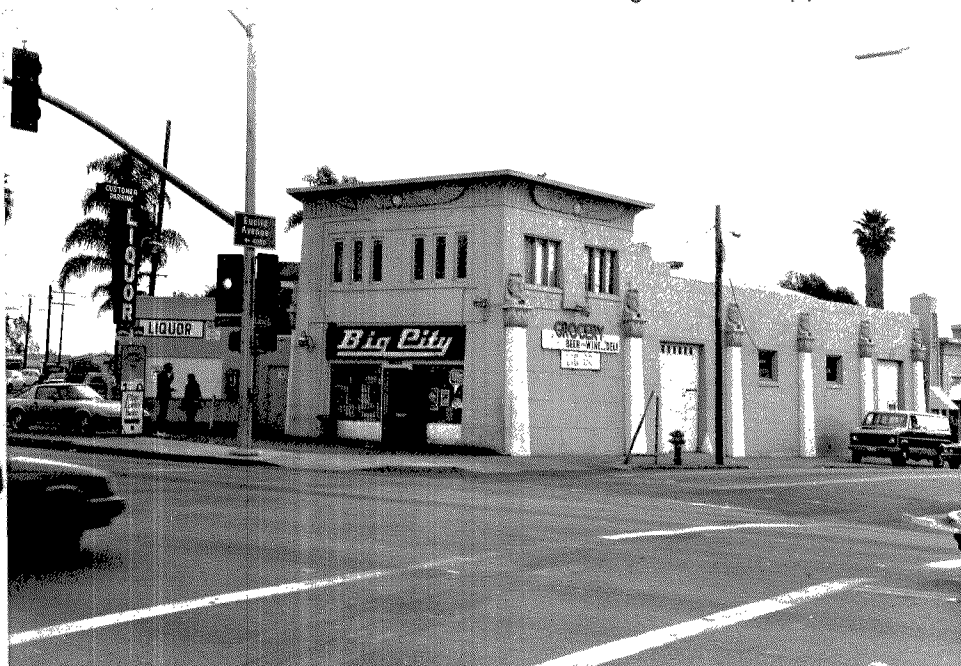
This concrete block commercial building has a two story section at its north end. The flat roof has a curved cornice with dentils on the two-story section and a smooth, curved cornice on the southern section. The cornice of the northern section displays decorative sun discs with cobra heads and vulture wings. The building is surrounded by pilasters with pharaoh head capitals spaced at about fifteen feet intervals. The second story windows on the north facade display decorative art glass. The southern section of the building is separated from the main building by an obelisk with Egyptian hieroglyphs. The entry to the southern section is flanked by lotus-bud-shaped pilasters supporting a curved cornice. A large garage door on the west facade has been enclosed. The words "Egyptian Garage" are embossed in the wall above this enclosed door. Two large wood bottom doors remain on the west facade. The walls of the building are battered and clad with stucco that has been scored to give the appearance of masonry block.

13. Condition: Excellent _____ Good X Fair _____ Deteriorated _____ No longer in existence _____
14. Alterations: windows replaced, enclosed garage door, addition
15. Surroundings: (Check more than one if necessary) Open land _____ Scattered buildings _____ Densely built-up _____
Residential X Industrial _____ Commercial X Other: _____
16. Threats to site: None known _____ Private development X Zoning _____ Vandalism X
Public Works project _____ Other: _____
17. Is the structure: On its original site? YES Moved? _____ Unknown? _____
18. Related features: _____

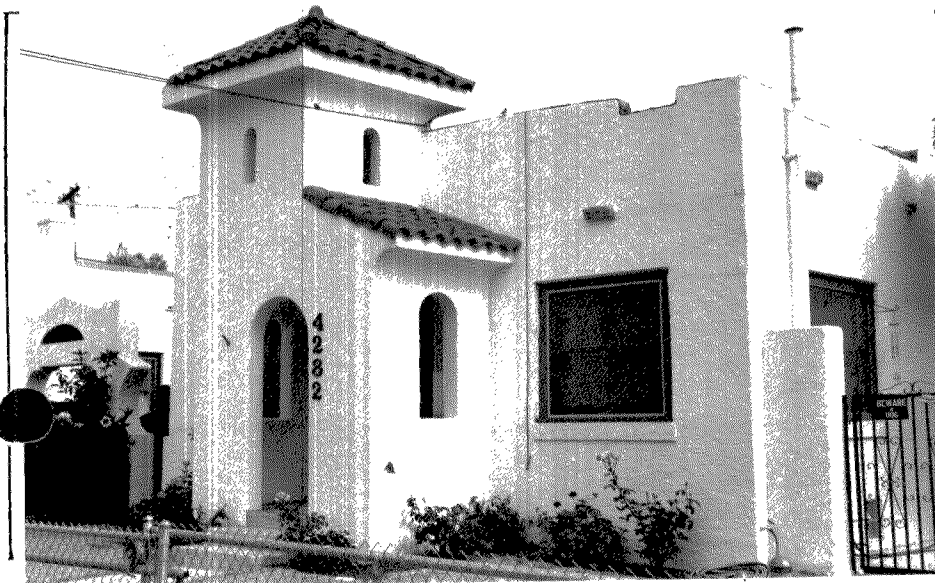
This small, Spanish Colonial Revival style single-family residence (with detached garage), near the northwestern corner of Landis and 43rd Streets, is set back from the sidewalk by a chain-link fenced small lawn area. The white stucco house, composed of structural clay tiles, has a flat roof hidden behind a raised stepped parapet. Below the parapet are several horizontal structural clay tile canales. All of the original double-hung, wood frame windows (and solid front door) are still in place. The south east driveway is guarded by a wrought iron fence attached to a free-standing wall. The most imposing visual feature of the house is its Moorish-like, hipped red tile roofed "torre." This torre, or turret, is offset to the left over the front entry. The porch area under the turret is pierced by a tall, arched entry and side openings. A red tile shed roof covers the east side of the porch. The house is one of a set of three similar Spanish Colonial Revival homes adjacent to each other.

13. Condition: Excellent ☒ Good _____ Fair _____ Deteriorated _____ No longer in existence _____

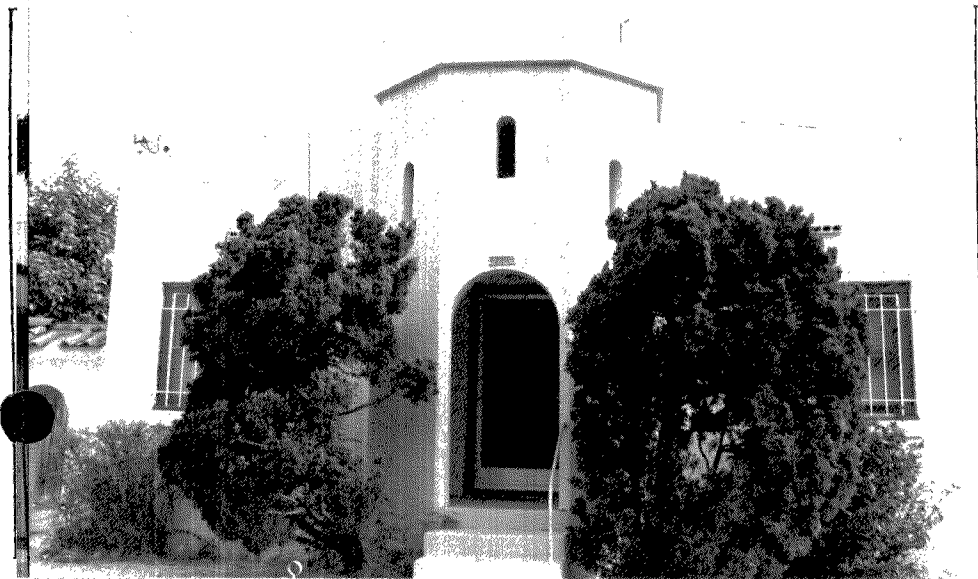
This small, Spanish Colonial Revival style single-family residence, which occupies the northwest corner of Landis and 43rd Streets, is set back from the sidewalk by a small lawn area behind a chain-link fence. The house is composed of structural clay tiles under stucco siding. The house has a flat roof hidden behind a raised stepped parapet. Under the parapet are several horizontal clay tile canales. Except for new aluminum frame windows installed in the east bay, the original double-hung, wood frame windows (and solid front door) are still in place. A free-standing attached wall, with an arched side entry, exists at the southwest corner of the dwelling. Behind the house, attached by a connecting wall, is a wood frame garage. The most imposing part of the structure is its crenellated, castle-like turret guarding the main entry along Landis Street. A three-step stoop leads up to a tall arched entry leading into the front porch. The "castle" house is one of three similar Spanish Colonial Revival structures arranged along the corner of Landis

13. Condition: Excellent ☒ Good ☐ Fair ☐ Deteriorated ☐ No longer in existence ☐
14. Alterations: Aluminum frame windows in east bay, iron security bars on all windows
15. Surroundings: (Check more than one if necessary) Open land ☐ Scattered buildings ☐ Densely built-up ☒
Residential ☒ Industrial ☐ Commercial ☒ Other: ☐
16. Threats to site: None known ☒ Private development ☐ Zoning ☐ Vandalism ☐
Public Works project ☐ Other: ☐
17. Is the structure: On its original site? ☒ Moved? ☐ Unknown? ☐
18. Related features: Similar home built by Stemen next door

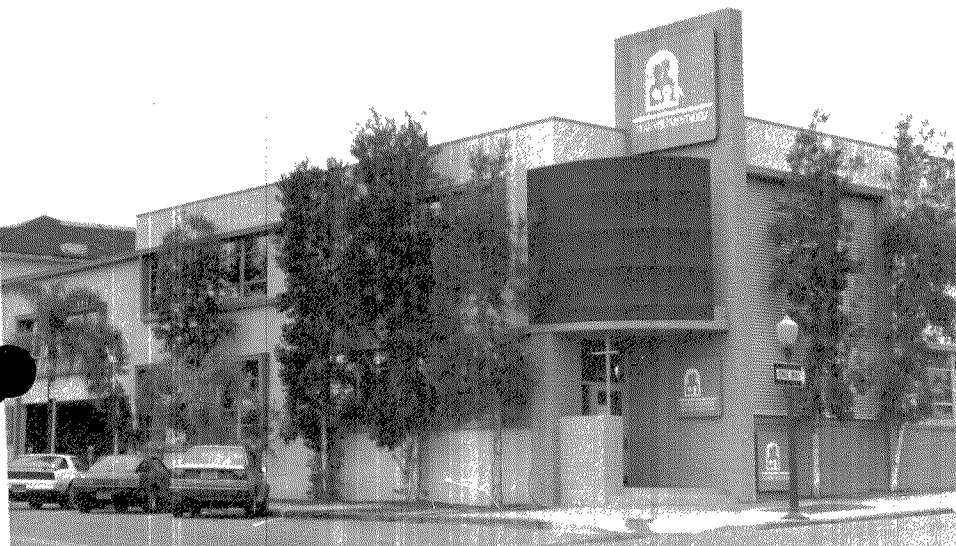
2100 5th Avenue is a two-story rectangular structure on a raised foundation. It has smooth stucco siding, a flat roof and a two story brick panel near the entry which extends above the roofline. The altered entry is surrounded by brick and has an unusual rounded canvas awning which is vertically placed over the two story brick panel. Rounded steps lead to the wood-framed glass door with a glass transom and side panels. The windows are placed in horizontal bands and have aluminum pivoting frames. On the southern facade, the windows are surrounded by a stucco box surround which extends onward near the top and continues to surround an open garage on the first level. Along 5th Avenue is a similar band of windows next to a large metal-louvered panel with glass brick beneath.

13. Condition: Excellent _____ Good x Fair _____ Deteriorated _____ No longer in existence _____

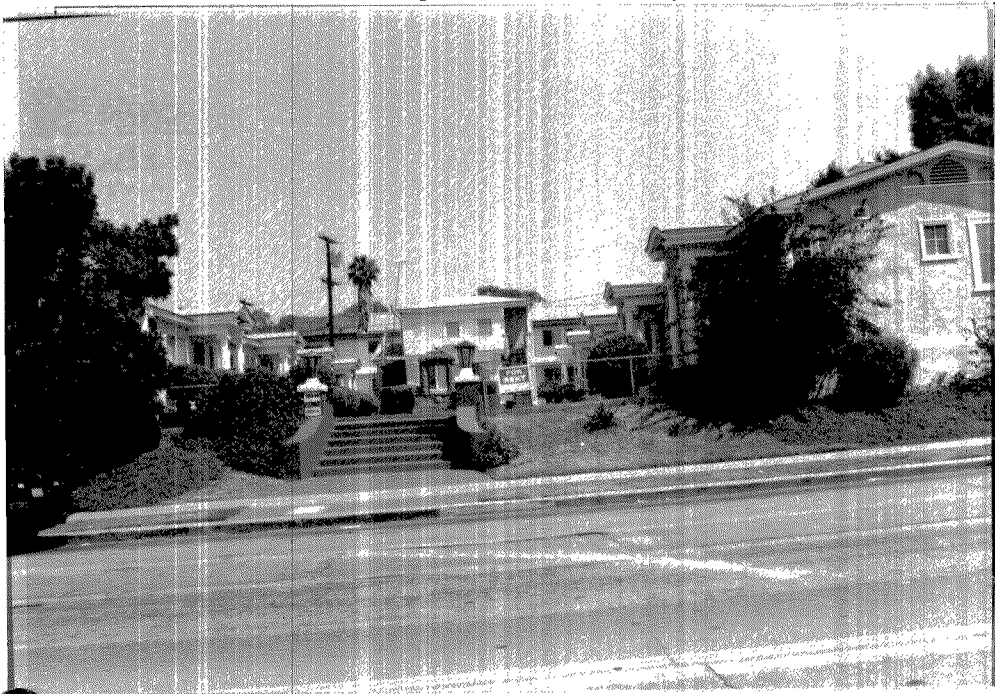
Photo Number: 120-20

Condition: Good

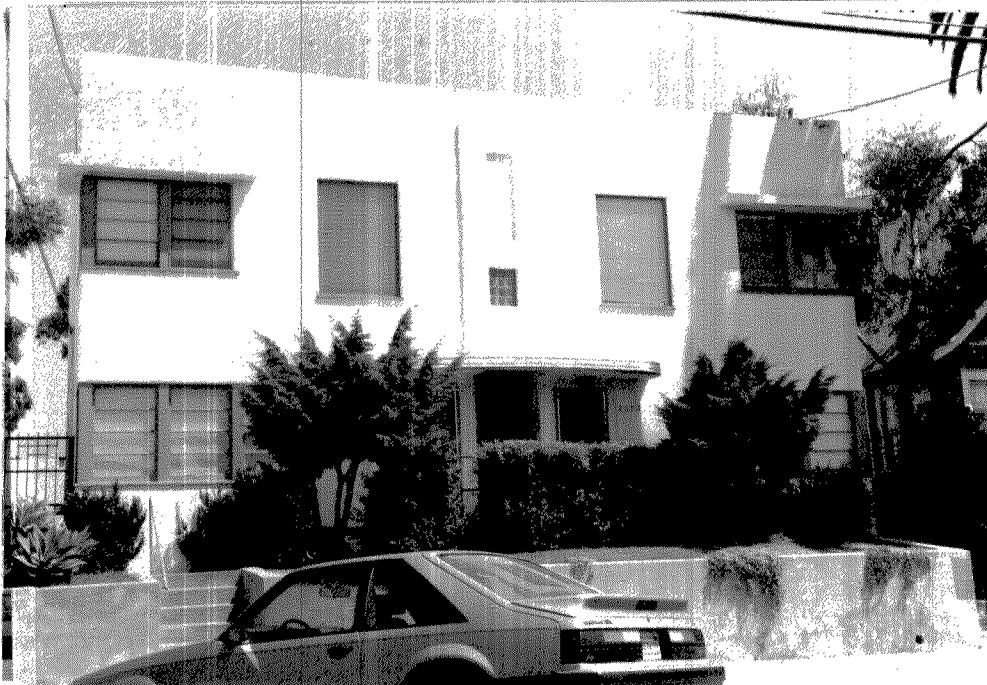
P5b. Description of Photo: (View, date, etc.)
Photo Number: 120-25
Date: June-October 1995

*P3a. Description: (Describe resource and its major elements. Include design, materials, condition, alterations, size, setting, and boundaries.)
Condition: Good

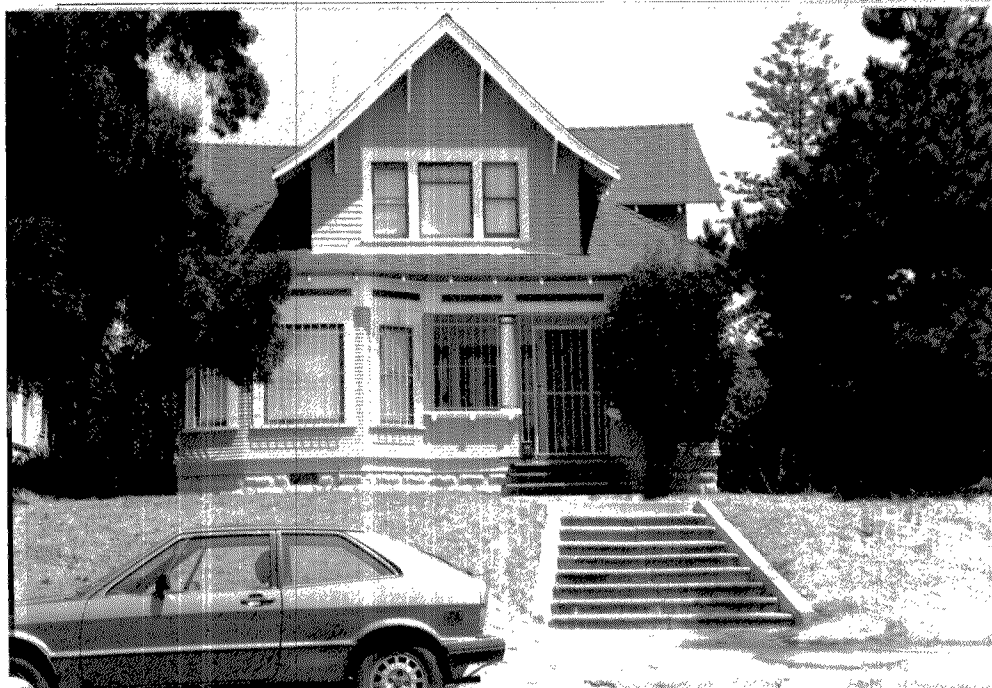
P5b. Description of Photo: (View, date, etc.)
Photo Number: 120-31
Date: June-October 1995

*P3a. Description: (Describe resource and its major elements. Include design, materials, condition, alterations, size, setting, and boundaries.)
Condition: Good
