HISTORICAL GREATER MID-CITY SAN DIEGO PRESERVATION STRATEGY

VOLUME 2

**HISTORIC
RESOURCES
INVENTORY FORMS
(DPR 523)
APN 452-705-02
THROUGH
APN 534-411-41**

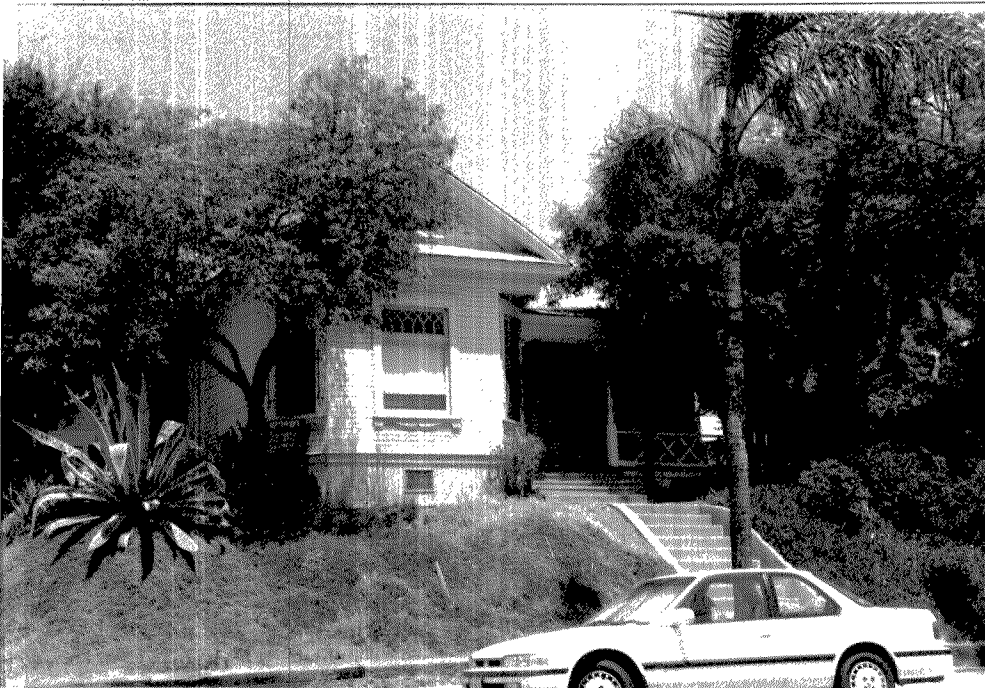
P5b. Description of Photo: (View, date, etc.)
Photo Number: 120-32
Date: June-October 1995

*P3a. Description: (Describe resource and its major elements. Include design, materials, condition, alterations, size, setting, and boundaries.)
Condition: Good

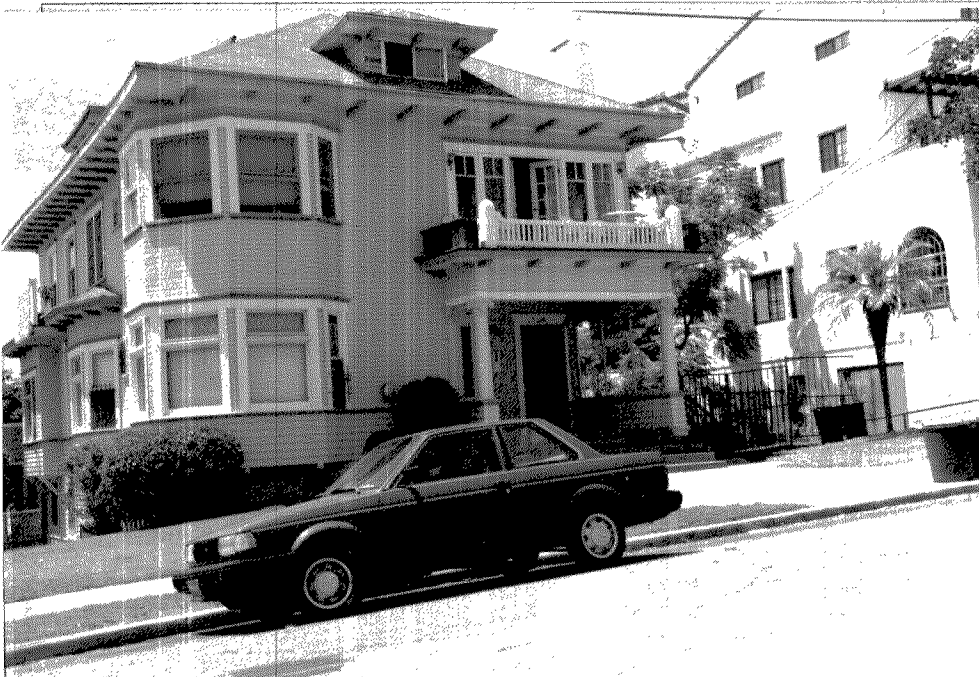
Photo Number: 121-08

*P3a. Description: (Describe resource and its major elements. Include design, materials, condition, alterations, size, setting, and boundaries.)
Condition: Good
