INDIVIDUAL BIOLOGICAL ASSESSMENT REPORT

Site Name/Facility:	<u>Cottonwood Channel Emergency Maintenance</u>
Master Program	
Map No.:	<u>120 & 121</u>
Date:	<u>February 10, 2016</u>
Biologist Name/Cell	<u>Scott Gressard (858-997-6874), Shana Carey (760-334-1993), and Paul</u>
Phone No.:	<u>Lemons (760) 479-4238</u>

Cottonwood Channel (MMP Map 120 & 121) - Emergency Channel Maintenance

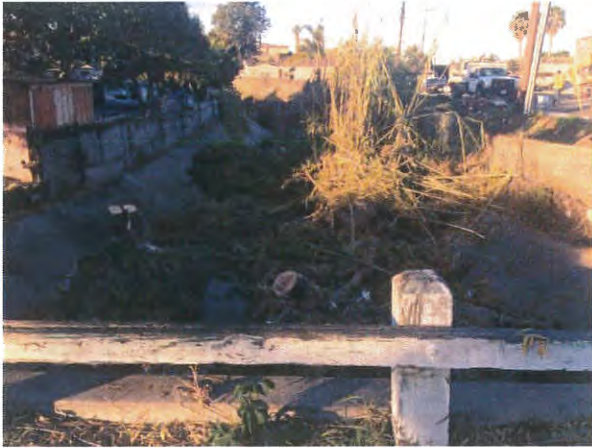
(December 27, 2015; 7:42am)

Photograph 1: Looking downstream (west) from 43rd Street/Nordica Avenue toward 42nd Street. (Photo shows the east end of MMP Map 120; Figure 3a).

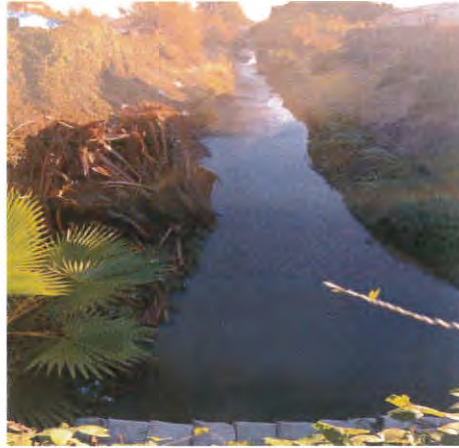
(December 29, 2015; 8:15am)

Photograph 2: Looking upstream (east) towards 43rd Street from 42nd Street at the proposed access/staging area. Sandbags are in place to prevent sedimentation downstream.

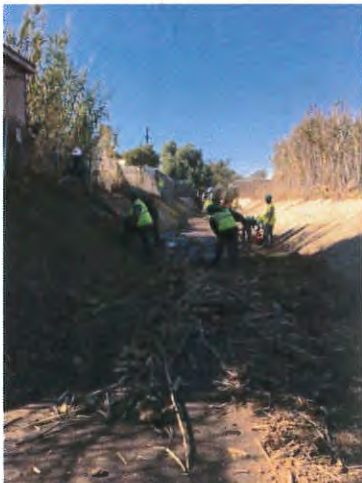
(December 29, 2015; 11:20am)

Photograph 3: Looking downstream (west) from inside the channel towards 42nd Street. Urban Corp. are seen here removing stands of Arundo growing in the east end of MMP Map 120; Figure 3a.

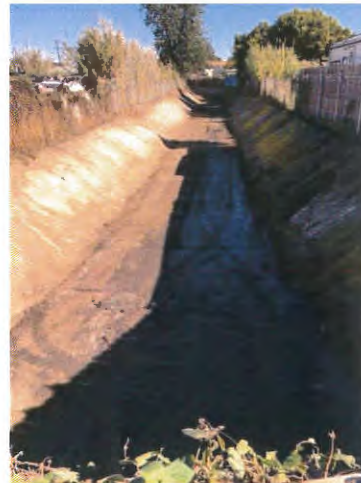
(December 29, 2015; 12:24pm)

Photograph 4: Looking upstream (east) while standing at the staging area on 42nd Street following completion of maintenance activities for the portion of channel east of 42nd Street.

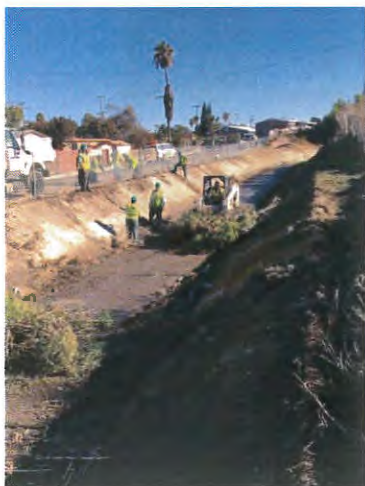
(December 30, 2015; 10:09am)

Photograph 5: Looking upstream (east) towards 41st Street from the south side of channel at the bobcat transporting sediment and vegetation for the excavator to pick up. This portion of the channel is running parallel to Cottonwood Street.

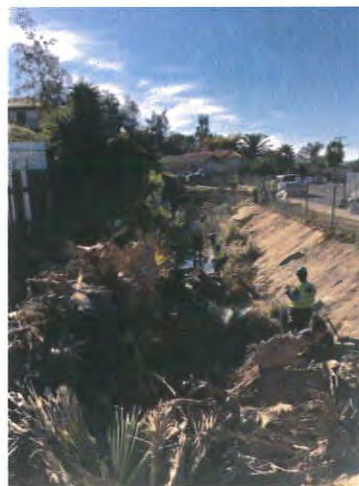
(December 30, 2015; 1:45pm)

Photograph 6: Looking downstream (west) at small portion of channel immediately west of 40th Street and parallel to Cottonwood Street. Urban Corp. are removing sediment and vegetation in preparation for excavation.

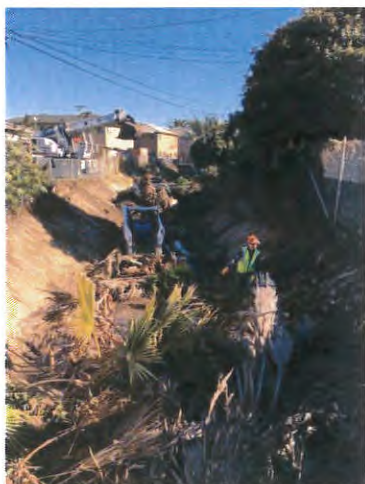
(December 31, 2015; 11:03am)

Photograph 7: Looking upstream (east) while standing at the access/staging Area on Osborn Street at crews removing sediment and vegetation (Photo shows west end of MMP Map 121; Fig 3b).

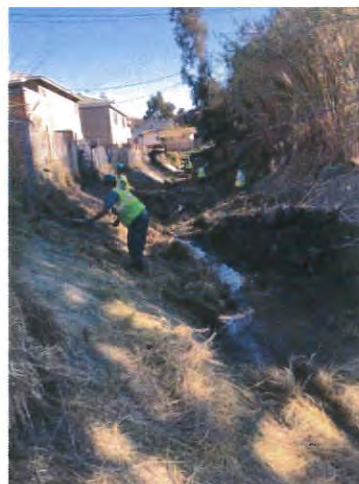
(December 31, 2015; 11:12am)

Photograph 8: Looking upstream (east) at the portion of channel needing maintenance that is closest to Osborn Street (MMP Map 121; Fig 3b). Urban Corp. are removing sediment and vegetation for bobcat to transport to excavator.

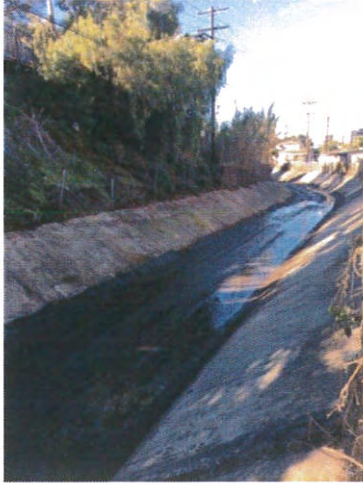
(January 1, 2016; 9:50am)

Photograph 9: Looking downstream (west) at the portion of channel between closest to Osborn Street following completion of maintenance activities.

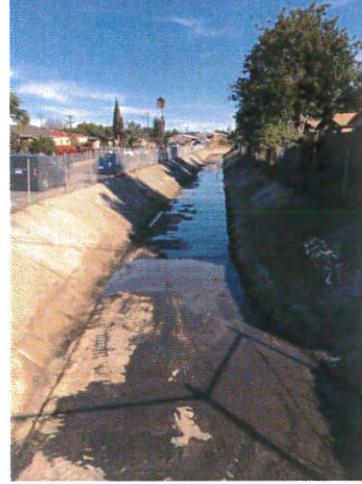
(January 1, 2016; 1:47pm)

Photograph 10: Looking upstream (east) at the portion of channel parallel to Cottonwood Street between 40th and 41st Streets following completion of maintenance activities.
