ALVARADO CREEK AFFORDABLE HOUSING PROJECT BIOLOGICAL SURVEY REPORT

CITY OF SAN DIEGO, SAN DIEGO COUNTY, CALIFORNIA

Revised May 2, 2022

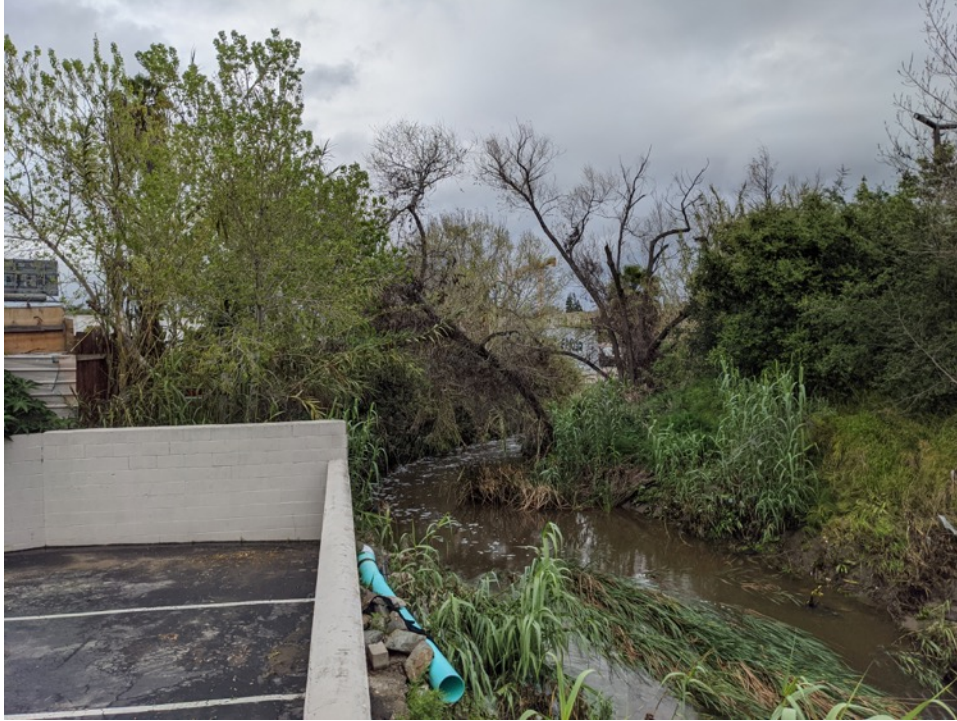
Photo 1: Northeast-facing view of the interface between Urban/Developed, Disturbed Wetland/ Non-vegetated Channel, and Southern Riparian Woodland habitats. New stormwater outflow headwall proposed for installation to the north of the current stormwater outflow pipe (light blue) visible next to the concrete wall. Photo taken from within the 100-ft Survey Area, south of the Project Boundary (Parcel 461-320-06-00).

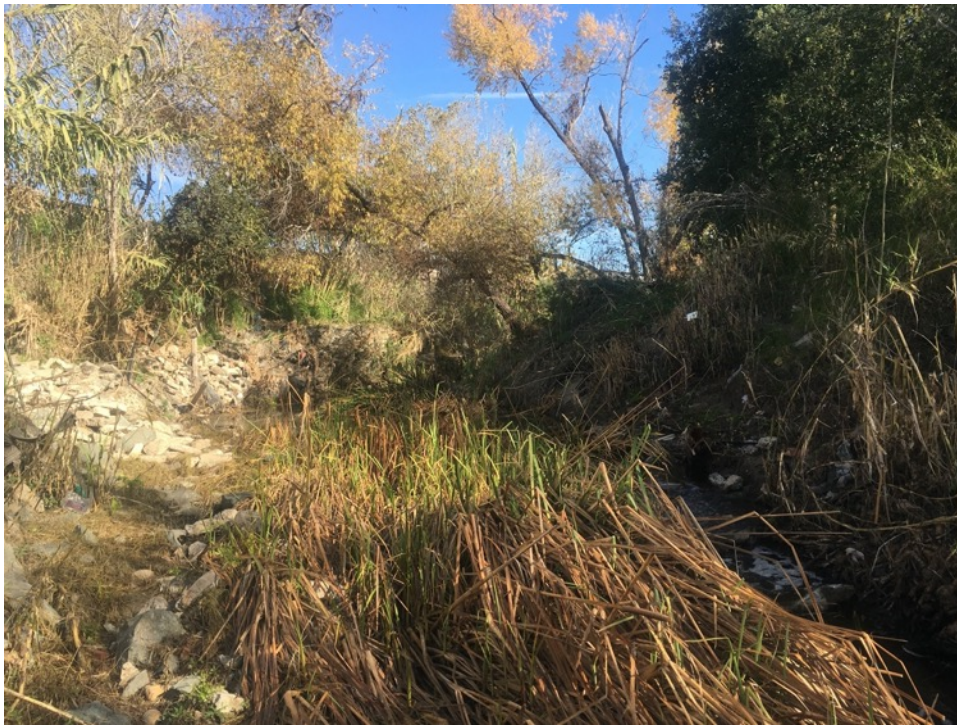
Photo 2: North-facing view of the Disturbed Wetland/ Non-vegetated Channel surrounded by Non-native Riparian habitat and Southern Riparian Woodland (top right). Rip-rap and debris visible within the channel bottom. This photo was taken near the southern portion of the Project Boundary (parcel 461-320-06-00).

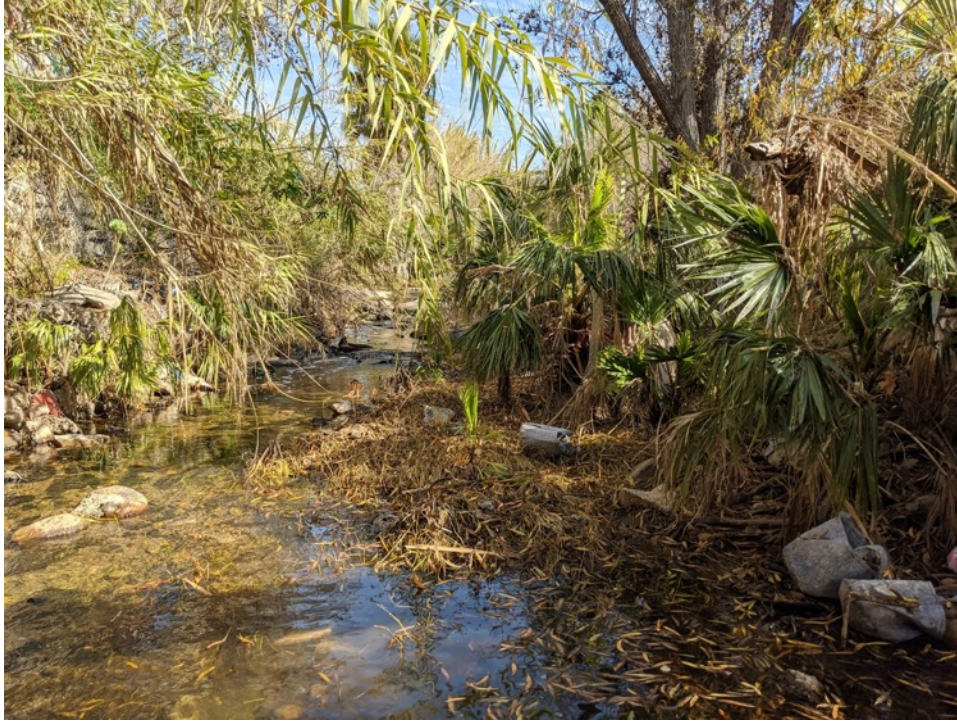
Photo 3: Northeast-facing view of Non-native Riparian habitat bisected by the Disturbed Wetland/ Non-vegetated Channel within the Project Area (parcel 461-320-06-00). Some examples of the anthropogenic disturbances (trash and debris) observed on-site, are represented in this photo.

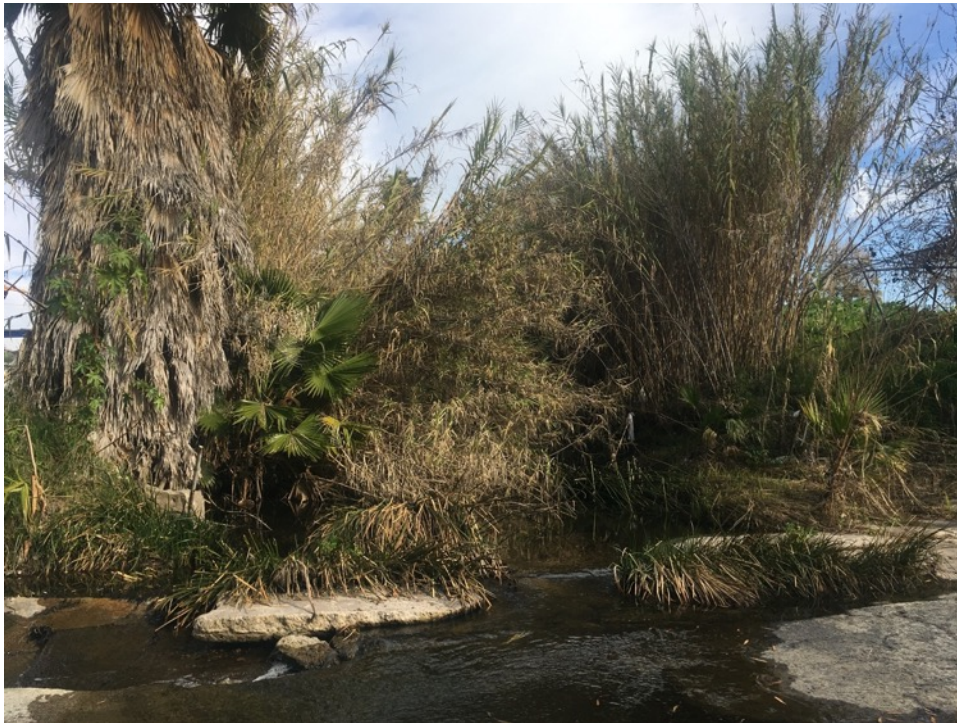
Photo 3: East-facing view of Non-native Riparian and Arundo-dominated Wetland habitats at the northwestern boundary of parcel 461-320-08-00. Existing road and Arizona crossing (visible at the bottom of this photo) are located at the intersection of all three parcels, 461-320-06-00 (to the west), 461-320-09-00 (to the northeast), and 461-320-08-00 (to the southeast).

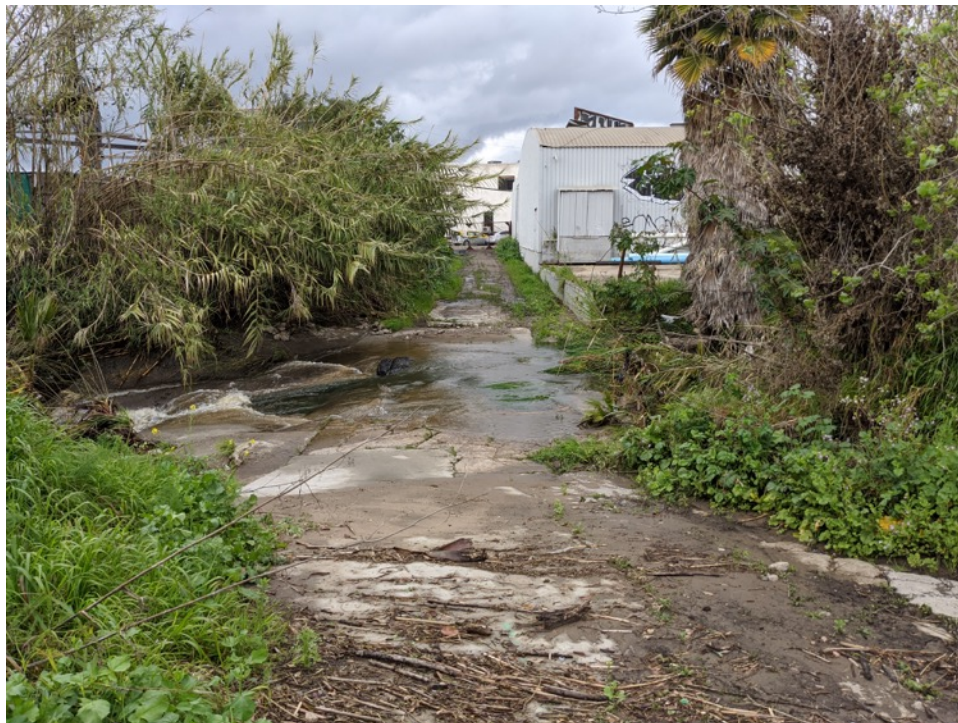
Photo 4: North northwest-facing photo of the existing road and Arizona crossing which intersect all three parcels. Temporary stormwater outflow headwall and permanent impacts proposed include installation of rip-rap for erosion control are proposed within Alvarado Creek.

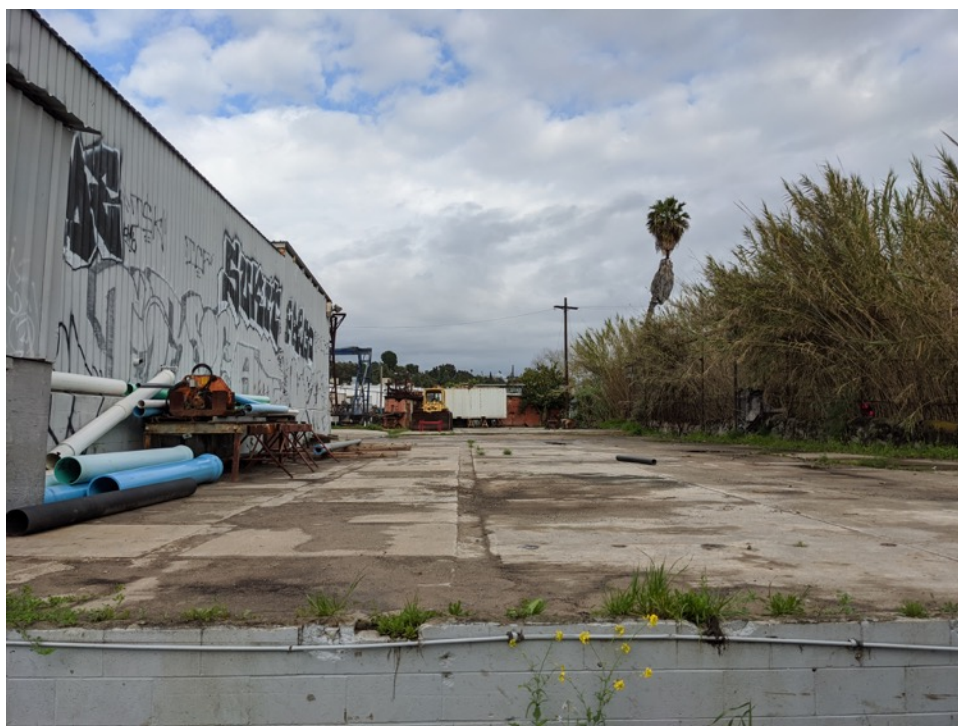
Photo 5: East-facing view of the commercial lot within parcel 461-320-09-00, northeast of the Arizona crossing. Temporary underground stormwater pipe will run east to west within this lot, and will terminate to the right, into Alvarado Creek. Arundo-dominated Wetland visible along the right side of the photo.

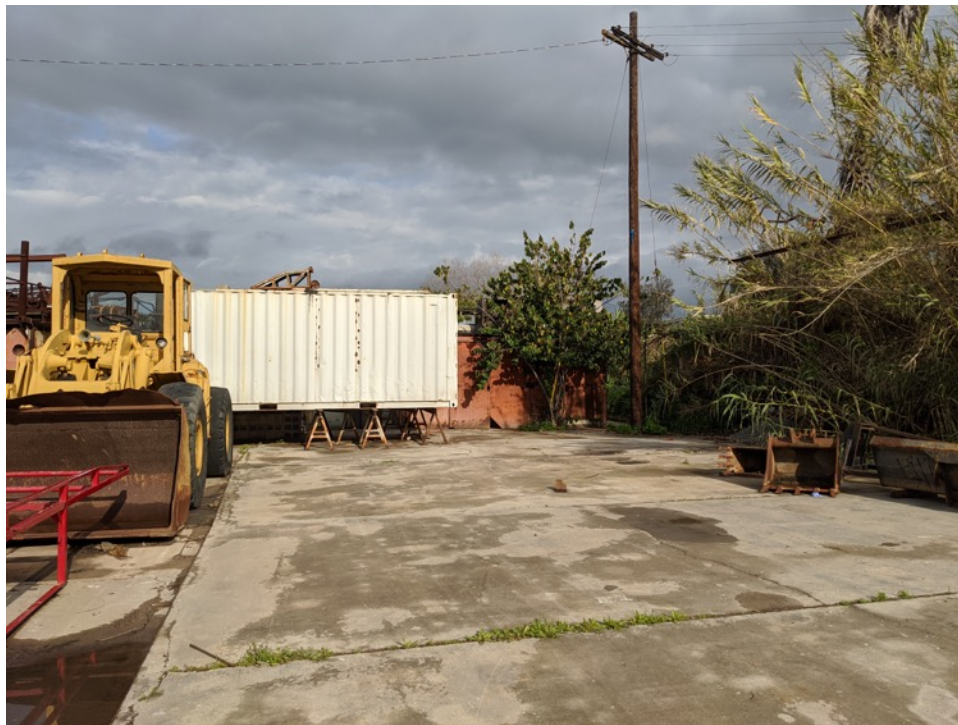
Photo 6: East-facing photo within the southeast corner of parcel 431-320-09-00, north of Alvarado Creek. Approximate location of a permanent stormwater outflow headwall into Alvarado Creek shown right of frame.

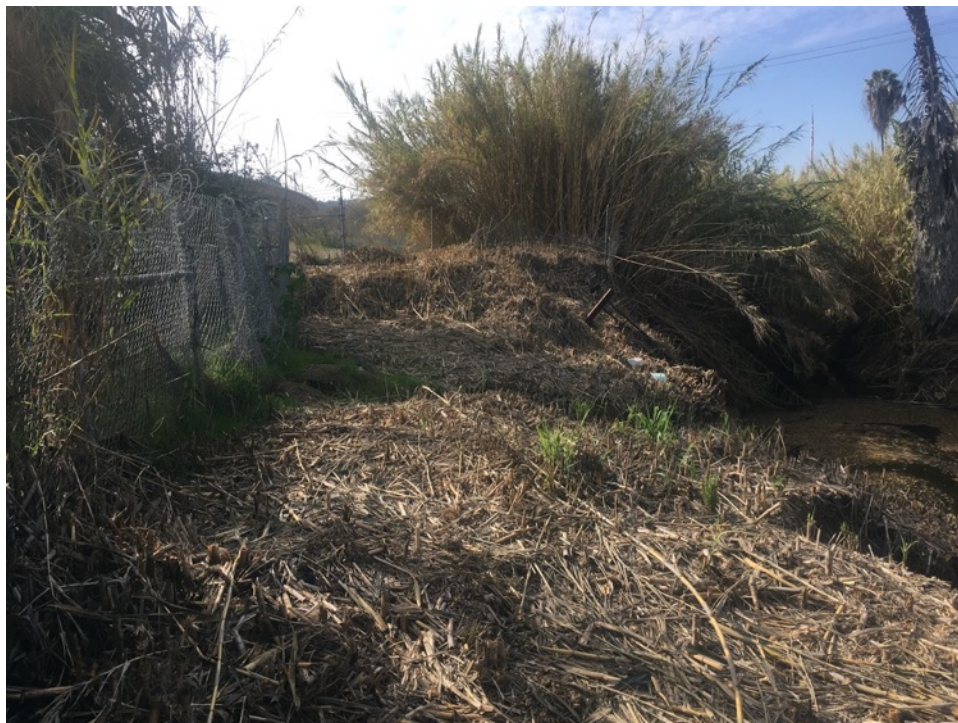
Photo 7: West-facing view of recently treated giant reed (*Arundo donax*) within the *Arundo*-dominated Wetland habitat, located at the eastern end of the Project (parcel 461-320-08-00) and the Survey Area. Untreated sections of giant reed with Project visible in the background of the photo.

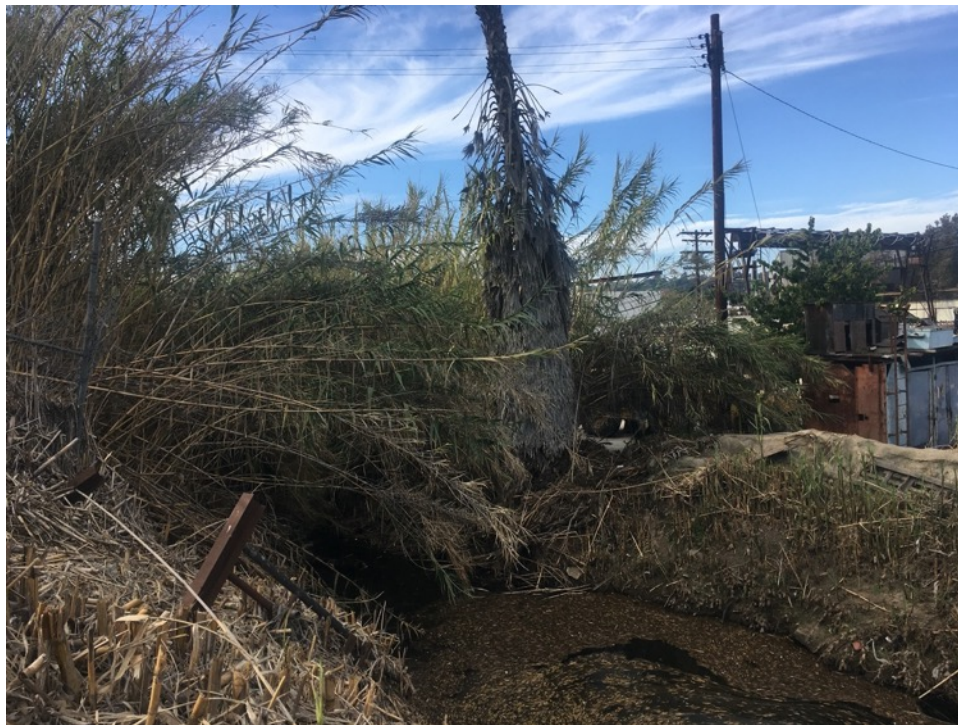
Photo 8: Northwest-facing view of where the sewer line relocation is proposed to cross Alvarado Creek. Permanent impacts proposed for this area include a concrete crossing. This photo was taken within the Project Boundary in the northeast corner of parcel 461-320-08-00.

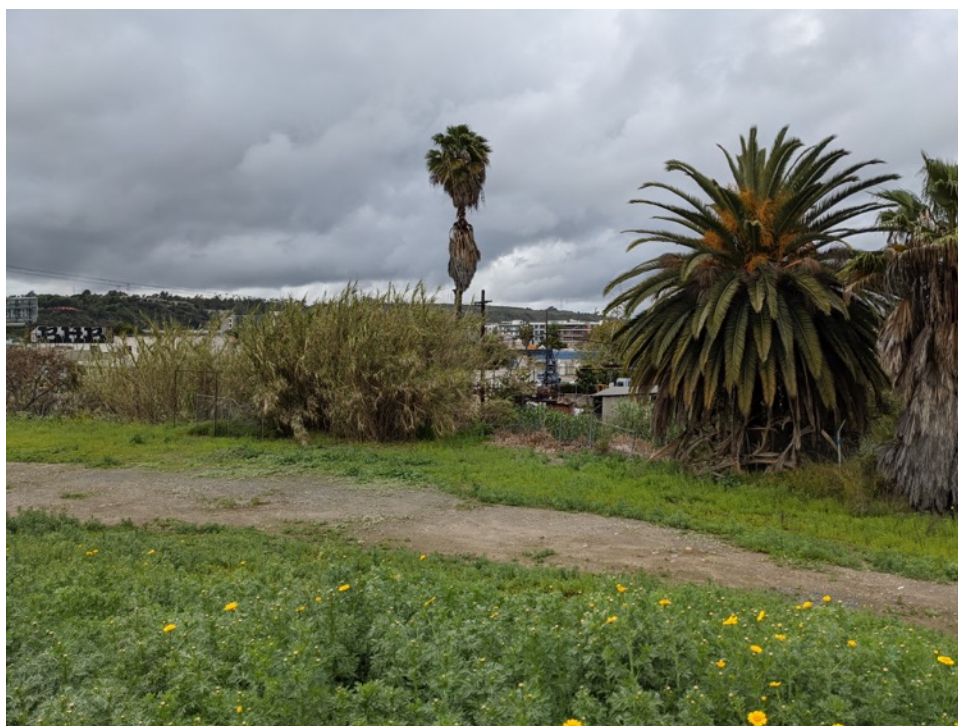
Photo 9: Northwest-facing view of the proposed sewer line to meet existing sewer line connection within parcel 461-320-08-00. Approximate sewer connection point and manhole location visible in the center foreground of this photo.

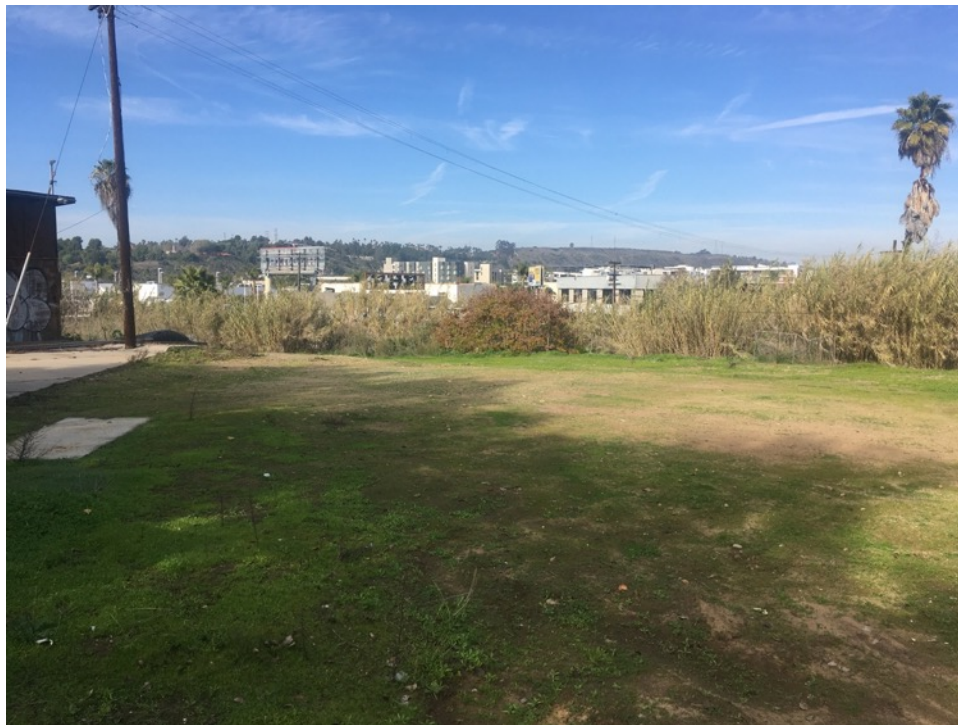
Photo 10: Northwest-facing overview of the Disturbed Land within parcel 461-320-08-00. Area shown is proposed for grading of new channel to expand the 100-year flood plain of Alvarado Creek. Area would be revegetated with wetland habitat following construction.

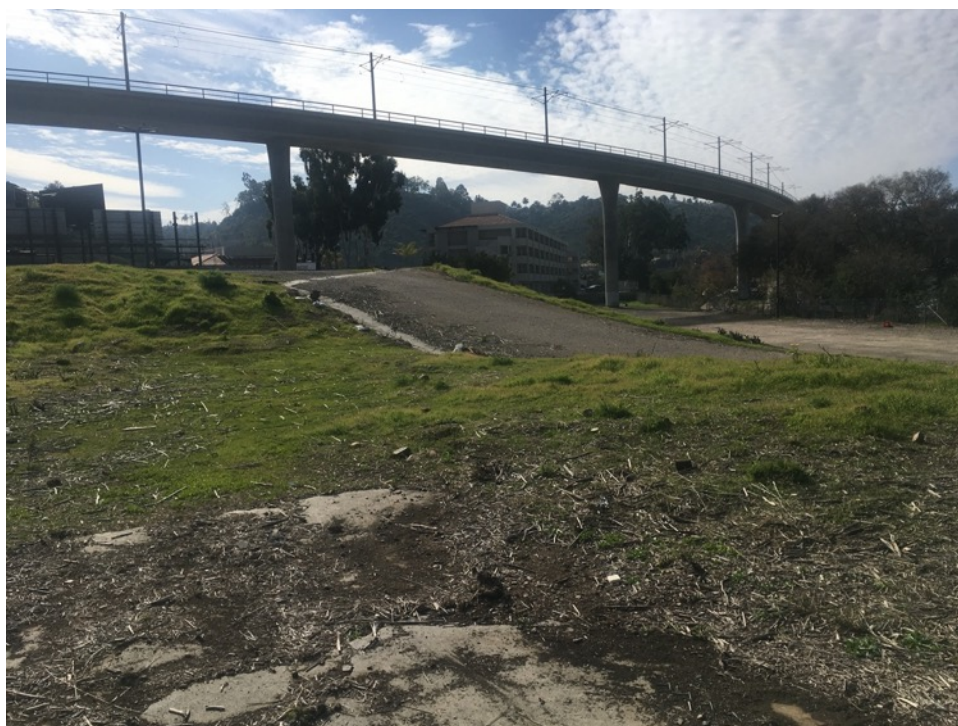
Photo 12: Southwest-facing view of the Disturbed Land within the Survey Area and south of the Project Boundary (parcel 461-320-06-00). Green Line trolley route visible in the background.

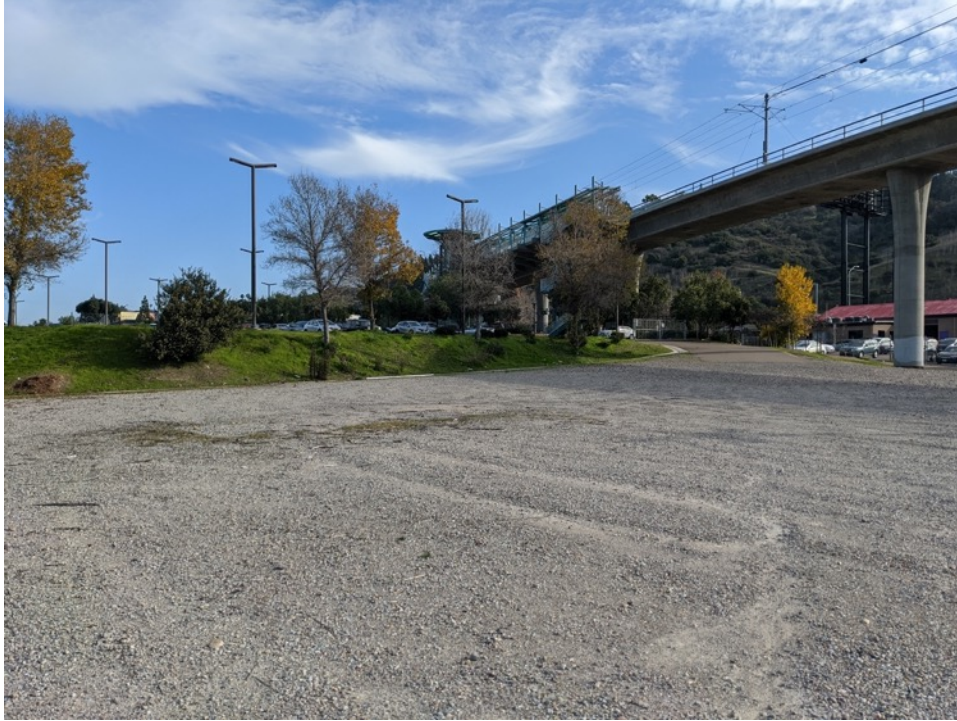
Photo 11: Southeast-facing view of the Disturbed Land and Urban/Developed habitats south of the Project Boundary (parcel 461-320-08-00). Grantville Trolley Station, parking lot, landscaped trees and vegetation visible in the photo background.

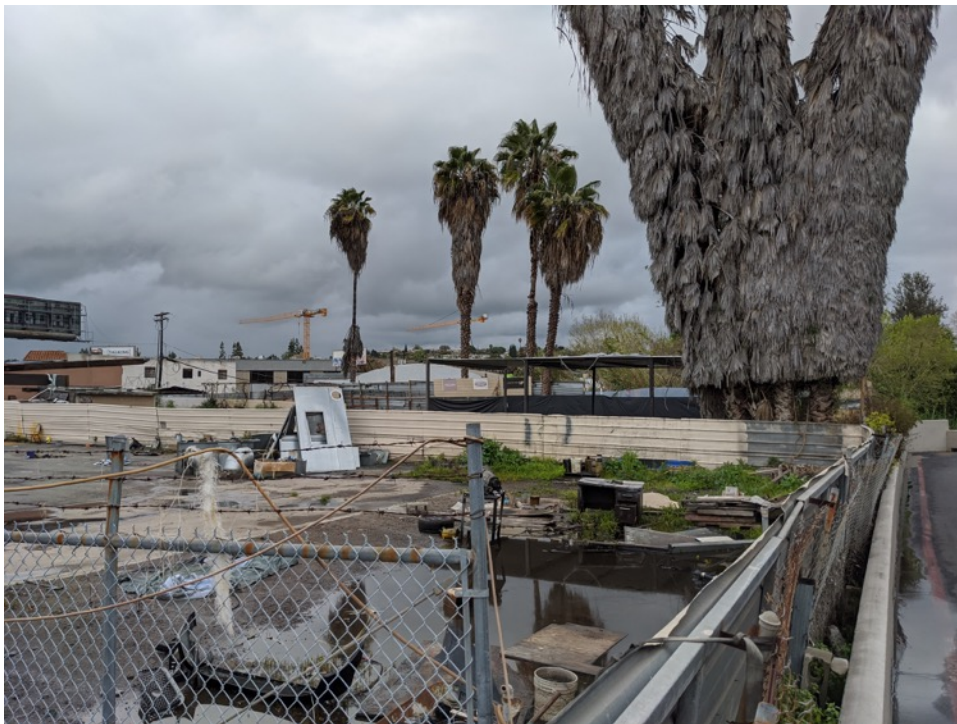
Photo 12: Northeast-facing photo of idle commercial lots and businesses within the Project Boundary; adjacent ESL visible beyond the palm trees in background. This photo was taken at the southern boundary of parcel 461-320-06-00; the concrete wall visible in the bottom right of the photo is the edge of the Project Boundary.

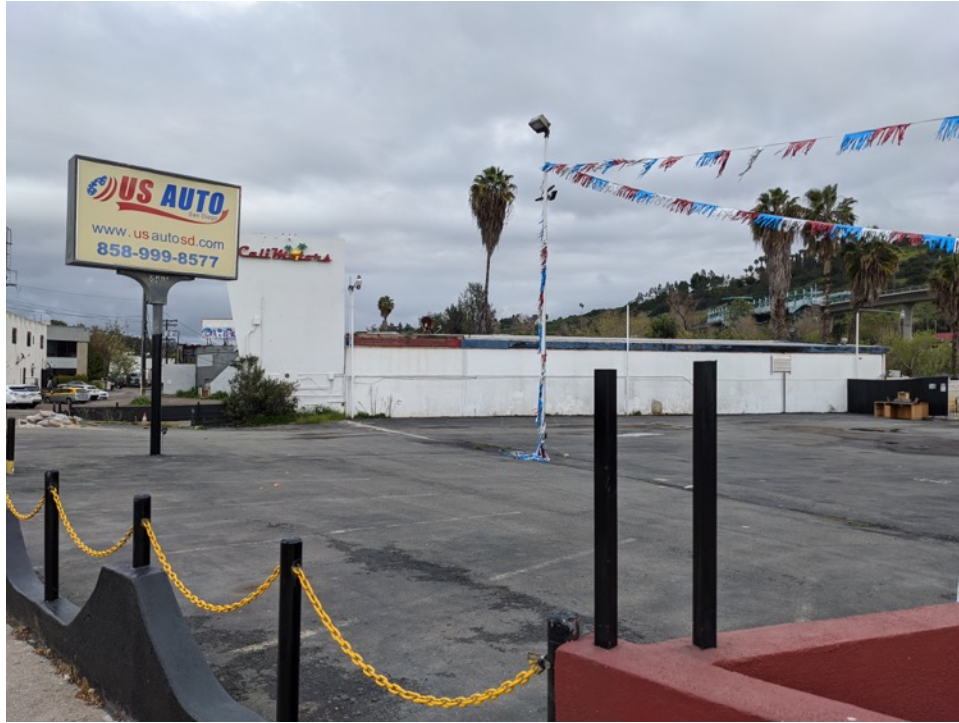
Photo 15: Southeast-facing view of the idle business parking lots and buildings within parcel 461-320-06-00; photo taken from the northwest corner of the parcel and the road shoulder of Mission Gorge Road.

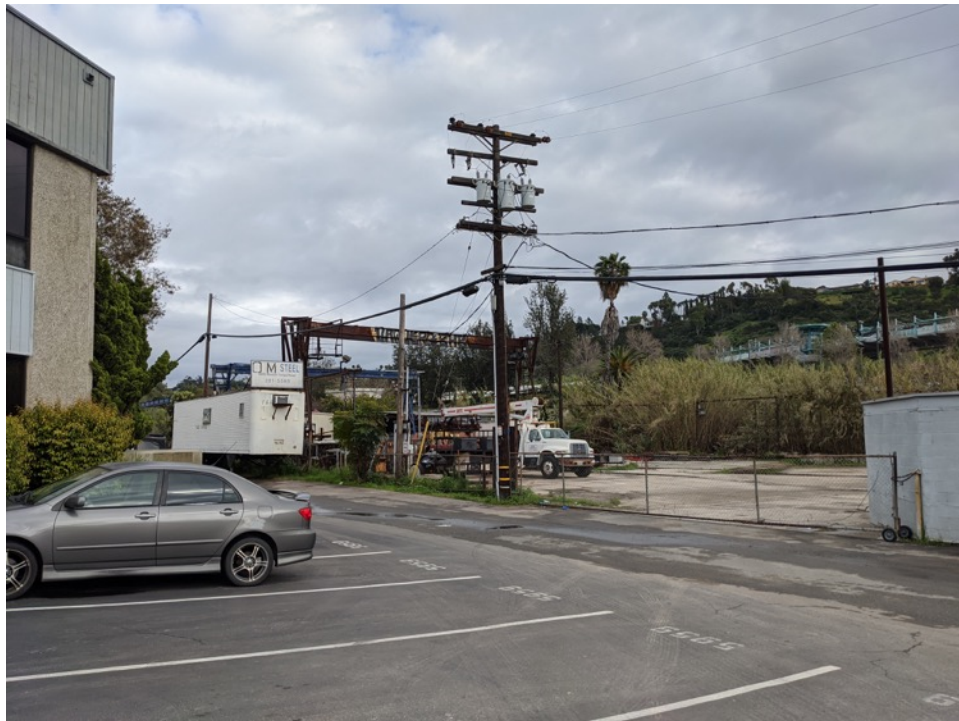
Photo 16: Southeast-facing view of parcel 461-320-09-00; the northern boundary of this parcel runs through the center of road/alley. Northernmost sewer line connection point is located to the right of the parking spaces and commercial office building (photo left).
