THE CITY OF SAN DIEGO

SUBJECT: Montezuma Creek MMP 66 (SCR), Project Review, Project No. 608835  
Department IO 21003732

Montezuma Creek Channel Maintenance

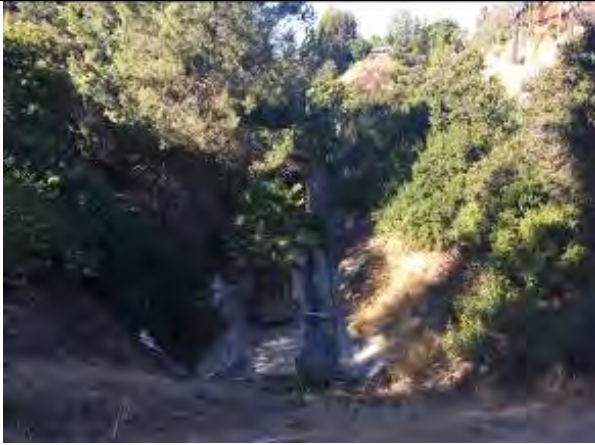
Taken from 54th Street at the eastern extent of Reach 2, facing west (downstream) toward Montezuma channel.

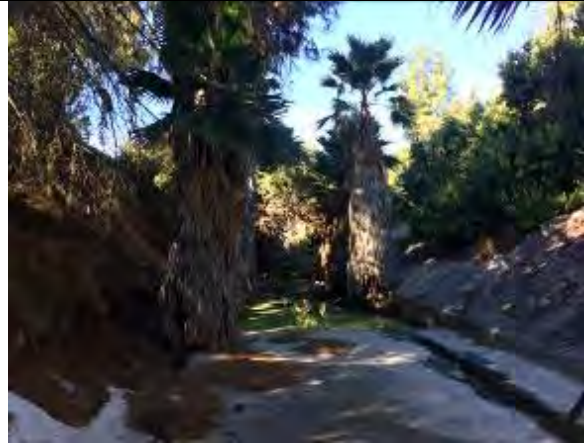
Taken within Montezuma channel, facing west (downstream) toward fan palm stand and ponded surface water at the end of the concrete-lined channel.

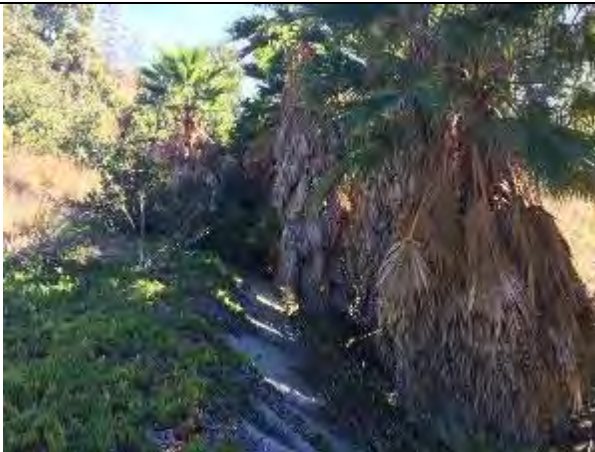
Taken from the downstream end of Reach 2, facing east (upstream) toward Montezuma Channel. Note fan palm stand in channel and iceplant dominating upland area to the north.

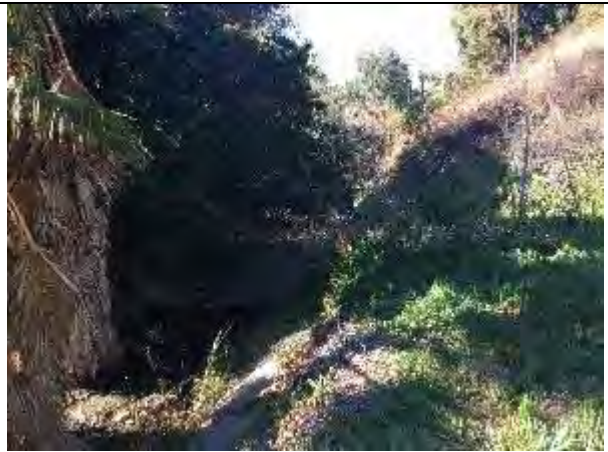
Taken from the downstream end of Reach 2, facing west (downstream) toward Montezuma Channel. The channel is concrete-lined from this point continuing west.

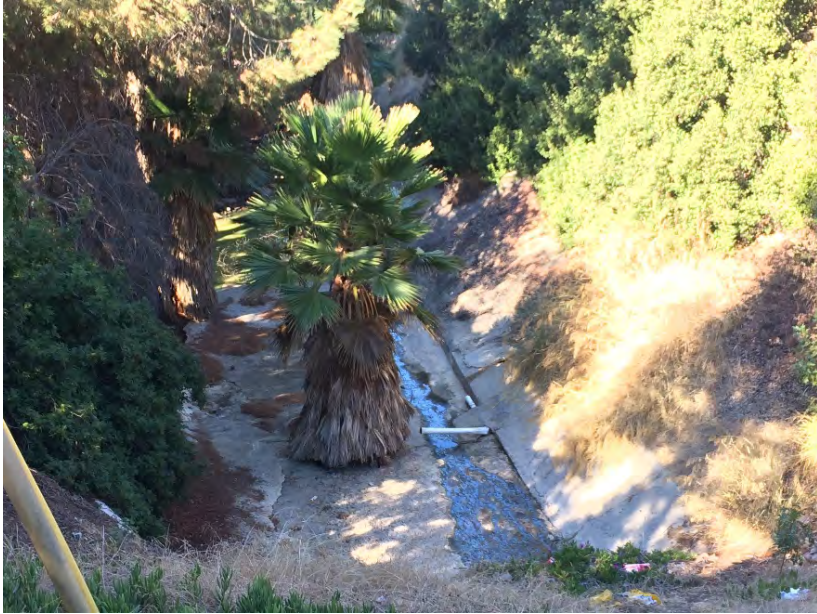
1 – East end of Reach 2, facing west.

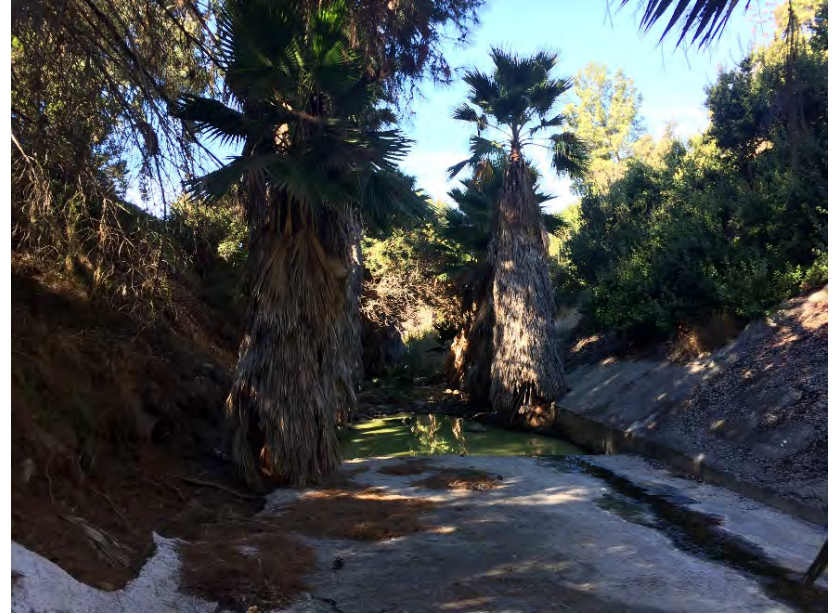
2 – Concrete-lined channel segment facing west.

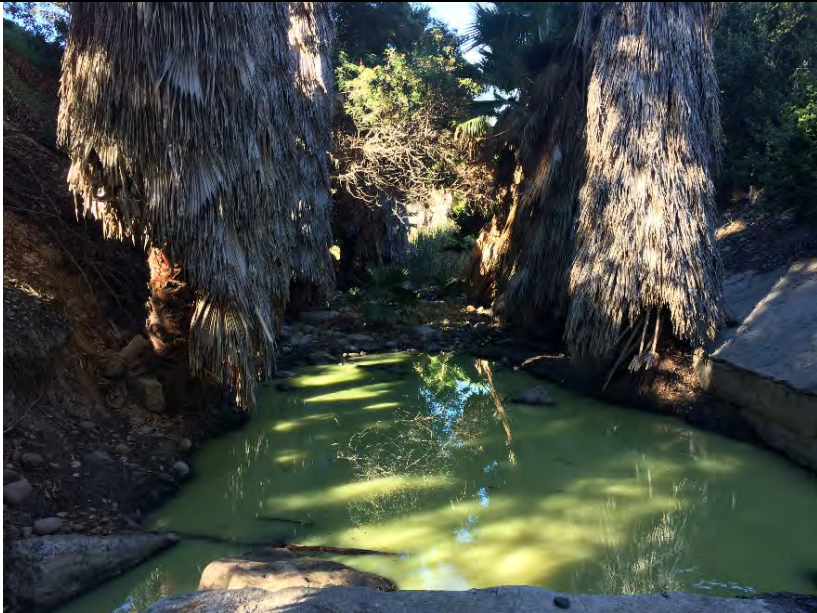
3 – End of concrete-lined channel, facing west.

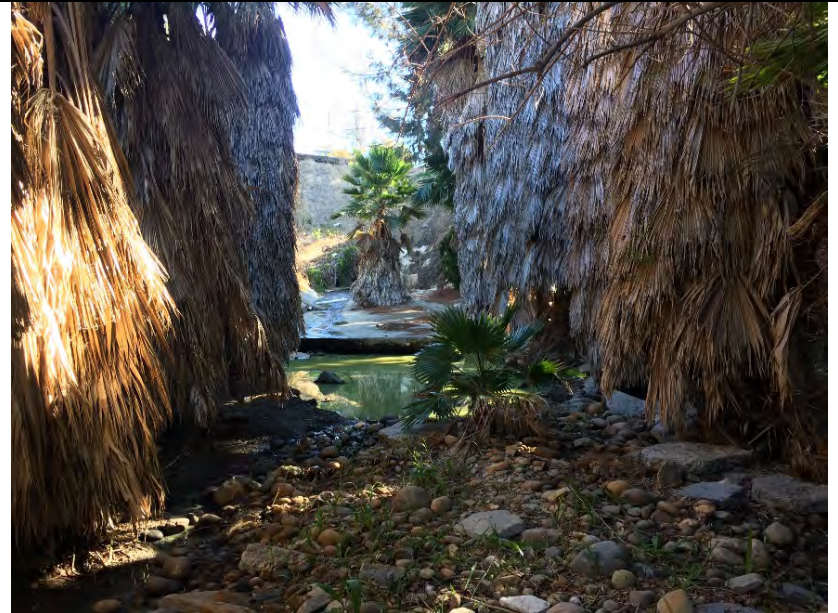
4 – Natural flood control channel with cobble substrate, facing east.

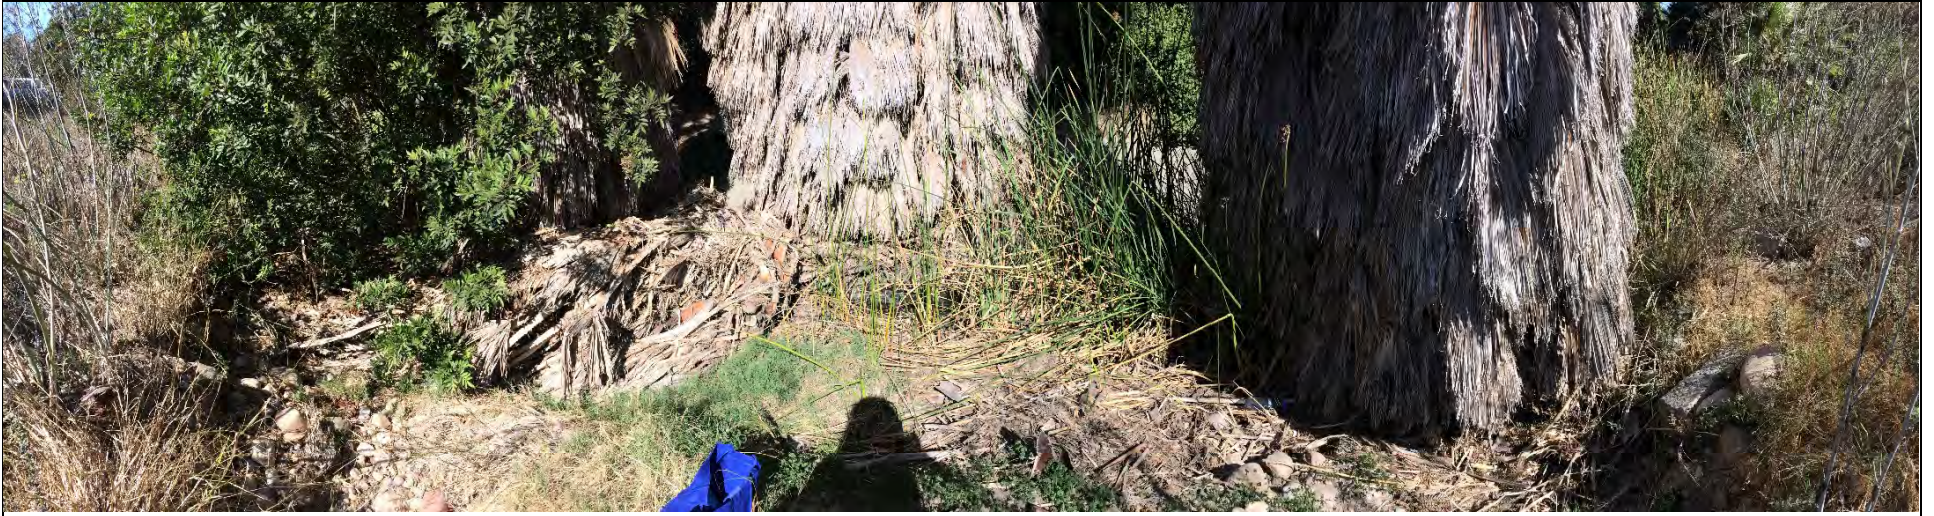
5 – Disturbed wetland (palm tree dominated), panorama going west to east.

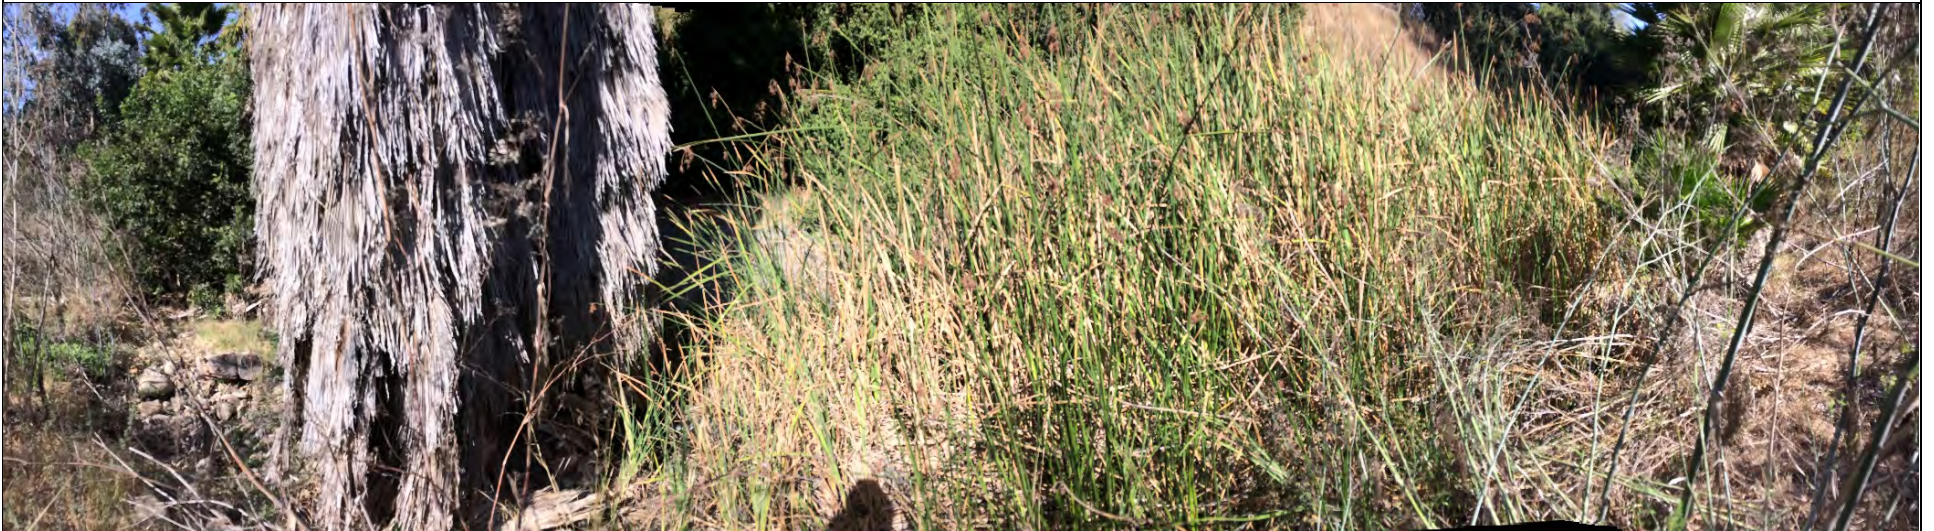
6 – Disturbed wetland (palm tree dominated) and freshwater marsh, panorama going west to east.

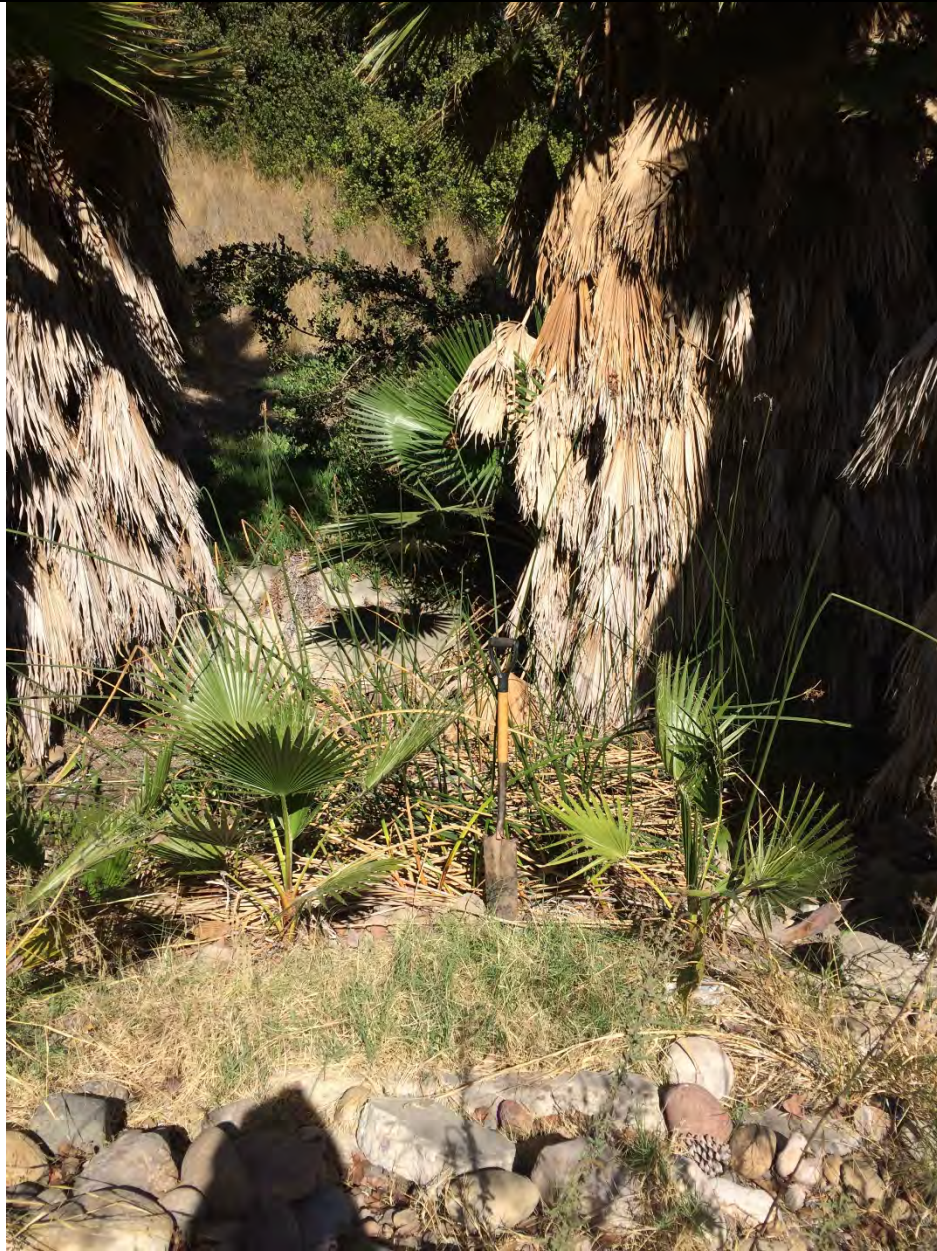
7 – Wetland Data Point W1 (wetland), facing north.

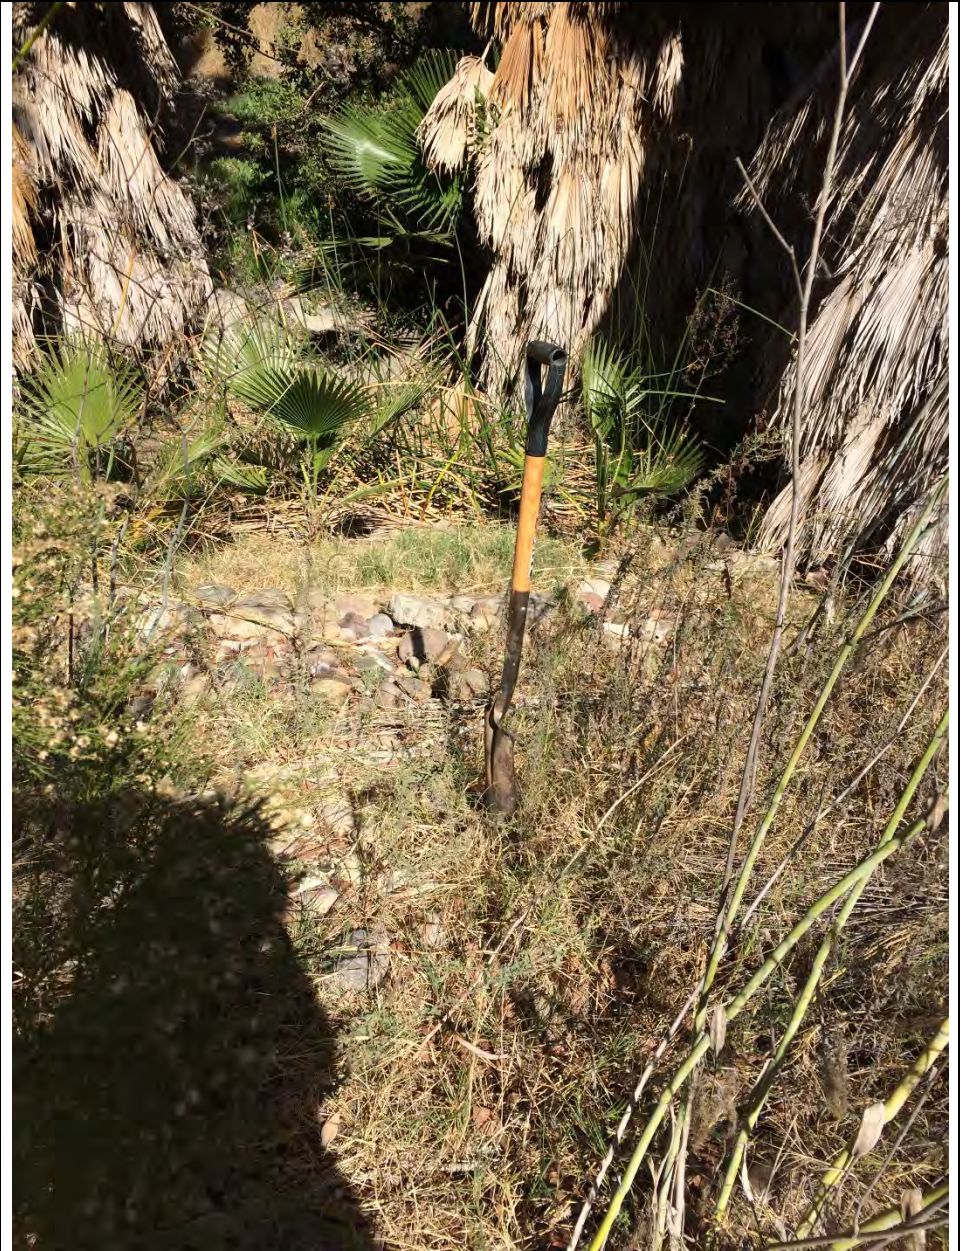
8 – Wetland Data Point U1 (upland), facing north.
