**Jurisdictional Waters/Wetland
Delineation for the San Diego Fire-
Rescue Air Operations Hangar
Project
San Diego, California**

Prepared for
Platt/Whitelaw Architects, Inc.
4034 30th Street
San Diego, CA 92104
Contact: Ms. Alison Whitelaw

Prepared by
RECON Environmental, Inc.
1927 Fifth Avenue
San Diego, CA 92101
P 619.308.9333

RECON Number 9078
December 4, 2019

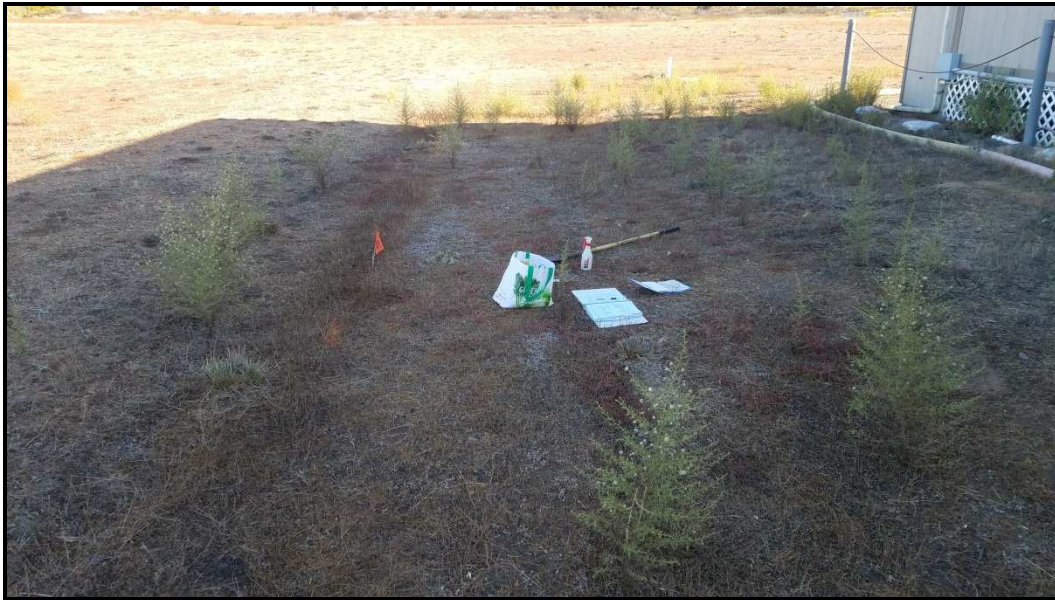
PHOTOGRAPH 3
 View of Vernal Pool in Central Portion of Project Area,
 Photopoint 3, Facing North
 Photo Date: November 1, 2019

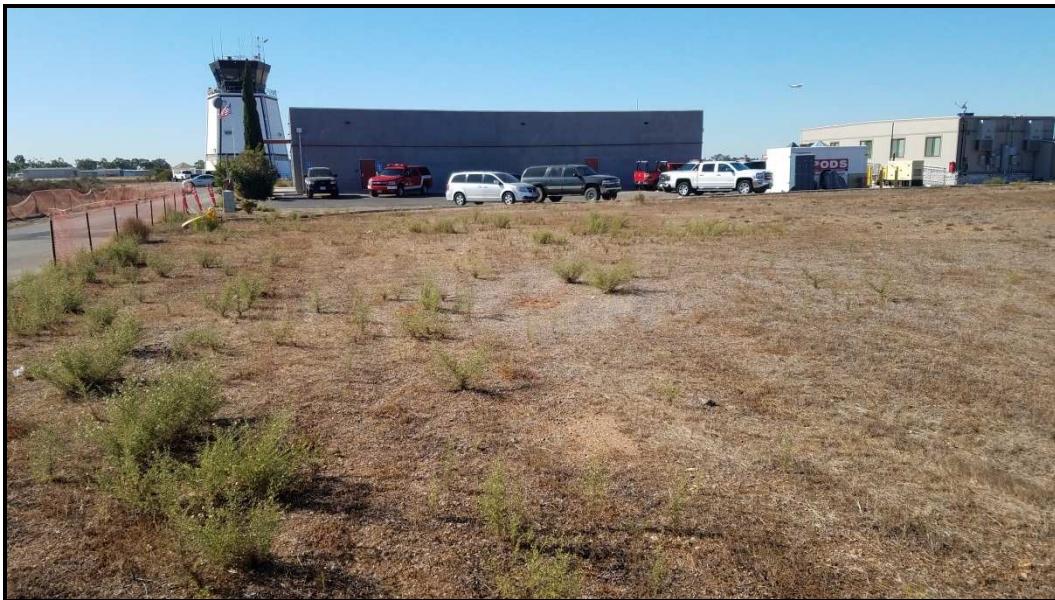
PHOTOGRAPH 4
 View of Vernal Pool in Eastern Portion of Project Area,
 Photopoint 4, Facing Southwest
 Photo Date: November 1, 2019

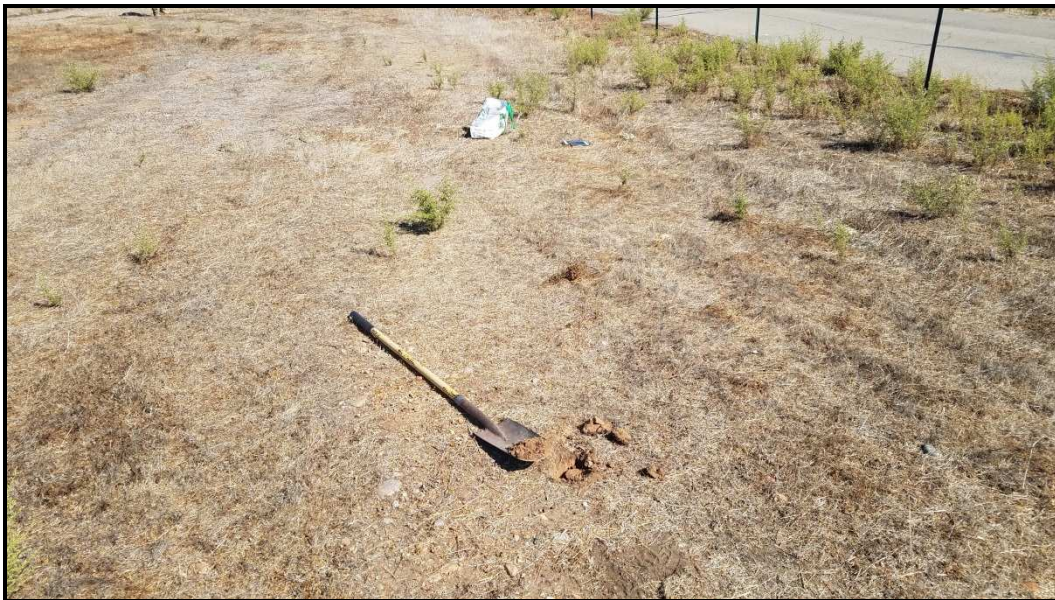
PHOTOGRAPH 6
View of Vernal Pool in Northeastern Portion of Project Area,
Photopoint 6, Facing Northeast
Photo Date: November 1, 2019

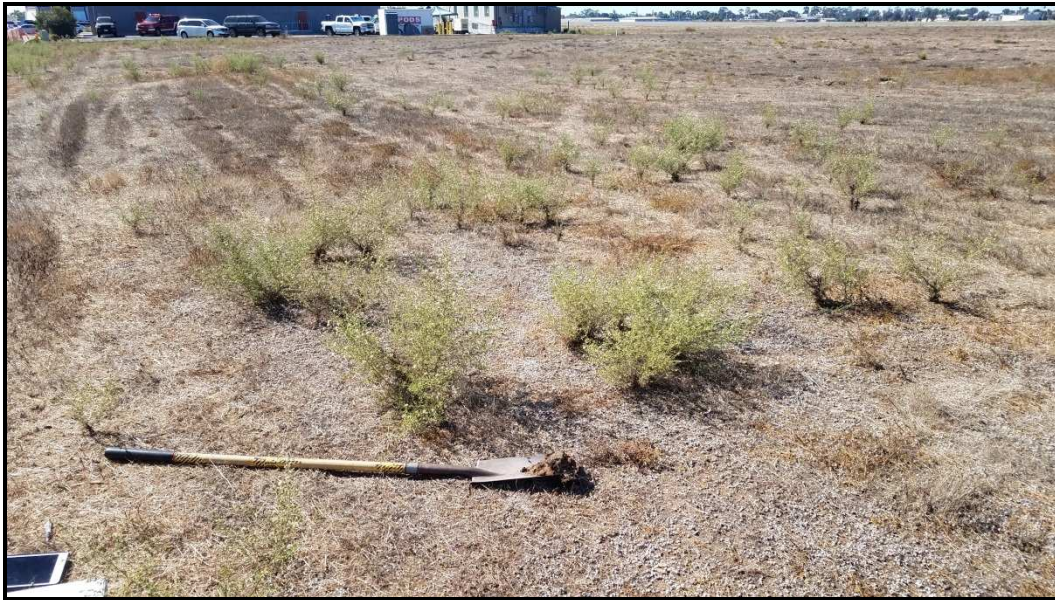
PHOTOGRAPH 7
View of Vernal Pool in Northeastern Portion of Project Area,
Photopoint 7, Facing Southwest
Photo Date: November 1, 2019

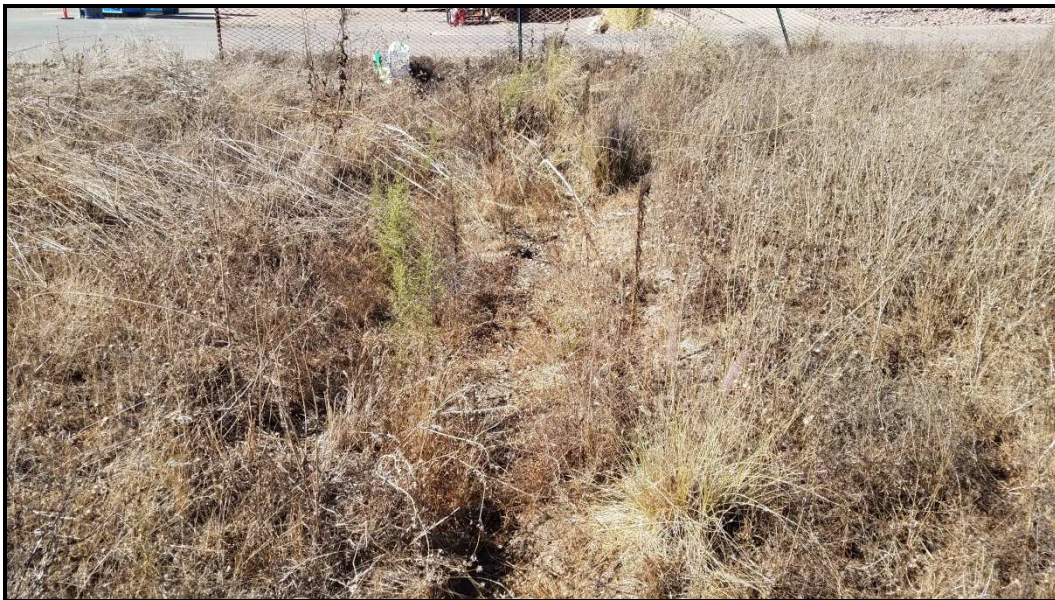
PHOTOGRAPH 8
View of Swale in East-Central Portion of Project Area,
Photopoint 7, Facing West
Photo Date: November 1, 2019

As mentioned above, the swale in the southeastern portion of the Review Area is fed by a culvert leading from the existing developed structures. The vegetation observed within this swale includes a number of herbaceous hydrophytic plant species, including hyssop loosestrife, tall flatsedge (*Cyperus eragrostis*; FACW), and toad rush (*Juncus bufonius*; FACW). Outside of the swale, the surrounding upland areas contained Diegan coastal sage scrub dominated by California buckwheat (*Eriogonum fasciculatum*; no indicator [NI]) and red brome.

One hydric soil indicator, redox depressions, was observed within the wetland swale (see Attachment 3, WDP 12). This swale appears to function as a depression based on local topography, but it does not contain vernal pool indicator plant species. Both biotic crusts and non-riverine sediment deposits were observed during the survey. This swale has direct connectivity to a drainage that occurs just outside the Review Area which receives overflowing water from the swale. From here, water is conveyed southward off-site through a culvert and into a series of storm drains and canyons as part of the downstream watershed.
