Subject: 3020 AND 3030 CALLAN ROAD
SAN DIEGO, CALIFORNIA
PHASE I ENVIRONMENTAL SITE ASSESSMENT

PHASE I ENVIRONMENTAL SITE ASSESSMENT

3020 AND 3030 CALLAN ROAD
SAN DIEGO, CALIFORNIA

PROJECT NO. 09763-06-01

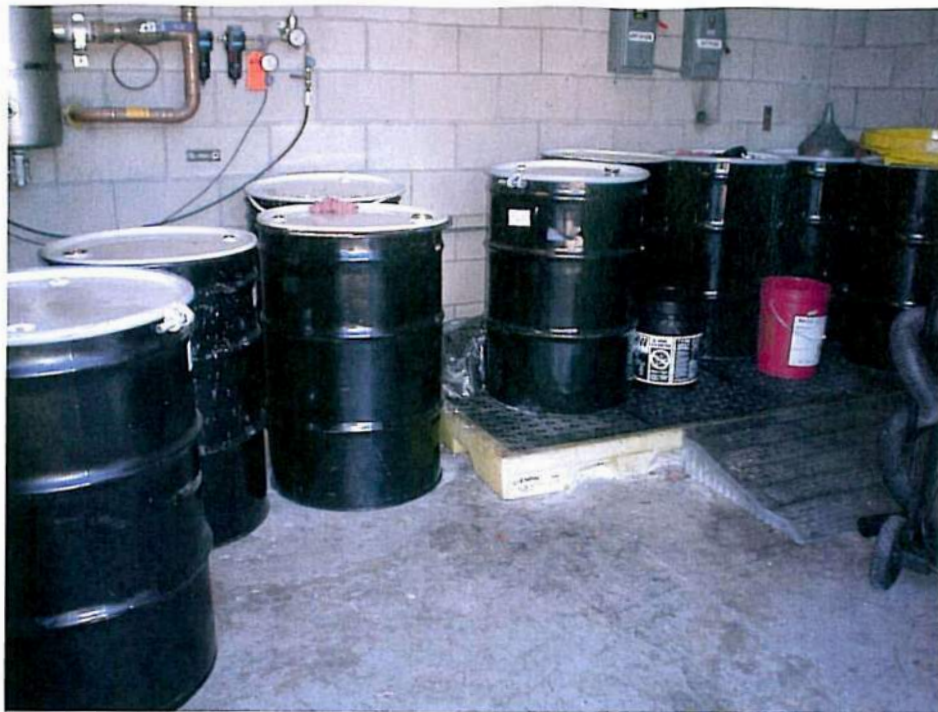
Photograph #3
Empty drums and drums containing waste oil and coolant within the hazardous waste storage room located on first floor of the site building.

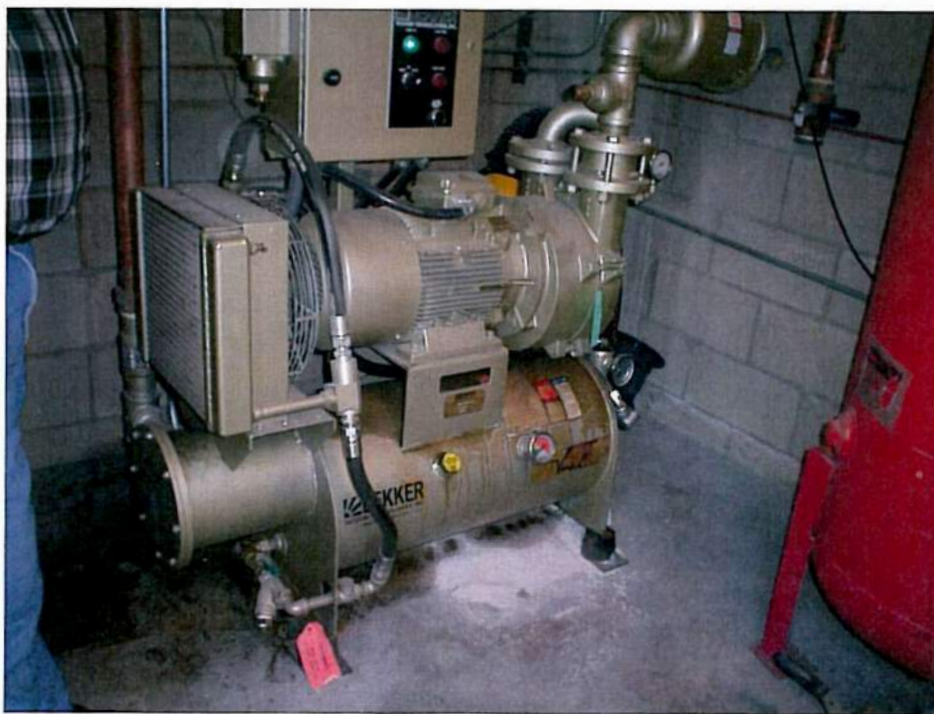
We observed evidence of leaked oil and de minimis areas of staining on the concrete flooring beneath a mechanical vacuum pump located within the hazardous waste storage room. Absorbent material, some of which was saturated with oil, was observed beneath the pump. Mr. Hand indicated that the absorbent material was placed beneath the pump in an effort to capture oil from an ongoing leak. The concrete within the hazardous waste storage room appeared to be in good condition with no evidence of cracks or corrosion.

Photograph #4
Vacuum pump located within the hazardous waste storage room.

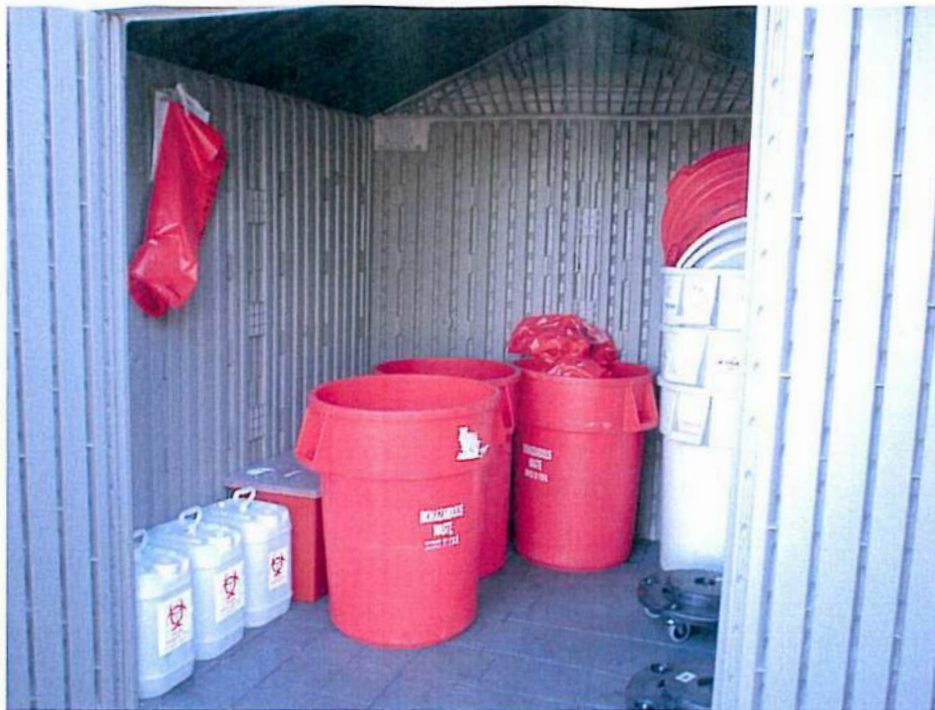
Photograph #5

Biohazardous waste storage shed located immediately northeast of the site building.

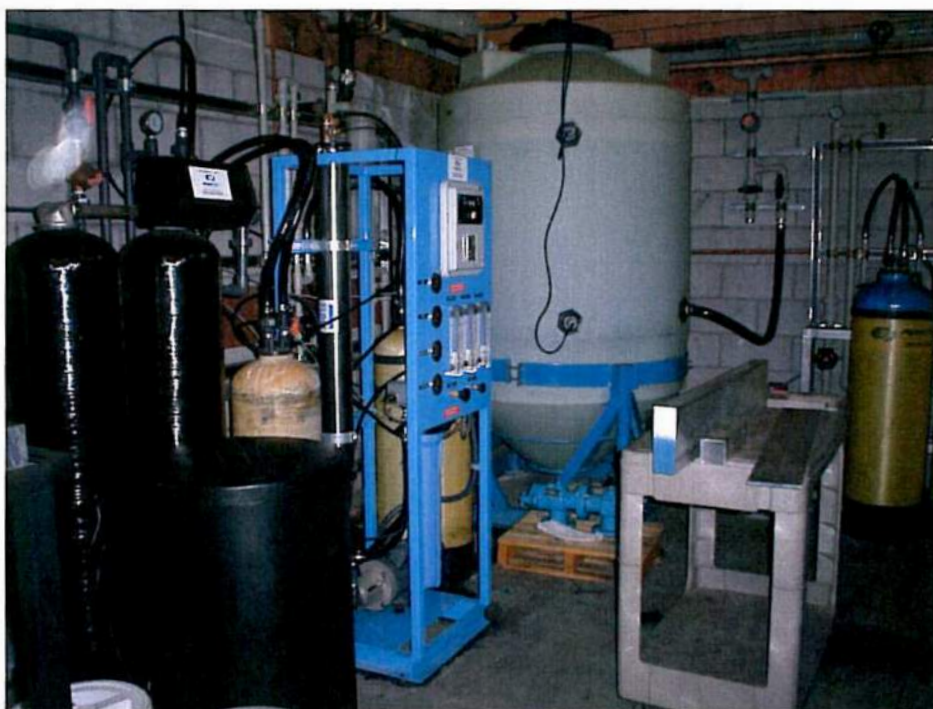
Photograph #6

**Equipment within the deionized (DI) water shed
located in the northeastern portion of the Site.**

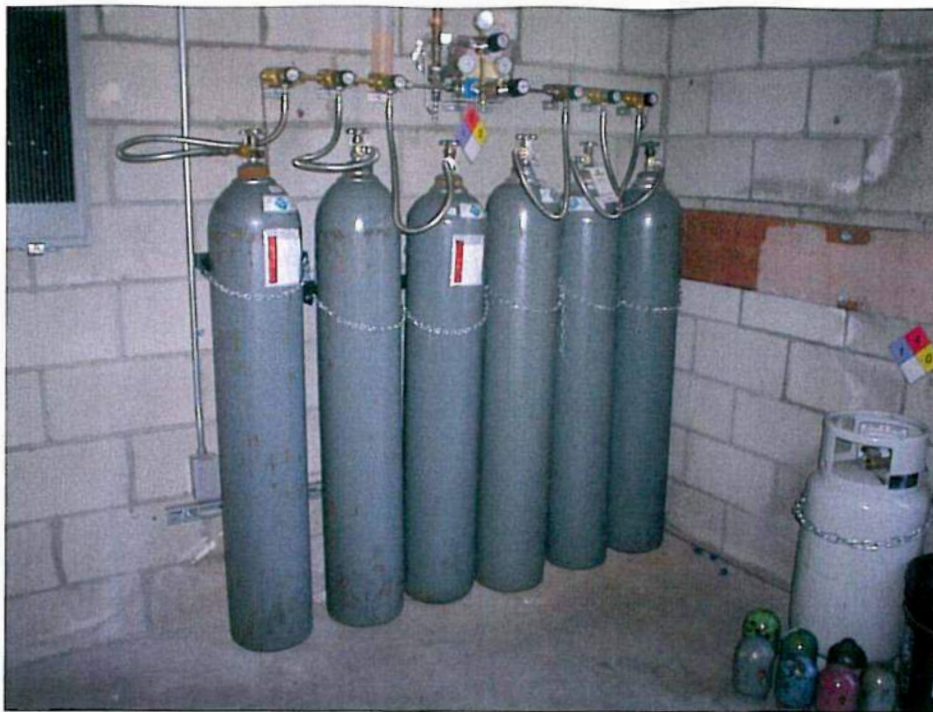
Photograph #7
Carbon dioxide cylinders located within the DI water shed.

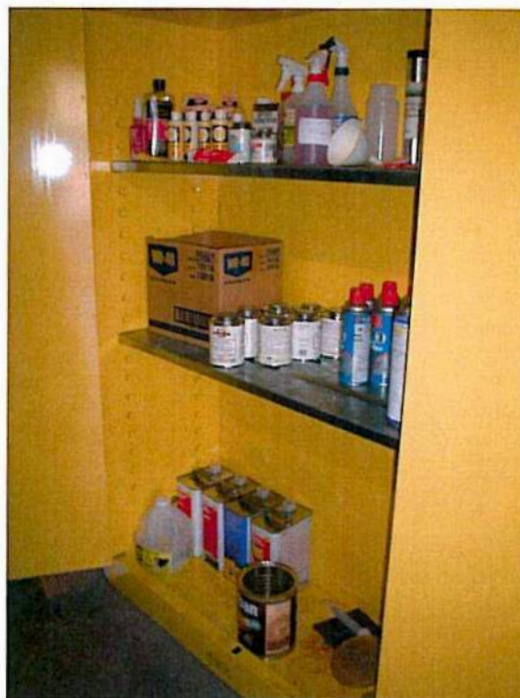
Photograph #8
Flammable hazardous materials storage cabinet located within the DI water shed.

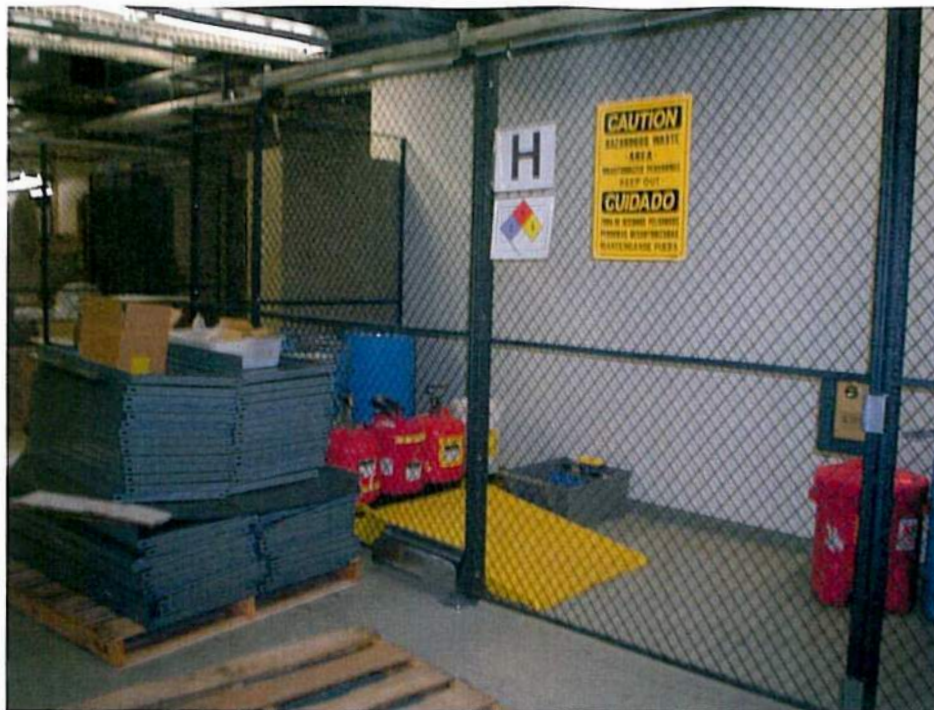
Photograph #11
Hazardous waste storage cage located within the warehouse.

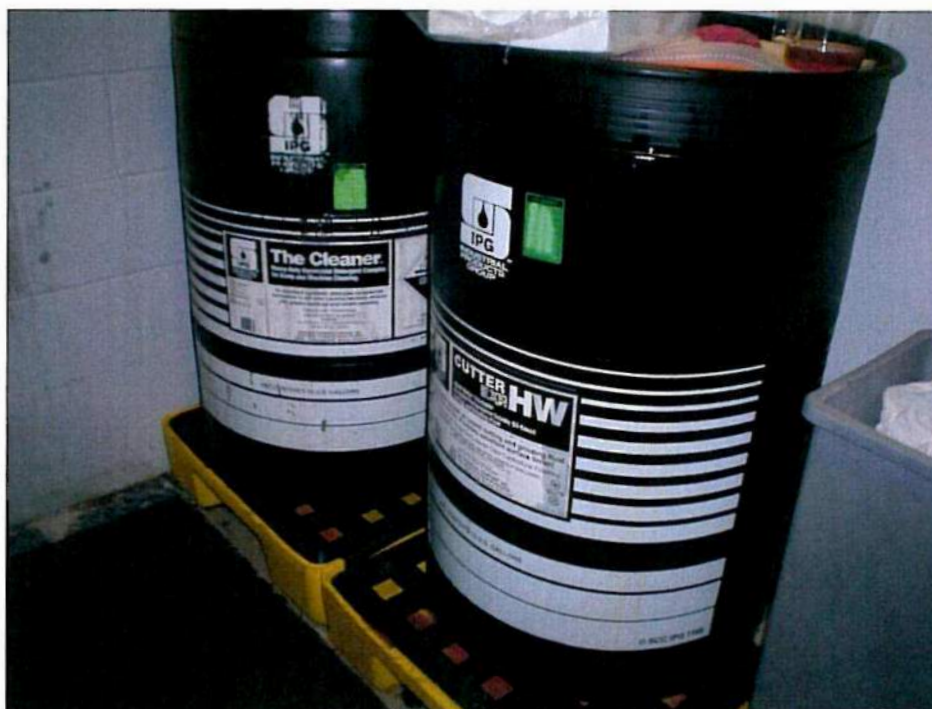
Cutting/grinding fluid	One 55-gallon plastic drum. Mr. Hand indicated that the fluid is used in the operation of the onsite mill equipment.	On top of a plastic pallet located within a room adjacent to the elevator equipment room in the northern portion of the first floor of the site building.	No	N
Synthetic lubricant	One 5-gallon plastic bucket.	Concrete flooring located within the hazardous waste storage room.	No	N
Sealing fluid	One 5-gallon plastic bucket.	Concrete flooring located within the hazardous waste storage room.	No	N
Coolant	One 5-gallon plastic bucket.	Concrete flooring located within the DI water shed.	No	N
Carbon dioxide	Six compressed gas cylinders.	Concrete flooring located within the DI water shed. Mr. Hand indicated that the cylinders are connected to a system which provides the gas to the various laboratories within the site building.	No	N
Propane	One compressed gas cylinder.	Concrete flooring located within the DI water shed.	No	N

Photograph #14
Drums containing germicidal detergent complex and cutting and grinding fluid stored on the first floor of the site building.

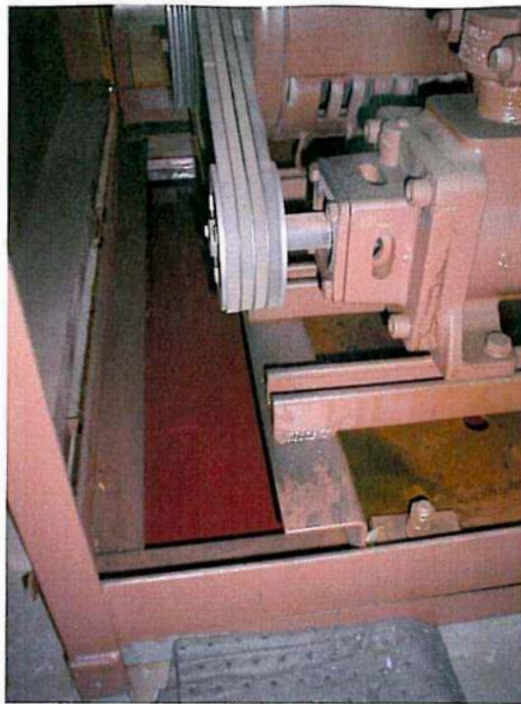
Potential PCB-Containing Equipment Onsite					
Type of Equipment	Date Installed	Location	PCB Containing (Y/N)	Rationale	Stains/Leaks Observed (Y/N)
Three hydraulic elevator operating units	1983	Two units are located within an equipment room located on the first floor in the northern portion of the site building. One unit is located within an equipment room located on the first floor in the southern portion of the site building.	N	I	Y – Pooled hydraulic oil was observed in the metal base of the unit located in the southern portion of the site building and in the metal base of one of the two units located in the northern portion of the site building.

Photograph #15
Pooled oil located at the base of elevator equipment located in the southern portion of the first floor of the site building.

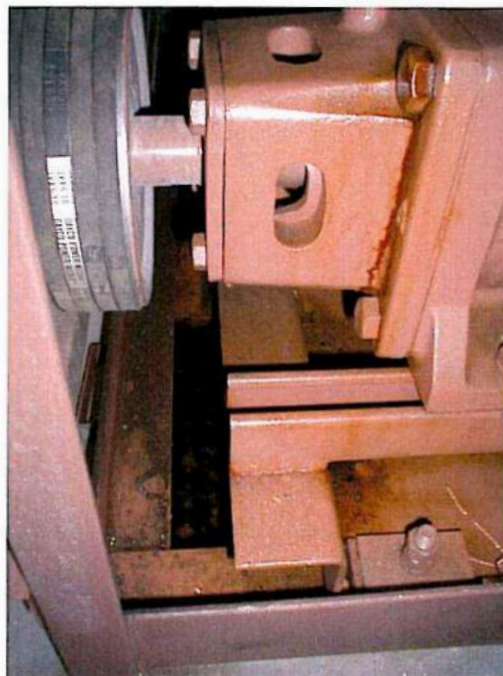
Photograph #16
Pooled oil located at the base of elevator equipment located in the northern portion of the first floor of the site building.

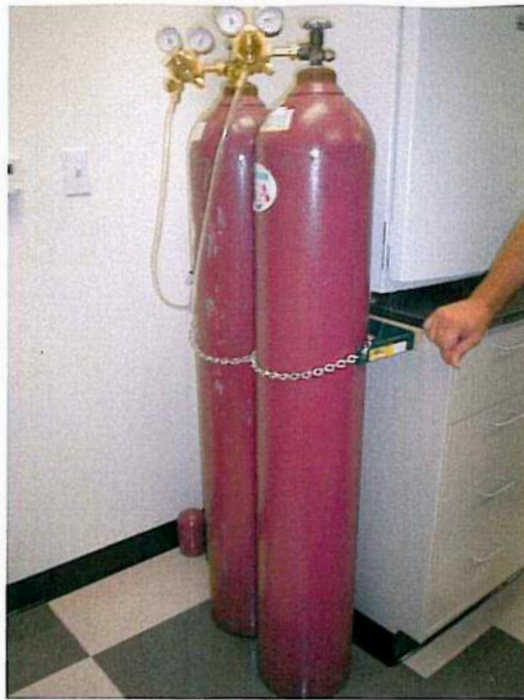
Photograph #17
Compressed nitrogen cylinder located within the main science laboratory on the second floor of the site building.

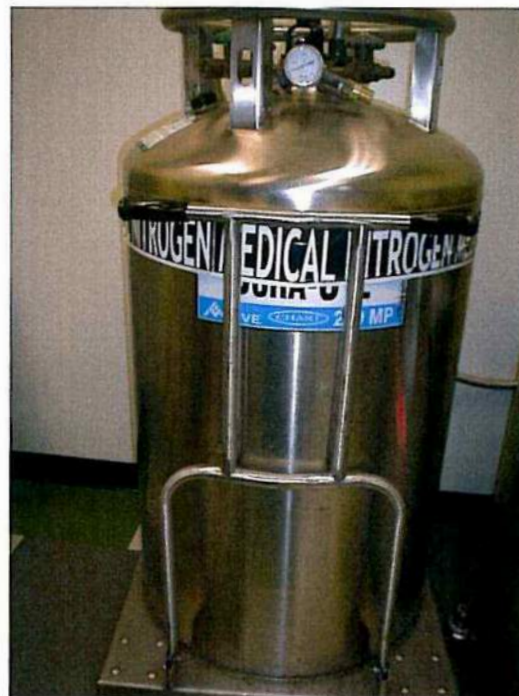
Hazardous Substances/Petroleum Products				
Type of Material	Quantity/ Container Type	Storage Location	Stains/Leaks Observed	REC (Y/N)
Liquid nitrogen	Three approximately 57-gallon metal holding tanks, and other laboratory equipment containing small amounts of the material.	Each of the holding tanks was mounted on metal dollies. Two of the holding tanks and the liquid nitrogen-containing equipment were observed within rooms located in the central portion the first floor of the site building. One of the holding tanks was observed on the second floor of the site building, within the "equipment room" of the main laboratory.	No	N
Argon	Two compressed gas cylinders.	Mounted on a metal dolly located within the machine shop.	No	N
Nitrogen gas	Three compressed gas cylinders.	Stored in rooms located adjacent to the main laboratory on the second floor of the site building. One was mounted on a metal dolly and two were chained to a cabinet.	No	N

Photograph #18
57-gallon liquid nitrogen storage tank located within the equipment room of the main science laboratory.

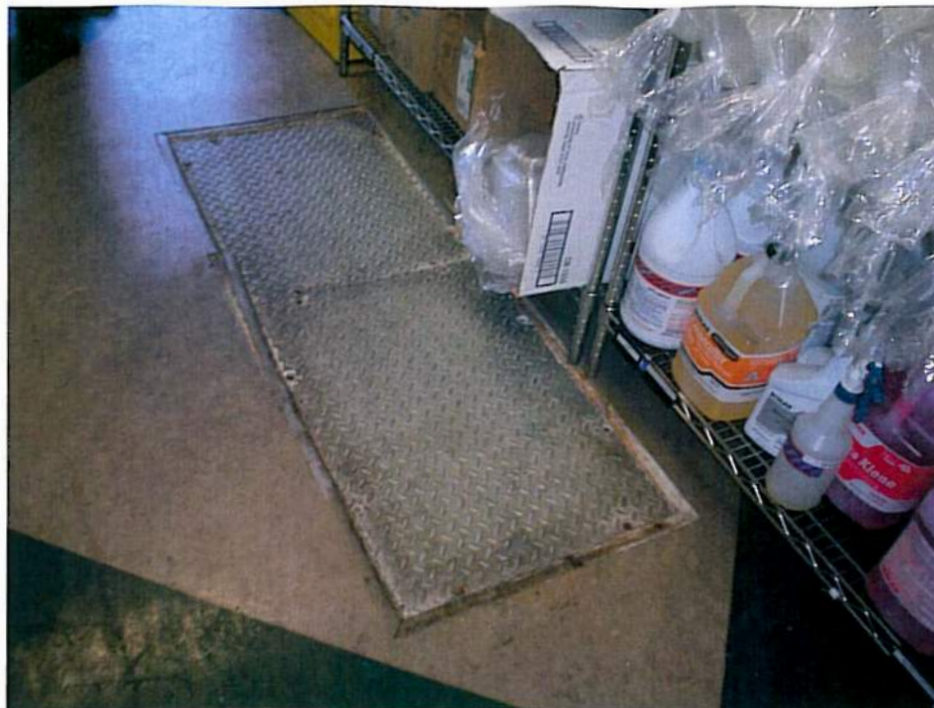
Photograph #19
Grease trap access covers adjacent to the food preparation room located on the first floor of the site building.

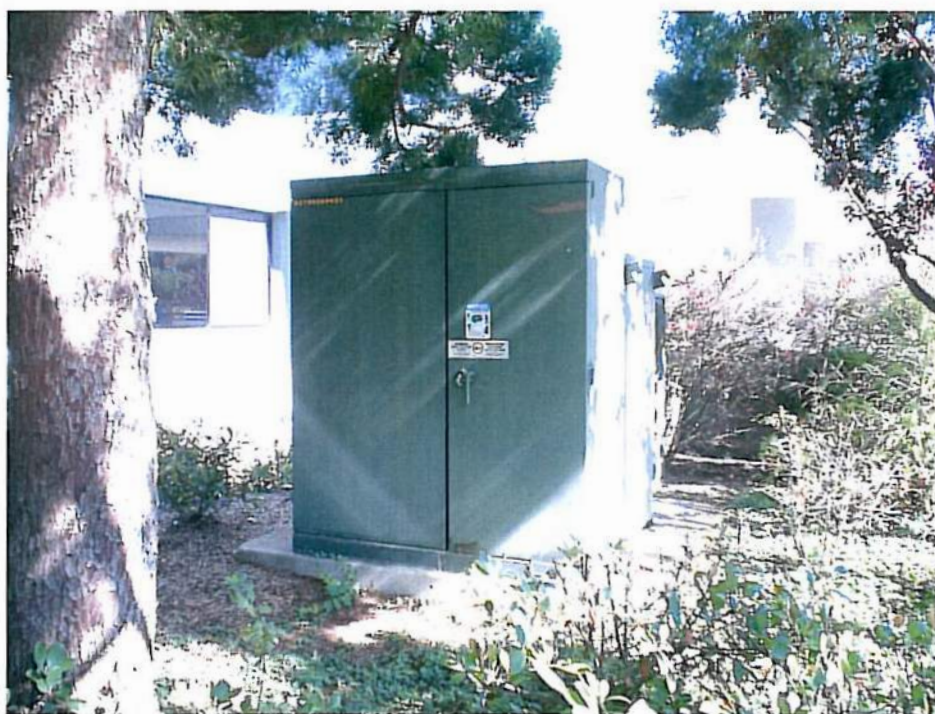
Potential PCB-Containing Equipment Onsite					
Type of Equipment	Date Installed	Location	PCB Containing (Y/N)	Rationale	Stains/Leaks Observed (Y/N)
Pad-mounted electrical transformer	1983	Immediately west of the site building.	N	I and U	N
Abbreviations/Notes: I = installation date (the manufacture of equipment containing PCBs was banned in 1977) U = utility company has stated that PCB transformers were never specified for distribution service

Photograph #20
Pad-mounted electrical transformer located on the west side of the site building.

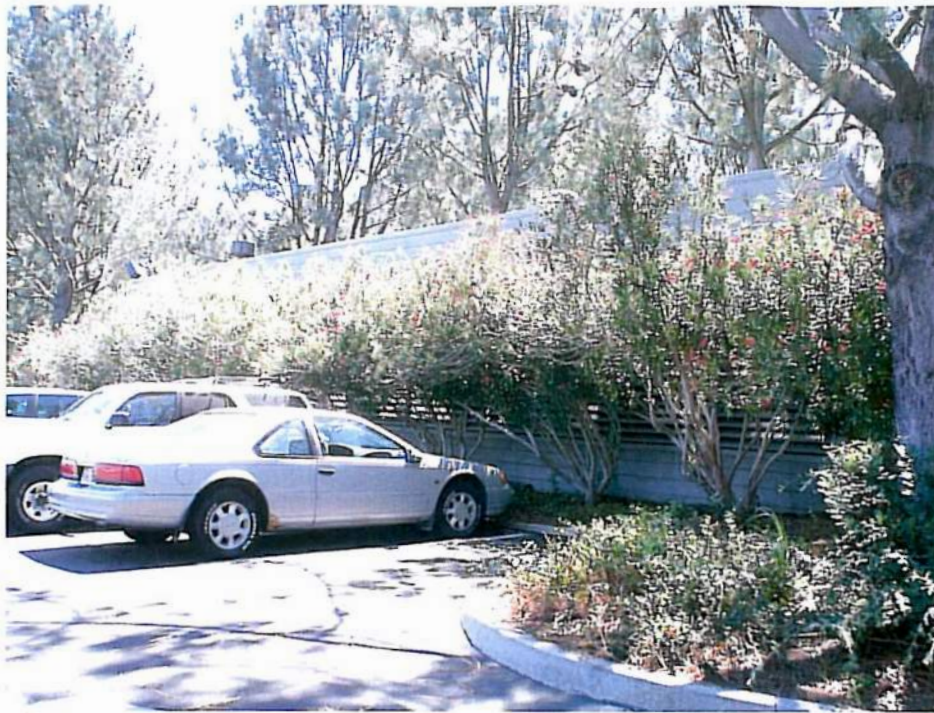
An approximately 1,815-square-foot CMU building containing HVAC equipment occupies the northwestern portion of the Site (hereinafter referred to as the mechanical equipment building). The HVAC equipment contained in the building includes a centrifugal chiller system and a cooling tower, as well as a natural gas-fired boiler. Mr. Hand indicated that a small amount of refrigerant is contained in the chiller equipment. Chilled water is pumped to chilled water fan coil units located within the site building to provide cool air. To heat the site building, hot water generated from the boiler is pumped to hot water fan coil units located within the site building. Mr. Hand reported that TRANE services the HVAC equipment contained in the mechanical equipment building on a quarterly basis. Additional air handling equipment is present on the east side of the site building. Potable hot water is reportedly provided by 50-gallon, natural gas-fired water heaters located within closets on the third floor of the site building.

Photograph #21
Eastern elevation of the mechanical equipment
building located in the northwestern portion of the Site.

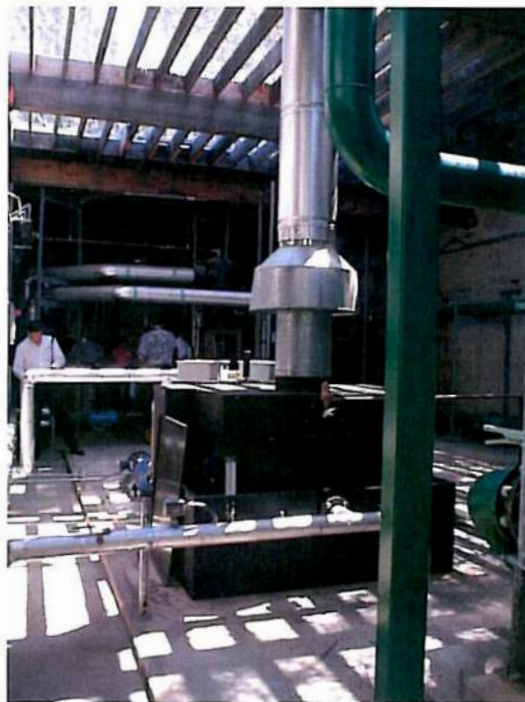
Photograph #22
Interior view of the mechanical equipment building.

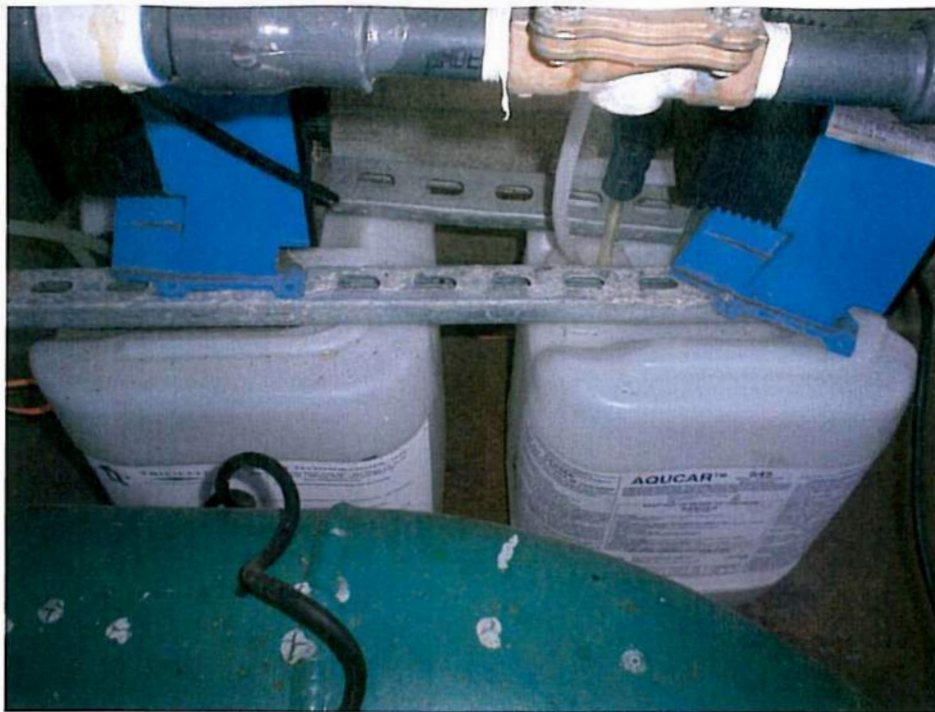
Photograph #23
Containers of antifoulant solution and water treatment microbiocide located within the mechanical equipment building.

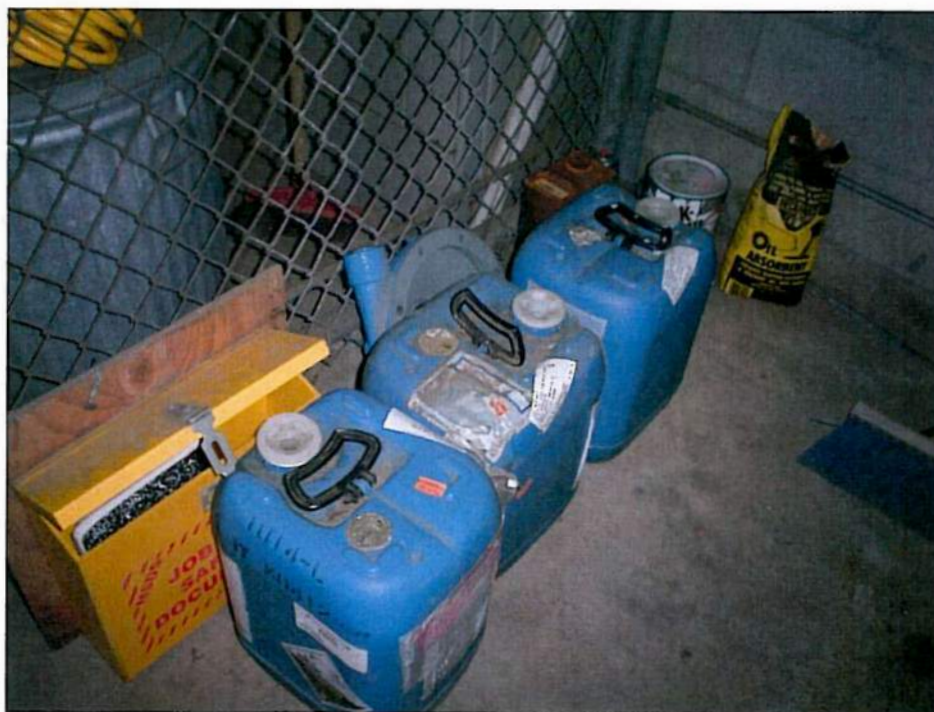
Hazardous Substances/Petroleum Products				
Type of Material	Quantity/ Container Type	Storage Location	Stains/Leaks Observed	REC (Y/N)
Cooling system treatment solution	One 55-gallon plastic drum.	Concrete floor of mechanical equipment building.	No	N
Antifoulant solution	One 5-gallon plastic container.	Concrete floor of mechanical equipment building.	No	N
Water treatment microbiocide	One 5-gallon plastic container.	Concrete floor of mechanical equipment building.	No	N
Various cooling system treatment solutions	Three 5-gallon plastic containers (labeled Formula 1014-L, Formula 5100, and Formula 3338, respectively).	Concrete floor of mechanical equipment building.	No	N
Germicidal detergent complex	One 55-gallon plastic drum. Mr. Hand indicated that the detergent is used in cleaning the onsite mill equipment.	On top of a plastic pallet located within a room adjacent to the elevator equipment room in the northern portion of the first floor of the site building.	No	N

Photograph #24
Containers of cooling system treatment chemicals located within the mechanical equipment building.
