**Biological Survey Report for the
El Capitan Dam Spillway
Vegetation Removal Project
San Diego, California**

Prepared for
City of San Diego
Public Utilities Department
9192 Topaz Way
San Diego, CA 92123
Contact: Ms. Megan Hickey

Prepared by
RECON Environmental, Inc.
3111 Camino del Rio North, Suite 600
San Diego, CA 92108
P 619.308.9333

RECON Number 8863
September 29, 2021

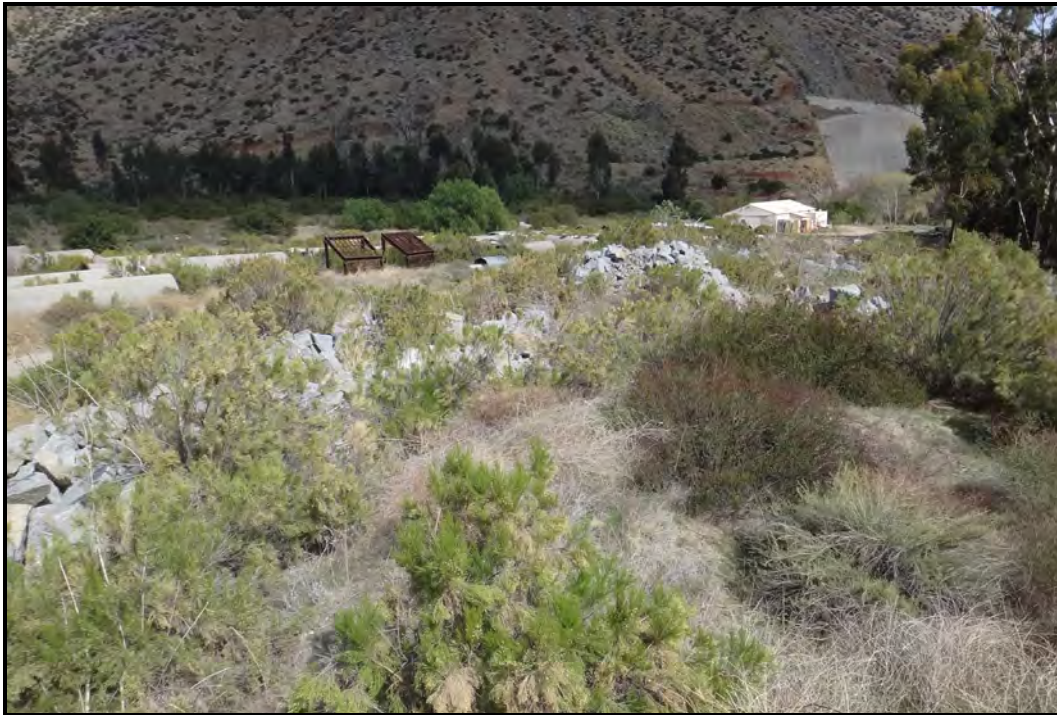
PHOTOGRAPH 13

Disturbed Diegan Coastal Sage Scrub in the Northwest Portion of the Survey Area, Facing East, Taken November 14, 2017

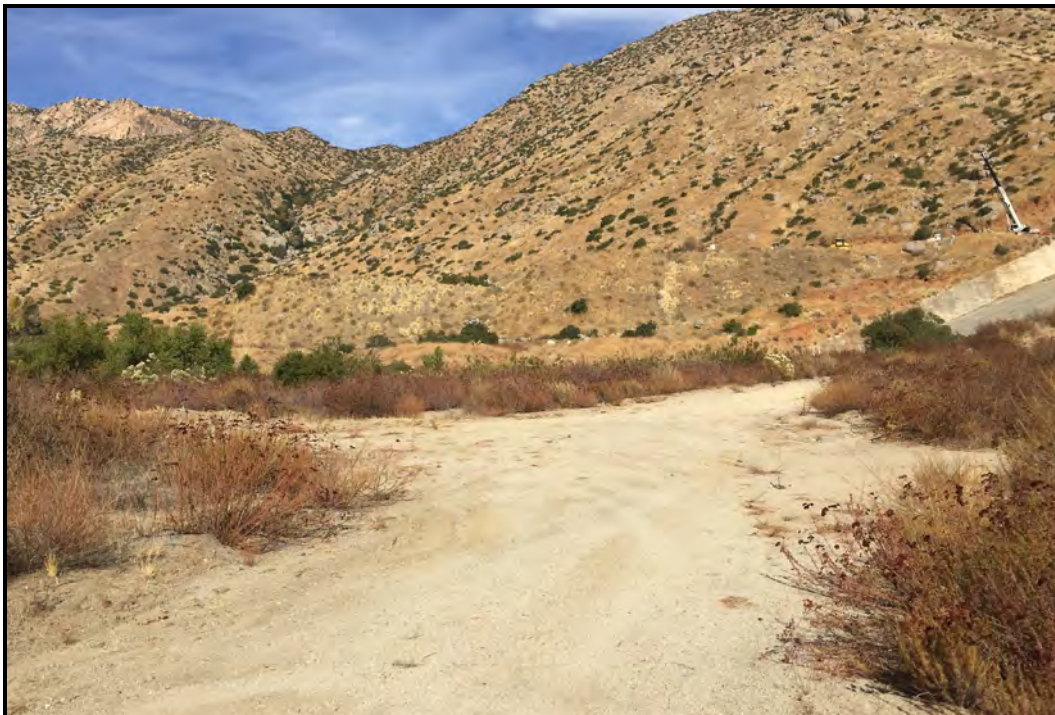
PHOTOGRAPH 17

Disturbed Land within an Access Road in the Central Portion of the Survey Area, Facing North, Taken November 14, 2017

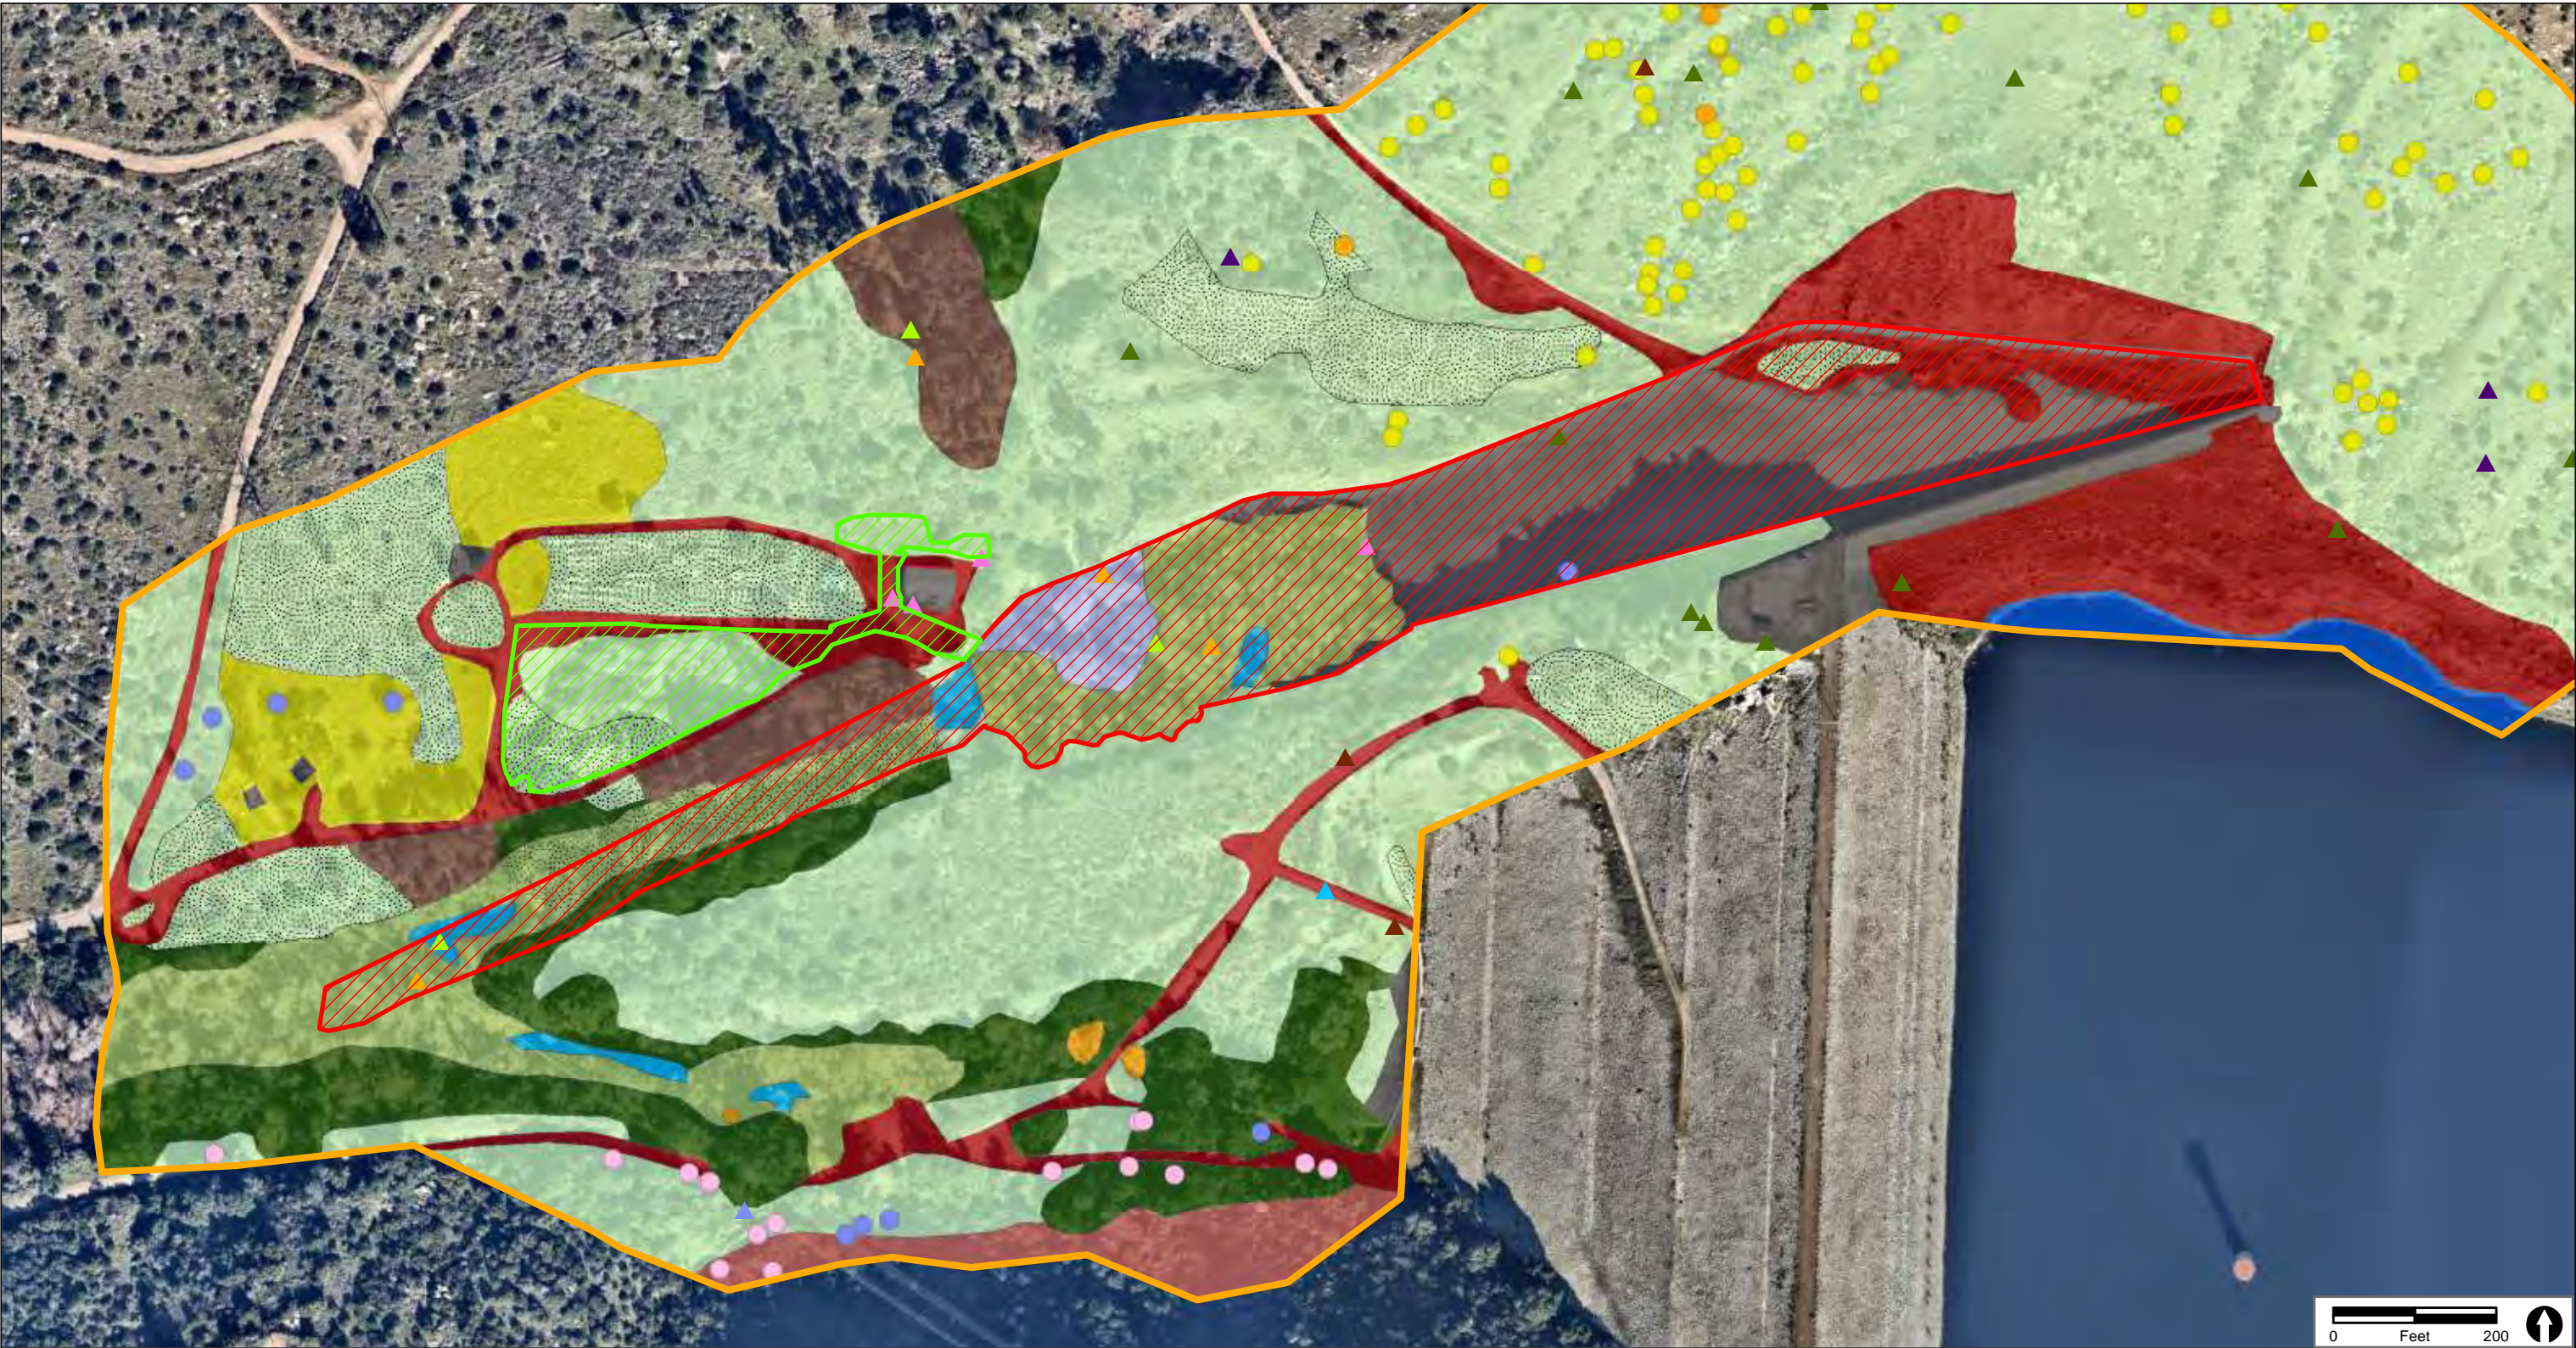
FIGURE 8
Impacts to Biological Resources

The project also would impact 1.36 acres of Diegan coastal sage scrub (Tier II), and disturbed Diegan coastal sage scrub (Tier II) (Figure 8; Table 5).

Some southern cottonwood-willow riparian forest canopy extends outside the southern boundary of the Lower Spillway. These trees are rooted within the spillway and would be directly impacted by the vegetation removal activities. The extent of this canopy to be directly impacted is included in the Vegetation Removal Area in Figure 8 and in the direct impact calculations in Table 5.

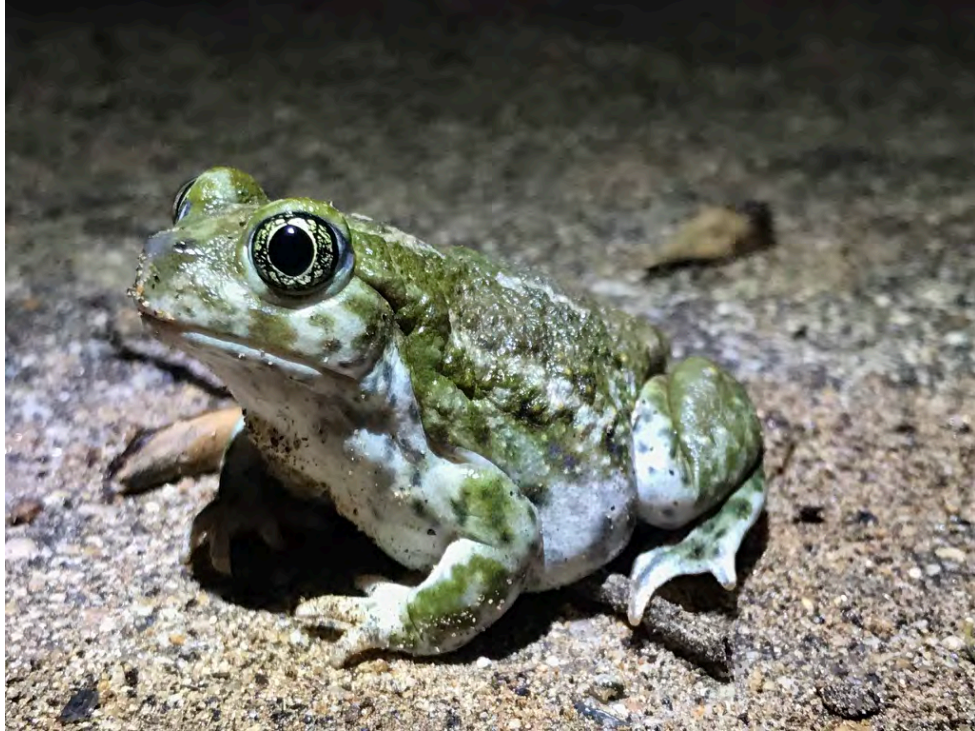
Photo 9. El Capitan Dam – Photo of western spadefoot (*Spea hammondi*), a CDFW Species of Special Concern, observed in upland habitat within the survey area. April 24, 2020.

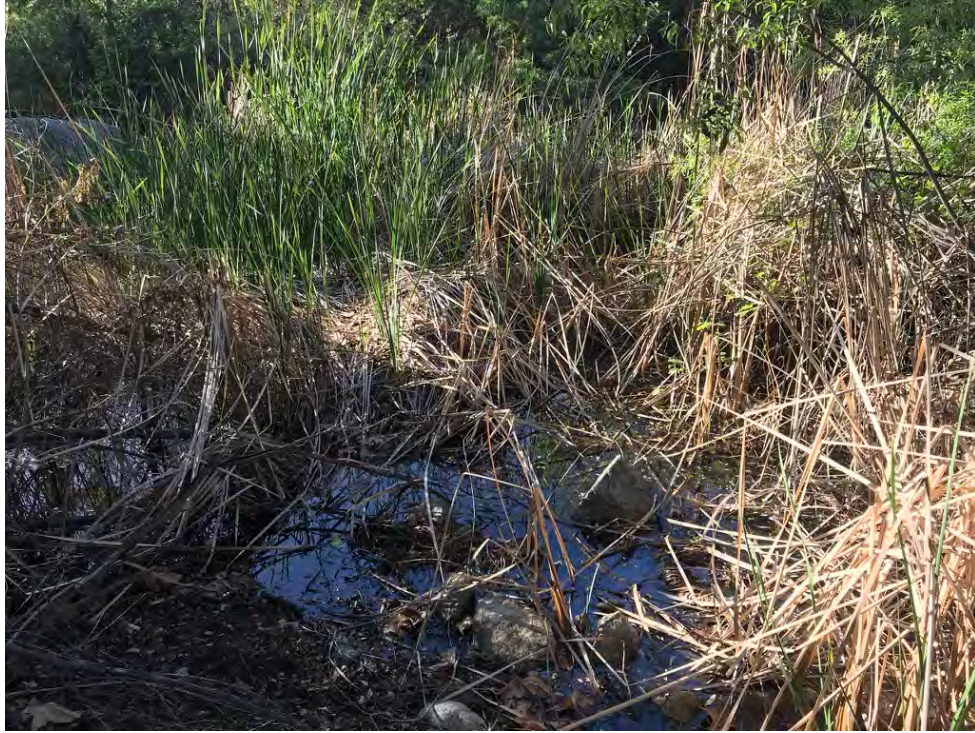
Photo 11. El Capitan Dam – View of small ponded area dominated by cattails. April 24, 2020.

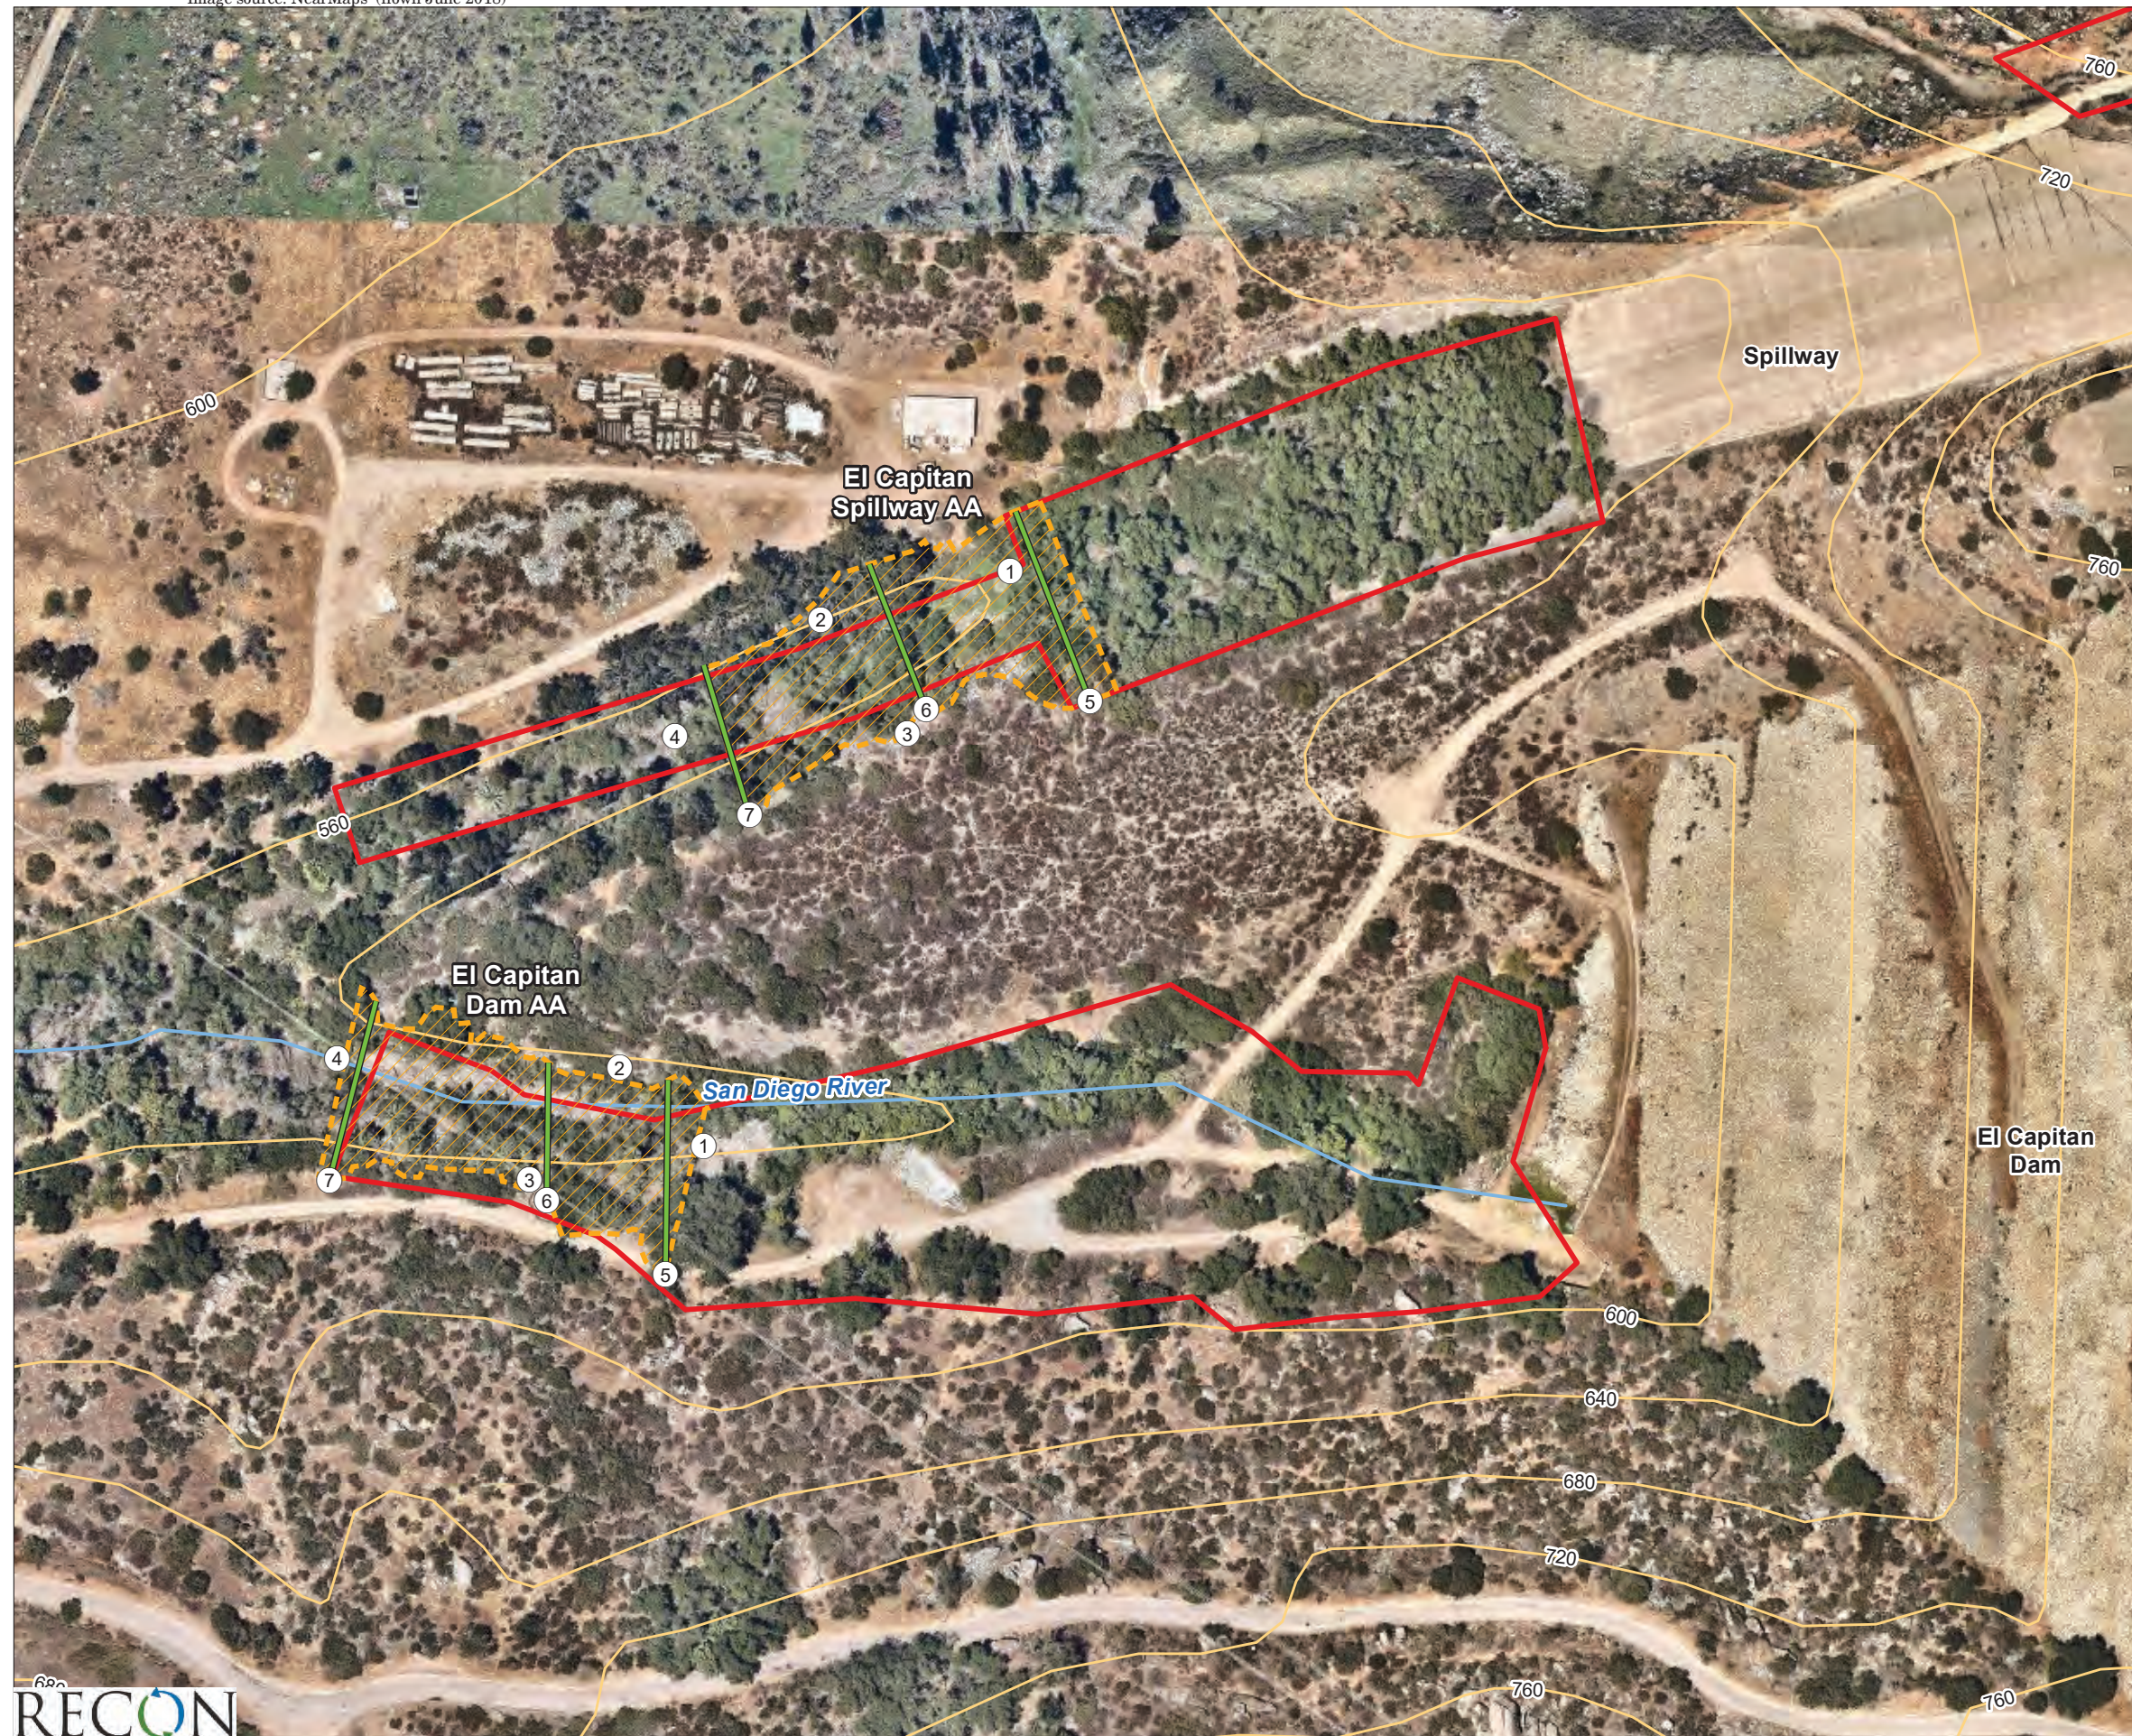
FIGURE 3
CRAM Assessment Areas

- Project Boundary
- 20-ft Contours
- Stream/River
- CRAM Assessment Area
- Transect
- Photo Point

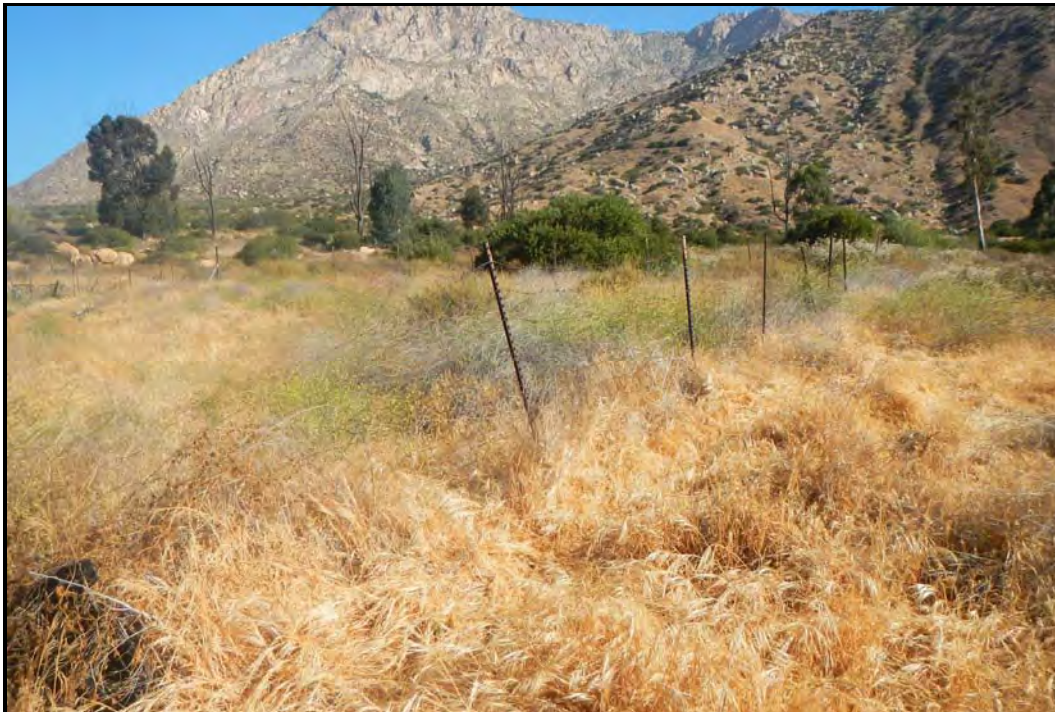
PHOTOGRAPH 18
El Capitan Spillway AA, View of Degraded Fence Included in Buffer
June 6, 2018
