**NATURAL ENVIRONMENT STUDY REPORT  
FOR THE EL CAMINO REAL  
ROAD/BRIDGE WIDENING PROJECT  
Project #2982, Sch. No. Pending**

June 13, 2006

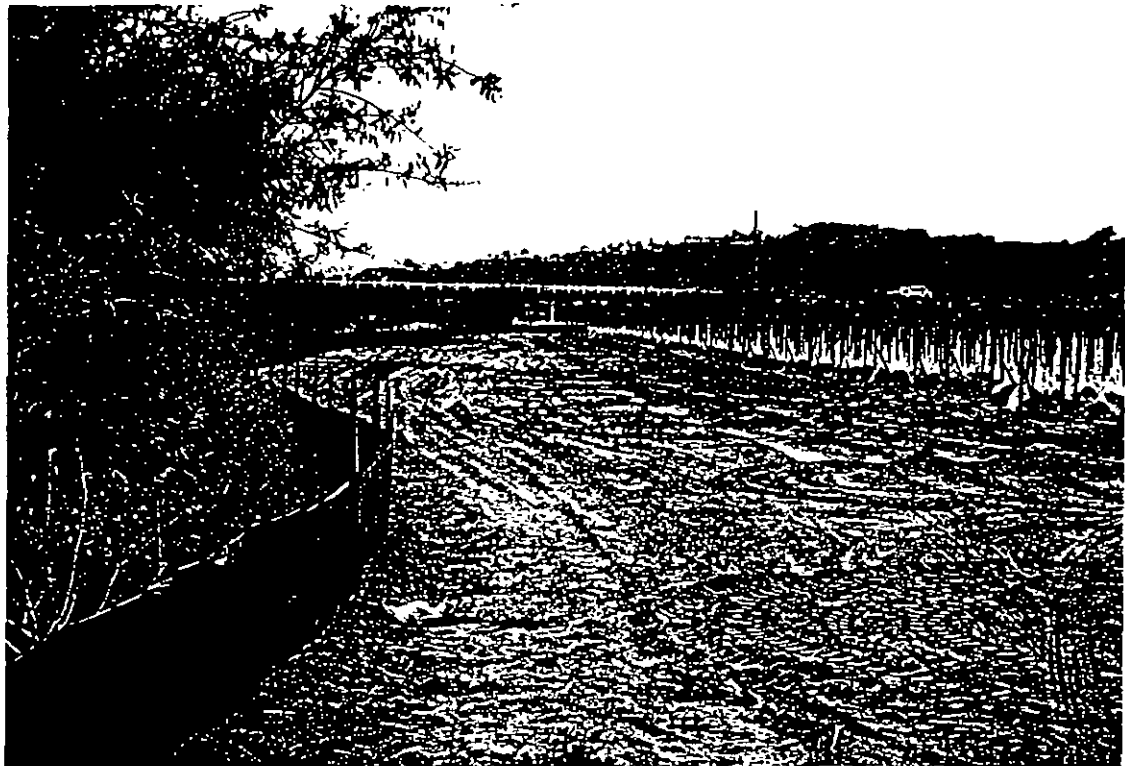
FIGURE 3. Photograph taken to the east. Fragmented southern willow scrub visible at the left side of the photo, north of the silt fencing.

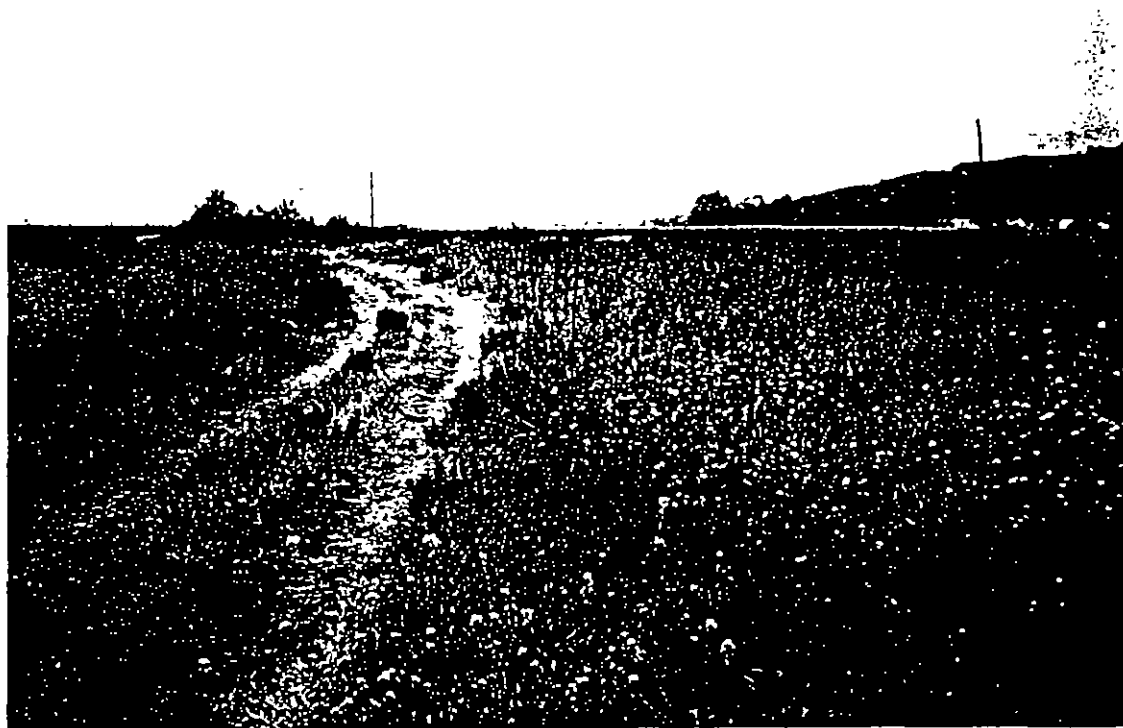
FIGURE 4. Photograph of ruderal vegetation along the southern bank of the San Dieguito River. Taken to the west.

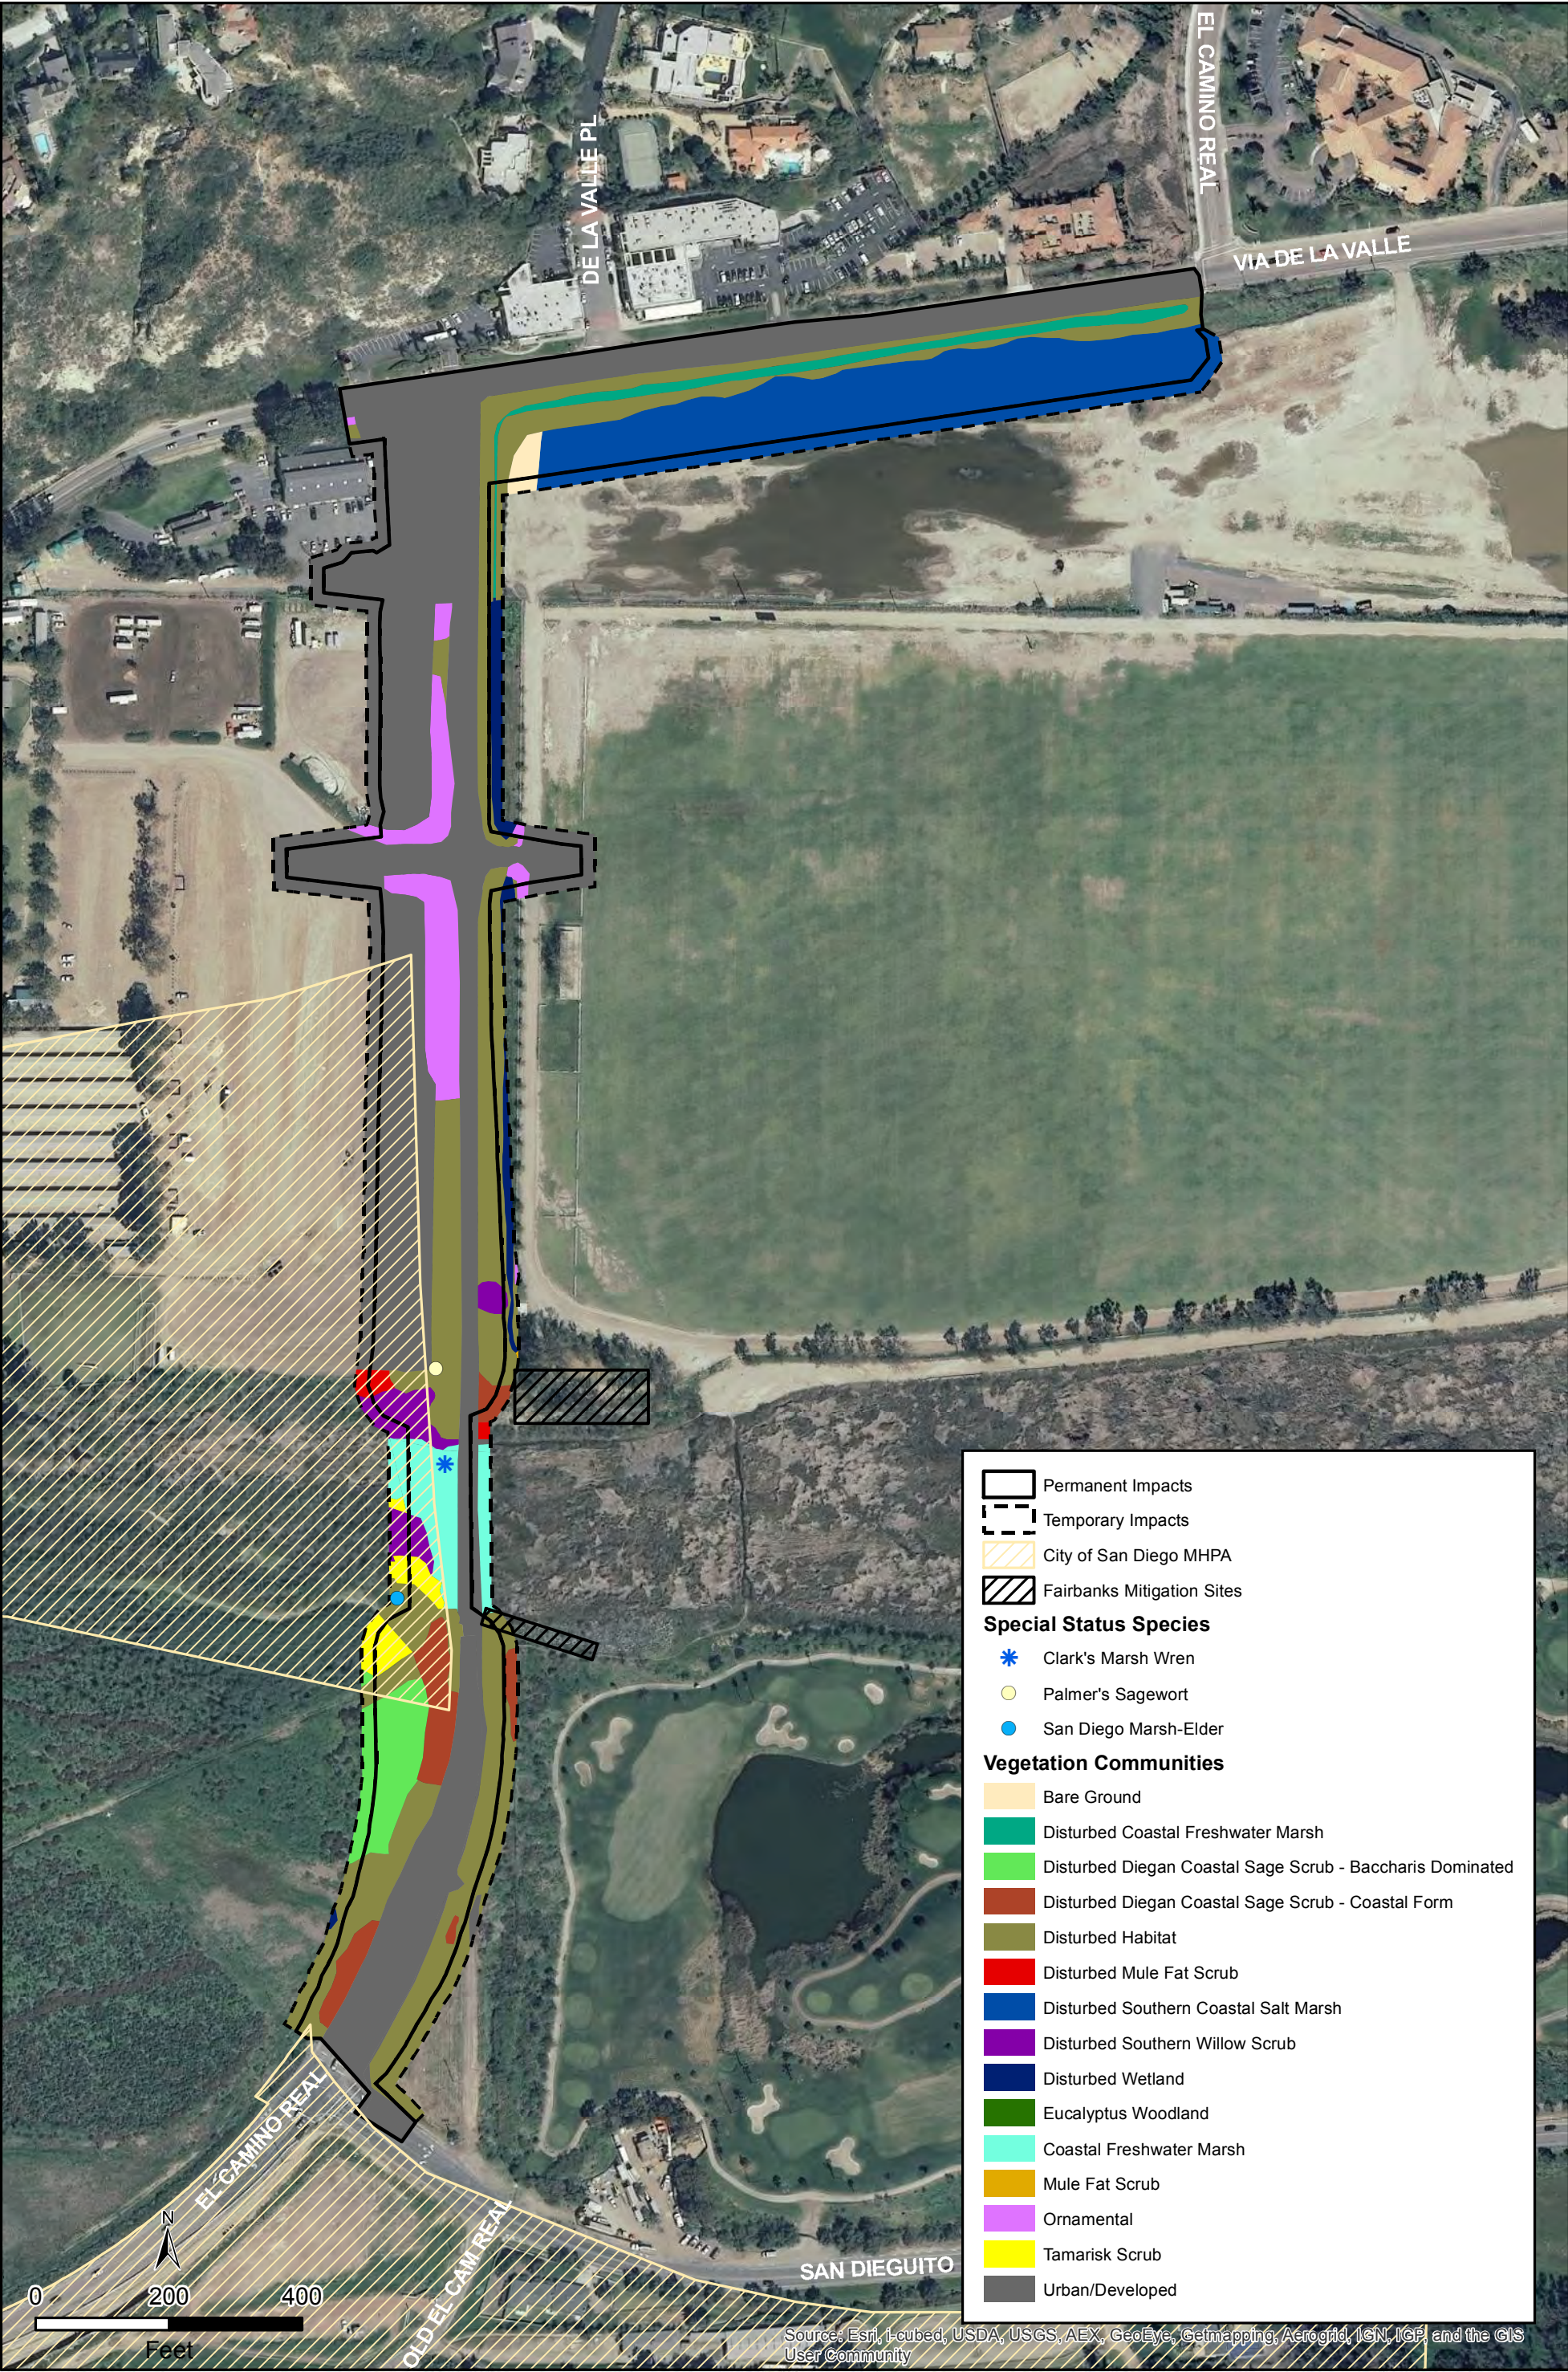
**Figure 6a**  
**Biological Resources Western Alternative**  
**El Camino Real Bridge Replacement Project**

A total of 18 vegetation communities and land cover types are present within the BSA: disturbed southern willow scrub, mule-fat scrub, disturbed mule-fat scrub, coastal freshwater marsh, disturbed coastal freshwater marsh, disturbed coastal brackish marsh, alkali marsh, disturbed southern coastal salt marsh, disturbed wetland, disturbed Diegan coastal sage scrub – coastal form, Disturbed coastal sage scrub – Baccharis dominated, tamarisk scrub non-native grassland, disturbed areas, eucalyptus woodland, ornamental, bare ground, and developed areas. All vegetation communities and land cover types are described below, summarized in Table 3-1, and depicted in Figures 6a-6e.

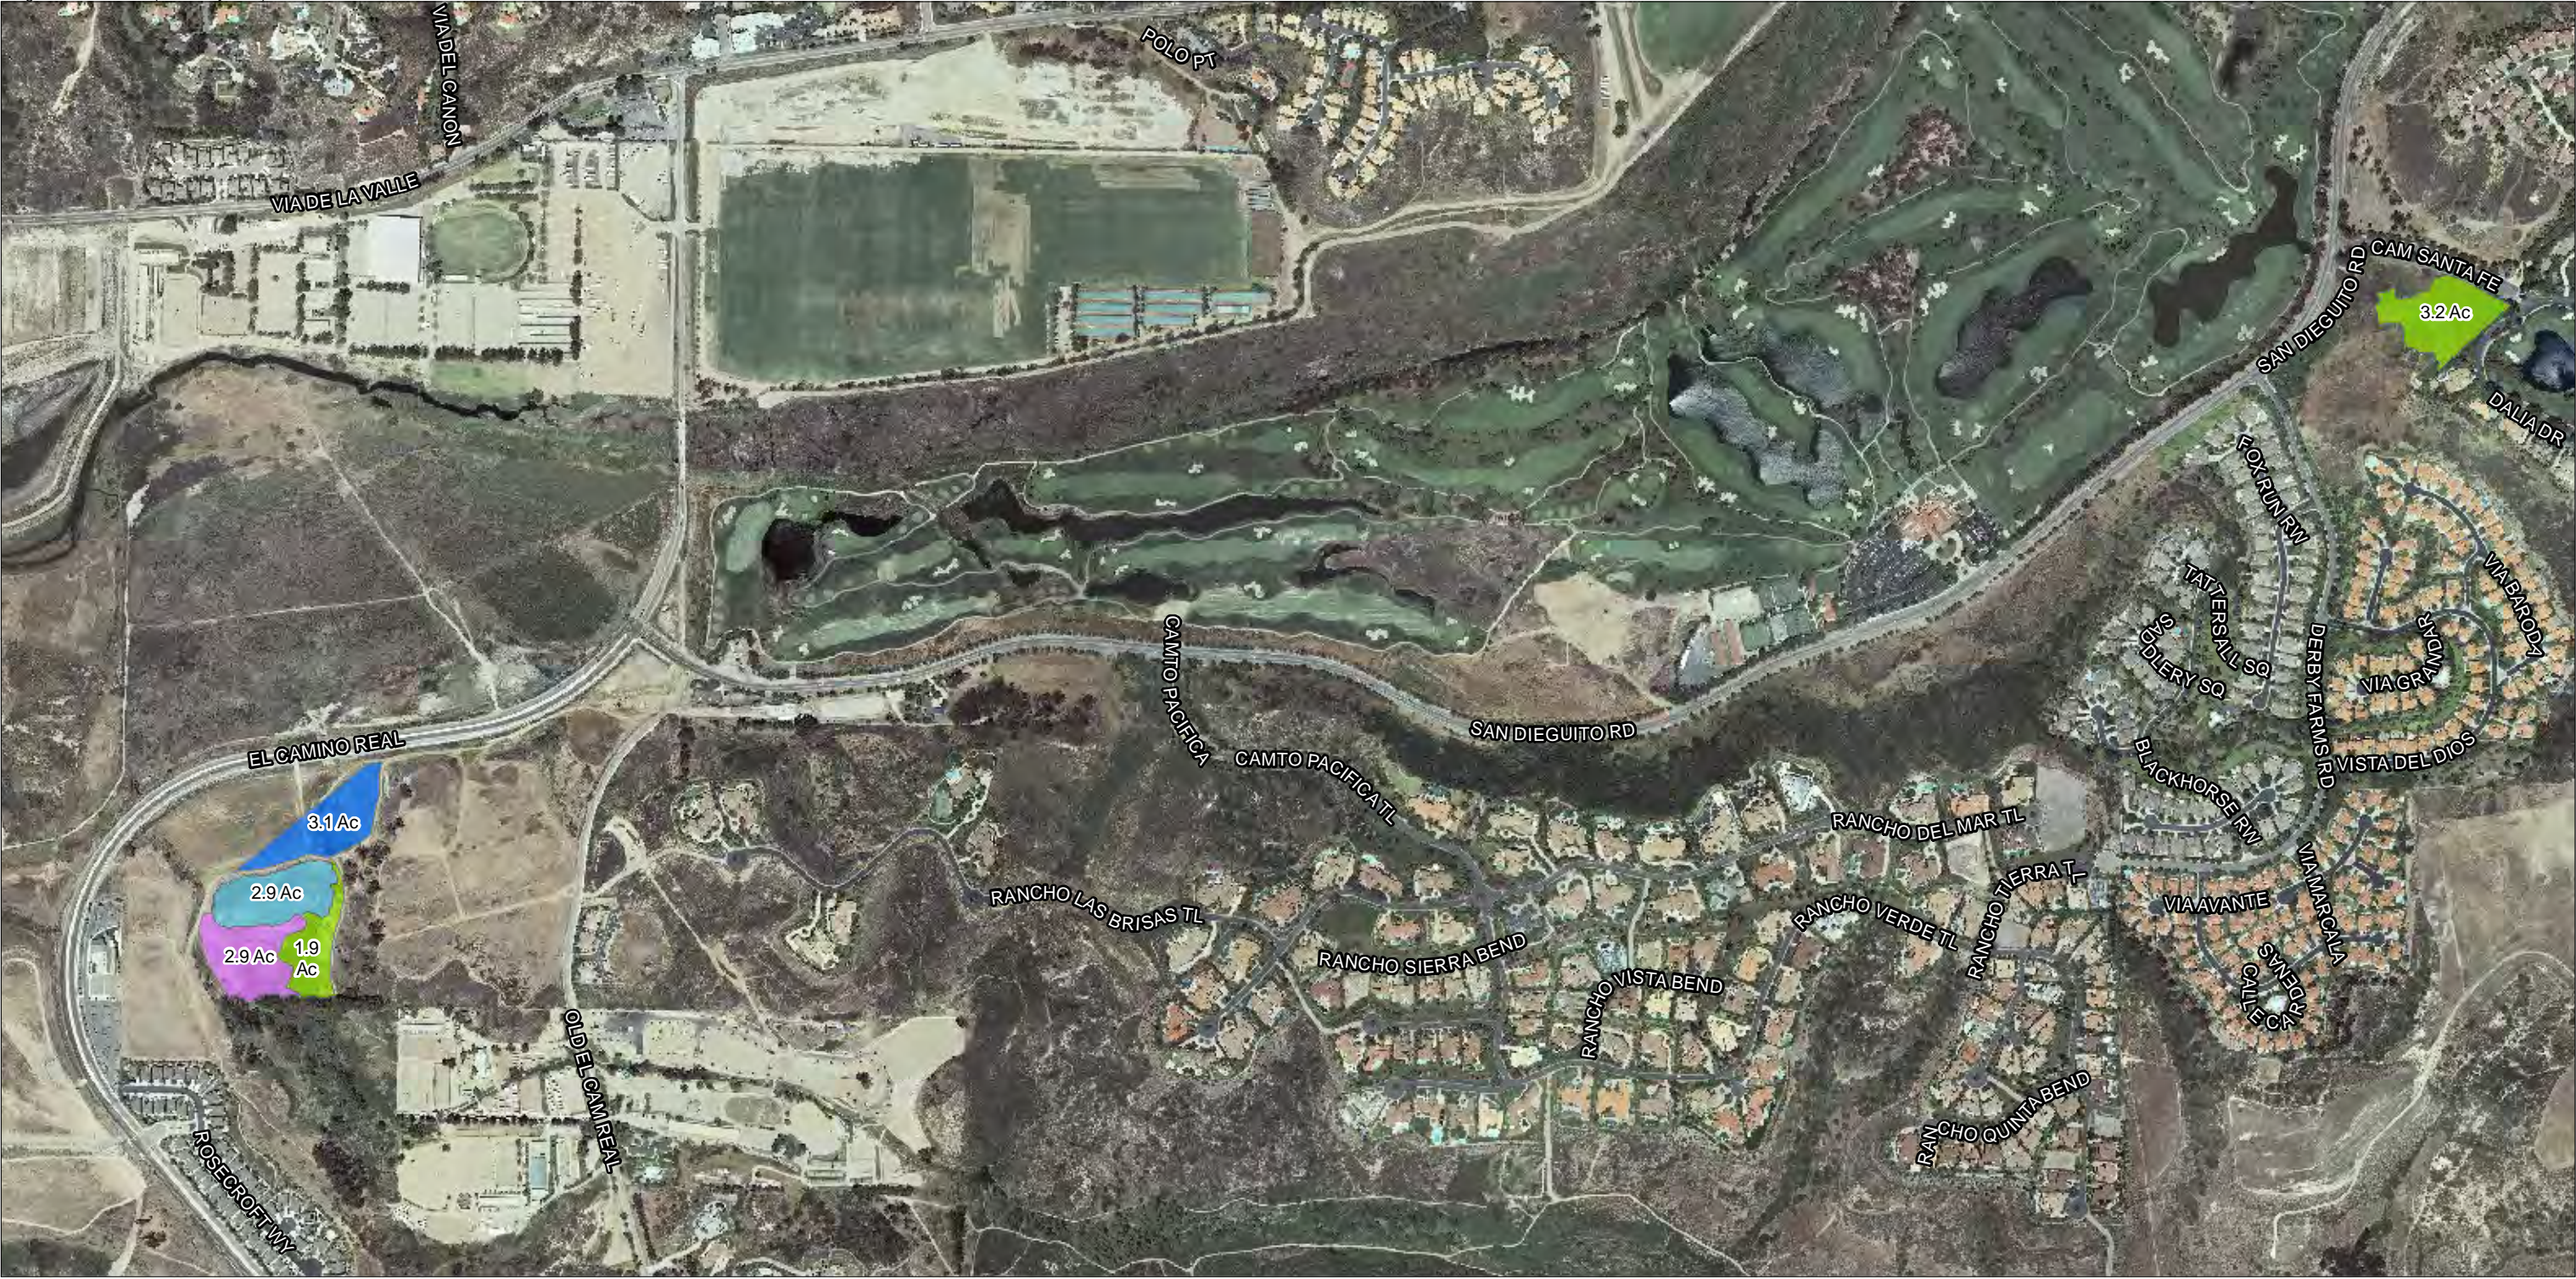
FIGURE  
7

Potential Mitigation Areas

- Cismontane Alkali Marsh Creation
- Freshwater Marsh Enhancement
- Cismontane Alkali Marsh Restoration
- Southern Willow Scrub Enhancement

As presented previously in Chapter 1, a conceptual restoration plan has been developed to compensate for impacts to sensitive wetland habitats. The restoration plan for the JPA mitigation site is illustrated in Figure 7, is presented in detail in Appendix K and is summarized below. The additional mitigation required for the Roundabout Alternative is illustrated in Figure 8, is presented in detail in Appendix K and is summarized following the JPA mitigation site description.

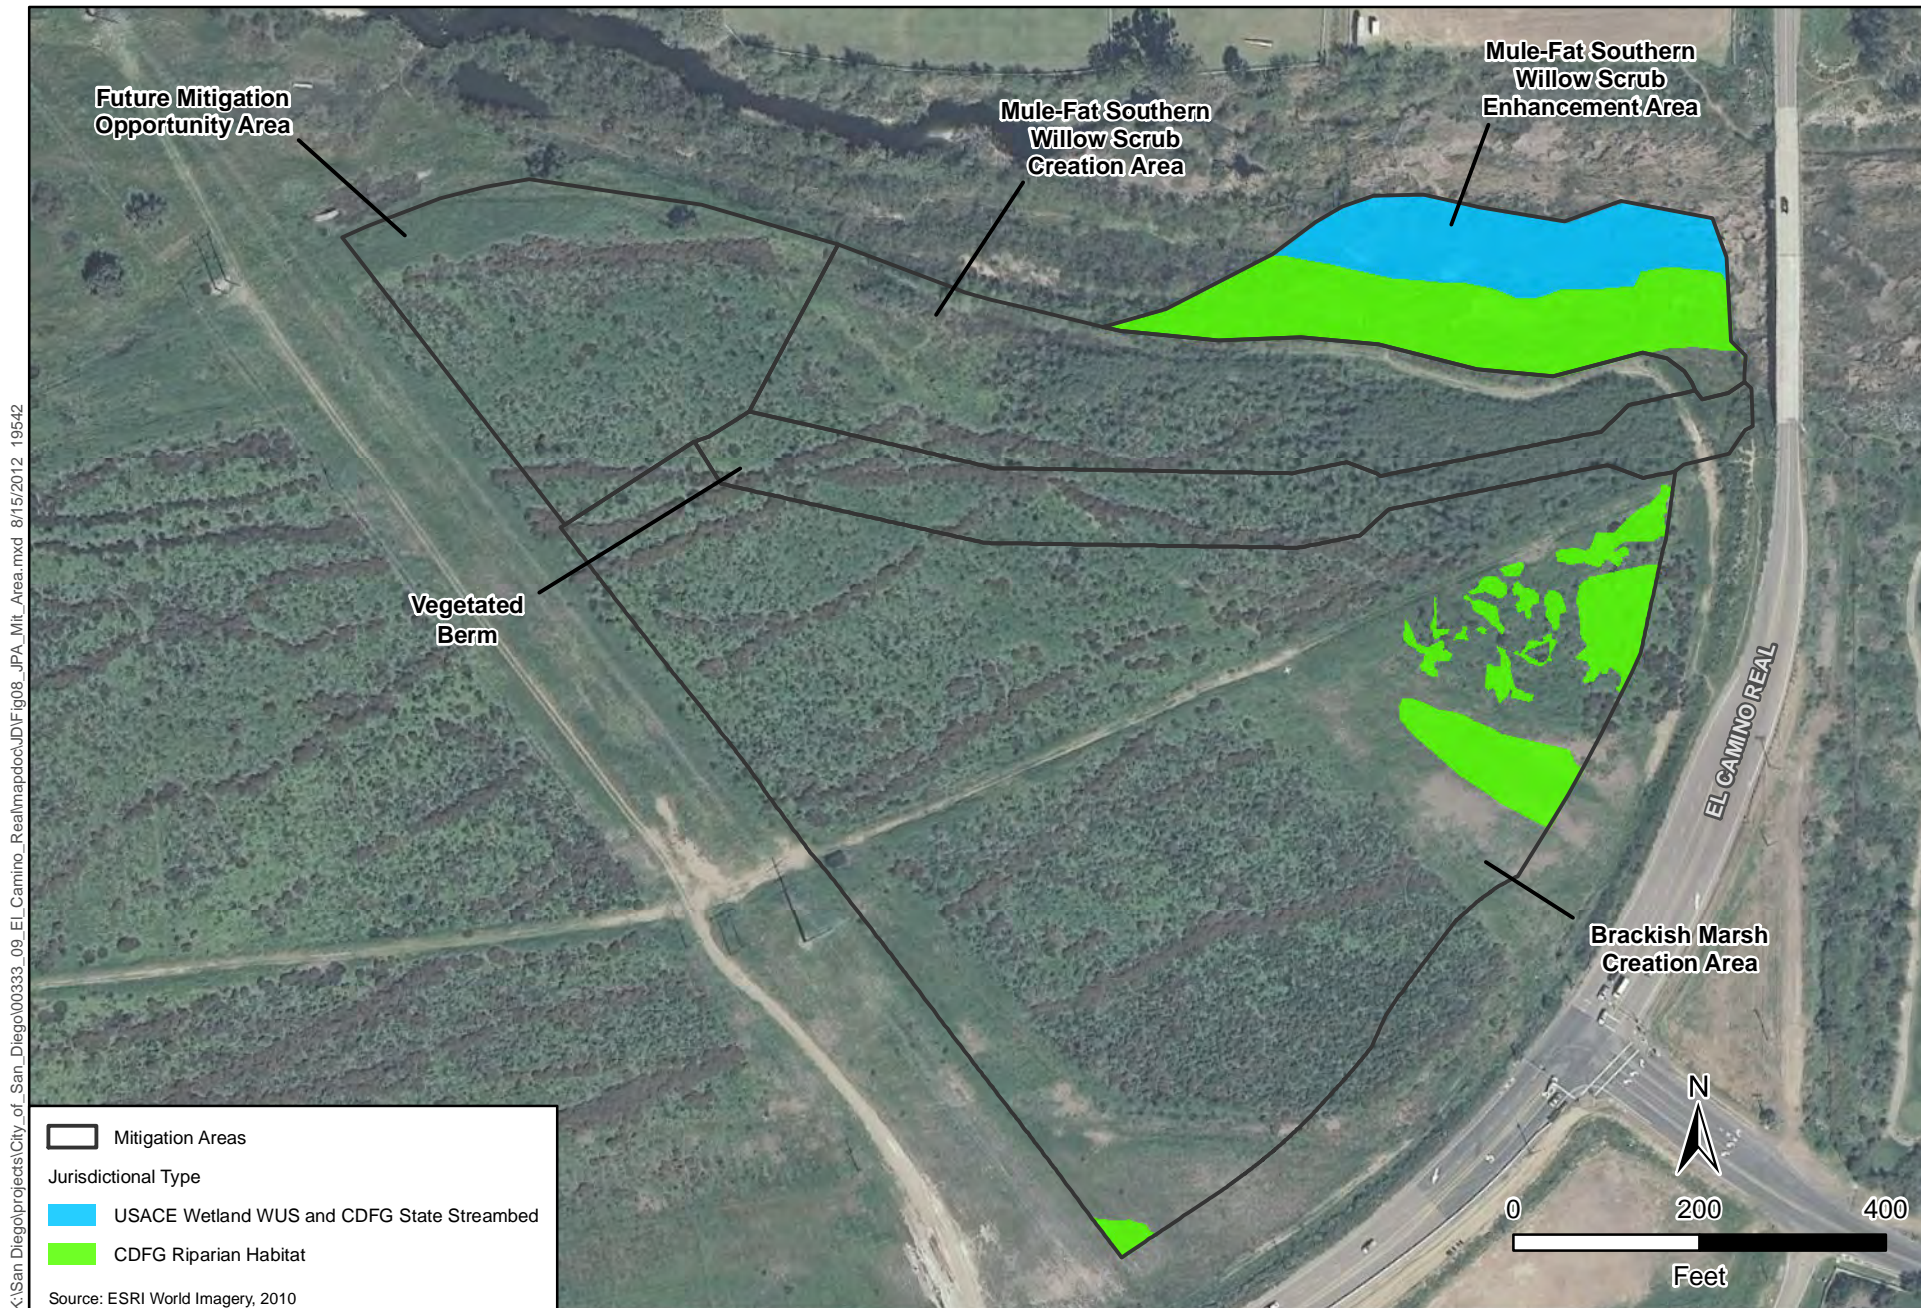
**Figure 7**  
**Jurisdictional Areas Roundabout Alternative**  
**Preliminary Jurisdictional Delineation for the El Camino Real Bridge Replacement Project**

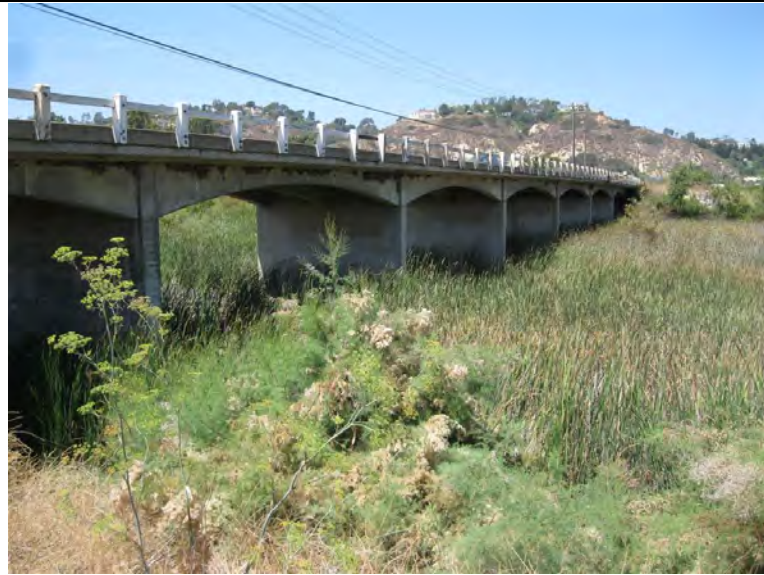
Photograph 1 El Camino Real Road Bridge over San Dieguito River. Facing north. August 2011.

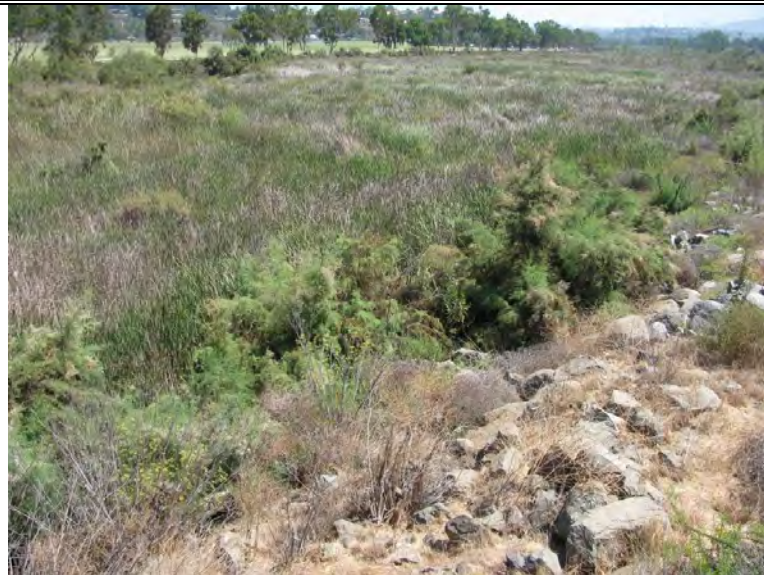
Photograph 2 Overview of San Dieguito River from south side of El Camino Real Road Bridge. Sample Points 1 and 2 were conducted in the foreground. August 2011. Facing east.

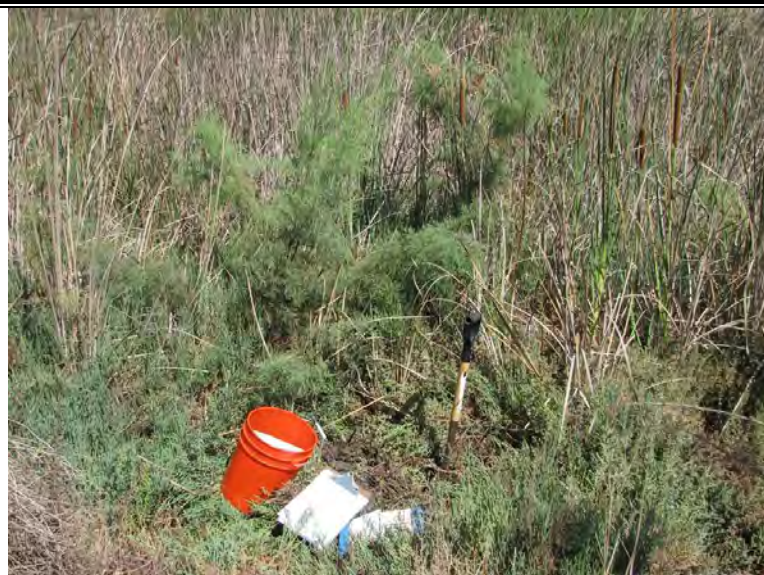
Photograph 3 Sample Point 1. Edge of freshwater marsh along San Dieguito River. USACE jurisdictional wetland WUS and CDFG State Streambed. August 2009.

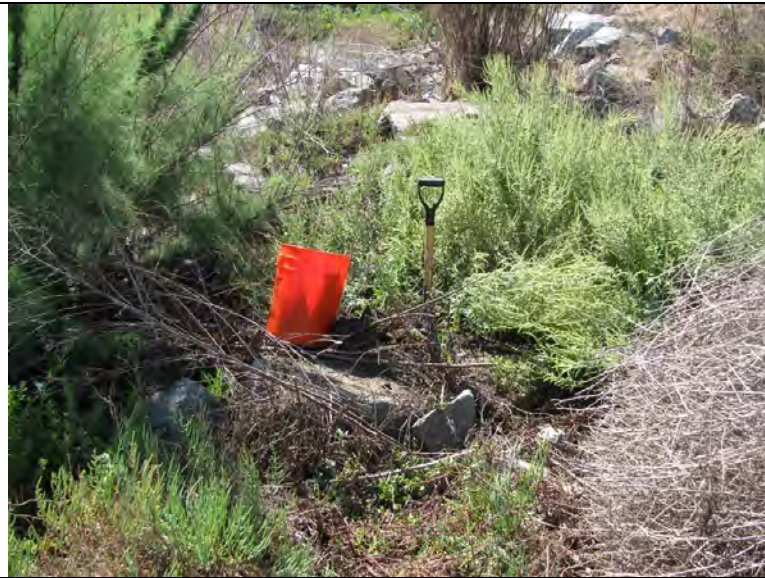
Photograph 4 Sample Point 2 outside of OHWM of San Dieguito River. August 2009.

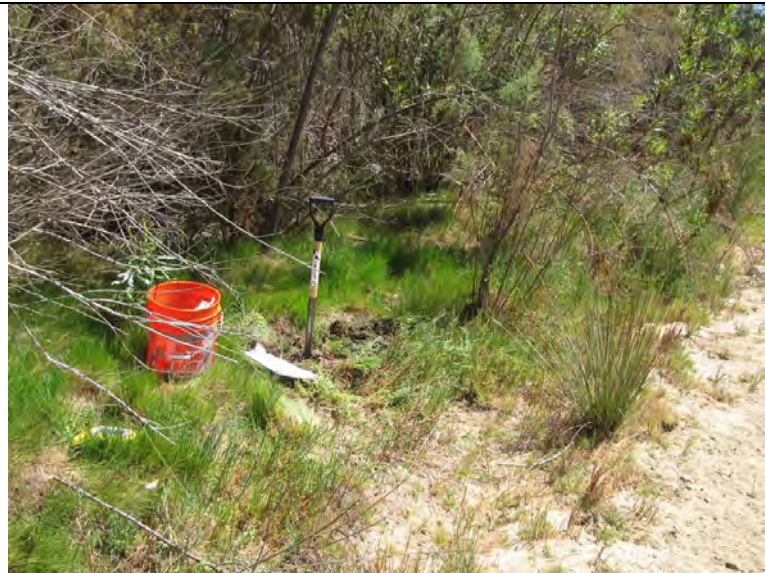
Photograph 5 Sample Point 3 on edge of mule fat scrub and freshwater marsh on north side of the San Dieguito River. August 2009. Facing South.

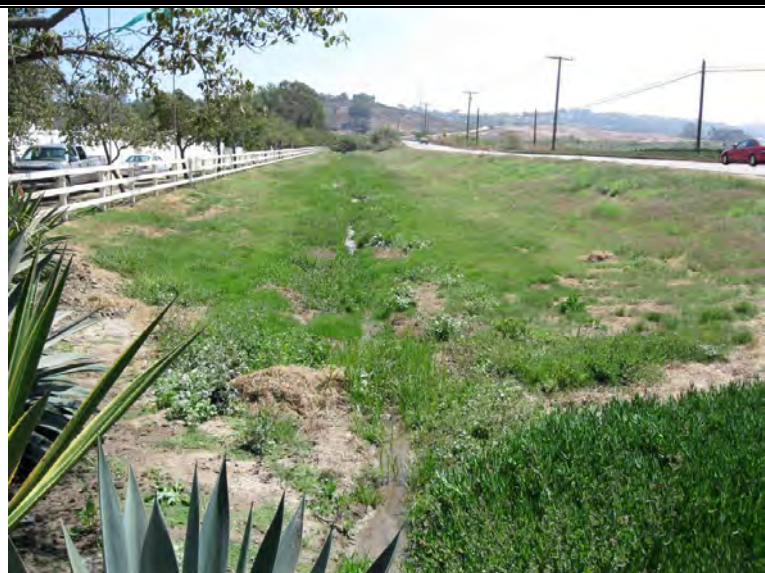
Photograph 6 Looking south along El Camino Real from driveway to polo fields. Overview of the mowed USACE wetland WUS.

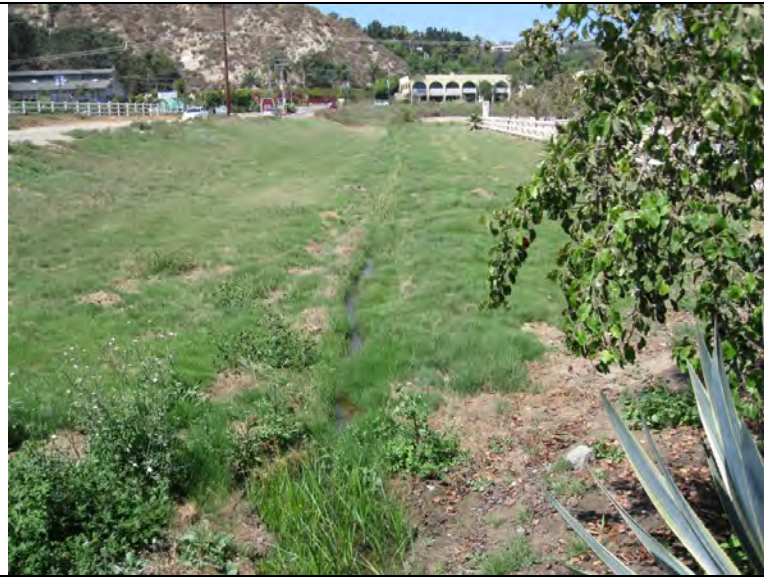
Photograph 7 Looking north along El Camino Real from driveway to Polo fields, of the mowed USACE wetland WUS. Location of Sample Points 7 and 11 in the foreground.

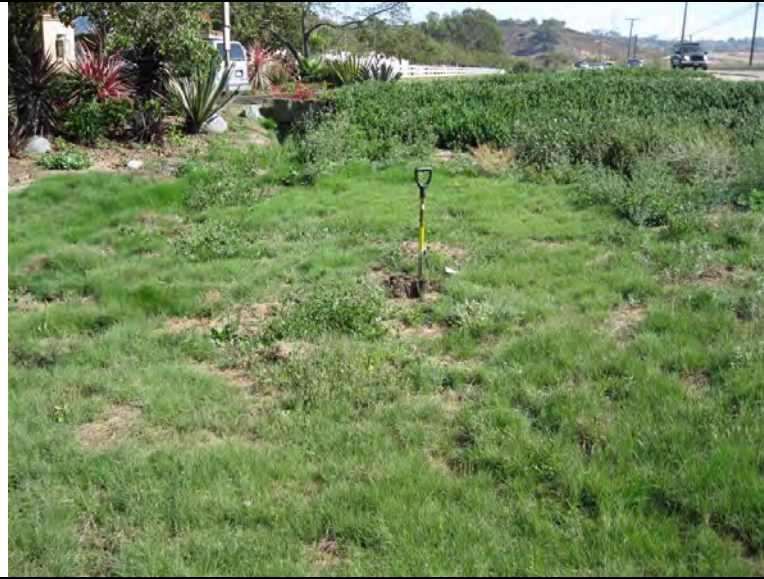
Photograph 8 Sample Point 7 in USACE wetland WUS and CDFG State Streambed. Wetland vegetation, soils, and hydrology present. Facing south.

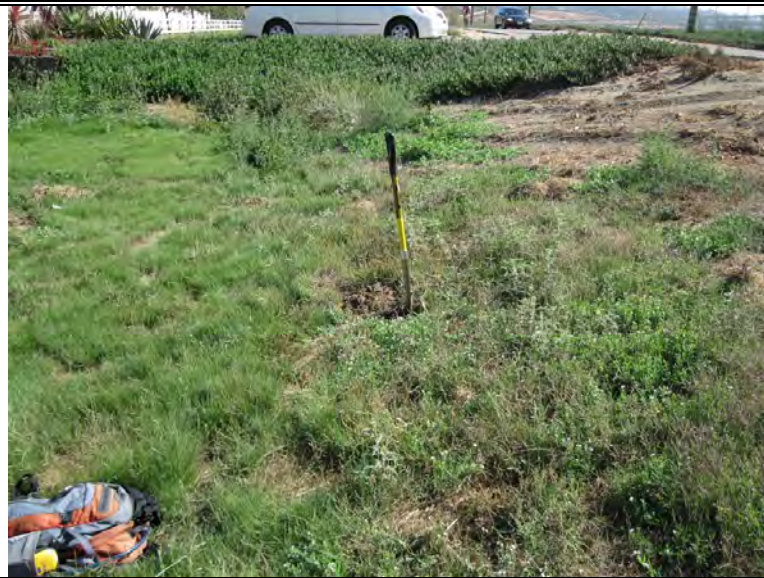
Photograph 9 Sample Point 11. Adjacent to Sample Point 7 and above the level of hydric soils. Facing south. August 2011.

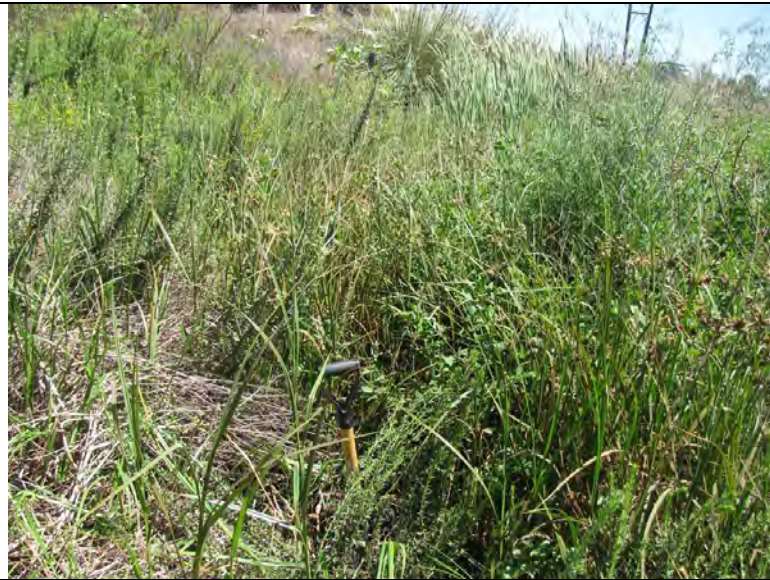
Photograph 9 Sample Point 6 in narrow strip of wetland vegetation surrounded by upland vegetation. August 2009.

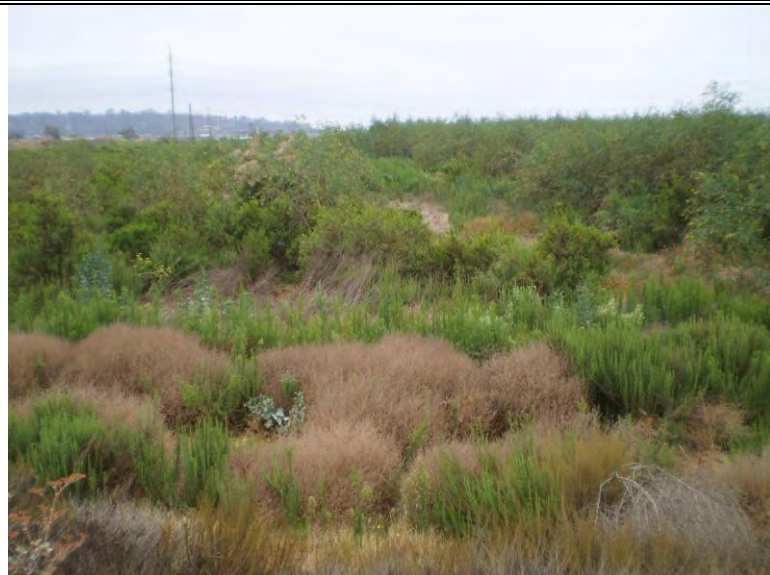
Photograph 11 Overview of JPA mitigation area. Enhancement Area in background to right. Creation area in background to left. Sample Point 13 in center. Taken from just south of El Camino Real Bridge. Facing east. August 2011.

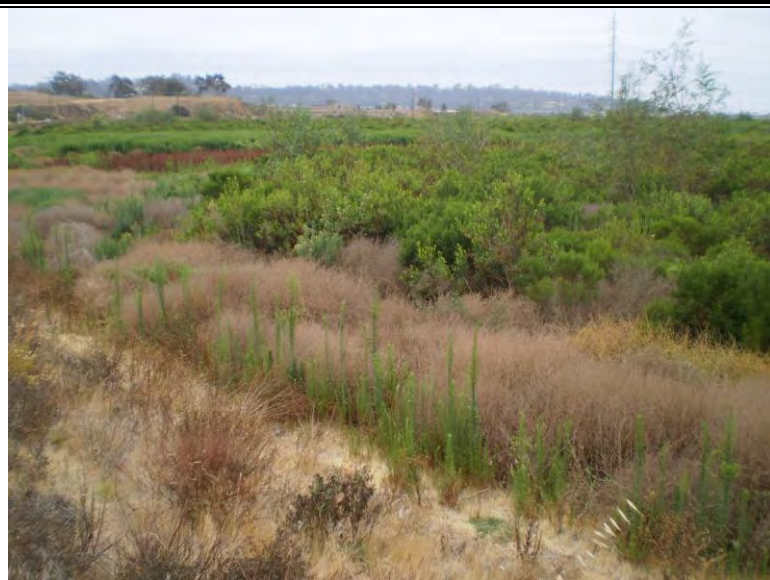
Photograph 12 Overview of JPA mitigation area. Taken from just south of El Camino Real Bridge. Facing southeast. August 2011

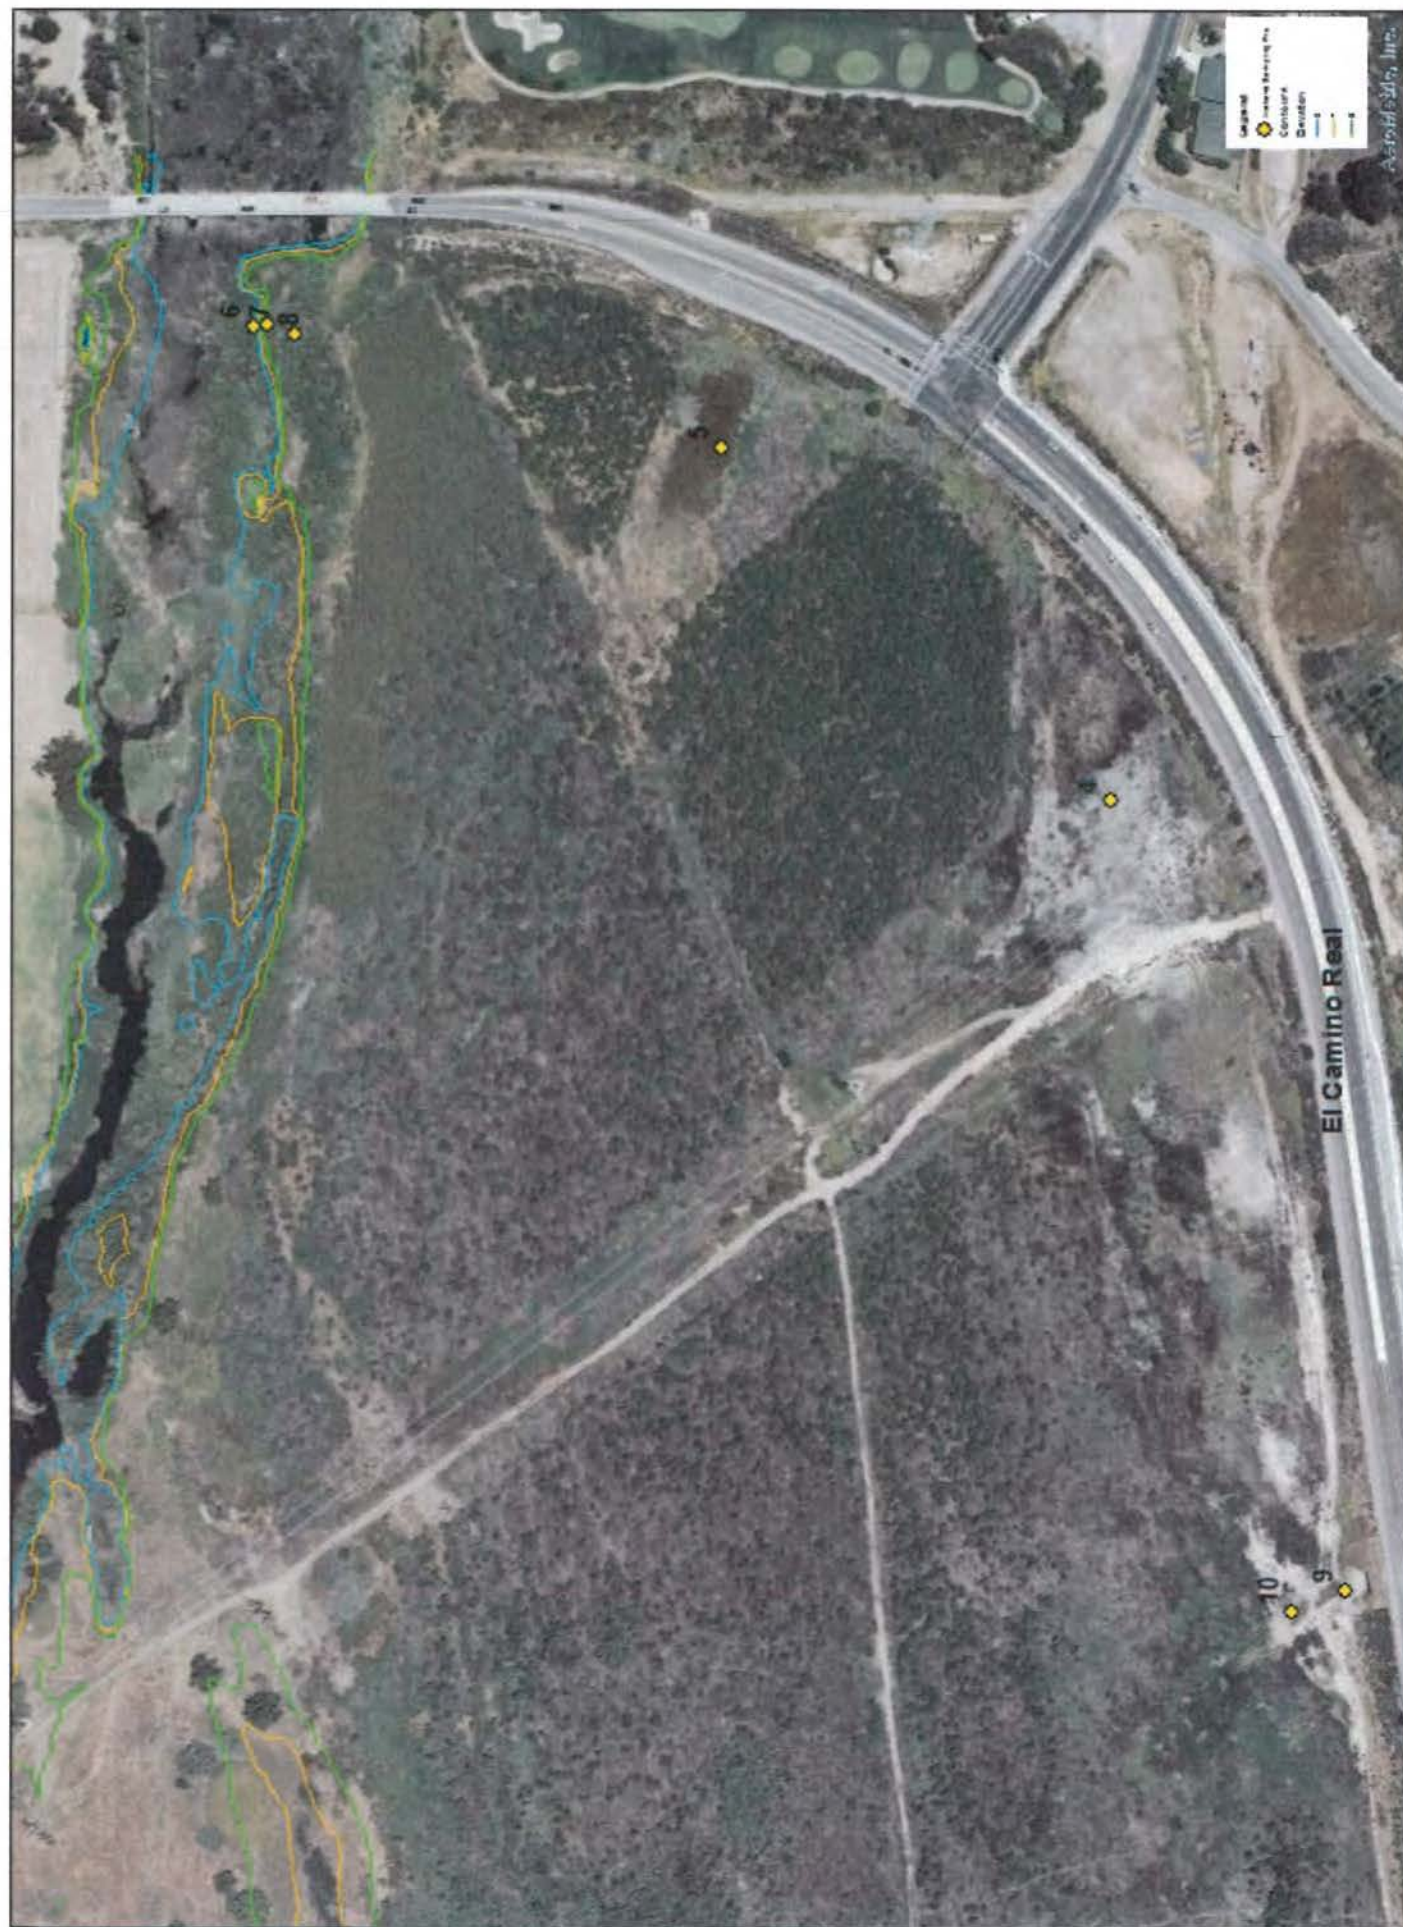
Figure 3a. Wetland Sample Points at the San Dieguito W19 Restoration Site

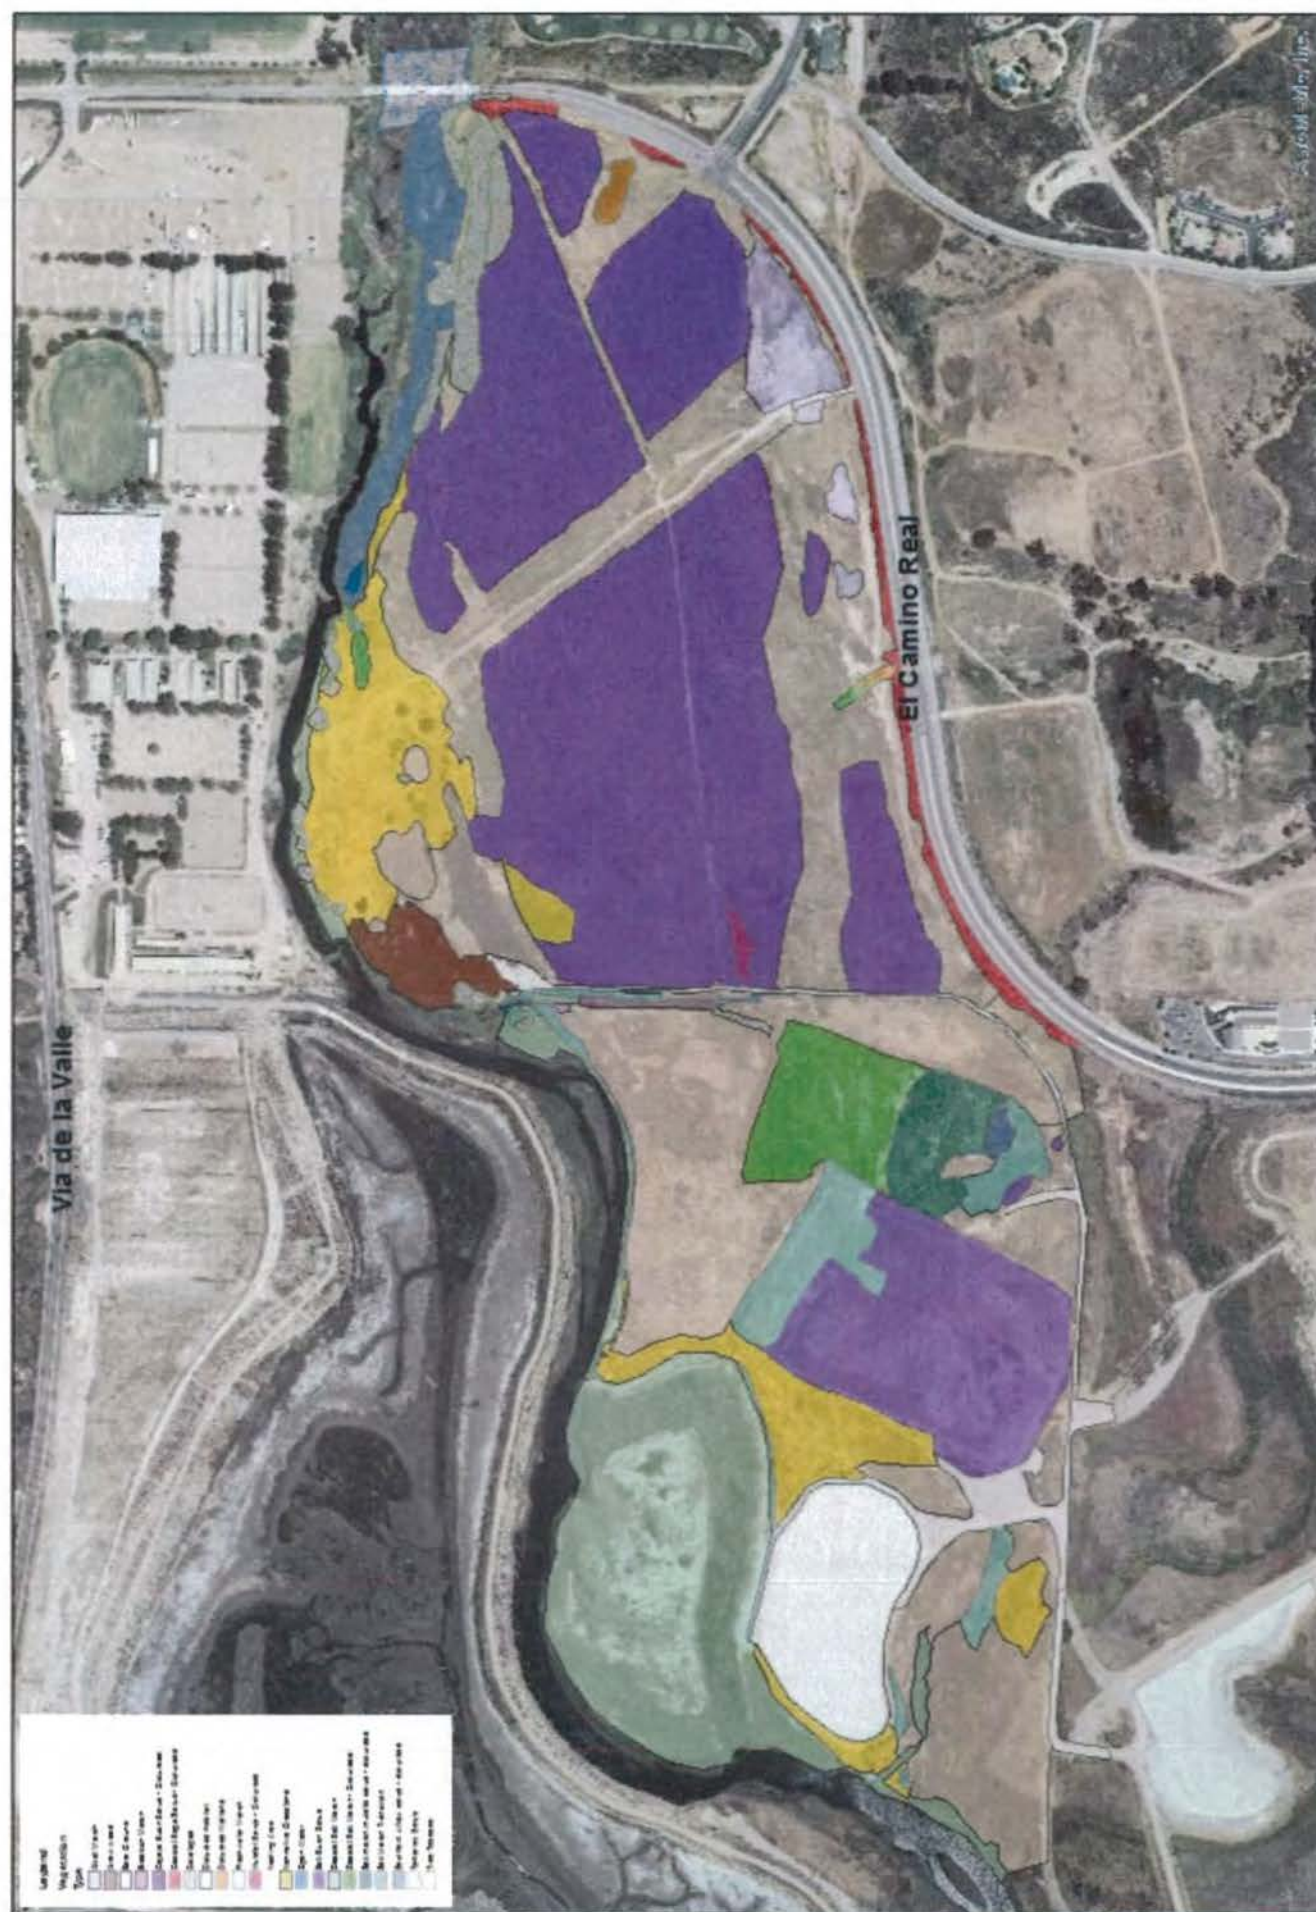
Figure 3b. Wetland Sample Points at the San Dieguito W19 Restoration Site
