**NATURAL ENVIRONMENT STUDY REPORT  
FOR THE EL CAMINO REAL  
ROAD/BRIDGE WIDENING PROJECT  
Project #2982, Sch. No. Pending**

June 13, 2006

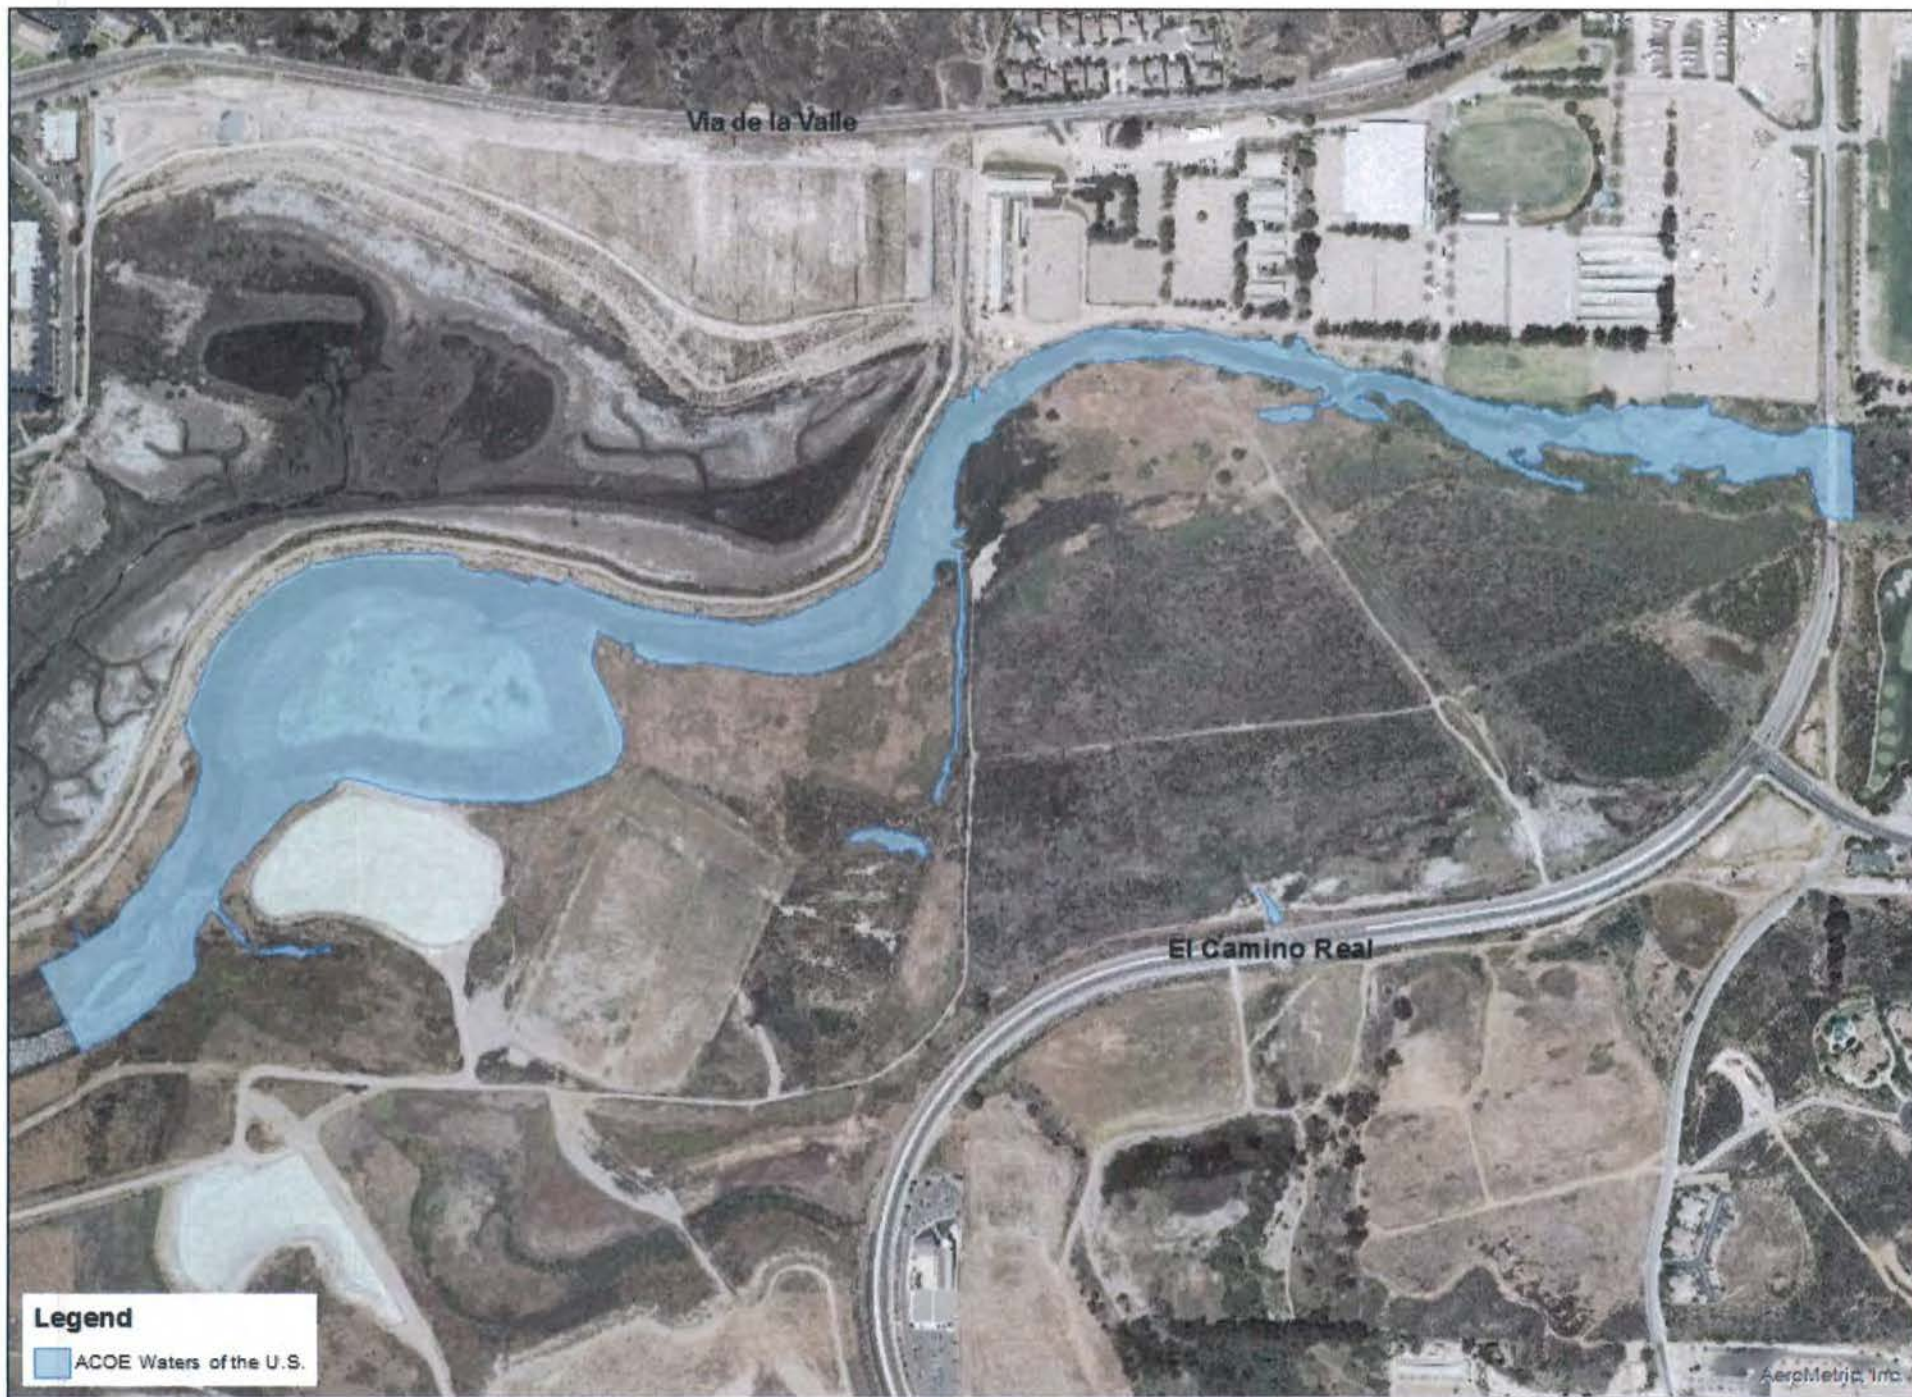
Figure 4. Vegetation Communities at San Dieguito W19 Restoration Site

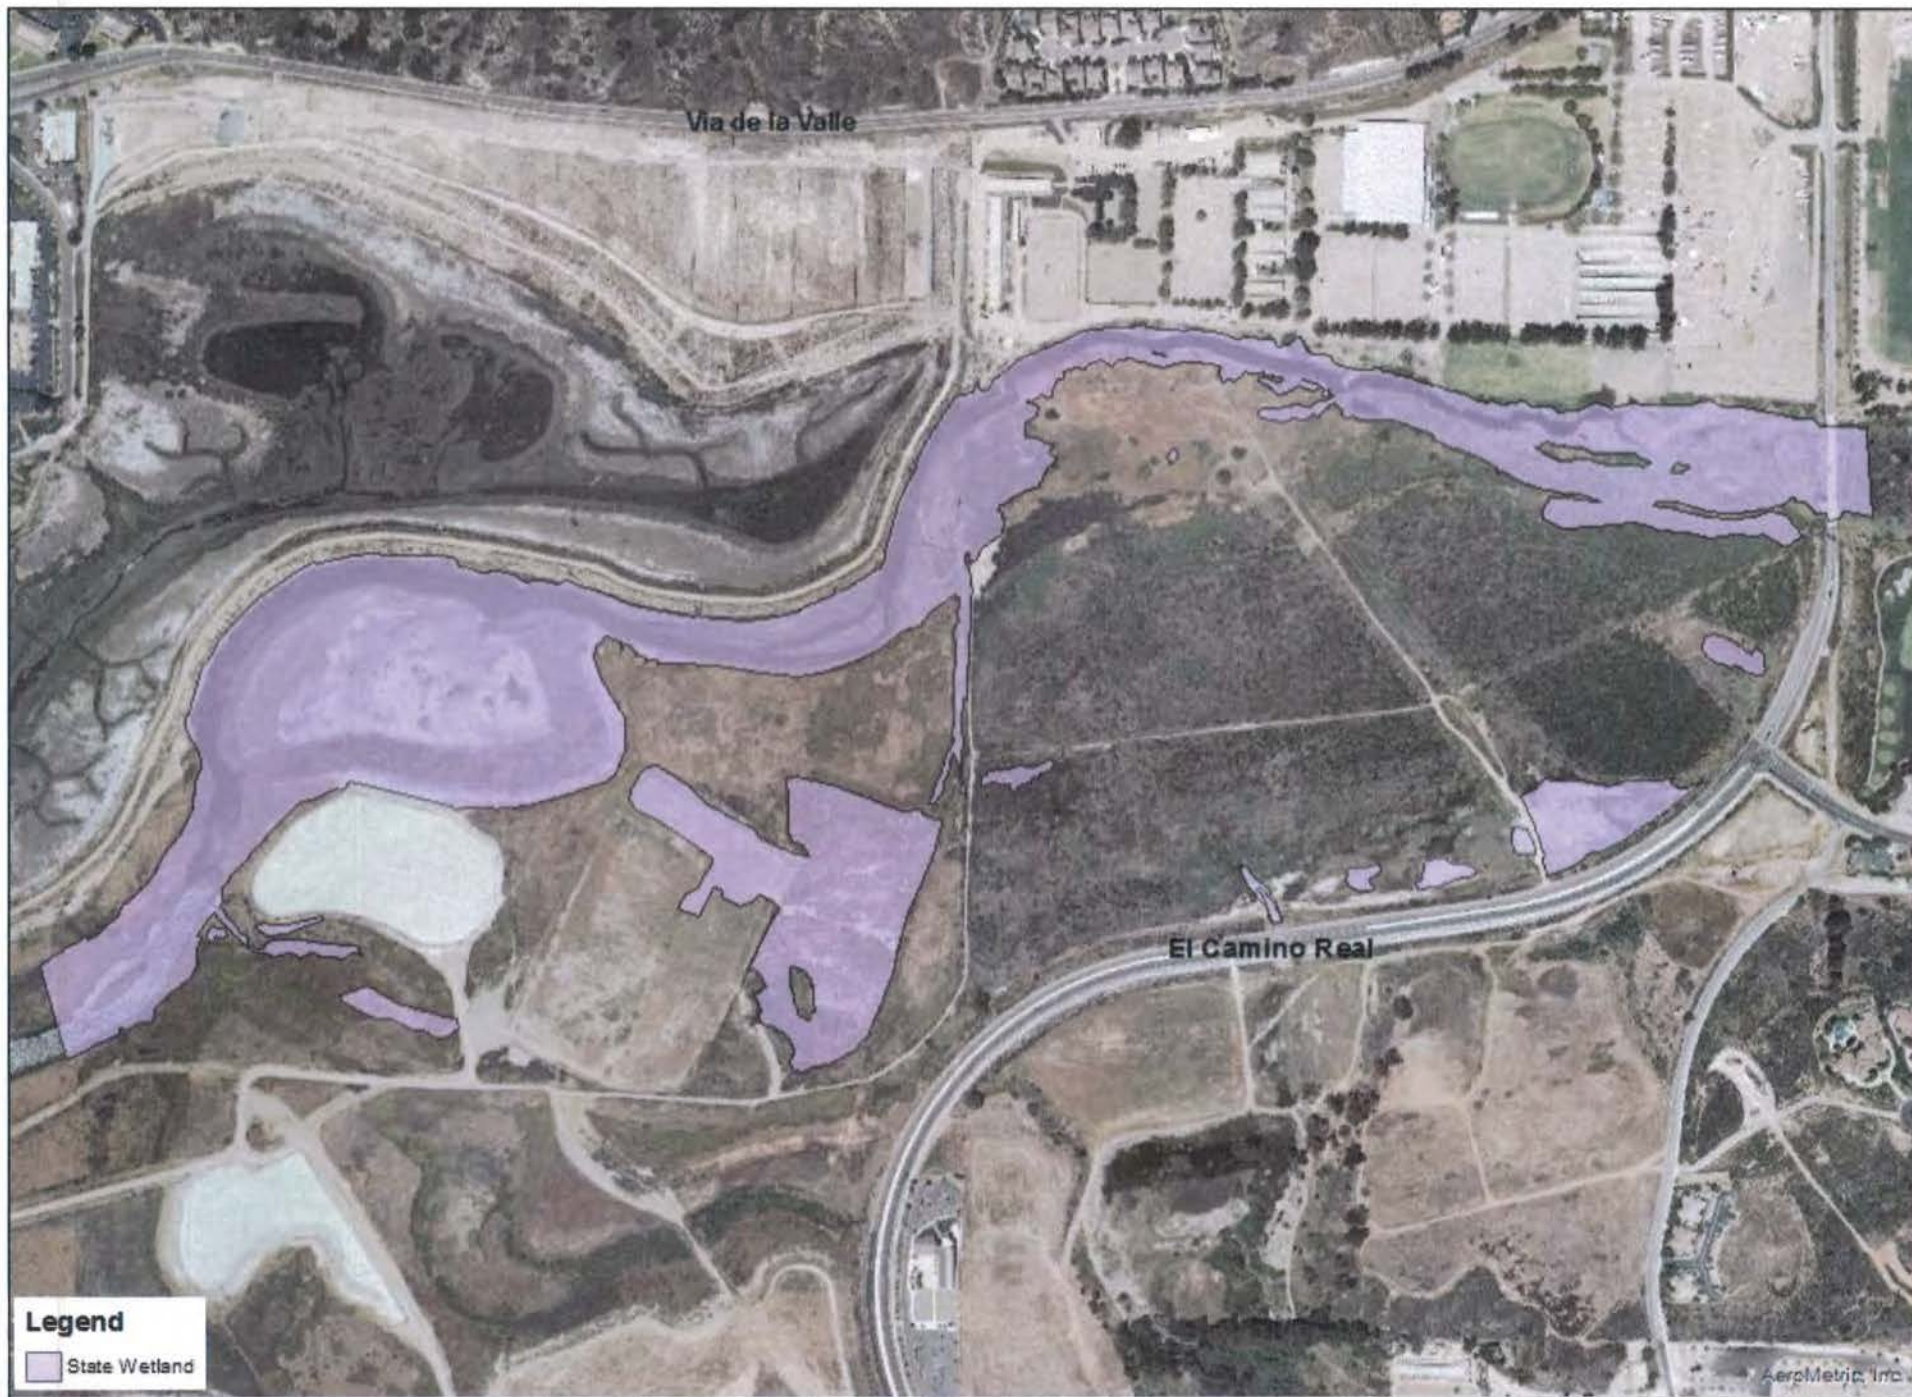
Figure 5. ACOE Jurisdictional Waters of the U.S. at the San Dieguito W19 Restoration Site

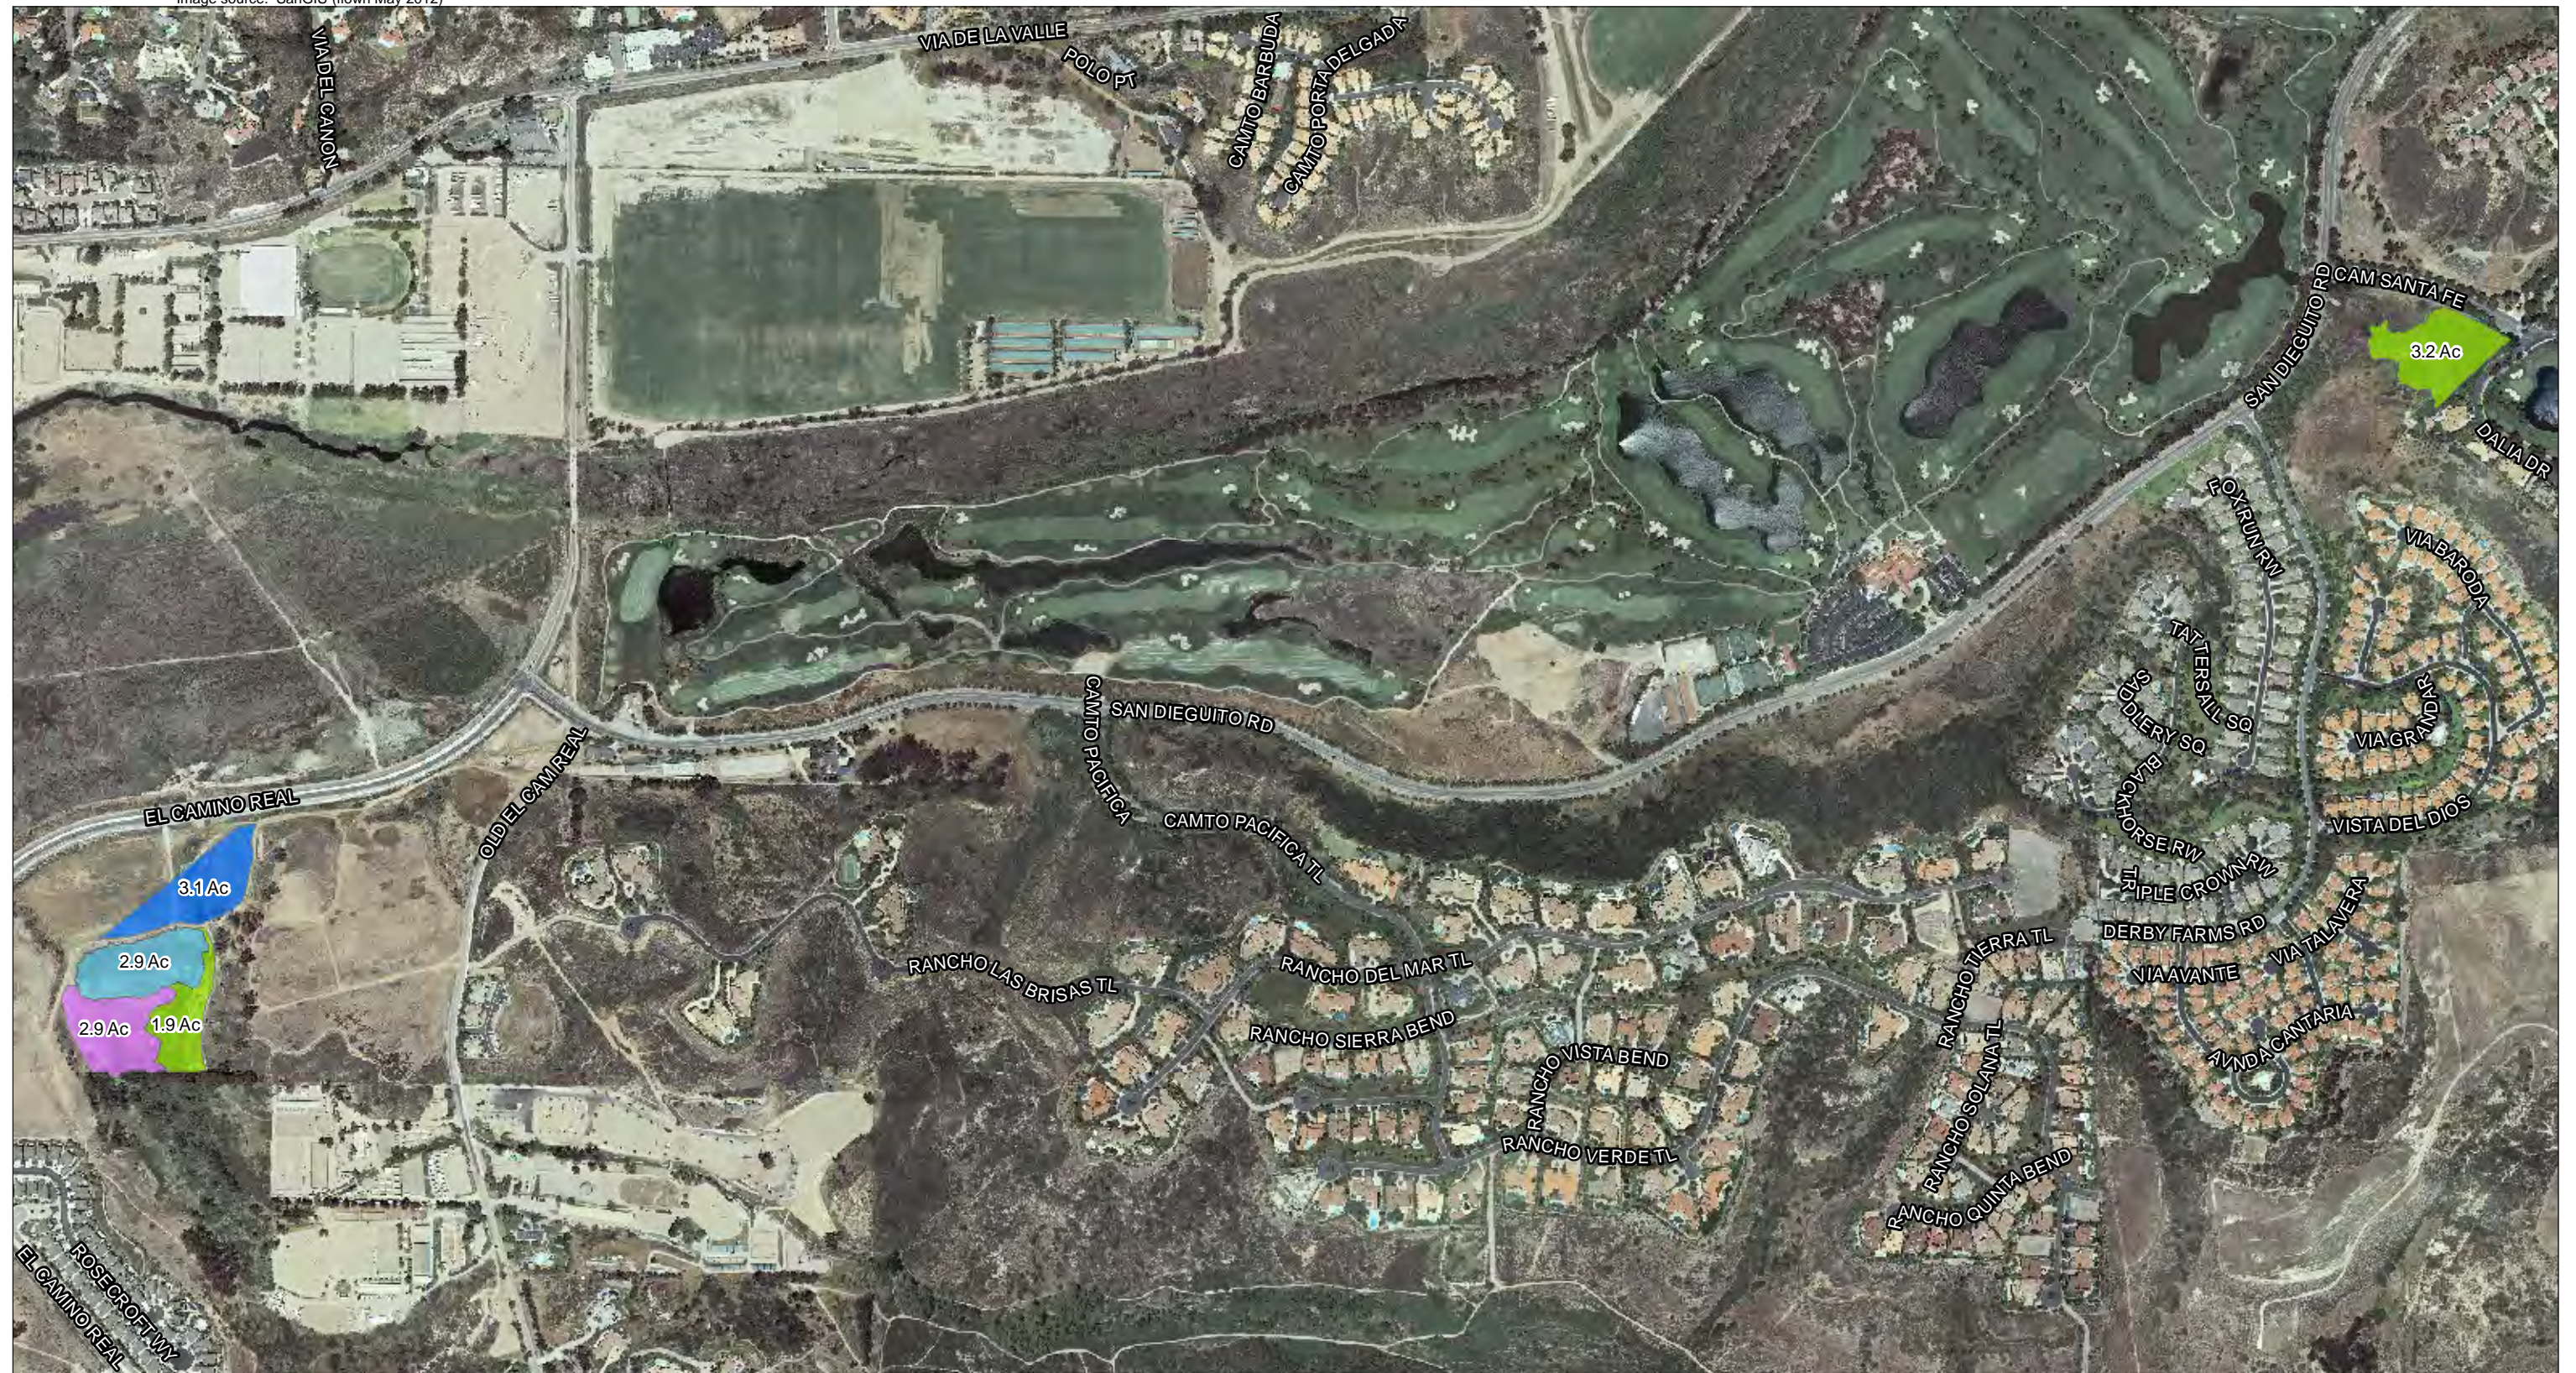
**Potential Mitigation Areas**

- Cismontane Alkali Marsh Creation
- Freshwater Marsh Enhancement
- Cismontane Alkali Marsh Restoration
- Southern Willow Scrub Enhancement

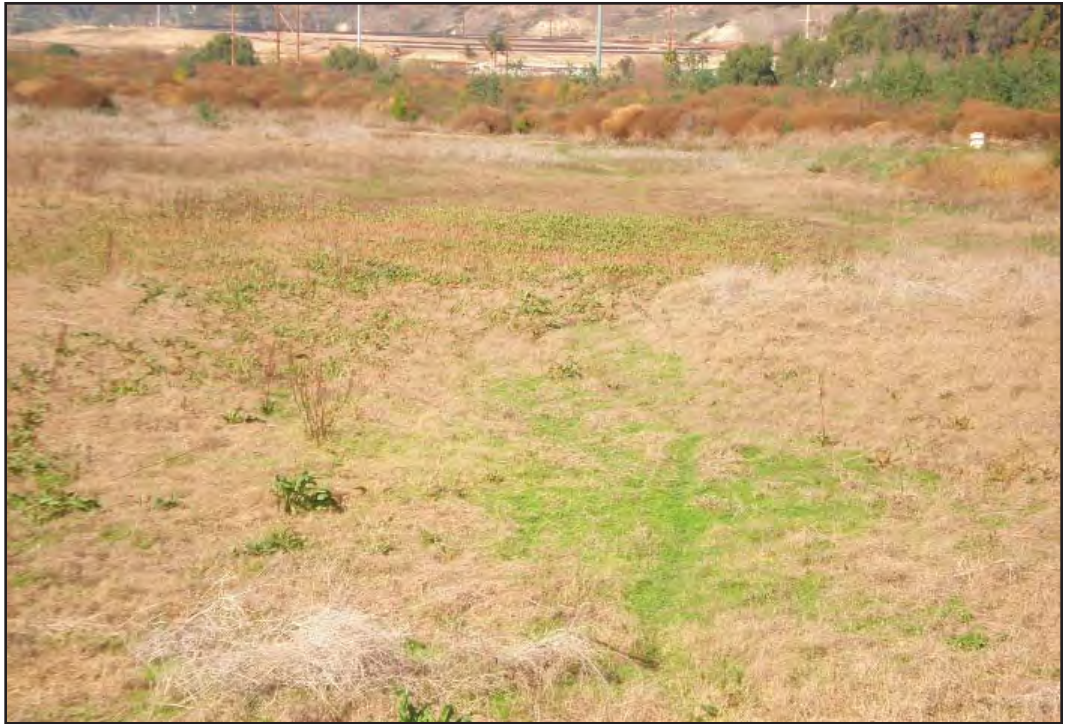
PHOTOGRAPH 1  
Proposed Freshwater Marsh Creation  
Area, Looking Northwest, January 2010

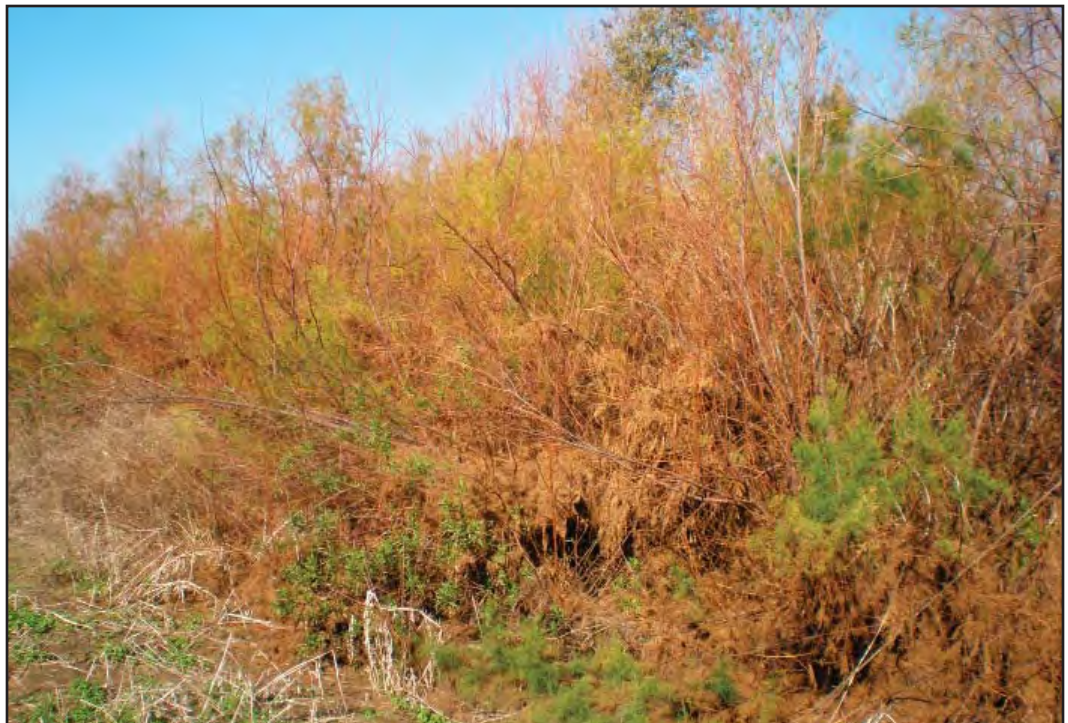
PHOTOGRAPH 2  
Proposed Riparian Scrub Enhancement  
Area, Looking West, January 2010

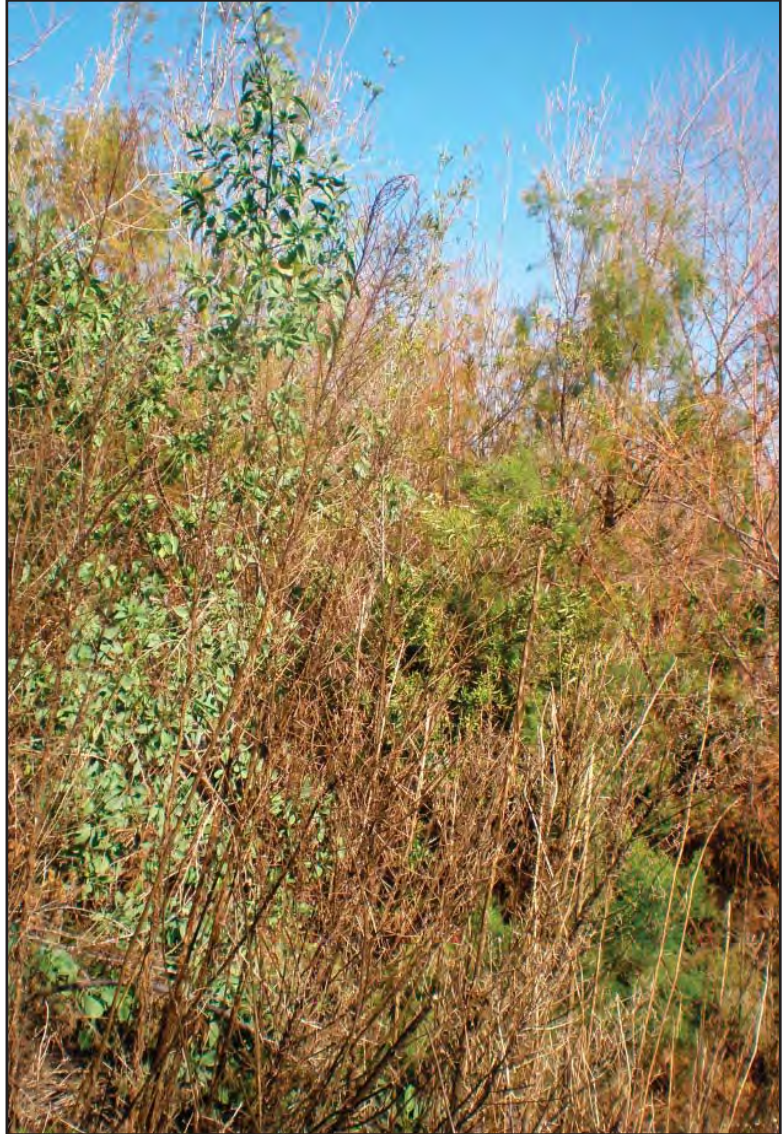
PHOTOGRAPH 3  
Proposed Riparian Scrub Off-Site Mitigation Area,  
Looking Southwest, January 2010

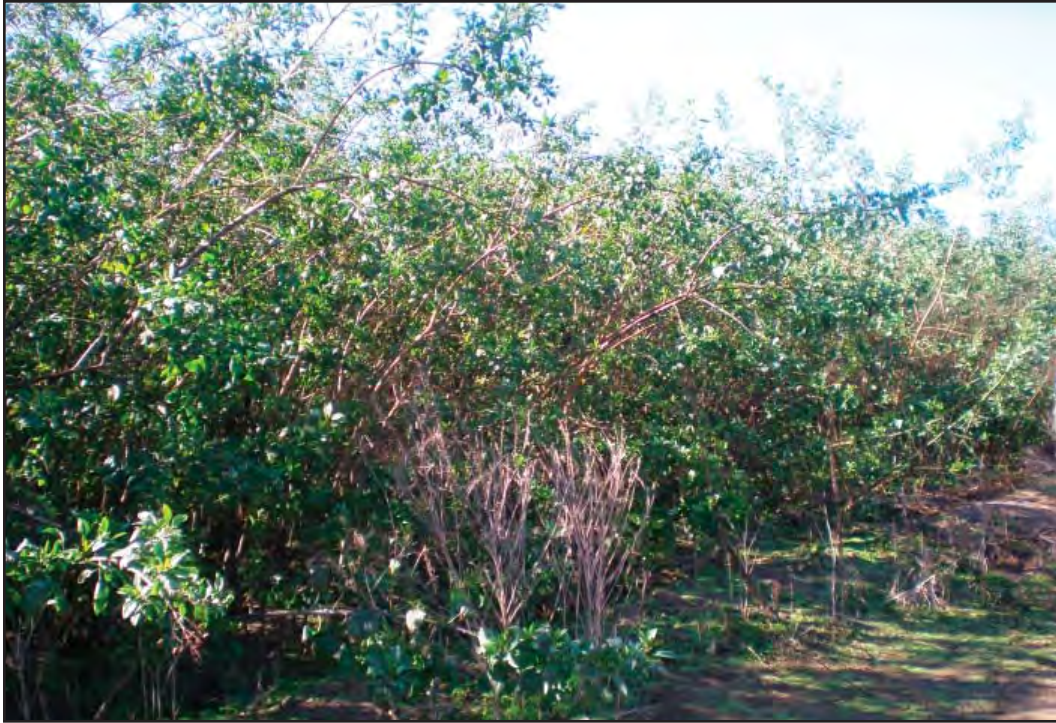
PHOTOGRAPH 4  
Large Tree Tobacco Growing in Off-Site Mitigation Area,  
Looking Southwest, January 2010

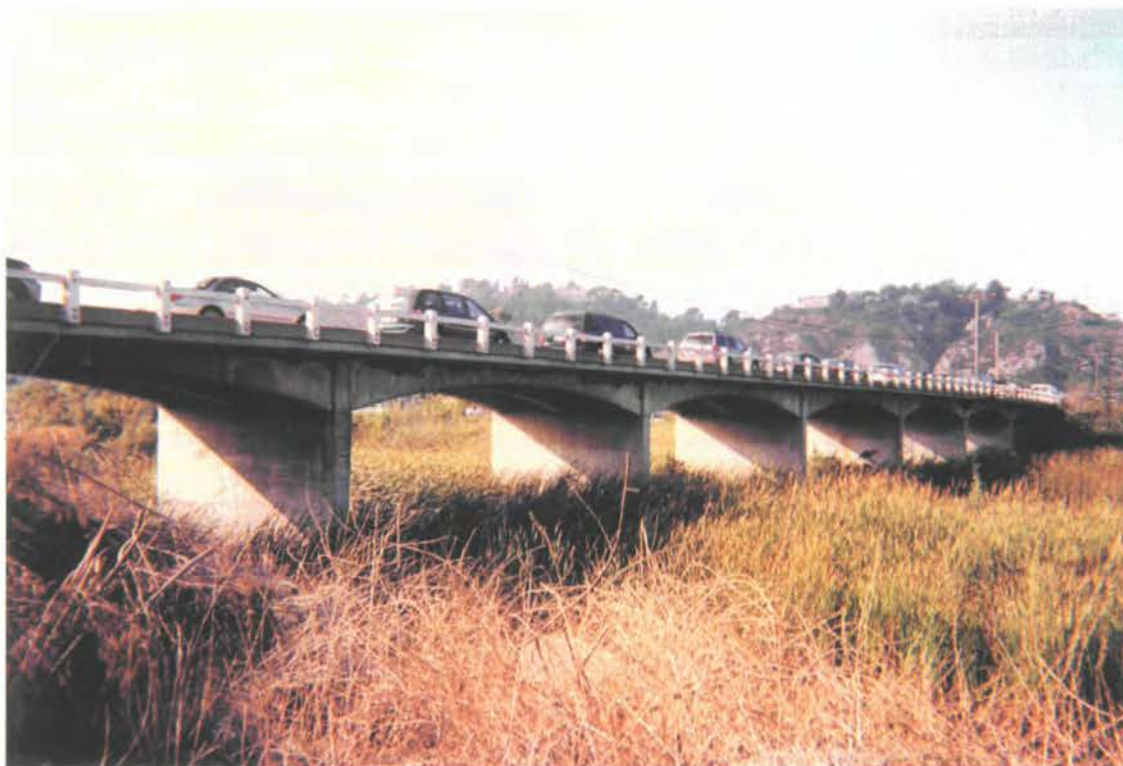
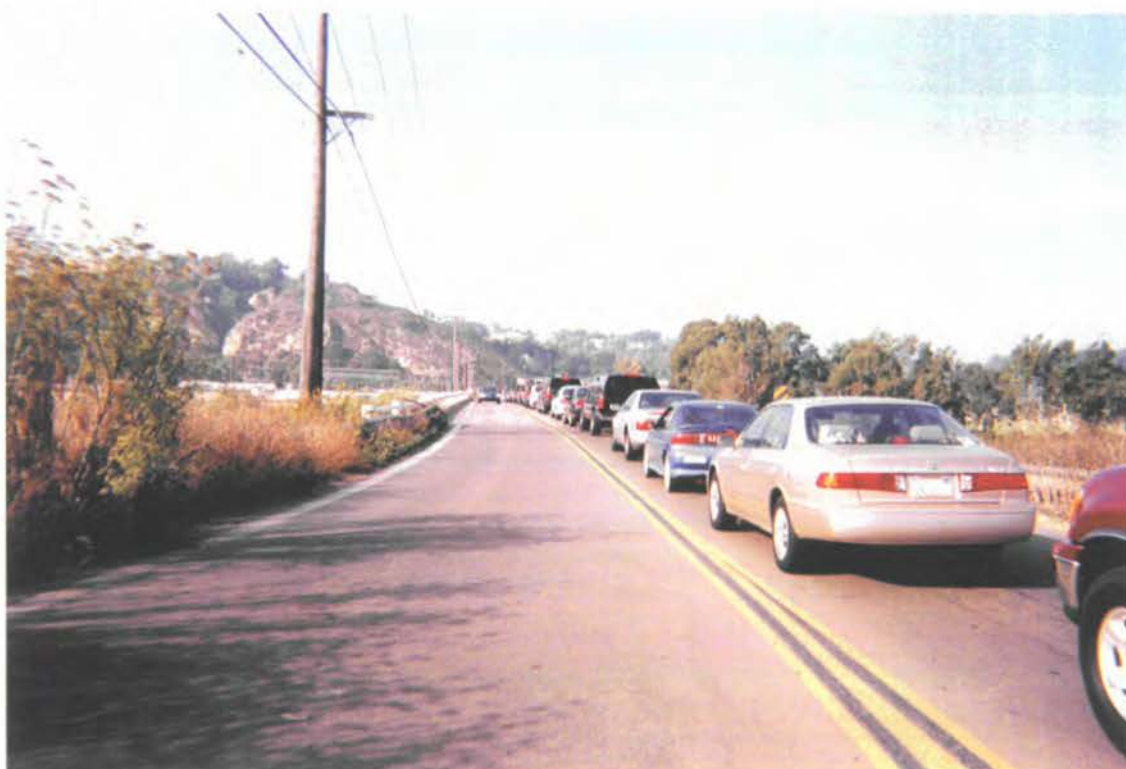
A. East Facade, Looking Northwest

B. Centerline, Looking North

## El Camino Real Bridge

The El Camino Real bridge is a 340' seven-span, reinforced concrete arched deck girder structure with cantilevered end spans (see Figures 3 and Appendix C). The bridge has two 13' abutment

cantilevers, two 42' end spans, and 5 46' intermediate spans. Designed by Donald R. Warren, a Los Angeles-based structural engineer, for the County of San Diego, it replaced a 171' pile trestle bridge in the same location. The bridge's reinforced concrete girder construction represents a type popular for highway bridge construction in the 1930s and 1940s and still in use today. This type became popular as a result of the simplicity of its construction, but generally has poor seismic resistance (Structsource 2003).

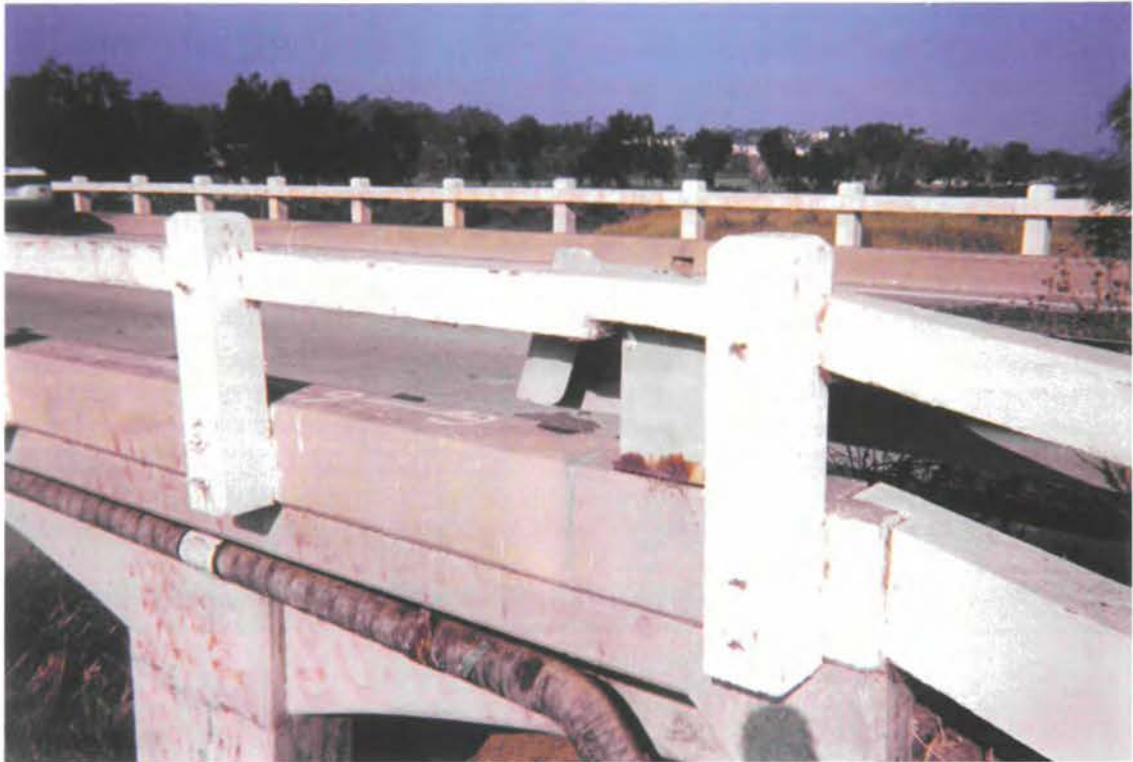
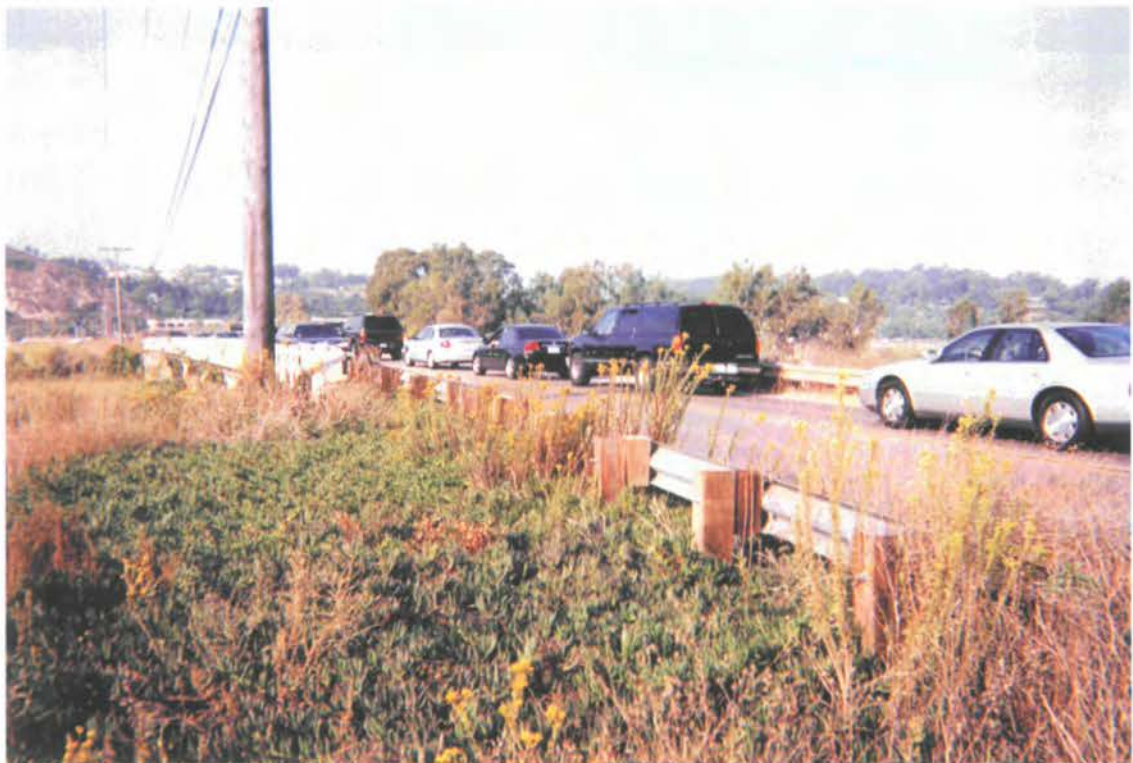
Figure 12

The bridge is 26' 8" wide with a 24' roadway (Figure 12). The overhanging deck, on a 1% slope from center, has a raised 1' by 1' concrete curb on either edge but lacks sidewalks. A timber post and sheet metal approach guardrail leads to a painted wooden timber railing approximately 3' high. The railing has 8" by 8" posts with 1" chamfer tops and 1/4" chamfer corners, and a single recessed 4" by 4" rail. The railing is attached to the deck by galvanized carriage bolts with cut washers. Posts are spaced every 6' on the end spans and 6 to 6 7/8" on intermediate spans.

A. Timber Railing

B. Approach Guardrail

In 1966, the bridge bearings were reconstructed by the City of San Diego (Appendix D). Three existing rockers were replaced with new expansion plate assemblies and the original expansion joint in span 4 was replaced with an expansion dam. No drawings illustrating the reconstruction activities following the 1979-1980 damage were found during research at the Transportation Engineering Department.
