**SUBJECT: GEOTECHNICAL INVESTIGATION**  
**Proposed Single Family Residence**  
**Lot 207, Alamazon Street, Peñasquitos Glens #4**  
**San Diego, California**

**GEOTECHNICAL INVESTIGATION  
PROPOSED SINGEL FAMILY RESIDENCE  
LOT 207 ALMAZON STREET, PEÑASQUITOS GLENS #4  
SAN DIEGO, CALIFORNIA**

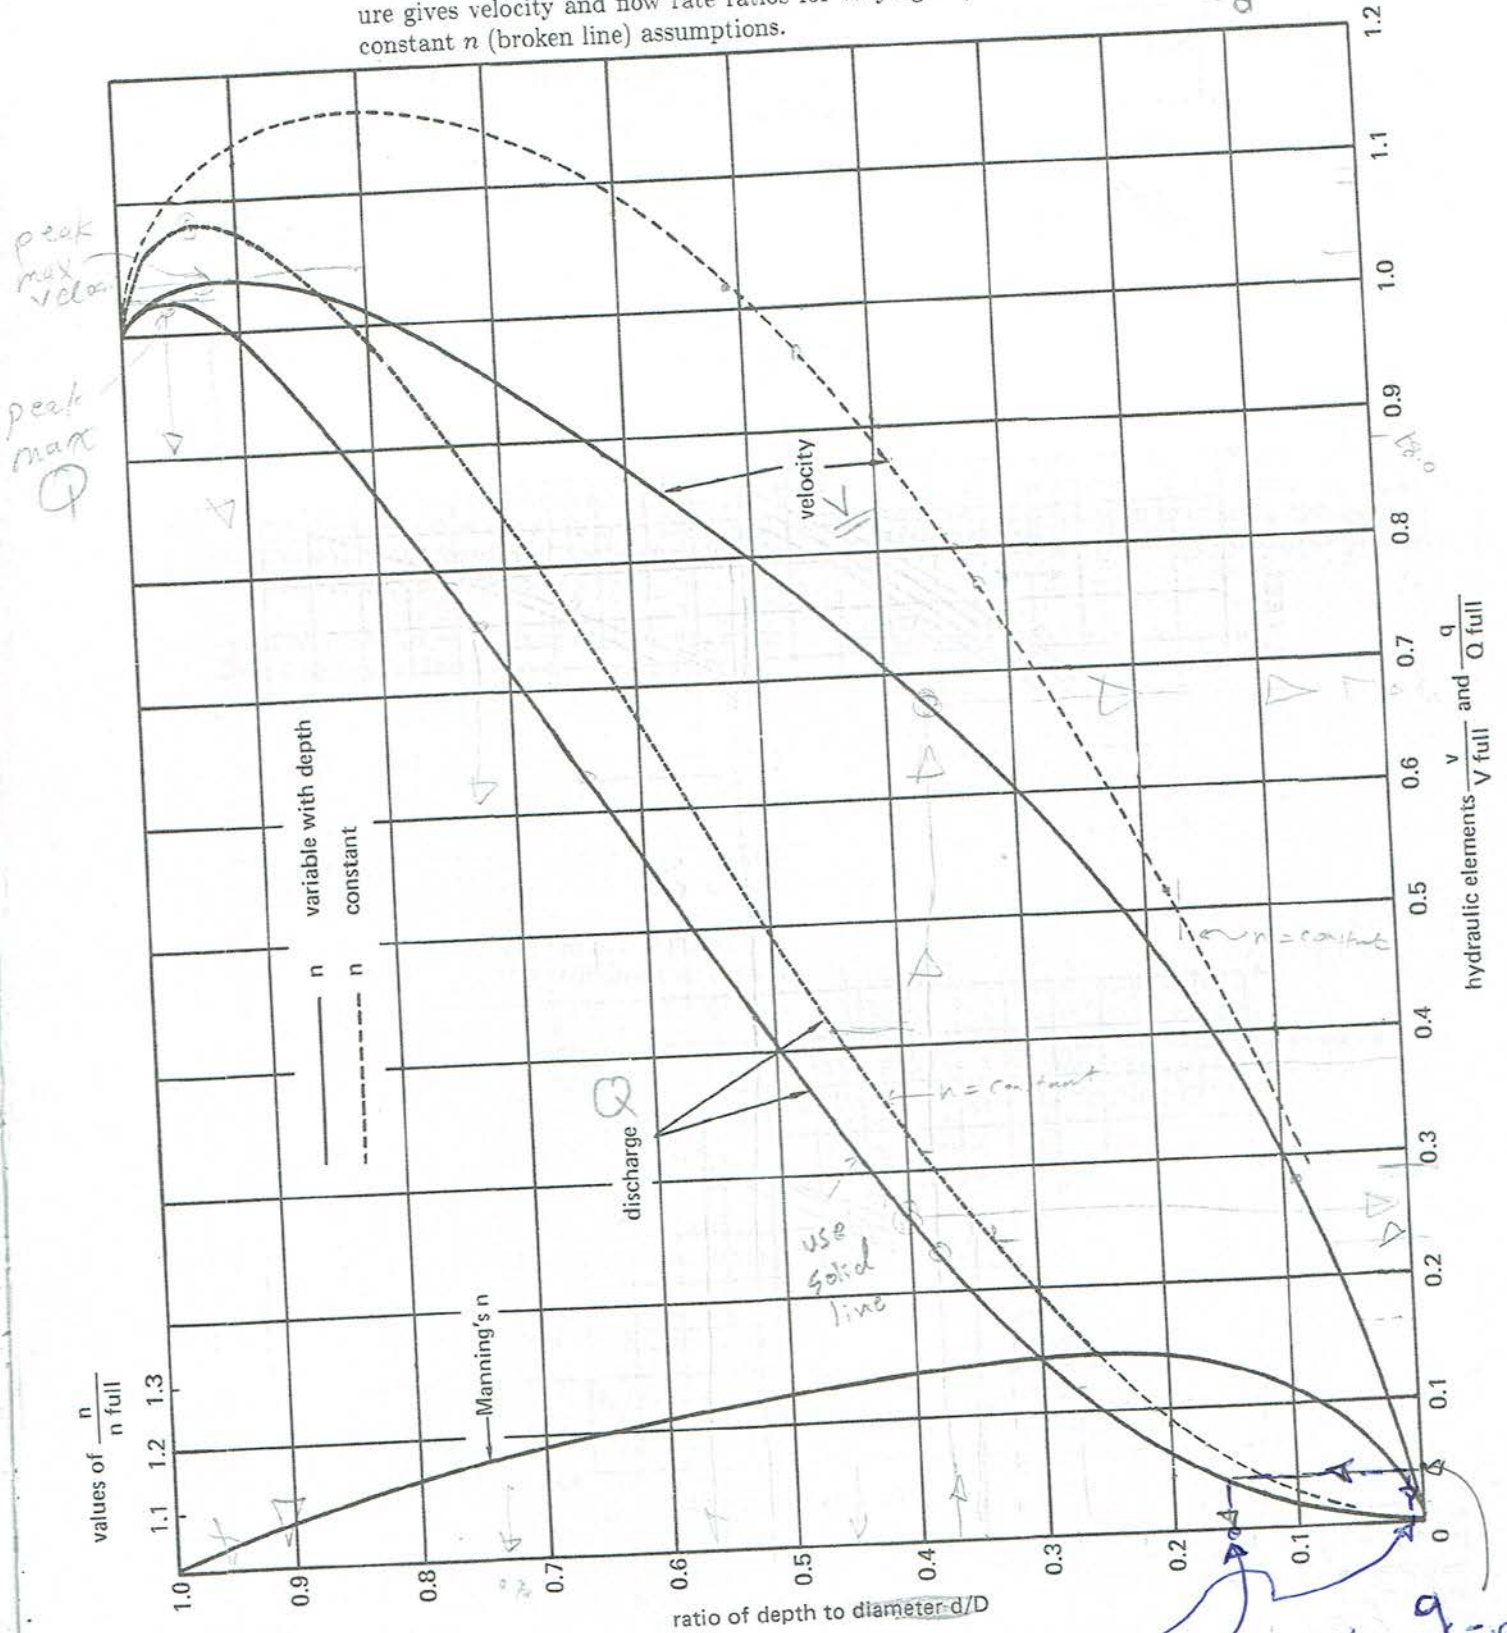
# Appendix C: Circular Channel Ratios

Experiments have shown that  $n$  varies slightly with depth. This figure gives velocity and flow rate ratios for varying  $n$  (solid line) and constant  $n$  (broken line) assumptions.

$$\frac{n}{V_{full}} = 0.01 \quad \text{then} \quad \frac{q}{Q} = 0.04 \text{ cfs}$$

$$\frac{d}{D} = 0.16 \quad \text{then}$$

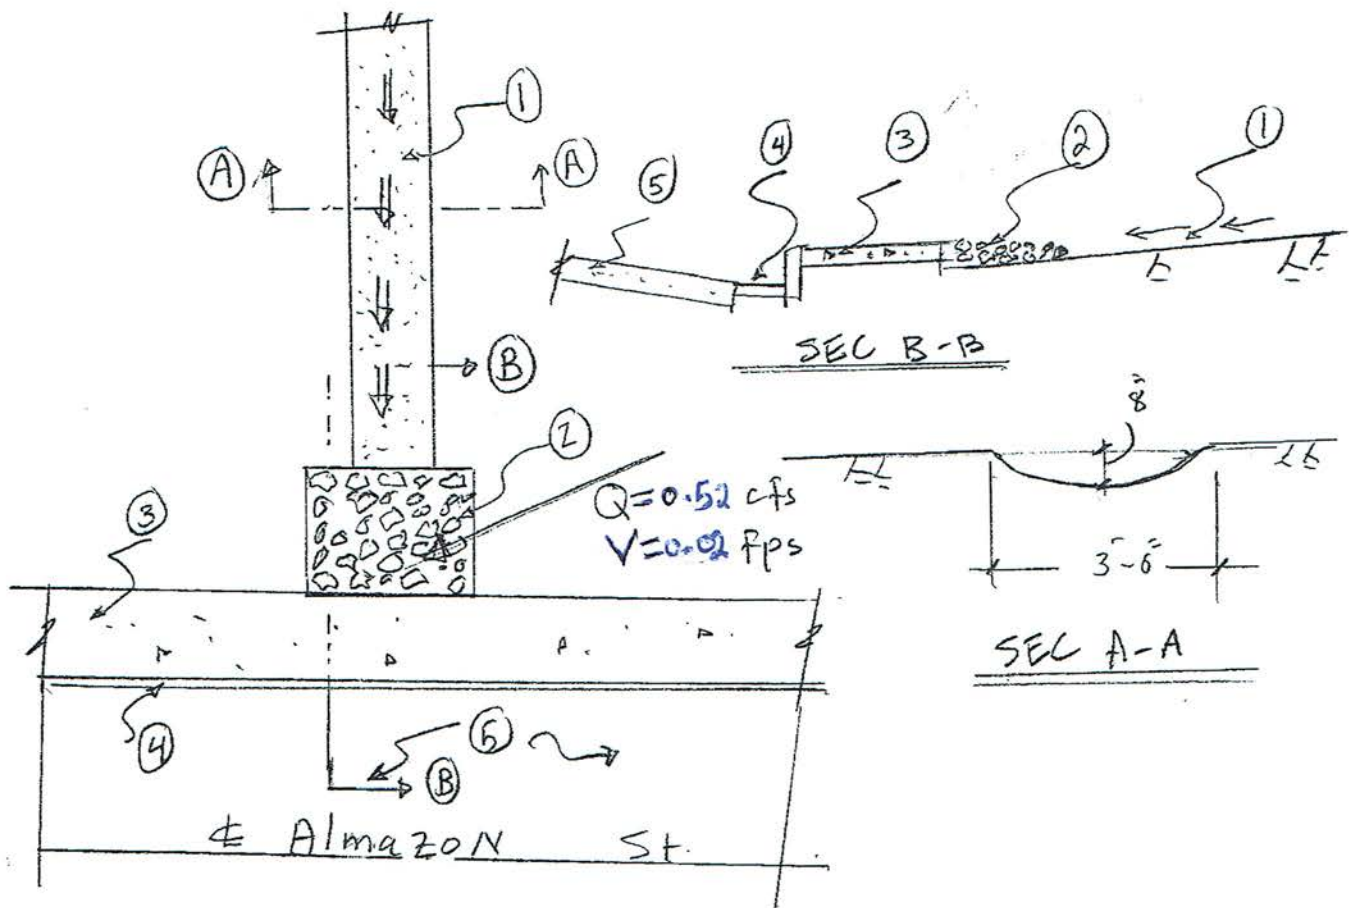
- ① (N) Vegetated Swale 3'6" width x 8" Deep.
- ② (N) 5' x 5' x 4" size RipRap.
- ③ (E) Concrete Sidewalk.
- ④ (E) Curb & gutter.
- ⑤ (E) Pavement

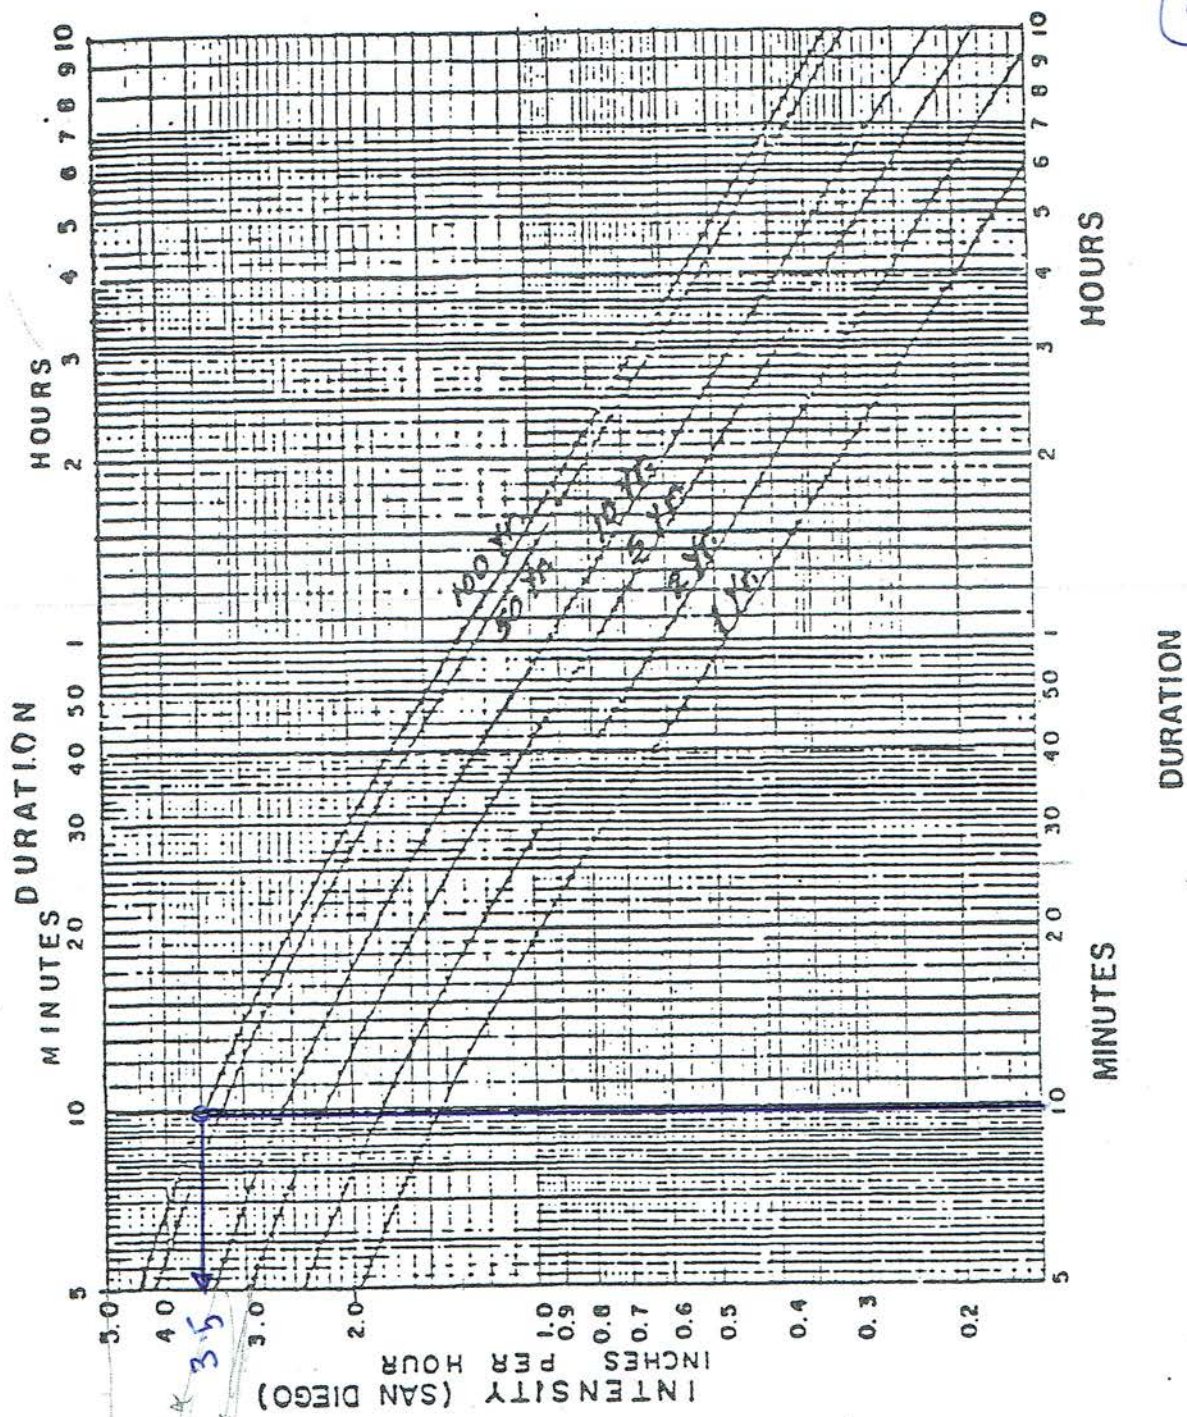
ELEV.	FACTOR
0-1500	1.00
1500-3000	1.25
3000-4000	1.42
4000-5000	1.60
5000-6000	1.70
DESERT	1.25

To obtain correct intensity, multiply intensity on chart by factor for design elevation.
