**COMBINED HISTORICAL
SURVEYS**

City of San Diego Planning Department

January 2005

**REVISED DRAFT
EAST VILLAGE
HISTORICAL PROPERTY SURVEY REPORT
2005**

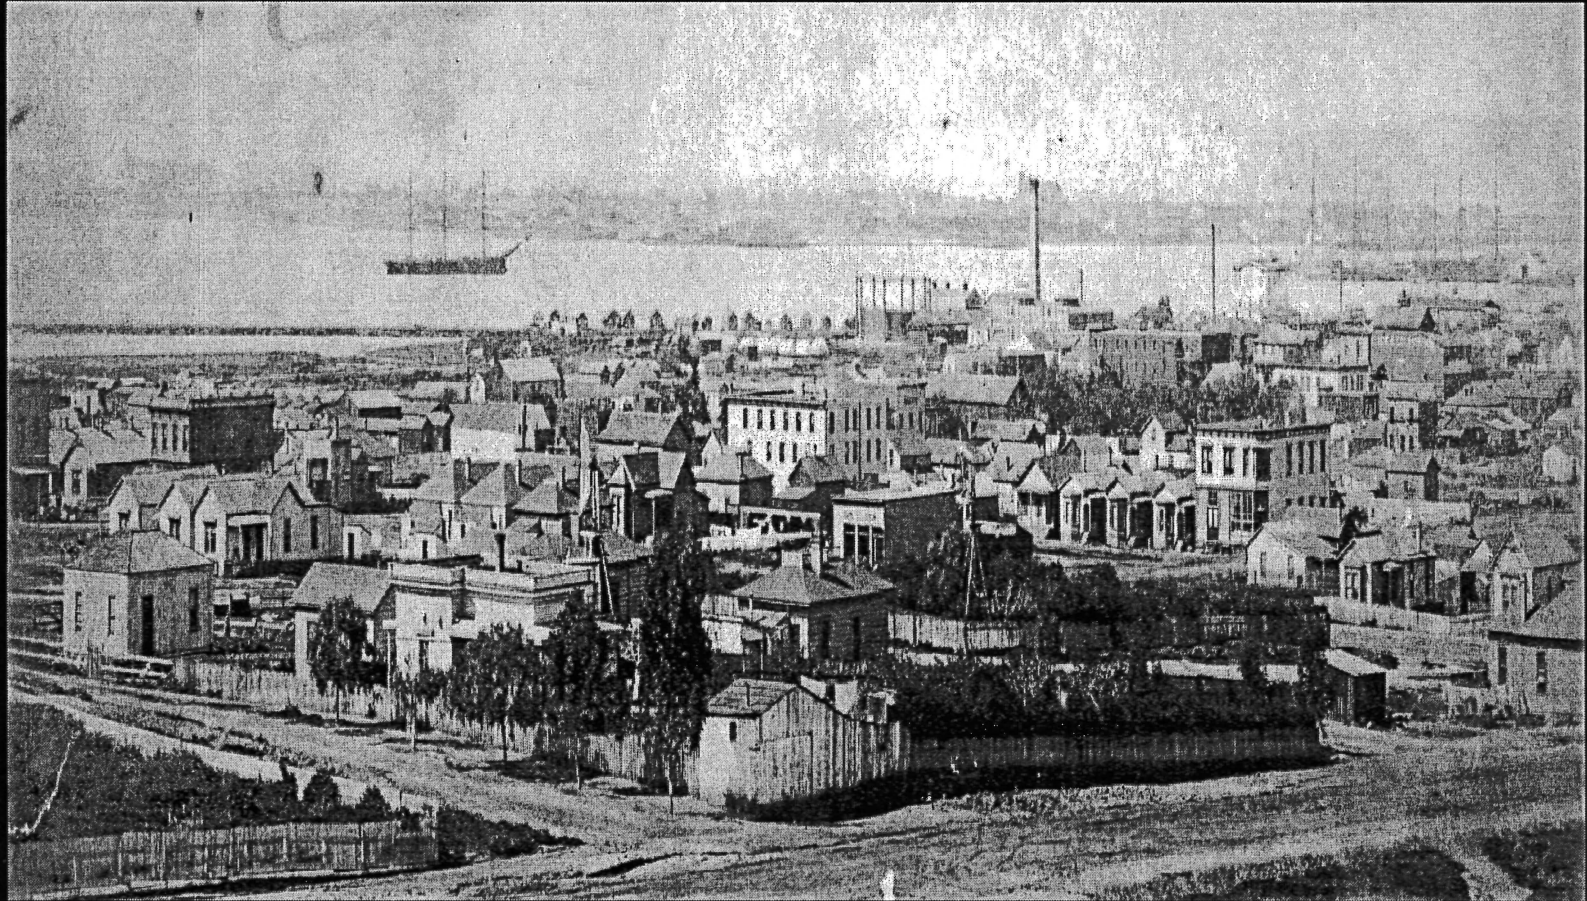
Photo 1. 15th & J looking West 1890

With the 1885 railroad connection, an influx of newcomers to the San Diego area sparked a four-year building boom. In the Bayside and Centre City East area, simple Victorian single-family cottages were erected on 16th and 17th Avenues to accommodate laborers, porters, clerks, and other blue collar workers (Photo 1). The Rood Rental cottage, Bay View Hotel, Sheldon House and Joseph Ireland Building are examples of Victorian structures built during the boom. Standard iron works erected its manufacturing business on the corner of 7th Avenue and L Street, and the Silver Gate Warehouse, owned by local entrepreneur John Ginty, was constructed on 8th Avenue and M Street (later Imperial) (Lia/Brandes 1989:2; Lia 1999:2).

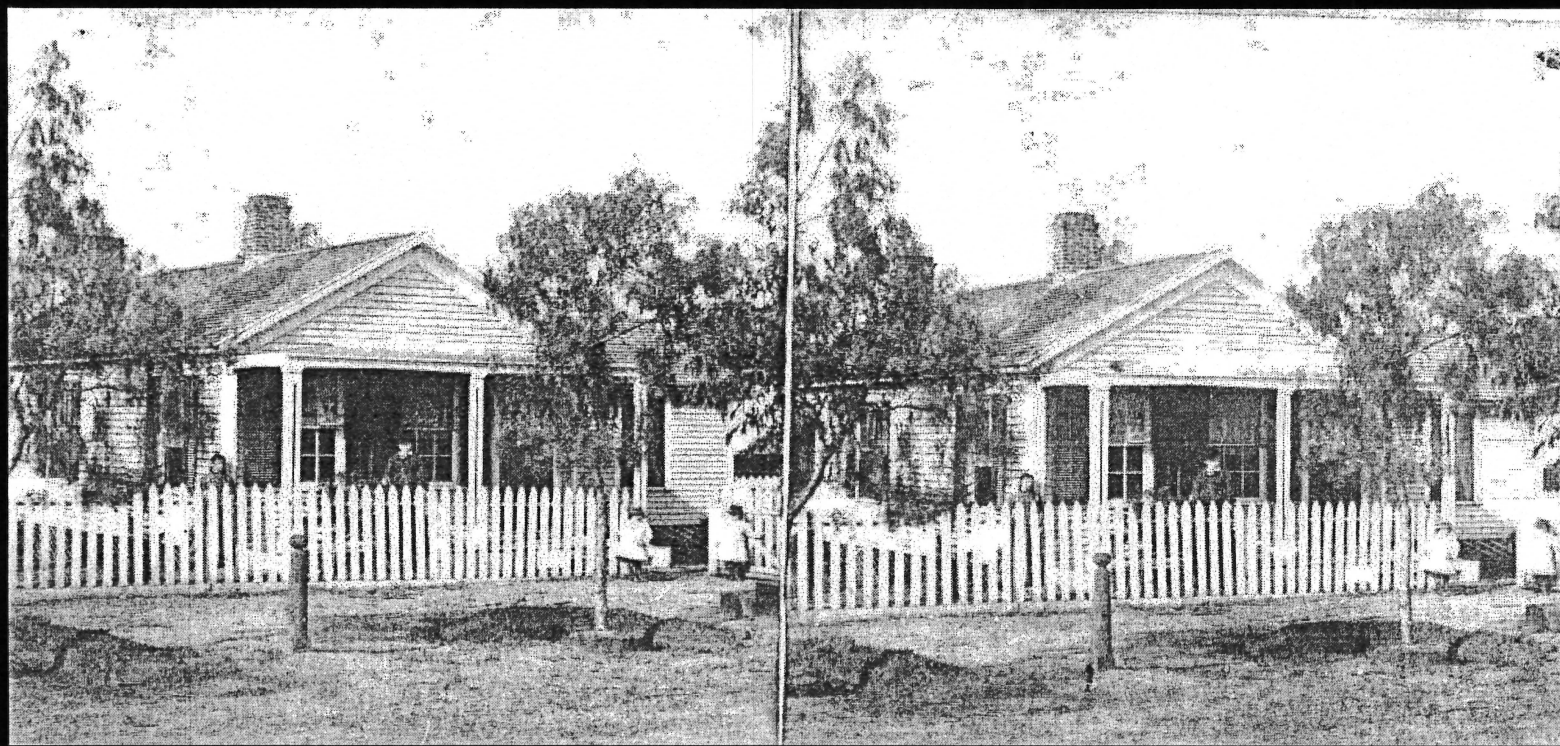
Photo 7.

For single family dwellings, a simple front gable faces the street, either as a latent nod to the Greek Revival or purely a utilitarian gesture to shed rain (Photo 7). A variation on this form is the front gable with perpendicular side wing, where the wing often sports a full or partial porch covered by a shed roof. Over time and as dictated by necessity, these simple houses incrementally added single story extensions off the rear elevation for ancillary functions. Medium pitched front or side gabled roofs, or hipped roofs with shallow open eaves are characteristic of these modest one and two story dwellings, while flat roofs predominate on the commercial blocks. Vertical double-hung windows prevailed, featuring one-over-one, four-over-four or six-over six light panes.

1870s Cottages

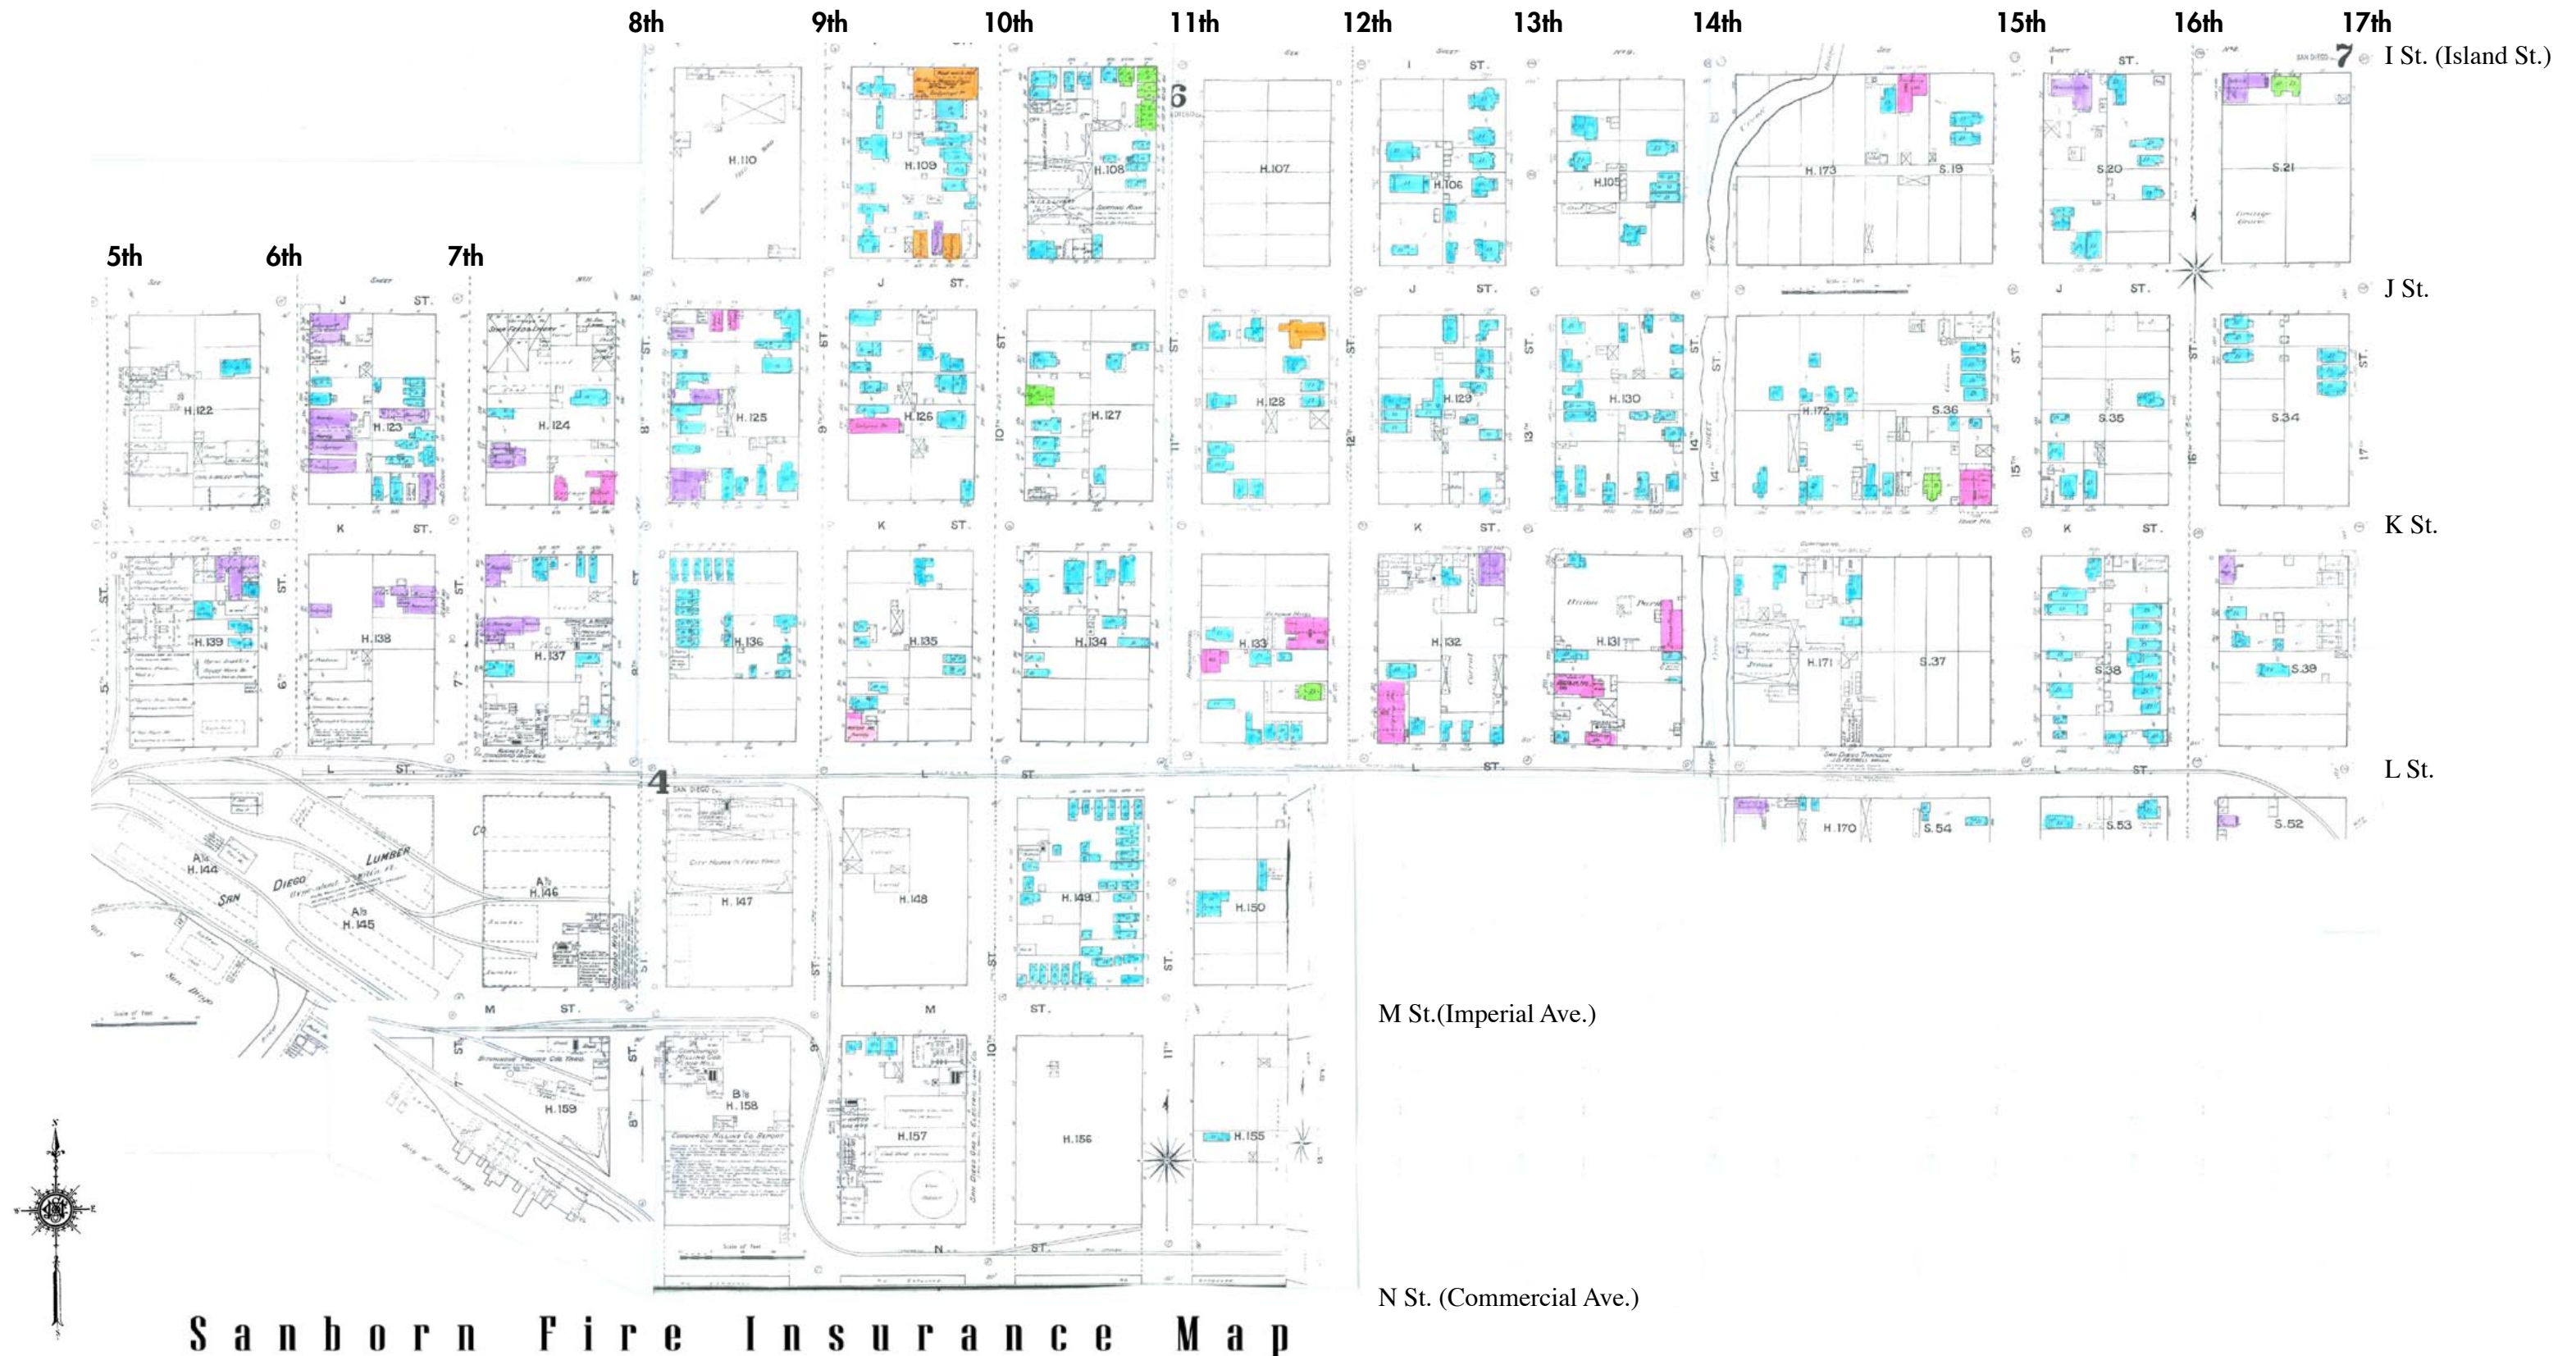
EAST VILLAGE RESIDENTIAL DEVELOPMENT 1888

By the late 1880s, the railroad had greatly influenced the city’s physical expansion and prosperity. The 1888 Sanborn (Appendix A: Maps 5A & 5B) shows development in East Village extending from 13th Street to 17th Street, with infill beginning in the westernmost lots platted as part of Sherman Heights in 1869. Out of approximately 120 blocks in the study area, only four have no development. Dwellings continue to be of modest scale and simple profile, particularly

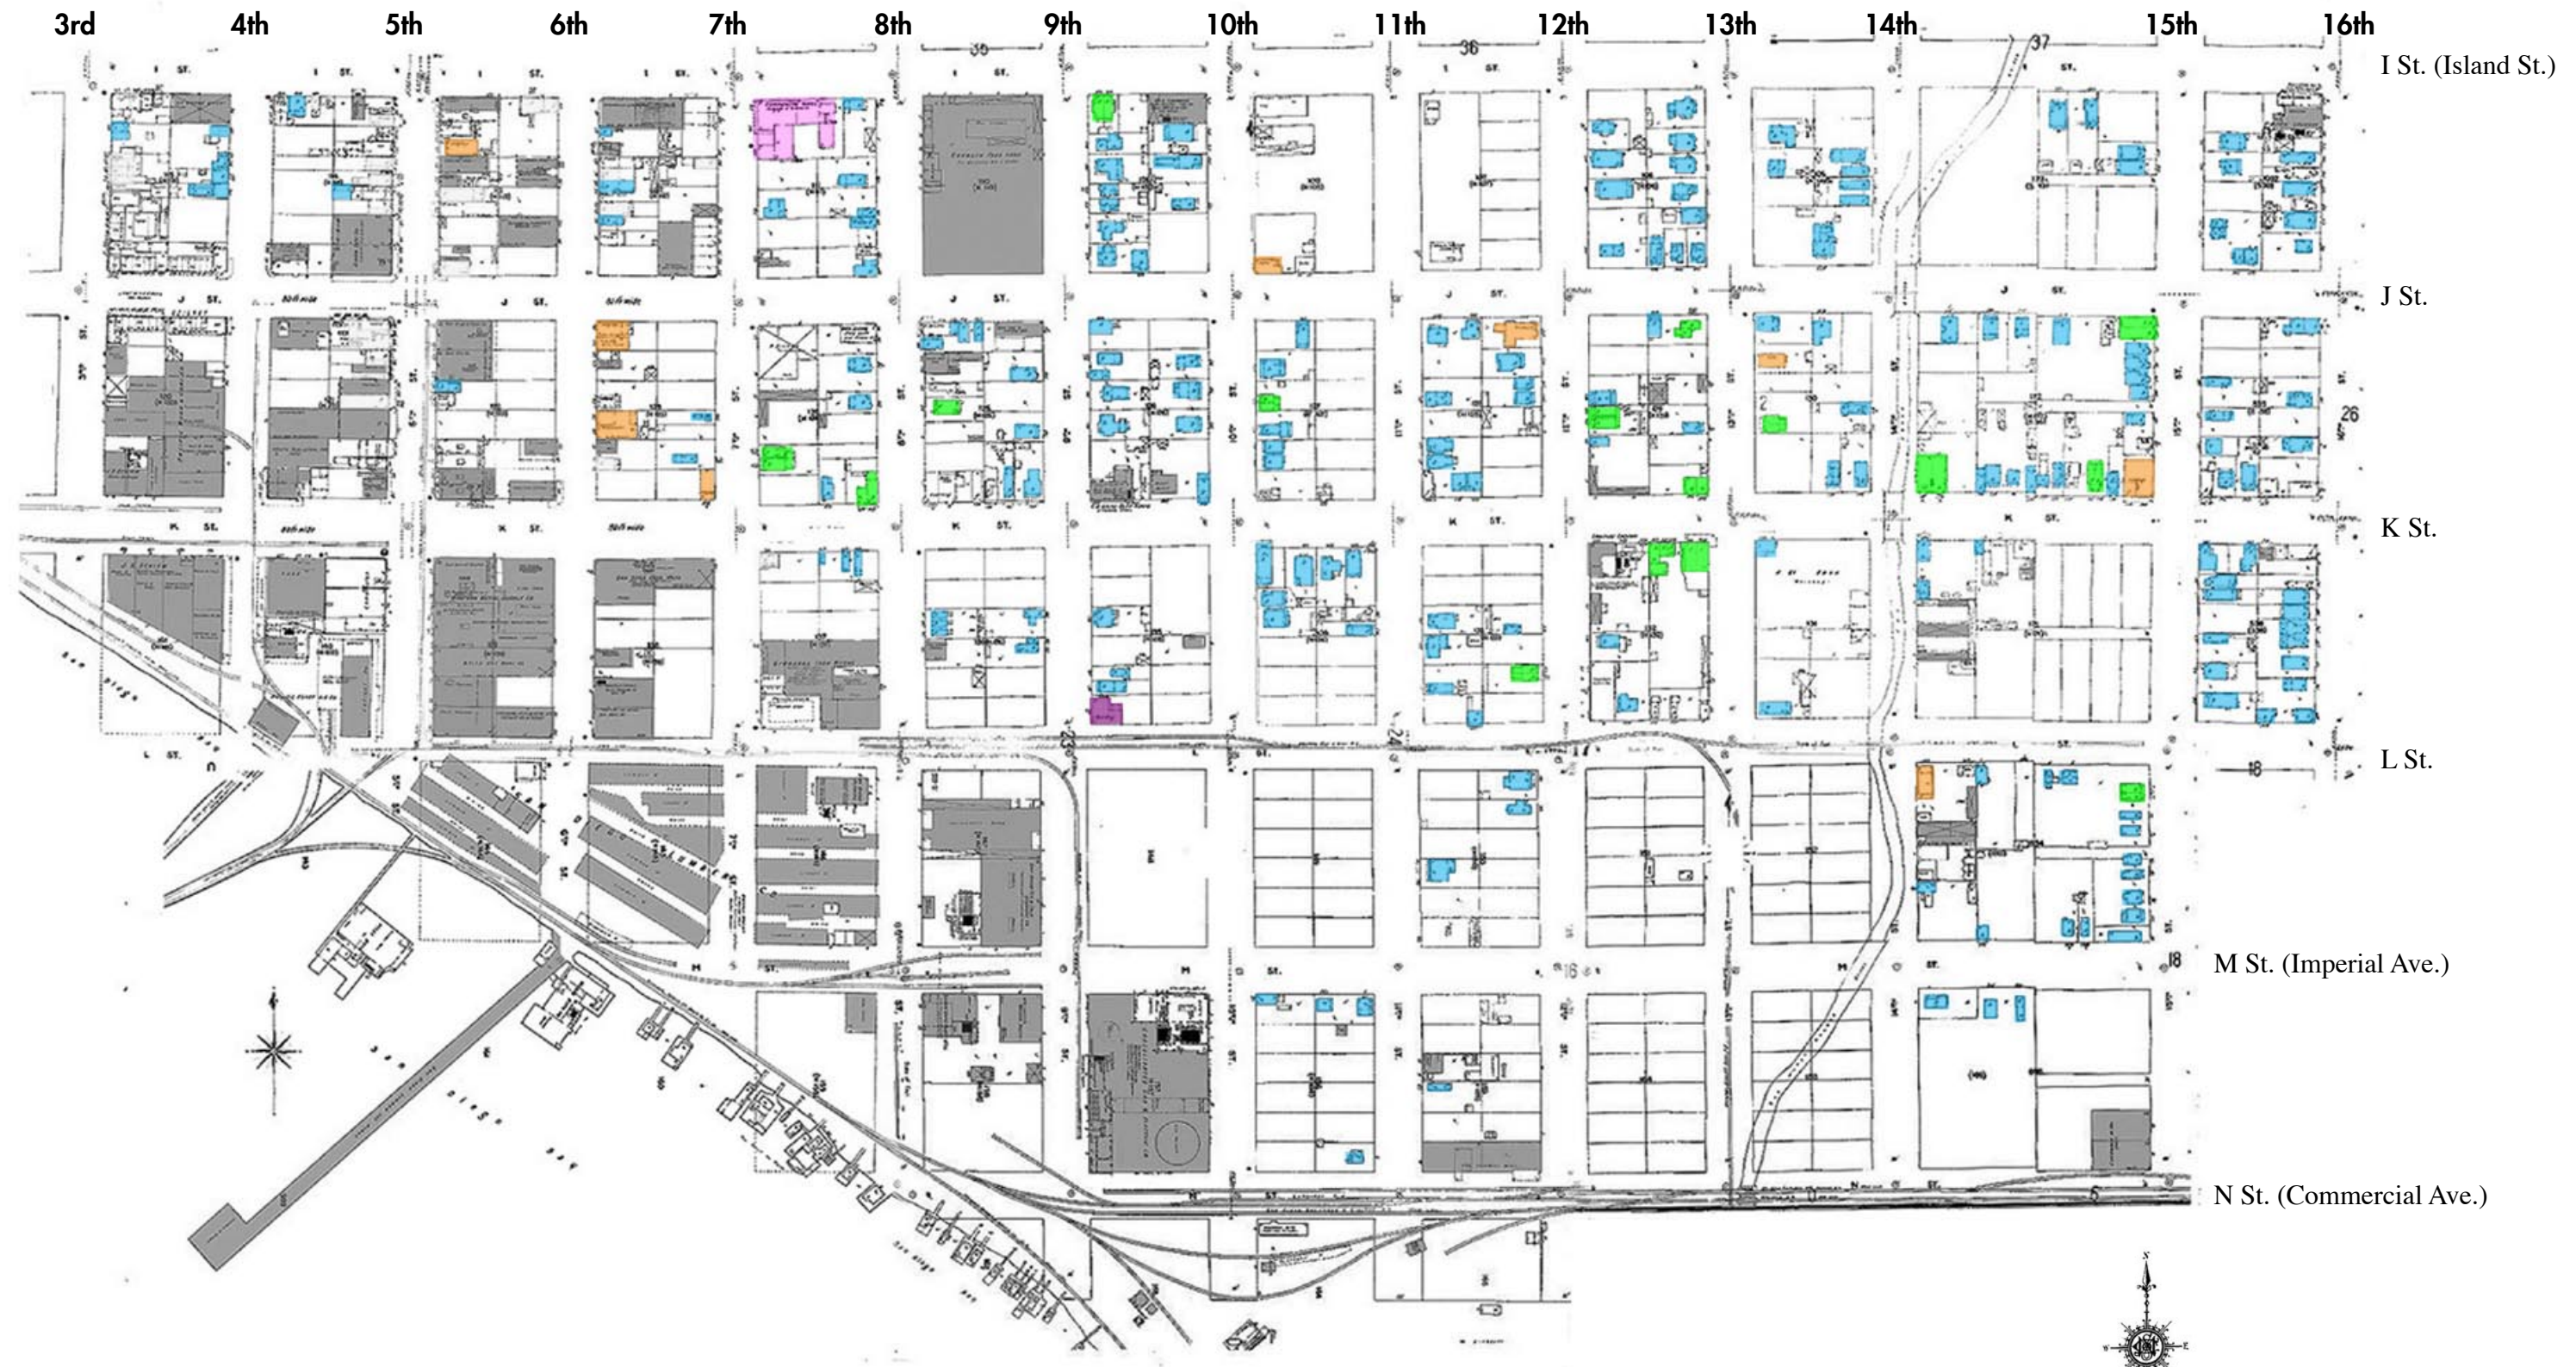
EAST VILLAGE RESIDENTIAL DEVELOPMENT 1906

In San Diego, the 1906 Sanborn Map (Appendix A: Maps 6A & 6B) reflects these wider national trends, as well as local economic recovery and continued urban expansion due to railroad-related in-migration. Population growth is evident in residential patterns that clearly reflect denser living conditions more characteristic of cities than of towns or villages. Hotels and boarding establishments have a diminished presence in East Village, while apartments or rooms-to-rent are now dispersed throughout the expanded business district between Fourth and Seventh Avenues. Many of these residential arrangements are located on the second or third floors of business blocks, strengthening the trend noticed on the 1888 Sanborn Map.

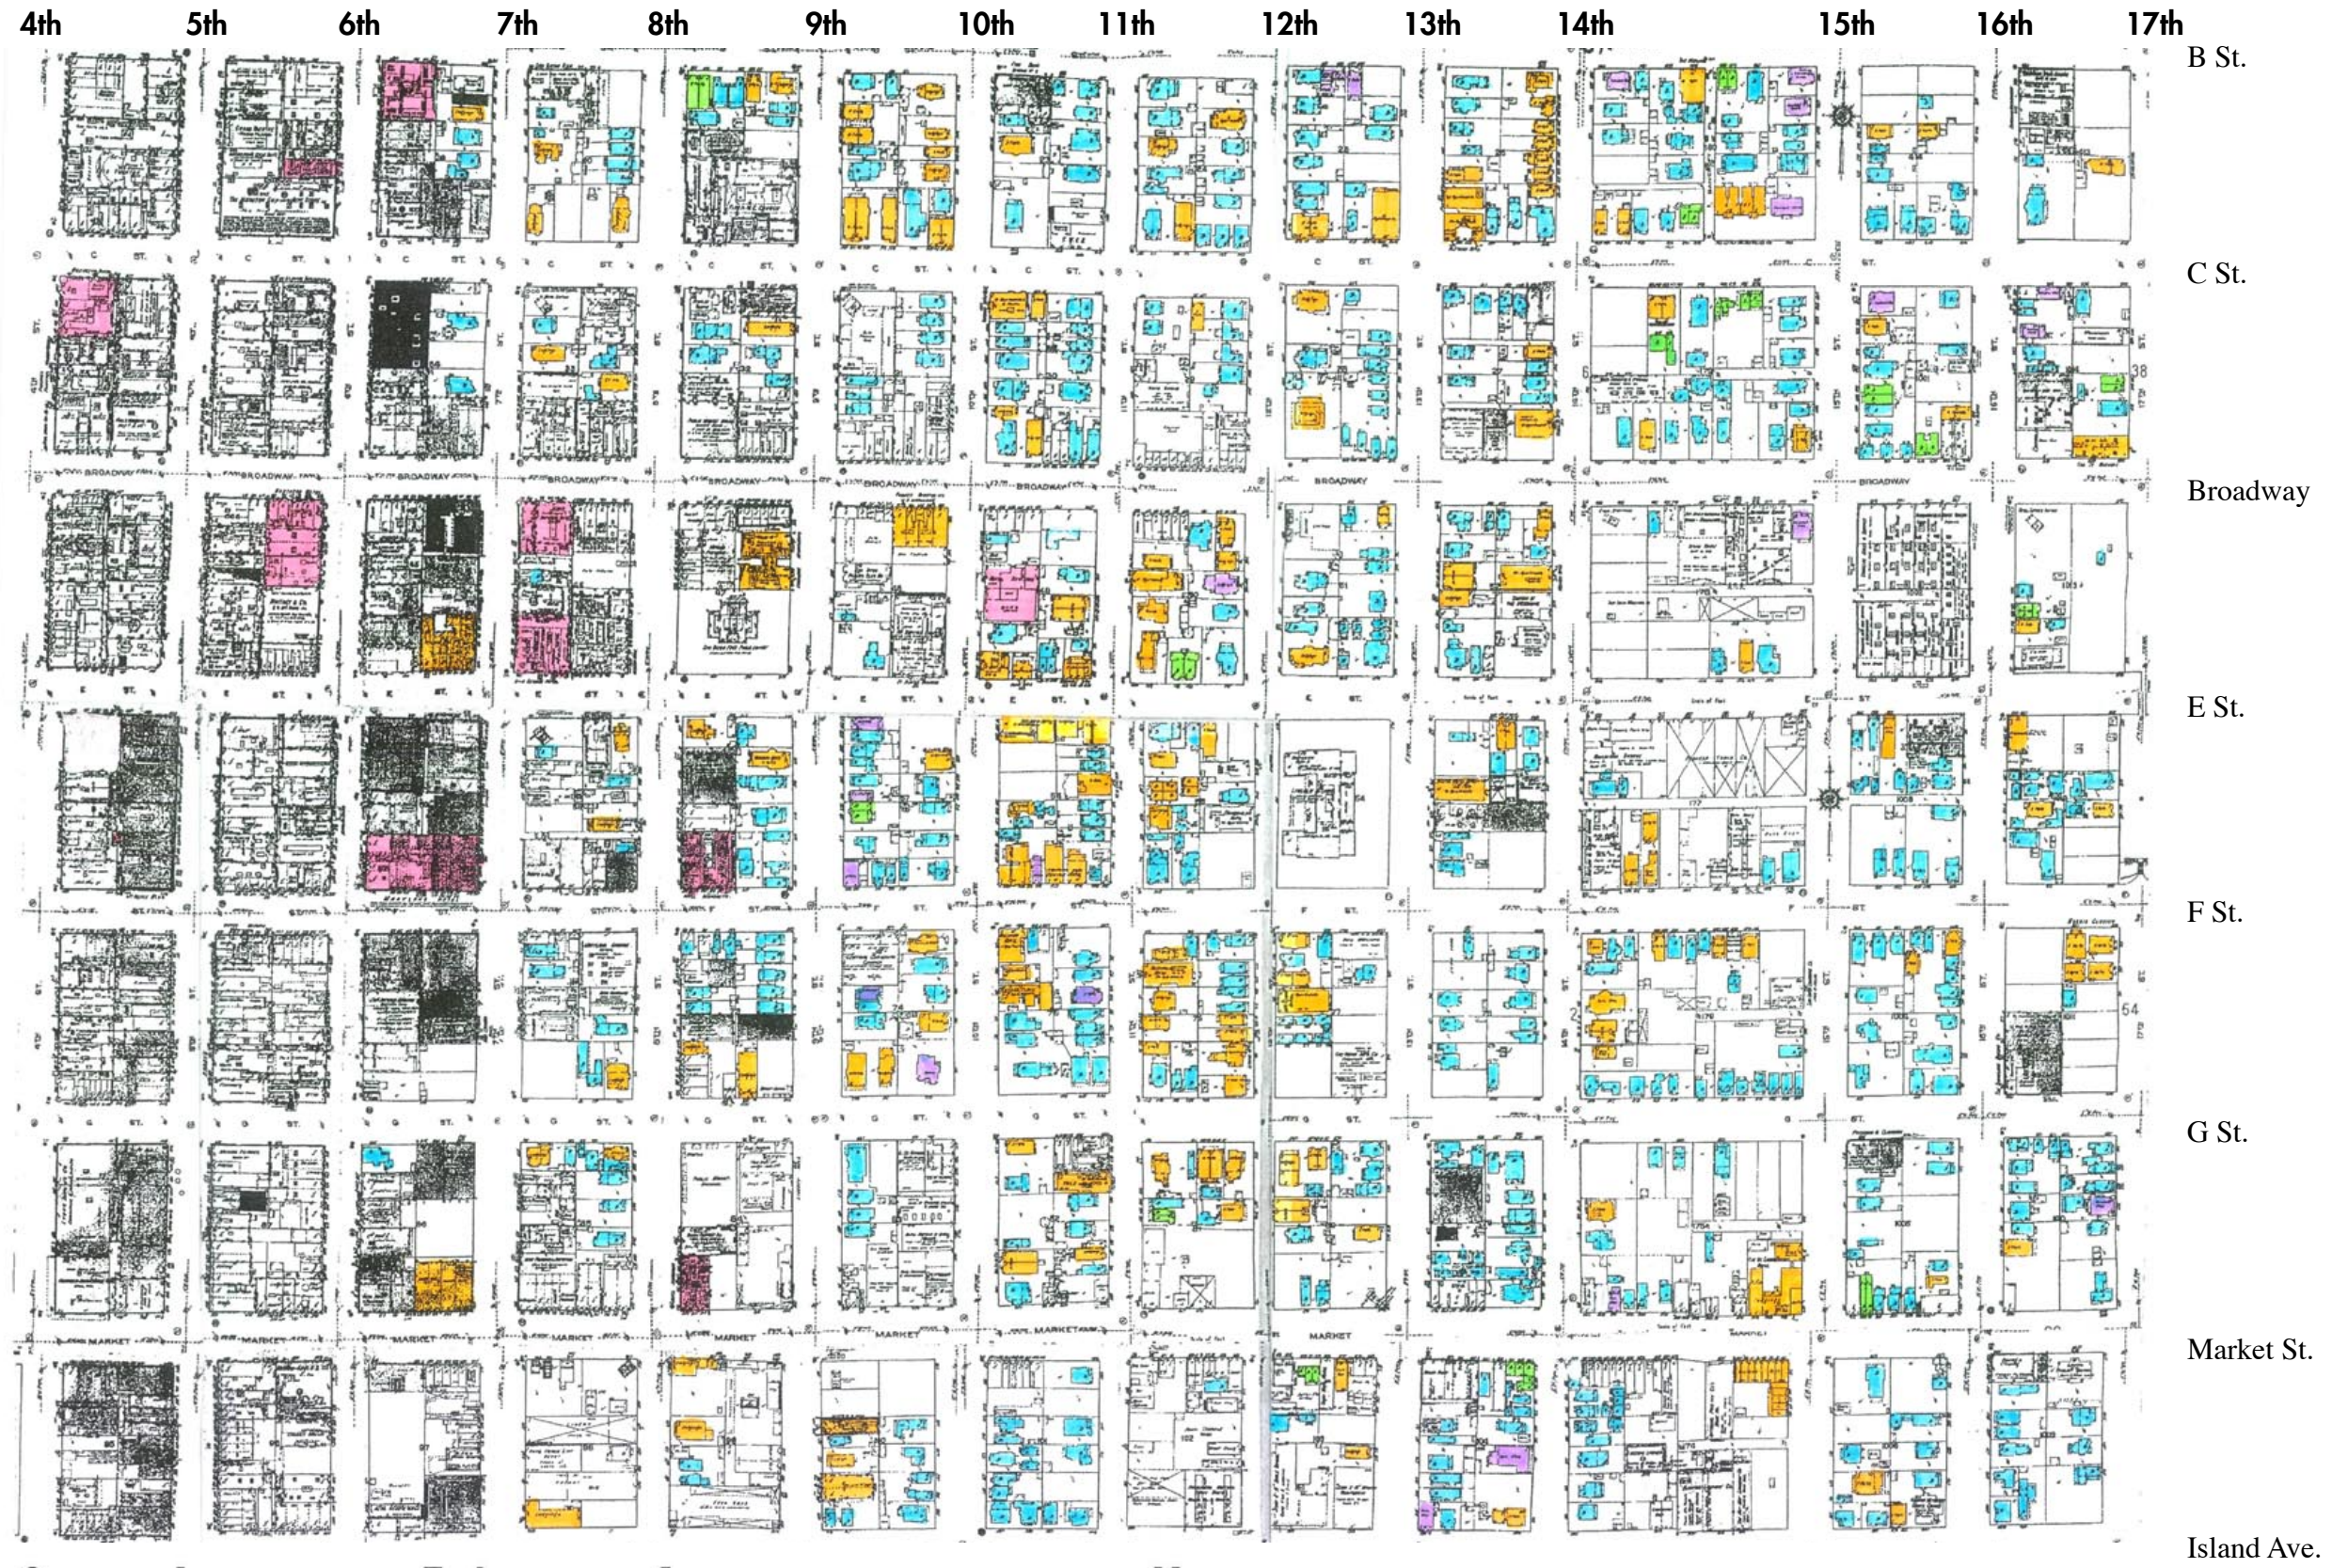
EAST VILLAGE RESIDENTIAL DEVELOPMENT 1921

By 1921, residential patterns noted in 1906 have matured and taken hold across the East Village study area (Appendix A: Maps 7A & 7B). Residential quarters have been universally eliminated from the business core, now solidly covering 4th through 7th Avenues. Five hotels accommodate short-term visitors, many now arriving in San Diego by automobile to enjoy the area's sunny climate and sandy beaches. Below Market Street, warehouse/industrial uses have expanded eastwards to 15th Street, mainly on vacant land south of L Street. Although modest worker housing remains throughout the study area, commercial and industrial buildings are beginning to encroach on the earlier residential nature of the area.

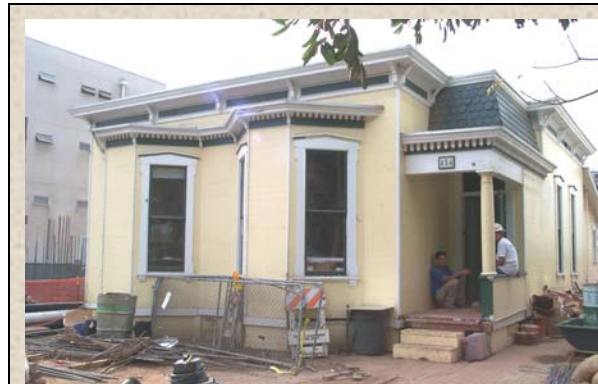
62. 454 13th Street (EV)
Wright House 1882

Two houses in the East Village Study area are rare representatives of a residential building style not common to San Diego. The Wright House (1882) and the Thomas House (1889) sport mansard roofs characteristic of the French Second Empire Style popularized during the reign of Napoleon III (1852-70). It was used extensively in American public buildings during the administration of Ulysses S. Grant (1869-1877), and found favor among the Gilded Era Nouveau Riche once architect Richard Morris Hunt returned from his studies at the Ecole des Beaux Arts in Paris and set up a fashionable practice in New York. The Wright House is a hybrid Italianate Victorian with a mansard roof over the porch, while the Thomas House is a rather late and very modest example of the Second Empire Style that was at its height in the 1870s and early 1880s. Its appearance in 1889 testifies as to how long it took fashion to arrive from Paris to the San Diego middle class. It is rare in San Diego.

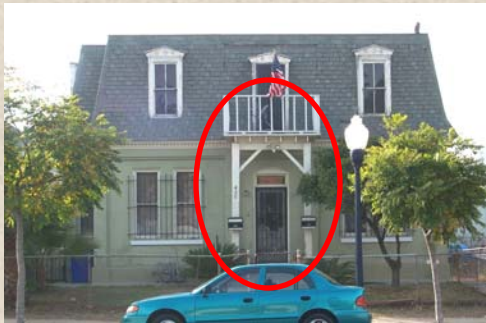
73. 430 17th Street (EV)

Henry & Hilda Thomas House
1889

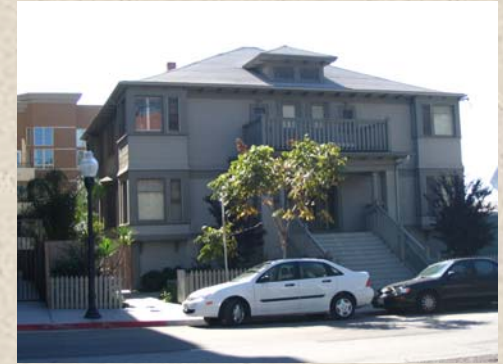
8. 1425-1431 C Street (EV)
Wm. E. Smythe Res. 1908

regular maintenance practices and appropriate rehabilitation techniques. Within the East Village study area, both simple one-story cottages and two-storey single-family dwellings in Transitional styles (moving from Victorian to Craftsman) are found. They feature regular massing captured within a square footprint and pyramidal roof, but retain controlled asymmetry in details like bay windows. Window styles and rhythms also shift from paired tall and narrow sashes to triplets with a large, fixed center panes flanked by narrower sashes and wide, flat window trim. Classical details like dentil moldings and columns also pay homage to the Classical Revival popularized by the 1893 Columbian Exposition in Chicago. The Hiatt House (1902), Kreiss/Wilcox House (1906), Lee House (1908), and Smythe House (1908) are good representative examples of these trends.

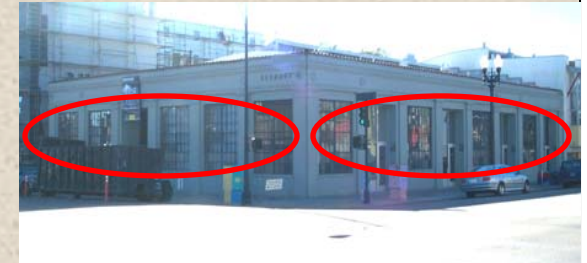
52. 760-770 11th Avenue (EV)
1025-1055 F Street
Schiller Book Bindery 1932

51	East Village	741	11th Avenue	5351330300	6Z	6Z	Note & File	Woodford Residence	Italianate	1887	Unknown	Exterior stuccoed; windows replaced
52	East Village	760-770/ 1025-1055	11th Avenue/ F Street	5351320700	7	5S2	C	Schiller Book Bindery	One Part Commercial Block with Neo-Classical influence (Taxpayer)	1932	Scott Quintin (Architect) Walter Trepte (Builder)	Taxpayer; Loft conversion meets Secretary's Standards for Rehabilitation
53	East Village	941	11th Avenue	5343330200	5S1	5S2	A, C	Hamilton Apartment Building	Italianate	1886/ 1907	John Campbell (Builder)	East Village residential cultural landscape
54	East Village	509	12th Avenue	5351510500	3S	3S	C	The New Bay View Hotel	Italianate	1889	Unknown	Corner towers and first floor balcony railing removed
55	Over 45	999	12th Avenue	5343411000	5S2	5S2	C	Ephraim Harris Grocery Store	Art Moderne (Streamline Modernistic)	c. 1925	Unknown	
56	Over 45	1015-1025	12th Avenue	5342060300	5S2	5S2	A, C	Ford Apartments/ Ford Motor Building	Art Moderne (Streamline Modernistic)	1937	Unknown	Auto-related resource; windows boarded

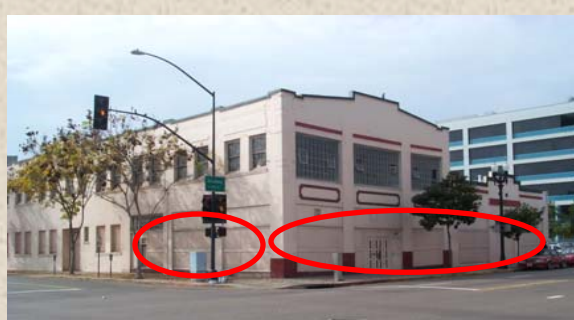
1. 1531-1541 Broadway
(EV)

Constructed in 1918; no substantial modifications and/or alterations noted.

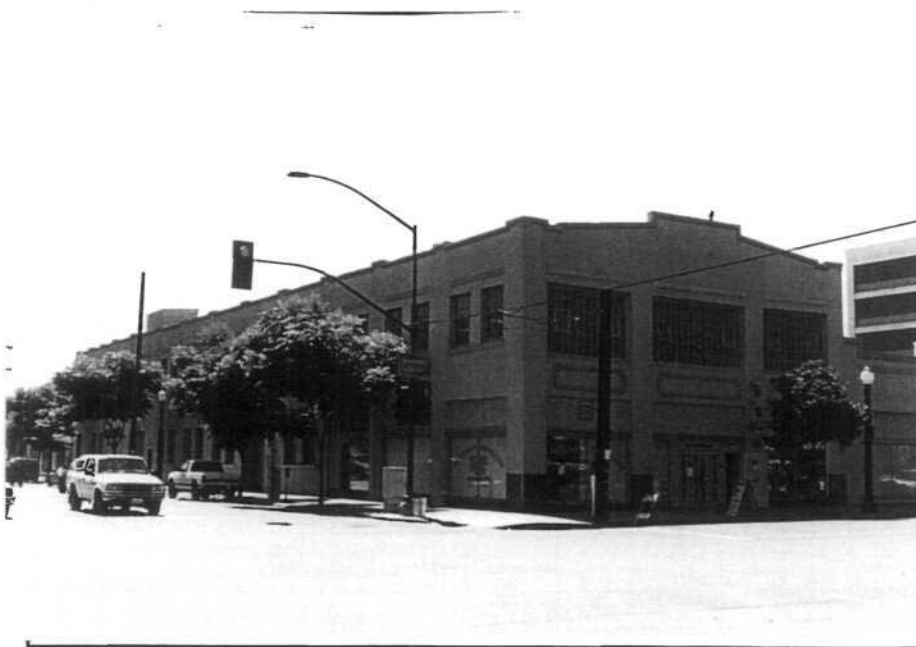
Originally constructed in 1918 for capitalist James E. Collumb, this two-story utilitarian structure has a general rectangular shaped plan and is adjoined to a smaller one-story building in the same style on the north west elevation. These buildings are collectively identified as 1531-1541 Broadway. Features include a flat roof with stepped parapets and coping, large plate glass windows on the ground floor, and multi-paned industrial style windows on the second floor. Exterior building materials consist of plastered brick and stucco for the walls, ceramic tile surrounding the lower portions of the ground floor windows, and most likely composition rolls for the roof. Clerestory windows have been in-filled, however the frame outlines are still present. Overall, the building appears to be in good condition.

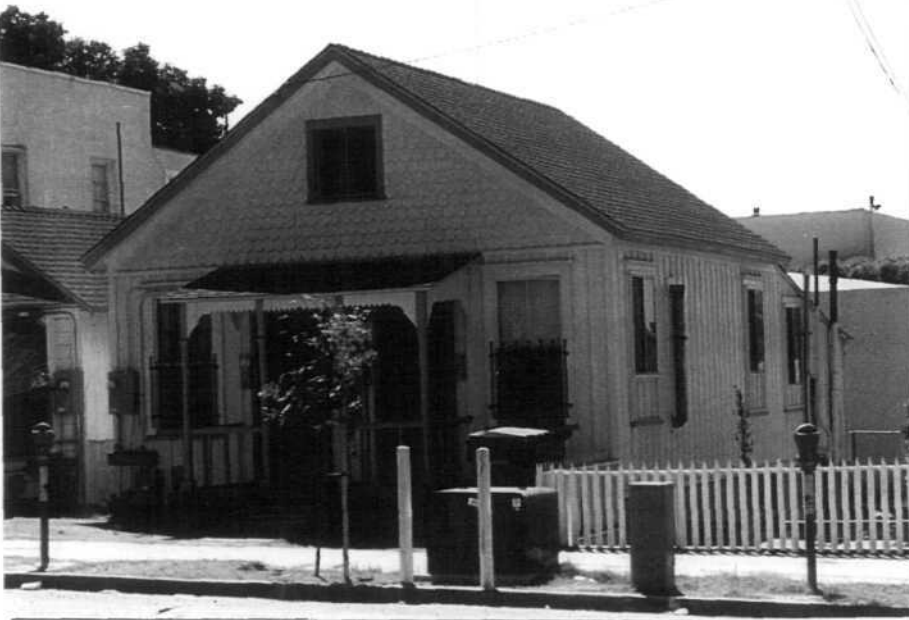
Originally constructed in approximately 1887, this two-story, multiple-family residence was constructed on a steeply sloping lot, in a layout similar to the neighboring 1317 and 1333 C Street residences. Features of the residence include a moderately pitched, front gabled roof with a slight, enclosed eave overhang. Exterior building materials consist of composition shingles for the roof, fish scale shingles on the gabled portion of the exterior wall down from the roof line, vertical board and batten siding on the street level second floor exterior walls, and horizontal shiplap siding on the first floor exterior walls. A centered front porch is present on the second story, street level of the residence. It features a shed style roof with composition shingles, supportive spindle posts, wood railing, and remnants of brackets and stick work. Rear additions have been made to the building. Overall, the 1321 C Street building appears to be in fair condition.

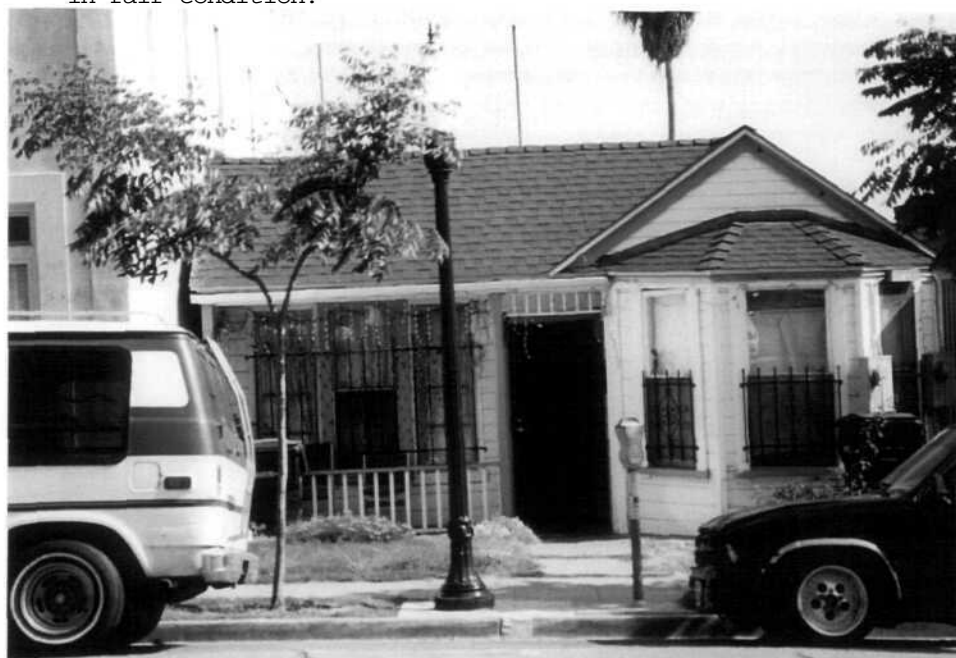
Originally constructed in approximately 1894, this two-story residence is located on a steeply sloped lot and is similar in layout to the neighboring 1317 and 1321 C Street residences. Designed in a Folk Victorian architectural style, the residence has a moderately pitched, cross gabled roof with no eave overhang, an angled bay window with a hipped roof and an entrance porch featuring wood railing, wood work along the porch eave and two wood posts for support. It appears that the original spindlework has been replaced with plain wood work that is present today. Exterior building materials consist of composition shingles for the roof and shiplap siding for the exterior walls. Windows appear to be double-hung sash and feature wood surrounds. Metal security bars cover the lower portions of the windows on the north, street facing elevation. Overall, the residence appears to be in fair condition.

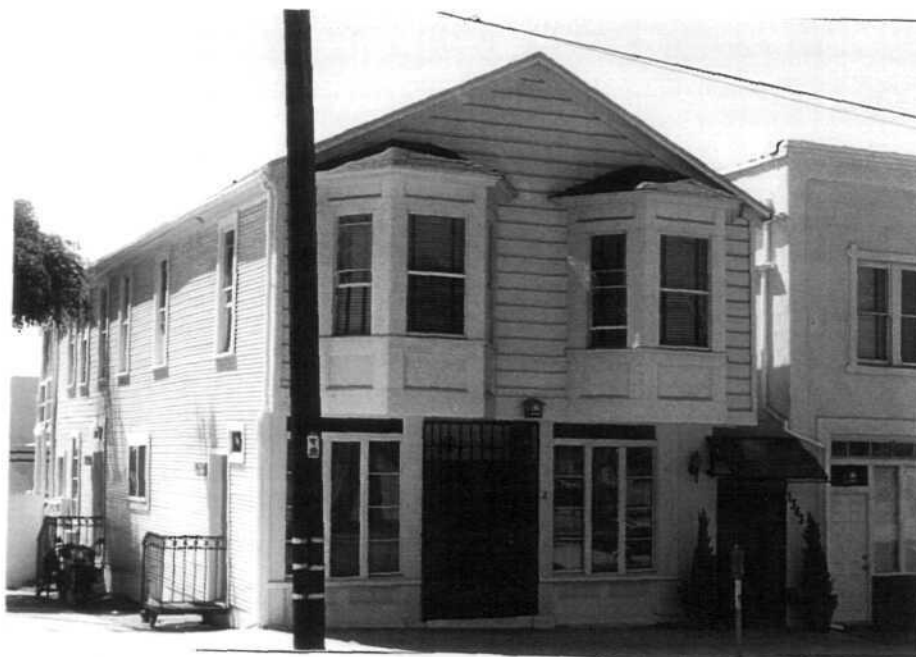
The two buildings shown in the photograph below are identified as 1343-1345 C Street. It is believed that these buildings were originally not associated with one another, and that they were eventually adjoined through a central staircase. The east Victorian portion was constructed in approximately 1887, and has a general rectangular shaped plan with a moderately pitched front gabled roof, and a slight enclosed eave overhang. Exterior building materials consist of composition shingles for the roof, clapboard siding for the east facade and shiplap siding for the north facade. It is a two-story, mixed-use building with residential units upstairs and commercial storefront space on the ground floor. (See DPR 523H, Continuation Sheet for more information)

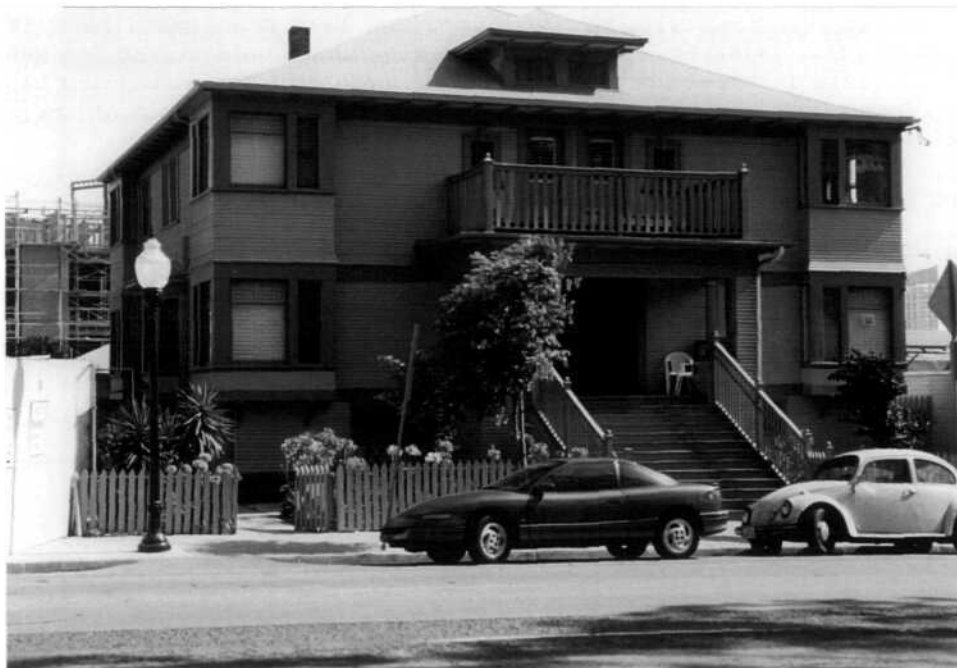
Originally constructed in 1908, this symmetrical, two-story, apartment building with basement is an excellent example of the early Prairie architectural style that is sometimes referred to as the **American Foursquare** or the **Prairie Box**. It has a general rectangular shaped plan and features a low pitched, hipped roof with widely overhanging eaves, and a centered hipped dormer, also with widely overhanging eaves, and a boxed cornice with **modillions**. This type of hipped dormer is typical of the early vernacular Prairie style. Wide wooden steps ascend to the first floor front porch, which is partially enclosed, has a flat roof with widely overhanging eaves, and features a square pillar covered with wood on the northern corners, as well as, a **single** Ionic column, also at each northern porch corner. (See DPR 523H, Continuation Sheet for more information)

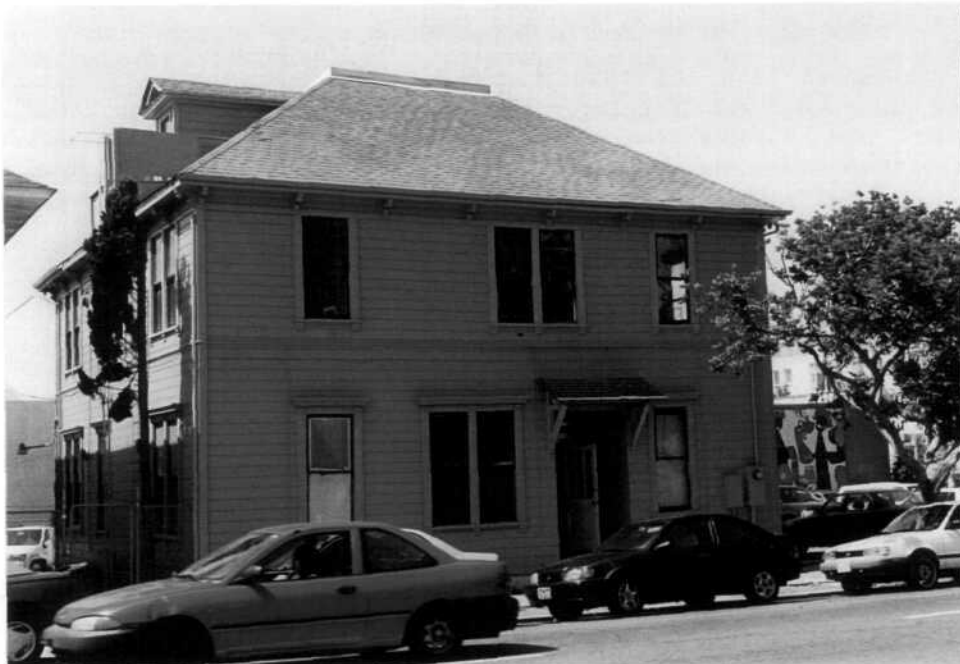
Originally constructed in **1886**, this two-story apartment building was designed in a vernacular **Italianate** architectural style. It has a **square** shaped plan and features a moderately pitched hipped roof with wide eave overhang, a gabled dormer on the east elevation, and brackets under the eaves at the roof line, as well as below the first and second story windows. Windows appear to be double-hung **sash** and feature wood surrounds and sills. The recessed front entrance to the building is covered by a shed style roof and supported by two large brackets. Exterior building materials consist of clapboard siding for the exterior walls and composition shingles for the **roof**. Overall, this building appears to be in fair condition.

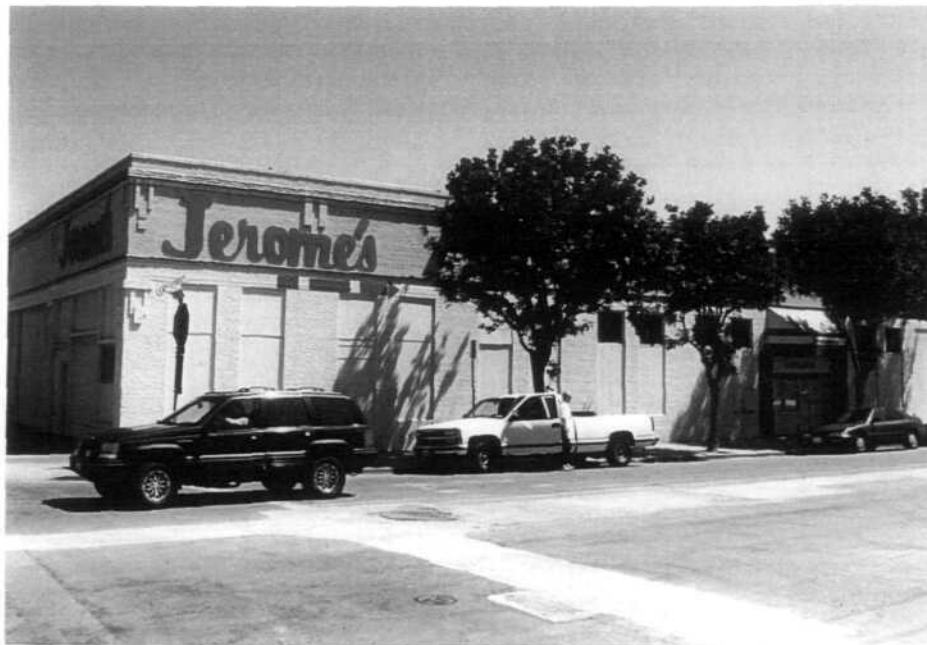
Originally constructed in approximately 1923, this One Part Commercial Block building has a general rectangular shaped plan, and features a flat roof, in-filled truck entrances on the north elevation separated by sets of pilasters, a series of in-filled windows and doors along the north and west elevations, a series of decorative brick bands spanning around the north and west elevations, and raised brick ornamentation, also present on the north and west elevations. The raised brick features are tri-partite, or a modified teardrop shape, and are similar to that of brackets in appearance and placement around the building, however, remain in a rectangular brick shape. (See DPR 523H, Continuation Sheet, for more information)

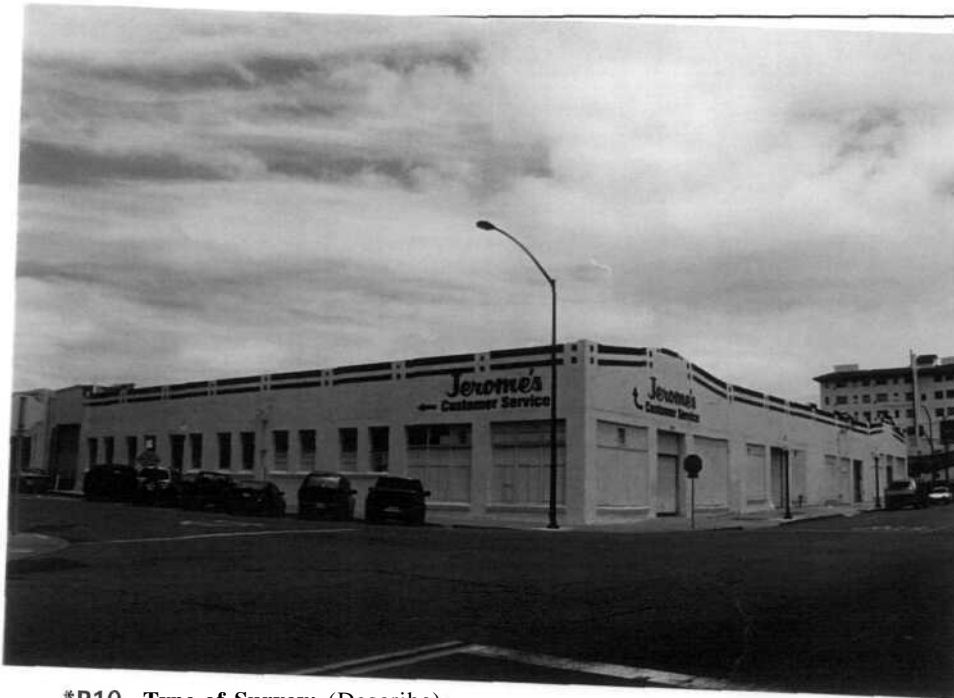
This resource consists of a Spanish Eclectic commercial building which encompasses two legal parcels on the southern half of Block 4. The building is currently used for Jerome's Furniture Company as a furniture storage/warehouse. The building originally appears to have been constructed c.1906-1921 as an automobile sales service building. The building is one-story in shape and is "C"-shaped. It extends along the southwest, south, and southeast sides of the block. The building features a flat roof with decorative parapets and pilasters. The exterior is stucco. The building features several bays and multi-paned window sections and appears to be in good condition.
