**COMBINED HISTORICAL
SURVEYS**

City of San Diego Planning Department

January 2005

**REVISED DRAFT
EAST VILLAGE
HISTORICAL PROPERTY SURVEY REPORT
2005**

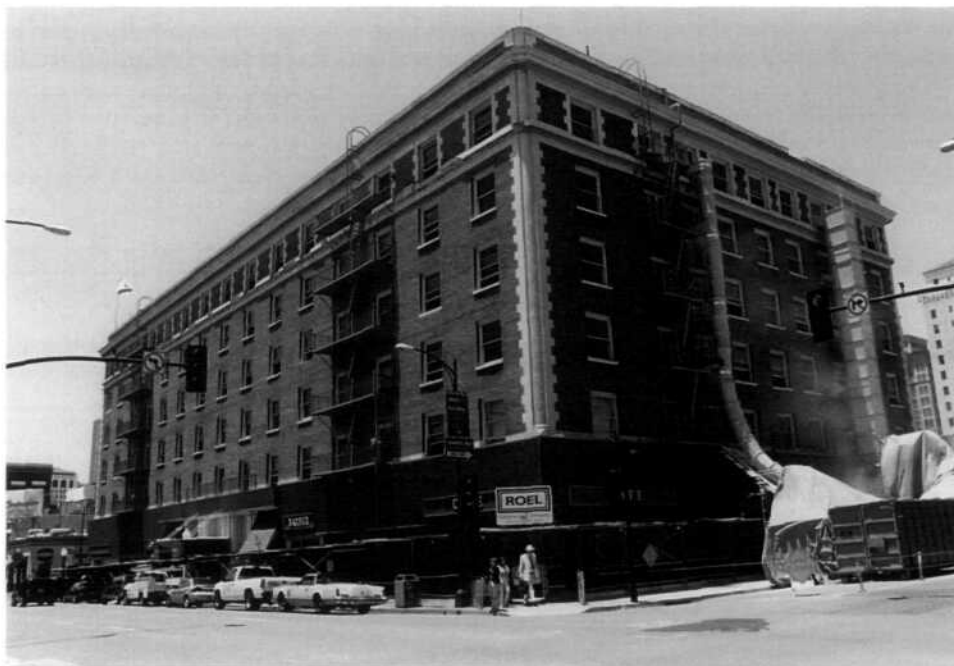
Originally constructed in 1914 and designed in a brick commercial architectural style with Italian Renaissance Revival elements the Maryland Hotel is a six-story commercial building, with basement and mezzanine. It has a general rectangular shaped plan measuring approximately 100 feet in width by 200 feet in length set on a reinforced concrete foundation. Framed by reinforced concrete and steel, features of the building include a flat roof with an ornamental cornice both above and below the sixth floor, corner quoins, and aligned double-hung windows. The ground floor features six store fronts divided by original ornamental stone pilasters with large fixed glass windows. The main entrance to the Maryland Hotel is recessed and is flanked by stepped pilasters with capitals. Overall, the building appears to be in good condition.

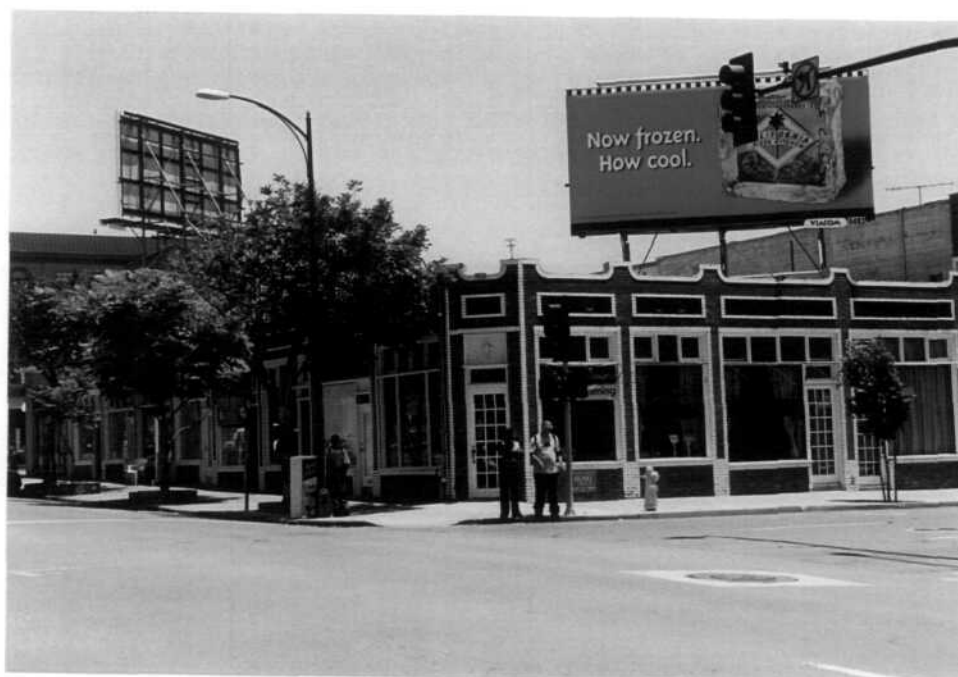
This one-story One-part Commercial Block brick building was constructed in 1924. Composed of exposed brick, the building features eleven bays (storefront windows) with a central entrance. An undulating parapet tops the flat roof with painted white brick courses. Each bay is composed of fixed glass set atop a brick base below upper transom windows. Overall, the building appears to be in good condition.

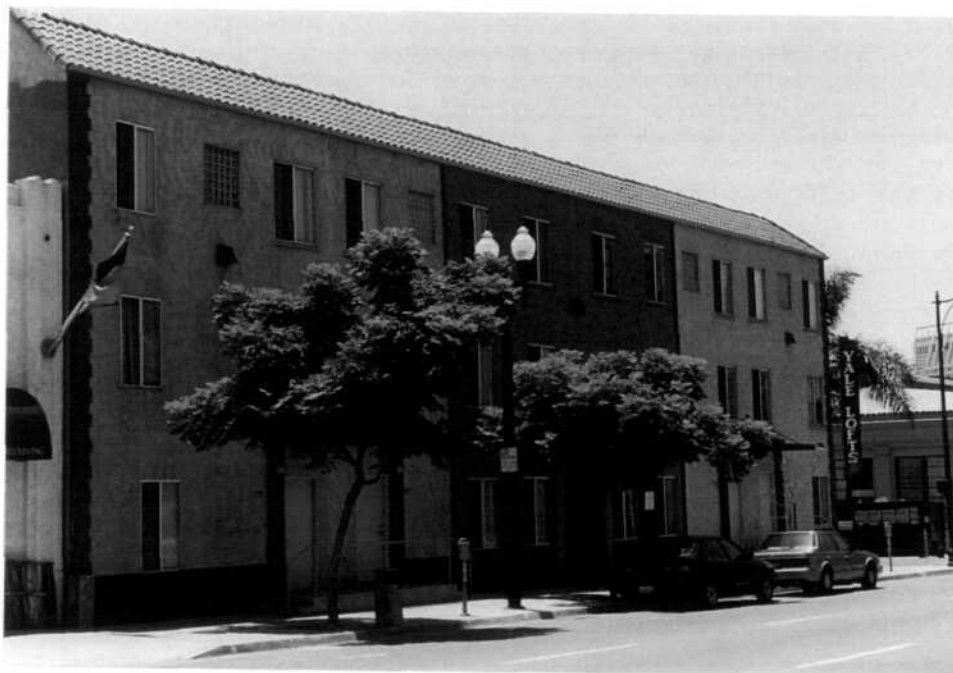
Originally constructed in 1927, this three-story building is a simple example of an 1920s Commercial Block Lodging House with a Spanish Eclectic influence. It has a rectangular shaped plan, and features a deck roof with two, hipped portions, northwest and northeast corner quions, and pilasters flanking the main entrance with an extended marquee above supported by chains. Two additional, smaller entrances on the north elevation also feature pilasters and a marquee. Exterior building materials consist of stucco-on-lath for the exterior walls, and Mission tiles over the hipped roof sections. Fenestration consists of horizontally aligned, sliding, metal framed windows on every floor. (See DPR 523H, Continuation Sheet for more information)

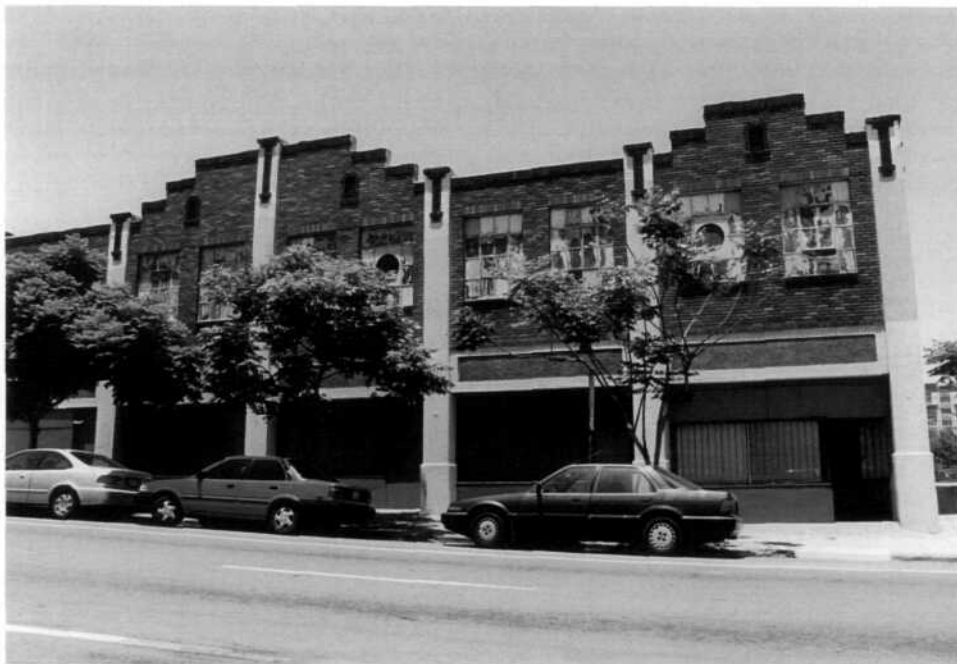
Originally constructed in approximately 1925, this Two-Part Commercial Block Building has a general **square** shaped plan, and features a **flat** roof with an extended parapet that varies in heights around the facades. The parapet is covered and capped with brickwork. The exterior facade is symmetrical and is divided into distinct sections by pilasters capped with brickwork. A horizontal band of applied, sealed asphalt painted blue divides the **two-floors**; the first-floor **consists** of approximately six **in-filled** window and garage bays, some of which are recessed. The second floor features multi-colored brickwork in both horizontal and vertical patterns, and each bay features two industrial style windows with a multi-pane sash pattern, featuring a central, four pane casement section bordered by twelve fixed **panes**. Overall, this building appears to be in fair condition.

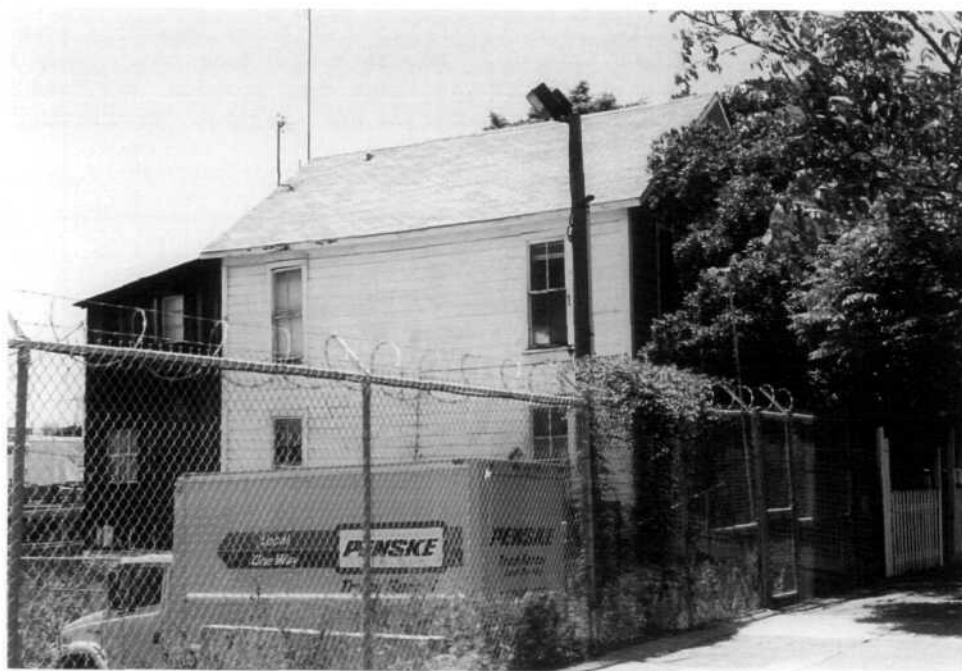
Originally constructed in approximately 1900, this **single-family**, three-story residence was designed in a Folk Victorian vernacular architectural style. It has a general rectangular shaped plan and features a moderately pitched front gabled roof with slight eave overhang, and an open, full length porch on the street facing facade. The porch features **stickwork**, wooden **posts** for support, and a shed style **roof**. Exterior building materials consist of shiplap siding with cornerboards for the exterior walls, and most likely composition shingles for the **roof**. A large tree obstructs the view of the front of the residence from the street. The poor condition of the residence and its **surroundings**, coupled with the presence of a major addition to the rear of the building results in the conclusion that this building has lost all architectural integrity.

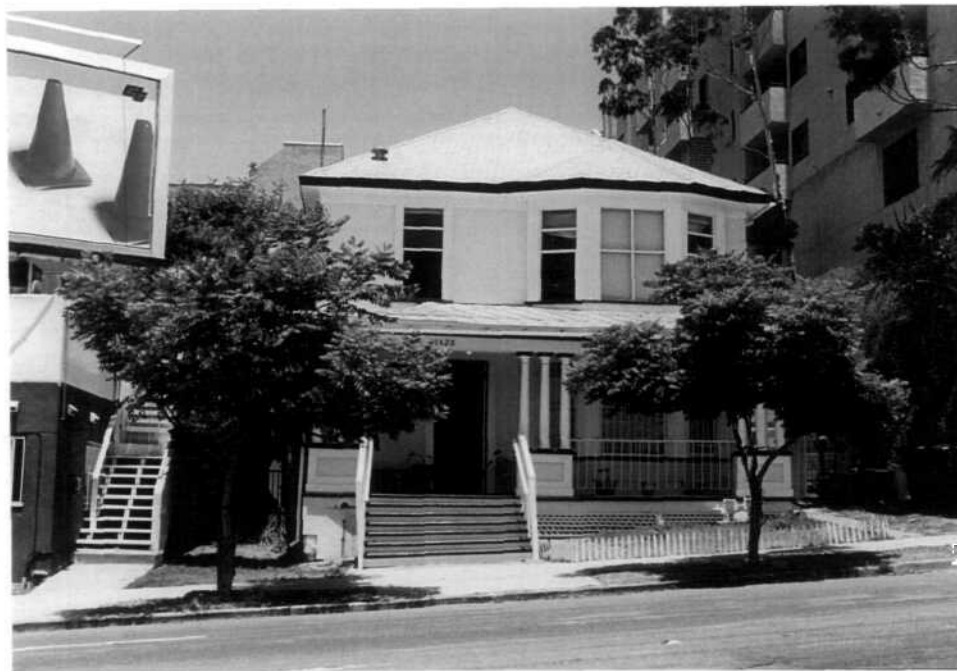
Constructed in approximately 1906, this two-story **asymmetrical, multiple-family** residence was designed in a Free Classic Hipped Roof Queen Anne vernacular style of Victorian **architecture**. It has a general square shaped plan and features a moderately pitched, hipped roof with a slight eave overhang, boxed cornice, and a red brick chimney located on the east eave wall. Typical to the Queen Anne style, a full length porch is present and features a boxed cornice, and classical columns raised on a wood pedestal to the level of the iron porch railing. Typical to the Free Classic style, the columns are grouped in units of **two**, and three on the street facing portion, and single columns are located at either end of the porch area. (See DPR 523H, Continuation Sheet for more information)

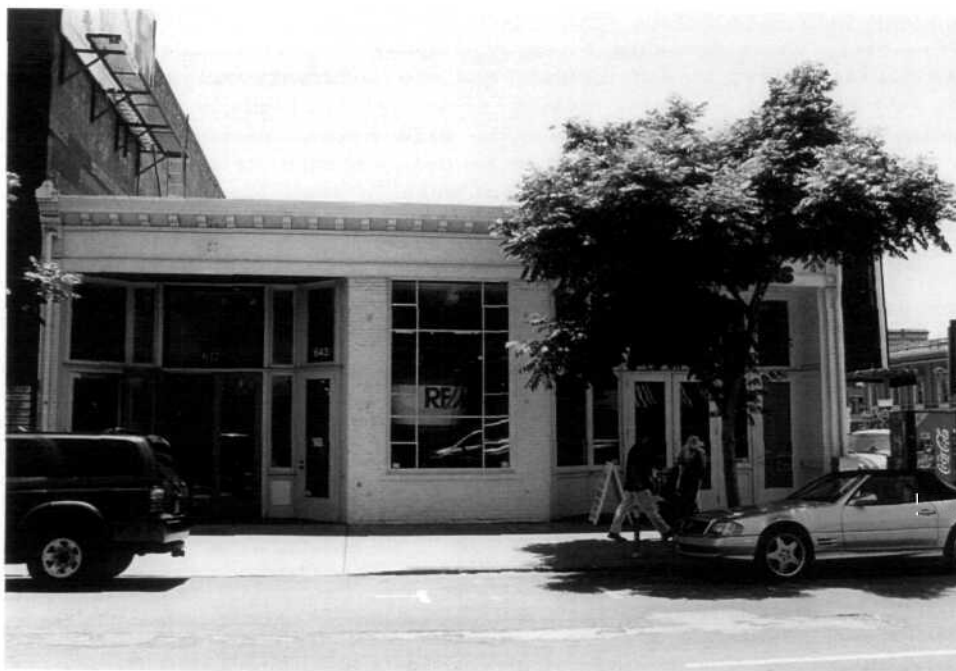
Originally constructed in 1888, this **single-story**, One Part Commercial Block building features an Enframed Wall Window, and was designed with an Italianate architectural **influence**. It has a general rectangular shaped plan, and a flat roof. The north, street facing elevation features recessed bow windows, a bracketed cornice, a protruding brick exterior wall portion which separates the recessed windows, and a central, single fixed window with a multiple pane pattern. Overall, the building appears to be in good condition.

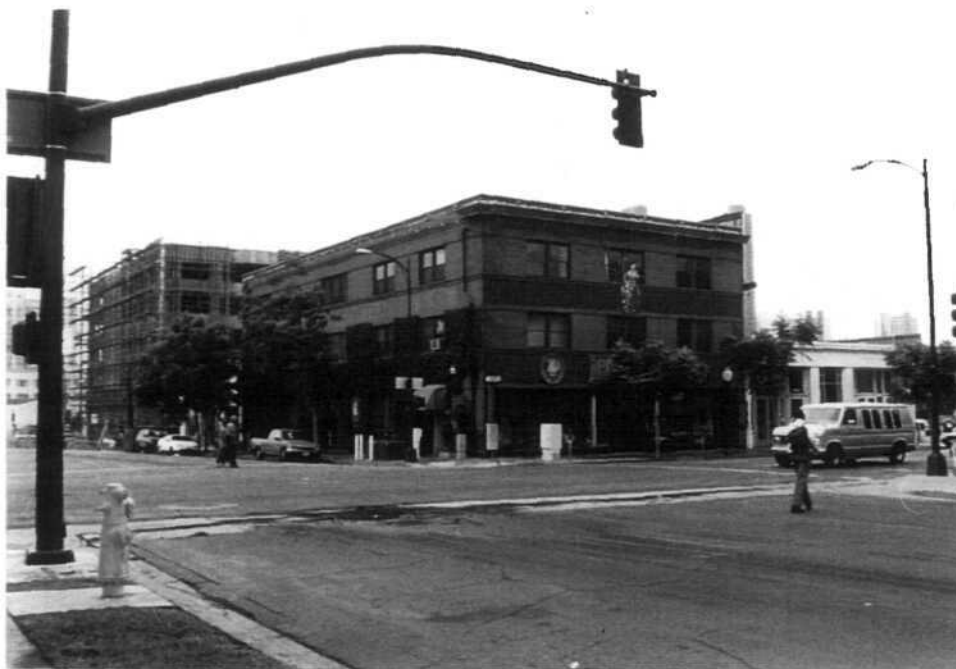
Originally constructed in 1909, this three-story brick and timber building was designed in a Two-Part Commercial Block style. It features a flat roof, a parapet, a boxed cornice on the north elevation, brick belt coursing between the third-floor window line and the cornice, and on the first and second floor window lines, and large enframed, ground floor storefront windows on the G Street and 7th Avenue facades. Fenestration consists of paired, double-hung windows on the second and third floors. The north elevation brick features painted bands between the second and third-floor windows. Overall, the building appears to be in good condition.

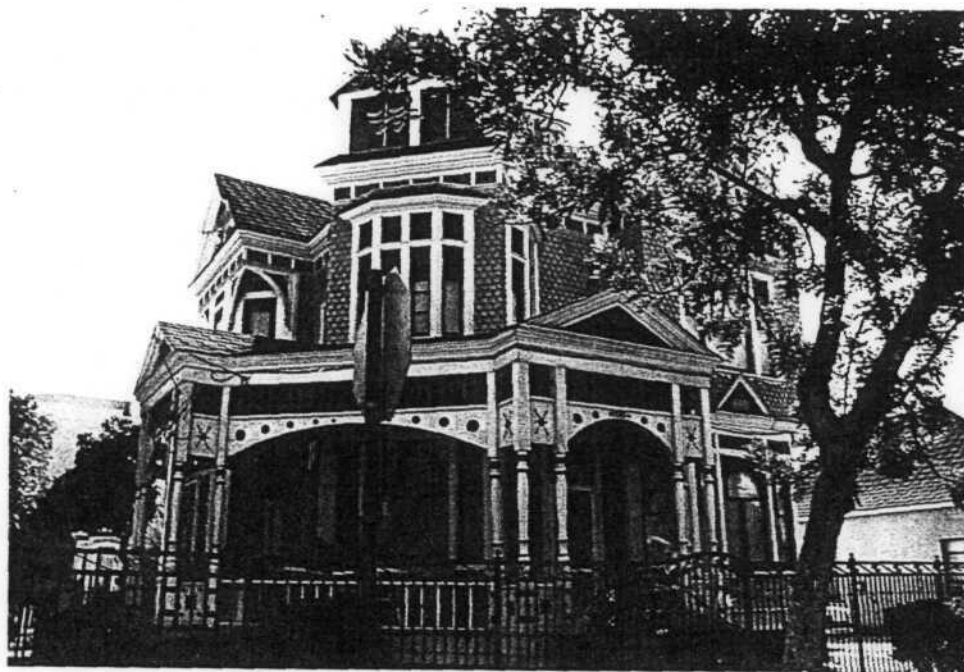
Originally constructed in 1886 at the corner of 11th Avenue and D Street (present-day Broadway) and relocated to this location in 1913, this two and one-half story residence was designed in the Queen Anne Spindlerwork style of Victorian architecture. The building features a high hipped roof with lower cross gables, a boxed cornice with a decorated frieze, two-story angled and square bay windows featuring pediments on top, cutaway corner windows featuring decorative corner brackets, and a wraparound entrance porch featuring turned posts, pediments, and spindlerwork.

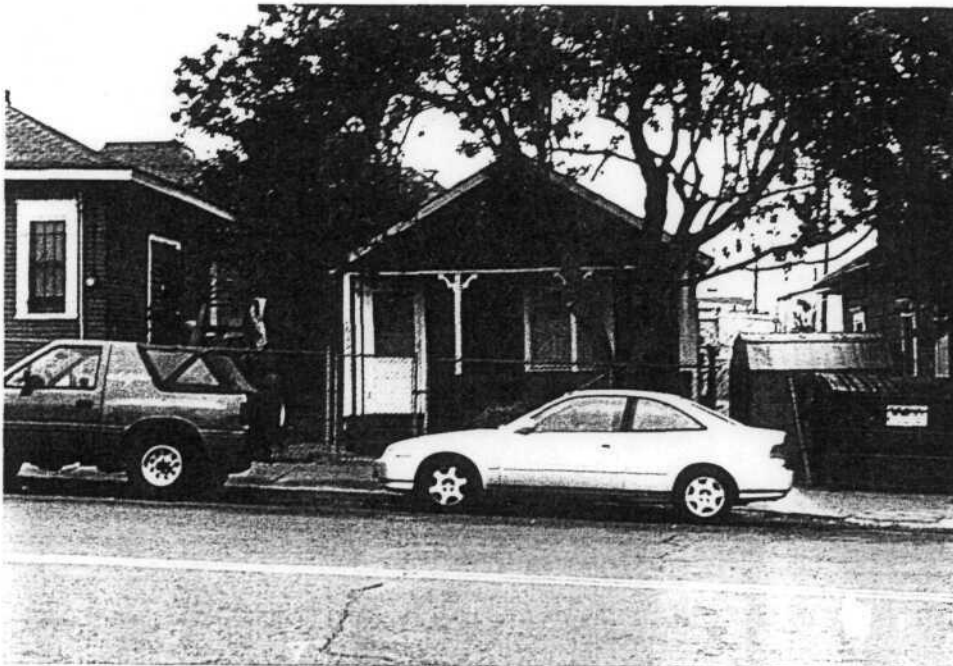
Originally constructed in approximately 1888, this single-story, single-family residence was designed in a Folk Victorian architectural style. It has a general square shaped plan, and features a front gabled roof of moderate pitch with slight enclosed eave overhang. A full length porch located on the front, north elevation features bracketed wood posts for support perched upon a low wood wall which partially encloses the porch area. Exterior building materials consist of composition shingles for the roof, vertical and horizontal board-and-batten siding for the exterior walls, and the north elevation focal window appears to be double-hung with a fixed upper sash. The front entrance is off center, located on the northeast corner of the residence and concrete steps painted green ascend to the front entrance. Overall, this building appears to be in good condition.

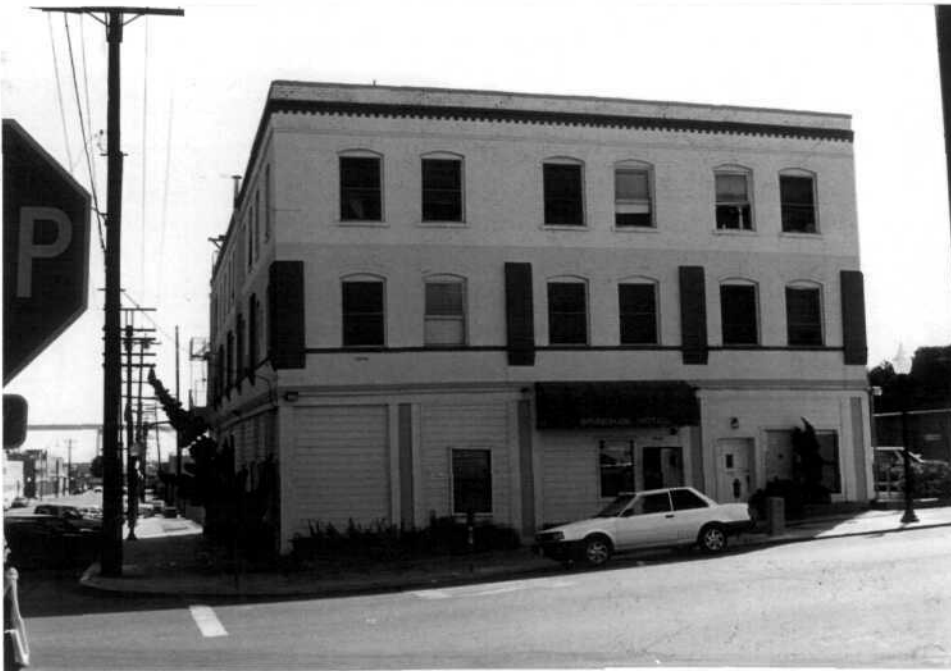
Originally constructed in 1912, this three-story building identified as the Workman Hotel is a simple example of an early Twentieth Century Commercial Block lodging house with an Italian Renaissance influence. The building features a rectangular shaped plan, with a flat roof, a dentil band spanning around the building's perimeter, corbeling below the dentil band, a series of second floor masonry elements located between every second window, and belt coursing below the second floor window sills. The second floor masonry elements feature corbeling at the base, and are painted in a dark color that contrasts against the lighter, surrounding buff colored brick. Fenestration on the second and third floors consists of aligned, rectangular, double-hung sash windows in wood frames that are grouped in pairs. (See DPR 523H, Continuation Sheet for more information)

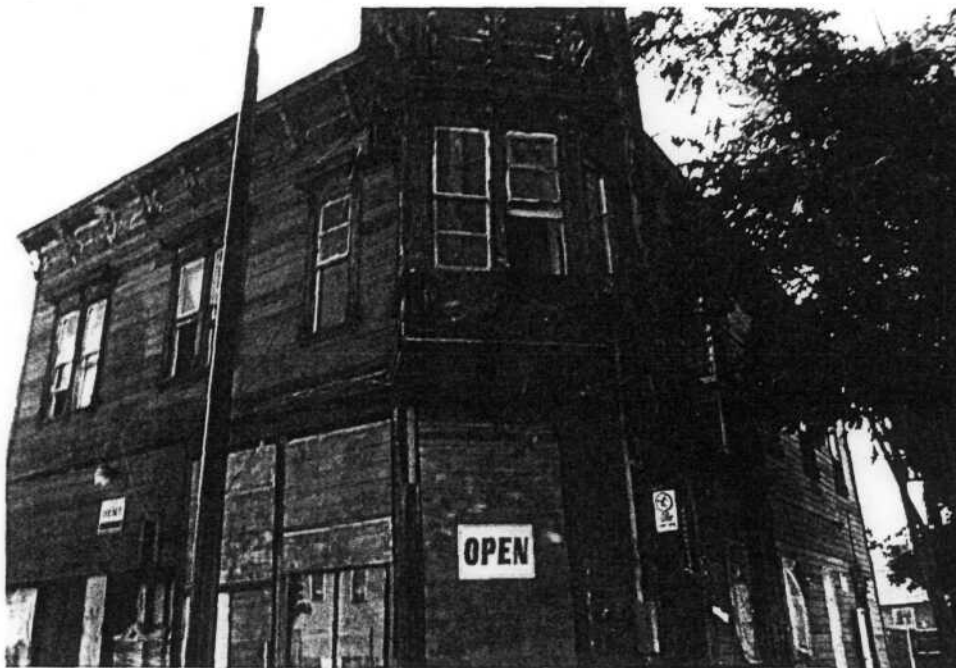
Originally constructed in 1888, this two-story, Italianate building stands on the southwest corner lot of the intersection of 15th Avenue and J Street. It has a general rectangular shaped plan, and features shiplap siding, a flat roof in the Townhouse style with a bracketed cornice, double-hung windows with wooden ornamental surrounds and decorated hoods, and a second floor square bay that is angled across the cutaway corner. The cornice brackets resemble turned spindles. On the ground floor, vertical boards replace the original features in the cutaway corner, and most likely a majority of the original first floor exterior building materials have been removed and/or replaced, including the original doors and windows. The asymmetrical facade features wooden doors at both ends of the building. (See DPR 523H, Continuation Sheet for more information)

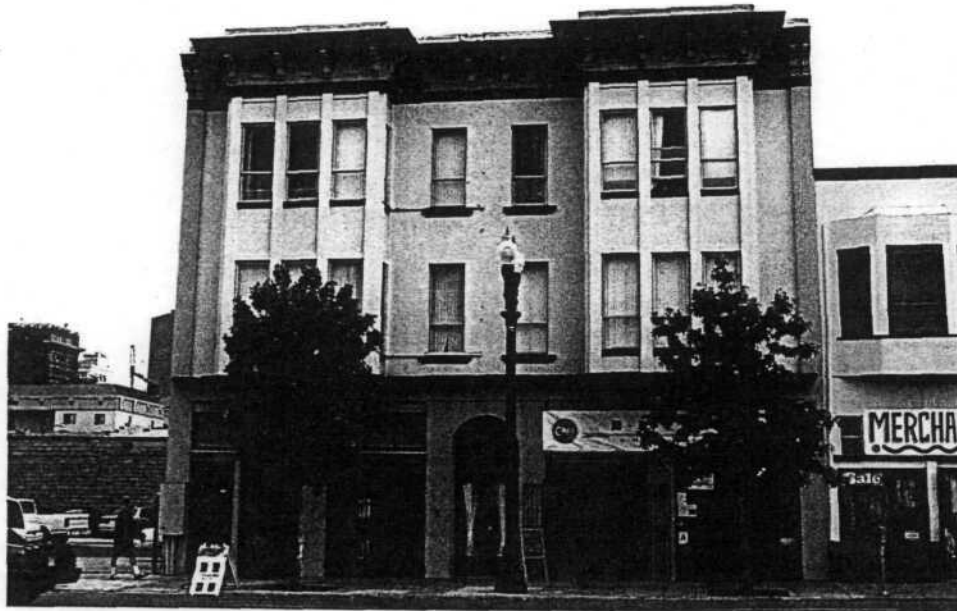
Originally constructed in approximately 1898, this building was designed in a Two-Part Commercial Block style with an Italianate architectural influence. It has a flat roof and features a bracketed boxed cornice, two large projecting rectangular bays spanning across the length of the second and third floors, and first floor shop front spaces (identified as 726 and 732 Market Street) which are separated by a central arched entry leading to the upper residential floors of the building. The first floor shop front windows are large fixed single panes of glass with a multi-pane sash pattern and clerestory windows above. Exterior building materials consist of stucco and red brick for the exterior walls, and most likely composition rolls for the roof. Overall, this building appears to be in good condition.

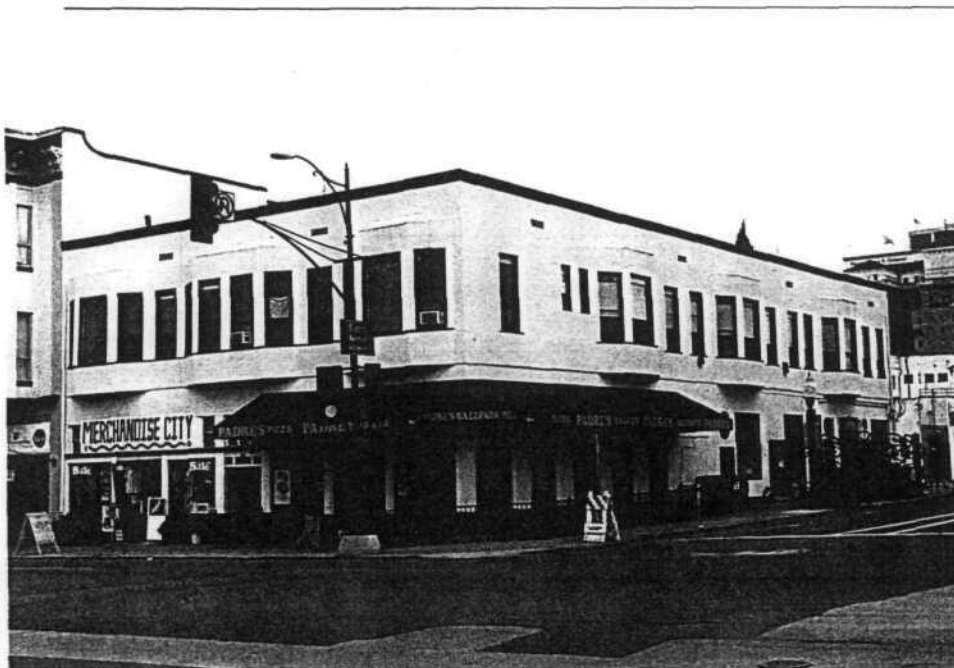
Originally constructed in 1896, this building was designed in a Two-Part **Commercial** Block style with an Italianate architectural influence. It has a general rectangular shaped plan and features a flat roof, rectangular **double-and-single-hung** windows aligned in a series of angled bays on the second floor, and first floor store fronts featuring single, large fixed panes for display and smaller vertical, rectangular shaped single-hung windows above. The first floor portion contains two shop fronts identified as 740 and 744 Market Street, with the second floor containing the residential portion identified as 742 Market Street. Rear entrances to the spaces are located on the east elevation along with additional store front **windows**. Exterior building materials consist of stucco over the original red brick, and most likely composition rolls for the **roof**. Overall, this building appears to be in good condition.

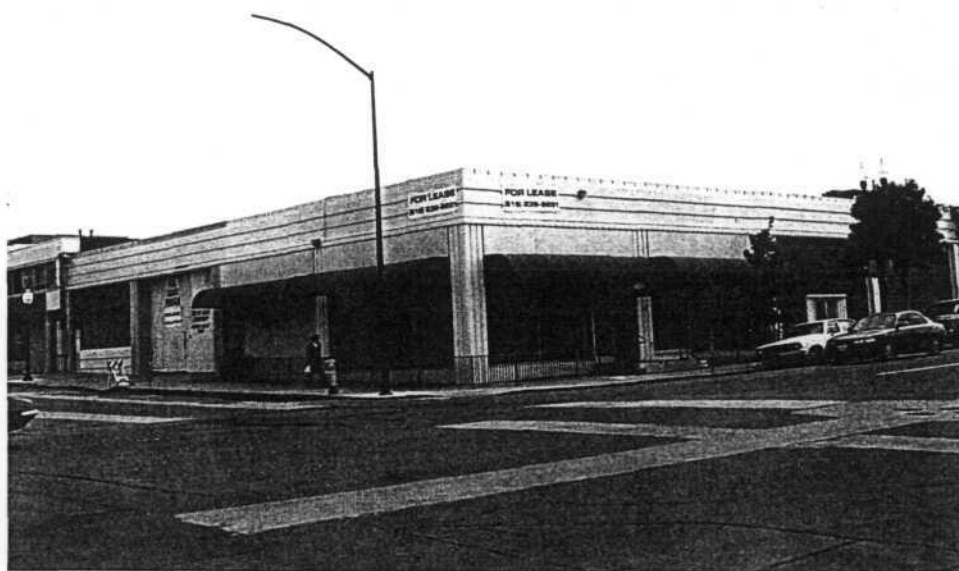
This One-Part Commercial Block styled building with Art Deco detailing was constructed in 1931. It features a flat roof with a parapet, enframed window wall portions divided by pilasters, (with each pilaster featuring engraved vertical lines) and eight bay sections. Three of the bays are storefronts, while several others are boarded or in-filled. The southeastern most bays are composed of block glass, which may have been added during the 1950s or 1960s. The building is concrete with a stucco-on-lath exterior. Overall, the building appears to be in fair condition.

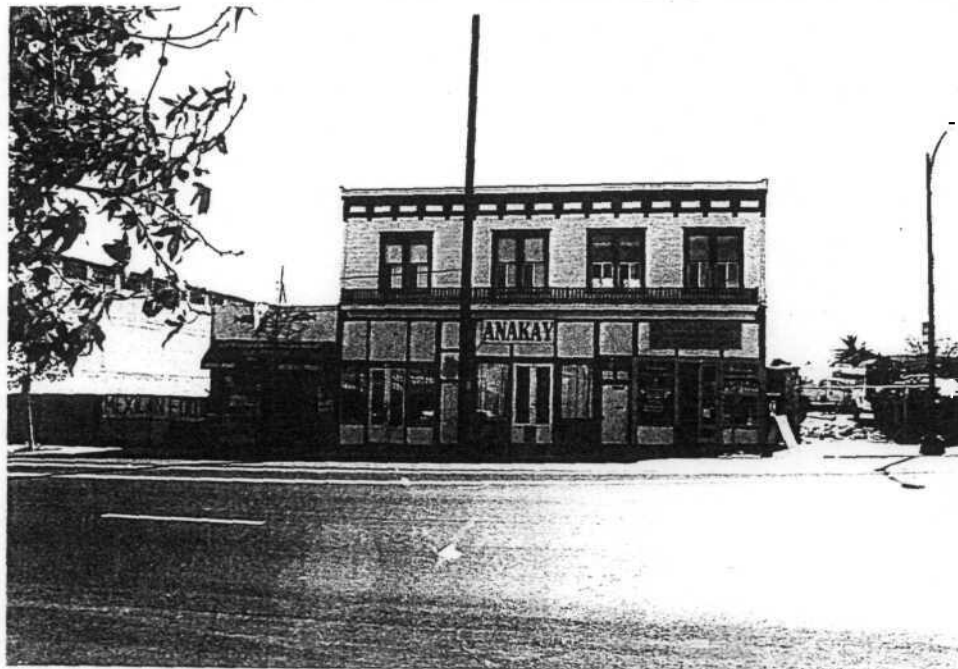
Originally constructed in 1888, this two-story wood framed building was designed in an Italianate architectural style. It has a general rectangular shaped plan, with an addition to the rear and features a flat roof with a parapet, a decorated cornice and frieze with brackets and a dentil band. The lower level features three shop fronts identified as 1425, 1427, and 1431 Market Street and two additional entrances presumably to the upstairs portion identified as 1427 and 1429 Market Street. Each of the three shopfront entrances feature double swinging doors surrounded on all sides by large fixed windows. The second floor features four sets of paired double-hung sash windows which have been modified to include sliders on the lower portion. Exterior building materials consist of horizontal clapboard siding with corner boards for the exterior walls, and most likely composition rolls for the roof. Overall, the building appears to be in good condition.

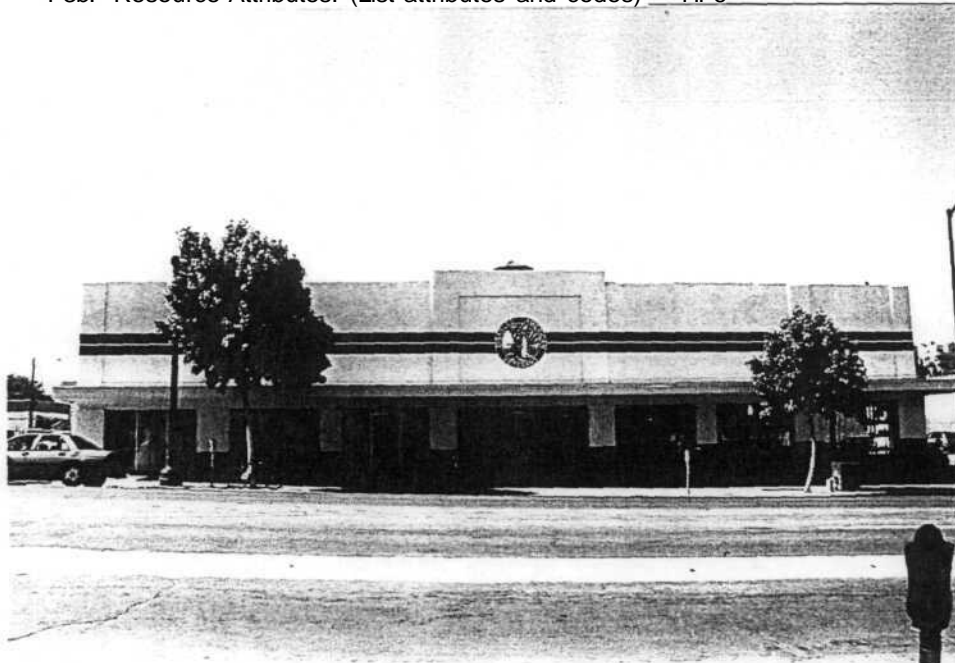
This one-story, Art Moderne commercial structure with mezzanine was originally constructed as a furniture company building c.1940. Square in shape, the building features a flat roof with stucco exterior. Along the lower front (east) storefront elevation, the building features a series of fixed bay windows, flanked by pilasters which appear to transition into decorative molding along the upper elevation section. The building features a prominent "U"-shaped element along the front elevation which includes the main entrance. This element begins as pilasters flanking the main entrance at the lower storefront, and rises upward as molding to form a central parapet above the roofline. The central face of this element below the roofline has been in-filled with stucco. The front elevation is divided by a projecting metal canopy which does not appear to be original. Small windows along the north elevation have been in-filled with air conditioning units. Overall, the building appears to be in good condition.

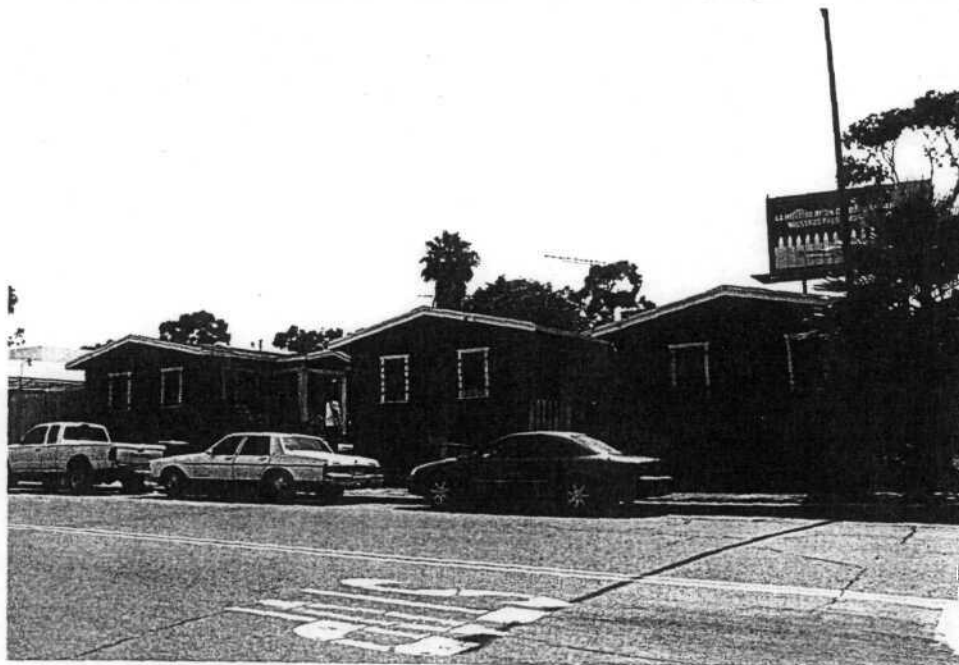
Originally constructed in 1924, the six bungalows shown in the photograph below are identified as 1704-1710 Market Street and 607-621 17th Avenue. Designed in a Craftsman vernacular architectural style, the six houses are identical in design and feature a rectangular shaped plan, with a low pitched, side gabled roof with an enclosed eave overhang, and an ornamental, center gabled entrance porch supported by one square post on each front corner. Exterior building materials consist of composition shingles for the roof, and horizontal clapboard siding for the exterior walls. Window types include individually placed double-hung sash and a triple window on each building that serves as the focal point. Each triple windows features a larger fixed center sash with a multi-pane sash pattern on the upper portion, flanked on both sides by a narrow double-hung sash window. Security bars cover the windows. Overall, the buildings appear to be in good condition.

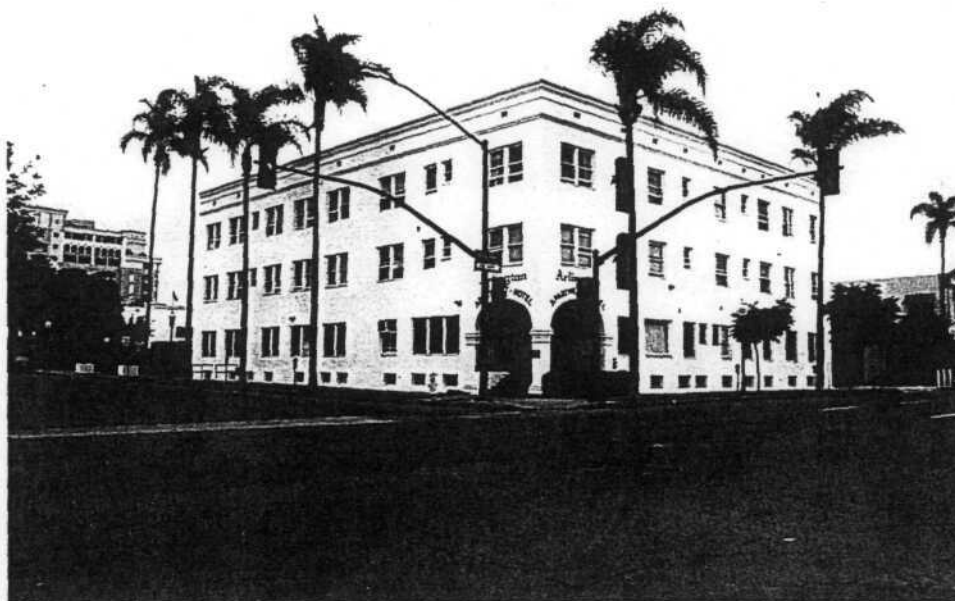
Originally constructed in 1928, this three-story apartment hotel was designed in a Spanish Eclectic architectural style with an early Modern influence. It has a general rectangular shaped plan and features a flat roof with a cornice spanning across all four facades, and a plain frieze dotted with patterned ventilation unit openings. Window types vary on all three floors and includes double-hung sash, single-hung sash, and single fixed sash patterns. The south facade features three arched openings indicating the location of the hallway on each floor. (See DPR 523H, Continuation Sheet for more information)

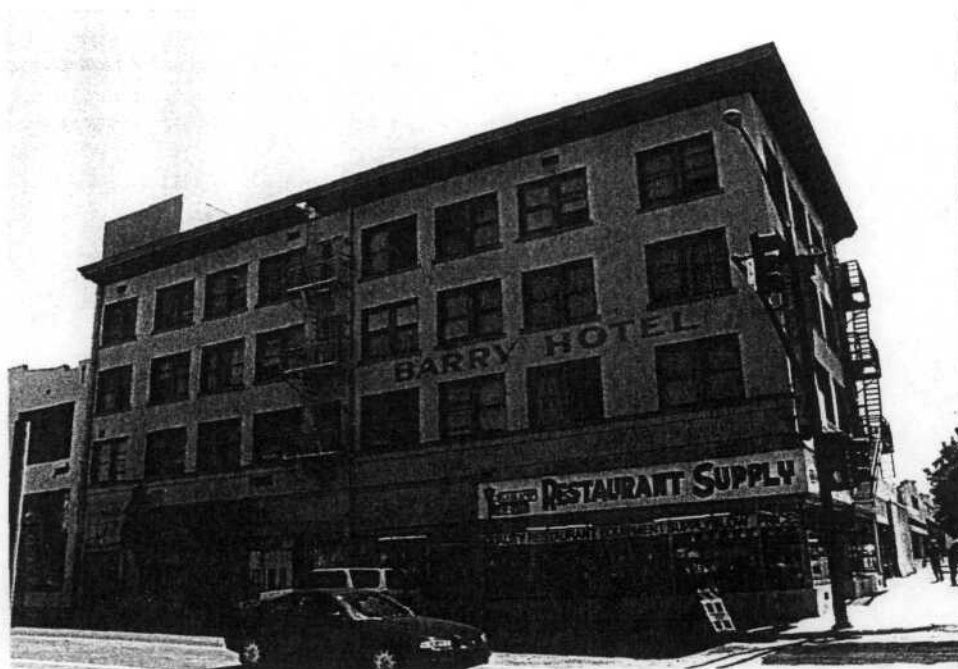
Originally constructed in 1913, **this** four-story building was designed in a Two-Part Commercial Block style. The upper portion consists of the second thru third **floors**, and features an overhanging boxed cornice with brackets and aligned, double-hung windows with wood sills, belt coursing between the first and second floors, and a plain frieze below the belt coursing. The first floor of the building is dedicated to commercial use, and features **signage**, large, fixed single panes of glass, double-entry doors for the commercial portion, and a recessed entrance with an awning for the upper residential hotel portion. Overall, the building appears to be in fair condition.

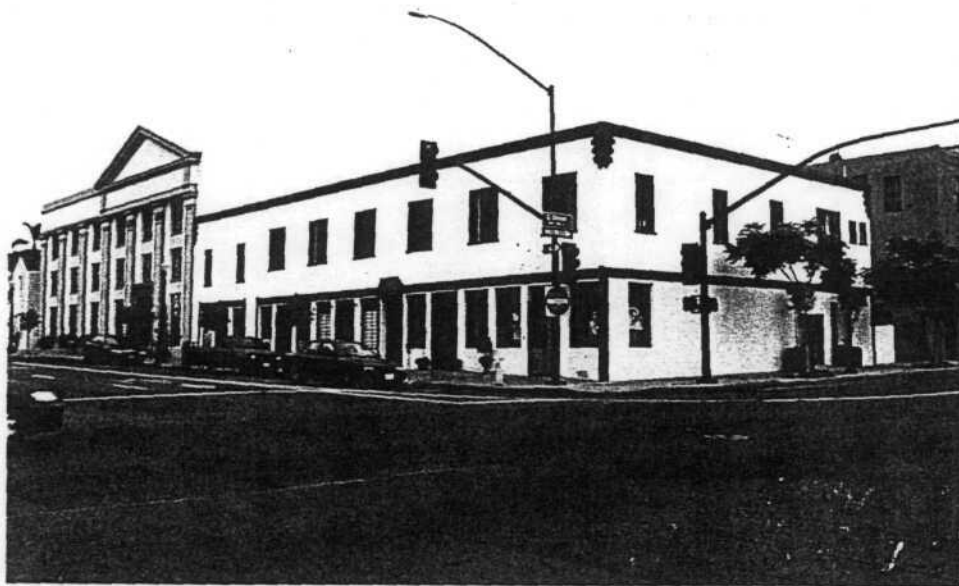
The building shown in the photograph below is identified as 703-723 8th Avenue, and the northernmost portion of the building was originally constructed in 1886 in a Victorian architectural style. The majority of the building is an addition constructed between 1907-1909, resulting in a Two-Part Commercial Block style building. It has a general rectangular shaped plan and features a flat roof with a series of recessed entrances to the various office spaces. The original windows have been replaced and types include: modern slider style, fixed with an upper transom, and possibly casement and double-hung. Exterior building materials consist of stucco-on-lath for the exterior walls, and most likely composition paper rolls for the roof. Overall, the exterior of the building appears to be in good condition.

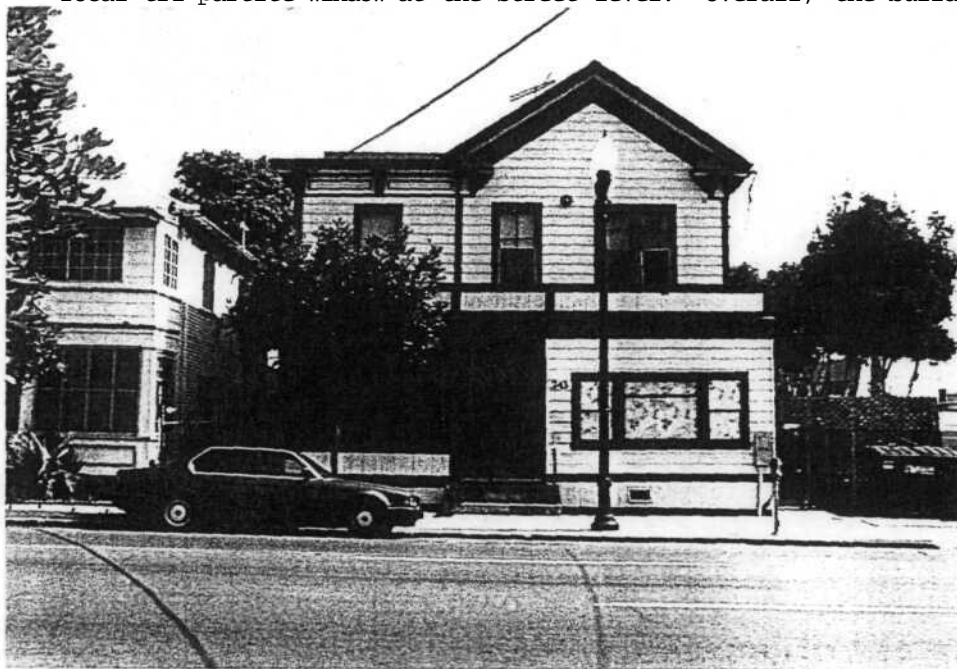
Originally constructed in approximately 1900, this two-story apartment house was designed in a Victorian vernacular architectural style for single-family use. It has a general rectangular shaped plan and features a low-pitched, hipped roof with a cross gable on the southwest roof line. Exterior building materials consist of composition shingles for the roof, horizontal shiplap siding for the exterior walls, and vertical clapboard siding for the second floor balcony enclosure. A first floor porch is present. It was most likely full length upon completion of original construction, and was partially enclosed to allow for additional living space. A full-length second floor balcony is also present, and is partially enclosed by a low wood wall approximately one foot high. West elevation window types consist of double-hung sash with a multi-pane sash pattern on the second floor, and a focal tri-partite window at the street level. Overall, the building appears to be in good condition.

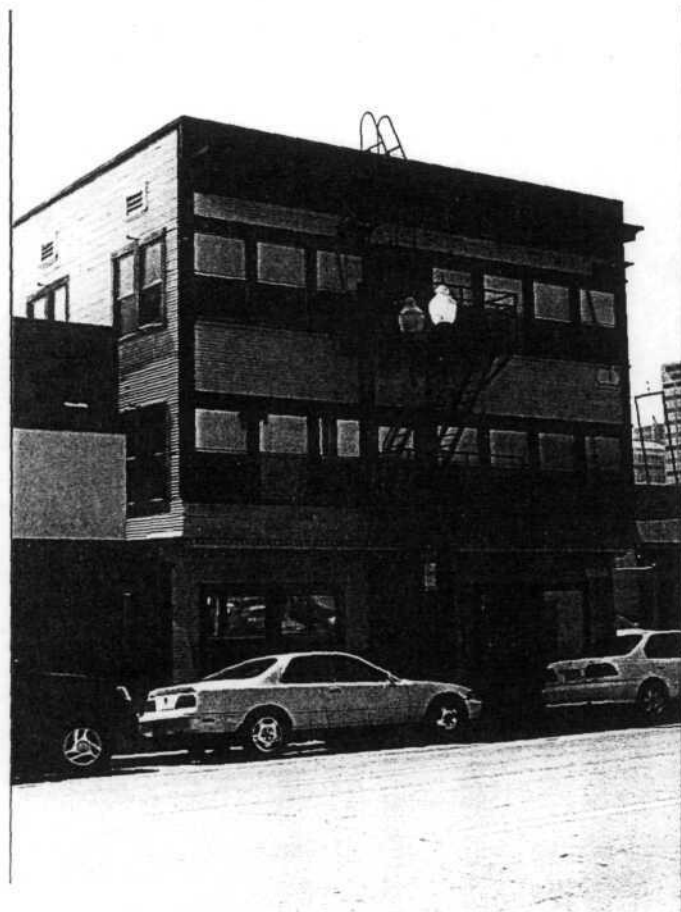
Originally constructed in 1912, this three-story, **multiple-family** residence was designed in a vernacular **townhouse** style with an Italian Renaissance influence. It has a general rectangular shaped plan and features a flat roof with a cornice on the east elevation, a **series** of double-hung ribbon windows on the second and third floors, a projecting, skirted awning feature over the first floor, and a centered first floor front entrance flanked on both sides by two contiguous double-hung windows. The entrance features double doors with an upper transom, and the flared skirt above is ornamented with a dentil band. Exterior building materials consist of clapboard siding for the exterior walls, and most likely composition paper for the **roof**. A fire escape and iron balconies are present at the second and third floor levels on the east **elevation**, and an exterior staircase is present on the north elevation, providing entrance to rear **units**. Overall, the building **appears** to be in good condition.

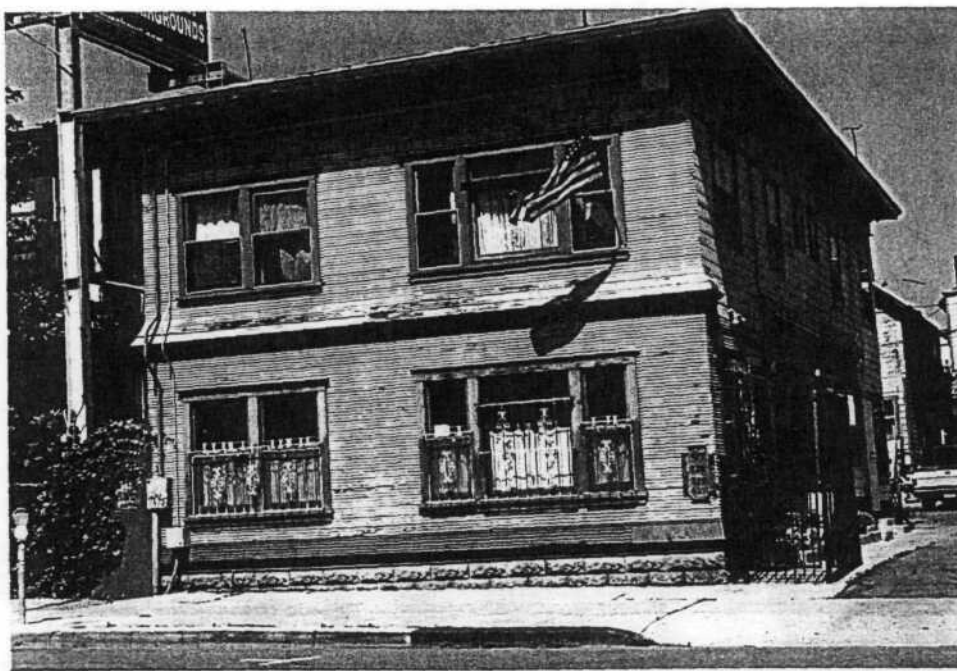
This lot contains three structures which are collectively identified as 727-733 ½ 11th Avenue. The two rear apartment buildings, believed to be identified as 727-733 11th Avenue, were originally constructed in approximately 1886 and appear to have been designed in a Folk **Victorian architectural** style. Both of the rear two-story buildings have a general rectangular shaped plan and feature gabled roofs of moderate pitch, horizontal clapboard siding and single or double-hung sash windows. Past documentation states that the original entrance porches to these two apartment buildings were on 12th Avenue and were removed and stuccoed over in the 1940s, thus eliminating access from 12th Avenue. (See DPR 523H, Continuation Sheet for more information)

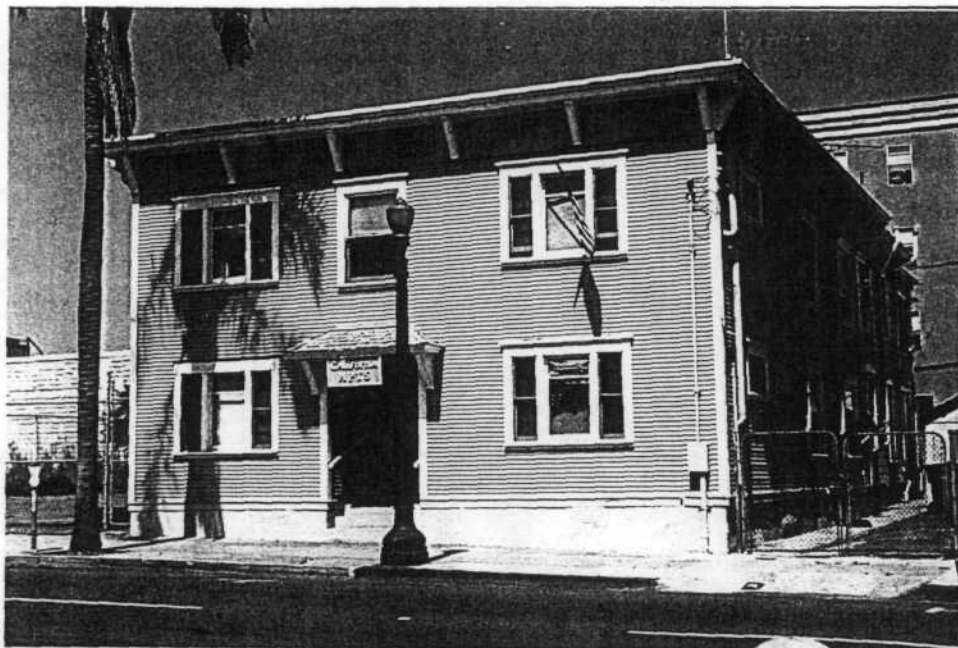
Constructed in 1907, the building shown in the photograph below is an addition to the original 1886 building which was first constructed on the property. Designed in an Italiante architectural style, this two-story building has a general rectangular shaped plan and features a flat roof with a wide eave overhang and decorative brackets. The west elevation features the main entrance, and has solid triangular brackets supporting the flat roof. The spaces between the brackets, in contrast with the horizontal clapboarding below, is laid with boards in a pattern at forty-five degree angles to the roof. The west elevation windows are tri-partite, featuring a center fixed portion flanked on both sides by a single, narrow double-hung window, and one double-hung window over the front entrance. The front entrance features an abbreviated hipped roof with supportive brackets. Overall, the exterior of the building appears to be in poor condition.

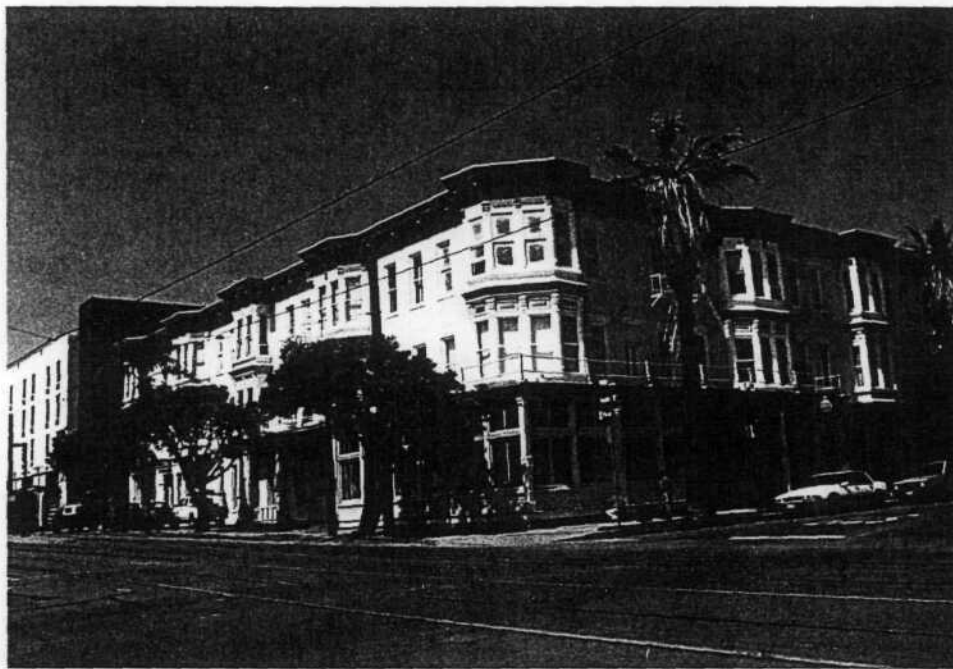
Originally constructed in 1889 by owner Joseph V. Collins, this three-story building was originally called the New Bay View Hotel, and is today known as the Palm Hotel. Designed in an Italianate architectural style, this large, rectangular shaped building features a flat roof, a bracketed cornice with a plain frieze spanning around the perimeter of the building, and eight rectangular, angular and octagonal bay windows. Placement of the horizontally aligned, double-hung sash windows alternates between the protruding bays and recessed, flat exterior wall portions. Exterior building materials consist of brick and wood, as well as glass for the enclosed first floor veranda. According to the 1988 Lia/Brandes Team Survey, balustrades on the second and third floors have been removed since 1926, as well as the two French Second Empire roofed towers that were once located at the north and south ends of the building. The Palm Hotel is a significant example of a 19th Century Italianate Hotel in San Diego architectural history. Located on 12th Avenue, adjacent to the eastern side of the Trolley line, the building's exterior appears to be in good condition.
