**COMBINED HISTORICAL
SURVEYS**

City of San Diego Planning Department

January 2005

**REVISED DRAFT
EAST VILLAGE
HISTORICAL PROPERTY SURVEY REPORT
2005**

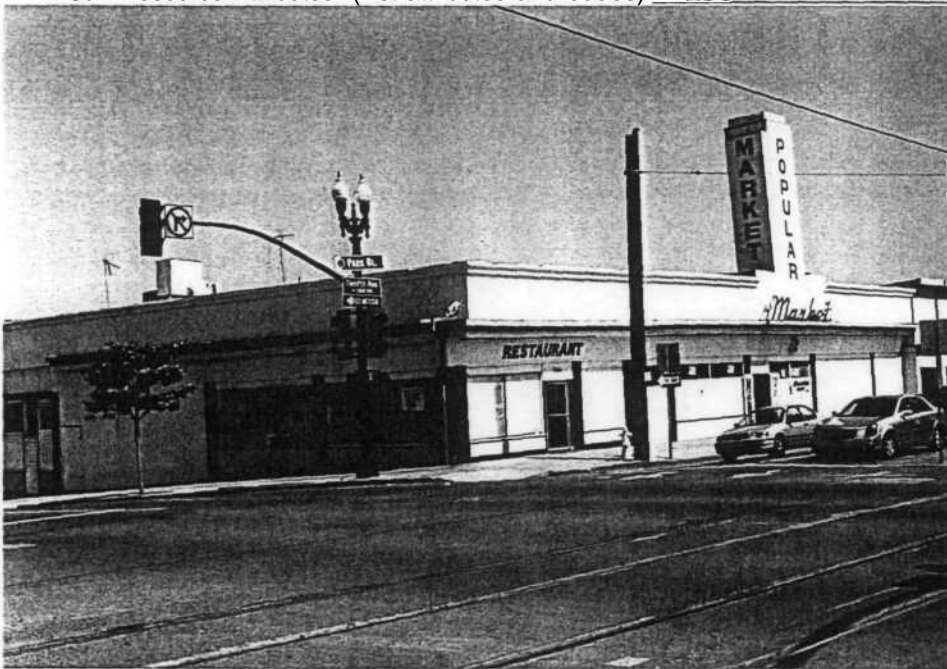
This one-story, commercial building was designed in an Art Moderne (streamline modernistic) architectural style and appears to have been constructed in 1925. Square in shape, the building has served a restaurant use (along the northwest elevation) and market use (along the southwest elevation) since at least 1940. The building features a flat roof with stepped cornice, broken slightly along the west elevation by a small parapet and projecting tower, identifying the building as the "Popular Market." Below the roofline, there is a projecting ledge which, along the west elevation, includes "Market" signage. A single entrance to the market, flanked by in-filled bays with pilasters and transom windows, exists along the west elevation, while a single, main entrance to the restaurant and fixed storefront windows exists along the northwest elevation. Another entrance to the restaurant is located along the northeast elevation. Decorative coping detail exists along the base of the west and northwest elevations. Overall, the building appears to be in good condition.

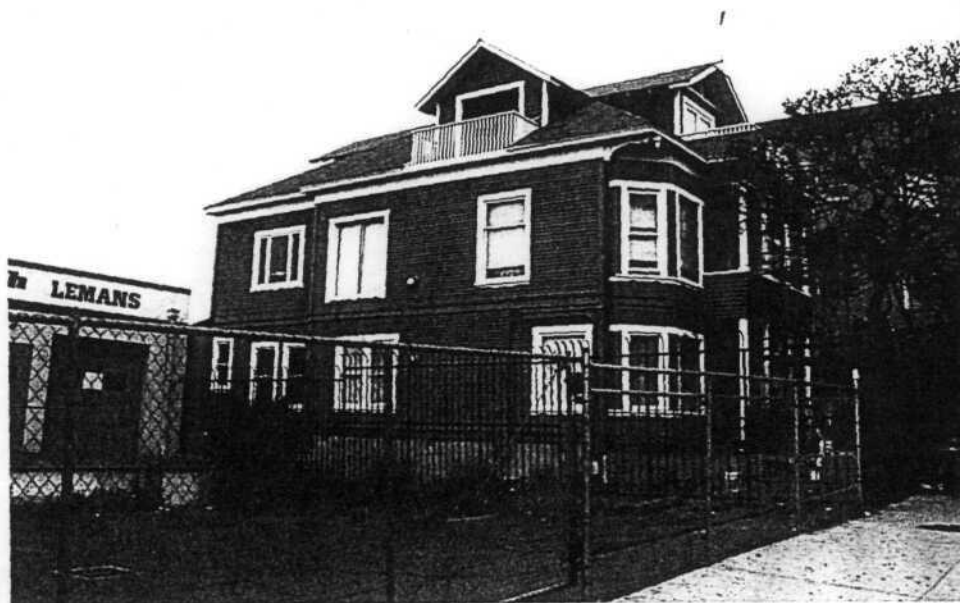
This **two-story**, Colonial Revival influenced building is believed to serve as a **single-family** residence. Rectangular in shape, the building features a medium pitched gabled on hipped roof with boxed cornices, dormer, plain frieze, shiplap siding with **cornerboards**, double-hung windows with pendants over corner bay windows, and decorations over the **lugsills**. The house is symmetrical with a **recessed** center entrance and a two tier porch at the front. The upper tier features four circular wood column supports and has an overhanging **pedimented** gable at the top, with **fishscale** shingles in the gable end. Overall, the residence appears to be in good condition.

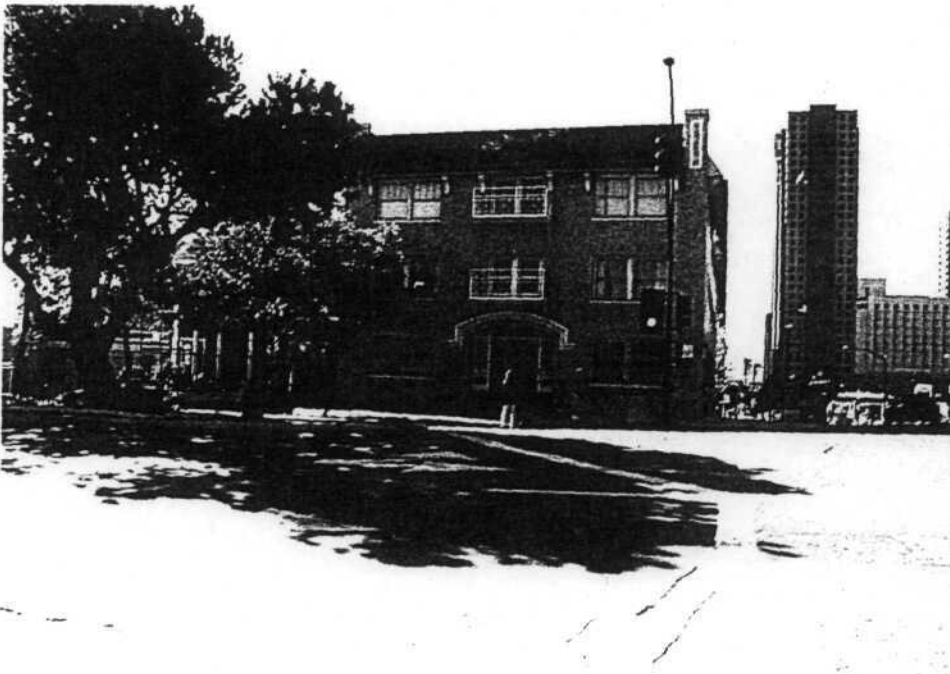
Originally constructed in 1925, the design of this three-story apartment building appears to have been influenced by the French Eclectic style. Typical to the French Eclectic style, the 1166 12th Avenue building features brick wall cladding, a symmetrical facade with a centered entry, and formal facade detailing, including an elongated, arched pediment over the recessed front entrance, one set of double french doors on each floor of the east, facing elevation, large, ornamental brackets around the buildings facade, and lastly, a flat roof with a faux mansard style roof section with a boxed cornice on the west and north elevations. Windows on the east facade are three-over-one paired, double-hung sash in a wood frame with brick sills, and the front entry doors feature an upper transom. Overall, the exterior of the building appears to be in excellent condition.

Originally constructed in 1925; second and third-floor balconies were fire escape ladders were removed between approximately 1988 and 2000, no other alterations/modifications known or noted.

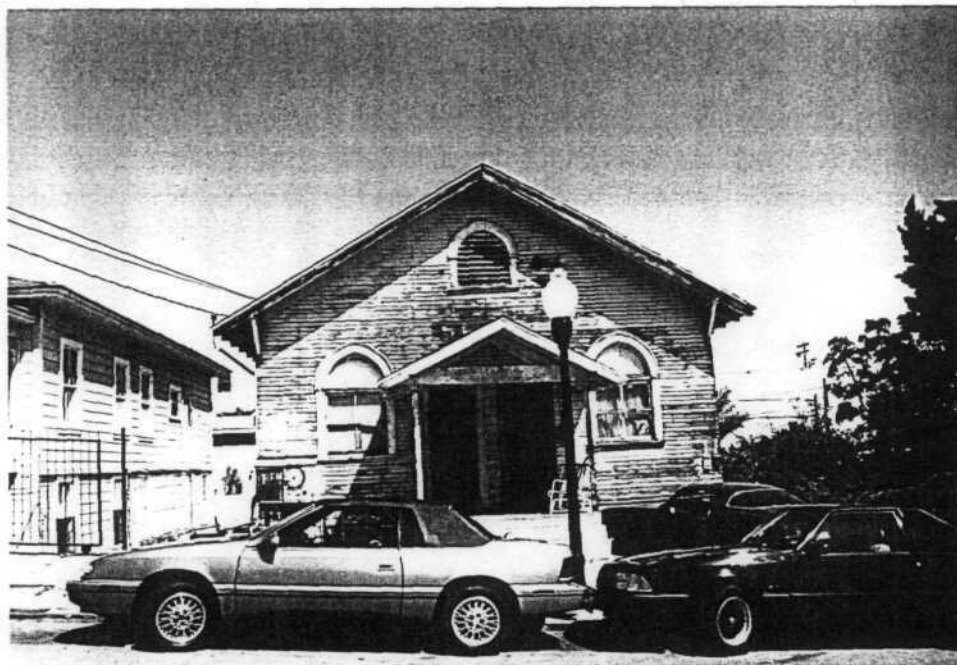
Originally constructed in approximately 1906-1907, this building is identified as 341-343 13th Avenue. Designed in a vernacular Polk Victorian architectural style, this residence consists of one-story of livable space with a basement built below the street level on the rear portion of the building. It has a general rectangular shaped plan, and features a moderately pitched, front gabled roof with an unenclosed eave overhang, exposed rafter tails, and supportive knee braces. Exterior building materials consist of clapboard siding for the exterior walls, and most likely, composition shingles for the roof.

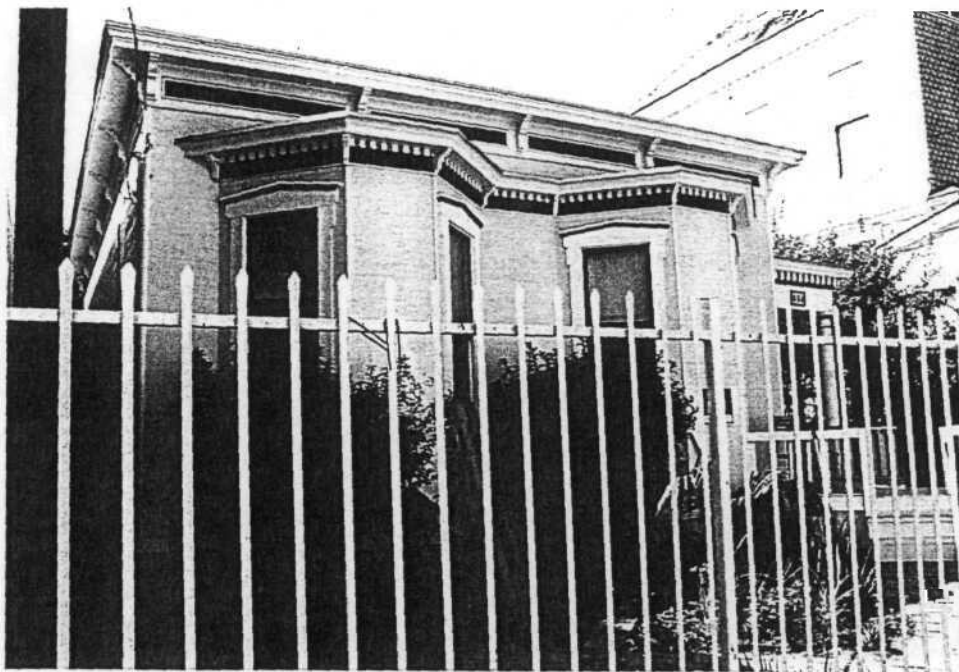
Originally constructed in 1882, this single-story, **single-family** residence was designed in an Italianate architectural style. It has a general square shaped plan and features a flat roof with a boxed cornice and scrolled brackets. Two flat roofed, angled bays are present on the east, street facing **elevation**, each featuring a center section devoid of a window, and flanked on both **sides** by a narrow double-hung window. The bays also feature a bracketed entablature, and a dentil band **spanning** across the roof line. A small porch area is present at the northeast corner of the residence and features a mansard roof with fishscale shingles, additional dentiled entablature, and a supportive column. At the time of field investigation activities, this house was undergoing maintenance and general **rehabilitation**. Overall, this house appears to be in good condition.

Constructed in 1882; according to past documentation, rooms have been added to the rear of the residence (Lia/Brandes:1988). No other apparent substantial alterations and/or modifications noted.

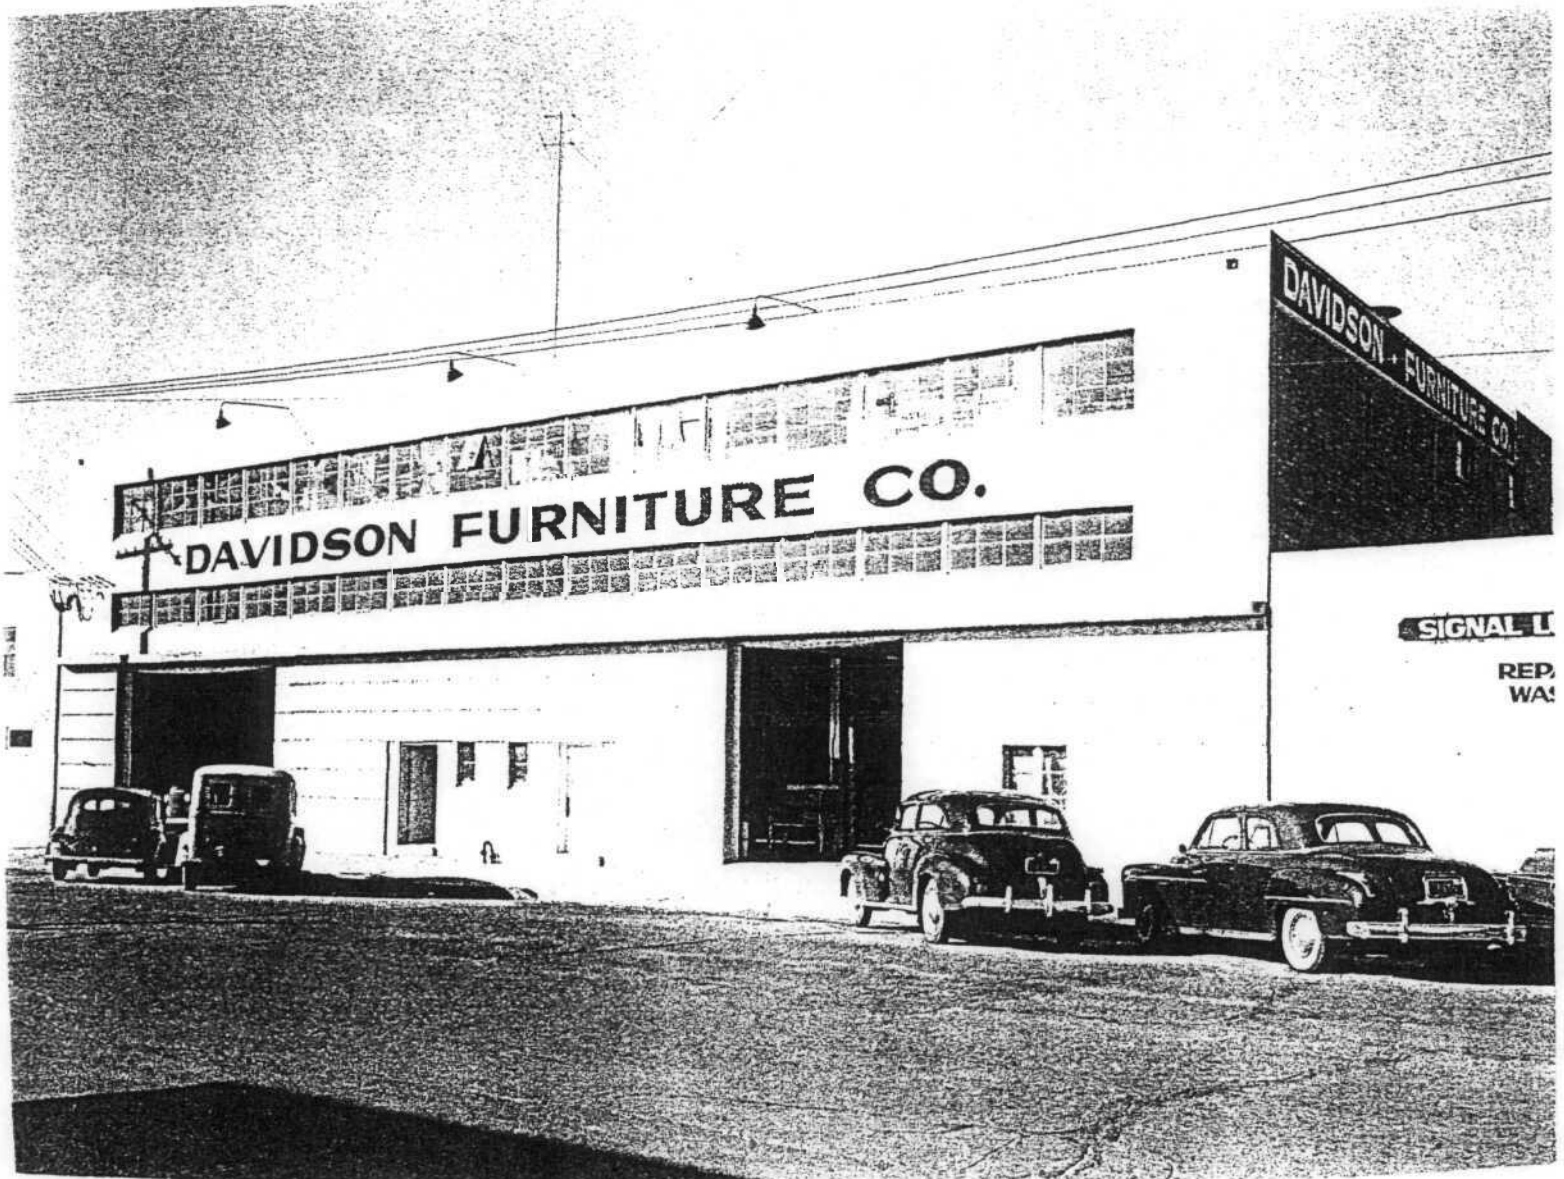
Historic Photograph (1950); Sensor 5-602; "Davidson Furniture Company"; Photograph Courtesy Of The San Diego Historical Society

This two-story, with mezzanine, commercial building, is believed to have been constructed for the Davidson Furniture Company as a warehouse in 1945. The building has not substantially changed in appearance since its construction. Designed in a Streamline Moderne/International style, the building is square in shape and set on a reinforced concrete foundation with concrete walls and brick. The building features a flat roof and stucco exterior. Along the main (east) elevation, the building is divided by coping which bisects the ground floor from the mezzanine and second floor. Along the ground floor, the building features broad horizontal grooves with two bay areas and "roll"up style metal doors. The horizontal grooves and coping dictate a strong Streamline Moderne/International style influence. Two entrances are separated by small double-hung windows. Along the mezzanine and second floor, there are two ribbon sets which contain multi-paned awning windows. Overall, the building appears to be in good condition.

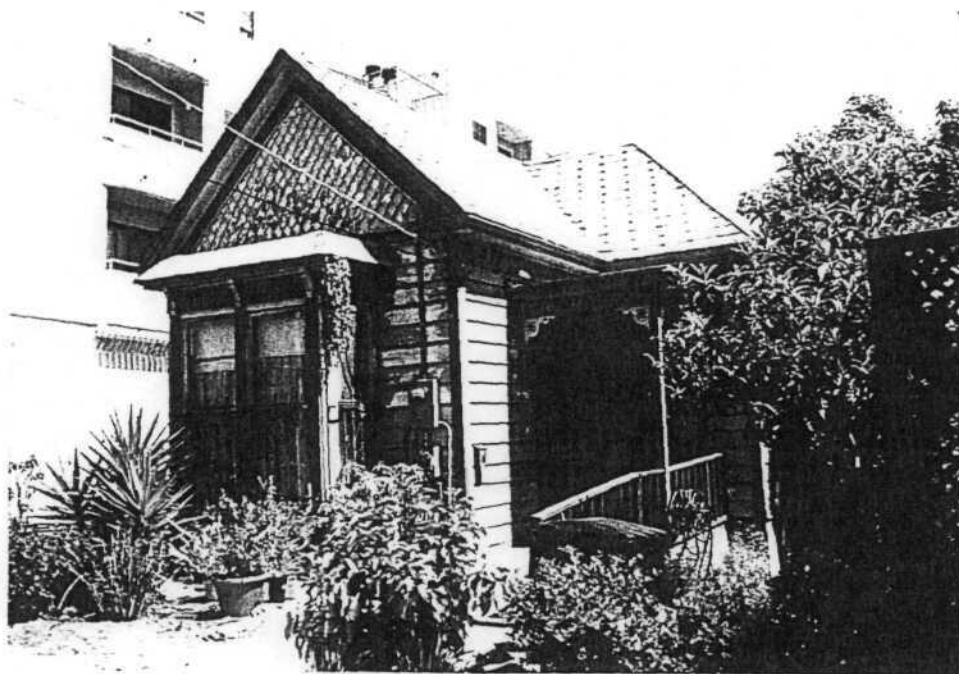
Originally constructed in approximately 1886, this single-story, single-family residence was designed in a Queen Anne cottage style of Victorian architecture. It has a general rectangular shaped plan, and features a hipped roof with a cross gabled portion featuring a boxed cornice and diamond shaped wood shingles on the west elevation. Other features include: a rectangular bay window on the west elevation with a hipped roof portion overhead, and four double-hung sash windows; a corner porch entrance supported by turned posts and featuring ornamental brackets, and an upper transom window above the front door. Exterior building materials consist of composition shingles for the roof, horizontal dropped, simple wood siding, and wood shingles for the exterior walls. Overall, the residence appears to be in fair condition.

Constructed in approximately 1886; no substantial alterations and/or modifications noted

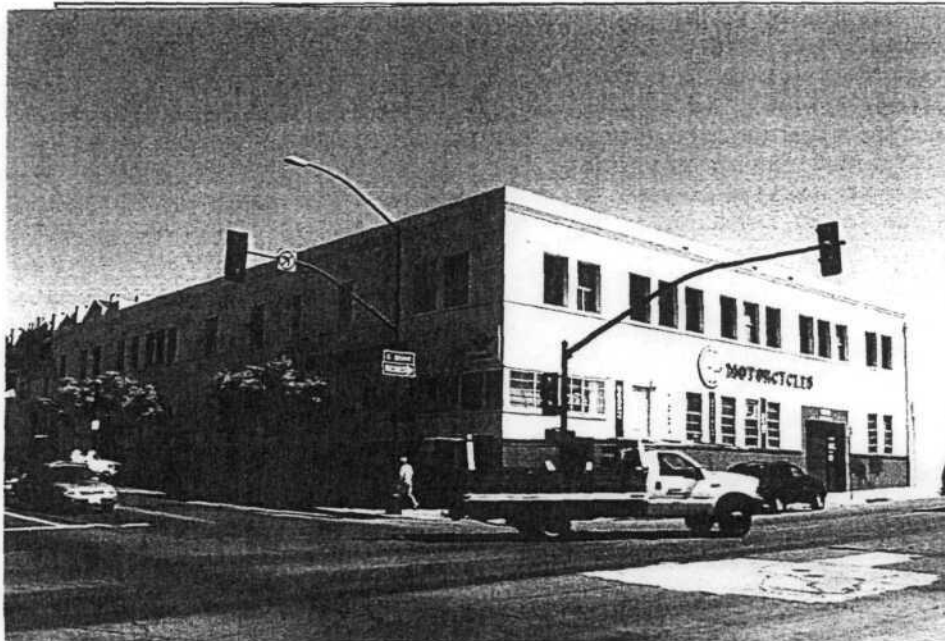
Originally constructed in 1914, this two-story **brick**, One Part Commercial Block style building has a rectangular shaped plan and features a flat **roof**, brick corbeling near the roof line, and brick belt coursing between the first and second floors. The **first** floor windows appear to be industrial style with a multi-pane sash pattern. The second floor window types vary between a fixed single-panes and **sliding** windows with an upper fixed portion. Overall, the building appears to be in good condition. Overall, the residence appears to be in good condition.

Originally constructed in 1914; original windows replaced, and others in-filled (dates unknown), single-story addition to the east side of the building (date unknown).

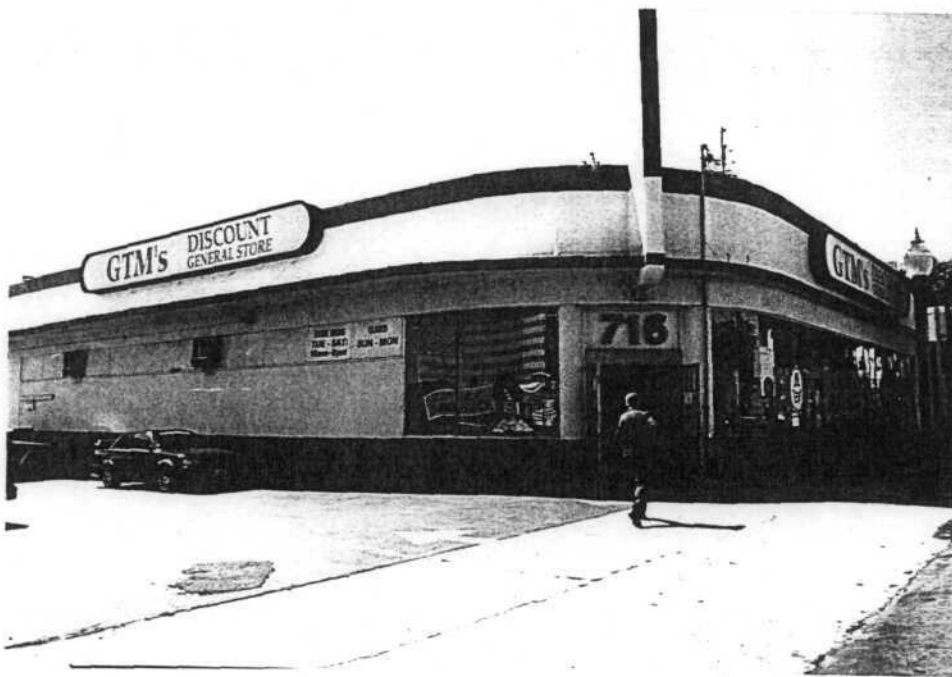
This one-story, commercial building is believed to have been designed in an Art Moderne (streamline modernistic) architectural style and constructed c. 1947. The building is rectangular in shape and features a rounded corner entrance along the southeast elevation. The building features a flat roof with projecting coping well underneath the roofline. Above the rounded corner entrance, there is a vertical tower element for signage. Additional newer signage is located along the south and east elevations, identifying the building as "GTM's Discount General Store." The exterior is stucco. Flanking the main entrance, there is a fixed storefront window to the west and a series of fixed storefront windows along the east elevation. A band of ribbon windows appear to have been in-filled along the south elevation. Overall, the building appears to be in good condition.

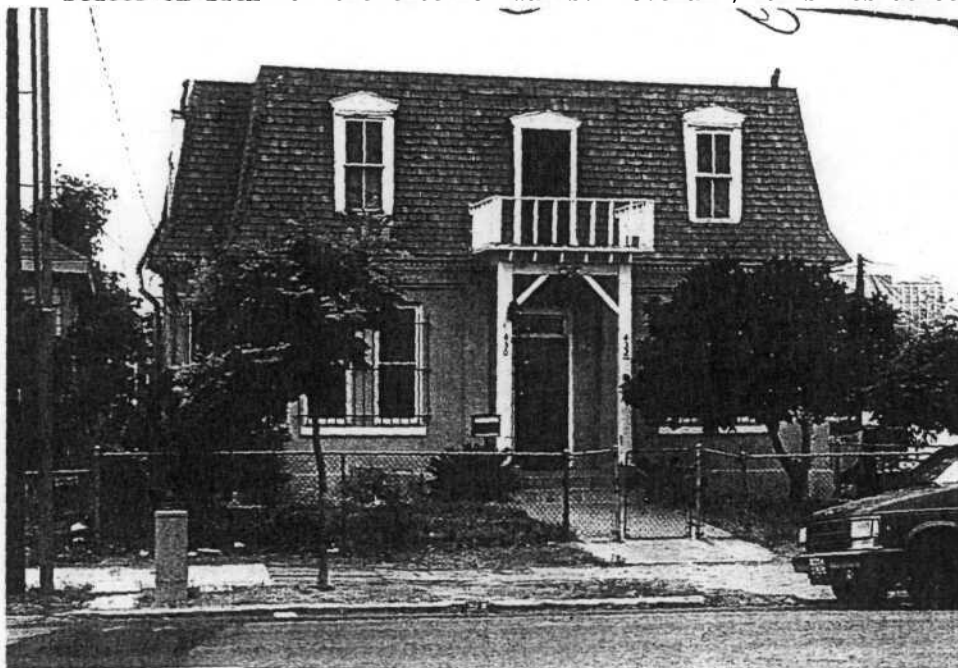
Originally constructed in 1889, this **one-and-one-half** story, single-family residence was designed in a Victorian Second Empire vernacular architectural style. It features a mansard style roof, a boxed cornice with a dentil band, two inset dormers with gabled pediments on the east elevation roof, a center front entry door with an upper transom above, and a centered second floor balcony supported by posts and brackets which form a small partial porch area at the front entrance. Windows types vary between double-hung sash with iron security bars on the first floor, and double-hung sash with a multi-pane sash pattern on the second story dormers. An interior end chimney is present on the south elevation, and an entry door to the second floor balcony with a gabled pediment is also present. -Exterior building materials consist of composition shingles for the roof, and **stucco-on-lath** for the exterior walls. Overall, this residence appears to be in fair condition.

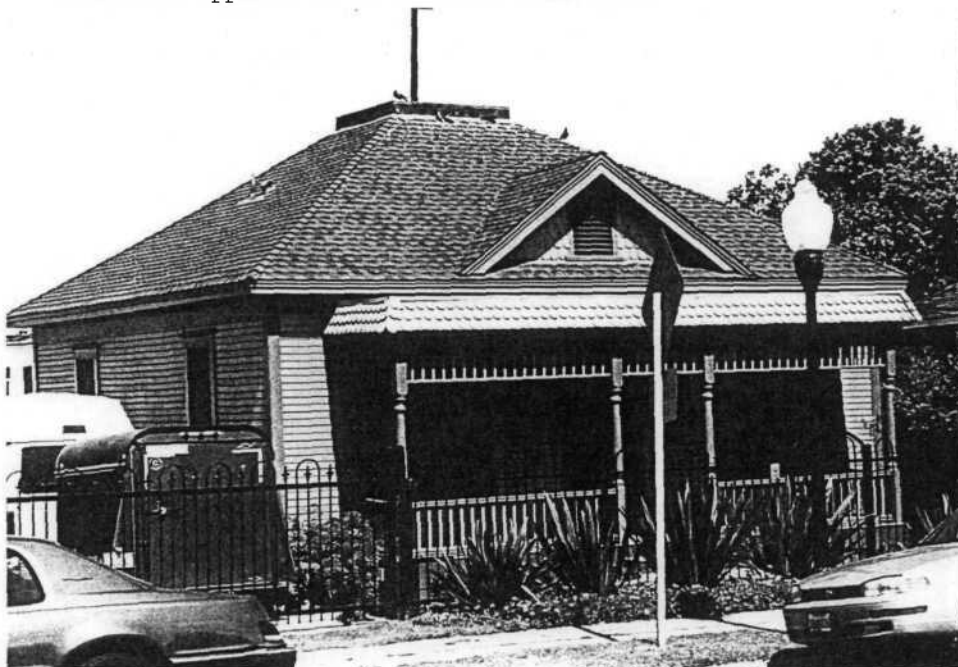
Originally constructed in 1890, this single-story, single-family residence was designed in a Folk Victorian architectural style. It has a general square shaped plan and features a moderately pitched, truncated and pyramidal hipped roof, with a slight enclosed eave overhang, and an ornamental center gabled dormer. An enclosed, nearly full-length front porch is present, and features a flat roof, a fishscale-shingles frieze, turned wooden spindle posts for support, and a low wall which partially encloses the porch area. Metal security bars fill in the space between the porch wall and porch roof line, and metal bars also appear to be present on all windows around the residence. Exterior building materials consist of composition shingles for the roof, and horizontal clapboard siding for the exterior walls. Windows appear to be double-hung sash. Overall, the exterior of the residence appears to be in fair condition.

Constructed in 1890; no substantial alterations and/or modifications noted

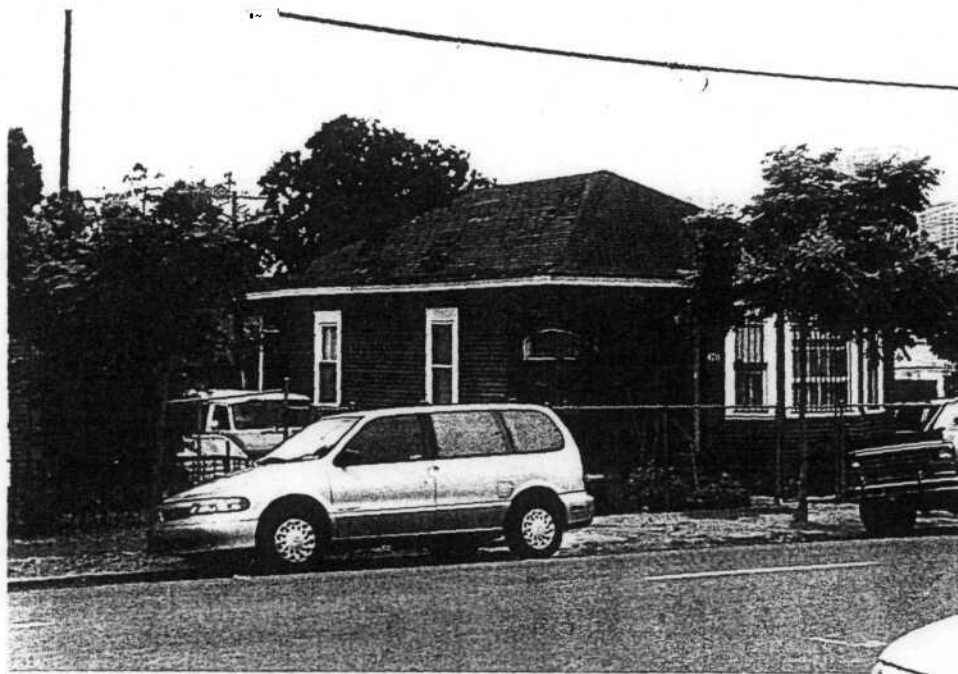
Originally constructed in approximately 1904, this single-story, single-family residence was designed in a Folk National architectural style. It has a general square shaped plan, and features a moderately pitched, hipped roof, with flaired eaves, a boxed cornice and plain frieze. A partial porch area is present on the east elevation, and features a low, partial wall portion with wood posts for support. Windows appear to be single or double-hung, some with an upper multi-pane sash pattern. An angled bay on the east elevation serves as the focal point for the residence. Exterior building materials consist of composition **shingles** for the roof and horizontal clapboard siding for the exterior walls. Overall, with the exception of the roof, the residence appears to be in good condition.

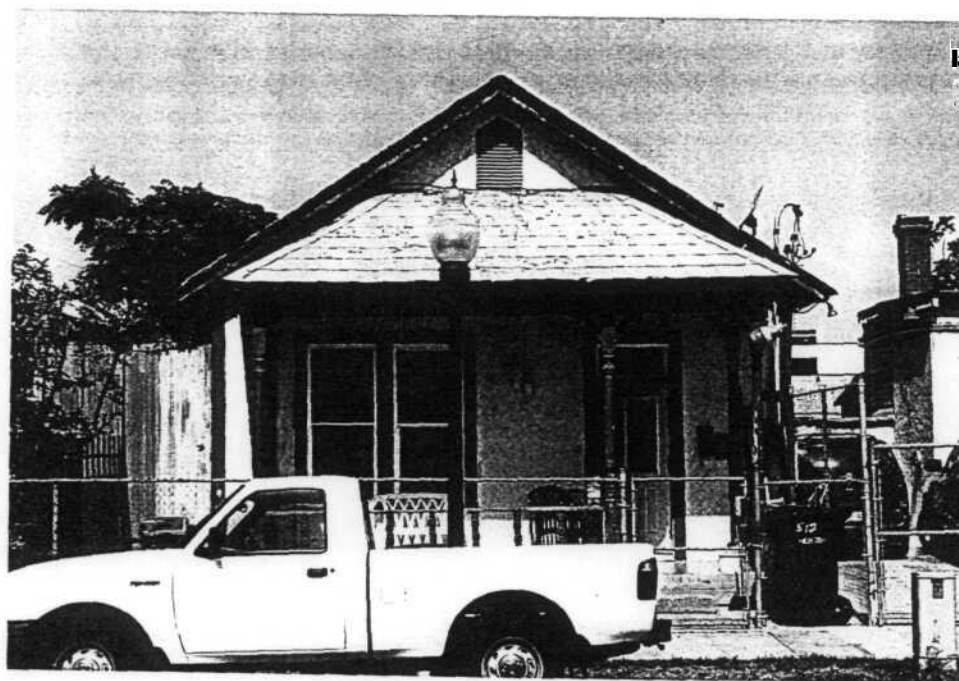
Originally constructed in approximately 1900, this single-story, single-family residence was designed in a Folk Victorian architectural style, and is identical to the neighboring 508 17th Street residence. It has a general rectangular shaped plan, and features a moderately pitched, front gabled roof, with a full length front porch. The porch features a separate shed style, hipped roof with a plain frieze, turned spindle posts with ornamental brackets, and thin wood balusters. Exterior building materials consist of composition shingles for the roof, and **stucco-on-lath** for the exterior walls. Windows appear to be double-hung sash, and there are two east elevation windows which serve as a focal point for the residence. Metal security bars cover these windows, and an attic vent is present on the front gable of the residence. Overall, this residence appears to be in good condition.

Originally constructed in approximately 1900; metal bars added over windows, original wood siding stuccoed over (dates unknown). No other major alterations and/or modifications noted.

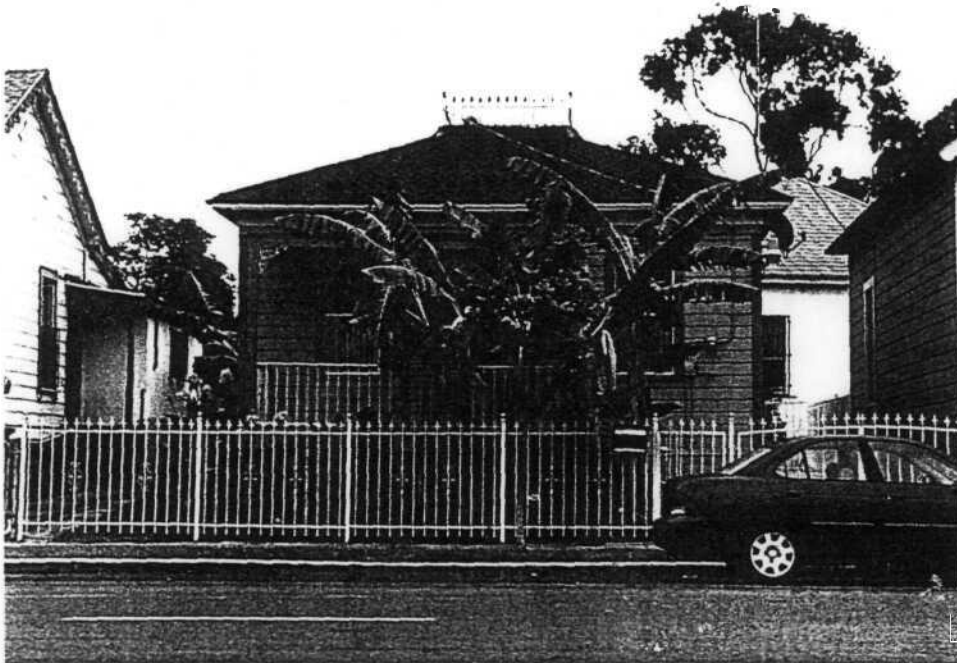
Originally constructed in approximately 1900, this single-story, single-family residence was designed in a Folk Victorian architectural style. It has a general square shaped plan and features a moderately pitched, truncated and pyramidal hipped roof with metal roof cresting, a boxed cornice, and a plain frieze. Exterior building materials consist of composition shingles for the roof, shiplap siding for the west elevation exterior wall, and board and batten siding for the north and south elevation exterior walls. A front entry porch is present and features supportive wooden posts with ornamental brackets made of iron, and matching iron railing which partially encloses the porch area. Windows are double-hung sash with a vertical, multi-pane sash pattern. Overall, the exterior of this residence appears to be in excellent condition.

Constructed in approximately 1900; no substantial alterations and/or modifications noted

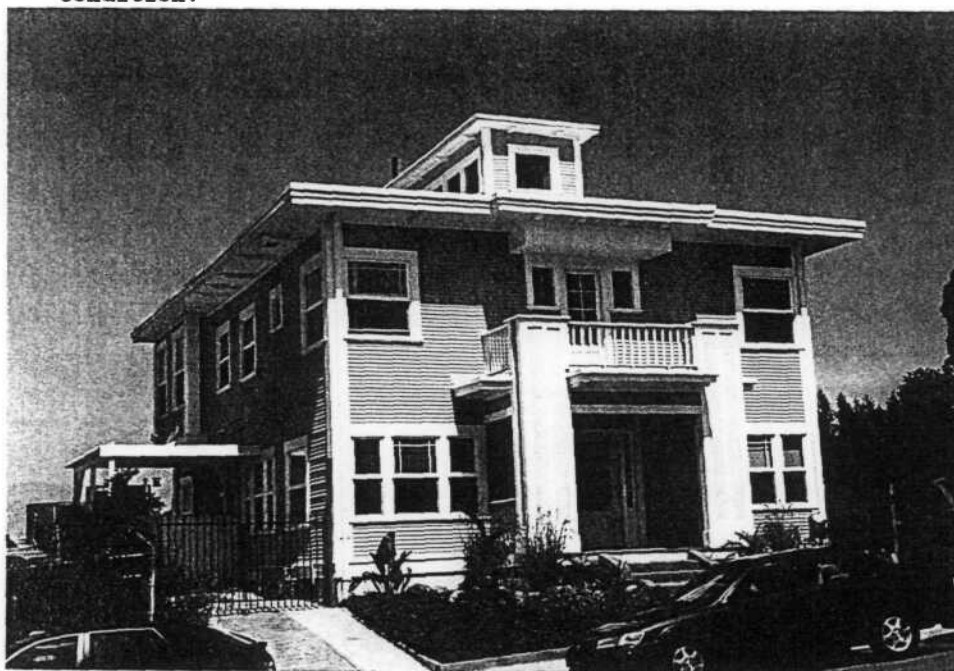
Originally constructed in approximately 1913, this two-story apartment house was designed in the Early Prairie architectural style. It has a general square **shaped**, symmetrical plan and features a nearly flat roof with wide eave **overhang**, and a boxed and bracketed cornice. A centered portico is present on the west elevation of the residence and features two oversized wooden pillars, and a balcony with wooden railing **above**. A centered, hipped dormer is present, and windows are double hung sash **type**. The first floor windows are **tri-partite**, featuring a center fixed portion with an upper multi-pane sash pattern, flanked on both sides by a narrow double-hung window. Iron security bars cover all the first floor **windows**. Exterior building materials consist of composition shingles for the roof, and clapboard siding for the exterior walls. Overall, this building appears to be in good **condition**.

Constructed in approximately 1913; no substantial alterations and/or modifications noted

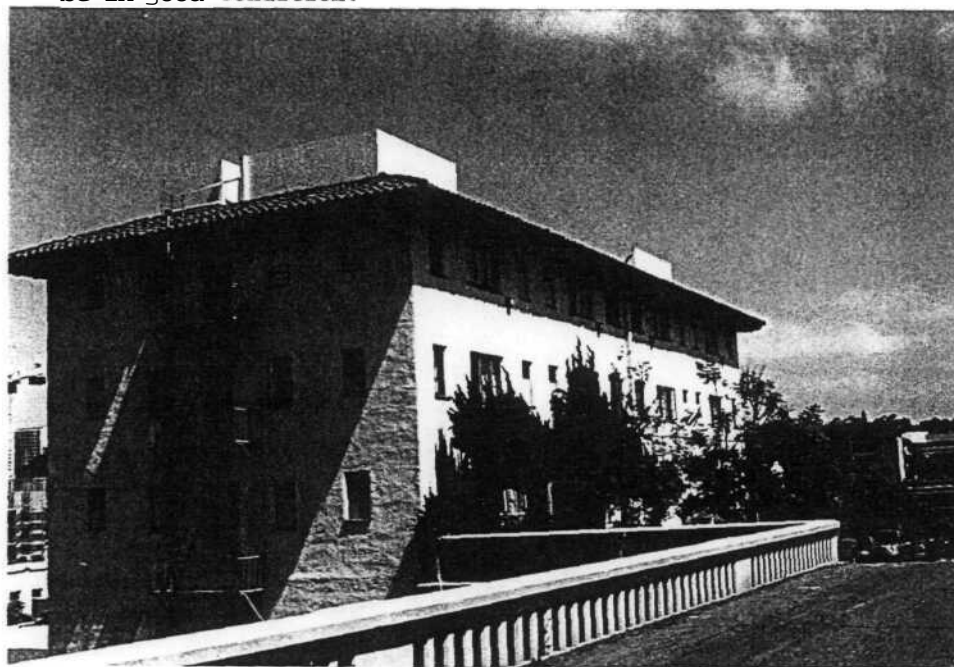
Originally constructed in 1929, this four-story apartment building with basement was designed in a Spanish Eclectic architectural style. Located on a sloping lot adjacent to Interstate 5, the building has a general rectangular shaped plan and features a moderately pitched, hipped roof with wide eave overhang and exposed beams, a centered roof tower, a recessed entry on the east elevation with an arched opening and decorative tiled walls, and a fire escape on the south elevation extending down the four floors. Exterior building materials consist of Spanish tiles for the roof and stucco-on-lath for the exterior walls. Window types vary between paired casements and single-hung sash, both in wood sills. The entrance to the building is on the east elevation, and an undeveloped lot is adjacent to the west elevation of the building. Overall, the exterior of this building appears to be in good condition.

Constructed in 1929; no substantial alterations and/or modifications noted.
