FINAL EL CUERVO DEL SUR WETLAND HABITAT MITIGATION AND MONITORING PLAN

City of San Diego
Transportation & Storm Water Department
2781 Caminito Chollas
San Diego, CA 92105

February 28, 2014

Updated February 25, 2015, with assistance from HELIX Environmental Planning,
Inc.

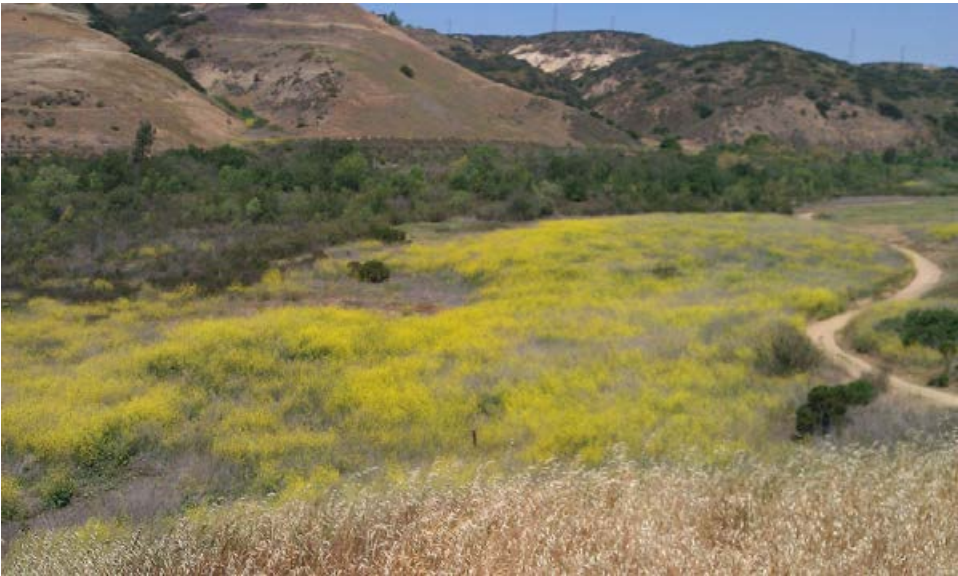
<p>Photograph A</p> <p>Date: 04-26-13</p> <p>Photopoint 1, photos A-D are sweeping overview shots moving from north to southwest across the Site. This photo is looking at the northern half of the mitigation site, bound by the dirt road to the right and existing riparian vegetation in the background. The yellow mustard will be restored or covered by soil.</p>

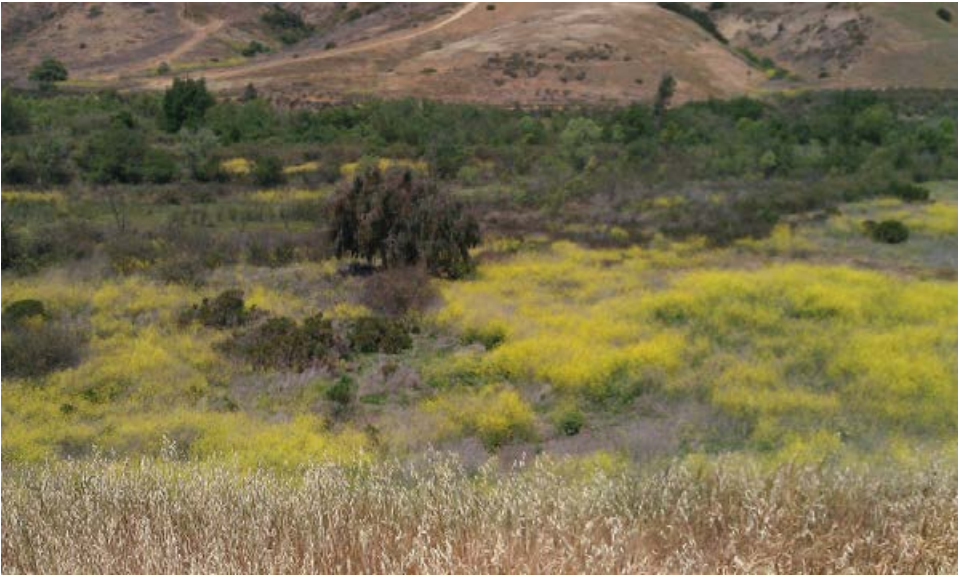
<p>Photograph B</p> <p>Date: 04-26-13</p> <p>Photopoint 1, this photo is looking northwest over the Site. Not the few native shrubs and large non-native eucalyptus tree in the center of the picture. The shrubs will be saved and the eucalyptus tree removed.</p>

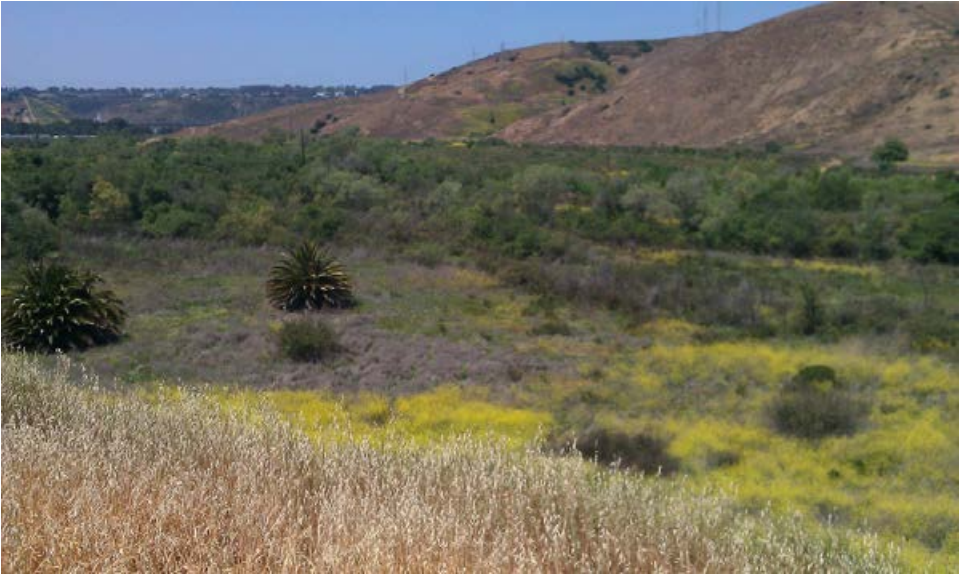
<p>Photograph C</p> <p>Date: 04-26-13</p> <p>Photopoint 1, this photograph is looking west over the Site (flat area in center of picture). Two of the three Canary Island date palms in the mitigation site are visible here. All three of these palm trees will be removed during the mitigation effort.</p>

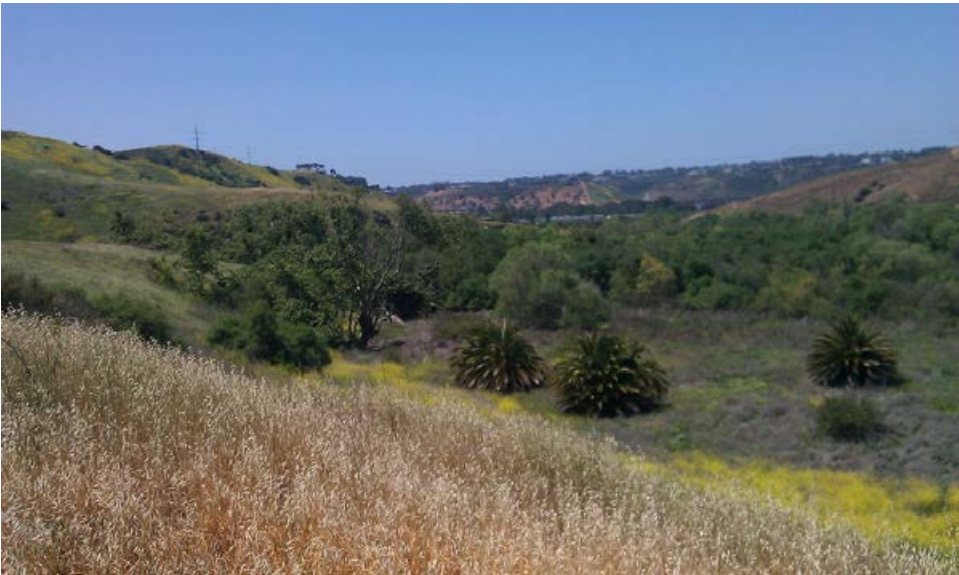
<p>Photograph D</p> <p>Date: 04-26-13</p> <p>Photopoint 1, this is the final picture in the panorama of the Site and shows all three palm trees and the confluence of Lopez Canyon into Los Peñasquitos Creek in the background. The mitigation site extends to the riparian vegetation, but includes the willow just beyond the palm trees, this tree will be saved.</p>

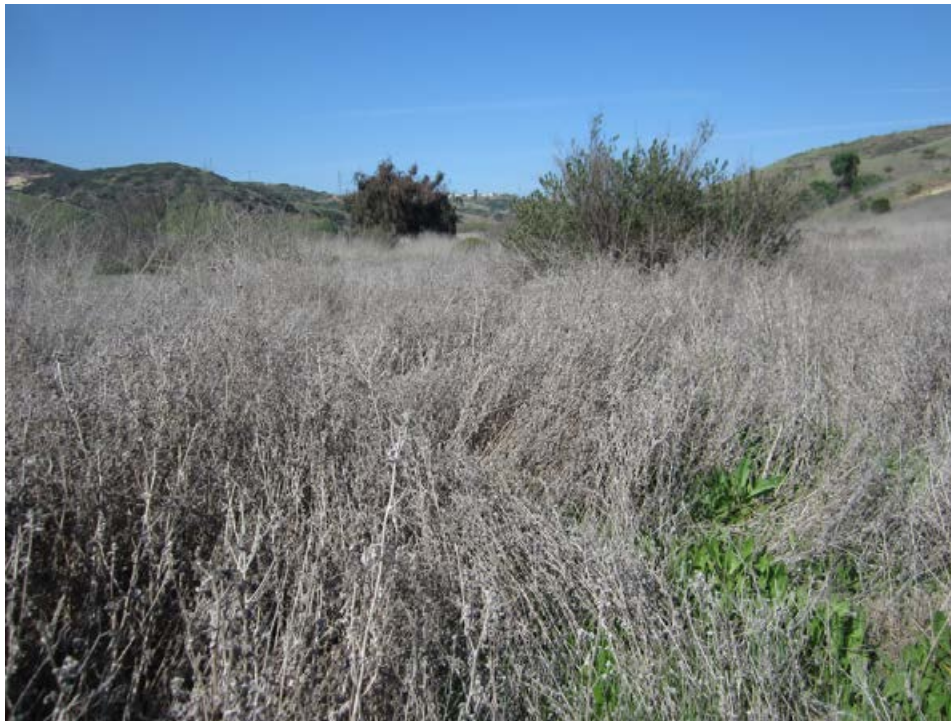
**Photograph E**

Photopoint 2, looking northeast from the center of the Site. The eucalyptus to be removed is visible in the background, will a native shrub that will be avoided is the closer shrub. The dead vegetation is composed of non-native species.
