INDIVIDUAL BIOLOGICAL ASSESSMENT REPORT

Site Name/Facility: Industrial Court. Channel Section 01 of 01

MSWSMP Map No.: 06a

Date: 9 July 2010

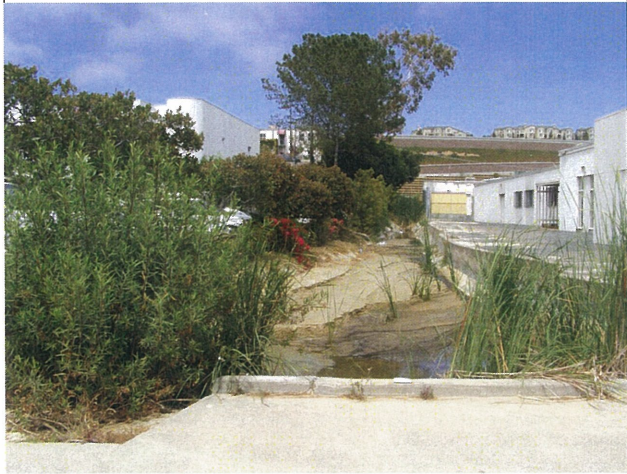
1. Concrete trapezoidal channel with freshwater marsh and unvegetated channel. Looking northeast from Sorrento Valley Road. 23 June 2010.

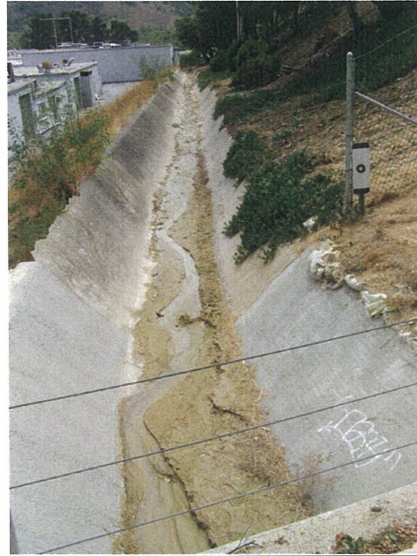
2. Concrete trapezoidal channel with freshwater marsh and unvegetated channel. Looking southwest from upper end of channel. 23 June 2010.
