INDIVIDUAL BIOLOGICAL ASSESSMENT REPORT

Site Name/Facility: Jamacha Channel Emergency Maintenance
Master Program
Map No.: 115
Date: February 16, 2016
Biologist Name/Cell
Phone No.: Scott Gressard (858-997-6874)

Jamacha Channel (MMP Map 115) - Emergency Channel Maintenance

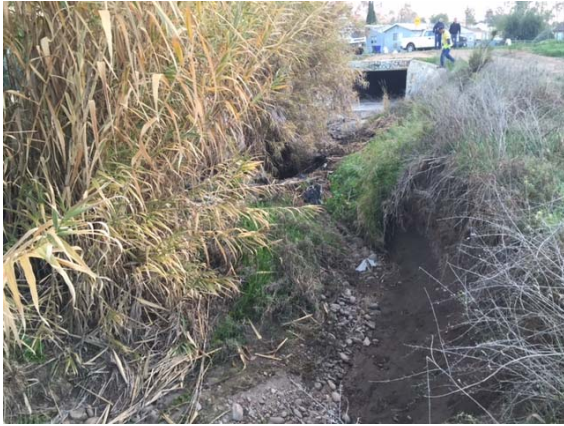
(January 3, 2016; 07:02 AM)

Photograph 1: Photo looking east toward the 69th St. culvert outlet within the channel at sediment and vegetation build-up.

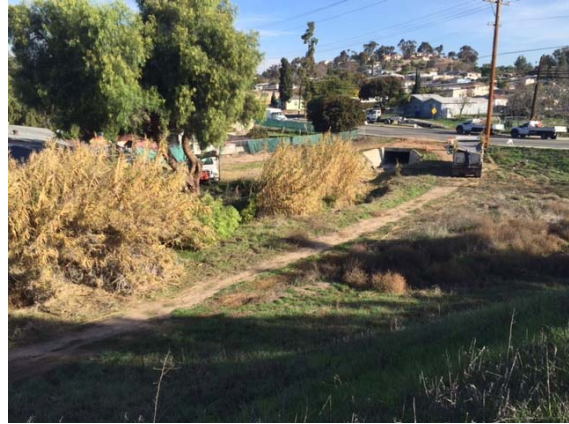
(January 3, 2016; 09:24 AM)

Photograph 2: Photo taken pre-construction during staging, looking northeast toward 69th St. from the disturbed land south of the channel.

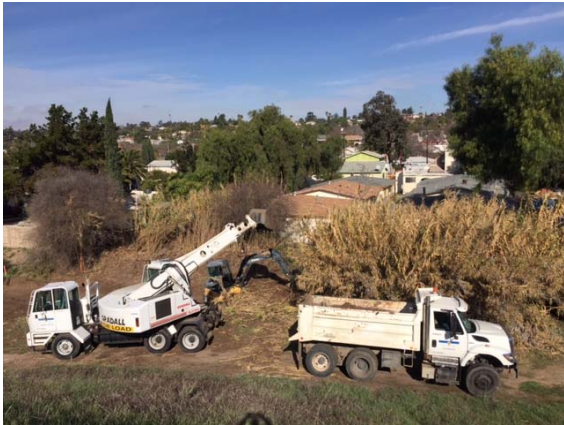
(January 3, 2016; 10:17 AM)

Photograph 3: Photo looking north at the Gradall and mini Excavator removing vegetation and sediment and the loading debris into dump trucks.

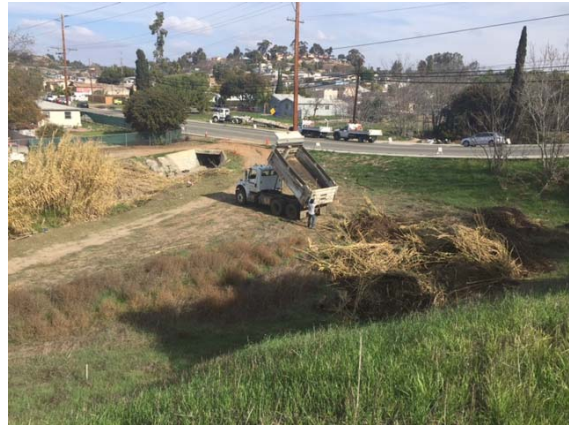
(January 3, 2016; 11:38 AM)

Photograph 4: Photo looking northeast of a dump truck unloading debris to a temporary stockpiling area before debris is taken to Miramar Landfill for disposal.

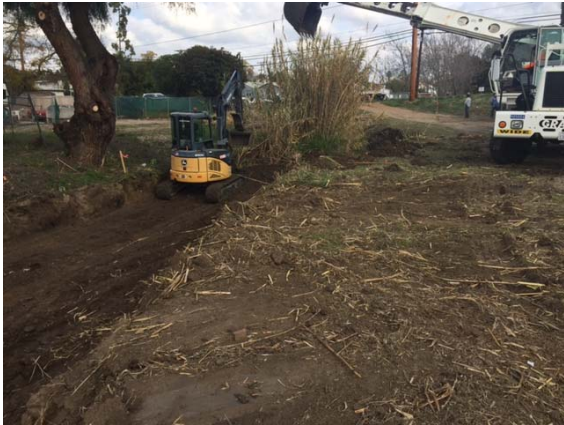
(January 3, 2016; 01:21 PM)

Photograph 5: Photo looking east at the mini-excavator in the channel removing vegetation and sediment within the channel.

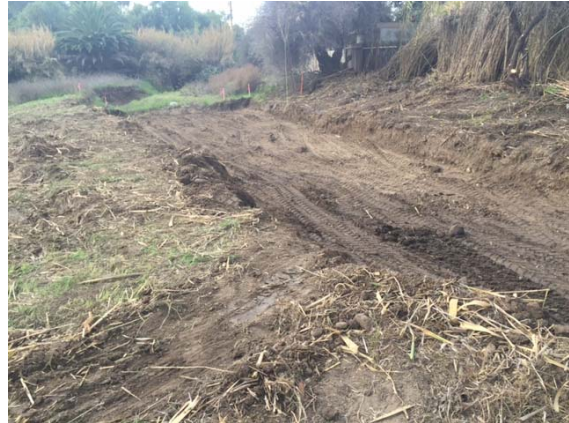
(January 3, 2016; 01:21 PM)

Photograph 6: Photo looking west at the removed vegetation and sediment in the channel during construction.

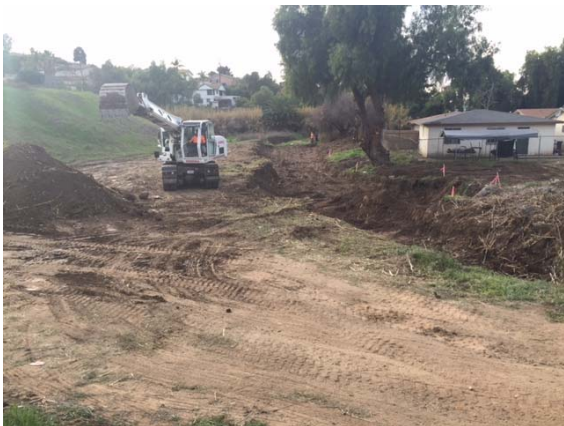
(January 3, 2016; 03:38 PM)

Photograph 7: Photo taken from 69th St. looking west at the Gradall removing vegetation and sediment from the channel and unloading debris into a temporary stockpile.

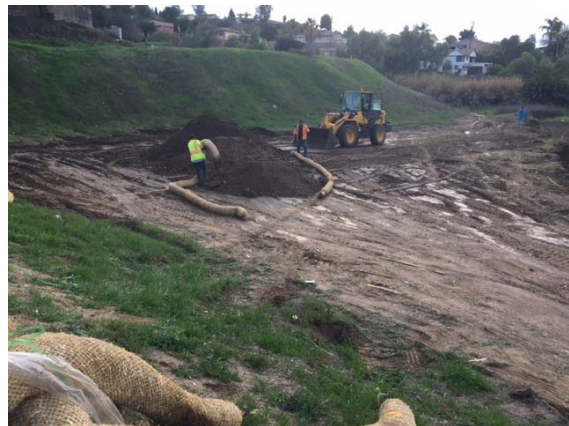
(January 3, 2016; 04:23 PM)

Photograph 8: Photo taken from 69th St. looking southwest at the BMPs around the stockpile area (i.e. fiber rolls). This material was taken to the Miramar Landfill post-construction.

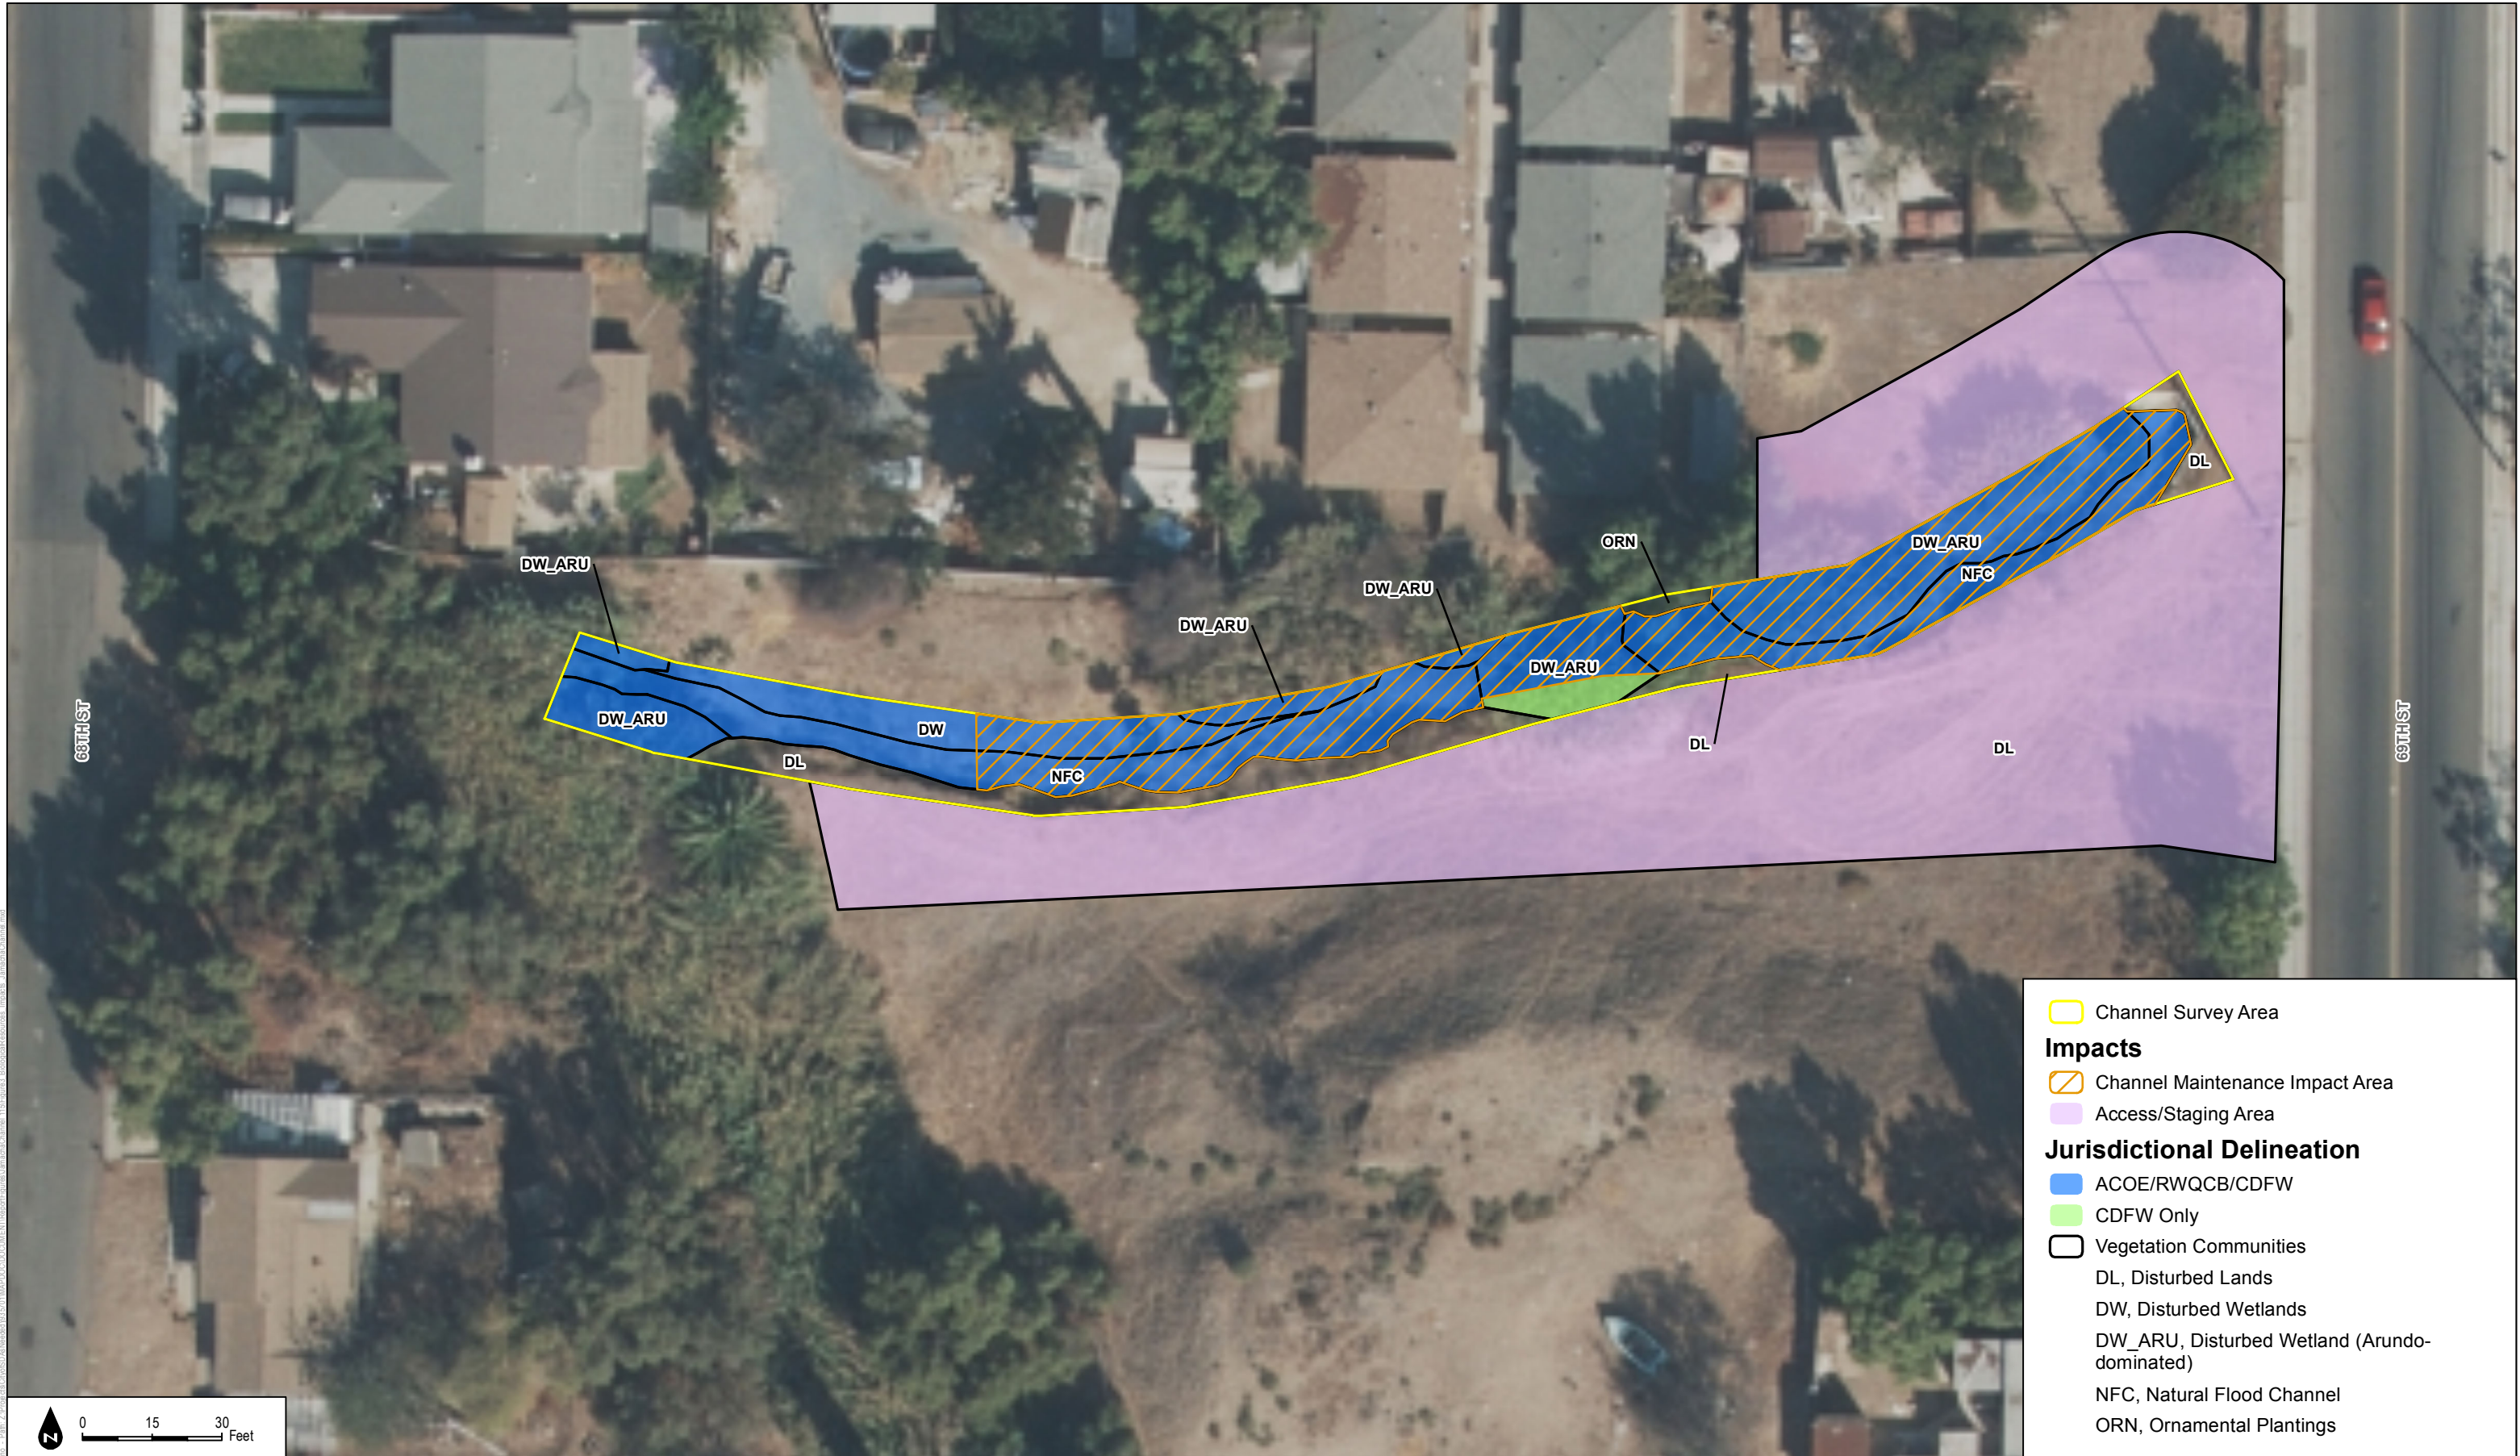
- Channel Survey Area
- Impacts**
- Channel Maintenance Impact Area
- Access/Staging Area
- Jurisdictional Delineation**
- ACOE/RWQCB/CDFW
- CDFW Only
- Vegetation Communities
 - DL, Disturbed Lands
 - DW, Disturbed Wetlands
 - DW_ARU, Disturbed Wetland (Arundo-dominated)
 - NFC, Natural Flood Channel
 - ORN, Ornamental Plantings

In the emergency maintenance section located east of the 69th St. culvert, San Diego CA (Attachment 2 - MMP Map 115; Figure 3), all sediment, vegetation, and debris were excavated from the channel. A mini Excavator and Gradall were the primary tools used to remove material. The equipment accessed the channel from the access and staging area adjacent to 69th St. as shown on Attachment 2 - MMP Map 115; Figure 3. Once the material was loaded into dump trucks, it was either taken to a temporary stockpiling location within the access area or taken directly to Miramar Landfill for disposal. Proper BMPs (i.e., fiber rolls) were installed around the stockpiled material from the channel. No sandbag berms or pumping equipment were used during maintenance as the channel remained dry during all work.
