# *Islenair Historic District*

Designated by the City of San Diego  
Historical Resources Board  
April 26, 2007

*Prepared by  
The City of San Diego  
City Planning and Community Investment Department  
Historical Resources Section*

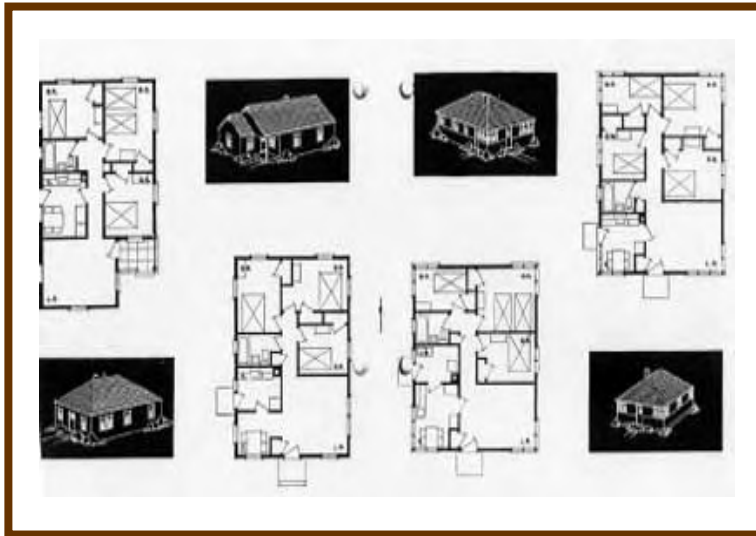
*Elevations and floor plans from the 1940 edition of FHA's "Principles of Planning Small Houses."*

measured 534-624 square feet with a kitchen, a multi-purpose living room, two bedrooms and one bathroom. By 1940 *Planning Small Houses* provided a more flexible system of design based on expandability, standardization, and variability. The simple one story "minimum house" could be expanded as needed to accommodate growing families and design could be influenced by individual taste through the addition of simple architectural features and elements such as gables, porches, materials, roof types, windows and shutters.<sup>15</sup>

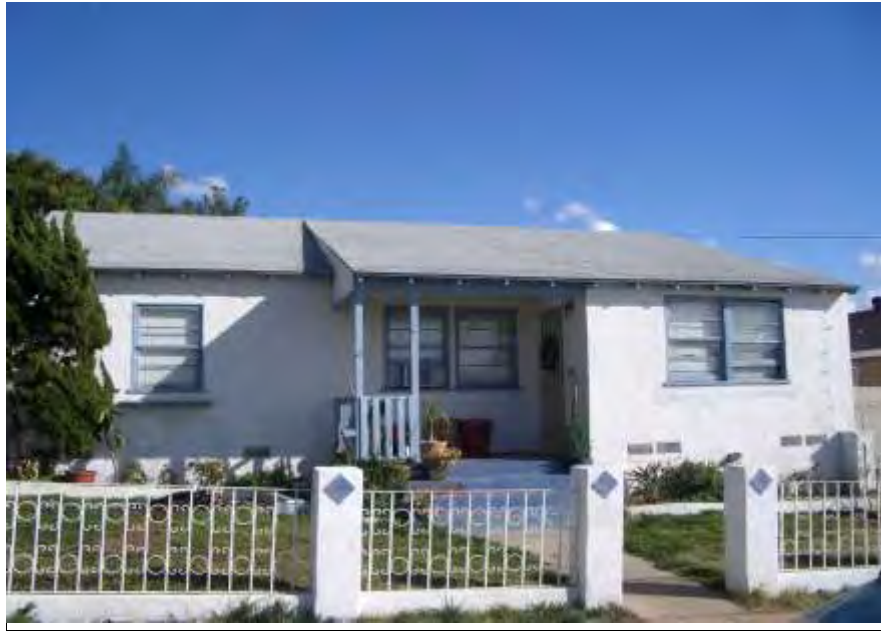
P5a. Photograph or Drawing (Photograph required for buildings, structures, and objects)

\* P3a. Description: (Describe resource and its major elements. Include design, materials, condition, alterations, size, setting, and boundaries.)  
The house at 3203 Belle Isle Drive was built in 1947 in the Minimal Traditional style and features a low-pitch side gable roof with composition shingles; slight eave overhang; exposed rafter tails; and a moderately textured stucco exterior. The porch, which is accessed by four concrete steps, is centered on the house and supported by two 4x4 wood posts. The entry door is set perpendicular to the street. Fenestration consists of 2-over-2 double hung wood frame and sash windows. The yard is enclosed with a 3-foot high wrought iron fence between stucco posts with tile detailing. Refer to BSOR Section B.6. for modifications and analysis of integrity.

Photo of the primary façade from the public right-of-way.

The house was built in 1947 per water and sewer connection records. Modifications include the use of moderately textured stucco; the use of a wrought iron security door; and the replacement of the composition roof with a new composition roof. The house is in good condition and retains a good to fair degree of integrity.

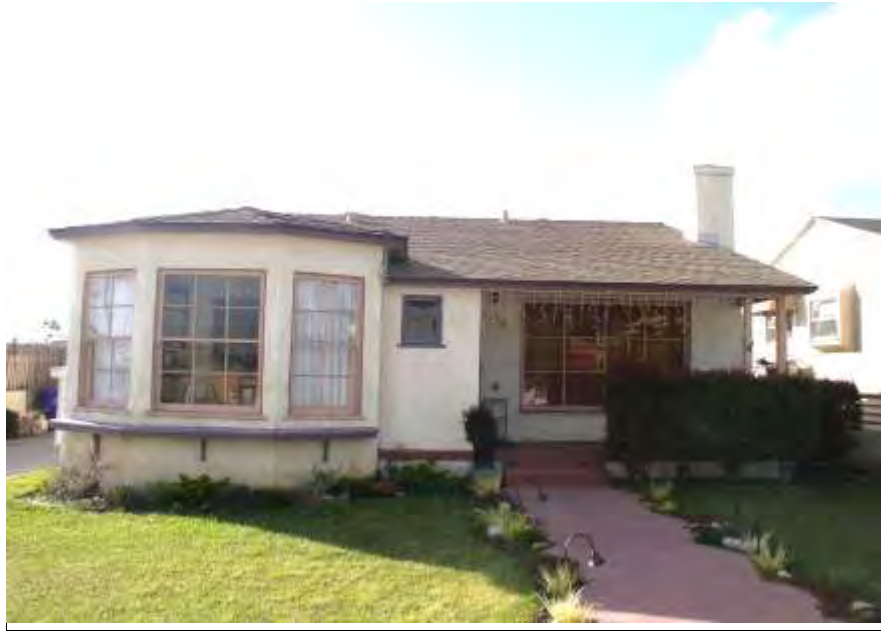
P5a. Photograph or Drawing (Photograph required for buildings, structures, and objects)

\* P3a. Description: (Describe resource and its major elements. Include design, materials, condition, alterations, size, setting, and boundaries.)  
The house at 3204 Belle Isle Drive was built in 1937 in the Minimal Traditional style and features a side gable roof with composition shingles; a slight eave overhang; a moderately textured stucco exterior; and a chimney at the side. The left hand side of the house features a hexagonal bay with a 6-over-6 double hung wood frame and sash window flanked by 4-over-4 double hung wood frame and sash windows. The entry porch, accessed by two concrete steps and supported by two 4x4 wood posts, is set to the right and includes a large 12-pane fixed window and an entry door set perpendicularly to the sidewalk. Refer to BSOR Section B.6. for modifications and analysis of integrity.

Photo of the primary façade from the public right-of-way.

The house was built in 1937 per water and sewer connection records. Modifications include the use of moderately textured stucco and the replacement of the composition roof with a new composition roof. The house is in good condition and retains a good to fair degree of integrity.

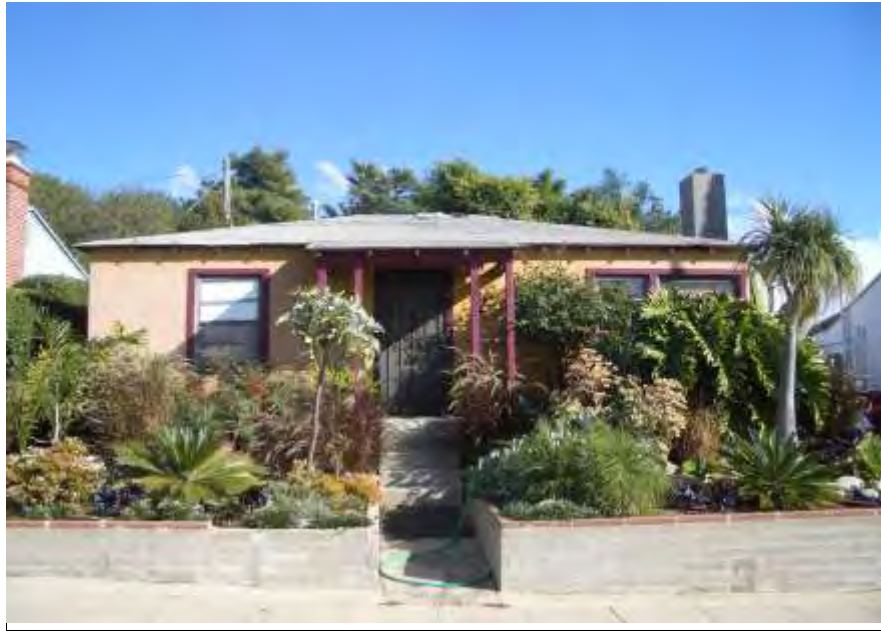
P5a. Photograph or Drawing (Photograph required for buildings, structures, and objects)

\* P3a. Description: (Describe resource and its major elements. Include design, materials, condition, alterations, size, setting, and boundaries.)  
The house at 3211 Belle Isle Drive was built in 1946 in the Minimal Traditional style and features a low-pitch hipped roof with composition shingles;a slight eave overhang; exposed raftertails; a smooth stucco exterior; and a brick chimney at the side. The entry porch, which is accessed by 5 concrete steps, is centered on the house and features a small roof projection supported by paired 4x4 wood posts. Fenestration consists of 2-over-2 double hung wood frame and sash windows and single pane fixed wood frame windows. Refer to BSOR Section B.6. for modifications and analysis of integrity.

Photo of the primary façade from the public right-of-way.

The house was built in 1946 per water and sewer connection records. Modifications include the replacement of the composition roof with a new composition roof and the use of a wrought iron security door. The house is in good condition and retains a good to fair degree of integrity.

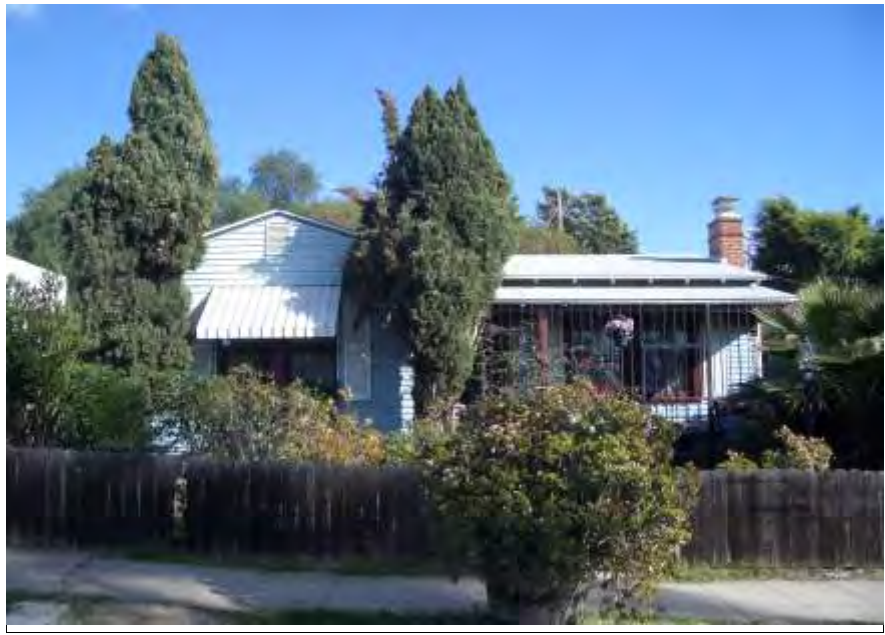
P5a. Photograph or Drawing (Photograph required for buildings, structures, and objects)

\* P3a. Description: (Describe resource and its major elements. Include design, materials, condition, alterations, size, setting, and boundaries.)  
The house at 3221 Belle Isle Drive was built in 1935 in the Minimal Traditional style and features a medium pitch cross gable roof with composition shingles; a slight eave overhang; exposed rafter tails; a clapboard exterior; and a brick chimney on the south side. The left hand side of the house features a front facing gable with a louvered outlet ventilator under the gable peak and an 8-lite wood frame window flanked by decorative shutters under an aluminum awning. The entry porch is located on the right hand side of the house and features a roof extension supported by wood posts. The entry door is set perpendicularly to the sidewalk. Fenestration consists of 1-over-1 double hung wood frame and sash windows with decorative wood shutters in some locations. Extensive use of wrought iron security bars have obscured the windows and completely enclosed the porch, however, these modifications are reversible. A weathered wood picket fence surrounds the property. Refer to BSOR Section B.6. for modifications and analysis of integrity.

The house was constructed in 1935 per water and sewer records. Modifications include the replacement of the composition roof with a new composition roof; the use of aluminum awnings; and the extensive use of wrought iron security bars on the windows and enclosing the entry porch. The house is in good condition and retains a good degree of integrity.

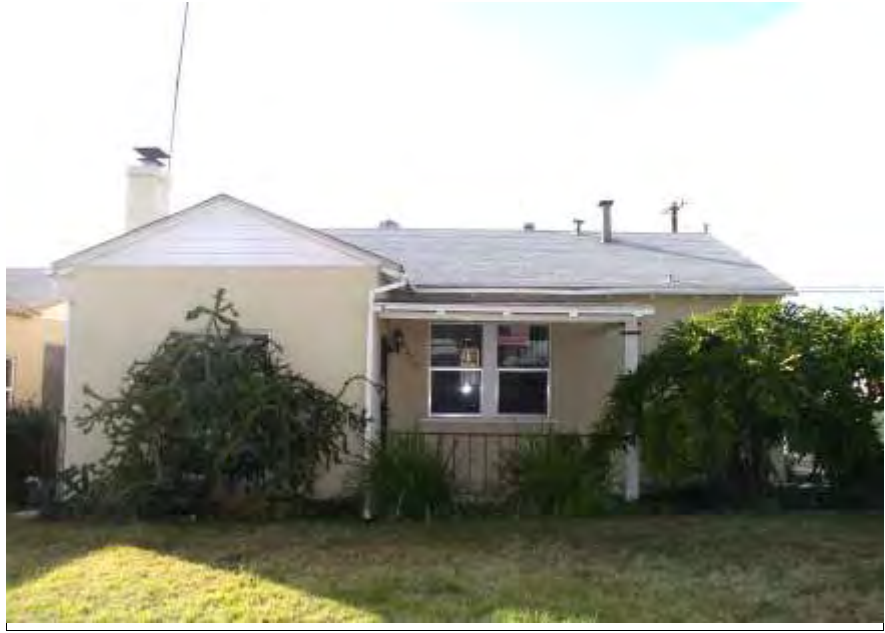
P5a. Photograph or Drawing (Photograph required for buildings, structures, and objects)

\* P3a. Description: (Describe resource and its major elements. Include design, materials, condition, alterations, size, setting, and boundaries.)  
The house at 3222 Belle Isle Drive was built in 1936 in the Minimal Traditional style and features a medium pitch cross gable roof with composition shingles; a slight eave overhang; exposed rafter tails; a moderately textured stucco exterior; and a chimney on the south side. The left hand side of the house features a front facing gable with clapboard in the gable end. The right hand side of the house features a flat-roof porch supported on wood posts and set slightly lower than the roofline. The porch cover appears to be an addition. Fenestration consists of 1-over-1 single hung and single pane fixed aluminum frame and sash windows. The entry door is set perpendicularly to the street. Refer to BSOR Section B.6. for modifications and analysis of integrity.

The house was constructed in 1936 per water and sewer records. Modifications include the use of moderately textured stucco, the replacement of the composition roofing with new composition roofing, the replacement of the wood frame windows with aluminum windows, the addition of a wrought iron security screen over the entry door, and the addition of a small entry porch cover. The house is in good condition and retains a fair degree of integrity.

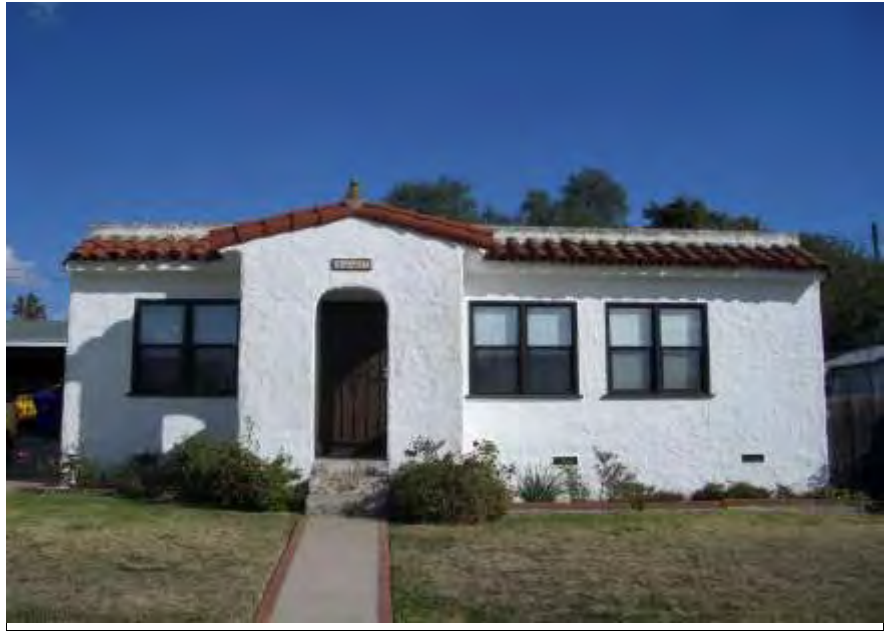
P5a. Photograph or Drawing (Photograph required for buildings, structures, and objects)

\* P3a. Description: (Describe resource and its major elements. Include design, materials, condition, alterations, size, setting, and boundaries.)  
The house at 3227 Belle Isle Drive was constructed in 1930 in the Spanish Eclectic style and features a flat roof with a clay tile shed roof at the parapet line; a low-pitch front-gable entry element set just off-center; and a generally smooth stucco exterior. The main entry is set under a projecting, front-gable element with an arched opening and is accessed via three concrete steps. Fenestration consists of paired 1-over-1 double hung aluminum frame and sash windows. The entry door is set parallel to the street. Refer to BSOR Section B.6. for modifications and analysis of integrity.

Photo of the primary façade from the public right-of-way.

The house was constructed in 1930 per water and sewer records. Modifications include the replacement of the wood frame and sash windows with aluminum frame and sash windows. The house is in good condition and retains a good to fair degree of integrity.

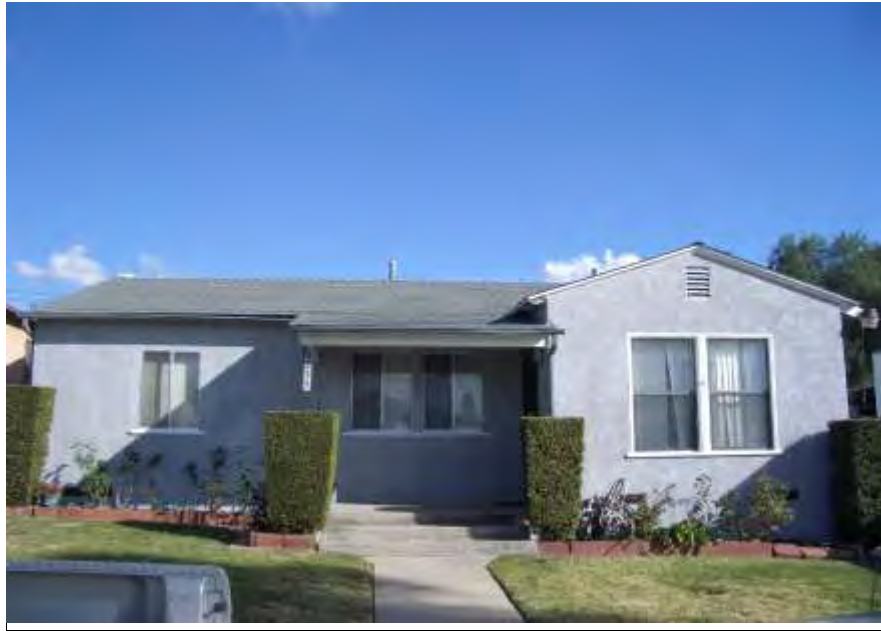
P5a. Photograph or Drawing (Photograph required for buildings, structures, and objects)

\* P3a. Description: (Describe resource and its major elements. Include design, materials, condition, alterations, size, setting, and boundaries.)  
The house at 3235 Belle Isle Drive was built in 1947 in the Minimal Traditional style and features a medium pitch cross gable roof with composition shingles; a slight eave overhang; and a moderately textured stucco exterior. The right hand side of the house features a front facing gable with a louvered outlet ventilator under the gable peak and paired 1-over-1 aluminum frame and sash windows. The entry porch, which is accessed via 4 concrete steps, is centered on the house and features a roof extension supported by a decorative wrought iron post. The entry door is set perpendicularly to the sidewalk. Fenestration consists of 1-over-1 double hung and casement aluminum frame and sash windows. Refer to BSOR Section B.6. for modifications and analysis of integrity.

Photo of the primary façade from the public right-of-way.

\* B6. Construction History: (Construction date, alterations, and date of alterations.)  
The house was constructed in 1947 per water and sewer records. Modifications include the use of moderately textured stucco, the replacement of the composition roof with a new composition roof, the replacement of the wood frame and sash window with aluminum windows, and the replacement of the porch post with a decorative wrought iron post. The house is in fair to good condition and retains a fair degree of integrity.

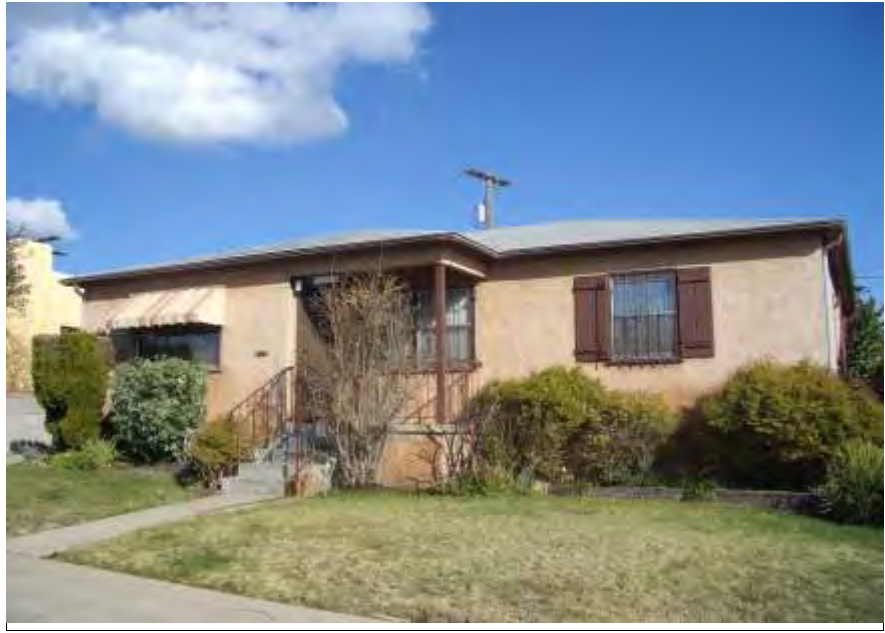
P5a. Photograph or Drawing (Photograph required for buildings, structures, and objects)

\* P3a. Description: (Describe resource and its major elements. Include design, materials, condition, alterations, size, setting, and boundaries.)  
The house at 3243 Belle Isle was built in 1950 in the Minimal Traditional style and features a low-pitch hipped roof with composition shingles; slight eave overhang; and a moderately textured stucco exterior. The entry porch, which is accessed via 5 concrete steps, is centered on the main façade and covered by a projection of the roofline supported on a single squared post. The entry door is set perpendicularly to the sidewalk. Fenestration consists of 1-over-1 single hung aluminum windows. The window to the far right of the entry features wood shutters and an aluminum awning covers the window to the left to the entry. Refer to BSOR Section B.6. for modifications and analysis of integrity.

The house was constructed in 1950 per water and sewer records. Modifications include the use of moderately textured stucco, the replacement of the composition roof with a new composition roof, the replacement of the windows with aluminum windows, and the use of a wrought iron stair railing and security bars over the windows. The house is in good condition and retains a good to fair degree of integrity.

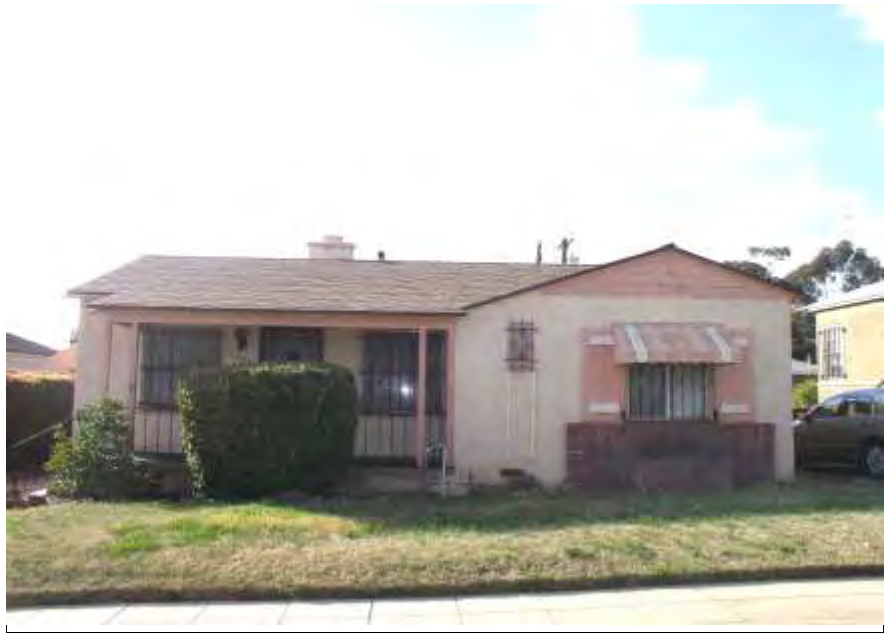
P5a. Photograph or Drawing (Photograph required for buildings, structures, and objects)

\* P3a. Description: (Describe resource and its major elements. Include design, materials, condition, alterations, size, setting, and boundaries.)  
The house at 3244 Belle Isle Drive was built in 1937 in the Minimal Traditional style and features medium-pitch cross-gable roof with composition shingles; a slight eave overhang; exposed rafter tails; a moderately textured stucco exterior; and a chimney on the west side. The right hand side of the house features a front facing gable with clapboard in the gable end, an aluminum slider window with wood shutters under an aluminum awning over a brick façade. The left hand side of the house features an entry porch, accessed by four concrete steps, under a projection of the roof supported on paired square posts. The entry door is set perpendicularly to the sidewalk. Fenestration consists of 3-over-3 double hung wood frame and sash windows and the aluminum slider window in the gable end. Wrought iron security bars cover the doors and windows. Refer to BSOR Section B.6. for modifications and analysis of integrity.

The house was constructed in 1937 per water and sewer records. Modifications include the use of moderately textured stucco, the replacement of the composition roof with a new composition roof, the replacement of one window with an aluminum window, and the use of a wrought iron stair railing and security bars over the windows. The house is in good condition and retains a fair degree of integrity.

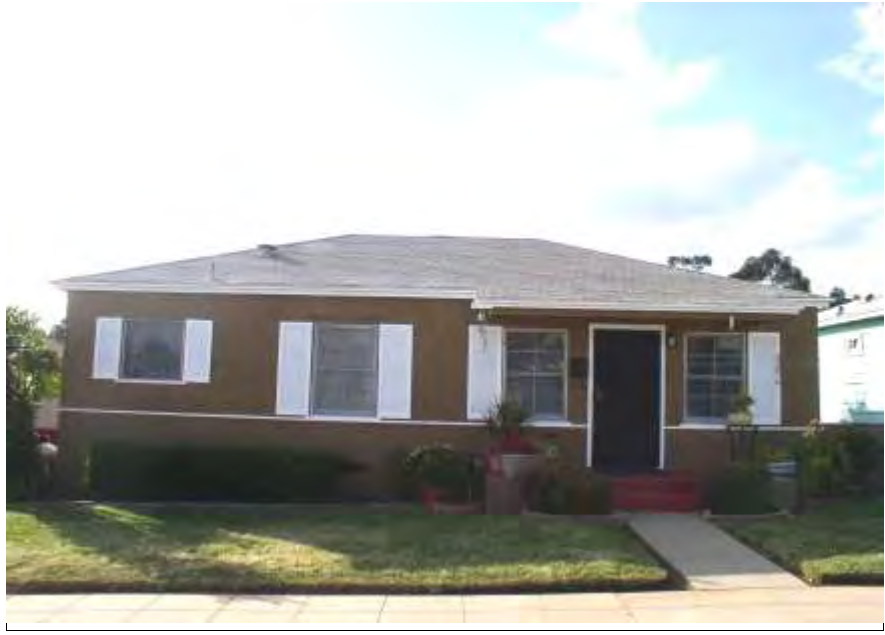
P5a. Photograph or Drawing (Photograph required for buildings, structures, and objects)

\* P3a. Description: (Describe resource and its major elements. Include design, materials, condition, alterations, size, setting, and boundaries.)  
The house at 3250 Belle Isle Drive was built in 1941 in the Minimal Traditional style and features a medium-pitch hipped roof with composition shingles; minimal eave overhang; and a heavily textured stucco exterior. The main entry is set to the left and is accessed by two concrete steps. Fenestration consists of 4-over-4 double hung wood windows with decorative shutters. The porch posts appear to have been removed at some point in time, and the wood frame and sash windows flanking the door may have been an early modification. Refer to BSOR Section B.6. for modifications and analysis of integrity.

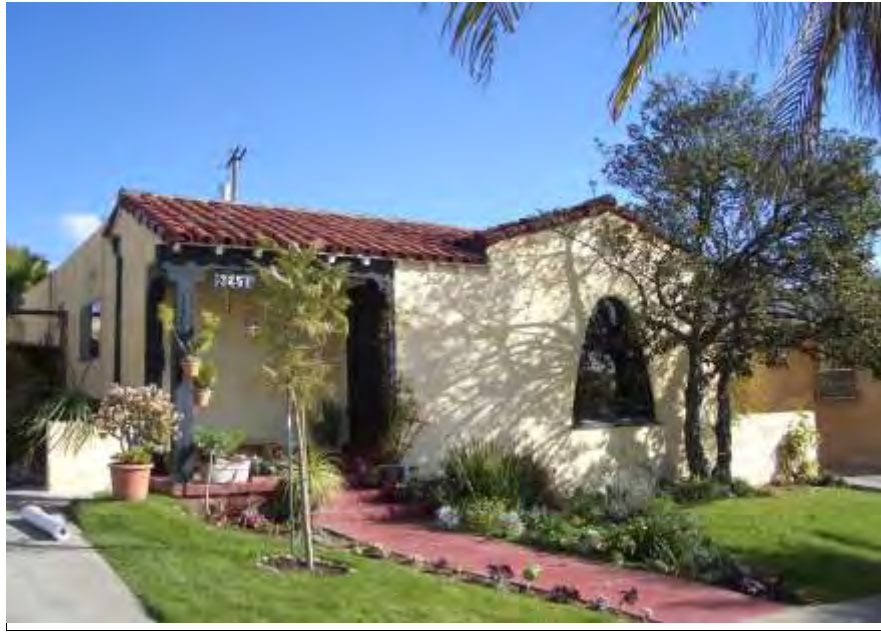
P5a. Photograph or Drawing (Photograph required for buildings, structures, and objects)

\* P3a. Description: (Describe resource and its major elements. Include design, materials, condition, alterations, size, setting, and boundaries.)  
The house at 3251 Belle Isle Drive was built in 1928 in the Spanish Eclectic style and features a flat roof with a clay tile shed roof at the parapet line; a medium-pitch front-gable bay set to the right; and a smooth stucco exterior. The entry porch is set to the left and is supported by a heavy square timber post. The entry door is set perpendicularly to the sidewalk. Fenestration consists of a fixed arch window in the gabled bay. Refer to BSOR Section B.6. for modifications and analysis of integrity.

Photo of the primary façade from the public right-of-way.

\* B6. Construction History: (Construction date, alterations, and date of alterations.)  
The house was constructed in 1928 per water and sewer records. Modifications include the possible in-kind replacement of the clay tile roof. The house is in excellent condition and retains a very good degree of integrity.

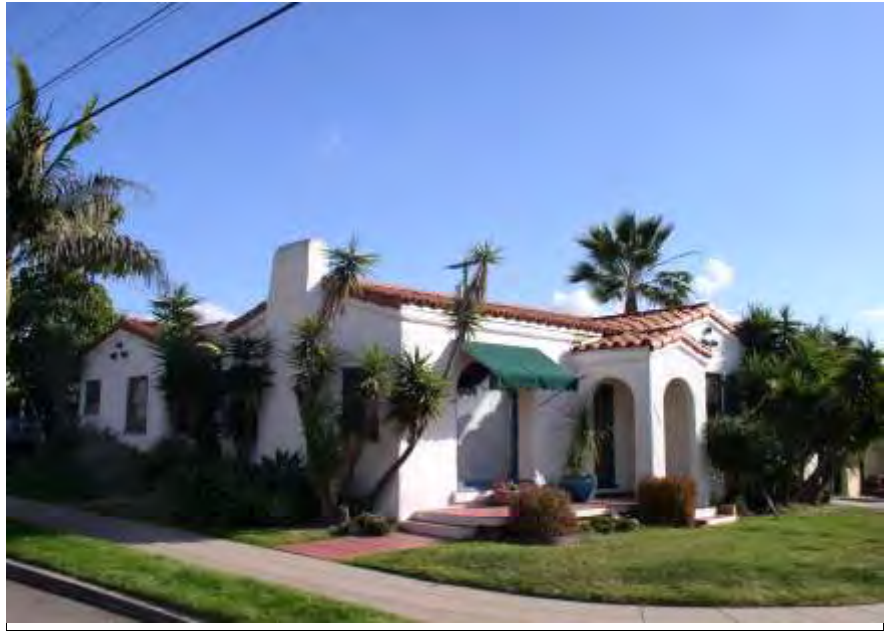
P5a. Photograph or Drawing (Photograph required for buildings, structures, and objects)

\* P3a. Description: (Describe resource and its major elements. Include design, materials, condition, alterations, size, setting, and boundaries.)  
The house at 3261 Belle Isle Drive was built in 1928 in the Spanish Eclectic style on a corner lot and features a cross gable clay tile roofs; clipped eaves with a rounded cornice; clay tile vents; smooth stucco walls; and a chimney on the north elevation. The entry accessed via two concrete steps and is centered on the main façade to the left of the front-facing gable bay and features a narrower projecting gable element with arched entryway. Fenestration consists of a 6-over-1 double hung wood window with decorative shutters in the gabled bay, a large fixed arched window to the left of the entry, and 1-over-1 double hung wood frame and sash windows on the north elevation. Refer to BSOR Section B.6. for modifications and analysis of integrity.

P5b. Description of Photo: (View, date, etc.)  
Photo of the primary façade from the public right-of-way.

The house was constructed in 1928 per water and sewer records. Modifications include the possible in-kind replacement of the clay tile roof. The house is in excellent condition and retains a very good degree of integrity.

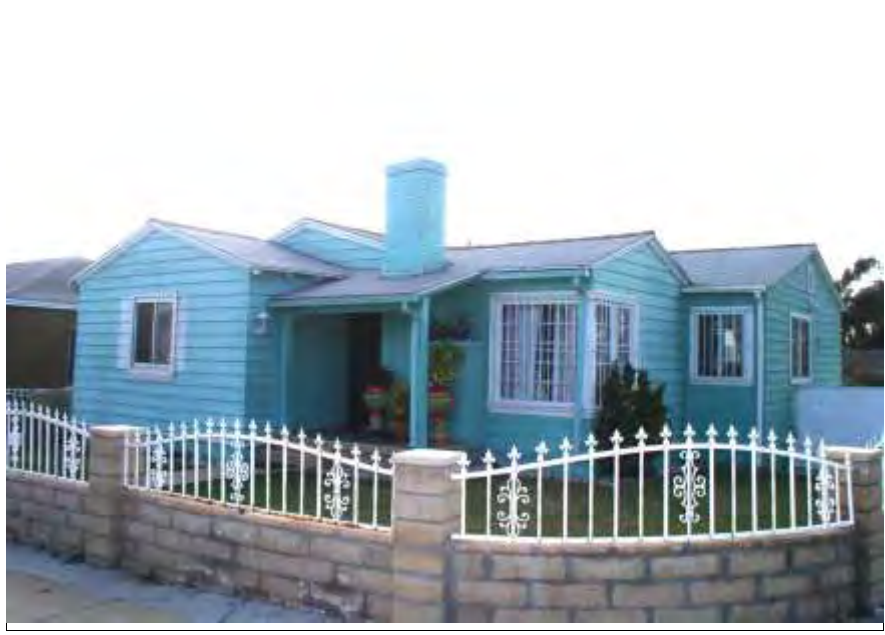
P5a. Photograph or Drawing (Photograph required for buildings, structures, and objects)

\* P3a. Description: (Describe resource and its major elements. Include design, materials, condition, alterations, size, setting, and boundaries.)  
The house at 3262 Belle Isle Drive was built in 1937 in the Minimal Traditional style on a corner lot and features multi-gabled roofs with composition shingles; clapboard siding; multiple recessed bays; and a brick chimney on the east façade. The main entry, accessed via two concrete steps, is set on the center bay and is covered by a shed roof projection supported on 4x4 wood posts. Fenestration consists of two fixed multi-light wood frame windows on the center bay, an 8-lite vinyl slider window, and an aluminum slider. Wrought iron security bars have been added to the doors and windows. An addition at the rear is visible, but is stepped back from the main façade and is clearly new. Refer to BSOR Section B.6. for modifications and analysis of integrity.

Photo of the primary façade from the public right-of-way.

The house was constructed in 1937 per water and sewer records. Modifications include the replacement of the composition roof with a new composition roof, the replacement of some windows with aluminum and vinyl windows, the use of a wrought iron security bars over the windows, and a 2002 addition at the rear which is visible, but stepped back from the main façade and clearly new. The house is in good to fair condition and retains a good to fair degree of integrity.

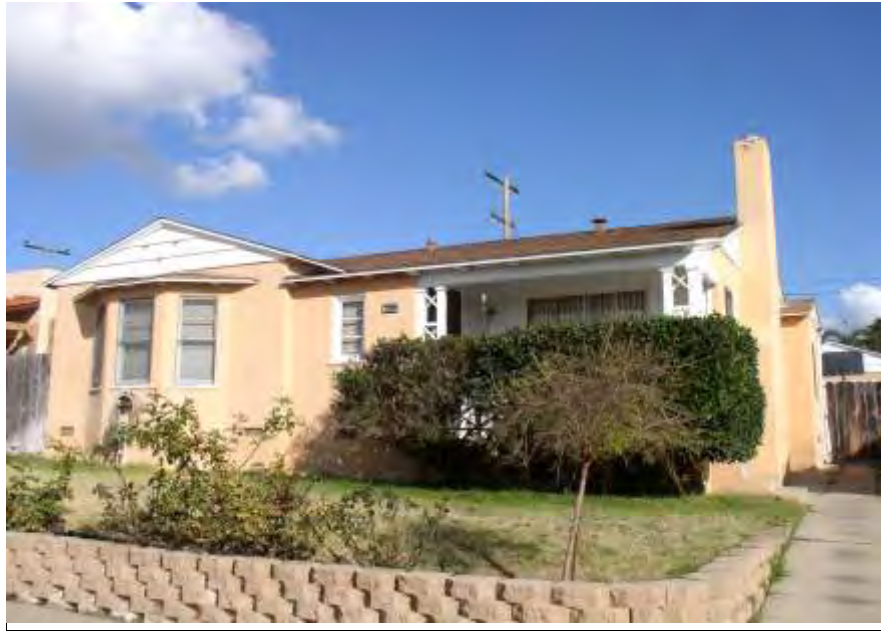
Photo of the primary façade from the public right-of-way.

The house was constructed in 1936 per water and sewer records. Modifications include the replacement of the composition roof with a new composition roof. The house is in good condition and retains a good to fair degree of integrity.

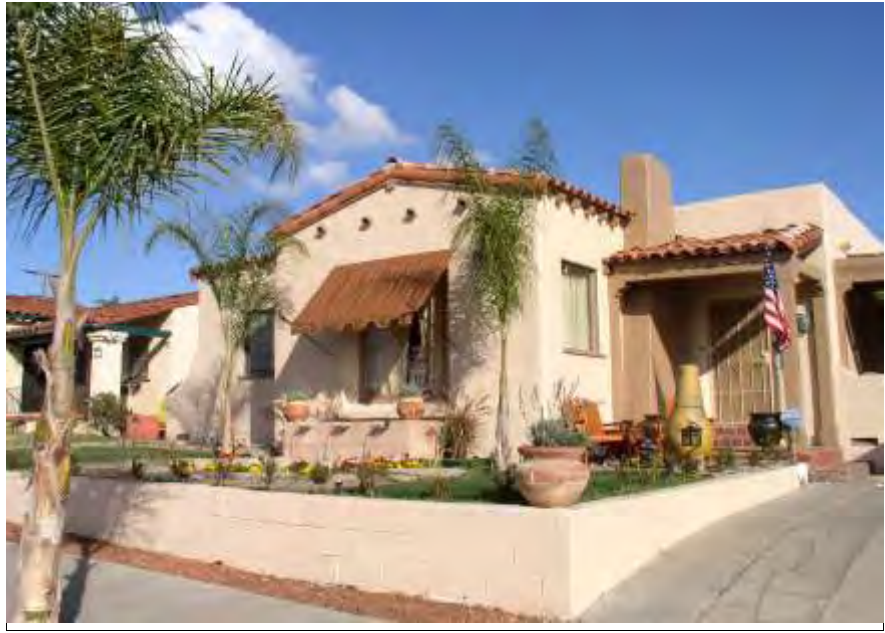
\* P3a. Description: (Describe resource and its major elements. Include design, materials, condition, alterations, size, setting, and boundaries.)  
The house located at 3403 Belle Isle Drive was built in 1928 in the Spanish Eclectic style and features a flat roof with parapet walls, a projecting front gable element flanked by simple shed roof elements; clay tile roofing; some exposed rafter tails; clay tile roof vents and drains; a smooth stucco exterior; and a chimney on the south elevation. The entry, accessed by two concrete steps, is set to the left of the projecting bay under the shed roof projection. The entry door is set parallel to the sidewalk. Fenestration consists of 8-lite casement and a large fixed single pane wood frame and sash window, as well as an aluminum sash louvered window to the left of the entry. Refer to BSOR Section B.6. for modifications and analysis of integrity.

P5b. Description of Photo: (View, date, etc.)  
Photo of the primary façade from the public right-of-way.

\* B6. Construction History: (Construction date, alterations, and date of alterations.)  
The house was constructed in 1928 per water and sewer records. Modifications include the replacement of a wood sash window with an aluminum sash louvered window within the original opening and frame, and the addition of a modest water feature under the fixed window on the projecting bay. The house is in good condition and retains a good to fair degree of integrity.

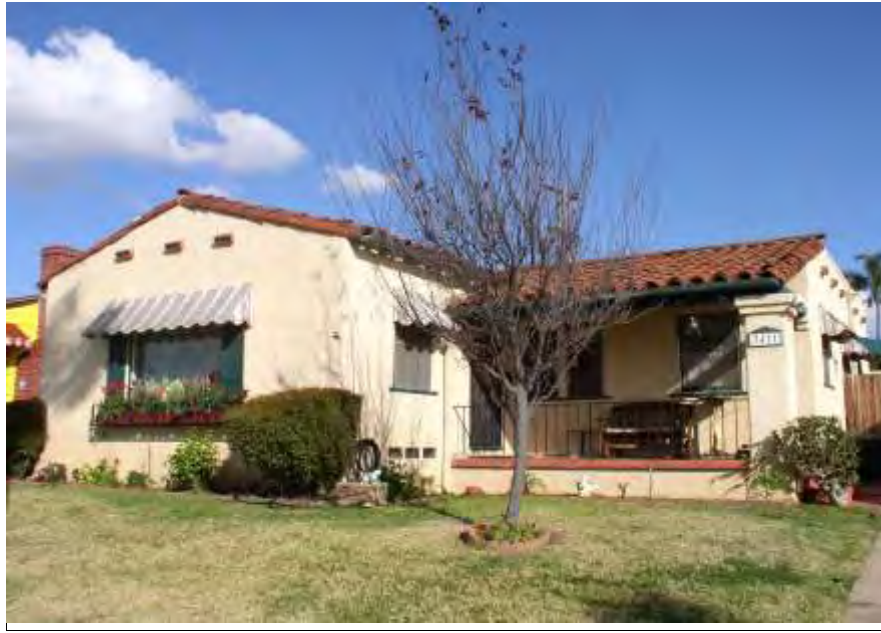
\* P3a. Description: (Describe resource and its major elements. Include design, materials, condition, alterations, size, setting, and boundaries.)  
The house located at 3411 Belle Isle Drive was built in 1936 in the Spanish Eclectic style and features a flat roof with a clay tile shed roof along the parapet line and a projecting front-gable bay; clay tile roof vents and drains; and a moderately textured stucco exterior. The entry, accessed via two concrete steps, is set to the left under the shed roof projection supported on a massive square stucco column. The entry door is set perpendicularly to the sidewalk. Fenestration consists of a large fixed wood frame window in the gable bay and 1-over-1 double hung wood frame and sash windows throughout. Refer to BSOR Section B.6. for modifications and analysis of integrity.

Photo of the primary façade from the public right-of-way.

\* B6. Construction History: (Construction date, alterations, and date of alterations.)  
The house was constructed in 1936 per water and sewer records. Modifications include the likely replacement of a simple wood post support with the large square stucco column, and the addition of fabric awnings over the windows. The house is in good condition and retains a good to fair degree of integrity.

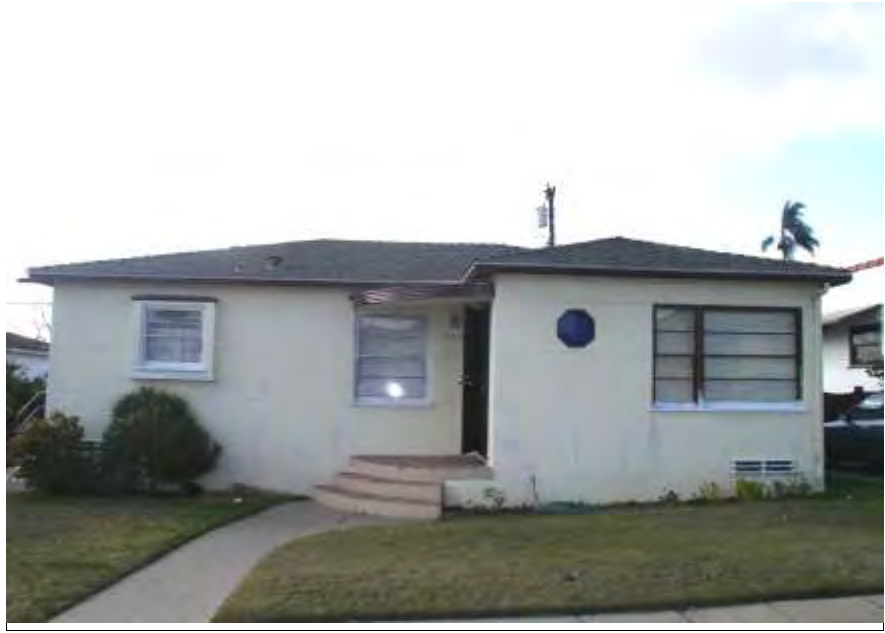
\* P3a. Description: (Describe resource and its major elements. Include design, materials, condition, alterations, size, setting, and boundaries.)  
The house at 3412 Belle Isle Drive was built in 1939 in the Minimal Traditional style with Art Deco influences and features a hipped roof; composition shingles; minimal eave overhang; and a stucco exterior with three horizontal lines running through the stucco in line with the fenestration. The entry, accessed via three rounded concrete steps, is set just right of center under a rounded, cantilevered stucco projection. The entry door is set perpendicularly to the sidewalk. Fenestration consists of 2-over-2 double hung wood frame and sash windows of varying sizes and a fixed hexagonal portal window. Refer to BSOR Section B.6. for modifications and analysis of integrity.

Photo of the primary façade from the public right-of-way.

The house was constructed in 1939 per water and sewer records. Modifications include the replacement of the composition roof with a new composition roof. The house is in good condition and retains a good degree of integrity.

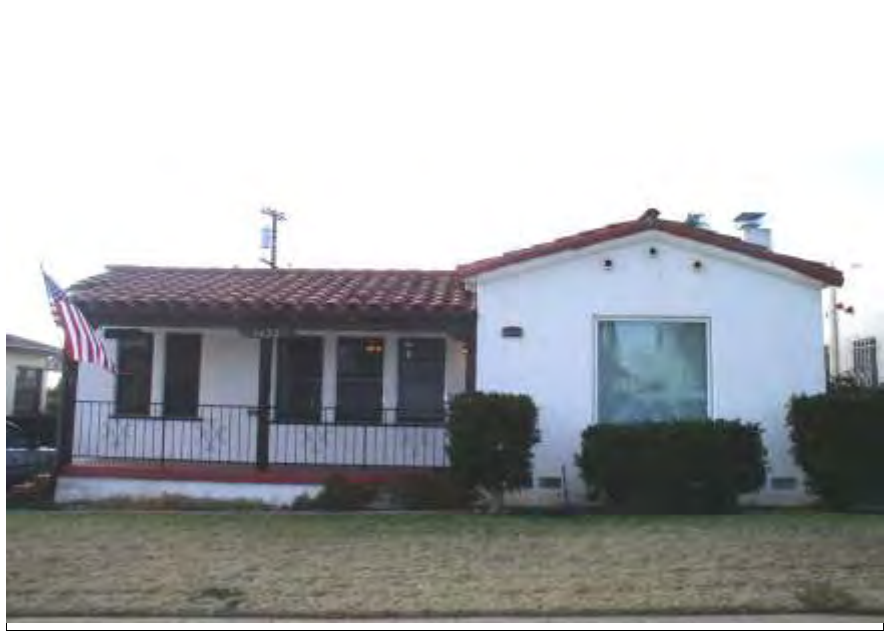
\* P3a. Description: (Describe resource and its major elements. Include design, materials, condition, alterations, size, setting, and boundaries.)  
The house at 3422 Belle Isle Drive was built in 1936 in the Spanish Eclectic style and features a flat roof with a clay tile shed roof along the parapet line and a projecting front-gable bay; clay tile roof vents and drains; a stucco exterior; and a chimney at the north elevation. The entry, accessed via four concrete steps, is set to the left under the shed roof projection supported by two square wood posts. The entry door is set perpendicularly to the sidewalk. Fenestration consists of 2-over-1 double hung wood frame and sash windows at the porch and a large fixed single pane vinyl window in the gable bay. Refer to BSOR Section B.6. for modifications and analysis of integrity.

Photo of the primary façade from the public right-of-way.

The house was constructed in 1936 per water and sewer records. Modifications include the replacement of the original fixed window in the gable bay with a vinyl fixed window within the same opening. The house is in good condition and retains a good to fair degree of integrity.

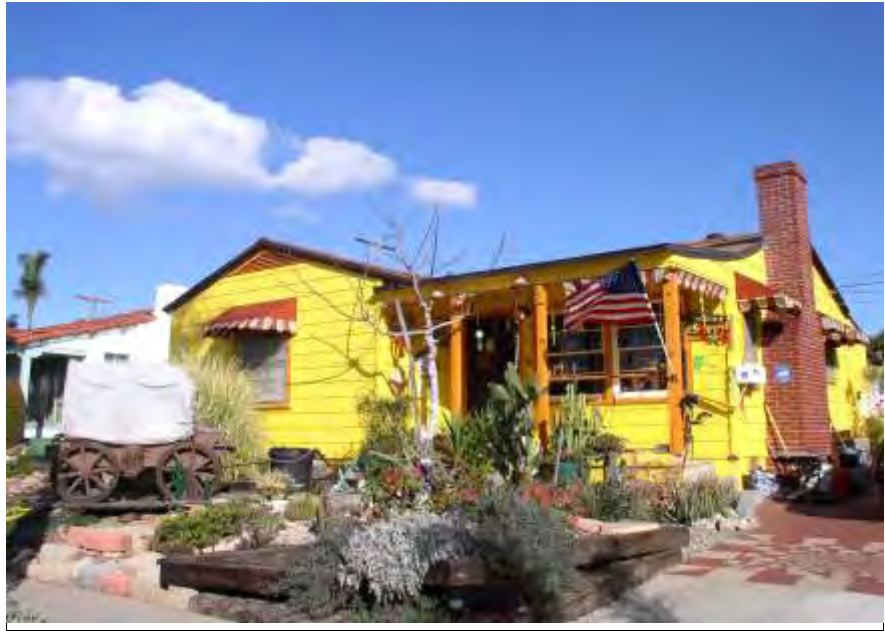
\* P3a. Description: (Describe resource and its major elements. Include design, materials, condition, alterations, size, setting, and boundaries.)  
The house at 3424 Belle Isle Drive was built in 1941 in the Minimal Traditional style and features a cross gable roof; composition shingles; clipped eaves; horizontal wood slat vents in the gable end; a wood clapboard exterior; and a brick chimney on the south elevation. The entry, accessed via three concrete steps, is set to the right under a roof projection supported by three square wood posts. The entry door is set parallel to the sidewalk. Fenestration consists of 2-over-2 double hung wood frame and sash windows. Ornamental landscape features have been added which are reversible. Refer to BSOR Section B.6. for modifications and analysis of integrity.

Photo of the primary façade from the public right-of-way.

The house was constructed in 1941 per water and sewer records. Modifications include the replacement of the composition roof with a new composition roof, the use of fabric awnings, and the addition of ornamental landscape features, which are reversible. The house is in good condition and retains a good degree of integrity.

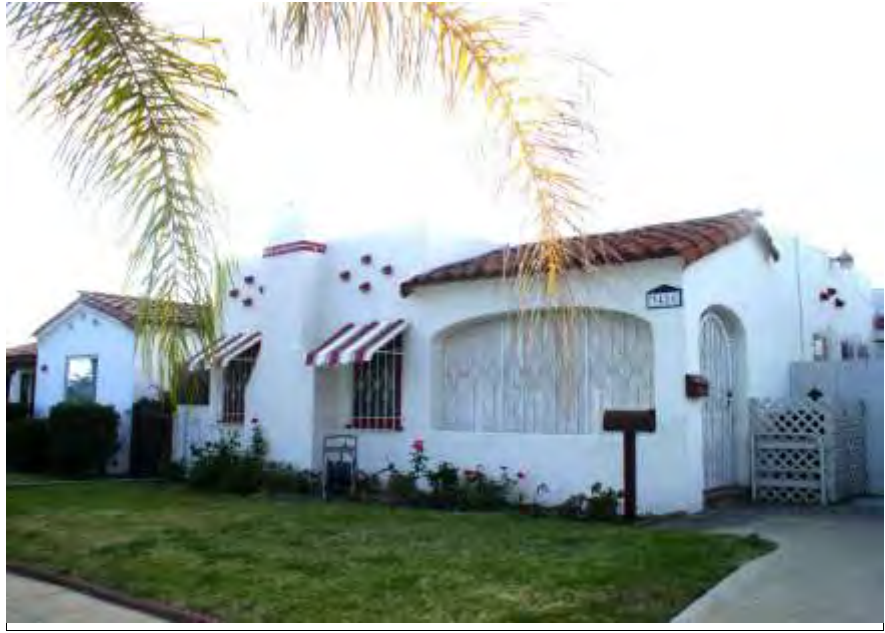
\* P3a. Description: (Describe resource and its major elements. Include design, materials, condition, alterations, size, setting, and boundaries.)  
The house at 3426 Belle Isle Drive was built in 1929 in the Spanish Eclectic style and features a flat roof with a clay tile shed roof along the parapet line; clay tile roof drains; a moderately textured stucco exterior; and a chimney along the east (main) elevation. The entry is set to the right and recessed under the shed tile roof. The porch is partially enclosed with an original half-height wall and arched opening under the shed roof. The chimney is set to the left of the entry and is flanked by four clay tile roof drains over fixed windows. Wrought iron security bars have been added to the windows and entry porch. Refer to BSOR Section B.6. for modifications and analysis of integrity.

Photo of the primary façade from the public right-of-way.

The house was constructed in 1929 per water and sewer records. Modifications include the use of wrought iron security bars at the windows and entry porch and the use of aluminum awnings over the windows. The house is in good condition and retains a good degree of integrity.

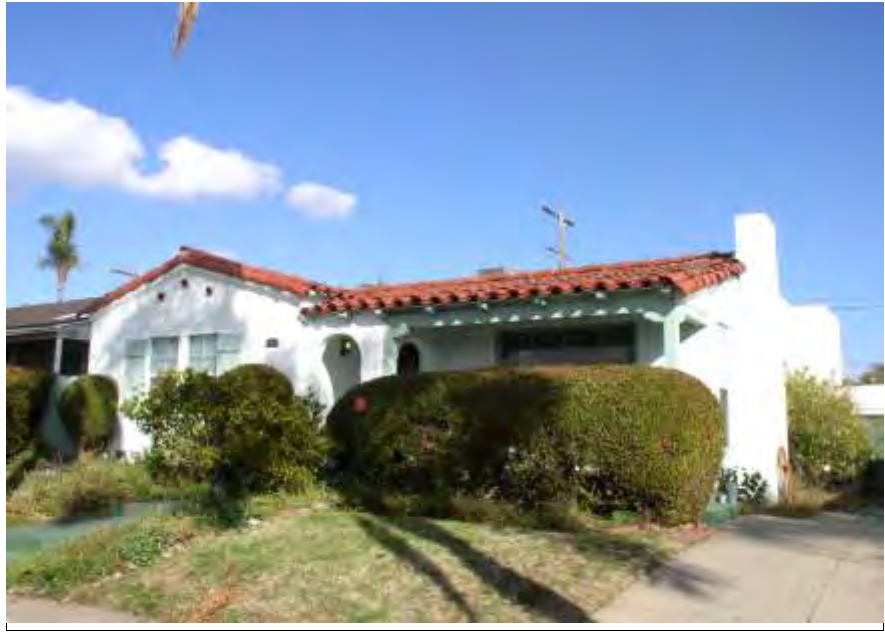
\* P3a. Description: (Describe resource and its major elements. Include design, materials, condition, alterations, size, setting, and boundaries.)  
The house at 3435 Belle Isle Drive was built in 1936 in the Spanish Eclectic style and features a flat roof with a clay tile shed roof along the parapet line and a projecting front-gable bay; clay tile roof vents and drains; a stucco exterior; and a chimney at the south elevation. The entry, accessed via two concrete steps, is set to the right under the shed roof projection supported by a square wood post. The entry door is set parallel to the sidewalk behind an arched stucco entrance connected to the porch. Fenestration consists of a 12-lite fixed wood frame window, 4-over-1 double hung vinyl frame and sash windows, and 6-over-6 double hung vinyl frame and sash windows. Refer to BSOR Section B.6. for modifications and analysis of integrity.

Photo of the primary façade from the public right-of-way.

The house was constructed in 1936 per water and sewer records. Modifications include the replacement of some original wood frame and sash windows with vinyl frame and sash windows. The house is in good condition and retains a good to fair degree of integrity.

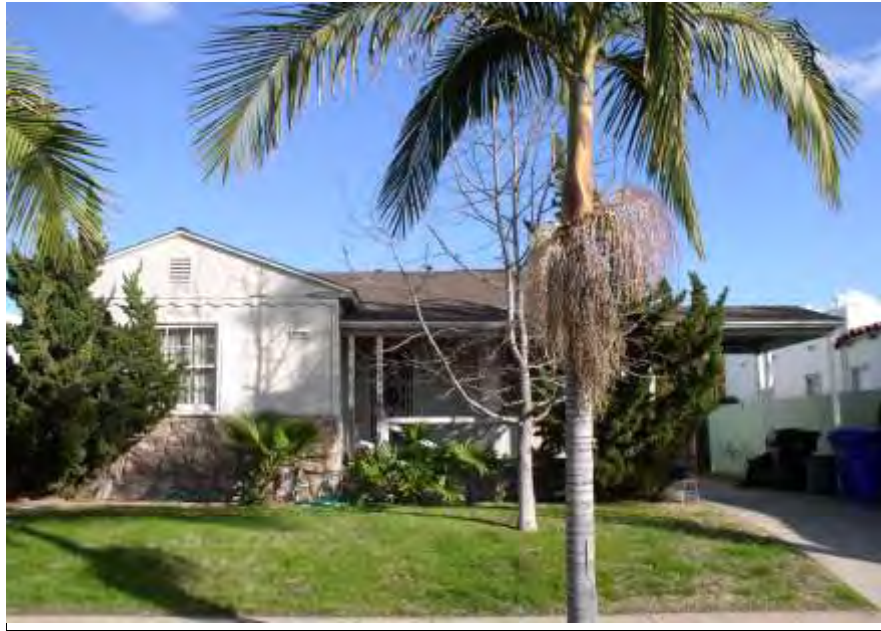
\* P3a. Description: (Describe resource and its major elements. Include design, materials, condition, alterations, size, setting, and boundaries.)  
The house at 3439 Belle Isle Drive was built in 1941 in the Minimal Traditional style with Ranch influences and features cross-gable roofs; composition shingles; clipped eaves; vertical wood siding in the gable end; a tongue and groove wood exterior; a stone veneer base; and an attached carport. The entry is set to the left under the shed roof projection supported by paired wood posts. The entry door is set perpendicularly to the sidewalk. Fenestration consists of 6-over-6 double hung wood frame and sash windows. Refer to BSOR Section B.6. for modifications and analysis of integrity.

Photo of the primary façade from the public right-of-way.

\* B6. Construction History: (Construction date, alterations, and date of alterations.)  
The house was constructed in 1941 per water and sewer records. Modifications include the replacement of the composition roof with a new composition roof and the addition of a stone veneer to the base of the building. The house is in good condition and retains a good to fair degree of integrity.

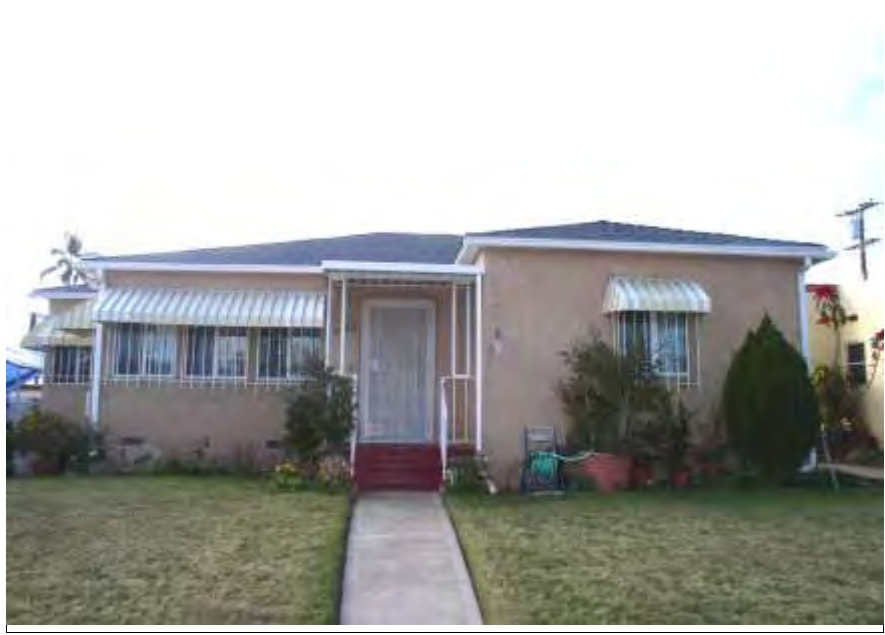
\* P3a. Description: (Describe resource and its major elements. Include design, materials, condition, alterations, size, setting, and boundaries.)  
The house at 3442 Belle Isle Drive was built in 1947 in the Minimal Traditional style and features multi-hipped roofs; composition shingles; clipped eaves; and a heavily textured stucco exterior. The entry, accessed via two concrete steps, is set to the left of a projecting bay and is covered by a small, added aluminum entry cover supported on thin aluminum posts. The entry door is set parallel to the sidewalk. Fenestration consists of multi-lite vinyl sliding windows covered by wrought iron security bars under aluminum awnings. Refer to BSOR Section B.6. for modifications and analysis of integrity.

Photo of the primary façade from the public right-of-way.

The house was constructed in 1947 per water and sewer records. Modifications include the replacement of the composition roof with a new composition roof, the use of heavily textured stucco, the replacement of the original wood windows with vinyl windows, the use of aluminum awnings, and the use of wrought iron security bars. The house is in good condition and retains a fair degree of integrity.

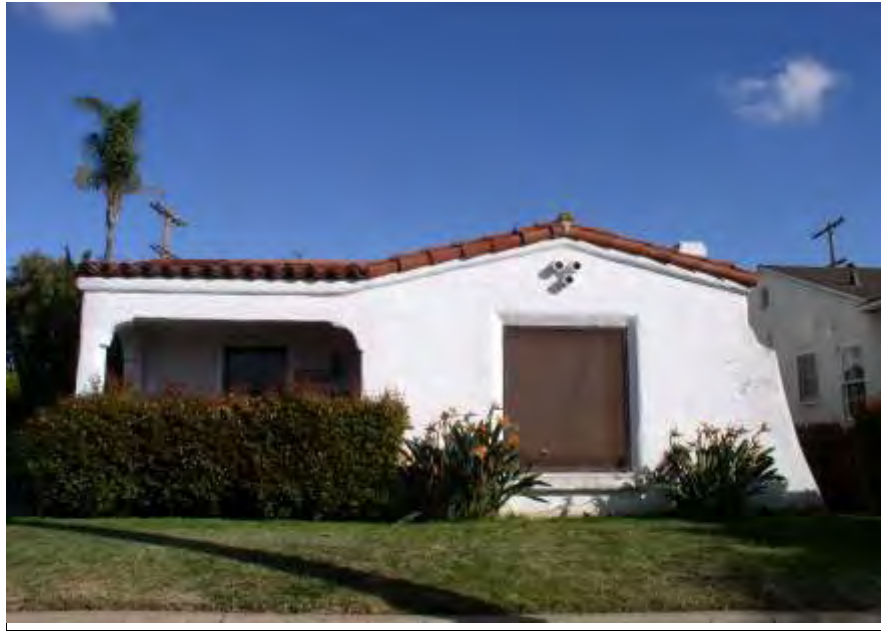
\* P3a. Description: (Describe resource and its major elements. Include design, materials, condition, alterations, size, setting, and boundaries.)  
The house at 3443 Belle Isle Drive was built in 1928 in the Spanish Eclectic style and features a flat roof with a clay tile shed roof along the parapet line and a front-gable bay; clay tile roof vents and drains; a stucco exterior; and a chimney at the south elevation. The entry is set to the left of the gable under the shed roof supported by a stucco post, which flows into an arched porch opening. The entry door is set perpendicularly to the sidewalk. Fenestration consists of a single pane fixed wood frame window in the gable bay and double hung wood frame and sash windows at the porch. Refer to BSOR Section B.6. for modifications and analysis of integrity.

Photo of the primary façade from the public right-of-way.

\* B6. Construction History: (Construction date, alterations, and date of alterations.)  
The house was constructed in 1928 per water and sewer records. The house is in good condition and retains a good degree of integrity.
