# *Islenair Historic District*

Designated by the City of San Diego  
Historical Resources Board  
April 26, 2007

*Prepared by  
The City of San Diego  
City Planning and Community Investment Department  
Historical Resources Section*

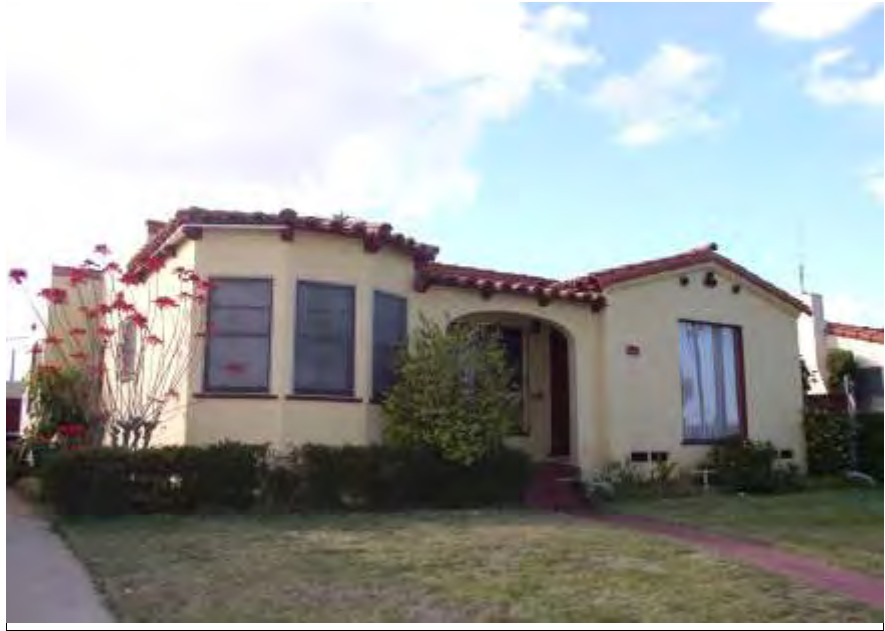
\* P3a. Description: (Describe resource and its major elements. Include design, materials, condition, alterations, size, setting, and boundaries.)  
The house at 3458 Belle Isle Drive was built in 1935 in the Spanish Eclectic style and features a flat roof with a clay tile shed roof along the parapet line, a front-gable bay to the right, and a hexagonal bay to the left; minimal eave overhang; exposed rafter tails; clay tile roof vents and drains; and a stucco exterior. The entry, accessed via two concrete steps, is centered under the shed roof and a low stucco arch. Fenestration consists of a large fixed single pane wood frame window in the gable bay, 2-over-1 double hung wood frame and sash windows in the hexagonal bay, and aluminum louvered windows flanking the entry door. Refer to BSOR Section B.6. for modifications and analysis of integrity.

Photo of the primary façade from the public right-of-way.

The house was constructed in 1935 per water and sewer records. Modifications include the use of aluminum louvered windows at the entry. The house is in good condition and retains a good degree of integrity.

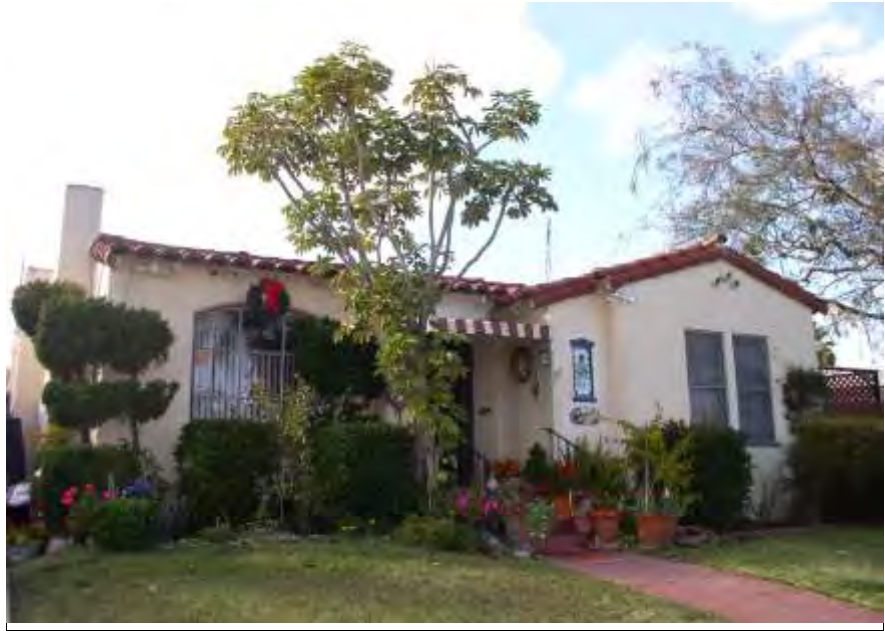
\* P3a. Description: (Describe resource and its major elements. Include design, materials, condition, alterations, size, setting, and boundaries.)  
The house at 3462 Belle Isle Drive was built in 1935 in the Spanish Eclectic style and features a flat roof with a clay tile shed roof along the parapet line and a projecting front-gable bay; clay tile roof vents and drains; a stucco exterior; and a chimney at the south elevation. The entry, accessed via four concrete steps, is set to the left of the gable under a fabric awning. The entry door is set parallel to the sidewalk. Fenestration consists of 2-over-2 double hung wood frame and sash windows in the gable end and a 9-lite, arched, fixed wood frame window to the left of the entry. Refer to BSOR Section B.6. for modifications and analysis of integrity.

Photo of the primary façade from the public right-of-way.

\* B6. Construction History: (Construction date, alterations, and date of alterations.)  
The house was constructed in 1935 per water and sewer records. The house is in good condition and retains a good degree of integrity.

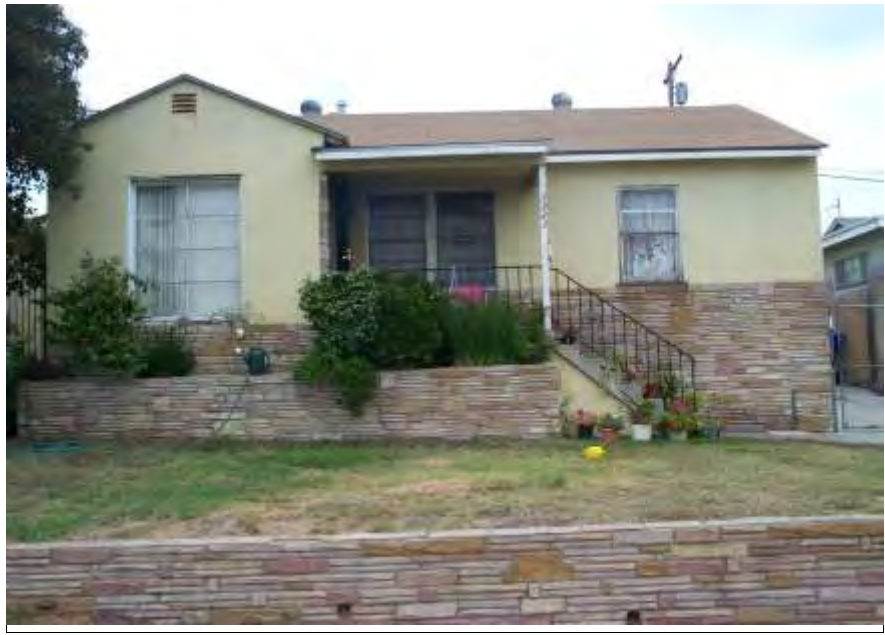
\* P3a. Description: (Describe resource and its major elements. Include design, materials, condition, alterations, size, setting, and boundaries.)  
The house at 3323 Euclid Avenue was built in 1947 in the Minimal Traditional style and features a cross gable roof; composition shingles; clipped eaves; horizontal slat vents in the gable end; a stucco exterior; and a cement veneer designed to appear as flagstone. The entry, accessed via seven concrete steps, is set to the right under a roof projection supported by a square wood post. The entry door is set perpendicularly to the sidewalk. Fenestration consists of 2-over-2 double hung wood frame and sash windows and an 8-lite fixed wood frame window. Ornamental cement retaining walls designed to appear as flagstone have been added which are reversible. Refer to BSOR Section B.6. for modifications and analysis of integrity.

Photo of the primary façade from the public right-of-way.

The house was constructed in 1947 per water and sewer records. Modifications include the replacement of the composition roof with a new composition roof and the use of decorative cement veneer. The house is in good condition and retains a good to fair degree of integrity.

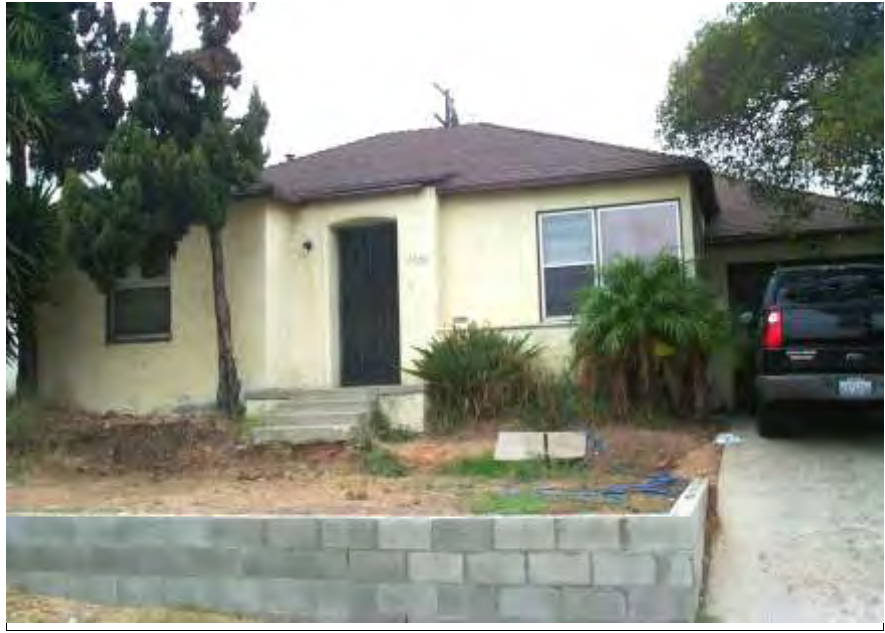
\* P3a. Description: (Describe resource and its major elements. Include design, materials, condition, alterations, size, setting, and boundaries.)  
The house at 3329 Euclid Avenue was built in 1946 in the Minimal Traditional style and features a multi-hipped roof; composition shingles; clipped eaves; and a stucco exterior. The entry, accessed via four concrete steps, is roughly centered on the façade and the entry door is set parallel to the sidewalk. Fenestration consists of 1-over-1 double hung aluminum and vinyl frame and sash windows and a single pane fixed vinyl frame window. A low cement block retaining wall has been added at the front property line. Refer to BSOR Section B.6. for modifications and analysis of integrity.

Photo of the primary façade from the public right-of-way.

The house was constructed in 1946 per San Diego County Assessor Property Characteristics. Modifications include the replacement of the composition roof with a new composition roof and the replacement of the original wood frame and sash windows with aluminum and vinyl frame and sash windows. The house is in good condition and retains a good to fair degree of integrity.

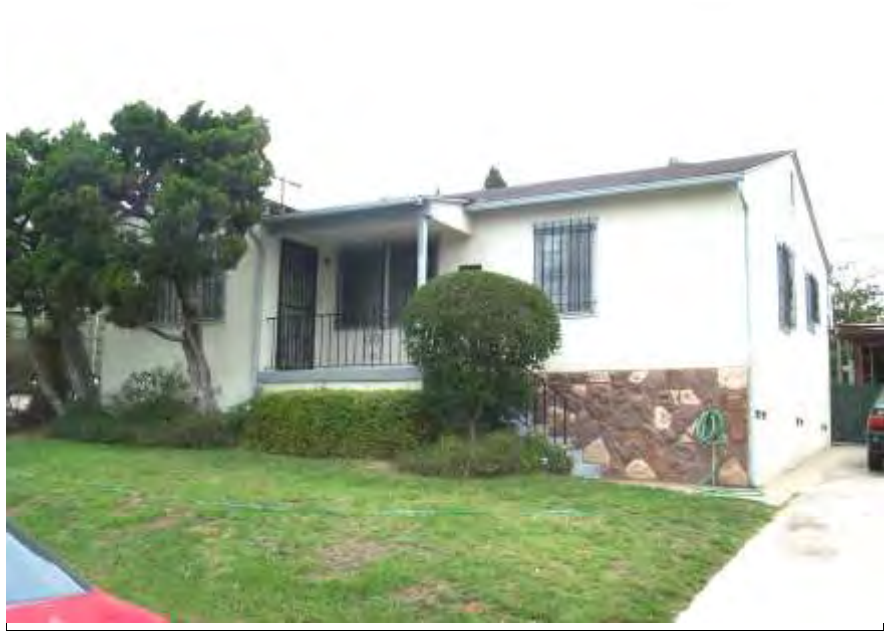
\* P3a. Description: (Describe resource and its major elements. Include design, materials, condition, alterations, size, setting, and boundaries.)  
The house at 3333 Euclid Avenue was built in 1946 in the Minimal Traditional style and features a cross gable roof; composition shingles; clipped eaves; horizontal slat vents in the gable end; a stucco exterior; and a cement veneer designed to appear as stone. The entry, accessed via seven concrete steps, is set to the right under a roof projection supported by a square wood post. The entry door is set perpendicularly to the sidewalk. Fenestration consists of paired 4-lite casement wood frame and sash windows with aluminum hinges. Wrought iron security bars have been added to the doors and windows. Refer to BSOR Section B.6. for modifications and analysis of integrity.

Photo of the primary façade from the public right-of-way.

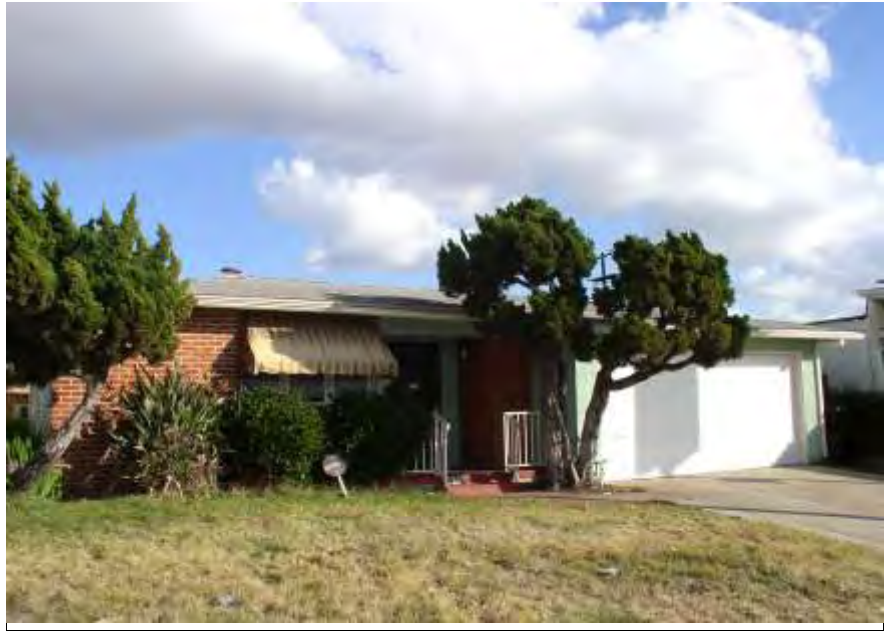
Photo of the primary façade from the public right-of-way.

The house was constructed in 1945 per San Diego County Assessor Property Characteristics. Modifications include the replacement of the composition roof with a new composition roof; the use of brick veneer; the replacement of the original wood frame windows with vinyl windows; the replacement of the highly prominent garage door with an aluminum roll-up door; the addition of a fabric awning. The house is in good condition and retains a fair degree of integrity.

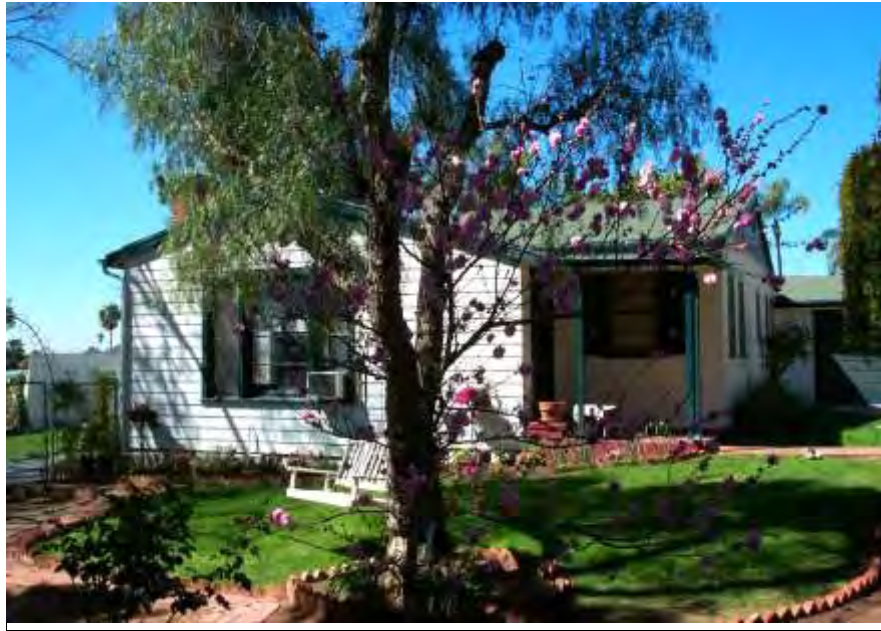
\* P3a. Description: (Describe resource and its major elements. Include design, materials, condition, alterations, size, setting, and boundaries.)  
The house at 3202 Isla Vista Drive was built in 1935 in the Minimal Traditional style and features a medium pitch cross gable roof with composition shingles; a slight eave overhang; and a wood clapboard exterior. The entry porch, which is at grade, is set to the right and features a roof extension supported by a square wood post. The entry door is set perpendicularly to the sidewalk. Fenestration consists of multi-lite and 1-over-1 double hung wood frame and sash windows. Refer to BSOR Section B.6. for modifications and analysis of integrity.

Photo of the primary façade from the public right-of-way.

The house was constructed in 1935 per water and sewer records. Modifications include the replacement of the composition roof with a new composition roof and the addition of a tall hedge, which obscures the house. The house is in good condition and retains a very good degree of integrity.

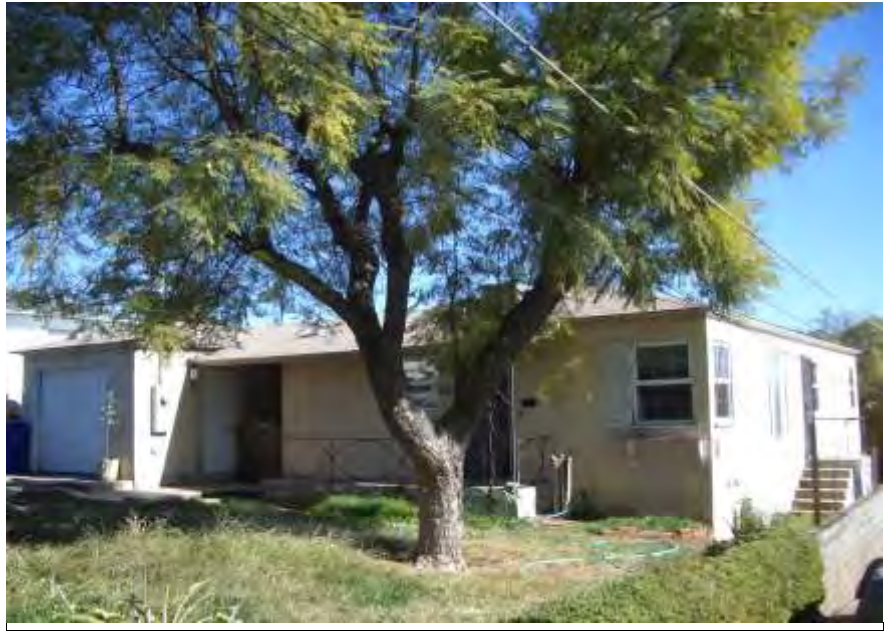
\* P3a. Description: (Describe resource and its major elements. Include design, materials, condition, alterations, size, setting, and boundaries.)  
The house at 3209 Isla Vista Drive was built in 1947 in the Minimal Traditional style with Ranch elements and features a multi-hipped roof with composition shingles; clipped eaves; and a textured stucco exterior. The entry porch, accessed via one concrete step, is set to the right and features a roof extension supported by a decorative wrought iron post. The entry door is set parallel to the sidewalk. The single car garage is set to the left and s connected to the house through a roof over a breezeway. Fenestration consists of 6-over-6 double hung vinyl sash windows in the original wood frames. Refer to BSOR Section B.6. for modifications and analysis of integrity.

Photo of the primary façade from the public right-of-way.

The house was constructed in 1947 per water and sewer records. Modifications include the replacement of the composition roof with a new composition roof, the use of textured stucco, and the replacement of the original wood sash windows with vinyl windows in the original wood frame openings. The house is in fair condition and retains a fair degree of integrity.

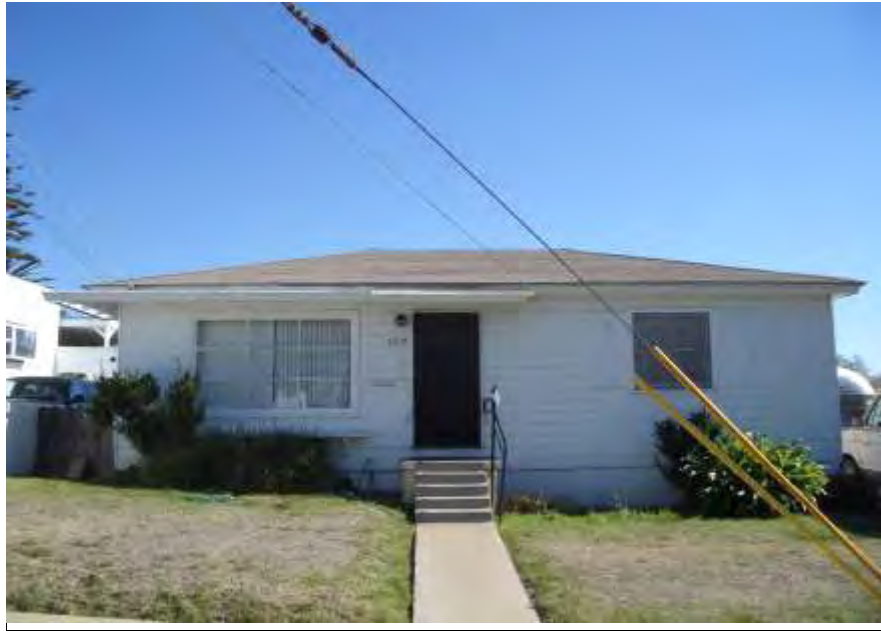
\* P3a. Description: (Describe resource and its major elements. Include design, materials, condition, alterations, size, setting, and boundaries.)  
The house at 3219 Isla Vista Drive was built in 1950 in the Minimal Traditional style and features a hipped roof with composition shingles; clipped eaves; and a wood clapboard exterior. The entry porch, accessed via five concrete steps, is centered on the façade under a slight roof extension. The entry door is set parallel to the sidewalk. Fenestration consists of a 9-lite fixed wood frame picture window and 2-over-2 double hung wood frame and sash windows. Refer to BSOR Section B.6. for modifications and analysis of integrity.

Photo of the primary façade from the public right-of-way.

The house was constructed in 1950 per water and sewer records. Modifications include the replacement of the composition roof with a new composition roof. The house is in good condition and retains a very good degree of integrity.

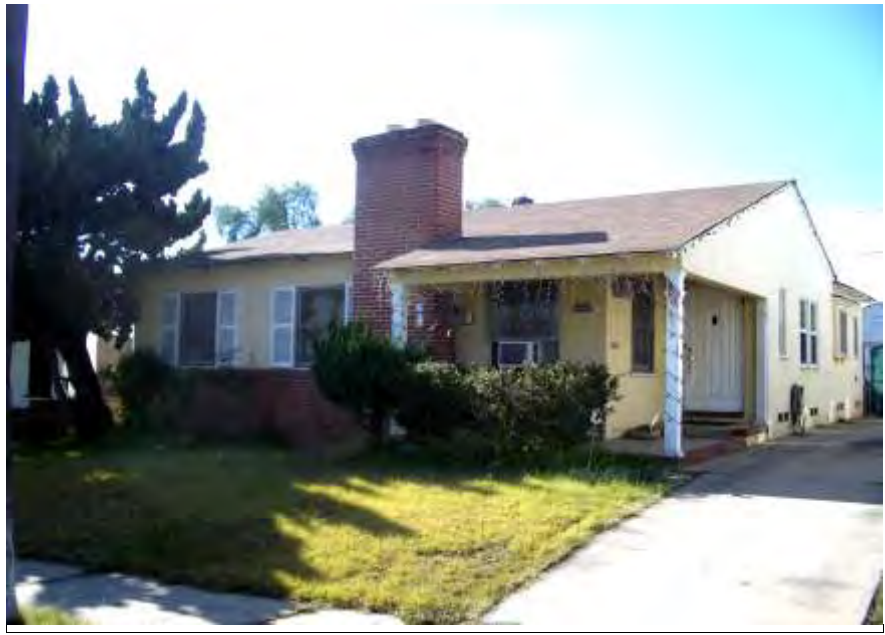
\* P3a. Description: (Describe resource and its major elements. Include design, materials, condition, alterations, size, setting, and boundaries.)  
The house at 3224 Isla Vista Drive was built in 1937 in the Minimal Traditional style and features a side-gable roof with composition shingles; clipped eaves; a stucco exterior; and a wide brick chimney on the east facade. The entry porch, accessed via two concrete steps, is set to the right and features a roof extension supported by a wood post. The entry door is set parallel to the sidewalk. Fenestration consists of 6-over-6 double hung wood frame and sash windows with decorative wood shutters. Refer to BSOR Section B.6. for modifications and analysis of integrity.

Photo of the primary façade from the public right-of-way.

The house was constructed in 1937 per water and sewer records. Modifications include the replacement of the composition roof with a new composition roof. The house is in good condition and retains a very good degree of integrity.

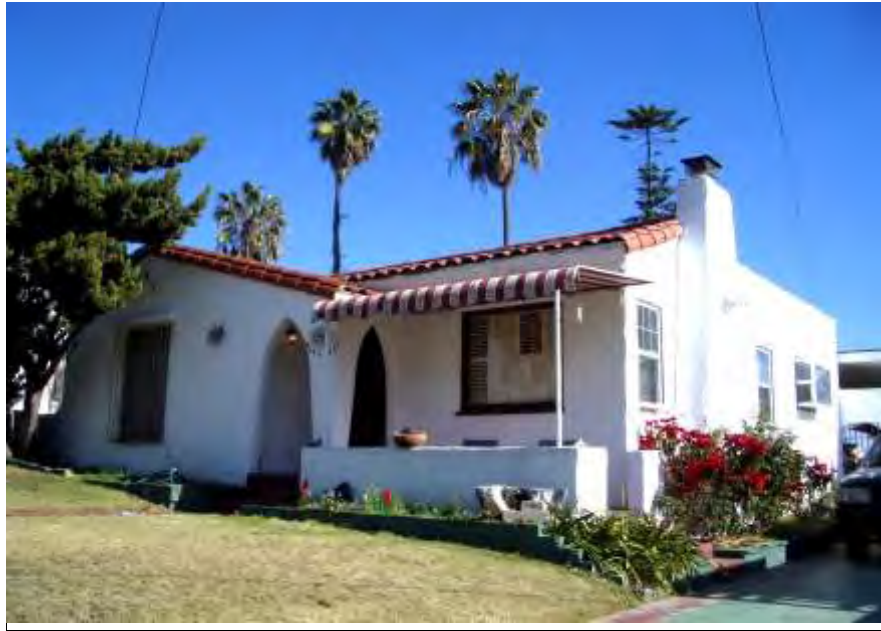
\* P3a. Description: (Describe resource and its major elements. Include design, materials, condition, alterations, size, setting, and boundaries.)  
The house at 3225 Isla Vista Drive was built in 1928 in the Spanish Eclectic style and features a flat roof with a clay tile shed roof along the parapet line and an asymmetrical front-gable bay; clay tile roof vents and drains; a stucco exterior; and a chimney at the south elevation. The entry is set under the longer end of the gable, recessed under a pointed arch opening. The entry door is set parallel to the sidewalk. Fenestration consists of fixed wood frame windows on the main, west façade; and casement and 6-over-6 double hung vinyl frame and sash windows on the south side elevation. Refer to BSOR Section B.6. for modifications and analysis of integrity.

Photo of the primary façade from the public right-of-way.

The house was constructed in 1928 per water and sewer records. Modifications include the replacement of the clay tile roof with new clay tile; the replacement of the original windows along the south side elevation; and the addition of a fabric awning on the main façade. The house is in good condition and retains a good degree of integrity.

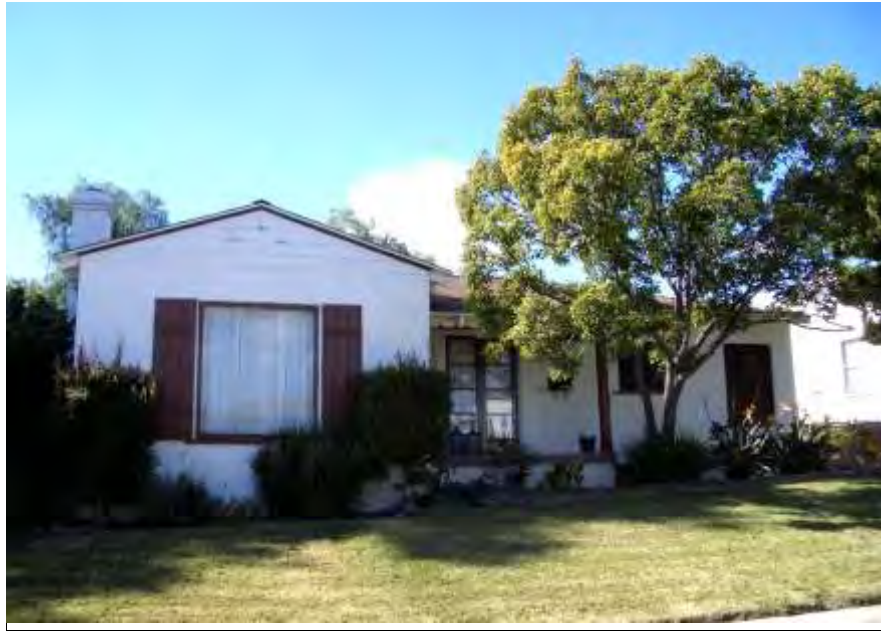
\* P3a. Description: (Describe resource and its major elements. Include design, materials, condition, alterations, size, setting, and boundaries.)  
The house at 3226 Isla Vista Drive was built in 1936 in the Minimal Traditional style and features a medium pitch cross gable roof with composition shingles; clipped eaves; wood clapboard in the gable end; and a stucco exterior. The entry porch, accessed via two concrete steps, is set to the right and features a roof extension supported by a square wood post. The entry door is set perpendicularly to the sidewalk. Fenestration consists of four-lite French doors, and single pane fixed and 1-over-1 double hung wood frame and sash windows. Refer to BSOR Section B.6. for modifications and analysis of integrity.

Photo of the primary façade from the public right-of-way.

The house was constructed in 1936 per water and sewer records. Modifications include the replacement of the composition roof with a new composition roof. The house is in good condition and retains a good degree of integrity.

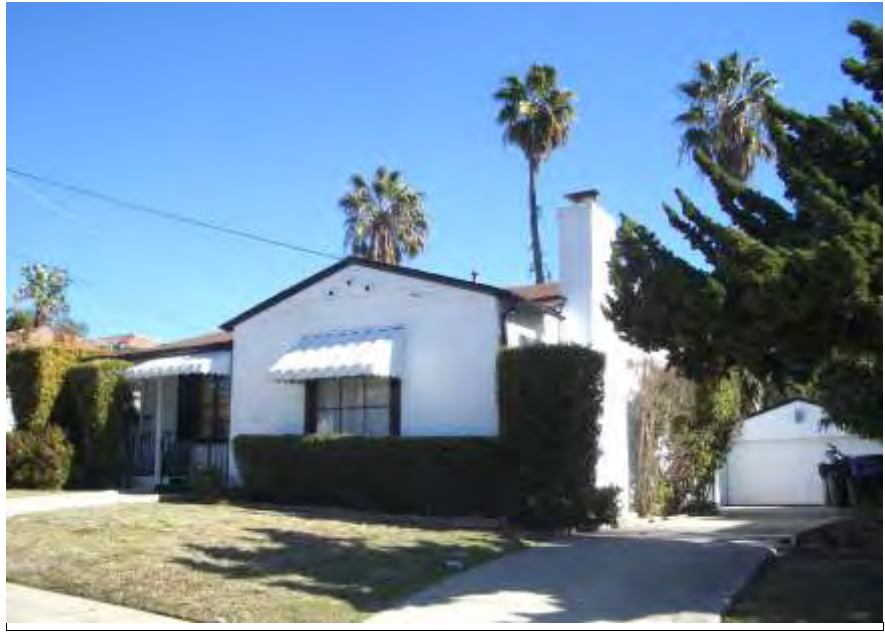
\* P3a. Description: (Describe resource and its major elements. Include design, materials, condition, alterations, size, setting, and boundaries.)  
The house at 3235 Isla Vista Drive was built in 1936 in the Minimal Traditional style and features a medium pitch cross gable roof with composition shingles; clipped eaves; wood clapboard and clay pipe vents in the gable end; and a stucco exterior. The entry porch, accessed via two concrete steps, is set to the left and features a roof extension supported by a square wood post. The entry door is set perpendicularly to the sidewalk. Fenestration consists of multi-lite fixed and casement wood frame and sash windows. Refer to BSOR Section B.6. for modifications and analysis of integrity.

Photo of the primary façade from the public right-of-way.

The house was constructed in 1936 per water and sewer records. Modifications include the replacement of the composition roof with a new composition roof and the addition of aluminum awnings. The house is in good condition and retains a good degree of integrity.

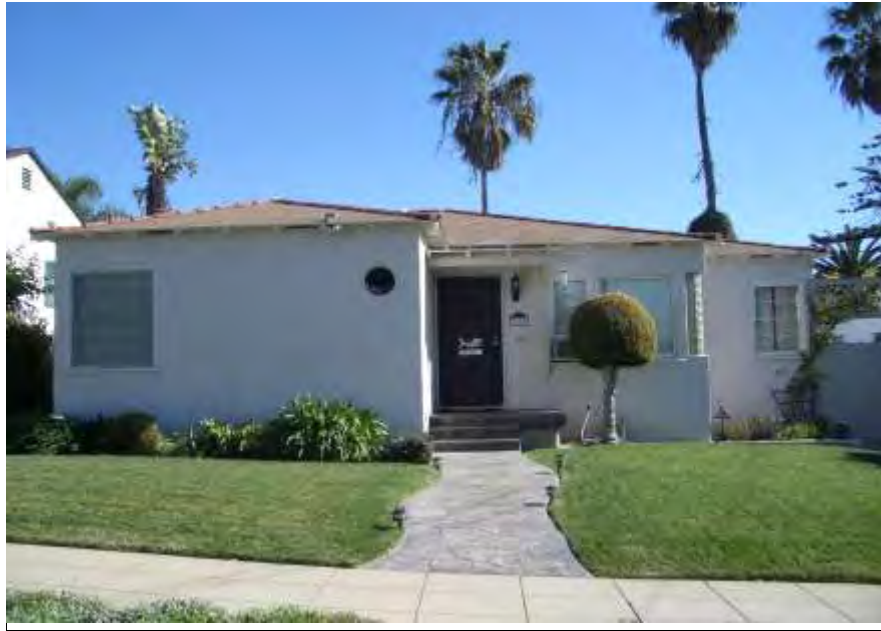
\* P3a. Description: (Describe resource and its major elements. Include design, materials, condition, alterations, size, setting, and boundaries.)  
The house at 3241 Isla Vista Drive was built in 1940 in the Minimal Traditional style with Art Moderne influences and features a multi-hipped roof with composition shingles; slight eave overhang with exposed rafter tails; and a textured stucco exterior. The entry porch, accessed via three concrete steps, is roughly centered on the façade and features a small projection supported by brackets. The entry door is set parallel to the sidewalk. Fenestration consists of single pane fixed and 2-over-2 double hung wood frame and sash windows. Art Moderne influences include a round portal window and the use of glass block at the corner. Refer to BSOR Section B.6. for modifications and analysis of integrity.

Photo of the primary façade from the public right-of-way.

The house was constructed in 1936 per water and sewer records. Modifications include the replacement of the composition roof with a new composition roof and a decorative cement walkway. The house is in good condition and retains a good to fair degree of integrity.

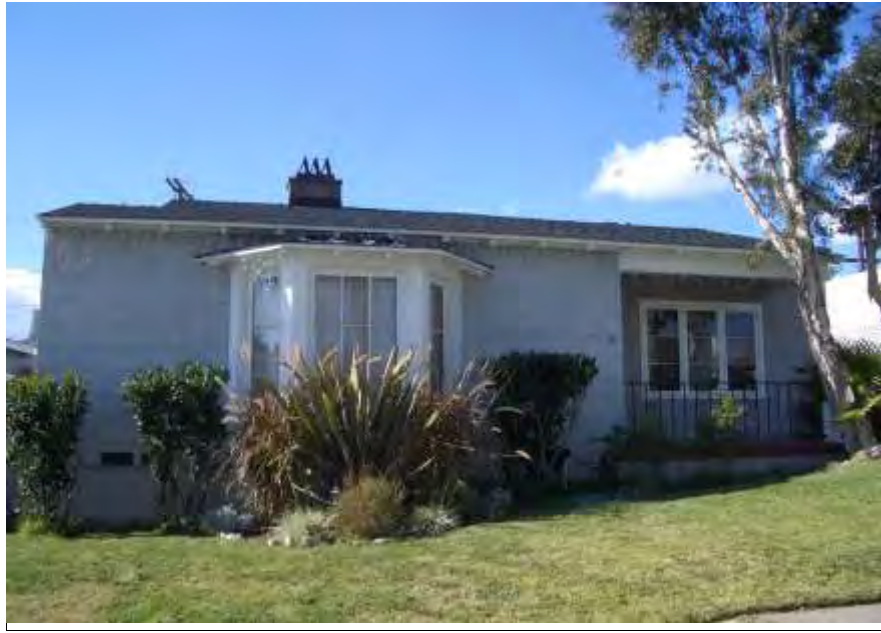
\* P3a. Description: (Describe resource and its major elements. Include design, materials, condition, alterations, size, setting, and boundaries.)  
The house at 3242 Isla Vista Drive was built in 1936 in the Minimal Traditional style with Ranch elements and features a side gable roof with composition shingles; vertical wood siding in the gable end; a slight eave overhang with exposed rafter tails; an asbestos shingle exterior; and a brick chimney at the ridgeline. The entry porch, accessed via two concrete steps, is set to the right and features a roof extension supported by a turned spindle wood post. The entry door is set perpendicularly to the sidewalk. Fenestration consists of multi-lite fixed and casement, as well as 1-over-1 double hung wood frame and sash windows. Refer to BSOR Section B.6. for modifications and analysis of integrity.

Photo of the primary façade from the public right-of-way.

The house was constructed in 1936 per water and sewer records. Modifications include the replacement of the composition roof with a new composition roof and the application of asbestos shingle siding, which appears to have been applied over the original siding, as evidenced by the relationship of the siding to the window frames. The house is in good condition and retains a fair degree of integrity.

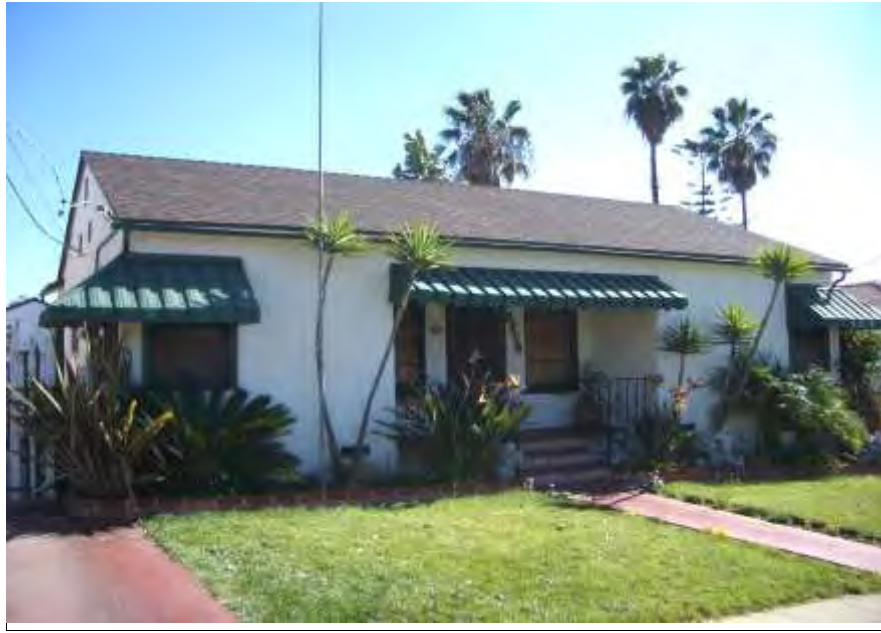
\* P3a. Description: (Describe resource and its major elements. Include design, materials, condition, alterations, size, setting, and boundaries.)  
The house at 3249 Isla Vista Drive was built in 1945 in the Minimal Traditional style and features a side gable roof with composition shingles; horizontal vents in the gable end; clipped eaves; and a smooth stucco exterior. The entry porch, accessed via three concrete steps, is centered and recessed three feet into the façade. The entry door is set parallel to the sidewalk. Fenestration consists of 4-over-4 and 1-over-1 double hung wood frame and sash windows under aluminum awnings. Refer to BSOR Section B.6. for modifications and analysis of integrity.

Photo of the primary façade from the public right-of-way.

The house was constructed in 1945 per water and sewer records. Modifications include the replacement of the composition roof with a new composition roof and the addition of aluminum awnings. The house is in good condition and retains a good degree of integrity.

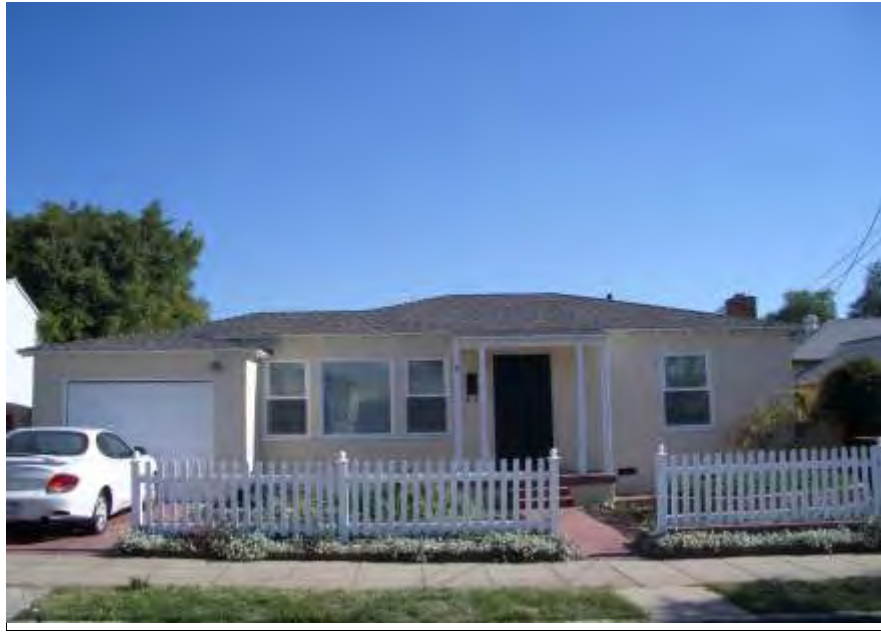
\* P3a. Description: (Describe resource and its major elements. Include design, materials, condition, alterations, size, setting, and boundaries.)  
The house at 3305 Isla Vista Drive was built in 1946 in the Minimal Traditional style and features a hipped roof with composition shingles; a slight eave overhang with rafter tails; and a textured stucco exterior. The entry, accessed via three concrete steps, is set just to the right under a roof projection supported by paired square wood posts. The entry door is set parallel to the sidewalk. Fenestration consists of single pane fixed and 1-over-1 double hung vinyl frame and sash windows. The garage is attached to the house and set forward a few feet. The yard is enclosed by a 3-foot wood picket fence. Refer to BSOR Section B.6. for modifications and analysis of integrity.

Photo of the primary façade from the public right-of-way.

The house was constructed in 1946 per water and sewer records. Modifications include the replacement of the composition roof with a new composition roof; the use of textured stucco; the replacement of the original wood frame windows with vinyl frame windows; and the replacement of the original wood garage door with a roll-up aluminum door. The house is in good condition and retains a fair degree of integrity.

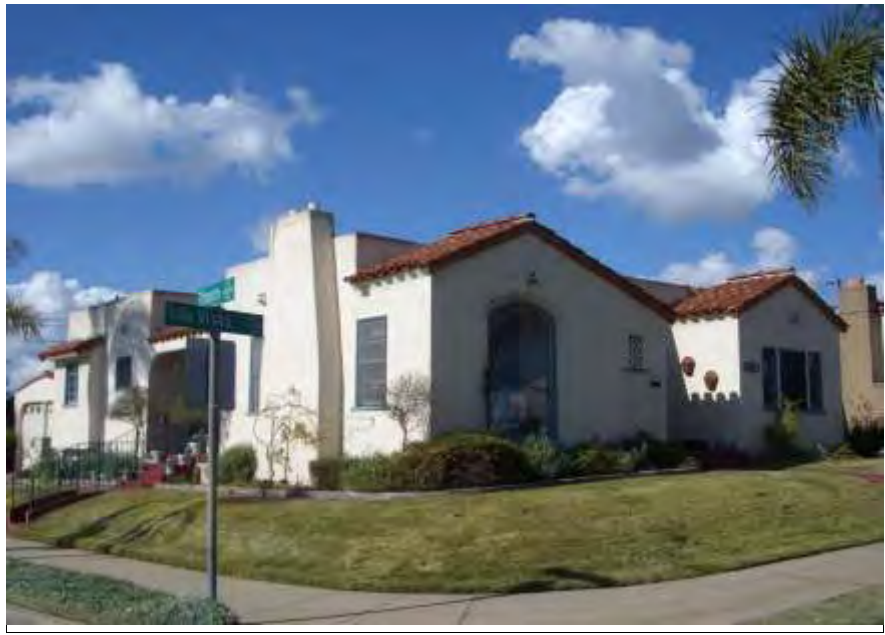
\* P3a. Description: (Describe resource and its major elements. Include design, materials, condition, alterations, size, setting, and boundaries.)  
The house at 3306 Isla Vista Drive was built in 1929 on a corner lot in the Spanish Eclectic style and features a flat roof with a clay tile shed roof along the parapet line and two projecting front-gable bays; clay tile roof vents and drains; a stucco exterior; and a chimney at the south elevation. The main entry, accessed via two concrete steps, is on the Isla Vista street elevation and is centered between the two projecting gables. The entry door is set parallel to the sidewalk. A secondary entry, accessed via 8 concrete steps, fronts onto Thorn Street and is recessed under a low arch opening. Fenestration consists of a large fixed wood frame window on the southern gable of the main façade; and multi-lite casement and 2-over-2 double hung wood frame and sash windows throughout. Refer to BSOR Section B.6. for modifications and analysis of integrity.

Photo of the primary façade from the public right-of-way.

The house was constructed in 1929 per water and sewer records. Modifications include the addition of window screens. The house is in good condition and retains a very good degree of integrity.

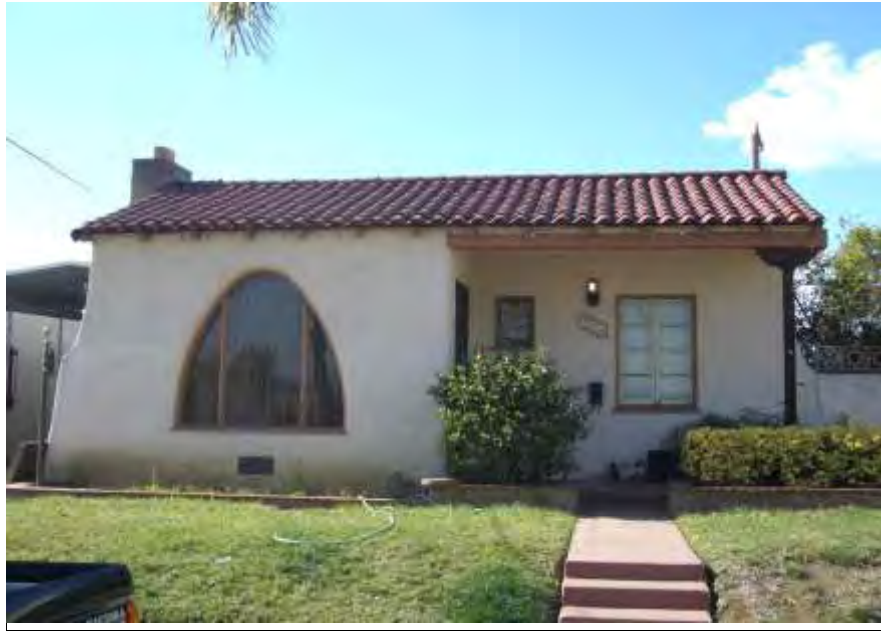
\* P3a. Description: (Describe resource and its major elements. Include design, materials, condition, alterations, size, setting, and boundaries.)  
The house at 3314 Isla Vista Drive was built in 1927 in the Spanish Eclectic style and features a flat roof with a clay tile shed roof along the parapet line; a stucco exterior; and a chimney at the south elevation. The main entry, accessed via five concrete steps, is set to the right under a roof projection supported by a square wood post. The entry door is set perpendicularly to the sidewalk. Fenestration consists of a large arched tri-partite fixed wood frame window; 4-lite casement wood frame and sash windows; and 2-over-2 double hung wood frame and sash windows. Refer to BSOR Section B.6. for modifications and analysis of integrity.

Photo of the primary façade from the public right-of-way.

The house was constructed in 1927 per water and sewer records. Modifications include the replacement of the clay tile roof with a new clay tile roof. The house is in good condition and retains a good degree of integrity.

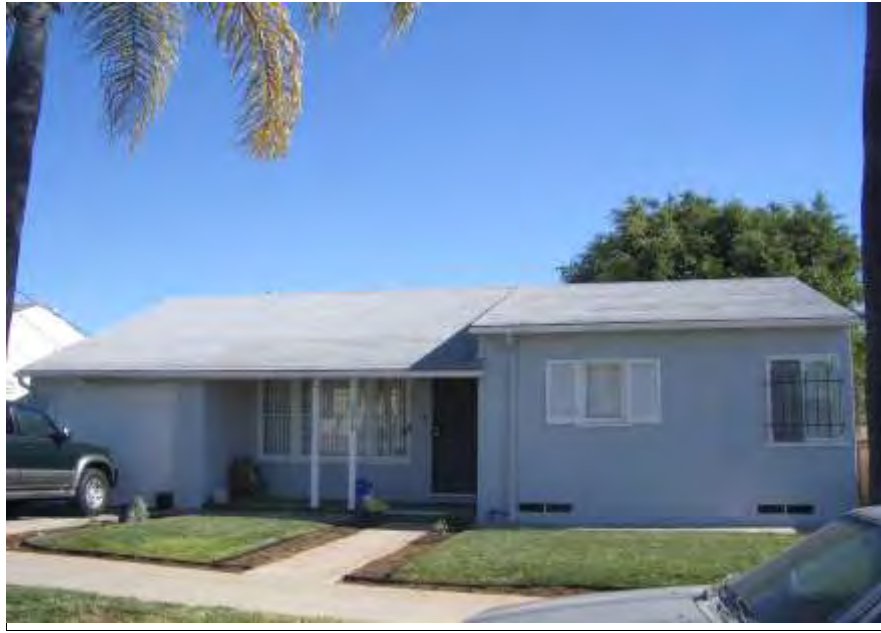
\* P3a. Description: (Describe resource and its major elements. Include design, materials, condition, alterations, size, setting, and boundaries.)  
The house at 3315 Isla Vista Drive was built in 1946 in the Minimal Traditional style and features a side gable roof with composition shingles; a slight eave overhang with rafter tails; and a textured stucco exterior. The entry, accessed via one concrete step, is set just to the left under a roof projection supported by paired square wood posts. The entry door is set parallel to the sidewalk. Fenestration consists of 2-over-2 double hung wood frame and sash windows and one vinyl slider window. The garage is attached to the house and set forward a few feet from the entry façade. Refer to BSOR Section B.6. for modifications and analysis of integrity.

Photo of the primary façade from the public right-of-way.

The house was constructed in 1946 per water and sewer records. Modifications include the replacement of the composition roof with a new composition roof; the use of textured stucco; the replacement of one original wood frame window with a vinyl window; and the replacement of the original wood garage door with a roll-up aluminum door. The house is in good condition and retains a good to fair degree of integrity.

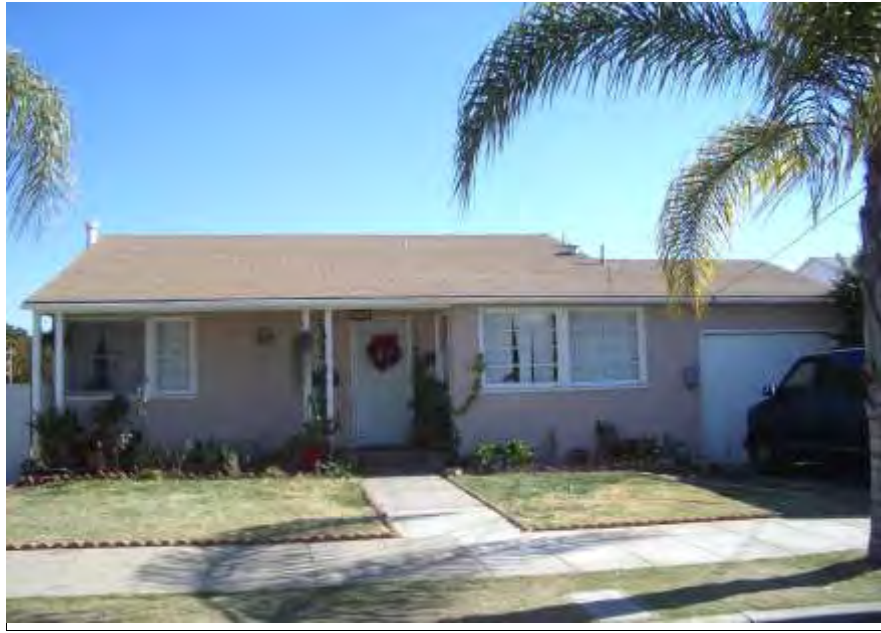
\* P3a. Description: (Describe resource and its major elements. Include design, materials, condition, alterations, size, setting, and boundaries.)  
The house at 3315 Isla Vista Drive was built in 1946 in the Minimal Traditional style and features a side gable roof with composition shingles; a slight eave overhang with rafter tails; and a textured stucco exterior. The entry, accessed via two concrete steps, is set just to the left under a roof projection supported by paired square wood posts. The entry door is set parallel to the sidewalk. Fenestration consists of 2-over-2 double hung wood frame and sash windows. The garage is attached to the house and is flush with the adjacent facade. Refer to BSOR Section B.6. for modifications and analysis of integrity.

Photo of the primary façade from the public right-of-way.

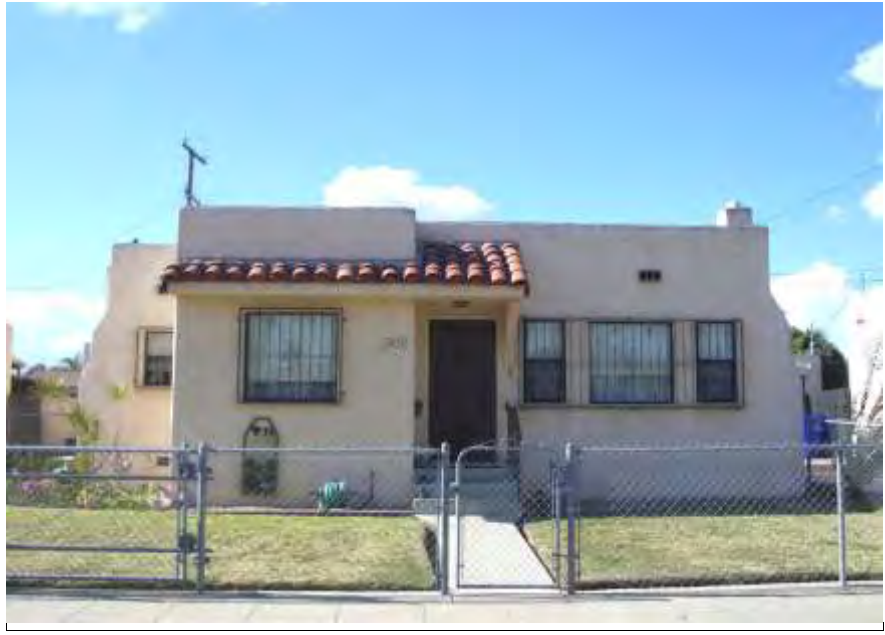
Photo of the primary façade from the public right-of-way.

The house was constructed in 1936 per water and sewer records. Modifications include the replacement of the clay tile roof with new clay tile; the use of textured stucco; the replacement of the original wood frame windows with aluminum windows; the addition of wrought iron security bars; and the addition of chain link fencing. The house is in good to fair condition and retains a good to fair degree of integrity.

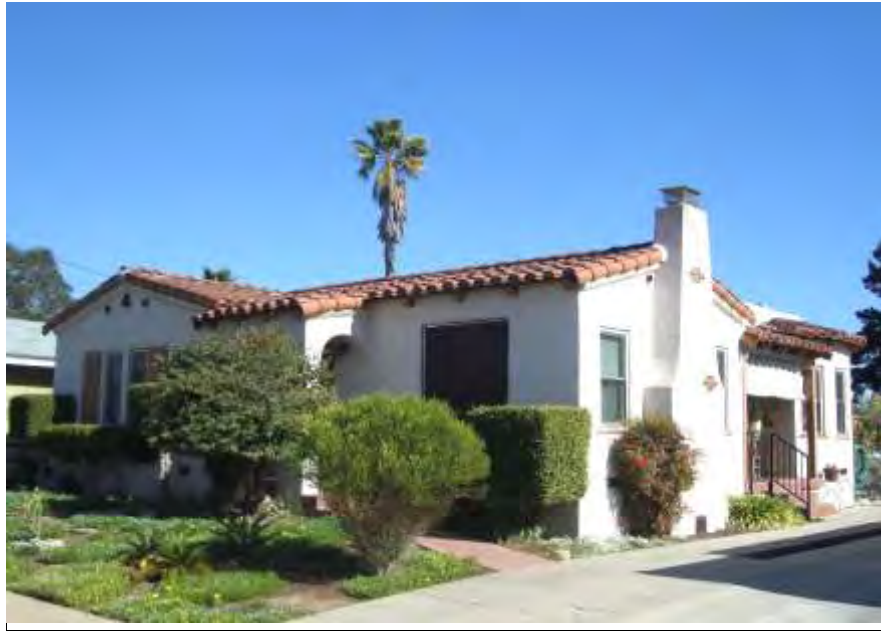
\* P3a. Description: (Describe resource and its major elements. Include design, materials, condition, alterations, size, setting, and boundaries.)  
The house at 3405 Isla Vista Drive was built in 1935 in the Spanish Eclectic style and features a flat roof with a clay tile shed roof along the parapet line and a front-gable bay; clay tile roof vents and drains; a textured stucco exterior; and a chimney at the south elevation. The entry, accessed via three concrete steps, is roughly centered on the façade to the right of the gable and, recessed under an arch opening with a clay tile roof. The entry door is set parallel to the sidewalk. Fenestration consists of single pane fixed wood frame windows and 1-over-1 double hung vinyl frame and sash windows throughout. Refer to BSOR Section B.6. for modifications and analysis of integrity.

Photo of the primary façade from the public right-of-way.

\* B6. Construction History: (Construction date, alterations, and date of alterations.)  
The house was constructed in 1935 per water and sewer records. Modifications include the replacement of the clay tile roof with new clay tile; the use of textured stucco; the replacement of some original wood frame windows with vinyl windows; and the use of window screens. The house is in good condition and retains a good to fair degree of integrity.

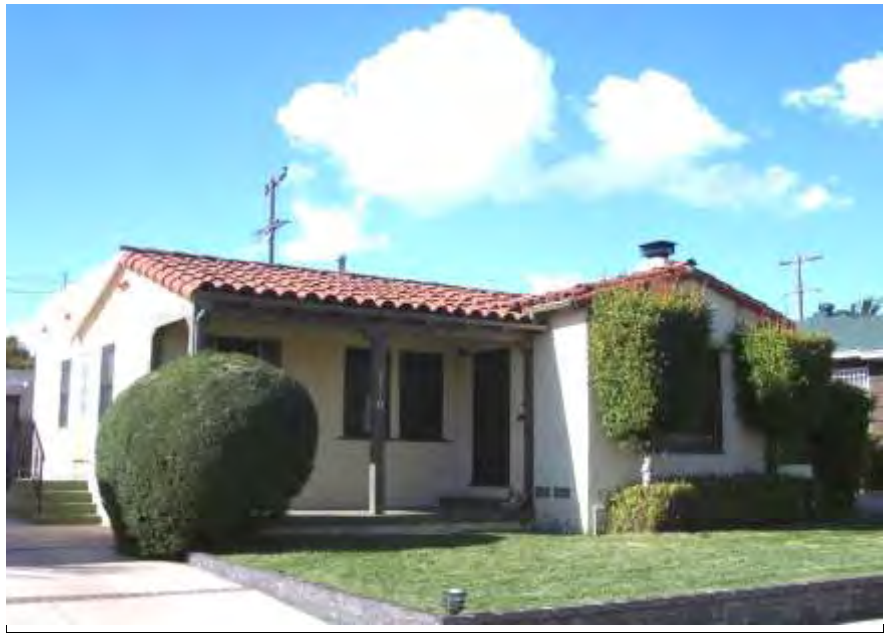
\* P3a. Description: (Describe resource and its major elements. Include design, materials, condition, alterations, size, setting, and boundaries.)  
The house at 3410 Isla Vista Drive was built in 1937 in the Spanish Eclectic style and features a flat roof with a clay tile shed roof along the parapet line and a front-gable bay; clay tile roof vents and drains; a stucco exterior; and a chimney at the north elevation. The entry, accessed via two concrete steps, is set just to the left of the gable bay under a roof projection supported by wood posts. The entry door is set perpendicularly to the sidewalk. Fenestration consists of a 3-pane fixed wood frame window in the gable bay and 2-over-2 double hung wood frame and sash windows throughout. Refer to BSOR Section B.6. for modifications and analysis of integrity.

Photo of the primary façade from the public right-of-way.

The house was constructed in 1937 per water and sewer records. Modifications include the replacement of the clay tile roof with new clay tile; the use of textured stucco; the replacement of some original wood frame windows with vinyl windows; and the use of window screens. The house is in good condition and retains a good degree of integrity.

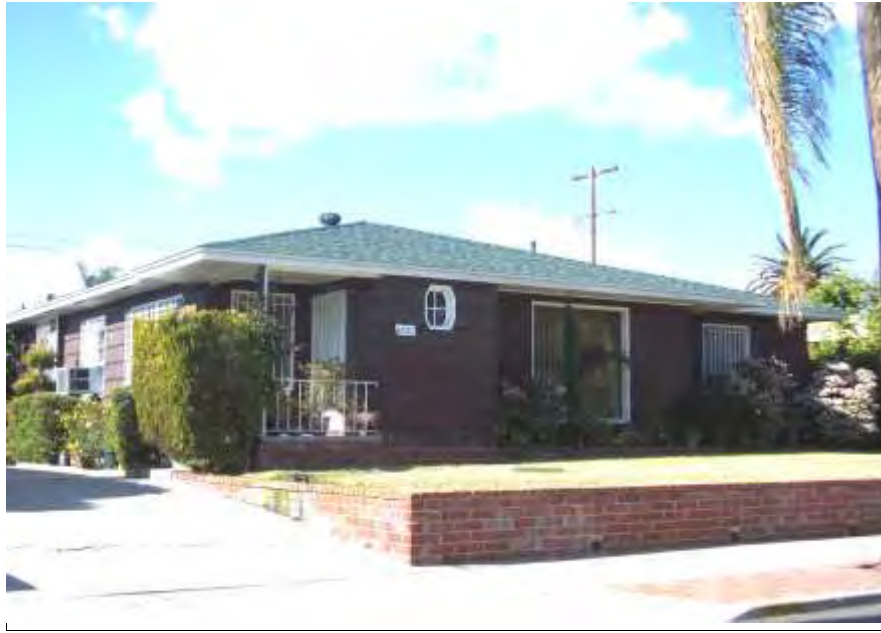
\* P3a. Description: (Describe resource and its major elements. Include design, materials, condition, alterations, size, setting, and boundaries.)  
The house at 3420 Isla Vista Drive was built in 1950 in the Ranch style and features a hipped roof with composition shingles; a slight eave overhang and soffit; and a wood shingle exterior. The entry, accessed via four concrete steps, is set to the left, with the entry door perpendicular to the sidewalk. Fenestration consists of single pane fixed and multi-lite wood frame and sash windows in varying sized. Wrought iron security bars have been added. A low brick retaining wall is at the property line. Refer to BSOR Section B.6. for modifications and analysis of integrity.

Photo of the primary façade from the public right-of-way.

The house was constructed in 1950 per water and sewer records. Modifications include the replacement of the composition roof with a new composition roof and the use of wrought iron security bars. The house is in good condition and retains a good degree of integrity.

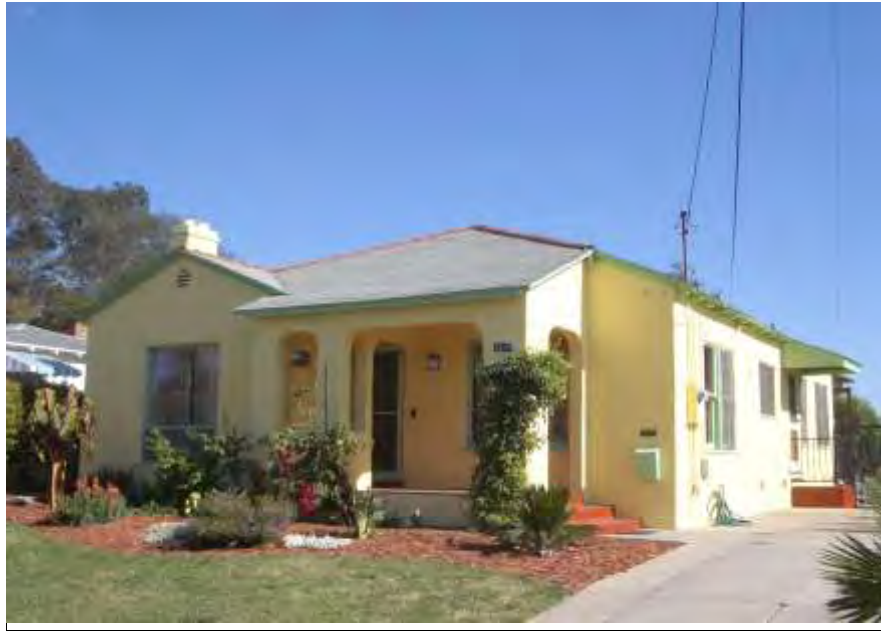
\* P3a. Description: (Describe resource and its major elements. Include design, materials, condition, alterations, size, setting, and boundaries.)  
The house at 3421 Isla Vista Drive was built in 1937 in the Minimal Traditional style and features a hipped roof with composition shingles and clay tile ridges; a slight eave overhang and exposed rafter tails; and a stucco exterior. The entry, accessed via three concrete steps, is set just to the right of the front bay under a newer roof projection supported by stucco arches. The entry door is set parallel to the sidewalk. Fenestration consists of 1-over-1 double hung wood frame and sash windows and a single pane fixed wood frame window with two aluminum jalousie windows underneath in the gable bay. Refer to BSOR Section B.6. for modifications and analysis of integrity.

Photo of the primary façade from the public right-of-way.

The house was constructed in 1937 per water and sewer records. Modifications include the replacement of the composition roof with a new composition roof; the enlargement of the front porch cover; and the addition of the aluminum jalousie windows. The house is in good condition and retains a fair degree of integrity.
