# *Islenair Historic District*

Designated by the City of San Diego  
Historical Resources Board  
April 26, 2007

*Prepared by  
The City of San Diego  
City Planning and Community Investment Department  
Historical Resources Section*

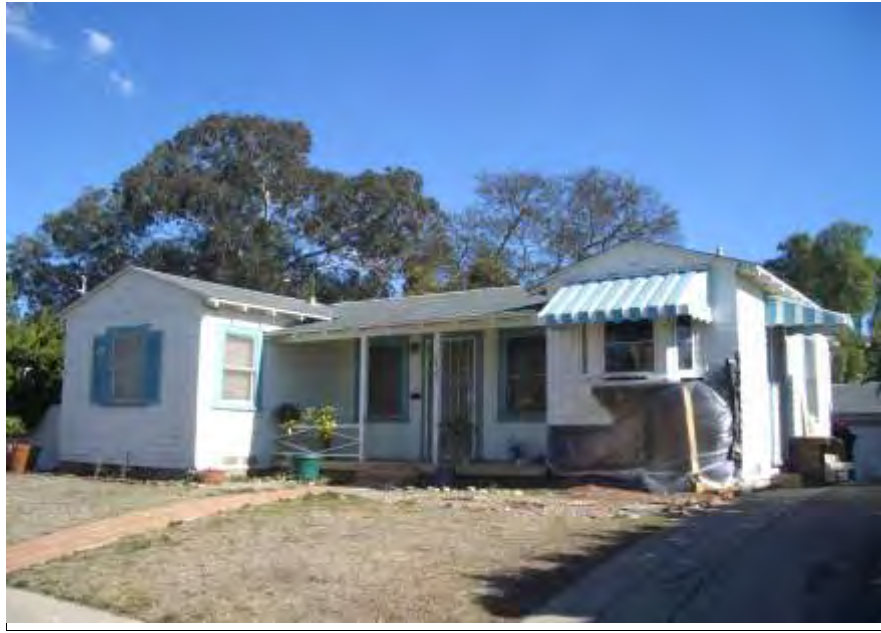
\* P3a. Description: (Describe resource and its major elements. Include design, materials, condition, alterations, size, setting, and boundaries.)  
The house at 3427 Isla Vista Drive was built in 1937 in the Minimal Traditional style with Ranch elements and features a "U" shaped floor plan; a cross gable roof with composition shingles; a slight eave overhang and exposed rafter tails; vertical wood siding in the gable end; and a wood clapboard exterior. The entry, accessed via two concrete steps, is centered on the façade between the two projecting gable bays under a roof projection supported by wood posts. The entry door is set parallel to the sidewalk. Fenestration consists of 1-over-1 double hung wood frame and sash windows. Aluminum awnings have been added above some windows. The house was undergoing some repair work to the plumbing at the time of the survey. It appears that the impacted area will likely be replaced and restored. Refer to BSOR Section B.6. for modifications and analysis of integrity.

Photo of the primary façade from the public right-of-way.

The house was constructed in 1937 per water and sewer records. Modifications include the replacement of the composition roof with a new composition roof and the addition of aluminum awnings. The house is in good condition and retains a good degree of integrity.

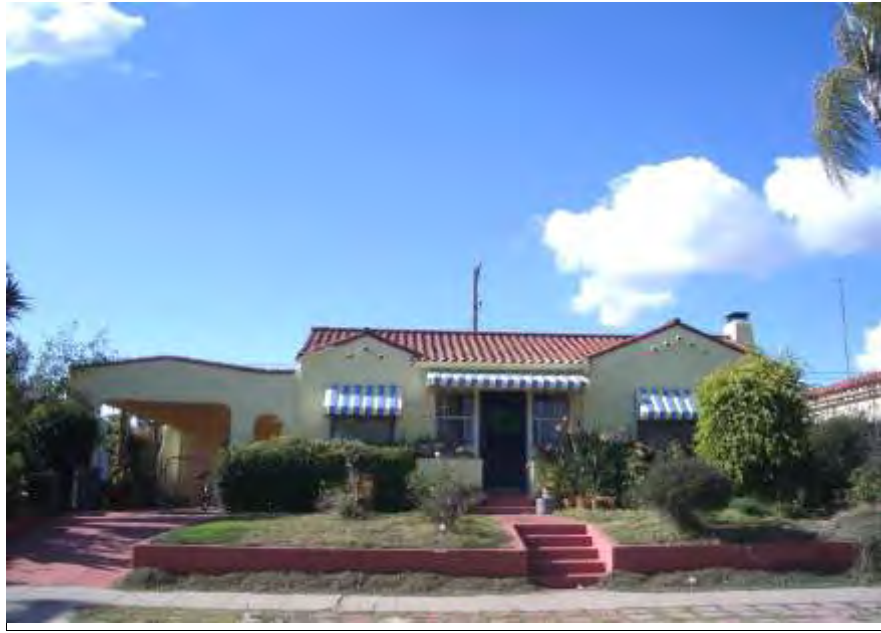
\* P3a. Description: (Describe resource and its major elements. Include design, materials, condition, alterations, size, setting, and boundaries.)  
The house at 3428 Isla Vista Drive was built in 1928 in the Spanish Eclectic style and features a flat roof with a clay tile shed roof along the parapet line and two projecting front-gable bays; clay tile roof vents and drains; a stucco exterior; and a chimney at the north elevation. The entry, accessed via eight concrete steps, is roughly centered on the façade between the gable bays. The entry door is set parallel to the sidewalk. The original entry porch was infilled with 50 square feet of habitable space. Fenestration consists of single-pane fixed wood frame windows in the gable bays and 1-over-1 double hung aluminum frame and sash windows flanking the entry door. Aluminum awnings have been added above the windows. A porte cochere was constructed on the south side of the house at an unknown date. Refer to BSOR Section B.6. for modifications and analysis of integrity.

Photo of the primary façade from the public right-of-way.

The house was constructed in 1928 per water and sewer records. Modifications include the replacement of the clay tile roof with new clay tile; the infill of the original porch in 1980 which added 50 square feet of habitable space to the house; the addition of aluminum awnings; and the construction of a porte cochere. The house is in good condition and retains a fair degree of integrity.

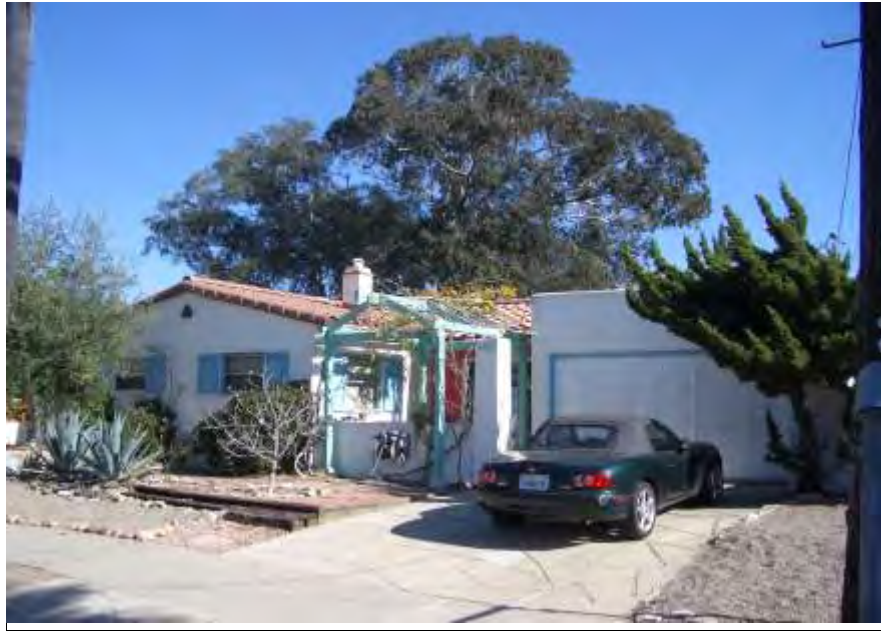
\* P3a. Description: (Describe resource and its major elements. Include design, materials, condition, alterations, size, setting, and boundaries.)  
The house at 3435 Isla Vista Drive was built in 1936 in the Minimal Traditional style with Ranch elements and features a "U" shaped floor plan; a cross gable roof with fiberglass shingles; a slight eave overhang; and a stucco and board and groove exterior. The entry is located in a courtyard between the two projecting gable bays created by the house and the garage. The entry door is set parallel to the sidewalk. Fenestration consists of 1-over-1 double hung aluminum frame and sash windows. Refer to BSOR Section B.6. for modifications and analysis of integrity.

P5b. Description of Photo: (View, date, etc.)  
Photo of the primary façade from the public right-of-way.

The house was constructed in 1937 per water and sewer records. Modifications include the replacement of the roof with a new fiberglass roof and the replacement of the original wood frame windows with aluminum frame windows. The garage may have been an early addition. The house is in good condition and retains a good to fair degree of integrity.

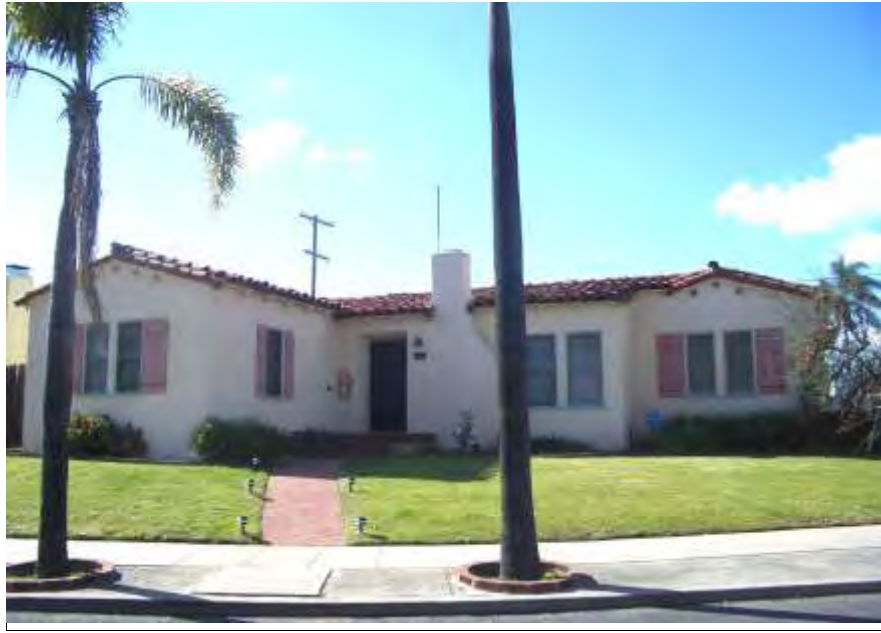
\* P3a. Description: (Describe resource and its major elements. Include design, materials, condition, alterations, size, setting, and boundaries.)  
The house at 3440 Isla Vista Drive was built in 1936 in the Spanish Eclectic style and features a flat roof with a clay tile shed roof along the parapet line and two projecting front-gable bays; slight eave overhang with exposed rafter tails; clay tile roof vents and drains; a textured stucco exterior; and a chimney at the east elevation. The entry, accessed via three concrete steps, is set to the left of the façade adjacent to the chimney. The entry door is set parallel to the sidewalk. Fenestration consists of 2-over-1 double hung wood frame windows with decorative wood shutters. Refer to BSOR Section B.6. for modifications and analysis of integrity.

Photo of the primary façade from the public right-of-way.

\* B6. Construction History: (Construction date, alterations, and date of alterations.)  
The house was constructed in 1936 per water and sewer records. Modifications include the use of textured stucco and the addition of window screens. The house is in good condition and retains a good to fair degree of integrity.

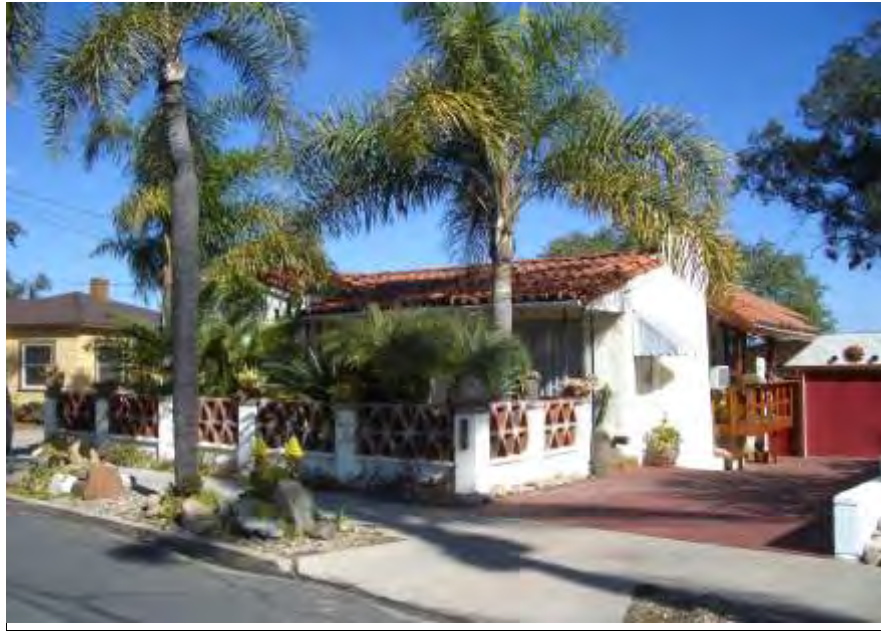
\* P3a. Description: (Describe resource and its major elements. Include design, materials, condition, alterations, size, setting, and boundaries.)  
The house at 3443 Isla Vista Drive was built in 1928 in the Spanish Eclectic style and features a flat roof with a clay tile shed roof along the parapet line and a projecting front-gable bay; clipped eaves; clay tile roof vents and drains; a stucco exterior; and a chimney at the south elevation. The entry, accessed via two concrete steps, is set to the right of the bay under a roof projection supported by a wrought iron post. The entry door is set parallel to the sidewalk. Fenestration consists of single pane fixed and louvered aluminum windows. An aluminum awning has been added above a side window. A 3-foot high stucco and terra cotta block wall is located at the property line. Landscaping obscures the house. Refer to BSOR Section B.6. for modifications and analysis of integrity.

Photo of the primary façade from the public right-of-way.

The house was constructed in 1936 per water and sewer records. Modifications include the replacement of the clay tile roof with a new clay tile roof; the replacement of the original wood frame windows with aluminum frame windows; the replacement of the wood porch post with a wrought iron post; the addition of an aluminum awning; the addition of a stucco and terra cotta block wall; and landscape overgrowth. The house is in good condition and retains a good to fair degree of integrity.

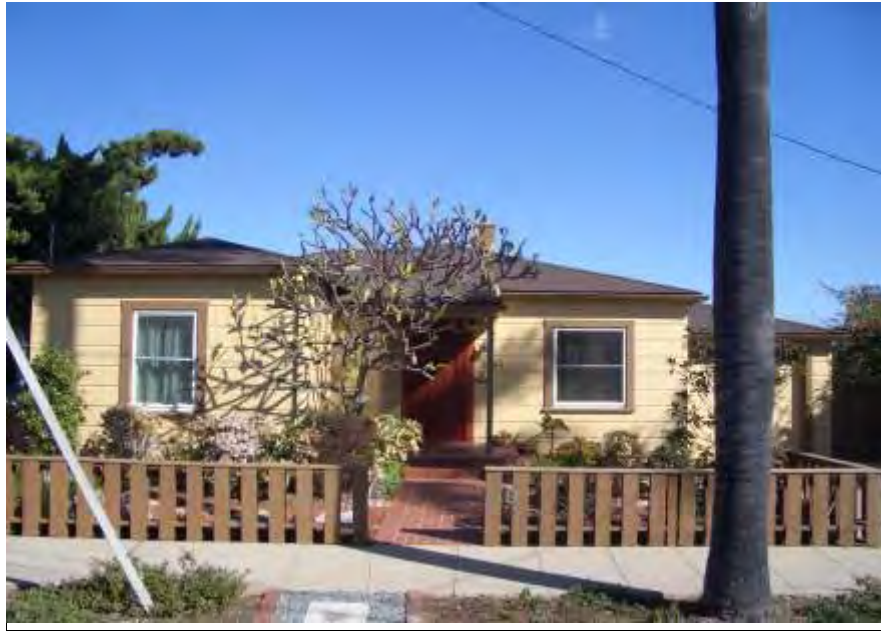
\* P3a. Description: (Describe resource and its major elements. Include design, materials, condition, alterations, size, setting, and boundaries.)  
The house at 3449 Isla Vista Drive was built in 1940 in the Minimal Traditional style and features a hipped roof with composition shingles; a slight eave overhang; and a horizontal wood exterior. The entry, accessed via two concrete steps, is roughly centered on the façade under a roof projection supported by a wood post. The entry door is set parallel to the sidewalk. Fenestration consists of 1-over-1 double hung vinyl frame and sash windows. Refer to BSOR Section B.6. for modifications and analysis of integrity.

Photo of the primary façade from the public right-of-way.

The house was constructed in 1940 per water and sewer records. Modifications include the replacement of the composition roof with a new composition roof and the replacement of the original 2-over-2 wood frame windows with 1-over-1 vinyl frame windows. The house is in good condition and retains a good to fair degree of integrity.

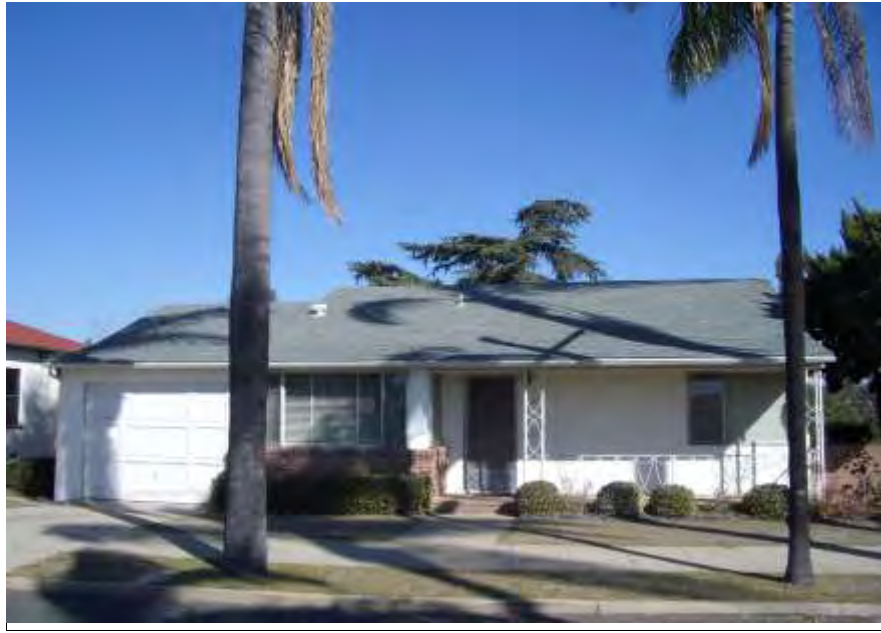
\* P3a. Description: (Describe resource and its major elements. Include design, materials, condition, alterations, size, setting, and boundaries.)  
The house at 3455 Isla Vista Drive was built in 1946 in the Minimal Traditional style and features a side gable roof with composition shingles; a slight eave overhang; and a stucco exterior with brick veneer beneath a picture window. The entry, accessed via one concrete step, is roughly centered on the façade under a roof projection supported by decorative wrought iron posts. The entry door is set parallel to the sidewalk. Fenestration consists of aluminum frame fixed and slider windows. The single-car garage is attached to the house and is flush with the main façade. Refer to BSOR Section B.6. for modifications and analysis of integrity.

Photo of the primary façade from the public right-of-way.

The house was constructed in 1946 per water and sewer records. Modifications include the replacement of the composition roof with a new composition roof; the replacement of the original wood frame windows with aluminum frame windows; the use of brick veneer; the replacement of the wood porch posts with wrought iron; and the replacement of the original garage door with a new wood door. The house is in good condition and retains a good to fair degree of integrity.

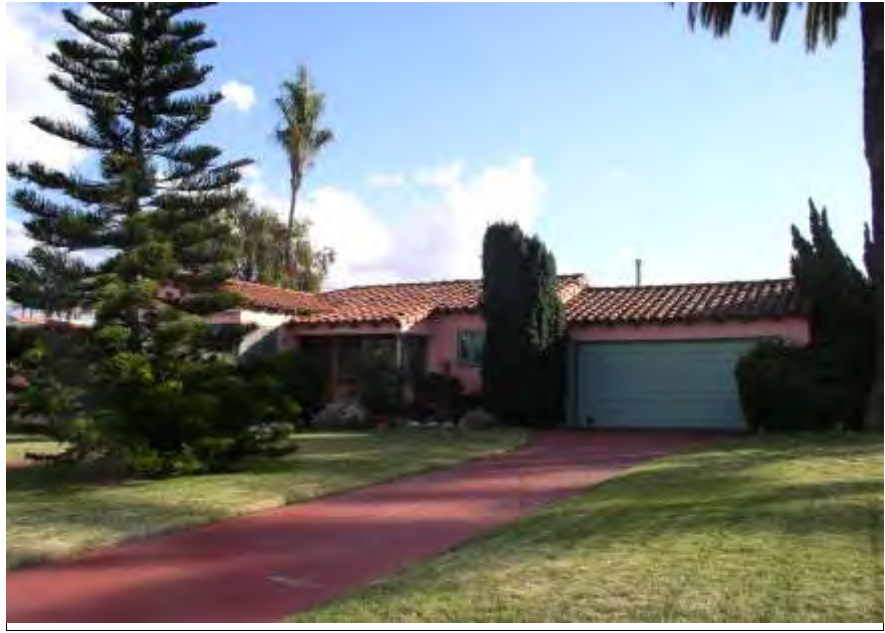
\* P3a. Description: (Describe resource and its major elements. Include design, materials, condition, alterations, size, setting, and boundaries.)  
The house at 3472 Isla Vista Drive was built in 1937 in the Spanish Eclectic style and features a cross gable clay tile roof with a front-gable bay; slight eave overhang with exposed rafter tails; clay tile roof vents and drains; and a stucco exterior. The entry is set to the right of the bay under a roof projection supported by wood posts. The entry door is set parallel to the sidewalk. Fenestration consists of 8-lite fixed, 4-lite casement and 4-over-4 double hung wood frame and sash windows. A two car garage is connected to the house and may have been added. Refer to BSOR Section B.6. for modifications and analysis of integrity.

Photo of the primary façade from the public right-of-way.

The house was constructed in 1937 per water and sewer records. Modifications include the replacement of the clay tile roof with a new clay tile roof and the addition of the two car garage connected to the house. The house is in good condition and retains a good degree of integrity.

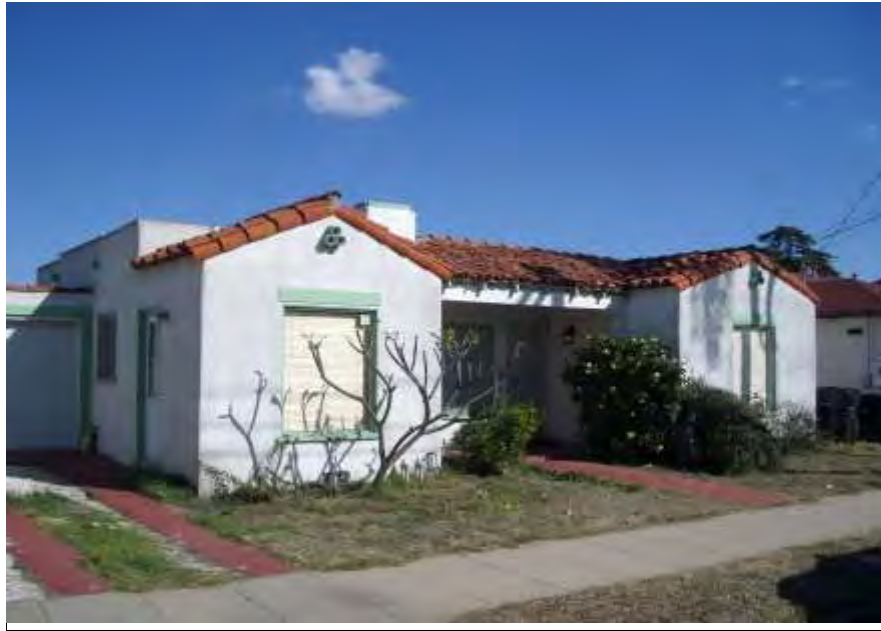
\* P3a. Description: (Describe resource and its major elements. Include design, materials, condition, alterations, size, setting, and boundaries.)  
The house at 3473 Isla Vista Drive was built in 1929 in the Spanish Eclectic style and features a flat roof with a clay tile shed roof along the parapet line and two projecting front-gable bays; clipped eaves; clay tile roof vents and drains; and a textured stucco exterior. The entry, accessed via one concrete step, is centered on the façade between the two projecting gable bays under a roof projection supported by wood timbers. The entry door is set parallel to the sidewalk. Fenestration consists of single pane fixed wood frame windows. Refer to BSOR Section B.6. for modifications and analysis of integrity.

Photo of the primary façade from the public right-of-way.

\* B6. Construction History: (Construction date, alterations, and date of alterations.)  
The house was constructed in 1929 per water and sewer records. Modifications include the replacement of the clay tile roof with a new clay tile roof; the use of textured stucco; and the addition of a wrought iron security gate at the entry door. The house is in good condition and retains a good degree of integrity.

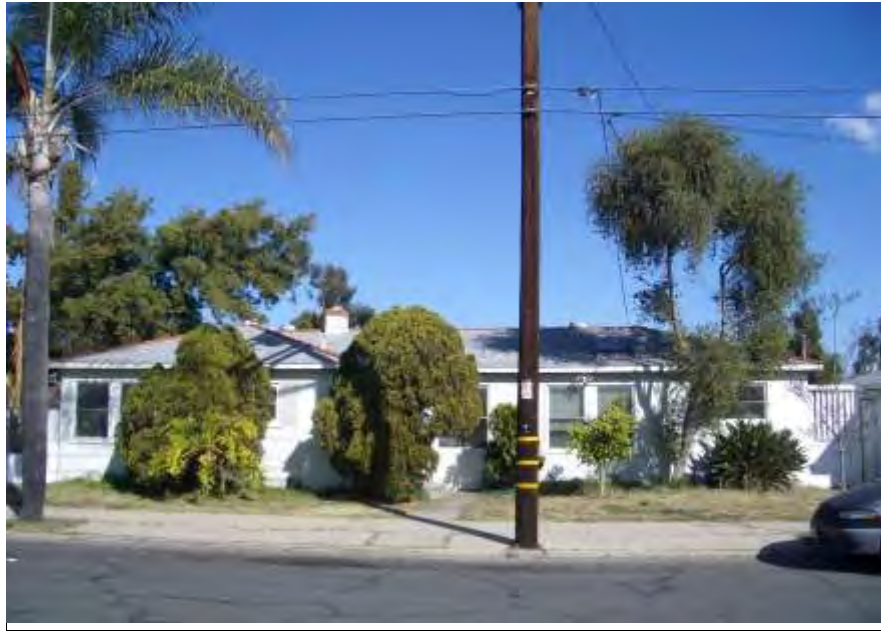
\* P3a. Description: (Describe resource and its major elements. Include design, materials, condition, alterations, size, setting, and boundaries.)  
The house at 3505 Isla Vista Drive was built in 1946 in the Minimal Traditional style and features a multi-hipped roof with composition shingles and clay tile ridges; a slight eave overhang; and a stucco exterior. The entry, accessed via two concrete steps, is set to the right of the bay under a roof projection supported by stacked concrete blocks. The entry door is set perpendicularly to the sidewalk. Fenestration consists of 1-over-1 vinyl frame and sash windows. The two-car garage is detached from the house and is set forward of the main façade. Refer to BSOR Section B.6. for modifications and analysis of integrity.

Photo of the primary façade from the public right-of-way.

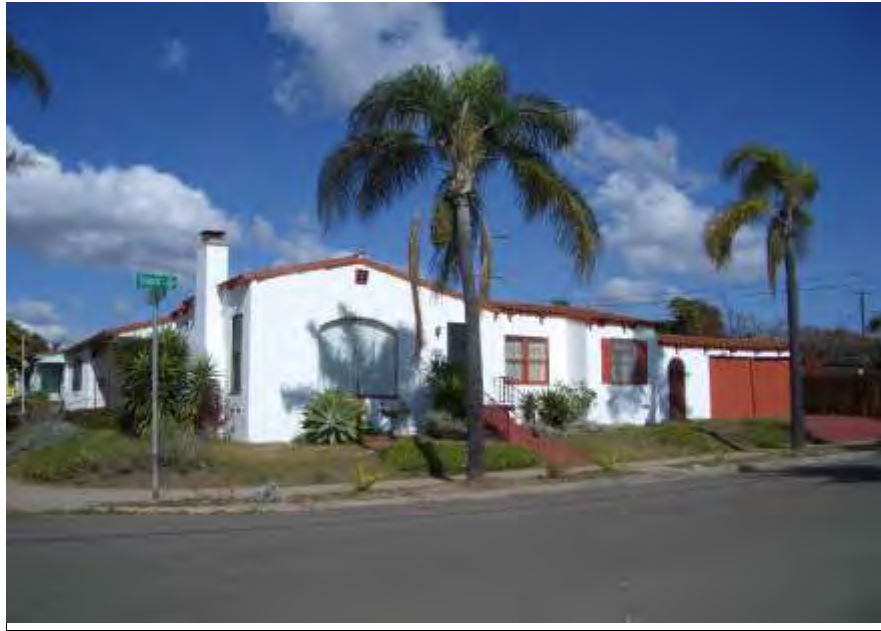
P5a. Photograph or Drawing (Photograph required for buildings, structures, and objects)

\* P3a. Description: (Describe resource and its major elements. Include design, materials, condition, alterations, size, setting, and boundaries.)  
The house at 4802 Thorn Street was built in 1931 on a corner lot in the Spanish Eclectic style and features a flat roof with a clay tile shed roof along the parapet line and a projecting front-gable bay; clipped eaves with exposed rafter tails; clay tile roof vents and drains; and a stucco exterior. The entry, accessed via nine concrete steps, is set to the right of the bay on the Thorn Street elevation. The entry door is set parallel to the sidewalk. Fenestration consists of single pane arched wood frame windows and 2-over-1 double hung wood frame and sash windows. The two-car garage is connected to the house by a garden gate and is set back from the main facade. Refer to BSOR Section B.6. for modifications and analysis of integrity.

Photo of the primary façade from the public right-of-way.

The house was constructed in 1931 per water and sewer records. Modifications include the replacement of the clay tile roof with a new clay tile roof. The house is in good condition and retains a good degree of integrity.

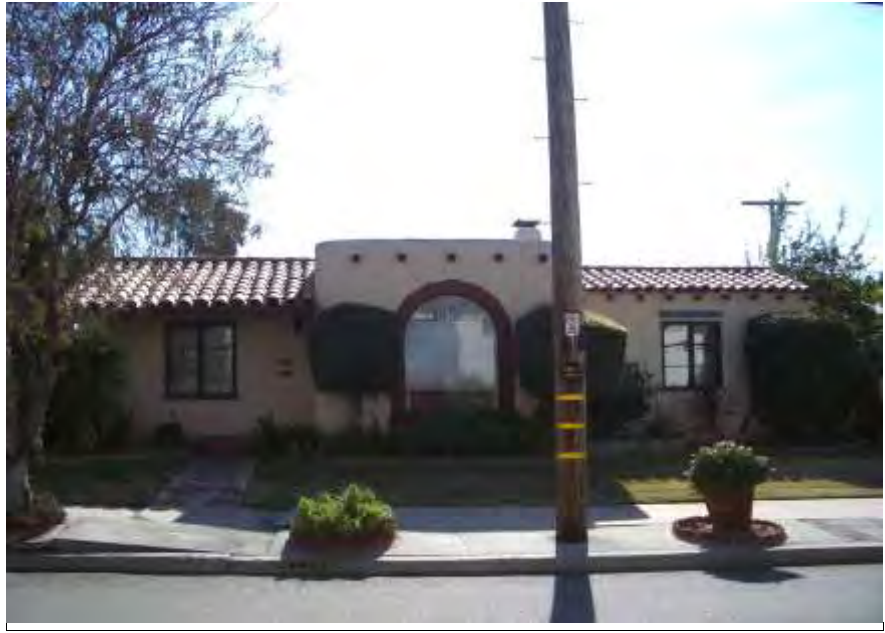
P5a. Photograph or Drawing (Photograph required for buildings, structures, and objects)

\* P3a. Description: (Describe resource and its major elements. Include design, materials, condition, alterations, size, setting, and boundaries.)  
The house at 4827 Thorn Street was built in 1931 on a corner lot in the Spanish Eclectic style and features a flat roof with a clay tile shed roof along portions of the parapet line; a projecting flat roof bay at the center of the Thorn Street elevation; a projecting hexagonal bay on the Isla Vista Drive elevation; clipped eaves with exposed rafter tails; clay tile roof vents and drains; and a stucco exterior. The entry, accessed via one concrete step, is set to the left of the bay on the Thorn Street elevation. The entry door is set perpendicularly to the sidewalk. A secondary entrance is located on the Isla Vista Drive elevation. Fenestration consists of a single pane arched wood frame window, 1-over-1 double hung, and paired 3-lite casement wood frame and sash windows.

Photo of the primary façade from the public right-of-way.

\* B6. Construction History: (Construction date, alterations, and date of alterations.)  
The house was constructed in 1931 per water and sewer records. The house is in very good condition and retains a very good degree of integrity.

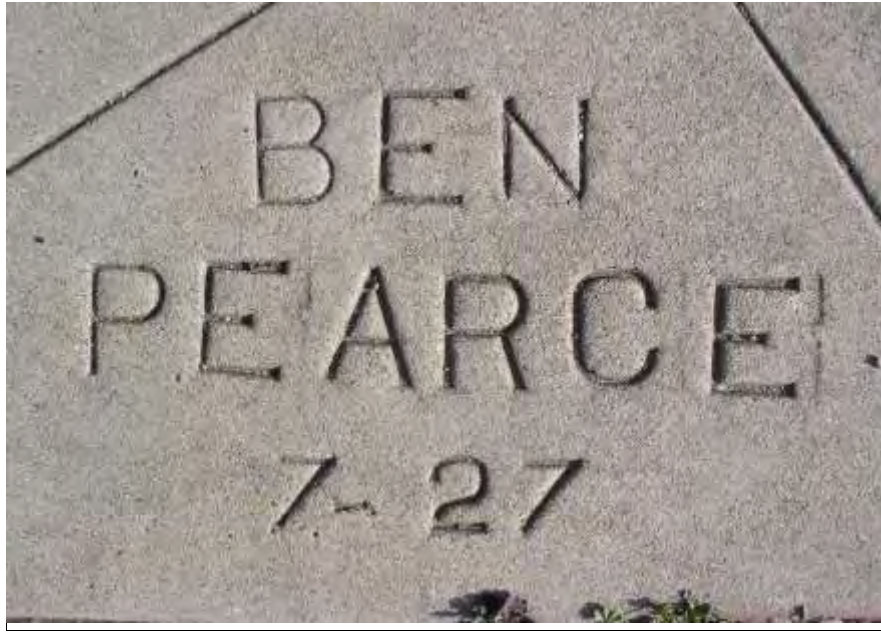
P5a. Photograph or Drawing (Photograph required for buildings, structures, and objects)

\* P3a. Description: (Describe resource and its major elements. Include design, materials, condition, alterations, size, setting, and boundaries.)  
This sidewalk stamp, dated 1927, identifies the name of a the contractor involved in the improvements for Islenair, Ben Pearce.

Photo of the stamp on the public right-of-way

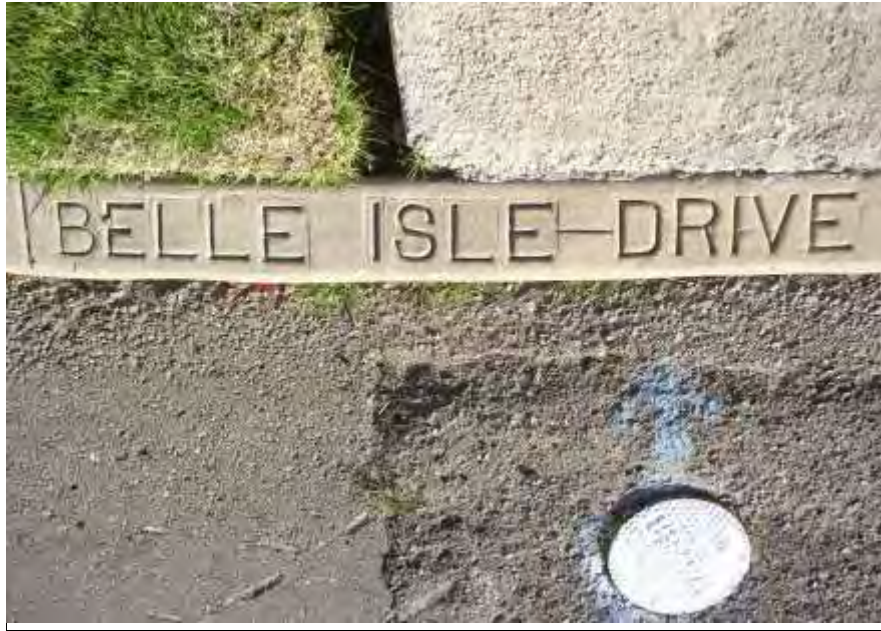
P5a. Photograph or Drawing (Photograph required for buildings, structures, and objects)

\* P3a. Description: (Describe resource and its major elements. Include design, materials, condition, alterations, size, setting, and boundaries.)  
This sidewalk stamp, dating from the installation of improvements, identifies the name of the street, Belle Isle Drive.

Photo of the stamp on the public right-of-way

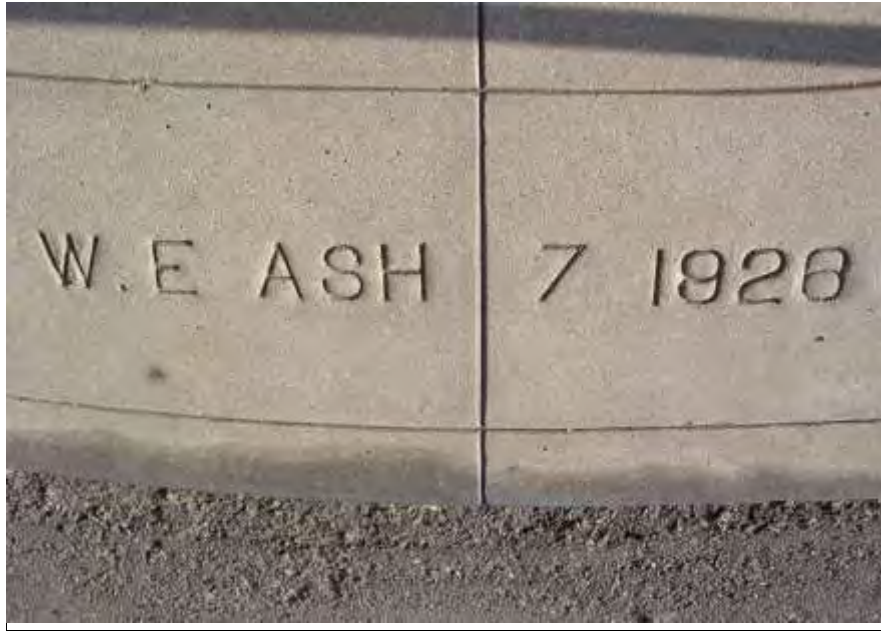
P5a. Photograph or Drawing (Photograph required for buildings, structures, and objects)

\* P3a. Description: (Describe resource and its major elements. Include design, materials, condition, alterations, size, setting, and boundaries.)  
This sidewalk stamp, dated 1926, identifies the name of a contractor involved in the improvements for Islenair, W.E. Ash.

Photo of the stamp on the public right-of-way

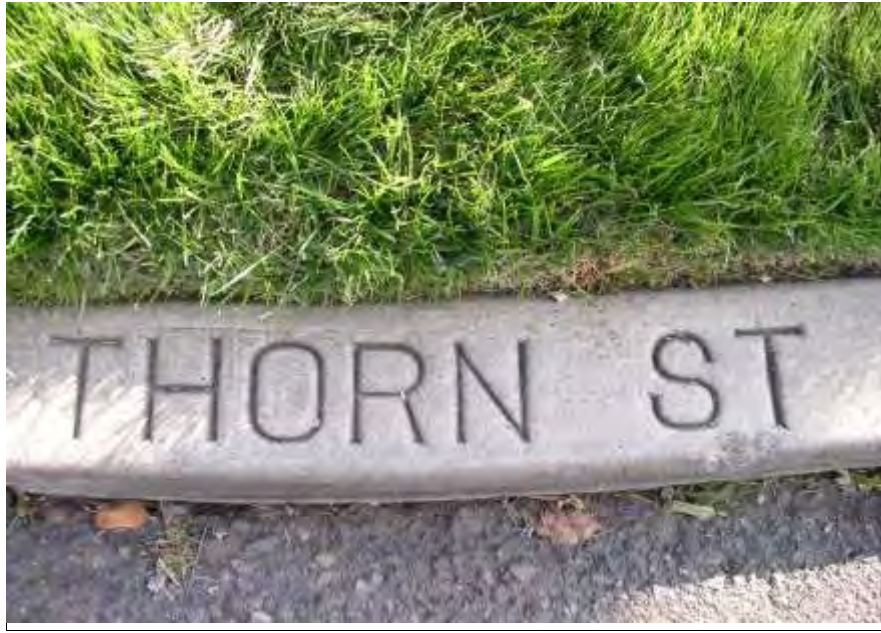
P5a. Photograph or Drawing (Photograph required for buildings, structures, and objects)

\* P3a. Description: (Describe resource and its major elements. Include design, materials, condition, alterations, size, setting, and boundaries.)  
This sidewalk stamp, dating from the installation of improvements, identifies the name of the street, Thorn Street.

Photo of the stamp on the public right-of-way

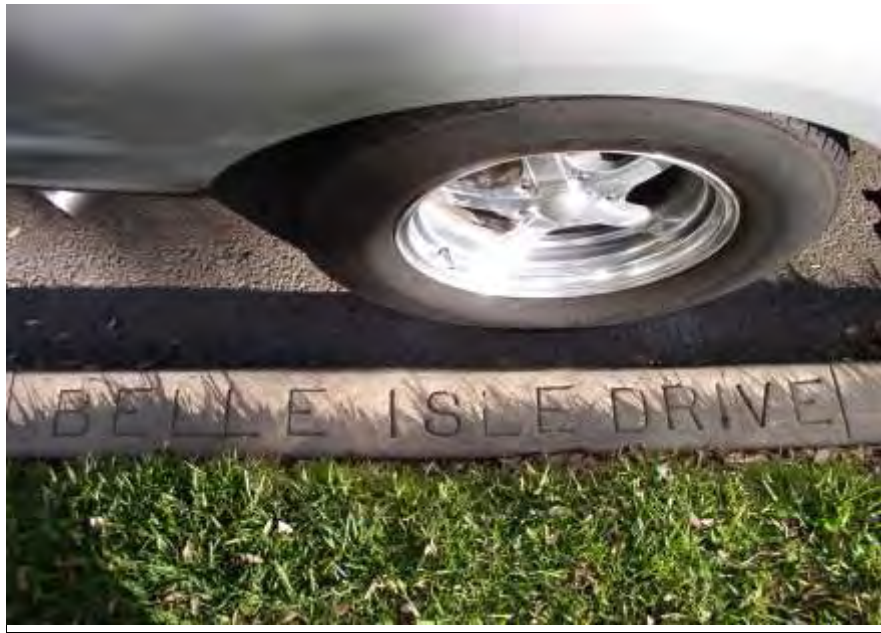
P5a. Photograph or Drawing (Photograph required for buildings, structures, and objects)

\* P3a. Description: (Describe resource and its major elements. Include design, materials, condition, alterations, size, setting, and boundaries.)  
This sidewalk stamp, dating from the installation of improvements, identifies the name of the street, Belle Isle Drive.

Photo of the stamp on the public right-of-way

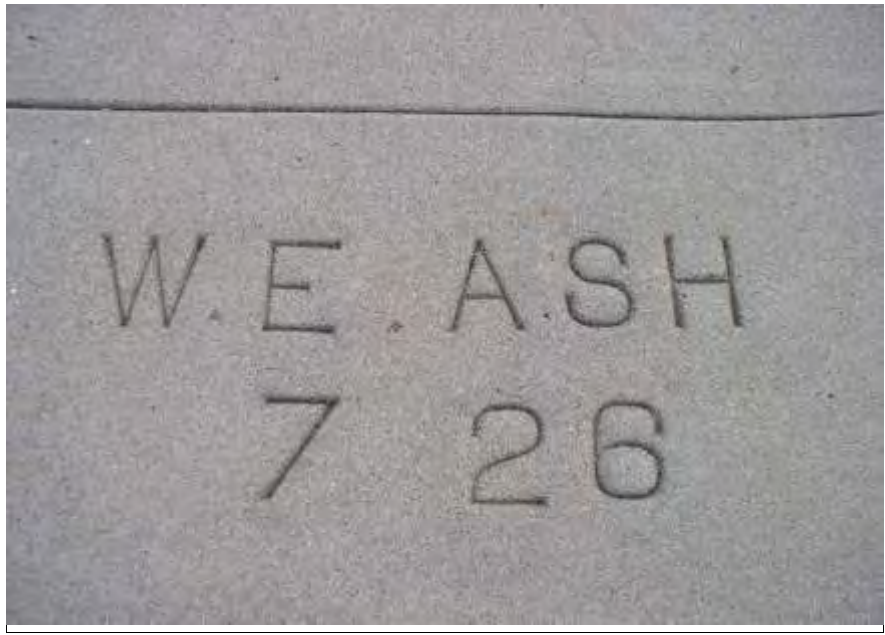
P5a. Photograph or Drawing (Photograph required for buildings, structures, and objects)

\* P3a. Description: (Describe resource and its major elements. Include design, materials, condition, alterations, size, setting, and boundaries.)  
This sidewalk stamp, dated 1926, identifies the name of a contractor involved in the improvements for Islenair, W.E. Ash.

Photo of the stamp on the public right-of-way

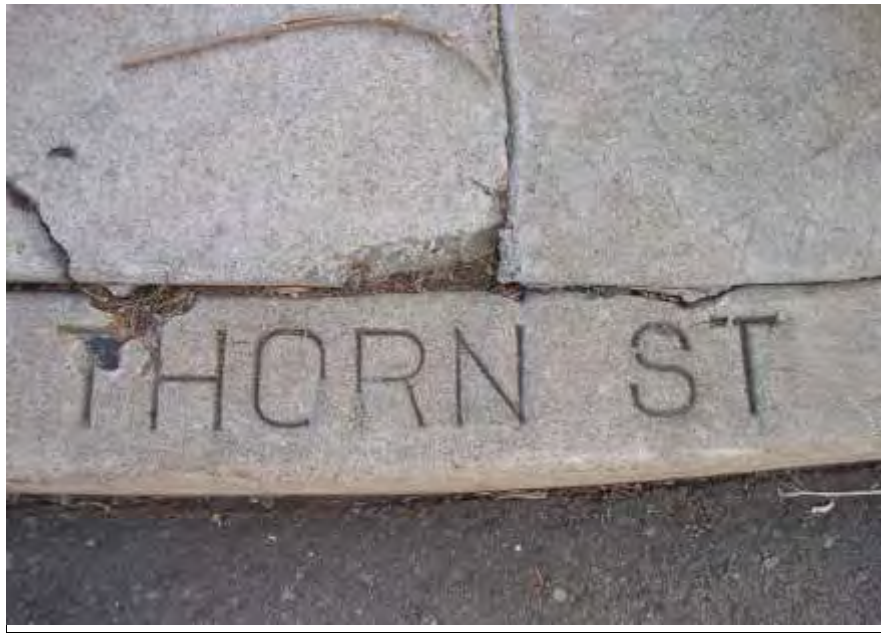
P5a. Photograph or Drawing (Photograph required for buildings, structures, and objects)

\* P3a. Description: (Describe resource and its major elements. Include design, materials, condition, alterations, size, setting, and boundaries.)  
This sidewalk stamp, dating from the installation of improvements, identifies the name of the street, Thorn Street.

Photo of the stamp on the public right-of-way

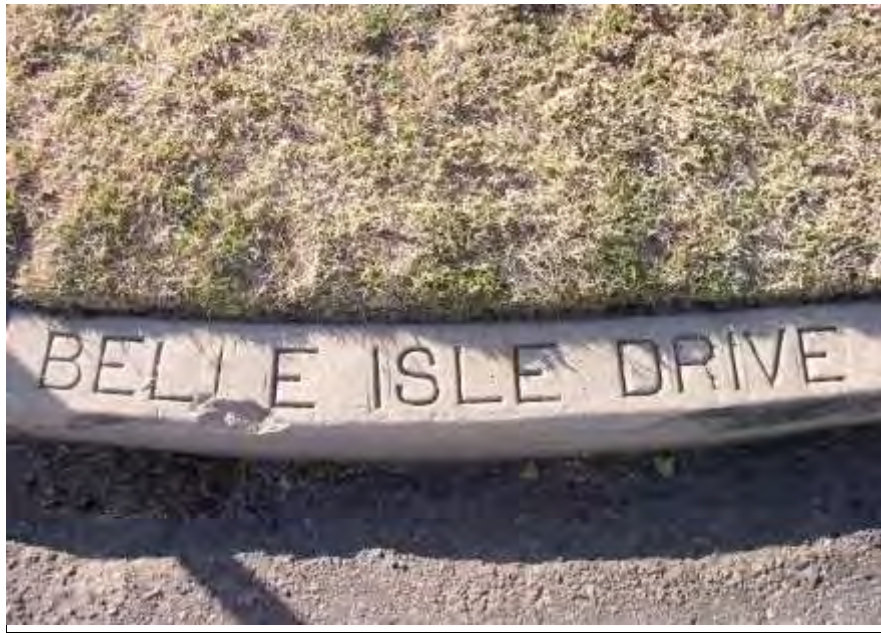
P5a. Photograph or Drawing (Photograph required for buildings, structures, and objects)

\* P3a. Description: (Describe resource and its major elements. Include design, materials, condition, alterations, size, setting, and boundaries.)  
This sidewalk stamp, dating from the installation of improvements, identifies the name of the street, Belle Isle Drive.

Photo of the stamp on the public right-of-way

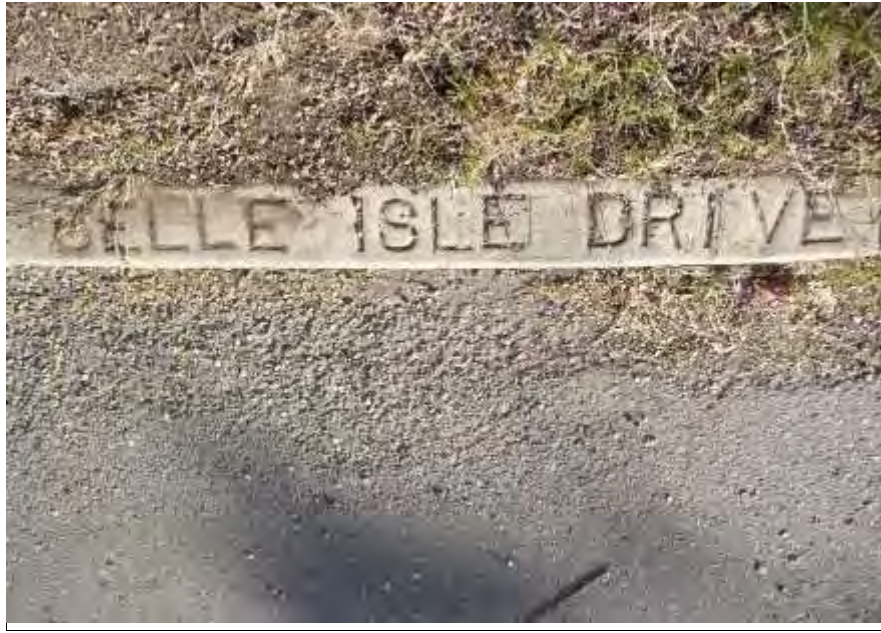
P5a. Photograph or Drawing (Photograph required for buildings, structures, and objects)

\* P3a. Description: (Describe resource and its major elements. Include design, materials, condition, alterations, size, setting, and boundaries.)  
This sidewalk stamp, dating from the installation of improvements, identifies the name of the street, Belle Isle Drive.

Photo of the stamp on the public right-of-way

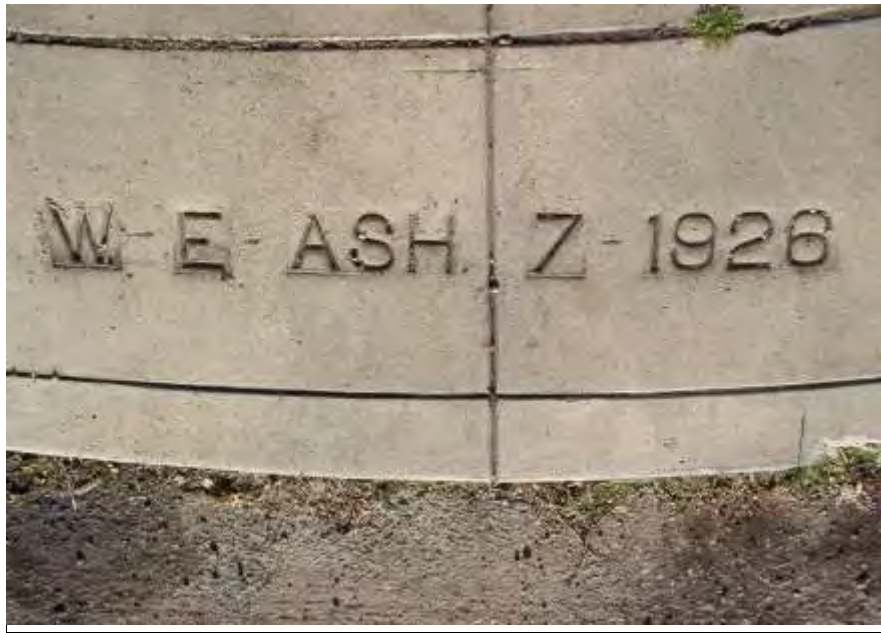
P5a. Photograph or Drawing (Photograph required for buildings, structures, and objects)

\* P3a. Description: (Describe resource and its major elements. Include design, materials, condition, alterations, size, setting, and boundaries.)  
This sidewalk stamp, dated 1926, identifies the name of a contractor involved in the improvements for Islenair, W.E. Ash.

Photo of the stamp on the public right-of-way

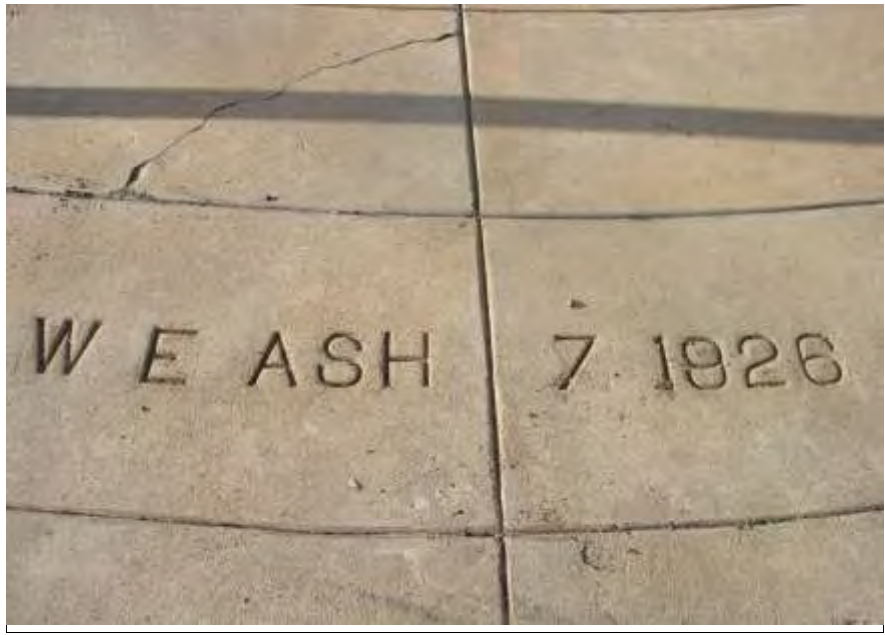
P5a. Photograph or Drawing (Photograph required for buildings, structures, and objects)

\* P3a. Description: (Describe resource and its major elements. Include design, materials, condition, alterations, size, setting, and boundaries.)  
This sidewalk stamp, dated 1926, identifies the name of a contractor involved in the improvements for Islenair, W.E. Ash.

Photo of the stamp on the public right-of-way

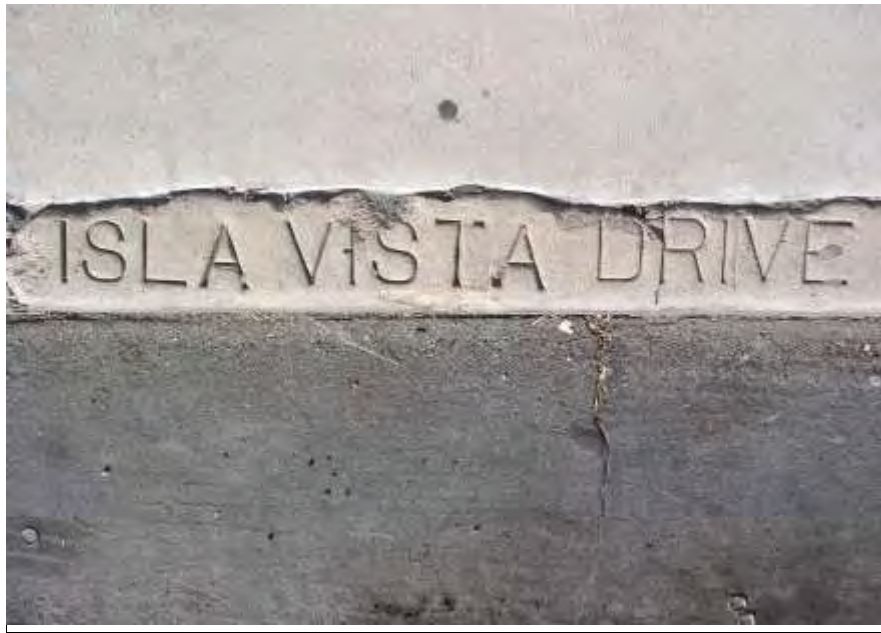
P5a. Photograph or Drawing (Photograph required for buildings, structures, and objects)

\* P3a. Description: (Describe resource and its major elements. Include design, materials, condition, alterations, size, setting, and boundaries.)  
This sidewalk stamp, dating from the installation of improvements, identifies the name of the street, Isla Vista Drive.

Photo of the stamp on the public right-of-way

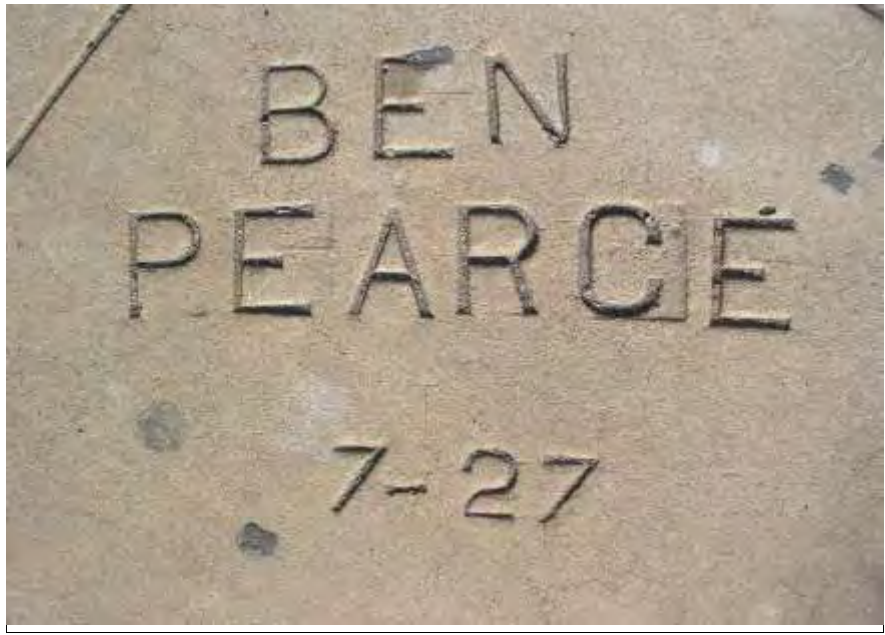
P5a. Photograph or Drawing (Photograph required for buildings, structures, and objects)

\* P3a. Description: (Describe resource and its major elements. Include design, materials, condition, alterations, size, setting, and boundaries.)  
This sidewalk stamp, dated 1927, identifies the name of a the contractor involved in the improvements for Islenair, Ben Pearce.

P5b. Description of Photo: (View, date, etc.)  
Photo of the stamp on the public right-of-way

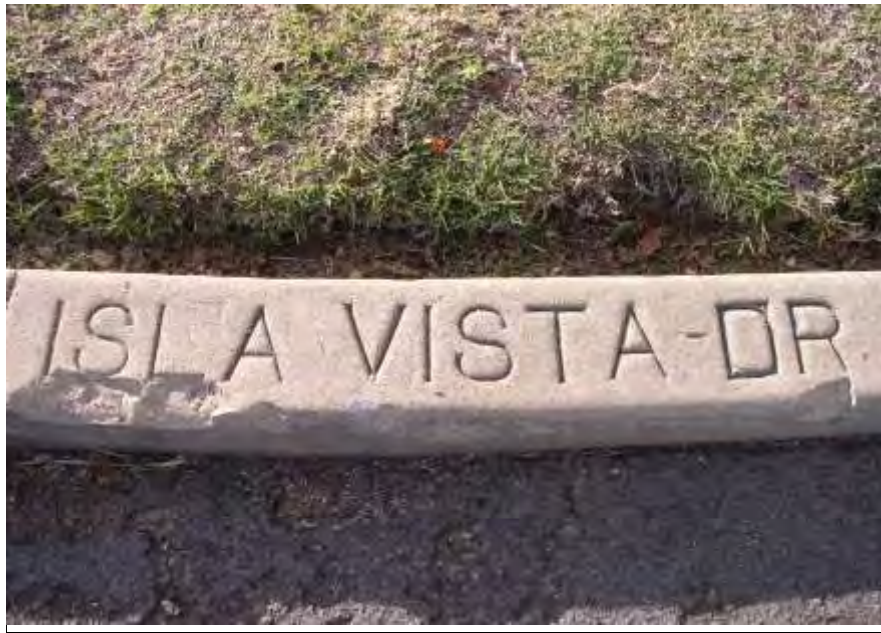
P5a. Photograph or Drawing (Photograph required for buildings, structures, and objects)

\* P3a. Description: (Describe resource and its major elements. Include design, materials, condition, alterations, size, setting, and boundaries.)  
This sidewalk stamp, dating from the installation of improvements, identifies the name of the street, Isla Vista Drive.

Photo of the stamp on the public right-of-way

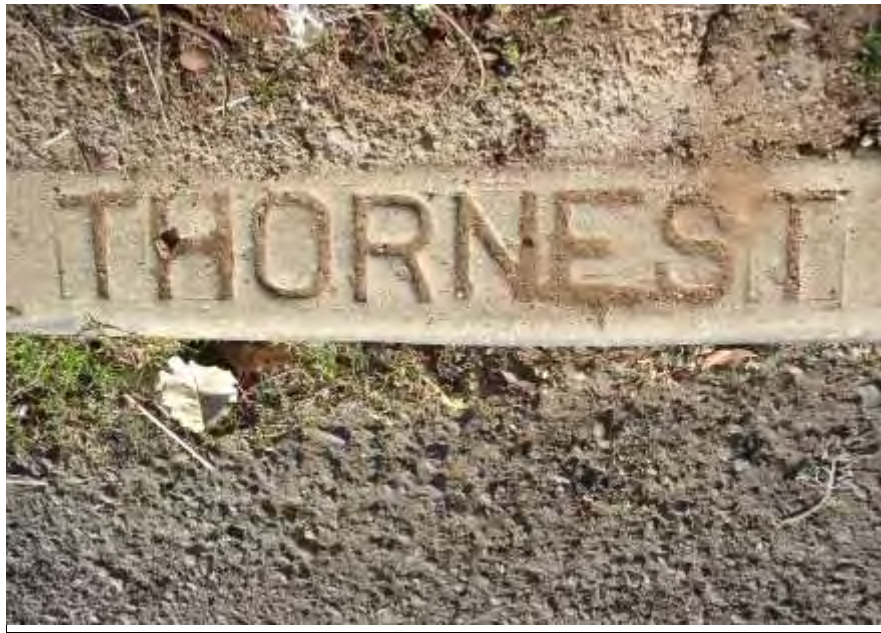
P5a. Photograph or Drawing (Photograph required for buildings, structures, and objects)

\* P3a. Description: (Describe resource and its major elements. Include design, materials, condition, alterations, size, setting, and boundaries.)  
This sidewalk stamp, dating from the installation of improvements, identifies the name of the street, Thorn Street.

Photo of the stamp on the public right-of-way

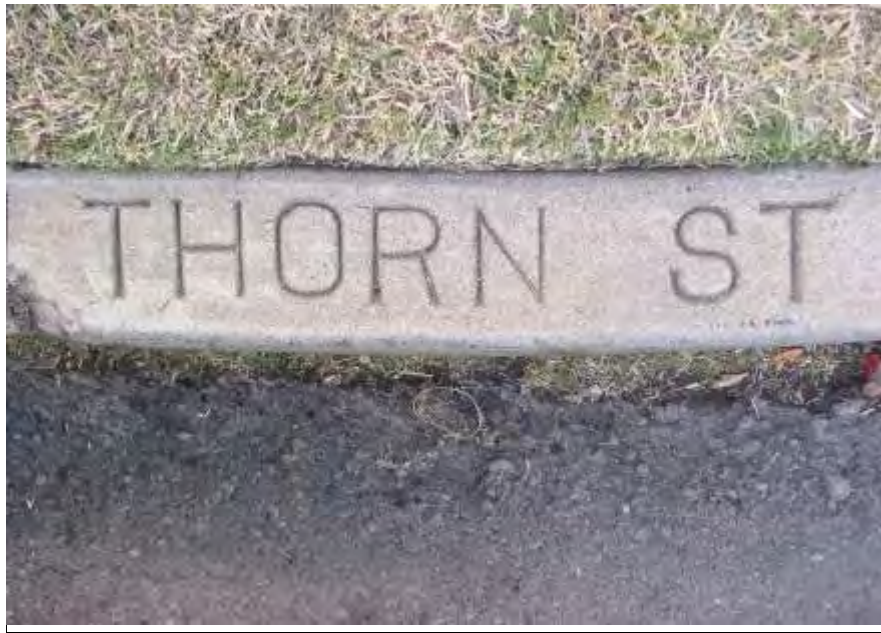
P5a. Photograph or Drawing (Photograph required for buildings, structures, and objects)

\* P3a. Description: (Describe resource and its major elements. Include design, materials, condition, alterations, size, setting, and boundaries.)  
This sidewalk stamp, dating from the installation of improvements, identifies the name of the street, Thorn Street.

Photo of the stamp on the public right-of-way

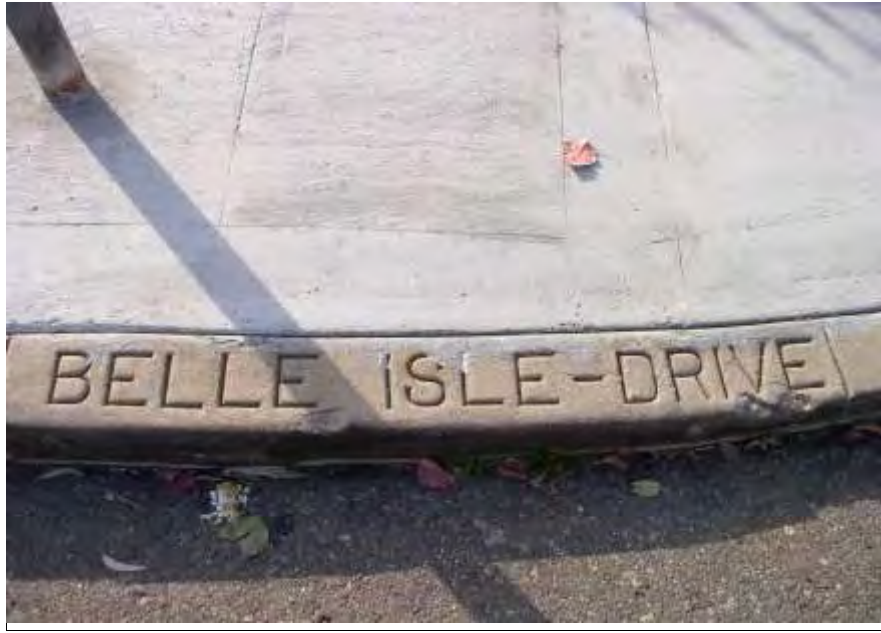
P5a. Photograph or Drawing (Photograph required for buildings, structures, and objects)

\* P3a. Description: (Describe resource and its major elements. Include design, materials, condition, alterations, size, setting, and boundaries.)  
This sidewalk stamp, dating from the installation of improvements, identifies the name of the street, Belle Isle Drive.

P5b. Description of Photo: (View, date, etc.)  
Photo of the stamp on the public right-of-way
