# *Islenair Historic District*

Designated by the City of San Diego  
Historical Resources Board  
April 26, 2007

*Prepared by  
The City of San Diego  
City Planning and Community Investment Department  
Historical Resources Section*

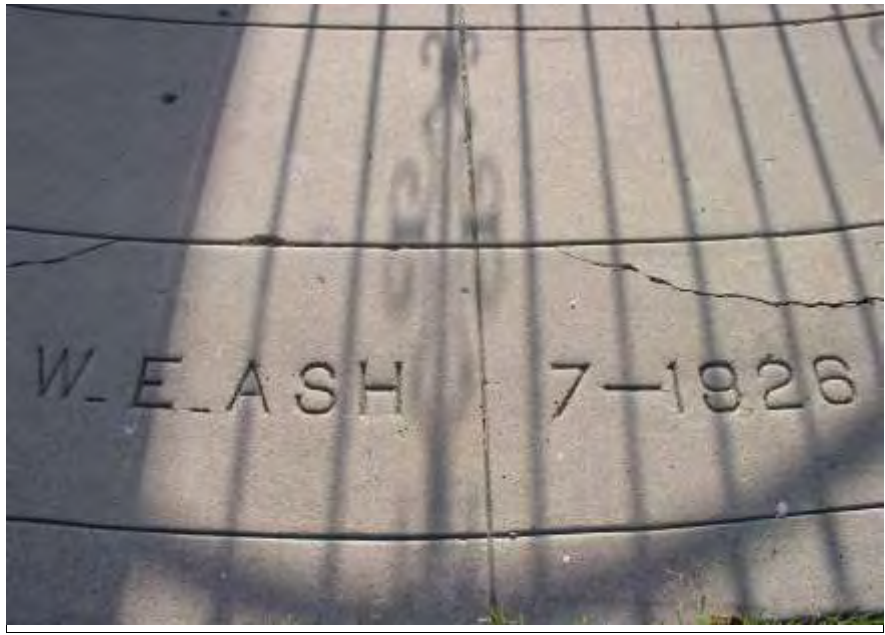
P5a. Photograph or Drawing (Photograph required for buildings, structures, and objects)

\* P3a. Description: (Describe resource and its major elements. Include design, materials, condition, alterations, size, setting, and boundaries.)  
This sidewalk stamp, dated 1926, identifies the name of a contractor involved in the improvements for Islenair, W.E. Ash.

P5b. Description of Photo: (View, date, etc.)  
Photo of the stamp on the public right-of-way

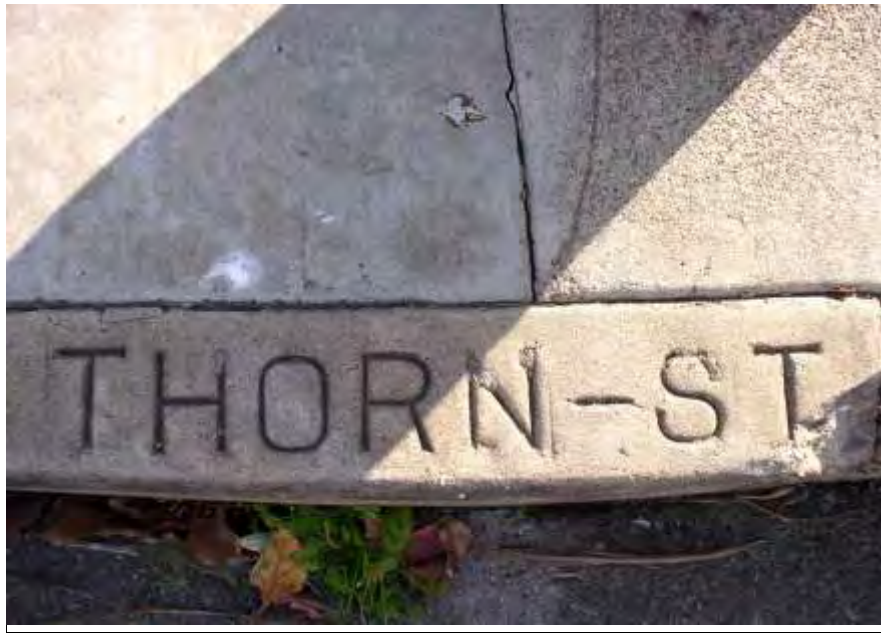
P5a. Photograph or Drawing (Photograph required for buildings, structures, and objects)

\* P3a. Description: (Describe resource and its major elements. Include design, materials, condition, alterations, size, setting, and boundaries.)  
This sidewalk stamp, dating from the installation of improvements, identifies the name of the street, Thorn Street.

Photo of the stamp on the public right-of-way

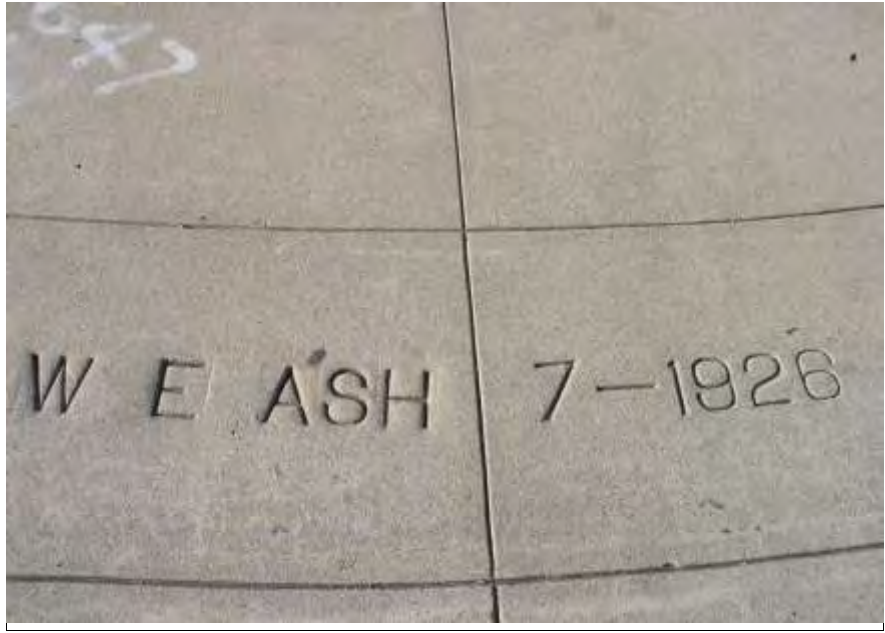
P5a. Photograph or Drawing (Photograph required for buildings, structures, and objects)

\* P3a. Description: (Describe resource and its major elements. Include design, materials, condition, alterations, size, setting, and boundaries.)  
This sidewalk stamp, dated 1926, identifies the name of a contractor involved in the improvements for Islenair, W.E. Ash.

P5b. Description of Photo: (View, date, etc.)  
Photo of the stamp on the public right-of-way

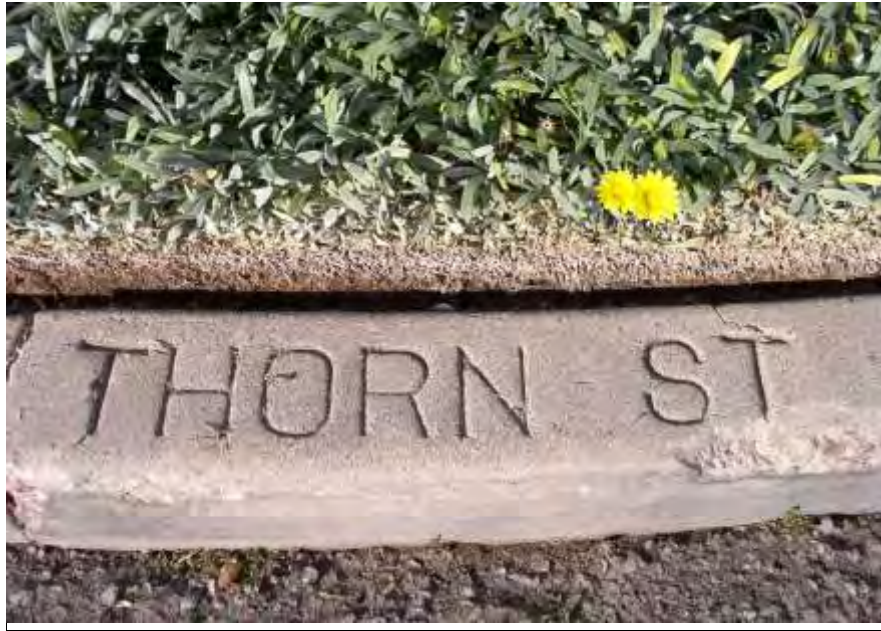
P5a. Photograph or Drawing (Photograph required for buildings, structures, and objects)

\* P3a. Description: (Describe resource and its major elements. Include design, materials, condition, alterations, size, setting, and boundaries.)  
This sidewalk stamp, dating from the installation of improvements, identifies the name of the street, Thorn Street.

Photo of the stamp on the public right-of-way

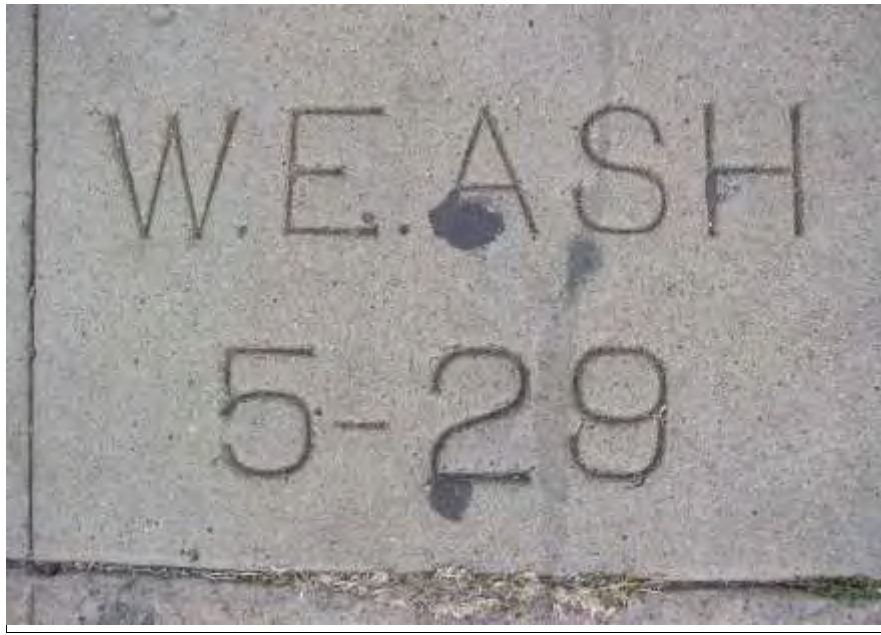
P5a. Photograph or Drawing (Photograph required for buildings, structures, and objects)

\* P3a. Description: (Describe resource and its major elements. Include design, materials, condition, alterations, size, setting, and boundaries.)  
This sidewalk stamp, dated 1929, identifies the name of a contractor involved in the improvements for Islenair, W.E. Ash.

Photo of the stamp on the public right-of-way

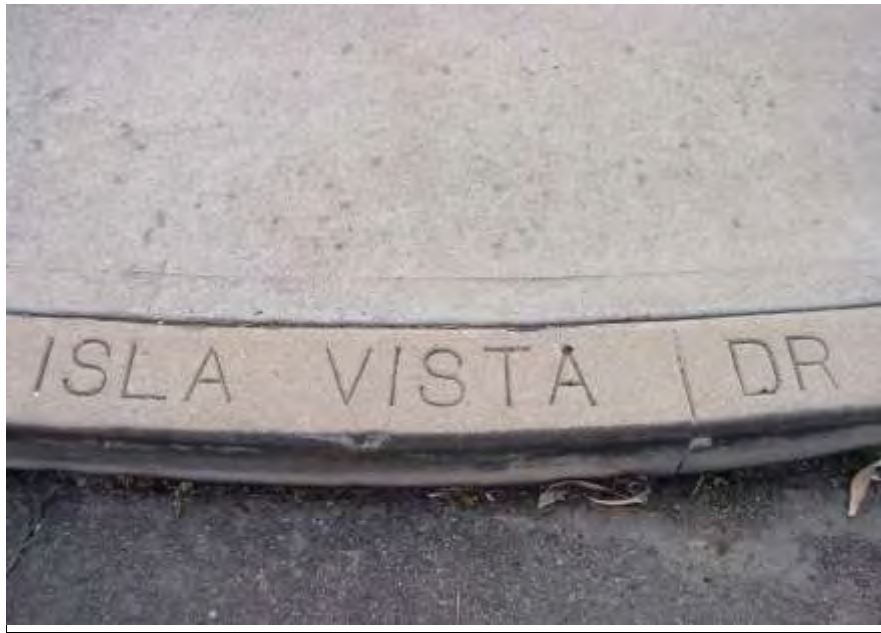
P5a. Photograph or Drawing (Photograph required for buildings, structures, and objects)

\* P3a. Description: (Describe resource and its major elements. Include design, materials, condition, alterations, size, setting, and boundaries.)  
This sidewalk stamp, dating from the installation of improvements, identifies the name of the street, Isla Vista Drive.

Photo of the stamp on the public right-of-way

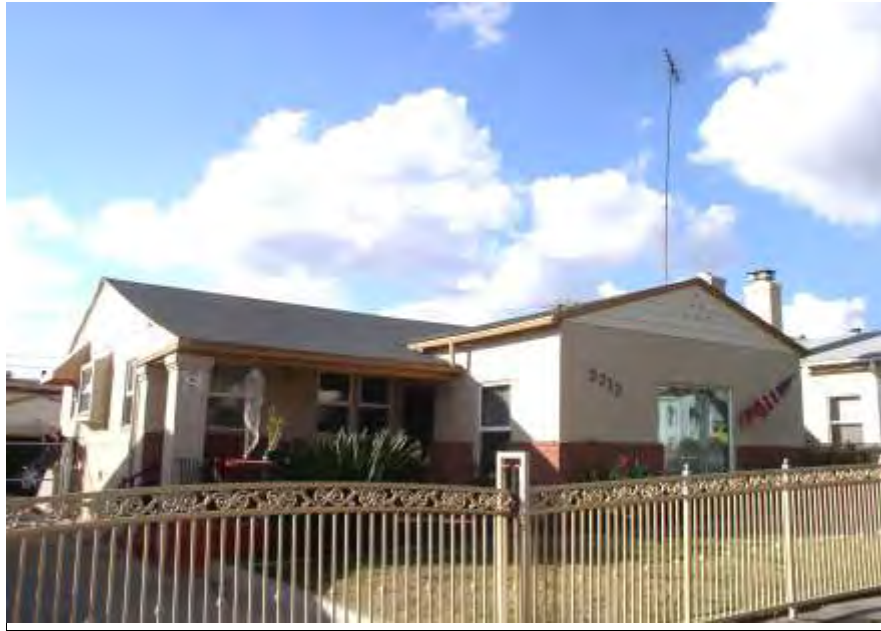
Photo of the primary façade from the public right-of-way.

The house was built in 1936 per water and sewer records. Modifications include the use of moderately textured stucco, the replacement of the composition roof with a new composition roof, the replacement of the wood frame and sash windows with vinyl windows, and the likely replacement of the wood post porch support with a large stucco column. The house is in fair to good condition and retains a fair to poor degree of integrity.

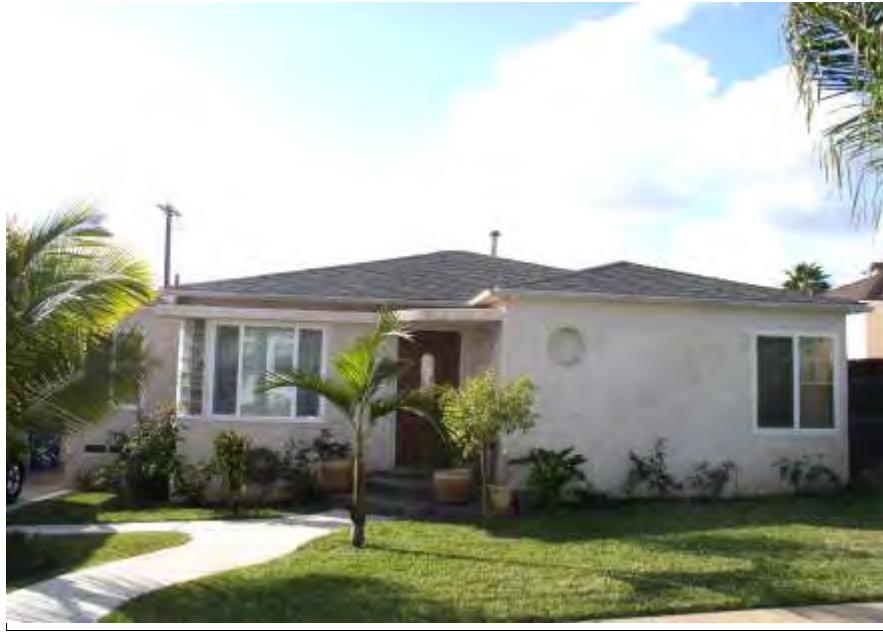
\* P3a. Description: (Describe resource and its major elements. Include design, materials, condition, alterations, size, setting, and boundaries.)  
The house at 3230 Belle Isle Drive was built in 1938 in the Minimal Traditional style with Art Moderne influences and features a medium-pitch hipped roof with composition shingles; slight eave overhang; and a heavily textured stucco exterior. The entry is accessed via two concrete steps which lead to the entry door. A curvilinear stucco projection cantilevers over the entry and the adjacent wall. Fenestration consists of 4-over-1 double hung vinyl frame and sash windows and a glass block element at the corner to the left of the entry. A round portal window has been filled in, but its location and size is still readily apparent. Refer to BSOR Section B.6. for modifications and analysis of integrity.

Photo of the primary façade from the public right-of-way.

The house was constructed in 1938 per water and sewer records. Modifications include the use of heavily textured stucco, the replacement of the composition roof with a new composition roof, the replacement of the wood frame and sash window with vinyl windows, and the round portal window, which was filled in. The house is in fair to good condition and retains a fair to poor degree of integrity.

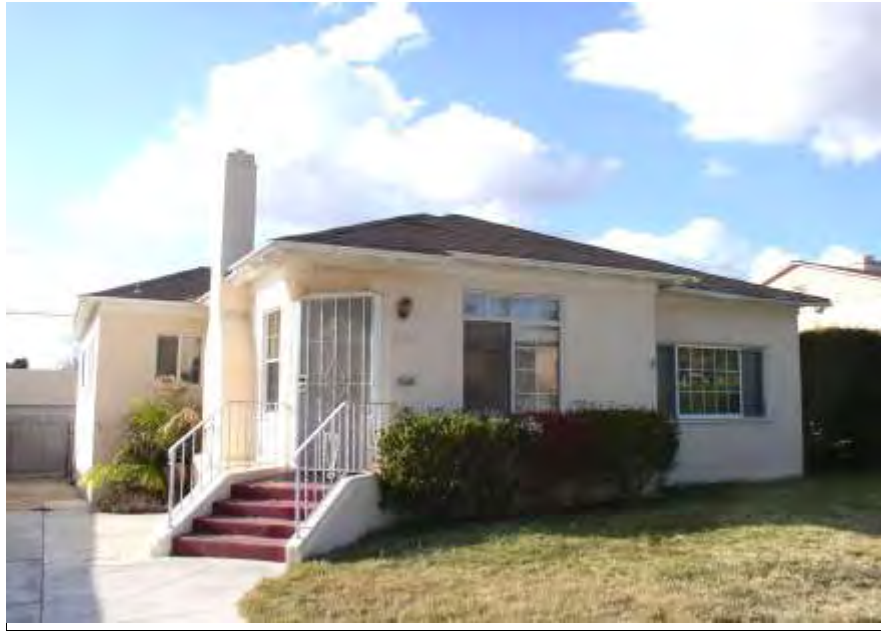
\* P3a. Description: (Describe resource and its major elements. Include design, materials, condition, alterations, size, setting, and boundaries.)  
The house at 3236 Belle Isle was built in 1937 in the Minimal Traditional style and features multi-hipped roof with composition shingles; a slight eave overhang; exposed notched eaves; a moderately textured stucco exterior; and a chimney on the south side of the house. The entry is set on the southeast corner of the house and is accessed via four concrete steps with a decorative wrought iron handrail. Fenestration consists of a 15-lite fixed vinyl frame window, 8-lite vinyl casement windows under a 4-lite vinyl transom, 4-over-4 double hung vinyl windows, and 6-lite vinyl casement windows. Wrought iron security bars cover the doors and windows. Refer to BSOR Section B.6. for modifications and analysis of integrity.

Photo of the primary façade from the public right-of-way.

The house was constructed in 1937 per water and sewer records. Modifications include the use of moderately textured stucco, which may have replaced clapboard siding, the replacement of the composition roof with a new composition roof, the replacement of the windows with vinyl windows, the use of wrought iron stair railing and security door, and the likely modification of the main façade. The house is in fair condition and retains a poor degree of integrity.

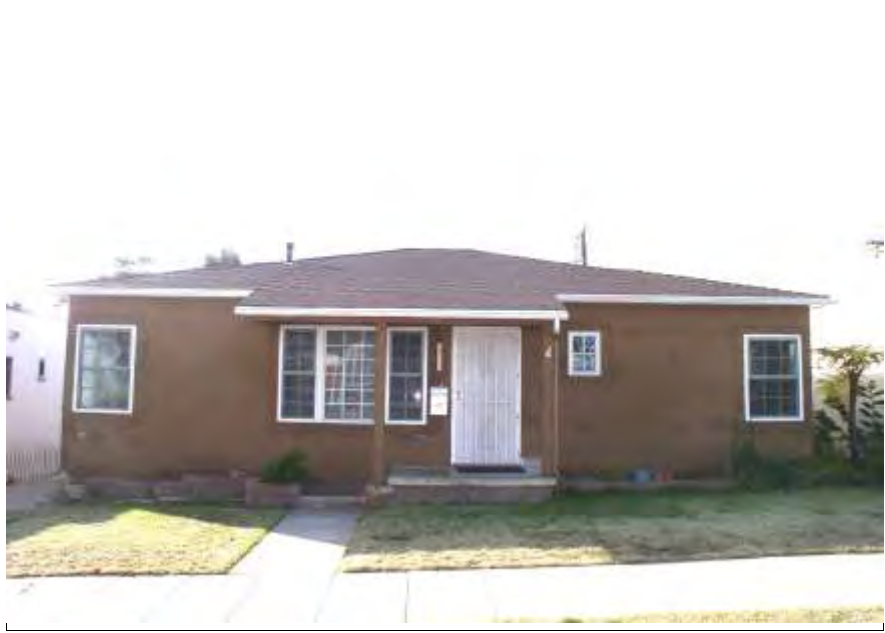
\* P3a. Description: (Describe resource and its major elements. Include design, materials, condition, alterations, size, setting, and boundaries.)  
The house at 3314 Belle Isle Drive was constructed in 1938 in the Minimal Traditional style and features a hipped roof with composition shingles; and a moderately textured stucco exterior. The entry is accessed via three concrete steps, is set to the left under a roof projection supported on two 4x4 wood posts. Fenestration consists of 6-over-6 double hung, 18-lite fixed, and 4-lite fixed vinyl frame and sash windows. Refer to BSOR Section B.6. for modifications and analysis of integrity.

Photo of the primary façade from the public right-of-way.

\* B6. Construction History: (Construction date, alterations, and date of alterations.)  
The house was constructed in 1938 per water and sewer records. Modifications include the use of moderately textured stucco, the replacement of the composition roof with a new composition roof, and the use of vinyl windows. The house is in good condition and retains a fair degree of integrity.

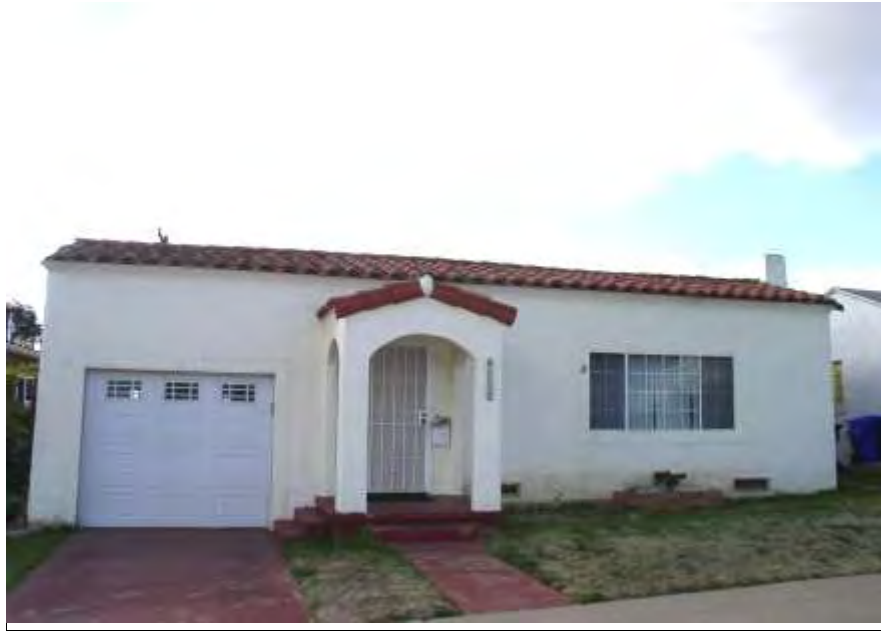
\* P3a. Description: (Describe resource and its major elements. Include design, materials, condition, alterations, size, setting, and boundaries.)  
The house at 3320 Belle Isle Drive was built in 1930 in the Spanish Eclectic style and features a flat roof with a shed clay tile roof at the parapet; clipped eaves; a smooth stucco exterior; and a chimney on the north elevation. The entry, accessed via three concrete steps, is set to the left and covered by a front-facing gable projection with arched openings on three sides (This element may have been added or modified). A 16-lite fixed vinyl window flanked by 8-lite vinyl windows replaced the original window and modified the size of the opening. The garage is set to the left of the entry, and the size of the opening appears to have been modified. Refer to BSOR Section B.6. for modifications and analysis of integrity.

Photo of the primary façade from the public right-of-way.

The house was constructed in 1930 per water and sewer records. Modifications include altering the size of the window openings, the use of vinyl windows, possible alteration of the entry, the use of a wrought iron security door, and modification of the garage opening. The house is in fair condition and retains a poor degree of integrity.

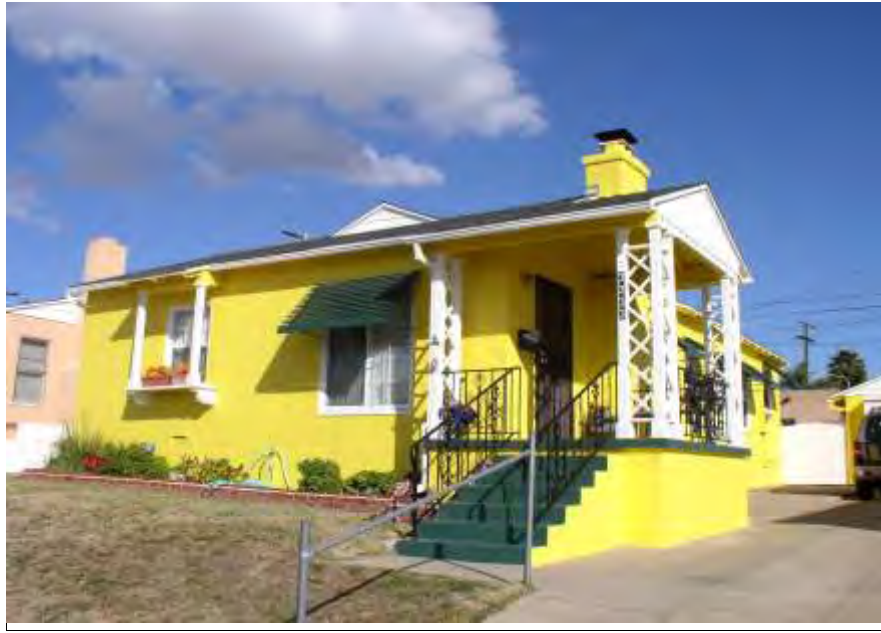
\* P3a. Description: (Describe resource and its major elements. Include design, materials, condition, alterations, size, setting, and boundaries.)  
The house at 3333 Belle Isle Drive was built in 1936 in the Minimal Traditional style and features a medium pitch cross-gable roof; composition shingles; slight eave overhang; exposed rafter tails in the original portion of the house; a stucco exterior; and a chimney on the south elevation. The original house is front gabled with horizontal clapboard in the gable end. A dominant side gable element was added to the front of the house to form a "T" intersection. The gable peak of the original portion of the house is still evident at the ridgeline of the addition. The addition features vertical wood siding in the gable end and minimal eave overhang with no raftertails. The entry, accessed via seven concrete steps with a wrought iron railing, is located at the south end of the side gable addition and is set under the gable end supported on several groupings of wood posts with cross supports. The entry door is set perpendicularly to the sidewalk. Fenestration consists of 6-over-6 double hung and 10-lite slider vinyl frame and sash windows. Green slatted metal awnings cover the windows. Refer to BSOR Section B.6. for modifications and analysis of integrity.

Photo of the primary façade from the public right-of-way.

The house was constructed in 1936 per water and sewer records. Modifications include the replacement of the composition roof with a new composition roof, the addition of a side gable element with porch to the front of the house (likely an early modification), the replacement of the original wood windows with vinyl windows (likely in the original openings), and the addition of green metal awnings. The house is in good condition and retains a poor degree of integrity.

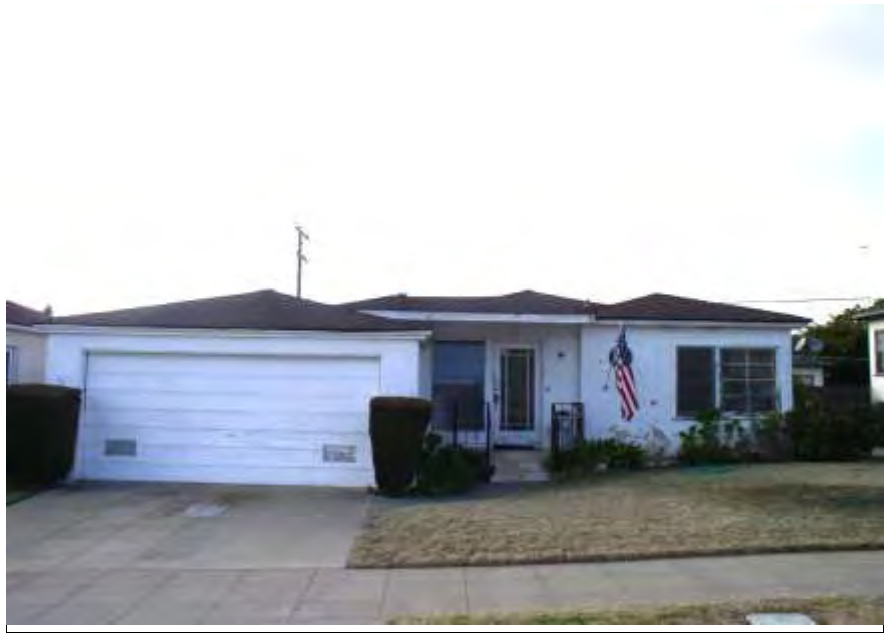
\* P3a. Description: (Describe resource and its major elements. Include design, materials, condition, alterations, size, setting, and boundaries.)  
The house located at 3404 Belle Isle Drive was built in 1939 in the Minimal Traditional style and features a multi-hipped roof; composition shingles; and a smooth stucco exterior. The house is "U" shaped with three bays: a dominant forward bay to the left which contains a two-car garage, a recessed central bay containing the entry accessed by three concrete steps, and a right bay set just forward of the central bay which contains a small round portal window, a 4-over-4 wood frame and sash window, and an 8-lite fixed wood frame window. An aluminum louvered window is set to the left of the entry door, which is parallel to the sidewalk. Refer to BSOR Section B.6. for modifications and analysis of integrity.

Photo of the primary façade from the public right-of-way.

The house was constructed in 1939 per water and sewer records. Modifications include the replacement of the composition roof with a new composition roof, and the enclosure and expansion of the porch to ad 760 square feet of habitable space in 1965. The date of construction for the garage is unknown. The house is in fair condition and retains a fair to poor degree of integrity.

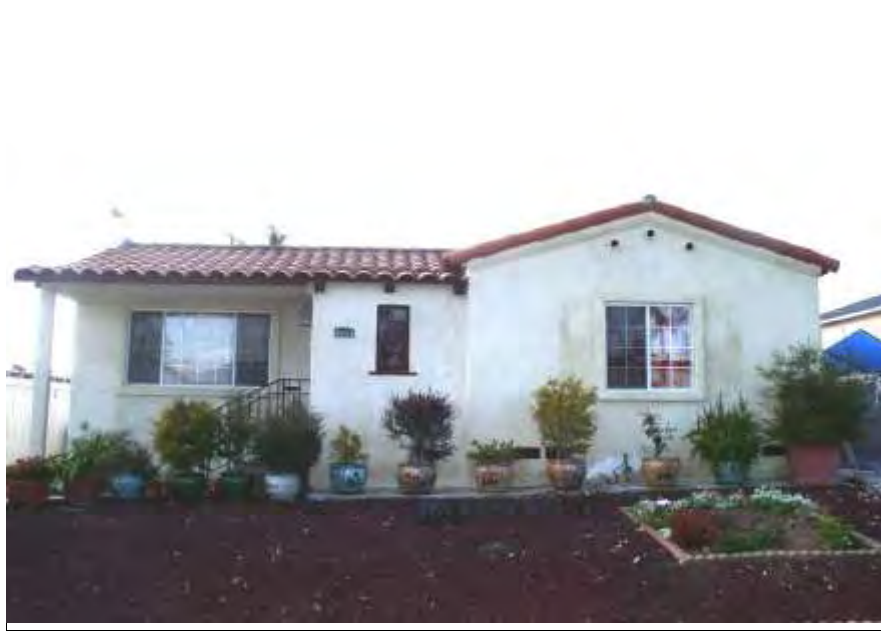
\* P3a. Description: (Describe resource and its major elements. Include design, materials, condition, alterations, size, setting, and boundaries.)  
The house at 3434 Belle Isle Drive was built in 1936 in the Spanish Eclectic style and features a flat roof with a clay tile shed roof along the parapet line and a projecting front-gable bay; clay tile roof vents and drains; a moderately textured stucco exterior; and a chimney at the south elevation. The entry, accessed via four concrete steps, is set to the left under the shed roof projection supported by a square wood post. The entry door is set perpendicularly to the sidewalk. Fenestration consists of a tripartite window with a 16-lite fixed vinyl window flanked by 8-lite sliding vinyl windows, and sash windows at the porch and an 8-lite sliding vinyl window in the gable bay. All windows are framed with a raised stucco surround. Refer to BSOR Section B.6. for modifications and analysis of integrity.

Photo of the primary façade from the public right-of-way.

The house was constructed in 1936 per water and sewer records. Modifications include the replacement of the clay-tile roof with a new clay tile roof, the use of moderately textured stucco, the extension of the shed roof over the entry porch, the replacement of the original windows with vinyl windows in modified openings, the addition of stucco surrounds around the windows, and the removal of the stucco grill from the small window to the right of the entry. These modifications occurred between 2002 and 2006. The house is in good condition and retains a fair to

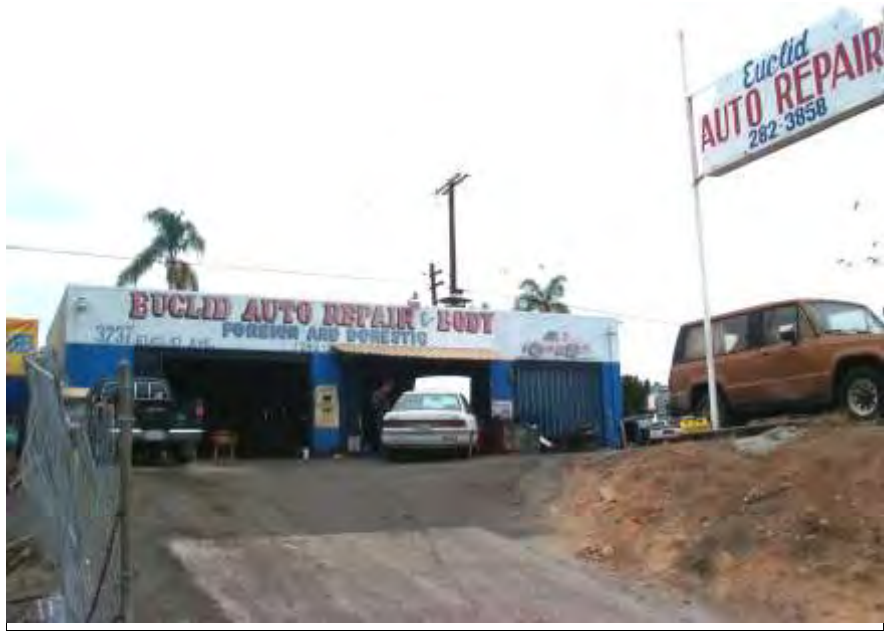
\* P3a. Description: (Describe resource and its major elements. Include design, materials, condition, alterations, size, setting, and boundaries.)  
The commercial auto-garage at 3237 Euclid Avenue is a utilitarian structure built in 1968 and features a flat roof and painted cement block walls. Fenestration consists of large openings at the garage bays with aluminum doors. Refer to BSOR Section B.6. for modifications and analysis of integrity.

Photo of the primary façade from the public right-of-way.

The commercial auto-garage was constructed in 1968 per the San Diego County Commercial Building Record. Modifications are unclear without historic photographs but appear to be minimal. The building is in fair condition and retains a fair degree of integrity.

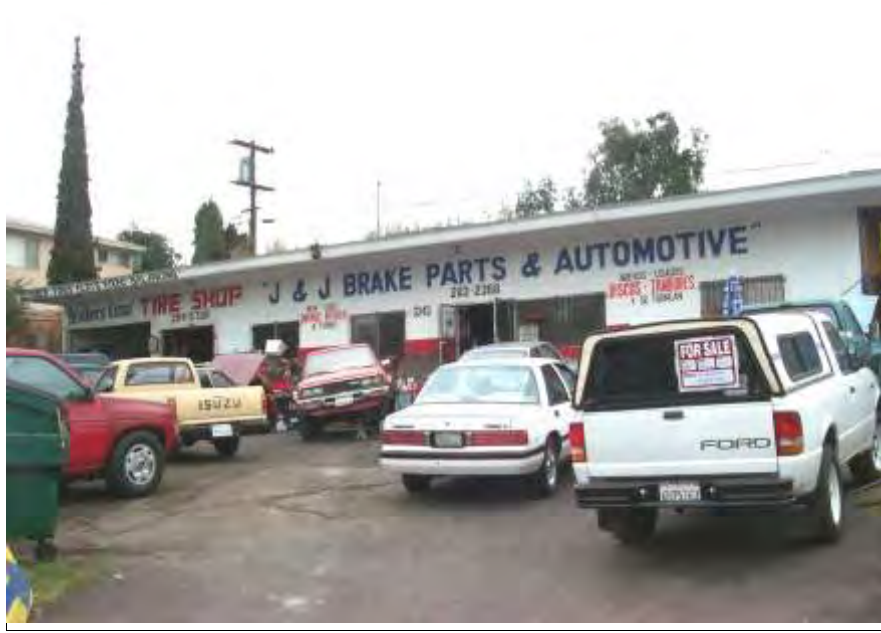
\* P3a. Description: (Describe resource and its major elements. Include design, materials, condition, alterations, size, setting, and boundaries.)  
The commercial auto-repair and tire shop at 3243 Euclid Avenue is a utilitarian structure built in 1958 and features a flat roof and painted stucco walls. Fenestration consists of aluminum doors and windows with wrought iron security bars, and large openings at the garage bays with roll-up doors. Refer to BSOR Section B.6. for modifications and analysis of integrity.

Photo of the primary façade from the public right-of-way.

The commercial auto-garage was constructed in 1958 per the San Diego County Commercial Building Record. Modifications are unclear without historic photographs but may include modification of the fenestration. The building is in fair condition and retains a fair degree of integrity.

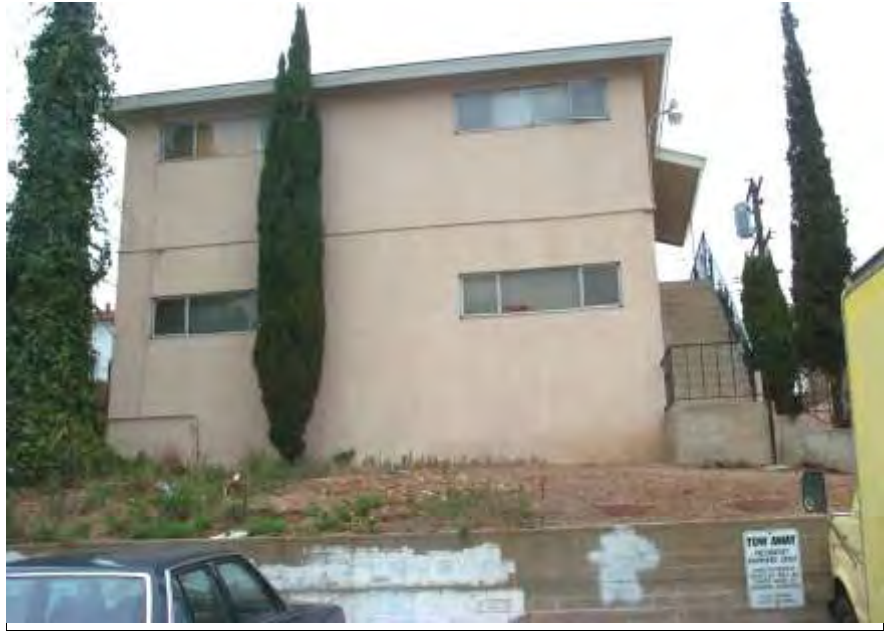
\* P3a. Description: (Describe resource and its major elements. Include design, materials, condition, alterations, size, setting, and boundaries.)  
The two-story multi-family residence at 3255 Euclid Avenue was built in 1958 in a contemporary style and features a flat roof with a slight eave and stucco walls. The entries to the units are on the south façade and are accessed via stairs with wrought iron railings. Fenestration consists of single pane sliding aluminum frame and sash windows. Refer to BSOR Section B.6. for modifications and analysis of integrity.

P5b. Description of Photo: (View, date, etc.)  
Photo of the primary façade from the public right-of-way.

The two-story multi-family residence was constructed in 1958 per the San Diego County Building Record. Modifications include the replacement of the composition roof with a new composition roof and the replacement of the original windows with aluminum frame and sash windows. The building is in good to fair condition and retains a good to fair degree of integrity.

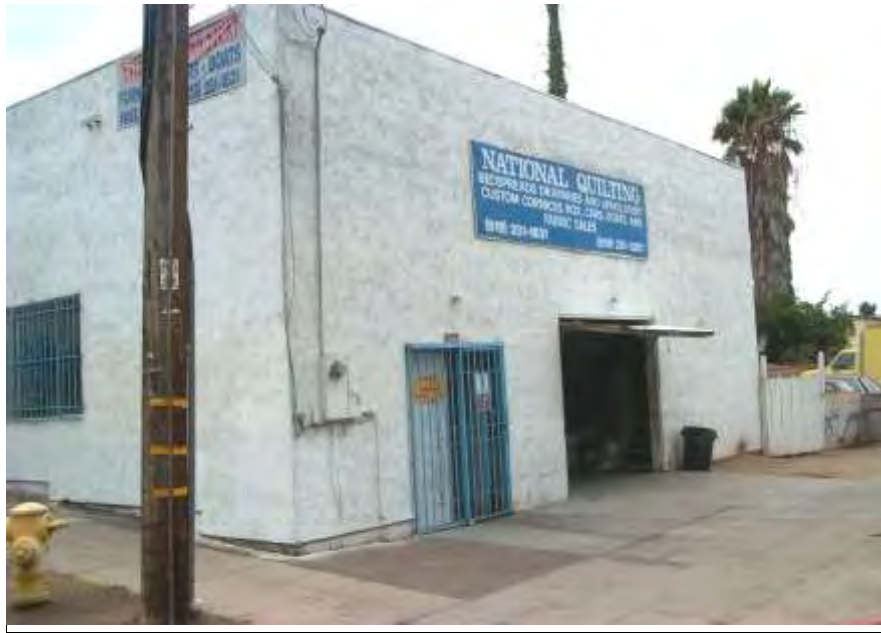
\* P3a. Description: (Describe resource and its major elements. Include design, materials, condition, alterations, size, setting, and boundaries.)  
The commercial/industrial building at 3275 Euclid Avenue, located on the same lot as 4769 Thorn Street, is a utilitarian structure built in 1979 and features a flat roof and roughly textured stucco walls. Fenestration consists of aluminum doors and windows with wrought iron security bars, and large openings at the service bays with roll-up doors. Refer to BSOR Section B.6. for modifications and analysis of integrity.

Photo of the primary façade from the public right-of-way.

The commercial/industrial building was constructed in 1979 per the San Diego County Commercial Building Record. Modifications are unclear without historic photographs. The building is in fair condition and retains a fair degree of integrity.

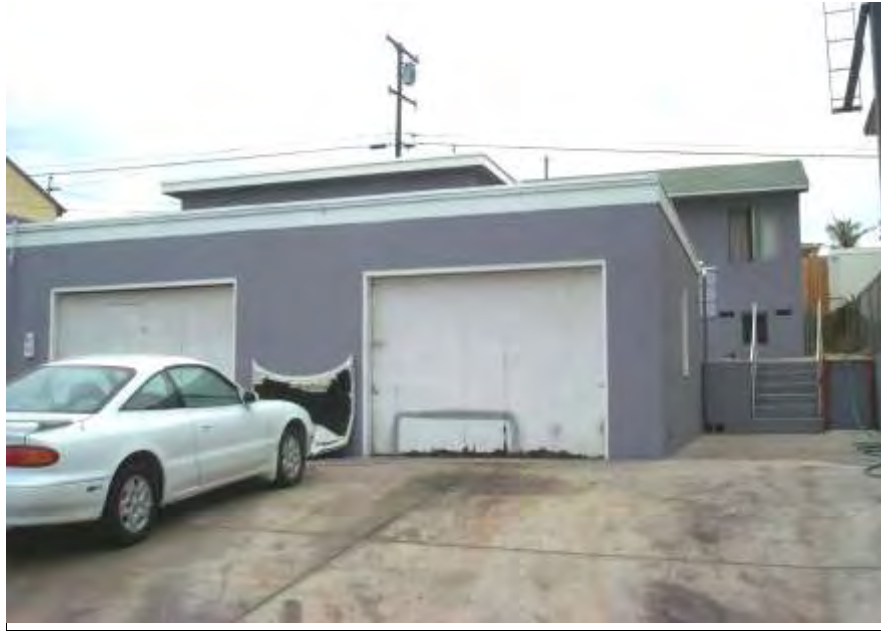
\* P3a. Description: (Describe resource and its major elements. Include design, materials, condition, alterations, size, setting, and boundaries.)  
The two-story multi-family residence at 3313 Euclid Avenue was built in 1951 in a contemporary style and features a medium pitch roof with composition shingles; a slight eave overhang; and stucco walls. The building is largely obscured by a large two-car garage. Fenestration consists of single pane sliding aluminum frame and sash windows. Refer to BSOR Section B.6. for modifications and analysis of integrity.

P5b. Description of Photo: (View, date, etc.)  
Photo of the primary façade from the public right-of-way.

The two-story multi-family residence was constructed in 1951 per the San Diego County Residential Building Record. Modifications include the replacement of the composition roof with a new composition roof; the replacement of the original windows with aluminum frame and sash windows; and the addition of a large garage which completely obscures the building. The building is in good to fair condition and retains a poor degree of integrity.

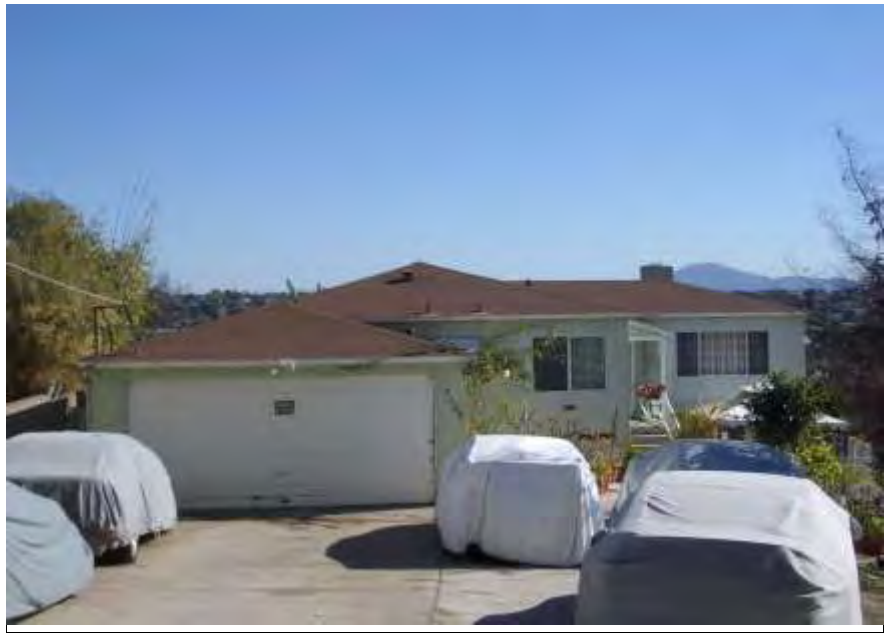
\* P3a. Description: (Describe resource and its major elements. Include design, materials, condition, alterations, size, setting, and boundaries.)  
The house at 3203 Isla Vista Drive was built in 1951 in the Minimal Traditional style with Split Level elements and features a multi-hipped roof with composition shingles; clipped eaves; and a textured stucco exterior. The entry porch, accessed via six concrete steps, is set to the right and features a roof extension supported by square wood posts. The entry door is set parallel to the sidewalk. Fenestration consists of 8-lite slider and 16-lite fixed vinyl frame and sash windows. Refer to BSOR Section B.6. for modifications and analysis of integrity.

Photo of the primary façade from the public right-of-way.

The house was constructed in 1951 per water and sewer records. Modifications include the replacement of the composition roof with a new composition roof, the use of textured stucco, and the replacement of the original wood windows with vinyl windows in enlarged openings. The house is in fair condition and retains a fair to poor degree of integrity.

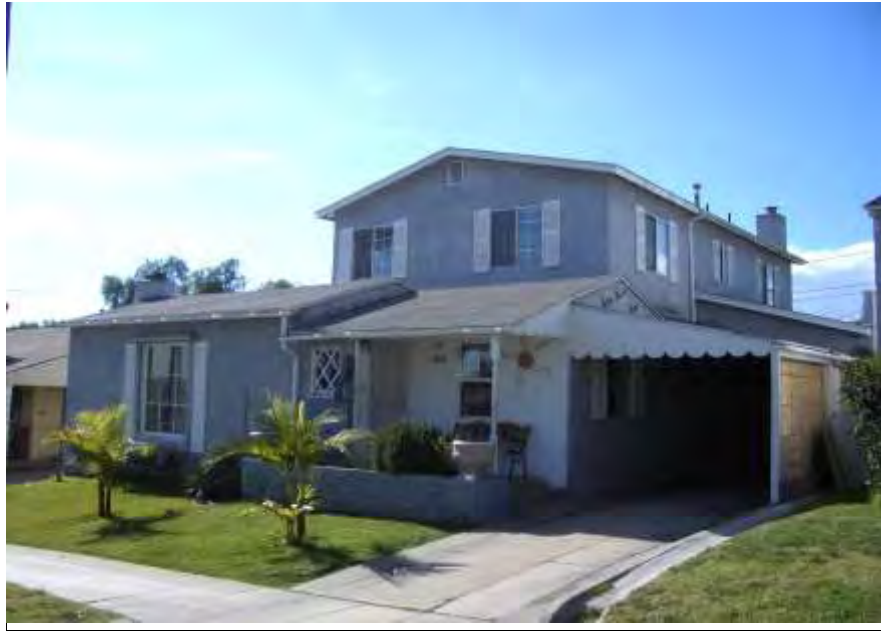
\* P3a. Description: (Describe resource and its major elements. Include design, materials, condition, alterations, size, setting, and boundaries.)  
The house at 3232 Isla Vista Drive was built in 1935 in the Minimal Traditional style and features a medium pitch side gable roof with composition shingles; clipped eaves; vertical wood siding in the gable end; and a textured stucco exterior. The entry porch, accessed via three concrete steps, is set to the right and features a roof extension supported by a turned spindle wood post. The entry door is set perpendicularly to the sidewalk. Fenestration consists of a nine-lite single pane fixed vinyl window and 4-over-4 double hung vinyl frame and sash windows. A carport has been added to the north side of the house and a front-facing gable second story addition has been added. Refer to BSOR Section B.6. for modifications and analysis of integrity.

Photo of the primary façade from the public right-of-way.

The house was constructed in 1935 per water and sewer records. Modifications include the replacement of the composition roof with a new composition roof; the use of textured stucco; the replacement of the original wood frame windows with vinyl windows; the addition of a carport; and the second story addition. The house is in good condition and retains a poor degree of integrity.

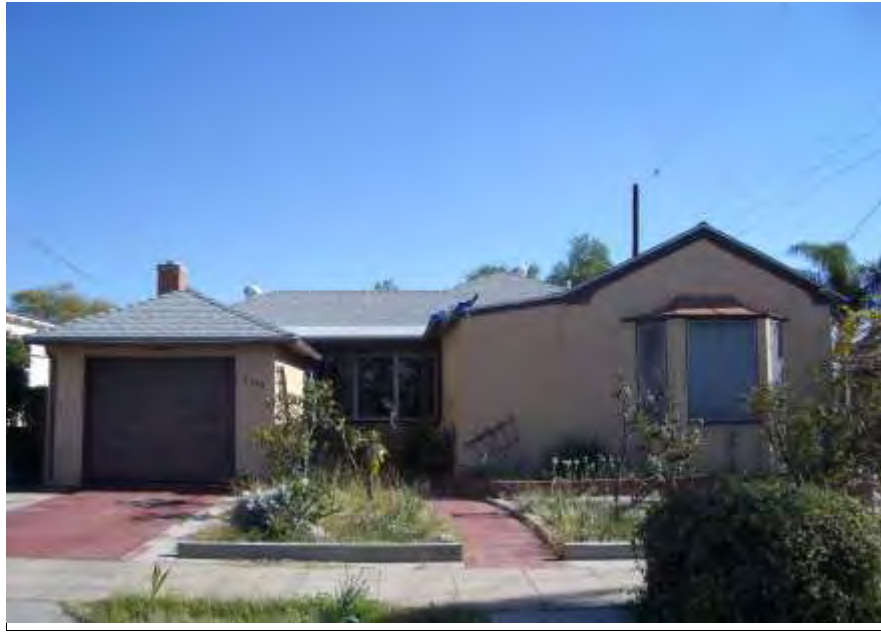
\* P3a. Description: (Describe resource and its major elements. Include design, materials, condition, alterations, size, setting, and boundaries.)  
The house at 3255 Isla Vista Drive was built in 1947 in the Minimal Traditional style and features a multi-hipped and gable roof with composition shingles; clipped eaves; and a textured stucco exterior. The entry is recessed behind a projecting front gable bay and a single car garage. The entry door is set parallel to the sidewalk. Fenestration consists of single pane fixed and 1-over-1 double hung aluminum frame and sash windows. The house appears to have undergone a number of additions and modifications, which have compromised the historic integrity of the structure. Refer to BSOR Section B.6. for modifications and analysis of integrity.

Photo of the primary façade from the public right-of-way.

The house was constructed in 1947 per water and sewer records. Modifications include several additions/alterations; the replacement of the composition roof with a new composition roof; and the replacement of the original windows with aluminum windows. The house is in fair condition and retains a poor degree of integrity.

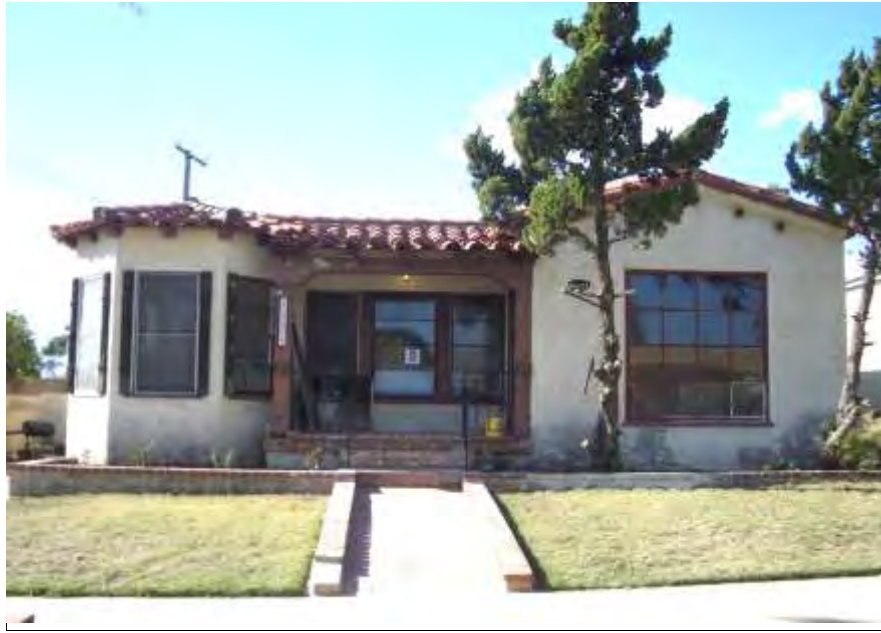
\* P3a. Description: (Describe resource and its major elements. Include design, materials, condition, alterations, size, setting, and boundaries.)  
The house at 3324 Isla Vista Drive was built in 1935 in the Spanish Eclectic style and features a flat roof with a clay tile shed roof along the parapet line and two projecting bays that include a front gable bay to the north and a hexagonal bay to the south; a textured stucco exterior; and a chimney at the north elevation. The main entry, accessed via three concrete steps, is roughly centered between the two bays under a roof projection supported by square wood timbers. The entry door is set perpendicularly to the sidewalk. Fenestration consists of a large 16-lite fixed wood frame window in the gable bay; and 2-over-2 double hung wood frame and sash windows in the hexagonal bay and throughout. Refer to BSOR Section B.6. for modifications and analysis of integrity.

Photo of the primary façade from the public right-of-way.

The house was constructed in 1935 per water and sewer records. Modifications include the use of textured stucco and the addition of window screens. The house is in good to fair condition and retains a good to fair degree of integrity.

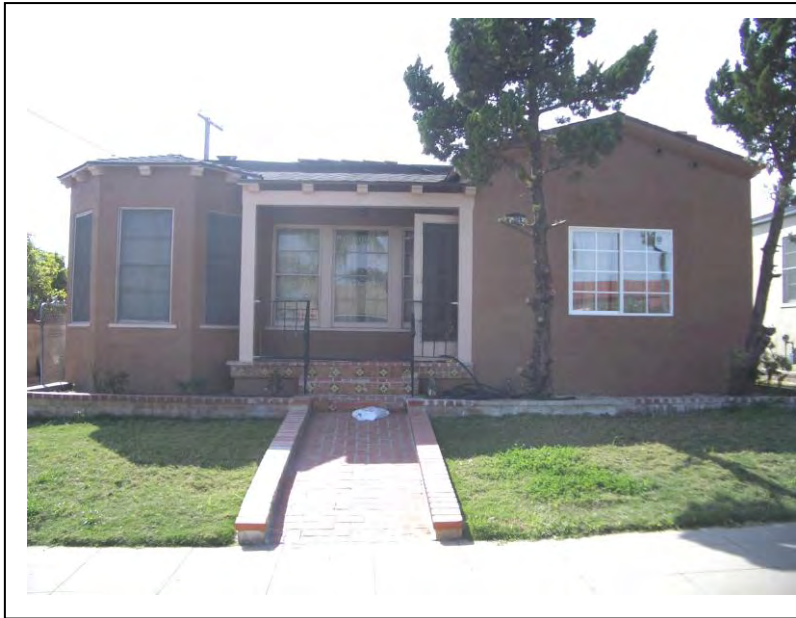
The house at 3324 Isla Vista Drive was built in 1935 in the Spanish Eclectic style and features a flat roof with a composite shingle shed roof along the parapet line and two projecting bays that include a front gable bay to the north and a hexagonal bay to the south; a textured stucco exterior; and a chimney at the north elevation. The main entry, accessed via three concrete steps, is roughly centered between the two bays under a roof projection supported by square wood timbers. The entry door is set perpendicularly to the sidewalk. Fenestration consists of a small 16-lite sliding vinyl window which replaced a large 16-lite fixed wood frame window in the gable bay; and 2-over-2 double hung wood frame and sash windows in the hexagonal bay and throughout. Refer to Continuation Sheet Section B.6. for modifications and analysis of integrity.

Photo of the primary façade from the  
Public right-of-way, taken 4/2/2007.

The house was constructed in 1935 per water and sewer records. Modifications include the use of textured stucco and the addition of window screens. Recent modifications since the January 17, 2007 survey include the replacement of the clay tile roof with composite shingles, the removal of the decorative wood elements adjacent to the windows on the hexagonal bay, and the removal of the large 16-lite fixed wood frame window which was replaced with a smaller, 16-lite sliding vinyl window. The house is in good to fair condition and retains a fair to poor degree of integrity.

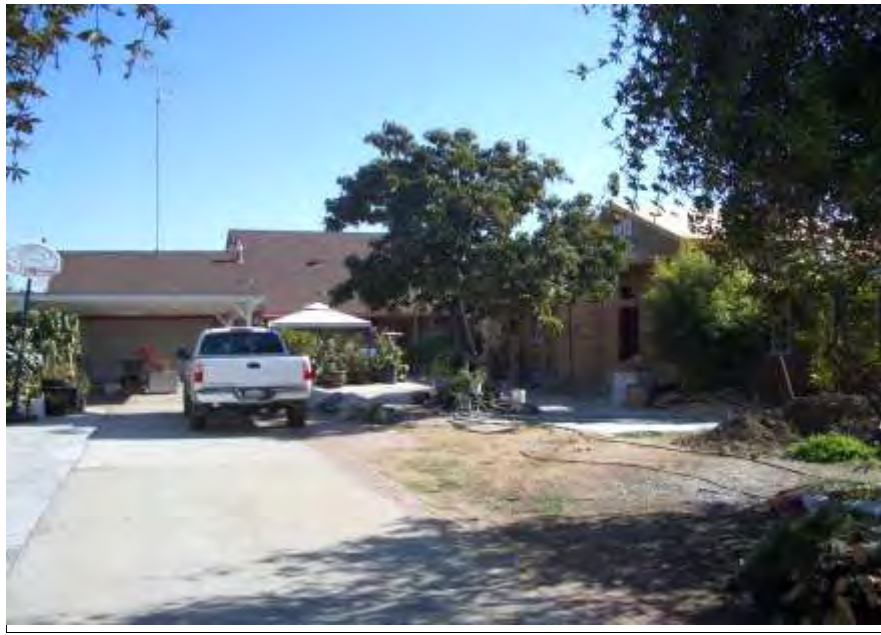
\* P3a. Description: (Describe resource and its major elements. Include design, materials, condition, alterations, size, setting, and boundaries.)  
The house at 3333 Isla Vista Drive was built in 1950 in the Ranch style and features a side gable roof with composition shingles; a slight eave overhang; and a concrete block exterior. The entry, which is at grade, is roughly centered under a roof projection supported by square wood posts. The entry door is set parallel to the sidewalk. Fenestration is not readily visible from the public right of way. A large addition at the front of the house is currently under construction. Refer to BSOR Section B.6. for modifications and analysis of integrity.

Photo of the primary façade from the public right-of-way.

\* B6. Construction History: (Construction date, alterations, and date of alterations.)  
The house was constructed in 1950 per water and sewer records. Modifications include the replacement of the composition roof with a new composition roof and a new, large addition at the front of the property which is not in keeping with the U.S. Secretary of the Interior's Standards. The house is in good condition and retains a poor degree of integrity.

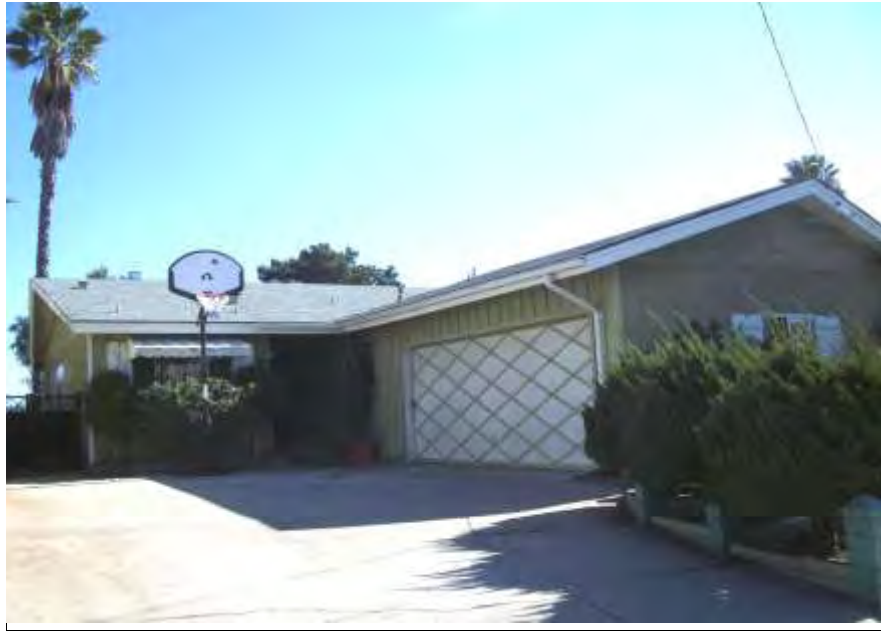
\* P3a. Description: (Describe resource and its major elements. Include design, materials, condition, alterations, size, setting, and boundaries.)  
The house at 3411 Isla Vista Drive was built in 1957 in the Ranch style and features an "L" shaped floor plan with a dominant two-car garage; cross-gable roofs with composition shingles; wood clapboard siding in the gable end; a stucco and wood board and batten exterior; and a chimney at the east elevation. The entry, accessed via one concrete step, is recessed into the façade under a roof projection. The entry door is set parallel to the sidewalk. Fenestration consists of aluminum frame and sash fixed and slider windows with decorative wood shutters. Aluminum awnings have been added above a main window. Refer to BSOR Section B.6. for modifications and analysis of integrity.

Photo of the primary façade from the public right-of-way.

The house was constructed in 1957 per water and sewer records. Modifications include the replacement of the composition roof with a new composition roof; the replacement of some original wood frame windows with aluminum windows; and the use of aluminum awnings. The house is in good condition and retains a good degree of integrity.
