# *Islenair Historic District*

Designated by the City of San Diego  
Historical Resources Board  
April 26, 2007

*Prepared by  
The City of San Diego  
City Planning and Community Investment Department  
Historical Resources Section*

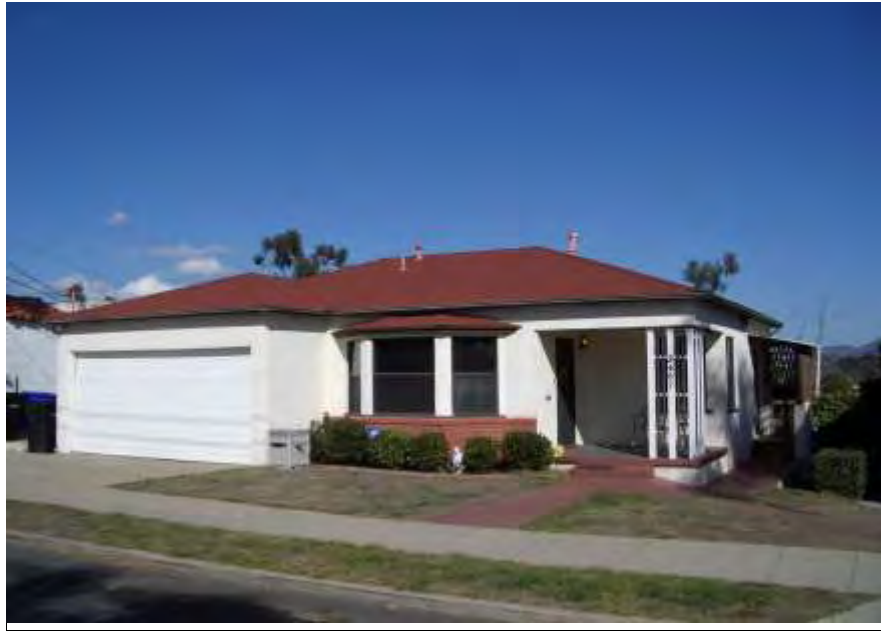
\* P3a. Description: (Describe resource and its major elements. Include design, materials, condition, alterations, size, setting, and boundaries.)  
The house at 3467 Isla Vista Drive was built in 1939 in the Minimal Traditional style and features a side gable roof with red composition shingles; a slight eave overhang; and a stucco exterior with brick veneer beneath a bay window. The entry, accessed via two concrete steps, is set to the right under a roof projection supported by five wood posts. The entry door is set perpendicularly to the sidewalk. Fenestration consists of 1-over-1 aluminum frame and sash windows. The two-car garage is attached to the house and is set forward of the main façade. Refer to BSOR Section B.6. for modifications and analysis of integrity.

Photo of the primary façade from the public right-of-way.

The house was constructed in 1939 per water and sewer records. Modifications include the replacement of the composition roof with a new red composition roof; the replacement of the original wood frame windows with aluminum frame windows; the likely addition of the bay window; the use of brick veneer; the likely replacement of the wood porch post(s); and the replacement of the original garage door with a new wood door. The house is in good condition and retains a fair to poor degree of integrity.

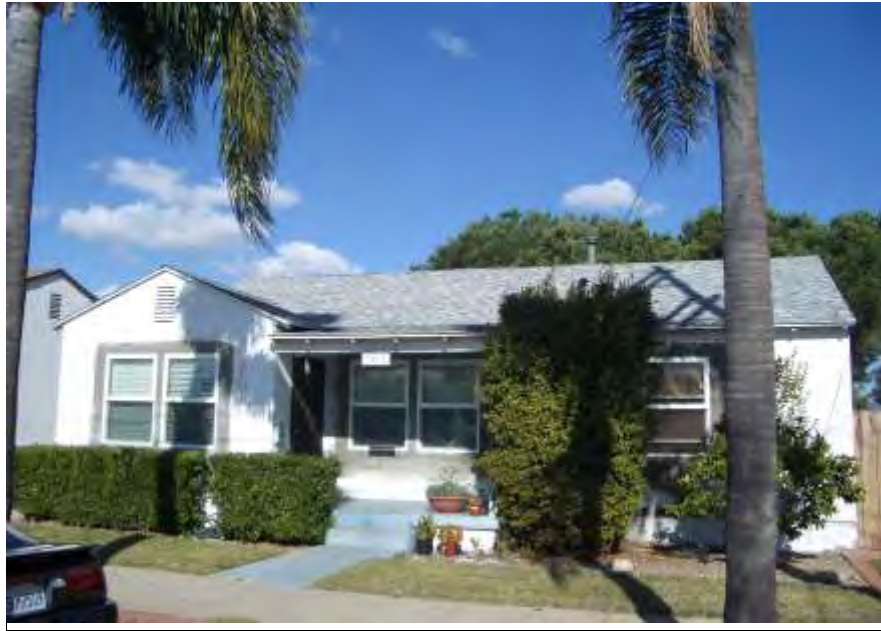
\* P3a. Description: (Describe resource and its major elements. Include design, materials, condition, alterations, size, setting, and boundaries.)  
The house at 3517 Isla Vista Drive was built in 1946 in the Minimal Traditional style and features a cross-gable roof with composition shingles; a slight eave overhang with exposed rafter tails; and a stucco exterior. The entry, accessed via two concrete steps, is set to the right of the bay under a roof projection. The entry door is set perpendicularly to the sidewalk. Fenestration consists of 1-over-1 double hung vinyl frame and sash windows in new and/or enlarged openings. Refer to BSOR Section B.6. for modifications and analysis of integrity.

P5b. Description of Photo: (View, date, etc.)  
Photo of the primary façade from the public right-of-way.

The house was constructed in 1946 per water and sewer records. Modifications include the replacement of the composition roof with a new composition roof; and the replacement of the original 6-over-6 wood frame windows with 1-over-1 vinyl frame windows in new and/or enlarged openings. The house is in good to fair condition and retains a fair to poor degree of integrity.

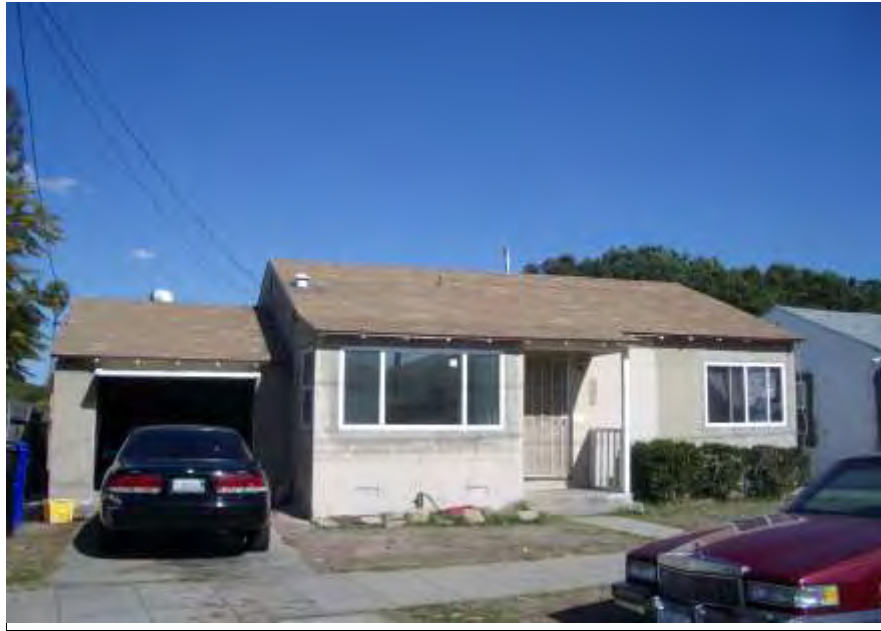
\* P3a. Description: (Describe resource and its major elements. Include design, materials, condition, alterations, size, setting, and boundaries.)  
The house at 3525 Isla Vista Drive was built in 1946 in the Minimal Traditional style and features a side gable roof with composition shingles; a slight eave overhang with exposed rafter tails; and a stucco exterior. The entry, accessed via two concrete steps, is set to the right of the bay under a roof projection supported by a wood post. The entry door is set parallel to the sidewalk. Fenestration consists of sliding vinyl frame and sash windows in new and/or enlarged openings. The single far garage is attached to the house and set back slightly from the main façade. Refer to BSOR Section B.6. for modifications and analysis of integrity.

Photo of the primary façade from the public right-of-way.

The house was constructed in 1946 per water and sewer records. Modifications include the replacement of the composition roof with a new composition roof; and the replacement of the original double hung and 16-lite fixed wood frame windows with sliding vinyl frame windows in new and/or enlarged openings. The house is in good to fair condition and retains a fair to poor degree of integrity.

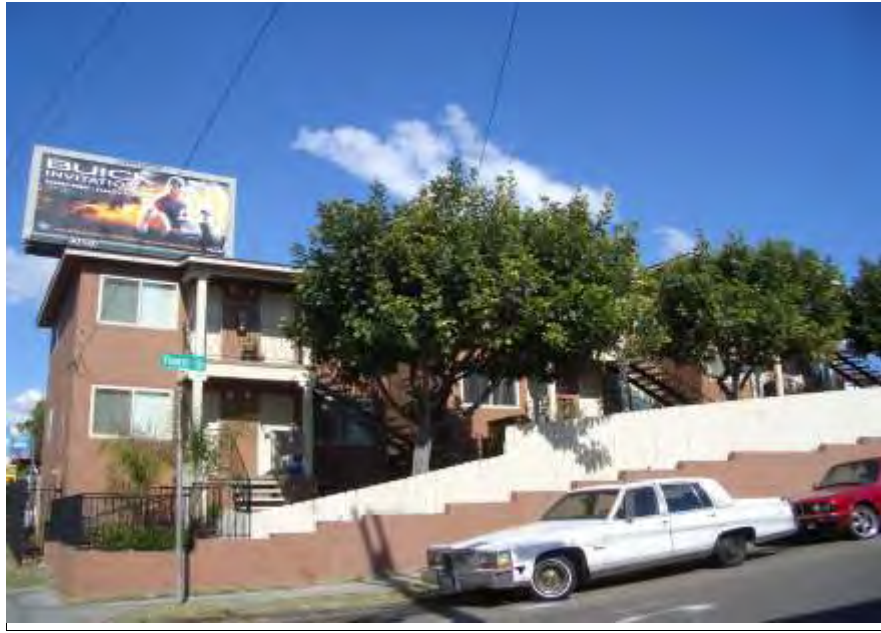
\* P3a. Description: (Describe resource and its major elements. Include design, materials, condition, alterations, size, setting, and boundaries.)  
The two-story multi-family residence at 4750 Thorn Street was built in 1958 on a corner lot in the Contemporary style and features a low-pitch roof with composition shingles; a slight eave overhang; and a textured stucco exterior. The entries are located under a roof projection supported by wood posts. Fenestration consists of vinyl slider windows. A cement block retaining wall and wood fence is located at the property line. Refer to BSOR Section B.6. for modifications and analysis of integrity.

Photo of the primary façade from the public right-of-way.

The multi-family residence was constructed in 1958 per MetroScan data. Modifications include the replacement of the composition roof with a new composition roof; the use of textured stucco; the replacement of the original wood frame and sash windows with vinyl slider windows; and the addition of a cement block retaining wall and wood fence. The building is in good to fair condition and retains a good to fair degree of integrity.

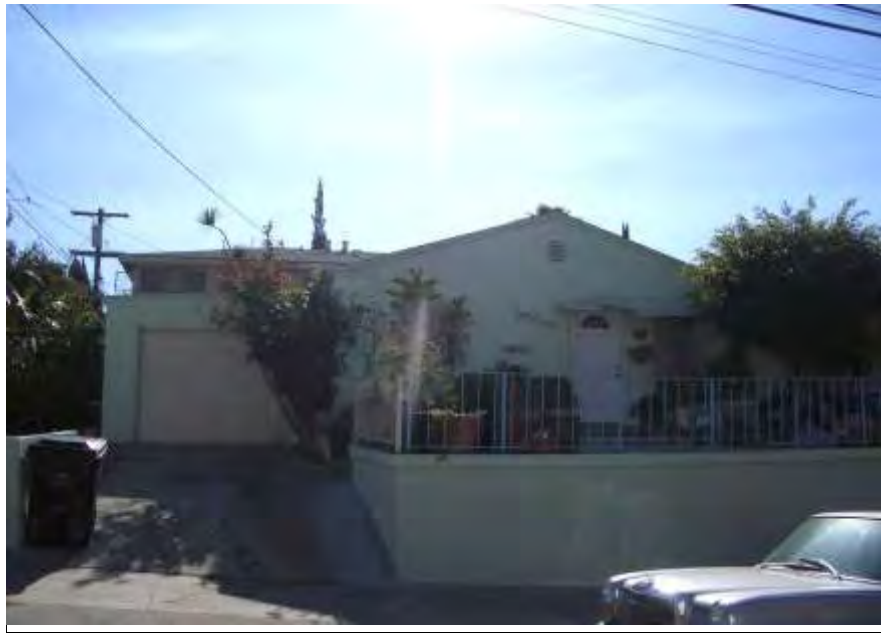
\* P3a. Description: (Describe resource and its major elements. Include design, materials, condition, alterations, size, setting, and boundaries.)  
The house at 4769 Thorn Street, located on the same lot as 3275 Euclid Avenue, was built in 1939 in the Minimal Traditional style and features a gable roof with composition shingles; clipped eaves; and a textured stucco exterior. The entry, accessed via two concrete steps, is set just right of center. The entry door is set parallel to the sidewalk. Fenestration consists of aluminum frame and sash slider windows with wrought iron security bars. The single far garage is attached to the house and is set back from the main façade. The house has been stripped of ornamentation. Refer to BSOR Section B.6. for modifications and analysis of integrity.

Photo of the primary façade from the public right-of-way.

The house was constructed in 1939 per the San Diego County Building Record. Modifications include the replacement of the composition roof with a new composition roof; the replacement of the original wood windows with aluminum windows; the removal of any ornamentation; and the replacement of the original garage door with a roll-up aluminum door. The house is in fair condition and retains a poor degree of integrity.

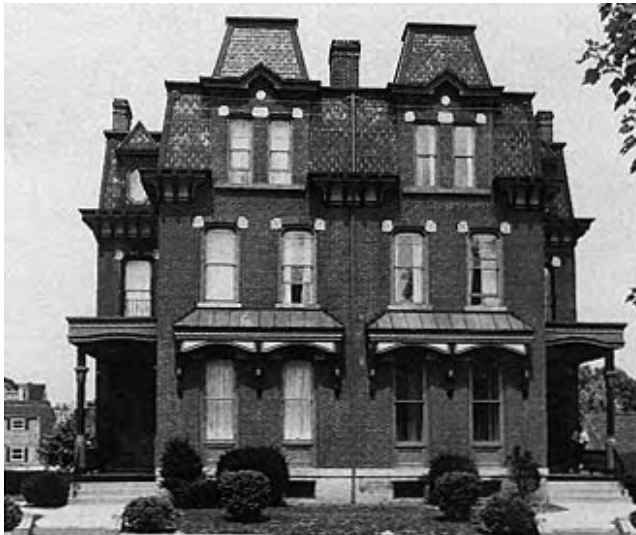
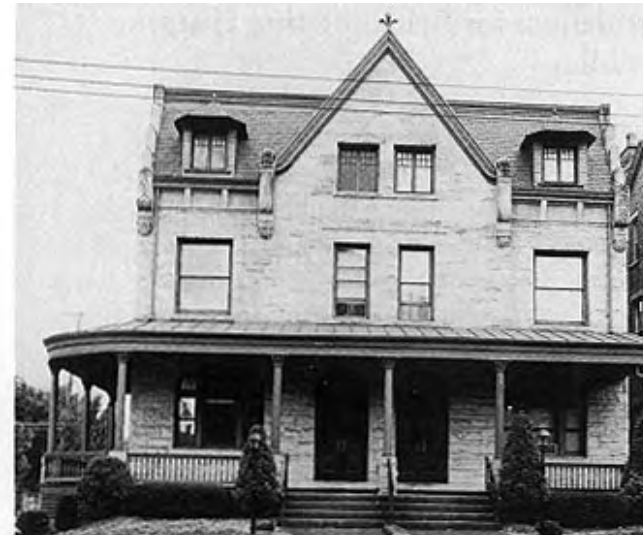
*Originally built as single-family, semi-detached duplexes, these houses were rehabilitated for a new use as rental apartments. While some alteration to non-significant interior features and spaces was necessary in each one, the exteriors were essentially preserved. Photos: Mistick, Inc.*

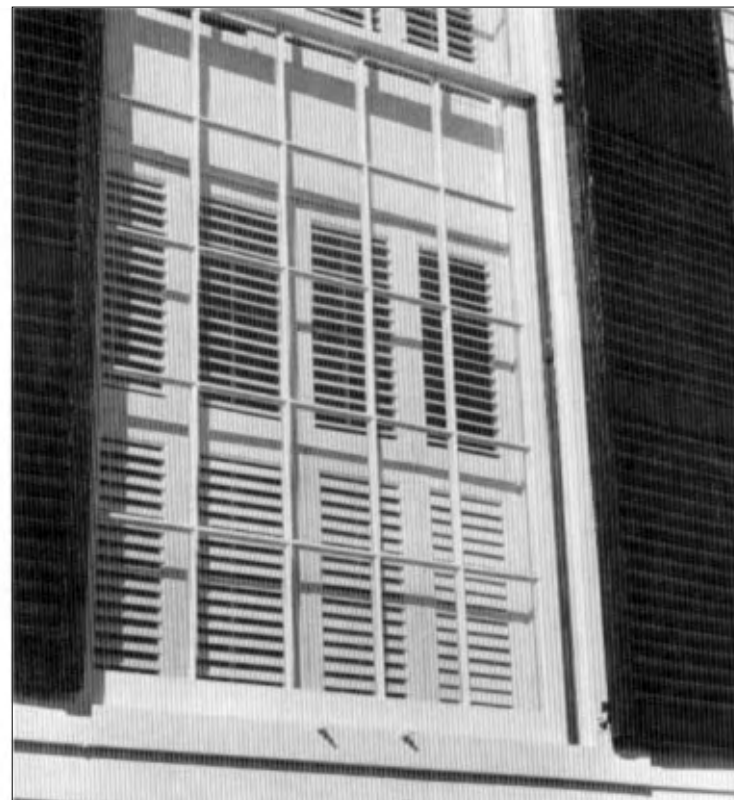
*According to the Standards for Rehabilitation, existing historic materials should be protected, maintained and repaired. In an exemplary project, the windows and shutters of this historic residence were carefully preserved.*

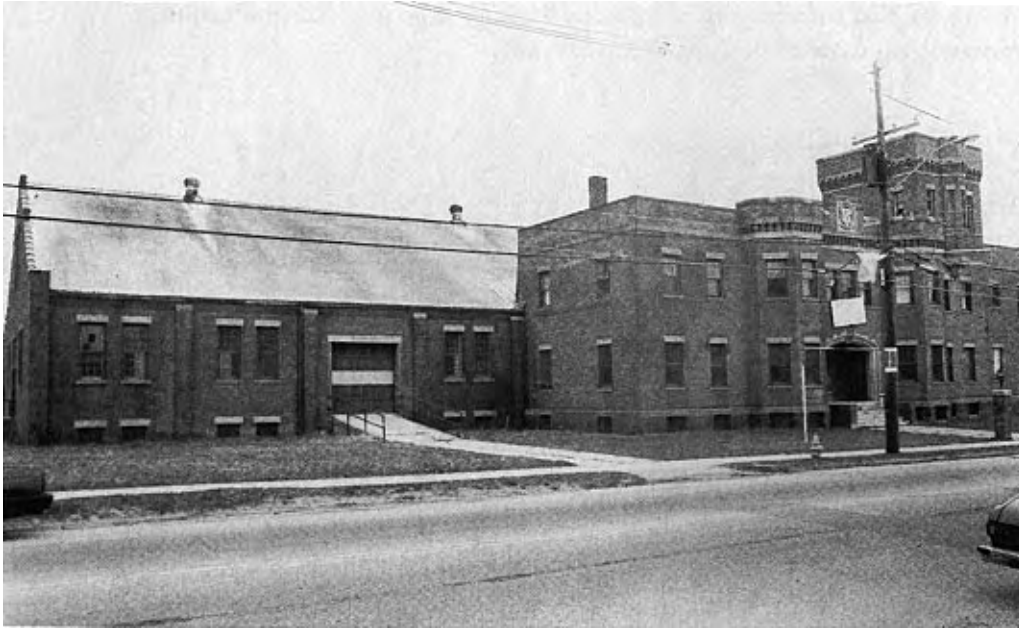
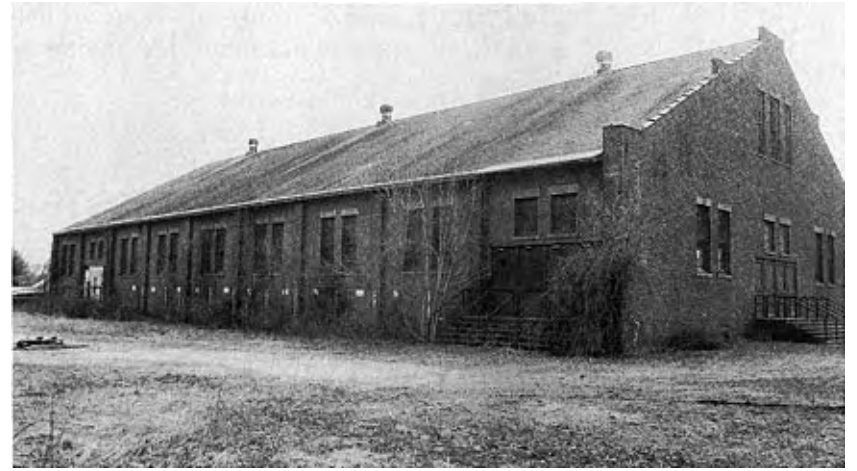
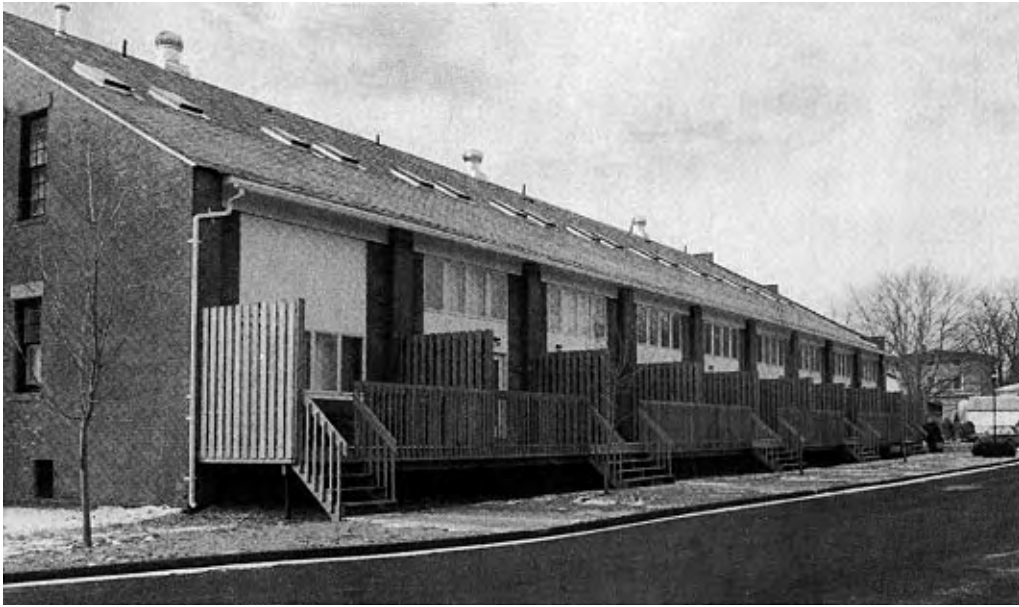
(a) An armory complex was rehabilitated for rental housing. (b) This view of the rear elevation shows the paired, nine-over-nine wood sash windows and high sills that characterized the building. (c) After inappropriate rehabilitation work, the same rear elevation is shown with new skylights added to the roof, prefabricated panels filling the former brick areas, and new wood decks and privacy fences. Because the work changed the historic character, the project did not meet the Standards.

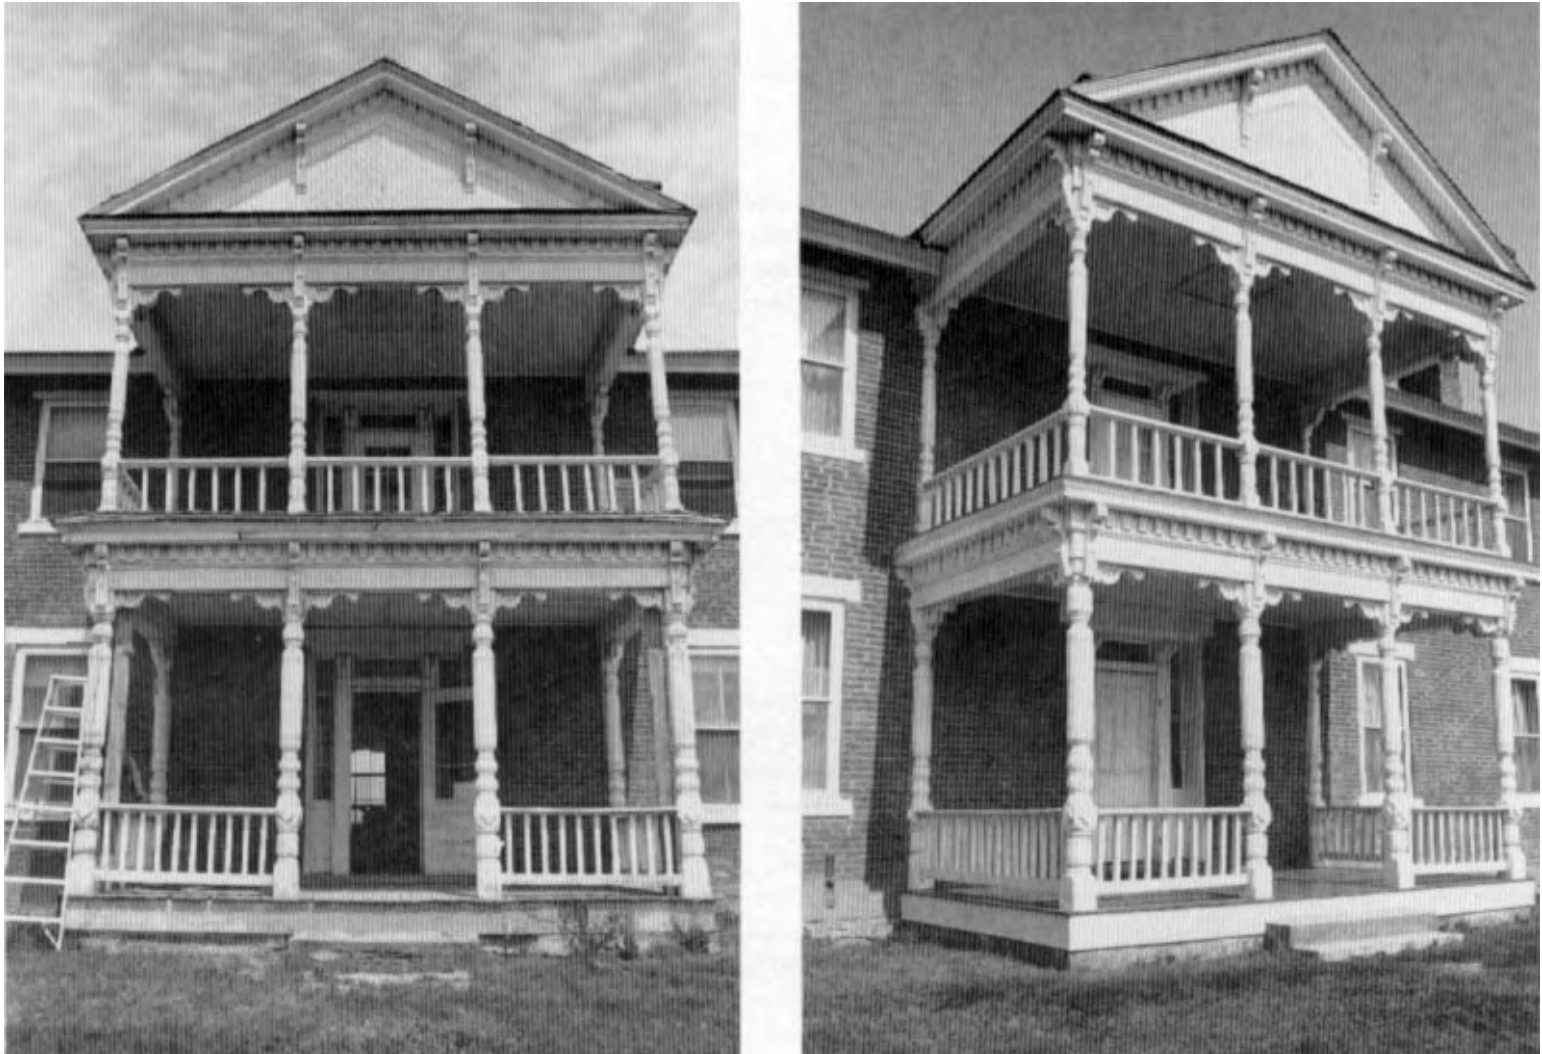
*In Rehabilitation, deteriorated features should be repaired, whenever possible, and replaced when the severity of the damage makes it necessary. Here, a two-story porch is seen prior to treatment (left). The floor boards are rotted out and the columns are in a state of collapse, supported only by crude, temporary shafts. Other components are in varying stages of decay. Appropriate work on the historic porch (right) included repairs to the porch rails; and total replacement of the extensively deteriorated columns and floor boards. Some dismantling of the porch was necessary.*

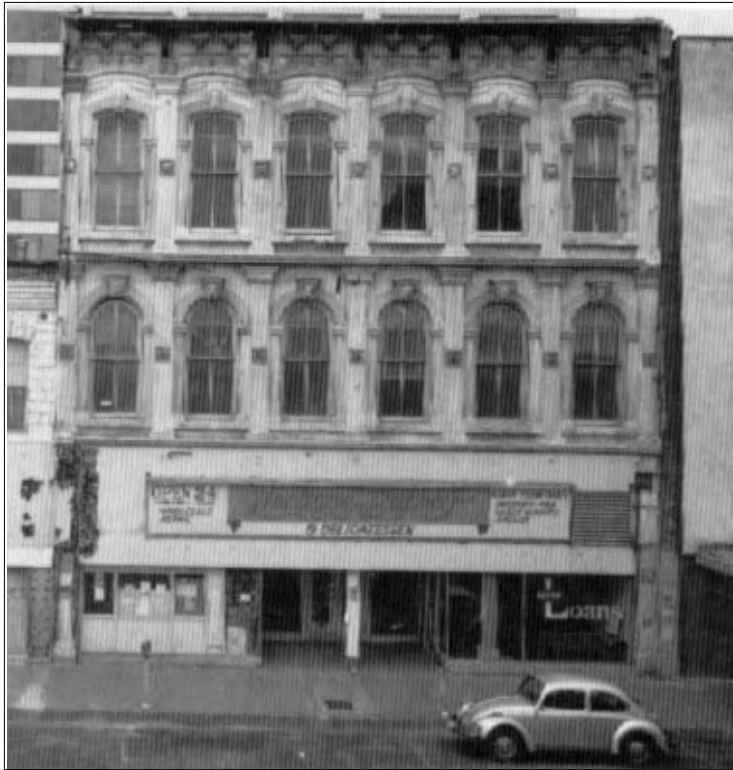
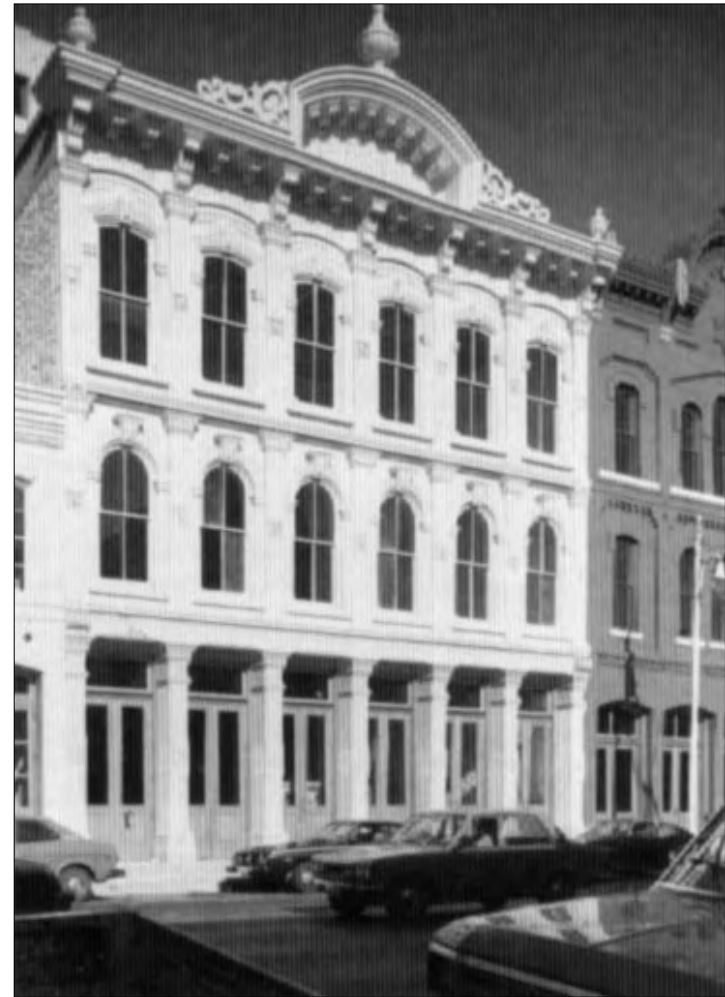
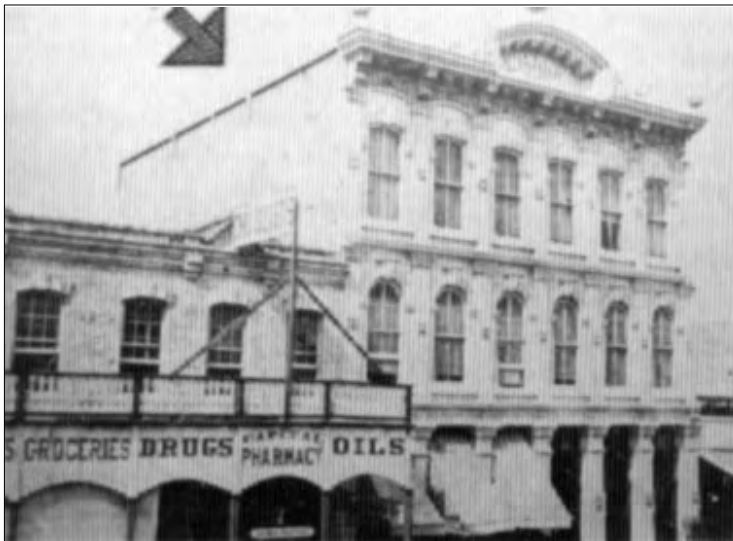
*In the treatment, Rehabilitation, one option for replacing missing historic features is to use pictorial documentation and/or physical evidence to re-create the historic feature. (a) In this example, the ornamental cornice of an 1866 limestone building was missing; and the ground level storefront had been extensively altered. (b) and (c) Based on the availability of photographic and other documentation, the owners were able to accurately restore the cornice and storefront to their historic configuration. A substitute material, fiberglass, was used to fabricate the missing pressed metal cornice, an acceptable alternative in this project. All work met the Standards.*

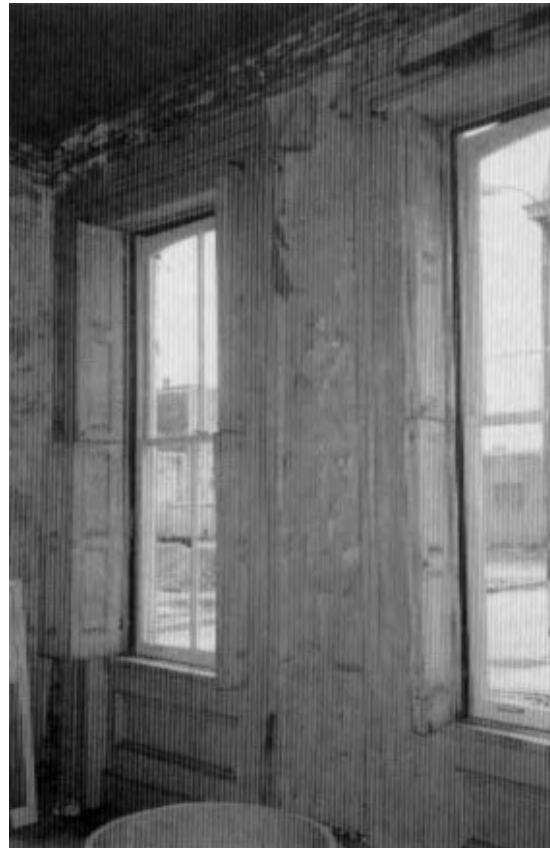
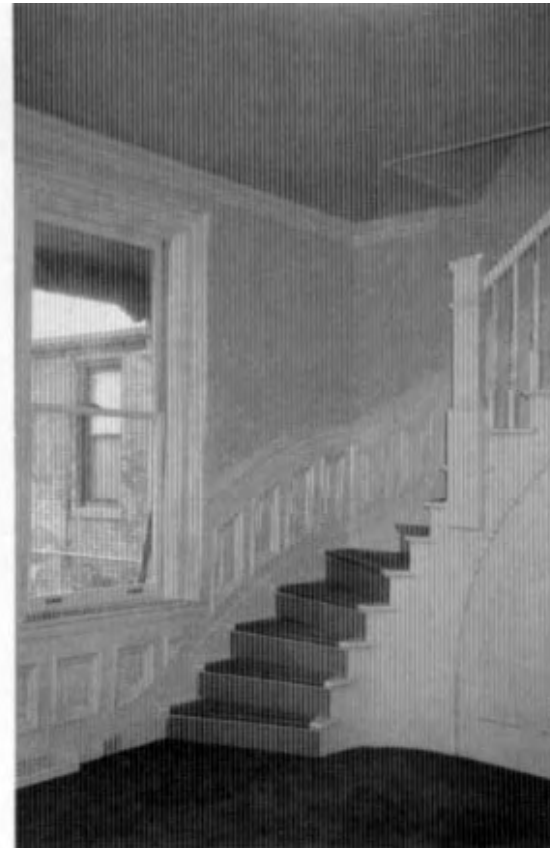
*Rehabilitating historic dwelling units often includes some level of lead-paint hazard abatement. Whenever lead-base paint begins to peel, chip, craze, or otherwise comes loose (a), it should be removed in a manner that protects the worker as well as the immediate environment. In this example (b), the deteriorating lead-paint was removed throughout the apartment building and a compatible primer and finish paint applied.*

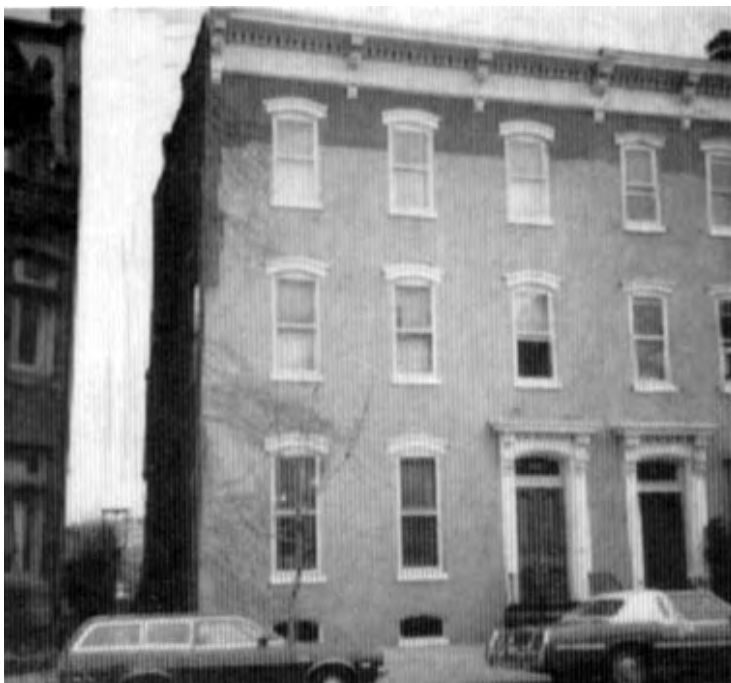
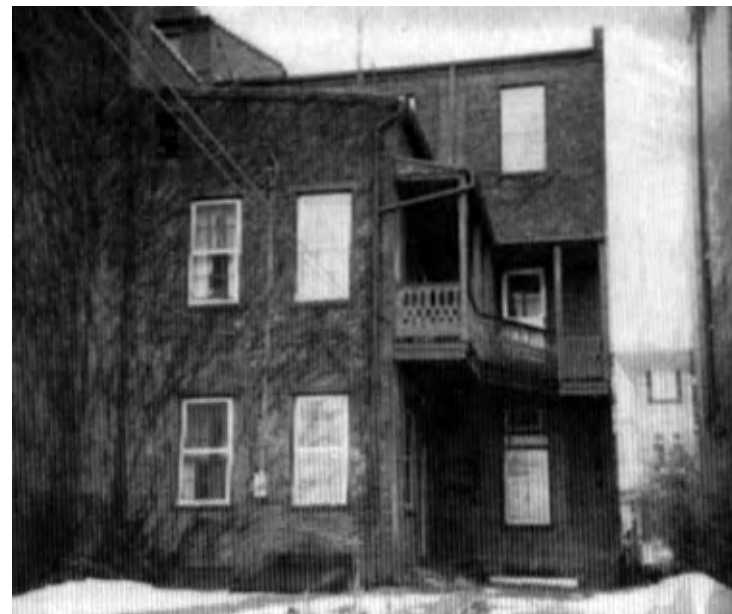
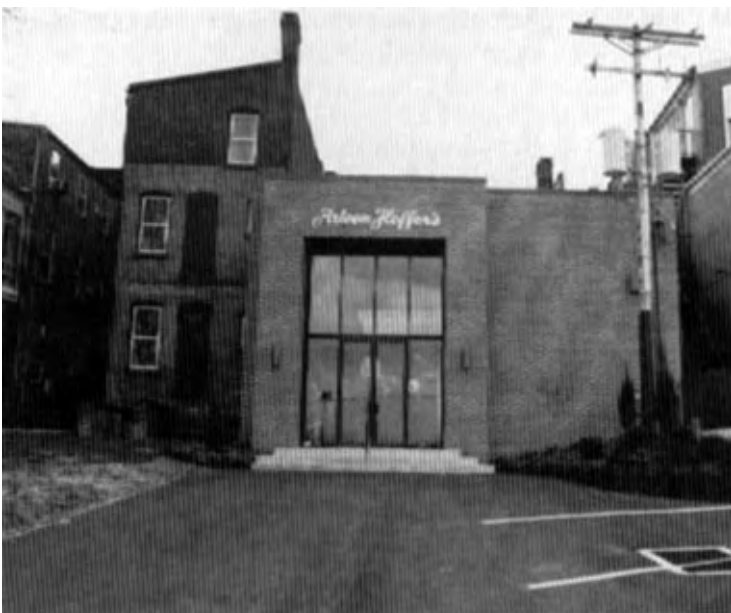
*If a rear elevation of a historic building is distinctive and highly visible in the neighborhood, altering it may not meet the Standards. (a and b) This 3-story brick rowhouse featured a second story gallery and brick kitchen wing characteristic of other residences in the district which backed onto a connecting roadway. (c) In the rehabilitation, the wing and gallery were demolished and a large addition constructed that severely impacted the building's historic form and character.*

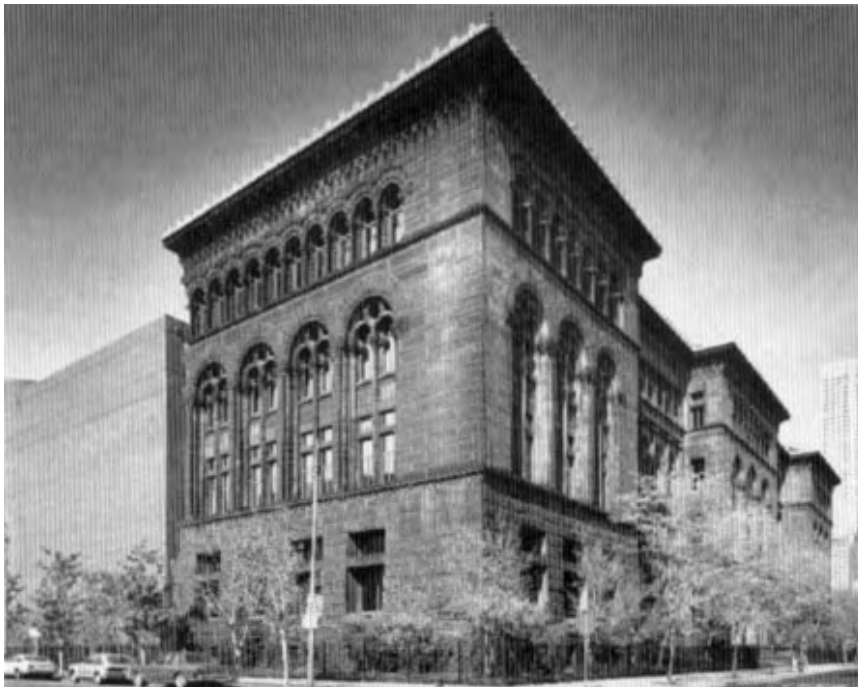
*Rehabilitation, like Preservation, acknowledges a building's change over time; the retention and repair of existing historic materials and features is thus always recommended. However, unlike Preservation, the dual goal of Rehabilitation is to—respectfully—add to or alter a building in order to meet new use requirements. This downtown Chicago library was expanded in 1981 when additional space was required with light and humidity control for the rare book collection. The compatible 10-story wing was linked to the historic block on side and rear elevations. Its simple design is compatible with the historic form, features, and detailing; old and new are clearly differentiated. Photo: Dave Clifton.*
