EAST VILLAGE

**COMBINED HISTORICAL
SURVEYS**

**REVISED DRAFT
EAST VILLAGE
HISTORICAL PROPERTY SURVEY REPORT
2005**

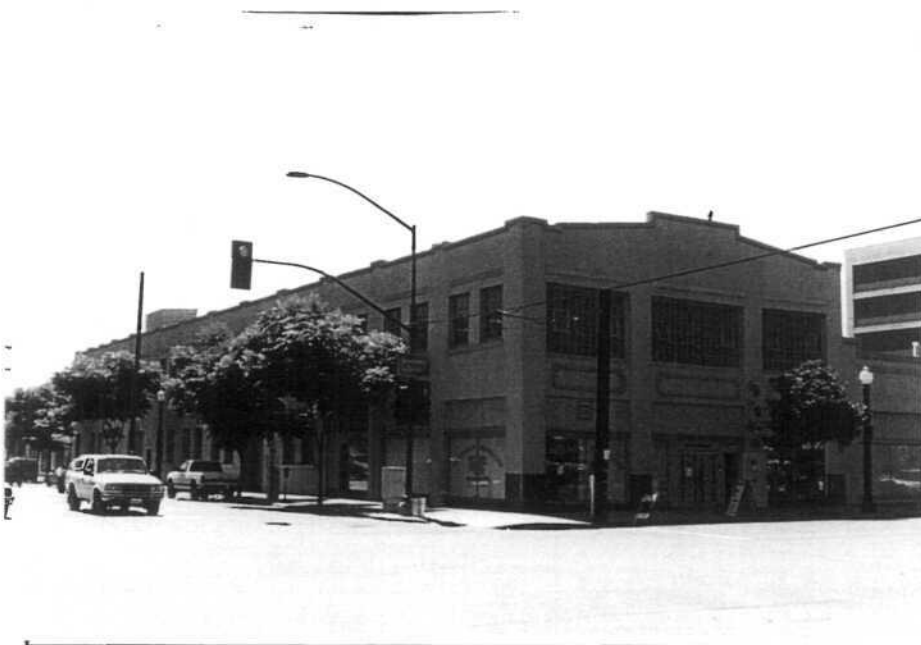
Originally **constructed** in 1918 for capitalist James E. **Collumb**, this two-story utilitarian structure has a general rectangular shaped plan and is adjoined to a smaller one-story building in the same style on the north west elevation. These buildings are collectively identified as 1531-1541 Broadway. Features include a flat roof with stepped parapets and coping, large plate glass windows on the ground floor, and **multi-paned** industrial style windows on the second floor. Exterior building materials consist of plastered brick and stucco for the walls, ceramic tile surrounding the lower portions of the ground floor windows, and most likely composition rolls for the roof. Clerestory windows have been in-filled, however the frame outlines are still present. Overall, the building appears to be in good condition.

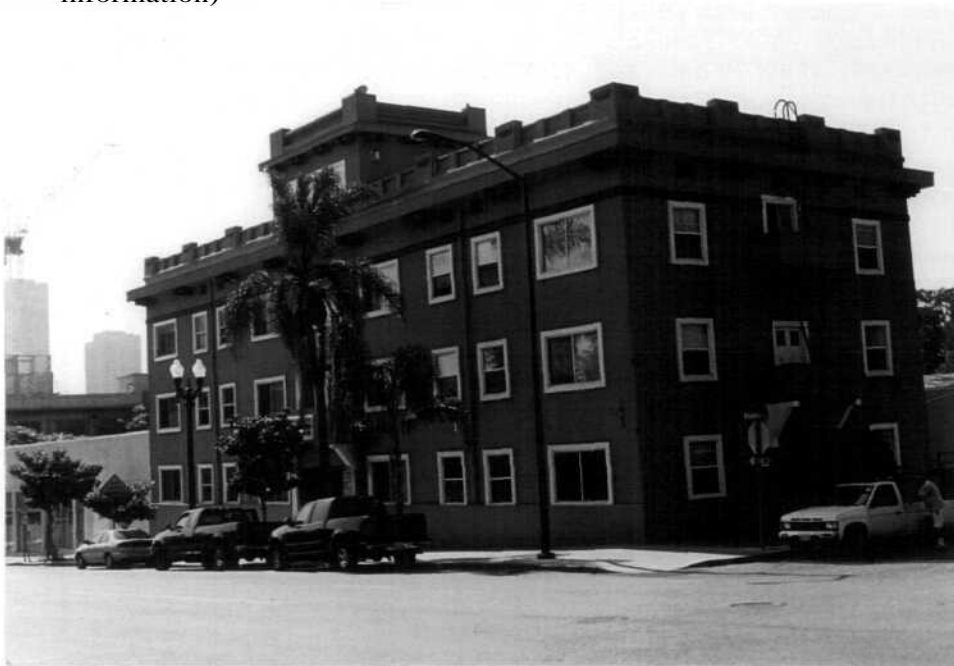
Originally constructed in 1912, this three-story apartment building with basement and forth-floor penthouse was designed in a High Italian Renaissance architectural style. Typical of the High style, it features a flat roof, a wide, extended cornice with paired brackets, a roof line balustrade featuring framed panels, and belt coursing above between the third-floor windows and the cornice line. The penthouse portion also features an extended cornice, paired brackets, and a raised parapet. The building is rectangular in shape and symmetrical in design and features a recessed, center front entrance flanked by wood molding and shaded above by a second floor balcony that is supported by two french knee braces that extend past the balcony line. (See DPR 523H, Continuation Sheet for more information)

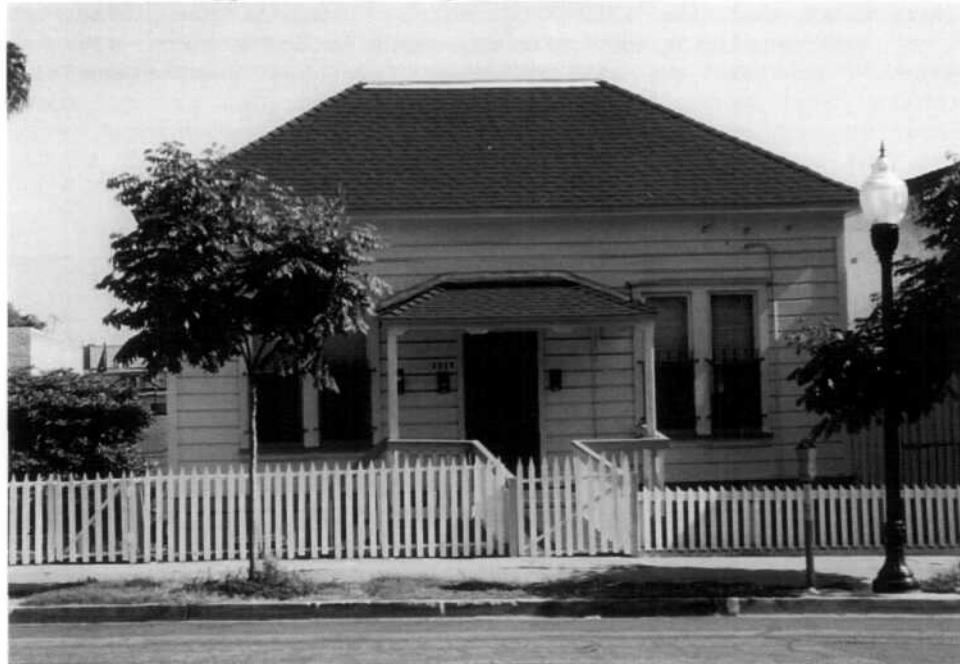
Originally constructed in 1887 on a steeply sloped lot, this two-story, **single-family** residence was designed in a Folk National architectural **style**, and the house itself is accessed through a short wooden bridge located between the sidewalk and the front entrance of the residence located on the second floor. It appears to have been modified through a rear addition. The residence features a symmetrical design, and a moderately pitched, hipped roof with a boxed cornice and a plain frieze. Exterior building materials consist of horizontal **shiplap** siding with corner boards for the exterior walls, and composition **shingles** for the roof. Windows appear to be single-hung or double-hung sash and feature wood **surrounds**. A small partial porch area is present at the front entrance and features an ornamental, centered, hipped roof supported by two wood posts. Overall, the 1317 C Street residence appears to be in good condition.

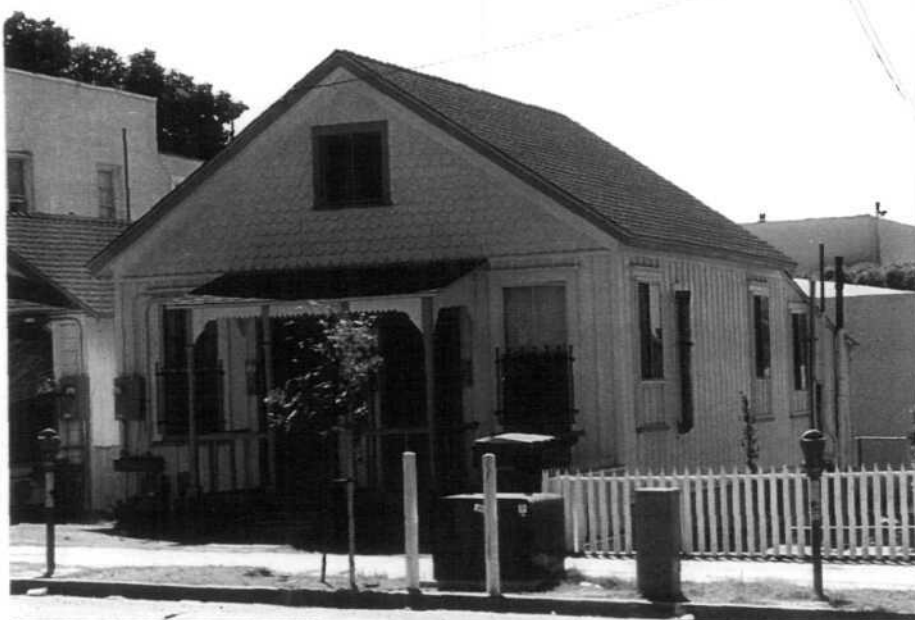
Originally constructed in approximately 1887, this two-story, multiple-family residence was constructed on a steeply sloping lot, in a layout similar to the neighboring 1317 and 1333 C Street residences. Features of the residence include a moderately pitched, front gabled roof with a slight, enclosed eave overhang. Exterior building materials consist of composition shingles for the roof, fish scale shingles on the gabled portion of the exterior wall down from the roof line, vertical board and batten siding on the street level second floor exterior walls, and horizontal shiplap siding on the first floor exterior walls. A centered front porch is present on the second story, street level of the residence. It features a shed style roof with composition shingles, supportive spindle posts, wood railing, and remnants of brackets and stick work. Rear additions have been made to the building. Overall, the 1321 C Street building appears to be in fair condition.

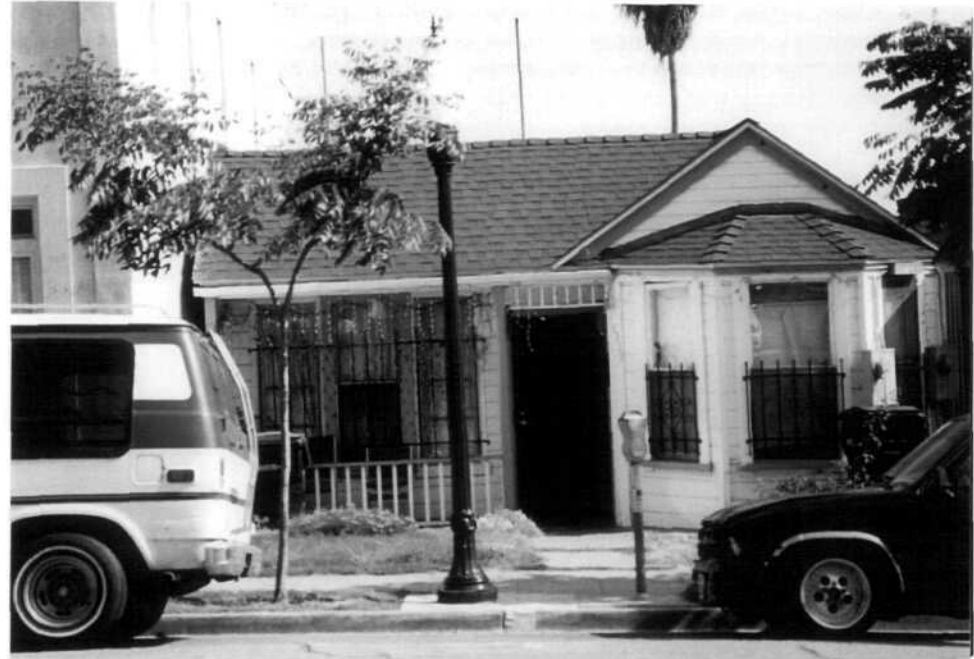
Originally constructed in approximately 1894, this two-story residence is located on a steeply sloped lot and is similar in layout to the neighboring 1317 and 1321 C Street residences. Designed in a Folk Victorian architectural style, the residence has a moderately pitched, cross gabled roof with no eave overhang, an angled bay window with a hipped roof and an entrance porch featuring wood railing, wood work along the porch eave and two wood posts for support. It appears that the original spindlework has been replaced with plain wood work that is present today. Exterior building materials consist of composition shingles for the roof and shiplap siding for the exterior walls. Windows appear to be double-hung sash and feature wood surrounds. Metal security bars cover the lower portions of the windows on the north, street facing elevation. Overall, the residence appears to be in fair condition.

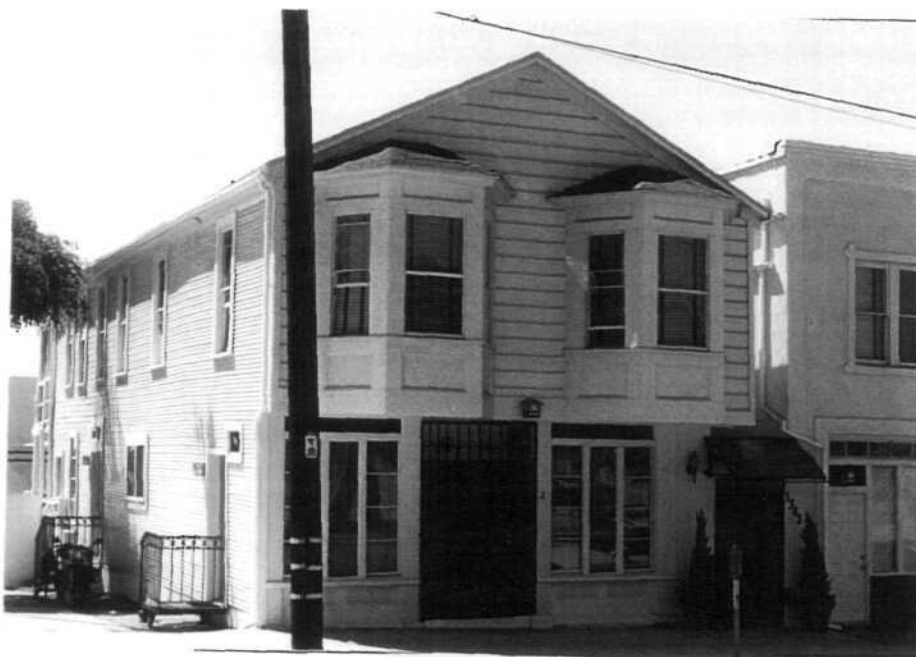
The two buildings shown in the photograph below are identified as 1343-1345 C Street. It is believed that these buildings were originally not associated with one another, and that they were eventually adjoined through a central staircase. The east Victorian portion was constructed in approximately 1887, and has a general rectangular shaped plan with a moderately pitched front gabled roof, and a slight enclosed eave overhang. Exterior building materials consist of composition shingles for the roof, clapboard siding for the east facade and shiplap siding for the north facade. It is a two-story, mixed-use building with residential units upstairs and commercial storefront space on the ground floor. (See DPR 523H, Continuation Sheet for more information)

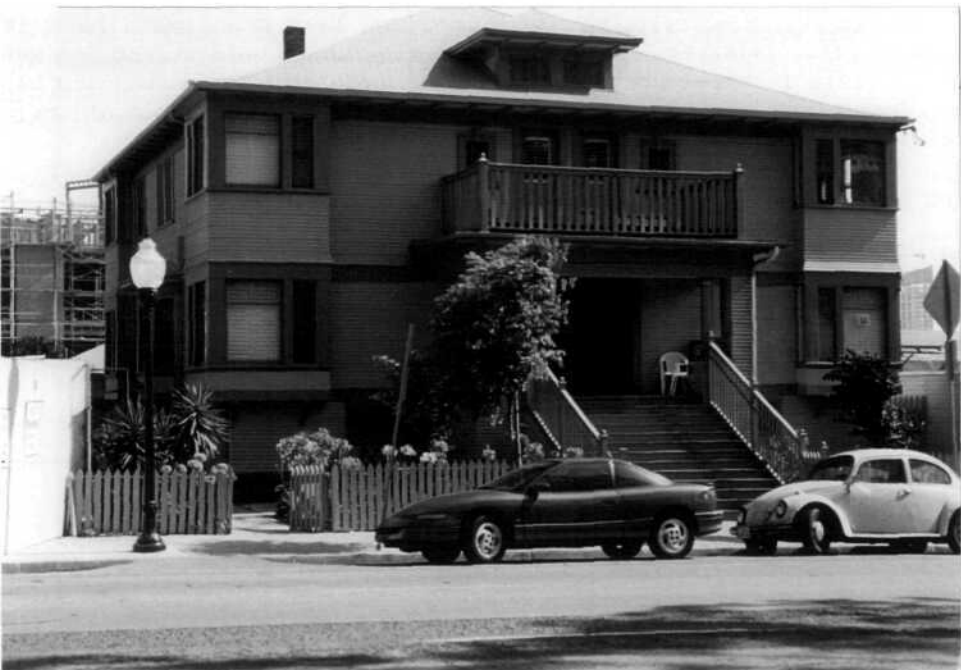
Originally constructed in 1908, this symmetrical, two-story, apartment building with basement is an excellent example of the early Prairie architectural style that is sometimes referred to as the **American Foursquare** or the **Prairie Box**. It has a general rectangular shaped plan and features a low pitched, hipped roof with widely overhanging eaves, and a centered hipped dormer, also with widely overhanging eaves, and a boxed cornice with modillions. This type of hipped dormer is typical of the early vernacular Prairie style. Wide wooden steps ascend to the first floor front porch, which is partially enclosed, has a flat roof with widely overhanging eaves, and features a square pillar covered with wood on the northern corners, as well as, a single Ionic column, also at each northern porch corner. (See DPR 523H, Continuation Sheet for more information)

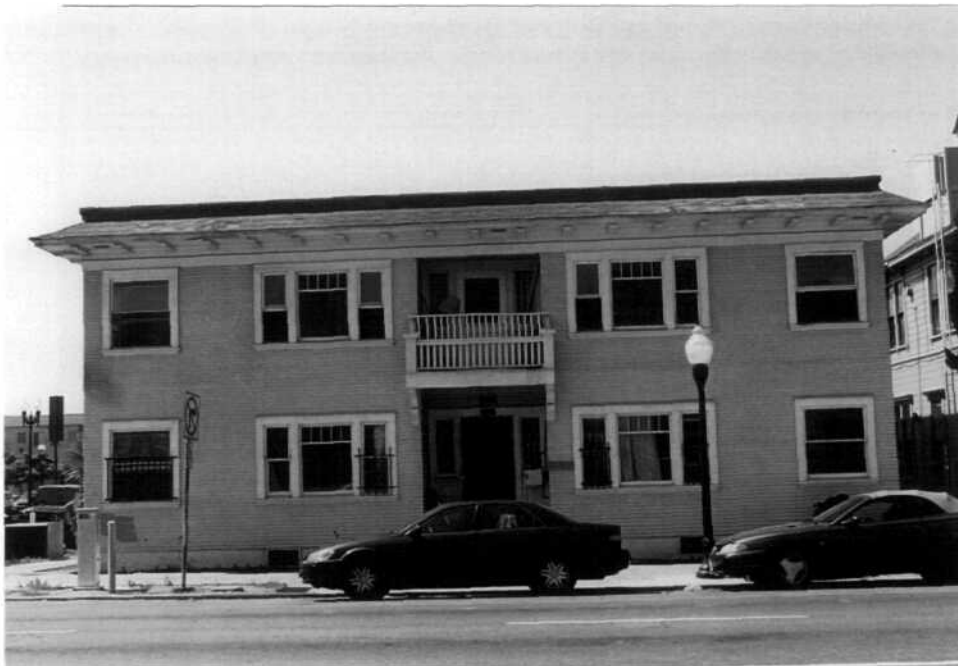
Originally constructed in 1913, this two-story apartment house was designed in an Italian Renaissance vernacular architectural style. It has a general square shaped plan and features a low pitched, hipped roof with wide eave overhang, and exposed rafter tails under the eave. A recessed front entrance is present at the center of the building and is shaded overhead by a second floor balcony. Supported by a bracket on each northern corner, the wood balcony features two miniature squared columns, and railing that has been extended upward. The second floor balcony features a recessed doorway similar to the first floor entrance. (See DPR 523H, Continuation Sheet for more information)

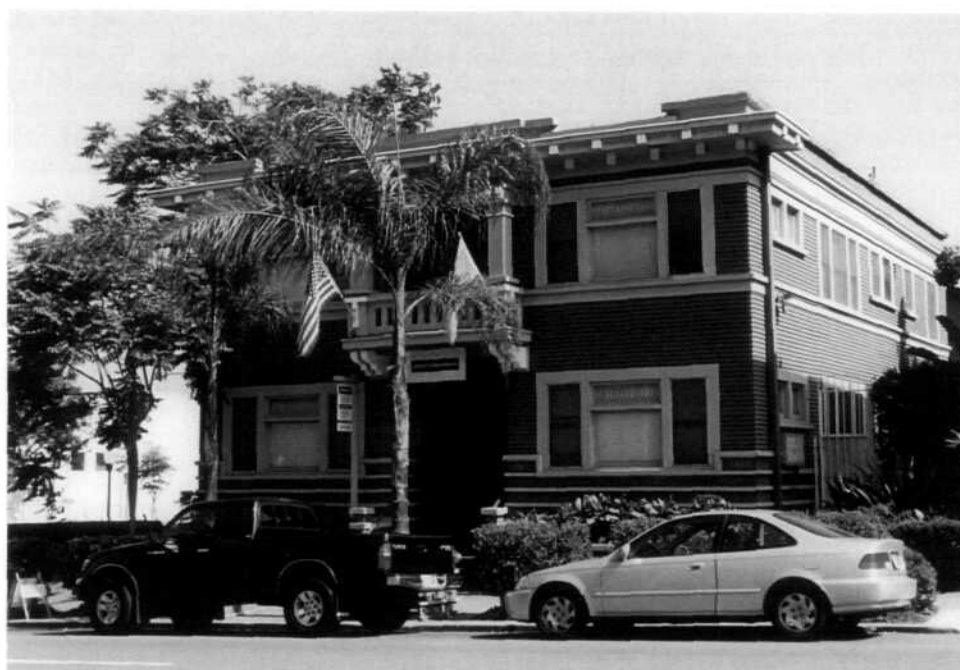
Originally **constructed** in approximately 1915, the building shown in the photograph below is identified as the "Hotel Mediterranean" located at 1329-1335 E Street. Designed in a flat roof Italian Renaissance style, this two-story building has a rectangular shaped plan and features a wide decorated cornice and frieze which extends out past the buildings edge. The street facing facade features a parapet, dentils, several levels of belt coursing (some spans around the perimeter of the building), and four triple windows, each with a large fixed window with a leaded glass transom at the center and a double-hung window flanking both sides.
(See DPR 523H, Continuation Sheet for more information)

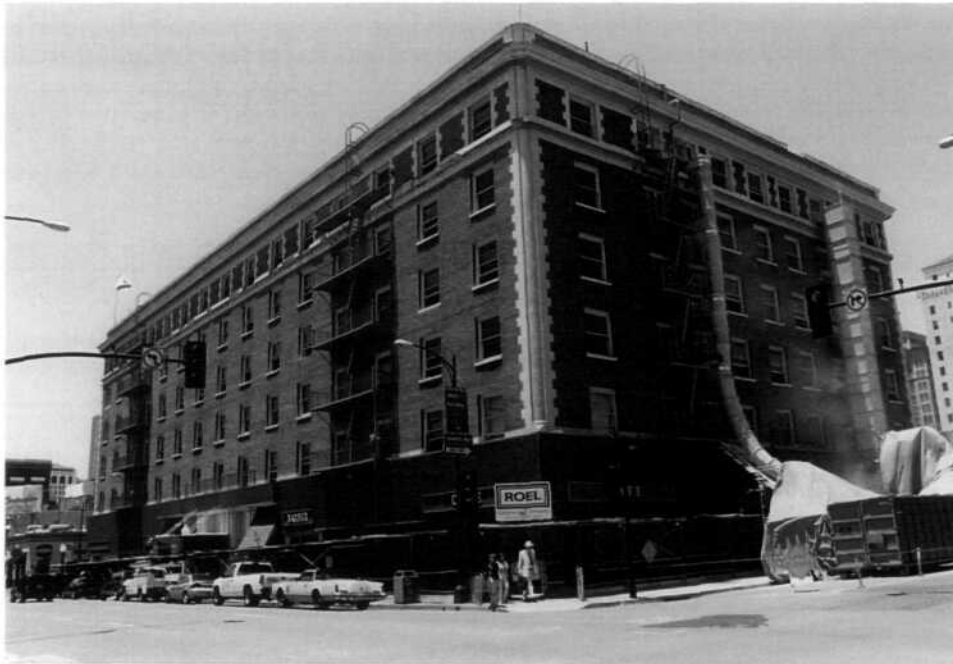
Originally constructed in 1914 and designed in a brick commercial architectural style with Italian Renaissance Revival elements the Maryland Hotel is a six-story commercial building, with basement and mezzanine. It has a general rectangular shaped plan measuring approximately 100 feet in width by 200 feet in length set on a reinforced concrete foundation. Framed by reinforced concrete and steel, features of the building include a flat roof with an ornamental cornice both above and below the sixth floor, corner quoins, and aligned double-hung windows. The ground floor features six store fronts divided by original ornamental stone pilasters with large fixed glass windows. The main entrance to the Maryland Hotel is recessed and is flanked by stepped pilasters with capitals. Overall, the building appears to be in good condition.

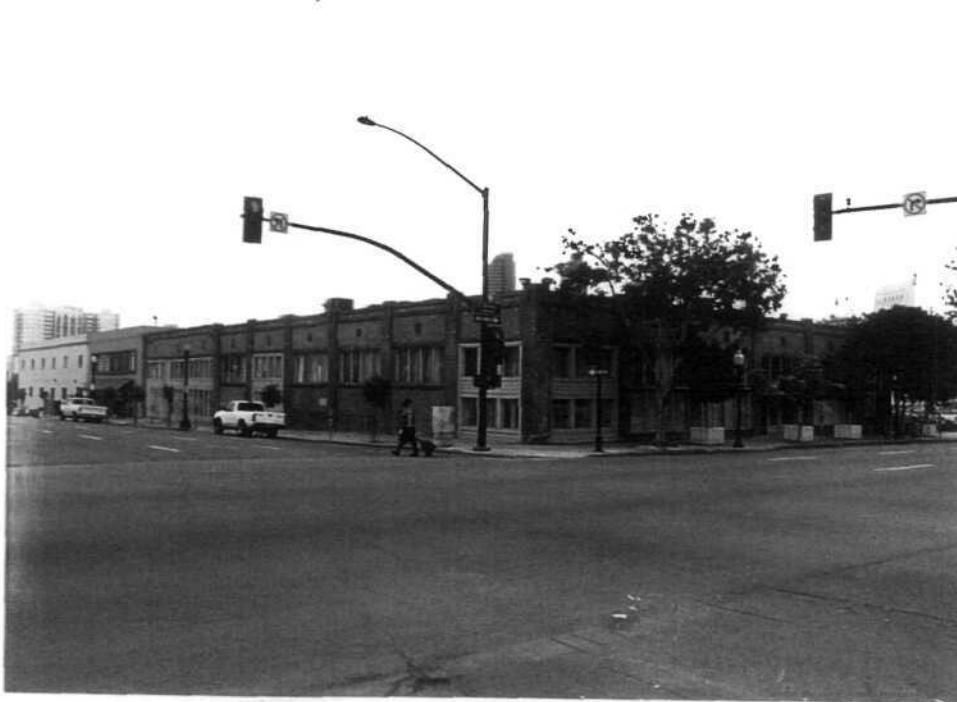
Originally constructed between 1907-1909, this single-story building is a well preserved example of a One Part **Commercial** Block building from the early Twentieth Century. Exterior building materials consist of red brick, glass, and wood. The building itself is divided into a series of bays which are marked on the exterior walls by brick pilasters. Each bay features a colored ornamental brick pattern above the window section. All windows around the buildings perimeter appear to be fixed, and recessed entries are present on the north and west elevation of the building. Overall, the building appears to be in excellent condition.

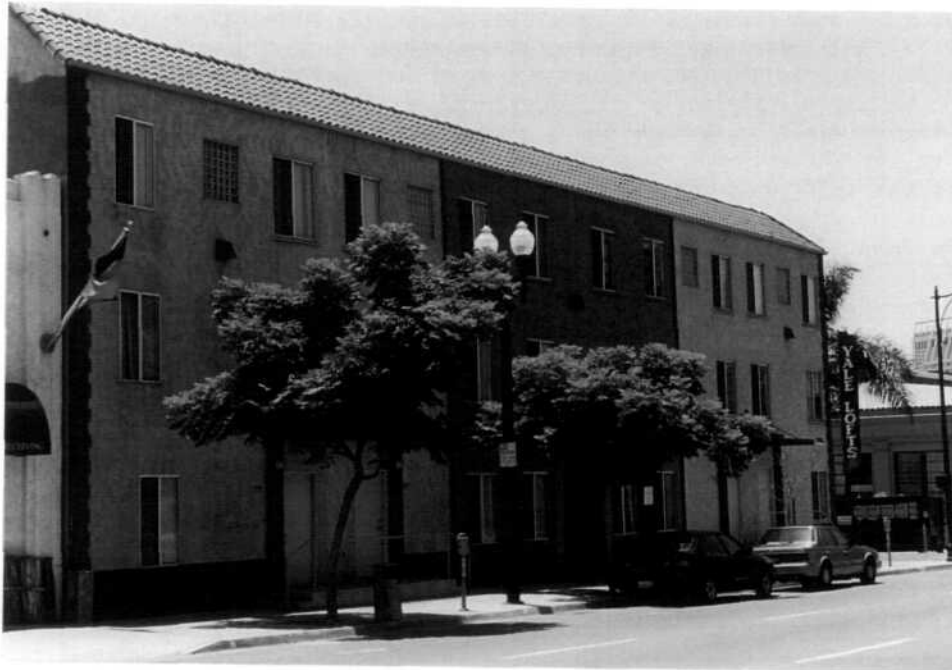
Originally constructed in 1927, this three-story building is a simple example of an 1920s Commercial Block Lodging House with a Spanish Eclectic influence. It has a rectangular shaped plan, and features a deck roof with two, hipped portions, northwest and northeast corner quoins, and pilasters flanking the main entrance with an extended marquee above supported by chains. Two additional, smaller entrances on the north elevation also feature pilasters and a marquee. Exterior building materials consist of stucco-on-lath for the exterior walls, and Mission tiles over the hipped roof sections. Fenestration consists of horizontally aligned, sliding, metal framed windows on every floor. (See DPR 523H, Continuation Sheet for more information)

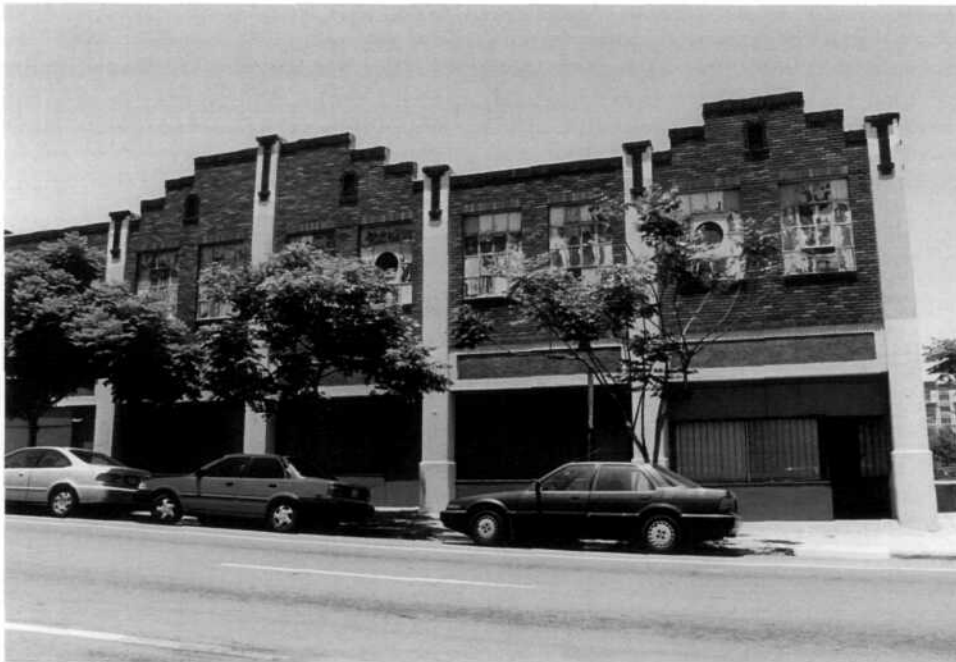
Originally constructed in approximately 1925, this Two-Part Commercial Block Building has a general square shaped plan, and features a flat roof with an extended parapet that varies in heights around the facades. The parapet is covered and capped with brickwork. The exterior facade is symmetrical and is divided into distinct sections by pilasters capped with brickwork. A horizontal band of applied, sealed asphalt painted blue divides the two-floors; the first-floor consists of approximately six in-filled window and garage bays, some of which are recessed. The second floor features multi-colored brickwork in both horizontal and vertical patterns, and each bay features two industrial style windows with a multi-pane sash pattern, featuring a central, four pane casement section bordered by twelve fixed panes. Overall, this building appears to be in fair condition.

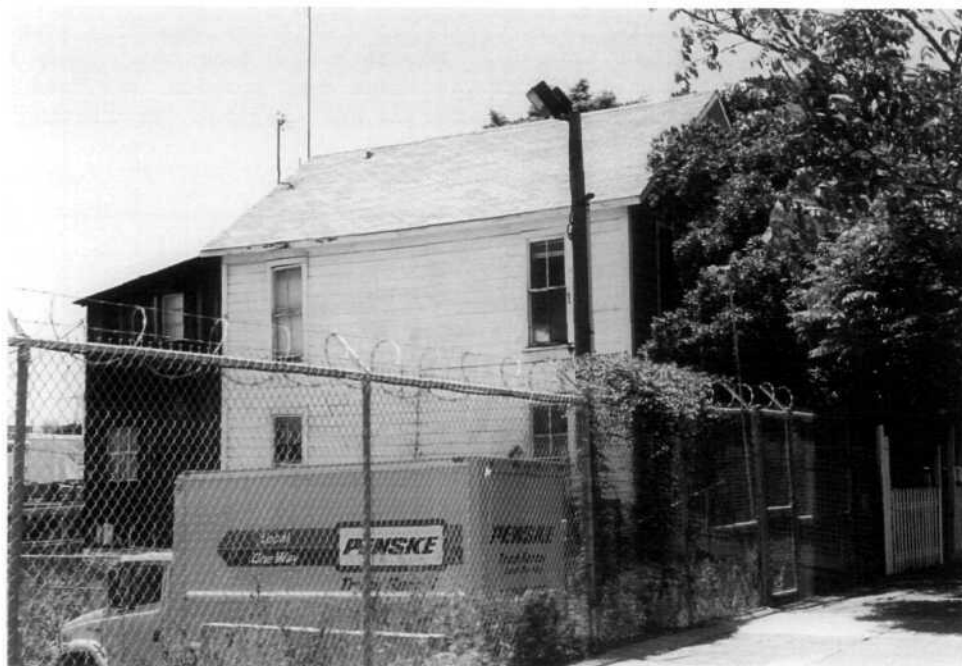
Originally constructed in approximately 1900, this **single-family**, three-story residence was designed in a Folk Victorian vernacular architectural style. It has a general rectangular shaped plan and features a moderately pitched front gabled roof with slight eave overhang, and an open, full length porch on the street facing facade. The porch features **stickwork**, wooden **posts** for support, and a shed style **roof**. Exterior building materials consist of shiplap siding with cornerboards for the exterior walls, and most likely composition shingles for the **roof**. A large tree obstructs the view of the front of the residence from the street. The poor condition of the residence and its **surroundings**, coupled with the presence of a major addition to the rear of the building results in the conclusion that this building has lost all architectural integrity.

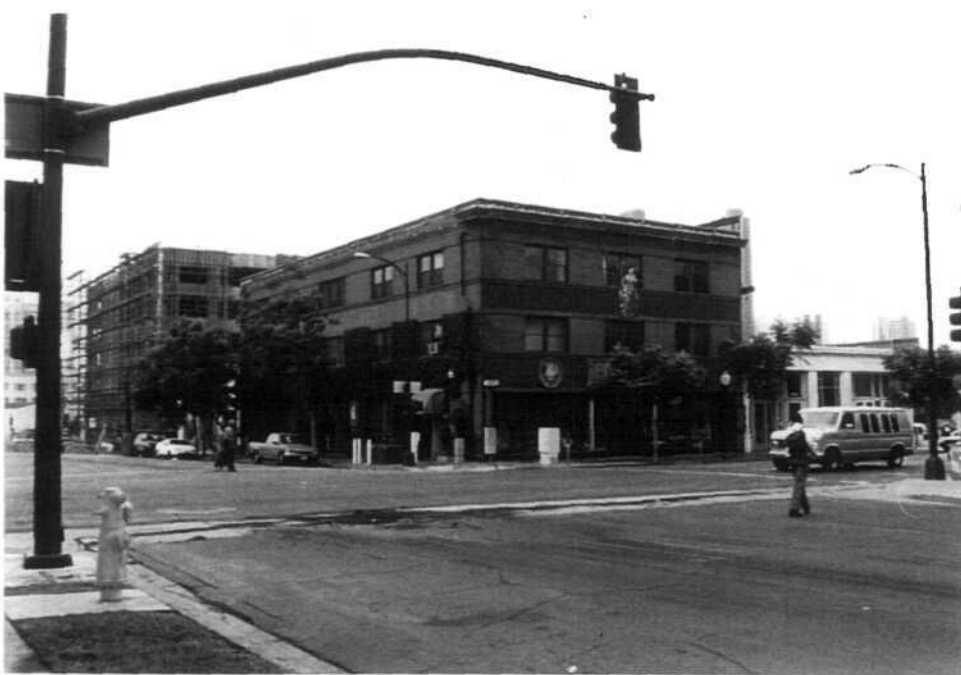
Originally constructed in 1909, this three-story brick and timber building was designed in a Two-Part Commercial Block style. It features a flat roof, a parapet, a boxed cornice on the north elevation, brick belt coursing between the third-floor window line and the cornice, and on the first and second floor window lines, and large enframed, ground floor storefront windows on the G Street and 7th Avenue facades. Fenestration consists of paired, double-hung windows on the second and third floors. The north elevation brick features painted bands between the second and third-floor windows. Overall, the building appears to be in good condition.

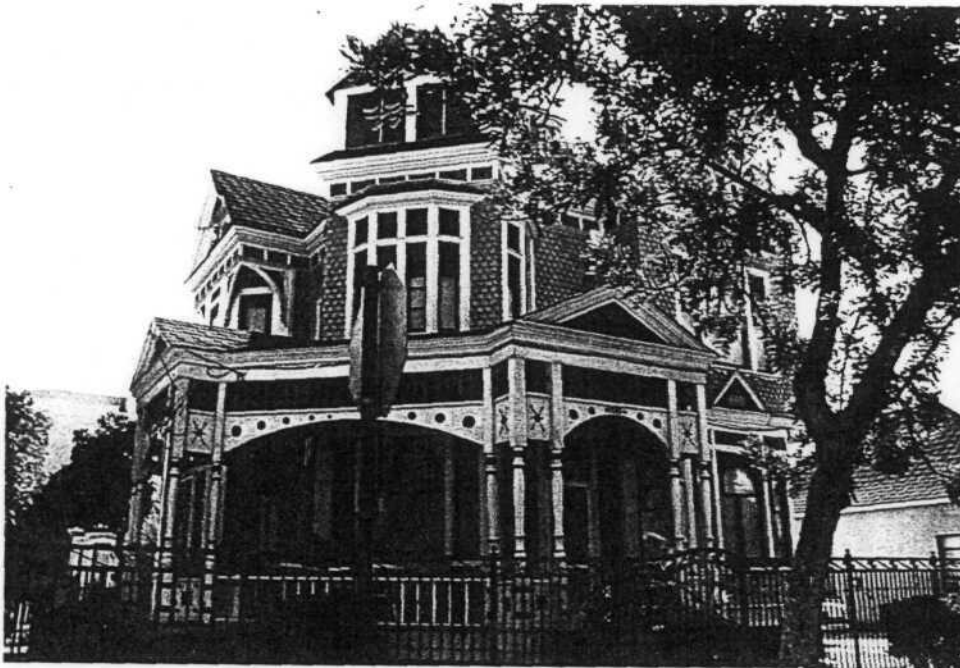
Originally constructed in 1886 at the corner of 11th Avenue and D Street (present-day Broadway) and relocated to this location in 1913, this two and one-half story residence was designed in the Queen Anne Spindework style of Victorian architecture. The building features a high hipped roof with lower cross gables, a boxed cornice with a decorated frieze, two-story angled and square bay windows featuring pediments on top, cutaway corner windows featuring decorative corner brackets, and a wraparound entrance porch featuring turned posts, pediments, and spindework. (See DPR 523H, Continuation Sheet for more information)

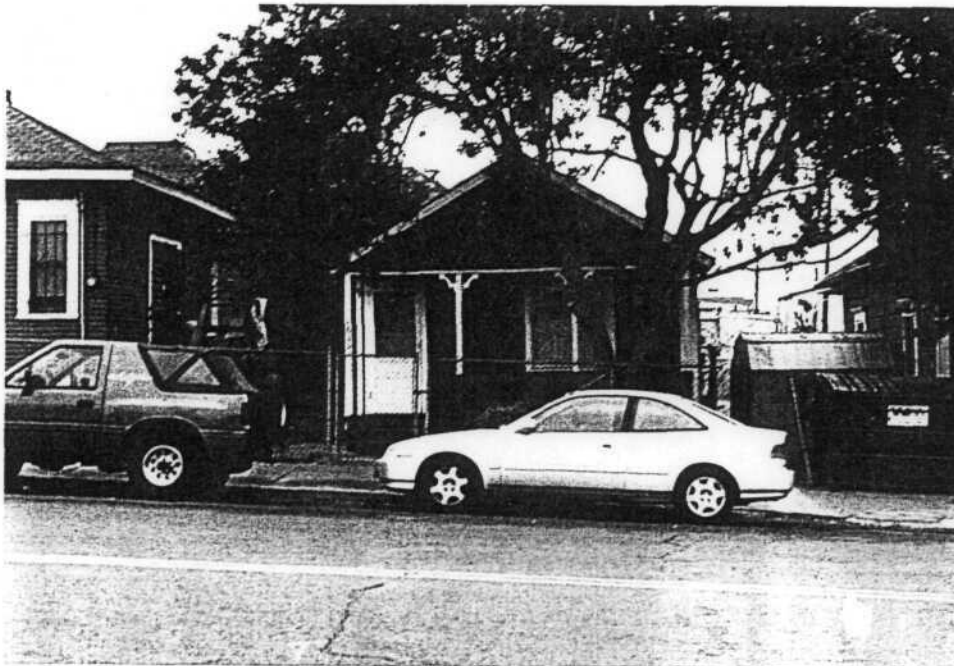
Originally constructed in approximately 1888, this single-story, single-family residence was designed in a Folk Victorian architectural style. It has a general square shaped plan, and features a front gabled roof of moderate pitch with slight enclosed eave overhang. A full length porch located on the front, north elevation features bracketed wood posts for support perched upon a low wood wall which partially encloses the porch area. Exterior building materials consist of composition shingles for the roof, vertical and horizontal board-and-batten siding for the exterior walls, and the north elevation focal window appears to be double-hung with a fixed upper sash. The front entrance is off center, located on the northeast corner of the residence and concrete steps painted green ascend to the front entrance. Overall, this building appears to be in good condition.

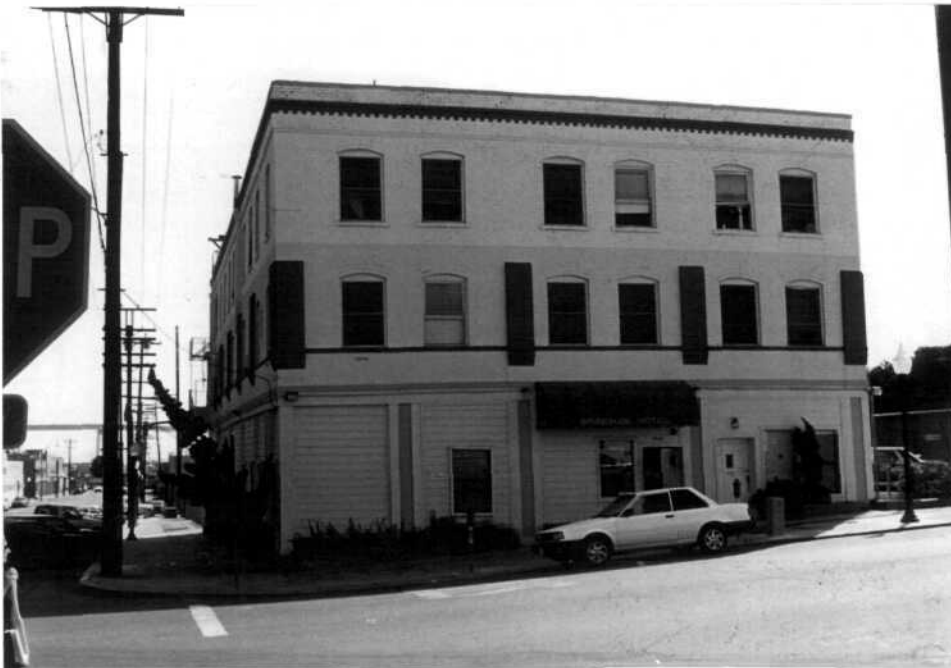
Originally constructed in 1912, this three-story building identified as the Workman Hotel is a simple example of an early Twentieth Century Commercial Block lodging house with an Italian Renaissance influence. The building features a rectangular shaped plan, with a flat roof, a dentil band spanning around the building's perimeter, corbeling below the dentil band, a series of second floor masonry elements located between every second window, and belt coursing below the second floor window sills. The second floor masonry elements feature corbeling at the base, and are painted in a dark color that contrasts against the lighter, surrounding buff colored brick. Fenestration on the second and third floors consists of aligned, rectangular, double-hung sash windows in wood frames that are grouped in pairs. (See DPR 523H, Continuation Sheet for more information)

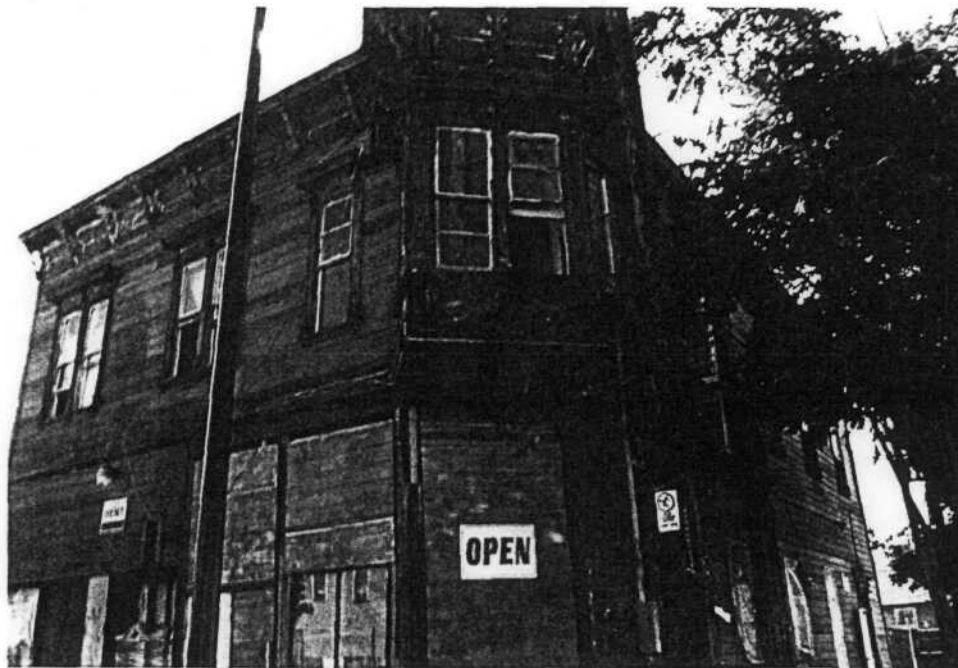
Originally constructed in 1888, this two-story, Italianate building stands on the southwest corner lot of the intersection of 15th Avenue and J Street. It has a general rectangular shaped plan, and features shiplap siding, a flat roof in the Townhouse style with a bracketed cornice, double-hung windows with wooden ornamental surrounds and decorated hoods, and a second floor square bay that is angled across the cutaway corner. The cornice brackets resemble turned spindles. On the ground floor, vertical boards replace the original features in the cutaway corner, and most likely a majority of the original first floor exterior building materials have been removed and/or replaced, including the original doors and windows. The asymmetrical facade features wooden doors at both ends of the building. (See DPR 523H, Continuation Sheet for more information)

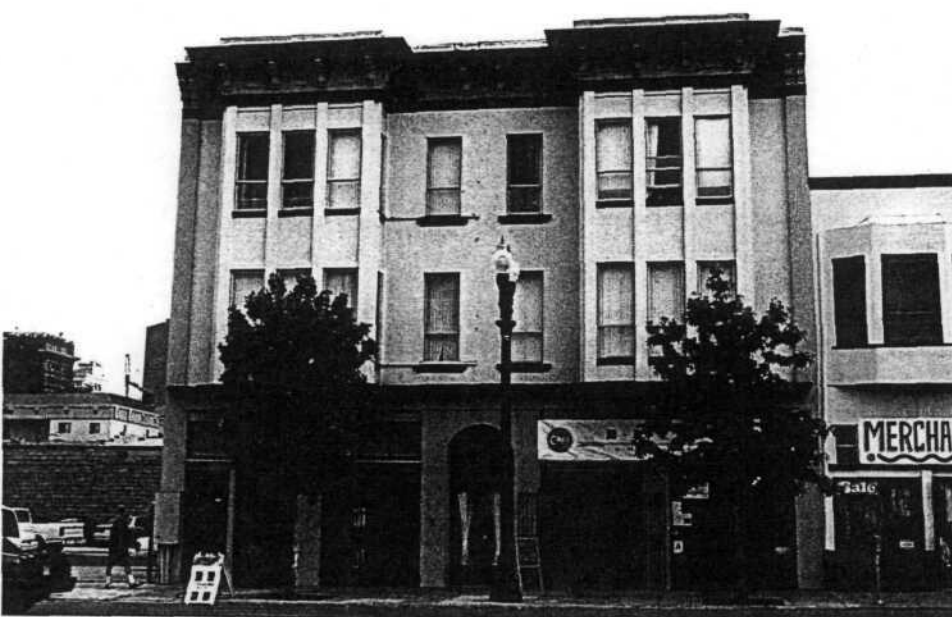
Originally constructed in approximately 1898, this building was designed in a Two-Part Commercial Block style with an Italianate architectural influence. It has a flat roof and features a bracketed boxed cornice, two large projecting rectangular bays spanning across the length of the second and third floors, and first floor shop front spaces (identified as 726 and 732 Market Street) which are separated by a central arched entry leading to the upper residential floors of the building. The first floor shop front windows are large fixed single panes of glass with a multi-pane sash pattern and clerestory windows above. Exterior building materials consist of stucco and red brick for the exterior walls, and most likely composition rolls for the roof. Overall, this building appears to be in good condition.

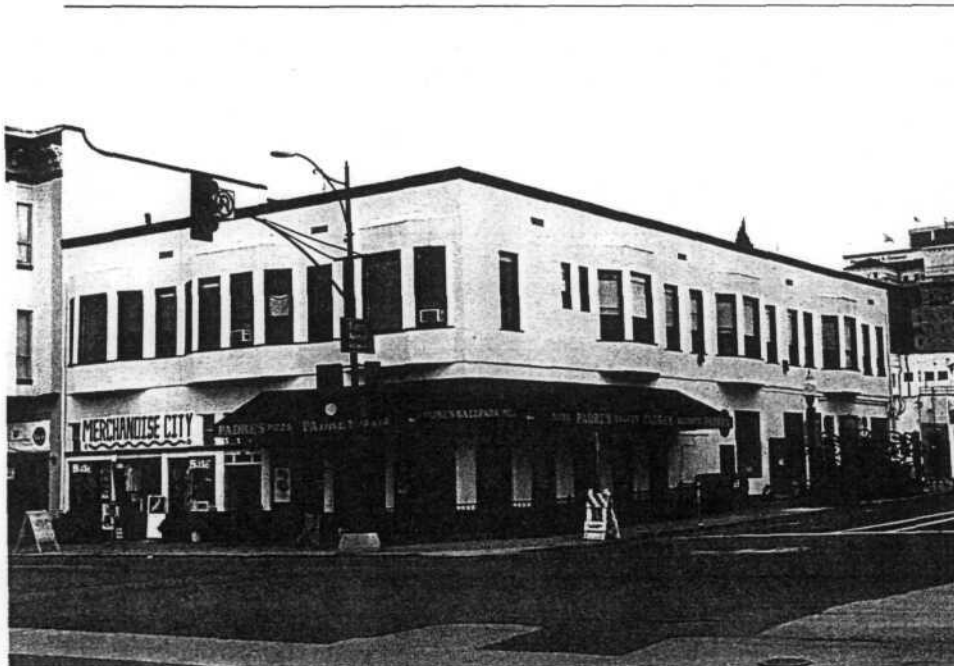
Originally constructed in 1896, this building was designed in a Two-Part **Commercial** Block style with an Italianate architectural influence. It has a general rectangular shaped plan and features a flat roof, rectangular **double-and-single-hung** windows aligned in a series of angled bays on the second floor, and first floor store fronts featuring single, large fixed panes for display and smaller vertical, rectangular shaped single-hung windows above. The first floor portion contains two shop fronts identified as 740 and 744 Market Street, with the second floor containing the residential portion identified as 742 Market Street. Rear entrances to the spaces are located on the east elevation along with additional store front **windows**. Exterior building materials consist of stucco over the original red brick, and most likely composition rolls for the **roof**. Overall, this building appears to be in good condition.

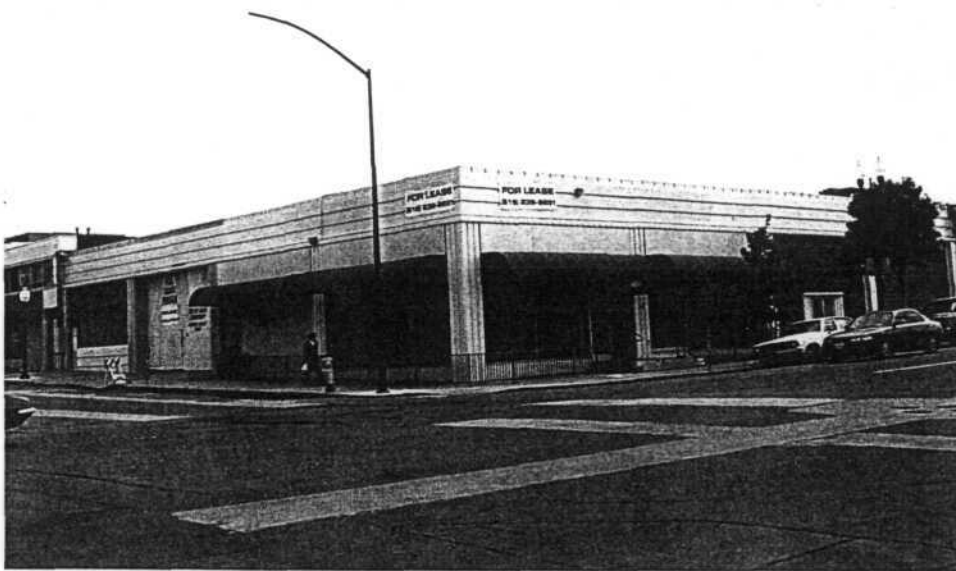
This One-Part Commercial Block styled building with Art Deco detailing was constructed in 1931. It features a flat roof with a parapet, enframed window wall portions divided by pilasters, (with each pilaster featuring engraved vertical lines) and eight bay sections. Three of the bays are storefronts, while several others are boarded or in-filled. The southeastern most bays are composed of block glass, which may have been added during the 1950s or 1960s. The building is concrete with a stucco-on-lath exterior. Overall, the building appears to be in fair condition.

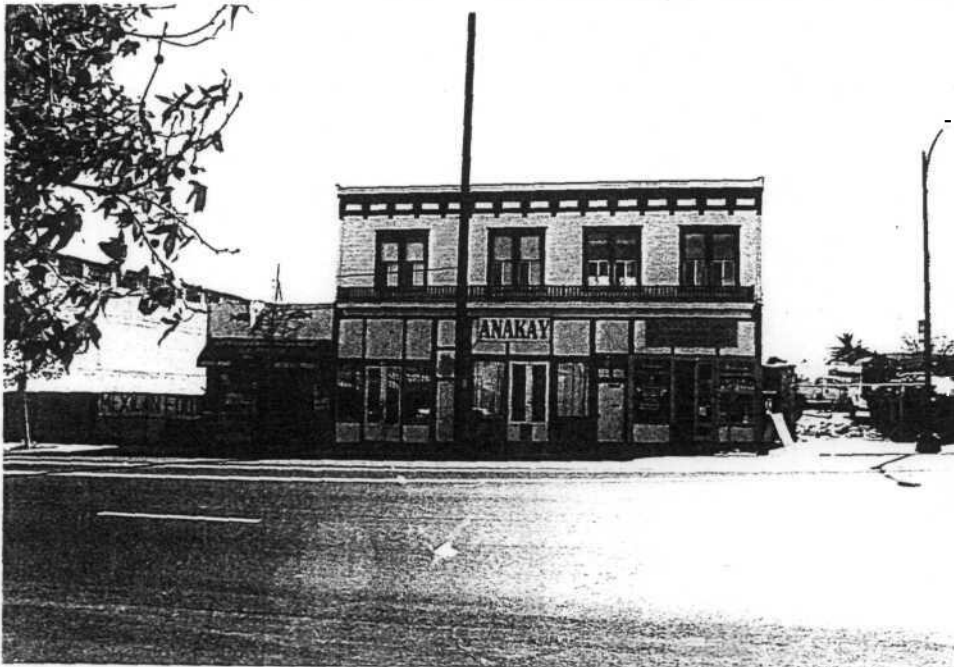
Originally constructed in 1888, this two-story wood framed building was designed in an Italianate architectural style. It has a general rectangular shaped plan, with an addition to the rear and features a flat roof with a parapet, a decorated cornice and frieze with brackets and a dentil band. The lower level features three shop fronts identified as 1425, 1427, and 1431 Market Street and two additional entrances presumably to the upstairs portion identified as 1427 and 1429 Market Street. Each of the three shopfront entrances feature double swinging doors surrounded on all sides by large fixed windows. The second floor features four sets of paired double-hung sash windows which have been modified to include sliders on the lower portion. Exterior building materials consist of horizontal clapboard siding with corner boards for the exterior walls, and most likely composition rolls for the roof. Overall, the building appears to be in good condition.

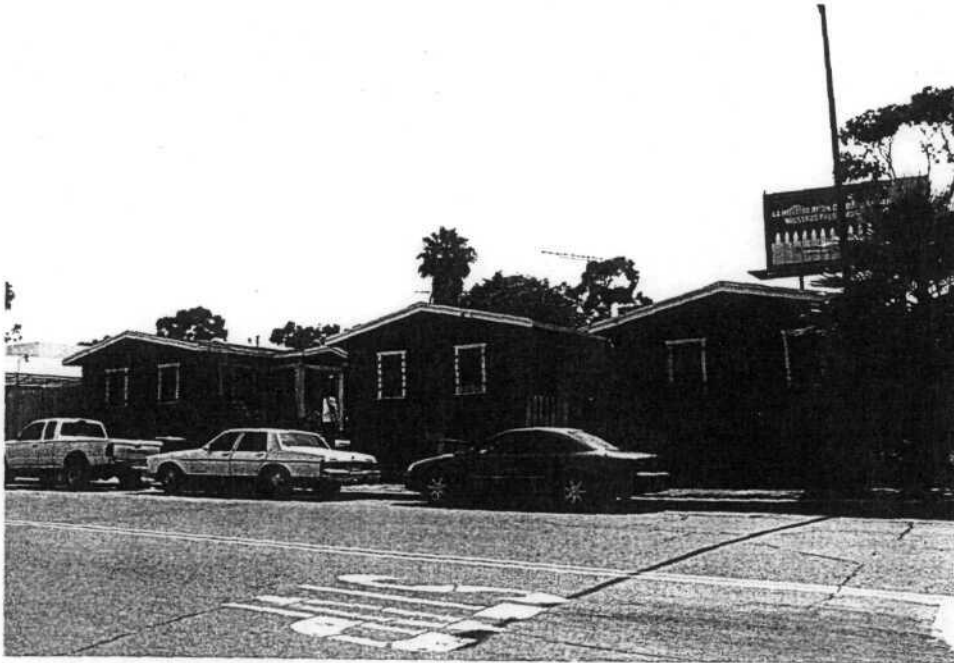
Originally constructed in 1924, the six bungalows shown in the photograph below are identified as 1704-1710 Market Street and 607-621 17th Avenue. Designed in a Craftsman vernacular architectural style, the six houses are identical in design and feature a rectangular shaped plan, with a low pitched, side gabled roof with an enclosed eave overhang, and an ornamental, center gabled entrance porch supported by one square post on each front corner. Exterior building materials consist of composition shingles for the roof, and horizontal clapboard siding for the exterior walls. Window types include individually placed double-hung sash and a triple window on each building that serves as the focal point. Each triple windows features a larger fixed center sash with a multi-pane sash pattern on the upper portion, flanked on both sides by a narrow double-hung sash window. Security bars cover the windows. Overall, the buildings appear to be in good condition.
