Stadium Wetland Mitigation Project (San Diego River)

Mitigation Plan

Final

March 13, 2015

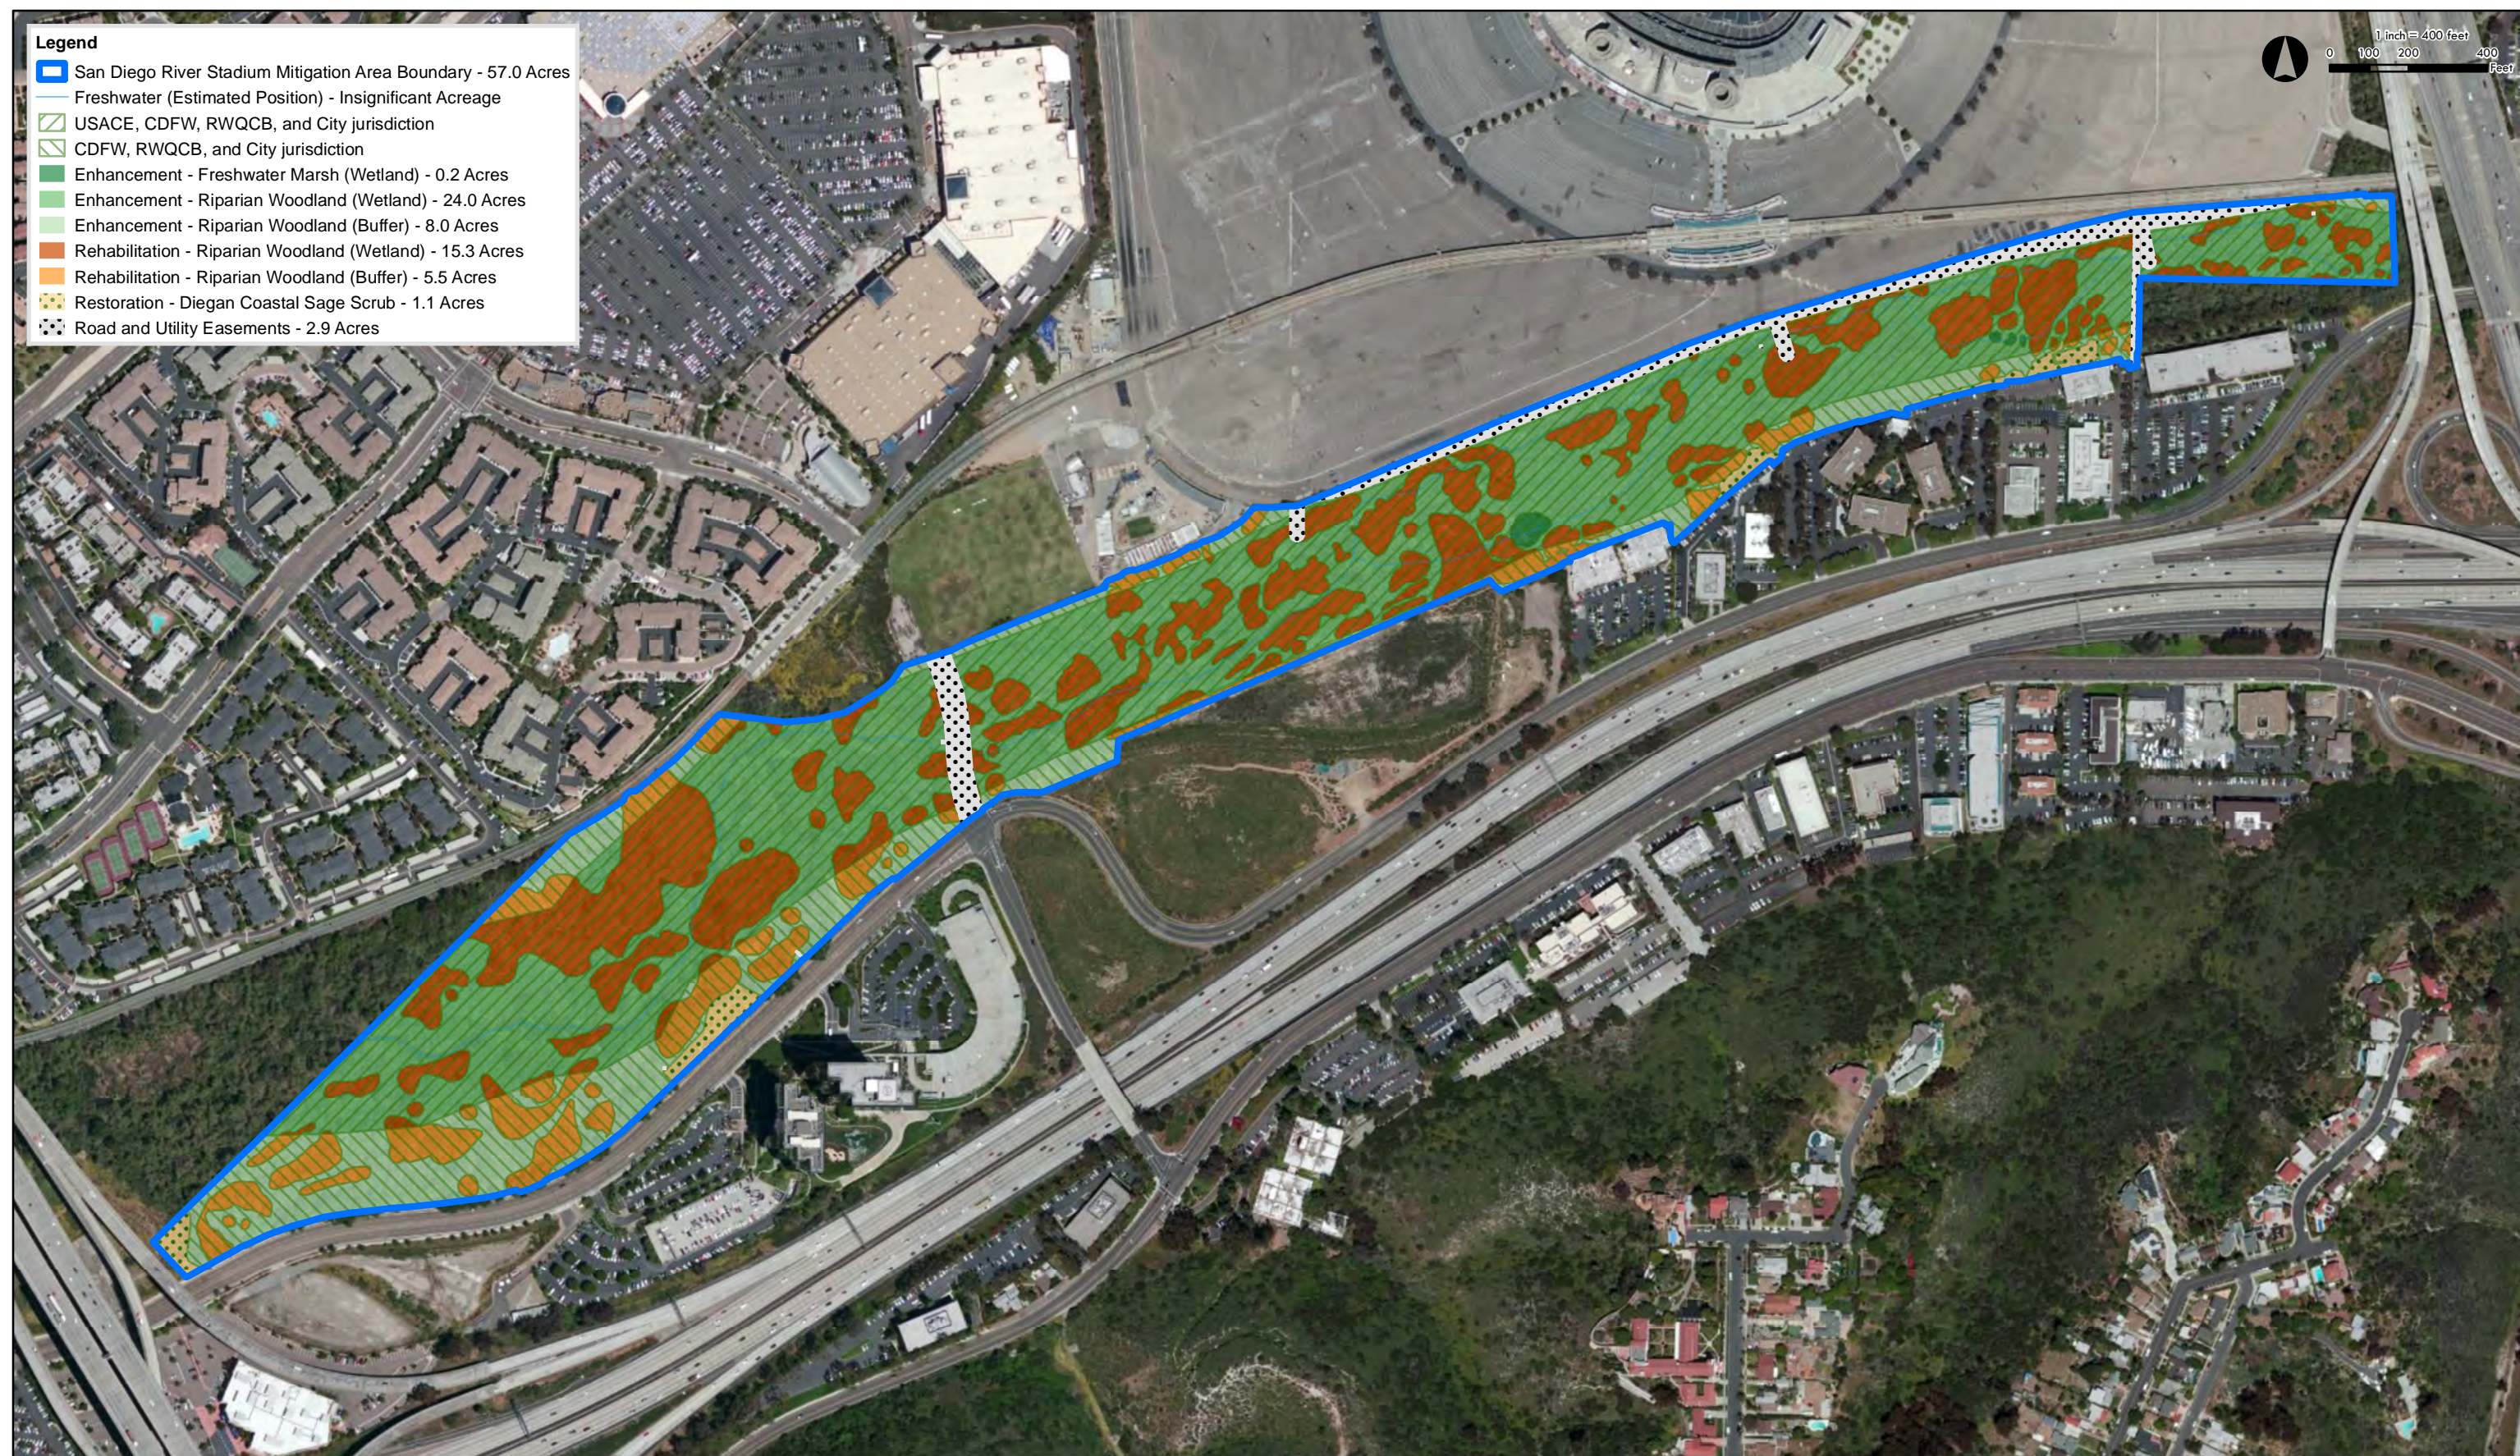
FIGURE 13
Mitigation Credit Areas

Non-Aquatic Mitigation Excluding Buffer Areas						
Non-native Grasslands	Coastal Scrub	Diegan Coastal Sage Scrub	Upland	Restoration	1.1	N/A
				Total	1.1

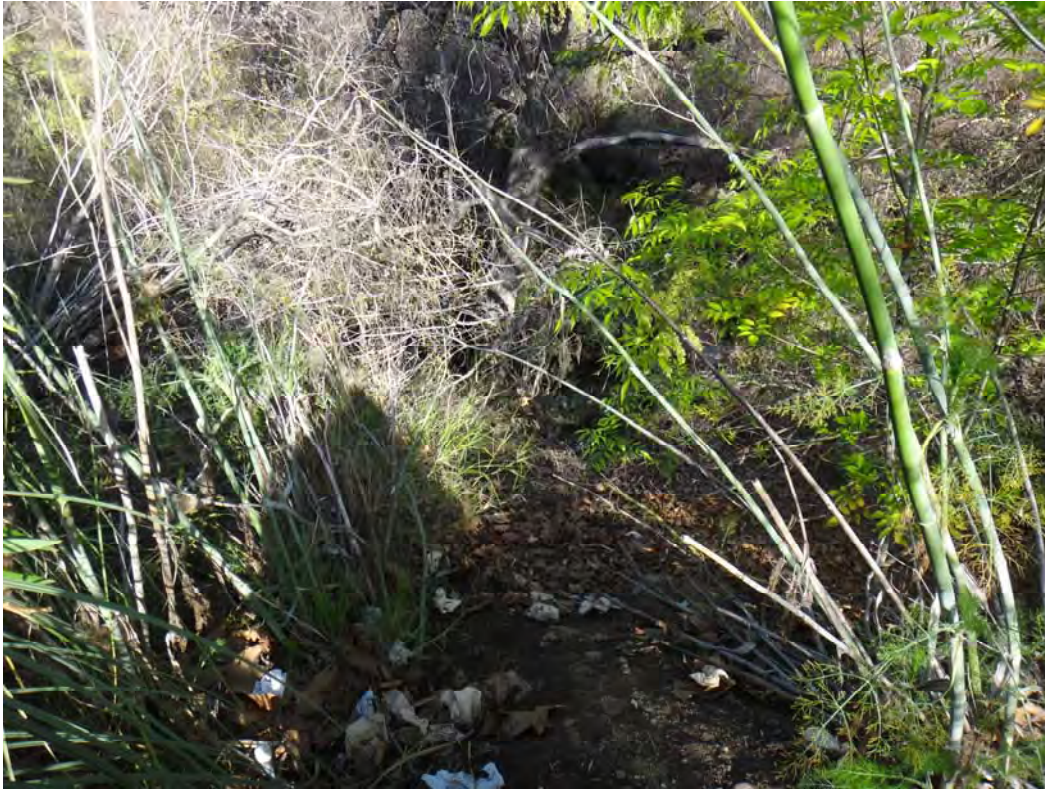
Photograph 13. Invasive vegetation and trash near the south bank of the San Diego River, facing north

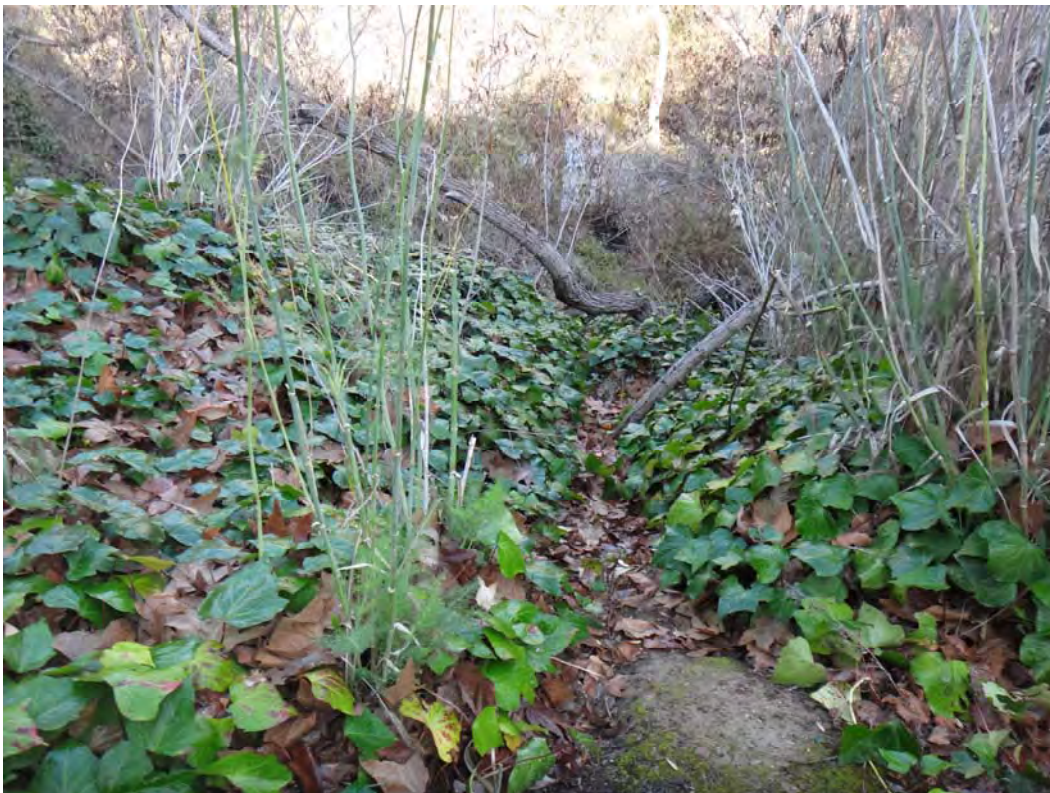
Photograph 14. Steep slope leading to the south bank of the San Diego River, facing north

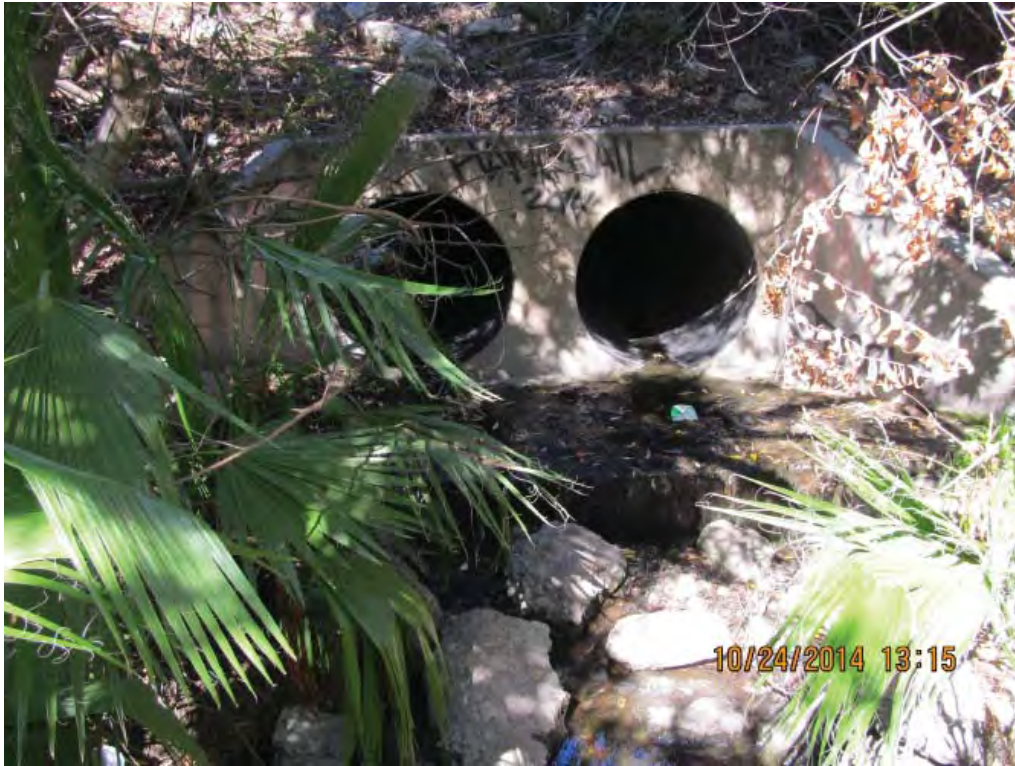
AA-3 Stormdrain outfall.

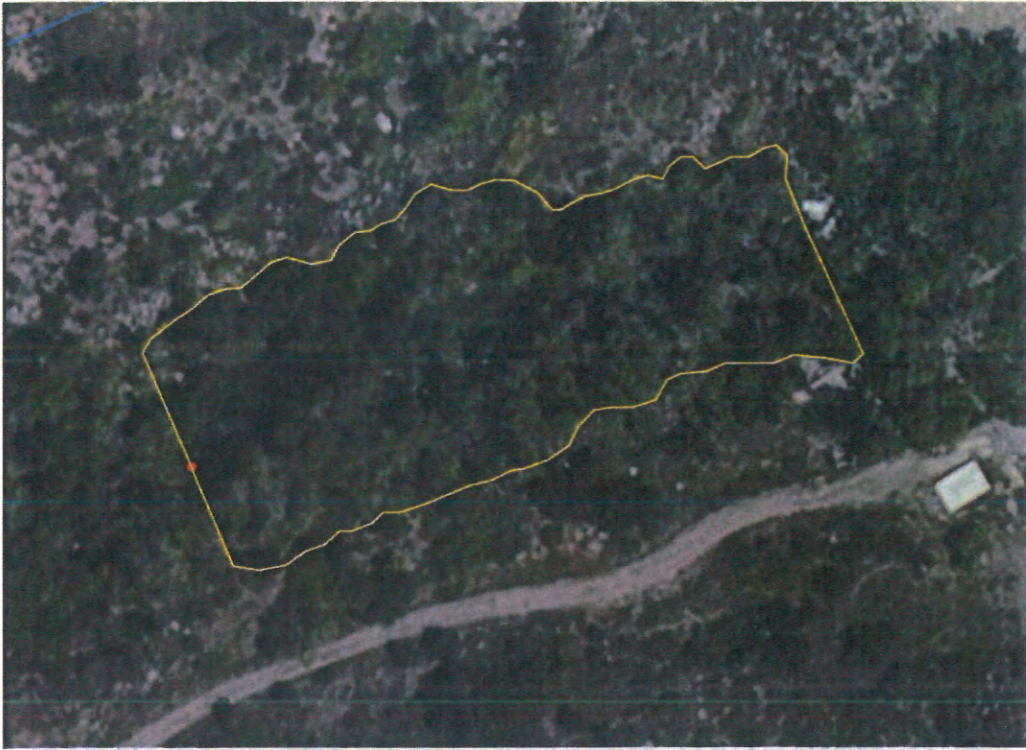
In the space provided below make a quick sketch of the AA, or perform the assessment directly on the aerial imagery; indicate where buffer is present, estimate the percentage of the AA perimeter providing buffer functions, and record the estimate amount in the space provided.

Percent of AA with Buffer: 100 %
