Lake Hodges HOS
Biological Assessment

Prepared for the City of San Diego

July 29, 2016

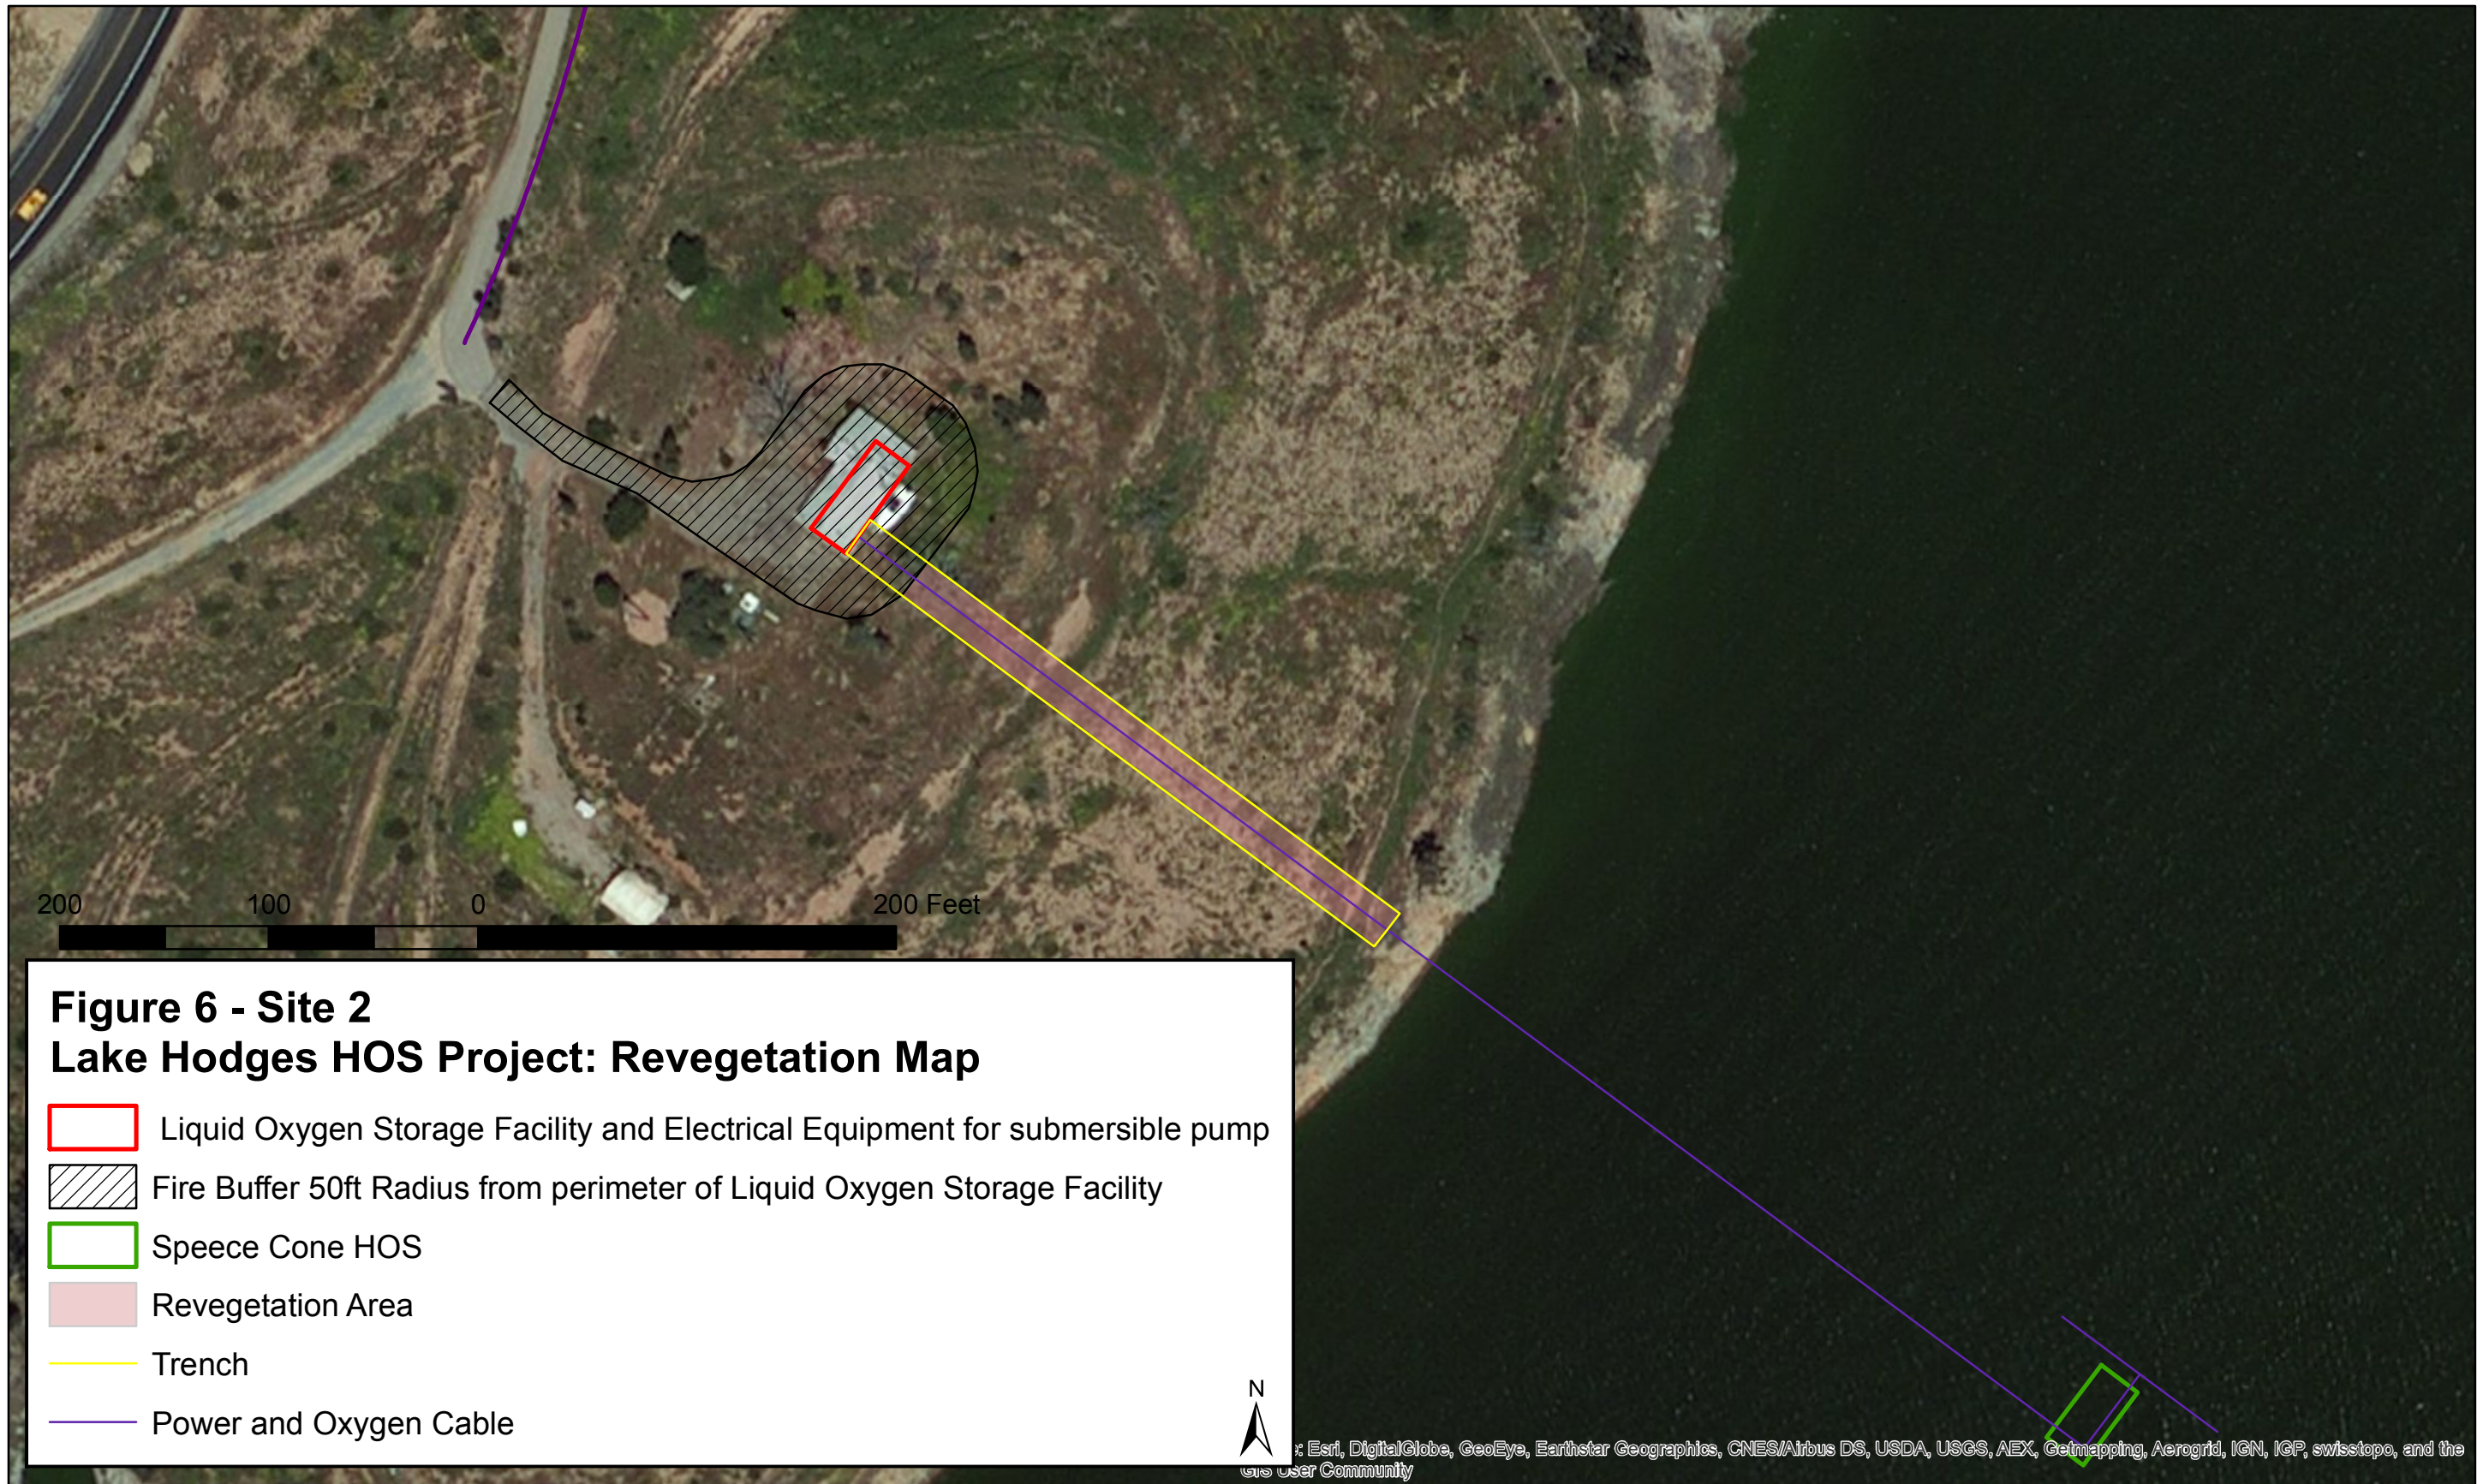
Figure 6 - Site 2
Lake Hodges HOS Project: Revegetation Map

- Liquid Oxygen Storage Facility and Electrical Equipment for submersible pump
- Fire Buffer 50ft Radius from perimeter of Liquid Oxygen Storage Facility
- Speece Cone HOS
- Revegetation Area
- Trench
- Power and Oxygen Cable

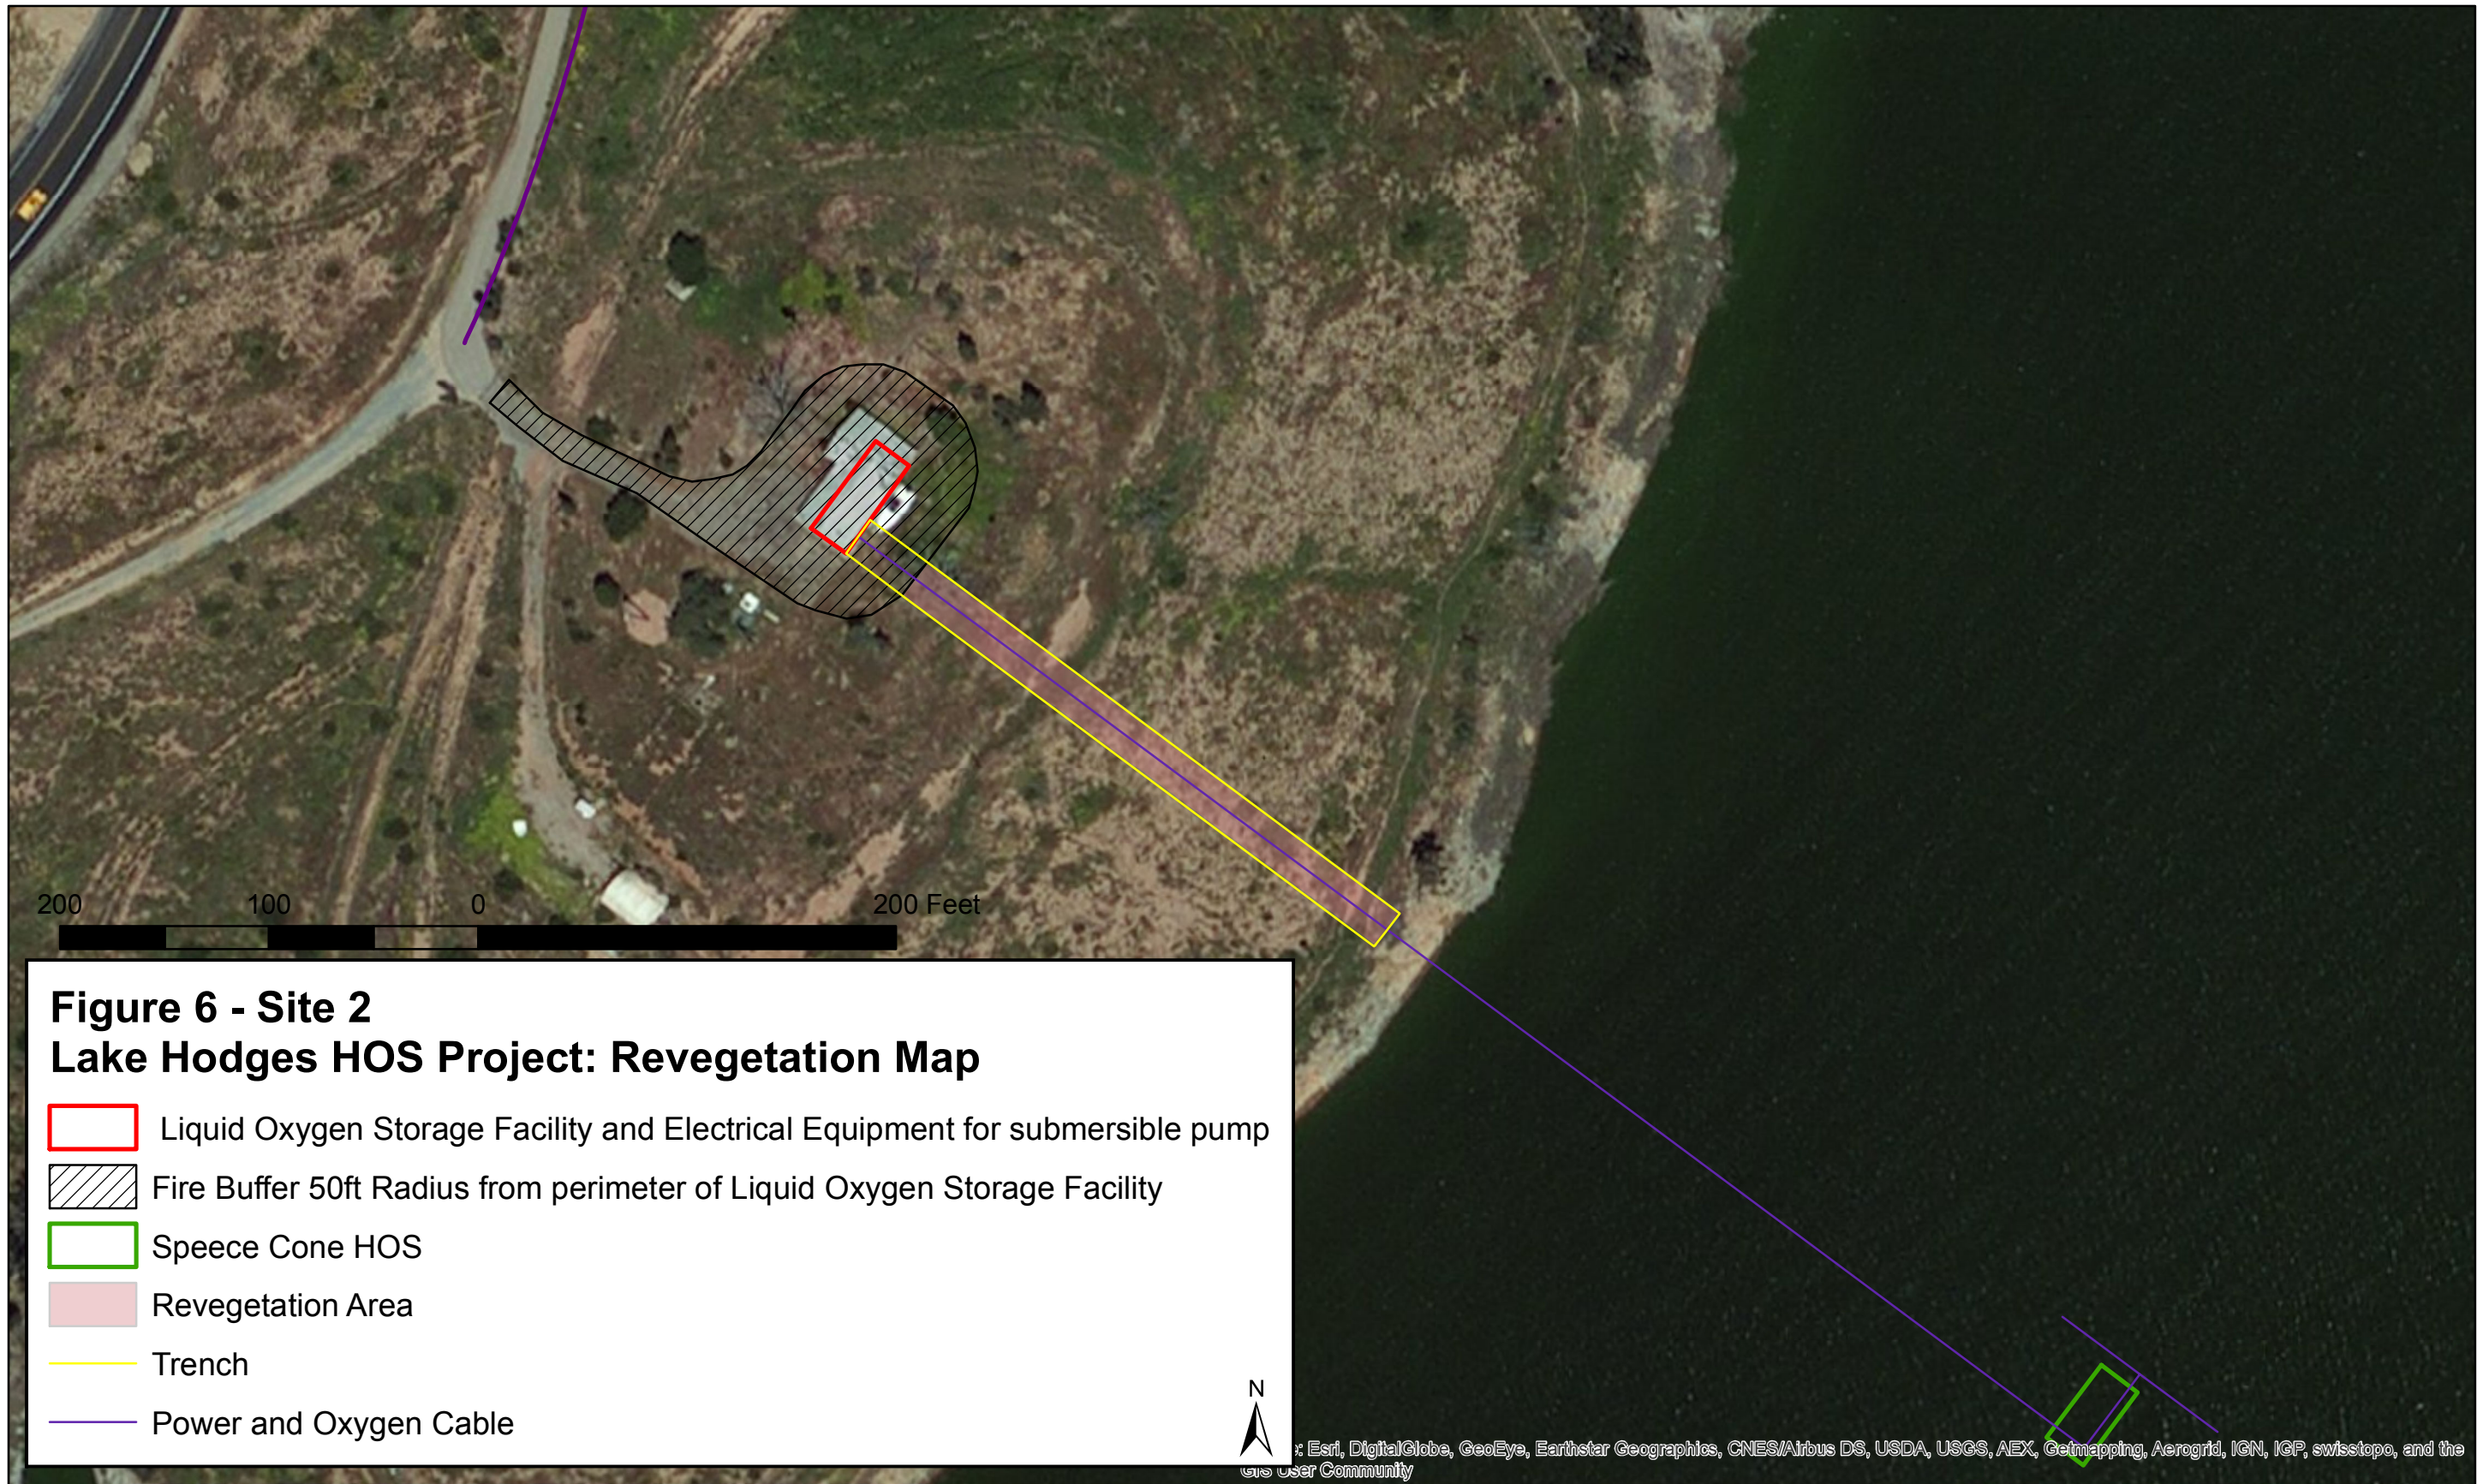
Figure 6 - Site 2
Lake Hodges HOS Project: Revegetation Map

- Liquid Oxygen Storage Facility and Electrical Equipment for submersible pump
- Fire Buffer 50ft Radius from perimeter of Liquid Oxygen Storage Facility
- Speece Cone HOS
- Revegetation Area
- Trench
- Power and Oxygen Cable
