INDIVIDUAL BIOLOGICAL ASSESSMENT REPORT

Site Name/Facility: Chollas Creek Channel Sections 02 and 03 of 03

MSWSMP Map No.: 91 and 93

Date: 12 October 2010

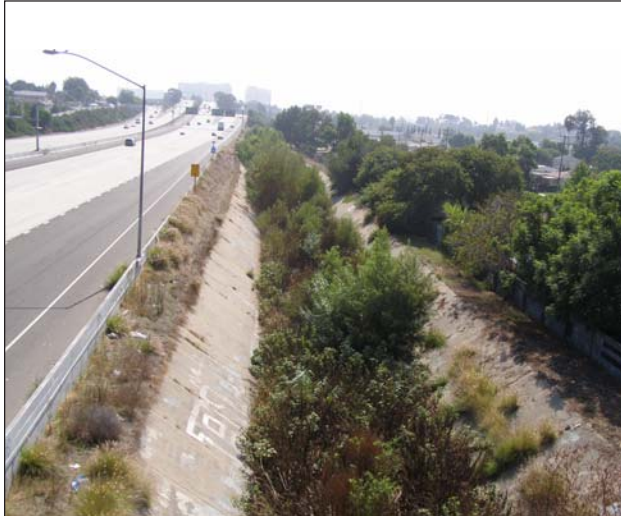
SITE PHOTOS Map 91_101310 LS

Concrete lined, trapezoidal channel with disturbed Riparian Scrub in foreground and southern willow scrub in background. Photo is looking south from Ocean View Blvd. Interstate 15 is to the right (east).

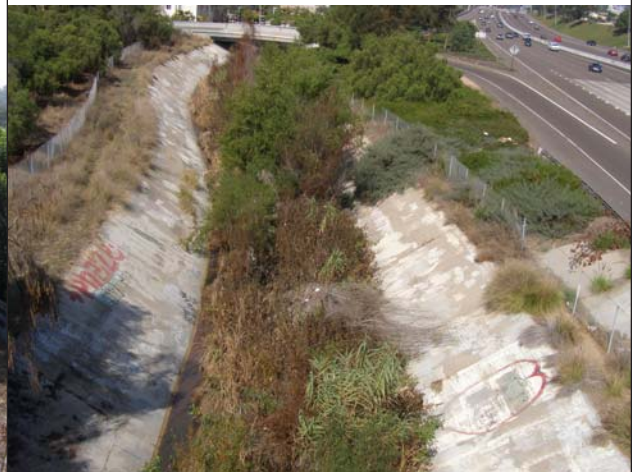
Concrete lined, trapezoidal channel with disturbed Riparian Scrub in foreground and background, and southern willow scrub in between. Photo is looking north from Ocean View Blvd. Interstate 15 is to the left (east).

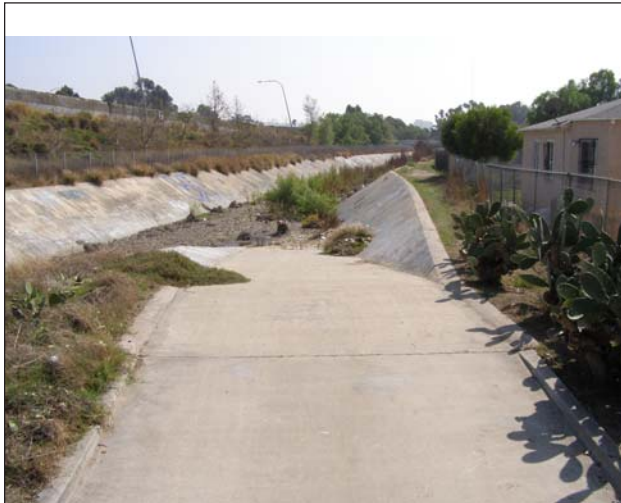
SITE PHOTO Map 93_101310 LS

Concrete lined, trapezoidal channel lacking vegetation and with disturbed riparian scrub growing on accumulated sediment. Photo is looking south along channel maintenance access point at Durant Street.

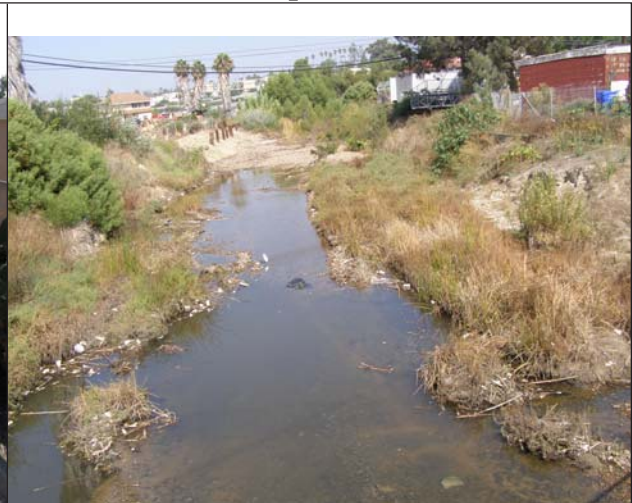
Unlined channel with open water and streambed in center of channel, brackish salt marsh on lower terrace, and disturbed habitat, non-native grassland, mule fat scrub and southern willow scrub growing on channel banks. Photo is looking north from National Avenue.
