Mission Bay PEIR

Restoration of Shoreline

Outline

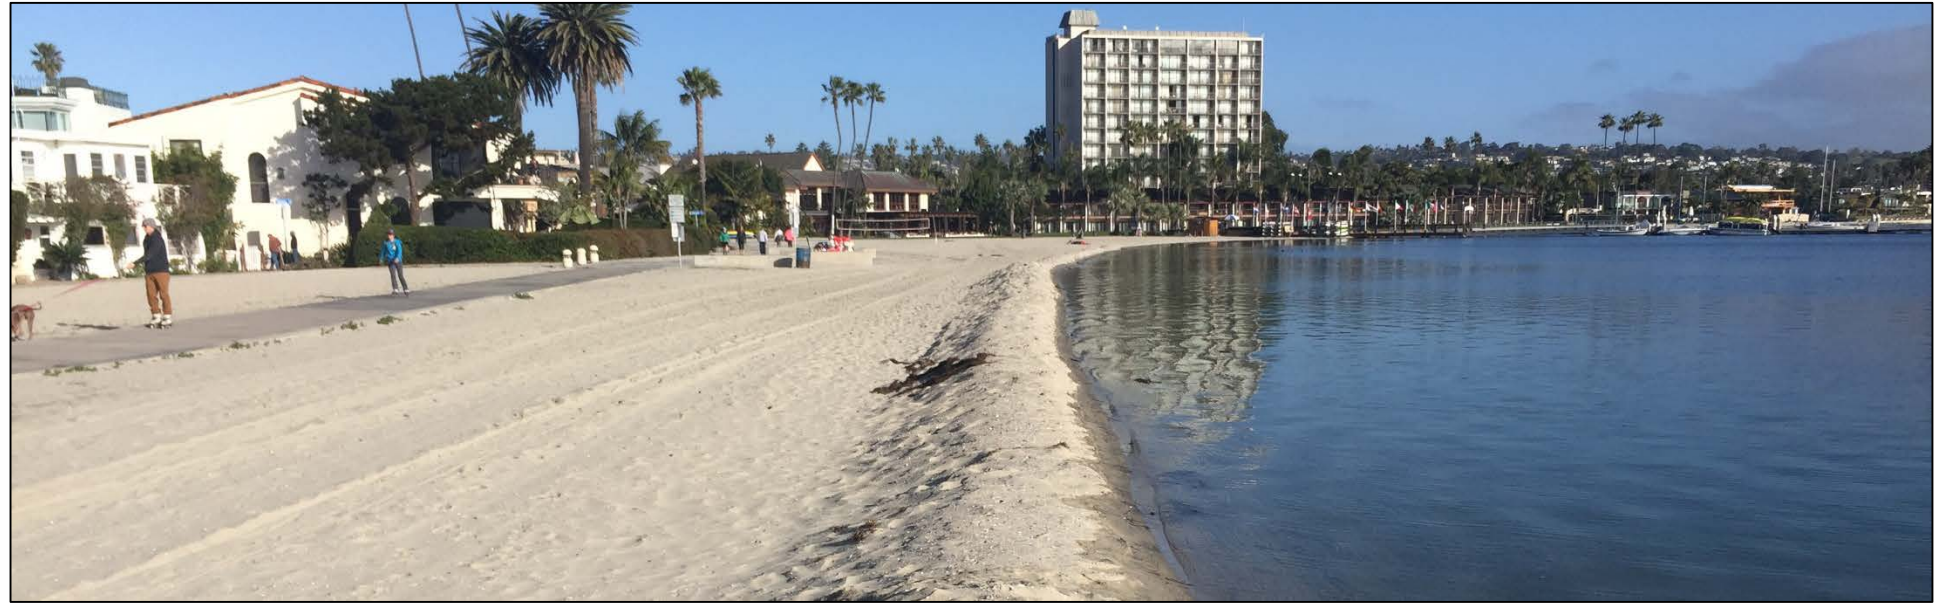
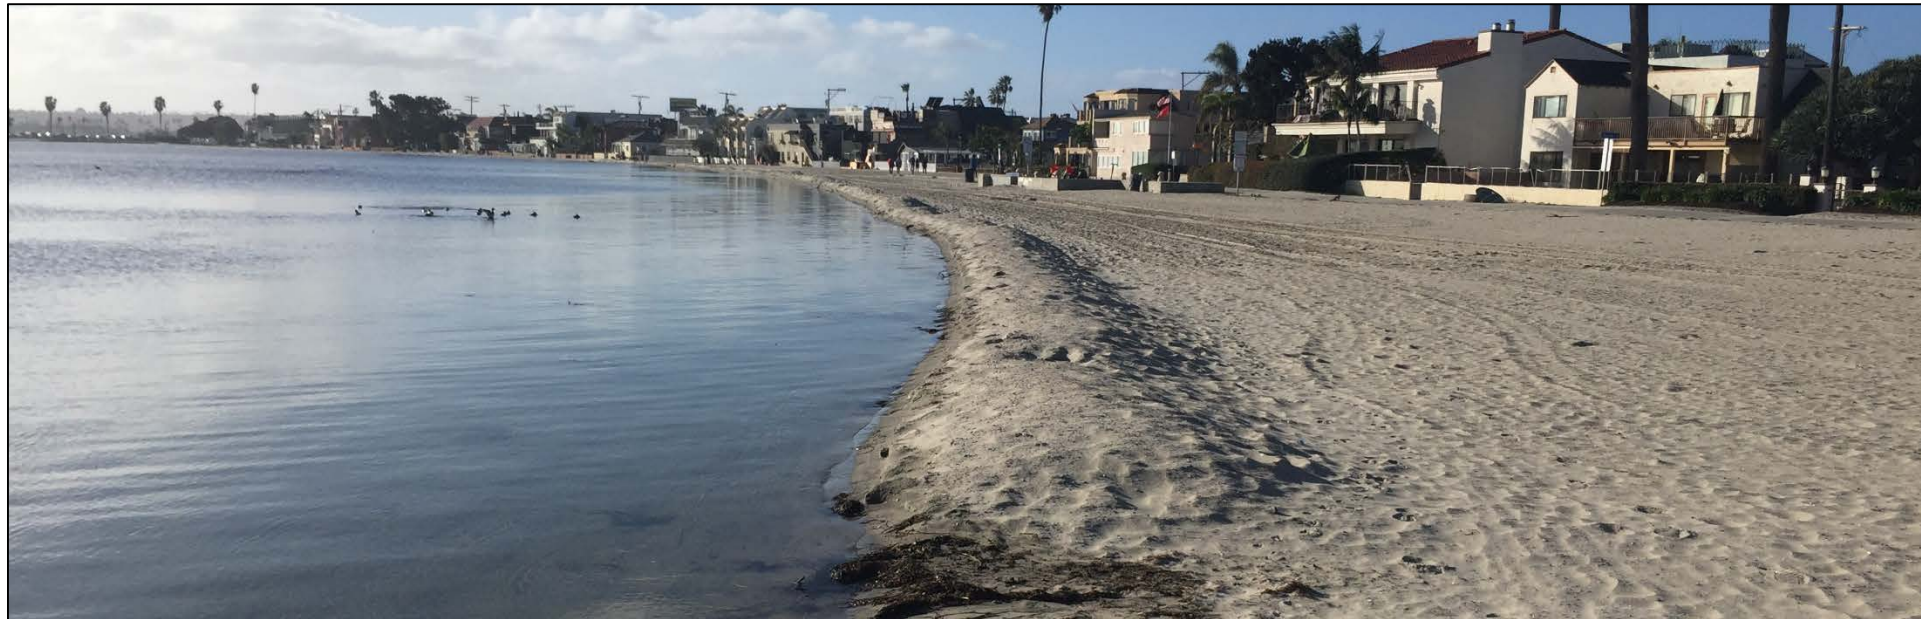
West Sail Bay – The Problem

- Beach width has reduced from ~75 ft (in 1964) to ~20 ft (in 2017)
- Winter berm is required to protect public pathway and residences from extreme high tide and storm conditions

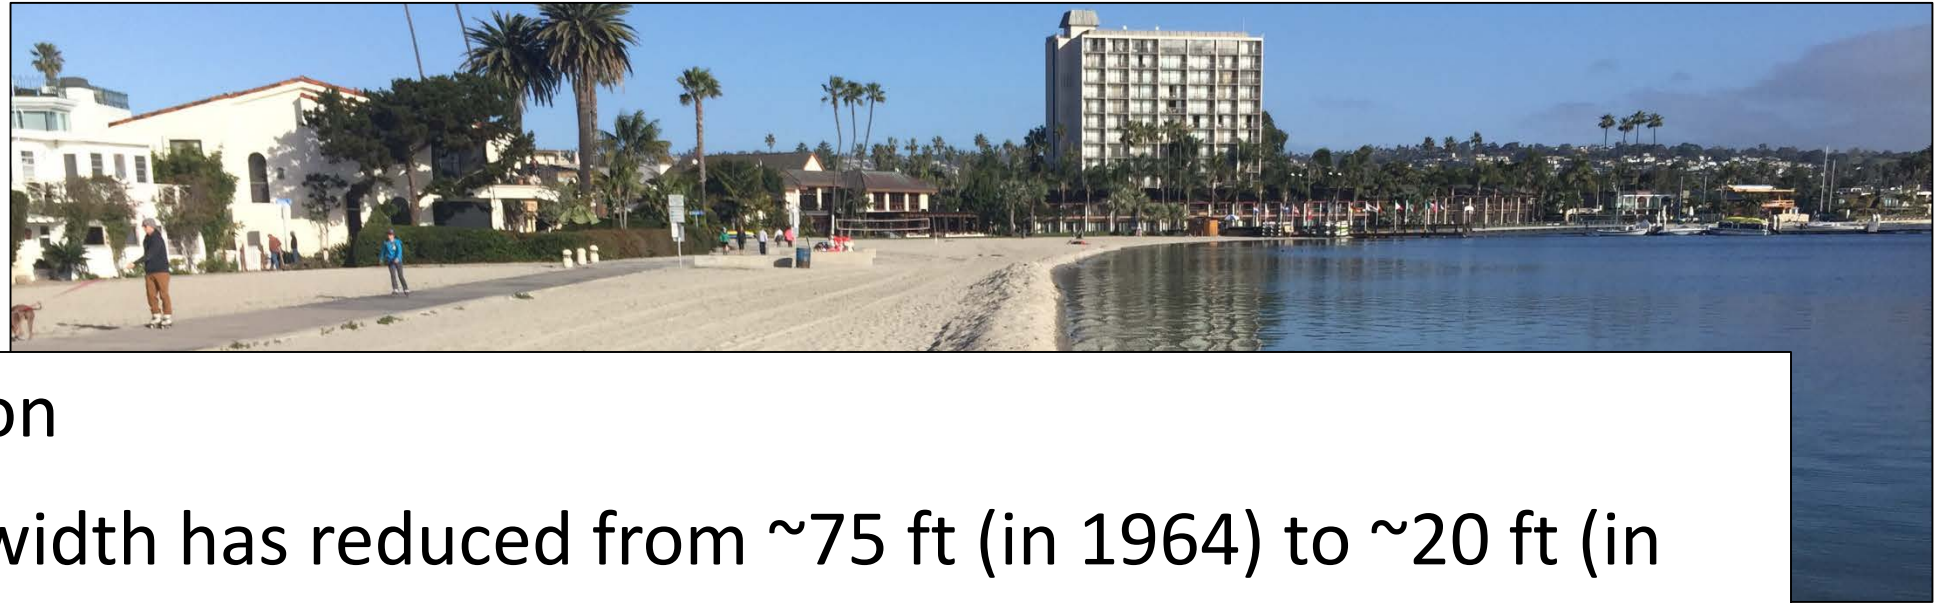
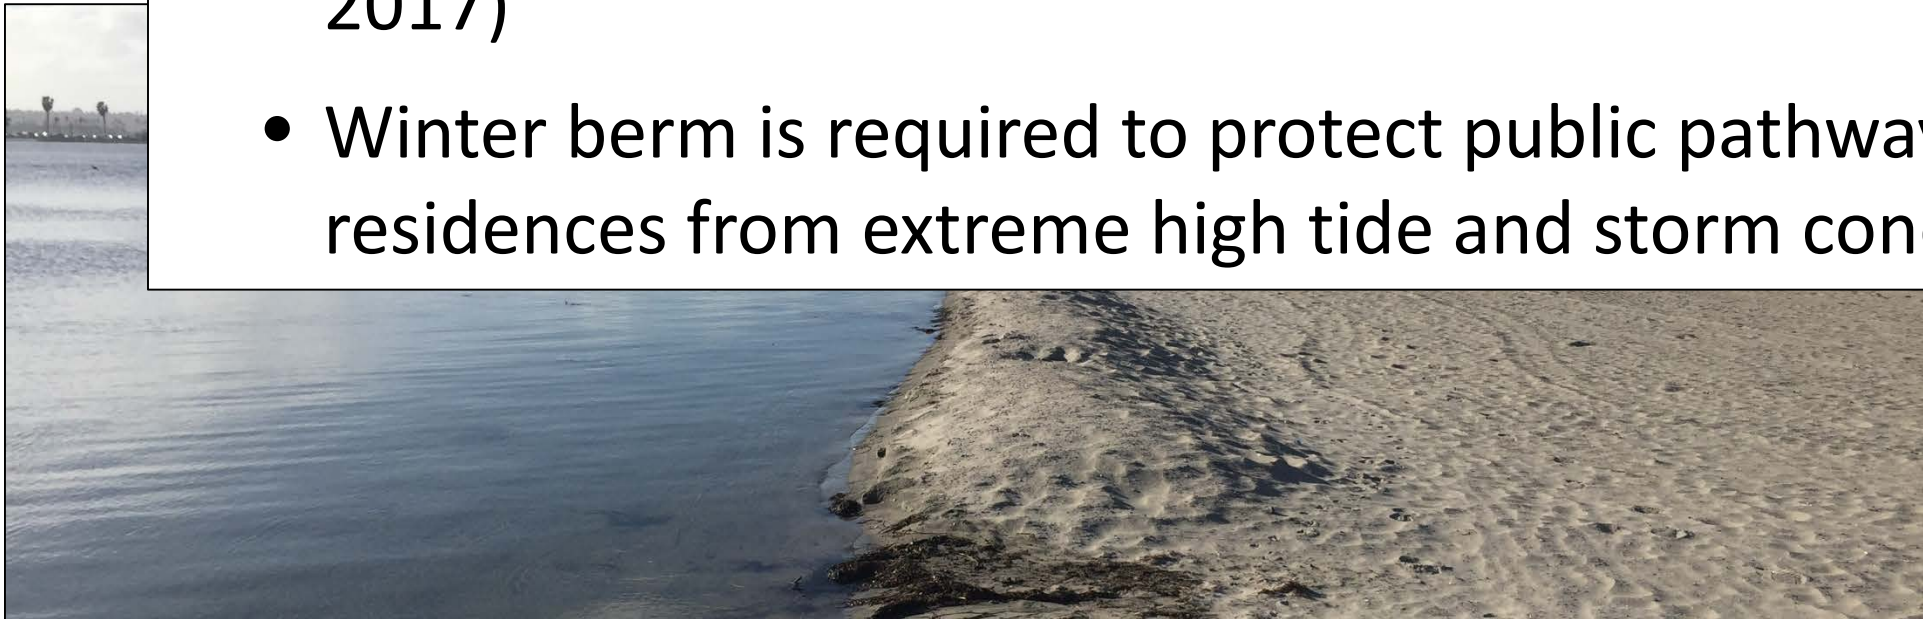
West Sail Bay – The Problem

Beach Erosion

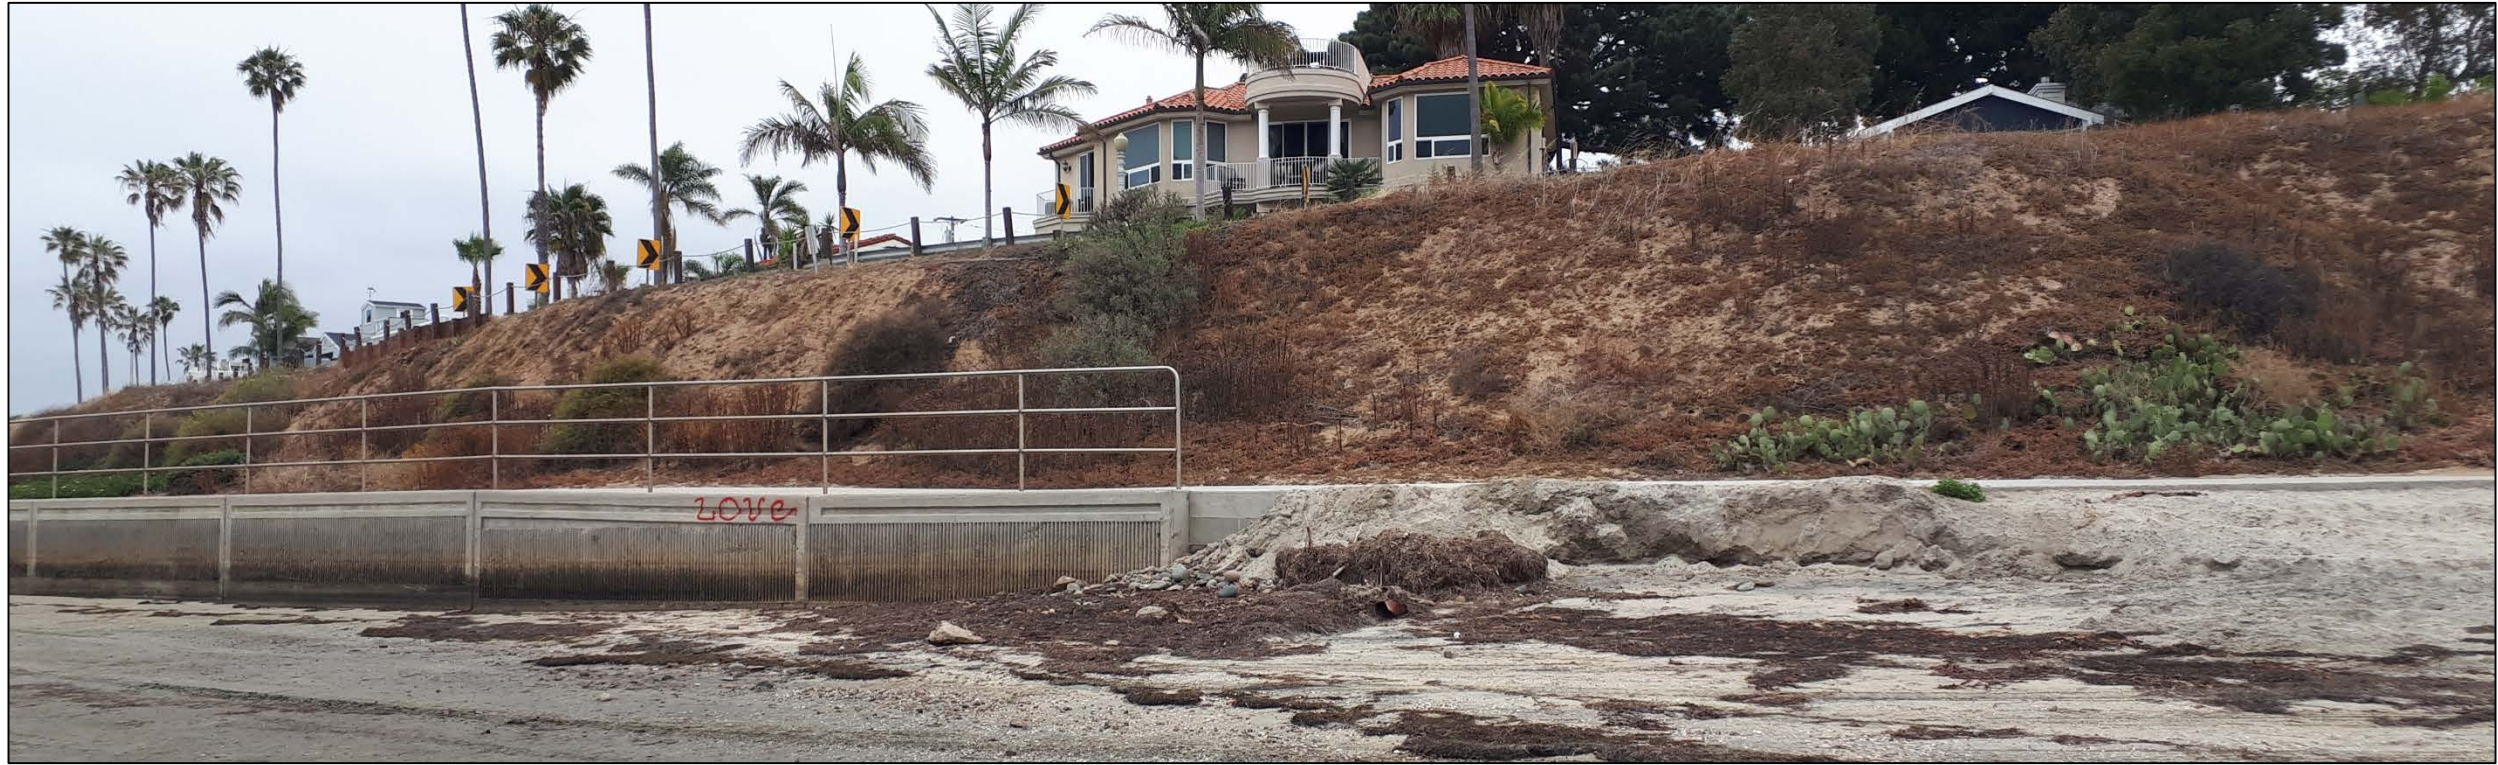
Crown Point – The Problem

“End Effects”

- Wave-induced beach erosion where existing seawall ends and transitions to beach
- Vulnerable public pathway and beach access

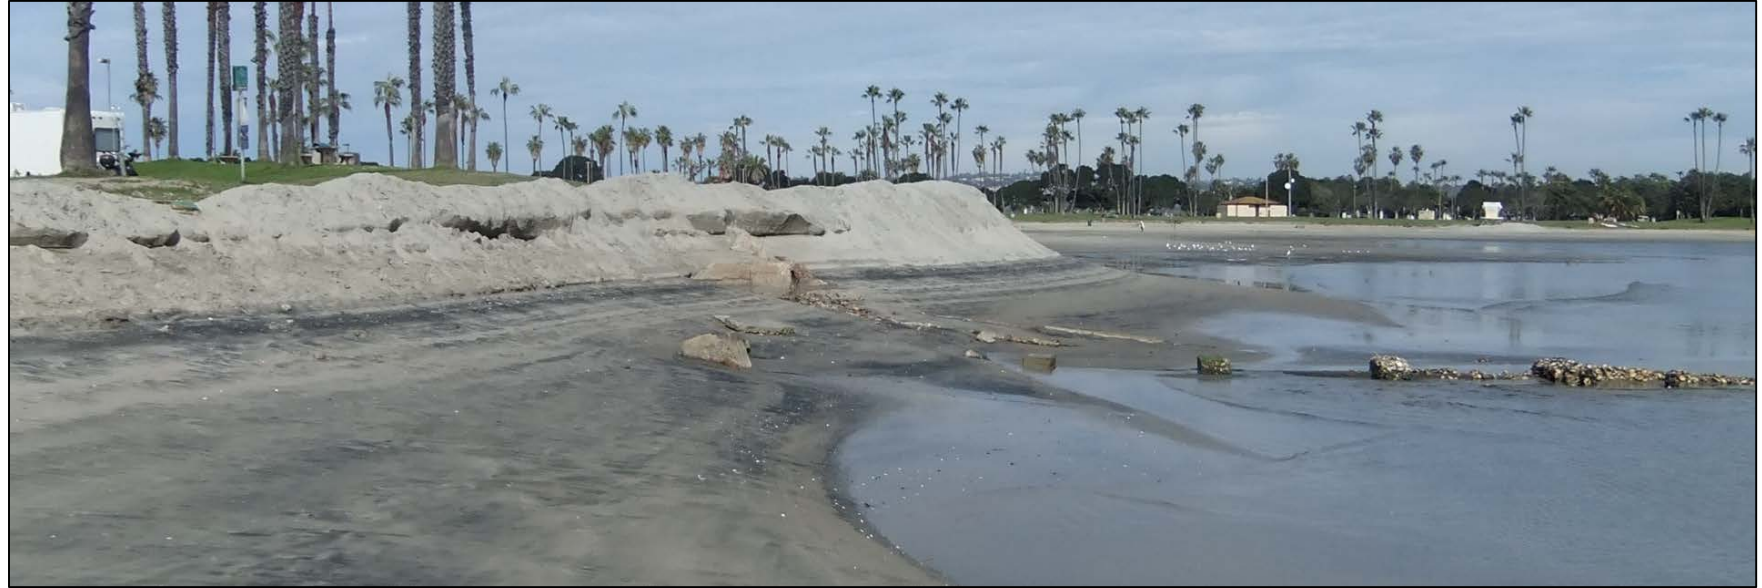
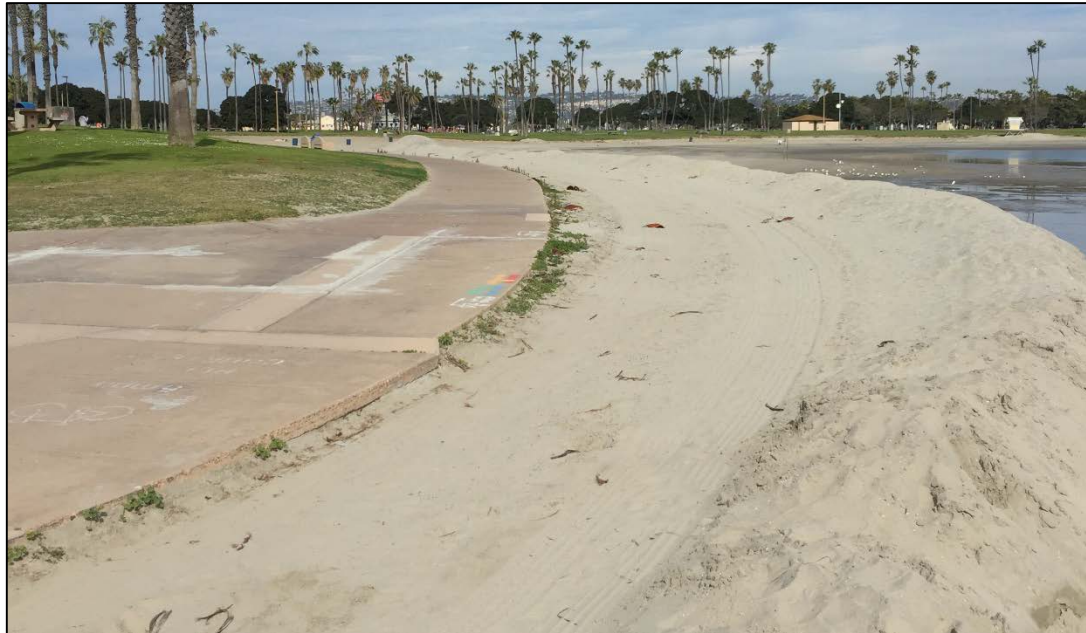
Bonita Cove – The Problem

- Beach erosion at the headland adjacent to San Fernando Pl
- Beach width has reduced from ~175 ft (in 1964) to ~24 ft (in 2017)
- Public pathway vulnerable to undermining and flooding
- Winter berms required to protect park and residences

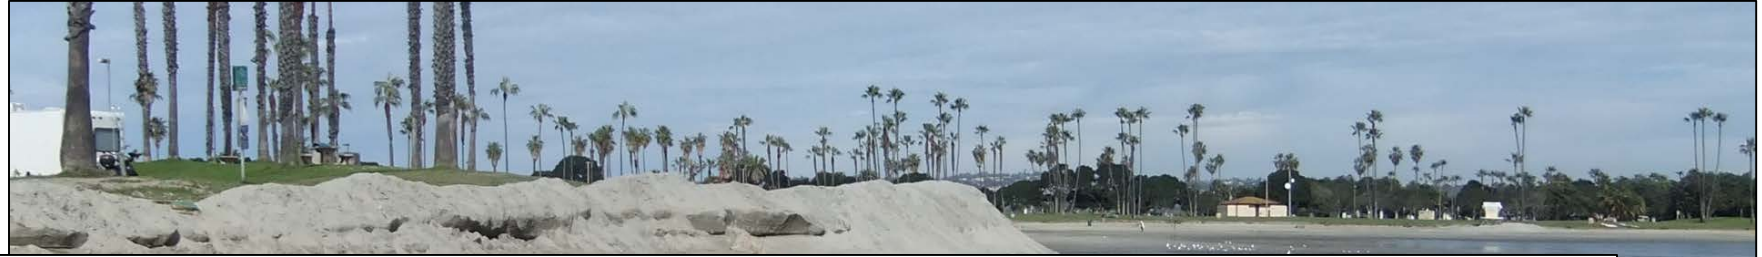
Bonita Cove – The Problem

Beach Erosion

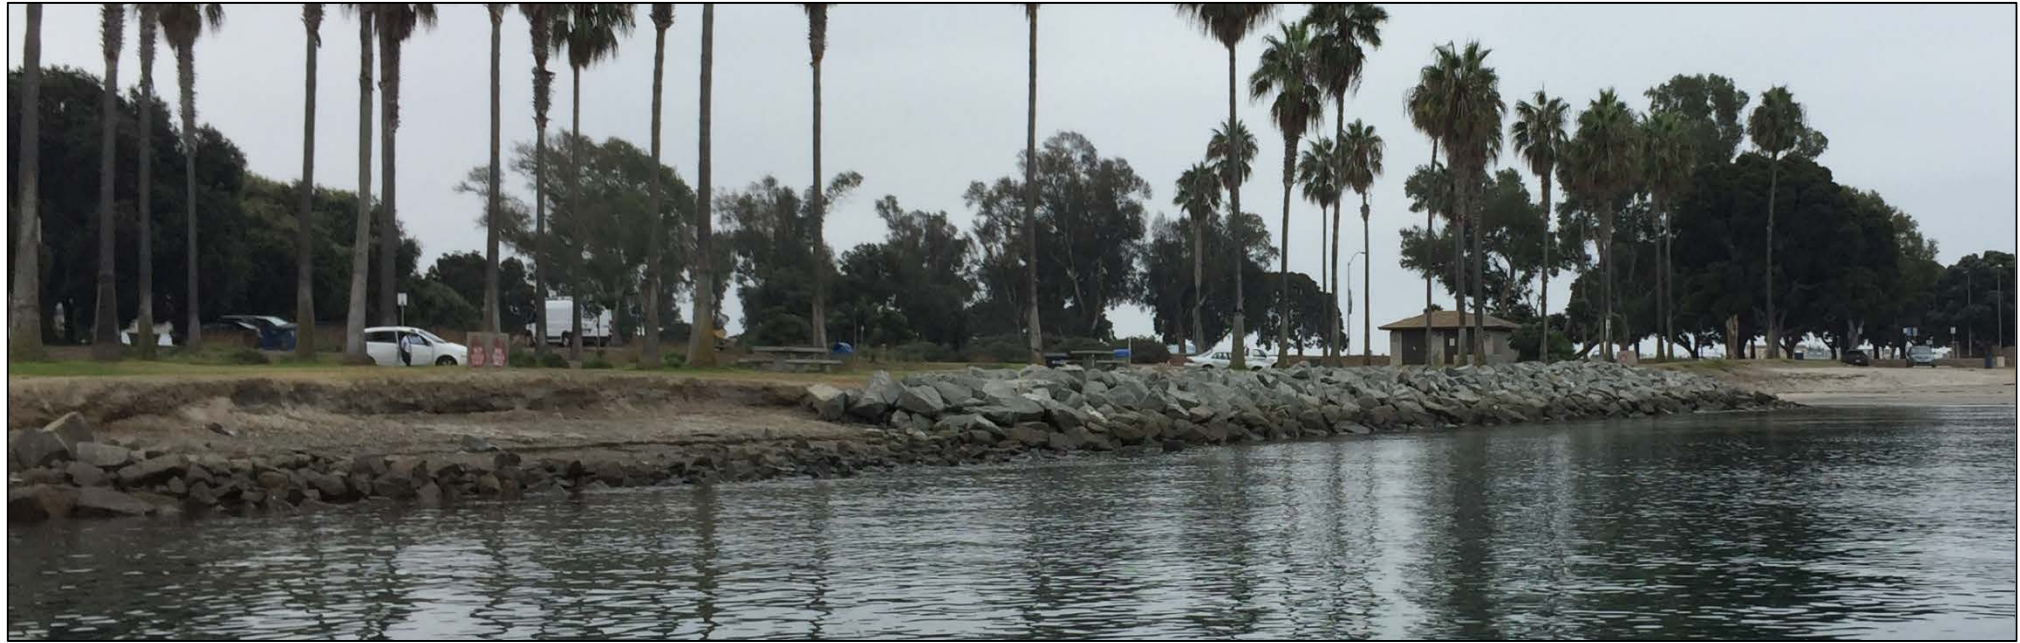
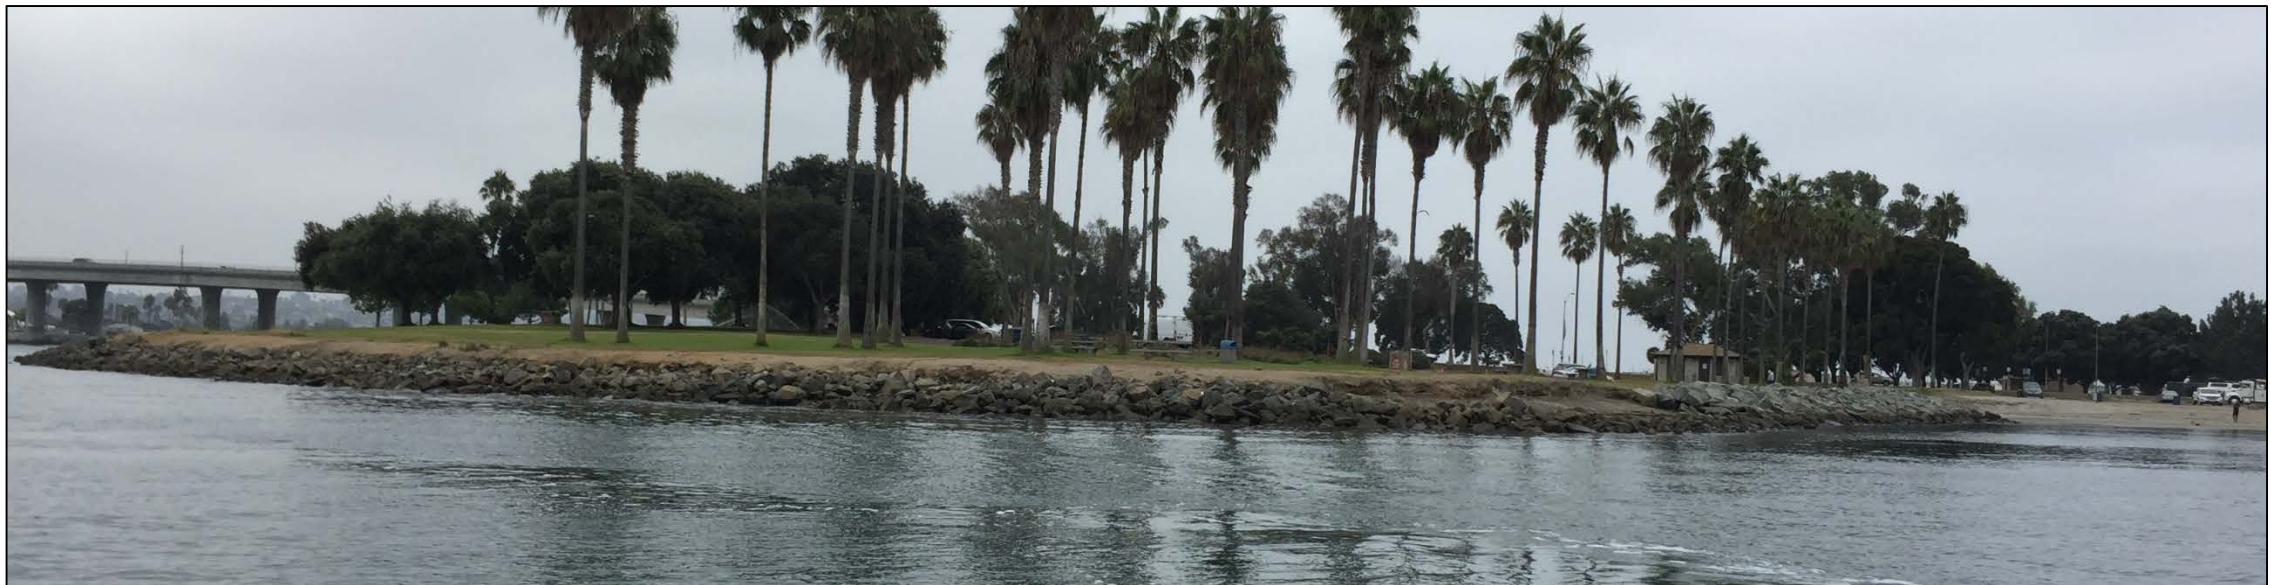
Ventura Cove Park – The Problem

“End Effects” & Erosion

- Wave-induced shoreline erosion where new revetment transitions to under-protected reach
- Displaced, low-elevation rip rap does not adequately protect the shoreline
- Potential upland runoff eroding shoreline

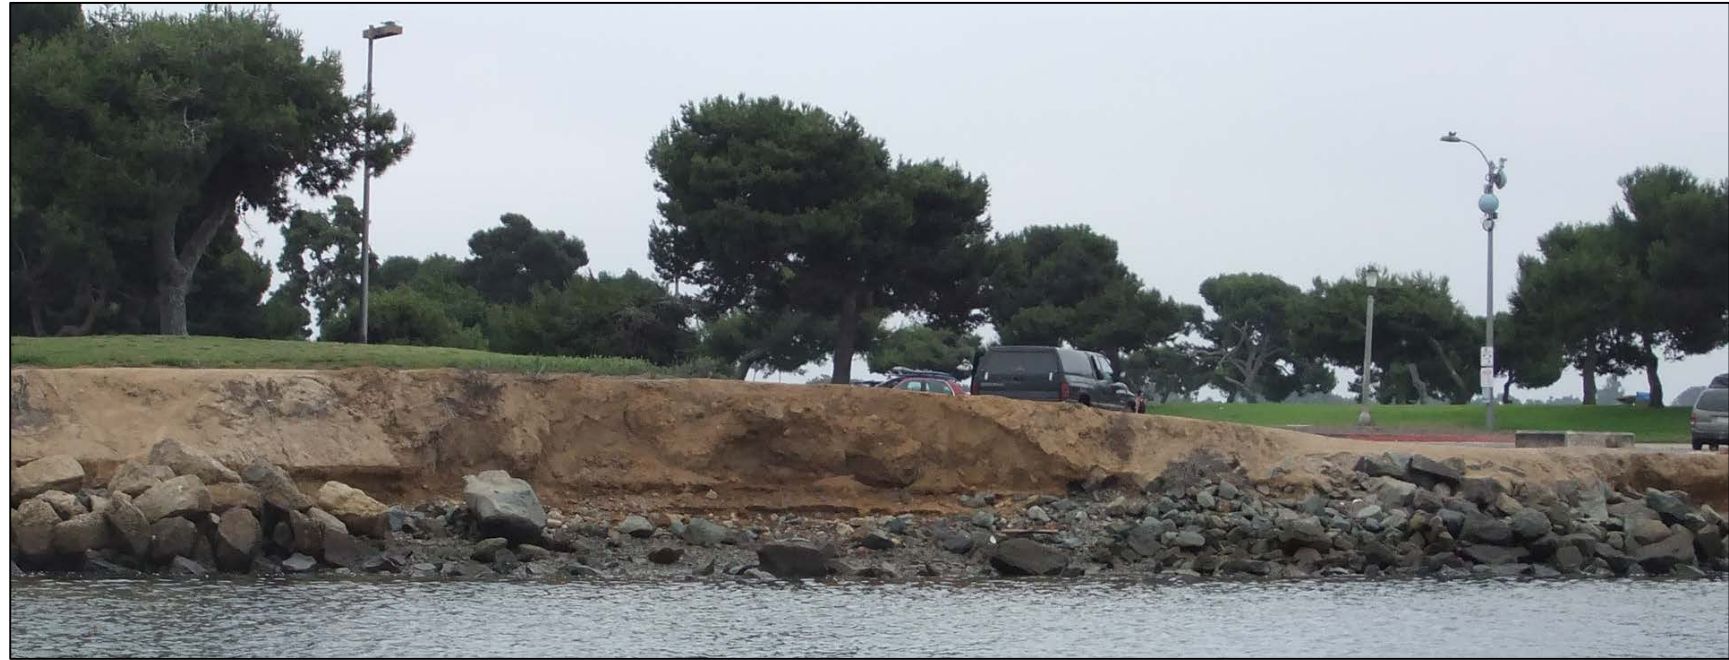
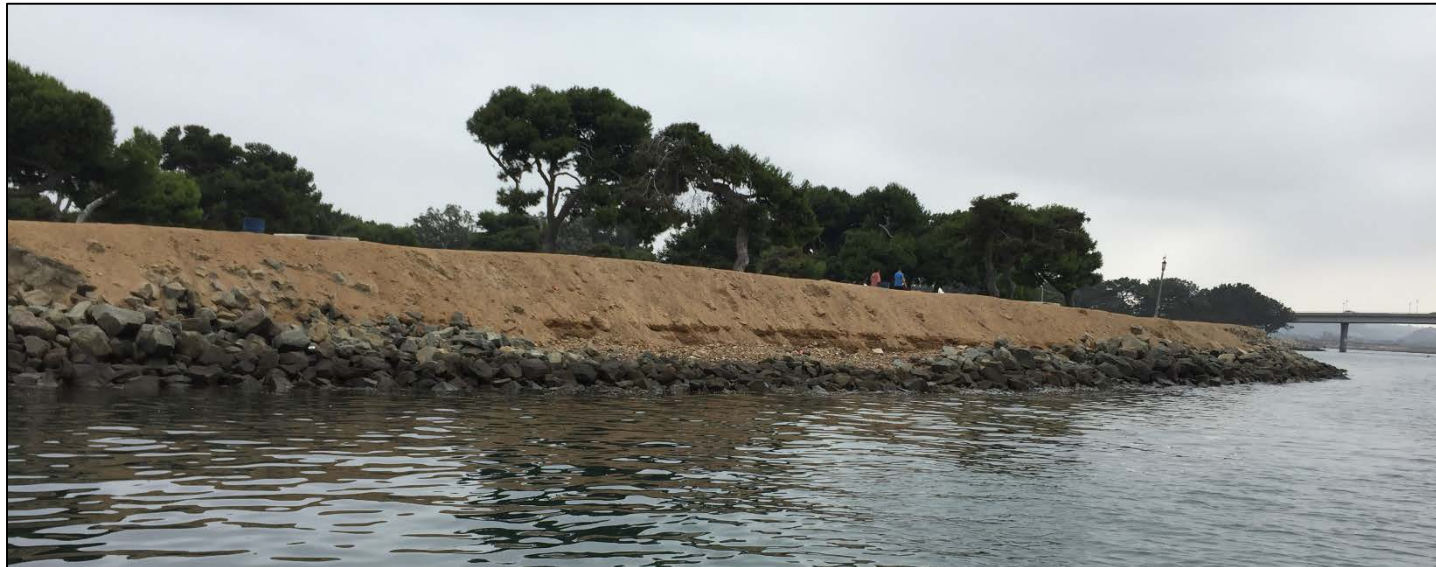
Vacation Island Southwest – The Problem

- Wave-induced shoreline erosion
- Displaced, low-elevation rip rap does not adequately protect the shoreline
- Potential upland runoff eroding shoreline

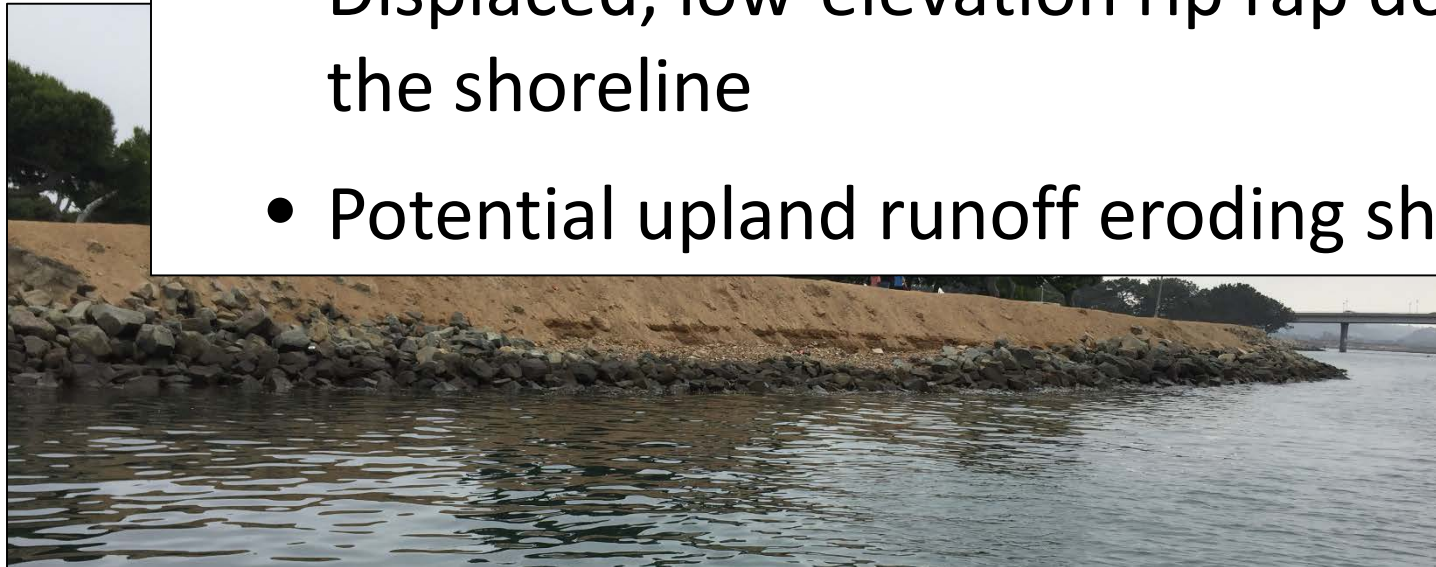
Vacation Island Southwest – The Problem

Shoreline Erosion

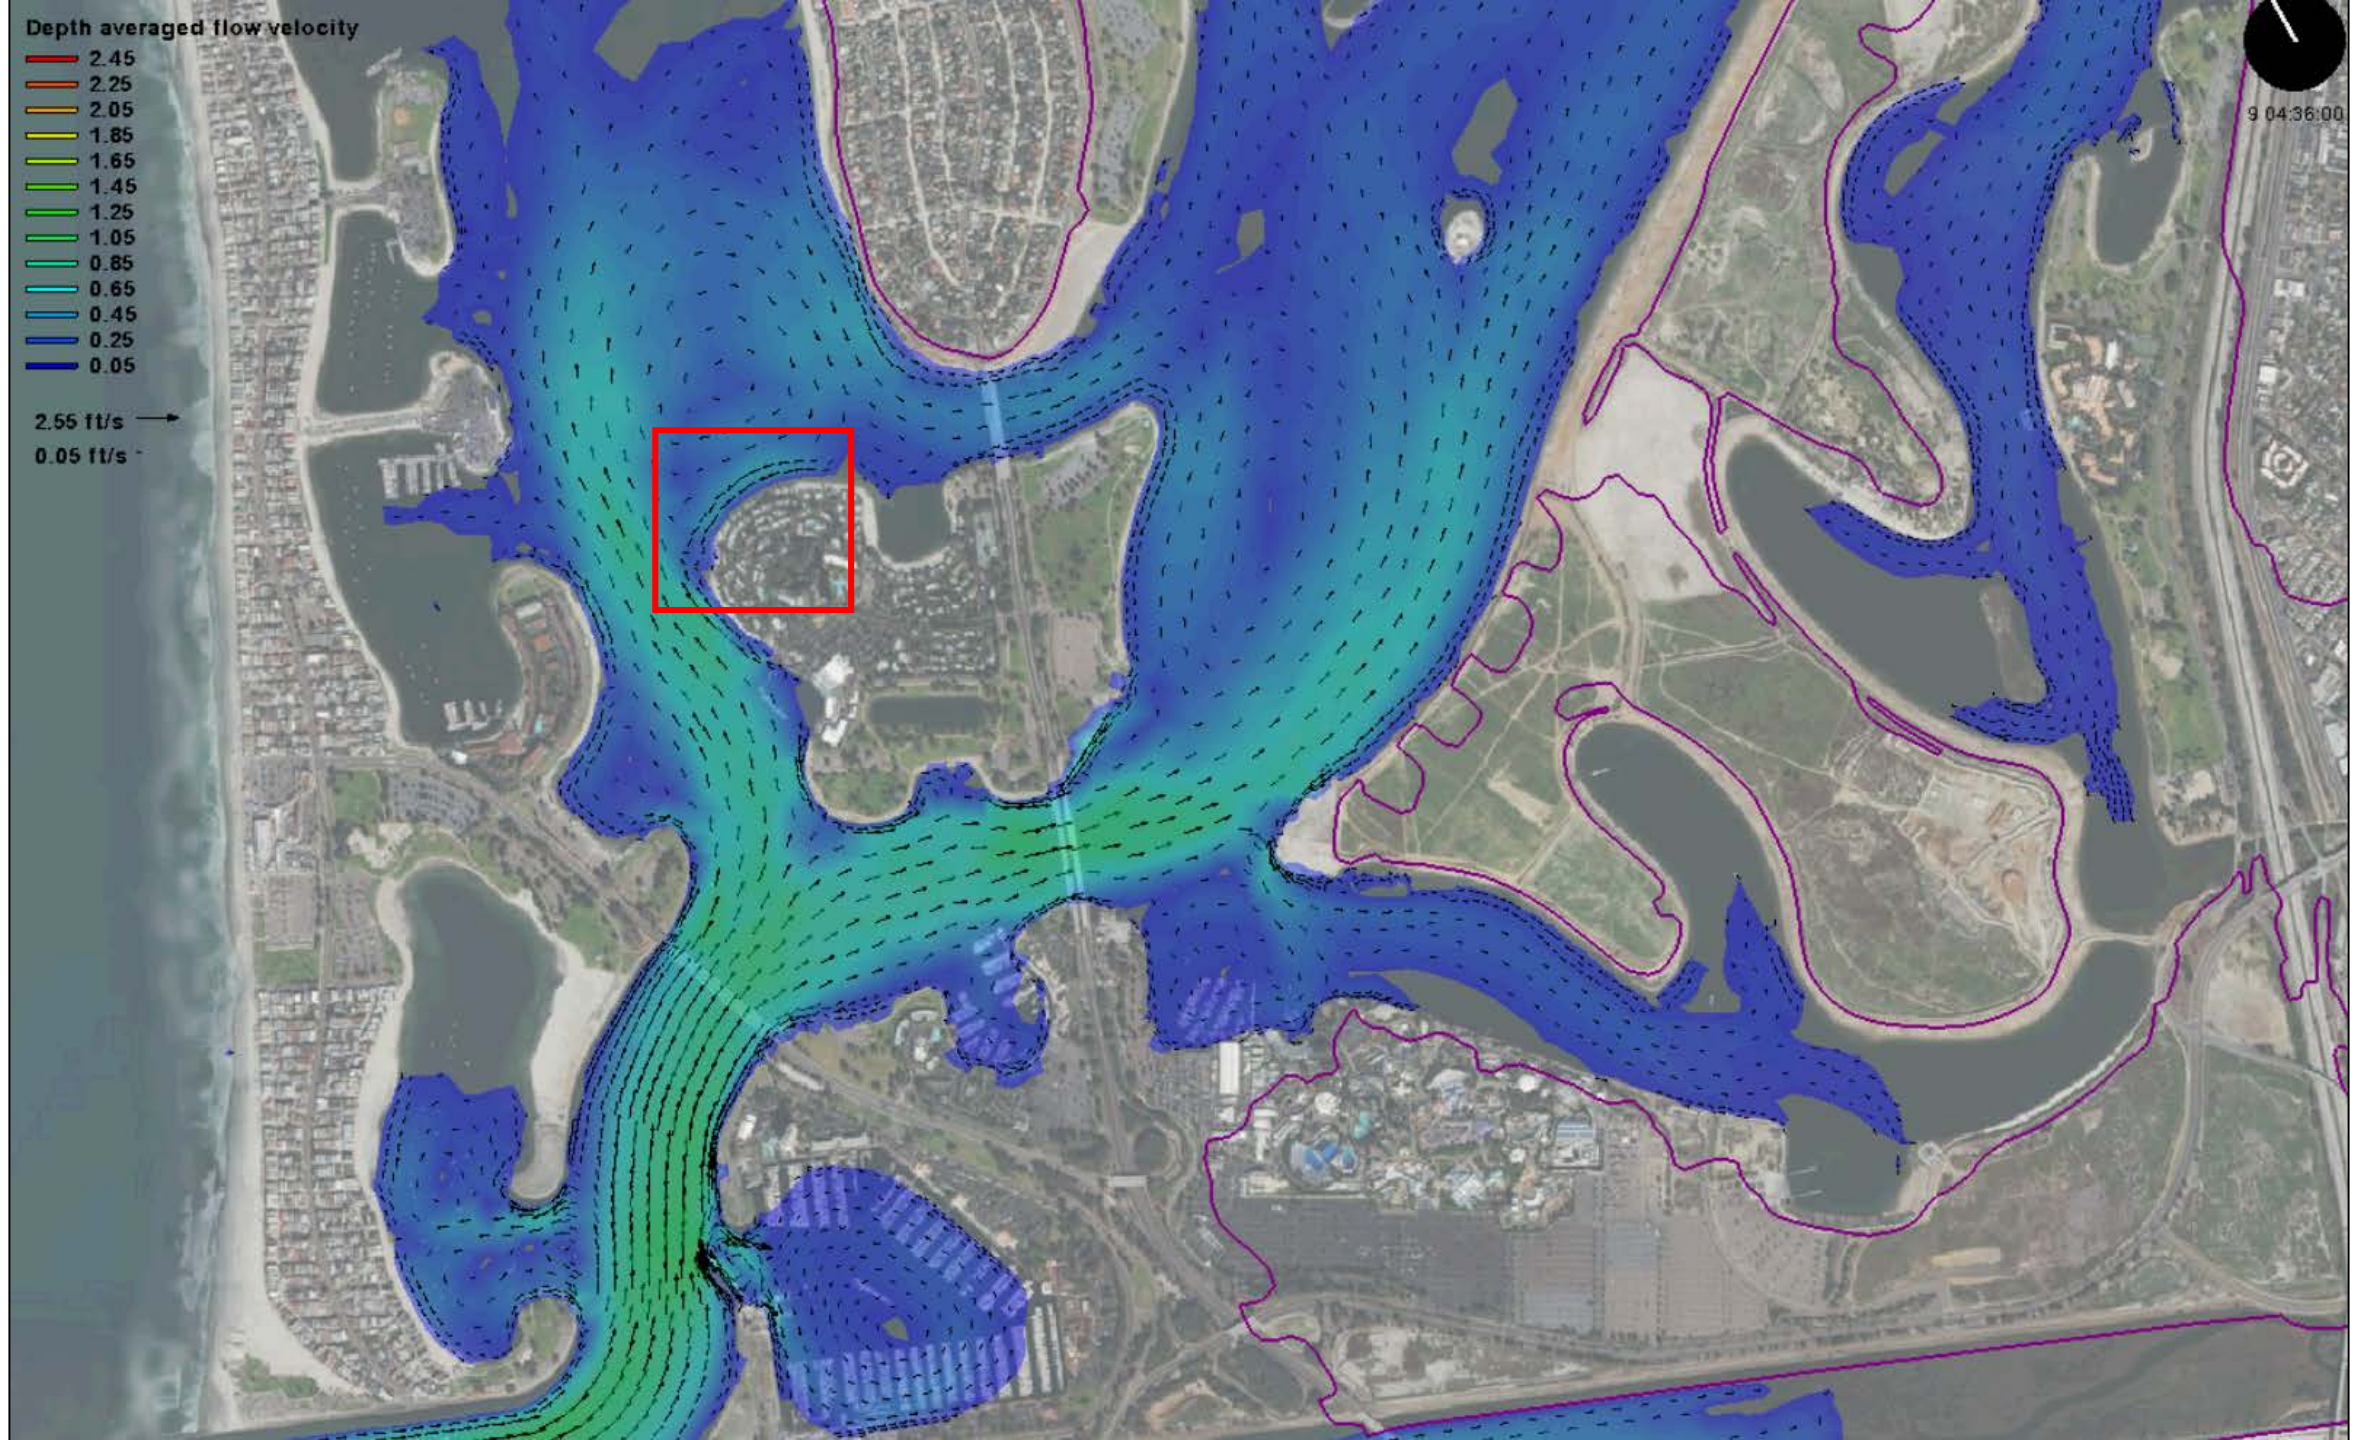
Depth averaged flow velocity

2.55 ft/s →
0.05 ft/s ←

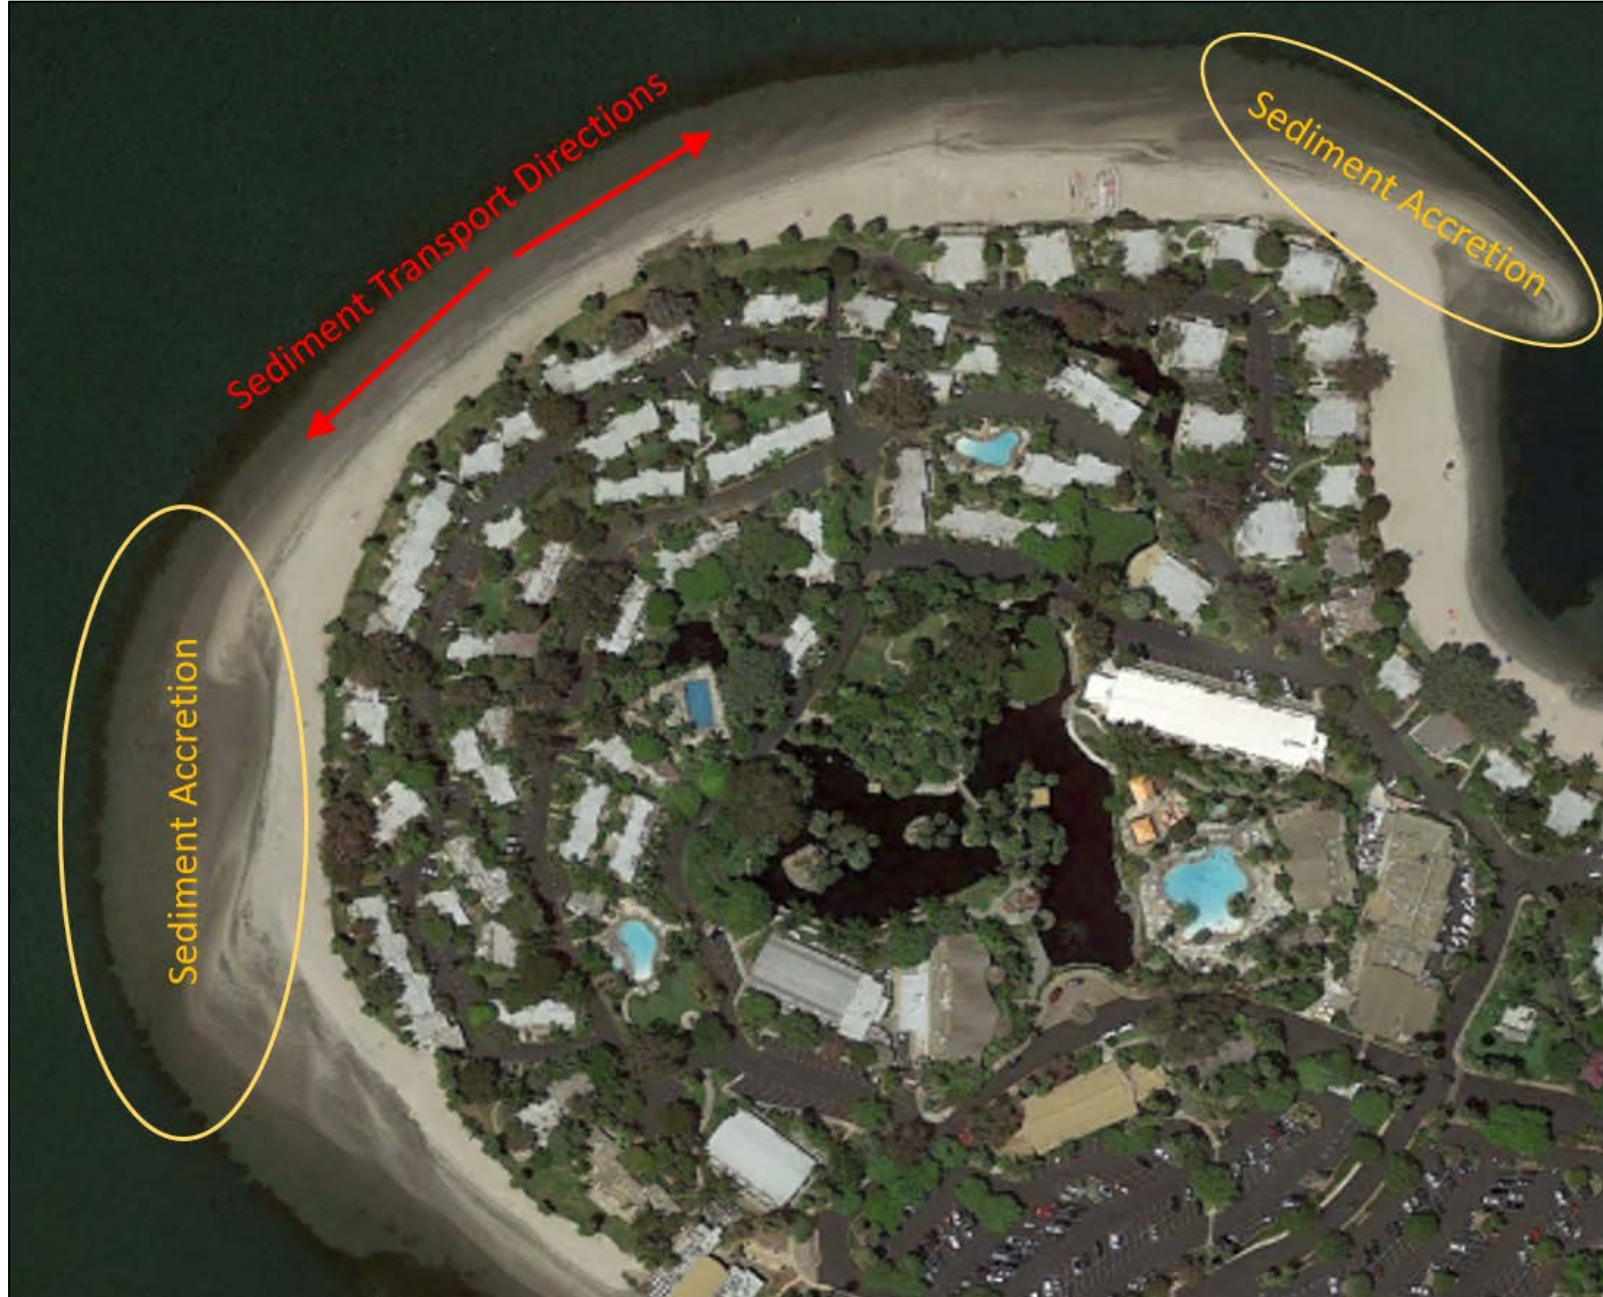
Vacation Island Northwest – The Problem

- Wave and current dynamics causing sand to move both east and west from the center of the headland
- Beach widths are decreasing, upland park vulnerable to undermining

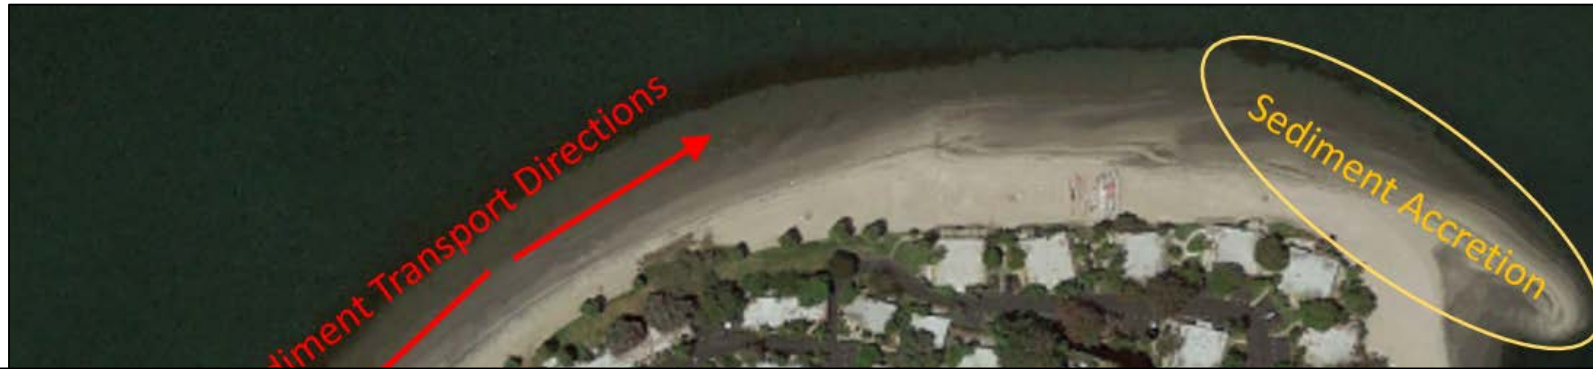
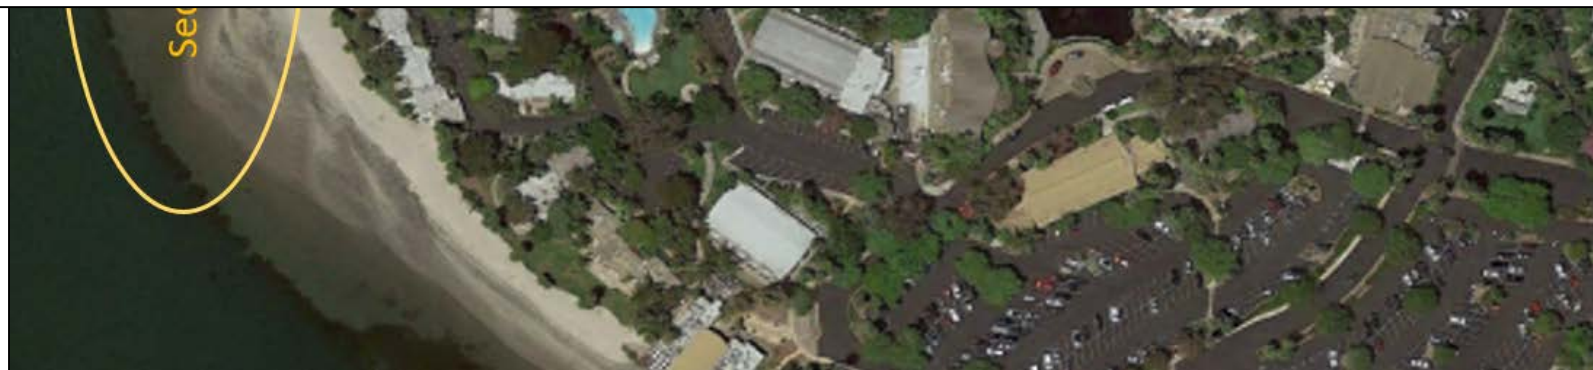
Vacation Island Northwest – The Problem

Beach Erosion
