Mission Bay PEIR

Restoration of Shoreline

Outline

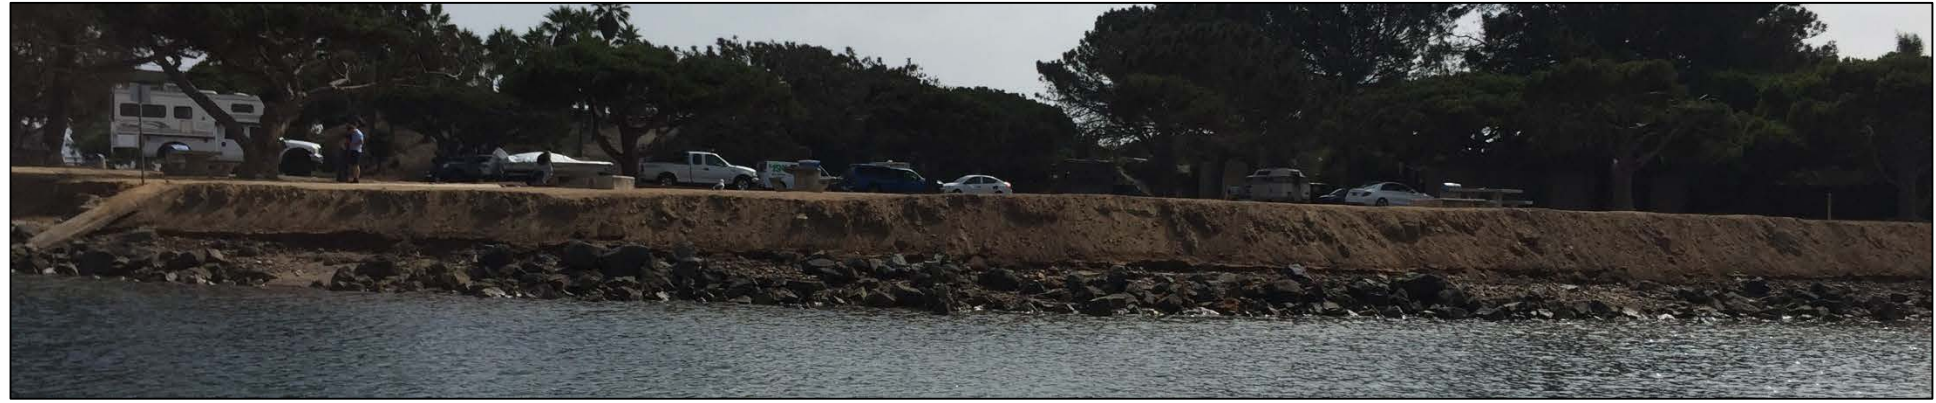
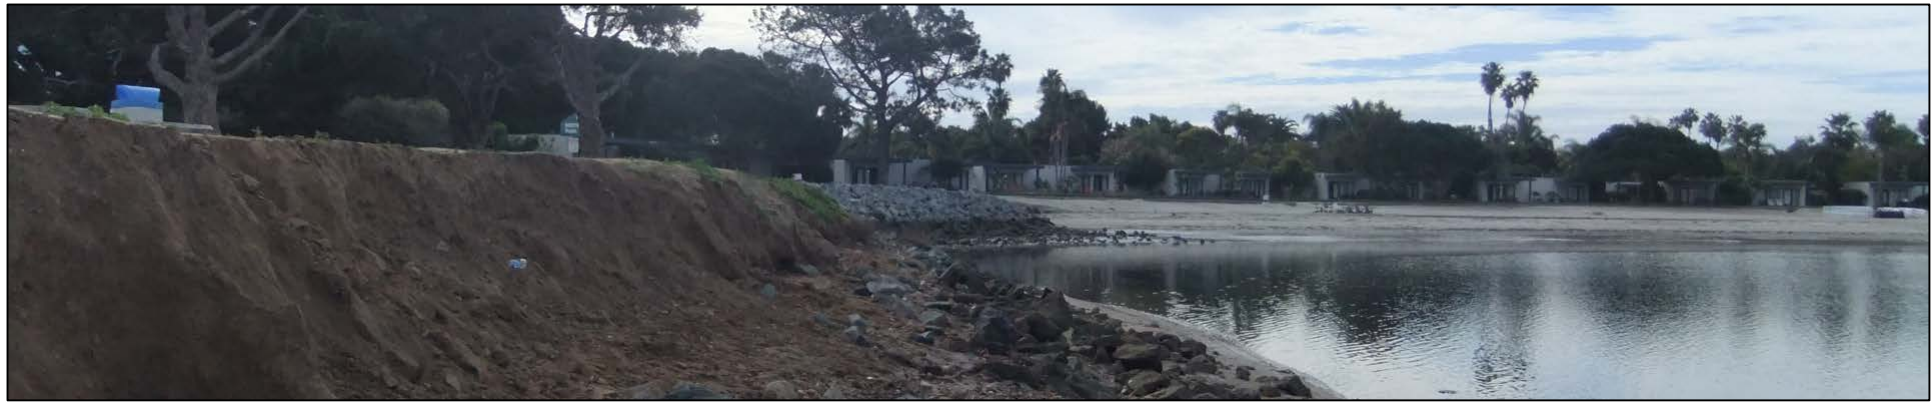
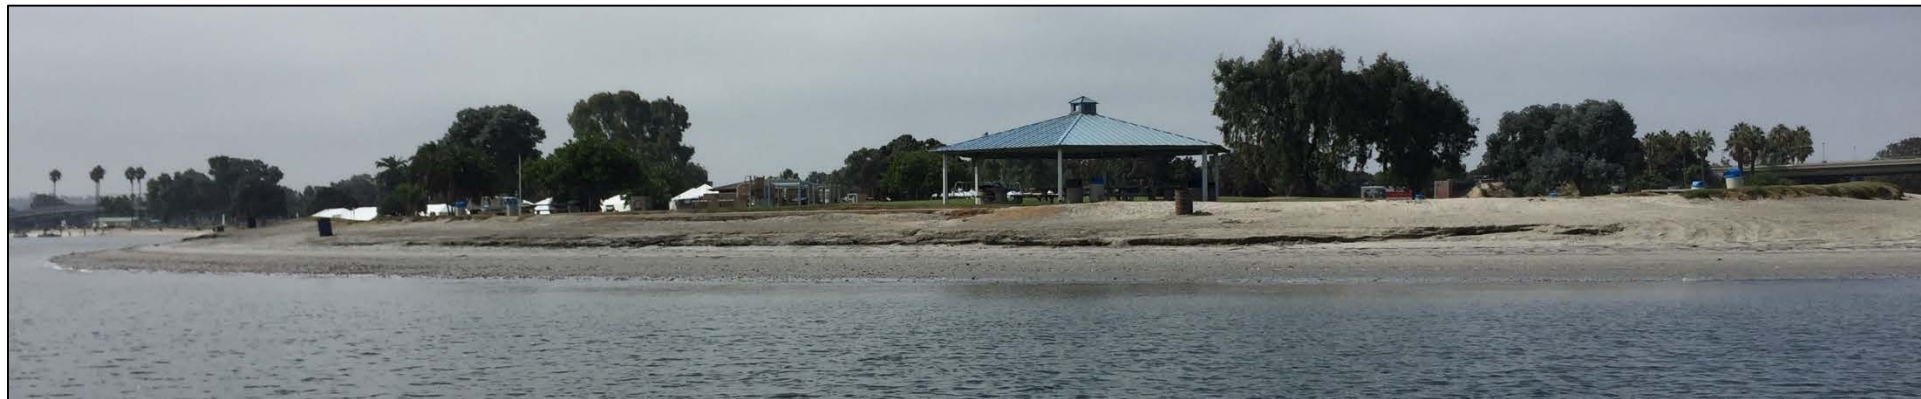
Vacation Island Northeast – The Problem

Shoreline Erosion – West of Ingraham St

- Wave-induced shoreline erosion
- Displaced, low-elevation rip rap does not adequately protect the shoreline
- Potential upland runoff eroding shoreline

Beach Erosion – Ski Beach

- Wave and current dynamics causing erosion of the shoreline
- Beach widths have reduced, upland park improvements vulnerable to undermining

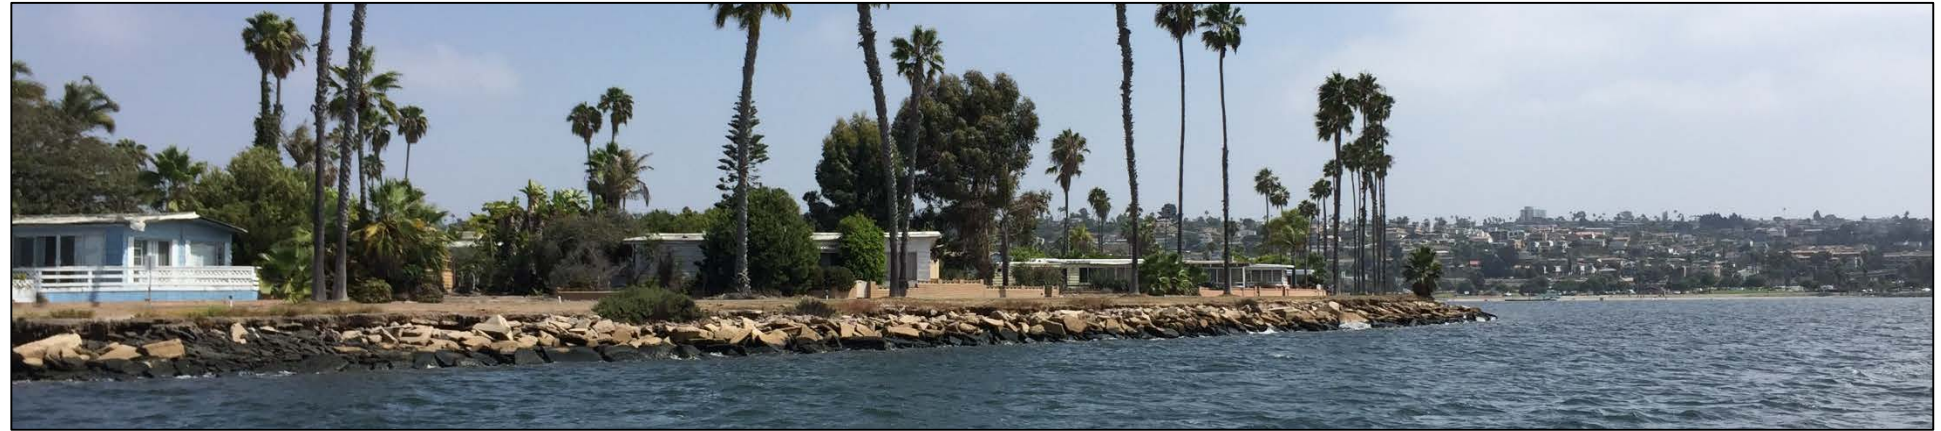
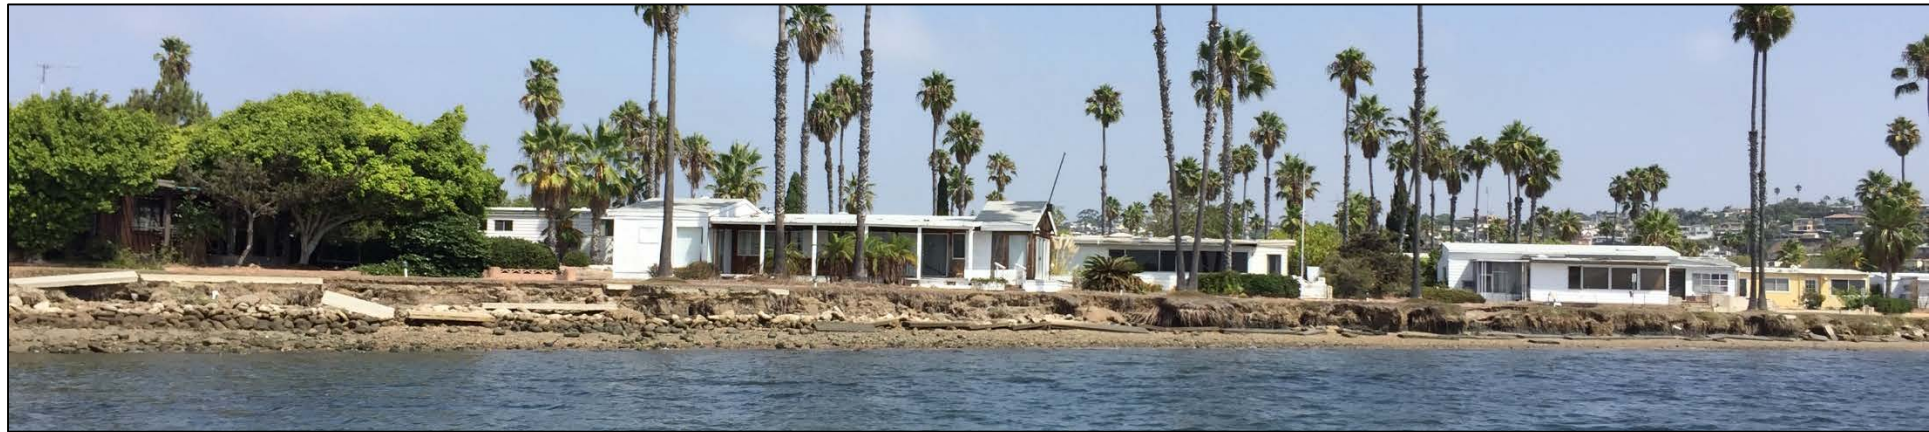
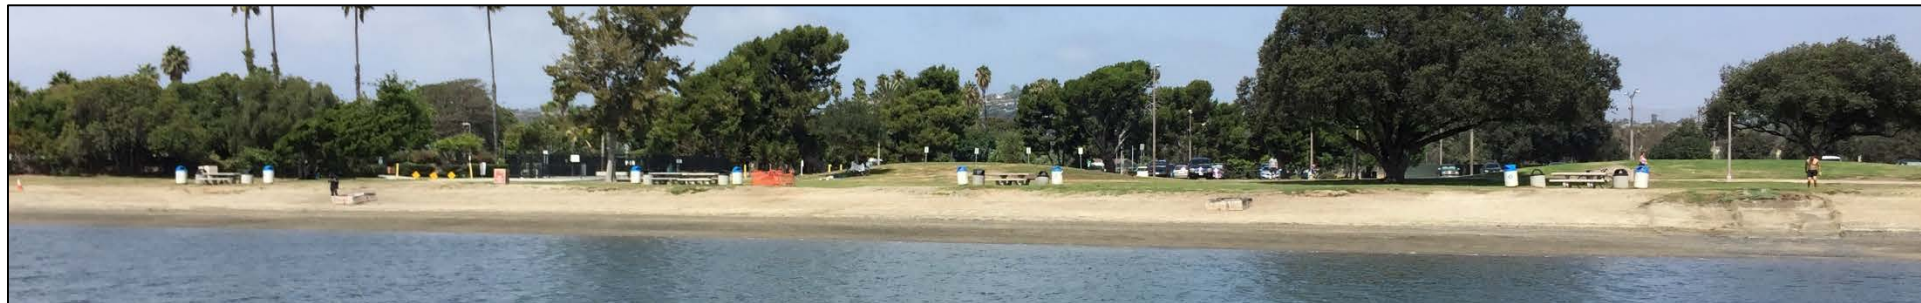
De Anza – The Problem

- Wave-induced shoreline erosion, focused at the “heel”
- Displaced, low-elevation rip rap does not adequately protect the shoreline

- Beach width is small, especially on north shore (~15 ft)
- Scarps developing between grassy park and sandy beach

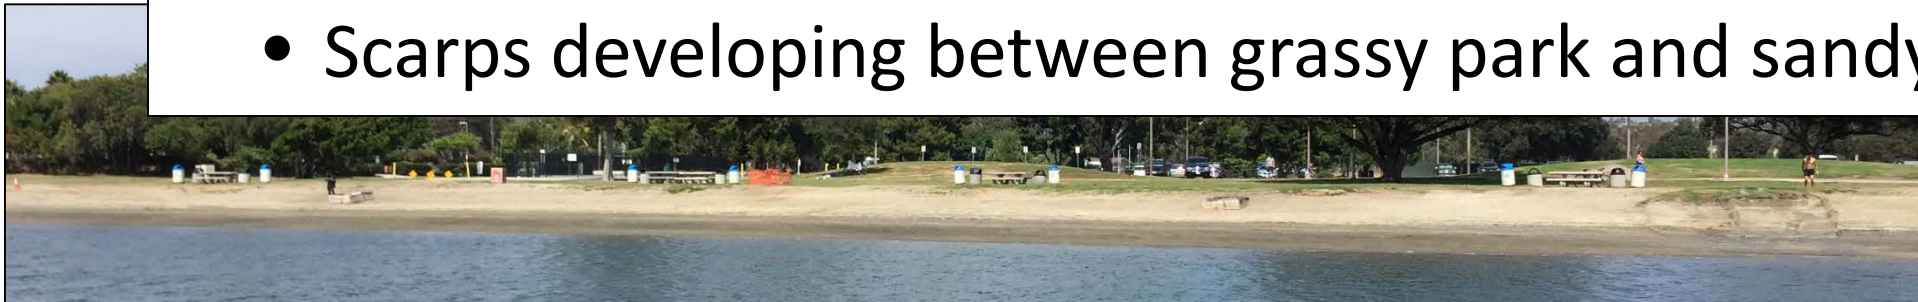
De Anza – The Problem

Shoreline Erosion – De Anza Point (Boot)

Beach Erosion – De Anza Cove

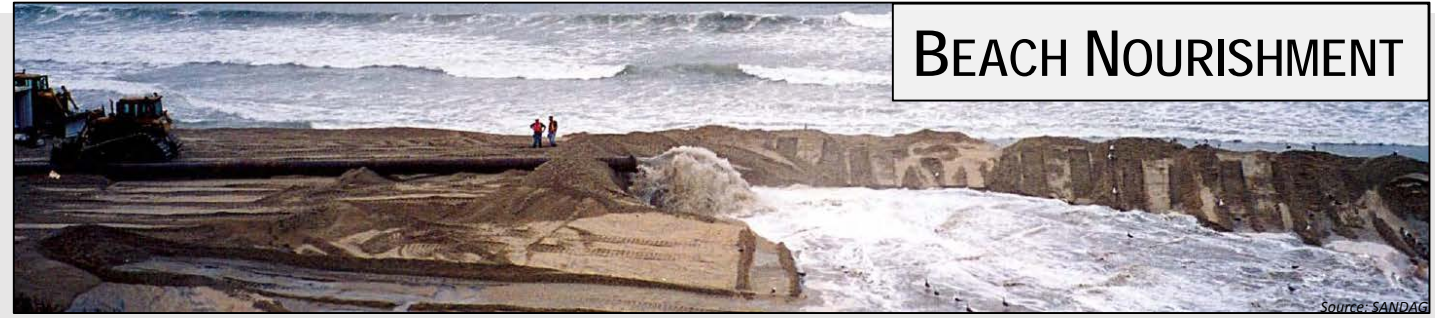
BEACH NOURISHMENT

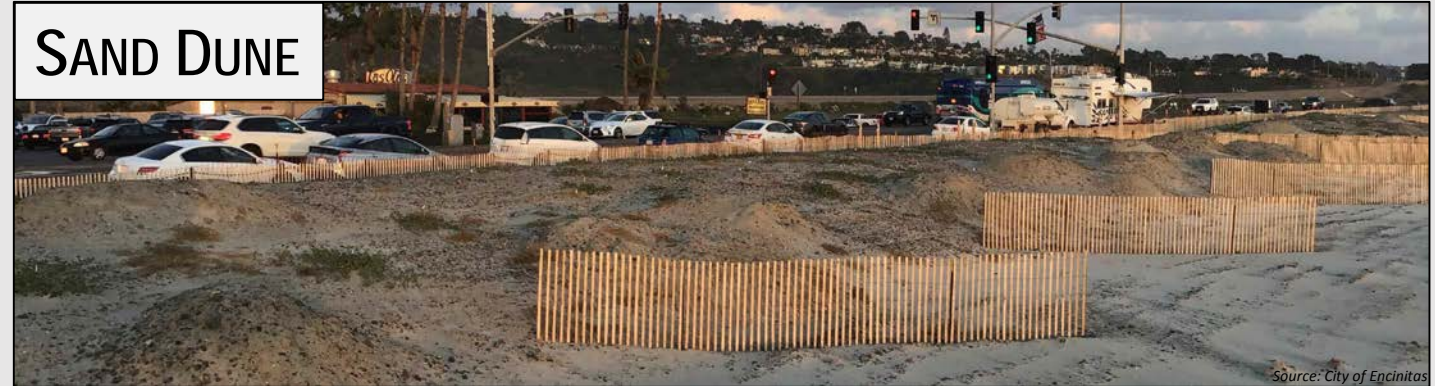
SAND DUNE

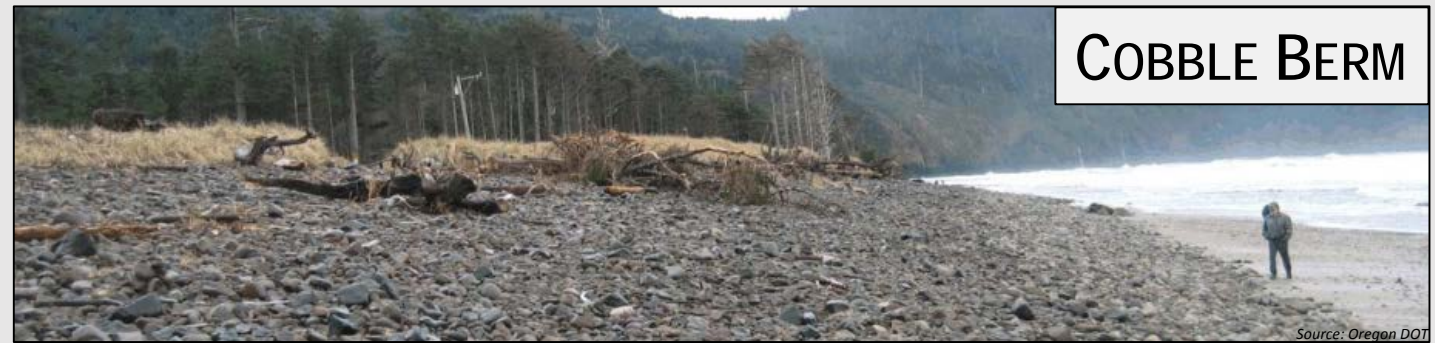
COBBLE BERM

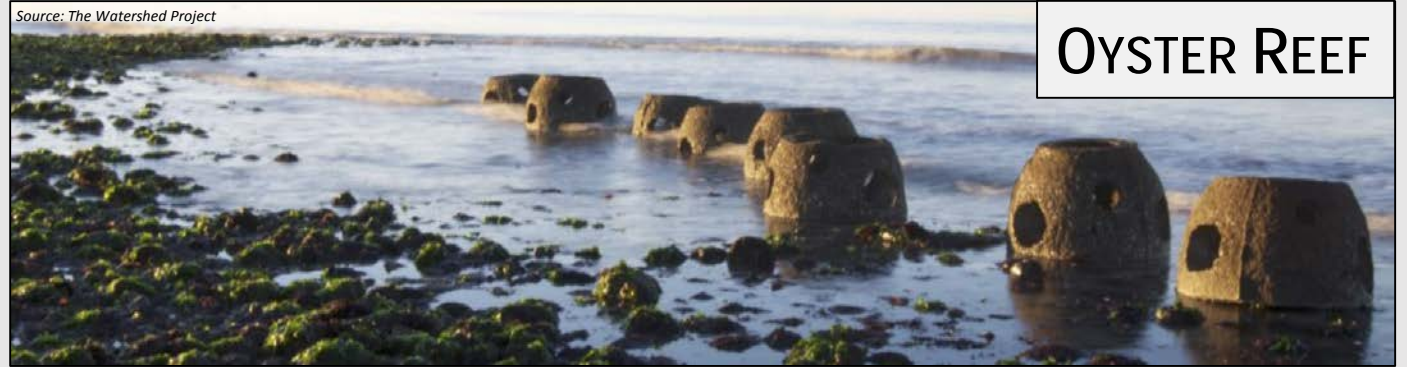
OYSTER REEF

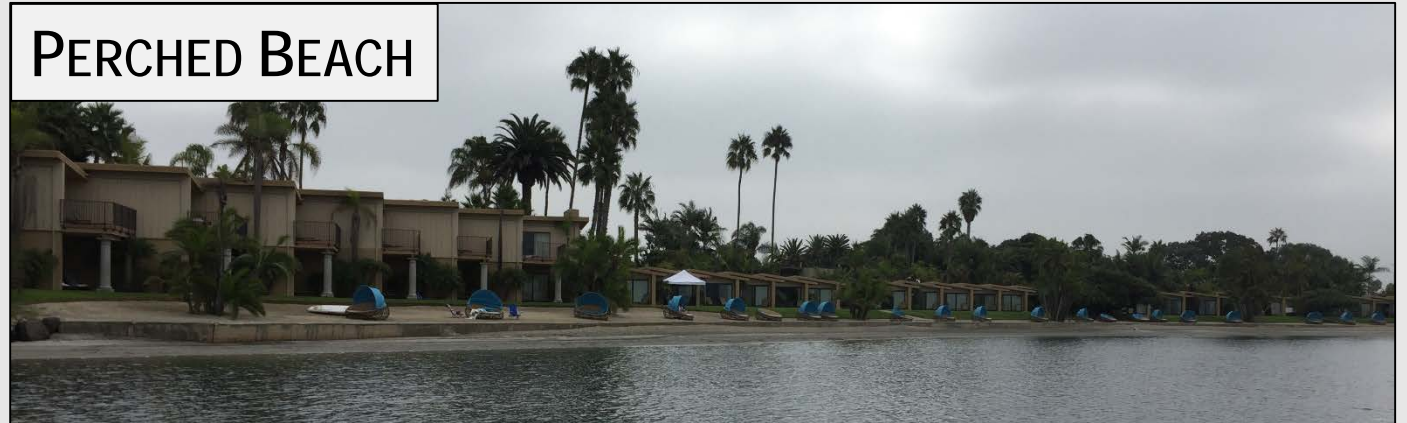
PERCHED BEACH

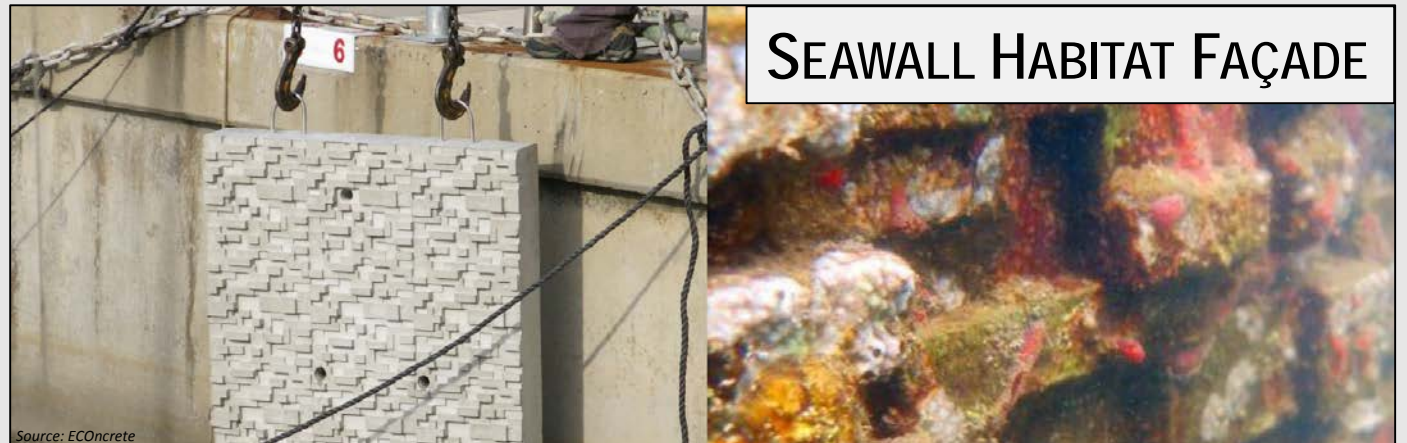
SEAWALL HABITAT FAÇADE

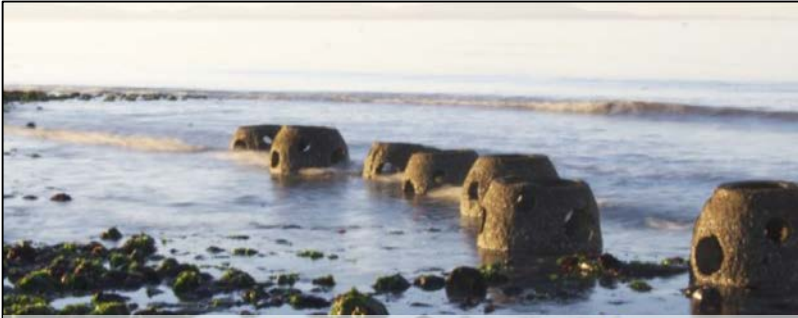
Reef Balls, San Francisco Bay
The Watershed Project

- Oysters are filter feeders which improve water quality and clarity.
- Oyster reefs provide a buffer from and are resilient to wave energy.
- Oysters reefs create nursery habitat for fish and bottom-feeders.

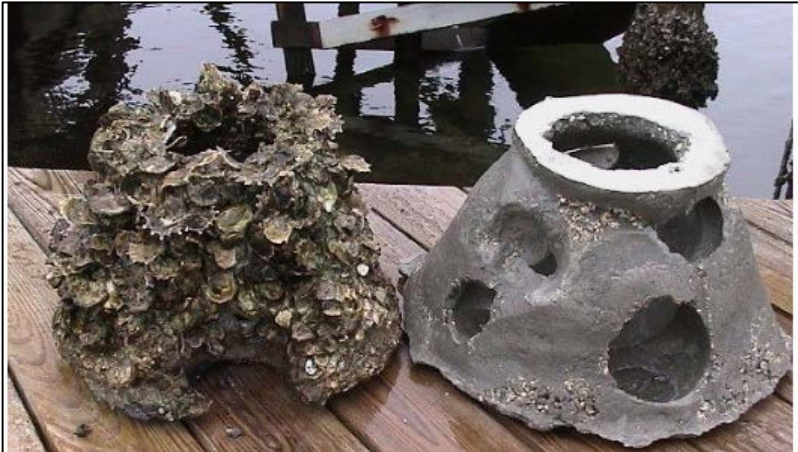
Coconut Fiber and Oyster Shells
OC Coastkeeper
