NAVAL TRAINING CENTER

SAN DIEGO

*Guidelines for the Treatment of
Historic Properties*

A u g u s t 1, 2 0 0 0

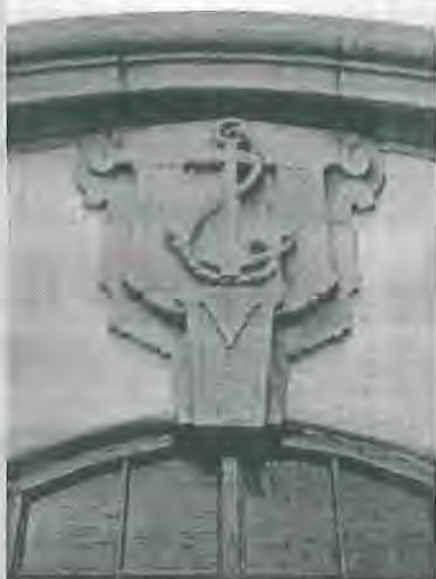
Cast stone Navy ornament flanking the main gate on Buildings 20 and 21. Photograph courtesy of Architect Milford Wayne Donaldson, FAIA, January 11, 2000.

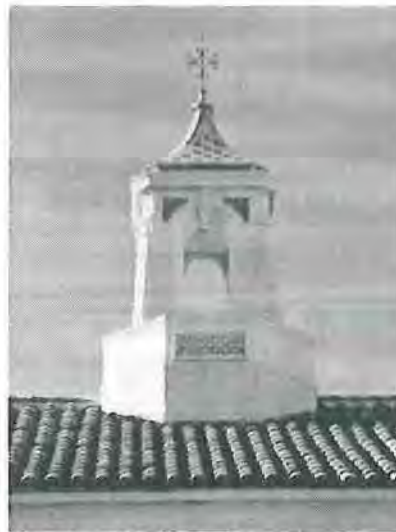
Cupola with decorative tile and plaster work atop Building 30. Photograph courtesy of Architect Milford Wayne Donaldson, FAIA, December 21, 1999.

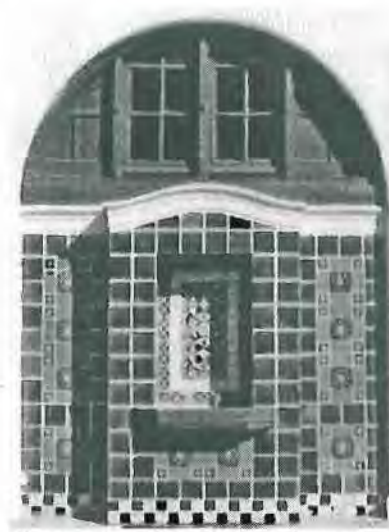
Decorative tile drinking fountain located near the main gate on Building 20 and 21. Photograph courtesy of Architect Milford Wayne Donaldson, FAIA, December 21, 1999.

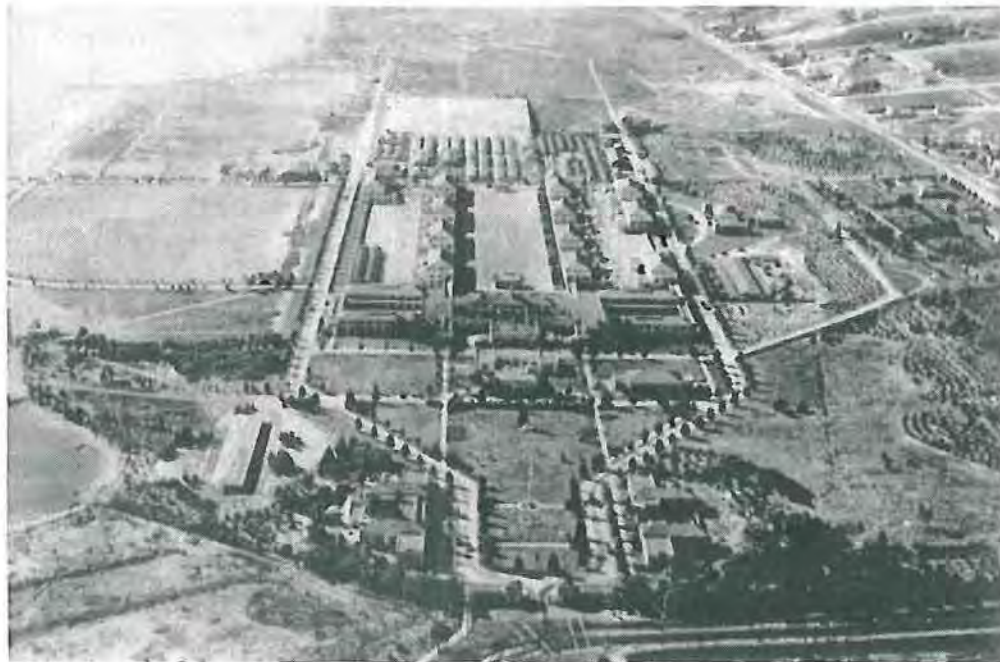
*Looking southwest at Naval Training Center, ca. 1924. Note the symmetry of design.
Photograph courtesy of the U.S. Navy.*

The Beaux Arts tradition dictated a formal approach to design and the resulting plan was a simplified version of the philosophy with two main axis along which buildings were placed to form symmetrical outdoor courts. Symmetry of overall design was important and created a simple, but effective, orderly complex of buildings. The coherence of the design and the interrelationship of the structures give a strong sense of identity to the base. The original concept was to have the north-south axis anchored by an administration building with a tower. This design was never built due to financial constraints and the second axis was never a strong element in the plan until the construction of new buildings in the 1940s.

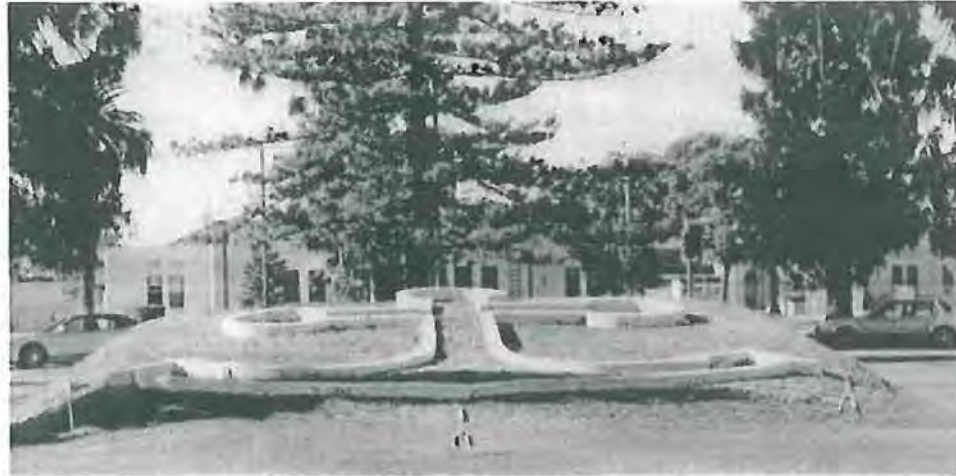
Looking southwest at the anchor feature located at Sellers Plaza. Photography courtesy of KTU+A, February 2000.

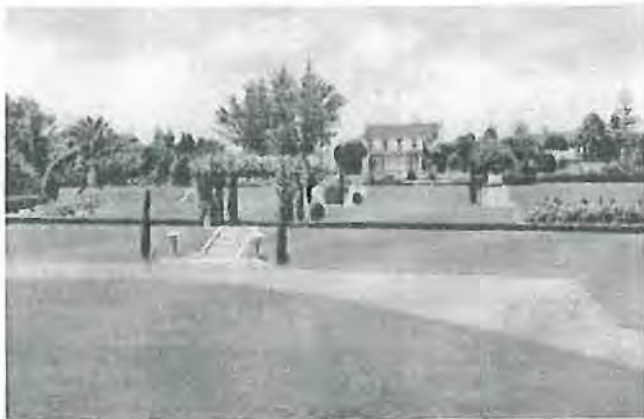
Terracing at the garden at Officers' Quarters A. Courtesy of Architect Milford Wayne Donaldson, FAIA historic postcard collection.

Preserving the existing terracing that occurs in the gardens and terraces of the Officers' Quarters.

Removing a topographic feature that is deteriorated and not replacing it, or replacing it with a new feature that does not convey the same visual appearance. For example, changing the stepped terracing to a curved slope in the Officers' gardens.

Designing and installing new topographic features when the historic feature is completely missing. It may be an accurate restoration using historical, pictorial and physical documentation of a new design that is compatible with the shape, slope, elevation, and contour of the historic topography. For example, utilizing cobblestone or concrete walls to complete the terracing in the Officers' gardens.

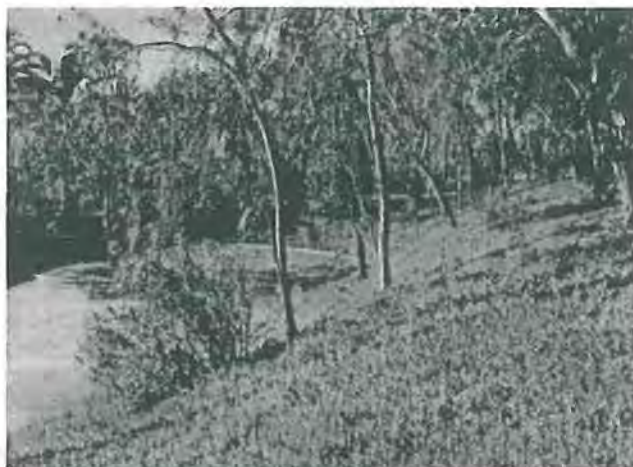
Landscaped slope northwest of Building 35. Photograph courtesy of KTU+A, February 2000.

Repair declining topographic features. For example, this may include replacing the plant materials (trees and groundcover) on the slope north of Building 35 that may contribute to future slope failure.

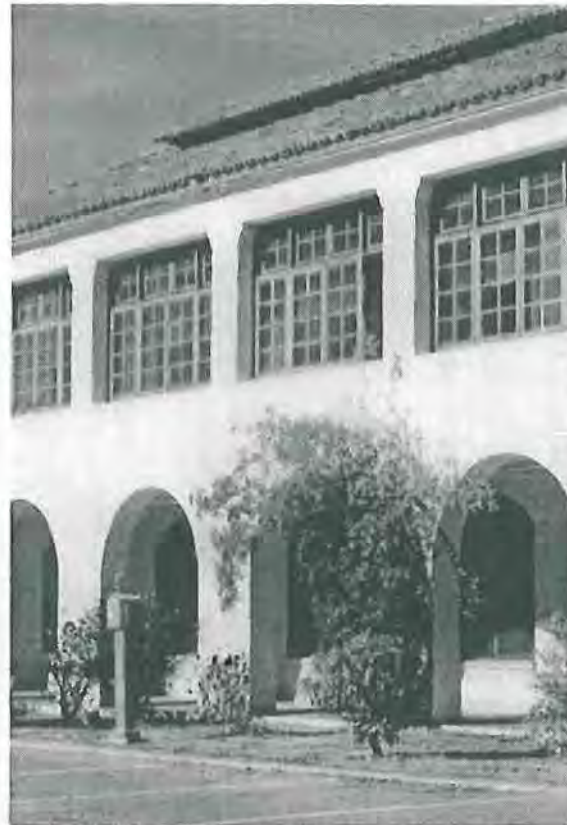
Bougainvillea on arcade column at Lawrence Court. Photograph courtesy of KTU+A, February 2000.

The transition areas from the hardscape to the buildings emphasized the repetitive architectural elements through varied height group plantings. Shrub plantings, in a symmetrical and balanced arrangement, were used primarily as foundation massings along building walls and corners, and to reinforce the walkways and building lines. Low-growing plant materials were used in the foreground, with the heights and density of plant materials increasing near the buildings. Trees and shrubs with flowers, unusual foliage or interesting branch shapes were highlighted against the solid colored walls of the buildings. Along the arcades in John Paul Jones Court and Lawrence Court, Italian Cypress (*Cupressus sempervirens*) were planted at the building corners and at the openings in the arcade leading to the interior courtyards. Hollywood Juniper (*Juniperus chinensis*) 'Torulosa' has been used extensively as a replacement for the Italian Cypress. Bougainvillea vines were planted on trellises on the arcade columns between the building entries, and shrubs were planted between the arcade openings.

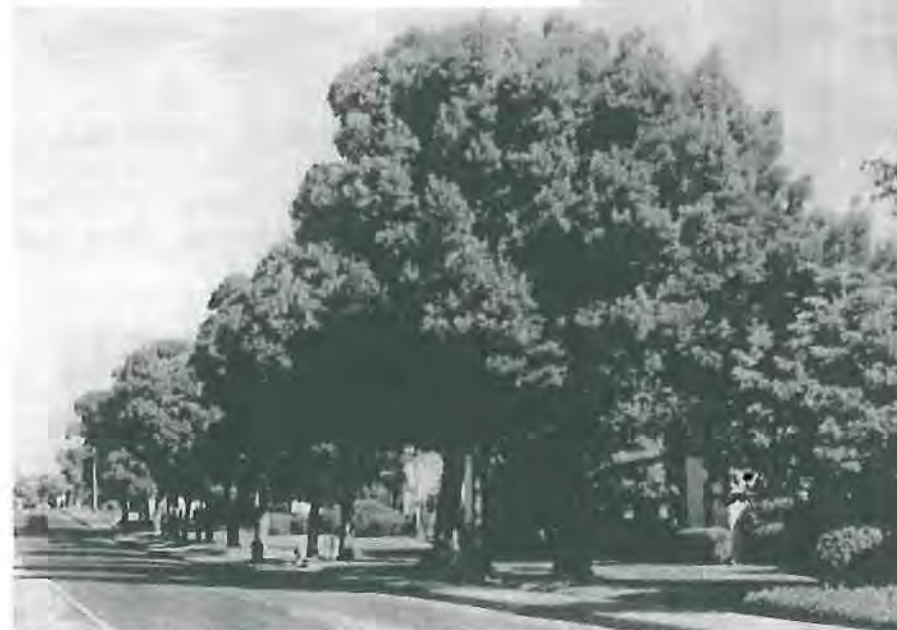
*Black Acacia trees lining Rosecrans Street in front of the Officers' Quarters.
Photograph courtesy of KTU+A, February 2000.*

Preserving the Black Acacia trees on Rosecrans Street in front of the Officers' Quarters. Although there have been problems with Black Acacia as a street tree, there is a sufficient setback from Rosecrans and these trees contribute to the historical character of the area. As trees die, they should be replaced in kind. If this species is not available, the Black Acacias should be replaced with a species with similar growth structure, size and color, but with a root system suitable for a street tree.

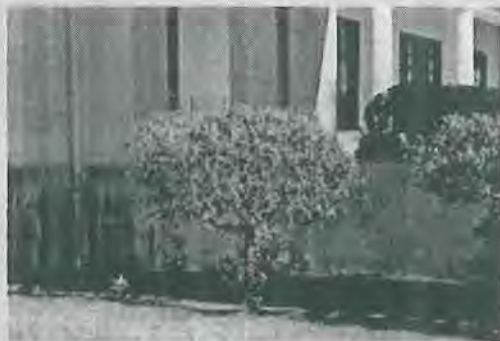
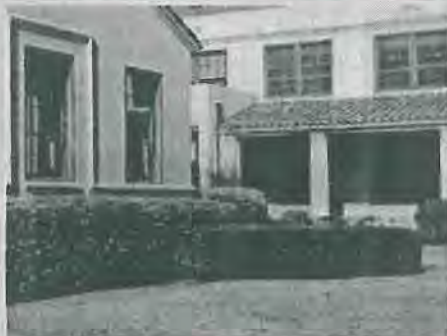
Examples of varying pruning practices at the Naval Training Center. Photograph courtesy of KTU+A, February 2000.

Utilizing maintenance practices that respect the habit, form, color, texture, bloom, fruit, fragrance, scale and context of historic vegetation. For example, the shrubs planted at the building foundations should be pruned to create a mass of plant materials, rather than pruning to maintain the individual shape of each shrub, as has been done at Headquarters Building around the rose garden.

Utilizing maintenance practices and techniques that are harmful to vegetation; for example, over- or under-irrigating or severe pruning that destroys the natural or intended shape, such as hedges.

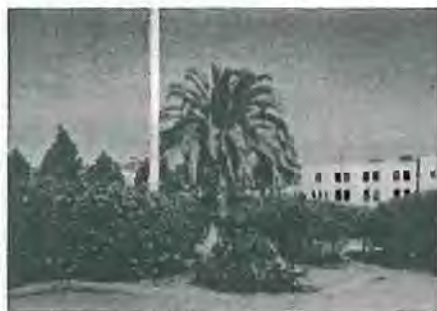
Canary Island Palm adjacent to the historic flagpole at Ingram Plaza. Photograph courtesy of KTU+A, February 2000.

Transplanting the Canary Island Palm adjacent to the flagpole in Ingram Plaza to another location at NTC. This palm was not planted in conjunction with the flagpole construction and is not in keeping with the concept of the view corridor in this area.

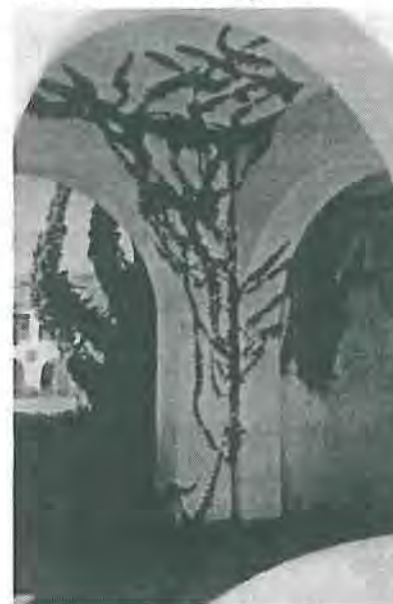
Ivy growing on arcades and building walls should be removed. Photograph courtesy of KTU+A, February 2000.

Removing all ivy growing on arcades and building walls. The ivy is invasive and will damage the structural features and integrity if left unchecked.

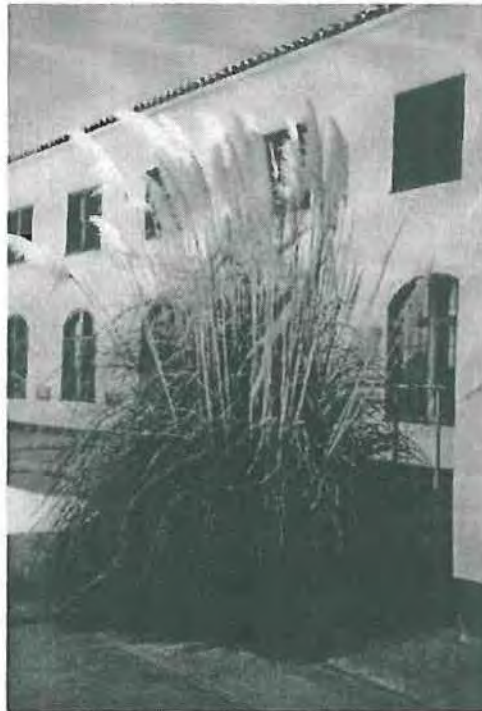
*Escaped (to grow wild, as a newly introduced plant) exotics such as this pampas grass should be removed.
Photograph courtesy of KTU+A, February 2000.*

Escaped exotics that have been “bird planted” should be removed.

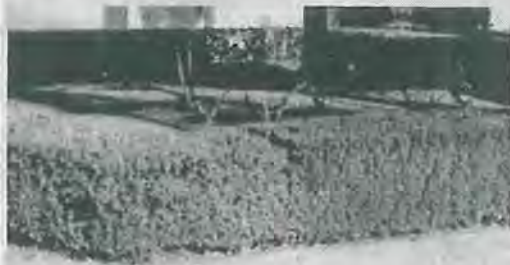
*Low hedges in the rose garden on the north side of Headquarters Building consist of both *Myrtus communis* 'Compacta' and *Buxus microphylla japonica* 'Compacta'. Photograph courtesy of KTU+A, February 2000.*

Replacing a variety of plant species with one species. For example, the low hedges in the rose garden on the north side of Headquarters Building consist of both *Myrtus communis* 'Compacta' and *Buxus microphylla japonica* 'Compacta'. Dead or diseased shrubs should be replaced with *Myrtus Communis* 'Compacta' until the species is consistent throughout the garden.

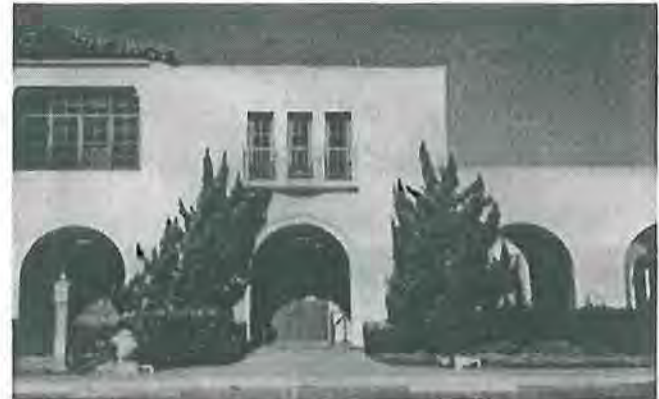
Hollywood Junipers were used to replace the original Italian Cypress planted along the arcades to indicate the building entries. During the rehabilitation of Lawrence Court and John Paul Jones Court, the Italian Cypress should be replanted. Photograph courtesy of KTU+A, February 2000.

Removing deteriorated historic vegetation and not replacing it, or replacing it with a new feature that does not convey the same visual appearance. For example, removing the vertical Italian Cypress or Hollywood Junipers along the arcade entries and replacing them with shrubs with a horizontal growth pattern

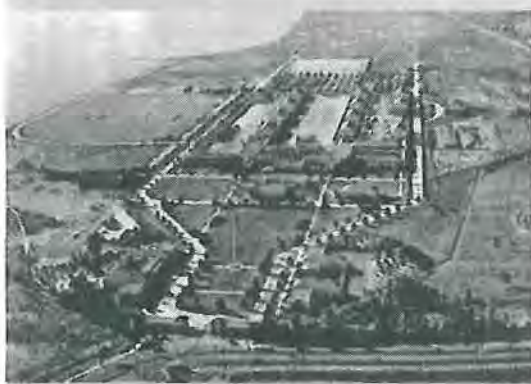
Consideration should be given to reconstructing the planted "anchor" visible in aerial photographs of Sellers Plaza in 1928. Photograph courtesy of the San Diego Historical Society Photograph Collection.

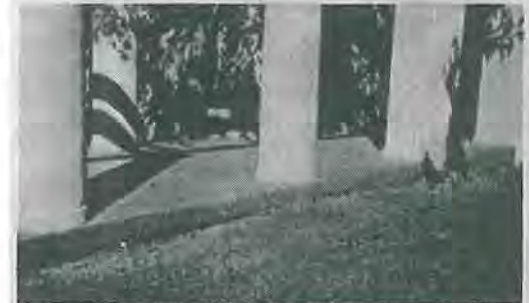
Painted brick banding found on the arcade walkways should be returned to the natural brick finish. Photograph courtesy of KTU+A, February 2000.

Replacing or destroying circulation features and materials when repair is possible. For example, not salvaging and reusing the historic brick banding located in the arcade.

Using physical evidence of form, detailing and alignment to reproduce a deteriorated circulation feature. If using the same kind of material is not technically, economically or environmentally feasible, then a compatible substitute material may be considered. For example, replacing in kind the brick banding in the arcade.

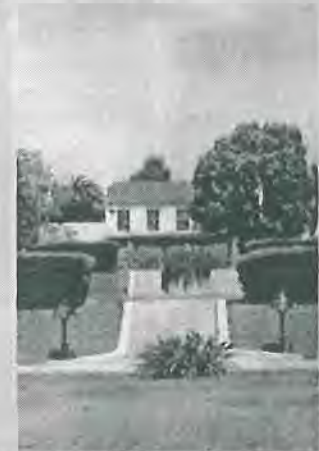
Steps throughout NTC were constructed with six to twelve inch wide "cheek walls." Photograph courtesy of KTU+A, May 2000.

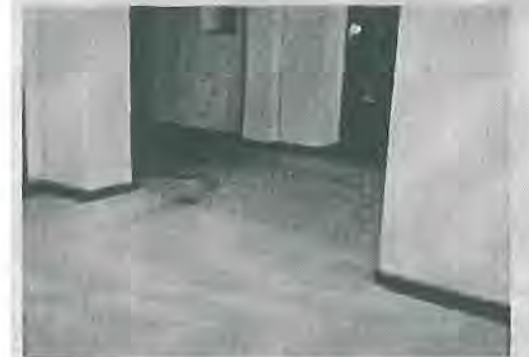
Brick banding has been replaced with concrete. Photograph courtesy of KTU+A, February 2000.

Replacing the missing brick banding in the arcade. For example, in some locations, the brick has been removed and the area patched with concrete

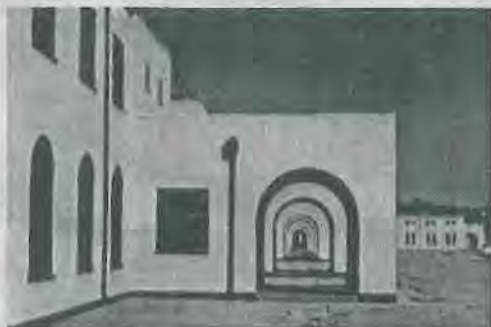
Inappropriate parking area directly next to historic building with no landscape buffer. Photograph courtesy of KTU+A, February 2000.

Placing a new feature where it may cause damage or is incompatible with the historic circulation. For example, adding on-street parking adjacent to the arcade buildings. Locating any new circulation feature in such a way that it detracts from or alters the historic circulation pattern.

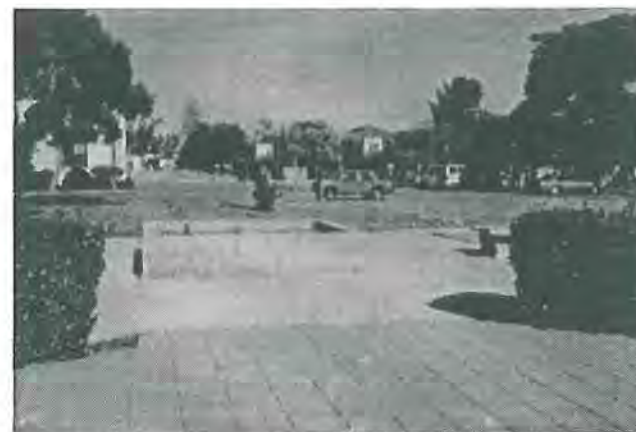
Existing contemporary paving material located adjacent to Luce Court should be removed. Photograph courtesy of KTU+A, February 2000.

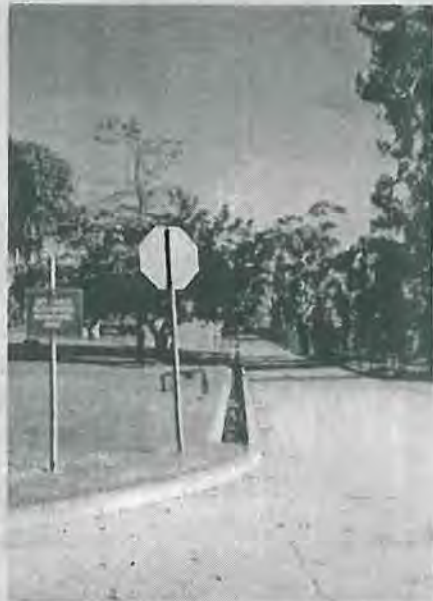
"Redwood Flume" along Woodworth Way. Photograph courtesy of KTU+A, February 2000.

The 1929 Planting Plan identifies a "ditch" and "redwood flume" at the lower edge of the officers gardens. Evidence of this "ditch" still exists along Woodworth Way.

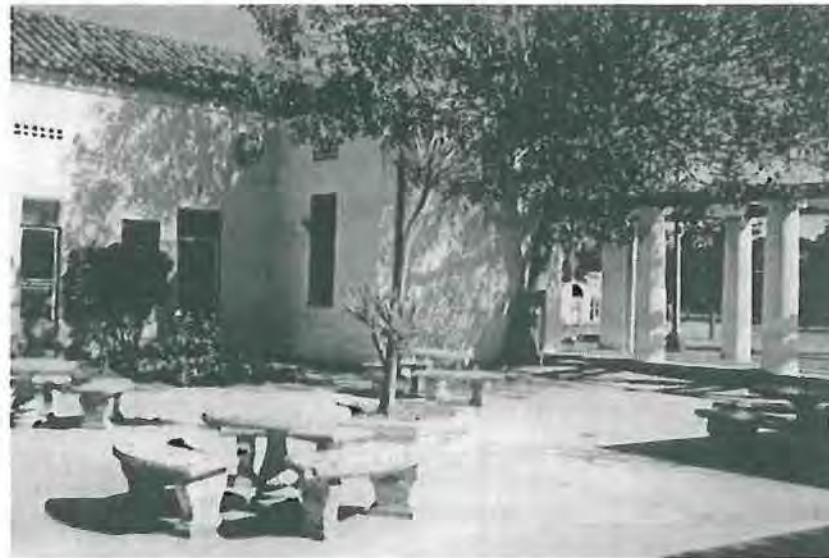
Concrete curb remains at location of previous pool under Building 202. Photograph courtesy of KTU+A, February 2000.

There is one water feature in the Historic District located just north of Headquarters Building in the courtyard between Buildings 201 and 202, aligned with Luce Court originally known as the "fish pond," this water feature was located in the center of the interesting ovals between Luce Court and Ingram Plaza. It is quasi-Moorish in style to complement the surrounding Spanish Revival buildings and is set in the midst of a formally-designed rose garden. The mechanical systems are almost certainly not original, but the remainder of the water feature and its surroundings appear to possess historical integrity.

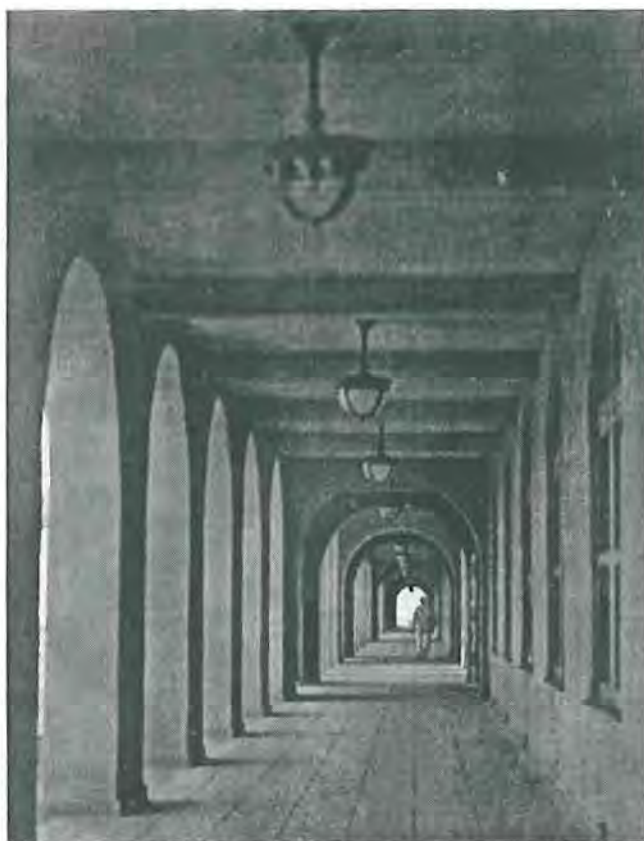
Pendant light fixture in arcades, ca. 1930. Courtesy of the San Diego Historical Society Photograph Collection.

None of the lighting system from the historical period has survived, although historic photographs do show street light fixtures similar to those used at the Marine Corps Recruit Depot as well as pendant light fixtures in the arcades, and hanging and wall mounted lights at Gate 1. Currently, two widely used contemporary styles of street and parking lot light fixtures are commonly seen at the Naval Training Center, the "shoe-box" and the "cobra." In general, it is recommended that all wall-mounted lights be removed and replaced with a consistent lighting system that complements the historic character of the District. The lighting system for the streets and parking lots should be consistent and in keeping with the historic character.

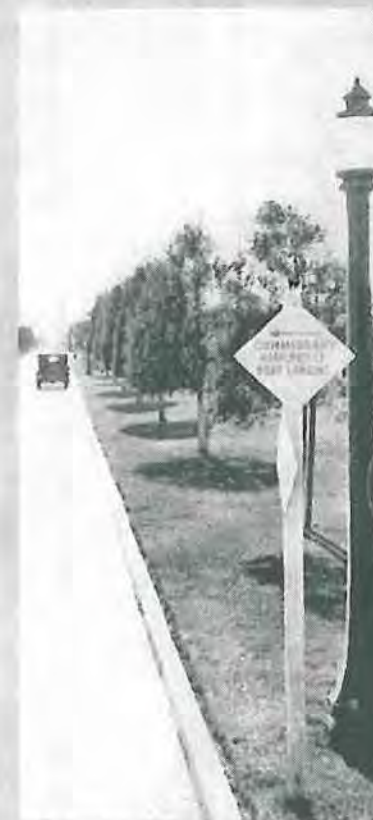
Historic streetlight fixture and signage on Truxtun Road, ca. mid 1920s. Courtesy of the San Diego Historical Society Photograph Collection.

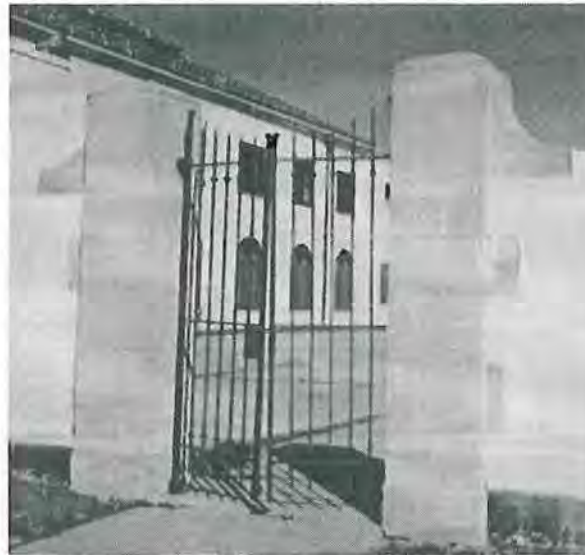
*Historic wrought iron gate on Dewey Road.
Photograph courtesy of KTU+A, February 2000.*

A limited amount of fencing and screening occurs at the Naval Training Center. With the exception of the wrought iron gates at the ends of the plazas between Barracks Buildings 2 and 26, and 5 and 18, and the fencing that occurs at Gate 1 in Sellers Plaza and Gate 3 on Roosevelt Road, all remaining fences and walls were constructed after 1945. Gate and fence mounting hardware is still attached to the arcade columns on the Barracks buildings north of Lawrence Court. A wrought iron gate was located in the center arcade, and matching wrought iron fencing was in the flanking arcades. Historic photographs should be reviewed to verify when these fences and gates existed. It is recommended that the chain link fence at Building 11 be removed.

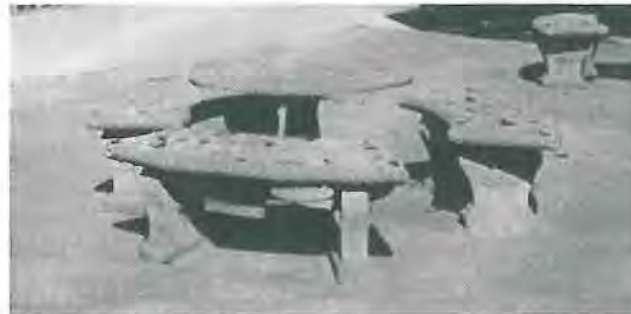
Unlike this concrete table and benches, introduction of site furnishings should be representative of the historic period. Photograph courtesy of KTU+A, February 2000.

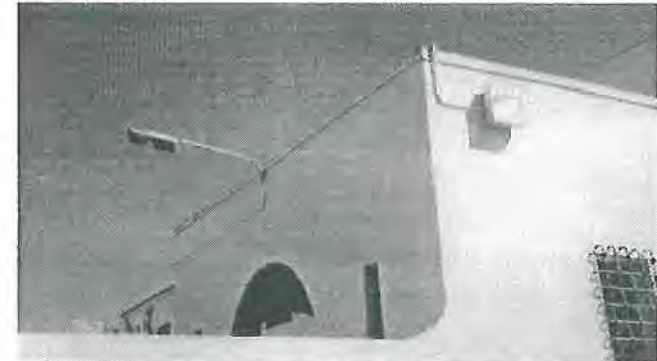
Inappropriate wall mounted light fixtures should be replaced. Photograph courtesy of KTU+A, February 2000.

Lighting – Removing all inappropriate lighting fixtures, including flood lights attached to building facades that can be seen by the public. Replace with appropriately styled pedestrian scale lighting or more appropriately detailed building lights. (These can be salvaged and installed elsewhere on NTC.)

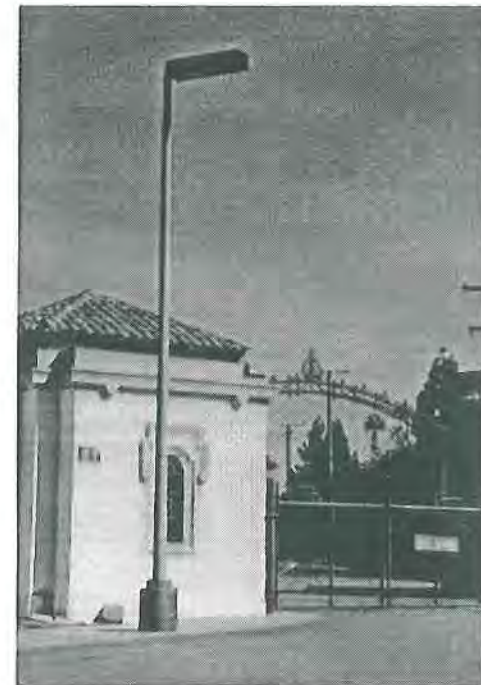
Contemporary street light fixtures, like this one found near Gate 1, should be replaced with new fixtures to match historic style. Photograph courtesy of KTU+A, February 2000.

Incorporating the recommended lights, including street, walkway, parking lot, pedestrian, hanging and wall mounted lights, into proposed improvements within the Historic District. This will strengthen the visual unity of the Historic District. Standardization also decreases maintenance costs by allowing for single item replacement stock.

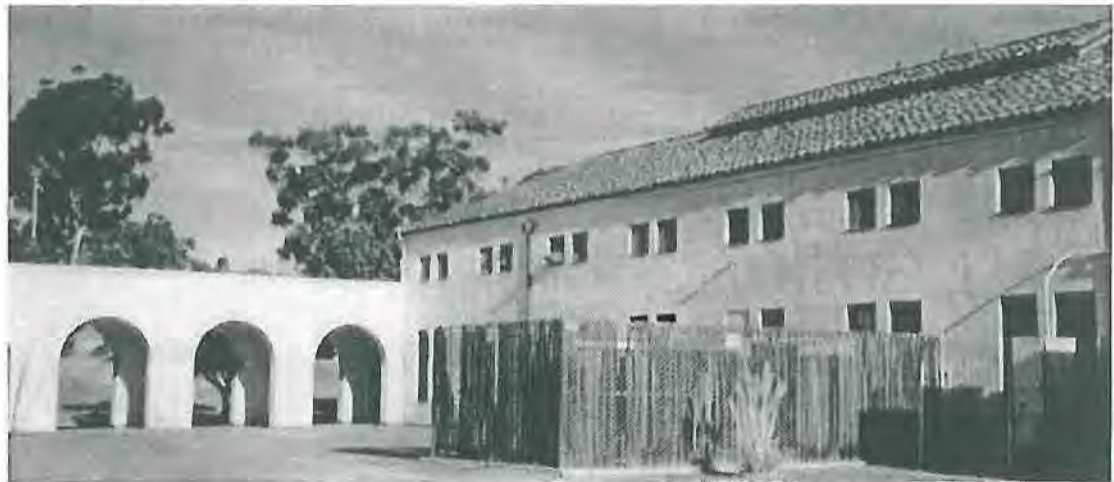
*Utility enclosures, like this one south of building 30, should be screened with shrubs and vines.
Photograph courtesy of KTUVA, February 2000.*

Most utility and transformer enclosures are encircled with chainlike fences fitted with wood slats. It is recommended that these structures instead be enclosed with walls stuccoed and painted to match the texture and color of the adjacent buildings, with an expanded metal or wrought iron gate for access. In several locations, concrete masonry and slump block walls have been constructed. These walls should also be stuccoed and painted to complement the adjacent buildings. Extraneous barbed wire, razor wire and other security features should be removed.

- **Trash and Utility Enclosures:** These facilities should be enclosed with a 6'-0" high concrete block wall with a stucco finish. It should have an integral color of matching the selected building color. Enclosures located in lawn areas should be separated from the lawn by a 6 inch high and 6 inch wide concrete mow strip. The enclosures should be screened with shrubs and vines.

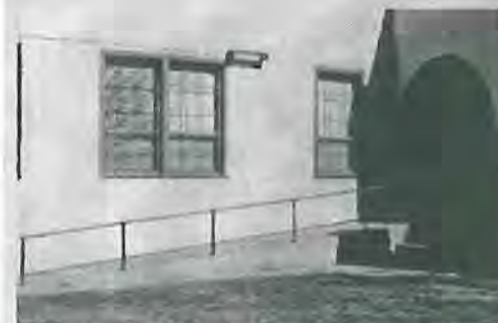
Access ramps should be added to side or secondary entrances to minimize impact the historic character of the main facade. Photograph courtesy of KTU+A, February 2000.

Making modifications for accessibility without considering the impact on the cultural landscape. For example, introducing a new access element (ramp or lift) that destroys the symmetry of a foundation planting along a building's main facade.

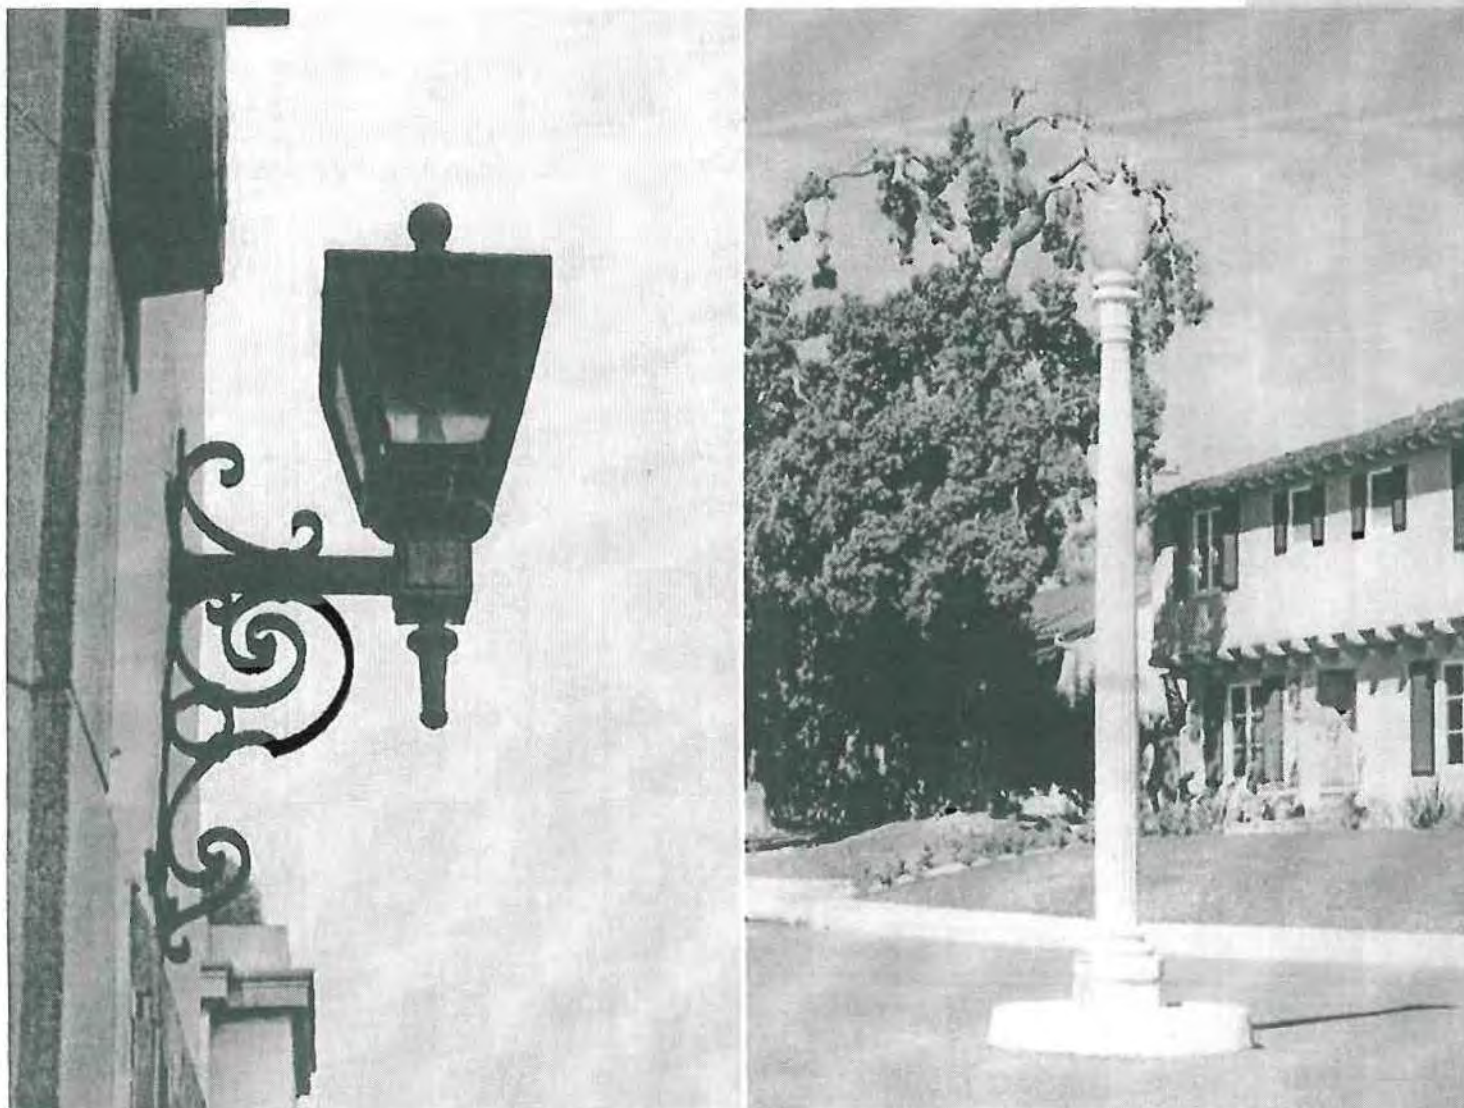
Two exterior light fixtures present at the Naval Training Center, January 2000. Photograph courtesy of Architect Milford Wayne Donaldson, FAIA.

Replacing energy inefficient features rather than improving their energy conservation potential. For example, replacing an entire historic light standard rather than retrofitting the fixture to be more efficient.

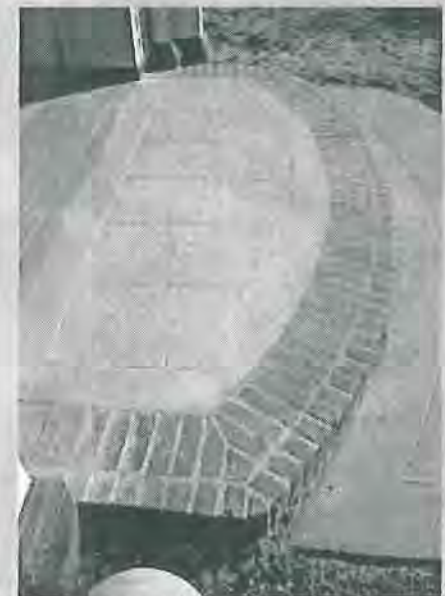
Masonry edging is typical at entrances to arcades and main building entrances. Photograph courtesy of Architect Milford Wayne Donaldson, FAIA, January 4, 2000.

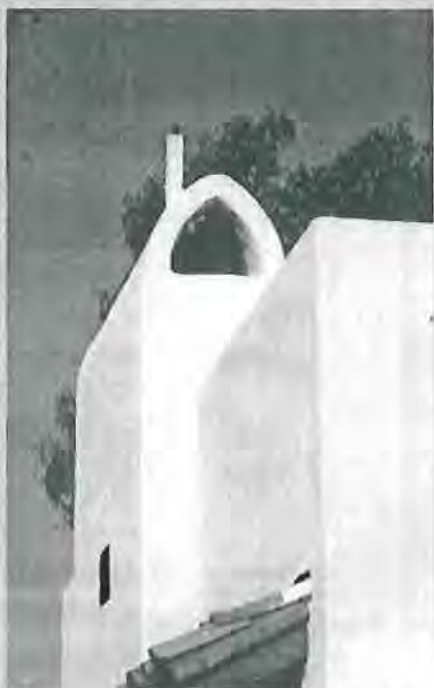
Plaster covered masonry chimneys are distinctive features on selected buildings at the Naval Training Center. Photograph courtesy of Architect Milford Wayne Donaldson, FALA, January 4, 2000.

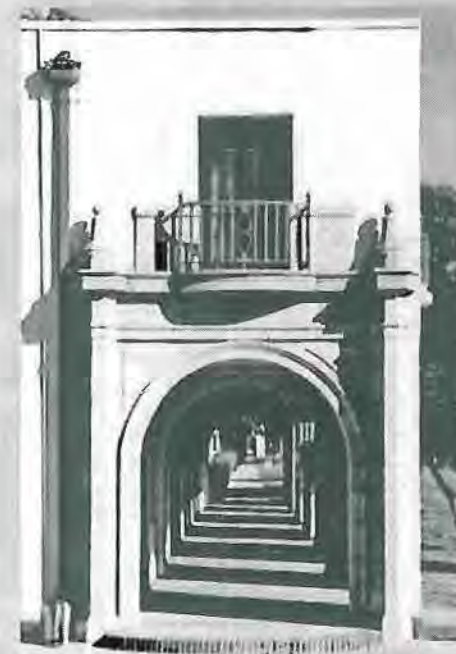
Cast stone entry to arcade and masonry edged walkway. Photograph courtesy of Architect Milford Wayne Donaldson, FAIA, December 21, 1999.

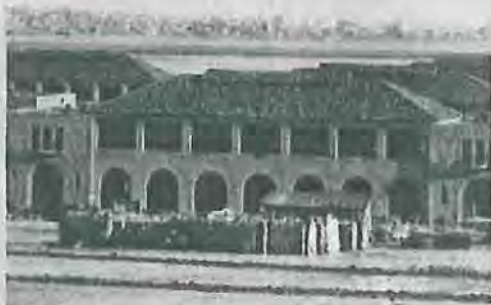
Hollow clay tile units stacked in front of a barracks building, ca. 1922. Photograph courtesy of the San Diego Historical Society Photograph Collection.

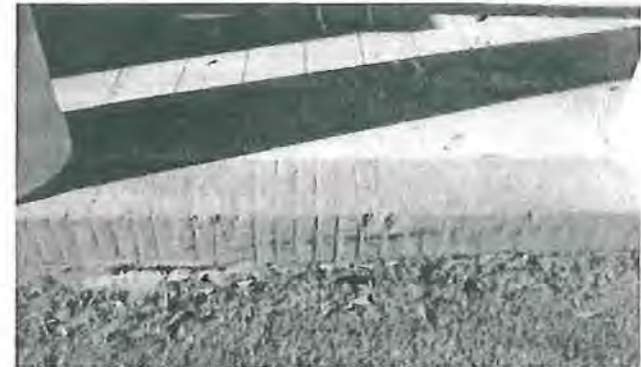
Inappropriate painted masonry edge which was originally left unpainted at Building 10. Photograph courtesy of Architect Milford Wayne Donaldson, FATA, January 10, 2000.

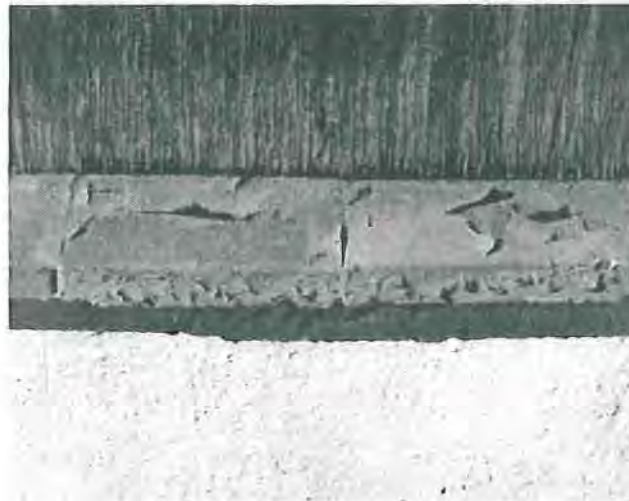
*Inappropriate paint and color applied to window sill tile.
Photograph courtesy of Architect Milford Wayne
Donaldson, FAIA, January 4, 2000.*

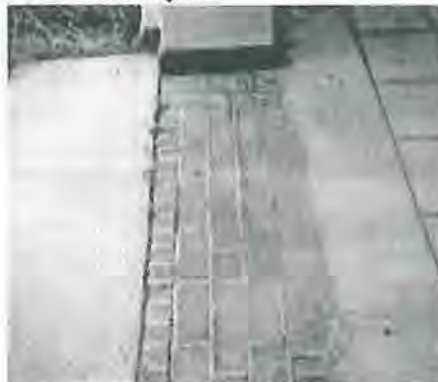
Brick edges at arcade walkway. Photograph courtesy of Architect Milford Wayne Donaldson, FAIA. January 11, 2000.

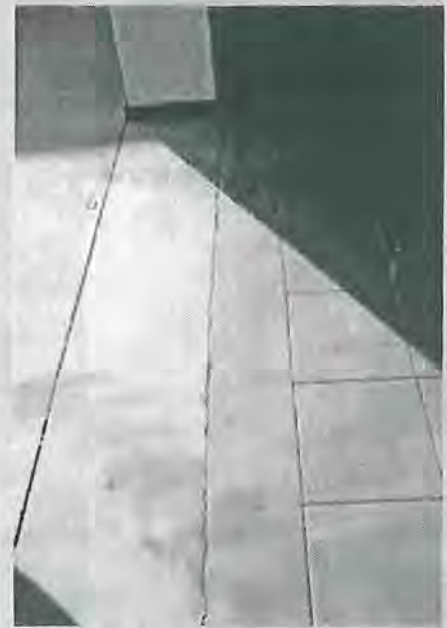
Inappropriate new concrete substituted for original masonry edge at arcade. Photograph courtesy of Architect Milford Wayne Donaldson, FAIA dated January 11, 2000.

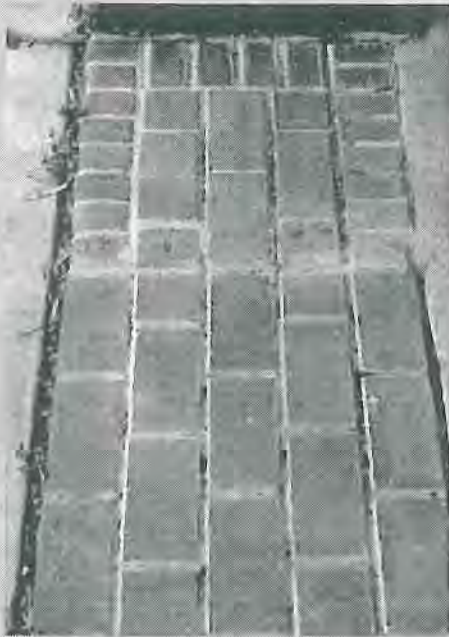
Inappropriate patch with modern brick not matching original pattern at Building 30. Photograph courtesy of Architect Milford Wayne Donaldson, FAIA, January 11, 2000.

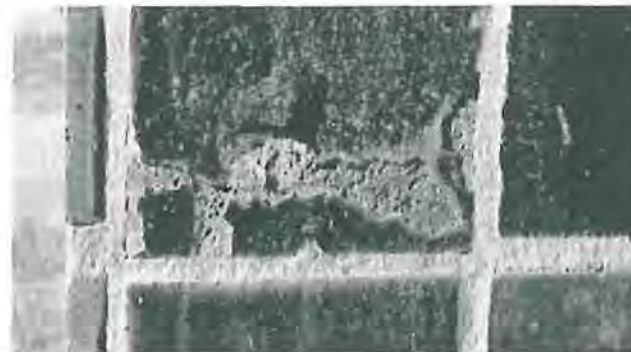
Glaze damage to terra cotta tile in the fountain near Building 20 and 21. Photograph courtesy of Architect Milford Wayne Donaldson, FAIA, January 10, 2000.

Using glazed terra cotta tile that does not match the originals in size, glaze, color, texture, density and profile.

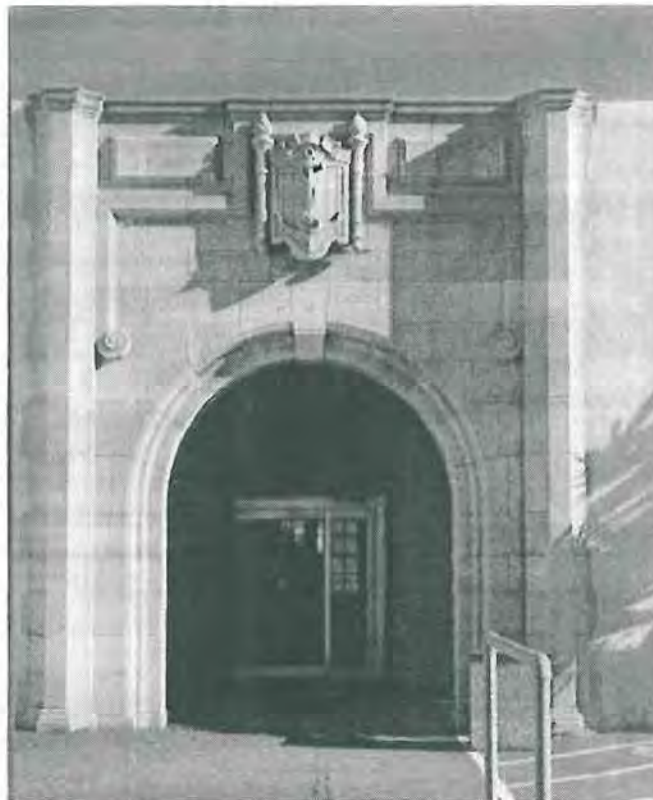
Cast stone entrance with anchor shield and torches at Building 1. Photograph courtesy of Architect Milford Wayne Donaldson, FAIA, January 4, 2000.

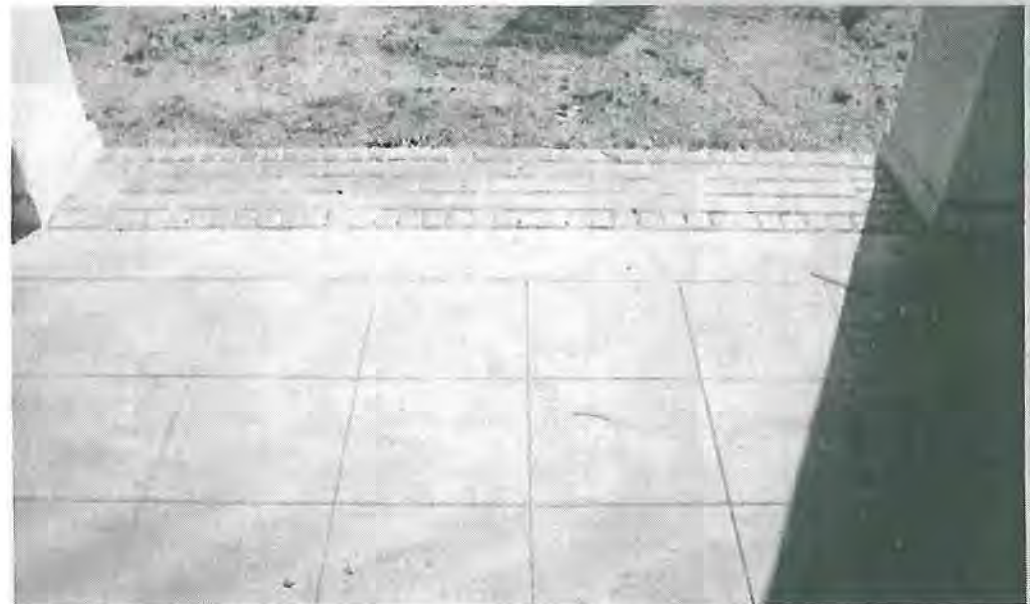
Traditional scored concrete walkway in arcades with brick edging adjacent to landscape area. Photo courtesy of Architect Milford Wayne Donaldson, FAIA, January 11, 2000.

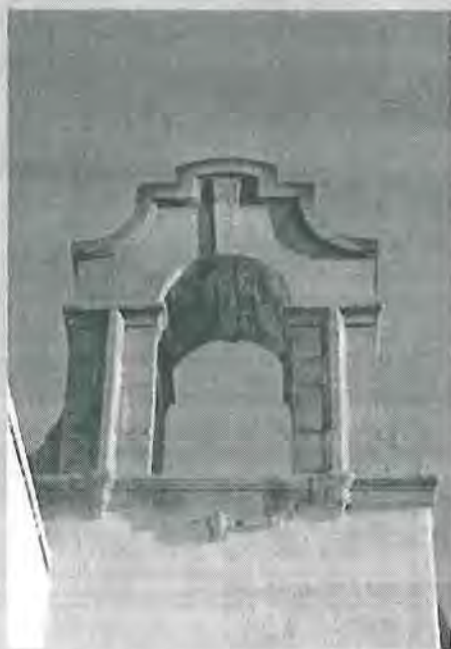
Cast stone bell tower at fire station Building 8. Photograph courtesy of Architect Milford Wayne Donaldson. FAIA, January 10, 2000.

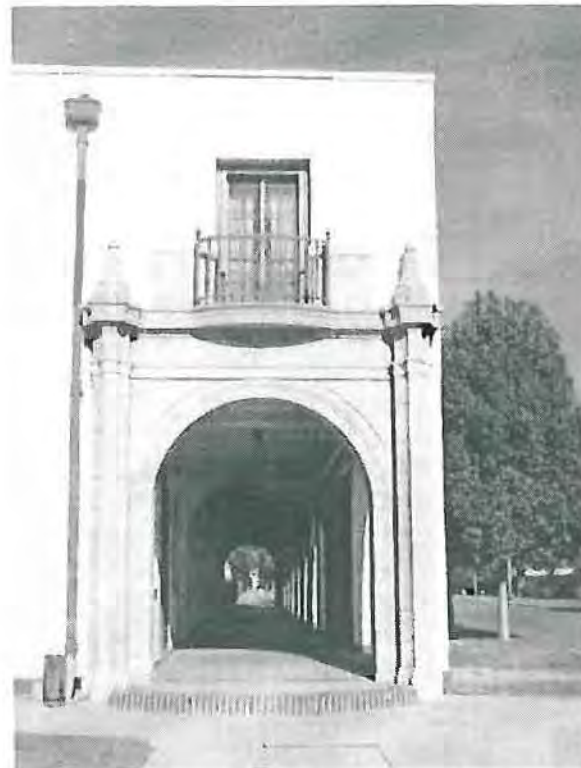
Cast concrete units form the entrance arch to the arcade. Photograph courtesy of Architect Milford Wayne Donaldson, FAIA, January 10, 2000.

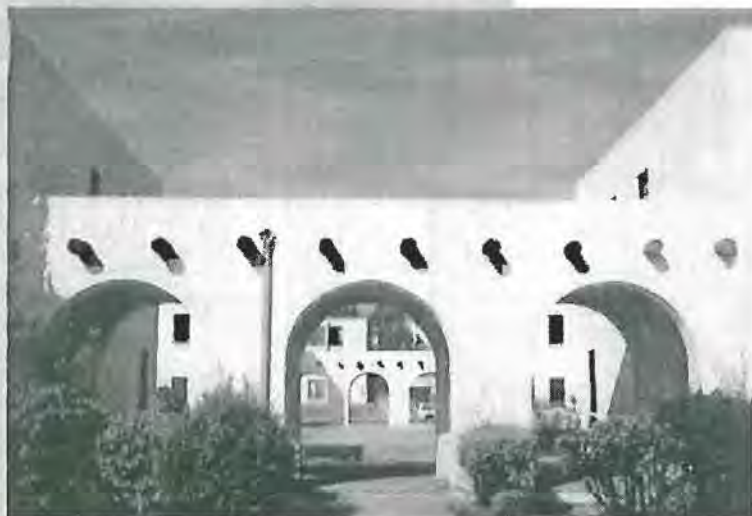
Wood vigas project beyond wall showing pueblo style architectural design influence. Photograph courtesy of Architect Milford Wayne Donaldson, FAIA, January 11, 2000.

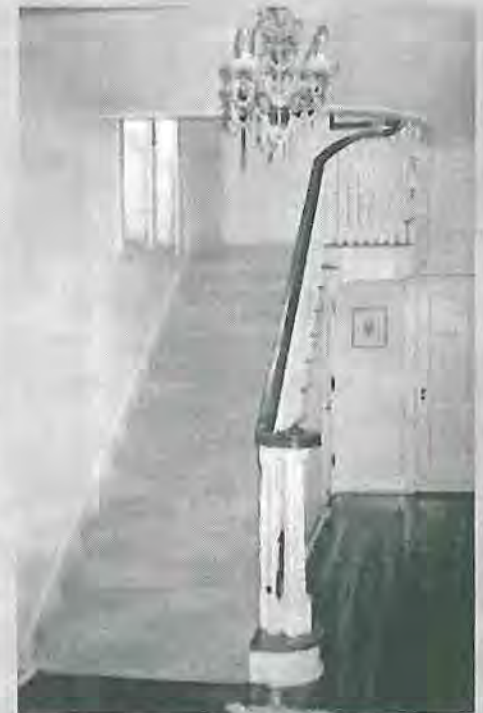
The wood stairway balustrade and finish detail add to the elegance of Officers' Quarters "A." Photograph courtesy of Architect Milford Wayne Donaldson, FAIA, February 1995.

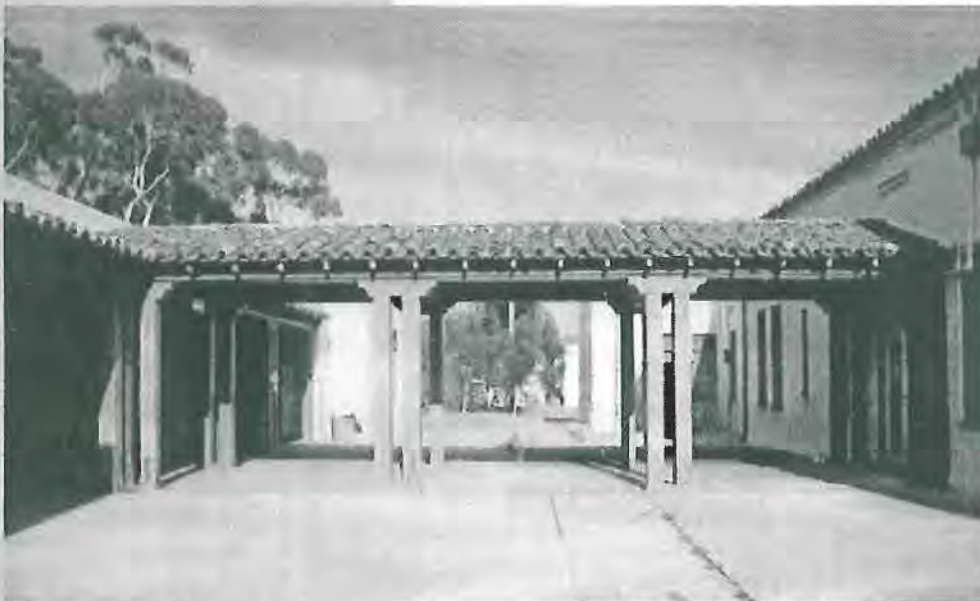
Simulated hand hewn wood posts and beams covered walkway. Photograph courtesy of Architect Milford Wayne Donaldson, FAIA, January 11, 2000.

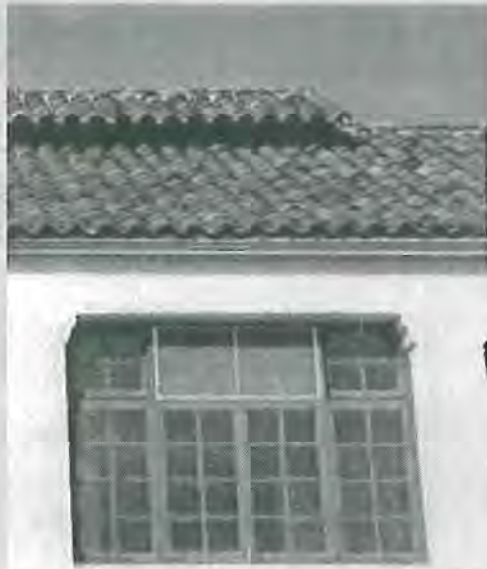
Wood framed raised roof for attic ventilation of barracks building. Note that the aluminum screen is not appropriate. Photograph courtesy of Architect Milford Wayne Donaldson, FAIA, January 11, 2000.

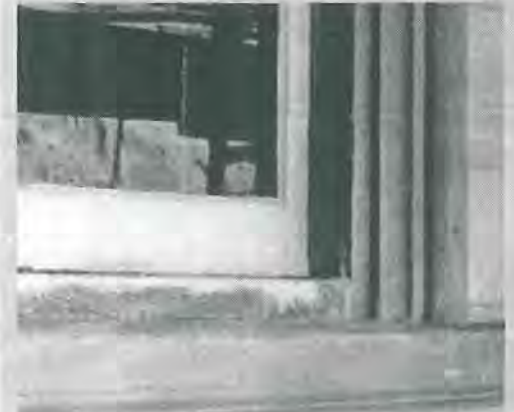
This photo illustrates the repair of a deteriorated wood sill using a wood consolidate. The voids in this weathered sill were filled with a compatible product. Once the product has dried it can be sanded down flush with adjacent surfaces and painted to match. Photograph courtesy of Architect Milford Wayne Donaldson, FAIA.

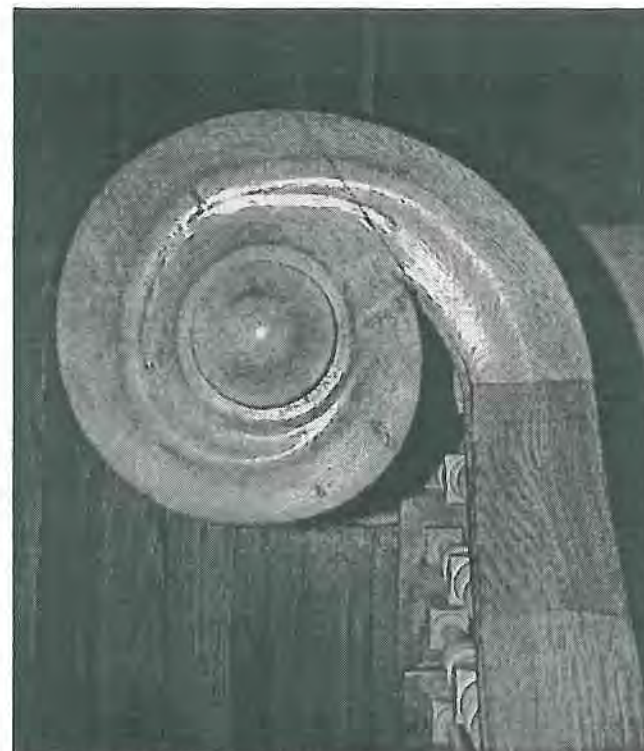
The intricate wood newel post cap in Officers' Quarters "A" is carved from one piece of wood. Photograph courtesy of Architect Milford Wayne Donaldson, FALA dated March 2, 2000.
